HUD CAPITAL NEEDS ASSESSMENT

Franklin Field
180-20 Stratton Street
Dorchester, Massachusetts 02124

AEI Project No. 463341
Site Inspection Date: July 12, 14, 25, and 27, 2022

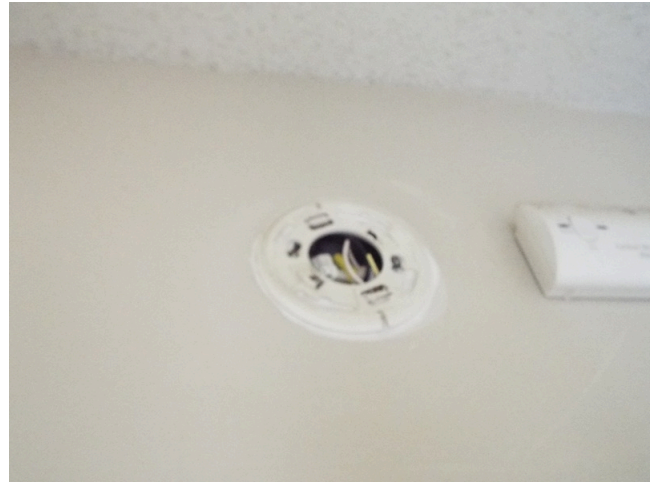
26. 1-bed-1-bath - unit 90D - building 19 - missing
smoke detector (Critical Repair)

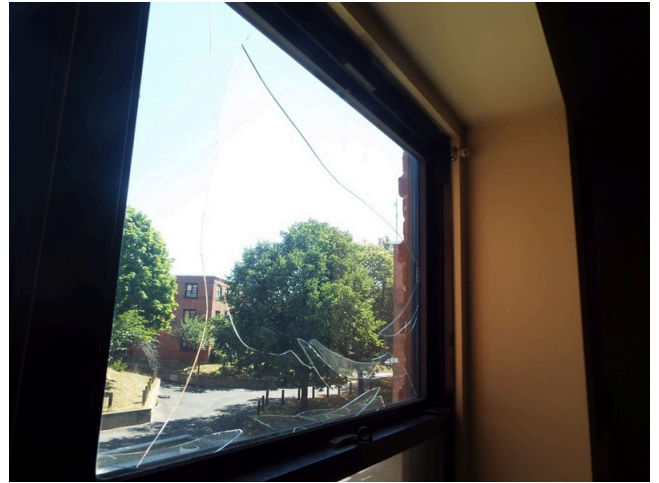
50. 2-bed-1-bath - unit 100B - building 12 - broken window glass (Critical Repair)

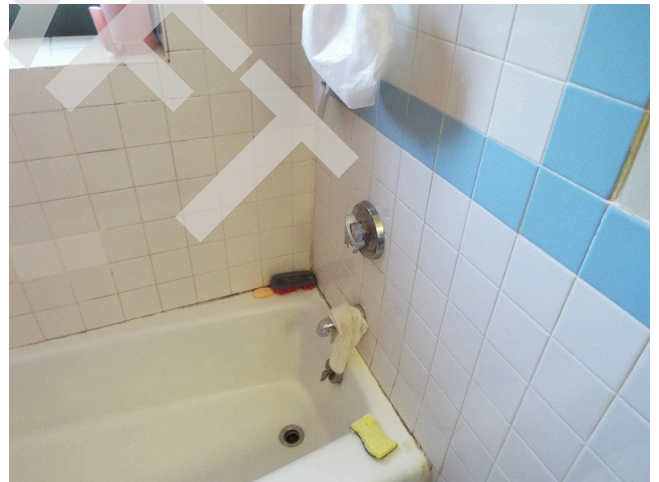
87. 2-bed-1-bath - unit 230D - building 1 - bathroom ceiling mold (Critical Repair)

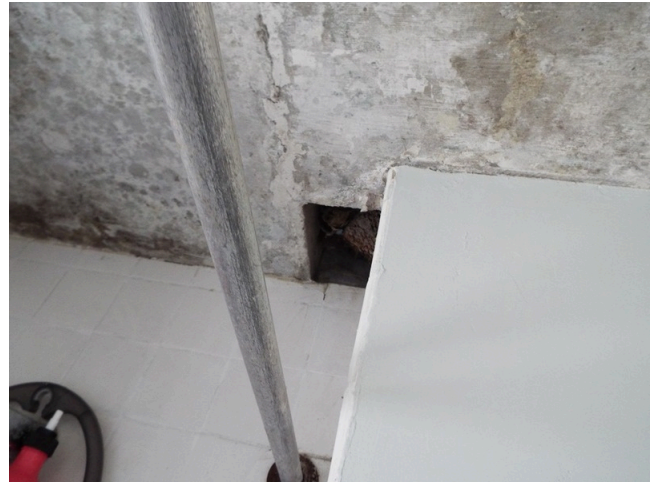
117. 3-bed-1.5-bath-TH - unit 22 - building 17 - washer wall condition (Non-Critical Repair)

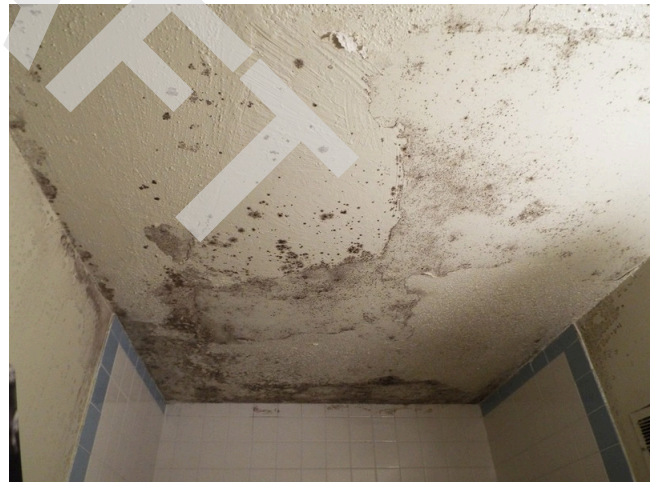
164. 3-bed-1.5-bath-TH - unit 214 - building 3 -
bathroom ceiling mold (Critical Repair)

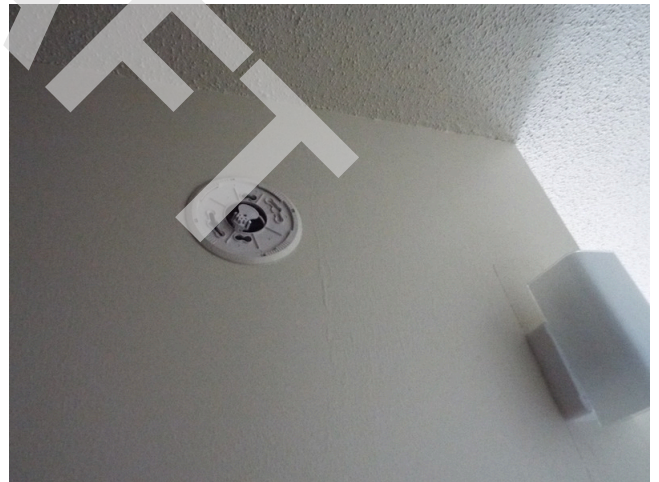
168. 3-bed-1.5-bath-TH - unit 214 - building 3 -
missing smoke detector (Critical Repair)

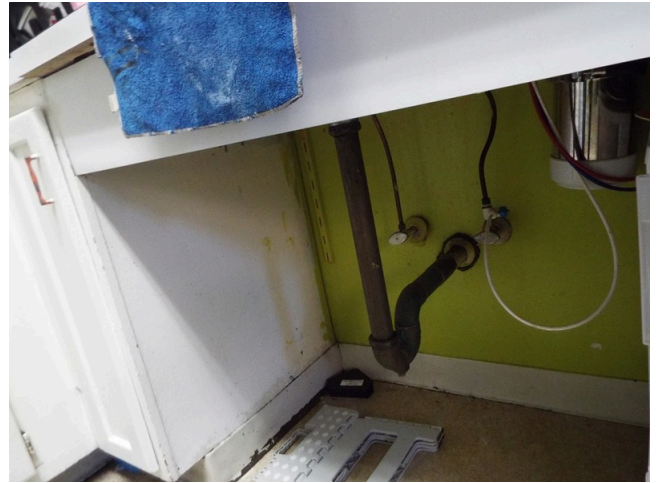
182. UFAS kitchen sink lacks pipe protection - unit 53 - building 8 (Critical Repair)

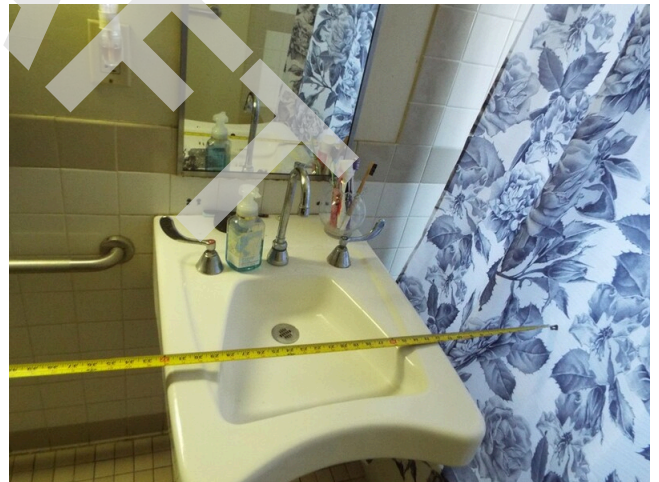
199. UFAS bathroom sink lacks pipe protection - unit
53 - building 8 (Critical Repair)

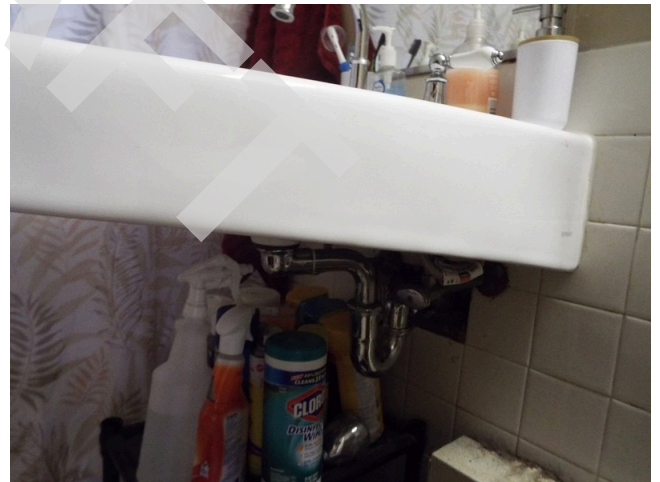
248. UFAS bathroom sink lacks pipe protection - unit 13 - building 4 (Critical Repair)

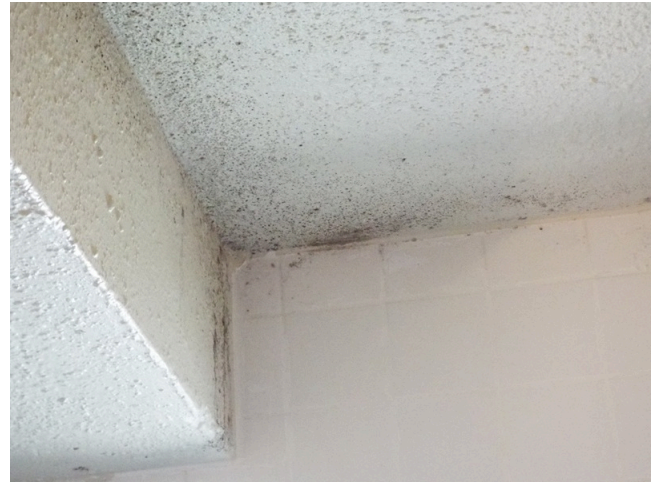
322. 5-bed-2-bath-TH - unit 140A - building 16 -
bathroom ceiling mold (Critical Repair)

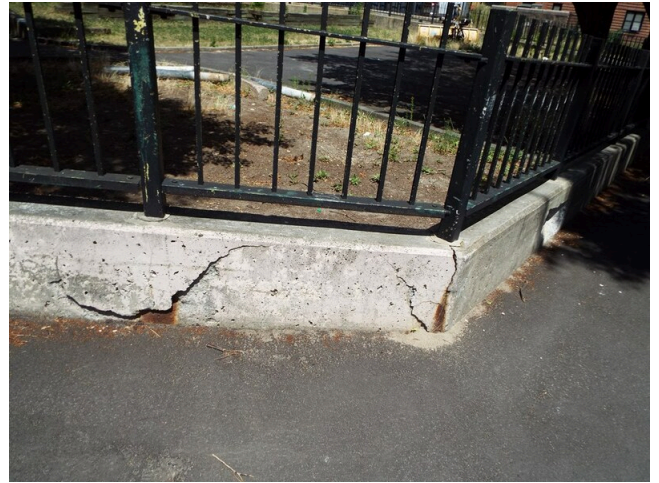
9. Concrete retaining wall spalling - rear building 9
(Non-Critical Repair)

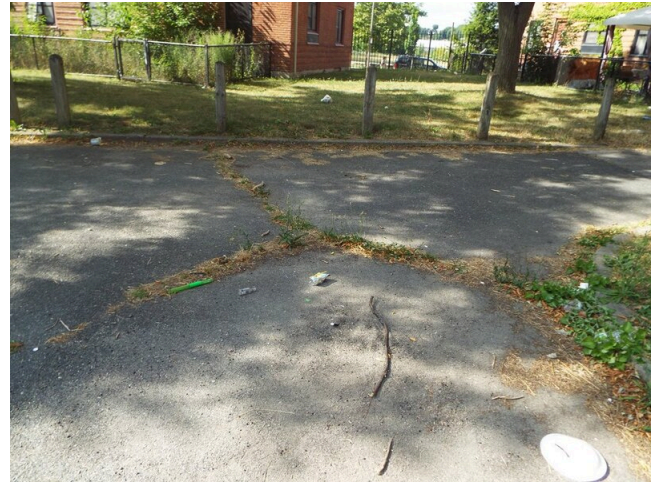
21. Asphalt paving - rear buildings 1 thru 6 (Non-Critical Repair)

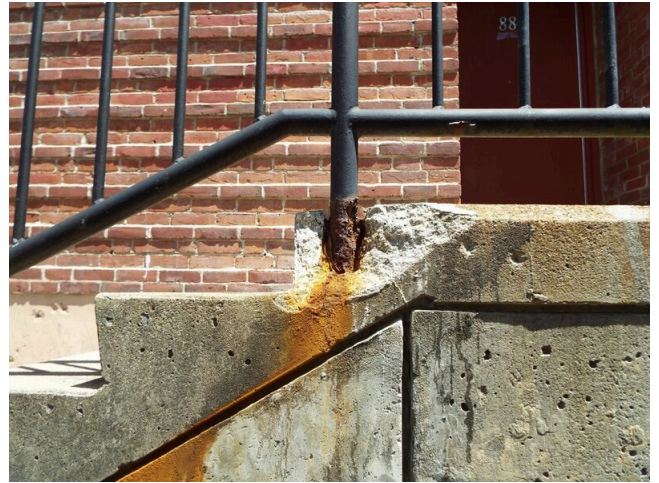
41. Concrete step spalling - building 19 (Non-Critical Repair)

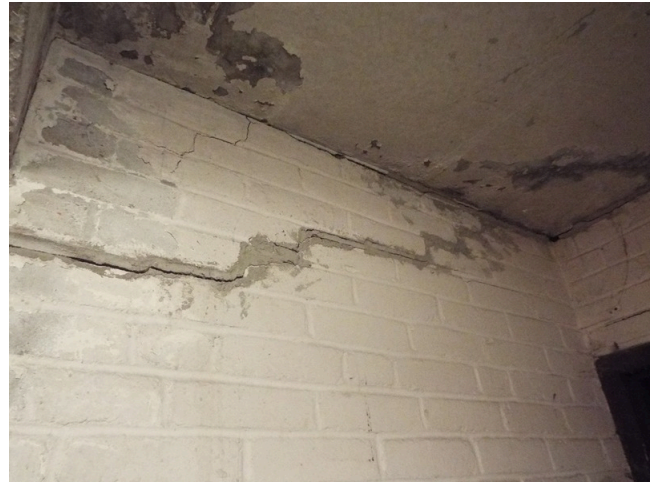
82. Masonry wall cracks - basement building 15
(Non-Critical Repair)

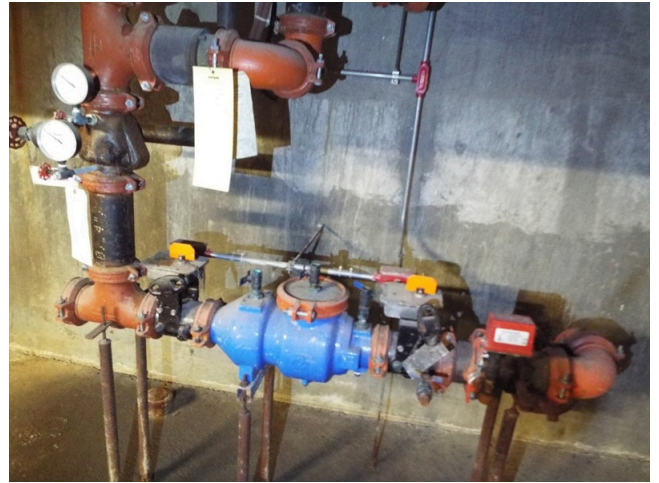
145. Pipe leak at repair - building 17 basement
(Non-Critical Repair)

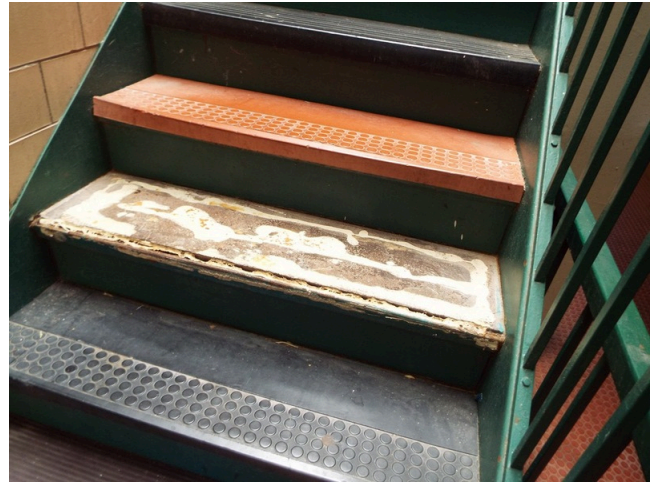
181. Interior stair tread condition - building 7
(Critical Repair)

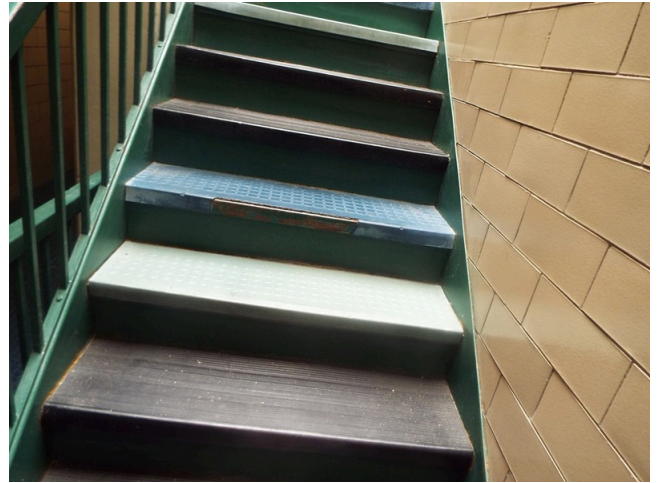
185. Interior stair tread condition - building 10
(Critical Repair)
