HUD CAPITAL NEEDS ASSESSMENT

Highland park
50 Highland Street
Boston, Massachusetts 02119

AEI Project No. 463344
Site Inspection Date: July 5, 2022

Boston Housing Authority
52 Chauncy Street
Boston, Massachusetts 02111

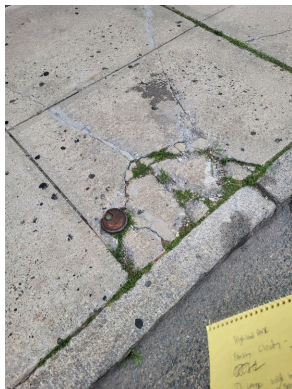
West elevation sidewalk damage trip hazard
(Critical Repair)

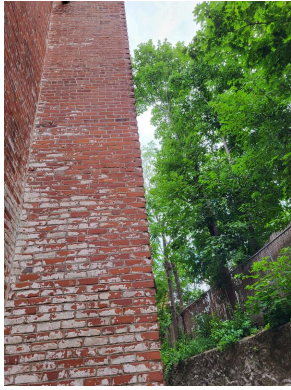
East elevation brick façade (Non-Critical Repair)

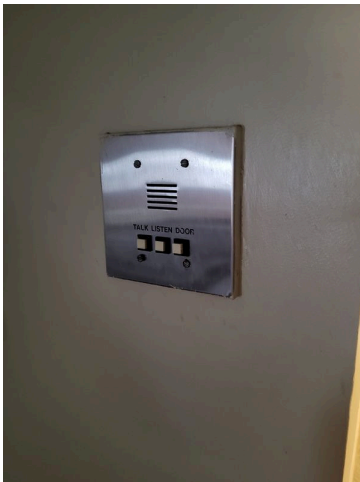
3. Apartment 54-2 intercom (Non-Critical Repair)

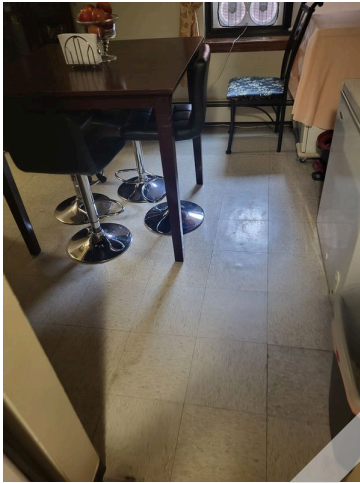
9. Apartment 54-2 dining area vinyl tile flooring
(Non-Critical Repair)

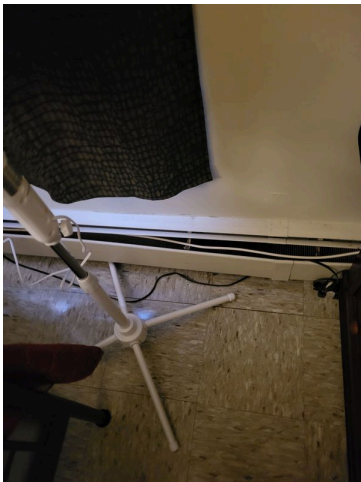
27. Apartment 54-2 bedroom hydronic baseboard
(Non-Critical Repair)

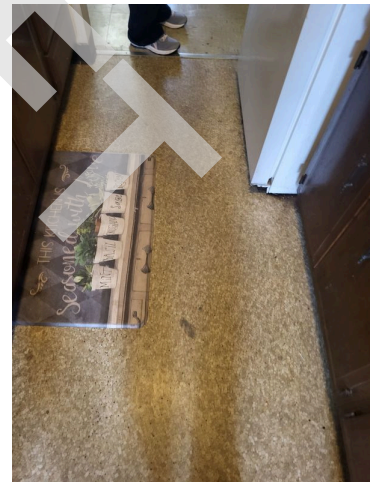
32. Apartment 56-3 kitchen sheet vinyl flooring
(Non-Critical Repair)

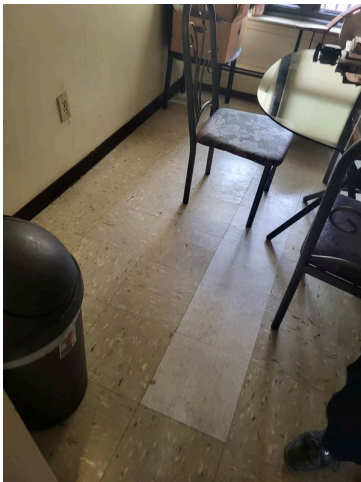
35. Apartment 56-3 dining room area vinyl tile flooring (Non-Critical Repair)

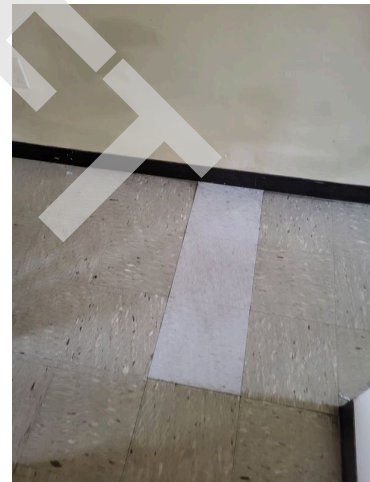
36. Apartment 56-3 living room area vinyl tile flooring (Non-Critical Repair)

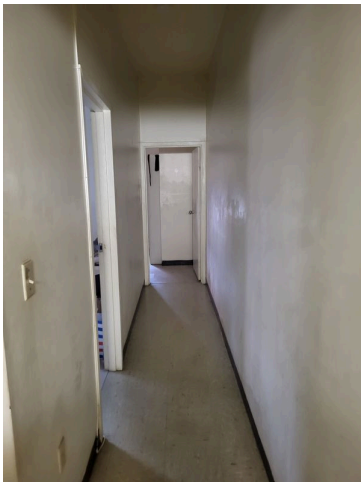
47. Apartment 56-3 hallway vinyl tile flooring (Non-Critical Repair)

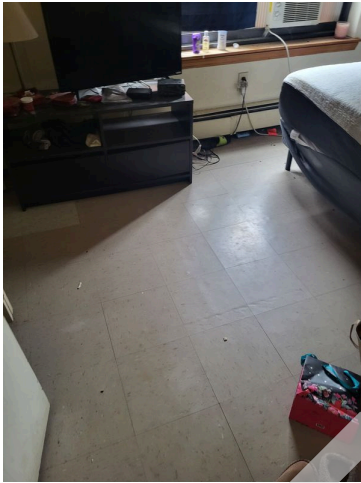
49. Apartment 56-3 bedroom vinyl tile flooring (Non-Critical Repair)

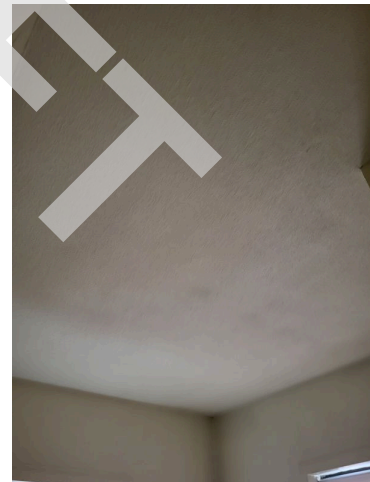
52. Apartment 56-3 bedroom missing smoke detector (Critical Repair)

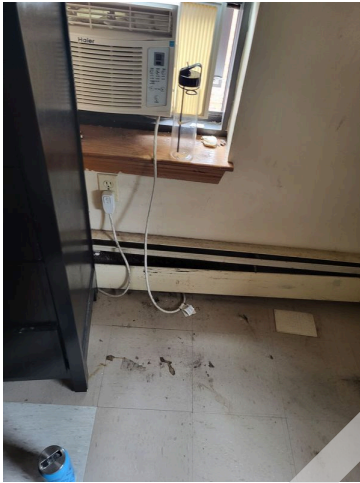
53. Apartment 56-3 bedroom hydronic baseboard damage (Non-Critical Repair)

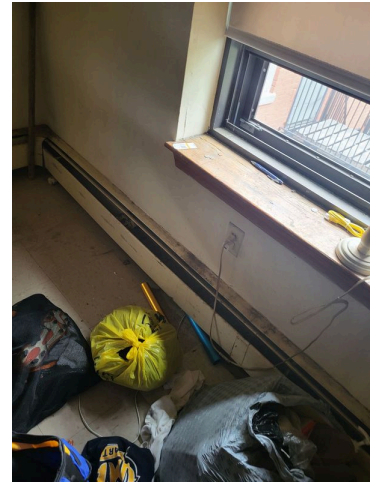
54. Apartment 56-3 hydronic baseboard electrical cord (Non-Critical Repair)

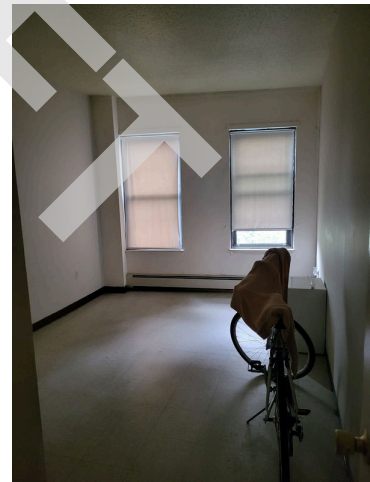
72. Apartment 58-3 bedroom missing smoke detector (Critical Repair)

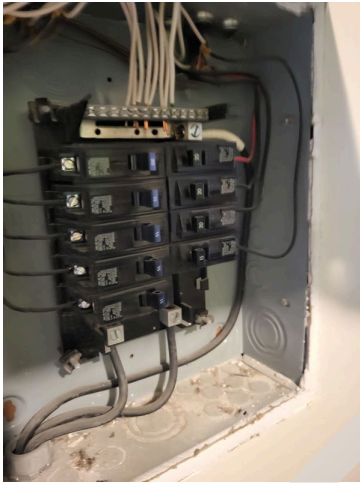
73. Apartment 58-3 circuit breaker box (Critical Repair)

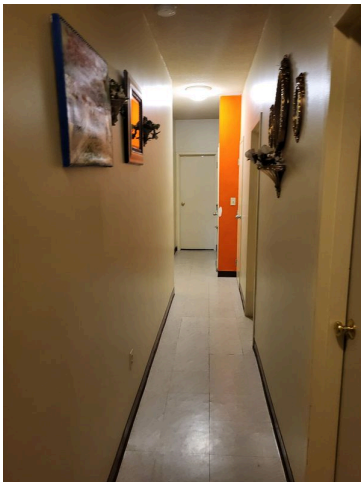
87. Apartment 52-3 hallway vinyl tile flooring (Non-Critical Repair)

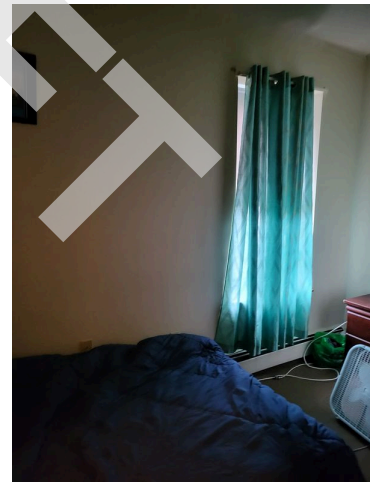
88. Apartment 52-3 bedroom missing smoke detector (Critical Repair)

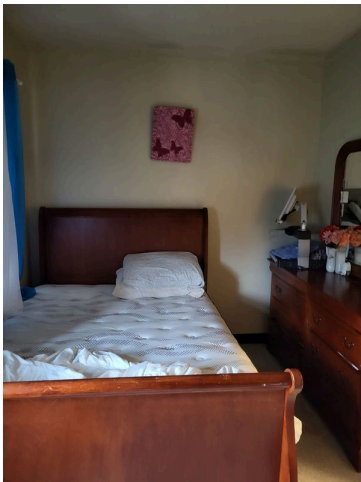
103. Apartment 52-3 bedroom missing smoke detector (Critical Repair)

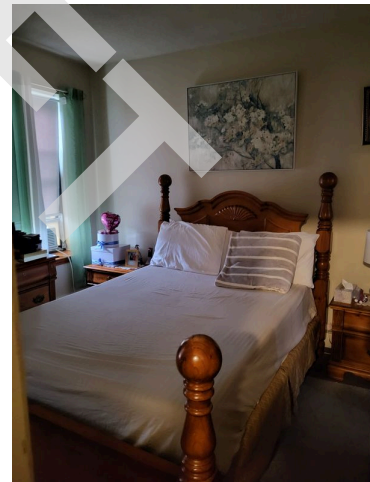
104. Apartment 52-3 bedroom missing smoke detector (Critical Repair)

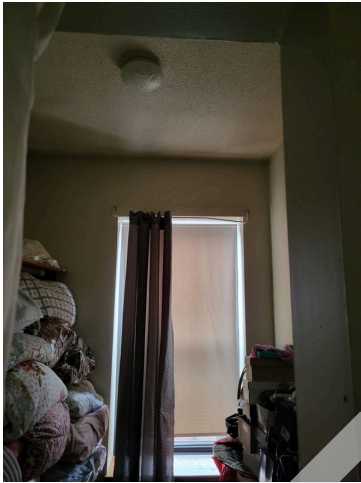
105. Apartment 52-3 bedroom light fixture and missing smoke detector (Critical Repair)

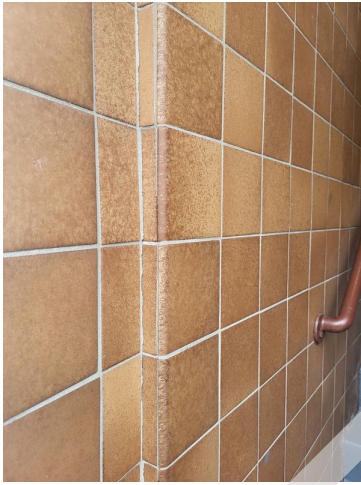
21. Building ingress/egress ceramic tile wall damage
(Non-Critical Repair)

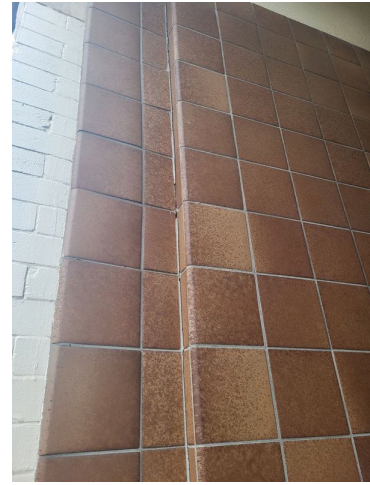
22. Building ingress/egress ceramic tile wall damage
(Non-Critical Repair)

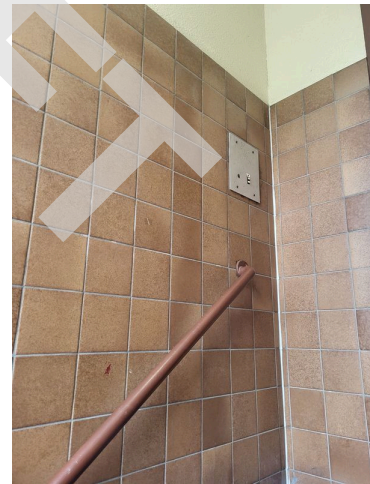
24. Building ingress/egress stairs railing and
intercom (Non-Critical Repair)

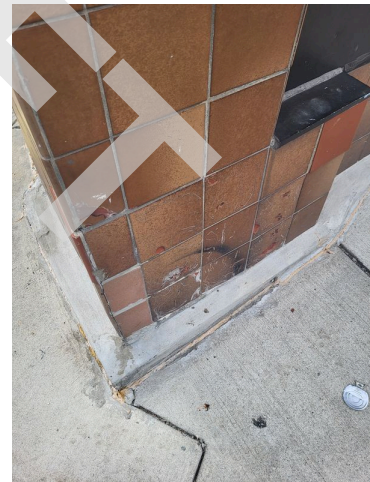
32. Exterior ceramic tile damage (Non-Critical Repair)

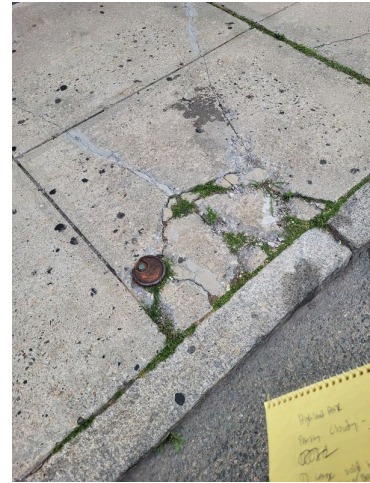
38. West elevation sidewalk damage trip hazard (Critical Repair)

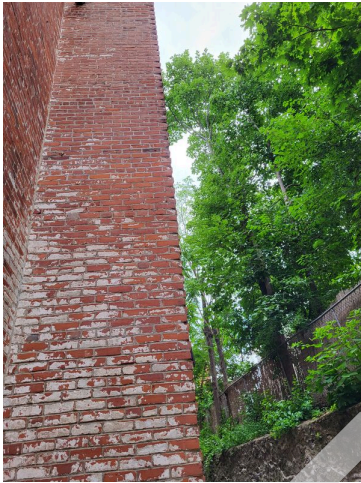
69. East elevation brick façade (Non-Critical Repair)

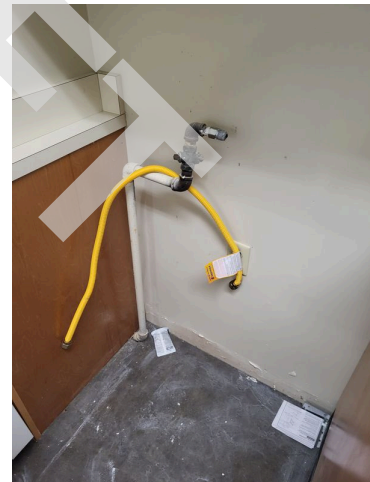
88. Community room kitchen area gas range hookup (Non-Critical Repair)

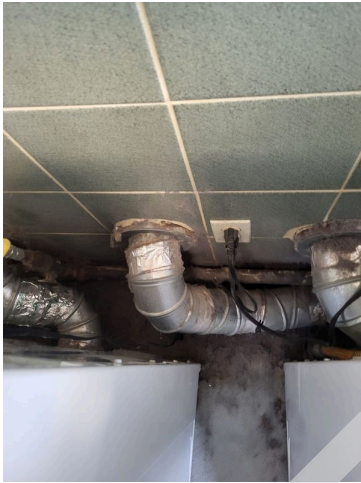
93. Laundry room dryer vent damaged (Non-Critical Repair)

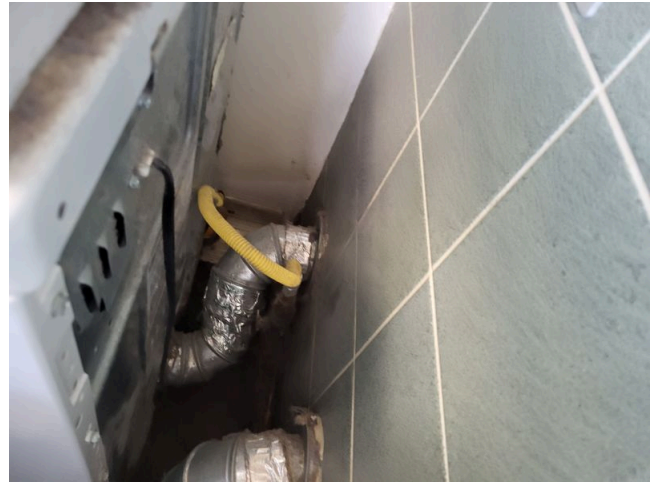
94. Laundry room dryer vent damaged (Non-Critical Repair)
