HUD CAPITAL NEEDS ASSESSMENT

Bellflower
24 Bellflower Street
Dorchester, Massachusetts 02125

AEI Project No. 463347
Site Inspection Date: July 8, 2022

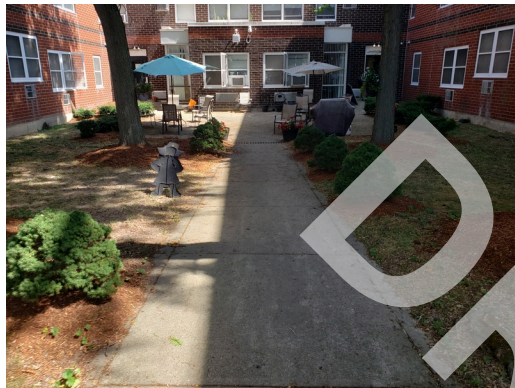
Sidewalk Ramp- Install Metal Hand Rail at Ramp (Critical Repair)

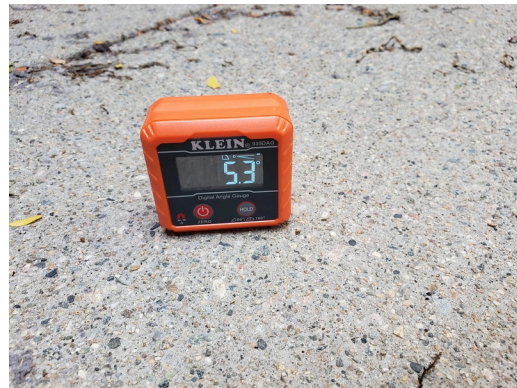
Sidewalk Ramp- Install Metal Hand Rail at Ramp (Critical Repair)

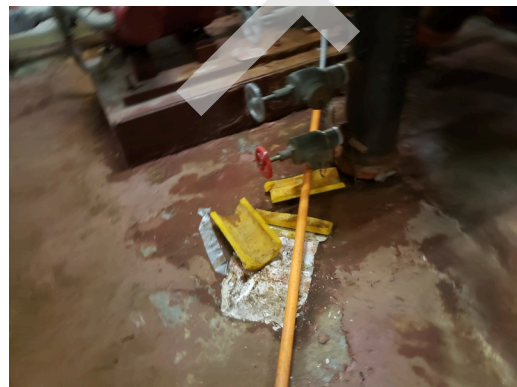
Address Leak in Boiler Room (Non-Critical Repair)

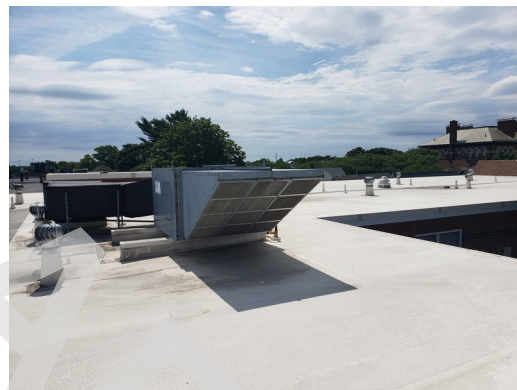
Roof-Top Make Up Air Unit (Non-Critical Repair)

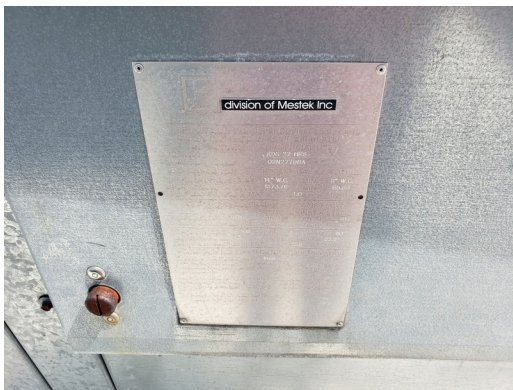
Roof-Top Make Up Air Unit (Non-Critical Repair)

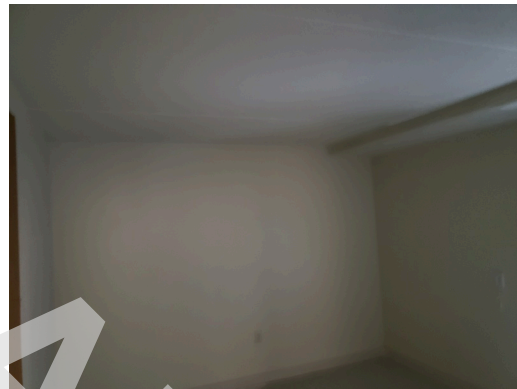
Unit 315- UFAS- 1bed/1bath- Bedroom- Install Bedroom Smoke Detectors Per HUD (Critical Repair)

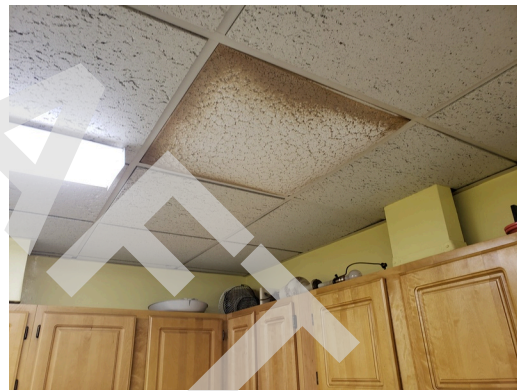
Common Area- Kitchen- Replace Damaged Acoustical Tile Ceiling - Common Area

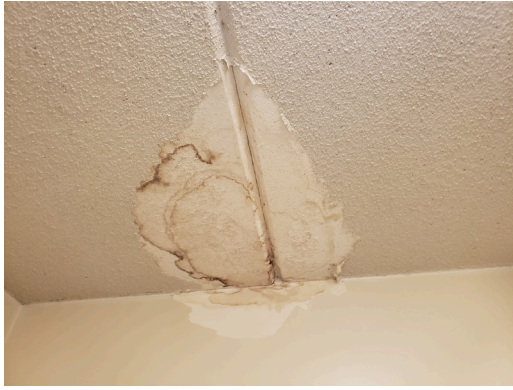
Unit 207- 1bed/1bath- Bathroom- Repair Damaged Ceiling (Non-Critical Repair)

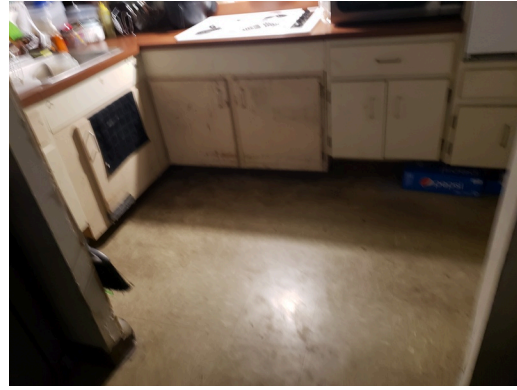
Unit 216- UFAS- 1bed/1bath- Kitchen- Replace Cabinets/Tops (Dwelling Units) (Older)(Non-Critical Repair)

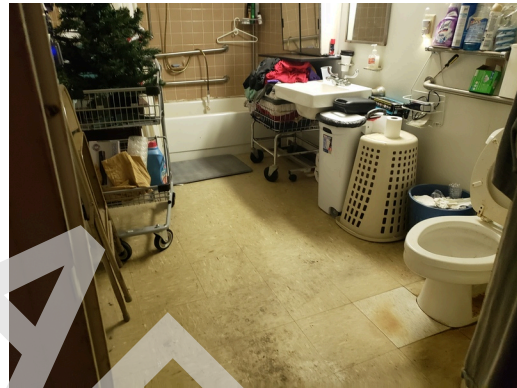
Unit 216- UFAS- 1bed/1bath- Replace Vinyl Flooring -1-Bed-Living Room, Kitchens and Baths (Dwelling Units) (Older) (Non-Critical Repair)

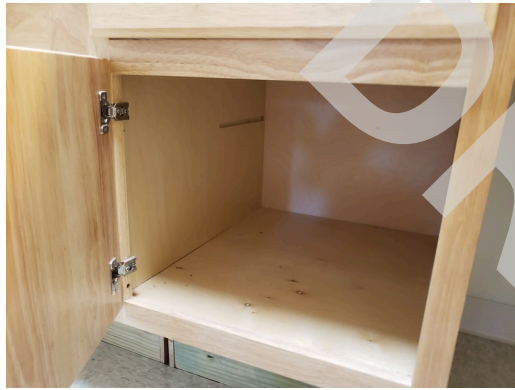
Unit 315- UFAS- 1bed/1bath- Kitchen- UFAS
Unit Kitchen Cabinet Modifications (Critical
Repair)

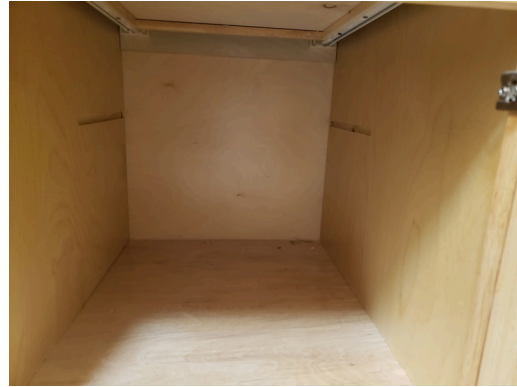
Unit 315- UFAS- 1bed/1bath- Kitchen- UFAS Unit Kitchen Cabinet Modifications (Critical Repair)

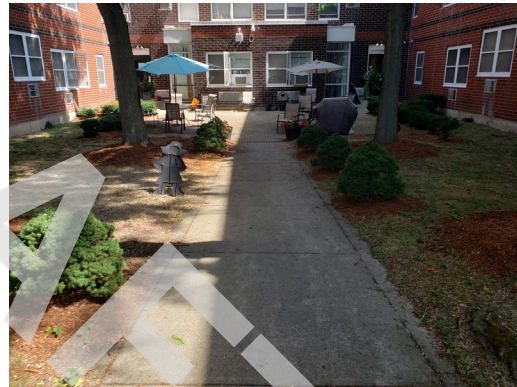
Sidewalk Ramp- Install Metal Hand Rail at Ramp (Critical Repair)

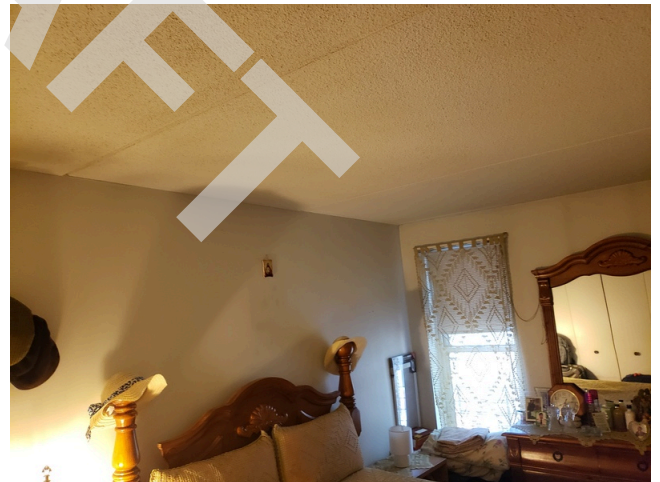
12. Unit 409- 1bed/1bath- Bedroom- Install Bedroom Smoke Detectors Per HUD (Critical Repair)

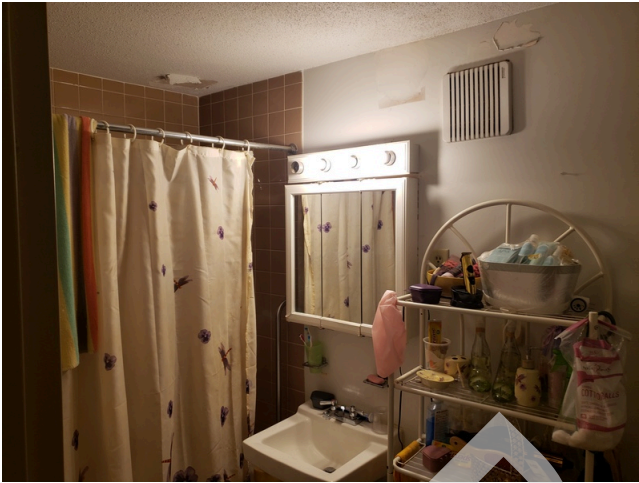
13. Unit 409- 1bed/1bath- Bathroom - Repair Damaged Ceiling (Non-Critical Repair)

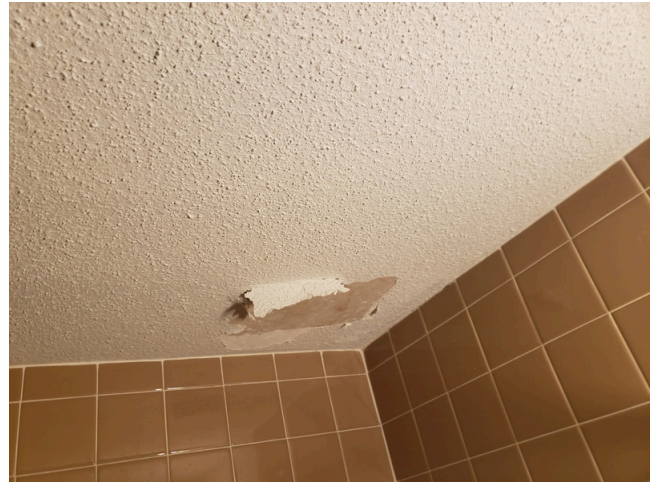
14. Unit 409- 1bed/1bath- Bathroom- Repair Damaged Ceiling (Non-Critical Repair)

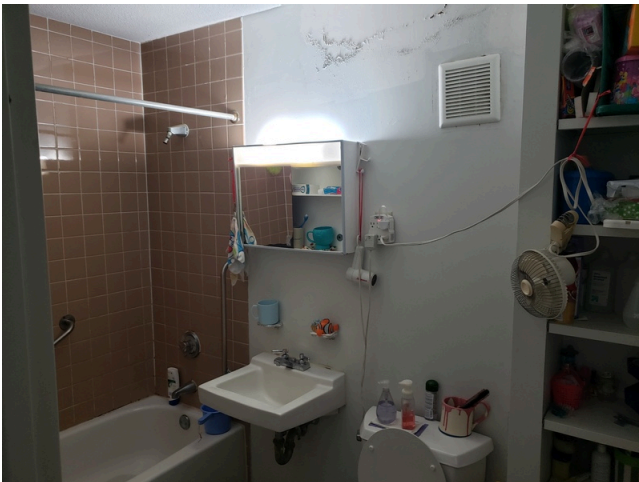
15. Unit 330- 1bed/1bath- Bathroom- Repair Damaged Ceiling (Non-Critical Repair)

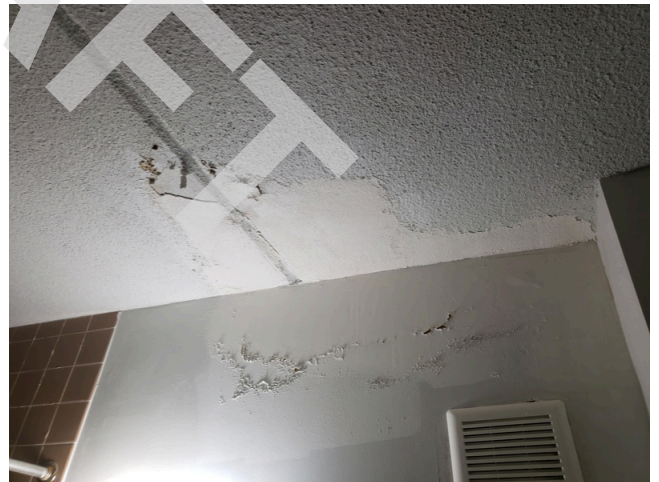
16. Unit 330- 1bed/1bath- Bathroom- Repair Damaged Ceiling (Non-Critical Repair)

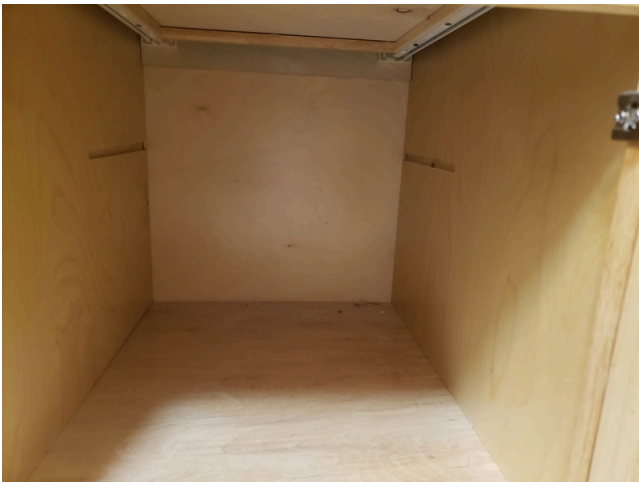
23. Unit 315- UFAS- 1bed/1bath- Kitchen- UFAS Unit Kitchen Cabinet Modifications (Critical Repair)

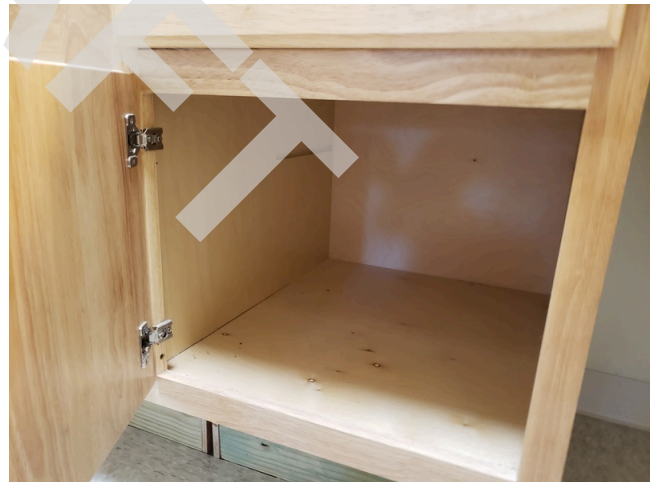
24. Unit 315- UFAS- 1bed/1bath- Kitchen- UFAS Unit Kitchen Cabinet Modifications (Critical Repair)

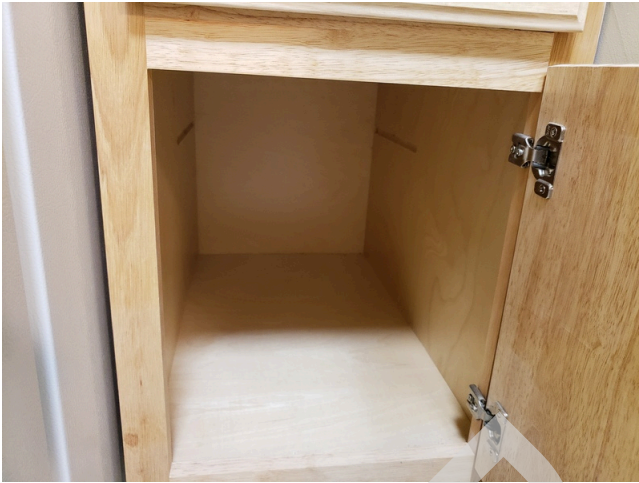
25. Unit 315- UFAS- 1bed/1bath- Kitchen- UFAS
Unit Kitchen Cabinet Modifications (Critical Repair)

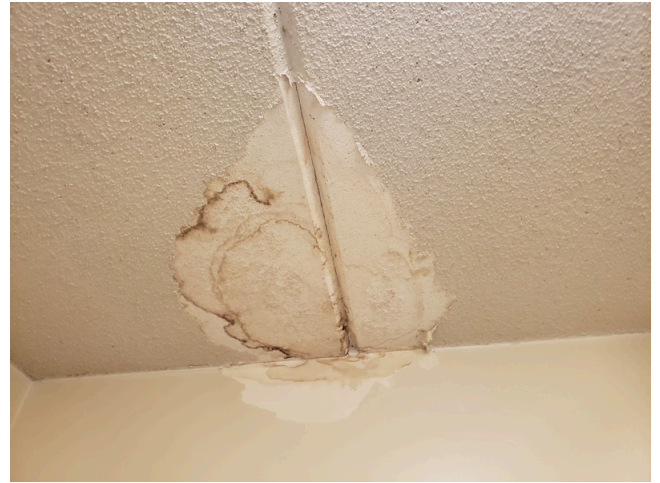
34. Unit 207- 1bed/1bath- Bathroom- Repair Damaged Ceiling (Non-Critical Repair)

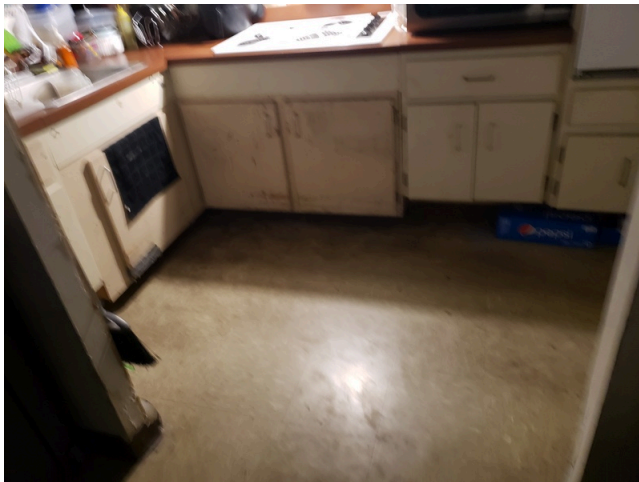
35. Unit 216- UFAS- 1bed/1bath- Kitchen- Replace Cabinets/Tops (Dwelling Units) (Older)(Non-Critical Repair)

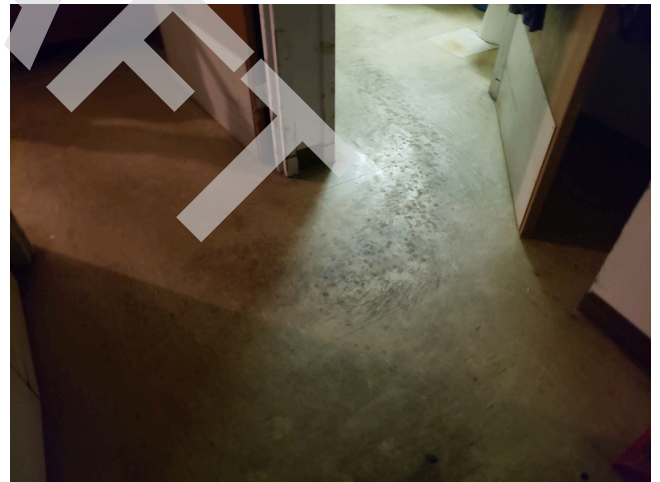
36. Unit 216- UFAS- 1bed/1bath- Replace Vinyl Flooring -1-Bed-Living Room, Kitchens and Baths (Dwelling Units) (Older) (Non-Critical Repair)

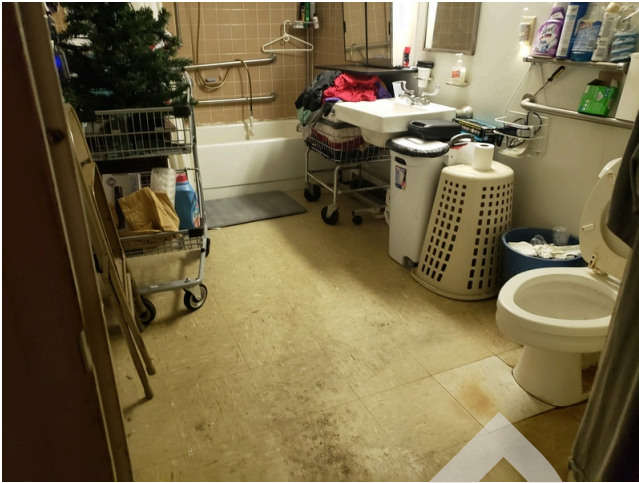
37. Unit 216- UFAS- 1bed/1bath- Replace Vinyl Flooring -1-Bed-Living Room, Kitchens and Baths (Dwelling Units) (Older) (Non-Critical Repair)

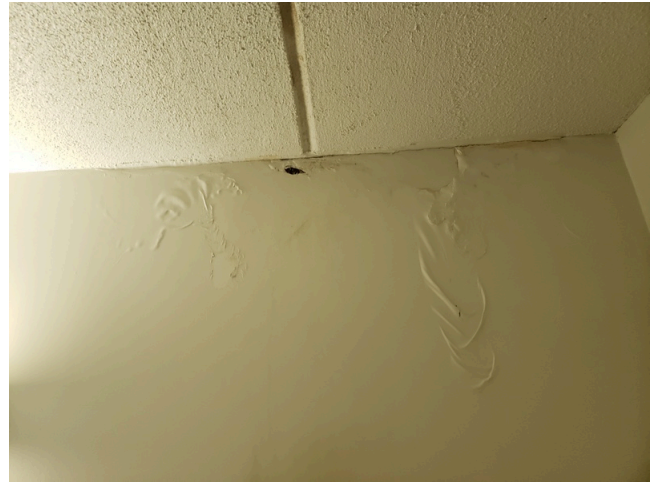
38. Unit 216- UFAS- 1bed/1bath- Bathroom- Repair Damaged Ceiling (Non-Critical Repair)

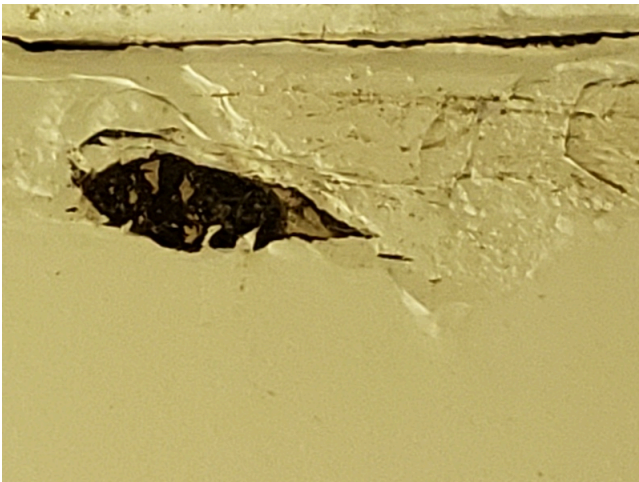
39. Unit 216- 2bed/1bath- Treat Mold (Critical Repair)

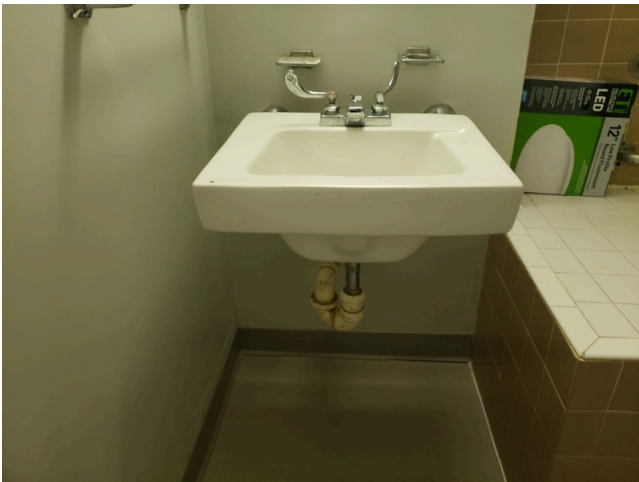
51. Unit 101-UFAS HDCP- 2bed/1bath-
Bathroom- Install Scald and Abrasion Sink Wrap
(Critical Repair)

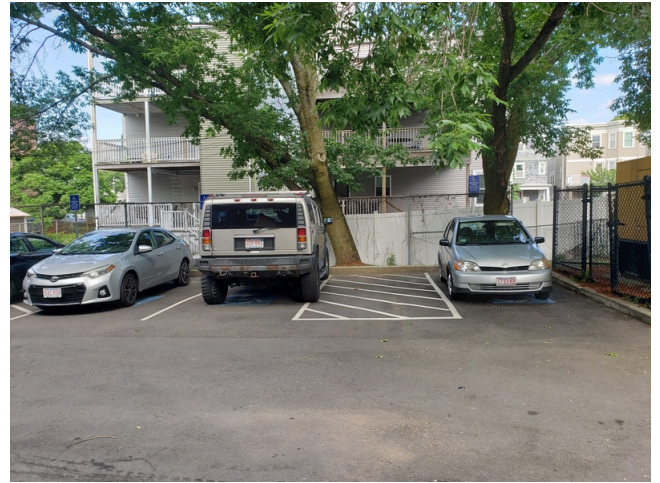
6. ADA Parking Lot- Install Van Accessible Parking Signage (Critical Repair)

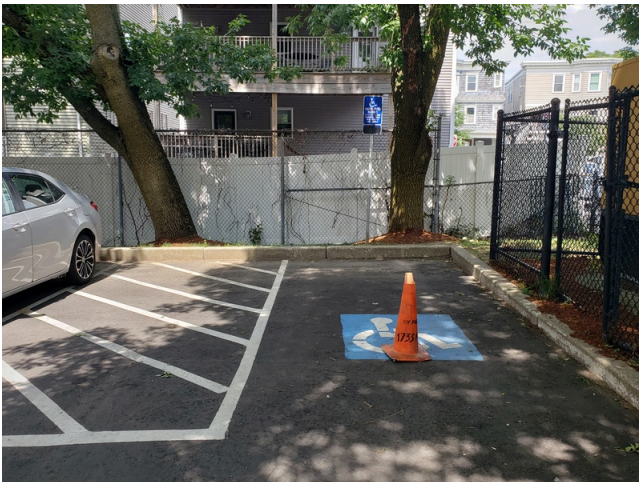
7. ADA Parking Lot- Install Van Accessible Parking Signage (Critical Repair)

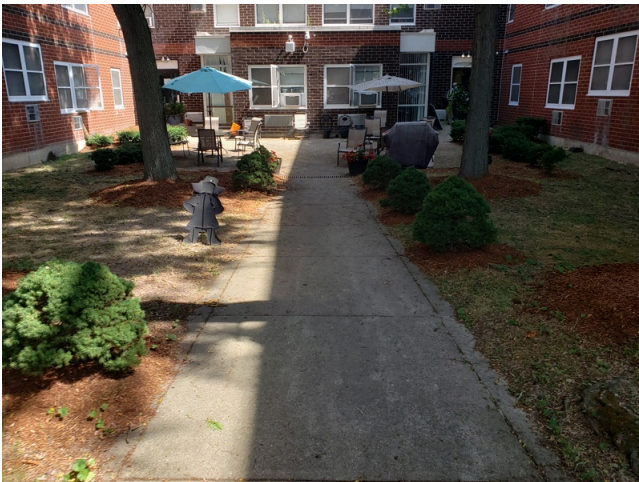
19. Sidewalk Ramp- Install Metal Hand Rail at Ramp
(Critical Repair)

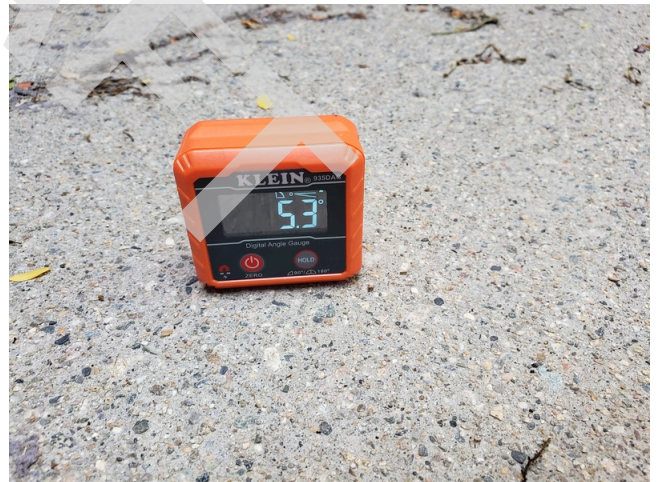
20. Sidewalk Ramp- Install Metal Hand Rail at Ramp
(Critical Repair)

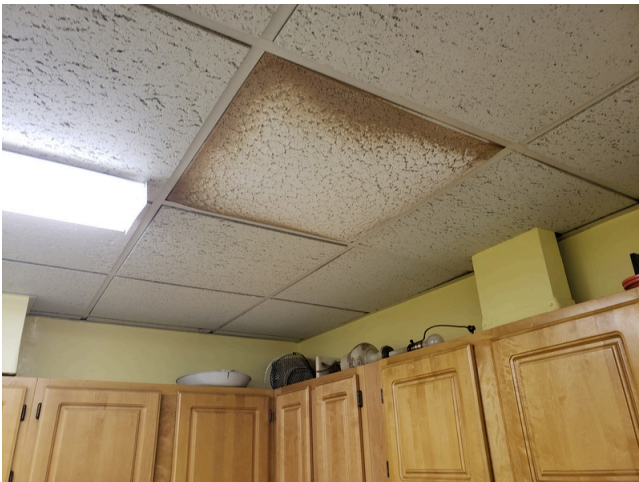
31. Common Area- Kitchen- Replace Damaged Acoustical Tile Ceiling - Common Area

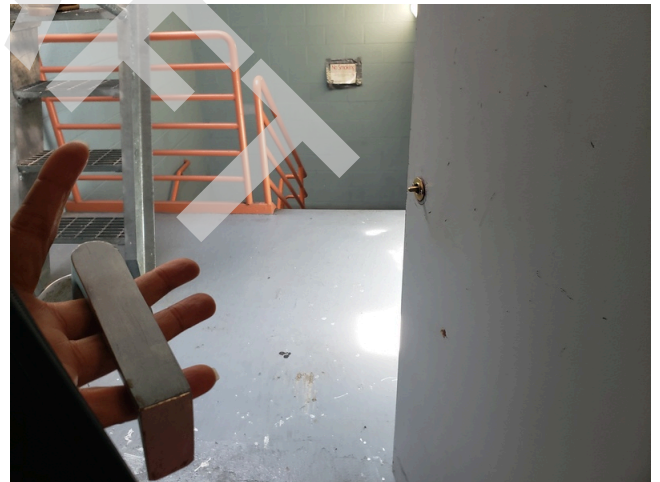
56. Repair Emergency Exit Door Hardware (Critical Repair)

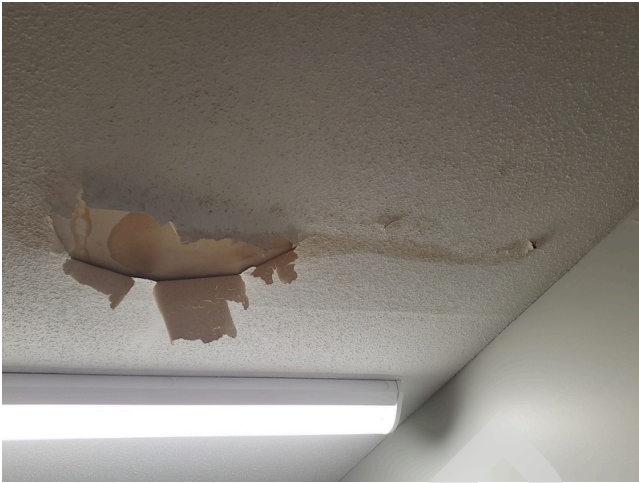
57. Common Area Hallway near Unit 317 - Repair Damaged Ceiling (Non-Critical Repair)

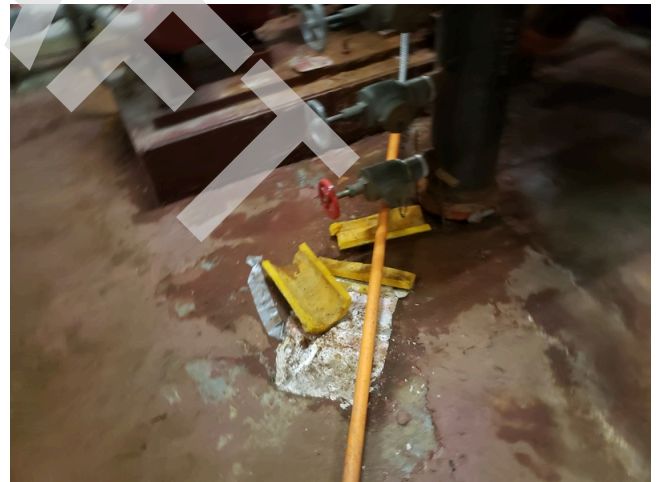
84. Address Leak in Boiler Room (Non-Critical Repair)

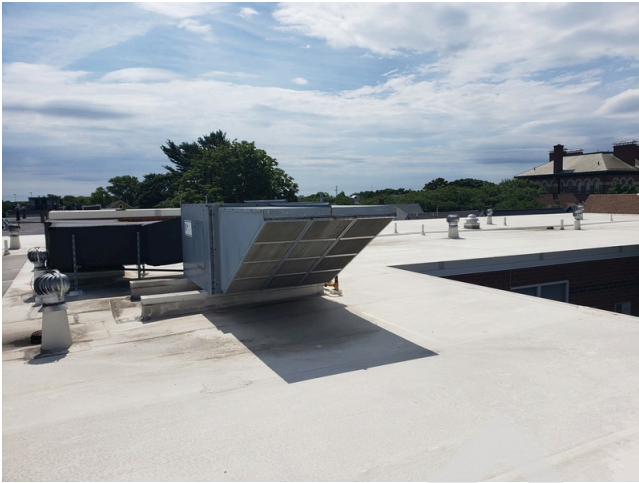
85. Roof-Top Make Up Air Unit (Non-Critical Repair)

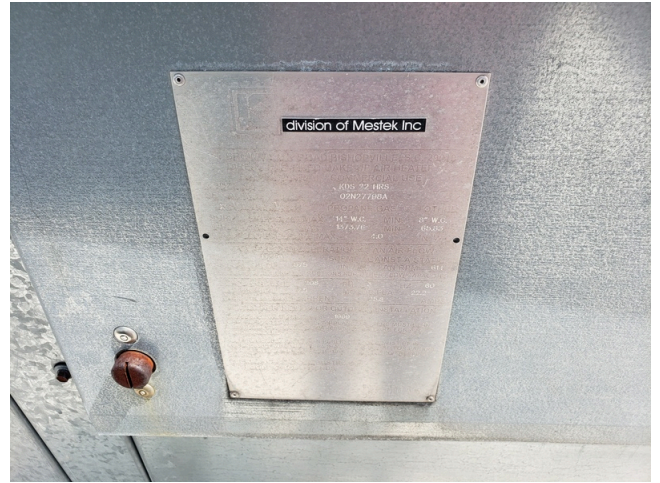
86. Roof-Top Make Up Air Unit (Non-Critical Repair)
