## HUD CAPITAL NEEDS ASSESSMENT

Washington Street  
91 Washington Street  
Brighton, Massachusetts 02135

AEI Project No. 463351  
Site Inspection Date: July 20, 2022

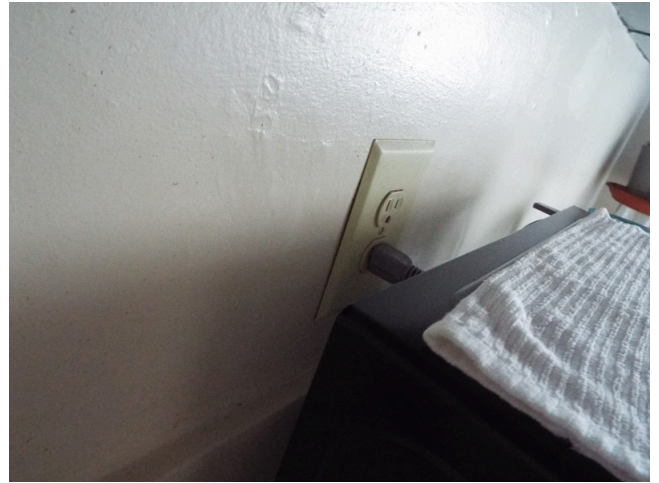
2. 1-bed-1-bath - unit 6 -kitchen lacks GFCI (Critical Repair)

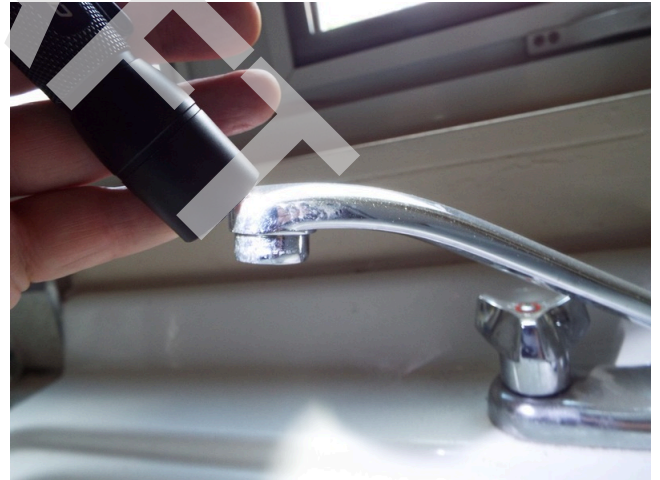
15. 1-bed-1-bath - unit 13 - kitchen lacks GFCI receptacle (Critical Repair)

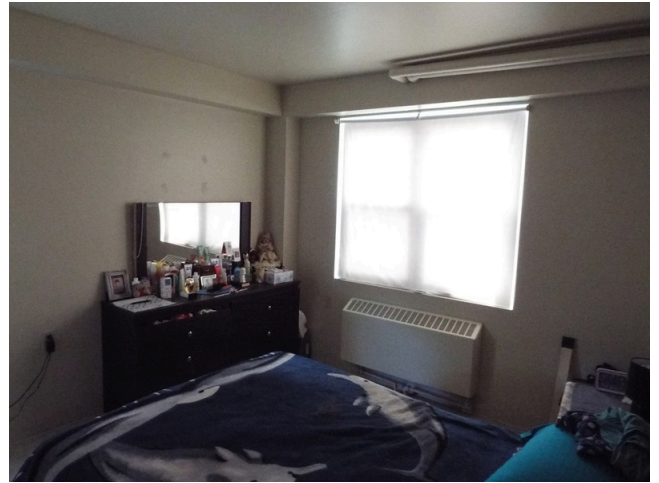
45. 1-bed-1-bath - unit 25 emergency call device  
(Non-Critical Repair)

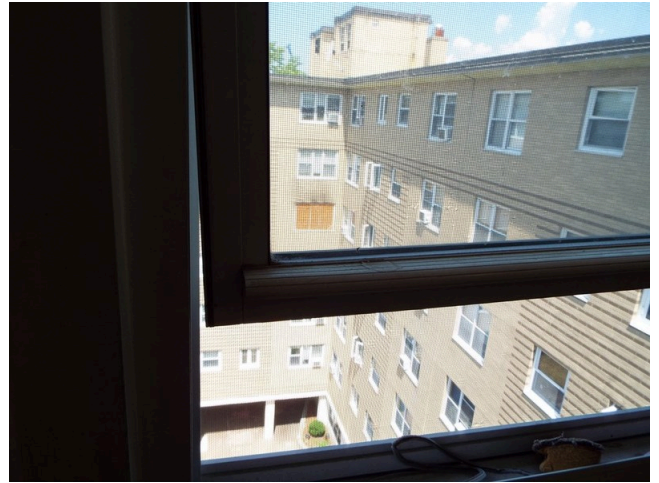
70. 1-bed-1-bath - unit 36 - window condition (Non-Critical Repair)

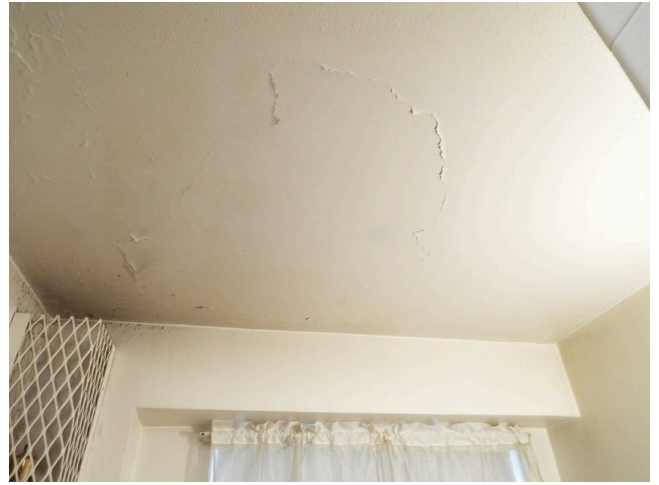
81. 1-bed-1-bath - unit 40 - ceiling paint condition  
(Non-Critical Repair)

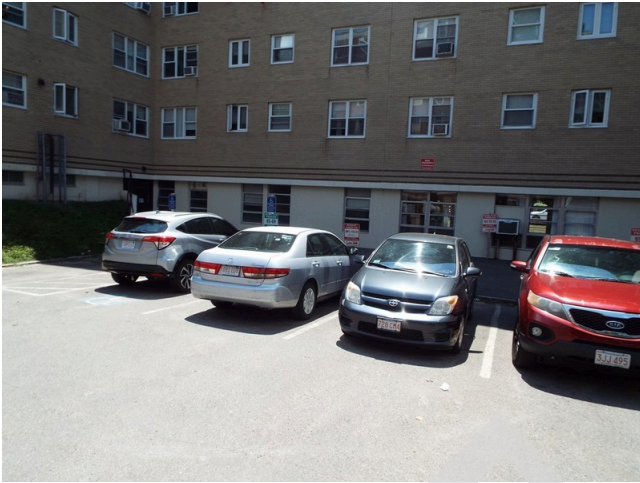
Deterioration, depressions and cracking of asphalt pavement was observed at the rear parking area and rear access drive. Repair is recommended. (Non-Critical Repair)

8. Rear access drive - pavement condition (Non-Critical Repair)

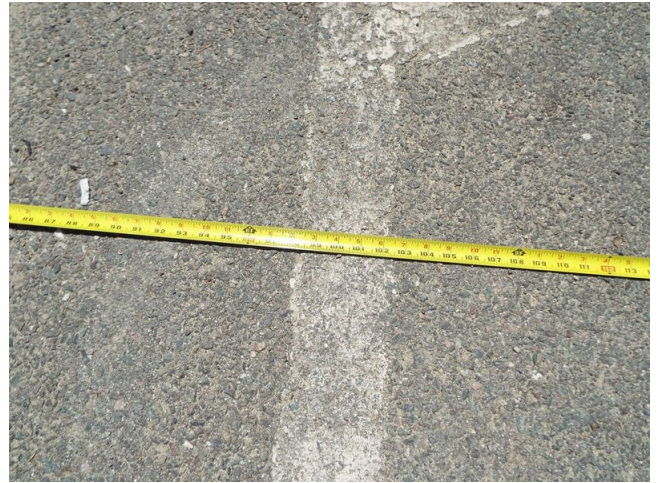
Worn seal coat and faded striping was observed at the rear parking area. Resealing and restriping is recommended. (Non-Critical Repair)

9. Seal coat and striping condition (Non-Critical Repair)

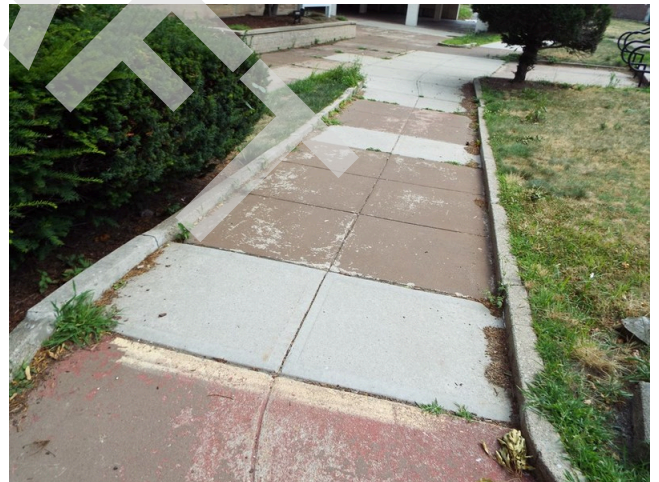
Deterioration and cracking of concrete pavement was observed throughout the sidewalks and plaza located at the front of the building. Repair is recommended. (Non-Critical Repair)

11. Concrete plaza, cracks/deteriorated stain (Non-Critical Repair)

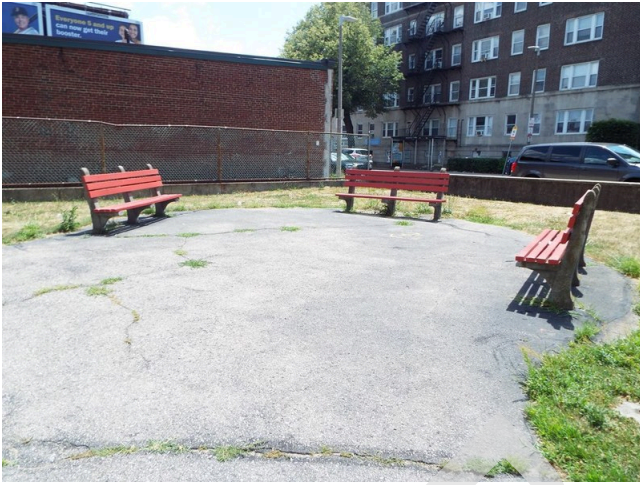
12. Sidewalk condition (Non-Critical Repair)

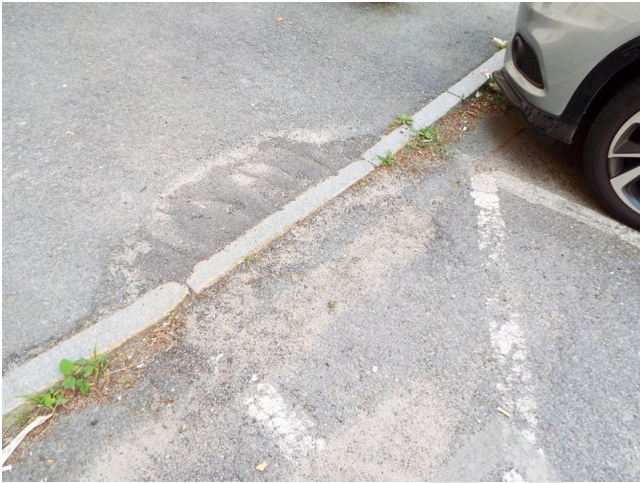
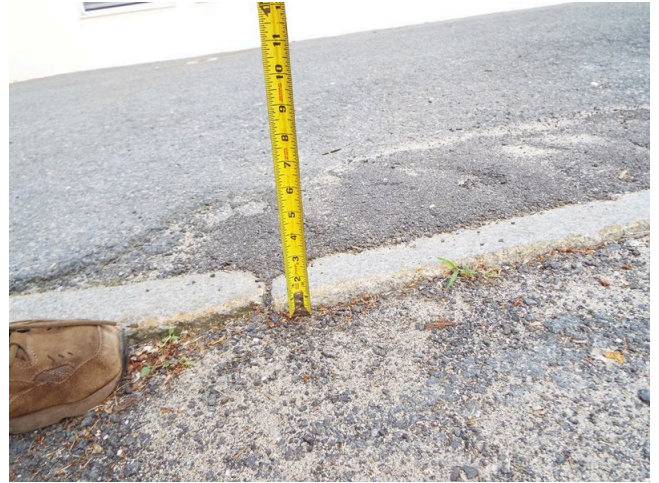
Differential settlement of asphalt pavement and a raised curb was observed at the accessible parking access aisle located at the rear of the building. The conditions represent a trip hazard. Repair is required. (Critical Repair)

17. Trip hazard - accessible parking access aisle  
(Critical Repair)

18. Trip hazard - accessible parking access aisle  
(Critical Repair)

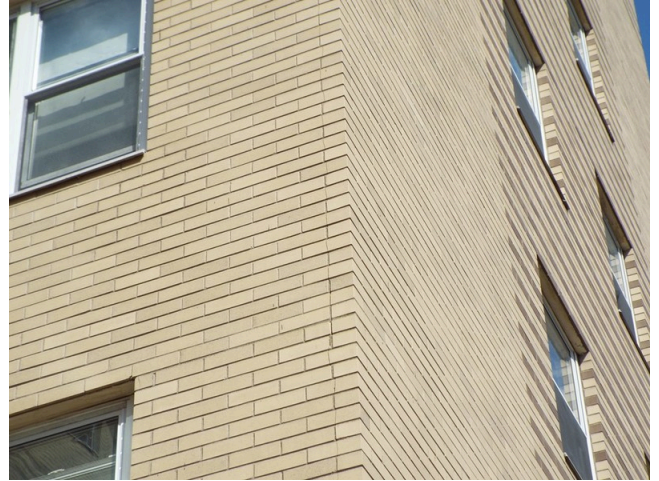
34. Vertical brick cracking - 91 wing (Non-Critical Repair)

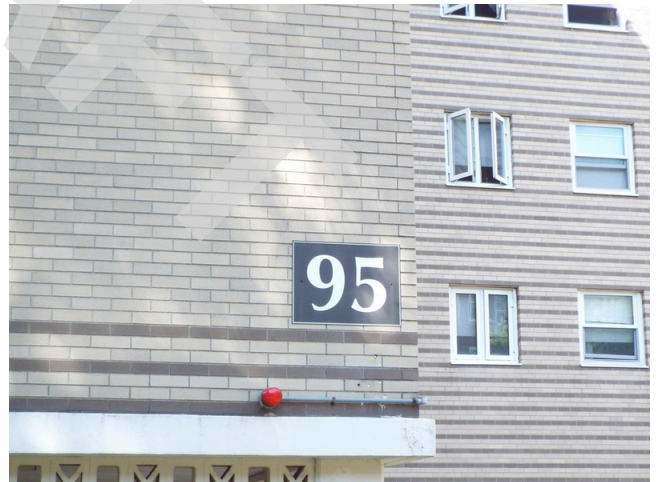
35. Vertical brick cracking - 95 wing (Non-Critical Repair)

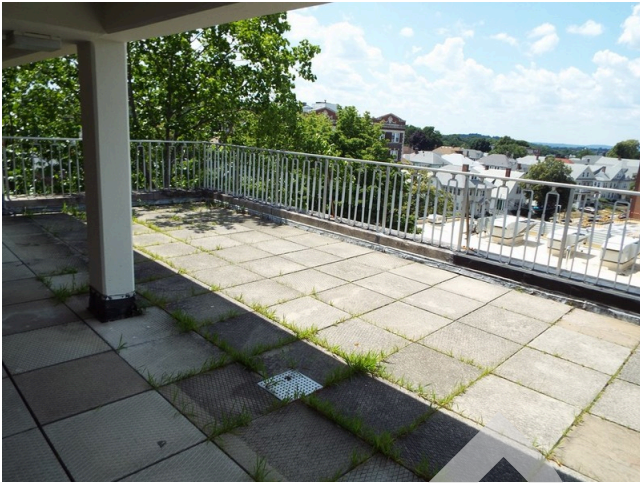
41. Rooftop terrace - 95 wing, treat weeds (Non-Critical Repair)

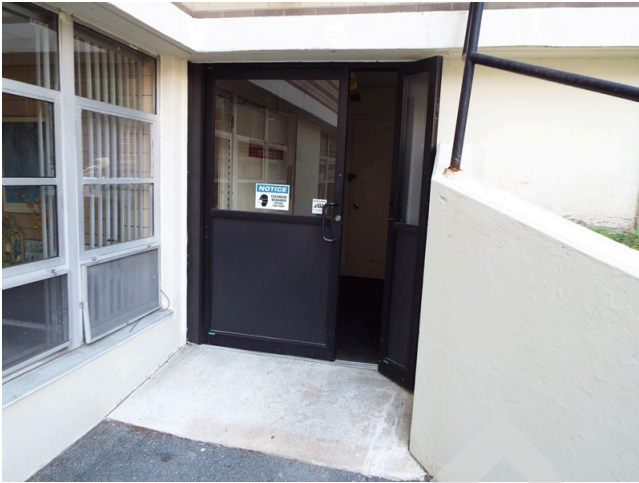
45. Damaged rear entry door (Critical Repair)

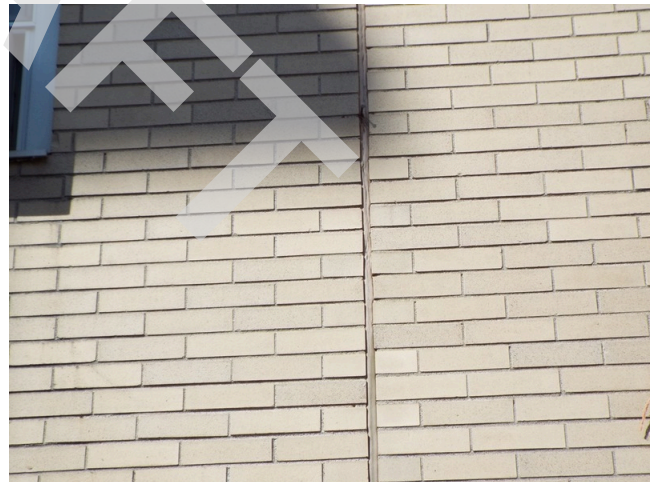
51. Sealant condition (Non-Critical Repair)

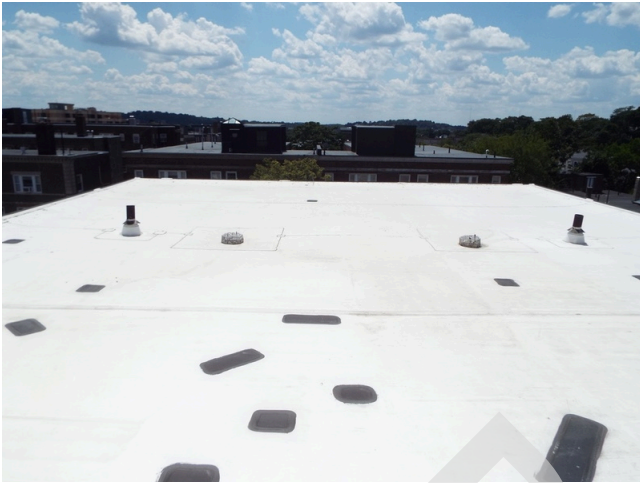
57. Roof overview (Non-Critical Repair)

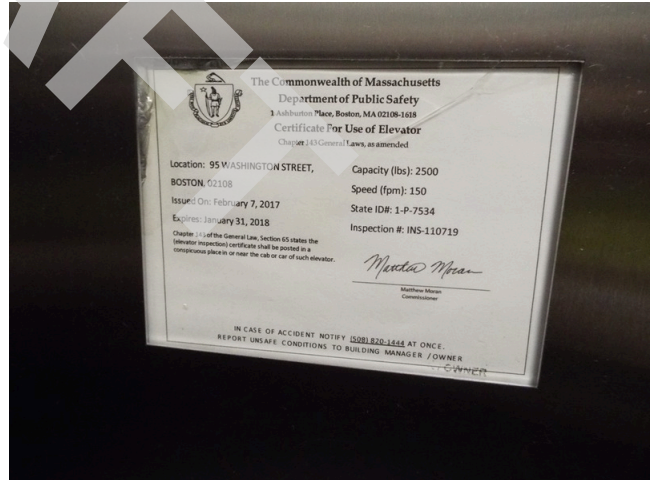
68. Expired elevator inspection (Non-Critical Repair)

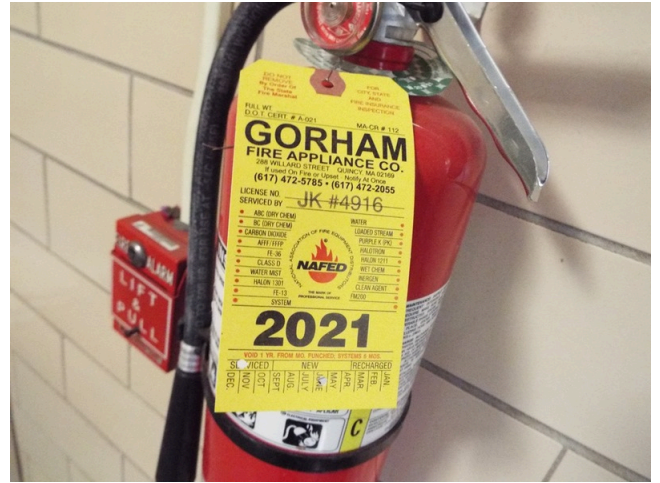
70. Fire extinguisher - expired service date (Critical Repair)

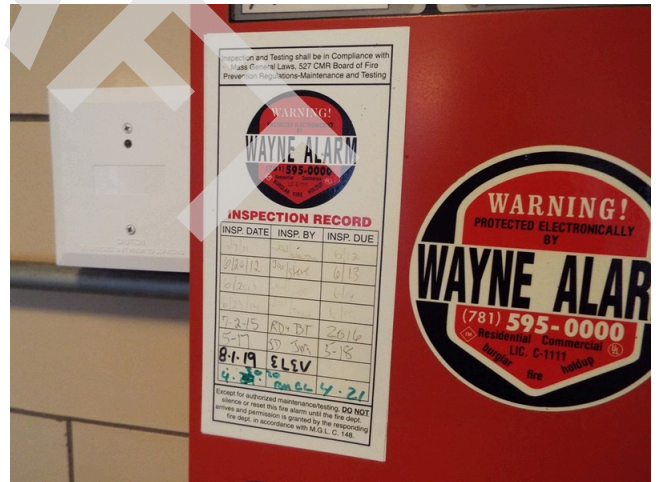
72. Expired fire alarm control panel inspection date (Critical Repair)

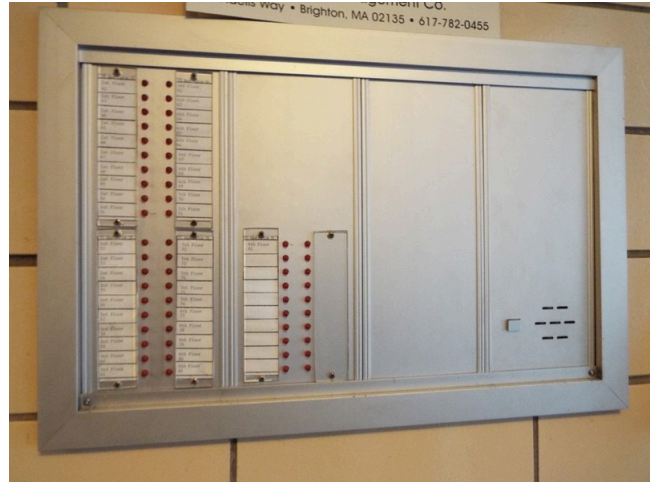
74. Emergency call annunciator panel (Non-Critical Repair)

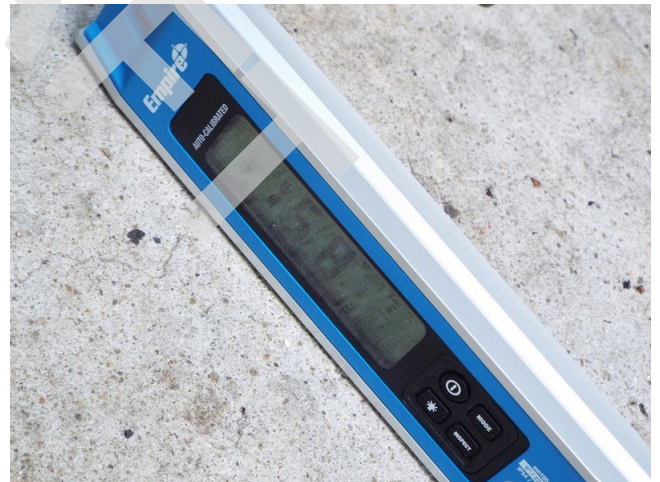
83. Accessible rear entry - slope exceeds allowable  
(Critical Repair)

84. Accessible rear entry - slope exceeds allowable  
(Critical Repair)

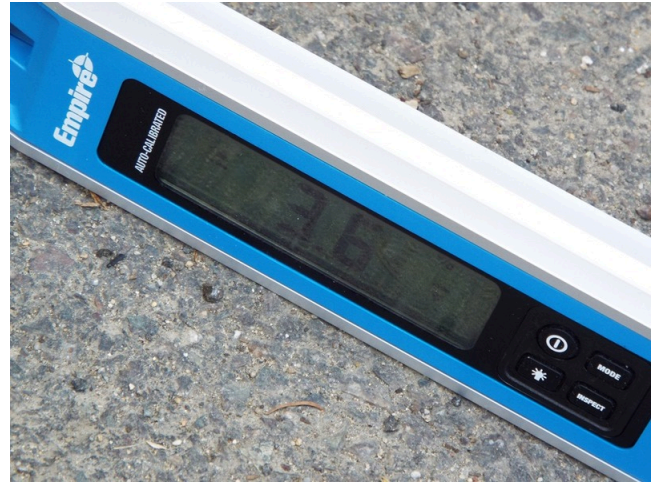
85. Accessible parking - cross slope exceeds allowable (Critical Repair)

86. Accessible parking - cross slope exceeds allowable (Critical Repair)

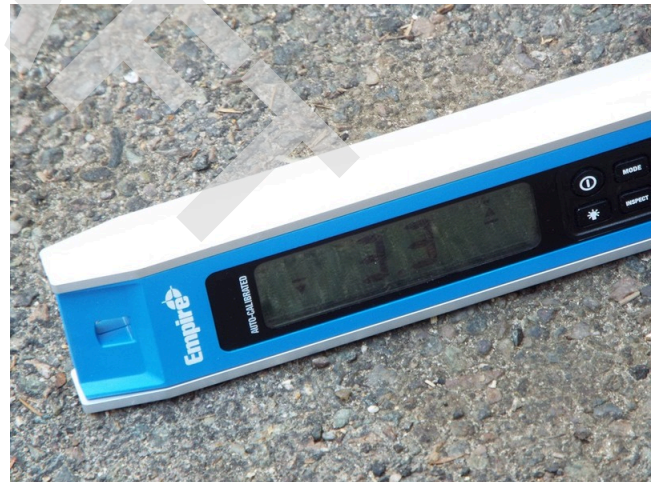
87. Accessible parking - running slope exceeds allowable (Critical Repair)

88. Accessible parking - running slope exceeds allowable (Critical Repair)

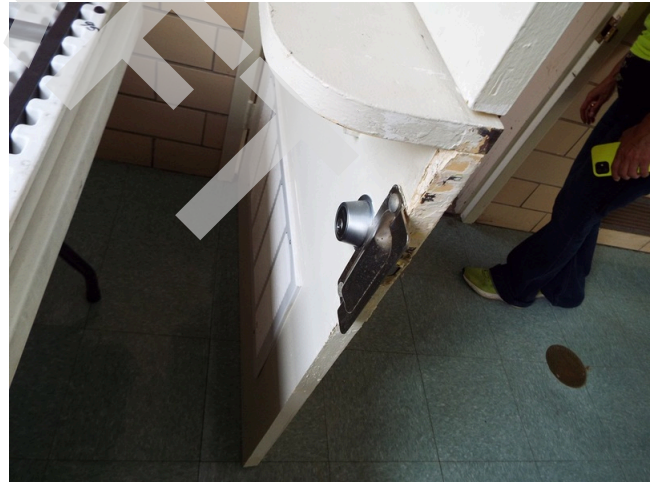
91. Common area - community room non-compliant thumbblatch hardware (Critical Repair)

92. Common area - kitchen door lacks lever hardware (Critical Repair)

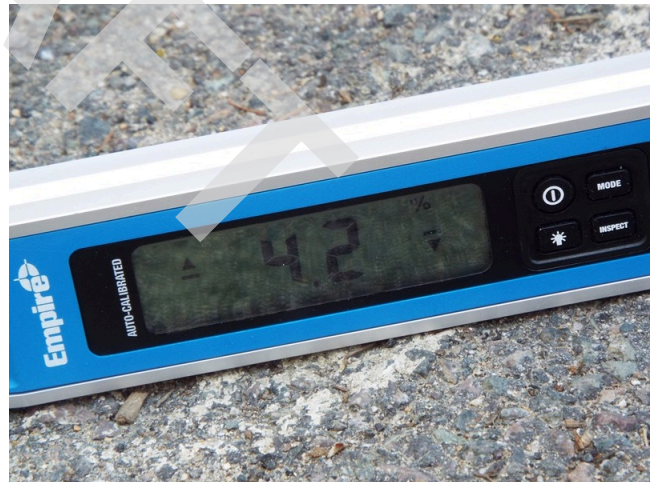
95. Accessible parking - cross slope exceeds allowable (Critical Repair)

96. Accessible parking - cross slope exceeds allowable (Critical Repair)

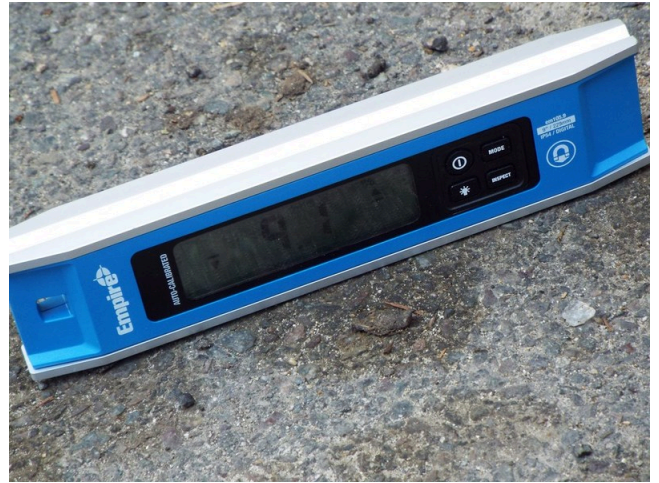
97. Accessible parking - running slope exceeds allowable (Critical Repair)

98. Accessible parking - running slope exceeds allowable (Critical Repair)

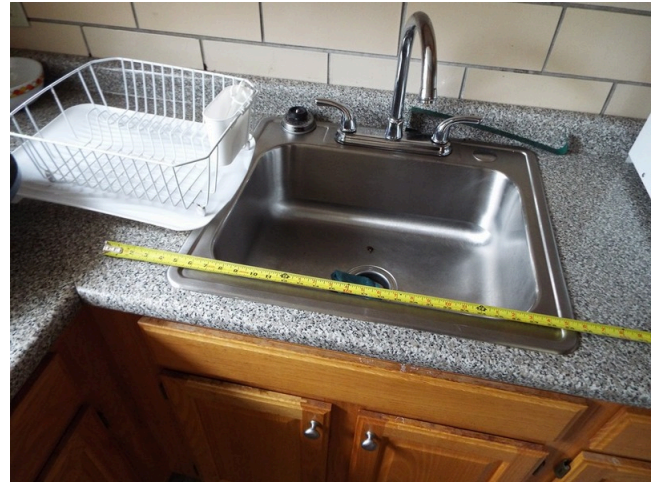
165. Common area - kitchen lacks 60 in turning radius (Critical Repair)

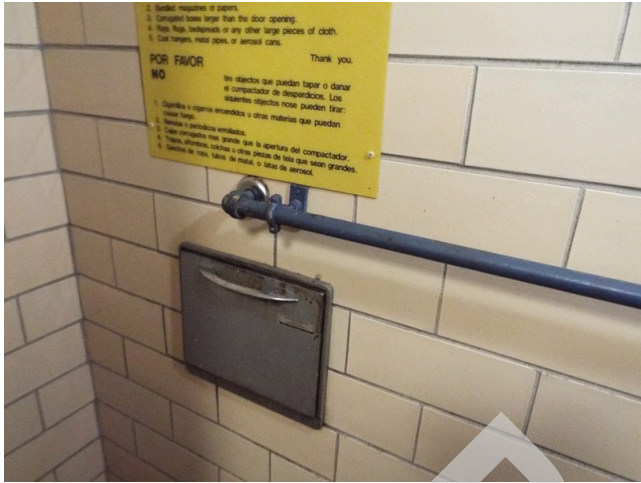
184. Knob hardware at Trash Chute rooms (Critical Repair)
