HUD MAP CAPITAL NEEDS ASSESSMENT

Davison
101 Davison Street
Hyde Park, Massachusetts 02136

AEI Project No. 463352
Site Inspection Date: July 13, 2022

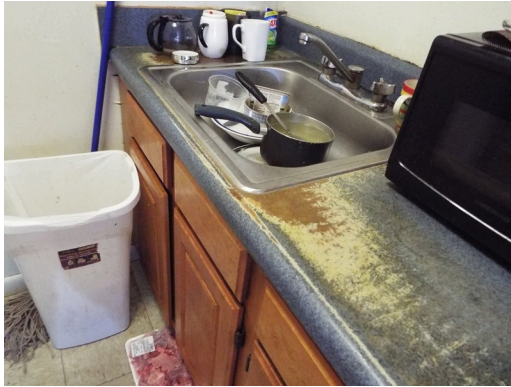
0-bed-1-bath - unit 13 - building 93-95 -
countertop condition (Non-Critical Repair)

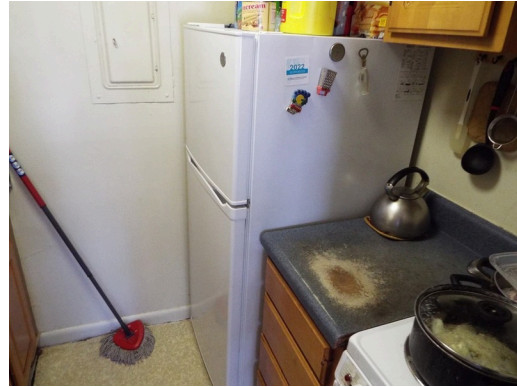
1-bed-1-bath - unit 32 - building 105-109 -
countertop condition (Non-Critical Repair)

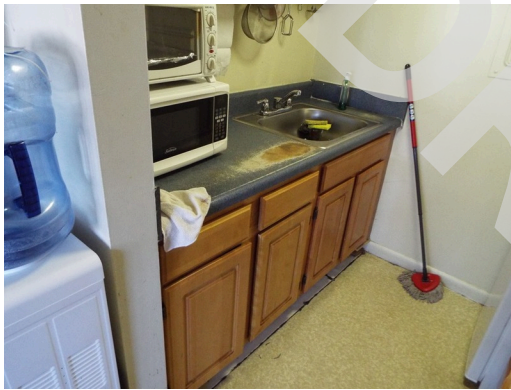
1-bed-1-bath - unit 32 - building 105-109 -
countertop condition (Non-Critical Repair)

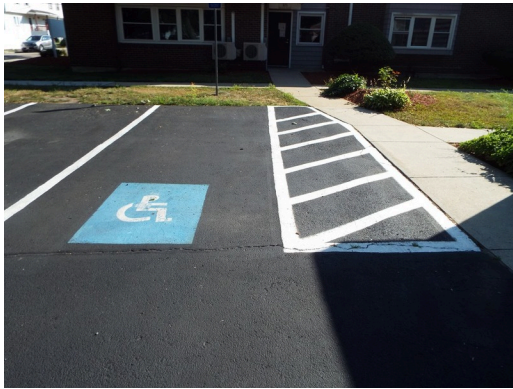
Accessible parking lacks van space and sign
(Critical Repair)

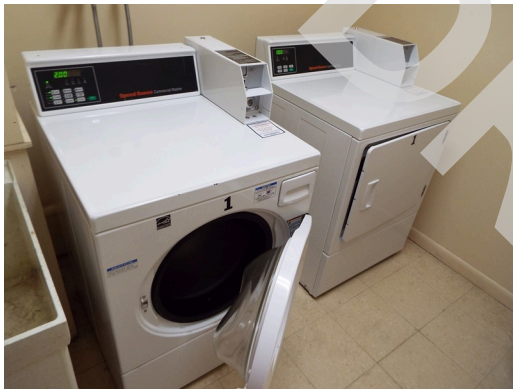
Community building - washer lacks front controls
(Critical Repair)

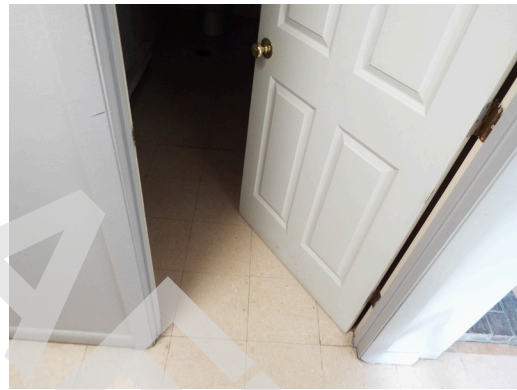
Community building - mens room door lacks lever hardware
(Critical Repair)

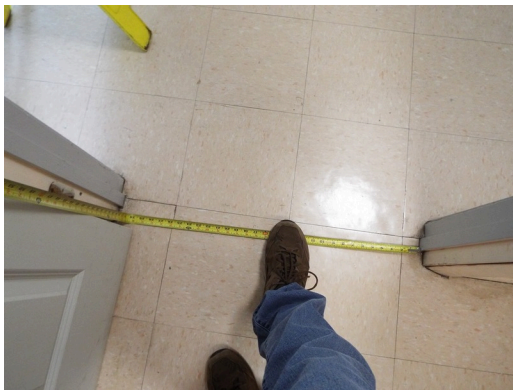
Community building - mens room door lacks minum 32 inch clearance
(Critical Repair)

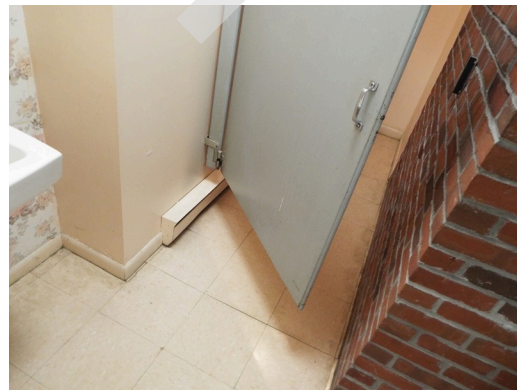
Community building - mens room lacks 60 inch turning clearance
(Critical Repair)

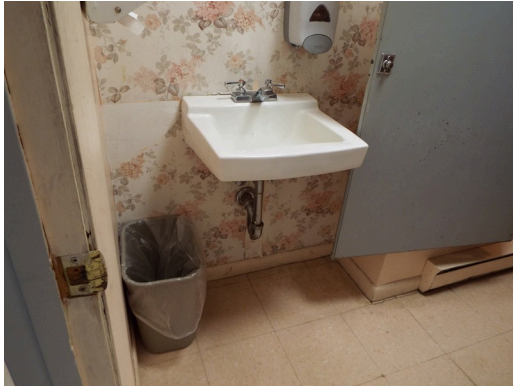
Community building - mens room sink lacks pipe protection (Critical Repair)

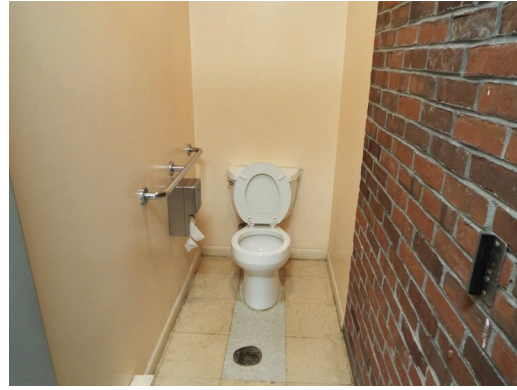
Community building - mens room toilet stall lacks rear grab bar (Critical Repair)

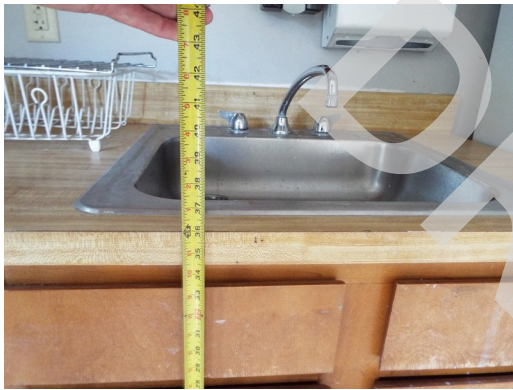
Community building - sink exceeds 34 inch maximum height (Critical Repair)

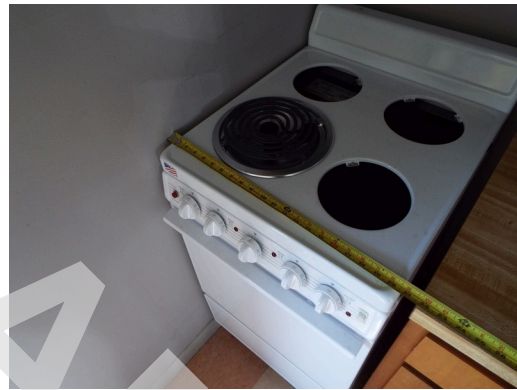
Community building - range lacks 30 inch front approach (Critical Repair)

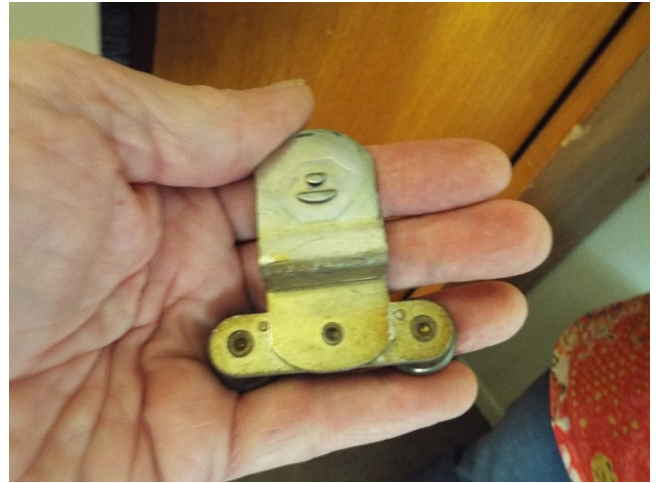
93. 0-bed-1-bath - unit 25 - building 105-109 - closet door hanger detached (Non-Critical Repair)

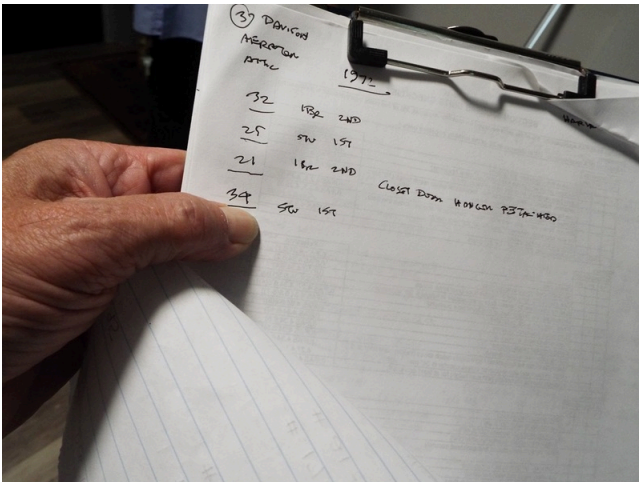
94. 0-bed-1-bath - unit 25 - building 105-109 - closet door hanger detached (Non-Critical Repair)

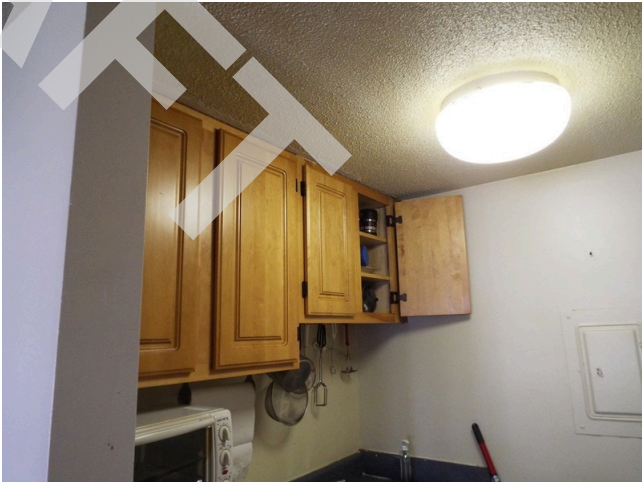
111. 1-bed-1-bath - unit 32 - building 105-109 -
countertop condition (Non-Critical Repair)

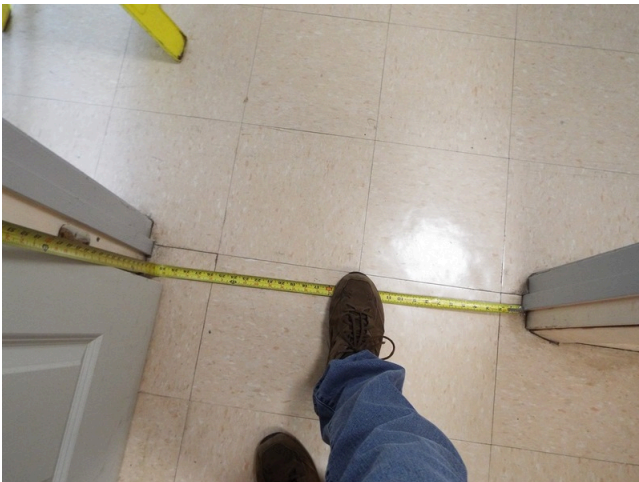
58. Community building - mens room door lacks lever hardware (Critical Repair)

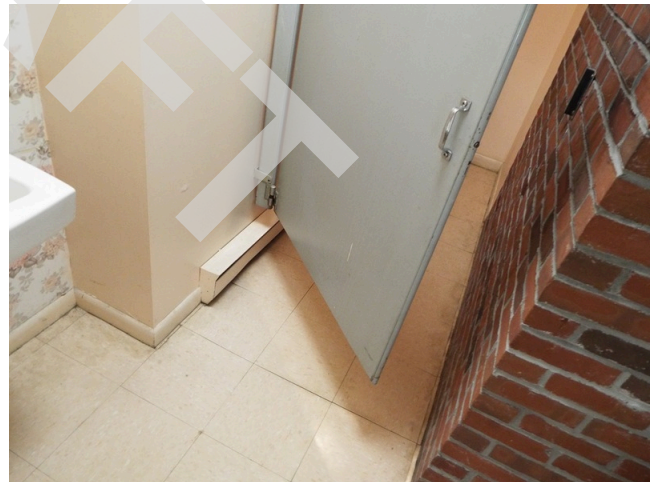
59. Community building - mens room door lacks minum 32 inch clearance (Critical Repair)

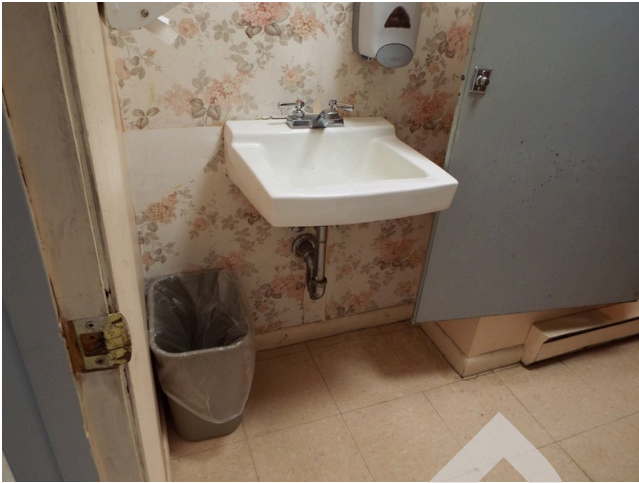
60. Community building - mens room lacks 60 inch turning clearance (Critical Repair)
