HUD MAP CAPITAL NEEDS ASSESSMENT

Ashmont
374 Ashmont Street
Dorchester, Massachusetts 02124

AEI Project No. 463355
Site Inspection Date: July 6, 2022

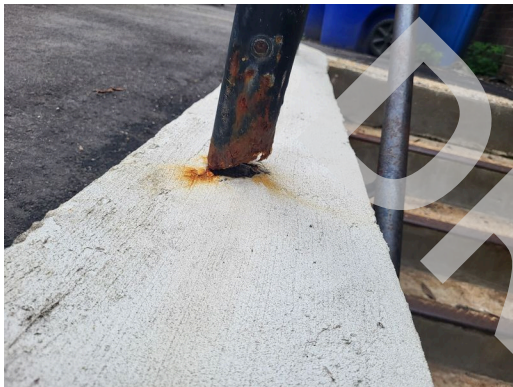
Basement ingress/egress railing rusted
(Non-Critical Repair)

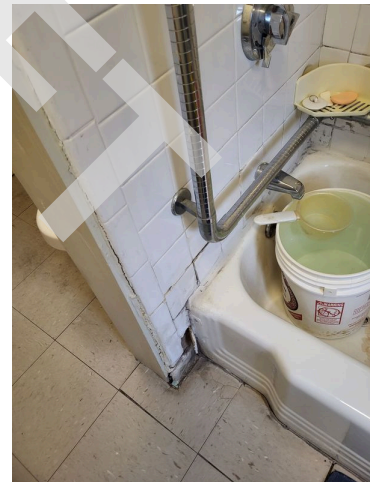
20. Apartment 346-10 bathroom bathtub tile damage (Non-Critical Repair)

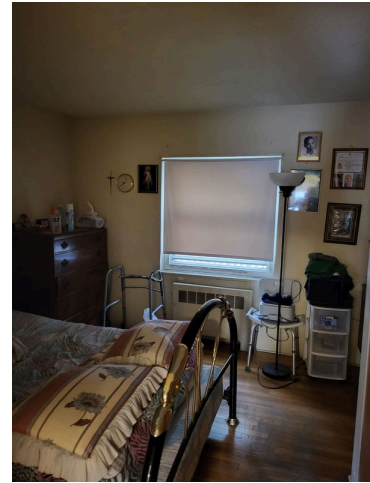
22. Apartment 346-10 bedroom missing smoke detector (Critical Repair)

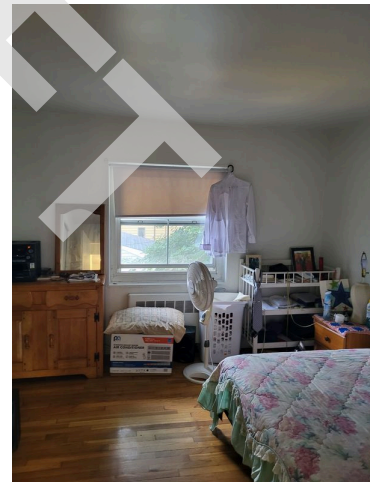
32. Apartment 352-19 bedroom missing smoke detector (Critical Repair)

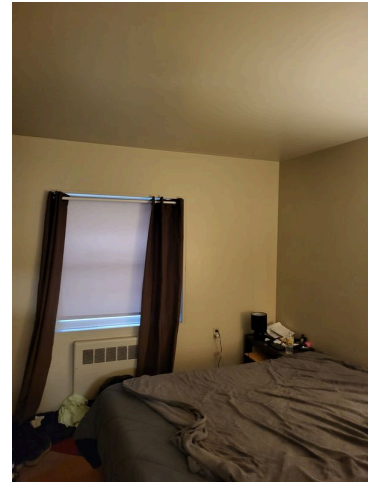
50. Apartment 354-21 bedroom missing smoke detector (Critical Repair)

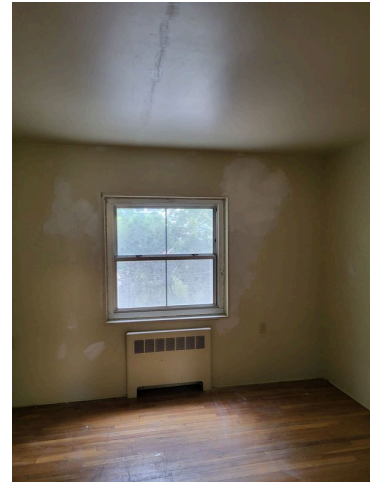
58. Apartment 356-25 bedroom missing smoke detector (Critical Repair)

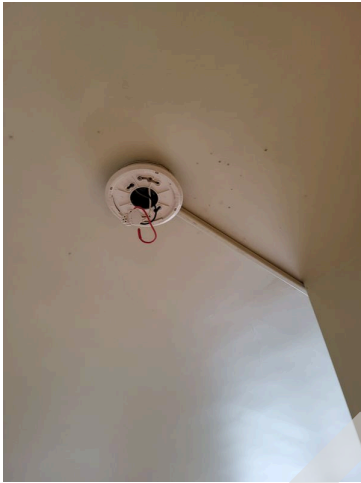
61. Apartment 356-25 missing smoke detector
(Critical Repair)

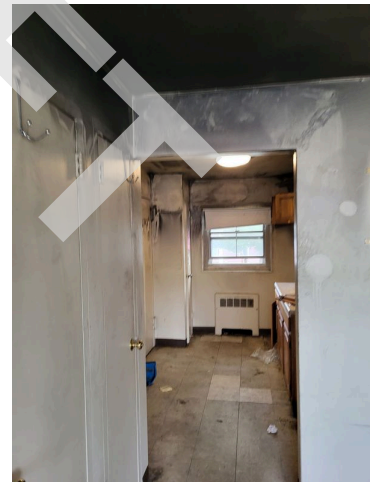
68. Apartment 370-46 fire and smoke damage (Non-Critical Repair)

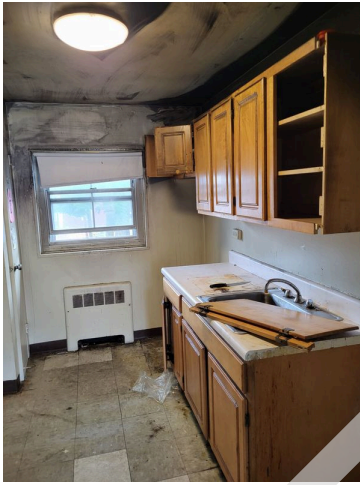
69. Apartment 370-46 kitchen fire and smoke damage (Non-Critical Repair)

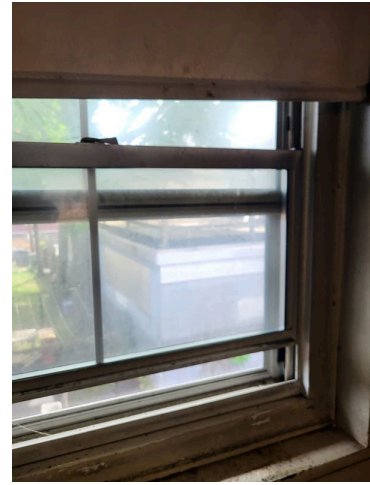
70. Apartment 370-46 kitchen window and frame (Non-Critical Repair)

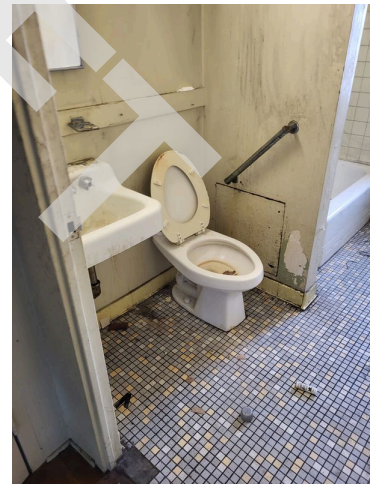
72. Apartment 370-46 bathroom toilet, grab bar, sink and floor (Non-Critical Repair)

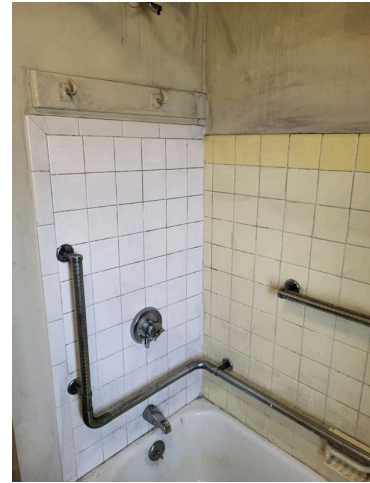
74. Apartment 370-46 bathroom bathtub tile (Non-Critical Repair)

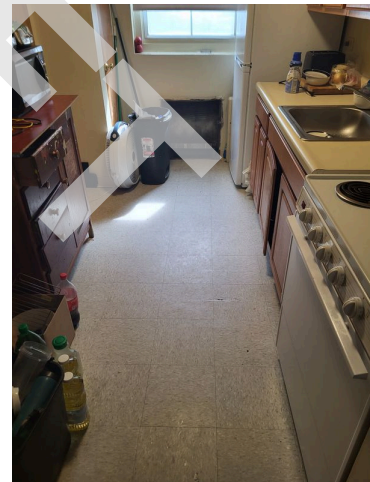
76. Apartment 364-36 kitchen floor (Non-Critical Repair)

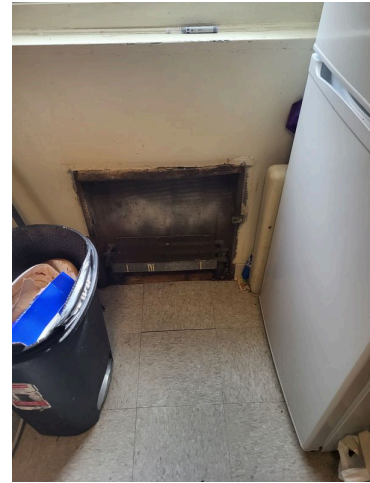
78. Apartment 364-36 kitchen radiator missing cover
(Non-Critical Repair)

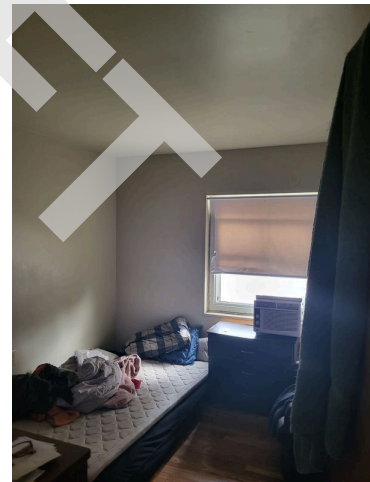
84. Apartment 364-36 bedroom missing smoke detector (Critical Repair)

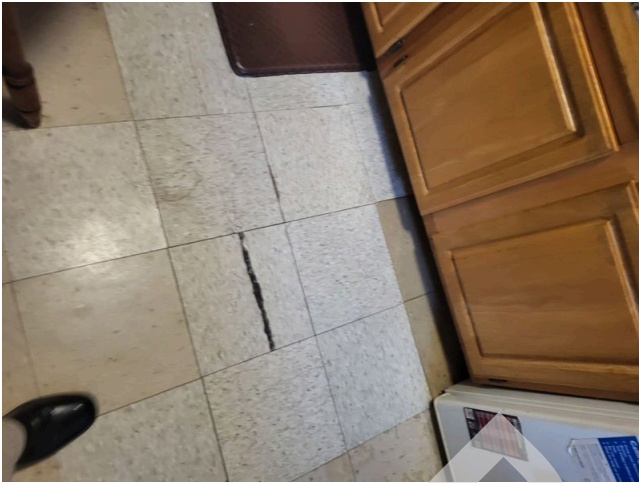
117. Apartment 342-1 kitchen floor (Non-Critical Repair)

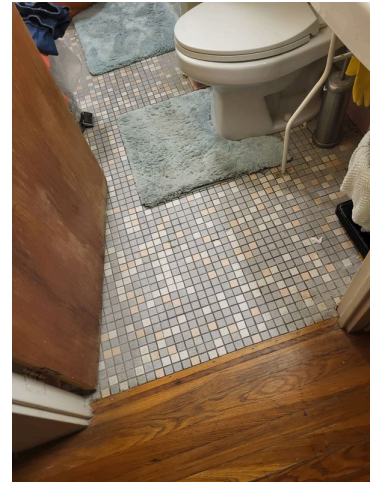
122. Apartment 342-1 bathroom flooring (Non-Critical Repair)

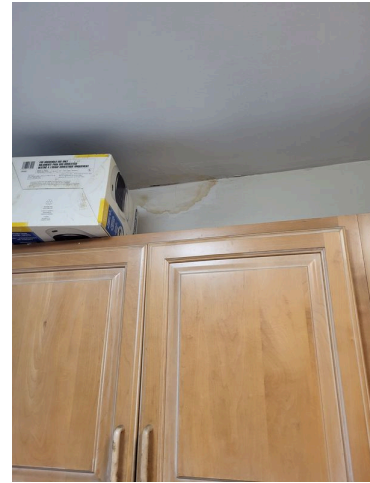
22. Common area kitchen ceiling damage (Non-Critical Repair)

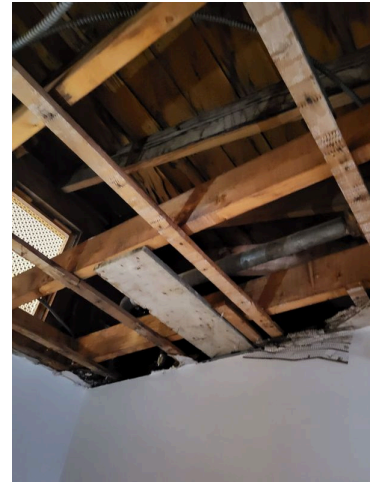
50. Common area restroom hole in ceiling (Non-Critical Repair)

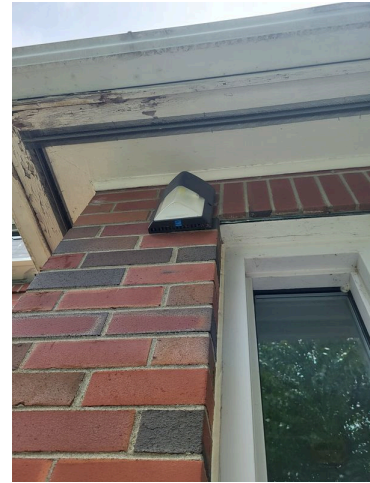
62. Apartment building 342-356 wood soffit damage

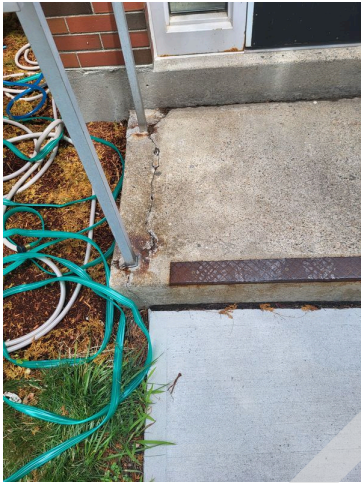
65. Apartment building 342-356 cracked concrete by stair railing (Non-Critical Repair)

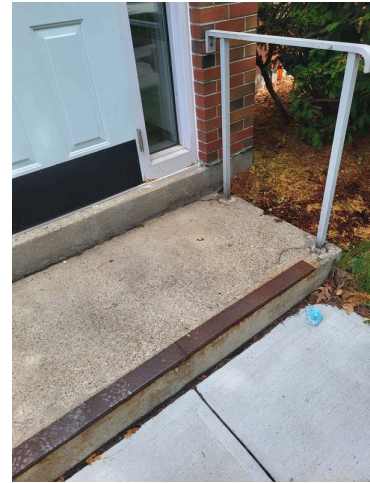
66. Apartment building 342-356 cracked concrete by stair railing (Non-Critical Repair)

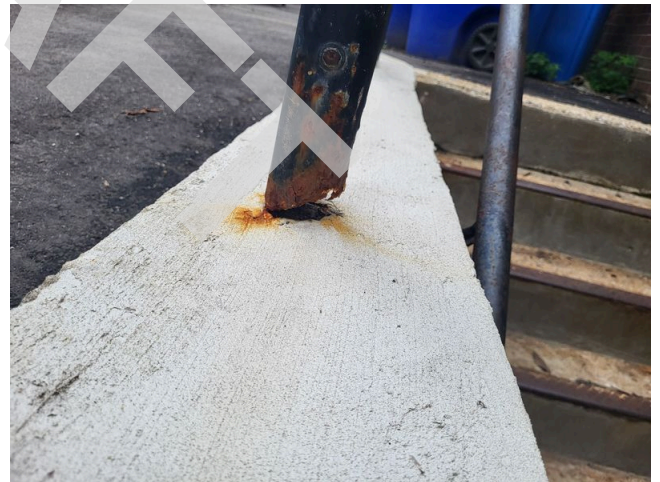
72. Basement ingress/egress railing rusted (Non-Critical Repair)

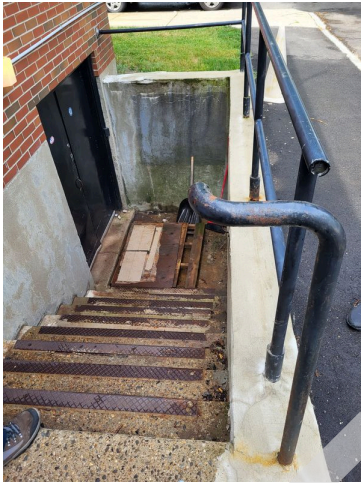
73. Basement ingress/egress railing damaged (Non-Critical Repair)

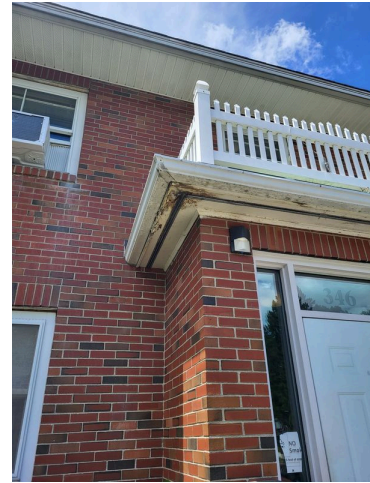
78. Apartment building 342-356 wood soffit damage
(Non-Critical Repair)

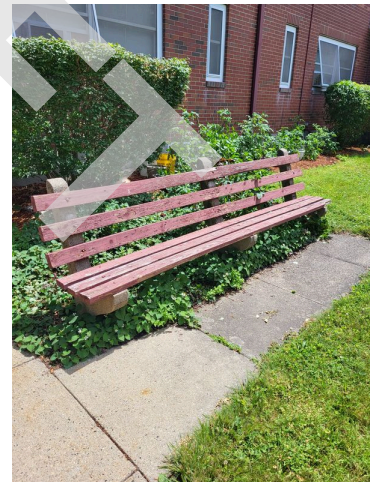
80. Exterior common area bench (Non-Critical
Repair)

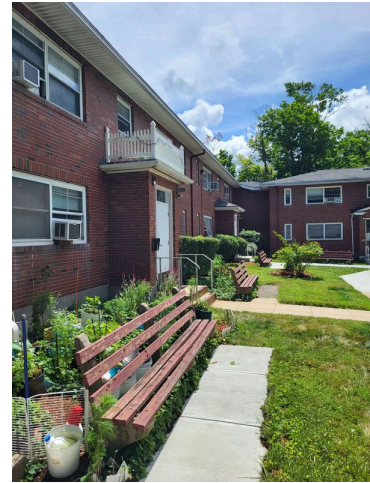
82. Exterior common area benches (Non-Critical Repair)

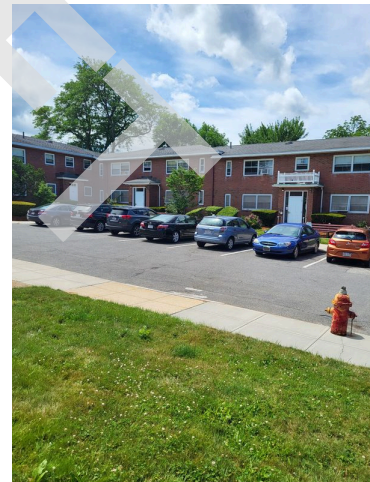
The asphalt driveway and parking area sealcoat was observed deteriorated with select areas of damage and past Estimated Use Life (EUL). In order to maintain the driveways and parking areas and improve the condition of the property, seal coat and restriping of the asphalt driveways and parking areas is recommended. (Non-Critical Repair)

84. Property parking lot (Non-Critical Repair)

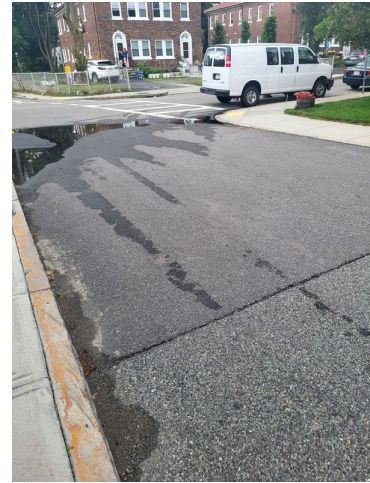
86. Property parking lot ingress/egress (Non-Critical Repair)

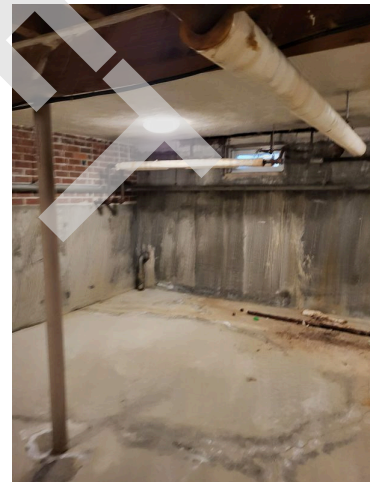
115. Basement pipe leak (Non-Critical Repair)

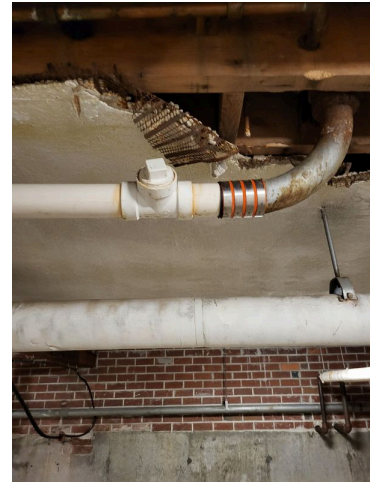
118. Basement ceiling damage (Non-Critical Repair)

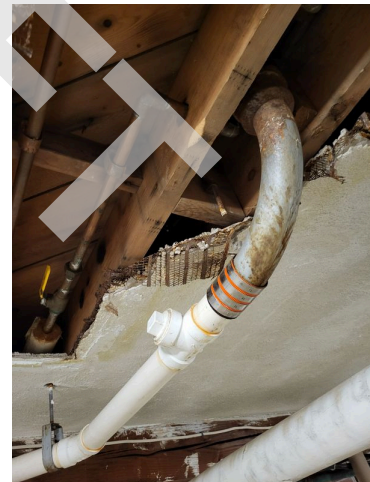
120. Basement ceiling damage (Non-Critical Repair)

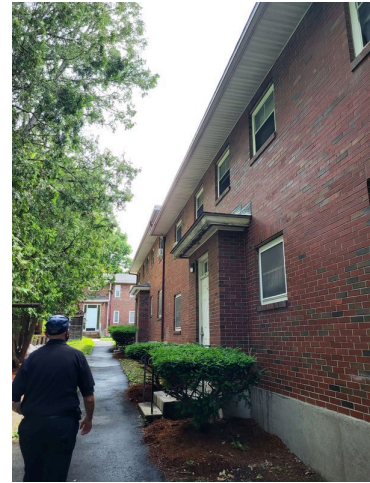
130. Apartment building wood soffit and trim damage (Non-Critical Repair)

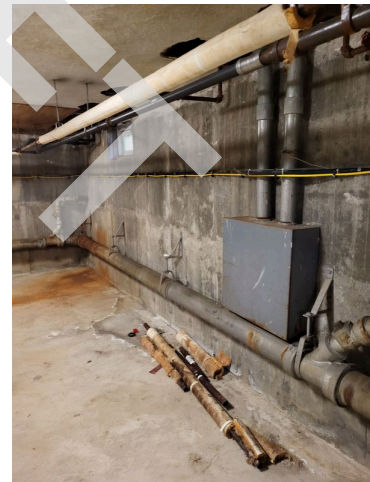
152. Basement ceiling damage (Non-Critical Repair)

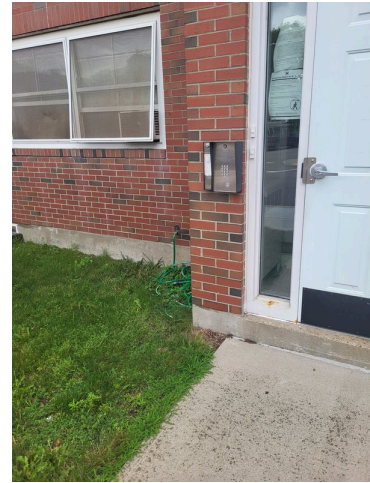
162. Apartment building intercom system (Non-Critical Repair)

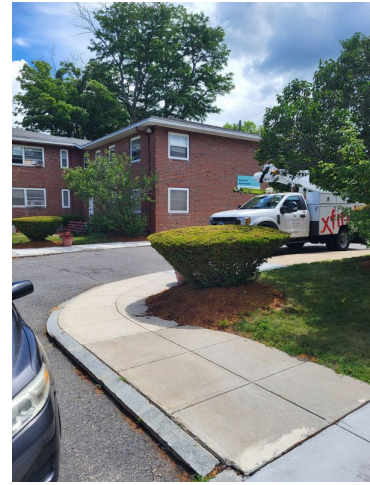
166. Property sidewalk trip hazard (Critical Repair)
