## HUD CAPITAL NEEDS ASSESSMENT

Margaret Collins (Pond St)  
29 Pond Street  
Jamaica Plain, Massachusetts 02130

AEI Project No. 463357  
Site Inspection Date: June 30, 2022

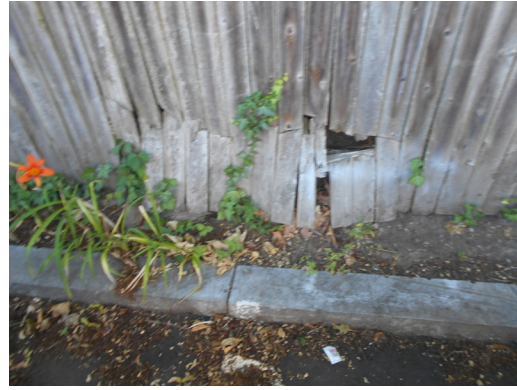
Parking lot wood fencing, damaged  
(Non-Critical Repair)

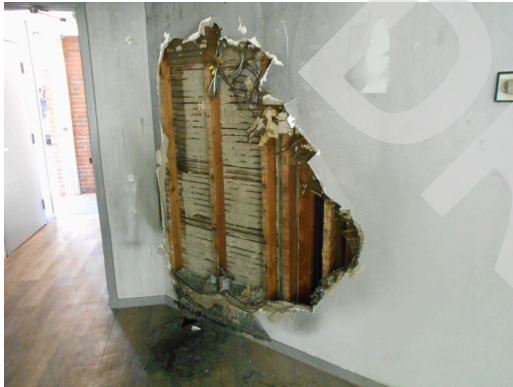
During the site visit the site was actively undergoing exterior painting around the tenant buildings. A fire occurred in the community building on June 12th, 2022. The fire damaged the main room walls and ceiling, as well as the women's restroom. At the time of the site inspection the building was deemed safe and repair work was about to begin.

Community building main room, damaged by fire (Non-Critical Repair)

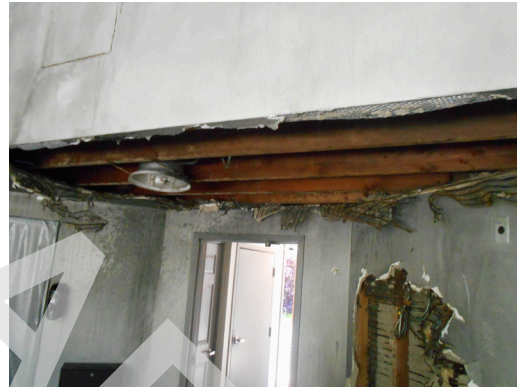
Community building main room, damaged by fire (Non-Critical Repair)

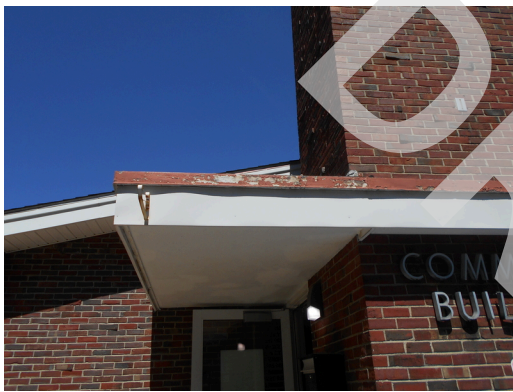
| Item | Description | Action | Condition |
|---|---|---|---|
| Painting | Resident buildings last painted in May 2022.<br>Paint chipping on community building | IM/RR | Good/Fair |

Community building, paint chipping  
(Non-Critical Repair)

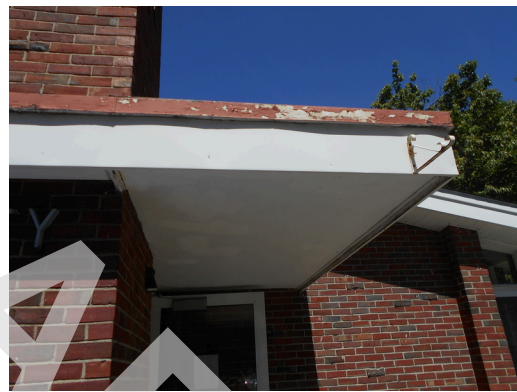
Community building, paint chipping  
(Non-Critical Repair)

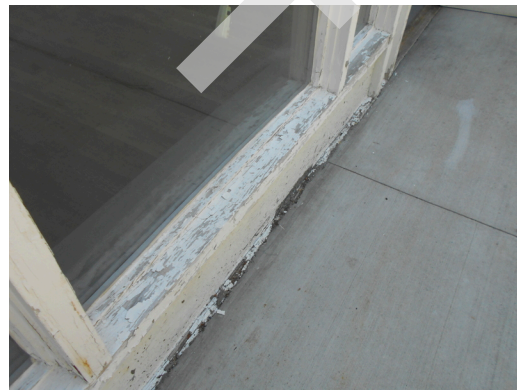
Community building rear façade, paint chipping  
(Non-Critical Repair)

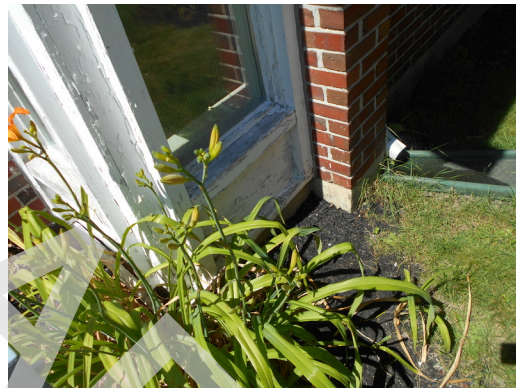
Community building window, paint chipping  
(Non-Critical Repair)

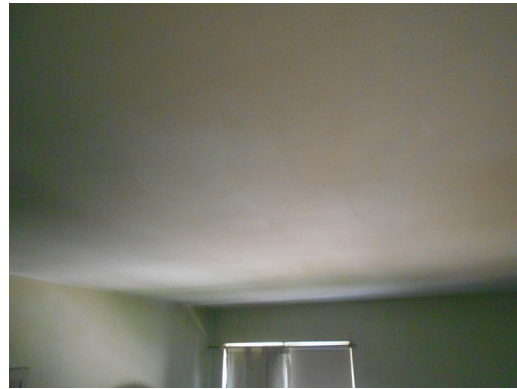
Building B, Unit 27, 2br/1ba - Bedroom 1 ceiling, no smoke detector (Critical Repair)

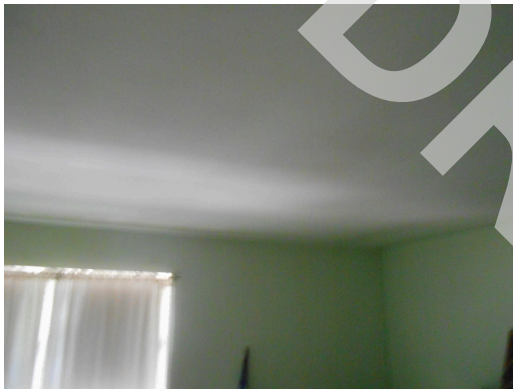
Building B, Unit 27, 2br/1ba - Bedroom 2 ceiling, no smoke detector (Critical Repair)

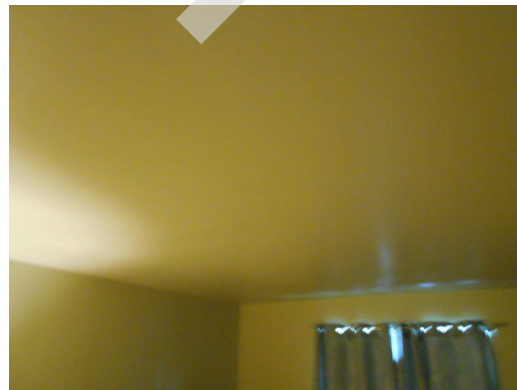
Building B, Unit 23, 1br/1ba - Bedroom ceiling, no smoke detector (Critical Repair)

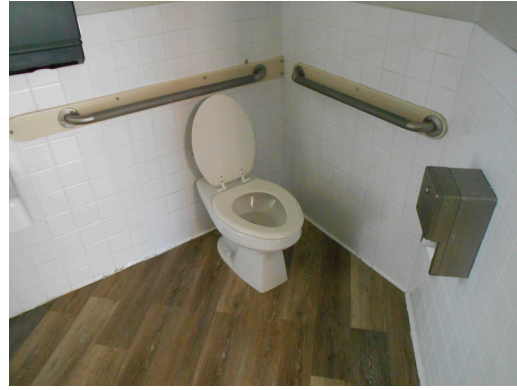
Men's public restroom, not enough clear floor space (Critical Repair)

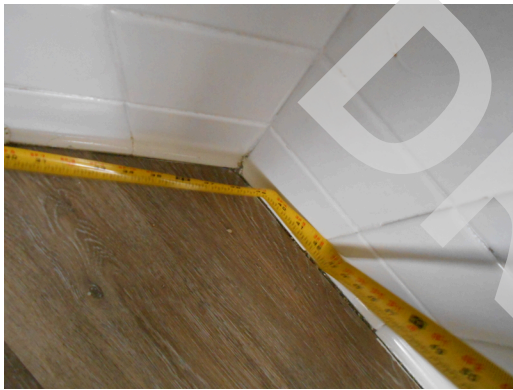
Men's public restroom, not enough clear floor space (Critical Repair)

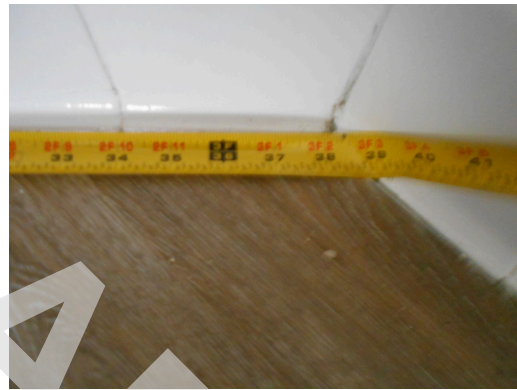
Men's public restroom, not enough clear floor space (Critical Repair)

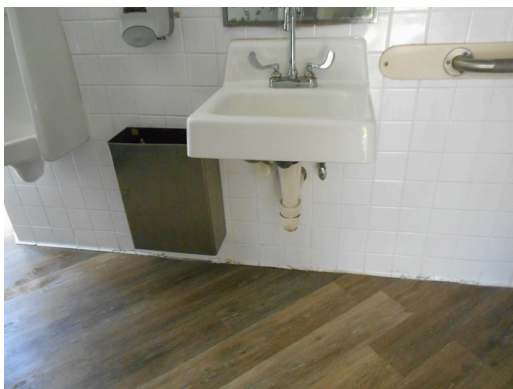
Men's public restroom, no scald abrasion protection (Critical Repair)

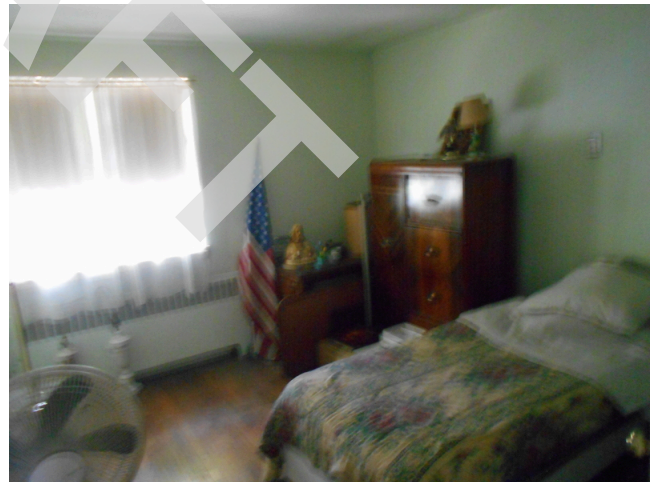
31. Building B, Unit 27, 2br/1ba - Bedroom 1 ceiling,  
no smoke detector (Critical Repair)

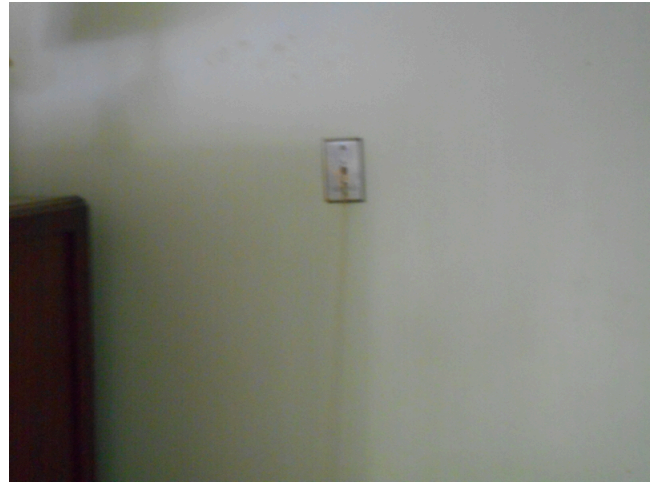
33. Building B, Unit 27, 2br/1ba - Bedroom 2 ceiling, no smoke detector (Critical Repair)

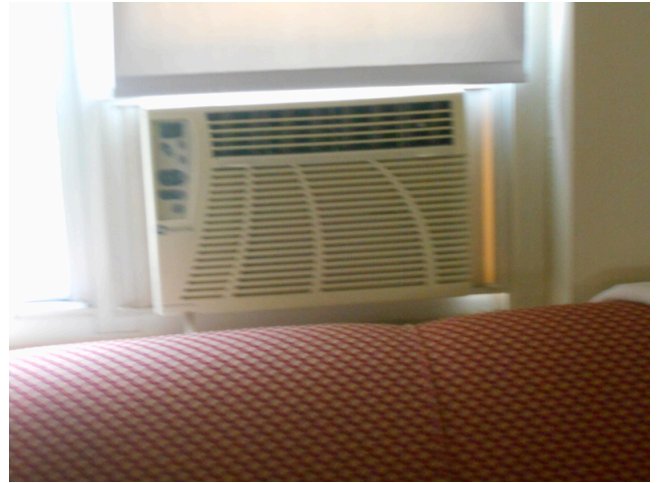
45. Building B, Unit 23, 1br/1ba - Bedroom ceiling, no smoke detector (Critical Repair)

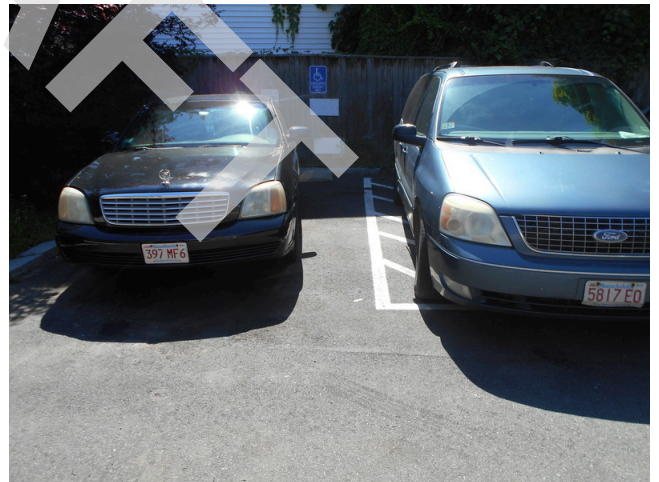
11. Parking lot wood fencing, damaged (Non-Critical Repair)

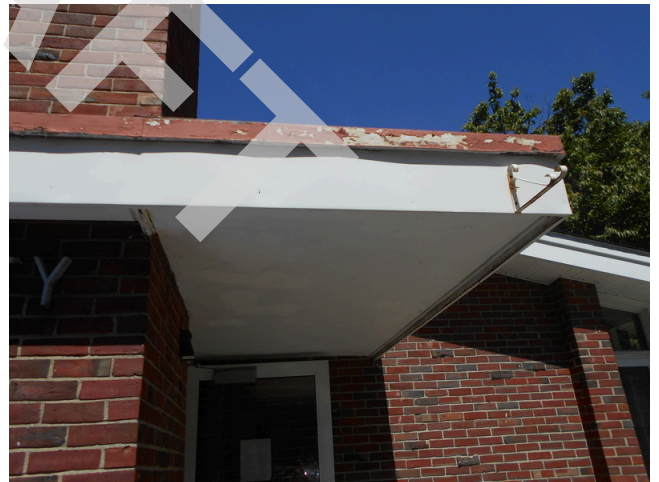
15. Community building, paint chipping (Non-Critical Repair)

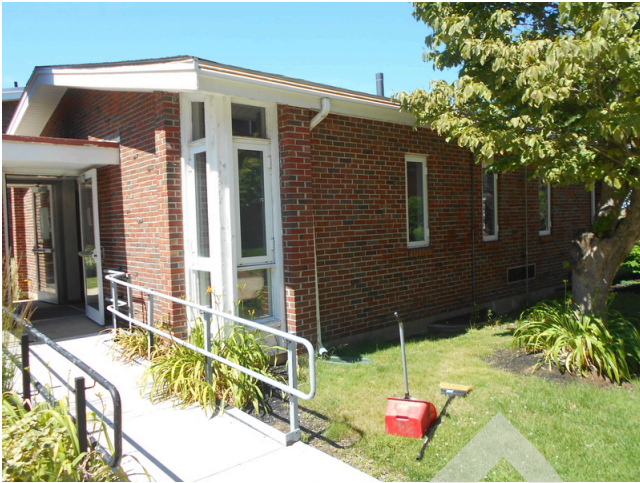
16. Community building, paint chipping (Non-Critical Repair)

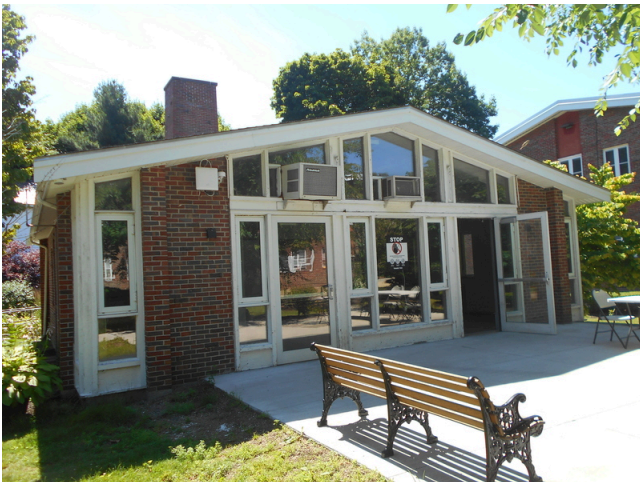
18. Community building window, paint chipping  
(Non-Critical Repair)

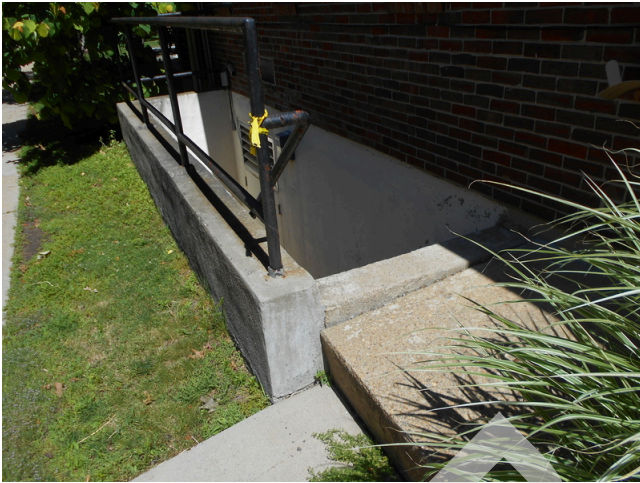
20. Community building rear façade, paint chipping  
(Non-Critical Repair)

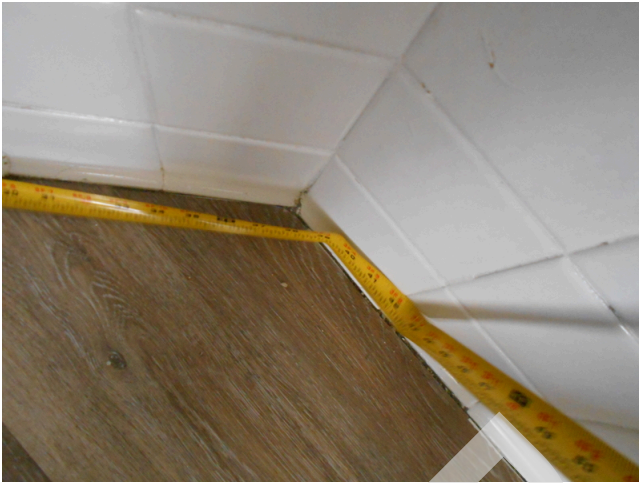
28. Men's public restroom, not enough clear floor space (Critical Repair)

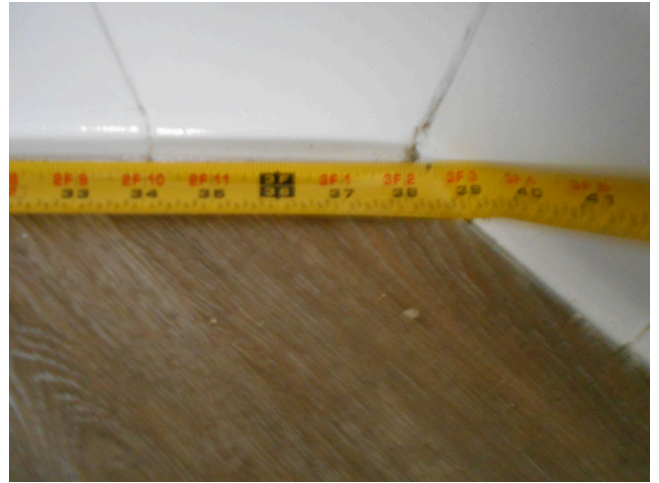
29. Men's public restroom, not enough clear floor space (Critical Repair)

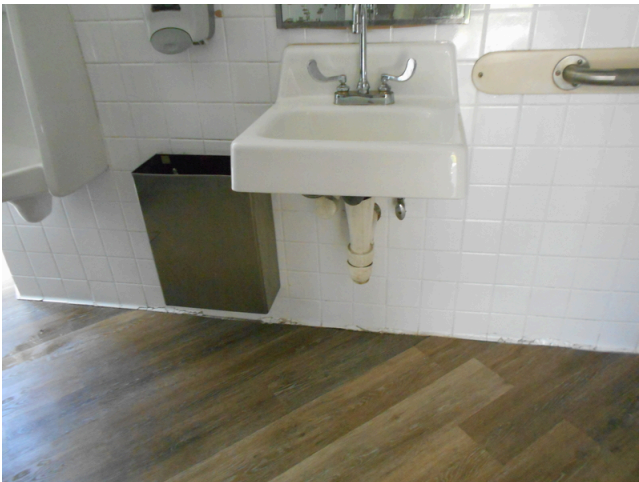
30. Men's public restroom, not enough clear floor space (Critical Repair)

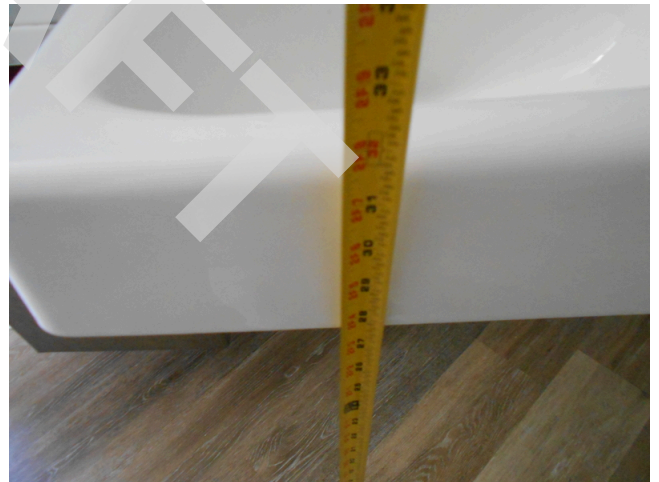
31. Men's public restroom, no scald abrasion protection (Critical Repair)

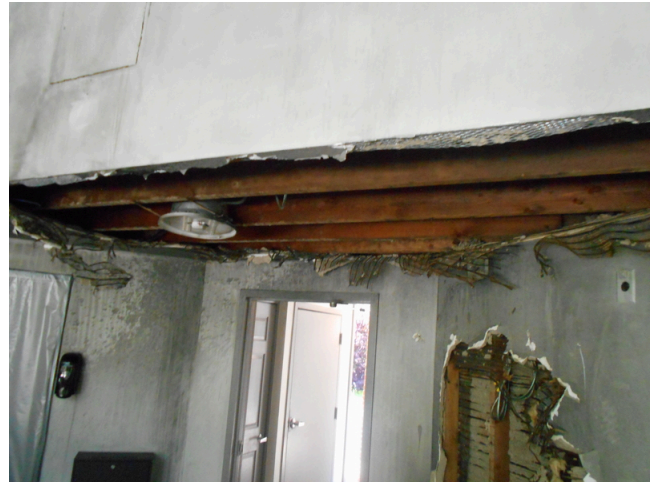
37. Community building main room, damaged by fire (Non-Critical Repair)

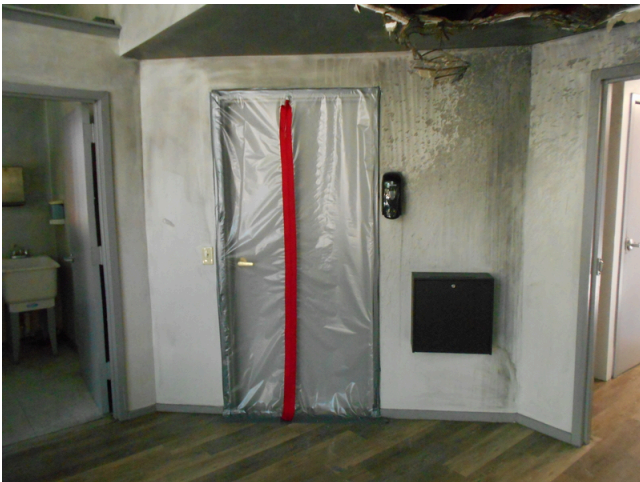
38. Community building main room, damaged by fire (Non-Critical Repair)

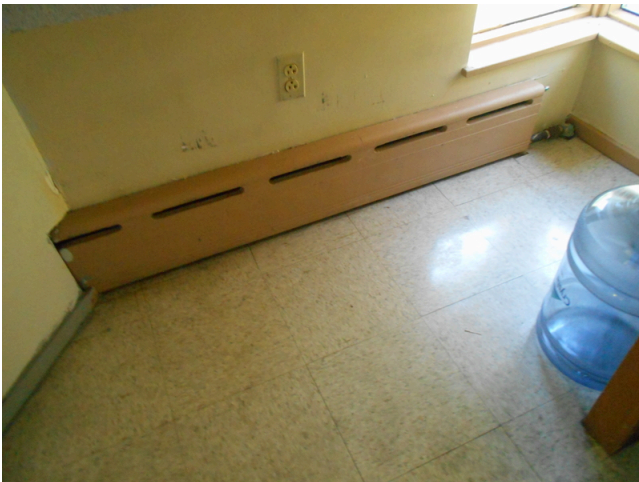
42. Community building laundry room, chipped vinyl tile floor (Non-Critical Repair)
