HUD CAPITAL NEEDS ASSESSMENT

ME McCormack
10 Kemp Street
South Boston, Massachusetts 02127

AEI Project No. 463360
Site Inspection Date: July 7th & July 8th

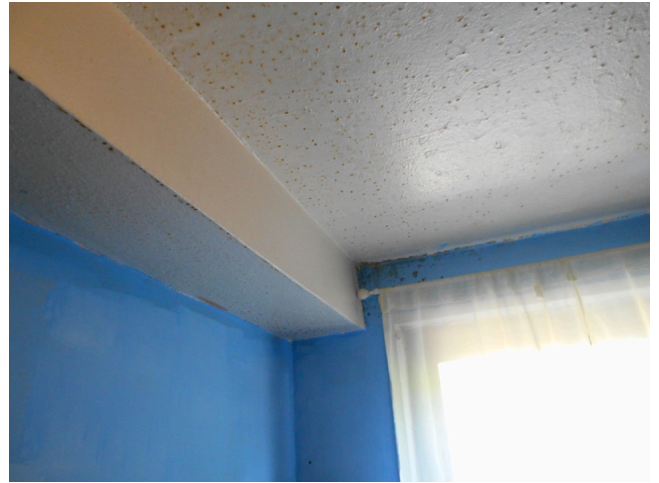
45. Building 2 unit 222, 2br/1ba - Kitchen ceiling, water damaged from uncovered stove (Non-Critical Repair)

46. Building 2 unit 222, 2br/1ba - Kitchen ceiling, water damaged from uncovered stove (Non-Critical Repair)

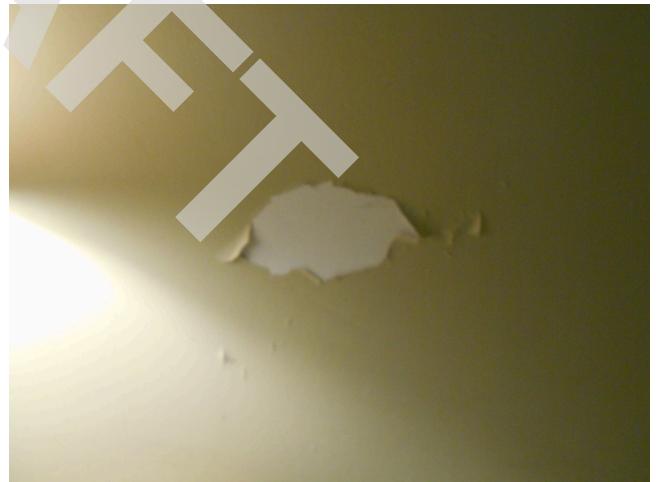
75. Building 3 unit 204, 28 O'Callaghan Way, 3br/
1ba Townhouse - Bedroom 2, damaged paint (Non-
Critical Repair)

76. Building 3 unit 204, 28 O'Callaghan Way, 3br/
1ba Townhouse - Bedroom 2, damaged paint (Non-
Critical Repair)

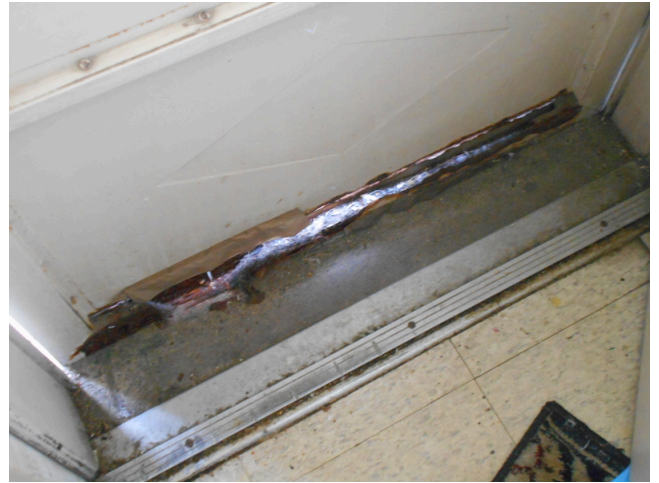
86. Building 4 unit 201, 34 O'Callaghan Way, 2br/1ba Townhouse - rear door (Non-Critical Repair)

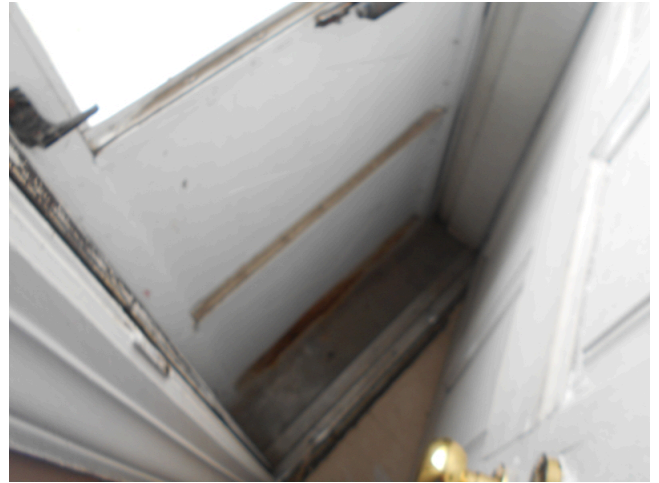
117. Building 5 unit 186, 64 O'Callaghan Way, 3br/1ba Townhouse - Rear door, damaged (Non-Critical Repair)

118. Building 5 unit 186, 64 O'Callaghan Way, 3br/1ba Townhouse - Rear door, damaged (Non-Critical Repair)

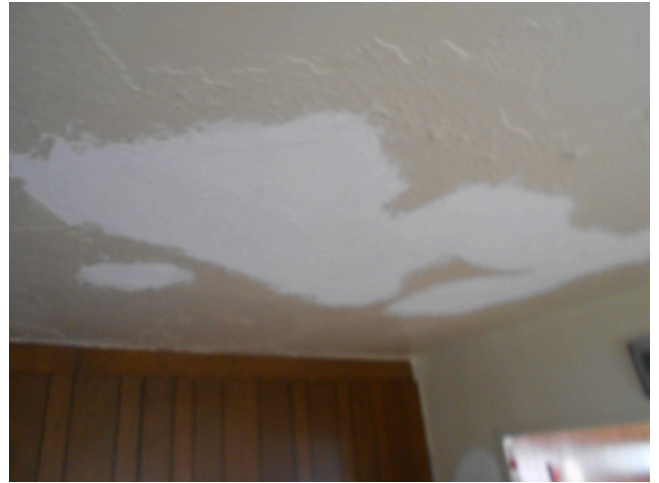
121. Building 9 unit 132, 172 O'Callaghan Way, 3br/
1ba Townhouse - Living area, paint damaged ceiling
(Non-Critical Repair)

122. Building 9 unit 132, 172 O'Callaghan Way, 3br/
1ba Townhouse - Living area, paint damaged ceiling
(Non-Critical Repair)

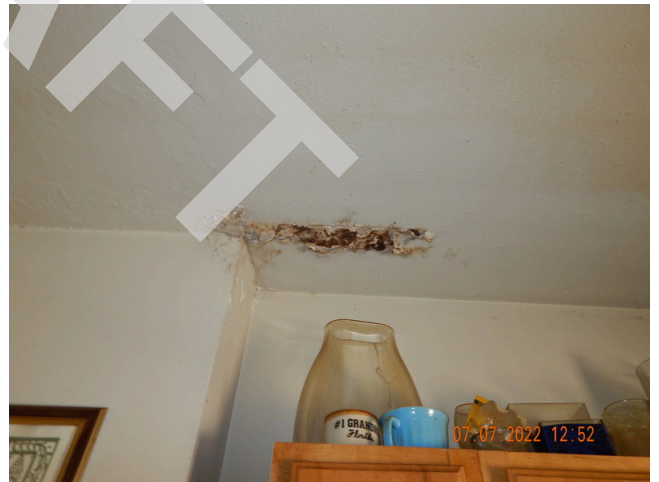
123. Building 9 unit 132, 172 O'Callaghan Way, 3br/
1ba Townhouse - Kitchen, water damaged ceiling
(Non-Critical Repair)

124. Mold, leak in Unit 1013

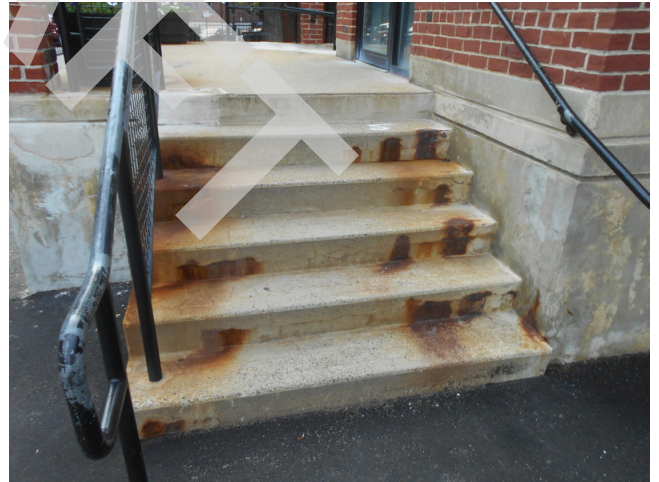
12. Leasing office concrete stairs, rebar rust (Non-Critical Repair)

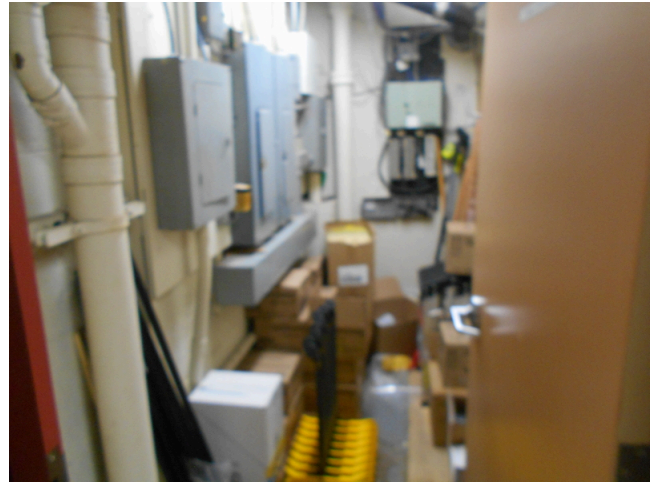
37. Leasing office basement, damaged vinyl tile
(Non-Critical Repair)

38. Leasing office electrical room, remove debris
from the room (Critical Repair)

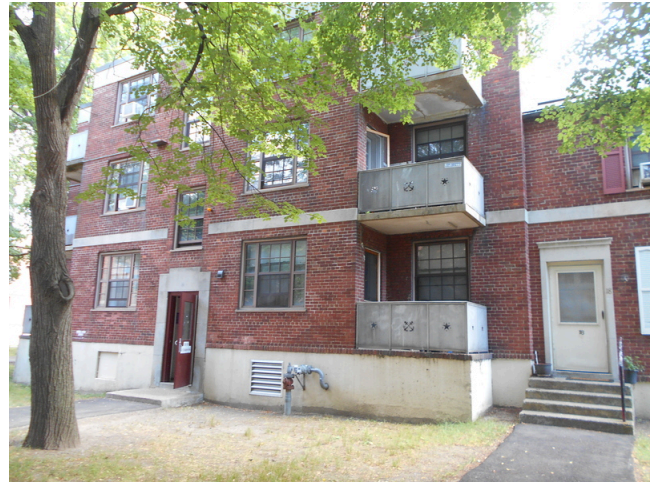
44. Building 3 handicap street parking, no curb cut or access aisle (Critical Repair)

45. Building 3 handicap street parking, no curb cut or access aisle (Critical Repair)

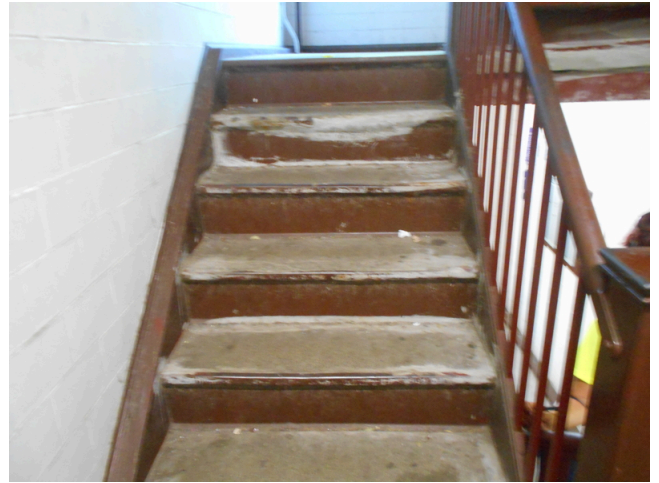
53. Typical stairwell, paint chipping (Non-Critical Repair)

54. Typical stairwell, stairs damaged (Non-Critical Repair)

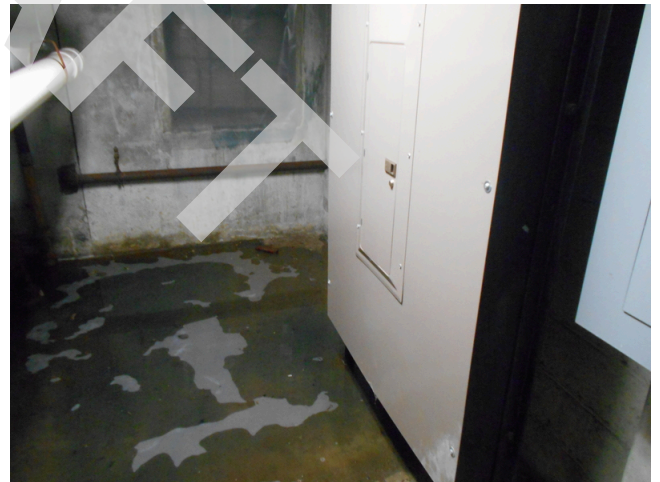
59. Building 1 basement water intrusion (Non-Critical Repair)

60. Building 1 basement water intrusion (Critical Repair)

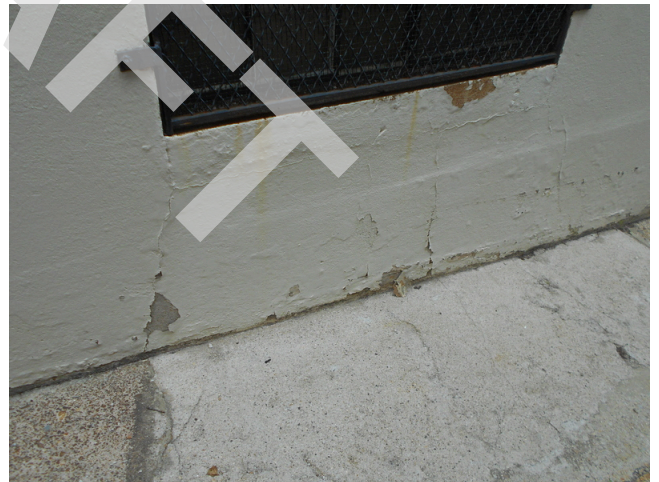
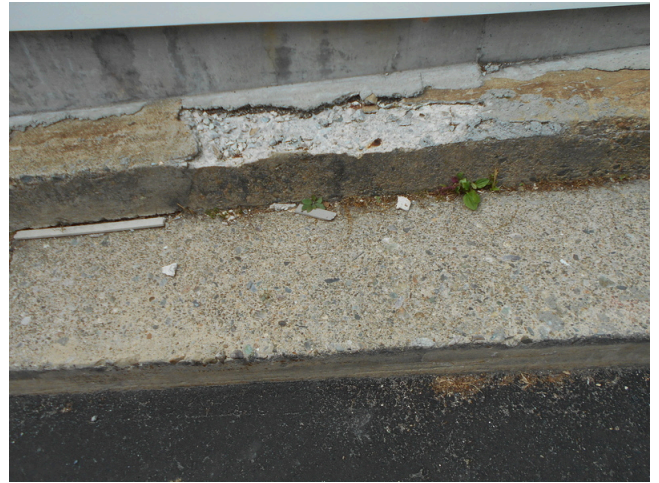
74. Paint chipping along side façade of leasing office
(Non-Critical Repair)

75. Paint chipping along side façade of leasing office
(Non-Critical Repair)

76. Paint chipping along side façade of leasing office
(Non-Critical Repair)

77. Paint chipping along side façade of leasing office
(Non-Critical Repair)

78. Leasing office side façade, damaged concrete
(Non-Critical Repair)

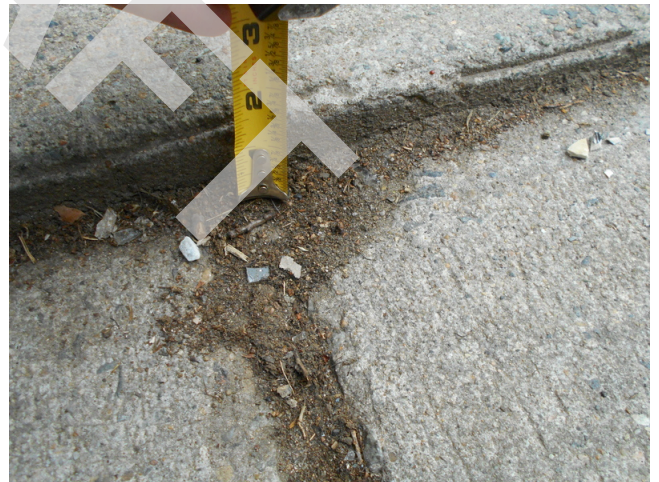
114. Concrete trip hazard between building 3 and building 4 (Critical Repair)

115. Concrete trip hazard between building 3 and building 4 (Critical Repair)

116. Concrete trip hazard between building 3 and building 4 (Critical Repair)

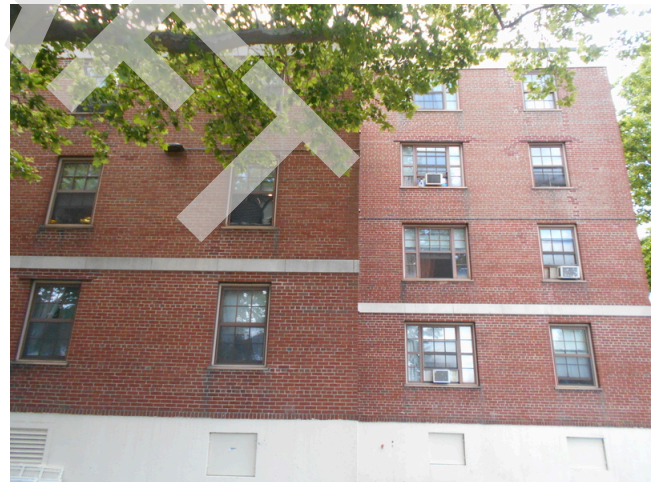
142. 3 O'Callaghan way entrance, damaged entry (Non-Critical Repair)

143. 3 O'Callaghan way entrance, damaged entry (Non-Critical Repair)

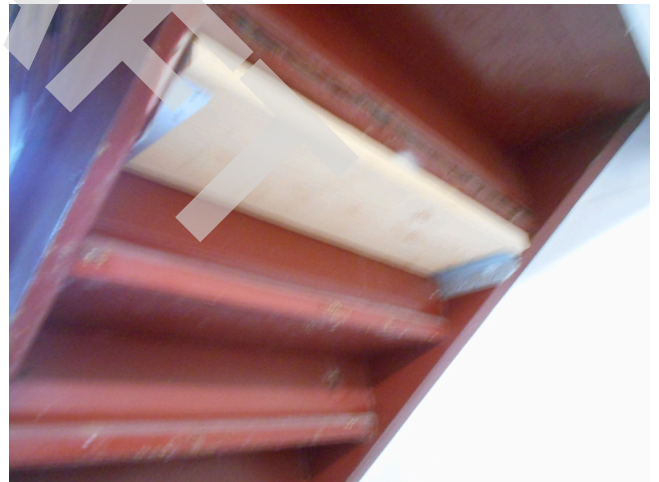
147. Building 32, 41 Logan way stairwell, damaged stairs (Non-Critical Repair)

148. Building 32, 41 Logan way stairwell, damaged stairs (Non-Critical Repair)

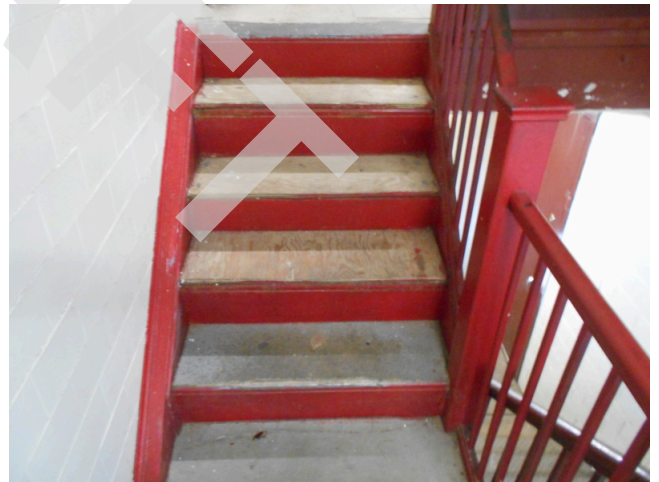
154. Building 32, 37 Logan way stairwell, damaged stairs (Non-Critical Repair)

155. Building 32, 37 Logan way stairwell, damaged stairs (Non-Critical Repair)

156. Building 32, 37 Logan way stairwell, damaged stairs (Non-Critical Repair)

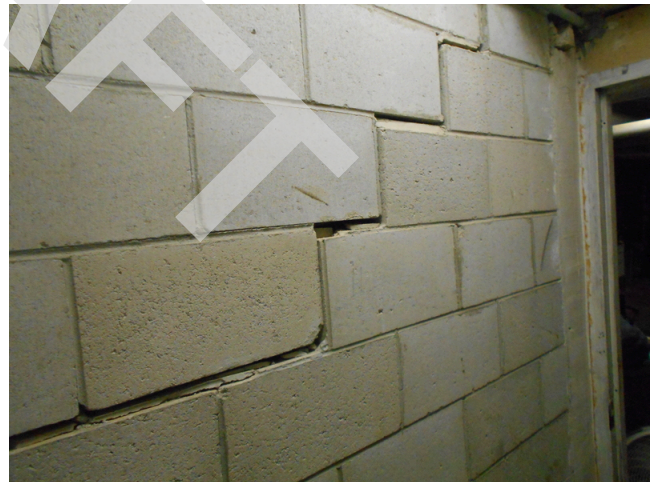
167. Building 30 basement, 15 Logan way, cracking CMU-wall (Non-Critical Repair)

168. Building 30 basement, 15 Logan way, cracking CMU-wall (Non-Critical Repair)

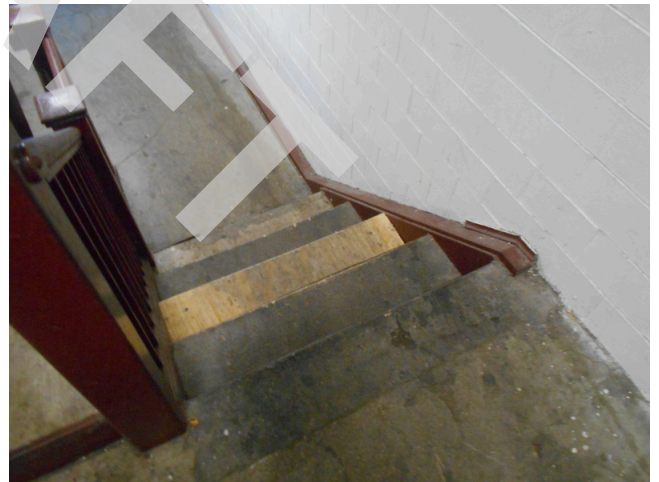
183. Building 19, 2 Sterling square stairwell, damaged stairs (Non-Critical Repair)

184. Building 19, 2 Sterling square stairwell, damaged stairs (Non-Critical Repair)

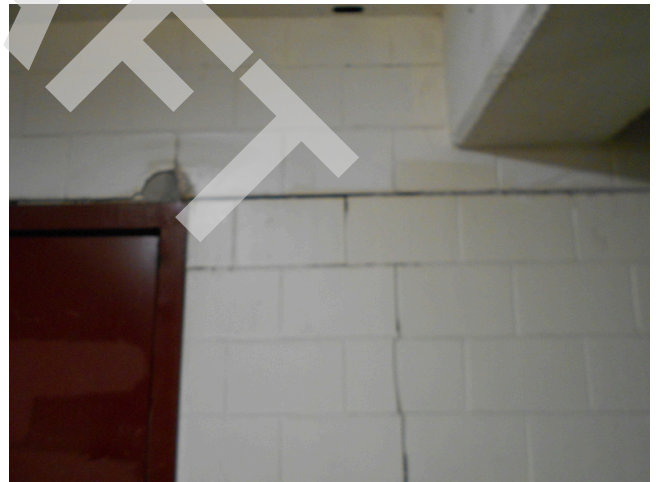
187. Building 23, 2 Logan Way basement, cracking CMU-wall (Non-Critical Repair)

188. Building 23, 2 Logan Way basement, cracking CMU-wall (Non-Critical Repair)

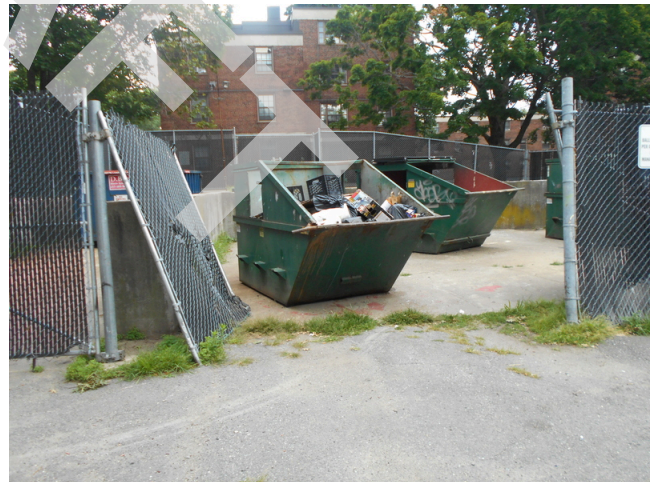
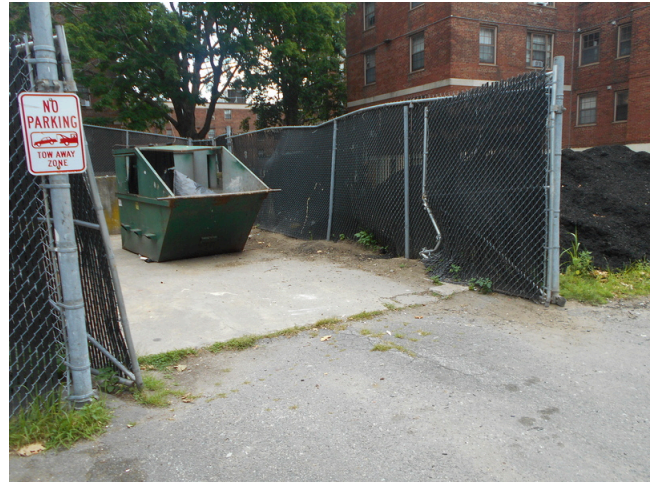
195. Refuse area by building 30, damaged fencing (Non-Critical Repair)

196. Refuse area by building 30, damaged fencing (Non-Critical Repair)

197. Refuse area by building 30, damaged fencing
(Non-Critical Repair)

198. Refuse area by building 30, damaged fencing
(Non-Critical Repair)

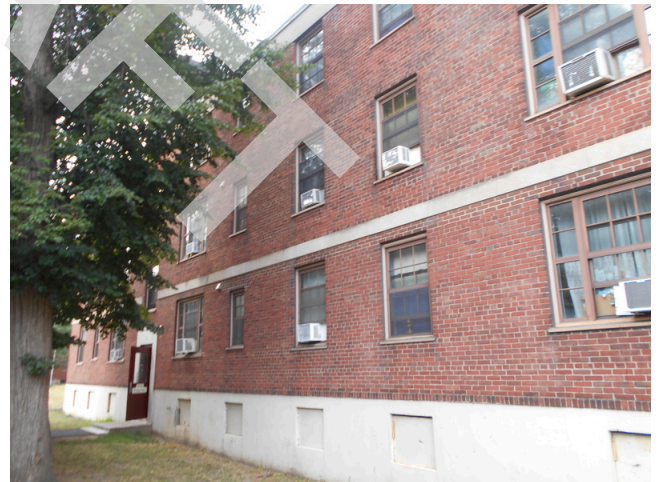
214. Building 32, 33 Logan way stairwell entrance, Concrete stairs at entrance eroded (Non-Critical Repair)

215. Building 32, 33 Logan way stairwell entrance, Concrete stairs at entrance eroded (Non-Critical Repair)

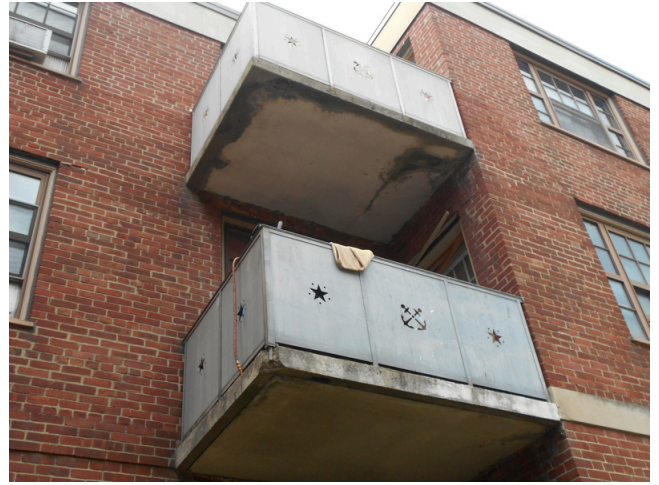
221. Building 32, concrete balcony, deterioration on underside (Critical Repair)

222. Building 32, concrete balcony, deterioration on underside (Critical Repair)

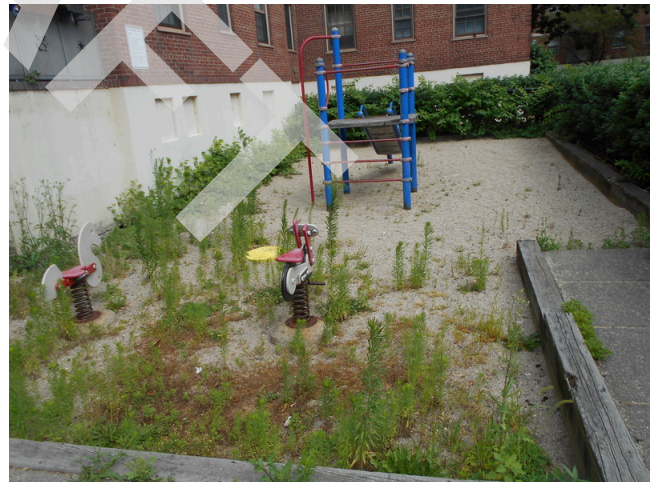
227. Playground by building 22, overgrown (Non-Critical Repair)

228. Playground by building 22, overgrown (Non-Critical Repair)
