**CAPITAL NEEDS ASSESSMENT (CNA)
CODMAN APARTMENTS (2-51)
784 WASHINGTON STREET
DORCHESTER, MASSACHUSETTS 02124**

D3G PROJECT NUMBER:

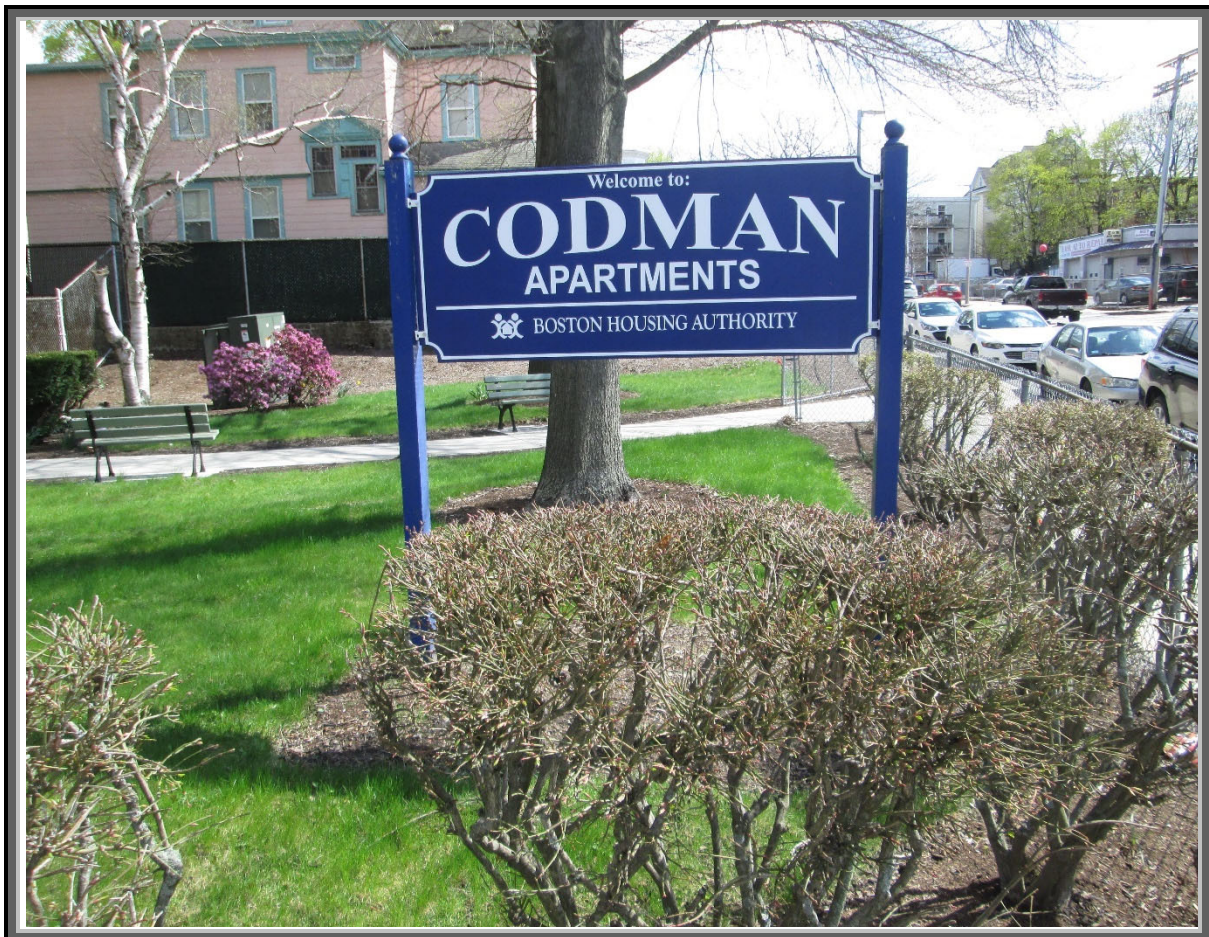
Site Description: Codman Apartments (2-51), located at 784 Washington Street in Dorchester, Massachusetts consists of one (1) seven-story age-restricted apartment building. The building features one hundred and two (102) dwelling units. According to property management, the building was constructed in 1972. According to tax records, the building is situated on 2.04 acres. According to D3G estimates, the building features an approximate gross area of 73,352 square feet. The property is in fair physical condition.

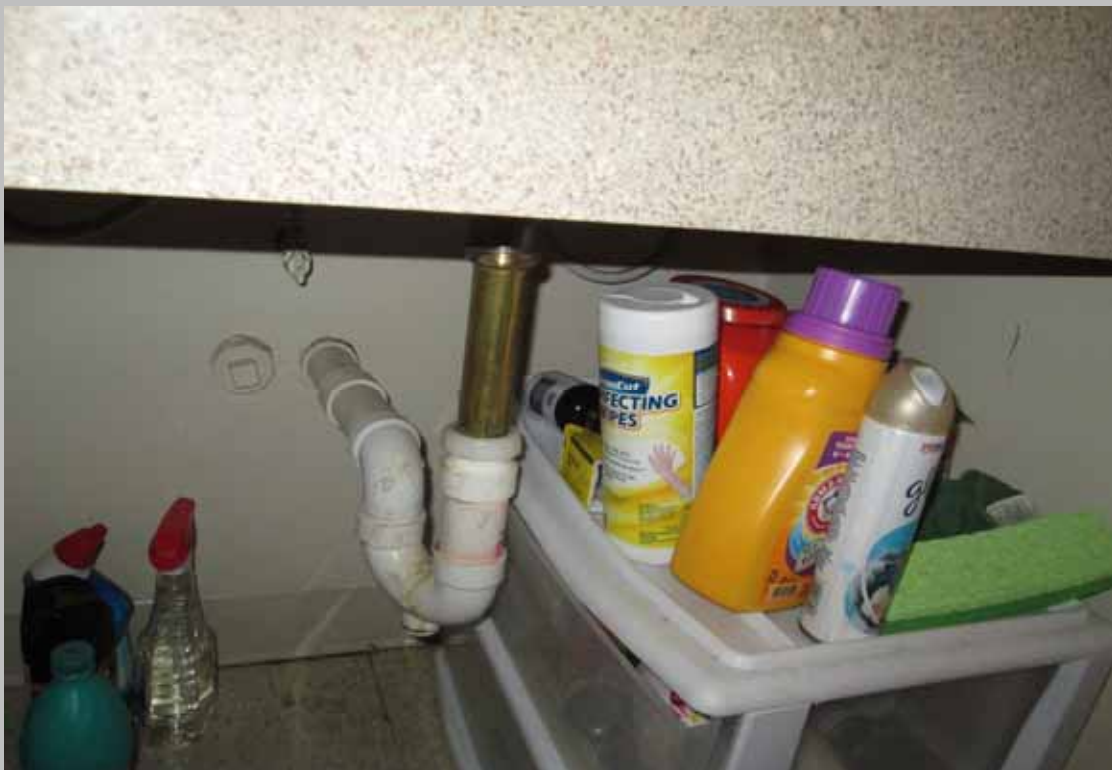
View of the kitchen sink in HC Unit 514 lacking scald and abrasion protection on piping (Critical Repairs)

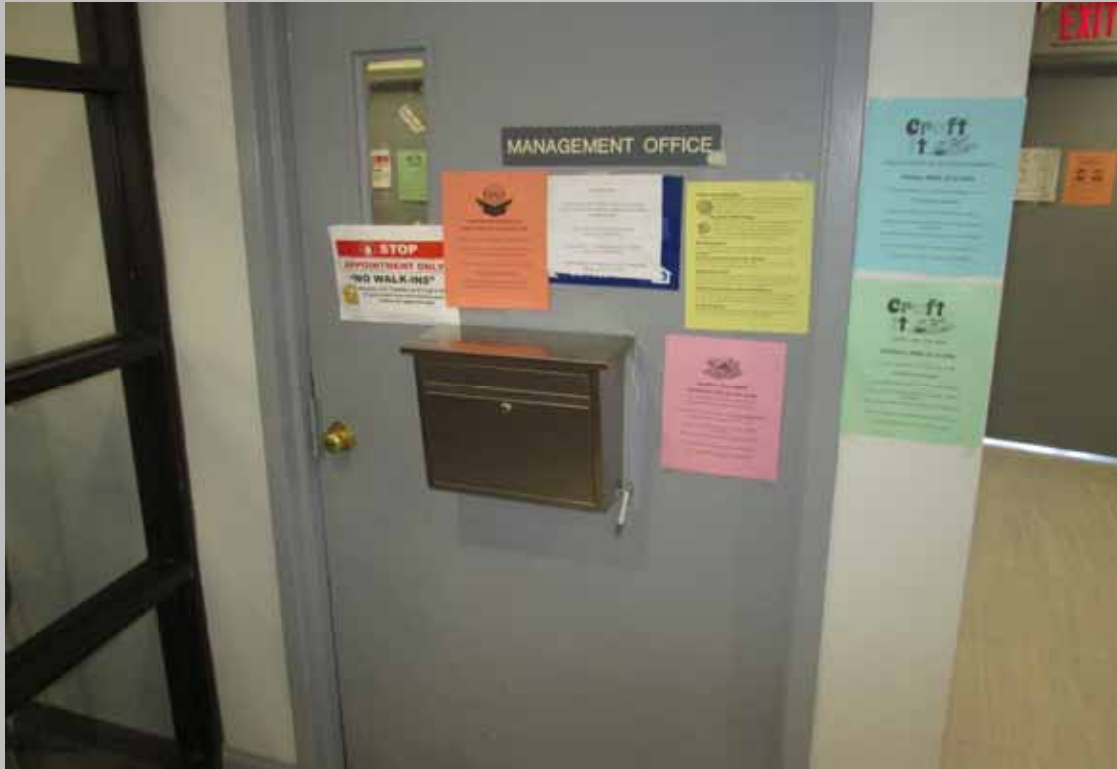
View of the public management office (leasing office) entry door lacking levered hardware (Critical Repair)

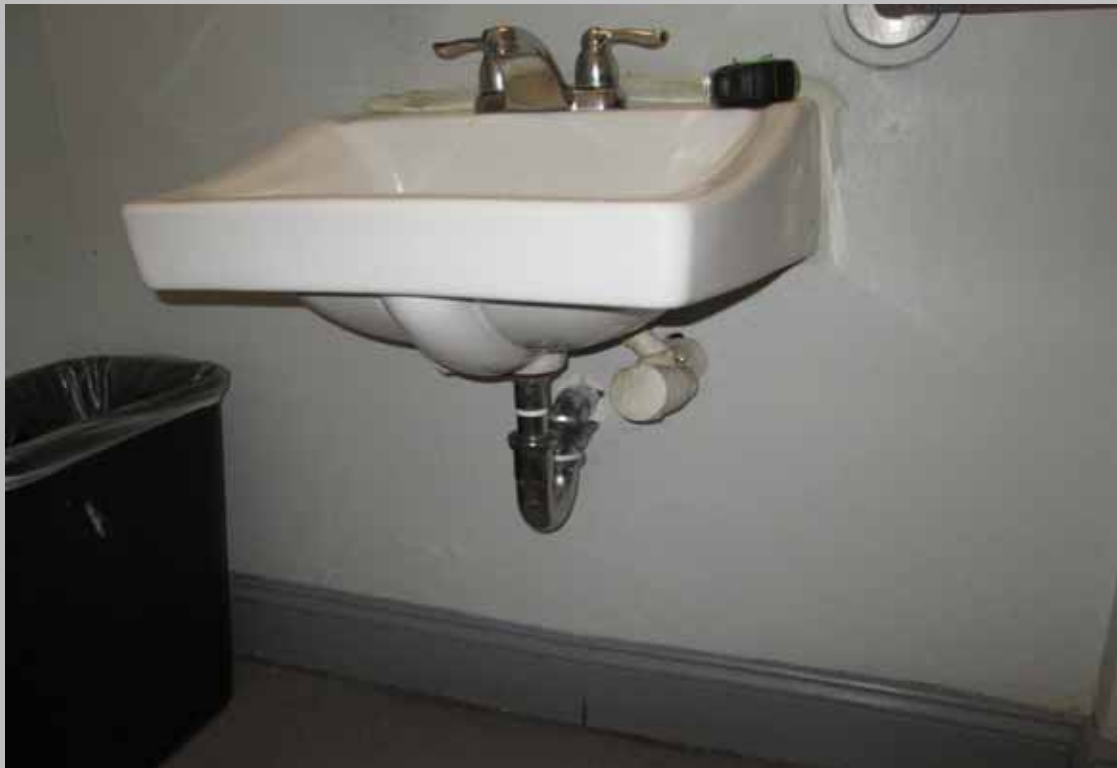
View of the common area restroom sink lacking scald and abrasion protection on piping (Critical Repair)

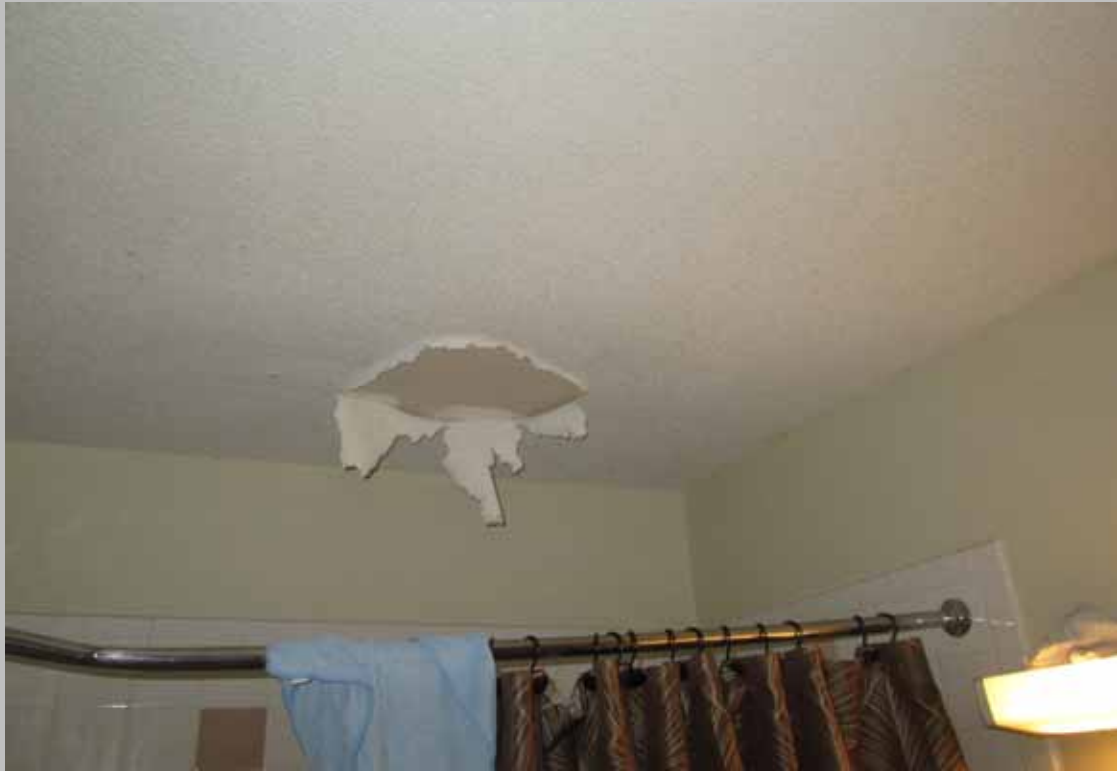
View of peeling paint in Unit 509
(Non-Critical Repair)

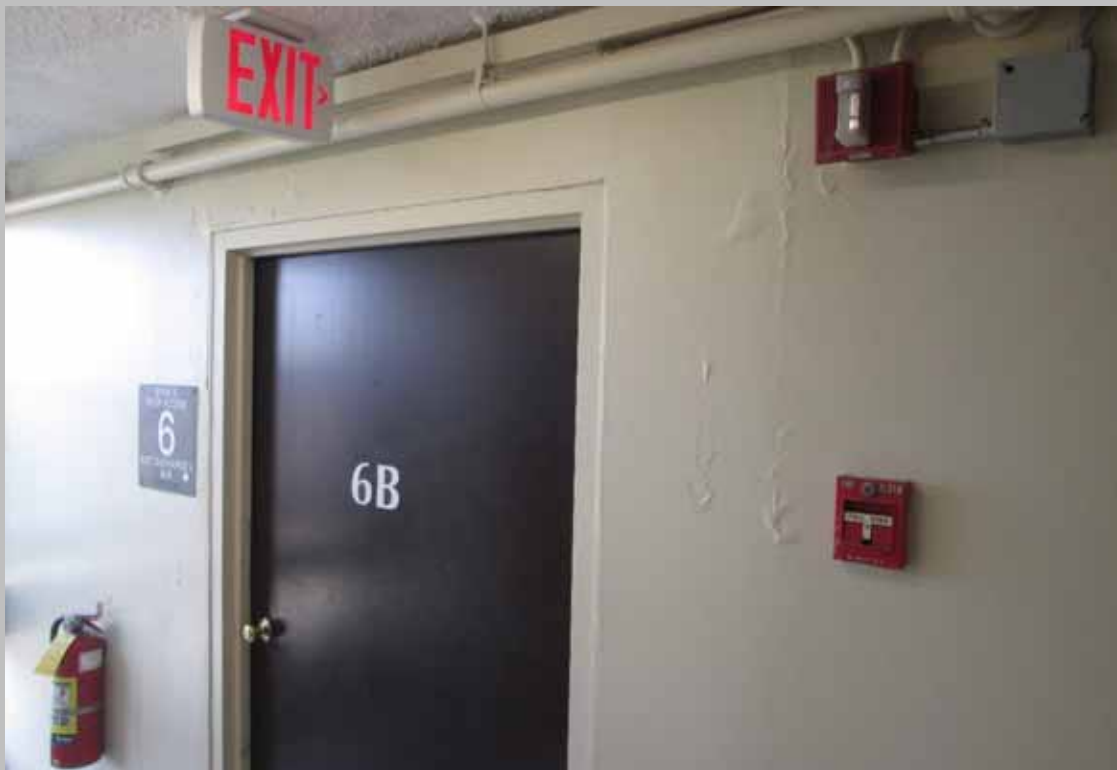
View of 6th floor hallway damage caused from the roof leak
(Non-Critical Repairs)

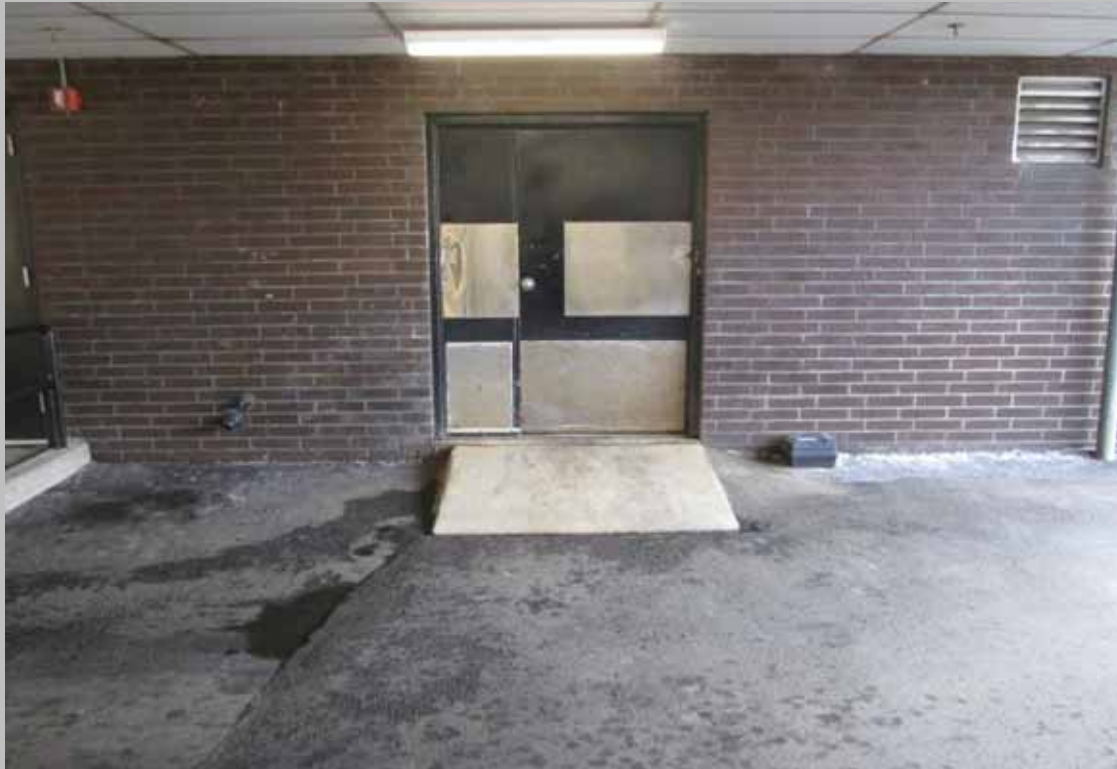
View of deteriorating brick mortar – select locations (Non-Critical Repair)

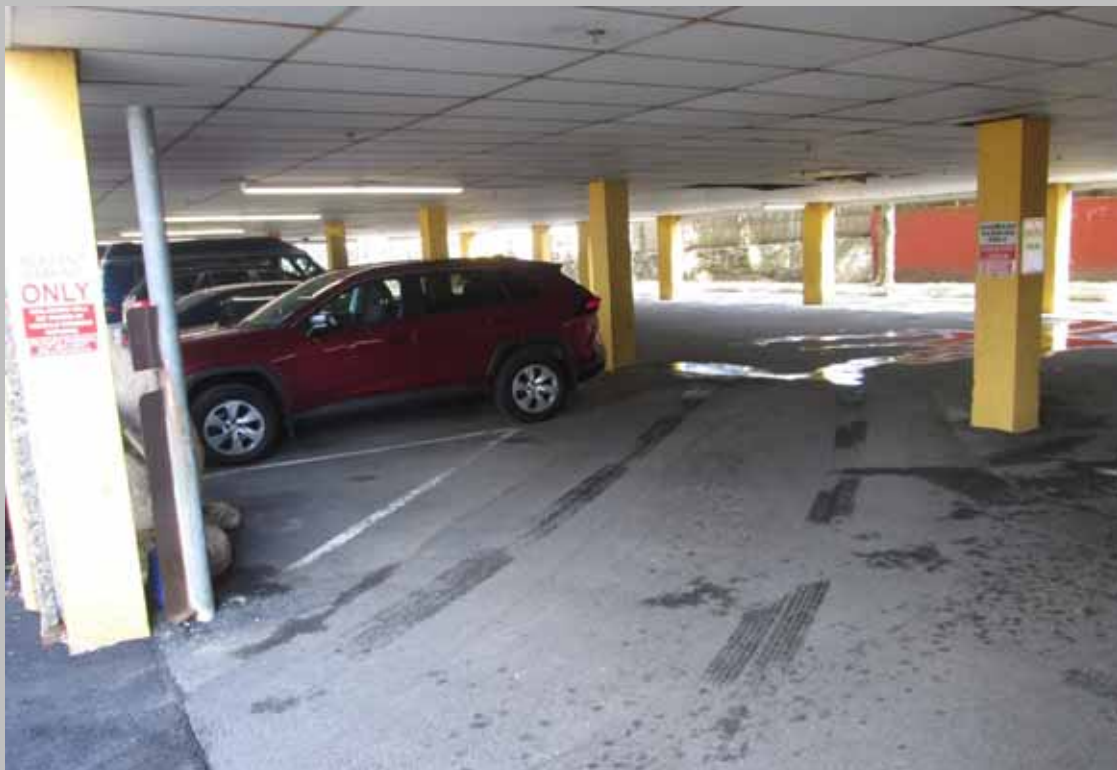
View of water damage to ceiling at covered parking area (Non-Critical Repair)

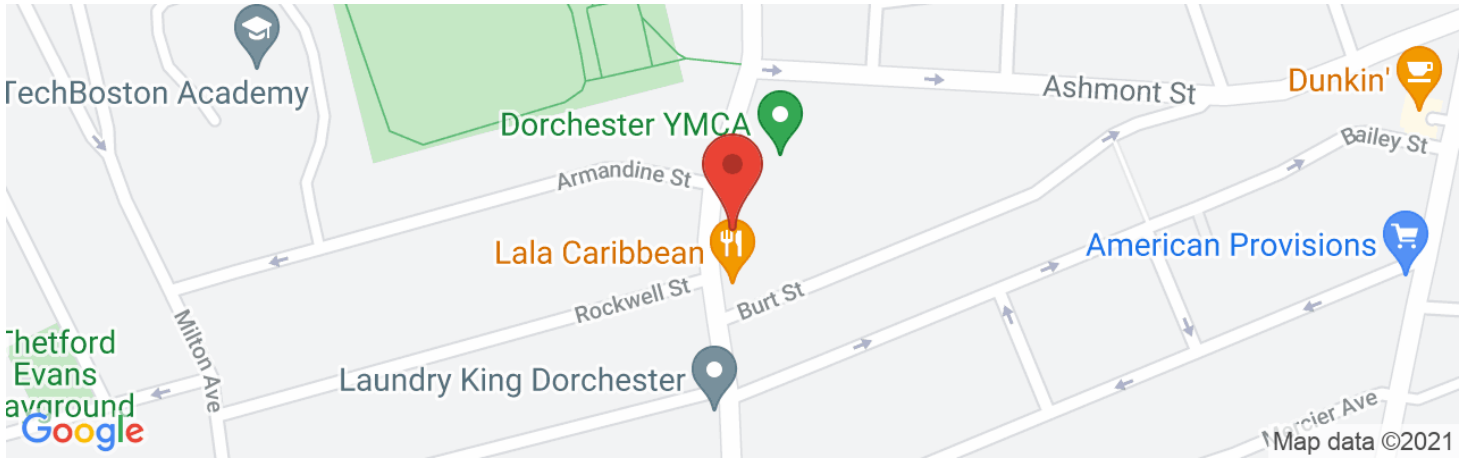
Date	5/13/2021, 10:30:22 AM
Design Code Reference Document	ASCE41-13
Custom Probability	
Site Class	D - Stiff Soil
