**CAPITAL NEEDS ASSESSMENT (CNA)  
FOLEY APARTMENTS (2-30)  
199 H STREET  
SOUTH BOSTON, MASSACHUSETTS 02127**

**D3G PROJECT NUMBER:  
2021-0372**

**FINAL REPORT ISSUE DATE:  
NOVEMBER 5, 2021**

**INSPECTION DATE:  
APRIL 19-20, 2021**

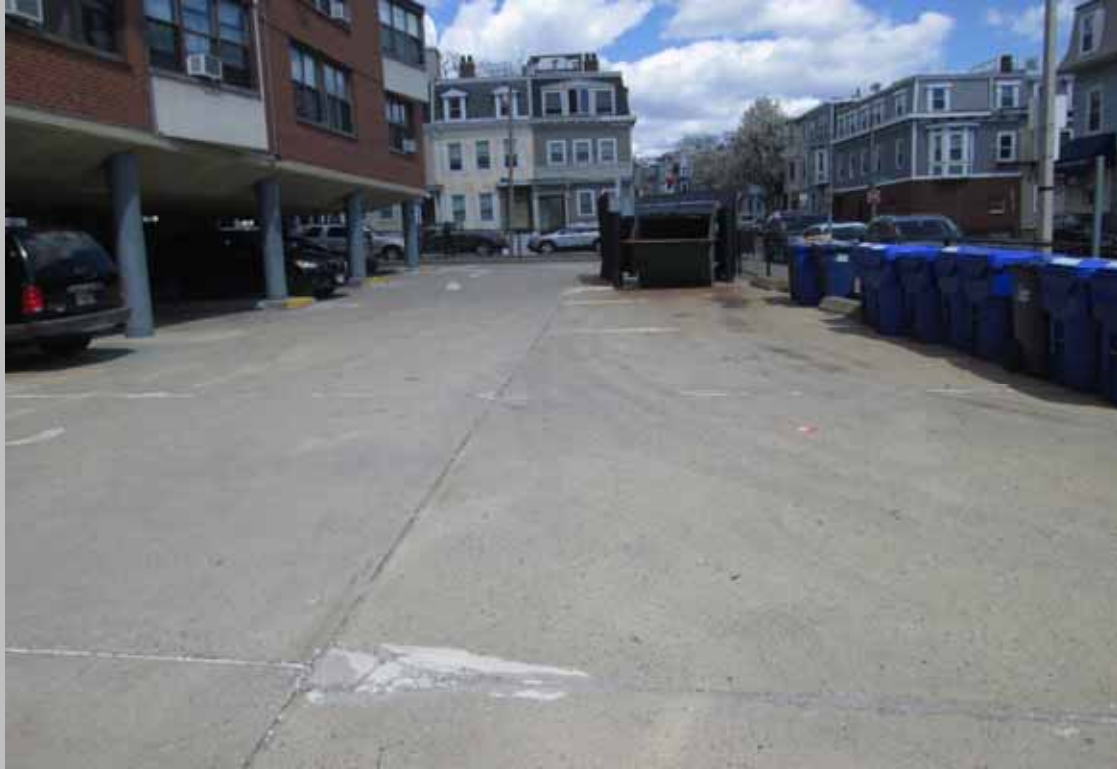
PHOTO #7

Concrete drive aisle

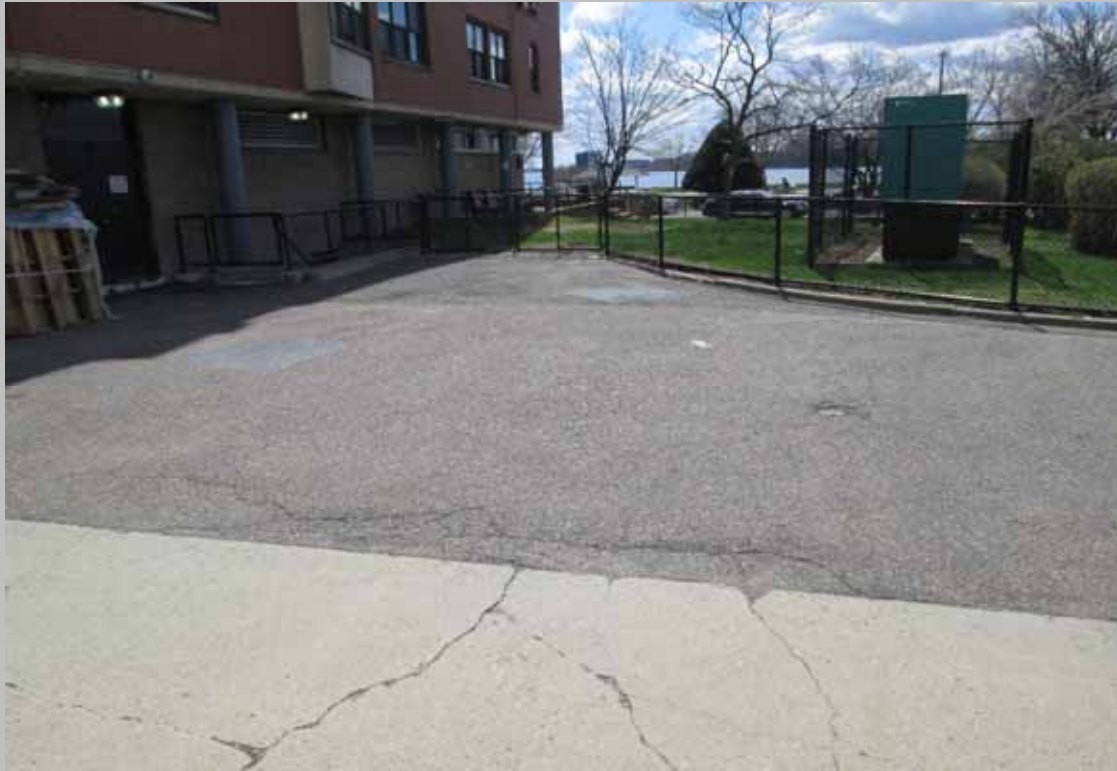
PHOTO #9

Asphalt area

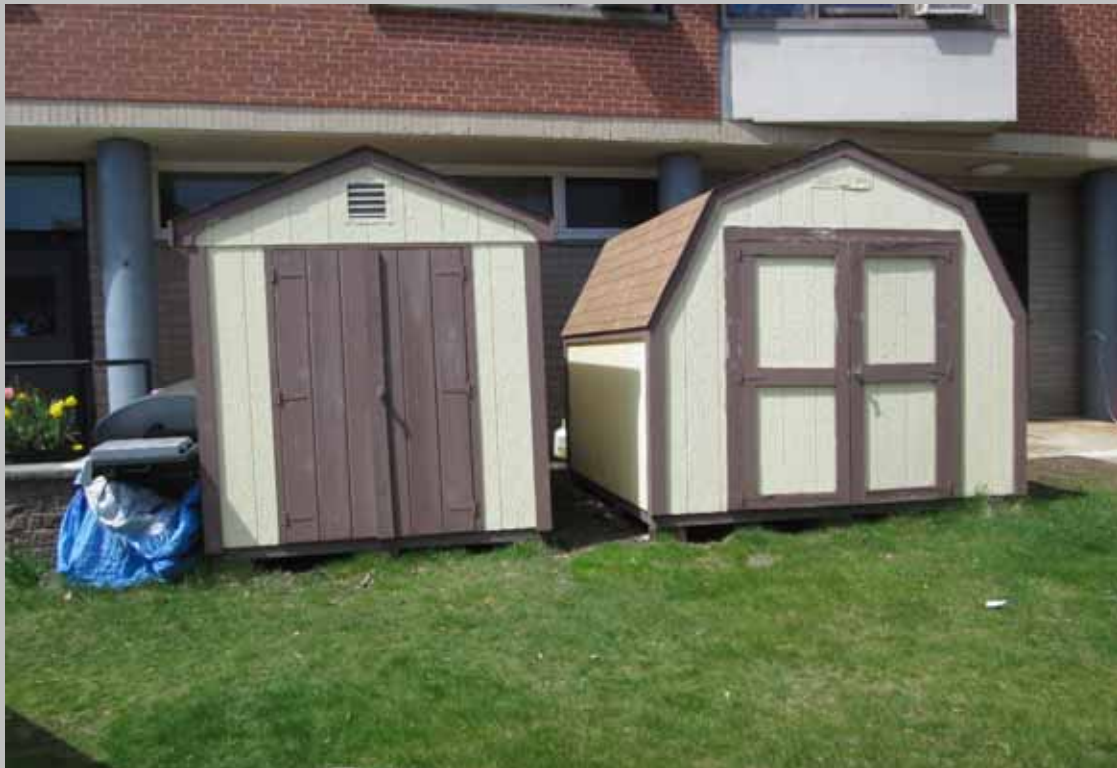
PHOTO #12

sheds were observed in fair physical condition and will require replacement during the estimate period.

Storage sheds

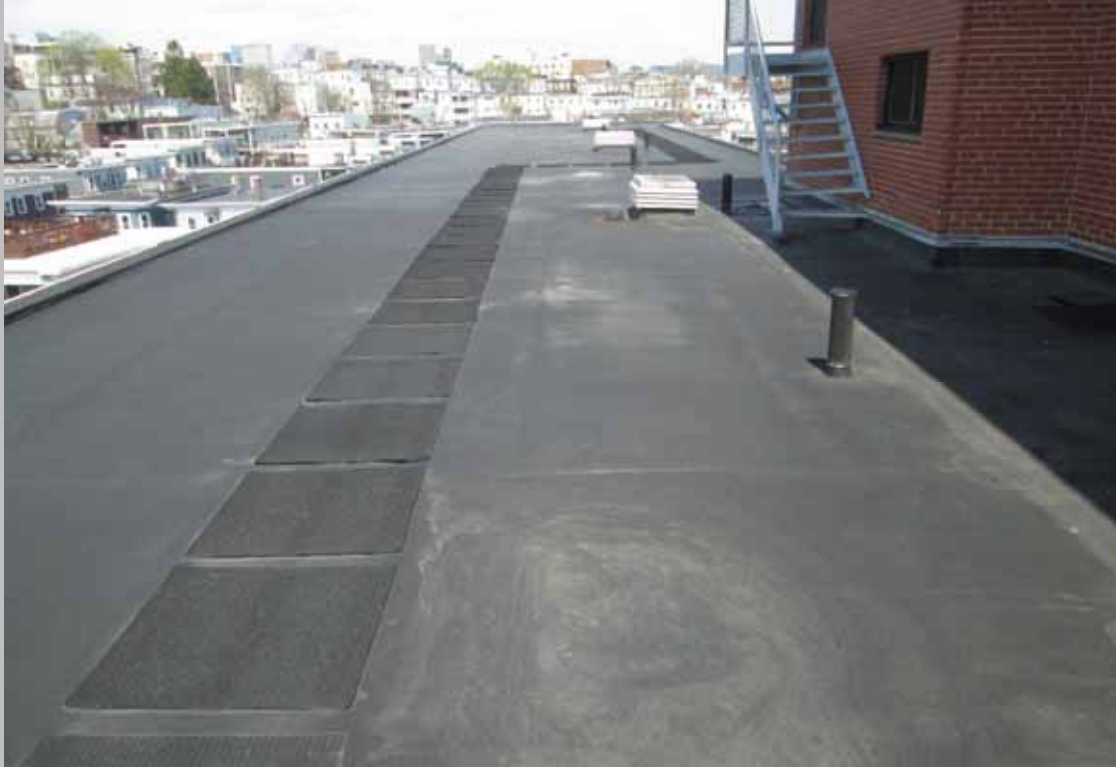
PHOTO #15

Roof surface – west side

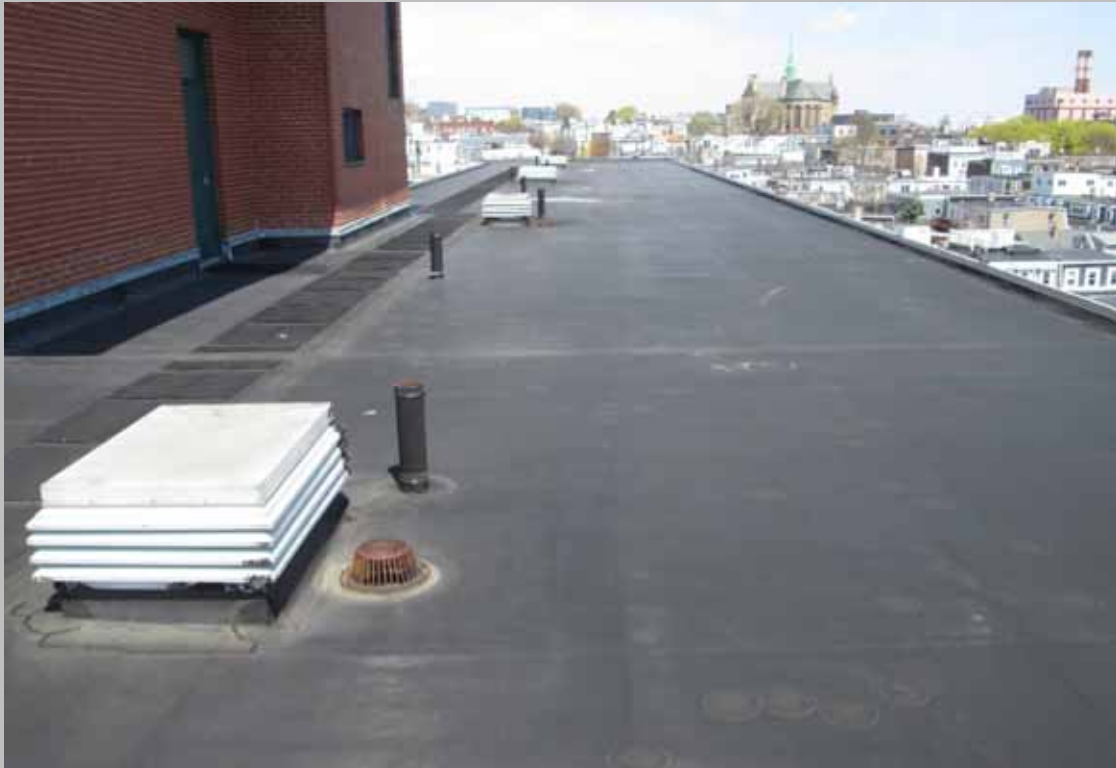
PHOTO #16

Roof surface – east side

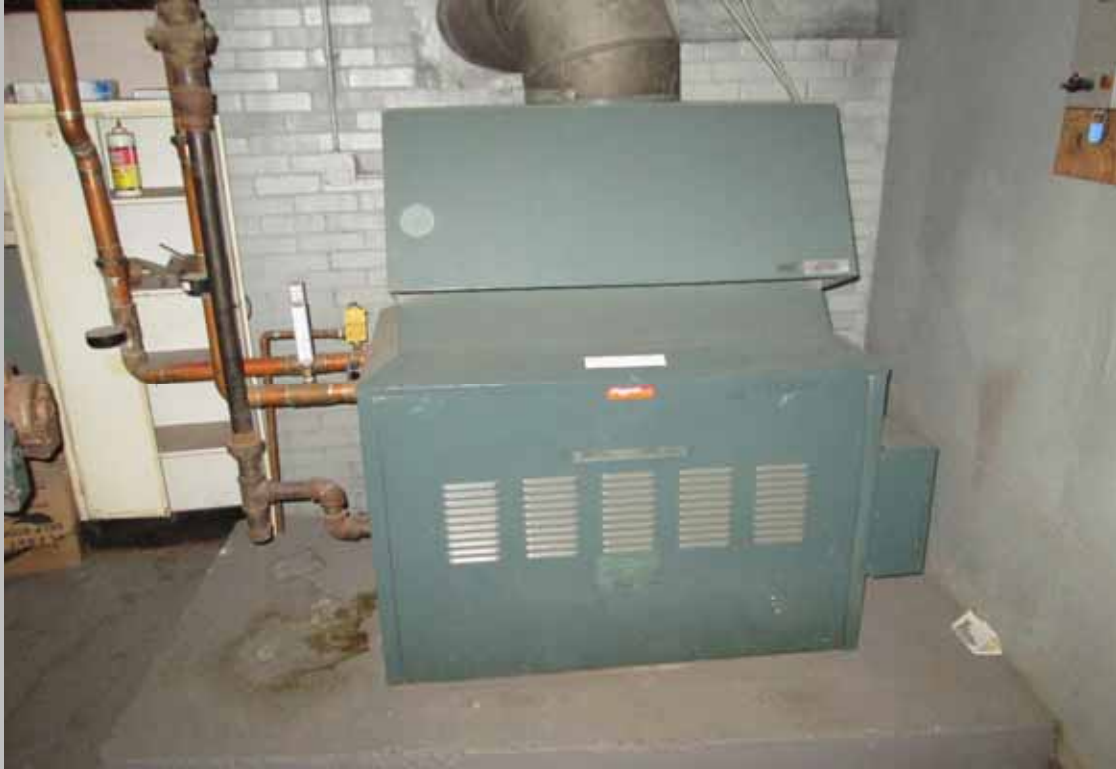
PHOTO #25

Raypack DHW boiler

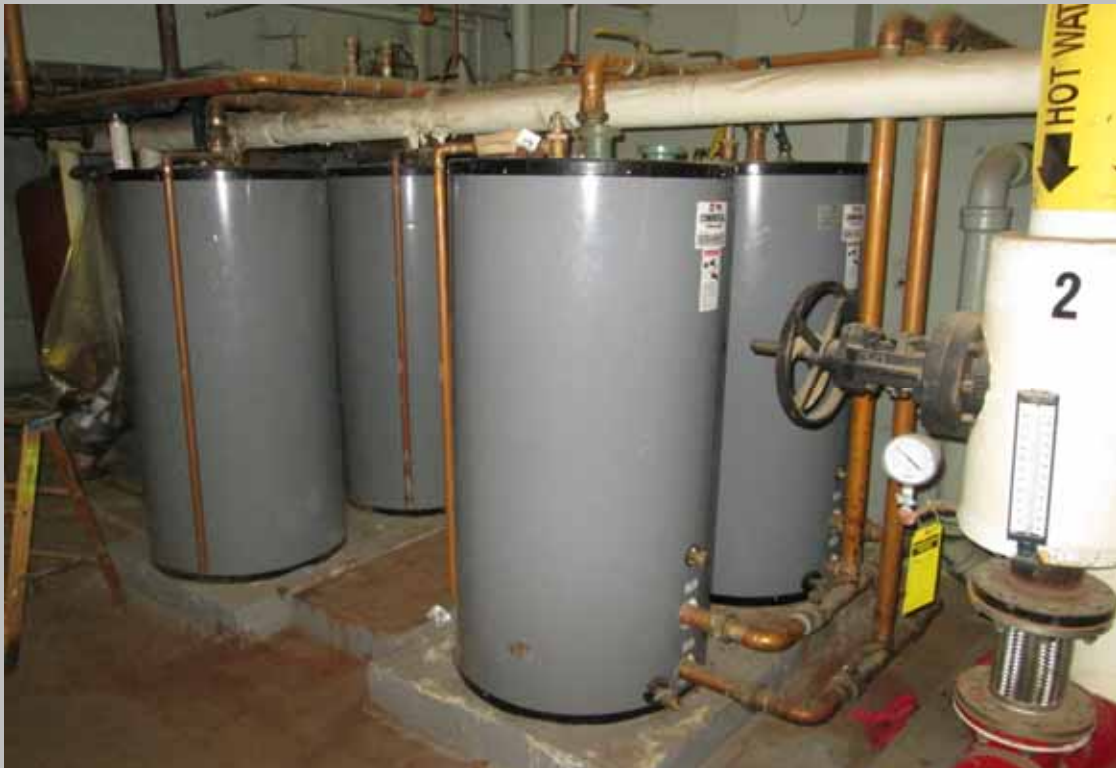
PHOTO #26

Potable hot water to the building is supplied by a natural gas-fired boiler and four (4) commercial storage tanks located in the boiler room in the partial basement. The equipment appears to have been installed in 2007 and was generally observed in fair to good physical condition. The recovery of the hot water system is reported to be sufficient for the number of fixtures served and no complaints concerning a lack of hot water were raised during the inspection. Replacement of the storage tanks is anticipated during the estimate period.

Rheem DHW commercial storage tanks

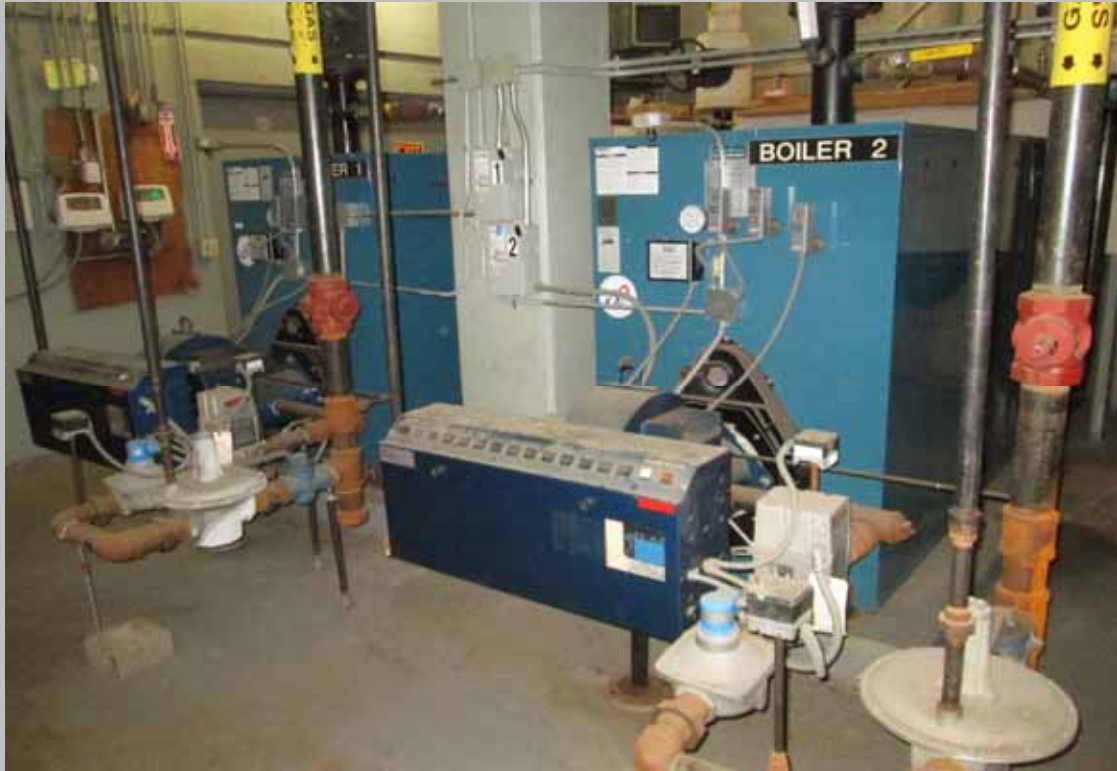
PHOTO #27

Burnham heating boilers

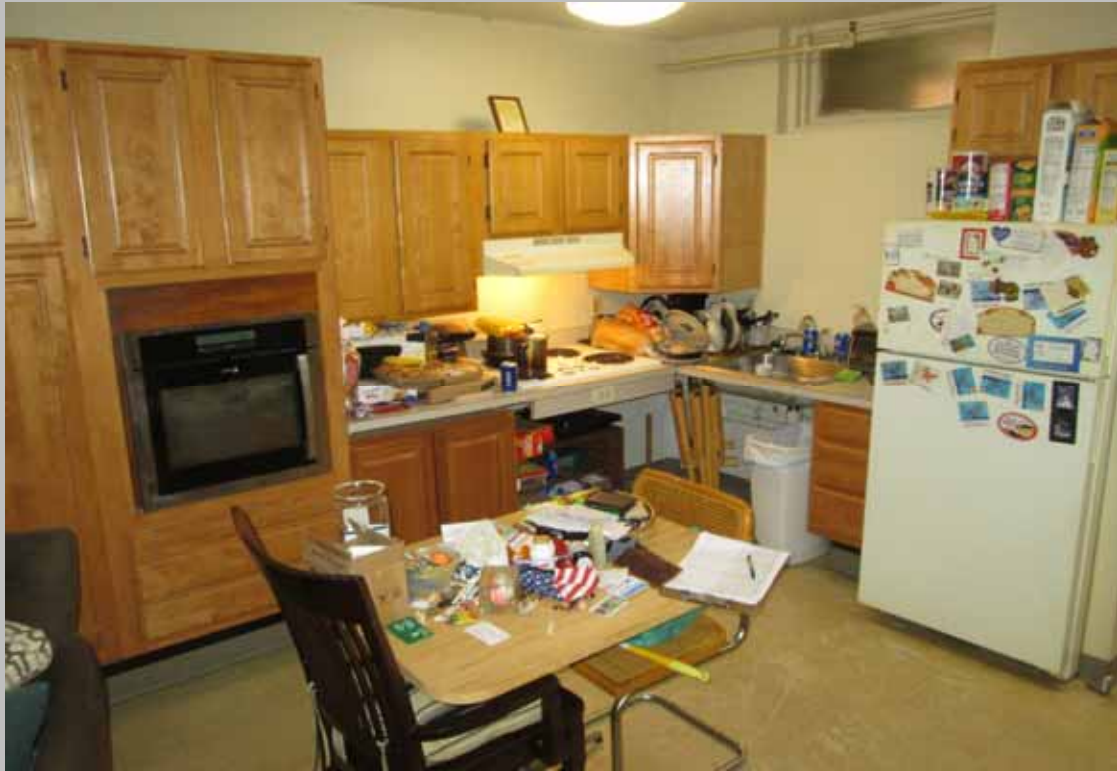
PHOTO #49

HC unit kitchen without 30-inch workspace

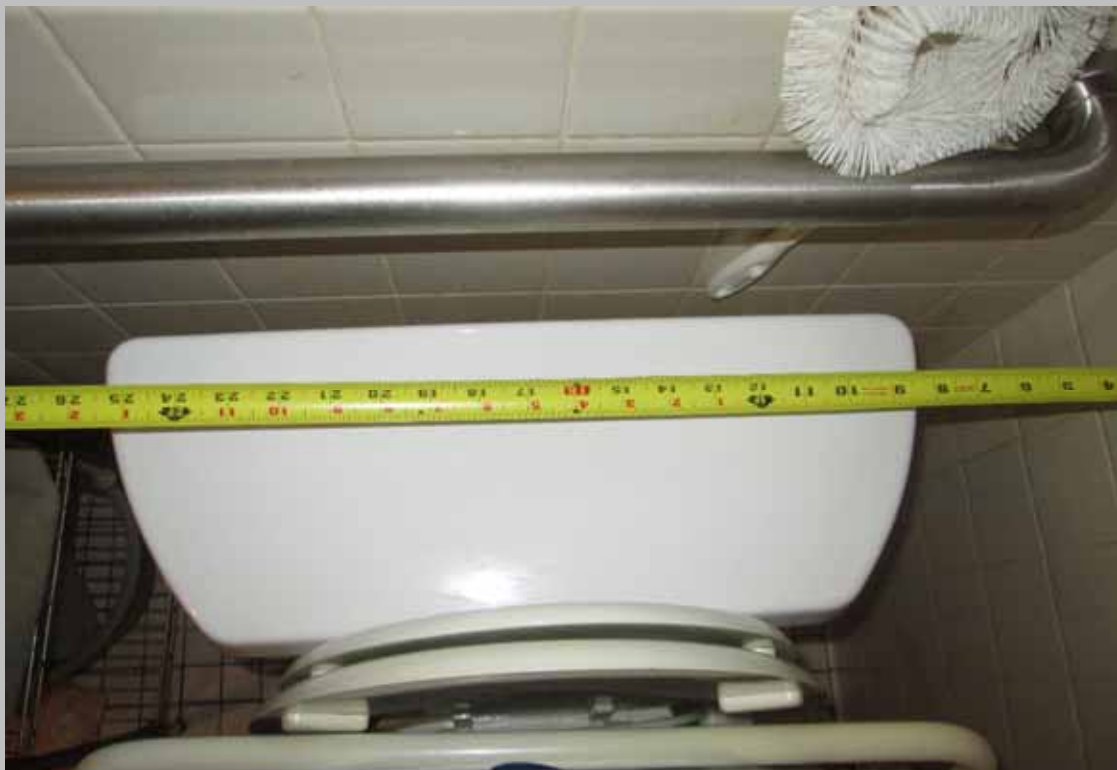
PHOTO #56

HC unit toilet centerline is not 18-inches from the adjacent wall

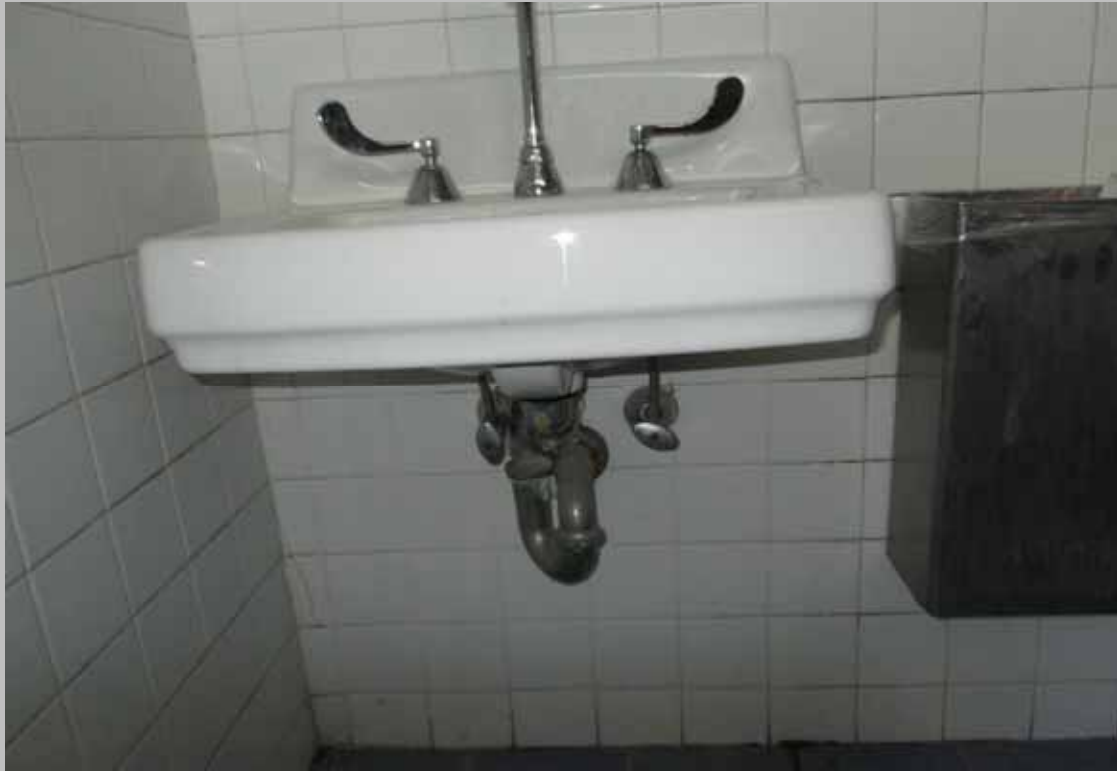
PHOTO #61

Common area restroom sink missing scald and abrasion protection on exposed piping  
(Critical Repairs)

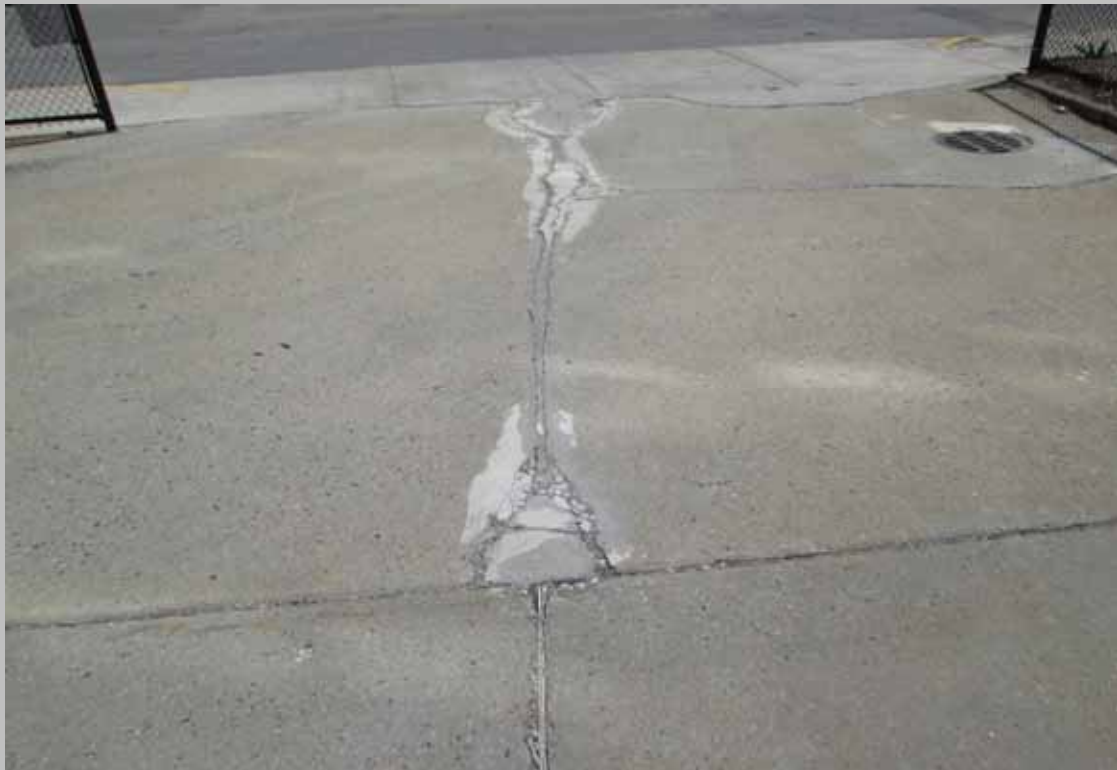
PHOTO #62

Cracked/damaged concrete  
(Non-Critical Repairs)

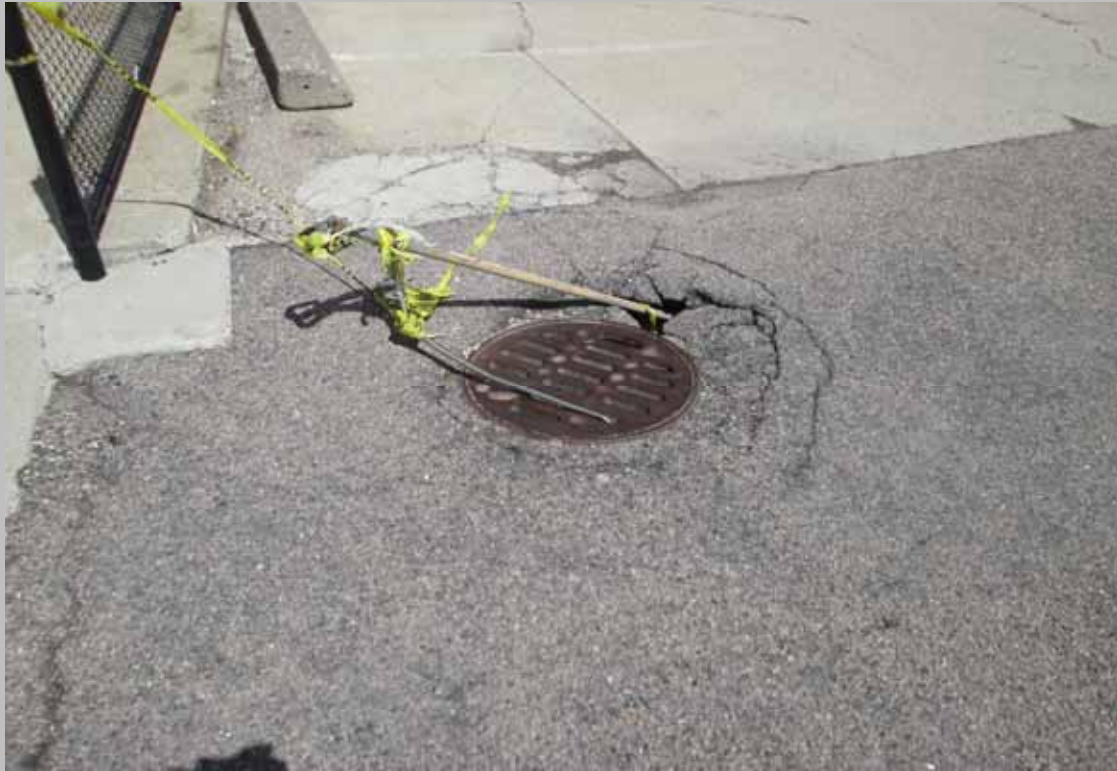
PHOTO #63

Damaged asphalt surface  
(Non-Critical Repairs)

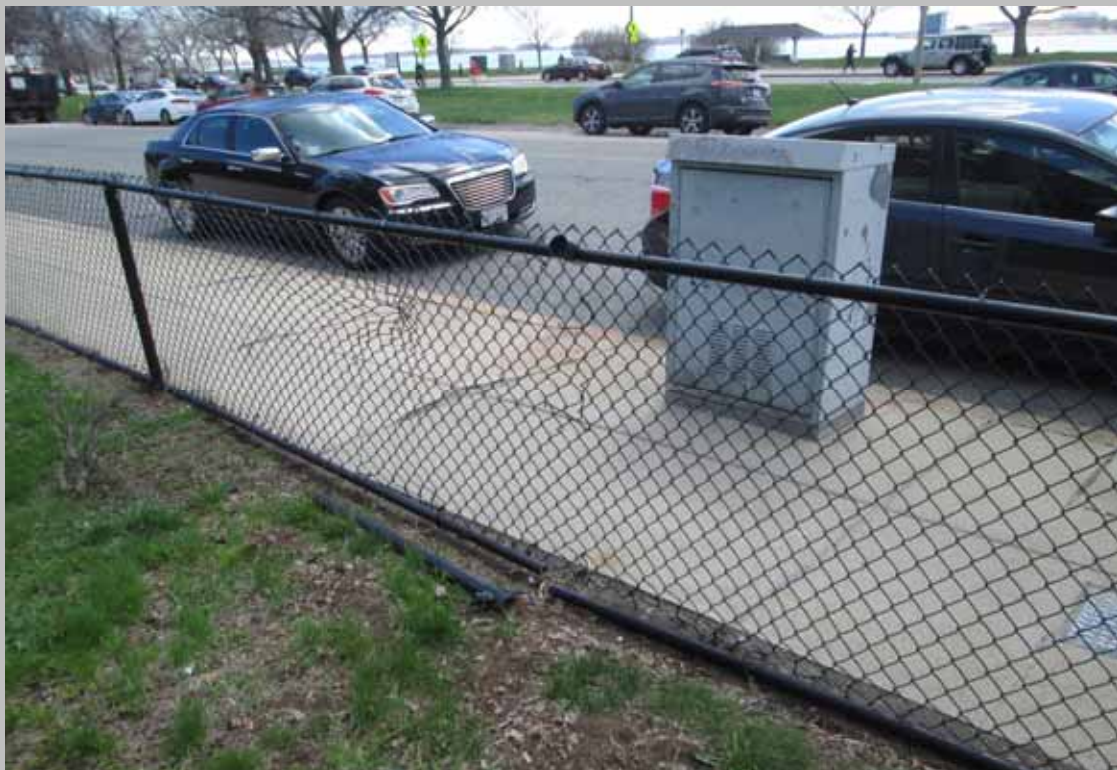
PHOTO #64

The property features 10-foot chain link fencing that encloses the generator and 4-foot chain-link fencing on select areas of the site perimeter. Fencing was observed in fair to good physical condition, with the exception of the 4-foot chain-link perimeter fencing that was observed with damage (Non-Critical Repair). Replacement of the chain-link fencing is anticipated during the estimate period.

Damaged fencing  
(Non-Critical Repairs)
