**CAPITAL NEEDS ASSESSMENT (CNA)  
HAMPTON HOUSE (2-98)  
155 NORTHAMPTON STREET  
BOSTON, MASSACHUSETTS 02118**

**D3G PROJECT NUMBER:  
2021-0375**

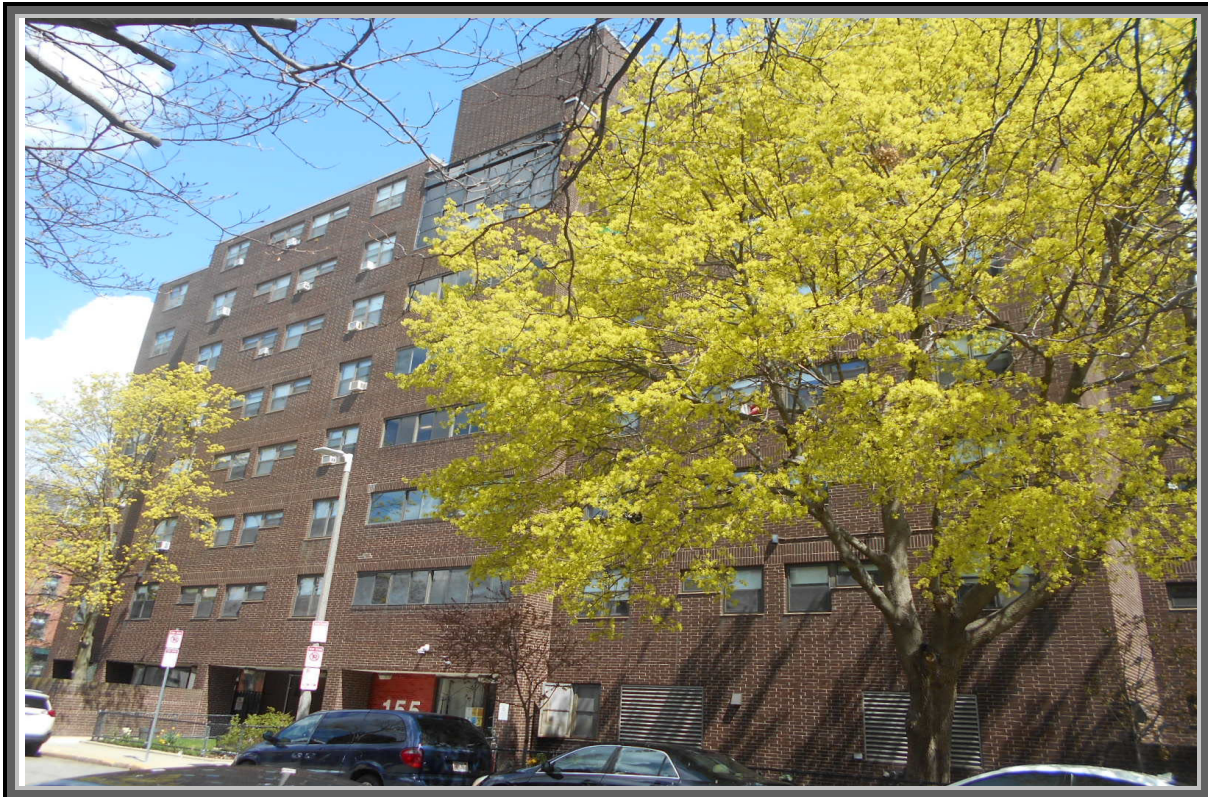
Site Description: Hampton House (2-98), located at 155 Northampton Street in Boston, Massachusetts consists of one (1) eight-story age-restricted apartment building. The building features seventy-eight (78) dwelling units. According to property management, the building was constructed in 1973. According to tax records, the building features an approximate gross area of 54,497 square feet and is situated on 0.41 acres. The property is in fair physical condition.

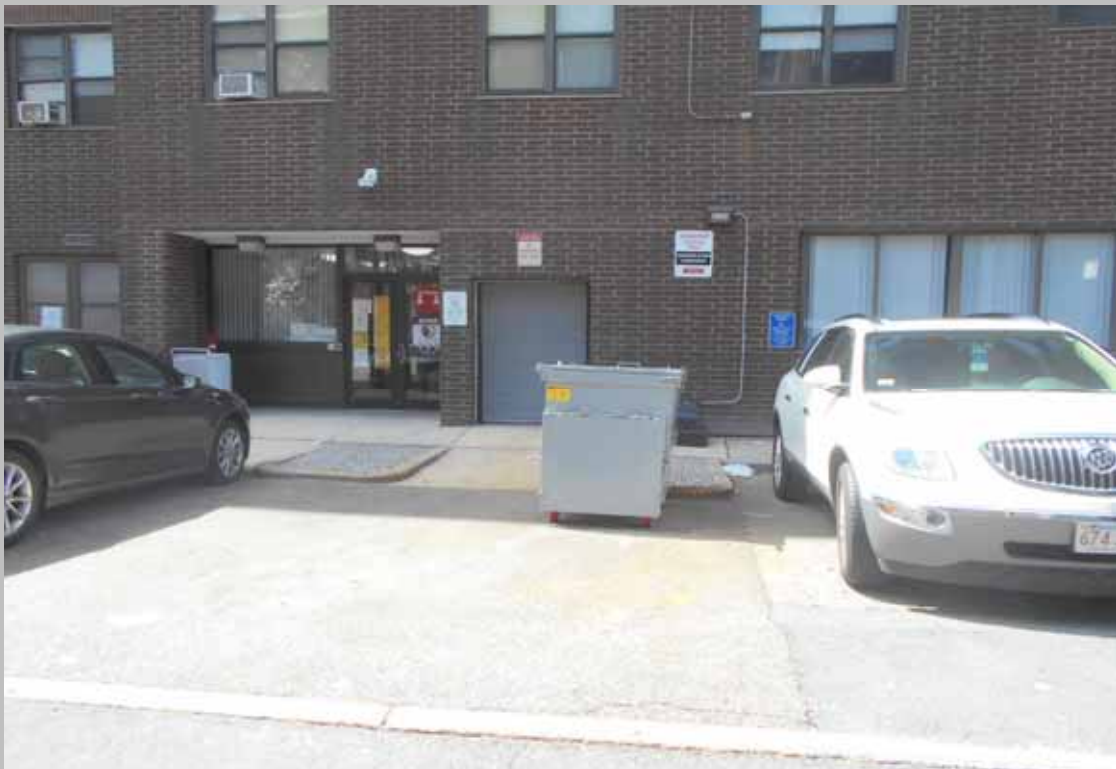
View of the designated handicapped parking space at the property (Critical Repair)

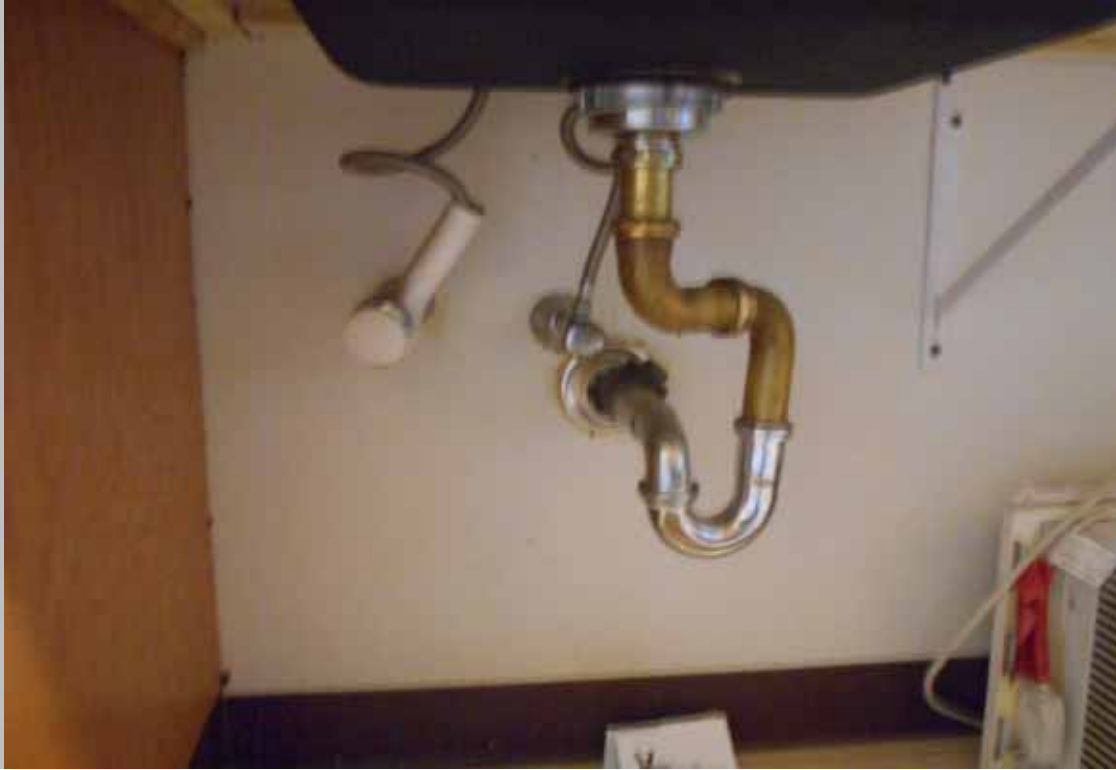
The designated handicapped dwelling unit kitchen sinks do not feature scald and abrasion protection at under-sink plumbing (Critical Repair)

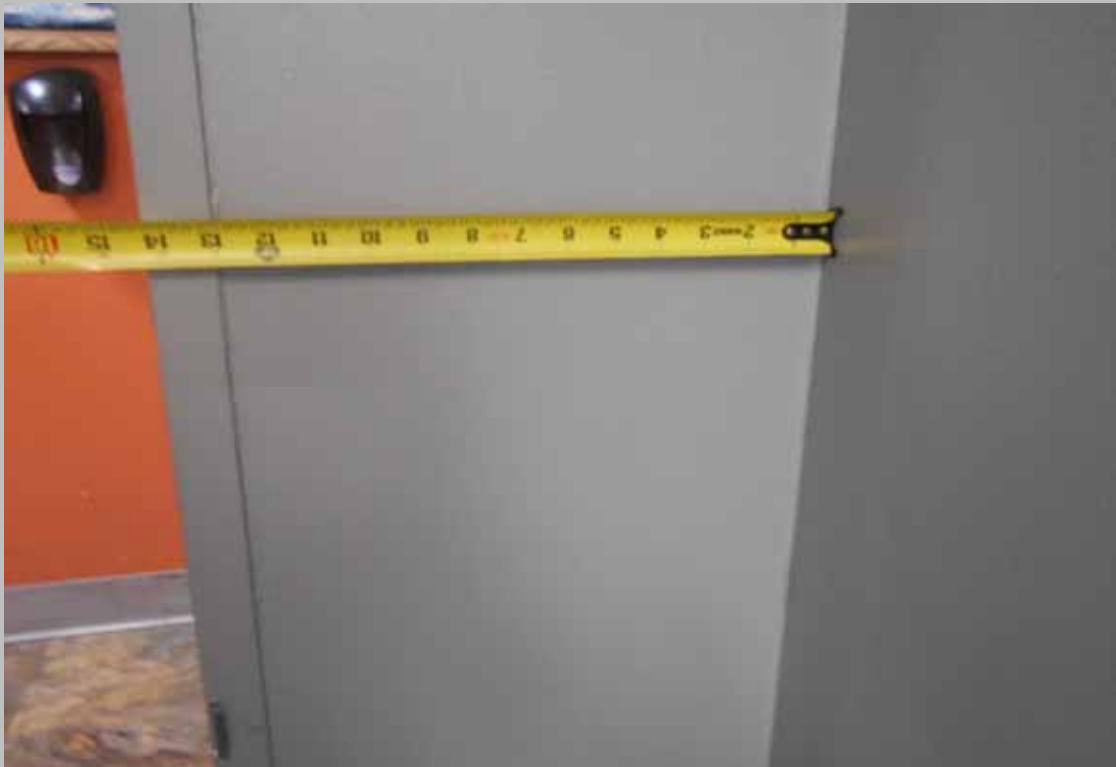
The common laundry room door does not feature 18 inches at the pull-side of the door (Critical Repair)

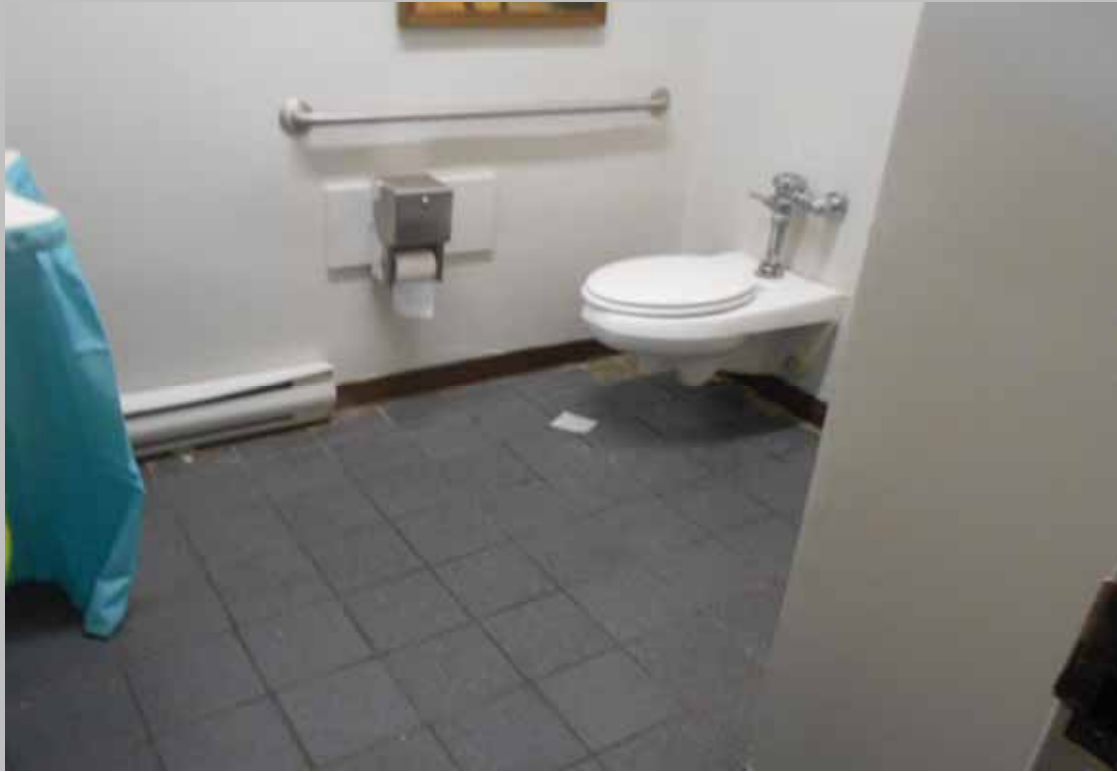
View of the men's public restroom toilet lacking a rear grab bar (Critical Repair)

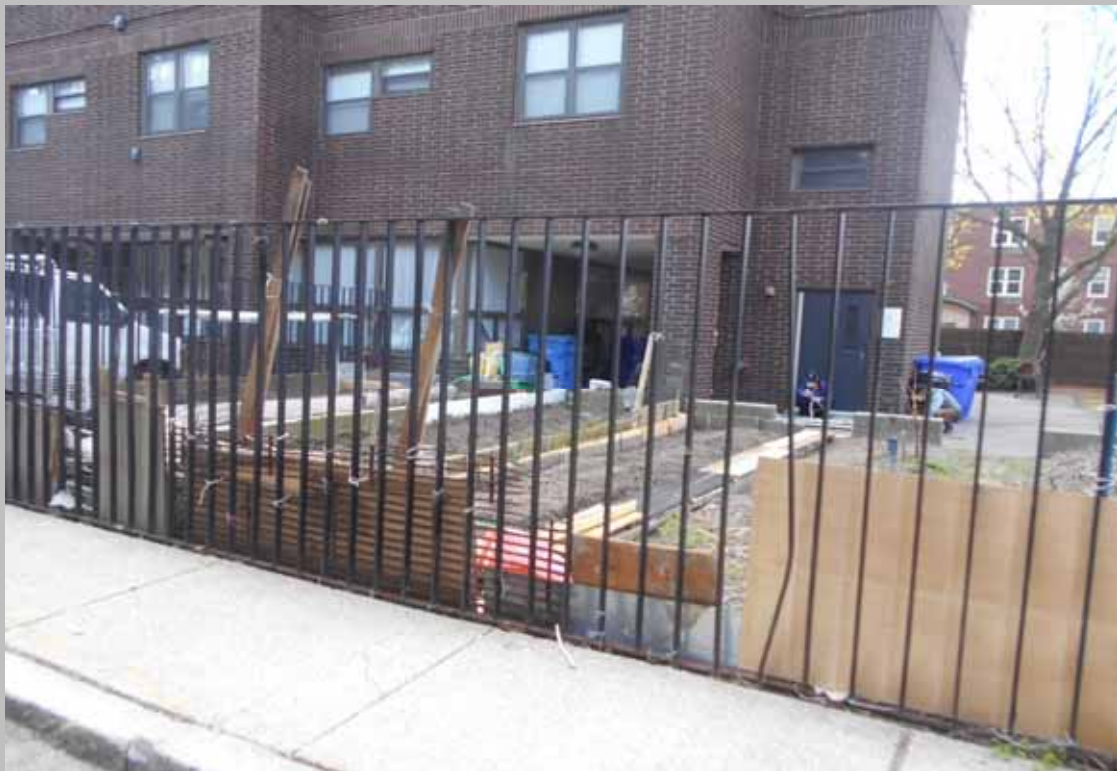
View of the damaged section of fencing outside of the community garden (Non-Critical Repair)

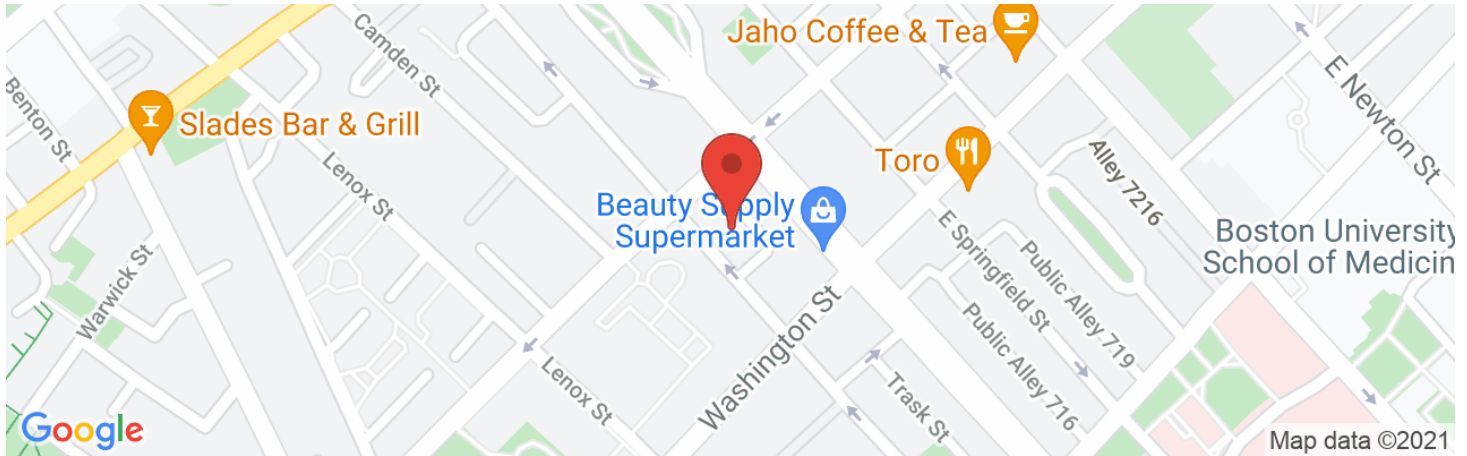
<b>Date</b>	5/10/2021, 12:45:13 PM
<b>Design Code Reference Document</b>	ASCE41-13
<b>Custom Probability</b>	
<b>Site Class</b>	E - Soft Clay Soil
