**CAPITAL NEEDS ASSESSMENT (CNA)
HASSAN APARTMENTS (2-62)
705 RIVER STREET
HYDE PARK, MASSACHUSETTS 02126**

**D3G PROJECT NUMBER:
2021-0376**

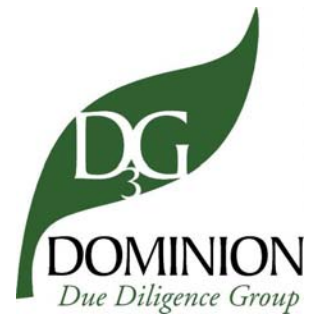
Property: Hassan Apartments (2-62)
705 River Street
Hyde Park, Massachusetts 02126

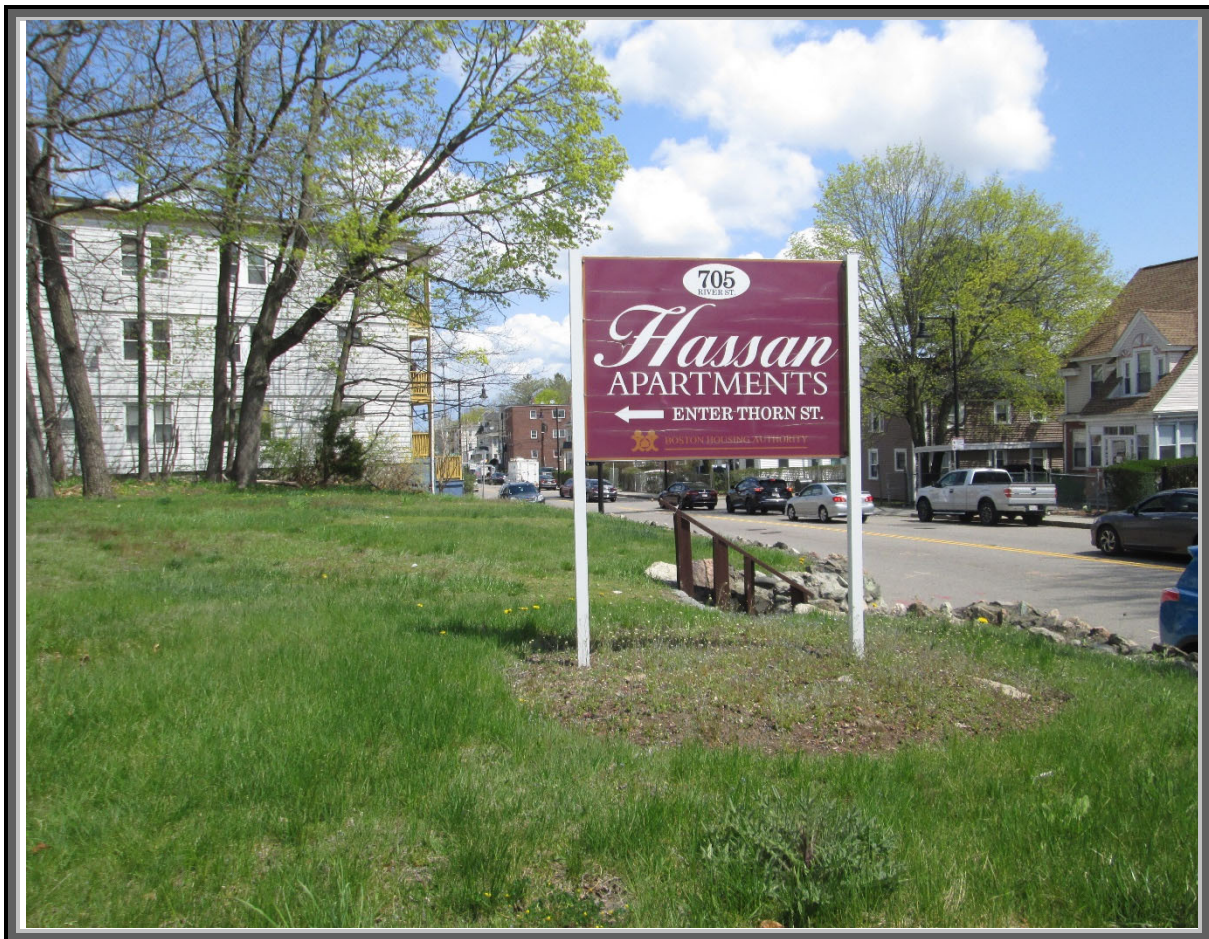
Site Description: Hassan Apartments (2-62), located at 705 River Street in Hyde Park, Massachusetts consists of one (1) four-story multi-family apartment building. The property features one hundred (100) dwelling units. According to property management, the building was constructed in 1975. According to available tax information, the building is situated on 2.05 acres. According to provided information and D3G estimates, the building features an approximate gross area of 75,040 square feet. The property is in fair to good physical condition.

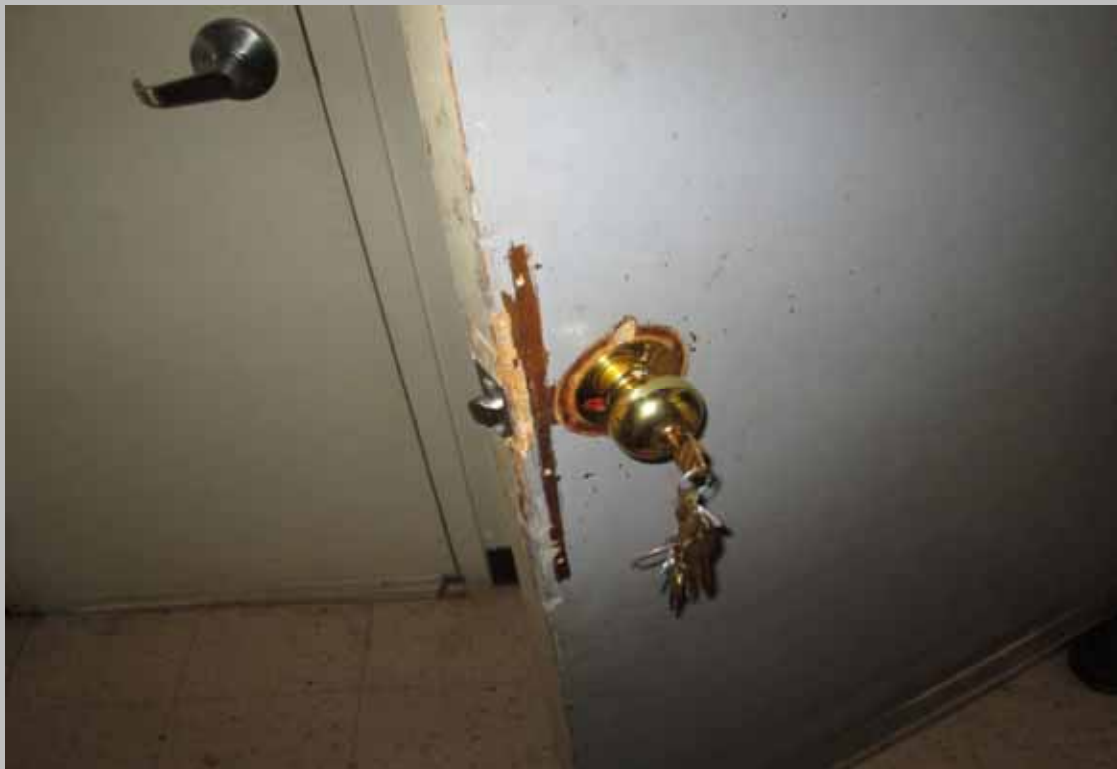
Handicapped Unit# 323 non-compliant door hardware (Critical Repair)

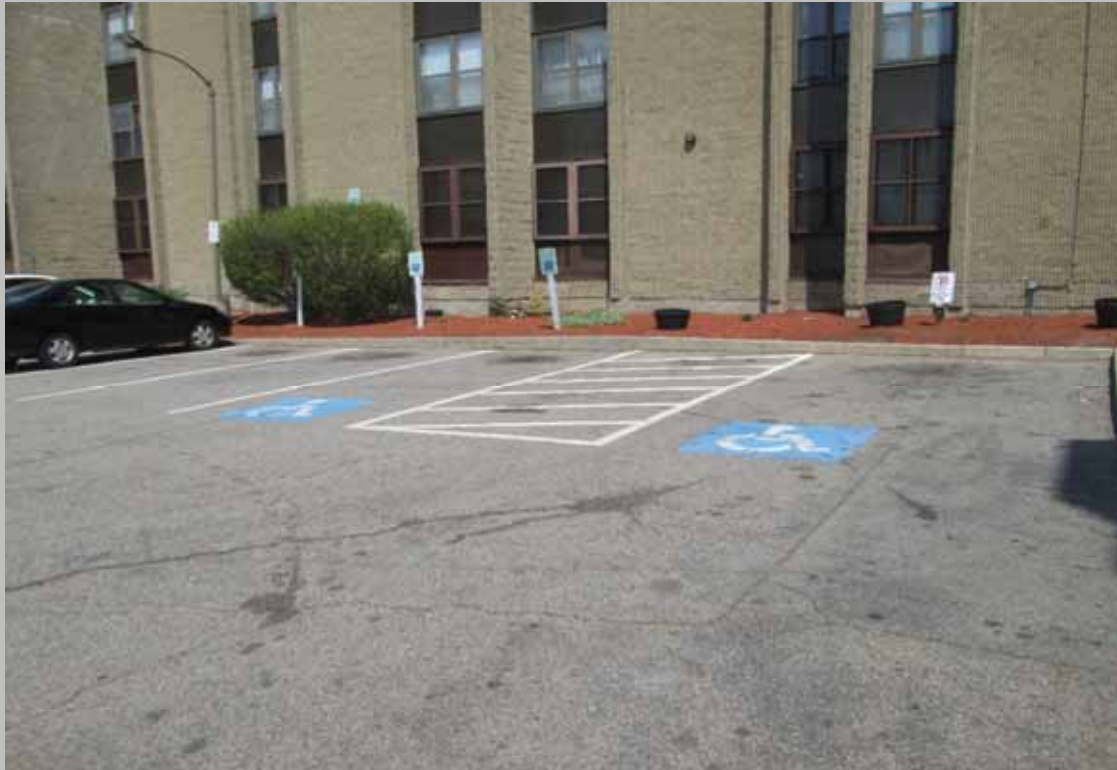
Handicapped parking without "Van-Accessible" sign (Critical Repair)

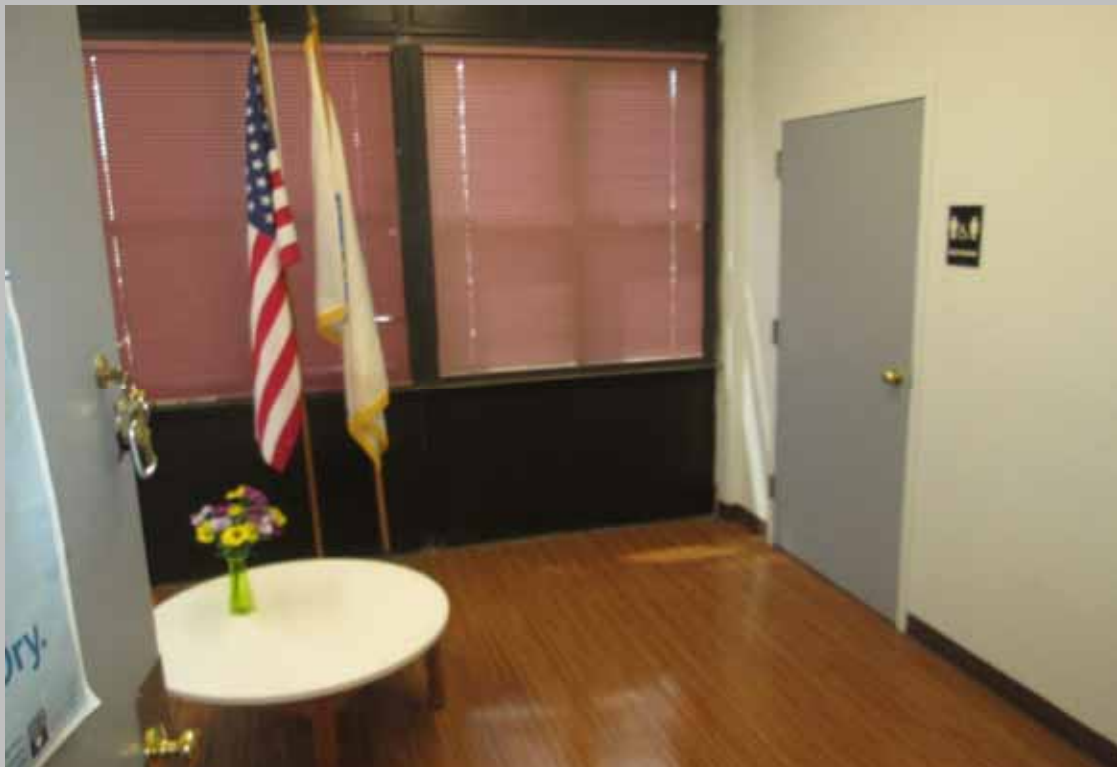
Community room area door and community uni-sex restroom door with non-compliant (knobbed) hardware (Critical Repair)

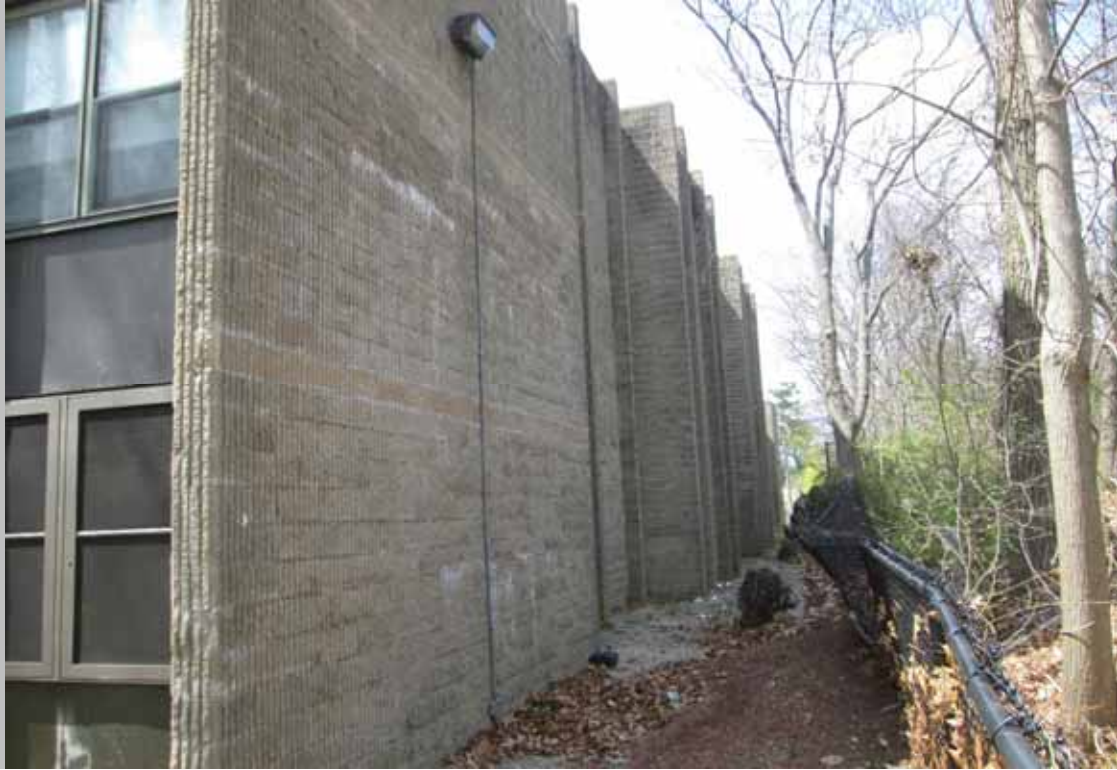
Damaged perimeter chain-link fencing (Non-Critical Repair)

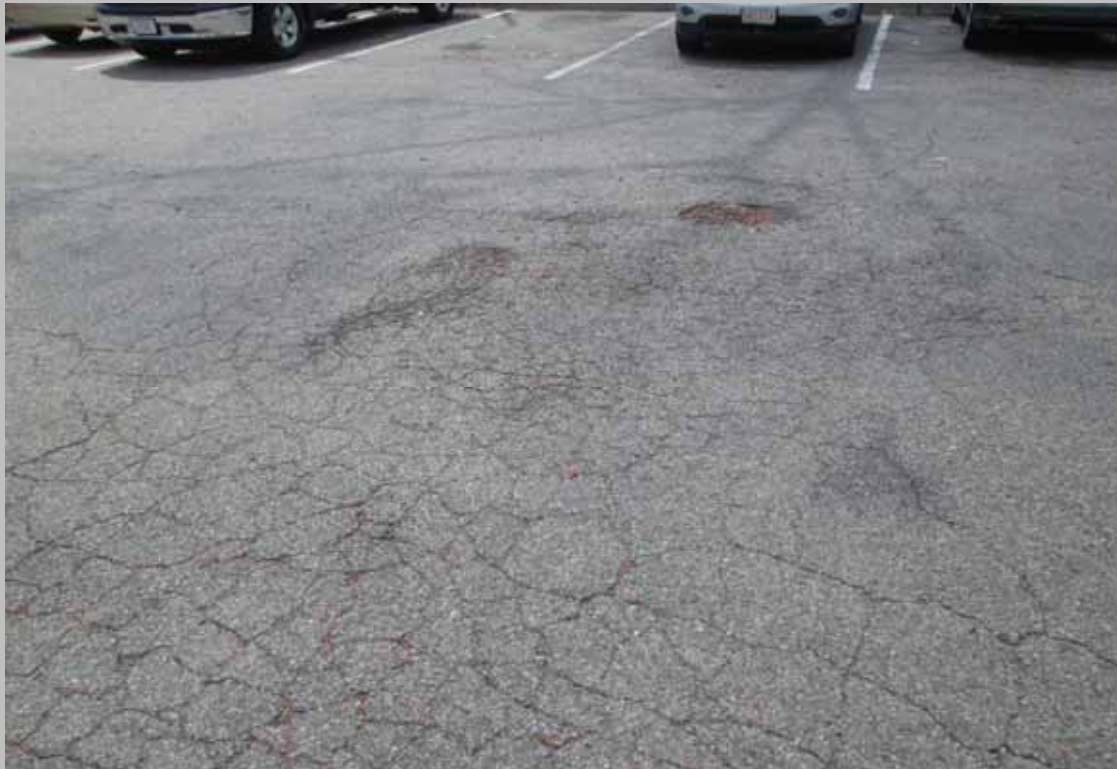
Site asphalt parking area (Non-Critical Repair)

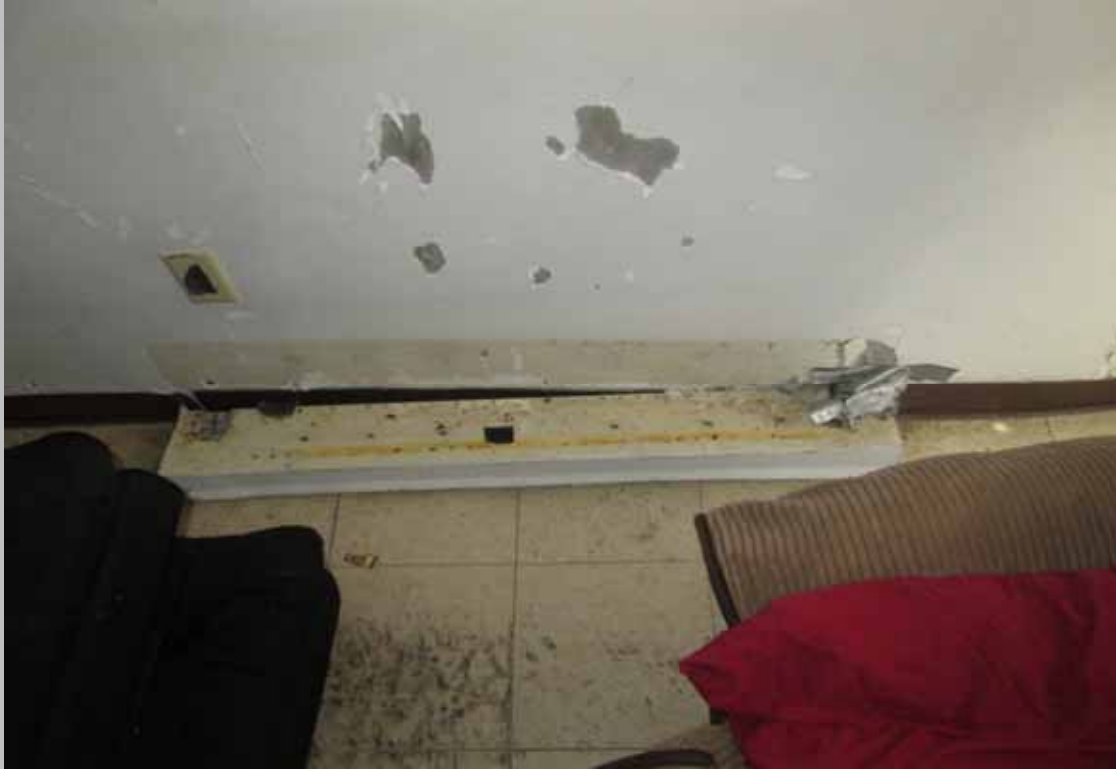
Damaged baseboard heater in Unit 318 (Non-Critical Repair)

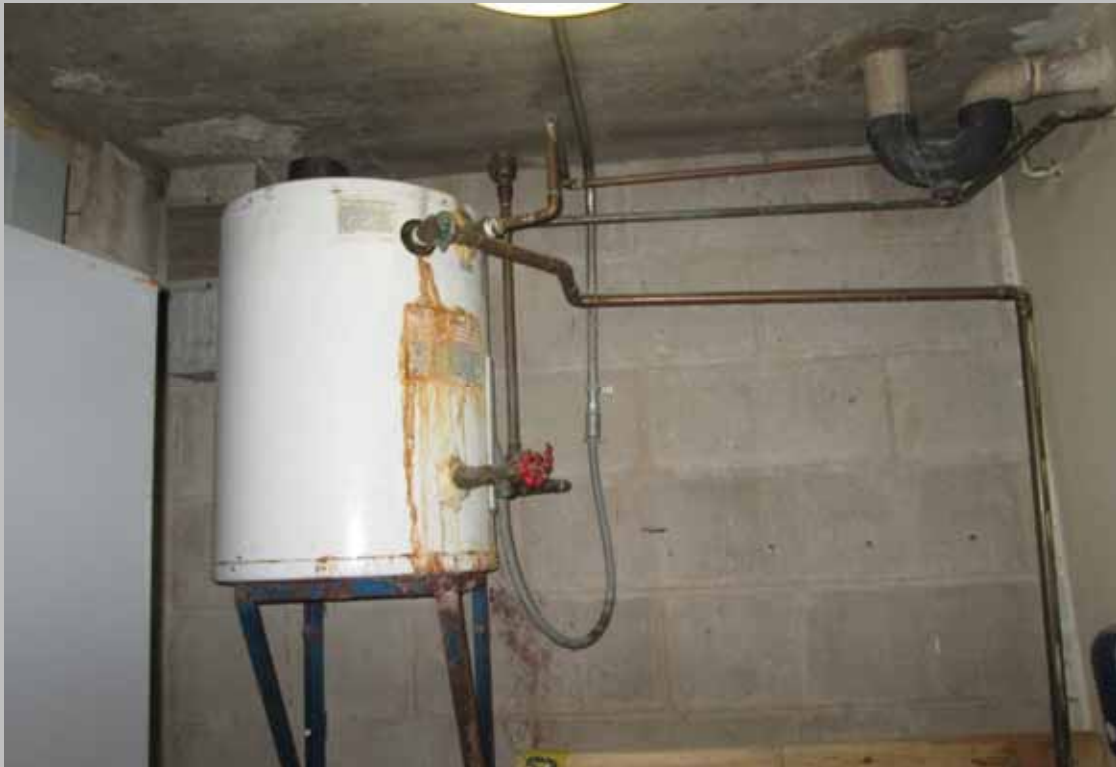
Mechanical electric hot water heater beyond EUL (Non-Critical Repair)

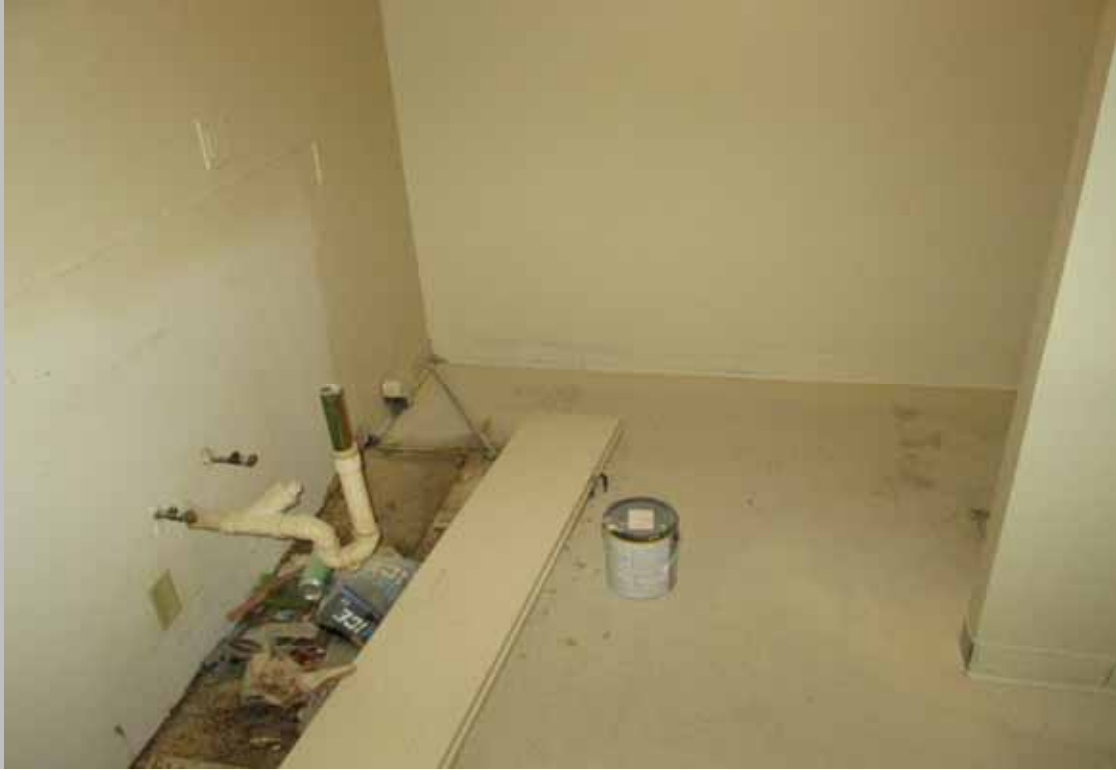
"Down" Unit 108 (Critical Repair)

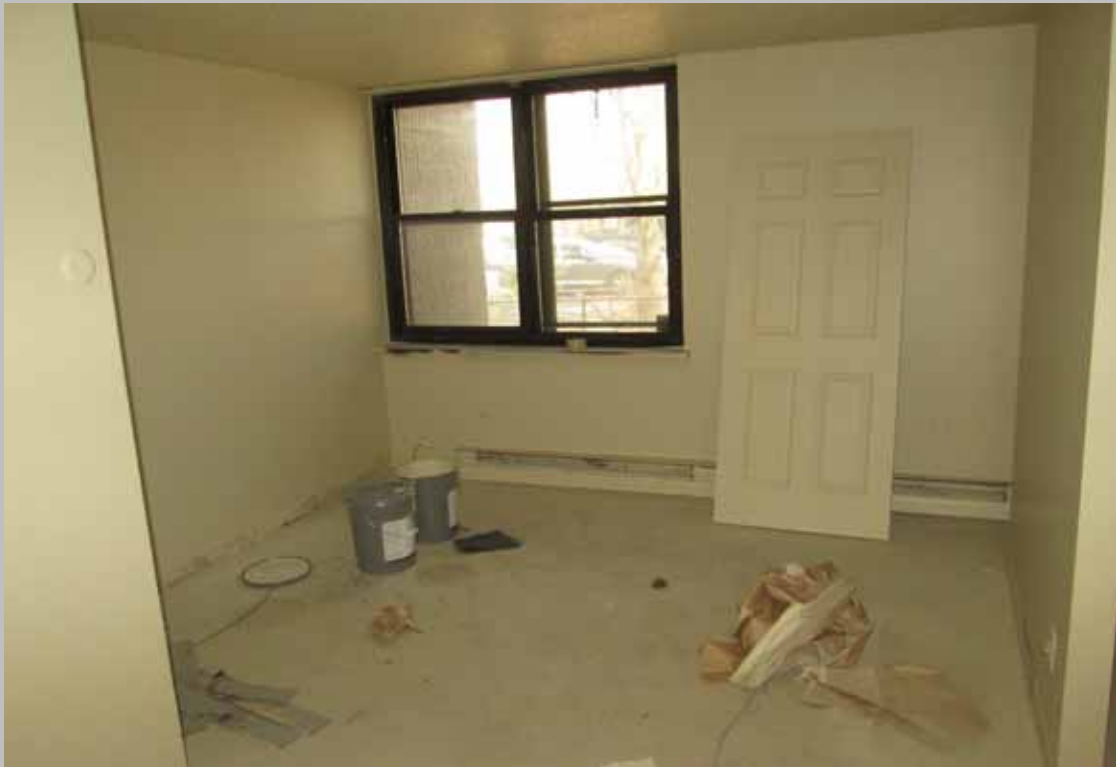
"Down" Unit 108 (Critical Repair)

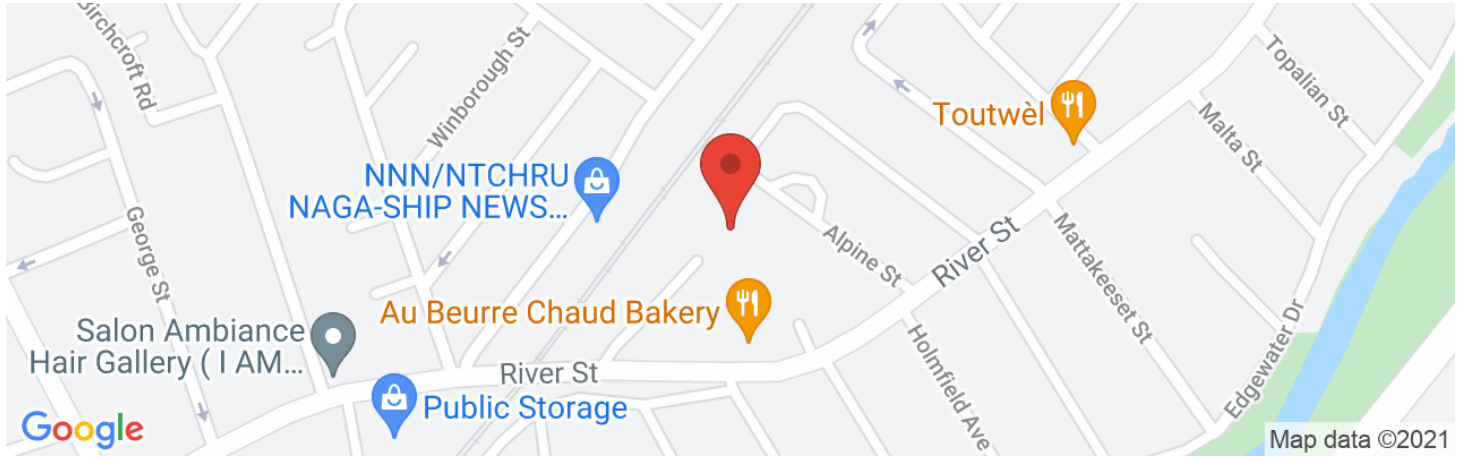
Date	4/20/2021, 8:08:54 PM
Design Code Reference Document	ASCE41-13
Custom Probability	
Site Class	E - Soft Clay Soil
