**CAPITAL NEEDS ASSESSMENT
PASCIUCCO (2-54)
330 BOWDOIN STREET
DORCHESTER, MASSACHUSETTS 02122**

**D3G PROJECT NUMBER:
2021-0377**

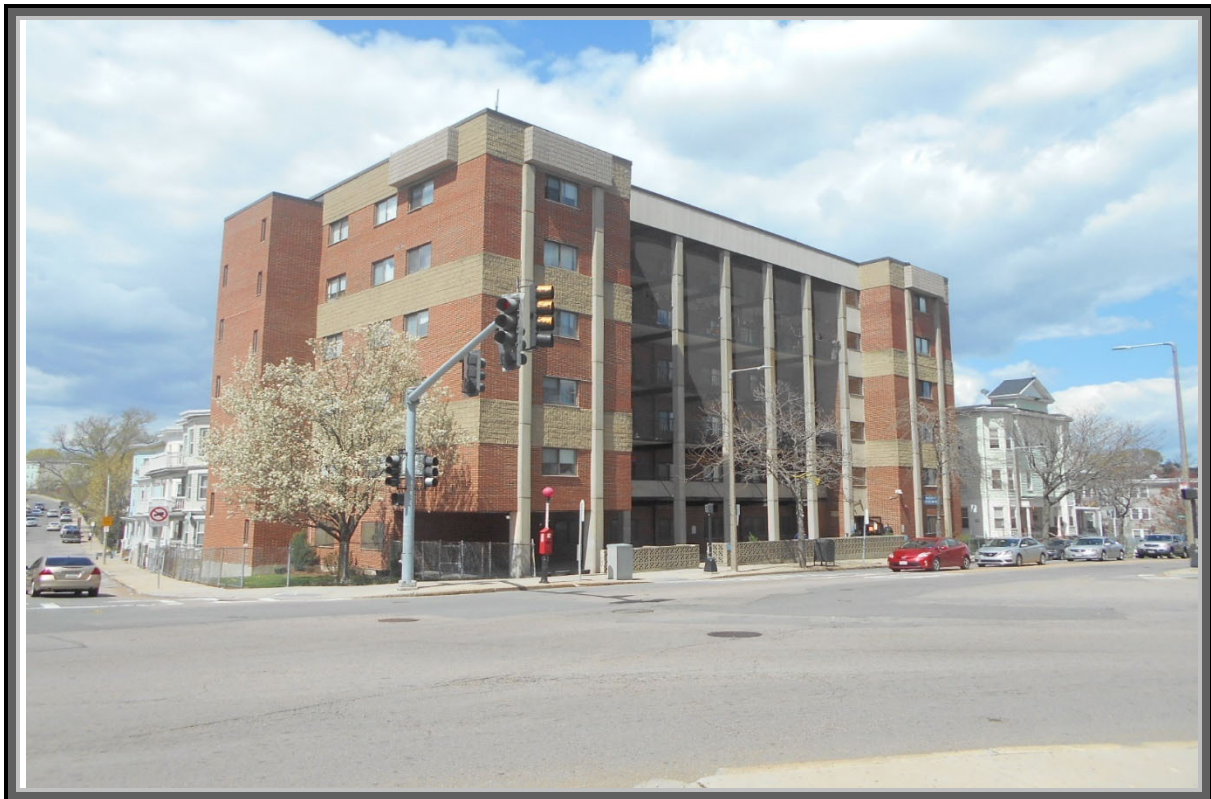
Site Description: Pasciucco (2-54), located at 330 Bowdoin Street in Dorchester, Massachusetts consists of one (1) six-story age-restricted apartment building with an underground parking garage. The building features ninety-six (96) dwelling units. According to property management, the building was constructed in 1973. According to tax records, the building features an approximate gross area of 78,821 square feet and is situated on 0.51 acres. The property is in fair physical condition.

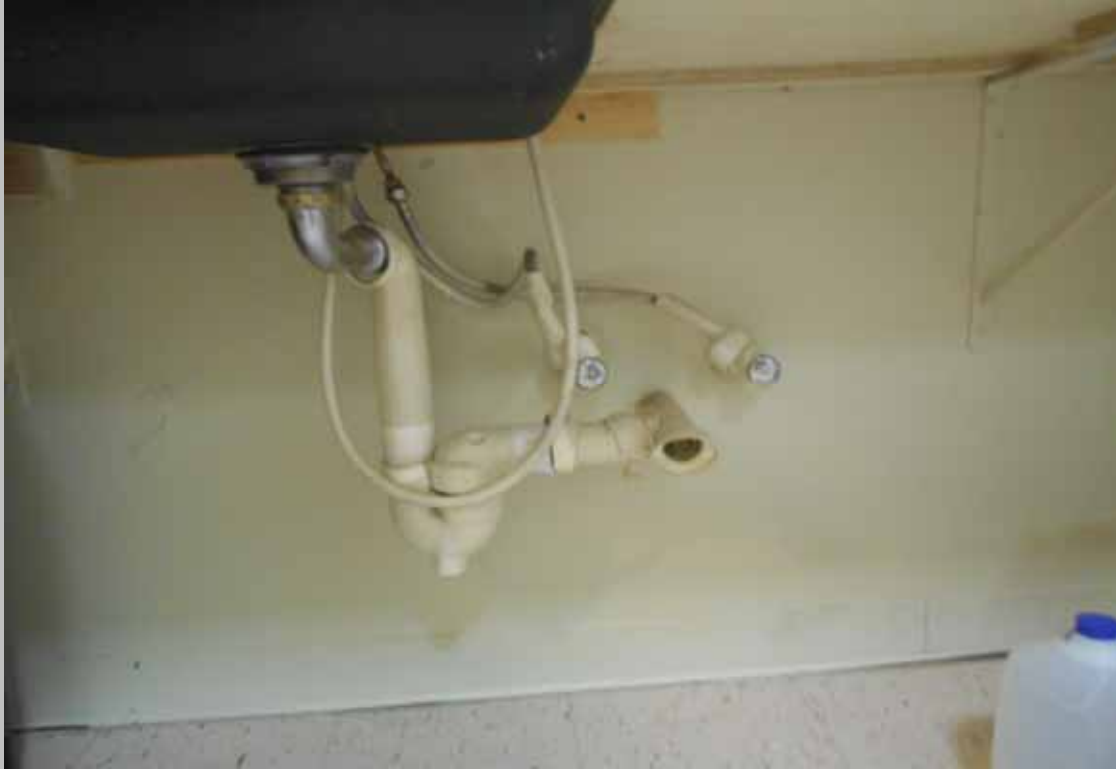
View of a compliant kitchen sink within a designated handicapped dwelling unit lacking compliant scald and abrasion protection (Critical Repair)

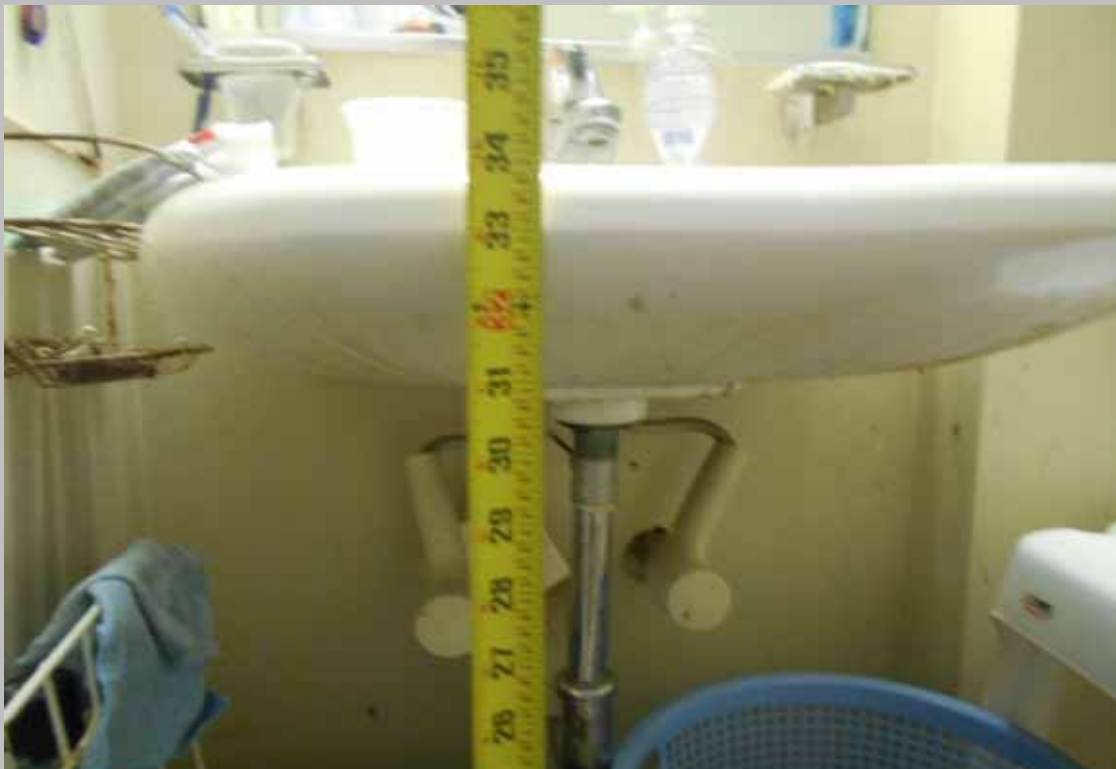
View of a compliant height bathroom sink within a designated handicapped dwelling unit lacking compliant scald and abrasion protection (Critical Repair)

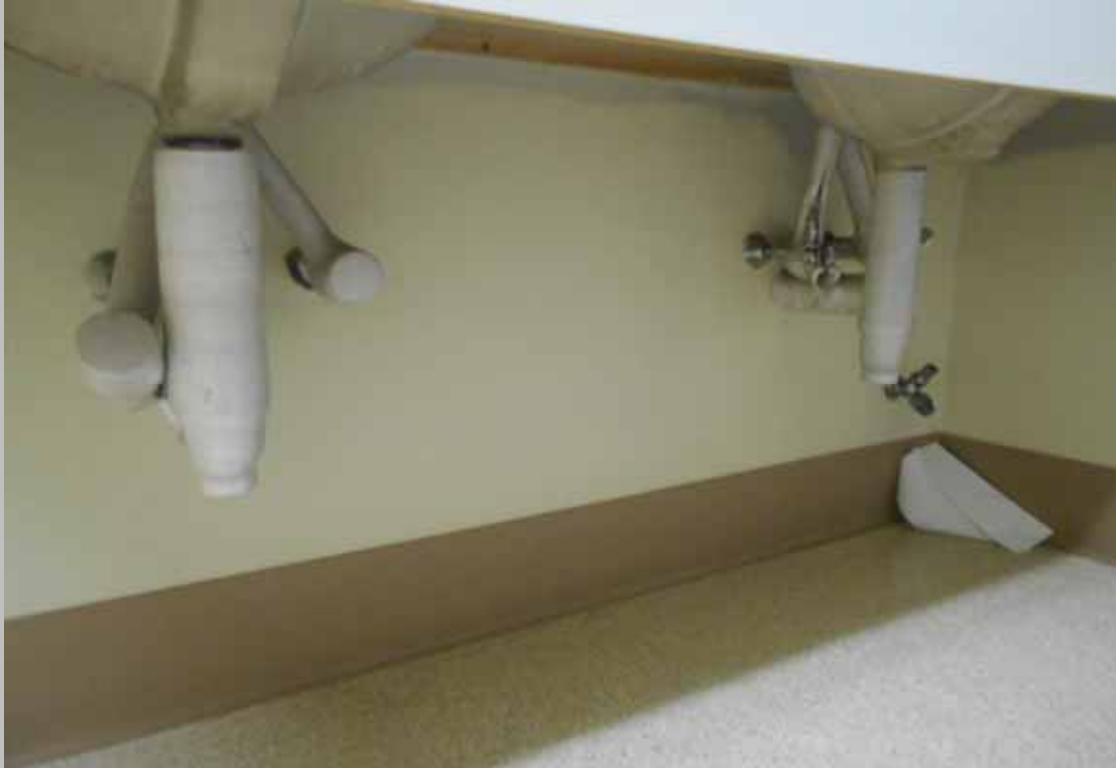
View of non-compliant partial scald and abrasion protection at the women's public restroom
(Critical Repair)

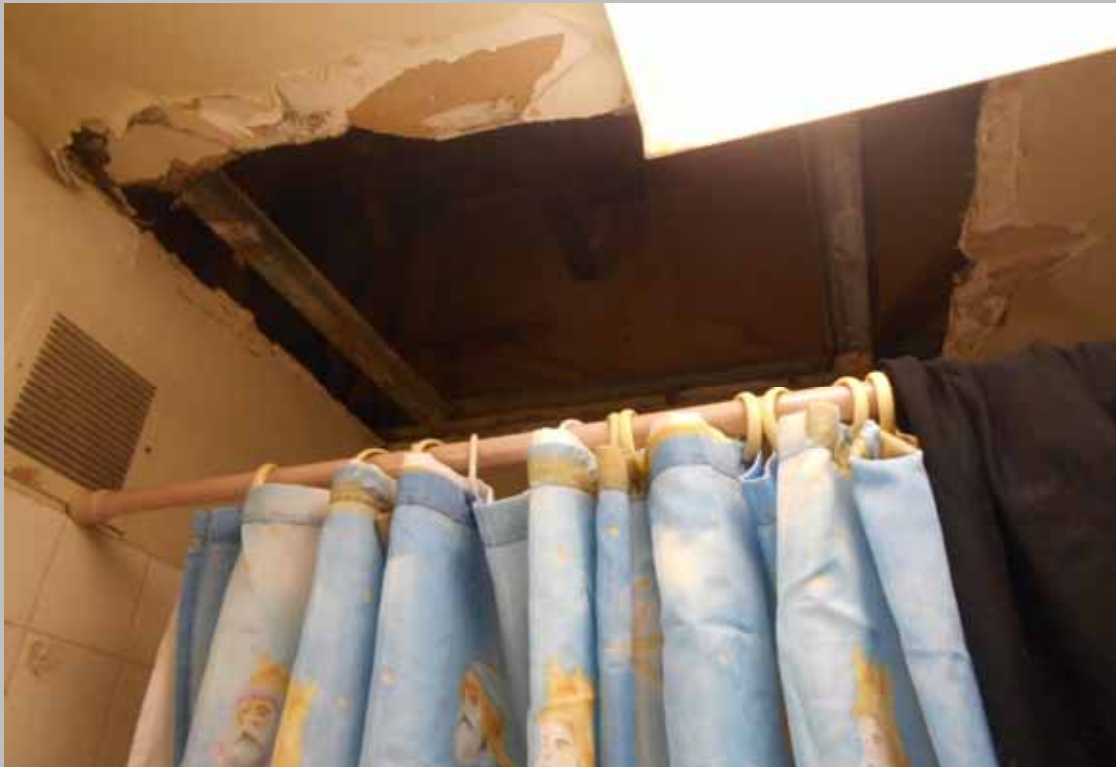
View of damaged GWB in the bathroom of dwelling unit 503 (Non-Critical Repair)

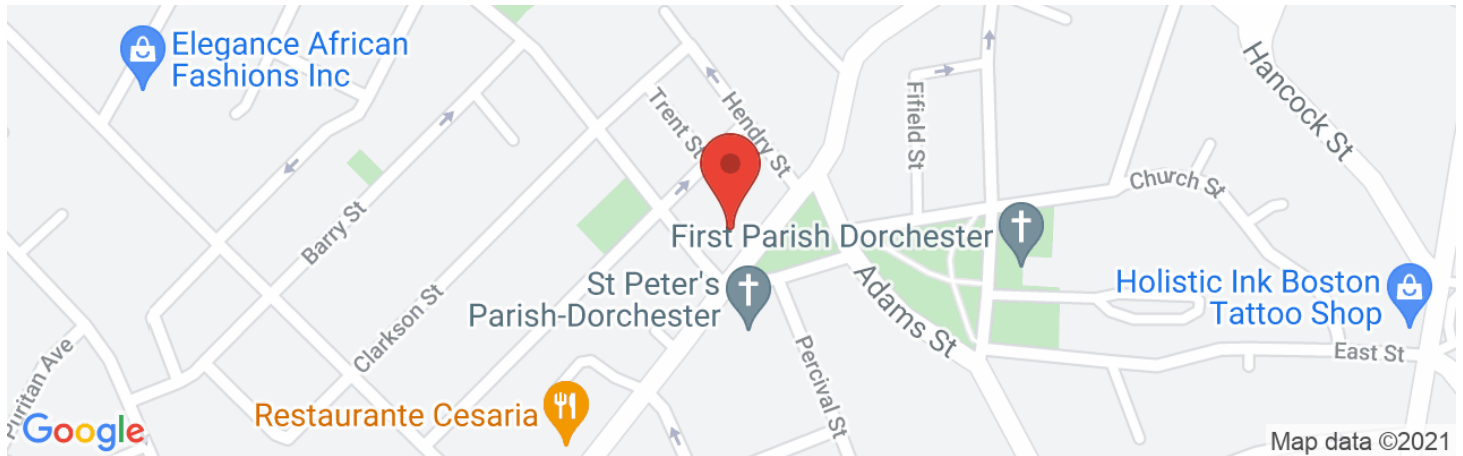
Date	5/20/2021, 2:52:20 PM
Design Code Reference Document	ASCE41-13
Custom Probability	
Site Class	E - Soft Clay Soil

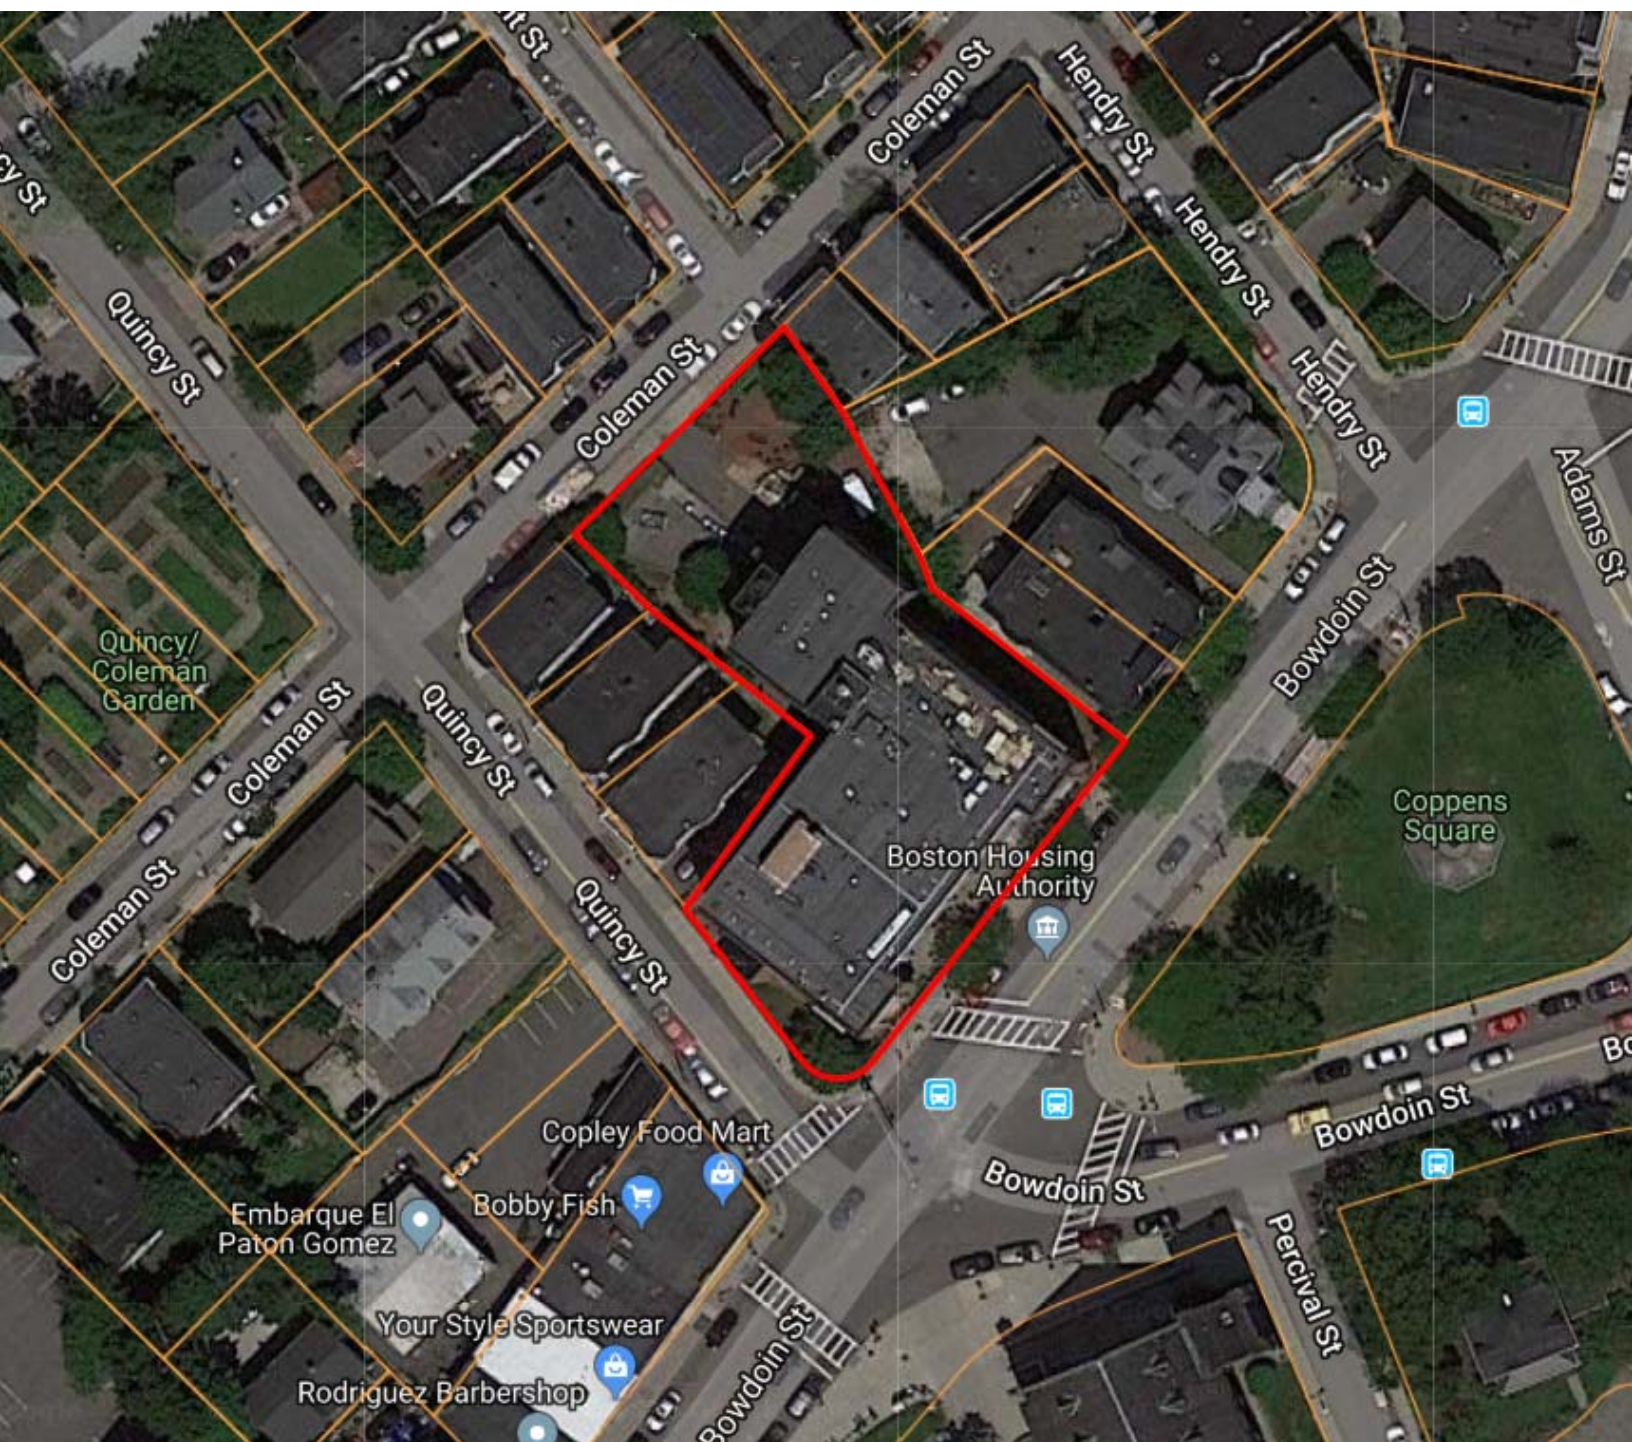
Plumbing (Refer to Chapter 31)	
Description	Gas Fired/Hot Water 100 Gallons
Location	2nd, 4th & 6th Floor
Age	Unknown
Water Meters	
Description/Location	
Ventilation & Air Conditioning Equipment (Refer to Chapter 32)	
System 1: Description, location & age	Window Units
Roof (Refer to Chapter 33)	
Type	10, 592 sq. ft. Membrane
Age	Unknown
Trash Compactor (Refer to Chapter 36)	
Type	Waste Compaction System
Other Significant Equipment & Systems	
Overhead Door	Model RG+ Plus
ASPHALT	7,668 sq. ft.
CEMENT	11,067 sq. ft.
Backflow Preventor	In basement fire pump room
