**CAPITAL NEEDS ASSESSMENT (CNA)
SPRING STREET APARTMENTS (2-70)
23 SPRING STREET
WEST ROXBURY, MASSACHUSETTS 02132**

D3G PROJECT NUMBER:

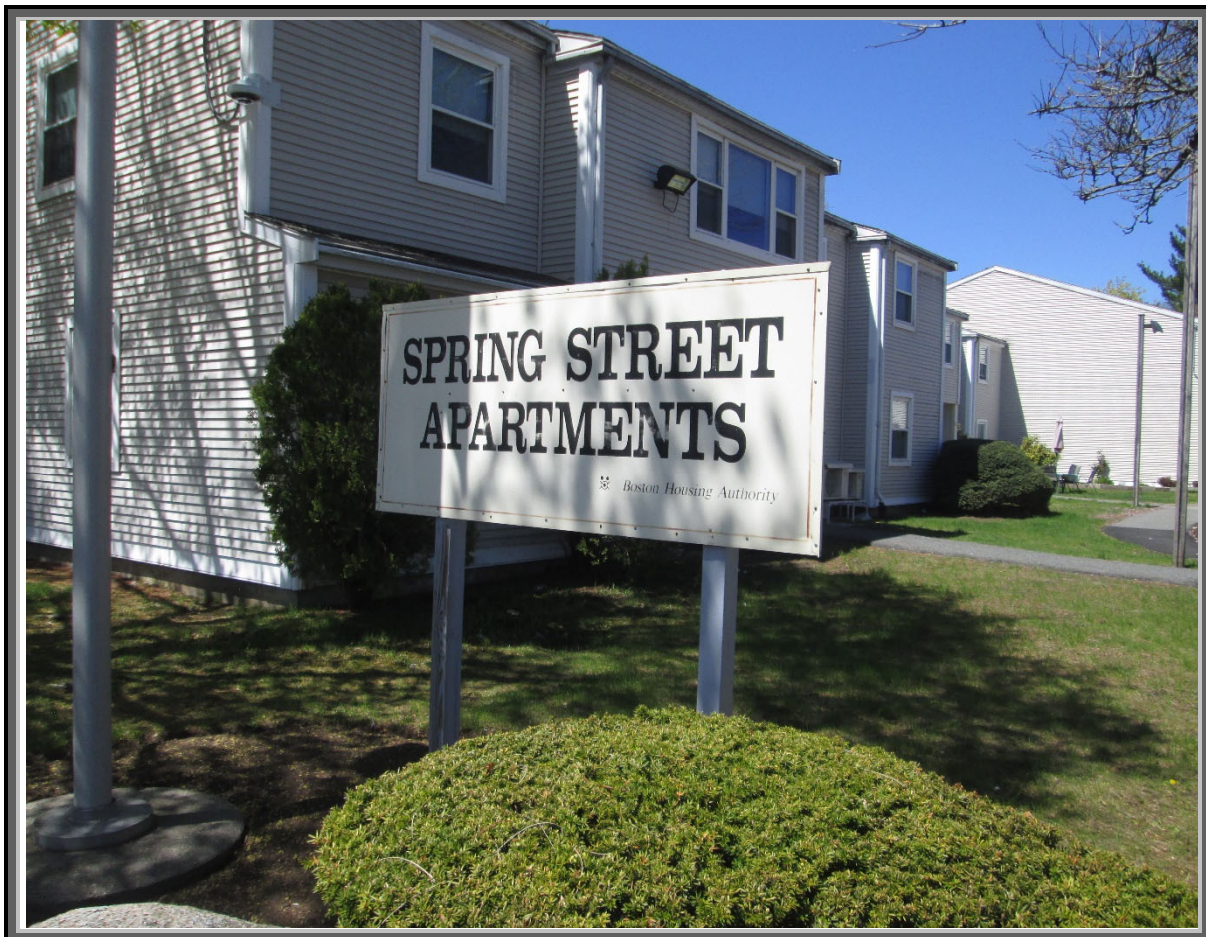
Site Description: Spring Street Apartments (2-70), located at 23 Spring Street in West Roxbury, Massachusetts consists of four (4) two-story and one (1) three-story multifamily apartment buildings as well as one (1) single-story community building. The property features one hundred four (104) dwelling units. According to available tax records, the buildings were constructed in 1977, feature an approximate gross area of 77,124 square feet, and are situated on 2.58 acres. The property is in fair physical condition.

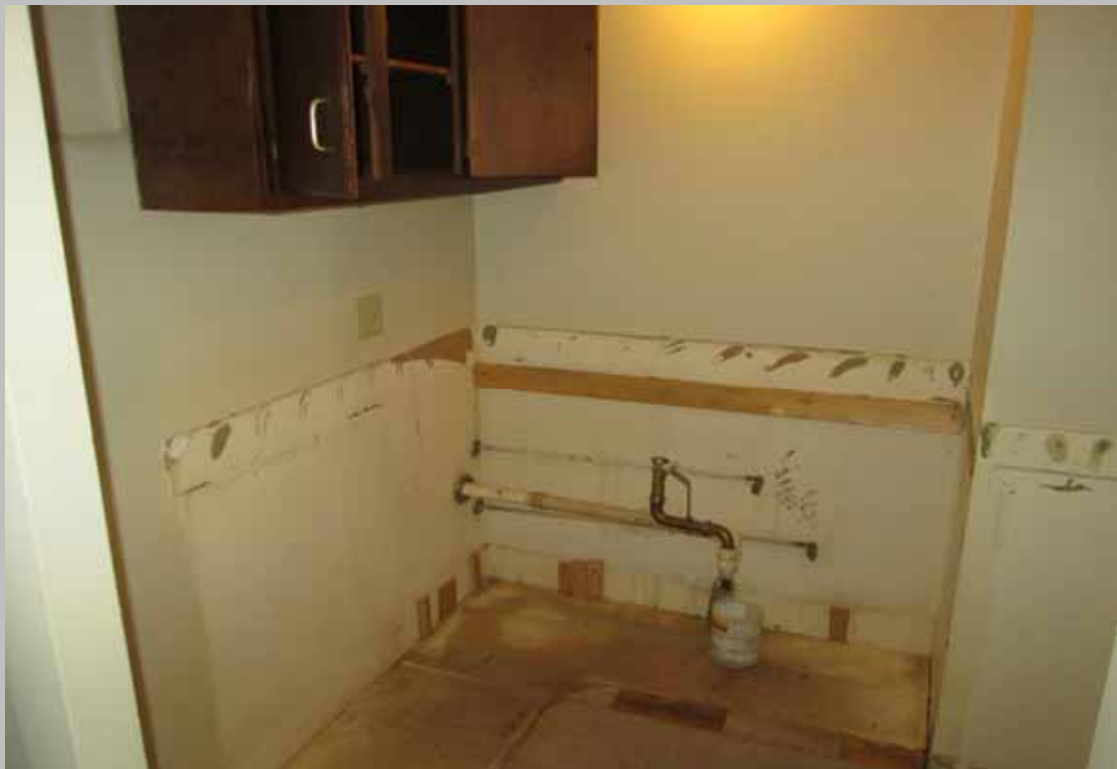
Down unit #98 (Non-Critical Repair)

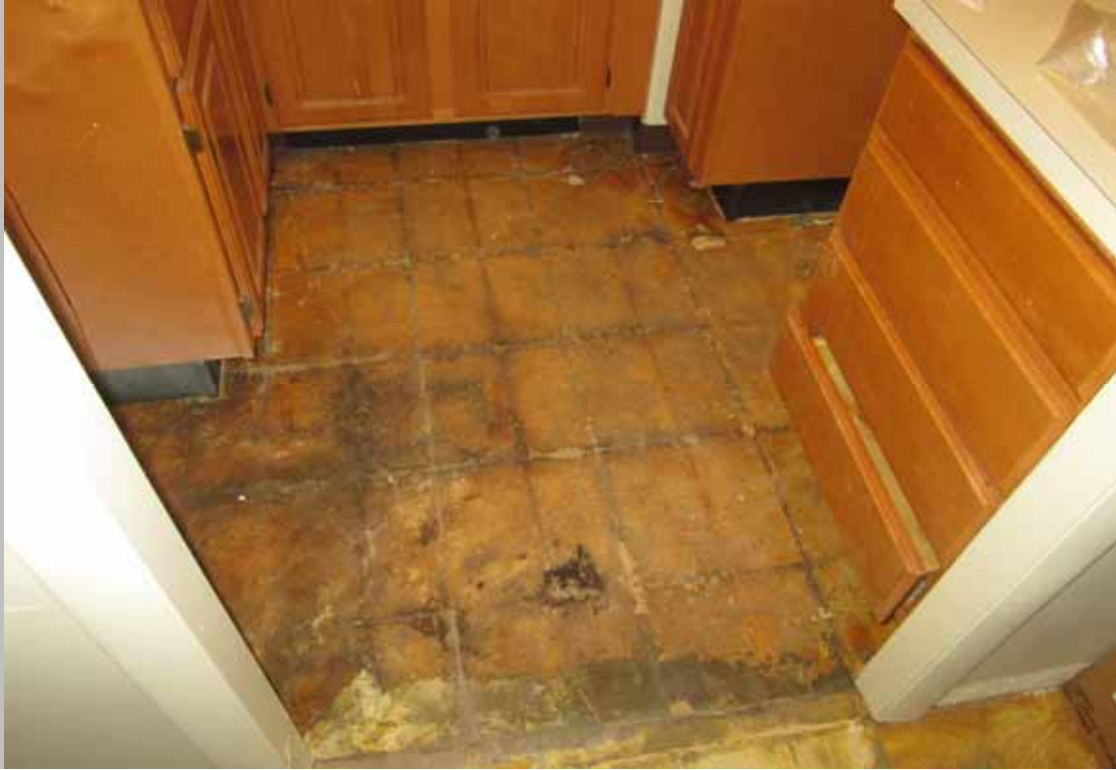
Down unit#16 (Non-Critical Repair)

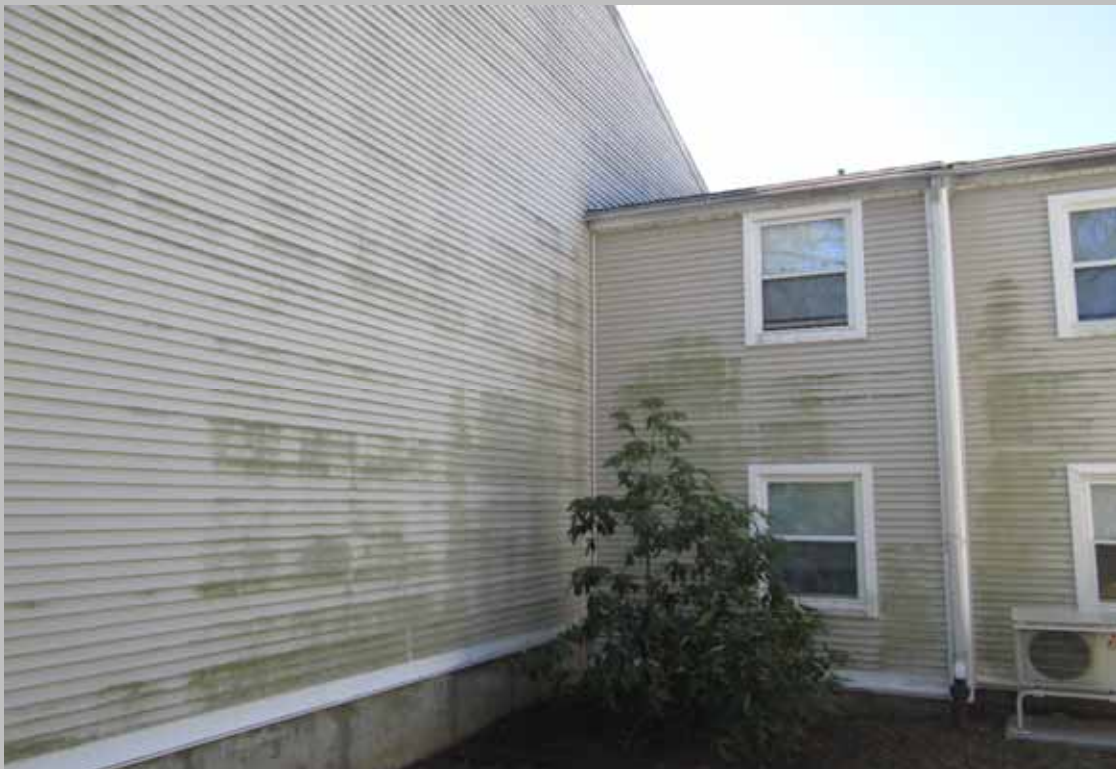
Mildew observed (Non-Critical Repair)

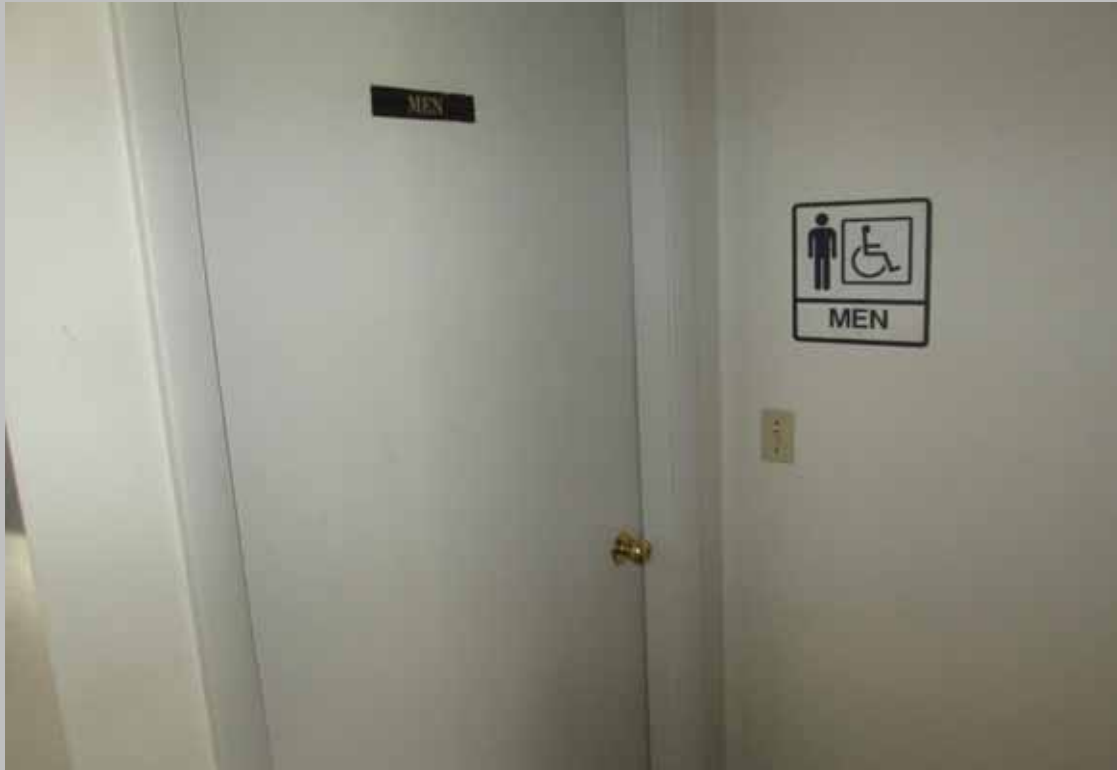
Men's public restroom with non-compliant door hardware (Critical-Repair)

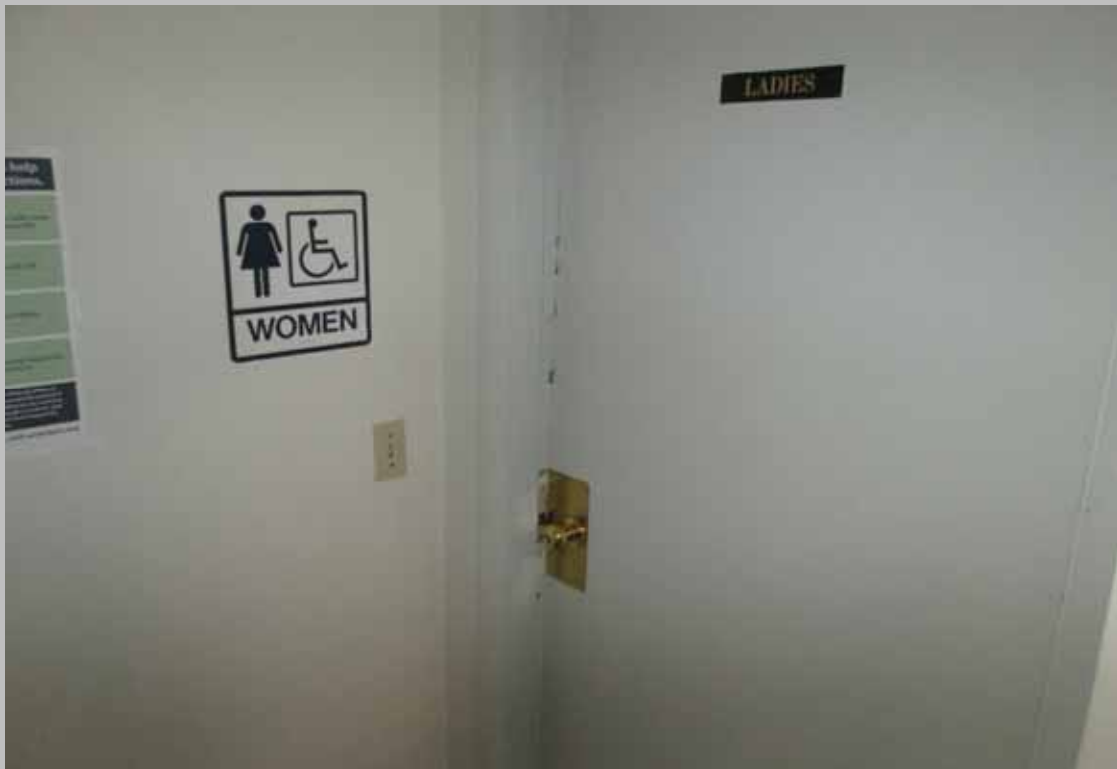
Women's public restroom with non-compliant door hardware (Critical-Repair)

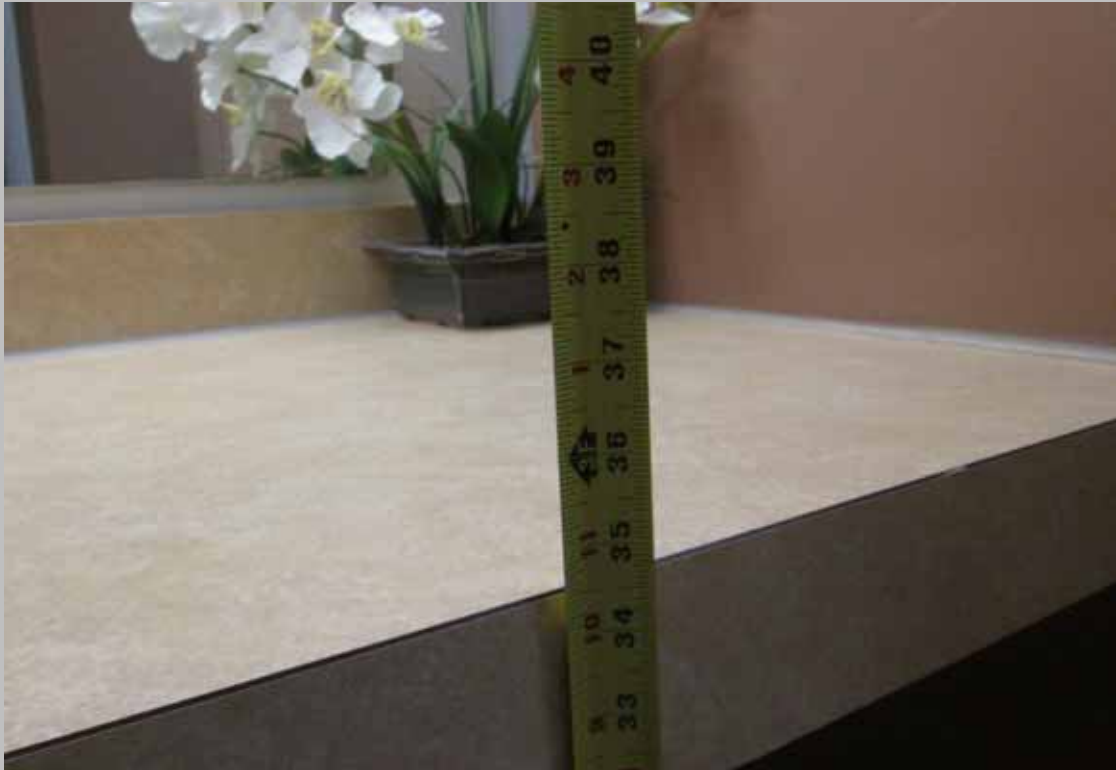
View of the women's public restroom sink mounted higher than 34-inches above the finished floor (Critical Repair)

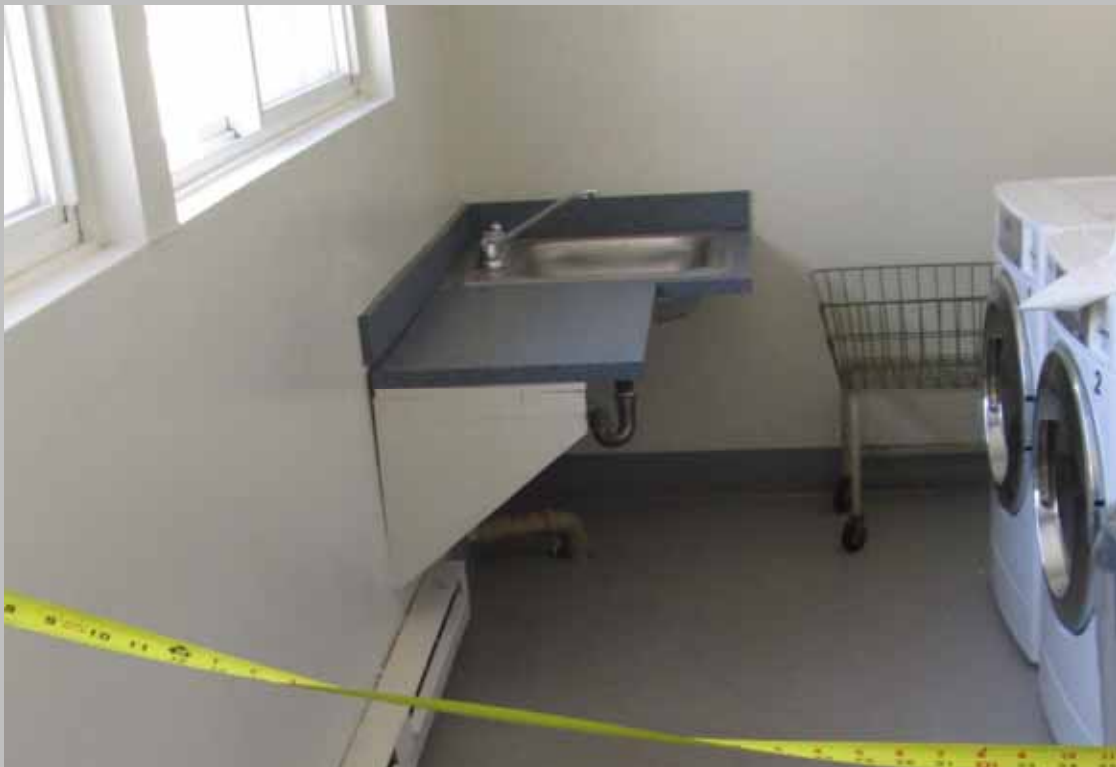
View of the common area laundry room sink lacking scald and abrasion protection (Critical Repair)

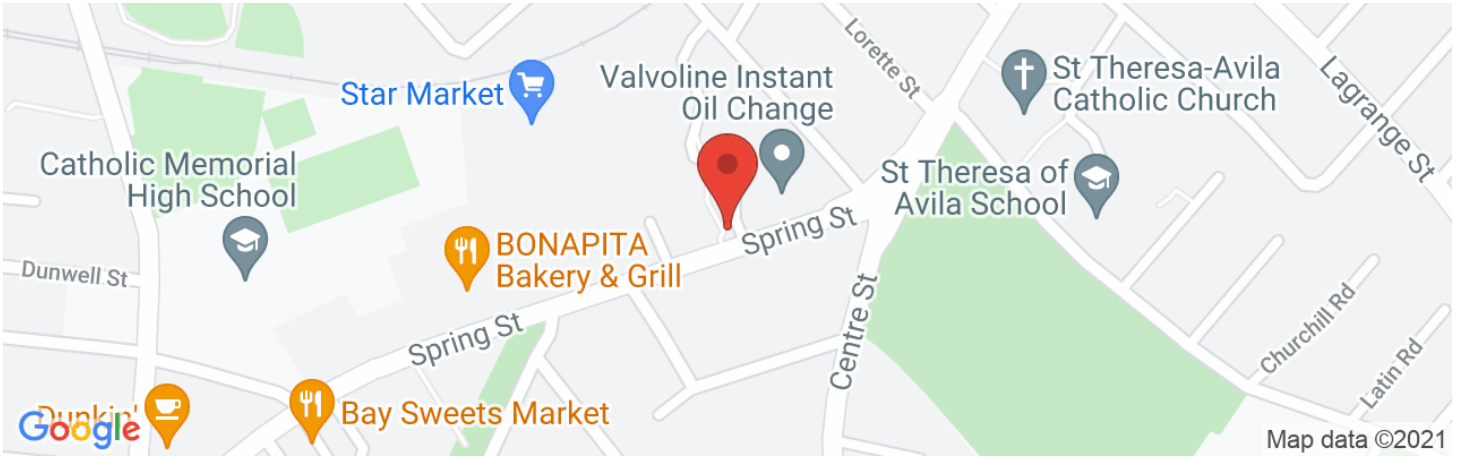
Date	4/20/2021, 8:45:44 PM
Design Code Reference Document	ASCE41-13
Custom Probability	
Site Class	E - Soft Clay Soil
