**CAPITAL NEEDS ASSESSMENT (CNA)
WASHINGTON MANOR (2-99)
1701 WASHINGTON STREET
BOSTON, MASSACHUSETTS 02118**

**D3G PROJECT NUMBER:
2021-0382**

**FINAL REPORT ISSUE DATE:
NOVEMBER 5, 2021**

**INSPECTION DATE:
APRIL 22, 2021**

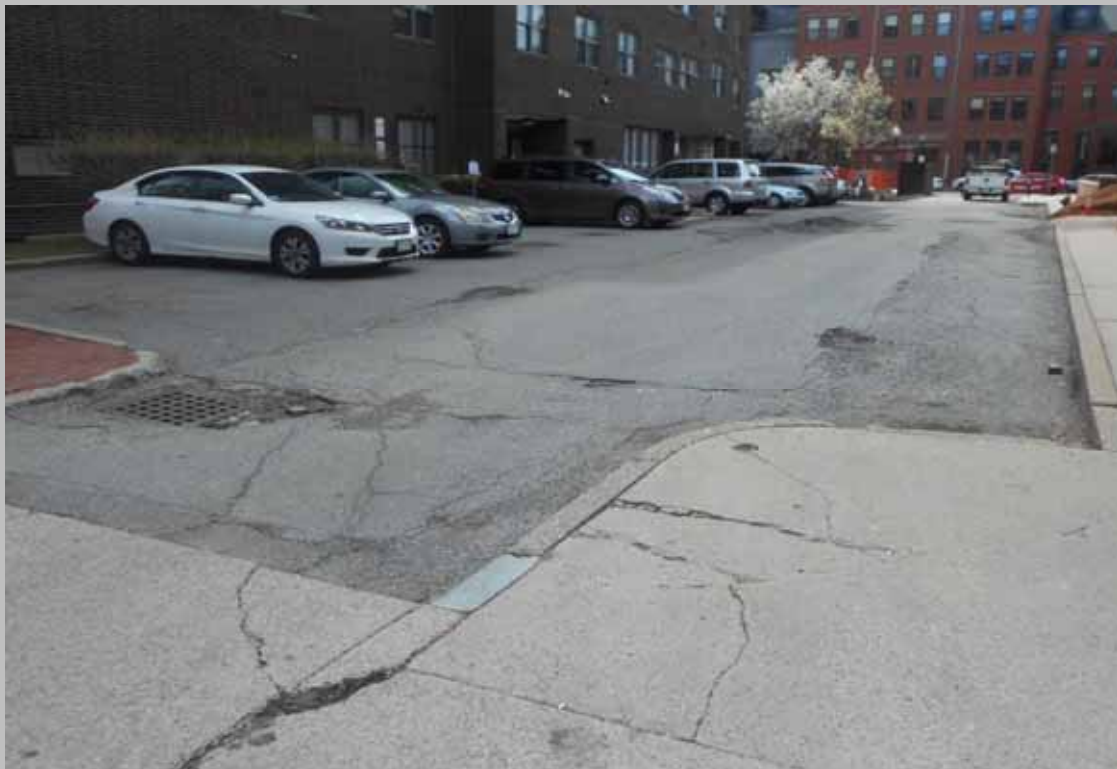
PHOTO #10

The property is situated in an urban area and provides limited off-street parking as well as limited parking at the rear of the building to (ten (10) parking spaces). The asphalt parking area was observed in poor physical condition and its refurbishment, along with re-sealing and re-stripping, have been noted as Non-Critical Repairs. It should be noted that most residents utilize public transportation or purchase city street parking permits. In addition, there are parking facilities nearby that offer monthly rates.

View of asphalt parking surface

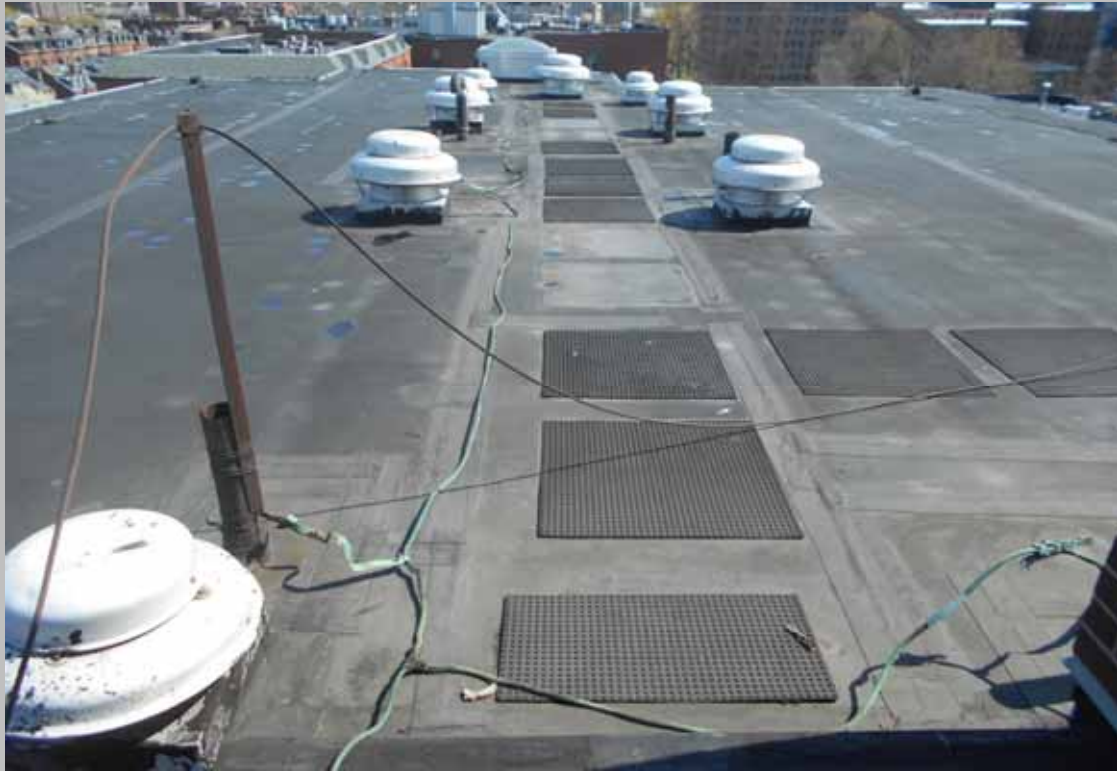
PHOTO #11

The building features a flat roof that features a built-up roofing assembly consisting of a fully adhered EPDM membrane, presumed to be over rigid insulation and fiber board. No leaks were reported and no seams or openings in the assembly were observed. Roofing was observed in fair physical condition. Replacement of the EPDM membrane is anticipated during the estimate period.

View of building roof

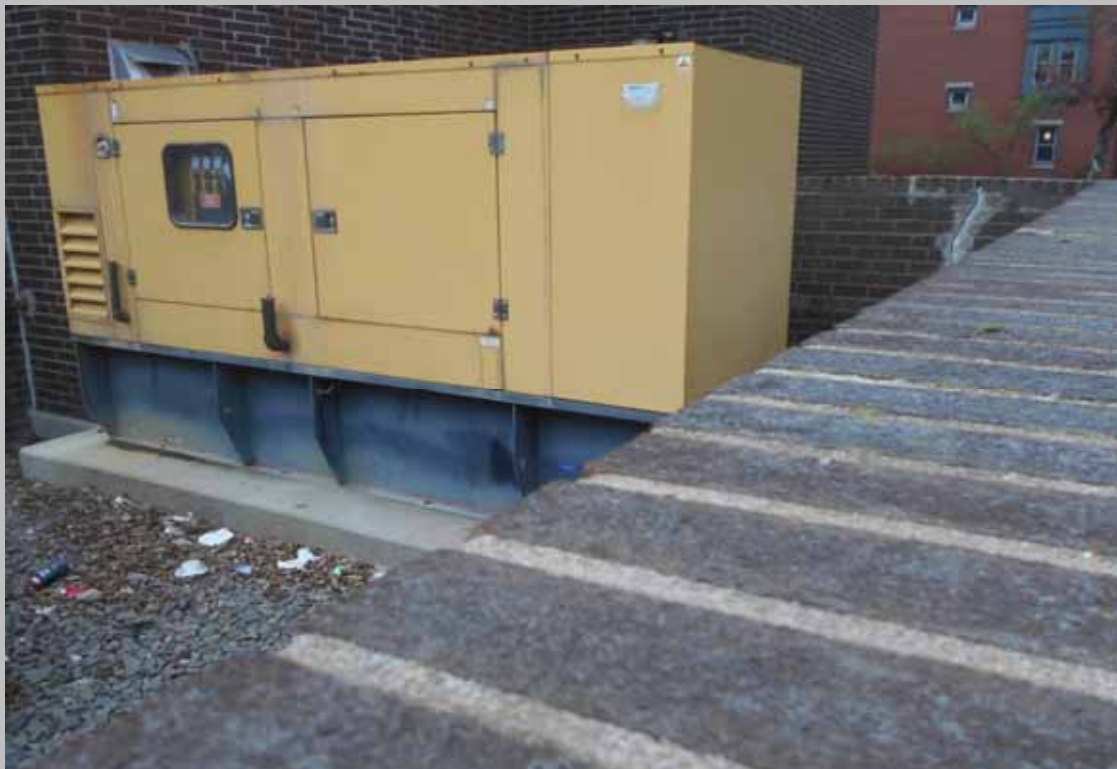
PHOTO #12

The property features a 150kW diesel emergency generator with a 200-gallon above ground storage tank positioned below the generator. The generator was observed in fair to good physical condition.

View of generator

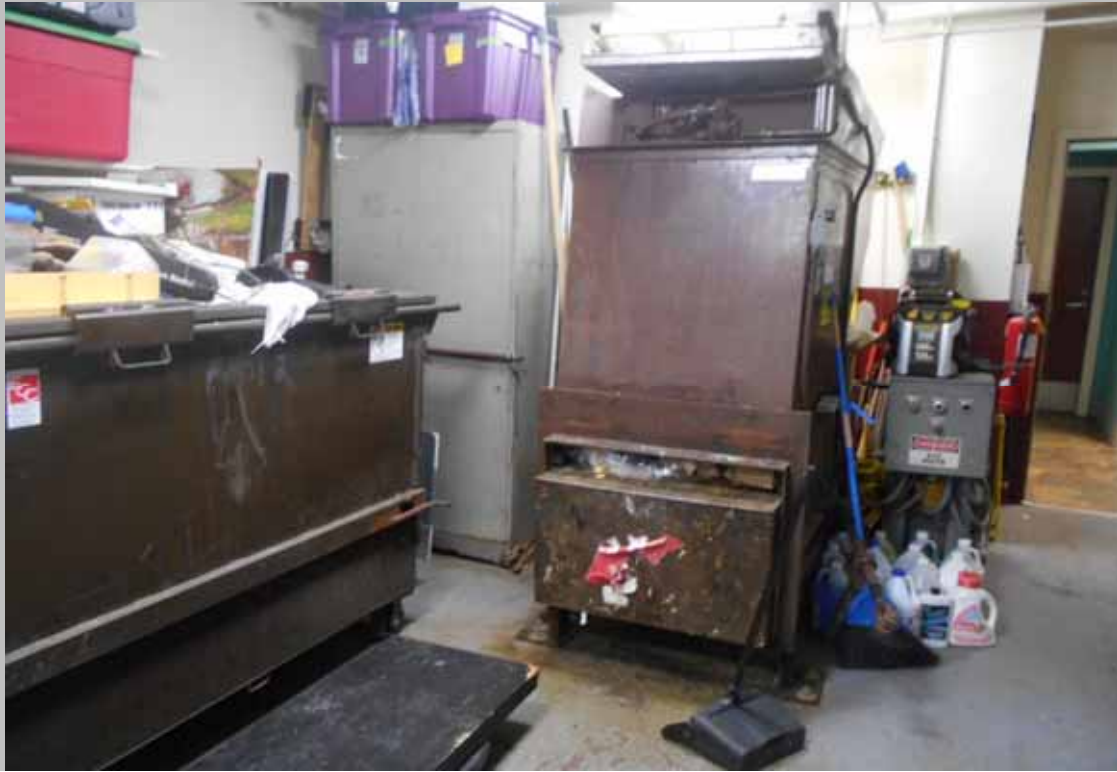
PHOTO #19

The property features a trash chute system that empties into a trash compactor located in a first-floor trash room. The compactor was observed in fair physical condition and is anticipated for replacement during the estimate period.

View of the trash compactor

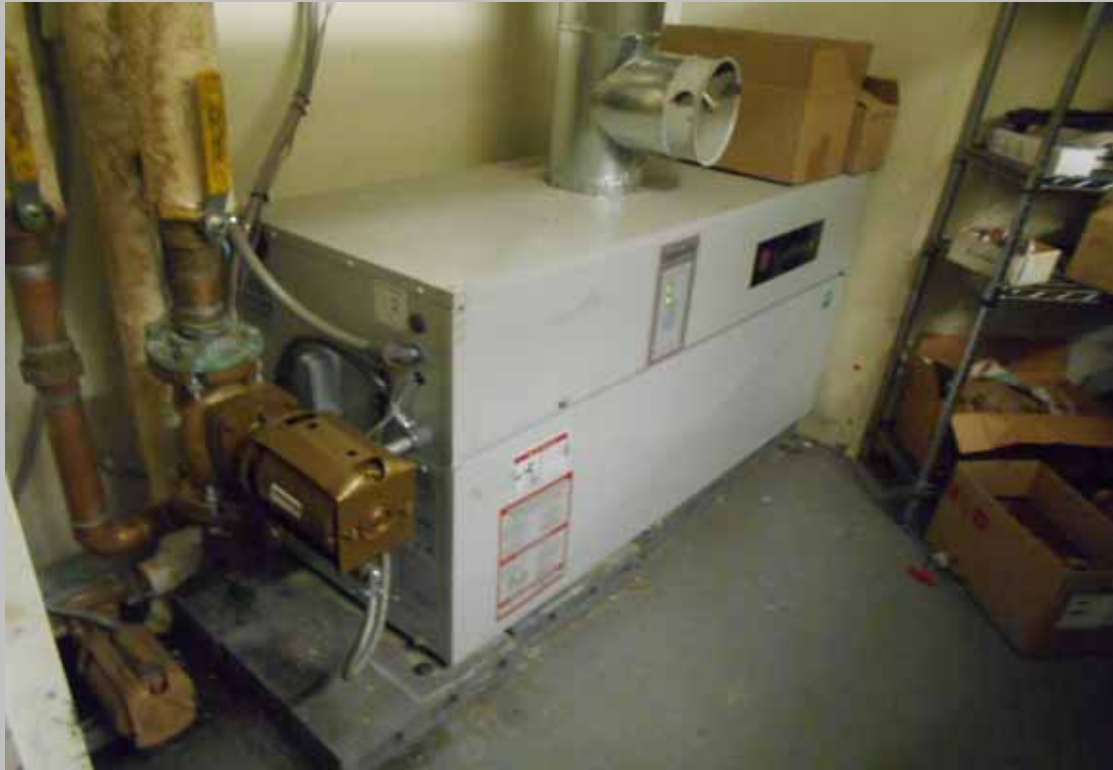
PHOTO #21

Potable hot water to the dwelling units and common areas is supplied by one (1) centrally located gas-fired DHW boiler that works in conjunction with four (4) hot water storage tanks located in a first-floor mechanical room. The systems and equipment were observed and reported to be in fair to good operating order. The replacement of the systems is anticipated during the estimate period.

View of the DHW boiler

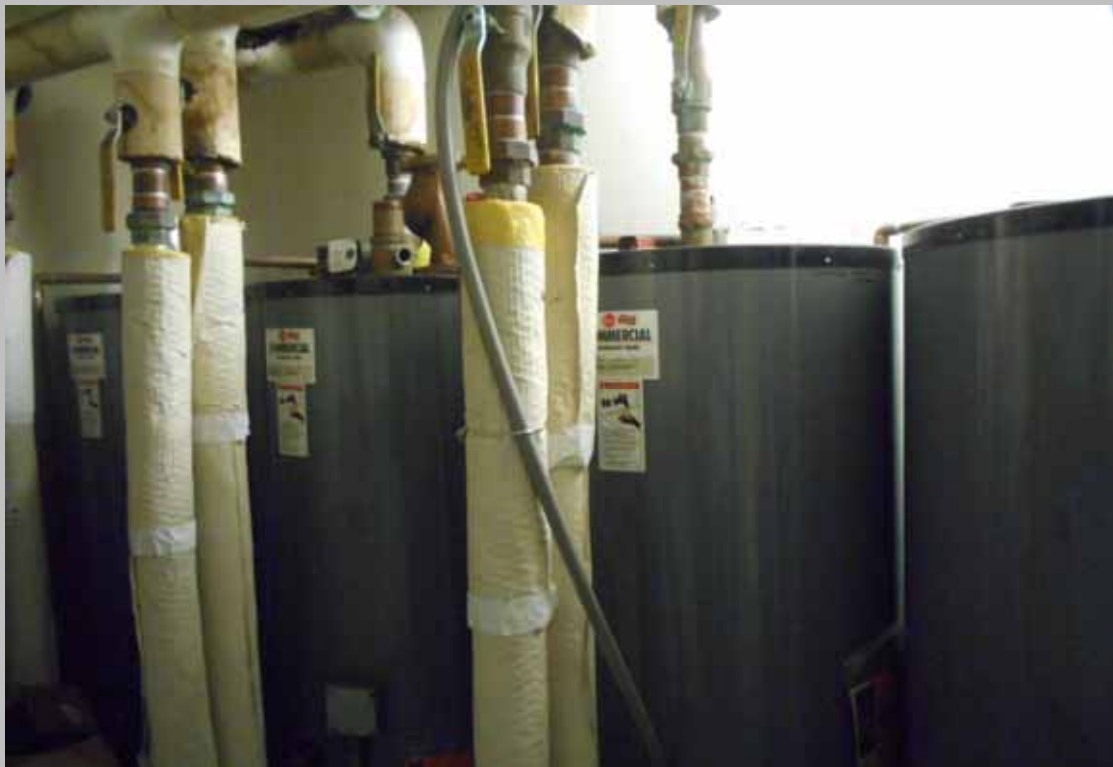
PHOTO #22

View of water storage tanks

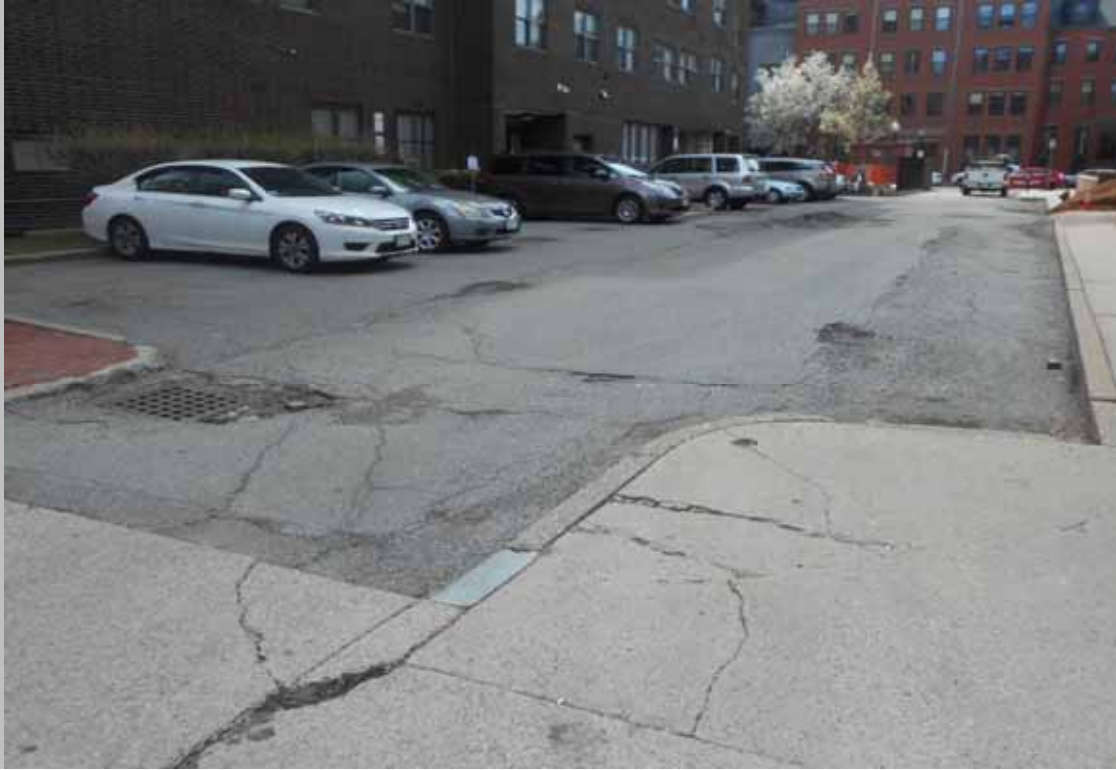
PHOTO #55

View of the parking lot in need of re-surfacing, re-sealing, and re-stripping (Non-Critical Repairs)

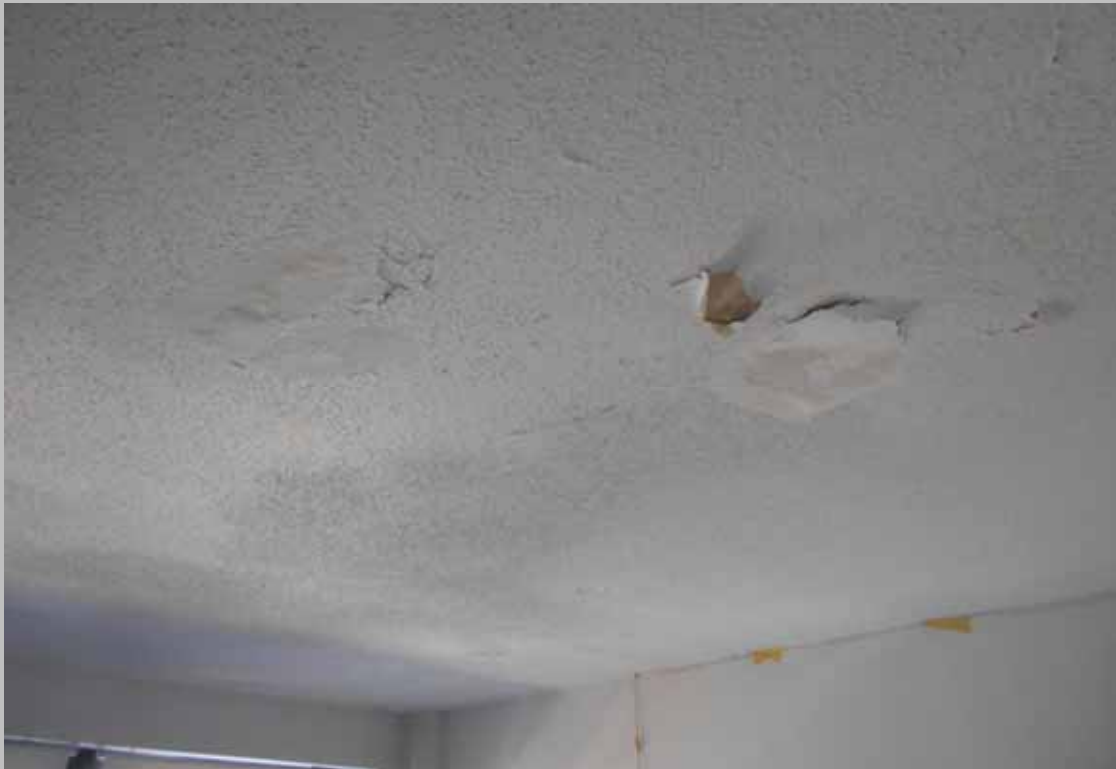
PHOTO #56

Interior wall and ceiling finishes within the dwelling units consist of painted GWB walls and ceilings – observed in fair physical condition (with the repair of select areas noted as Non-Critical Repairs). Flooring in the units consists of various vinyl products and ceramic tile in the designated handicapped unit bathrooms – all observed in fair to good condition. The replacement of the flooring is anticipated during the estimate period.

View of an example of a dwelling unit GWB in need of repair and re-painting (Non-Critical RepairS)

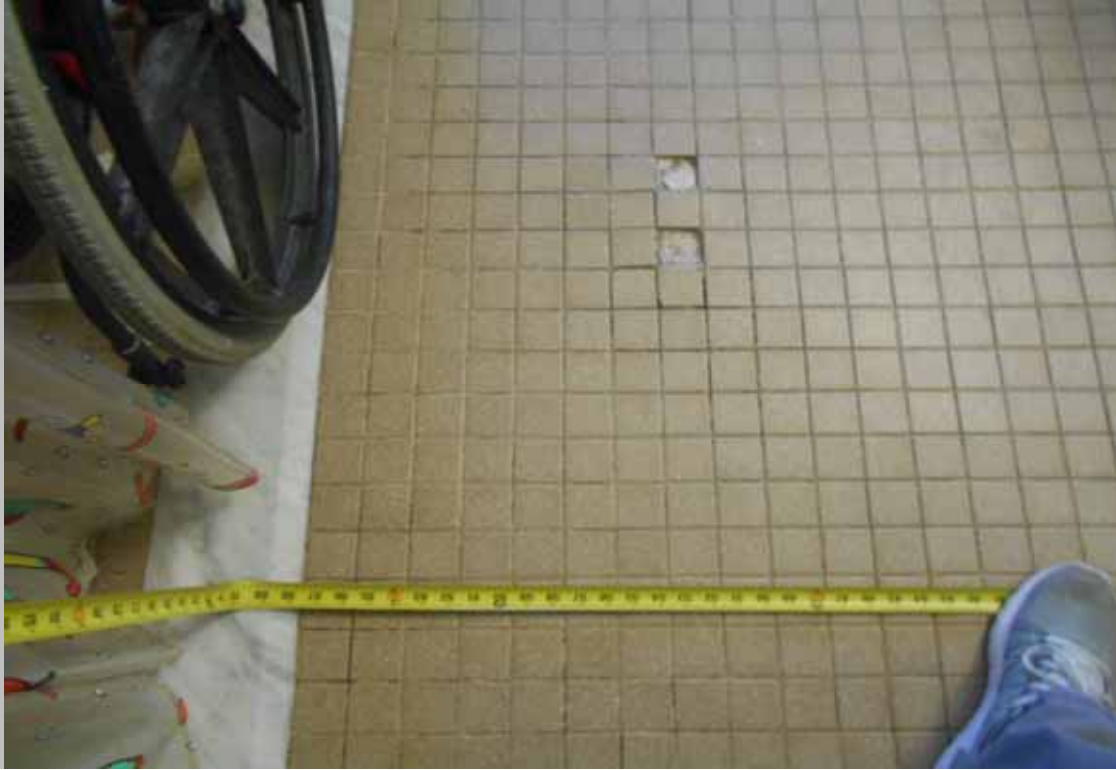
PHOTO #57

View of damaged ceramic tile bathroom flooring in unit 407 (Non-Critical Repair)

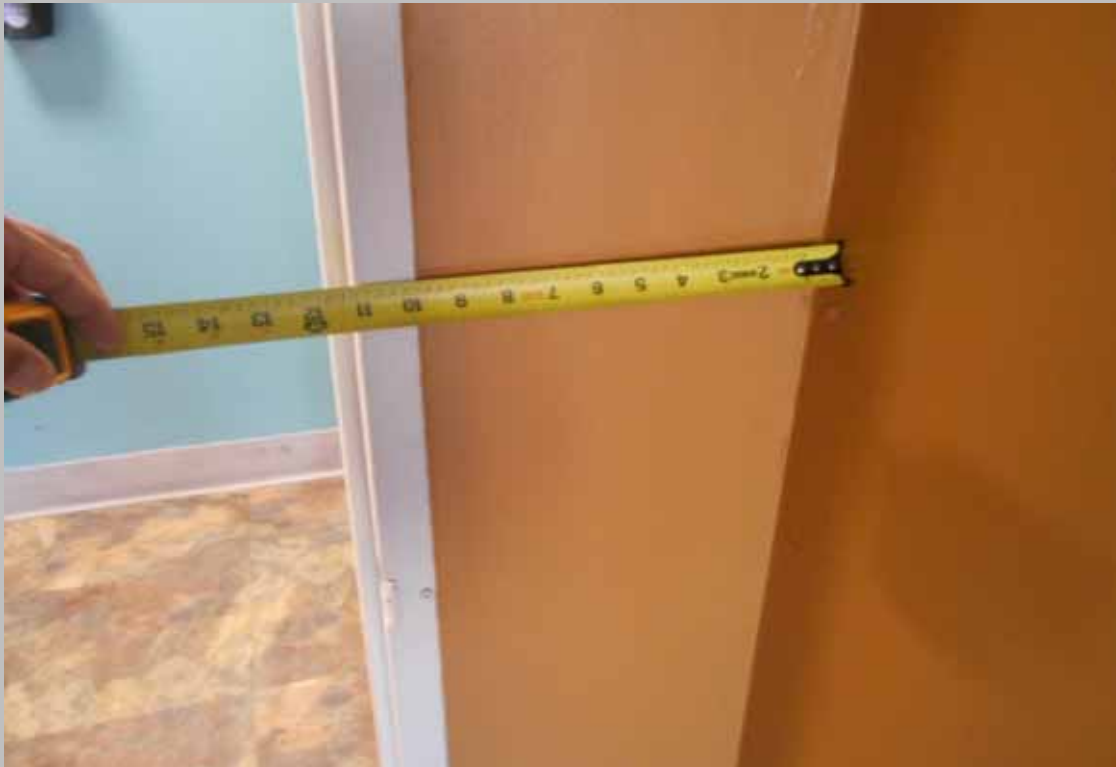
PHOTO #58

The common laundry room door does not feature 18 inches at the pull side of the door (Critical Repair)

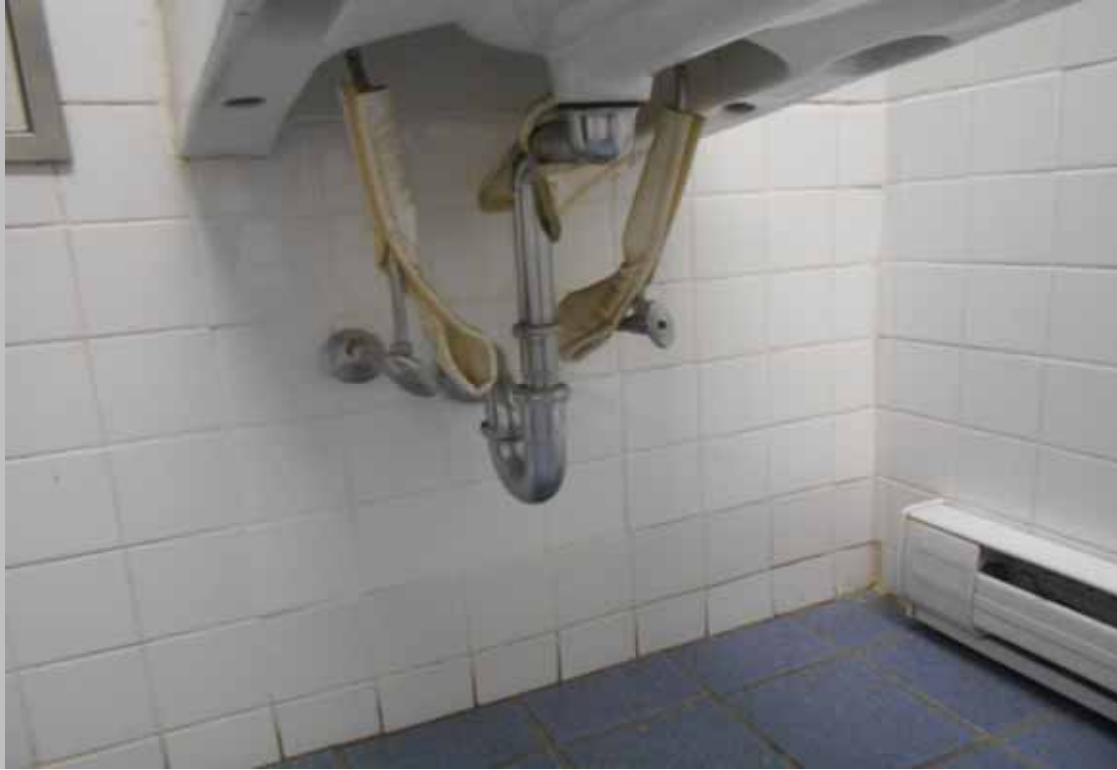
PHOTO #59

The Men's and Women's public restroom sinks feature non-compliant partial scald and abrasion protection at under-sink plumbing (Critical Repair)

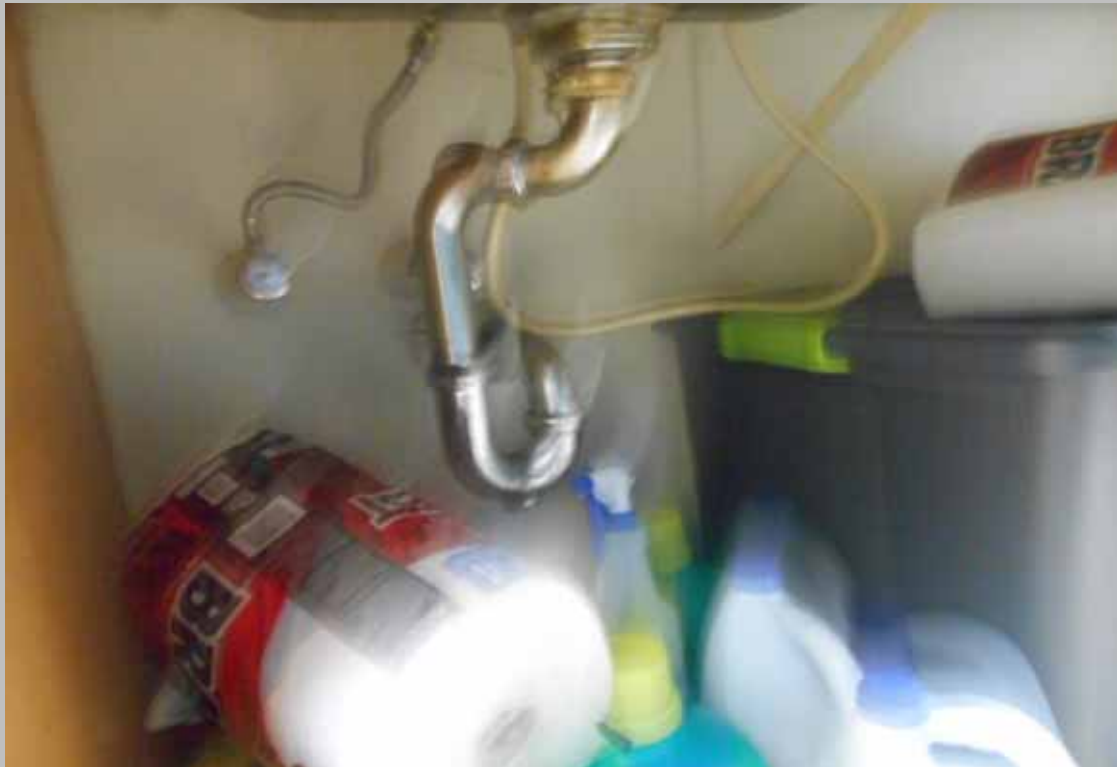
PHOTO #60

The designated handicapped dwelling unit kitchen sinks do not feature scald and abrasion protection at under-sink plumbing (Critical Repair)
