**CAPITAL NEEDS ASSESSMENT (CNA)  
WEST NINTH STREET (2-36)  
185 WEST NINTH STREET  
SOUTH BOSTON, MASSACHUSETTS 02127**

**2021-0383**

**NOVEMBER 5, 2021**

**APRIL 19-20, 2021**

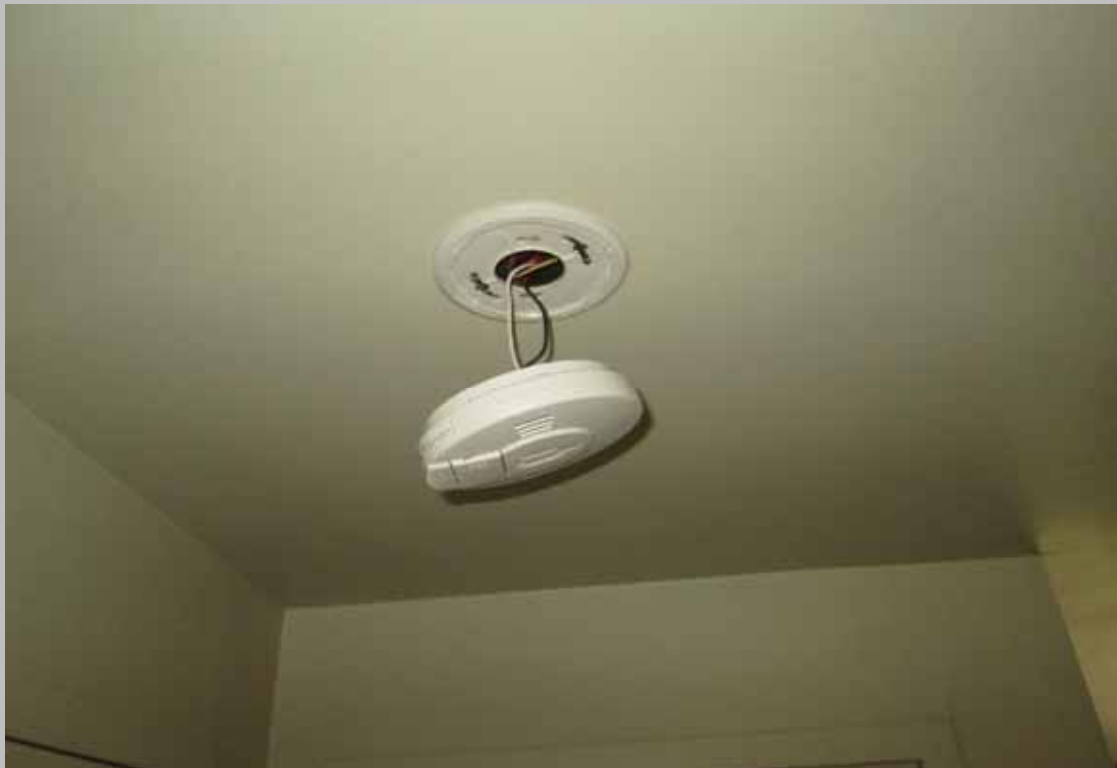
PHOTO #30

Dwelling units contain hard-wired smoke detectors located within the immediate vicinity of the bedroom areas; however, they do not feature smoke detectors in the bedrooms (Critical Repair). Per HUD MAP Guidelines; according to Life Safety Code (NFPA 101), paragraph 31.3.4.5.1, smoke alarms must be installed outside every sleeping area in the immediate vicinity of the bedrooms and on all levels of the dwelling unit, including basements. In addition to the NFPA requirements, the regulation in 24 CFR 200.76 requires that smoke detectors must also be installed inside each sleeping area. The smoke detectors can be either hard wired or battery powered. Battery powered smoke detectors must have the following features: the cell must be tamper-resistant; the cells cannot be used in any other toy or appliance; the cells must have a ten-year life (i.e. lithium battery); the smoke detector may have a manual silencing device to clear unwanted alarms such as cooking smoke. For the purpose of this report we have budgeted battery powered smoke detectors, allowable by the HUD MAP Guidelines. It is recommended to contact the local municipality to determine if battery powered smoke detectors are allowable.

View of a typical smoke detector - dwelling unit

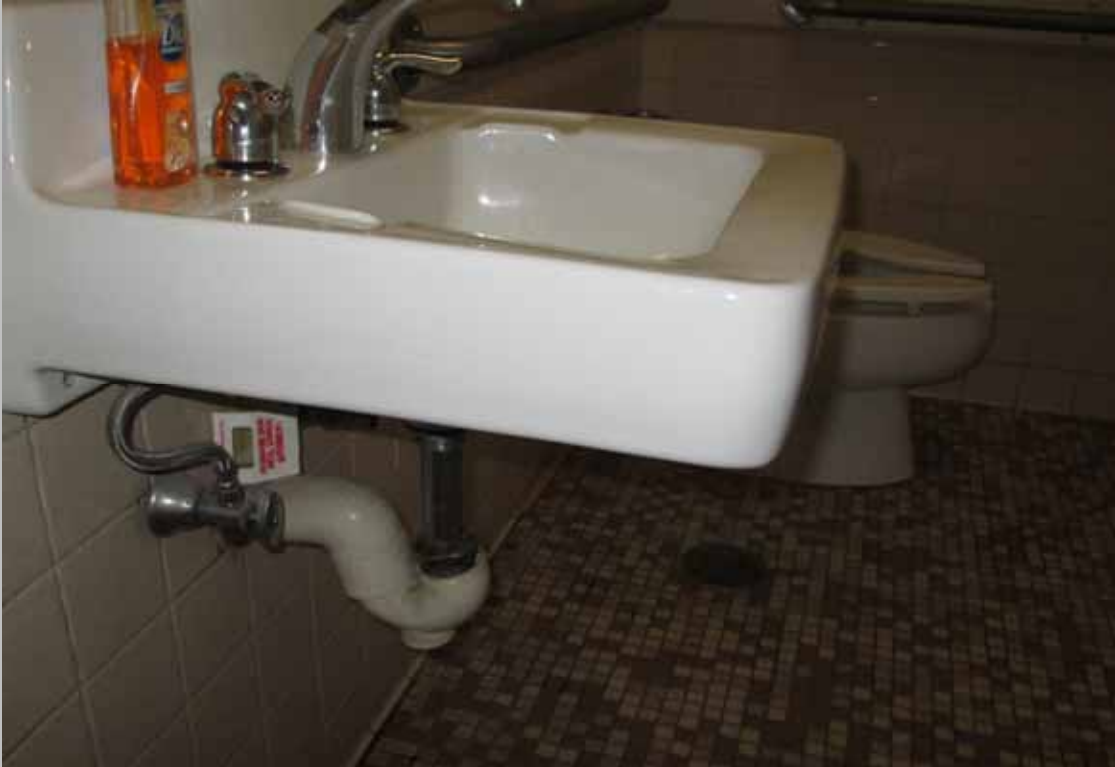
PHOTO #59

View of missing scald and abrasion protection at the women’s public restroom sink (Critical Repair)

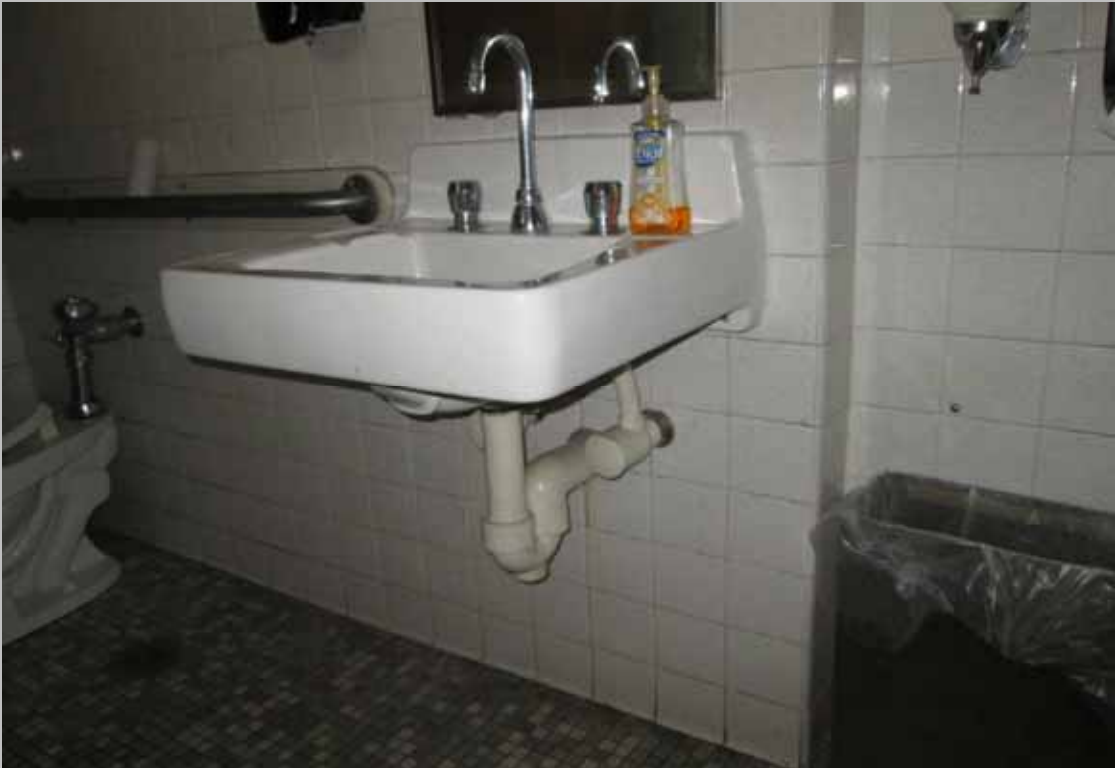
PHOTO #60

View of non-compliant sink hardware in the men’s public restroom (Critical Repair)

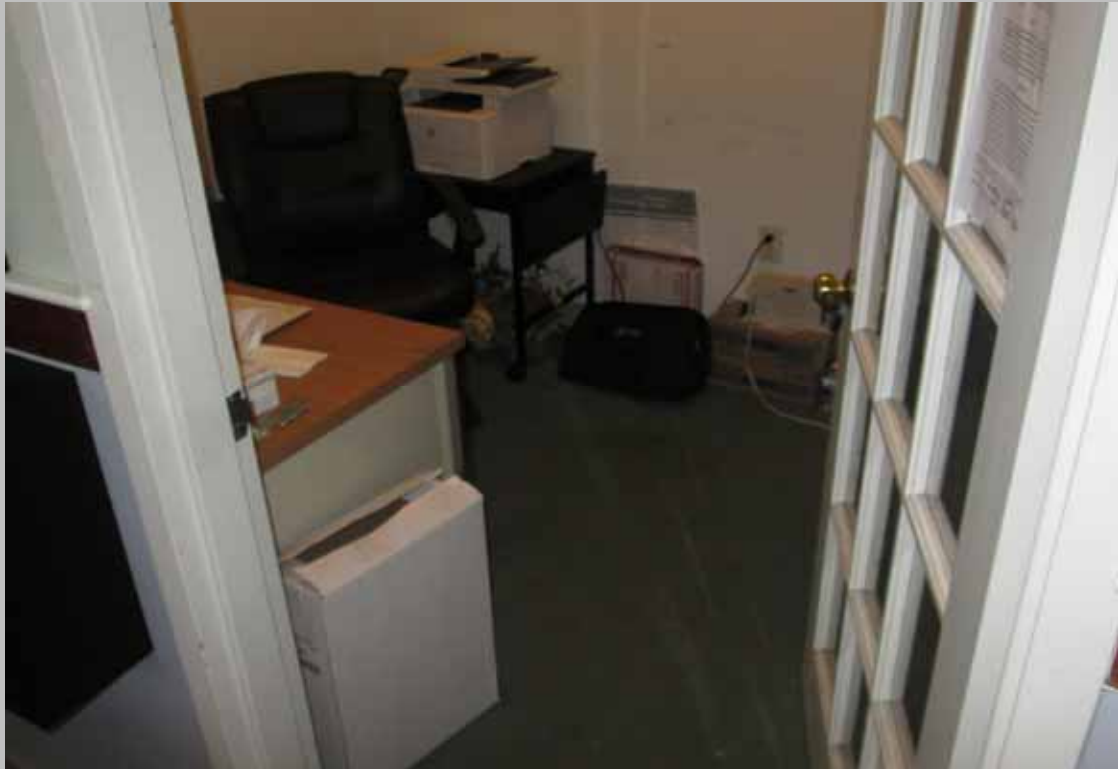
PHOTO #61

View of non-compliant knobbed hardware located at the leasing office entry door (Critical Repair)

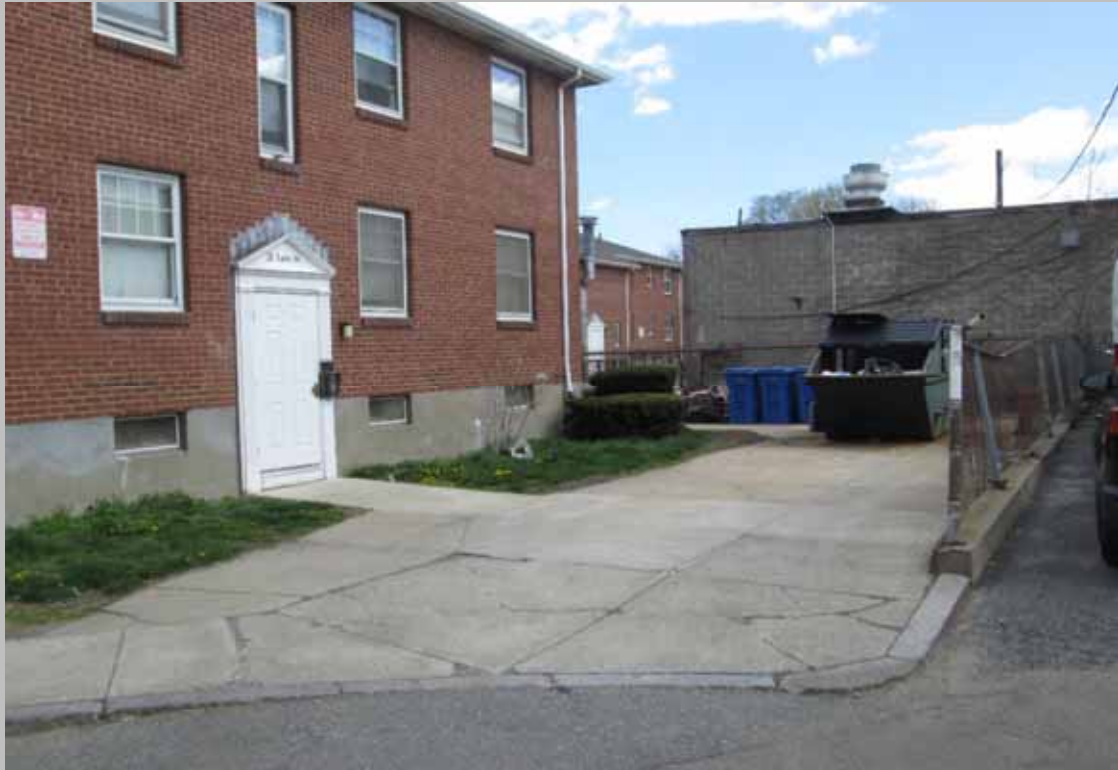
PHOTO #62

View of a potential trip hazard outside of the entry to 21 Lark Street - Critical Repair

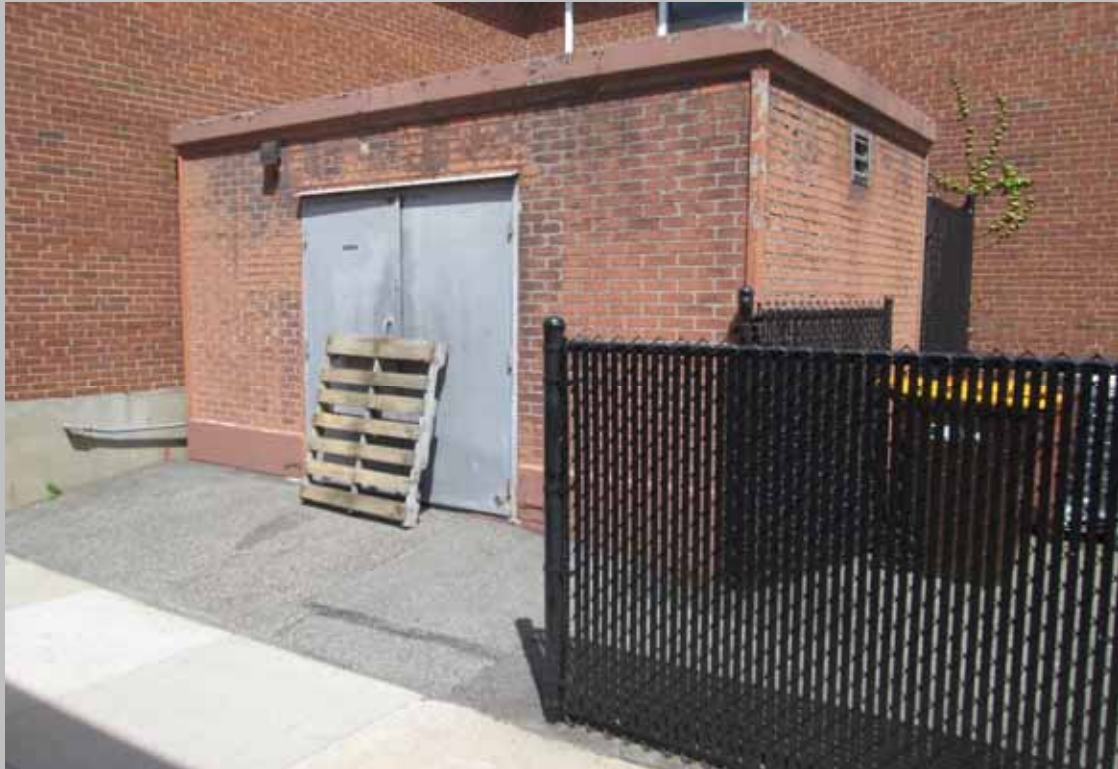
PHOTO #63

View of faded and rusted metal doors at maintenance building  
(Non-Critical Repairs)

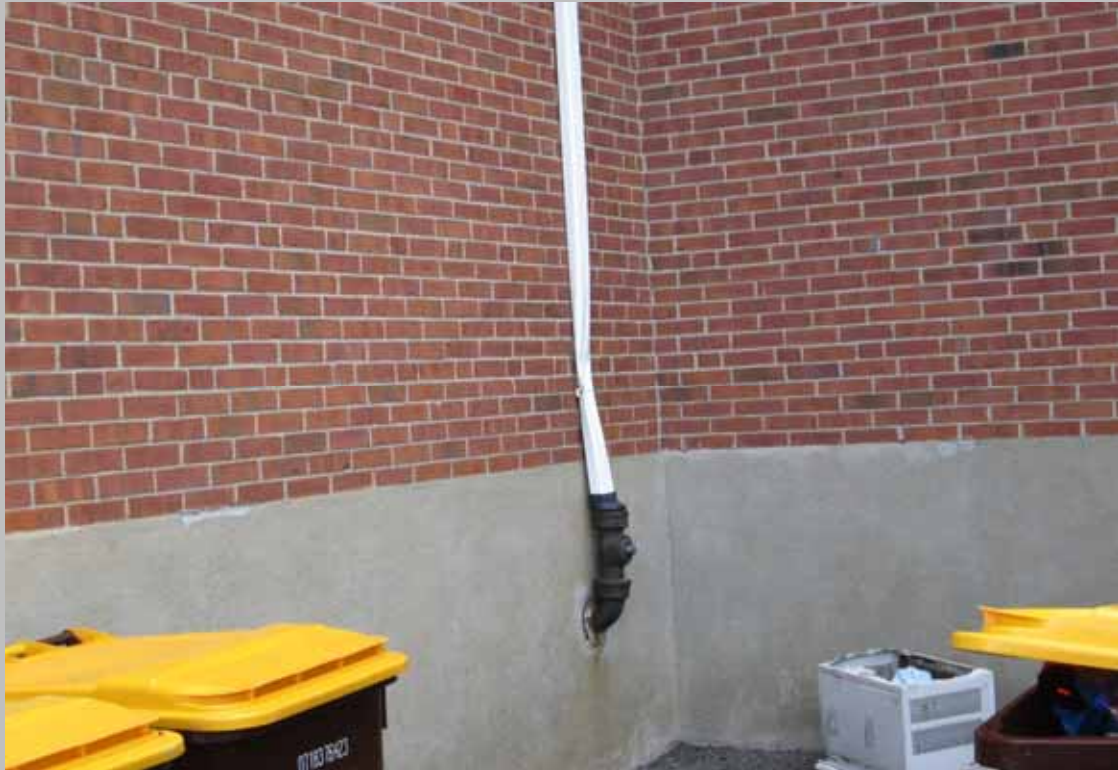
PHOTO #64

View of dented aluminum downspout  
(Non-Critical Repairs)

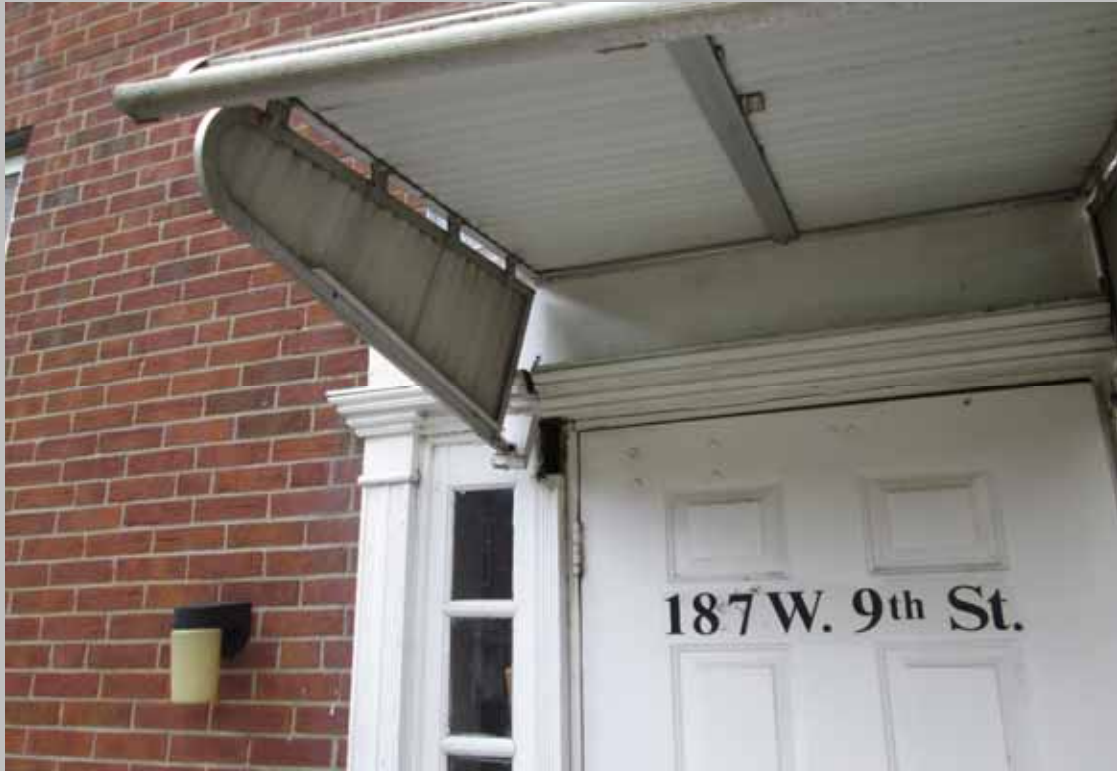
PHOTO #65

View of unsecured awning  
(Non-Critical Repairs)

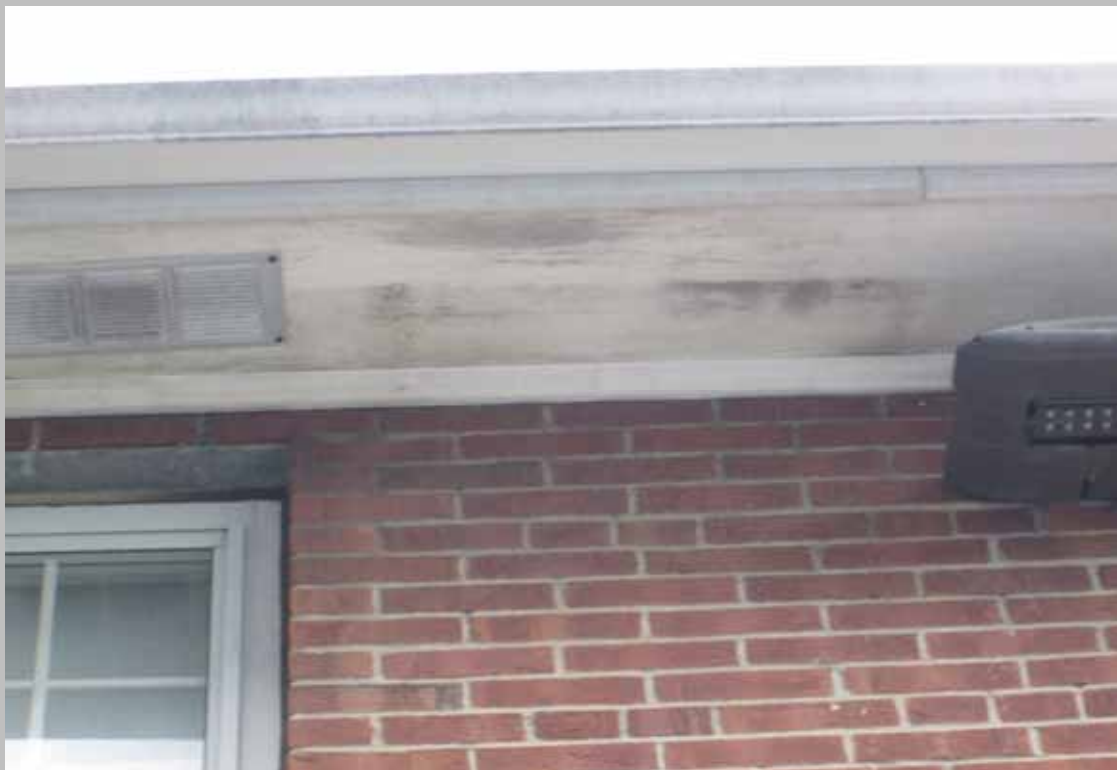
PHOTO #66

View of exterior mildew growth in need of pressure washing (Non-Critical Repair)
