HUD CAPITAL NEEDS ASSESSMENT

JJ Meade
5 Melville Avenue
Boston, Massachusetts 02124

AEI Project No. 463349
Site Inspection Date: July 27, 2022

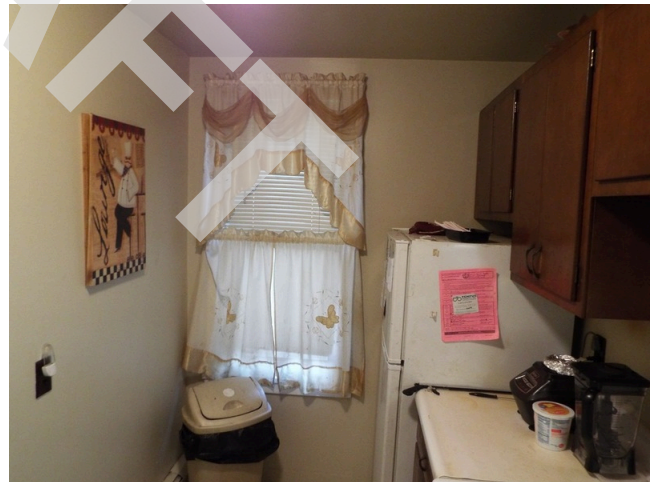
3. 1-bed-1-bath - unit 38 - range malfunction
(Critical Repair)

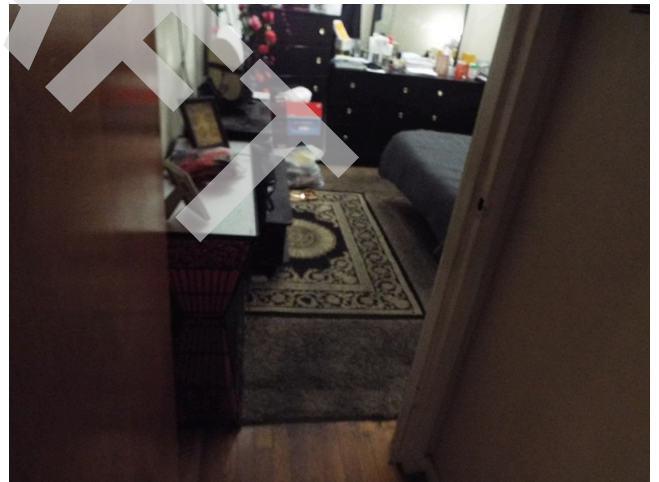
11. 1-bed-1-bath - unit 38 - door lock condition
(Critical Repair)

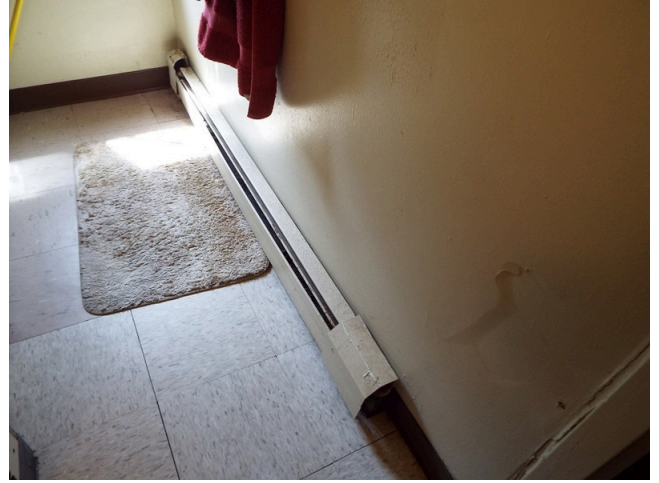
42. 1-bed-1-bath - unit 6 - baseboard heat cover condition (Non-Critical Repair)

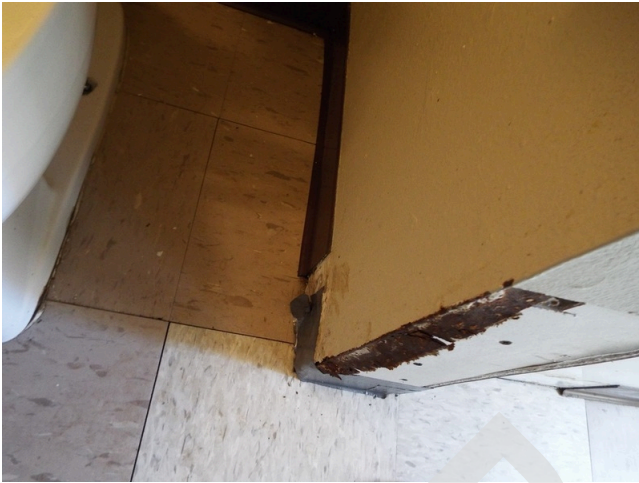
44. 1-bed-1-bath - unit 6 - wall condition (Non-Critical Repair)

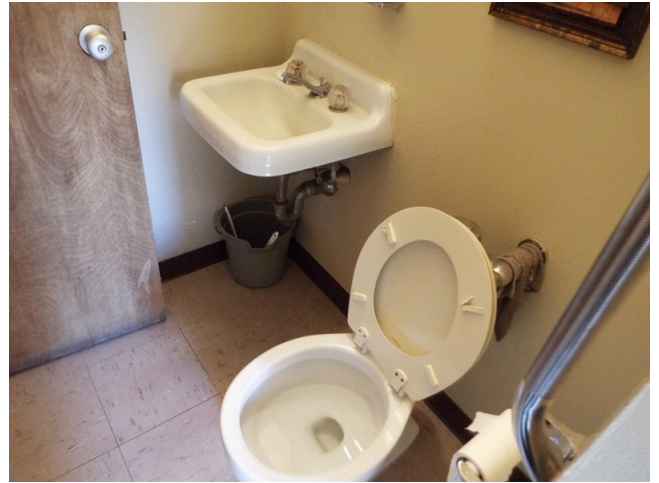
45. 1-bed-1-bath - unit 6 - wall condition (Non-Critical Repair)

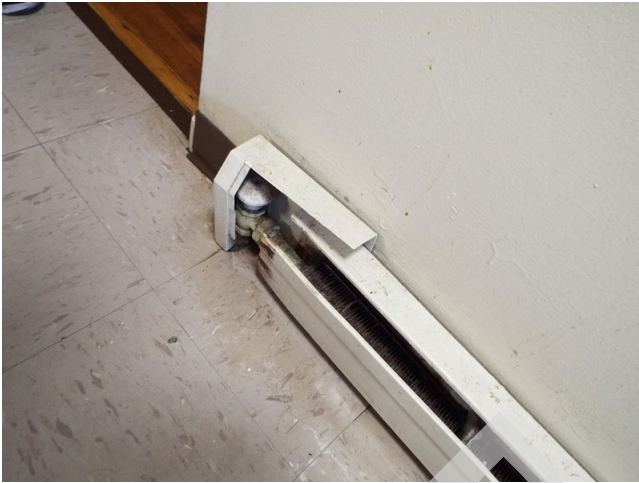
52. 1-bed-1-bath - unit 6 - baseboard heat cover condition (Non-Critical Repair)

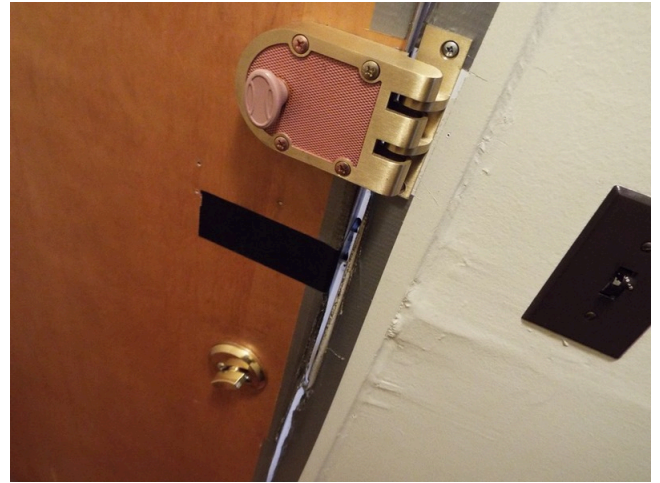
58. 1-bed-1-bath - unit 6 - door gap (Non-Critical Repair)

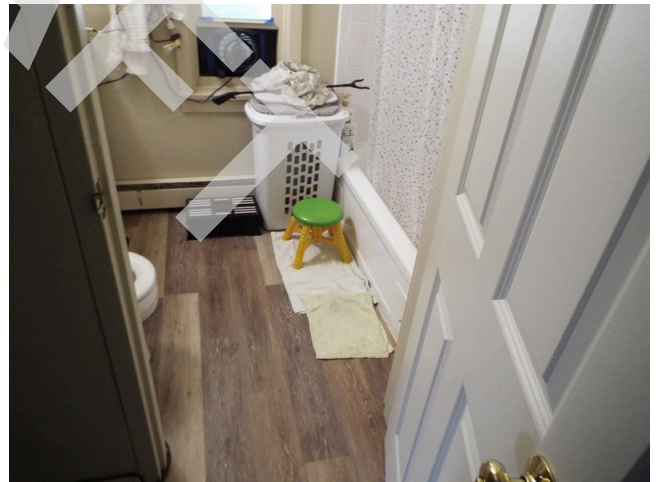
63. 2-bed-1-bath - unit 40 - baseboard heat cover condition (Non-Critical Repair)

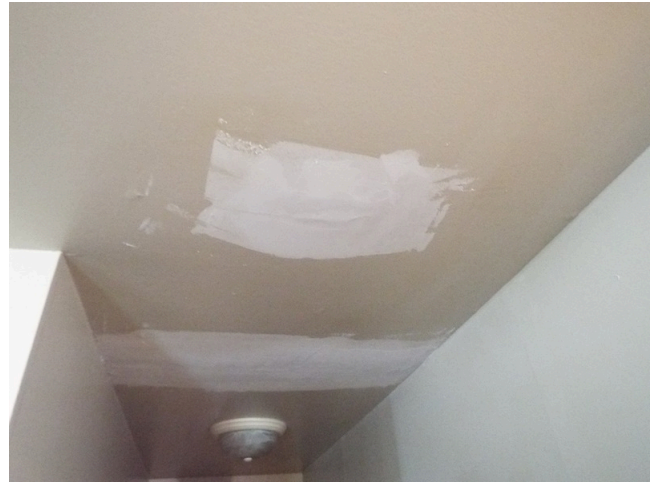
74. 1-bed-1-bath - unit 2 - ceiling condition (Non-Critical Repair)

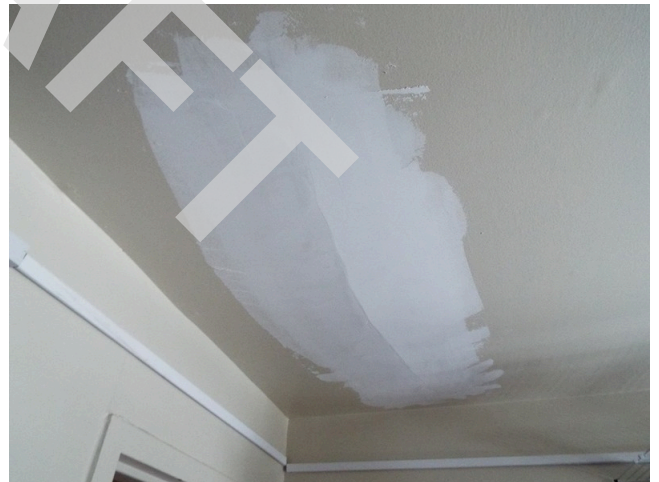
87. 1-bed-1-bath - unit 2 - ceiling condition (Non-Critical Repair)

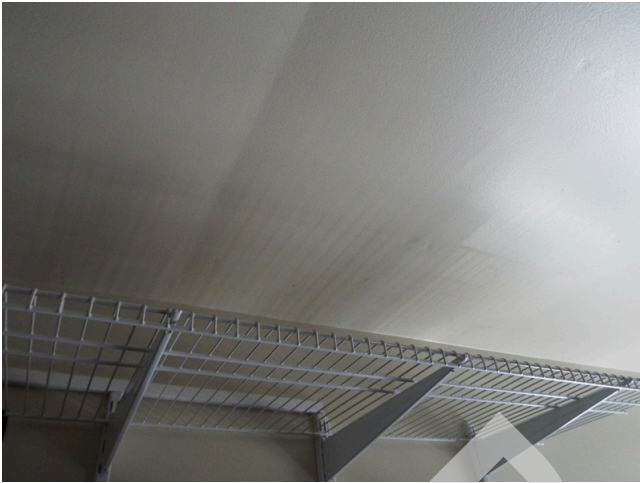
88. 1-bed-1-bath - unit 2 - ceiling condition (Non-Critical Repair)

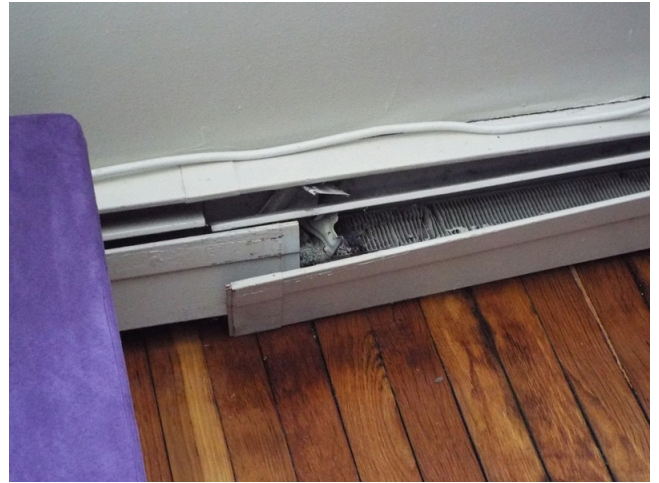
90. 1-bed-1-bath - unit 2 - baseboard heat cover condition (Non-Critical Repair)

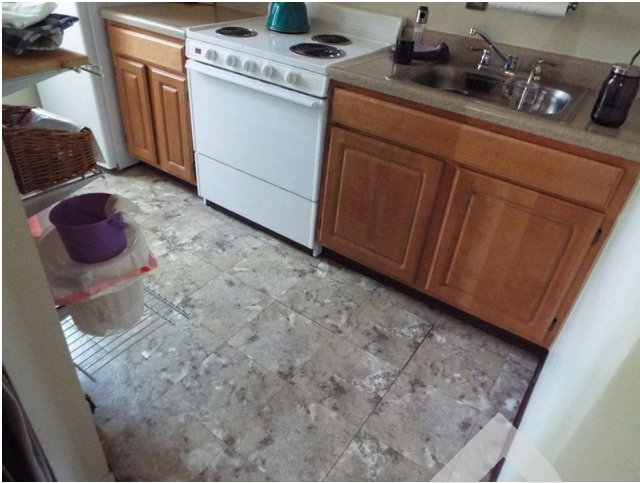
92. 1-bed-1-bath - unit 2 - range malfunction (Critical Repair)

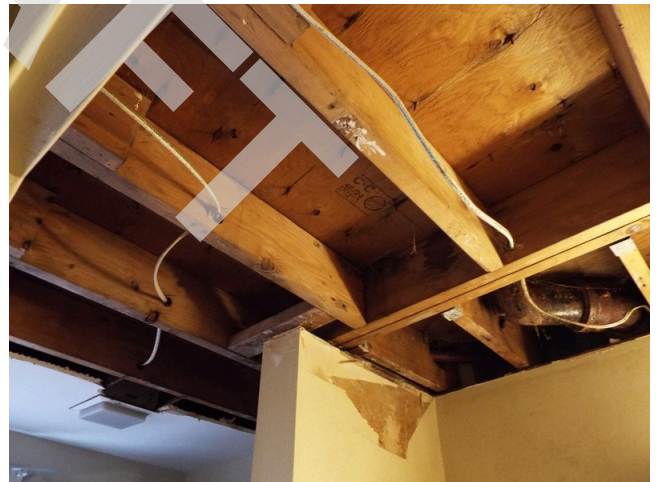
116. 1-bed-1-bath - unit 15 - ceiling condition (Non-Critical Repair)

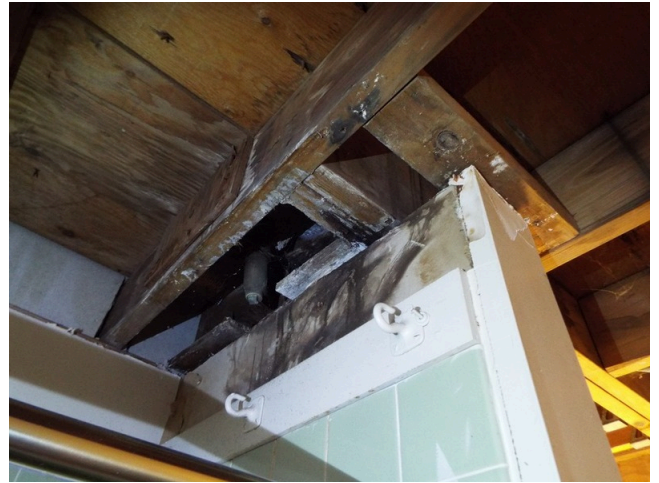
118. 1-bed-1-bath - unit 15 - ceiling condition (Non-Critical Repair)

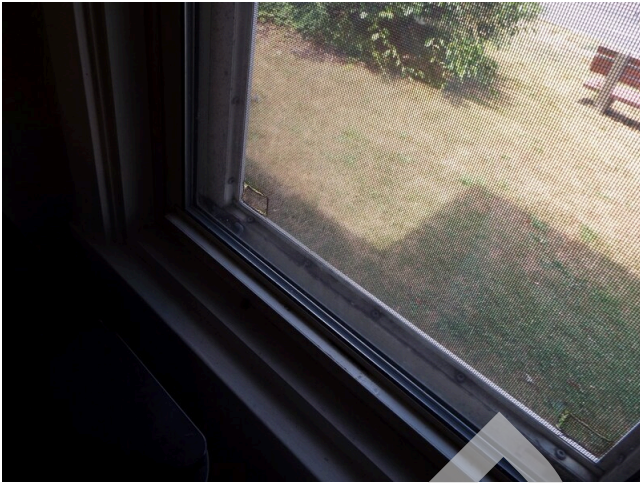
121. 1-bed-1-bath - unit 27 - screen damage (Non-Critical Repair)

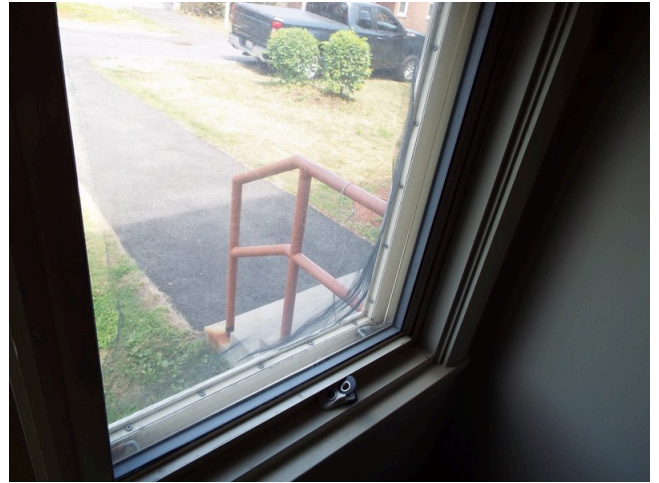
122. 1-bed-1-bath - unit 27 - screen damage (Non-Critical Repair)

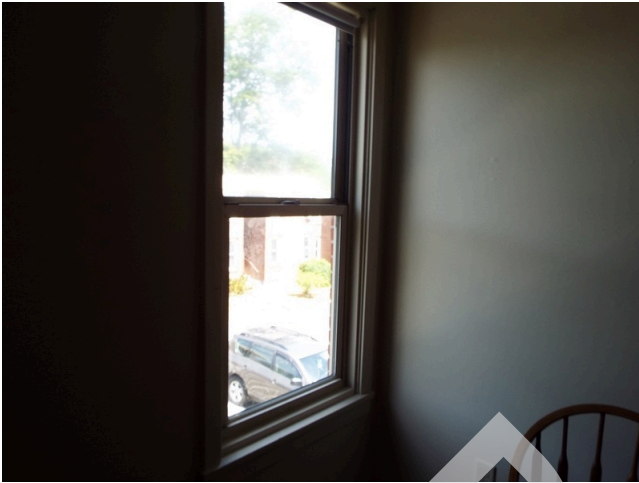
133. 1-bed-1-bath - unit 27 - missing screen (Non-Critical Repair)

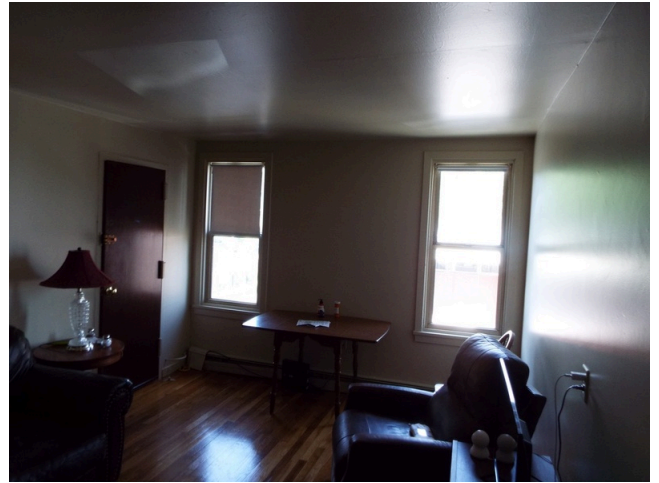
135. 1-bed-1-bath - unit 22 - missing screen (Non-Critical Repair)

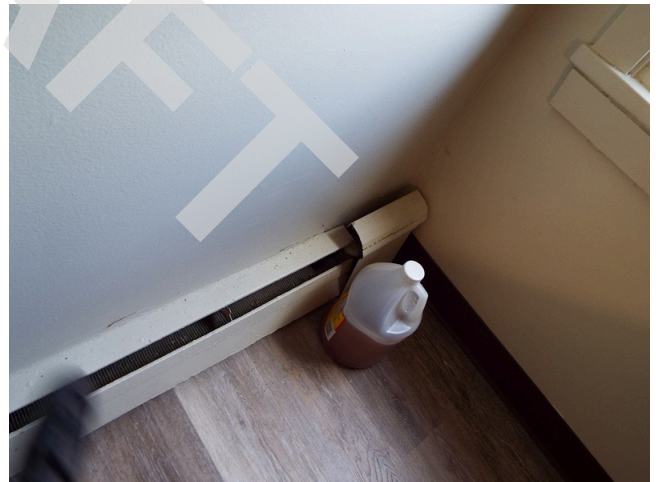
136. 1-bed-1-bath - unit 22 - baseboard heat cover condition (Non-Critical Repair)

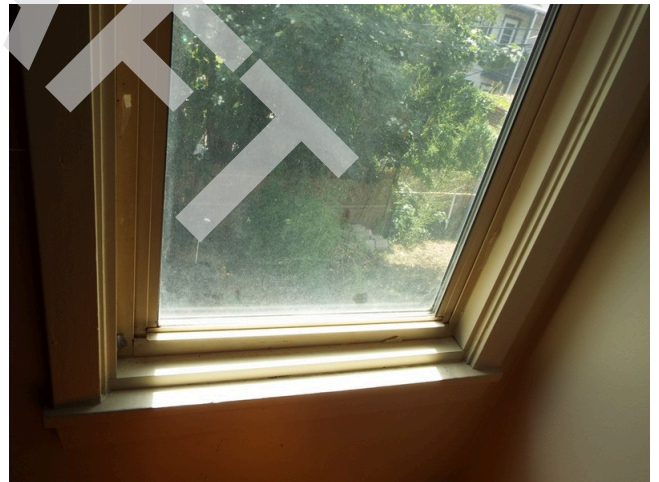
140. 1-bed-1-bath - unit 22 - missing screen (Non-Critical Repair)

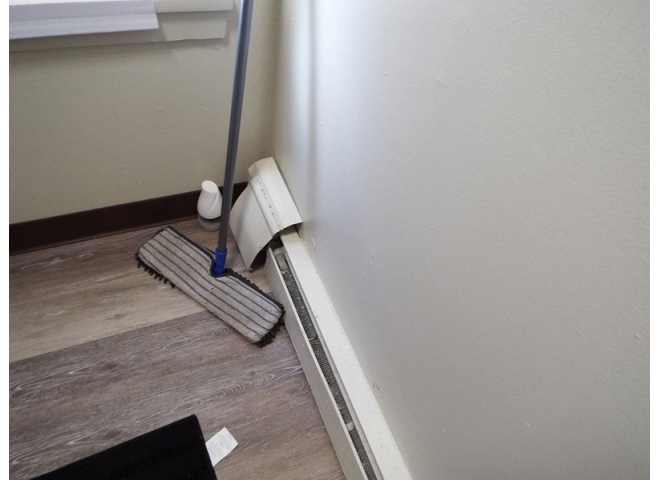
146. 1-bed-1-bath - unit 22 - baseboard heat cover condition (Non-Critical Repair)

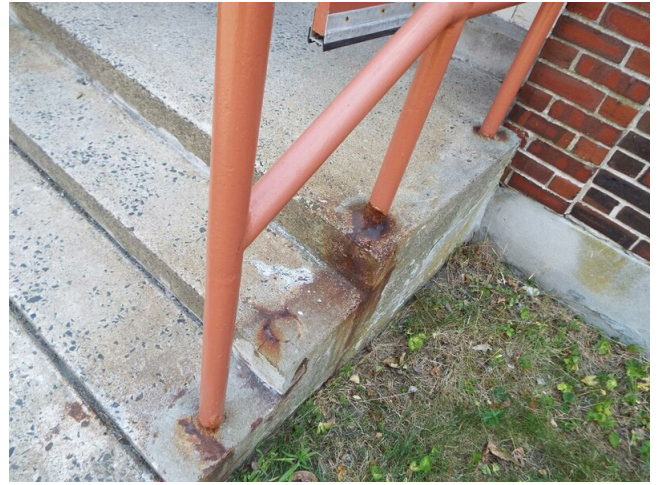
AEI observed deterioration of metal handrail post bases located at building entry steps at building 13 and 15, and concrete spalling at building 13. Repair is required to make the assemblies safe (Critical Repair).

18. Handrail post base condition - building 15
(Critical Repair)

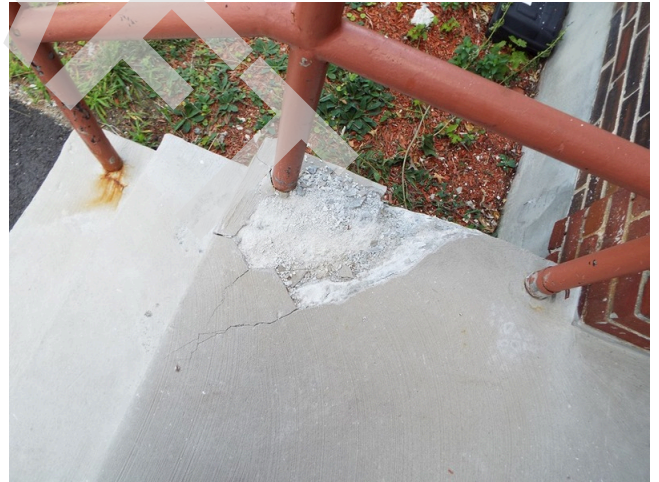
20. Building 13 entry - concrete step spalling
(Critical Repair)

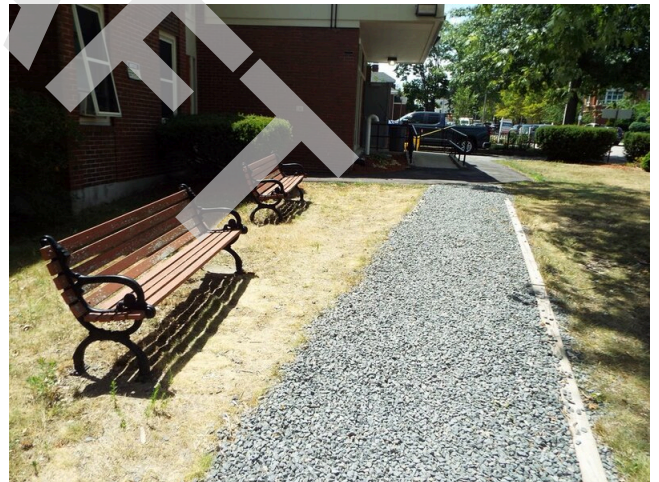
AEI observed areas of bare earth on the lawn adjacent to the asphalt paved access drive on the north side of building 11-15A. Restoration of the area is required. (Non-Critical Repair)

23. Landscaping - bare earth (Non-Critical Repair)

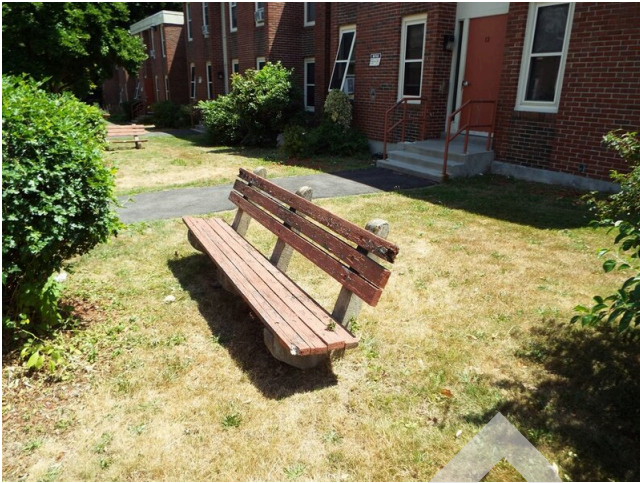
AEI observed significant deterioration of wood benches located throughout the property. Repairs are required. (Non-Critical Repair)

25. Bench condition (Non-Critical Repair)

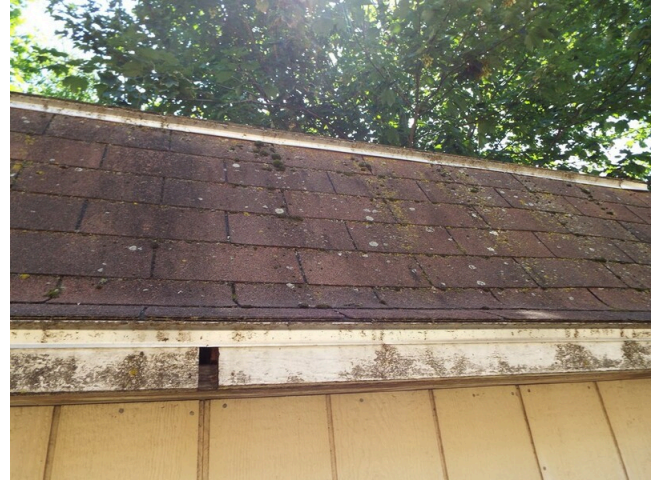
30. Utility shed fascia and roof condition (Non-Critical Repair)

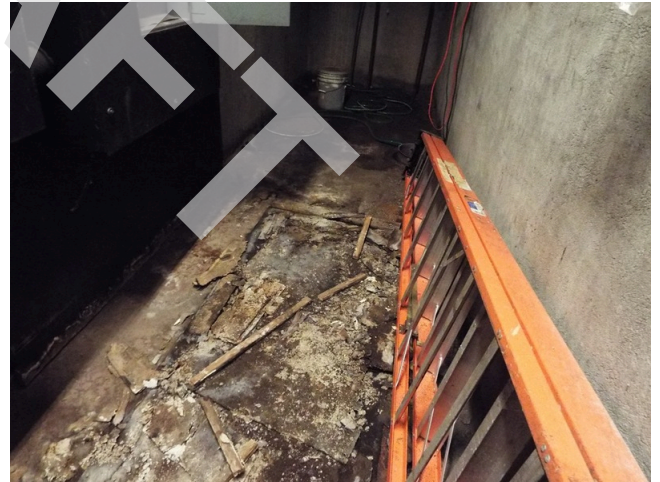
32. Boiler room - moisture condition (Non-Critical Repair)

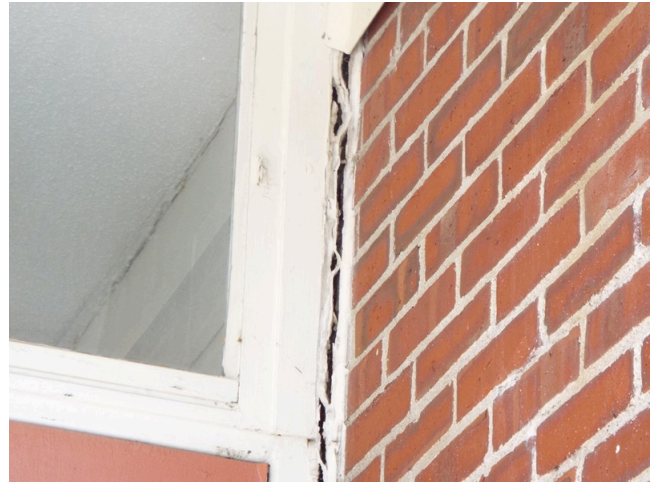
42. Sealant condition - community center rear door
(Non-Critical Repair)

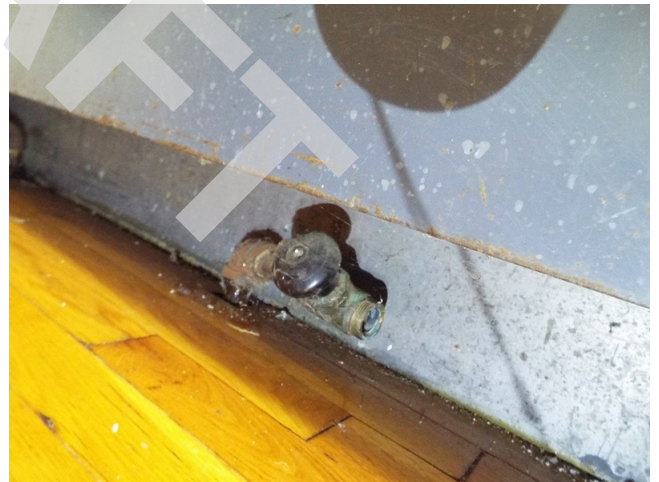
60. Vestibule heater disconnected - building 7 (Non-Critical Repair)

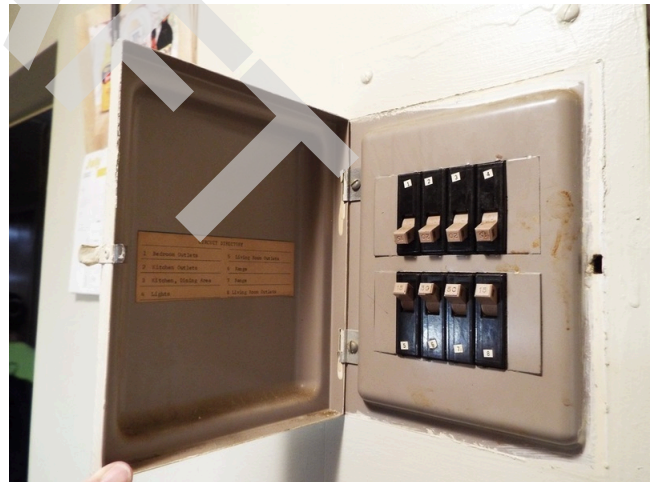
63. Meter sockets - electric room, stab lock breakers
(Critical Repair)

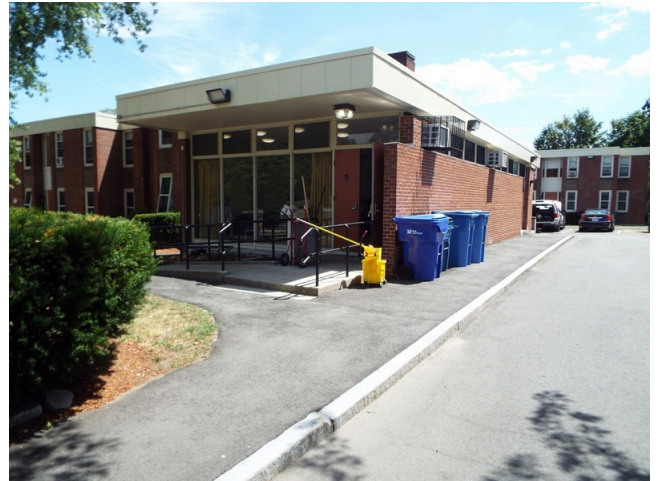
78. Community room entry lacks directional signage to accessible parking (Critical Repair)

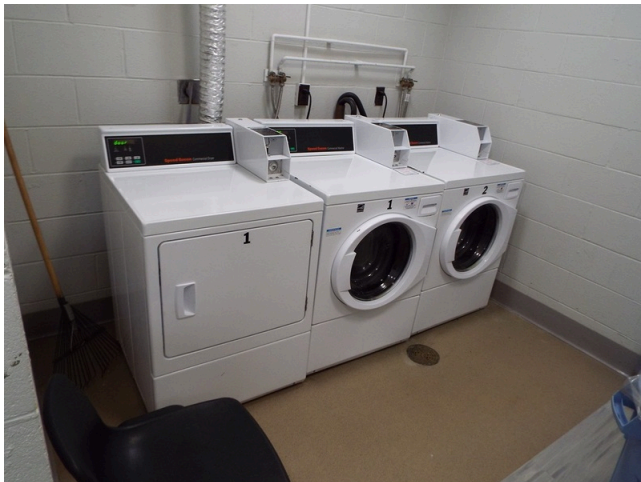
79. Community room - washer lacks front controls (Critical Repair)

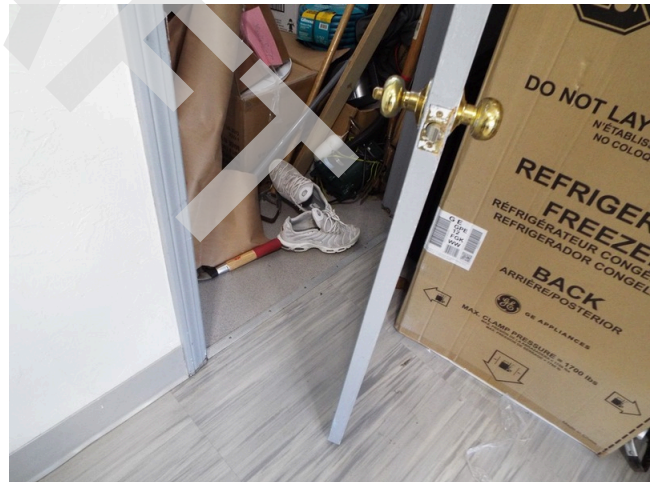
80. Community room - kitchenette door lacks lever hardware (Critical Repair)
