HUD CAPITAL NEEDS ASSESSMENT

Groveland
15 Mary Moore Beatty Circle
Mattapan, Massachusetts 02126

AEI Project No. 463353
Site Inspection Date: July 7, 2022

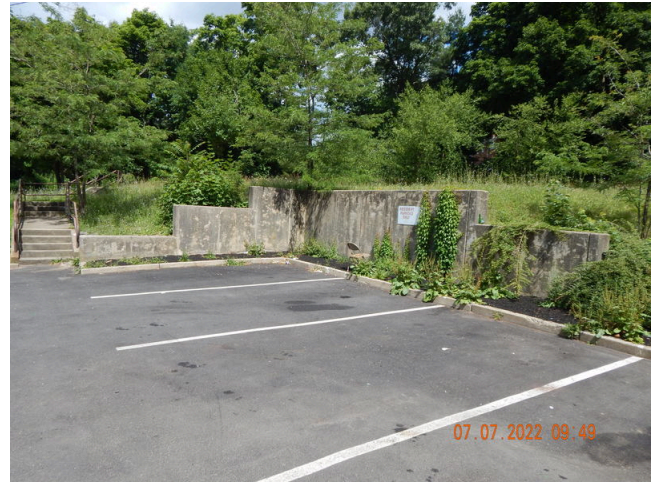
15. Paving, Curbing, & Parking: Typical accessible parking spaces found throughout the property, missing vertical sign (Critical Repair)

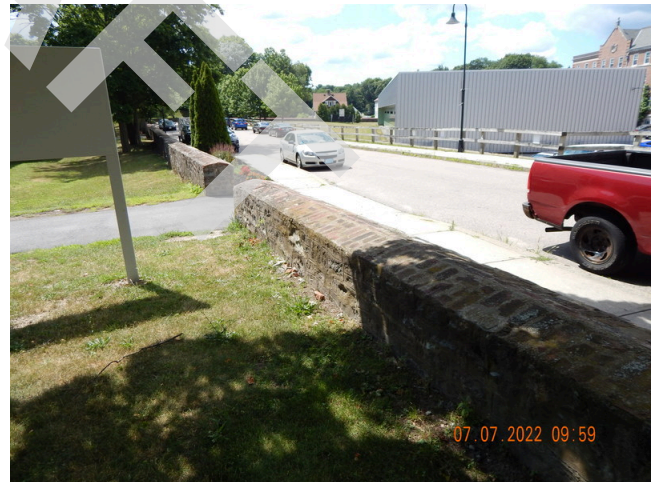
28. Landscaping & Appurtenances: Damaged Masonry wall found on the south perimeter of the property. (Non-Critical Repair)

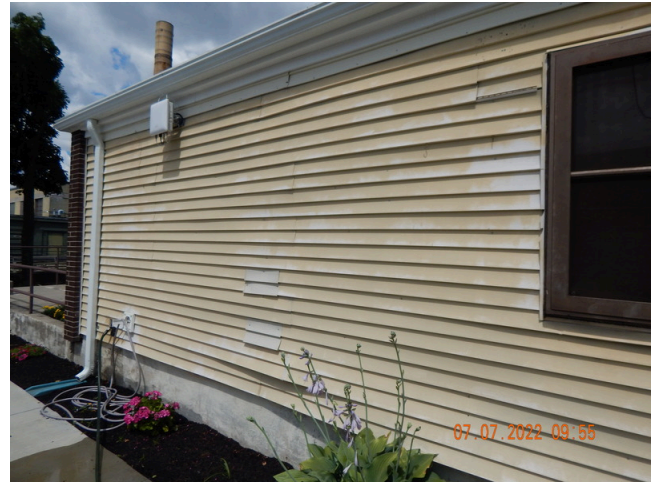
66. Sidewall System: Typical damaged or weathered sidewall vinyl siding found throughout the site. (Non-Critical Repair)

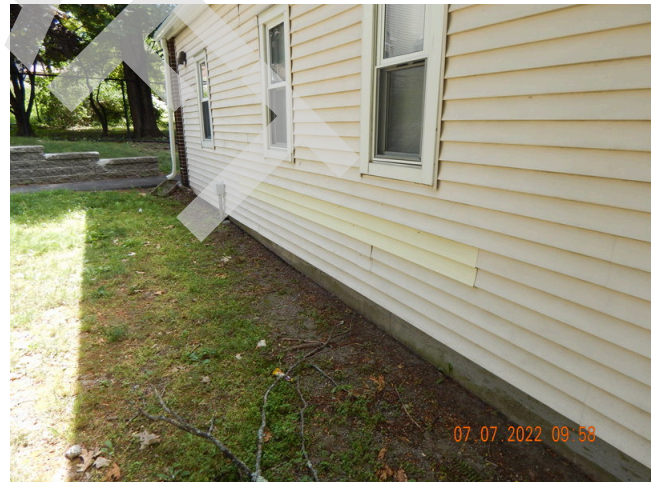
68. Sidewall System: Typical damaged or weathered sidewall vinyl siding found throughout the site. (Non-Critical Repair)

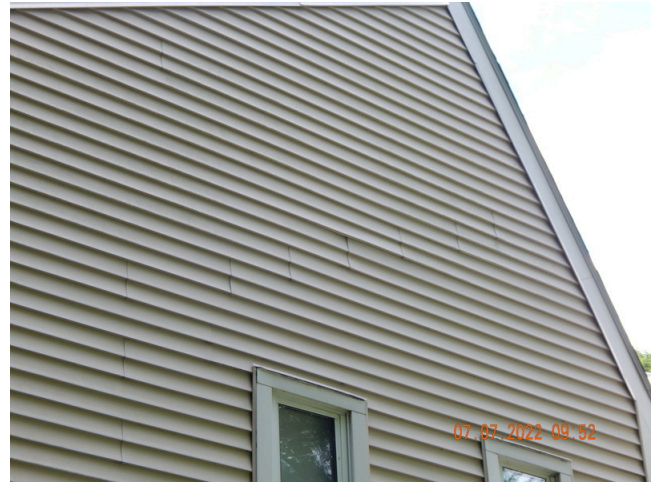
70. Sidewall System: Typical damaged or weathered sidewall vinyl siding found throughout the site.
(Non-Critical Repair)

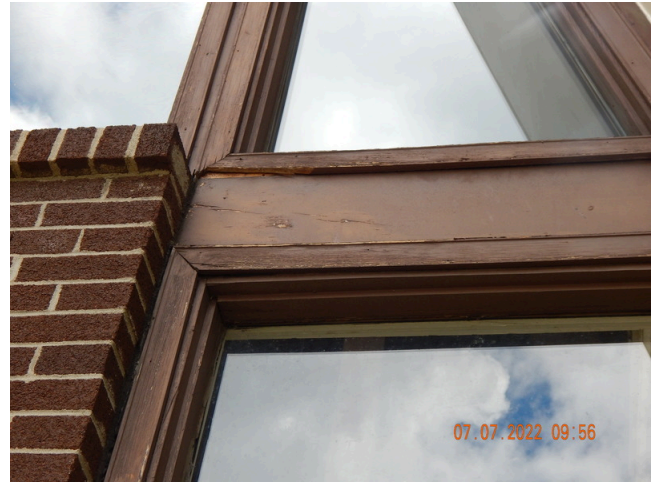
78. Sidewall System: Typical damaged or weathered wood trim found throughout the community building. (Non-Critical Repair)

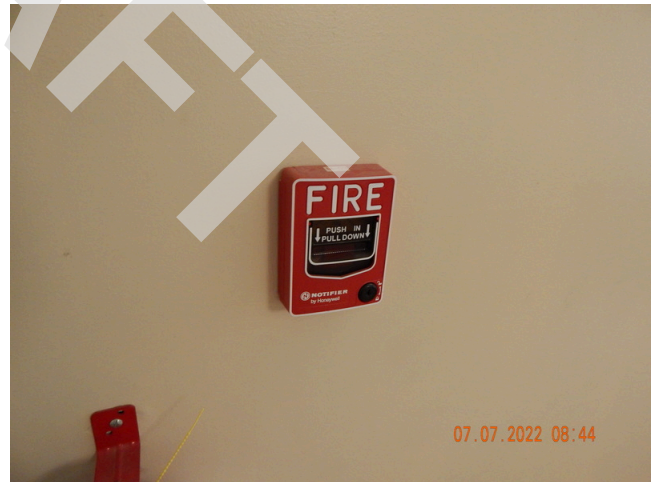
137. Life & Fire Safety: Fire alarm system found throughout the site (Missing inspection tag). (Critical Repair)

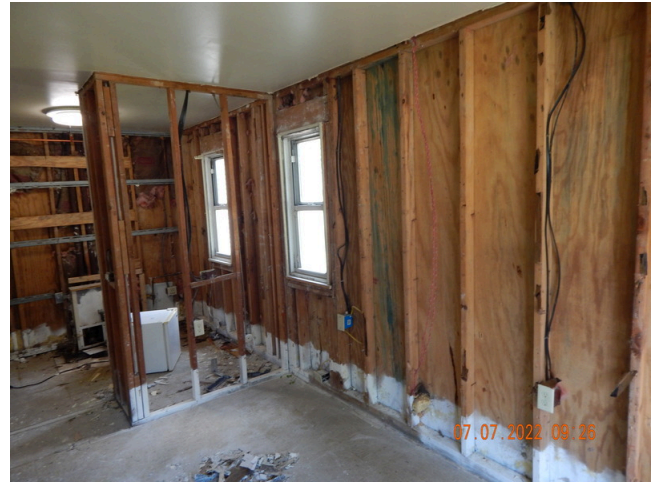
146. Dwelling Unit Interior Elements: Unit 26 gutted and unfinished. (Critical Repair)

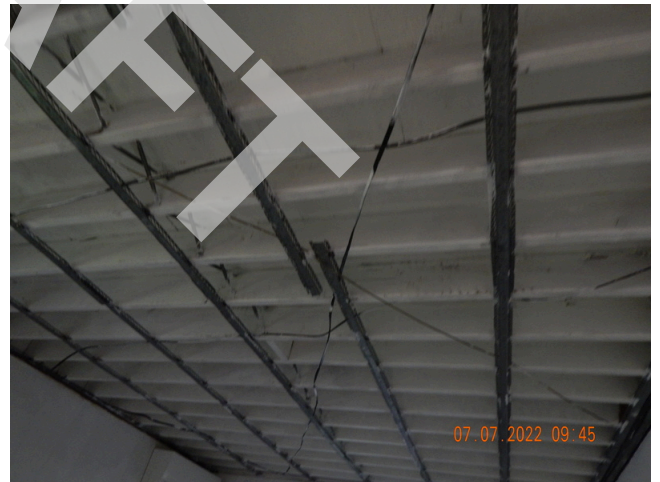
148. Dwelling Unit Interior Elements: Unit 42 gutted and unfinished. (Critical Repair)
