## HUD MAP CAPITAL NEEDS ASSESSMENT

Annapolis  
52 Sumner Street  
Dorchester, Massachusetts 02125

AEI Project No. 463356  
Site Inspection Date: July 6, 2022

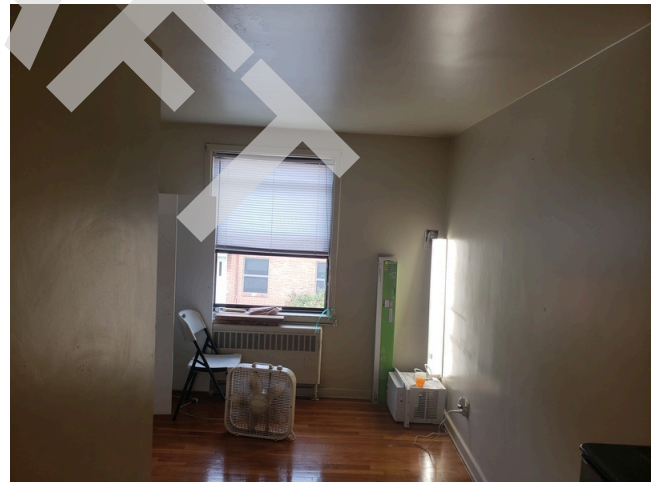
19. Building 2; Unit: 35; Floor: 2; Style: 1 Bed / 1 Bath: Living room with missing finishes. (Critical Repair)

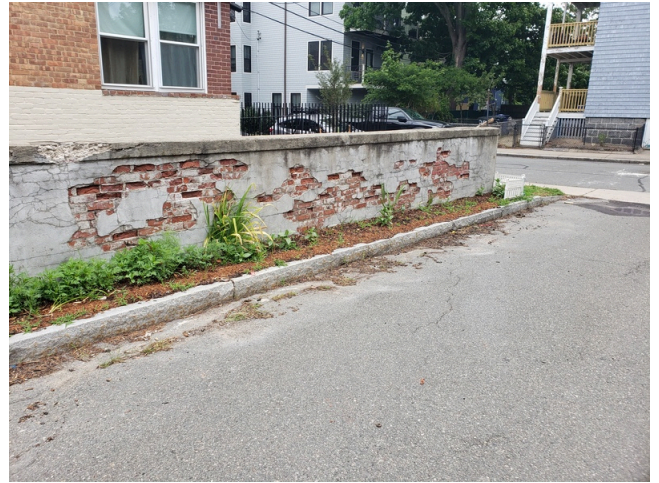
6. Landscaping & Appurtenances: Damaged CMU wall found on the north perimeter of the property. (Non-Critical Repair)

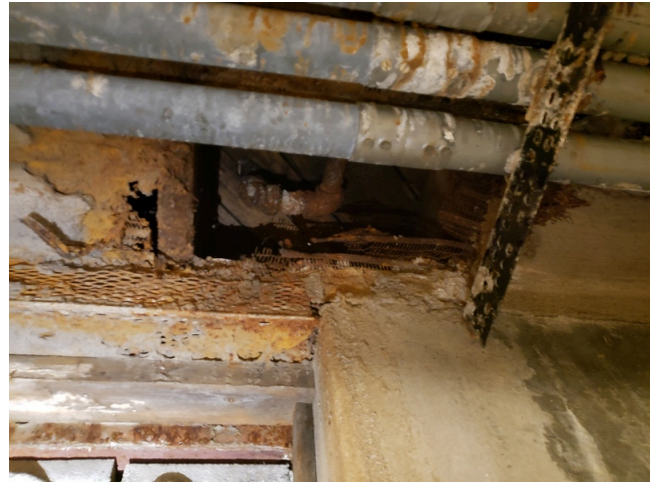
30. Foundation: Typical cracks on basement walls and ceilings found throughout the site. (Critical Repair)

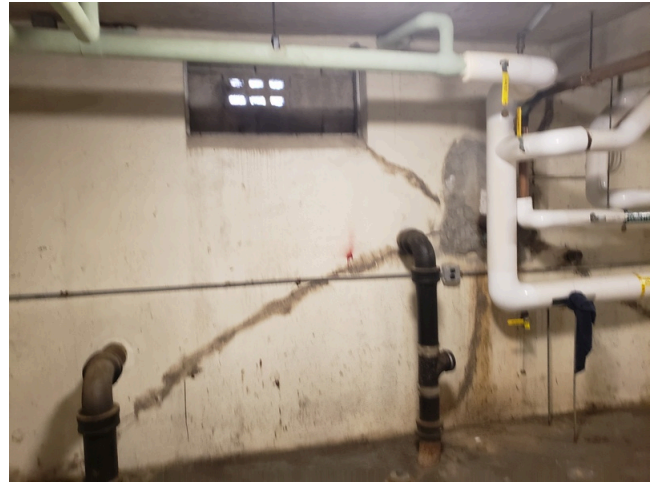
34. Foundation: Typical cracks on basement walls and ceilings found throughout the site. (Critical Repair)

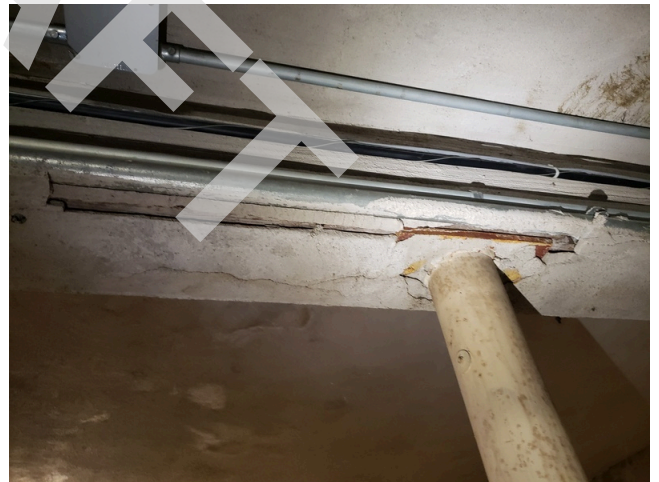
36. Foundation: Typical cracks on basement walls and ceilings found throughout the site. (Critical Repair)

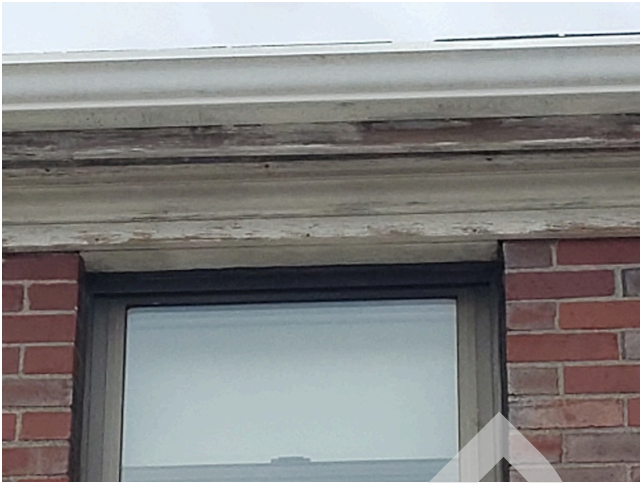
37. Attics & Eaves: Typical perforated eaves vents found throughout the site (Non-Critical Repair)

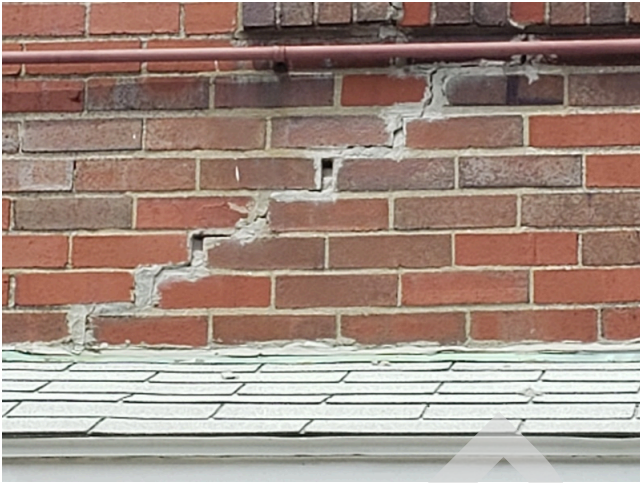
45. Sidewall System: Typical cracked unpainted brick found throughout the site. (Non-Critical Repair)

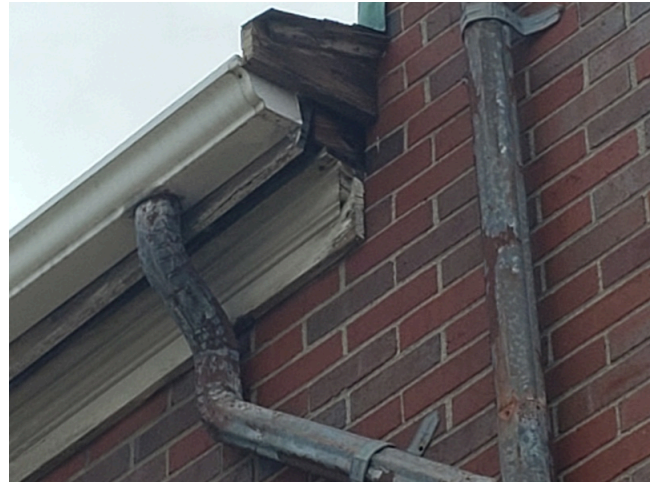
46. Sidewall System: Typical weathered and damaged wood trim found throughout the site. (Non-Critical Repair)

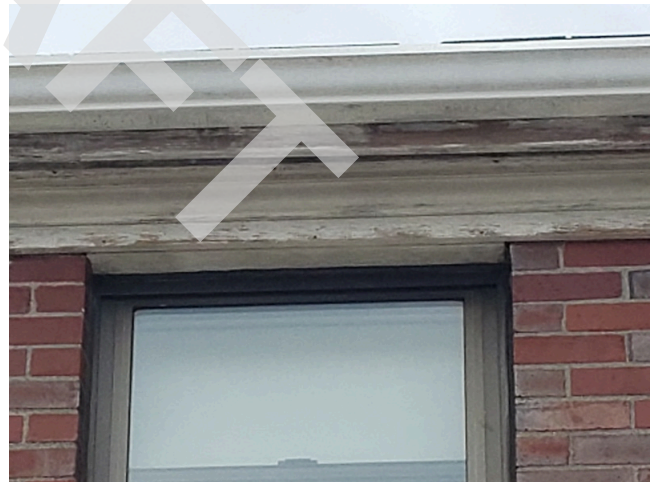
48. Sidewall System: Typical weathered and damaged wood trim found throughout the site. (Non-Critical Repair)

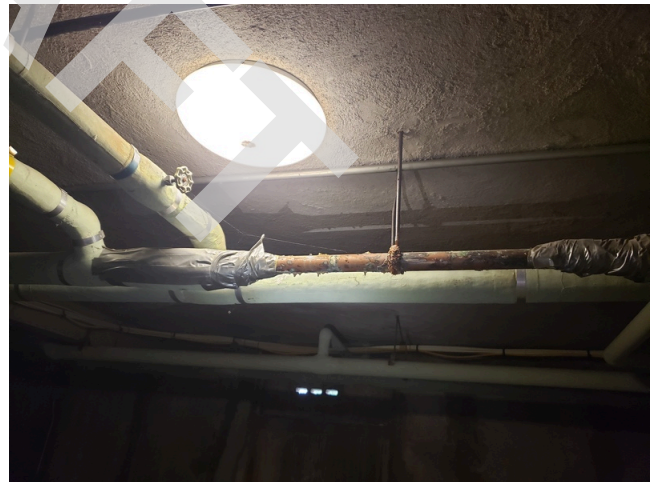
76. Plumbing: Typical corroded pipes found throughout the property. (Non-Critical Repair)

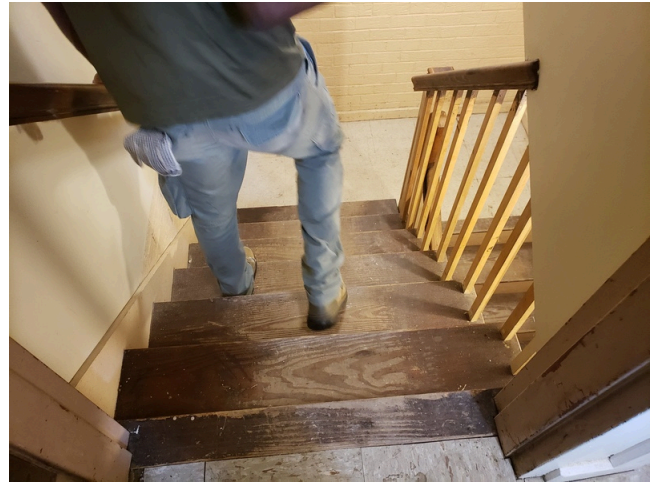
102. Common Area Interior Elements: Typical staircase with worn down finishes found throughout the site. (Non-Critical Repair)

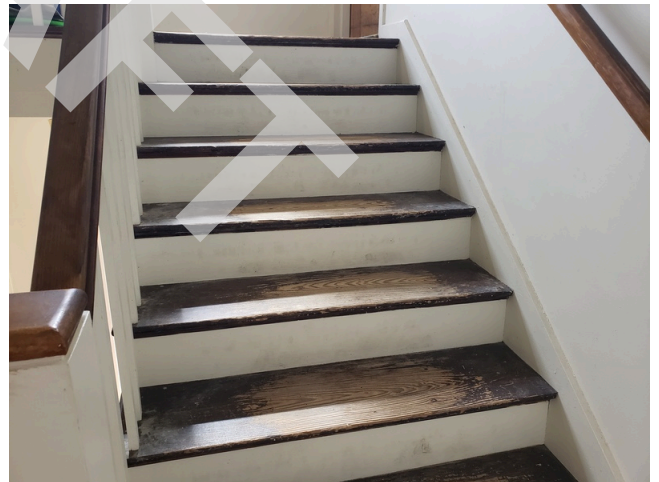
104. Common Area Interior Elements: Typical staircase with worn down finishes found throughout the site. (Non-Critical Repair)

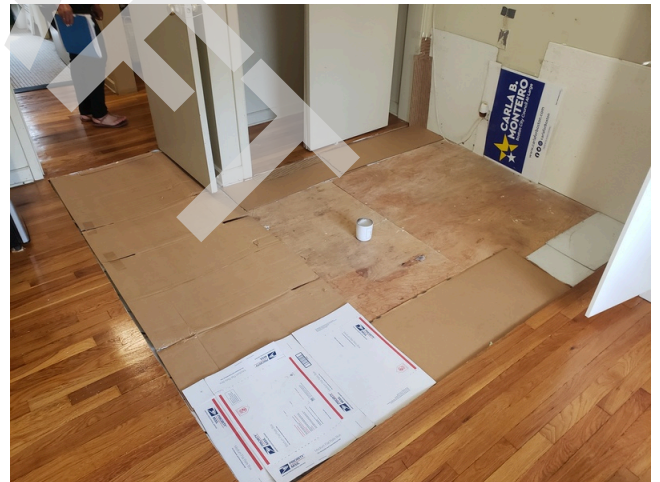
108. Dwelling Unit Interior Elements: Removed flooring and finishes due to decomposing body removal. (Critical Repair)

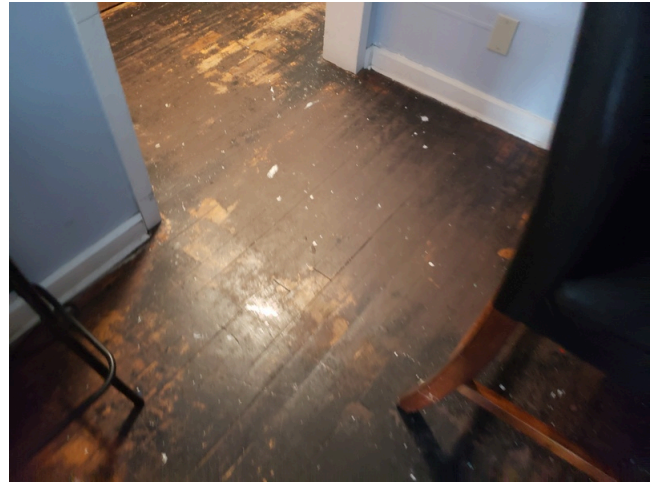
110. Dwelling Unit Interior Elements: Damaged finishes observed in unit 4. (Non-Critical Repair)

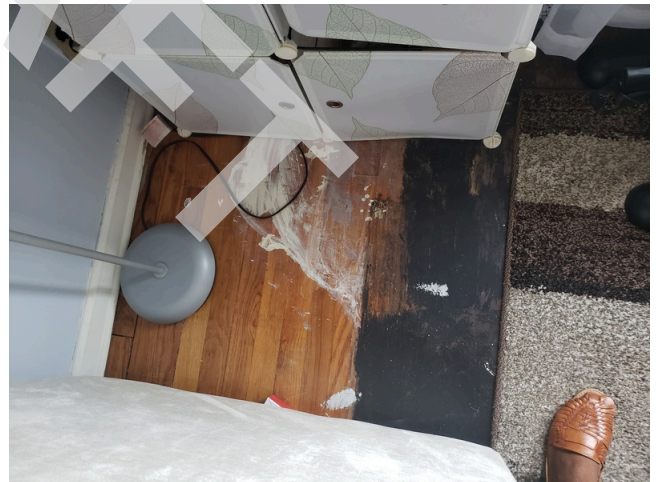
112. Dwelling Unit Interior Elements: Damaged finishes observed in unit 4. (Non-Critical Repair)

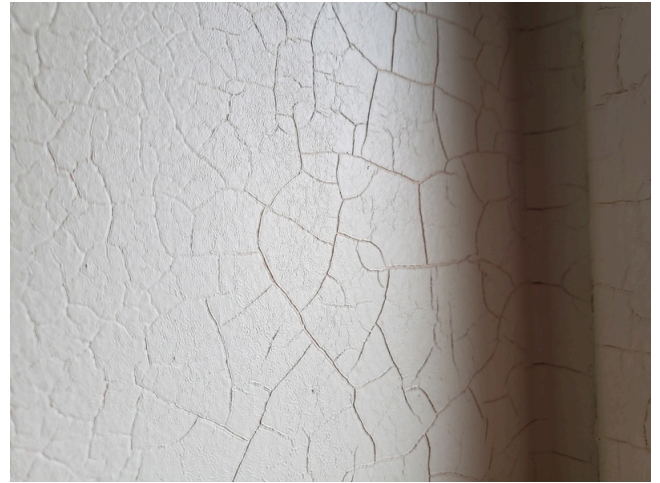
114. Dwelling Unit Interior Elements: Damaged finishes observed in unit 20. (Non-Critical Repair)

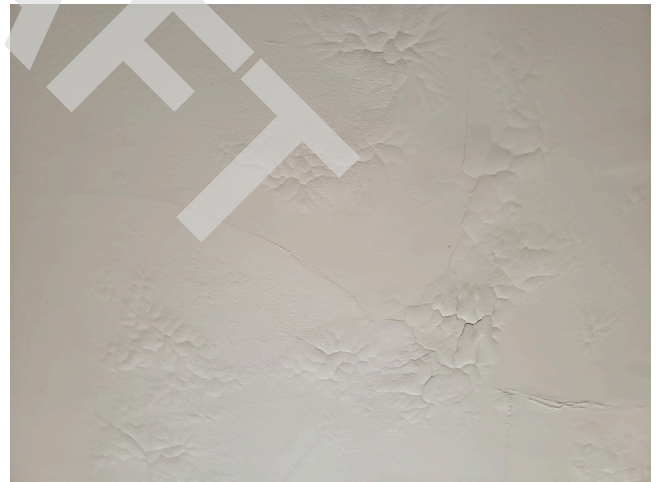
116. Dwelling Unit Interior Elements: Damaged finishes observed in unit 20. (Non-Critical Repair)

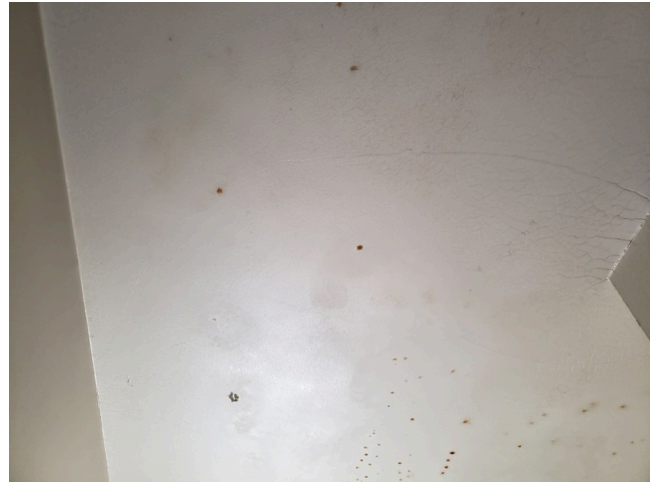
118. Dwelling Unit Interior Elements: Damaged finishes observed in unit 20. (Non-Critical Repair)

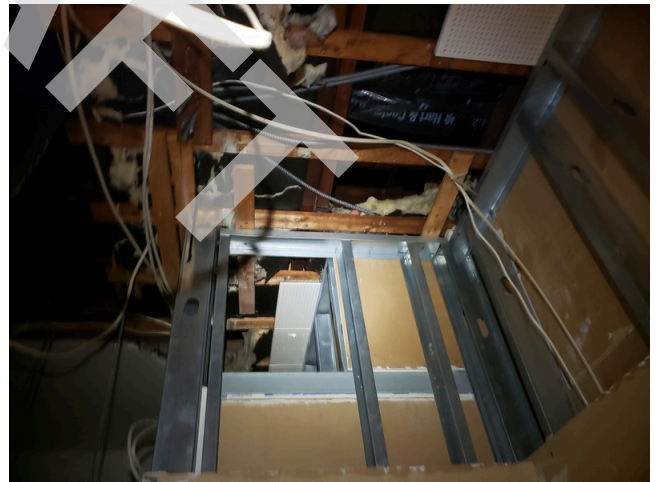
120. Dwelling Unit Interior Elements: Typical damaged sheetrock ceilings found throughout the site. (Non-Critical Repair)

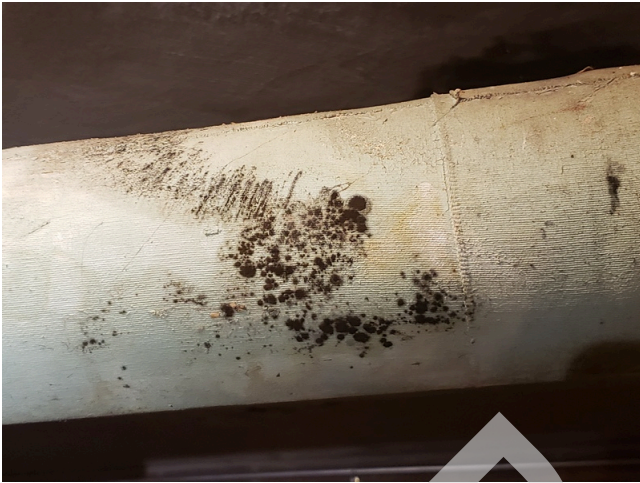
129. Moisture and Microbial Growth: Mold on water pipes observed throughout the site. (Critical Repair)

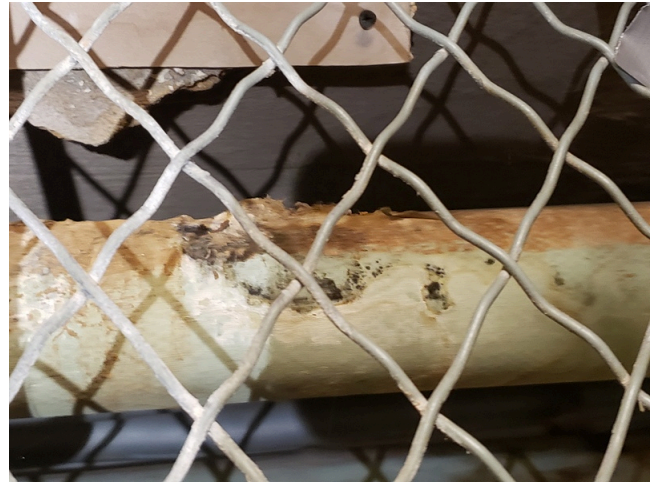
130. Moisture and Microbial Growth: Mold on water pipes observed throughout the site. (Critical Repair)
