**CAPITAL NEEDS ASSESSMENT (CNA)
FREDERICK DOUGLASS (2-44)
755 TREMONT STREET
BOSTON, MASSACHUSETTS 02118**

**D3G PROJECT NUMBER:
2021-0373**

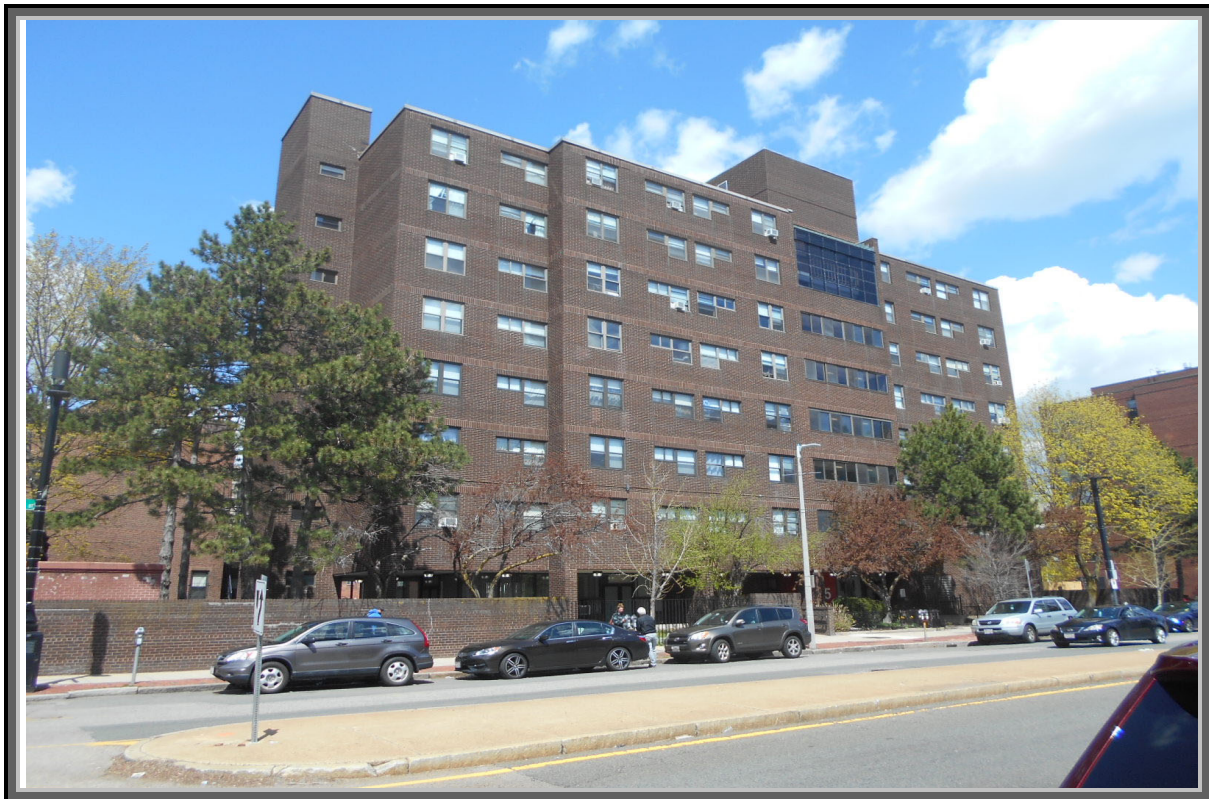
Site Description: Frederick Douglass (2-44), located at 755 Tremont Street in Boston, Massachusetts consists of one (1) eight-story age-restricted apartment building and one (1) one-story storage building. The building features seventy-eight (78) dwelling units. According to property management, the building was constructed in 1973. According to tax records, the building features an approximate gross area of 54,897 square feet and is situated on 0.48 acres. The property is in fair physical condition.

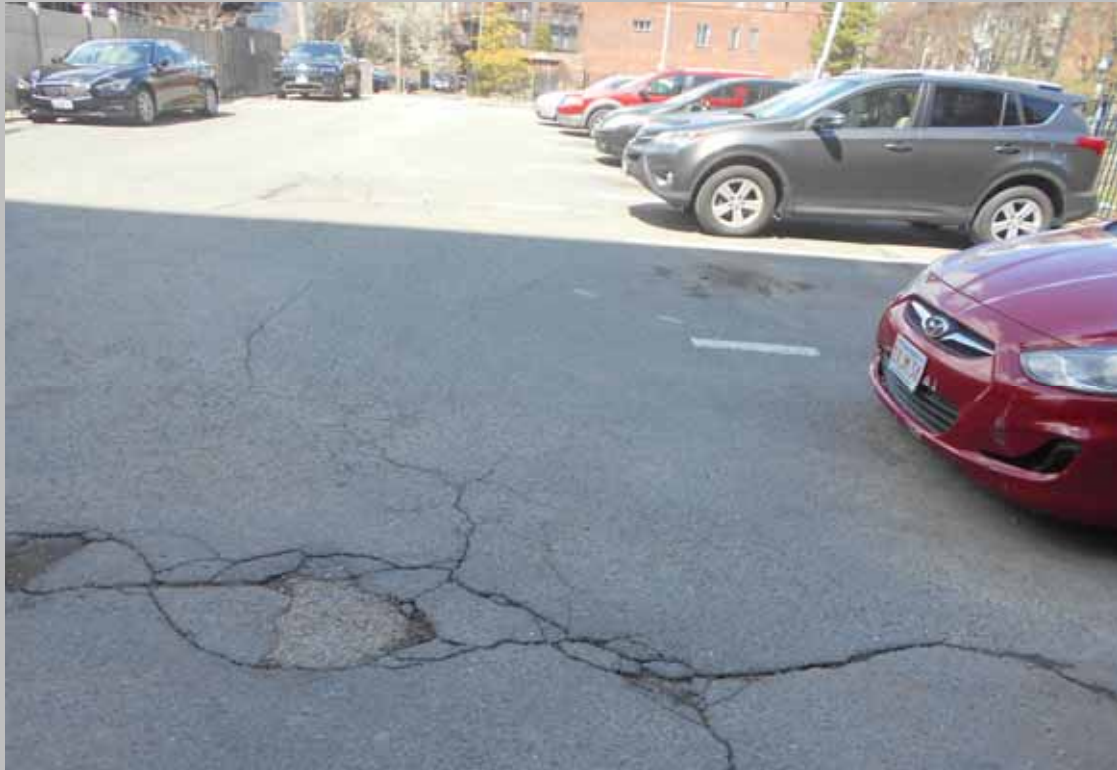
The property does not feature a designated van accessible parking space (Critical Repair)

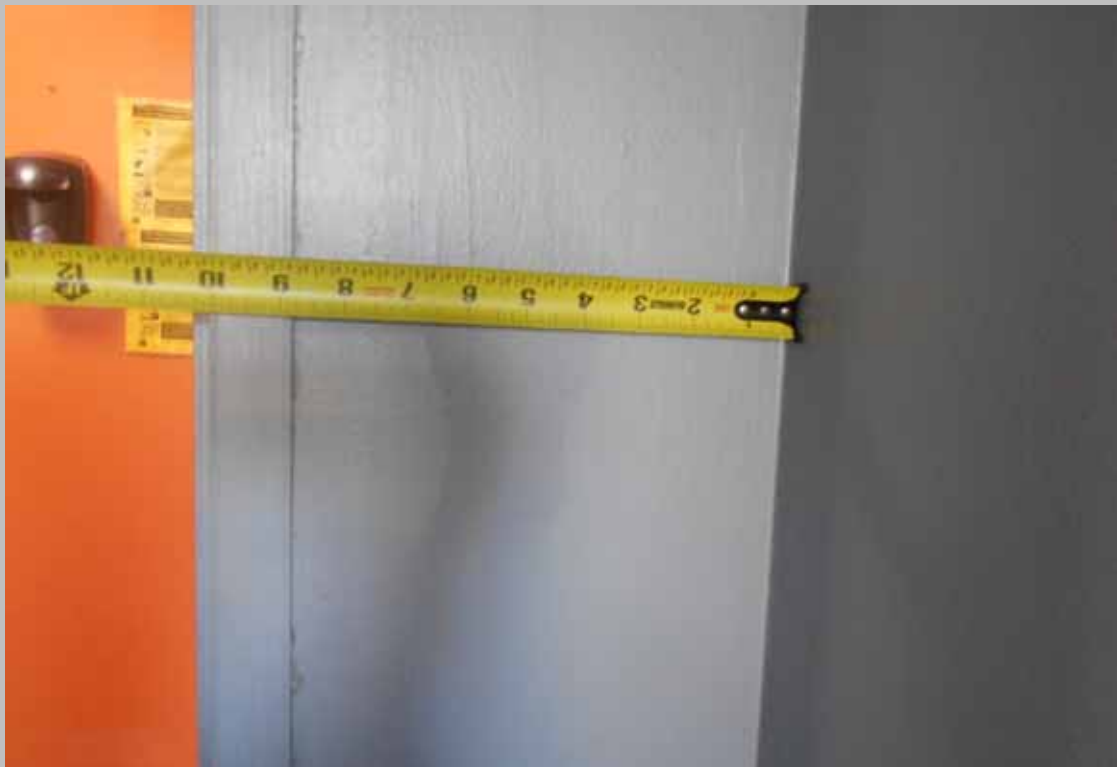
The common area laundry room door does not feature 18 inches at the pull-side of the door (Critical Repair)

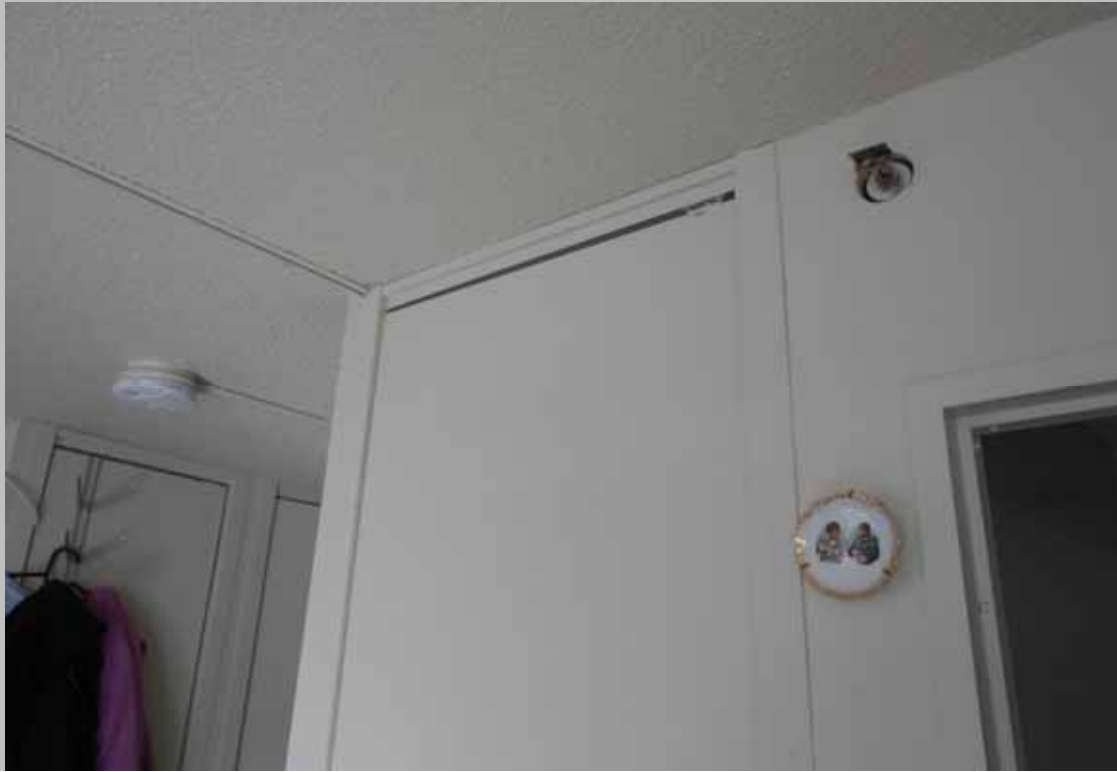
Dwelling unit 711 is missing an escutcheon plate at the sprinkler head above the bathroom door
(Critical Repair)

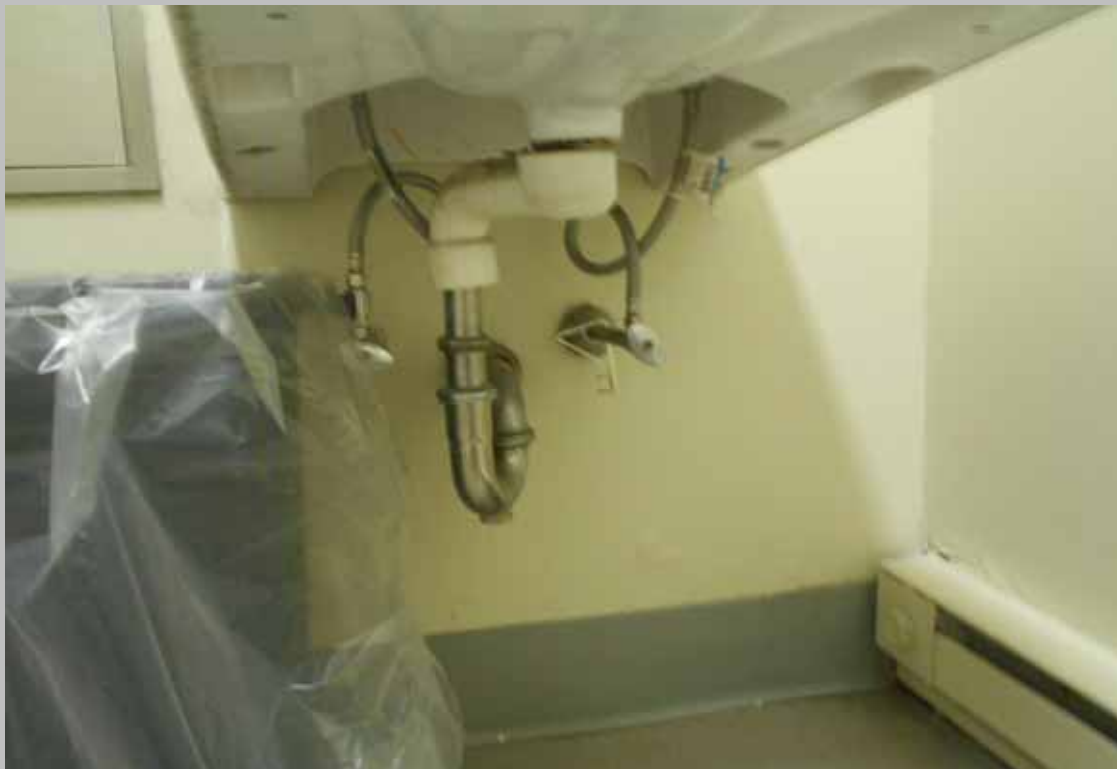
The common area Men's restroom sink is missing scald and abrasion protection at the under-sink plumbing (Critical Repair)

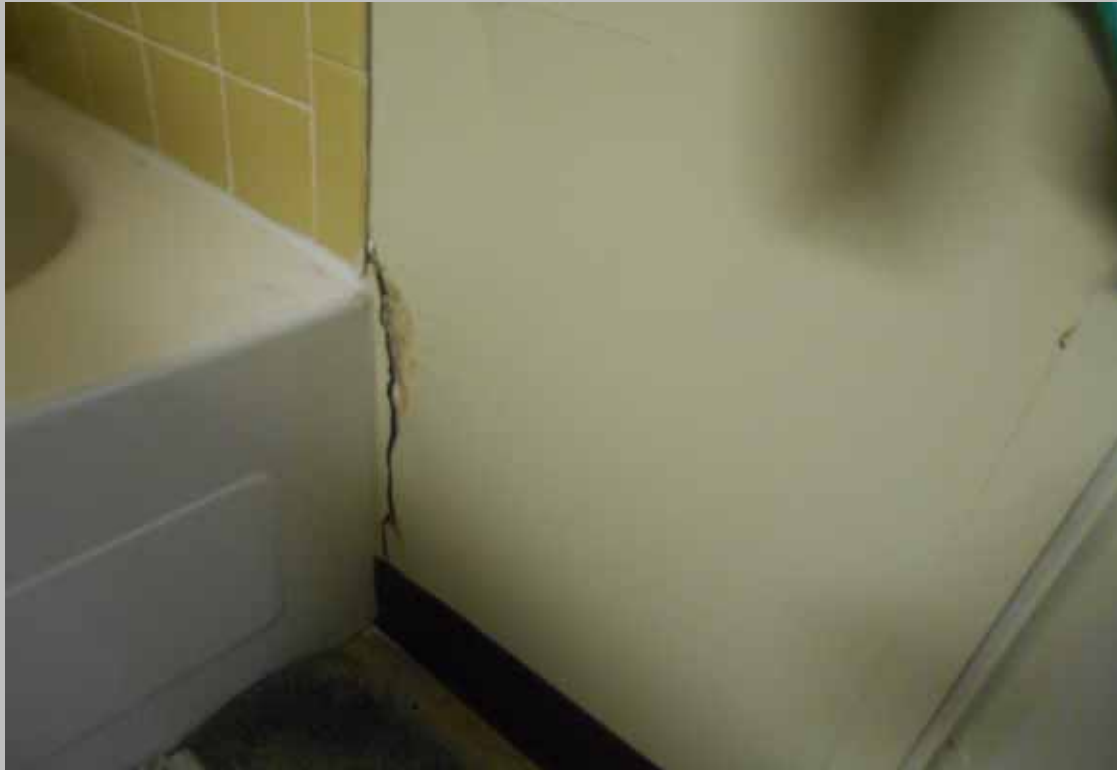
View of the damaged bathroom wall within dwelling unit 511 (Non-Critical Repair)

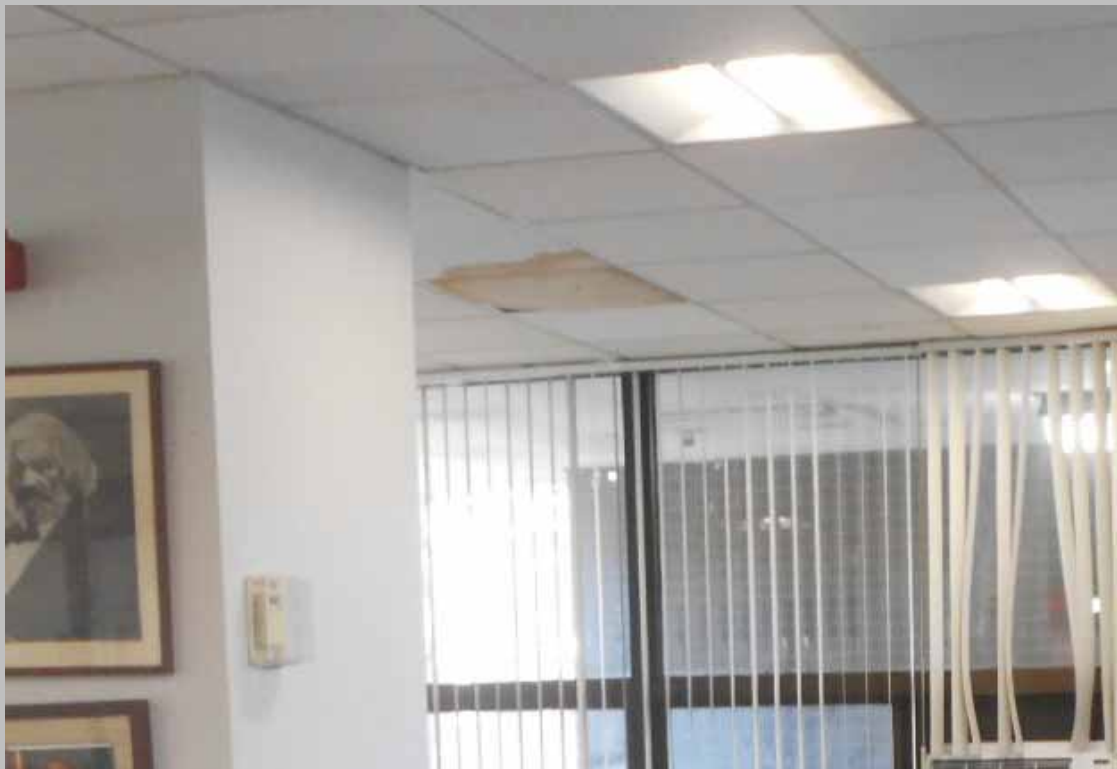
View of the water stained ACT in the common area sitting area (Non-Critical Repair)

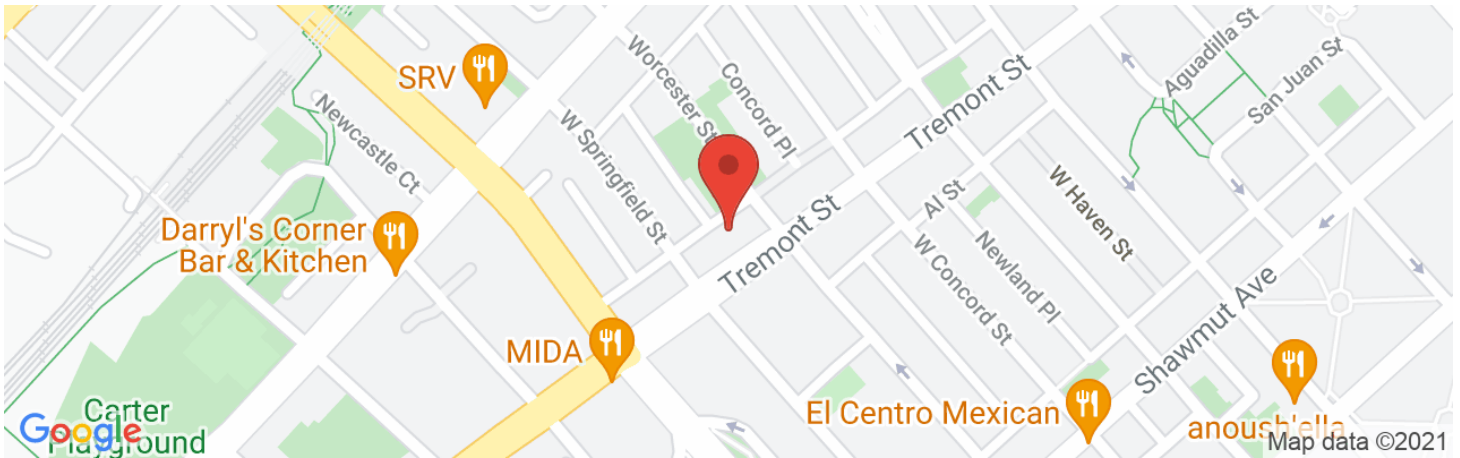
Date	5/20/2021, 2:15:09 PM
Design Code Reference Document	ASCE41-13
Custom Probability	
Site Class	E - Soft Clay Soil
