**CAPITAL NEEDS ASSESSMENT (CNA)
GENERAL WARREN APARTMENTS (2-44)
114 RUTHERFORD AVENUE
CHARLESTOWN, MASSACHUSETTS 02129**

D3G PROJECT NUMBER:

2021-0374

FINAL REPORT ISSUE DATE:

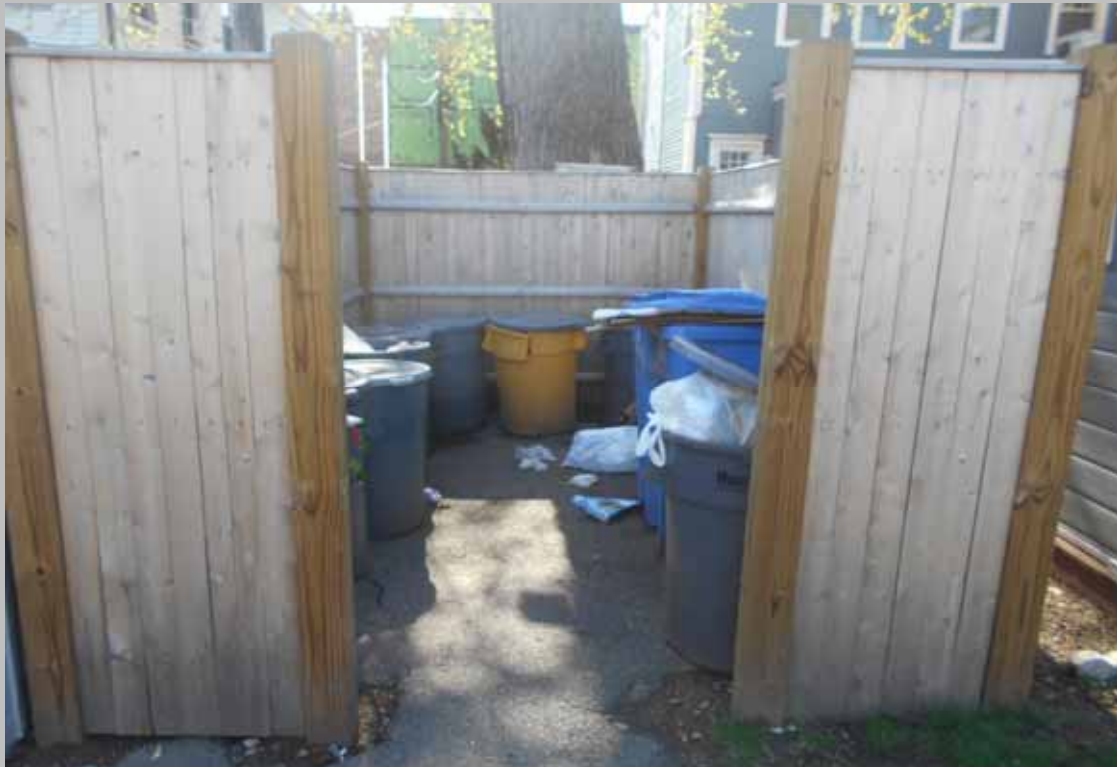
PHOTO #14

The property features approximately ten (10) dumpsters surrounded by wooden stockade fence enclosures that were observed in fair physical condition. Replacement of the dumpster enclosures is anticipated during the estimate period.

Typical dumpster enclosure

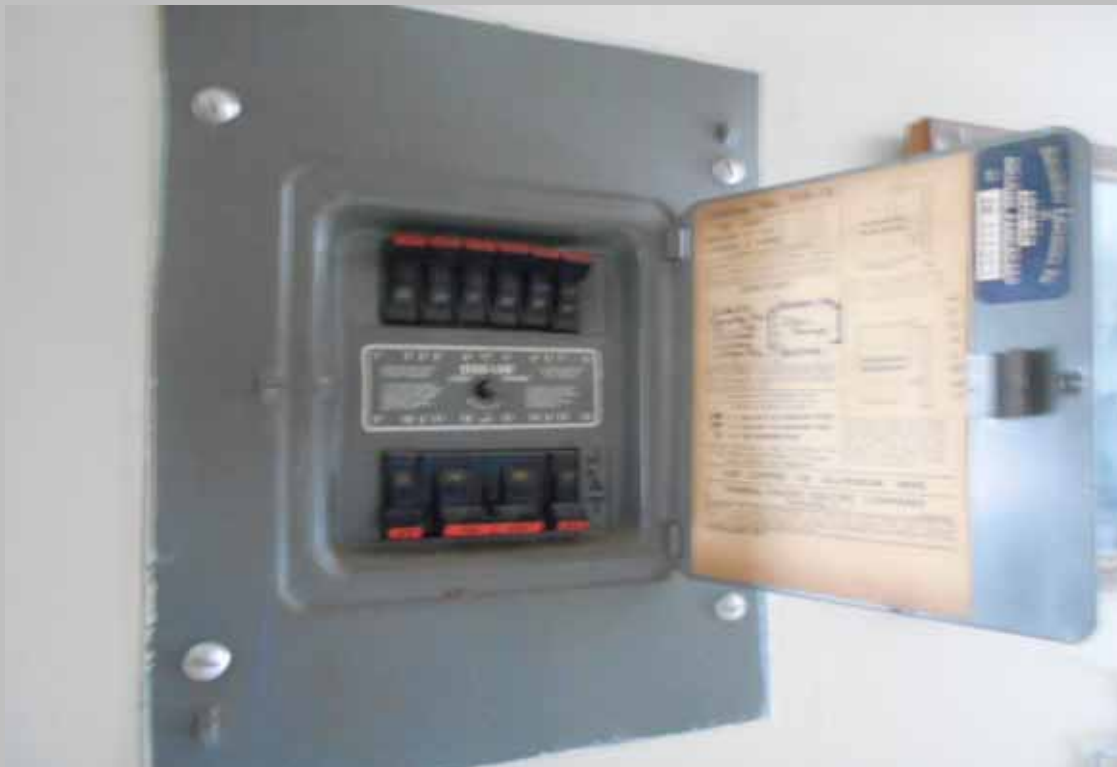
PHOTO #22

The property receives electrical power from pole-mounted transformers. The dwelling units were observed with Federal Pacific Stab-Lok electrical panels. Federal Pacific Electric "Stab-Lok" service panels and breakers may pose a fire hazard and can fail to trip in response to over current, leading to electrical fires. Failures are documented in Consumer Product Safety Commission (CPSC) and independent testing, as well as multiple documented cases of fires resulting from failure of this product. Upon the replacement of the Stab-Lok electrical panels the installation of another brand that has a current UL listing and provides improved protection and reliability is recommended.

Federal Pacific Stab-Lok electric breaker panel - install new brand upon replacement (dwelling units)

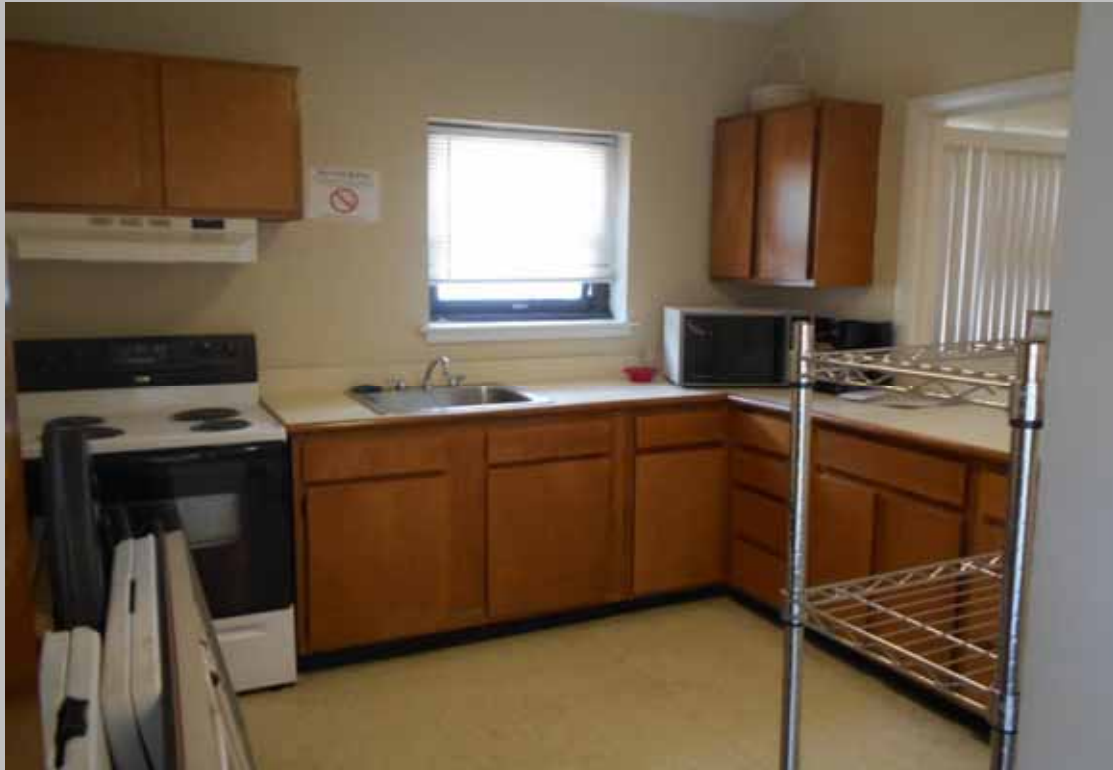
PHOTO #25

Community kitchen (Community Center 1) - lacking a front controlled range/oven unit, roll-under access at the sink, and lowered upper cabinetry

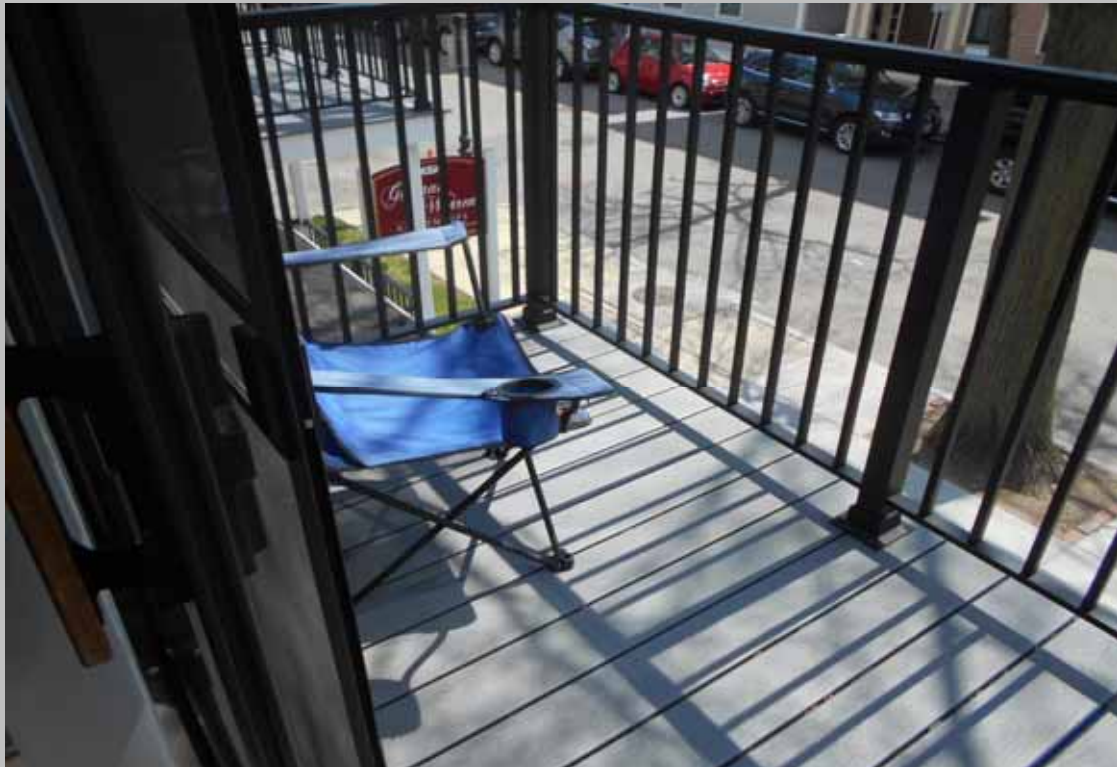
PHOTO #46

Dwelling units on upper floors feature balconies and dwelling units on ground floors feature concrete patios. The balconies are constructed of trex decking boards and feature metal railing systems. The balcony and railing systems were observed in fair to good physical condition. The refurbishment of the balconies and patios is anticipated during the estimate period.

Typical balcony (dwelling units)

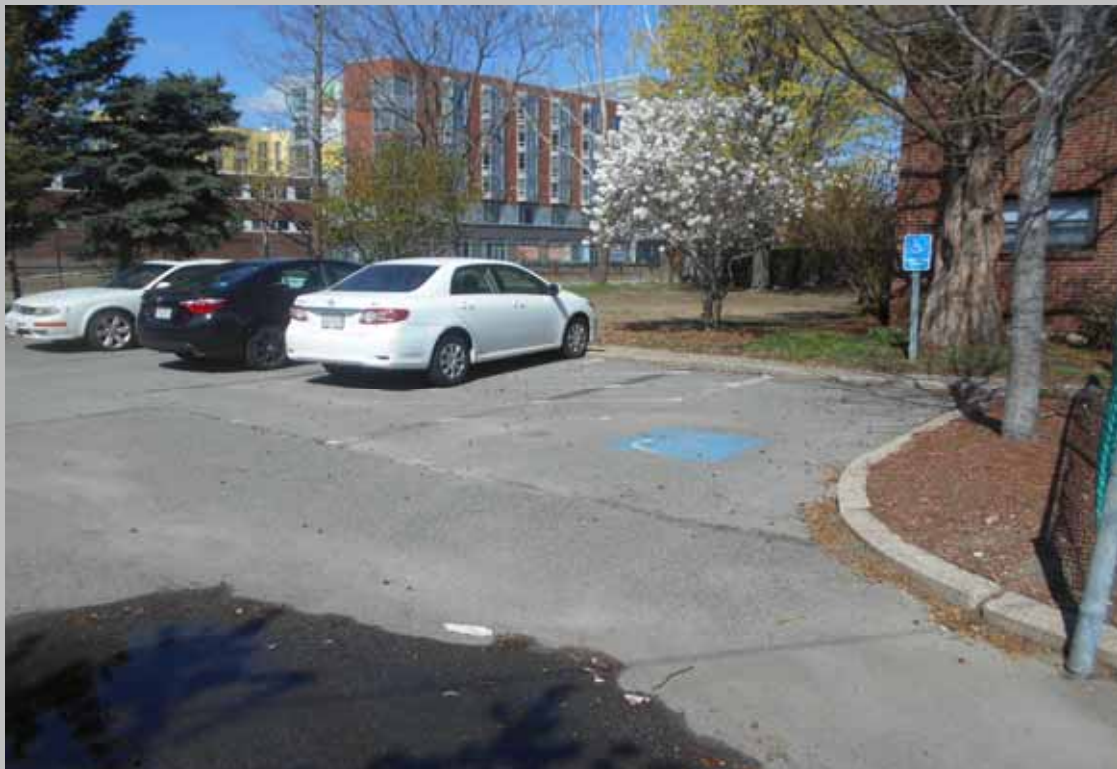
PHOTO #52

Parking lot missing a van-accessible handicapped parking space (Non-Compliant, ADA) –
Critical Repair

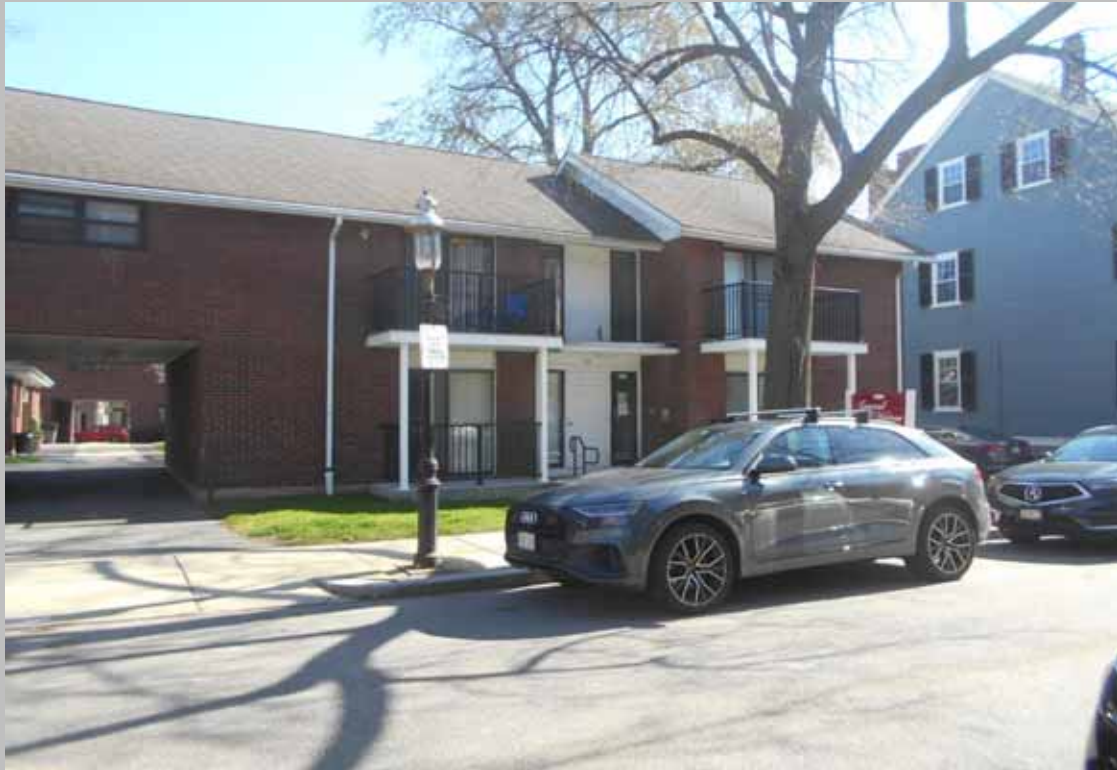
PHOTO #53

Primary entrance to leasing/management office - not connected to the accessible route (the rear entrance to the building is connected to the accessible route)

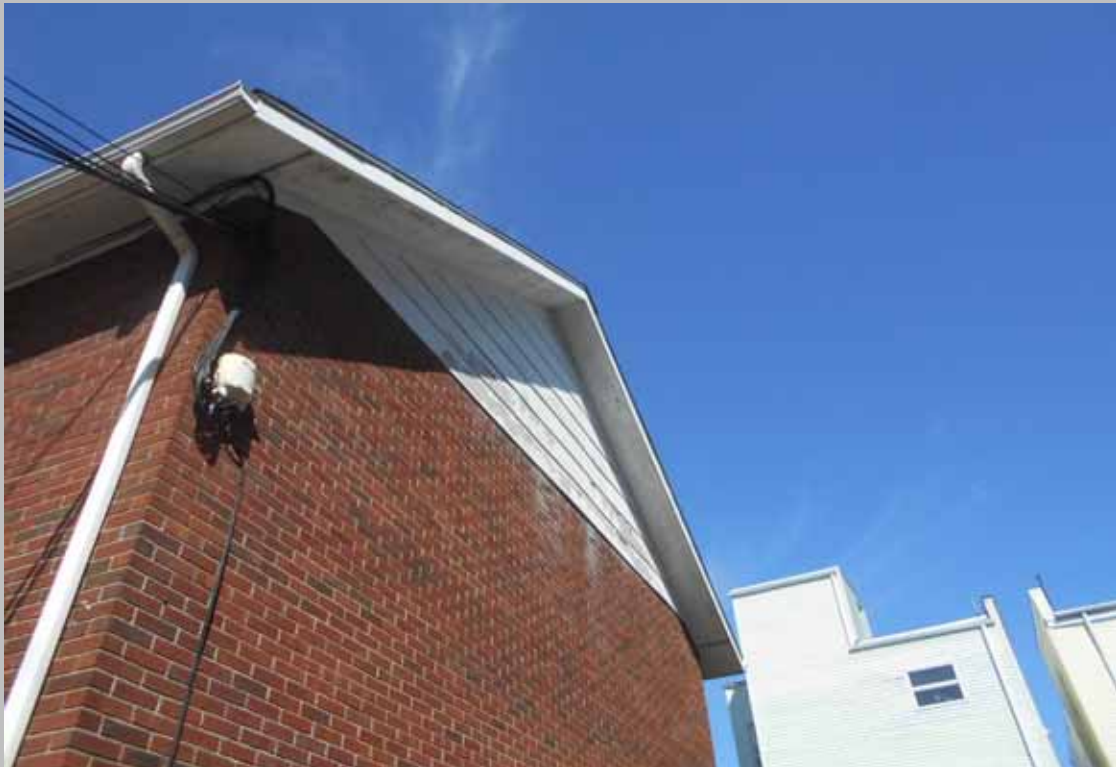
PHOTO #60

Exterior walls consist of conventional wood framing surfaced with a combination of brick veneer and aluminum siding. The buildings also feature aluminum fascia and painted wooden soffit panels that were observed in good physical condition. The exterior façades were observed in fair physical condition; however, multiple previously painted areas of siding and trim were observed with peeling/missing paint (Non-Critical Repair).

Example of siding in need of re-painting – 26 Union Street (Non-Critical Repair)

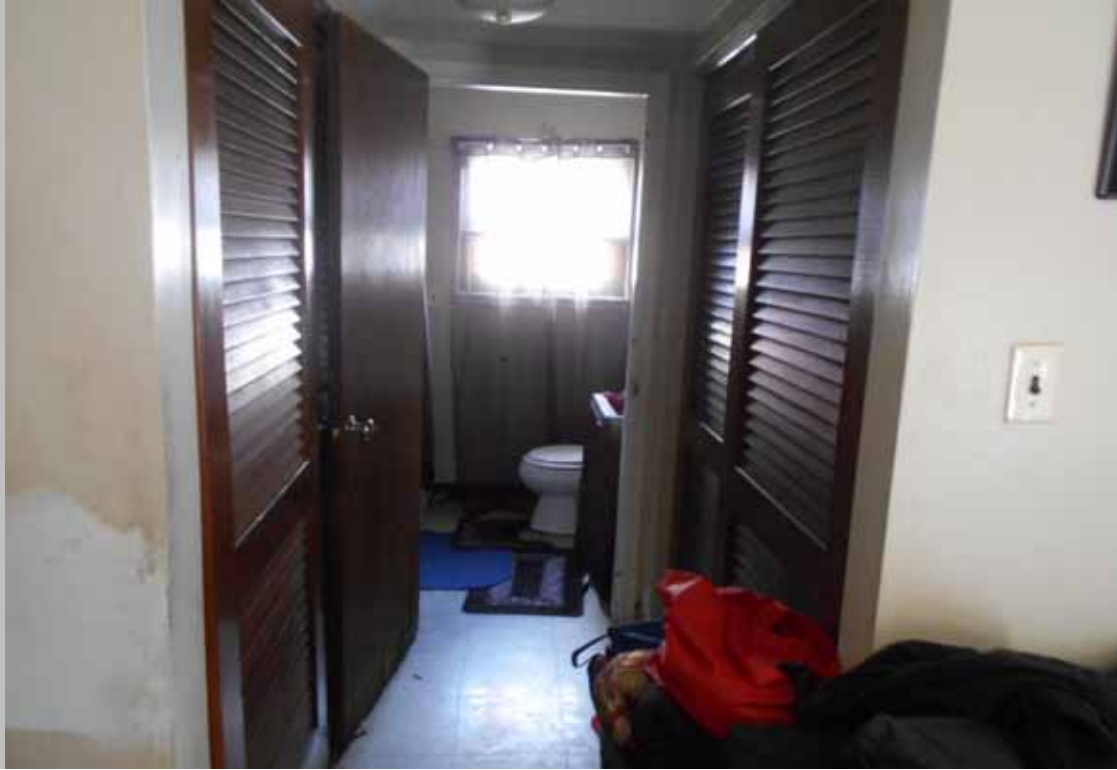
PHOTO #61

Interior wall and ceiling finishes within the dwelling units consist of painted GWB walls and textured GWB ceilings that were observed in fair to good physical condition; however, a section of drywall in the living room of dwelling unit 25 (Building 47 Washington Street) was observed with missing paint (Non-Critical Repair). Flooring in the units consist of vinyl products and carpet that were observed in fair to good condition. It should be noted that future replacement of flooring will reportedly be with durable vinyl products such as luxury vinyl tile (LVT).

Missing paint along drywall - dwelling unit 25/47 Washington Street (Non-Critical Repair)

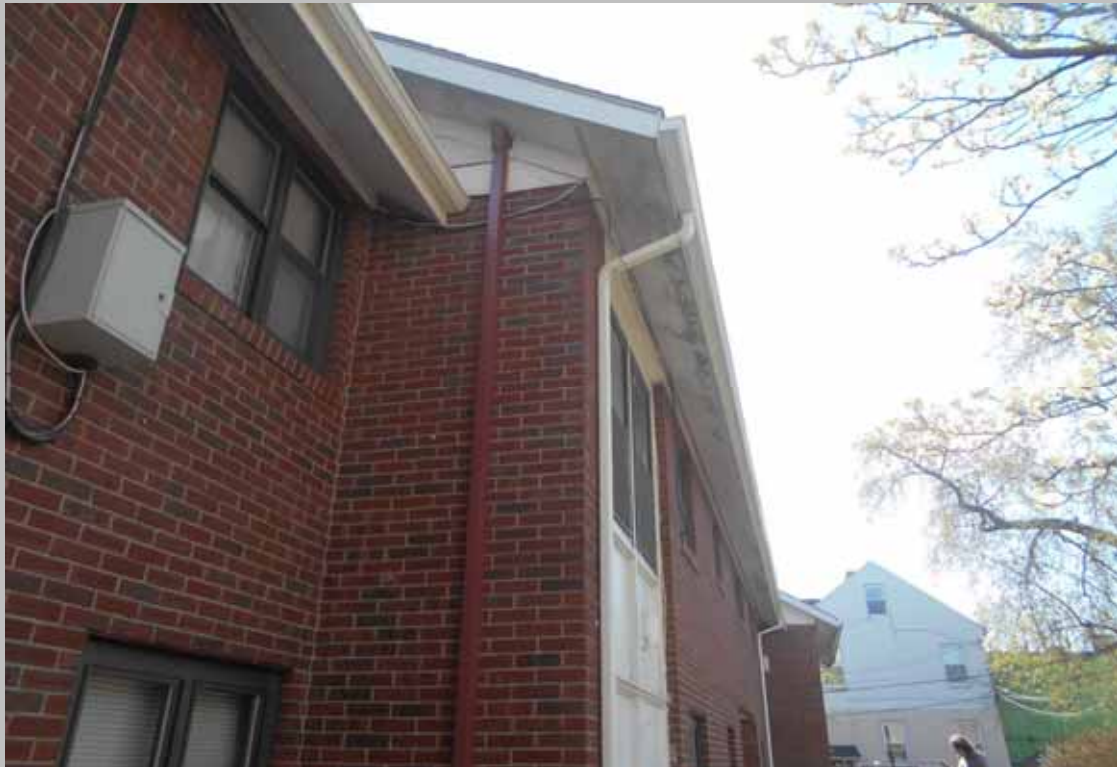
PHOTO #67

Example of a building exterior with mildew growth in need of pressure washing (Non-Critical Repair)
