**CAPITAL NEEDS ASSESSMENT (CNA)
PATRICIA WHITE APARTMENTS
20 WASHINGTON STREET
BRIGHTON, MASSACHUSETTS 02135**

**D3G PROJECT NUMBER:
2020-2130**

**FINAL REPORT ISSUE DATE:
FEBRUARY 4, 2021**

**INSPECTION DATES:
NOVEMBER 23 AND 24, 2020**

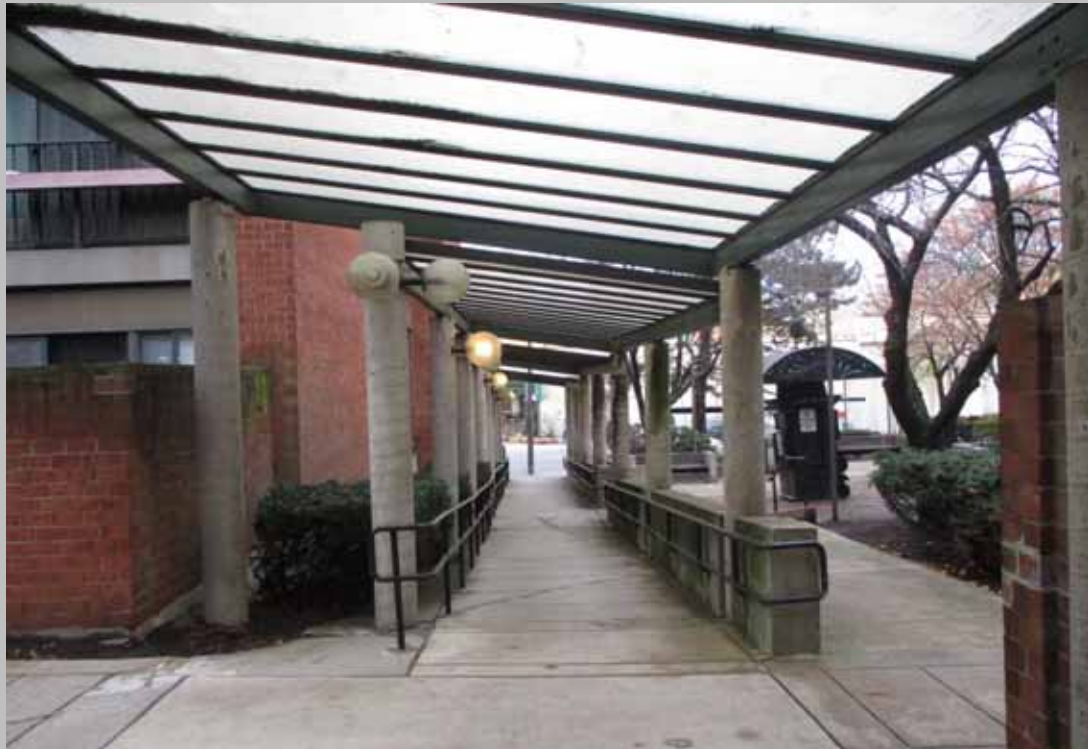
PHOTO #24

There is a steel and Plexiglass structure covering the walkway from Washington Street all the way up to the main building entrance. This structure appeared to be in fair condition. Refurbishment/replacement of the steel and Plexiglass walkway cover is anticipated during the estimate period.

Covered walk from Washington Street to front entrance.

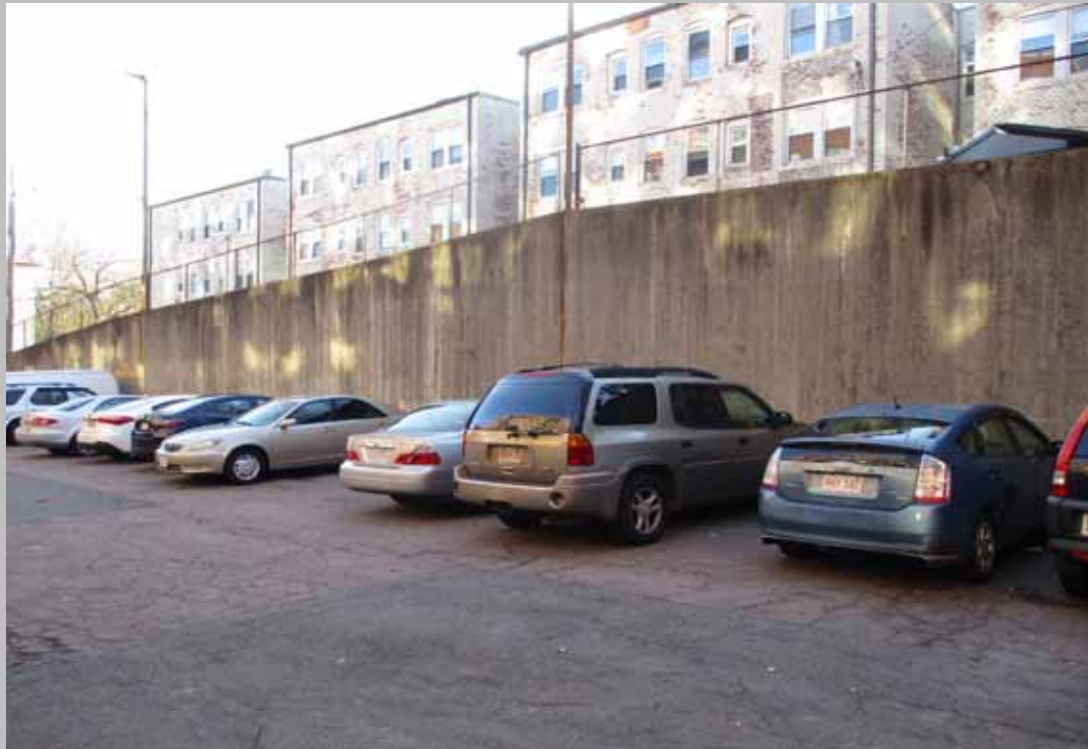
PHOTO #26

The property features a 12’ tall retaining wall at the back of the parking area. The wall was observed in fair physical condition. Refurbishment/replacement of the retaining wall is anticipated during the estimate period.

Retaining wall along parking area.

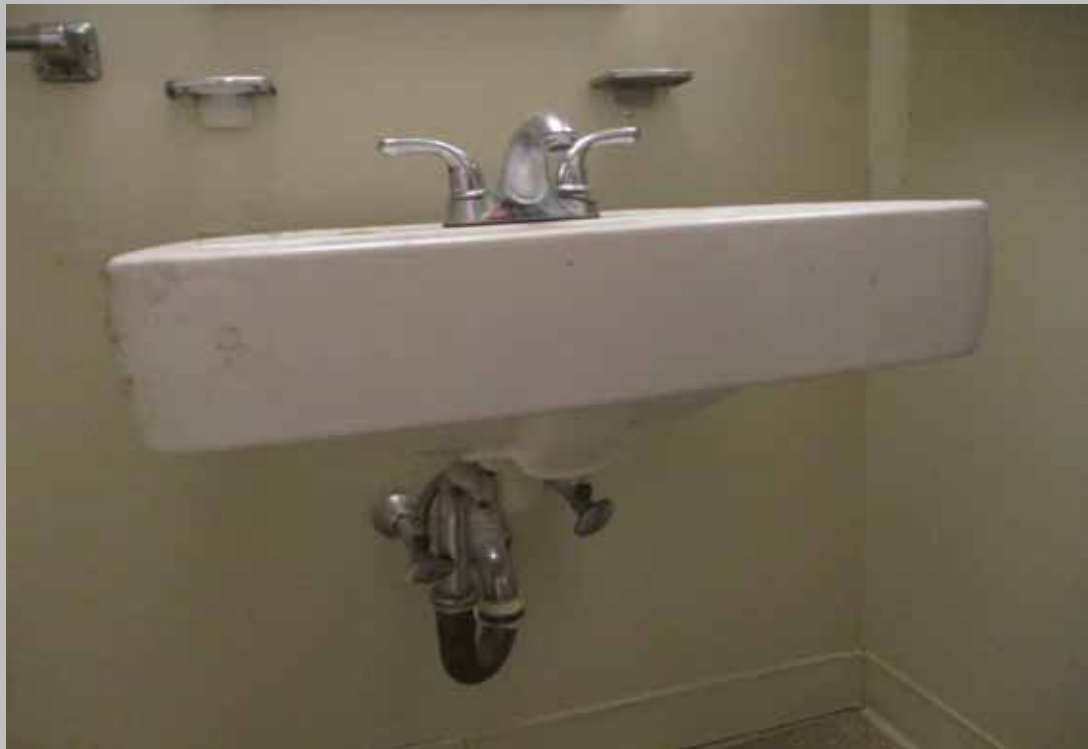
PHOTO #129

Bathroom sink missing scald proof piping.

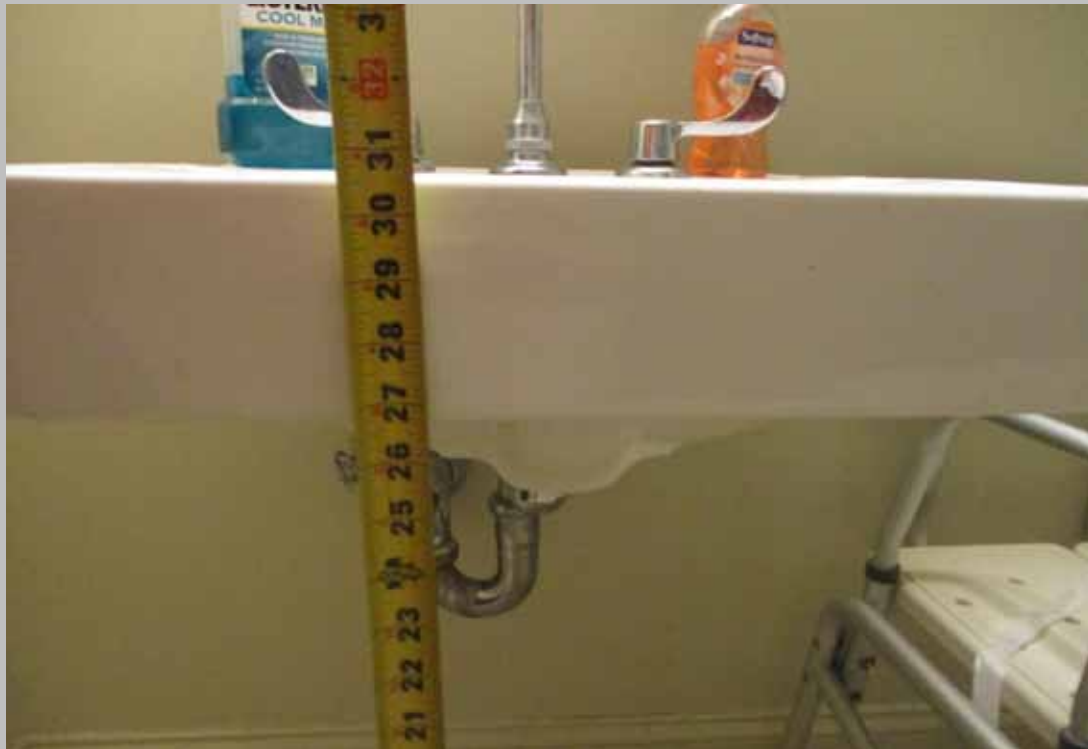
PHOTO #143

Bathroom sink height, levered hardware, missing scald proof piping Unit 221.

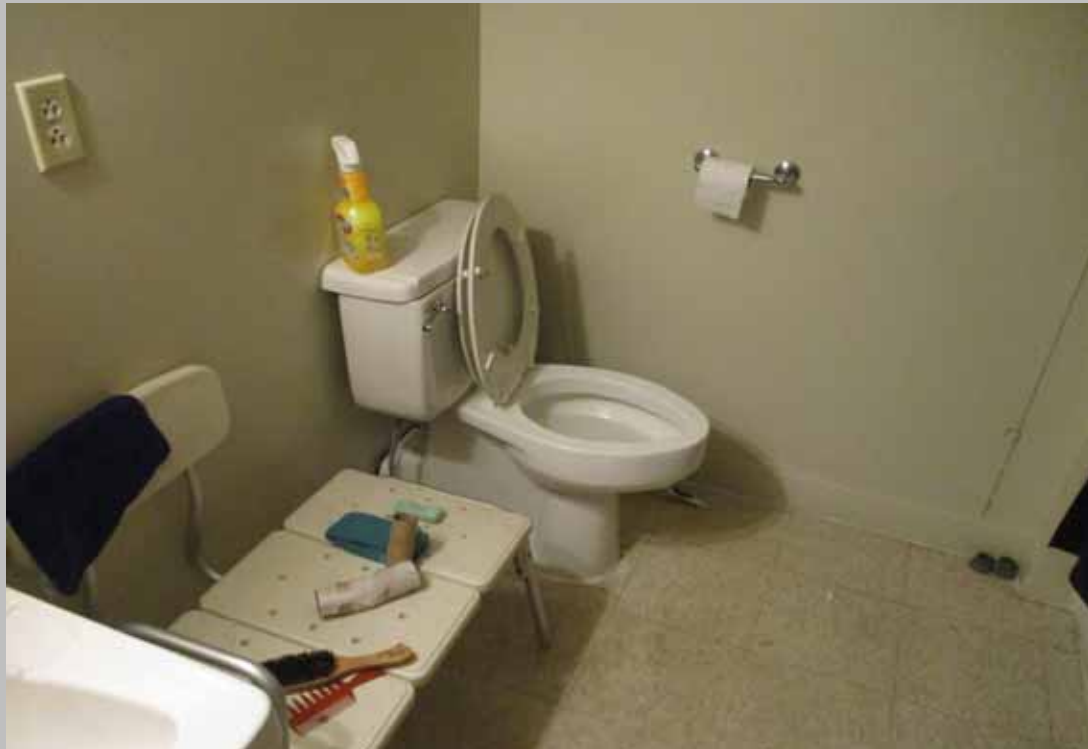
PHOTO #144

Toilet missing grab bars Unit 221.

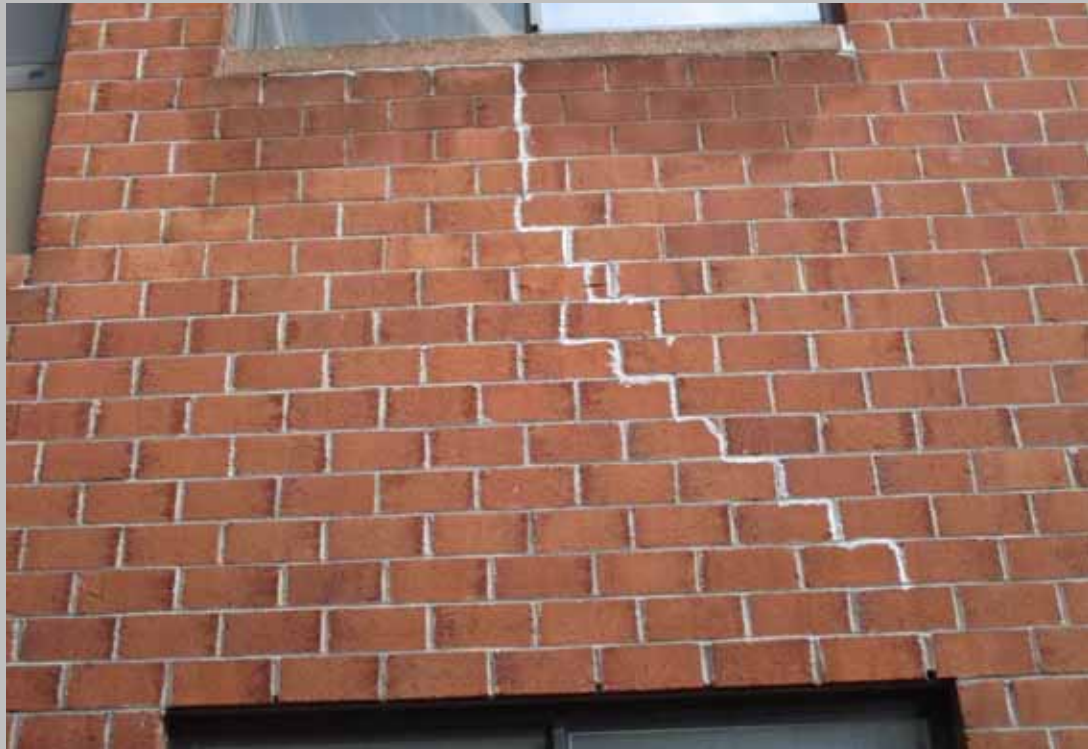
PHOTO #164

The exterior wall assemblies consist of reinforced concrete surfaced with brick veneer. The exterior walls were observed in good to fair physical condition. One area of the façade near the entrance to the carport, had a repaired step crack. Several areas of the southwest side of the façade showed visible repaired cracks up along the entire façade and upper elevator tower. Further study is recommended through a façade inspection during the estimate period.

Step crack in brick façade, inner southeastern side of building by carport entrance.

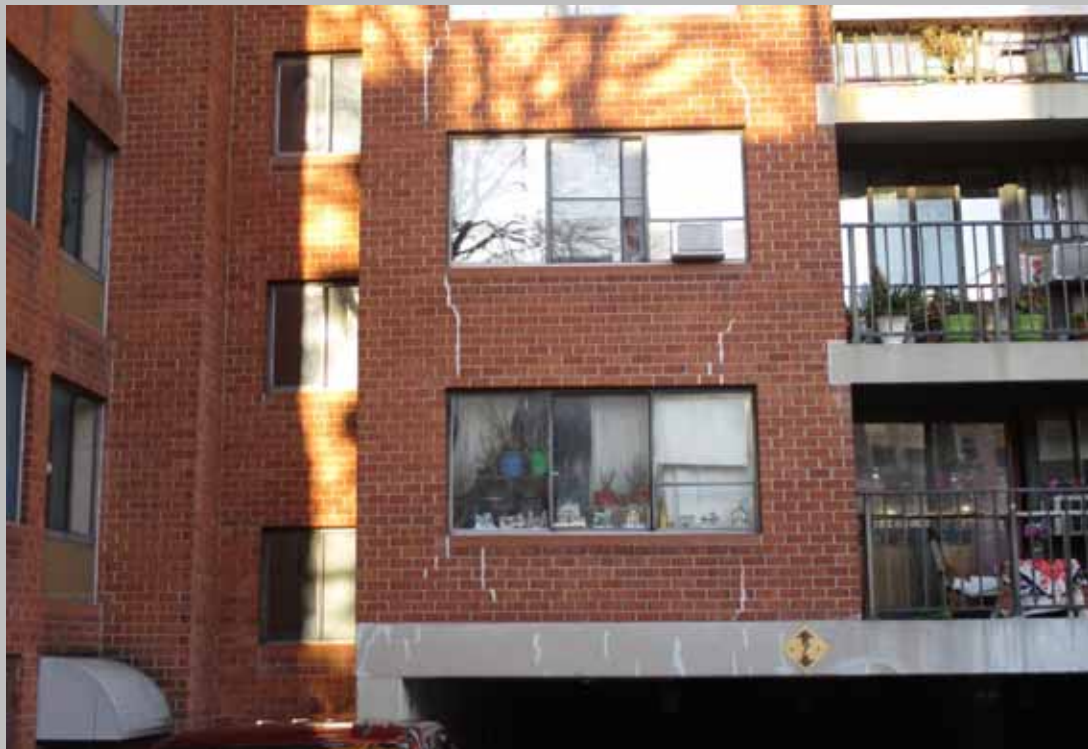
PHOTO #165

Repaired cracks in southern façade.

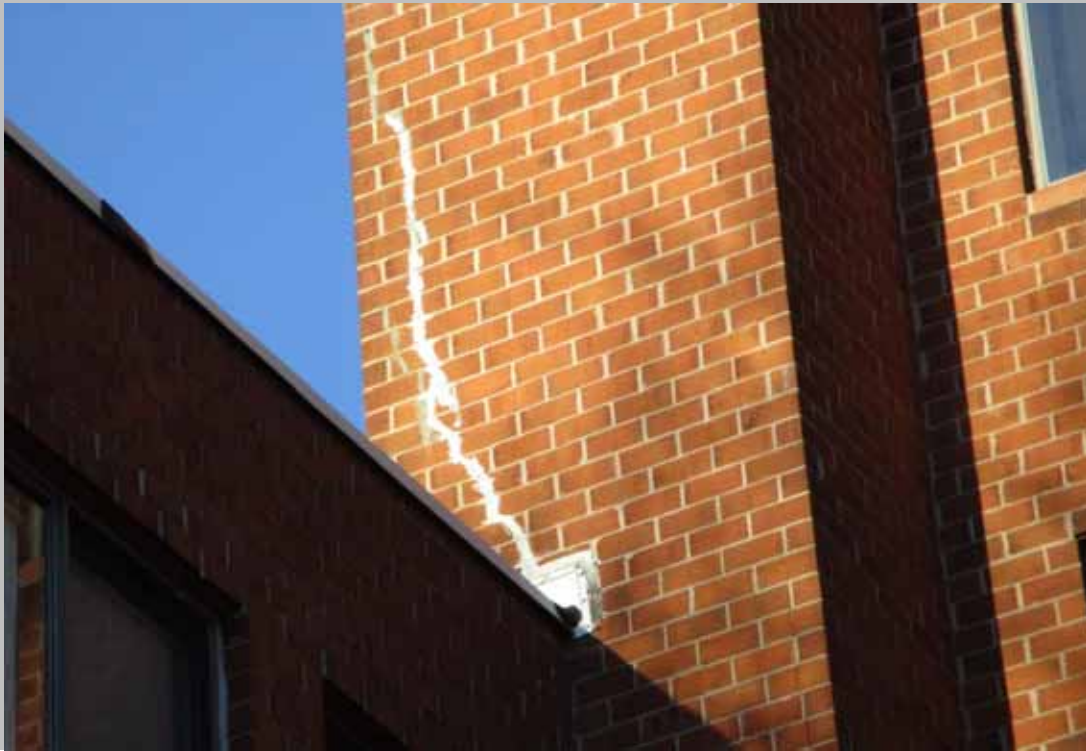
PHOTO #166

Evidence of another crack repair in upper brick work.

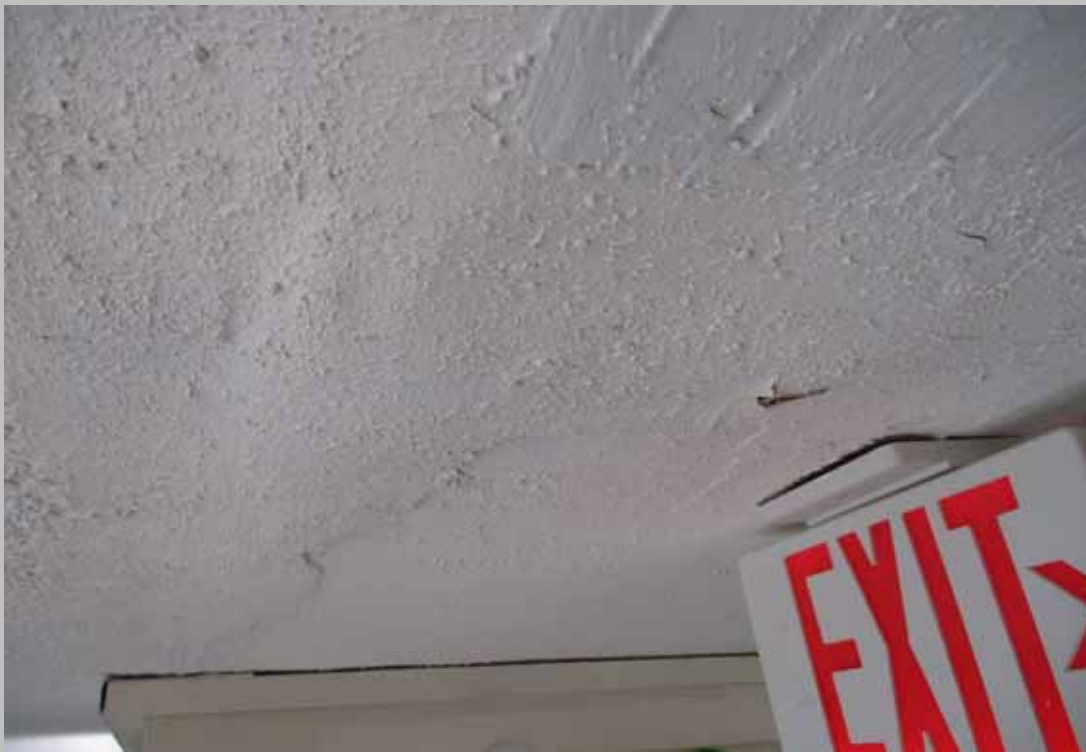
PHOTO #167

Buildings feature flat roofs consisting of fully adhered TPO membrane, presumed to be over rigid insulation and fiber board. No leaks were reported, overall, except a small area in the 5th floor corridor that has been repaired repeatedly. However, no seams or openings in the assemblies were observed. The building features roof drains that were observed in fair physical condition. Overall, roofing was observed in fair physical condition. Replacement of the roofing membrane is anticipated during the estimate period.

Evidence of recent roof leak and multiple repairs 5th floor corridor.
