**CAPITAL NEEDS ASSESSMENT (CNA)
ROCKLAND TOWERS (2-50)
5300 WASHINGTON STREET
WEST ROXBURY, MASSACHUSETTS 02132**

**D3G PROJECT NUMBER:
2021-0378**

**FINAL REPORT ISSUE DATE:
OCTOBER 14, 2021**

**INSPECTION DATES:
APRIL 19 & 22, 2021**

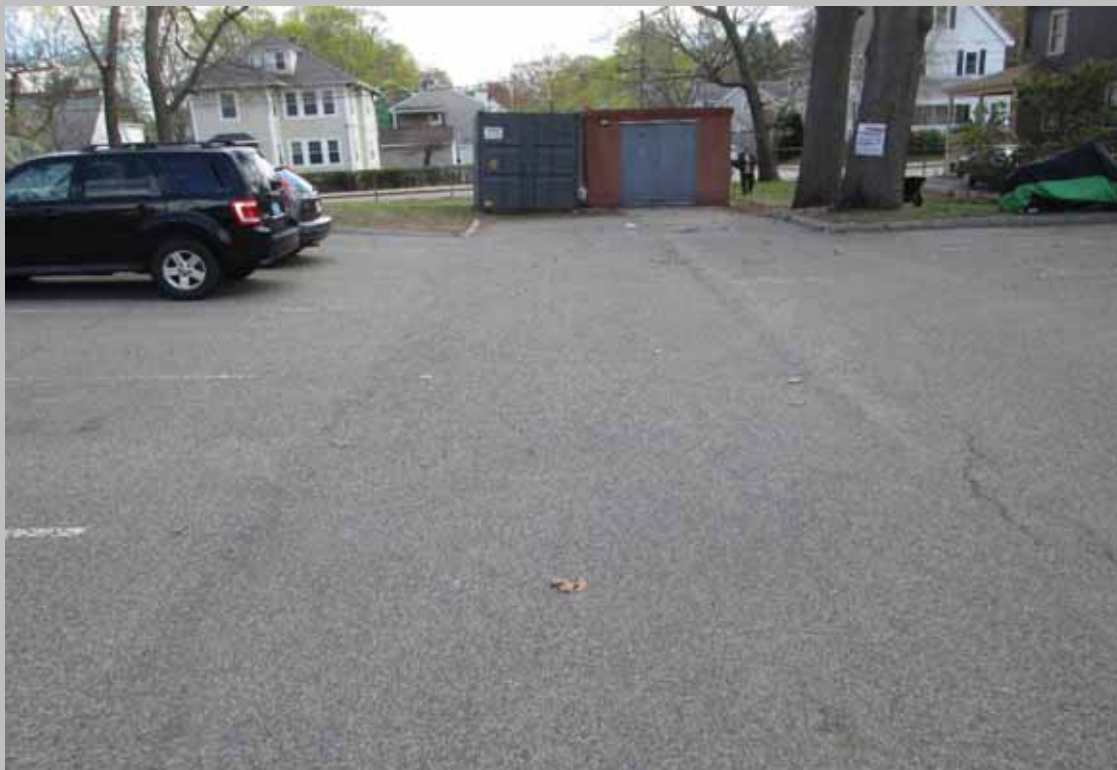
PHOTO #10

The site features asphalt drive aisles and parking. Vehicular capacity is approximately thirty (30) marked parking spaces, with parking space configuration designed for continuous traffic flow and convenient access to building. The overall asphalt parking areas were observed in fair to good physical condition. The sealcoating and restriping of the parking spaces is anticipated during the estimate period.

View of asphalt parking surface condition

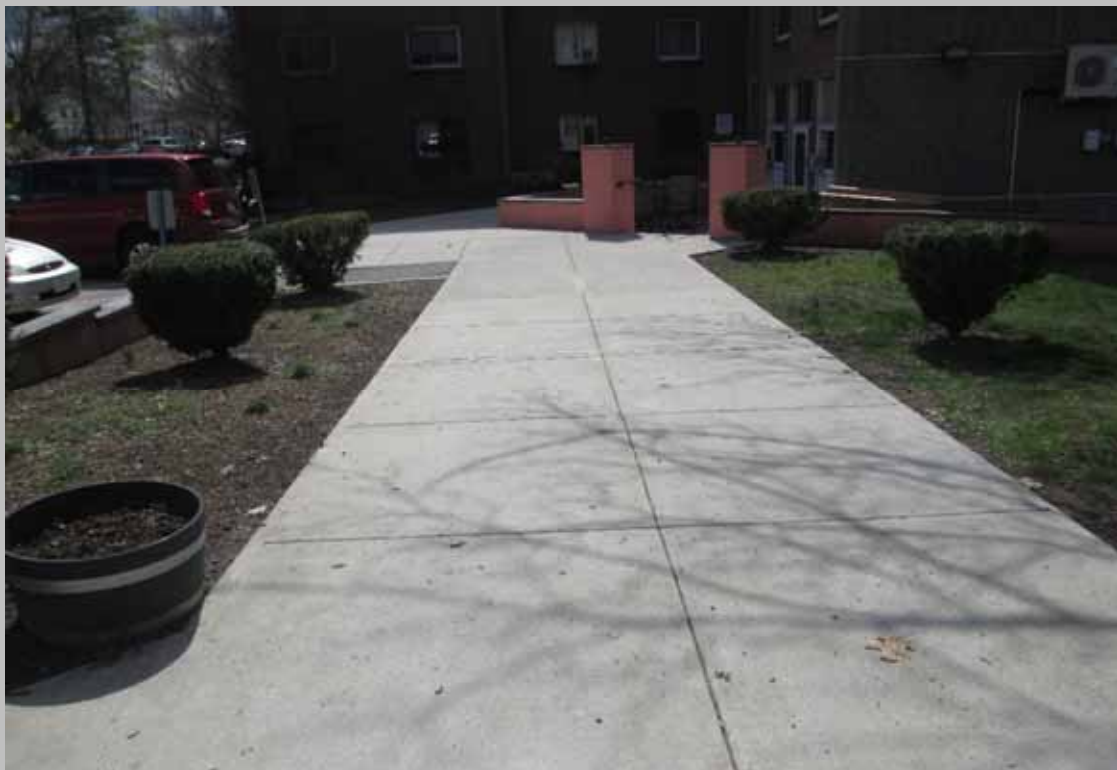
PHOTO #12

View of concrete sidewalk condition

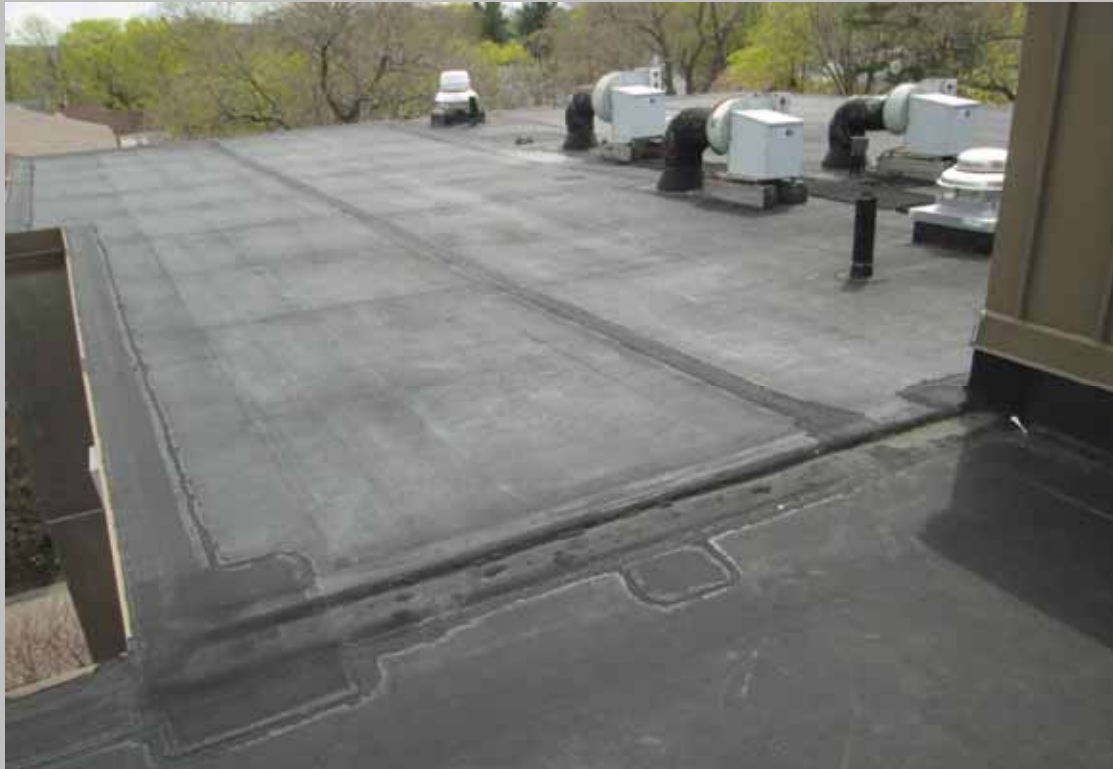
PHOTO #13

The buildings feature flat, built up roofing (BUR) assemblies consisting of an adhered EPDM membrane, presumed to be over rigid insulation and fiber board. The roof systems appeared in fair to good physical condition with no leaks reported or evidence of leaks observed during the inspection. The apartment building features internal roof drains that were observed in good physical condition. Replacement of the roof surface is anticipated during the estimate period.

View of building roof

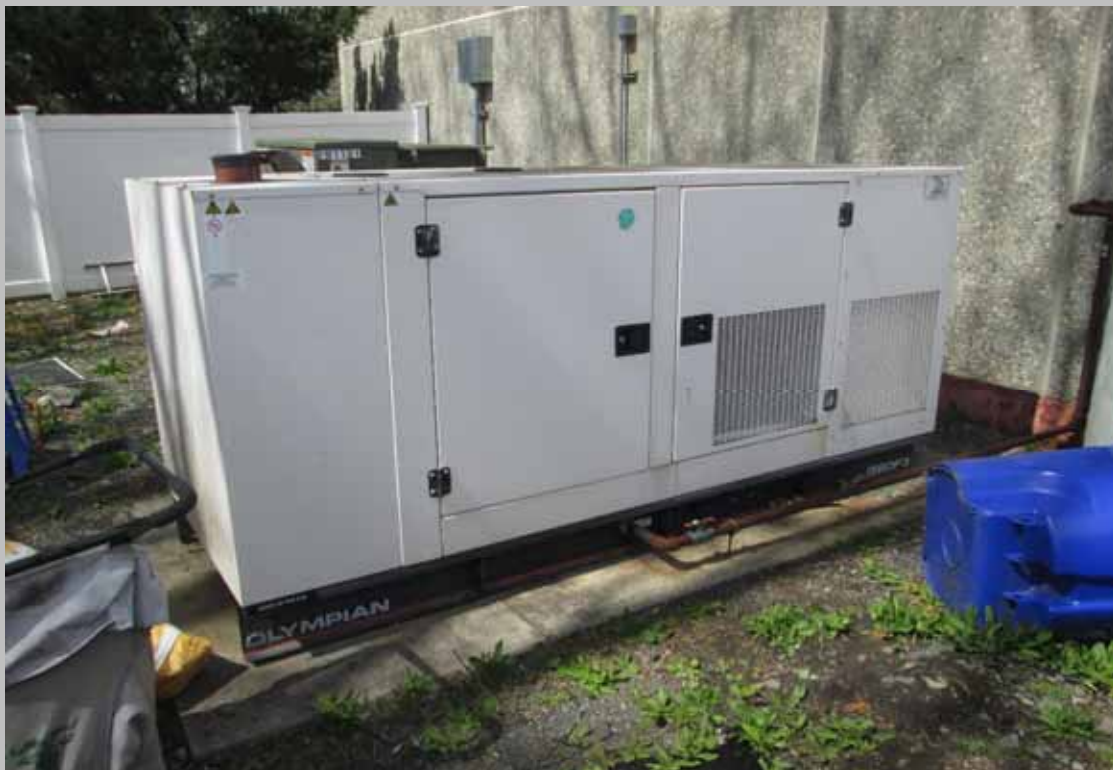
PHOTO #14

The property features an emergency generator with an above ground storage tank. The generator has a power rating of 75kW. The generator was observed in fair physical condition, and replacement is anticipated during the estimate period.

View of the emergency generator

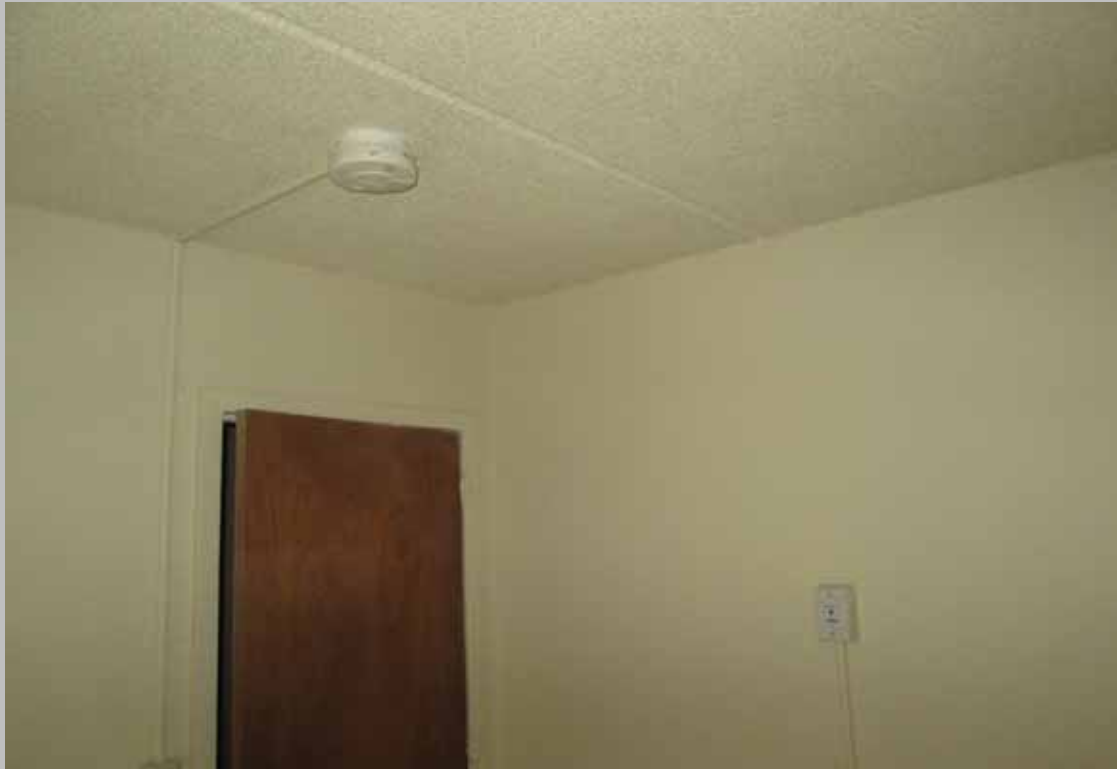
PHOTO #25

Dwelling units contain hard-wired smoke detectors located within the immediate vicinity of the bedroom areas; however, the one-bedroom dwelling units do not feature any smoke detectors in the bedrooms (Critical Repair). Per HUD MAP Guidelines; according to Life Safety Code (NFPA 101), paragraph 31.3.4.5.1, smoke alarms must be installed outside every sleeping area in the immediate vicinity of the bedrooms and on all levels of the dwelling unit, including basements. In addition to the NFPA requirements, the regulation in 24 CFR 200.76 requires that smoke detectors must also be installed inside each sleeping area. The smoke detectors can be either hard wired or battery powered. Battery powered smoke detectors must have the following features: the cell must be tamper-resistant; the cells cannot be used in any other toy or appliance; the cells must have a ten-year life (i.e. lithium battery); the smoke detector may have a manual silencing device to clear unwanted alarms such as cooking smoke. For the purpose of this report we have budgeted battery powered smoke detectors, allowable by the HUD MAP Guidelines. It is recommended to contact the local municipality to determine if battery powered smoke detectors are allowable.

View of a smoke detector - dwelling unit

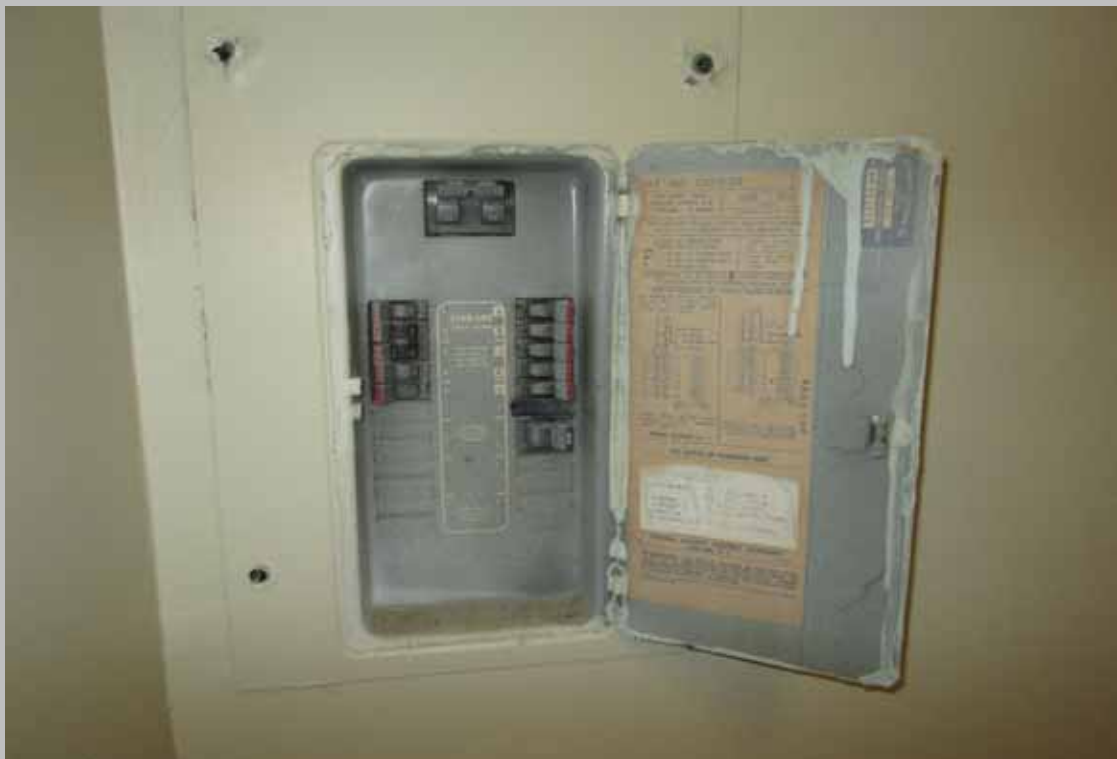
PHOTO #26

The property receives electrical power from a pad-mounted transformer. The dwelling units were observed with Federal Pacific Stab-Lok electrical panels. Federal Pacific Electric "Stab-Lok" service panels and breakers may pose a fire hazard and can fail to trip in response to over current, leading to electrical fires. Failures are documented in Consumer Product Safety Commission (CPSC) and independent testing, as well as multiple documented cases of fires resulting from failure of this product. No issues with the panels were reported or observed; therefore, immediate replacement is not required at this time. It is recommended for a qualified electrical contractor to inspect and evaluate the panels to determine whether or not these specific panels require to be replaced with another brand that has a current UL listing and that provides improved protection and reliability.

View of an electric breaker panel - dwelling unit

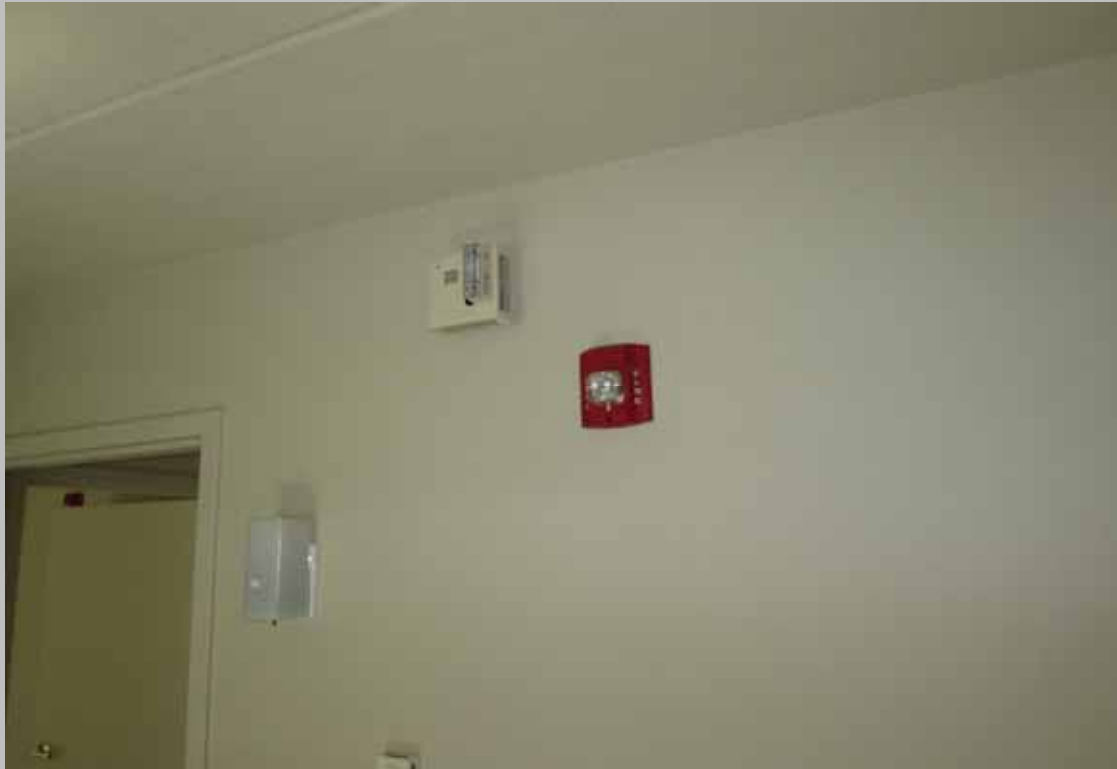
PHOTO #29

The property receives project based federal financial assistance and is therefore, required to provide audio/visual smoke alarms in 2% of the dwelling units, outside of the designated handicapped dwelling units. The property features audio/visual alarms; however, they are all located in the designated handicapped dwelling units (Critical Repair).

View of an A/V alarms - dwelling unit

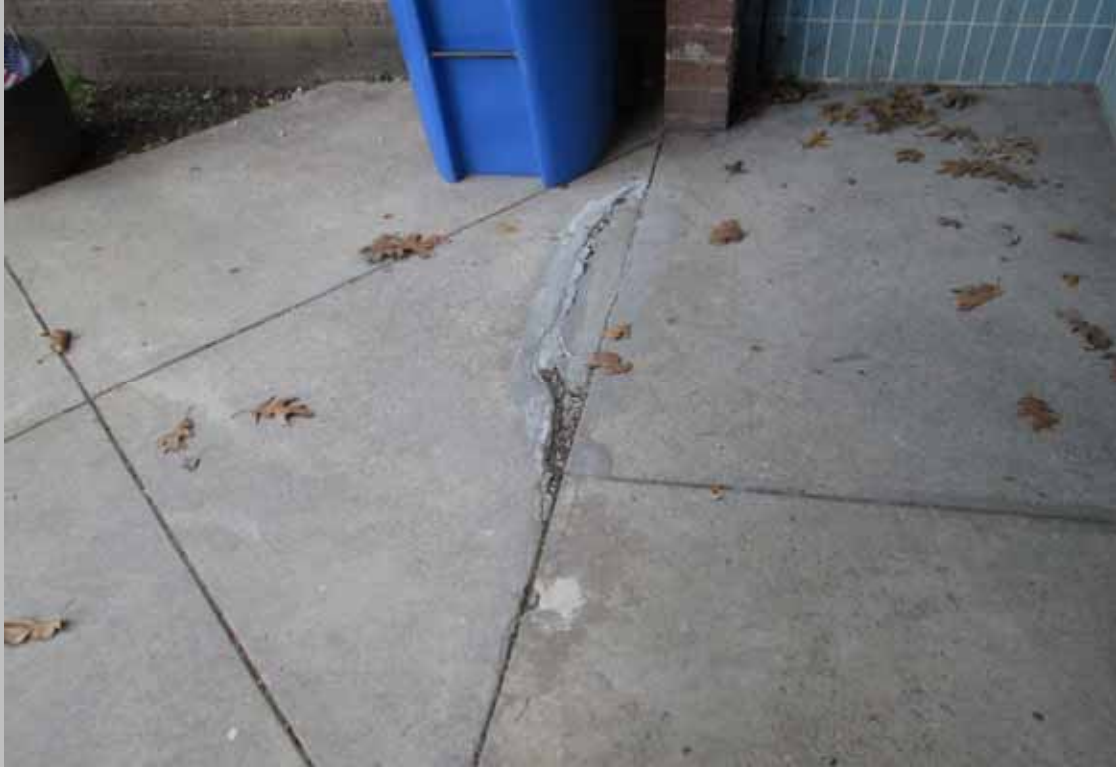
PHOTO #57

The site features concrete sidewalk and patio areas. The concrete walks and patio areas were observed in generally good physical condition with the exception of a trip hazard located at the building entrance which has been noted as a Critical Repair. The refurbishment/repair of the concrete walkways is not anticipated during the estimate period. A section of retaining wall located near the parking area was observed to be damaged and has been noted as a Non-Critical Repair.

View of the trip hazard located outside of the main entry door
(Critical Repairs)

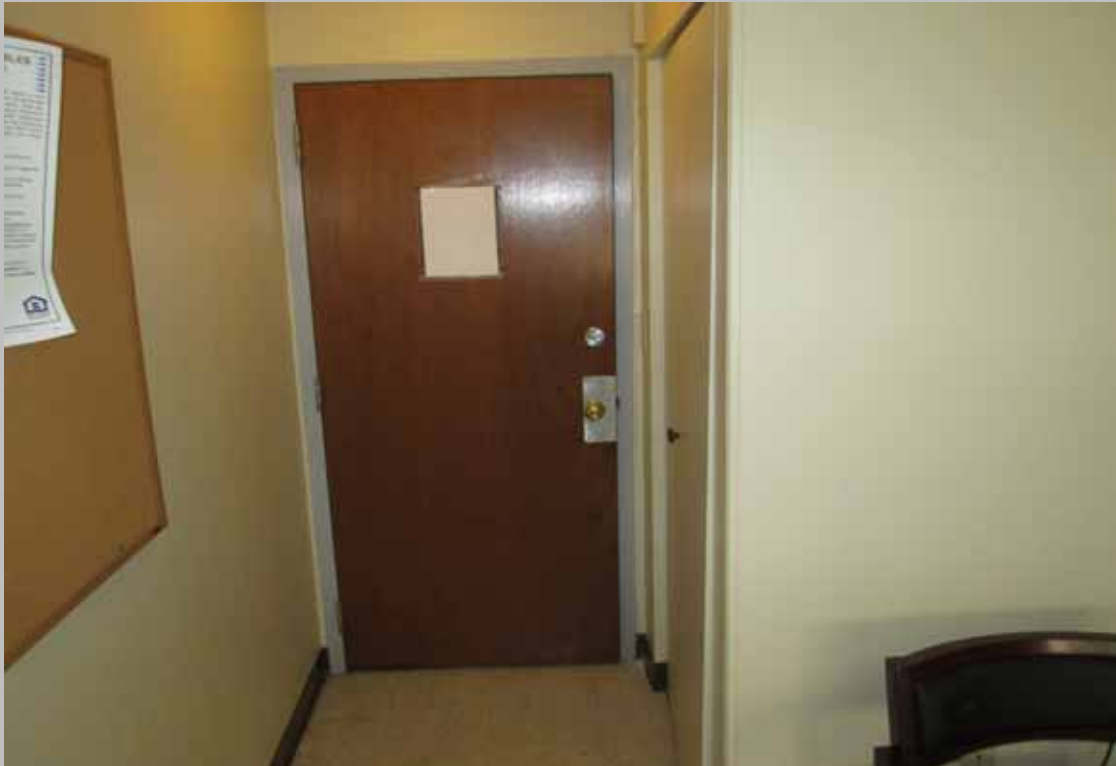
PHOTO #58

View of management office door without 18-inches clear maneuvering space and lacking levered hardware (Critical Repairs)

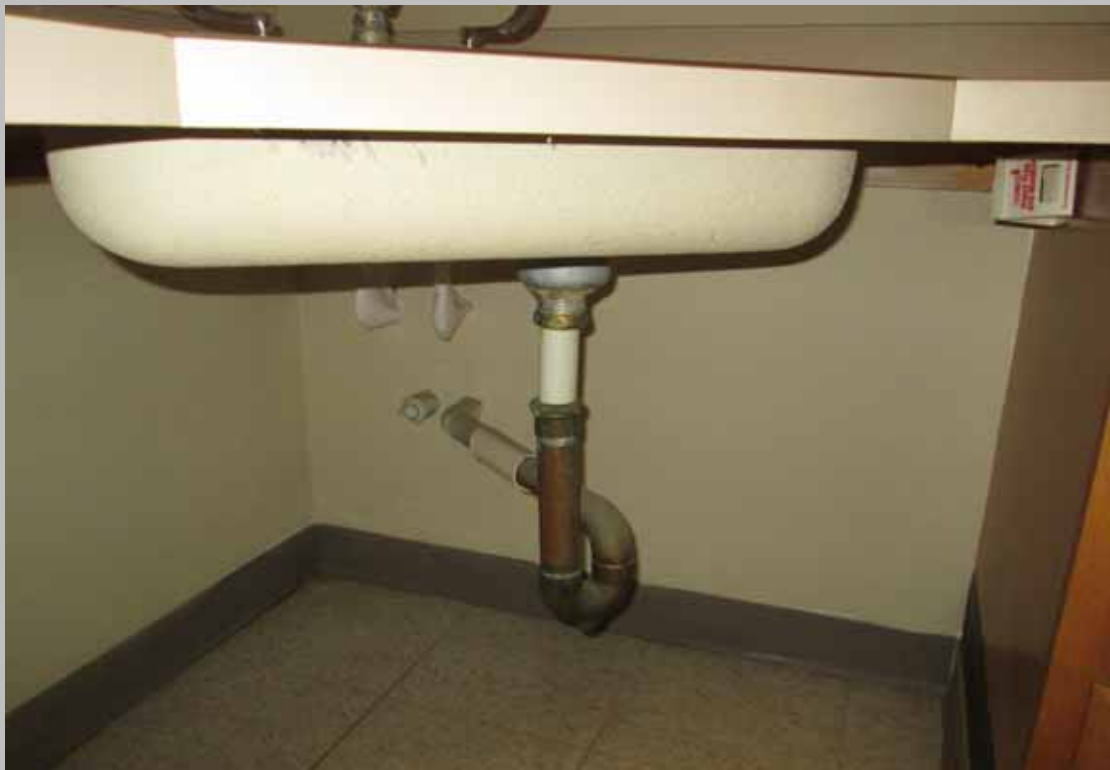
PHOTO #59

View of kitchen sink in HC Unit 17 without scald and abrasion protection
(Critical Repair)

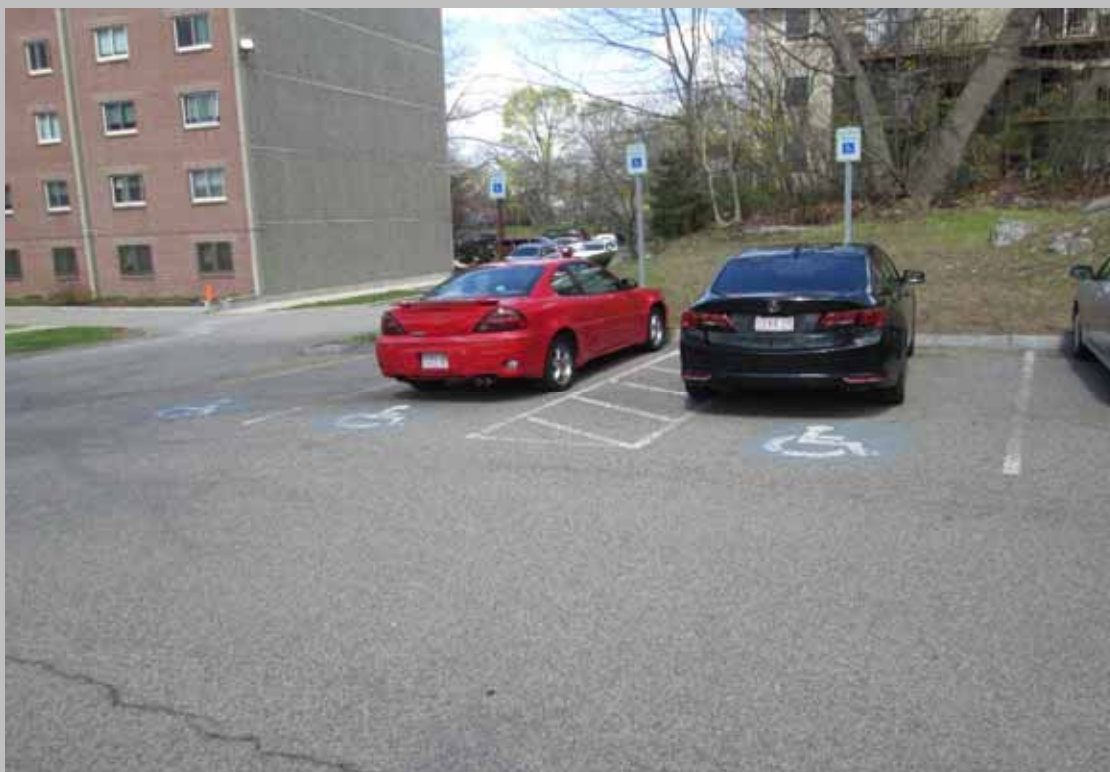
PHOTO #60

View of existing handicapped parking lacking a van accessible space
(Critical Repair)

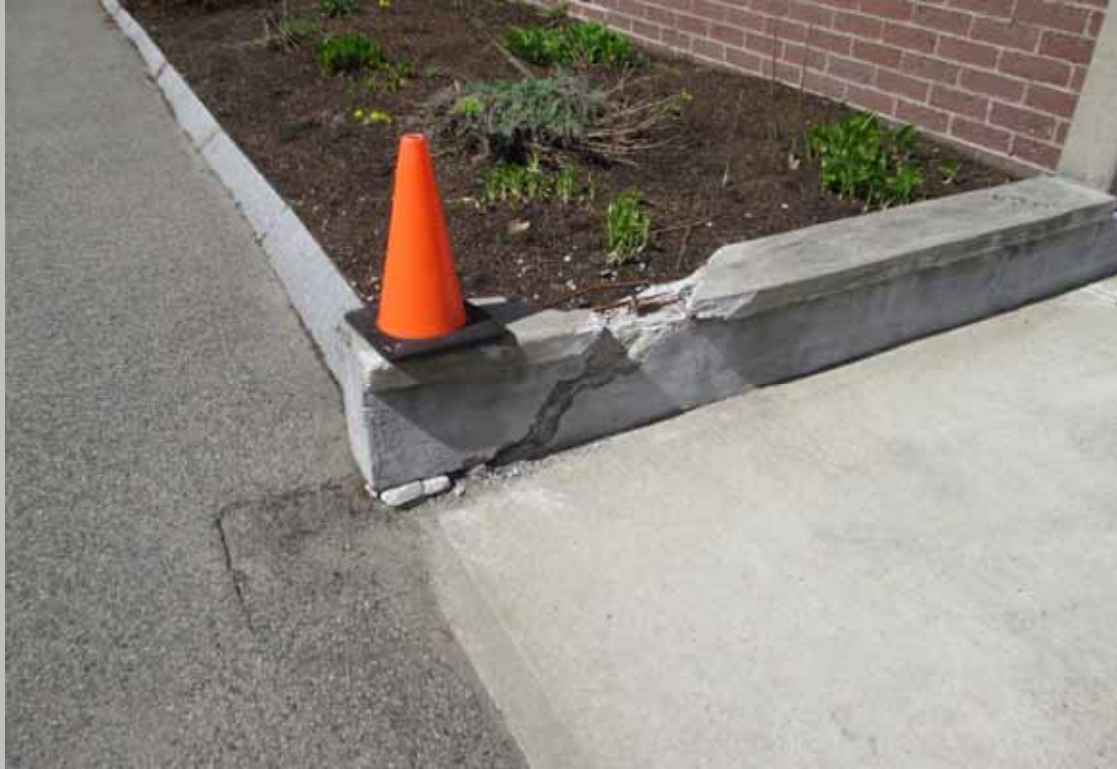
PHOTO #61

View of damaged concrete wall at south sidewalk
(Non-Critical Repairs)

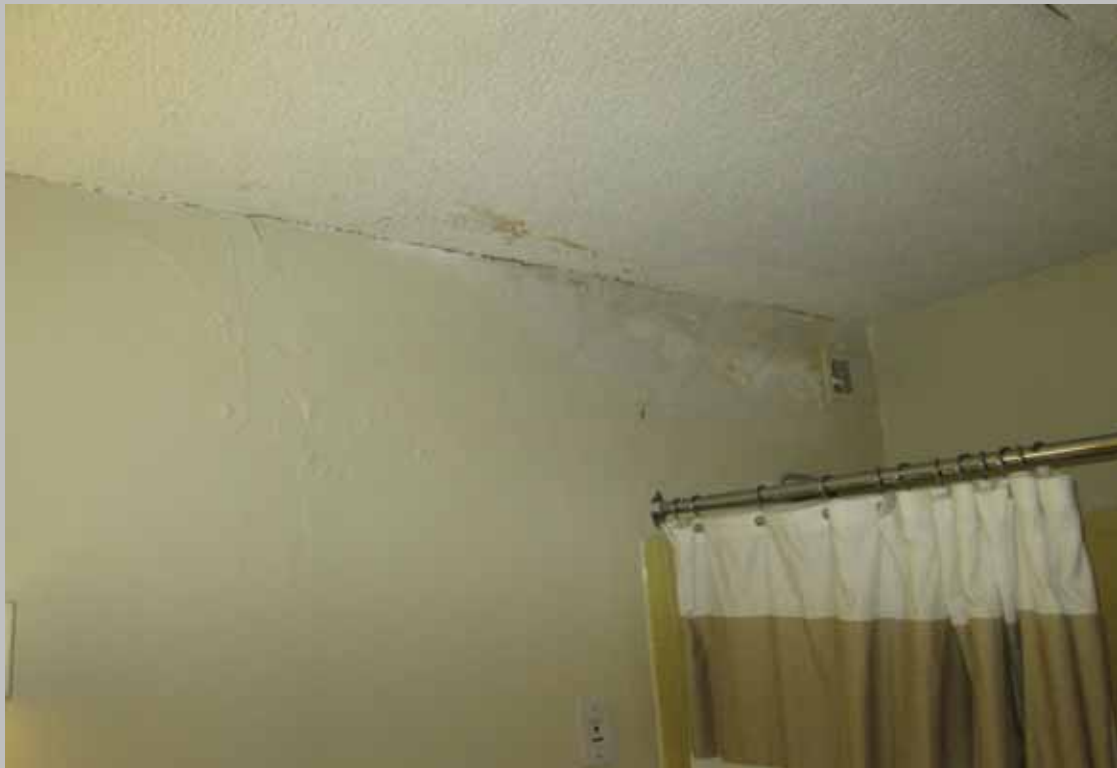
PHOTO #62

View of water damage in Unit 43
(Non-Critical Repair)
