**CAPITAL NEEDS ASSESSMENT (CNA)
ROSLYN APARTMENTS (2-72)
27 CLIFFMONT STREET
ROSLINDALE, MASSACHUSETTS 02131**

**D3G PROJECT NUMBER:
2021-0379**

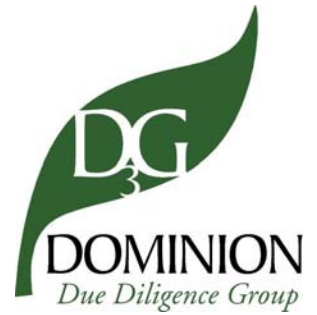
Property: Roslyn Apartments (2-72)
27 Cliffmont Street
Roslindale, Massachusetts 02131

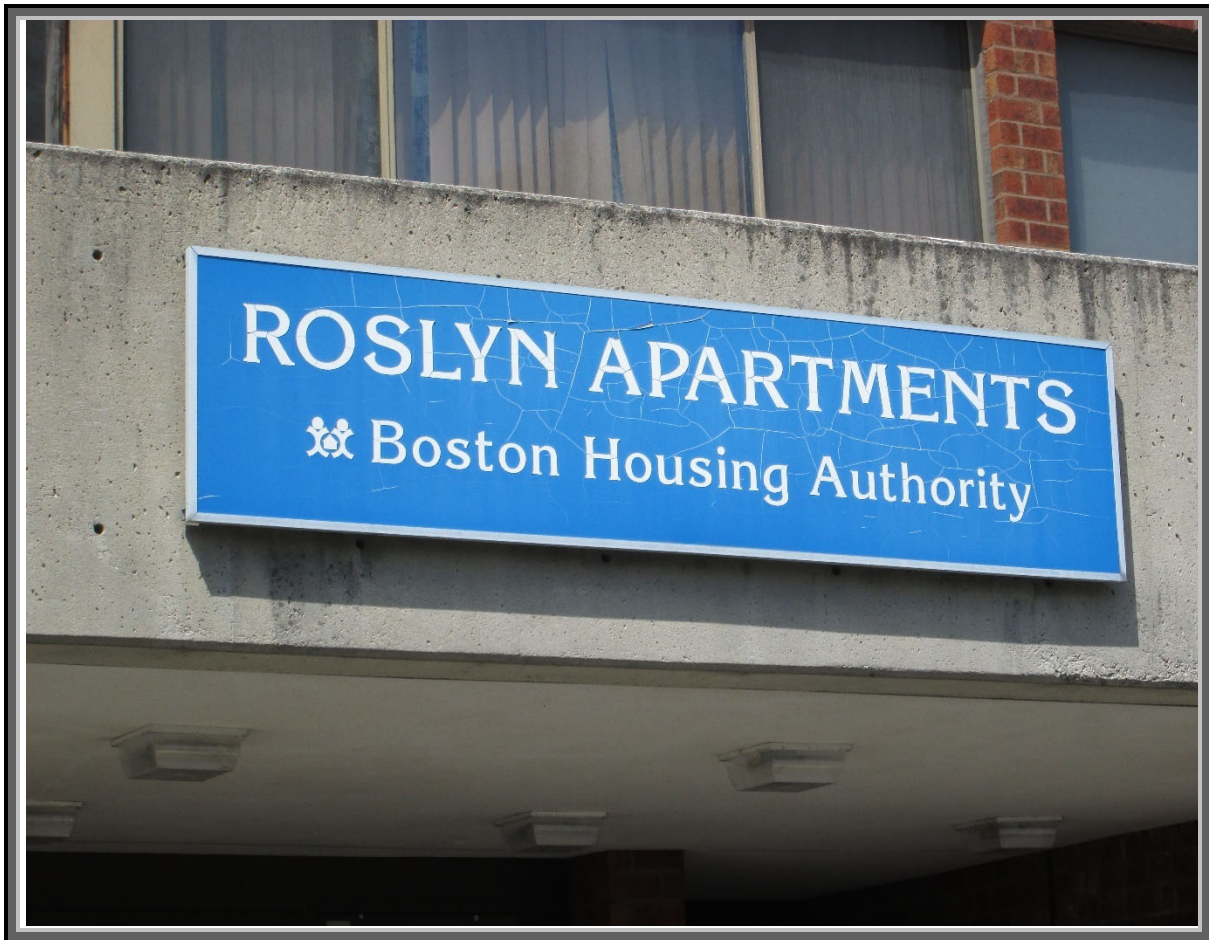
Site Description: Roslyn Apartments (2-72), located at 27 Cliffmont Street in Roslindale, Massachusetts consists of one (1) six-story age-restricted apartment building. The building features one hundred nineteen (119) dwelling units. According to tax records, the building was constructed in 1977 and is situated on 2.40 acres. According to D3G estimates, the building features an approximate gross area of 93,693 square feet. The property is in fair physical condition.

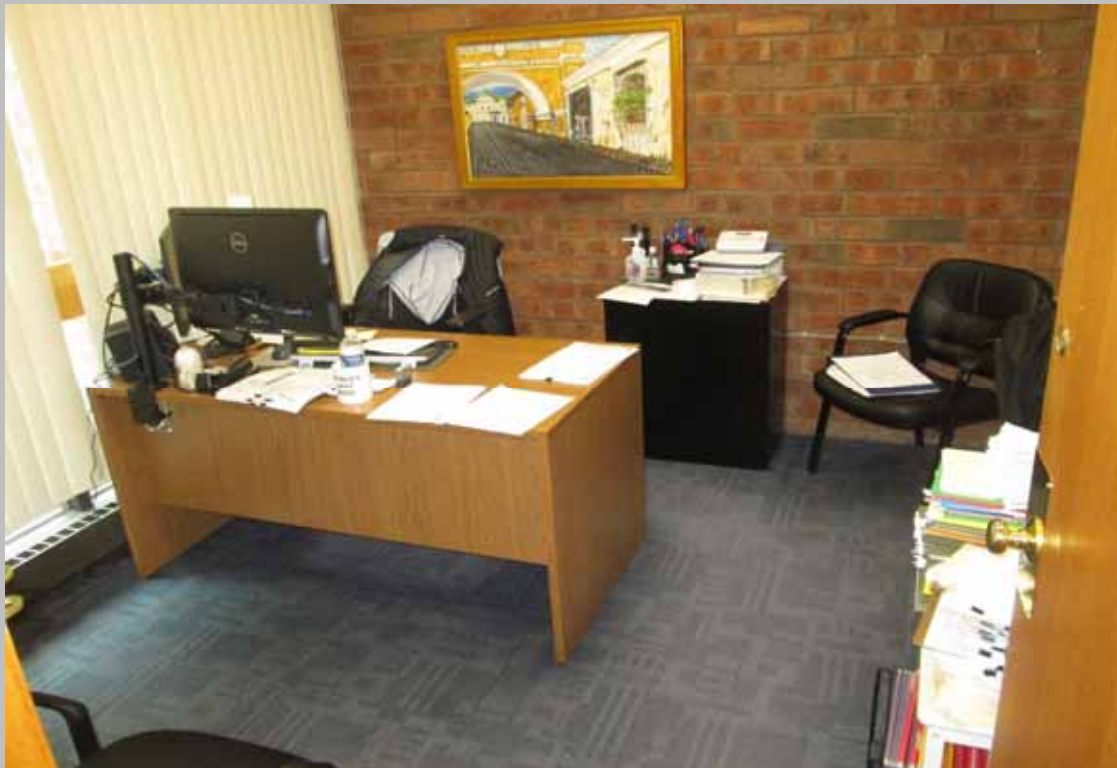
View of the property manager's office – featuring non-compliant knobbed entry door hardware (Critical Repair)

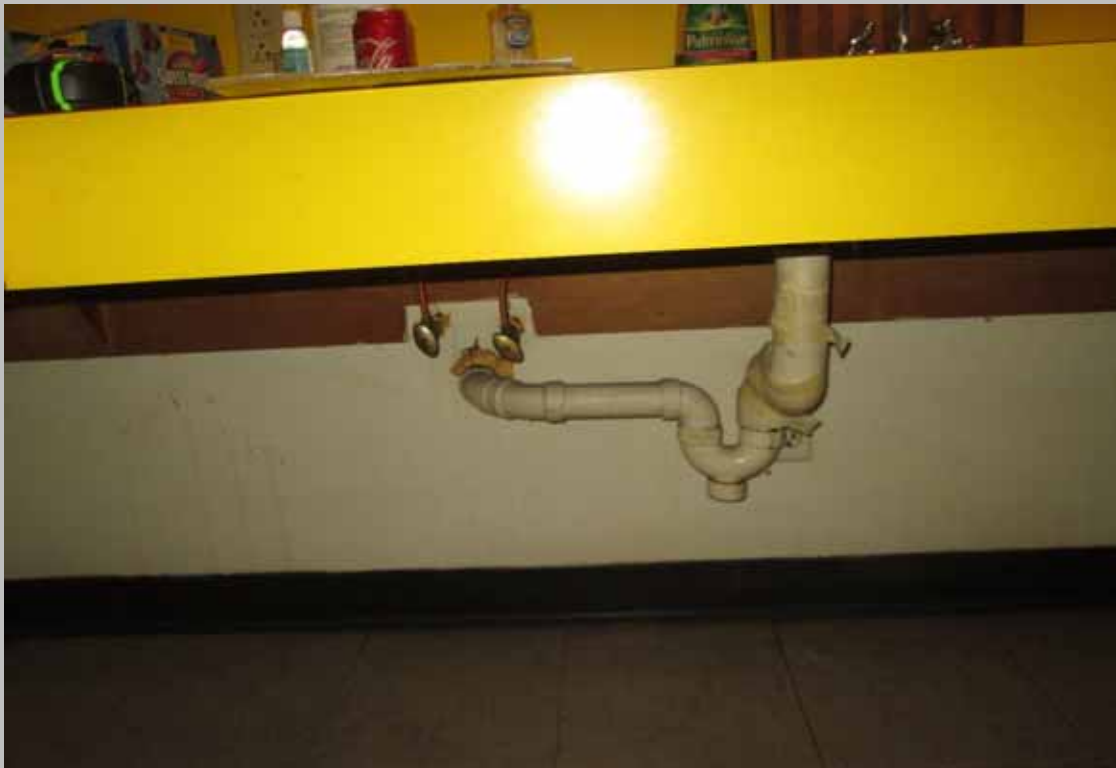
View of a typical HC dwelling unit kitchen sink without scald and abrasion protection on piping
(Critical Repair)

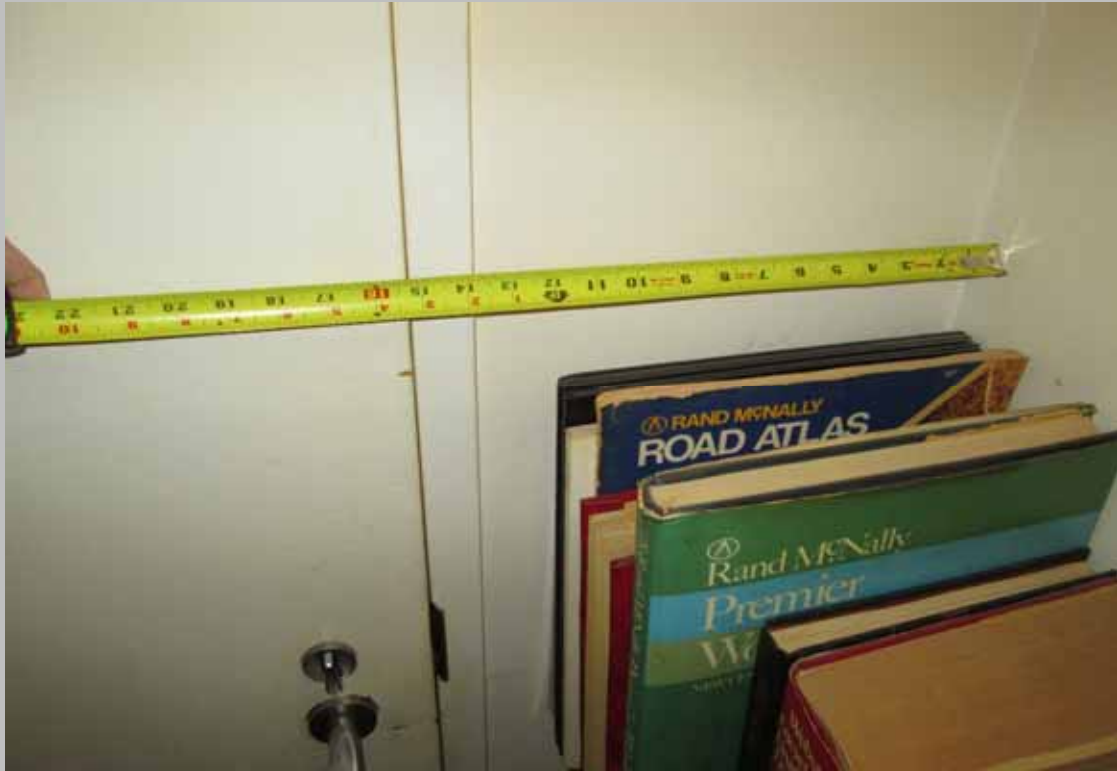
View of 16-inches at the pull-side of the primary entry door at HC Unit 102
(Critical Repair)

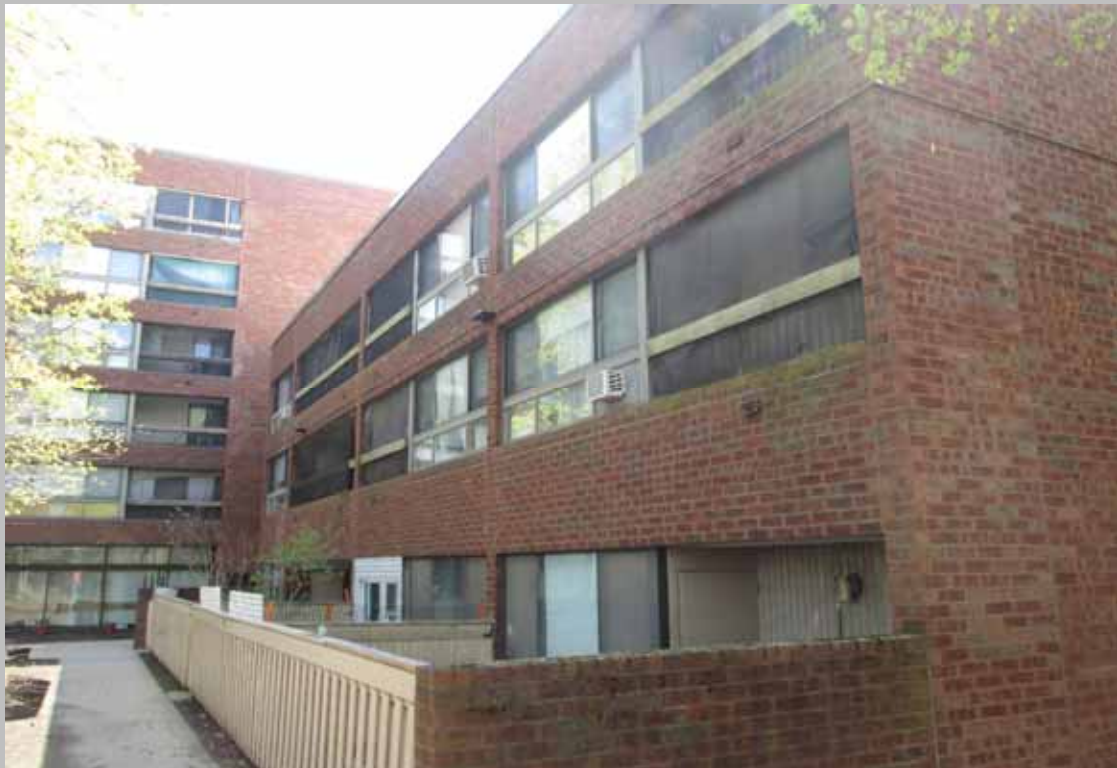
View of a portion of mildew growth on the building exterior in need of pressure washing (Non-Critical Repair)

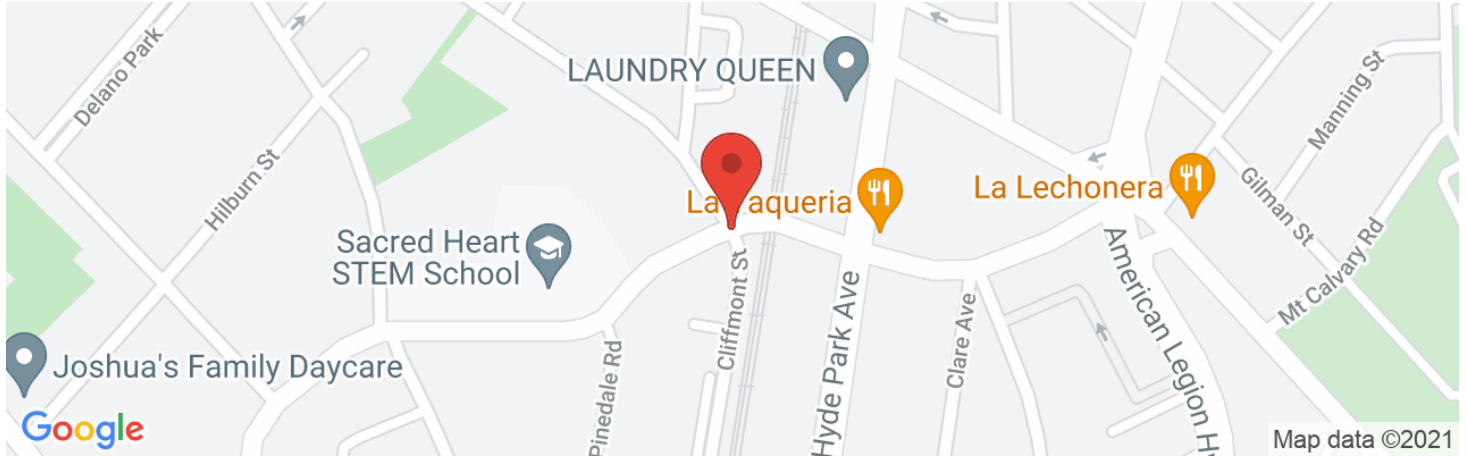
Date	5/18/2021, 9:55:39 AM
Design Code Reference Document	ASCE41-13
Custom Probability	
Site Class	D - Stiff Soil
