**CAPITAL NEEDS ASSESSMENT (CNA)
TORRE UNIDAD APARTMENTS
80 WEST DEDHAM STREET
BOSTON, MASSACHUSETTS 02118**

**D3G PROJECT NUMBER:
2021-0368**

**DRAFT REPORT ISSUE DATE:
APRIL 23, 2021**

**INSPECTION DATE:
MARCH 4, 2021**

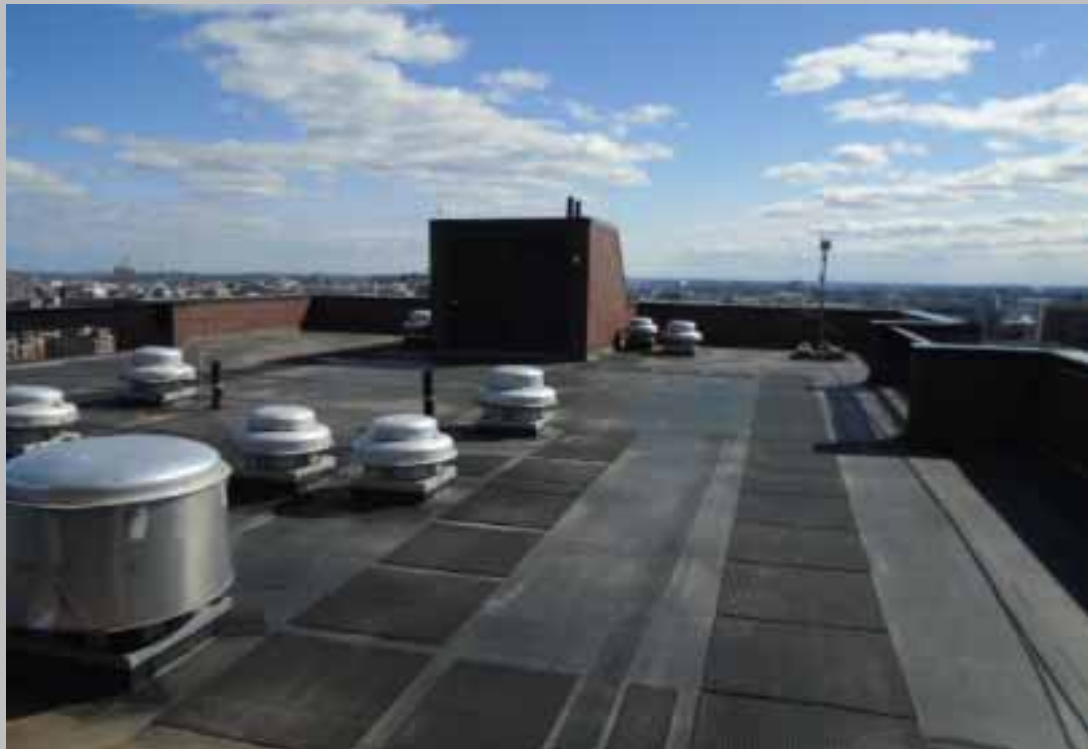
PHOTO #26

Building feature flat roof built up roofing (BUR) assemblies consisting of a fully adhered rubber membrane, presumed to be over rigid insulation and fiber board. No leaks were reported and no seams or openings in the assembly was observed. The building features roof drains and roof scuppers that were observed in fair physical condition. Overall, roofing was observed in fair physical condition. Replacement of the roofing membrane is anticipated during the estimate period. Roof replaced in 2019.

Roof Area

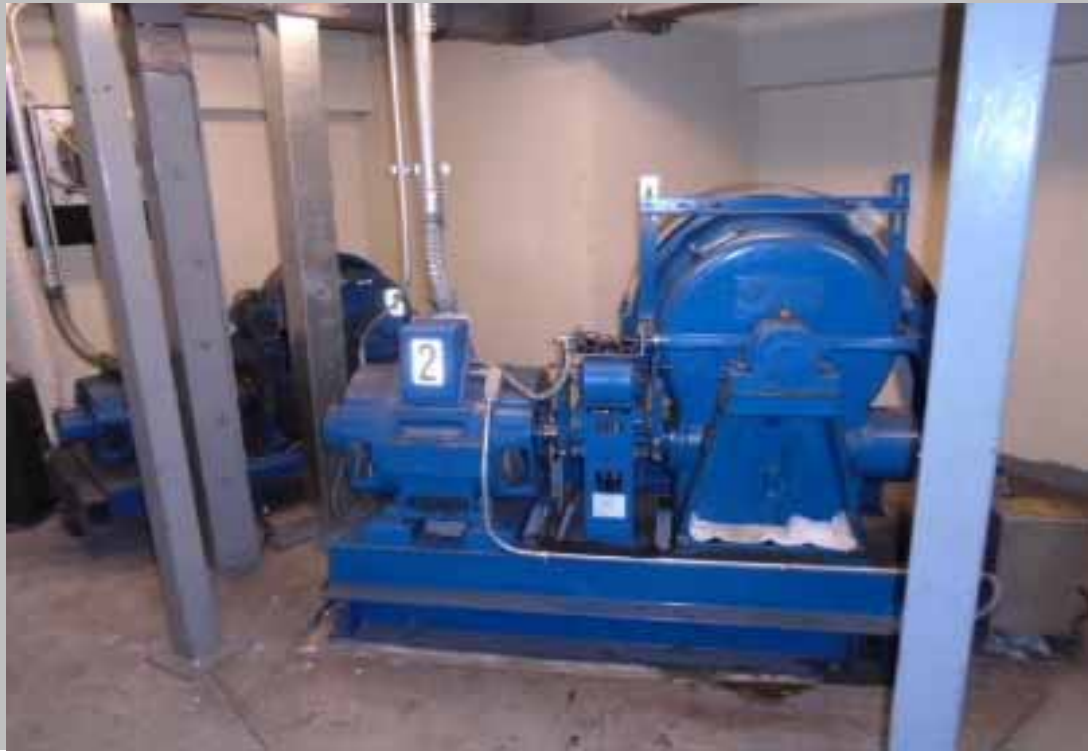
PHOTO #27

Elevators require consistent repairs. Undersized for current Elderly/ Disabled resident Population.

Poor Condition.

Elevator Room

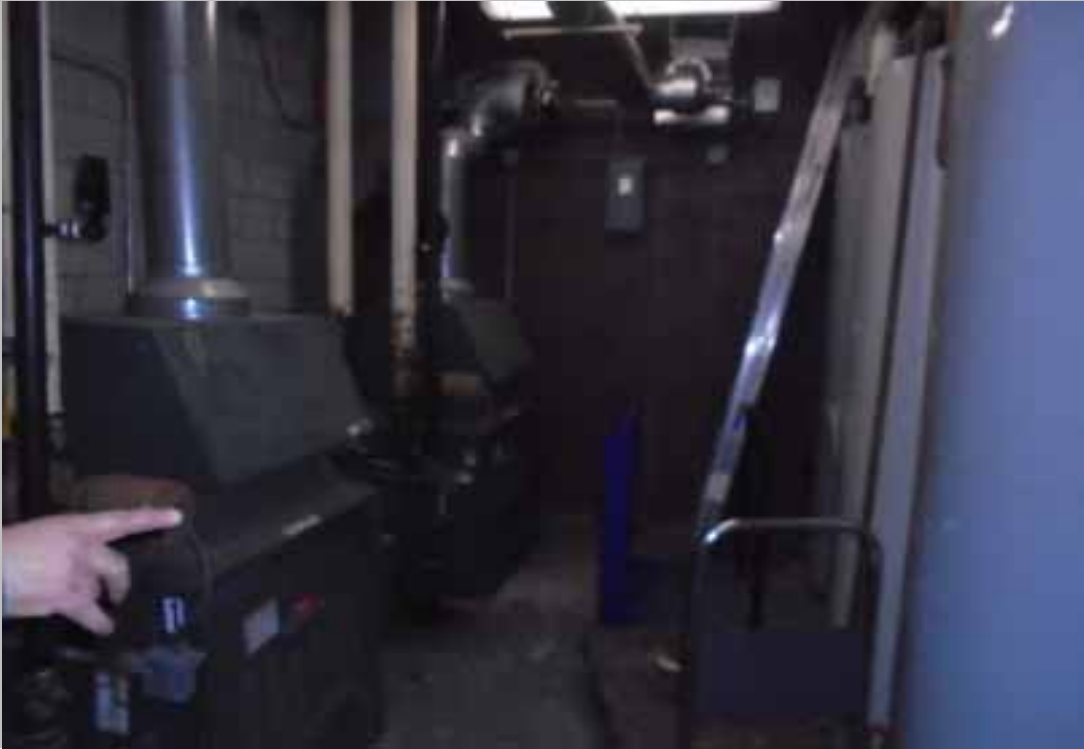
PHOTO #29

of fixtures served and no complaints concerning a lack of hot water were raised during the inspection. The boilers were observed in fair physical condition.

Boilers

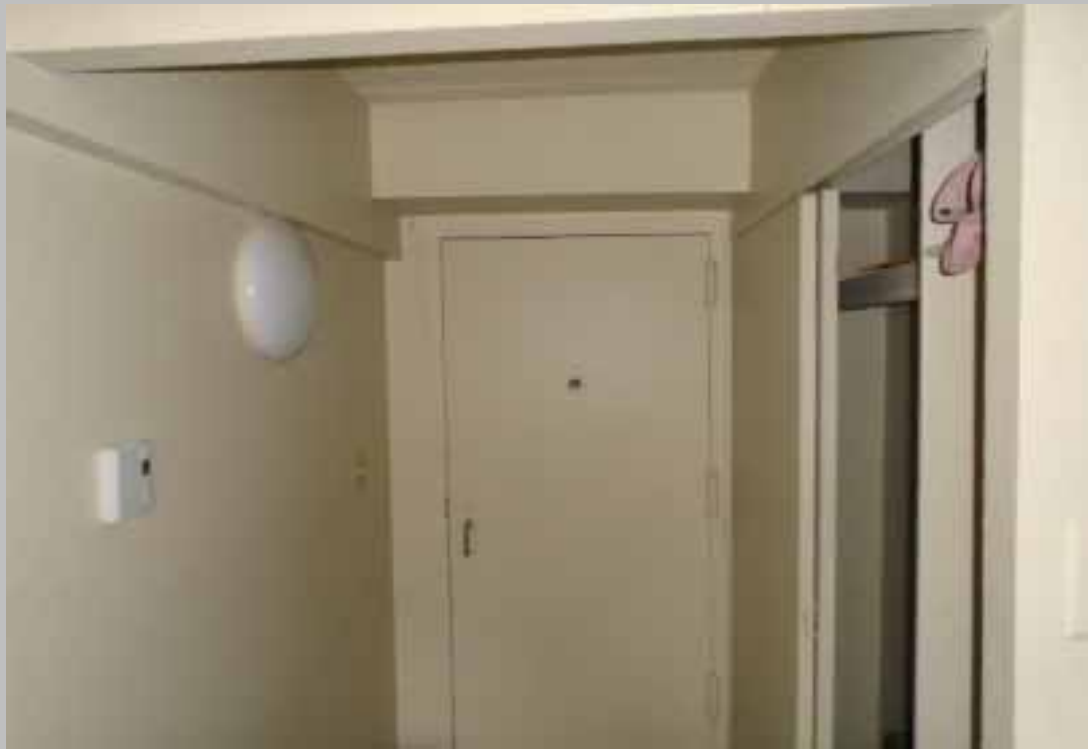
PHOTO #32

Install Automatic Door Openers at the Ten (10) Designated Handicapped Dwelling Units (Critical Repair)

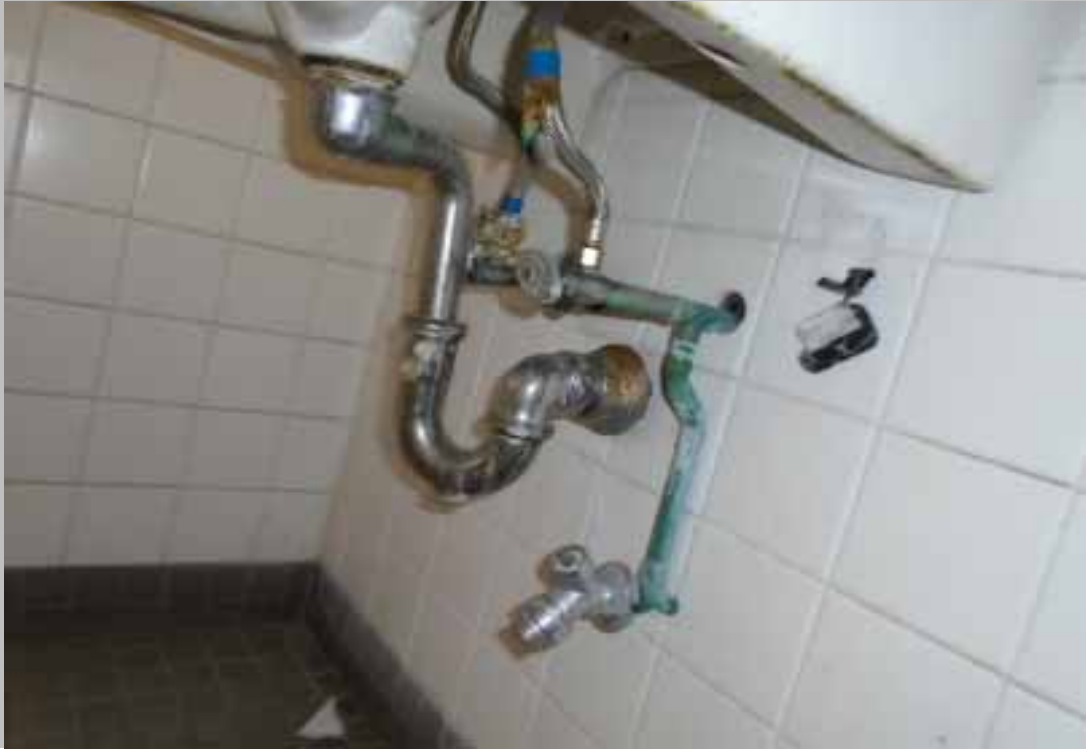
PHOTO #33

Install Scald and Abrasion Protection at Men's Public Restroom Sink (Critical Repair)

Repair Number	ASTM Section #	HUD Map Guide Repair Level	Repair Notes	# Of Units	Unit Of Measure	Unit Cost	Total
1	3.7.1	Repair	The sink in the men's public restroom was observed without scald and abrasion sink pipe wrapping. In order to comply with the Americans with Disabilities Act (ADA), the installation of scald and abrasion sink pipe wrapping is required.	1	Each	\$75.00	\$75.00

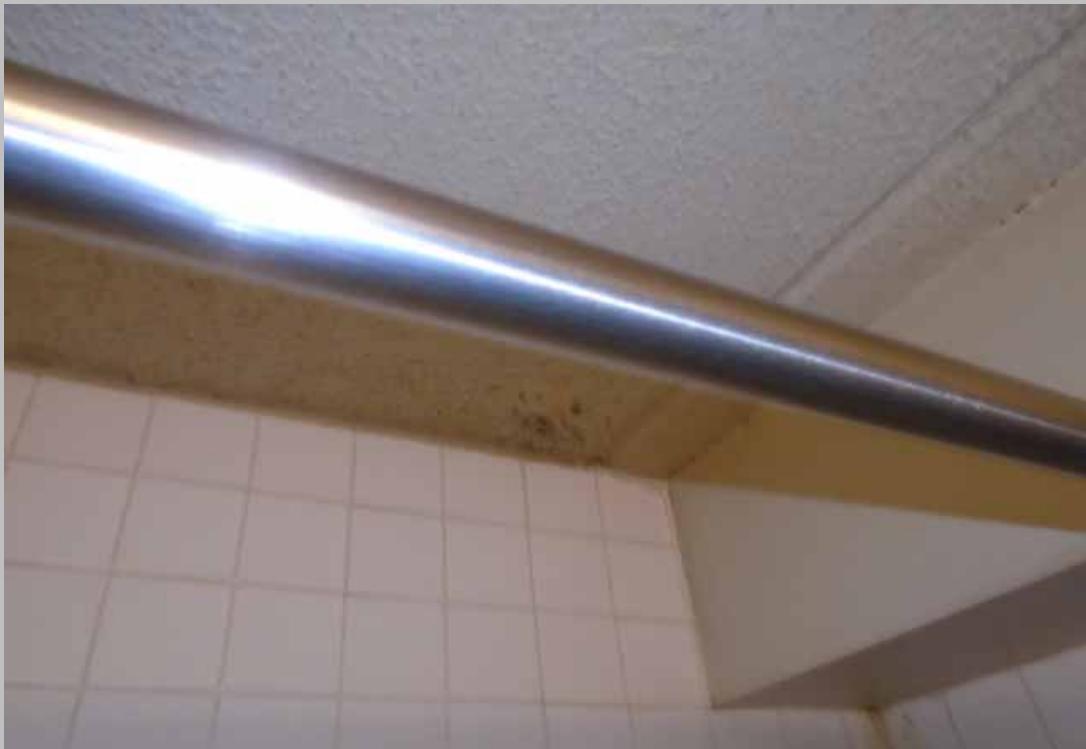
PHOTO #34

Remove Mildew in Unit 804 Bathroom Ceiling (Non-Critical Repair)

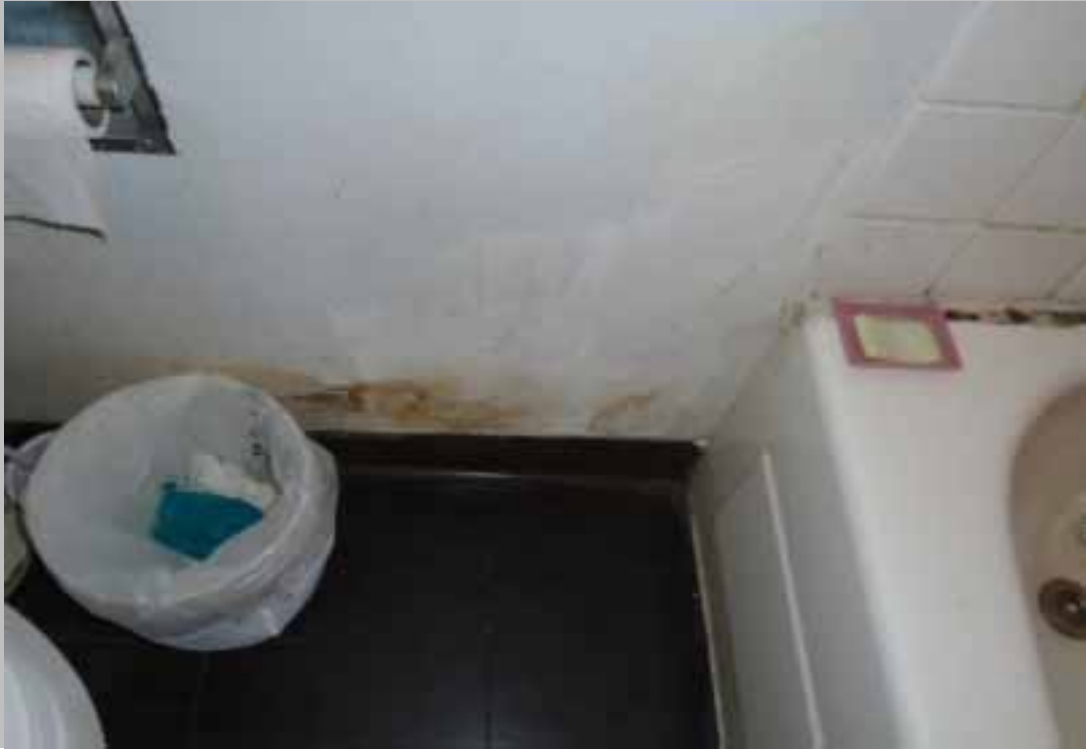
PHOTO #35

Fix Bathroom Wall in Unit 1703 (Non-Critical Repair)

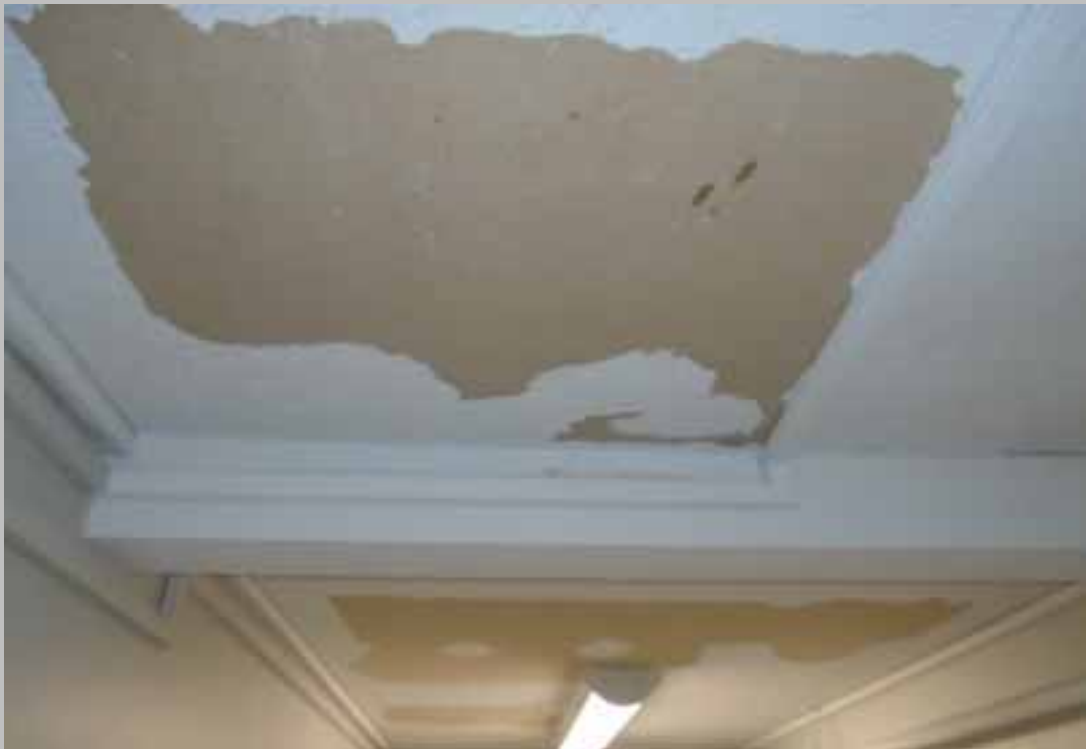
PHOTO #36

Paint Common Hallway Ceiling on the 7th Floor (Non-Critical Repair)

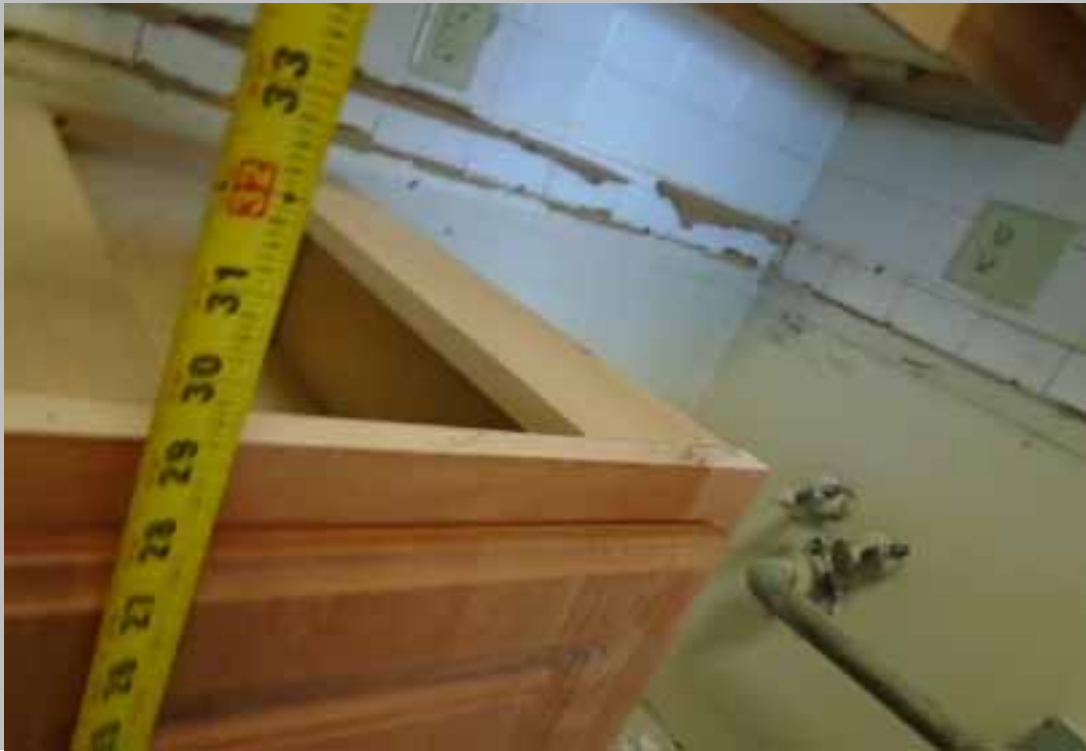
PHOTO #37

Complete Turn in Unit 1412 (Non-Critical Repair)

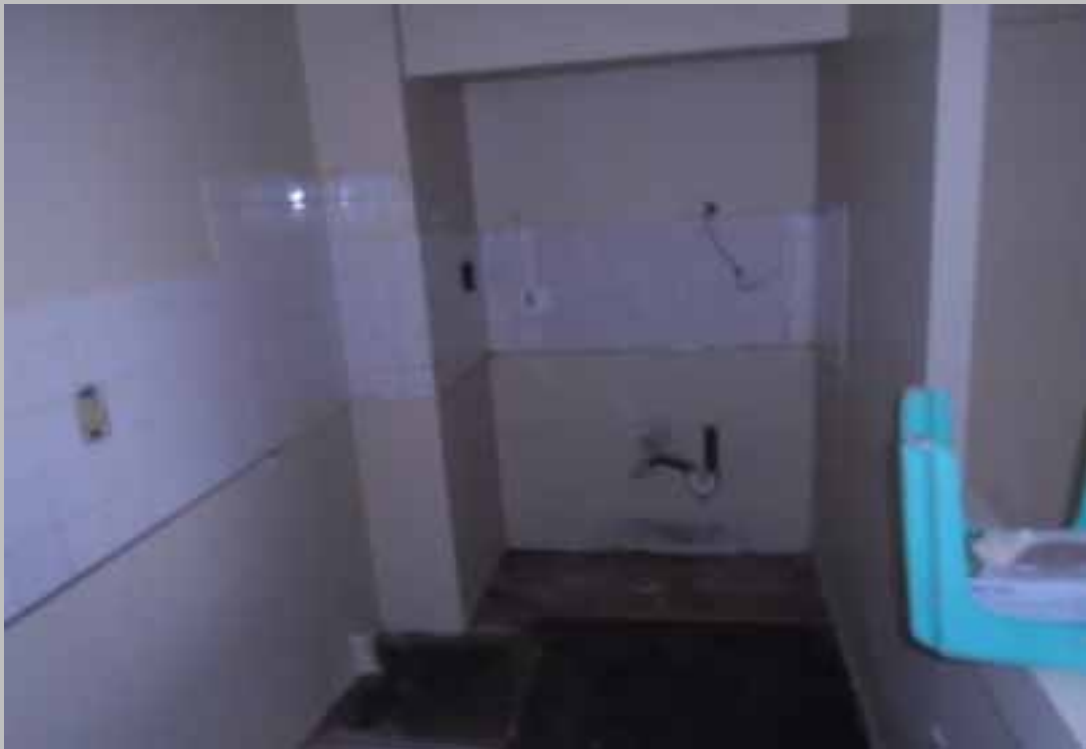
PHOTO #38

Complete Turn in Unit 607 (Non-Critical Repair)
