**CAPITAL NEEDS ASSESSMENT (CNA)
RUTH LILLIAN BARKLEY APARTMENTS (1-06)
1472 WASHINGTON STREET
SOUTH END, MASSACHUSETTS 02118**

**D3G PROJECT NUMBER:
2021-0380**

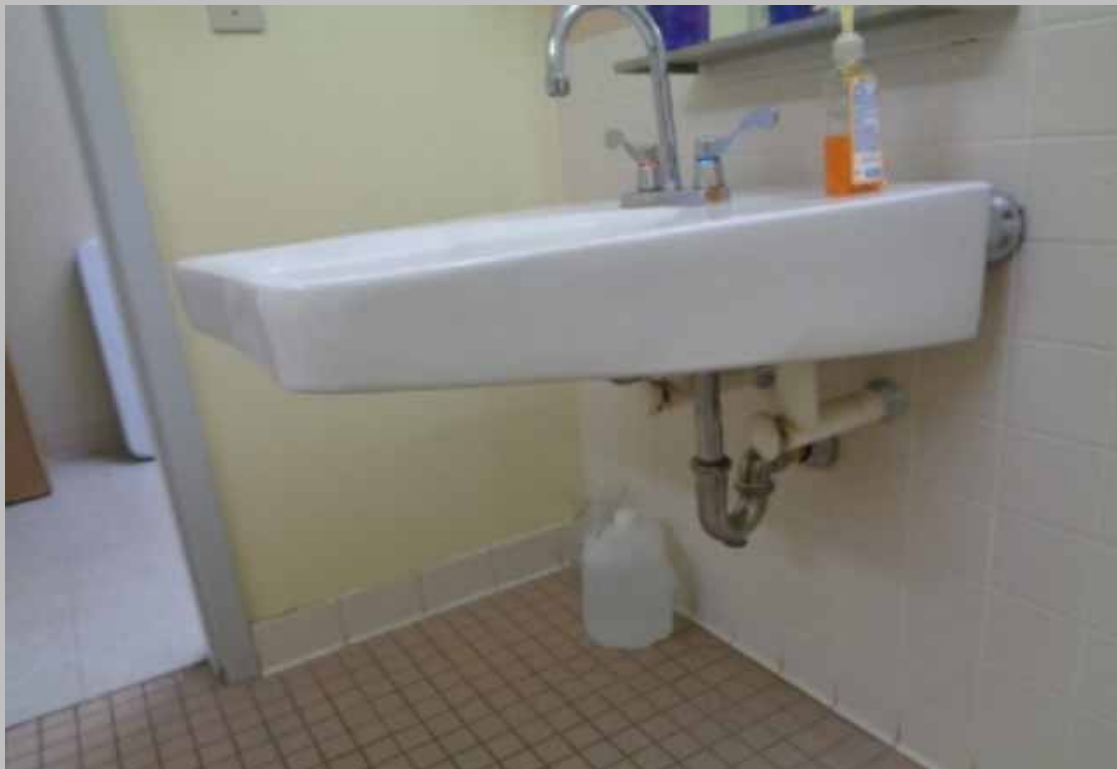
Common restroom missing S&A protection (Critical Repair)

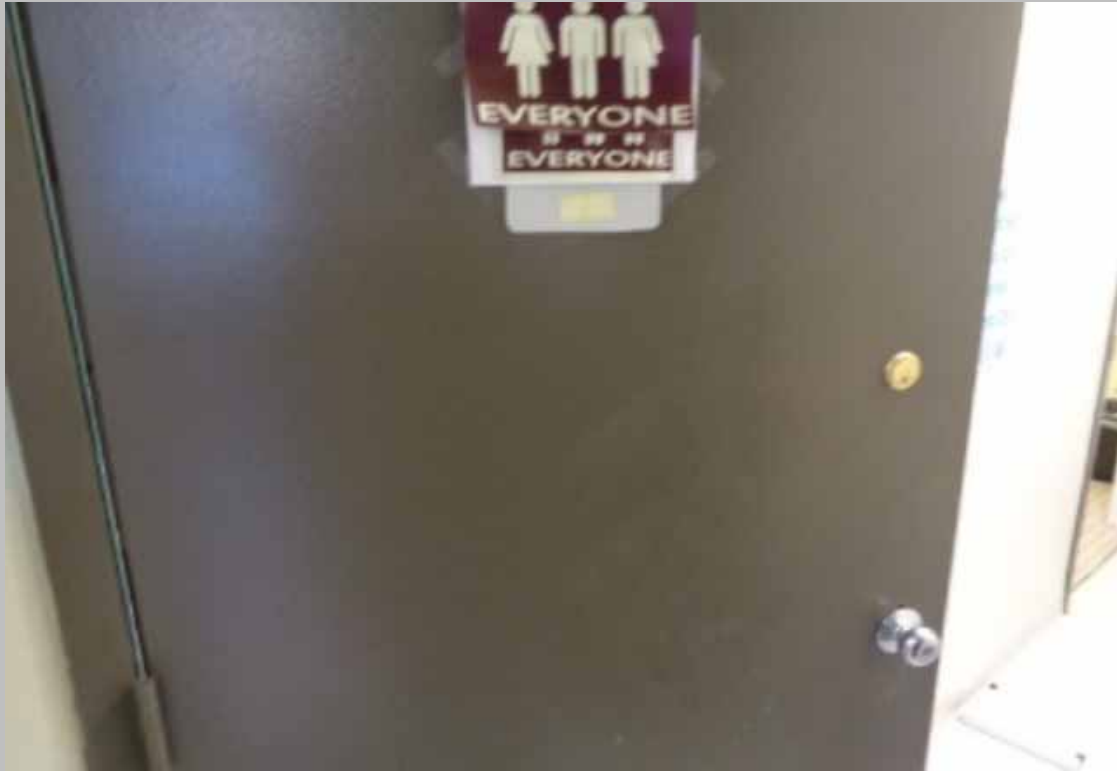
Common restroom door with non-compliant knob hardware (Critical Repair)

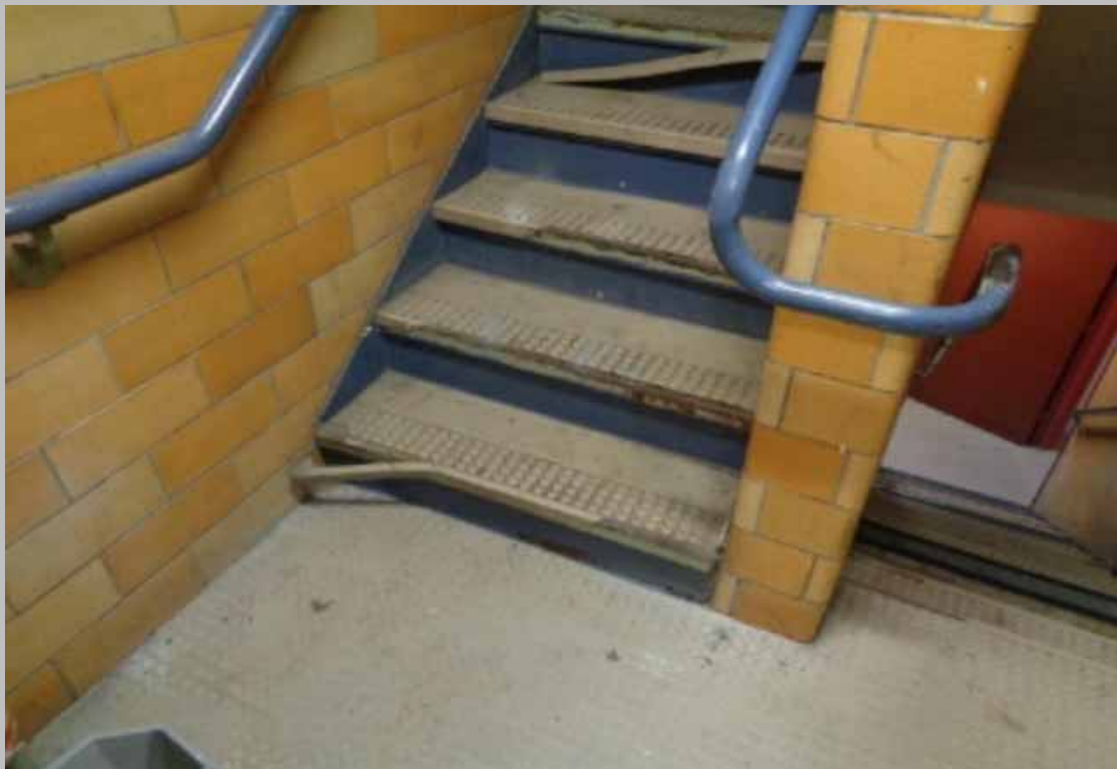
Interior common stair tread (Critical Repair)

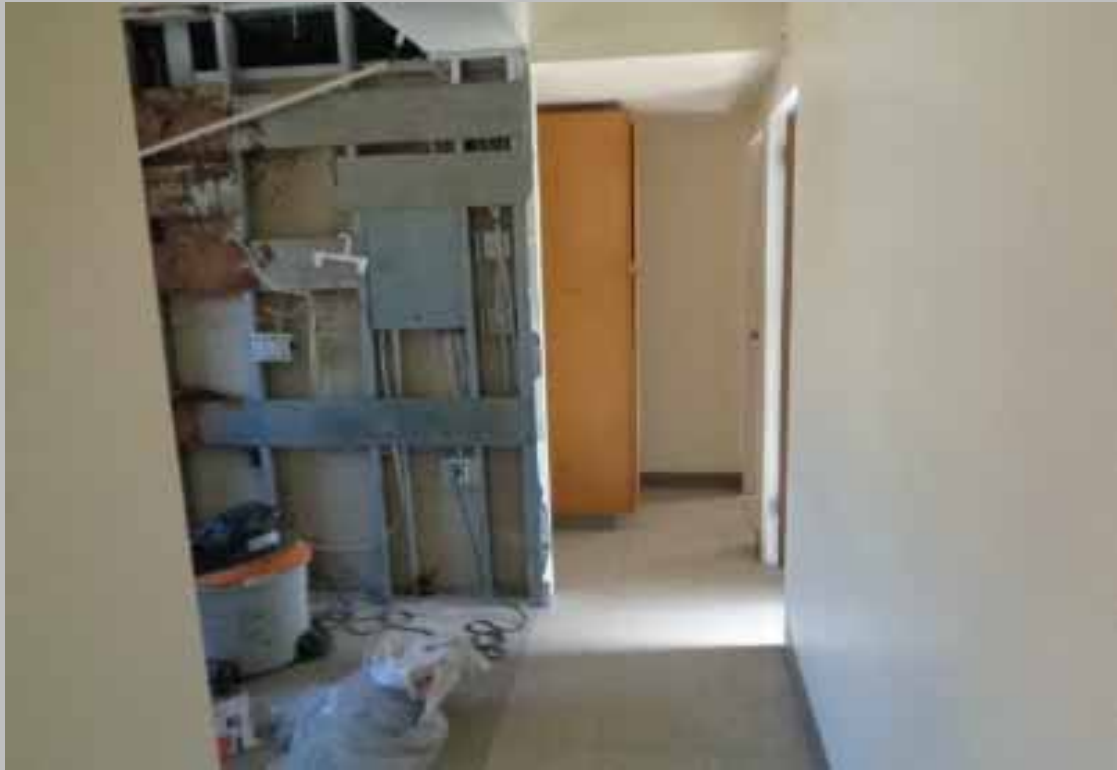
Down unit (Non-Critical Repair)

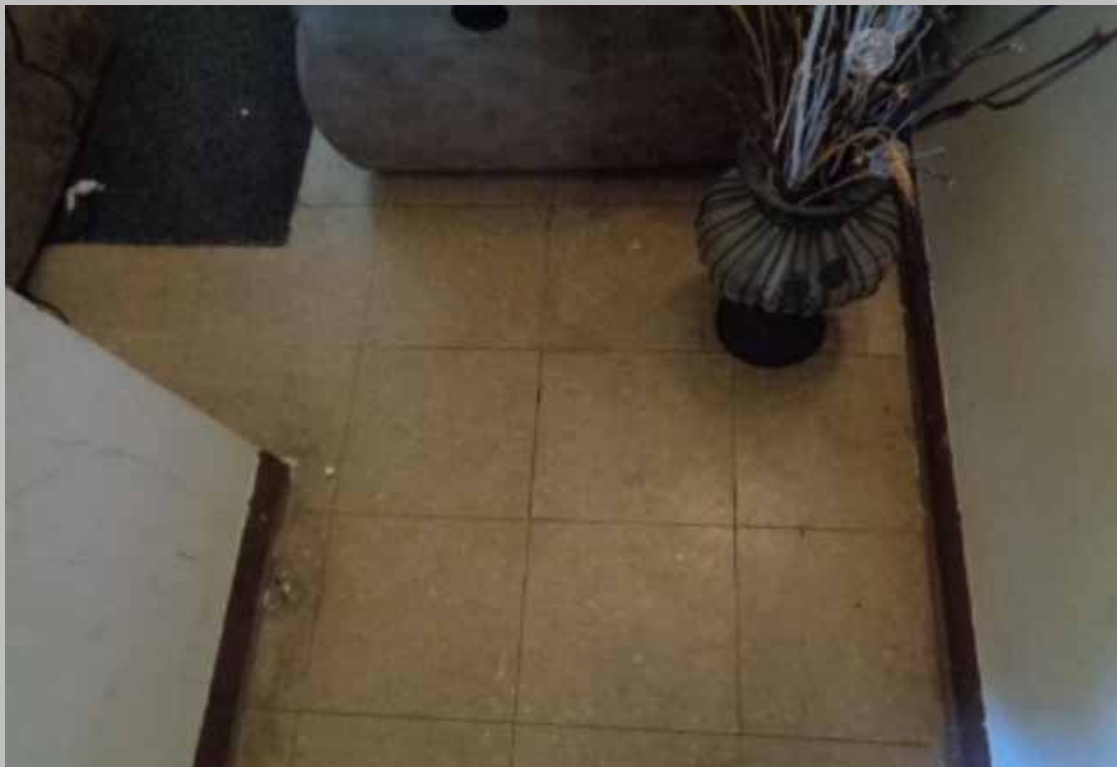
Unit flooring beyond EUL (Non-Critical Repair)

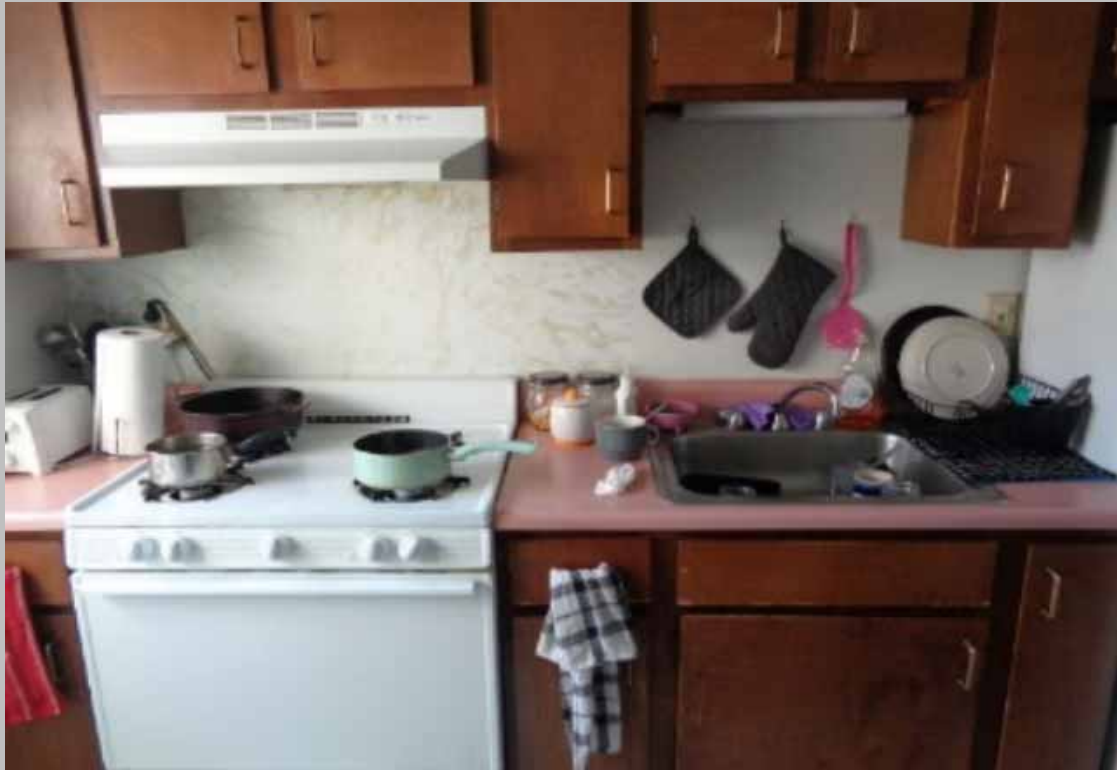
Kitchen cabinets/countertops beyond EUL

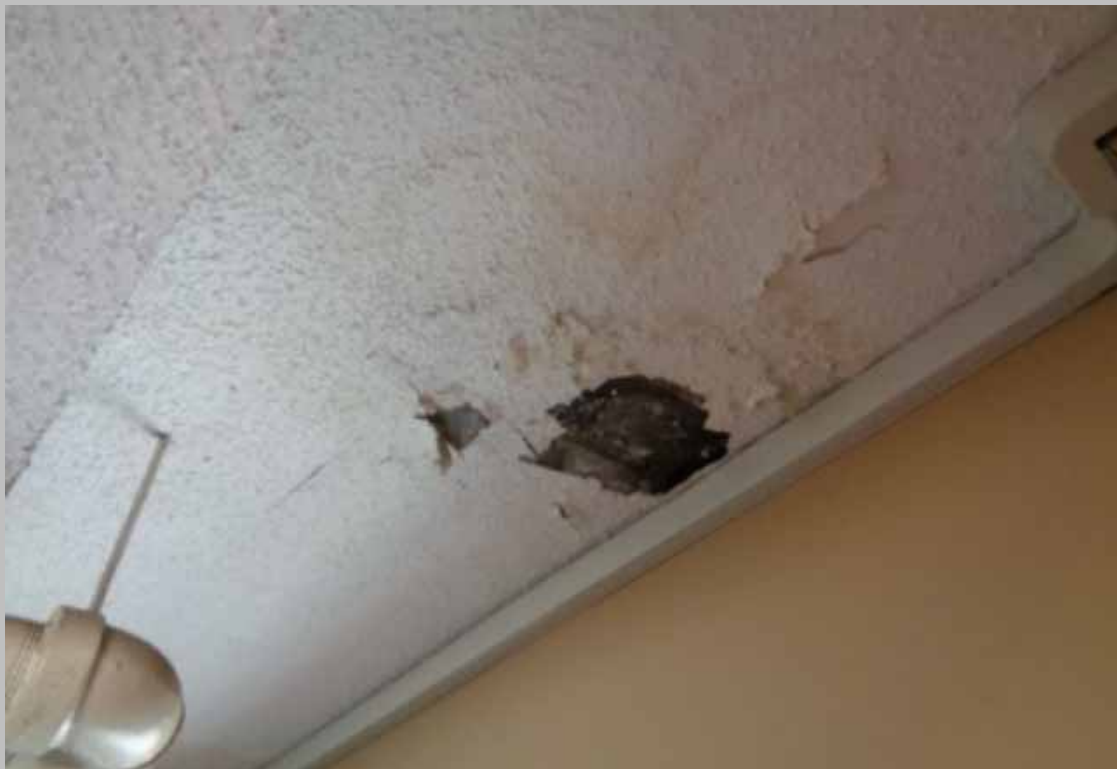
14 E Brookline hallway repair (Non-Critical Repair)

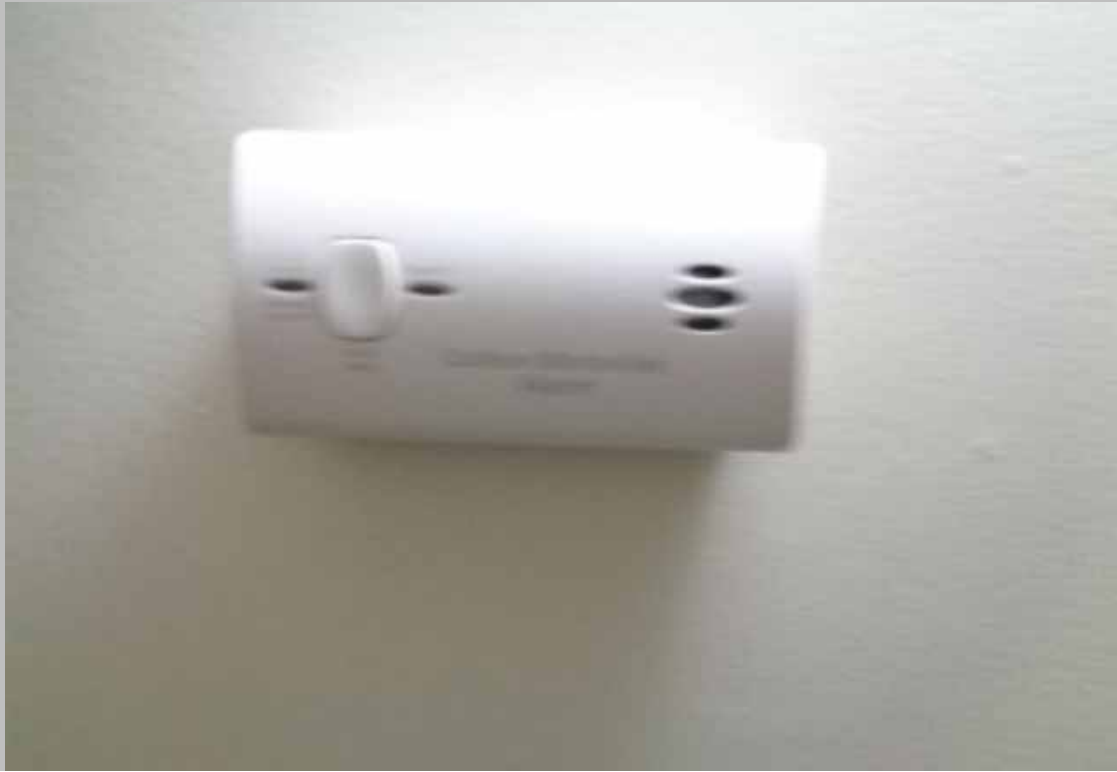
Carbon Monoxide Detector

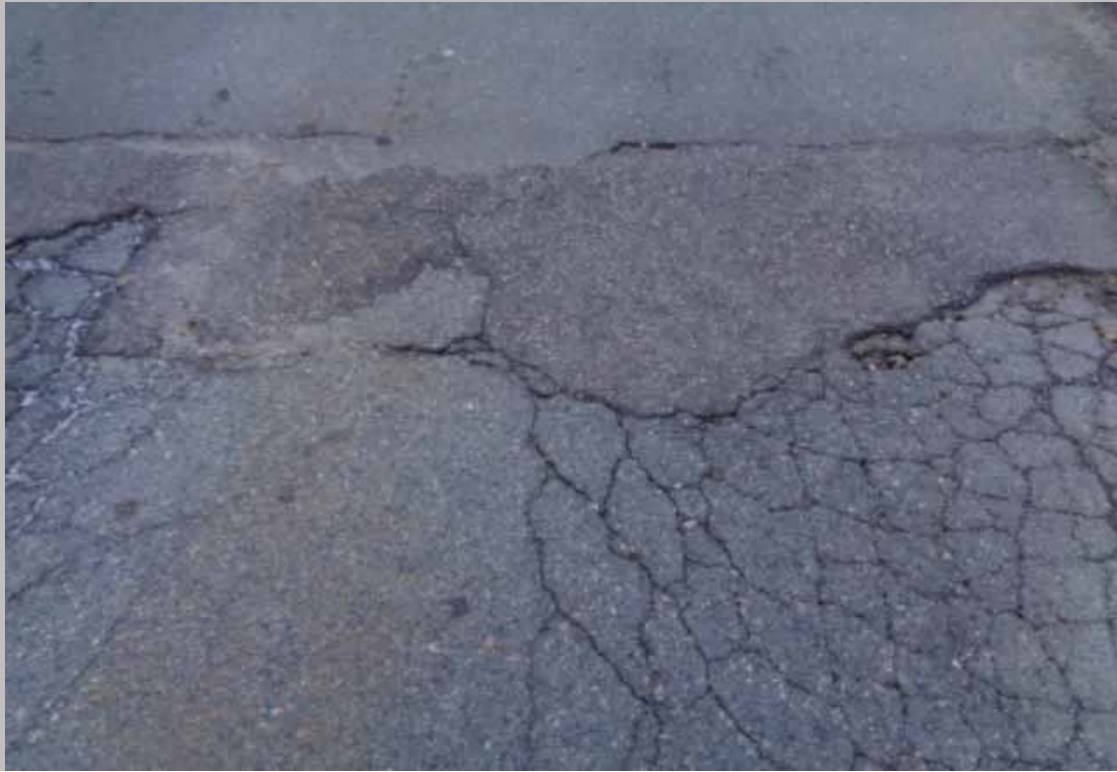
Asphalt parking area (Non-Critical Repair)

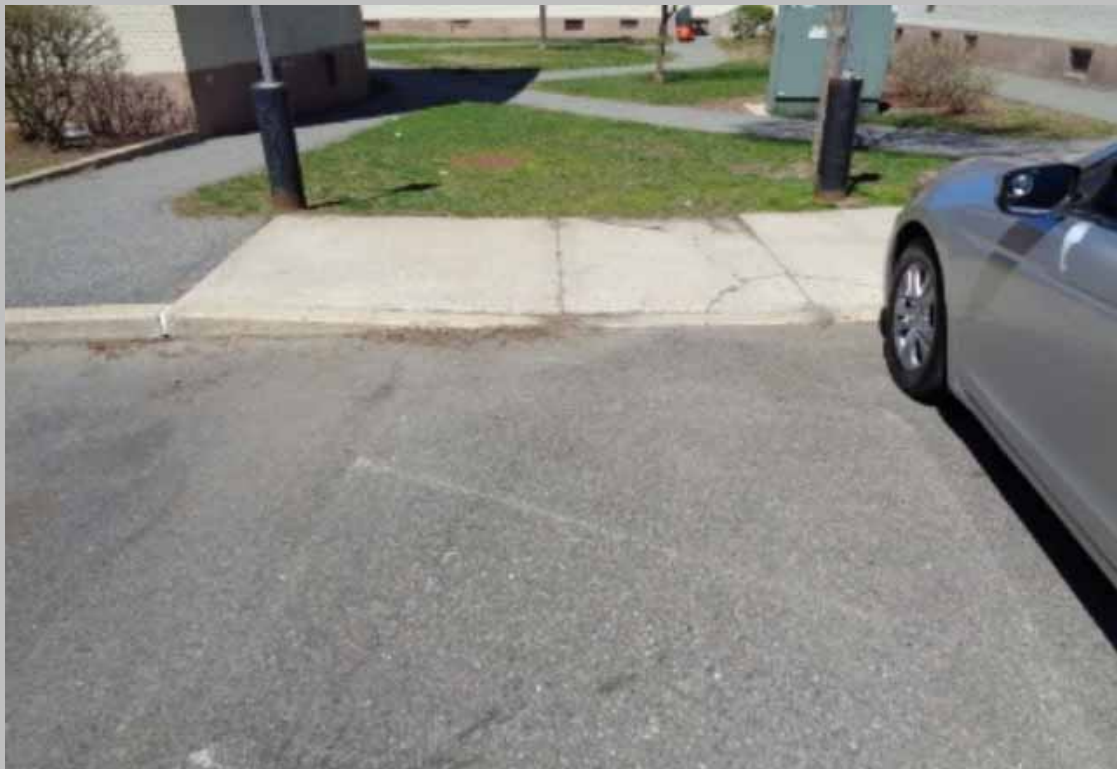
Faded line striping (Non-Critical Repair)

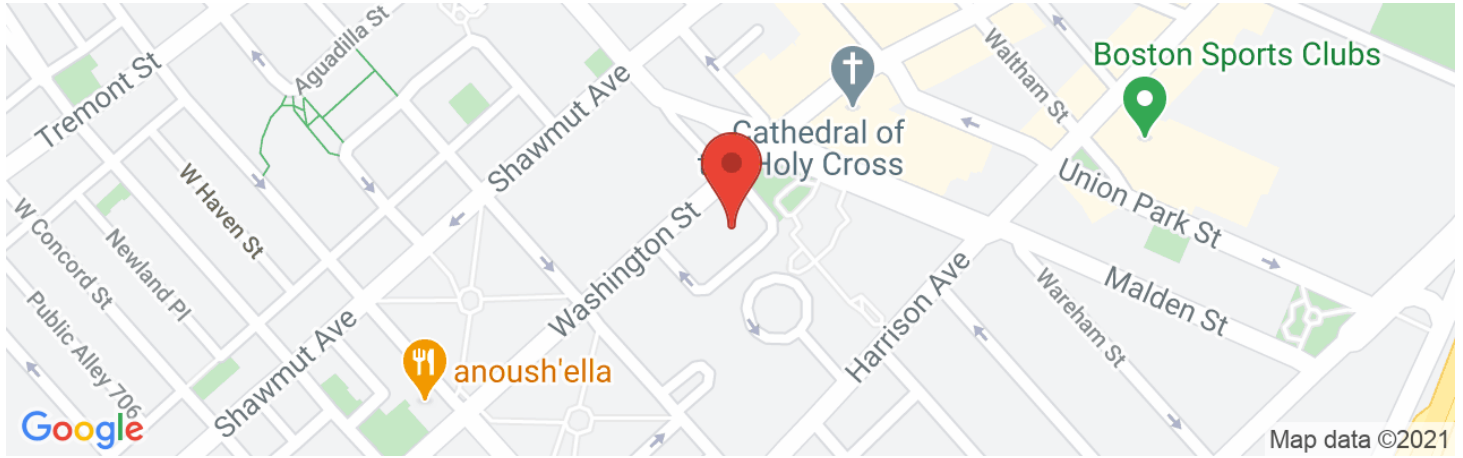
Date	4/13/2021, 10:40:30 AM
Design Code Reference Document	ASCE41-13
Custom Probability	
Site Class	E - Soft Clay Soil
