HUD CAPITAL NEEDS ASSESSMENT

Franklin Field
180-20 Stratton Street
Dorchester, Massachusetts 02124

AEI Project No. 463341
Site Inspection Date: July 12, 14, 25, and 27, 2022

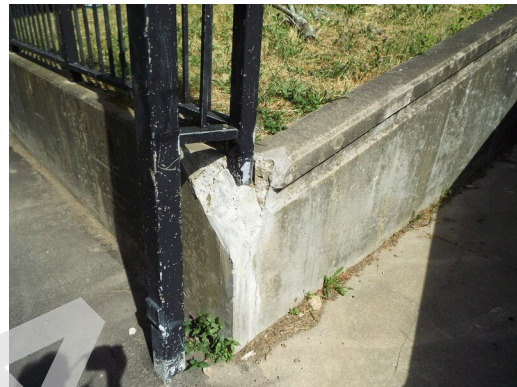
Spalling and deterioration was observed at concrete retaining walls located at buildings 9, 12 and 19. Repair is recommended. (Non-Critical Repair)

Concrete retaining wall spalling - building 19
(Non-Critical Repair)

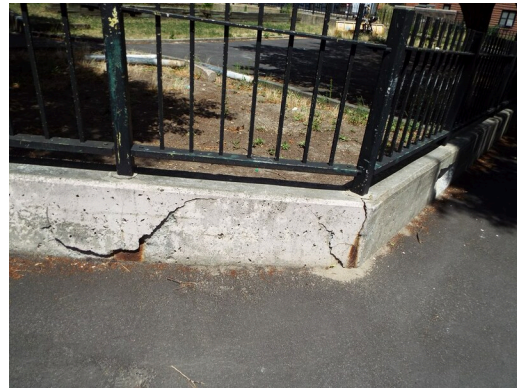
Concrete retaining wall spalling - rear building 9 (Non-Critical Repair)

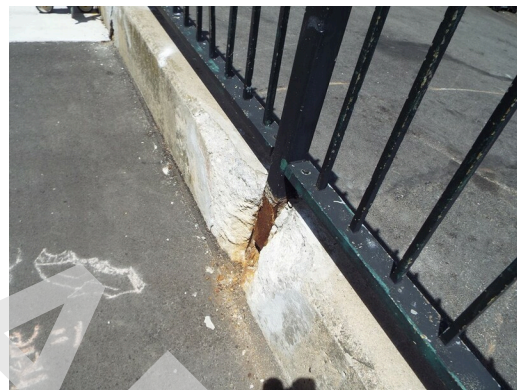
Concrete retaining wall spalling - rear building 12 (Non-Critical Repair)

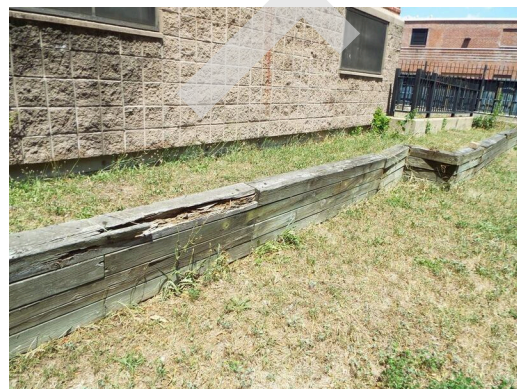
Deterioration was observed at landscape timber retaining walls located at building 9 rear. Repair is recommended. (Non-Critical Repair)

Wood timber retaining wall condition - rear building 9 (Non-Critical Repair)

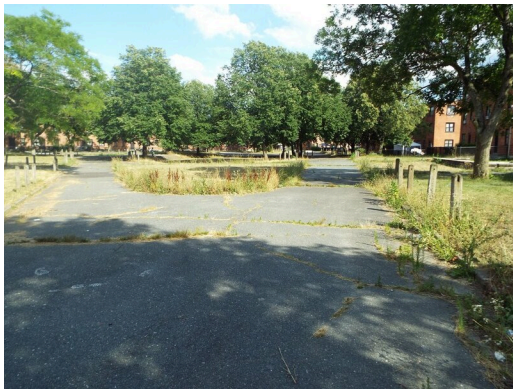
Cracking and was observed at asphalt pavement at scattered locations at the rear of buildings 1 thru 6, and 14 thru 19. Repair is recommended. (Non-Critical Repair)

Asphalt paving - rear buildings 1 thru 6 (Non-Critical Repair)

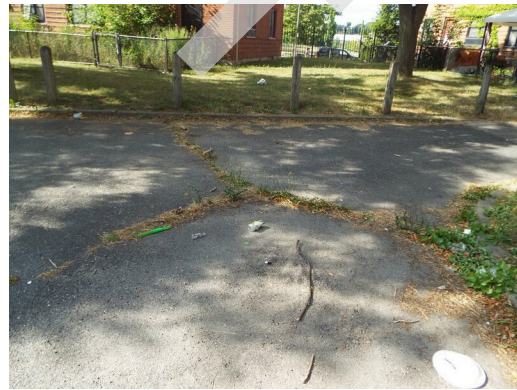
Asphalt pavement cracking building 3 rear (Non-Critical Repair)

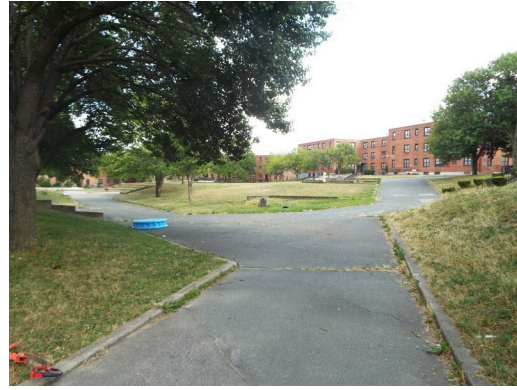
Asphalt paving - buildings 14 thru 19
(Non-Critical Repair)

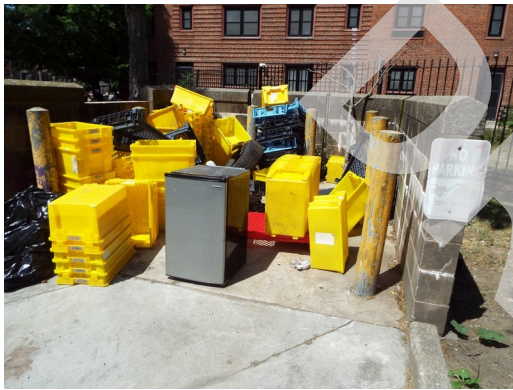
Cracking and differential settlement was observed at concrete dumpster pads located at buildings 1 (qty 2), 7 10, 14-17, 15-16, and 18-19 . Repair is recommended. (Non-Critical Repair)

Dumpster pad condition - building 1
(Non-Critical Repair)

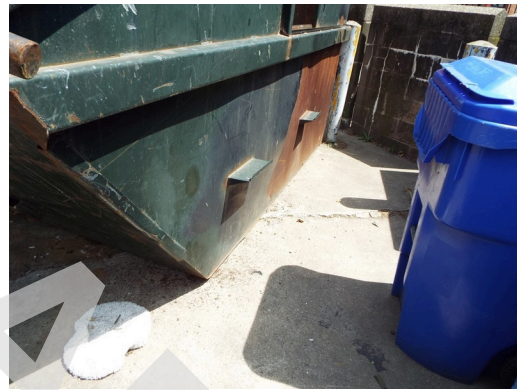
Dumpster pad condition - building 1
(Non-Critical Repair)

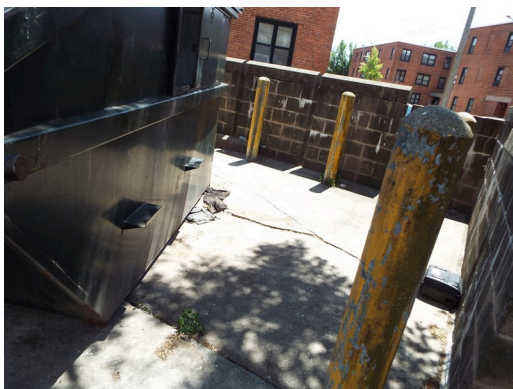
Dumpster pad condition - building 7
(Non-Critical Repair)

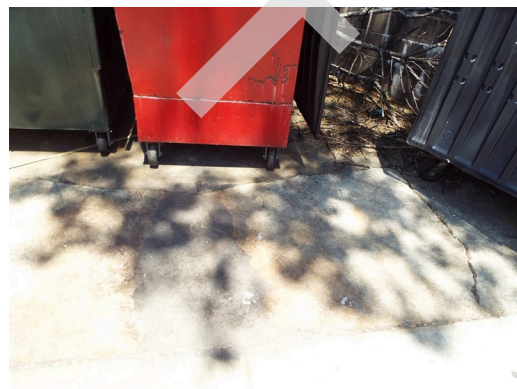
Dumpster pad condition - building 10
(Non-Critical Repair)

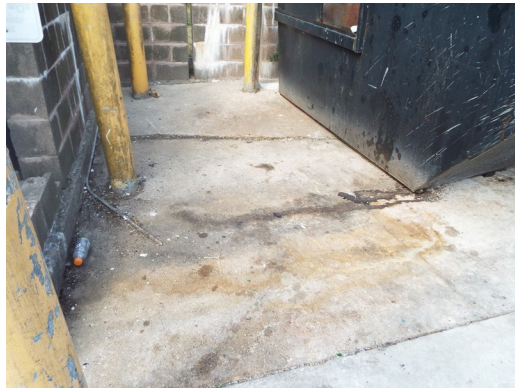
Dumpster pad condition - building 14-17
(Non-Critical Repair)

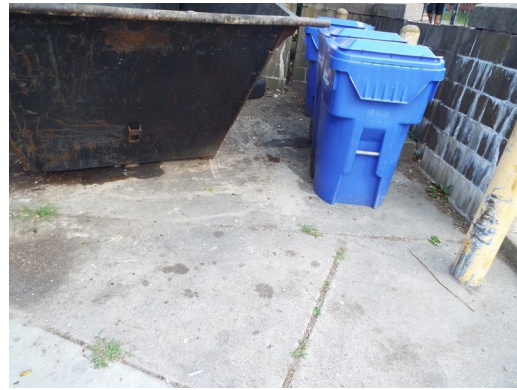
Dumpster pad condition - building 15-16
(Non-Critical Repair)

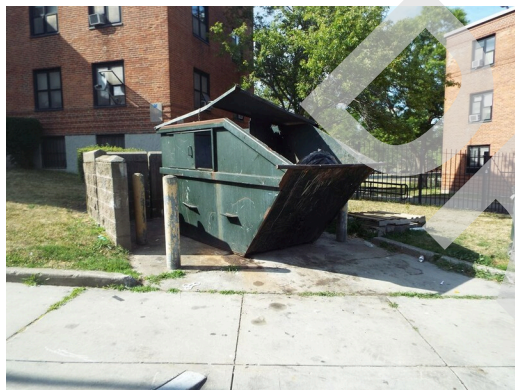
Dumpster pad condition - building 18-19
(Non-Critical Repair)

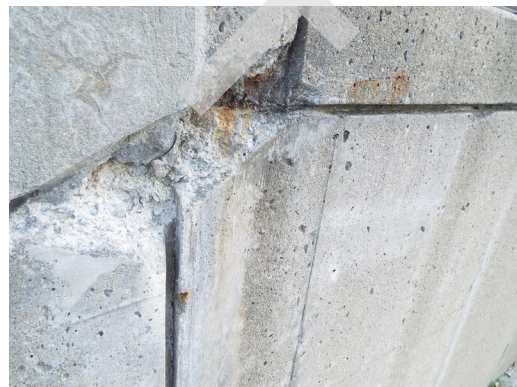
Spalling and cracking of concrete was observed at exterior stairs located at buildings 7, 15, 16, 17, and 19. Repair is recommended. (Non-Critical Repair)

Concrete stair spalling - building 15
(Non-Critical Repair)

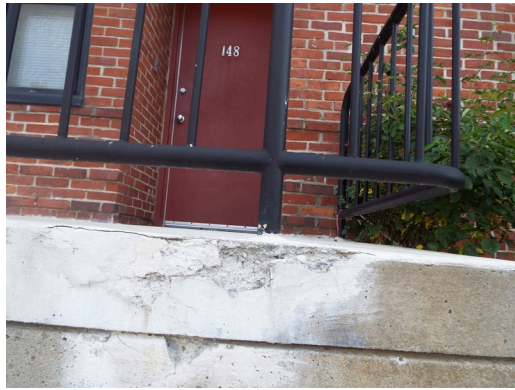
Concrete stair spalling - building 16
(Non-Critical Repair)

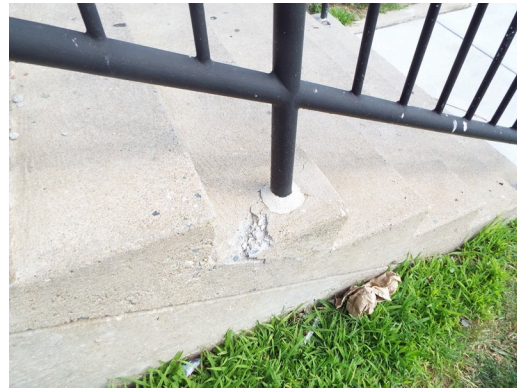
Concrete step spalling - building 17
(Non-Critical Repair)

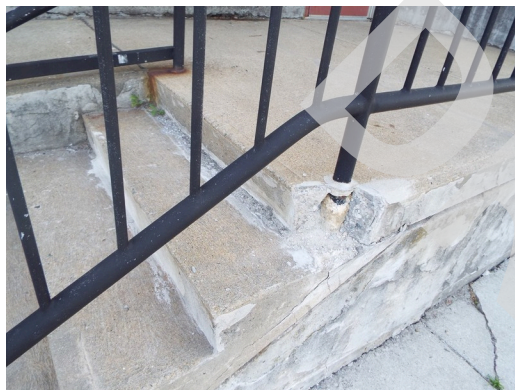
Concrete step spalling - building 19
(Non-Critical Repair)

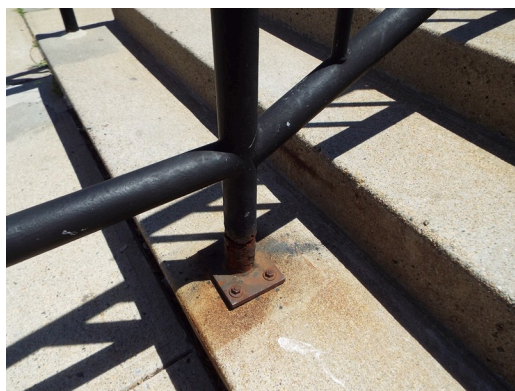
Deterioration of metal handrail post bases was observed at exterior stairs located at building 7, unit 88 and building 12 leasing office. Repair is recommended. (Non-Critical Repair)

Handrail post base condition - building 12
(Non-Critical Repair)

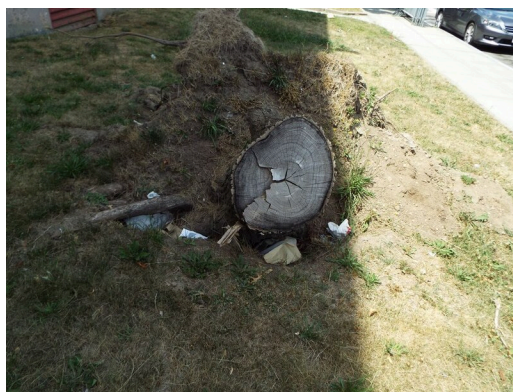
A hole was observed at a tree stump located at building 4. The hole represents a trip hazard. Stump removal and backfill of the hole is required. (Critical Repair)

Hole at stump - building 4 (Critical Repair)

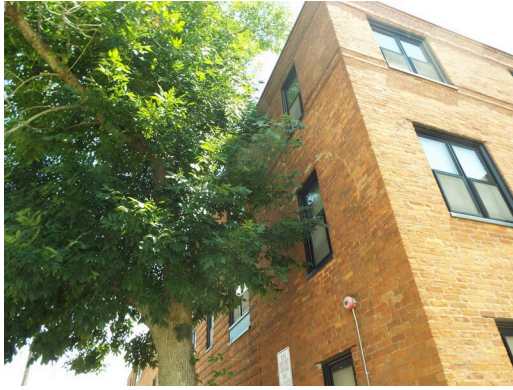
Weeds and overgrown vegetation was observed throughout the property. Overhanging trees were observed at buildings 2, 8 and 12. Removal of the overgrown vegetation and trimming of trees is required. (Non-Critical Repair)

Overhanging tree - building 8 (Non-Critical Repair)

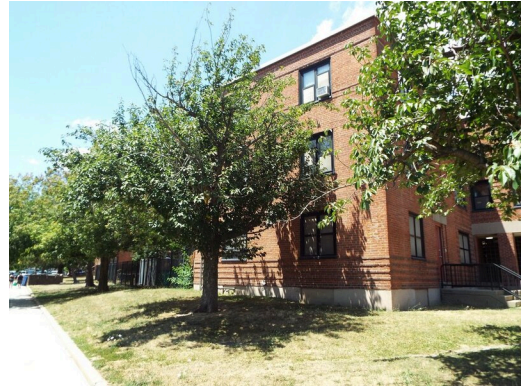
Overhanging tree - building 12 (Non-Critical Repair)

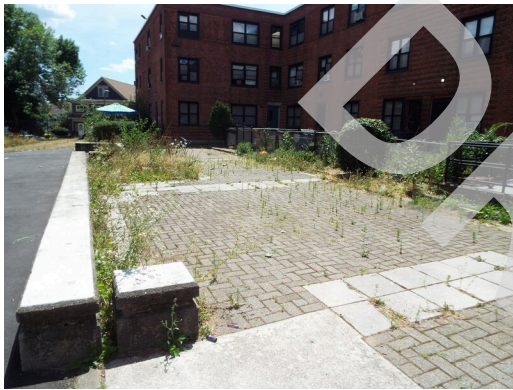
Overgrown vegetation - building 7 (Non-Critical Repair)

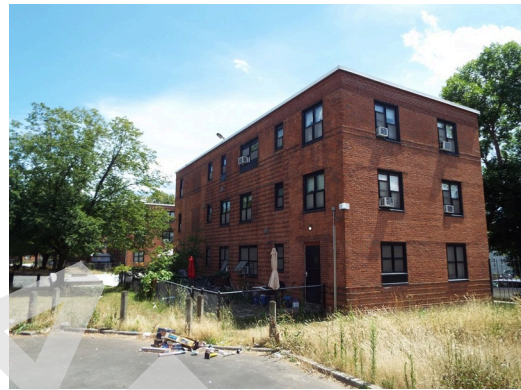
Overgrown vegetation - building 10 (Non-Critical Repair)

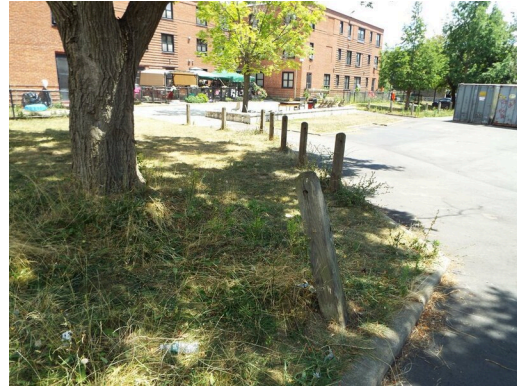
Wood fence post condition - rear buildings
9-12(Non-Critical Repair)

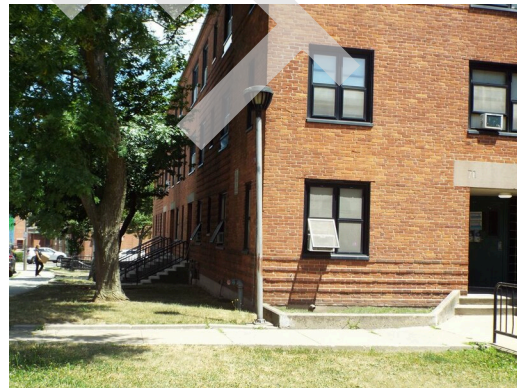
The decorative pole-mounted lights are in fair condition. There is significant evidence of wear and the fixtures have exceeded their Estimated Useful Life (EUL). AEI recommends that the decorative pole-mounted lights be replaced. (Non-Critical Repair)

Decorative pole mounted lighting condition
(Non-Critical Repair)

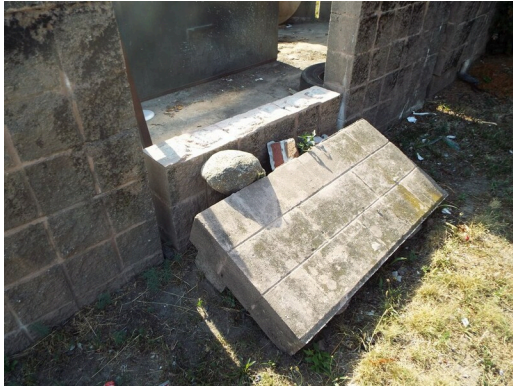
Damaged CMU walls and precast concrete caps were observed at dumpster enclosures located at buildings 1 (qty 2), 5, 7, 10, 14-15, 14-17 and 15-16. Repairs are recommended. (Non-Critical Repair)

Dumpster enclosure wall damage - building 5
(Non-Critical Repair)

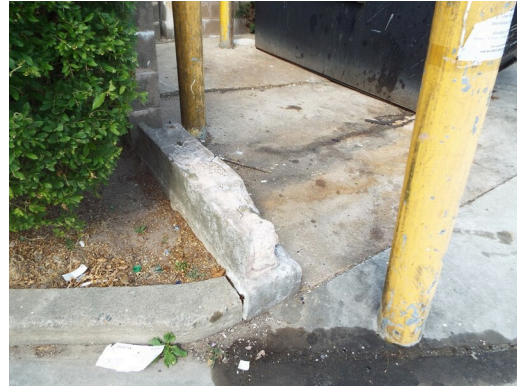
Dumpster wall damage - building 14-17
(Non-Critical Repair)

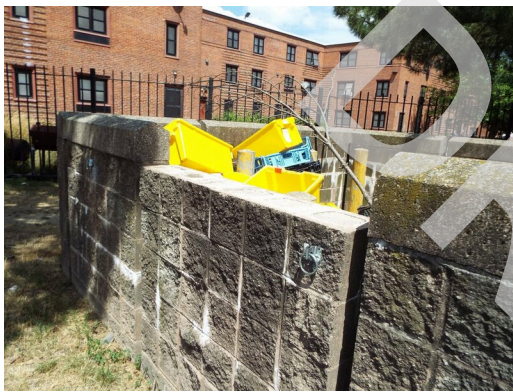
Missing dumpster enclosure cap section -
building 1 (Non-Critical Repair)

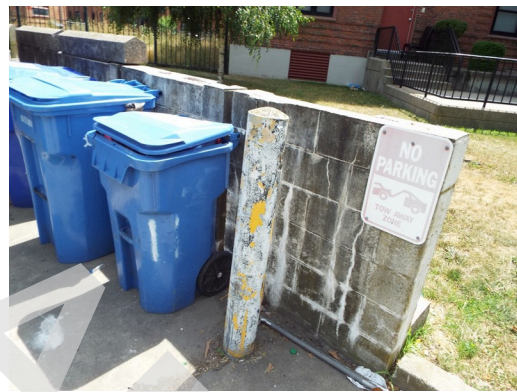
Missing dumpster enclosure cap section -
building 1 (Non-Critical Repair)

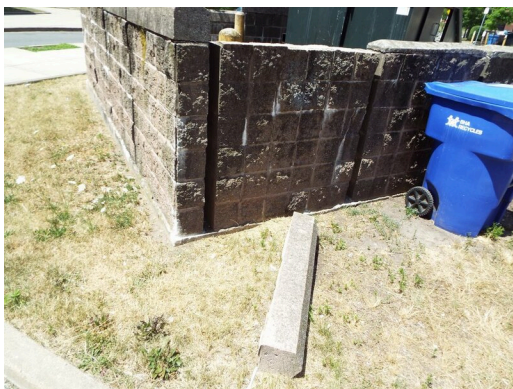
Missing dumpster enclosure cap section -
building 7 (Non-Critical Repair)

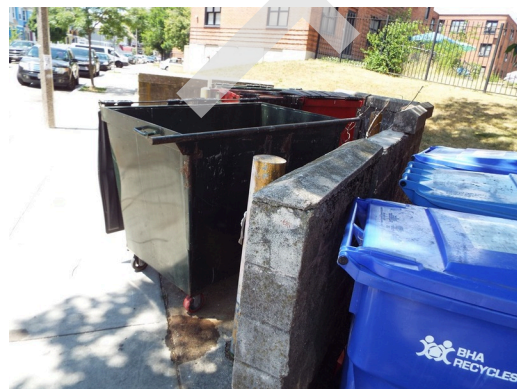
Missing dumpster enclosure cap section -
building 10 (Non-Critical Repair)

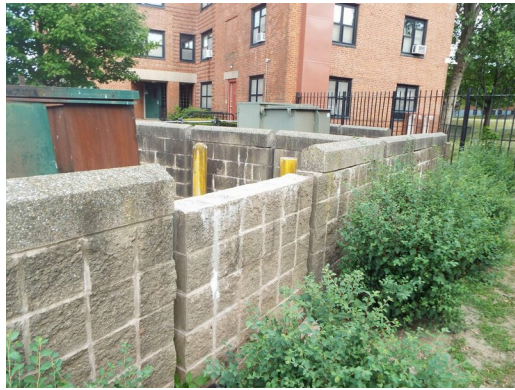
Missing dumpster enclosure cap section - building 14-15 (Non-Critical Repair)

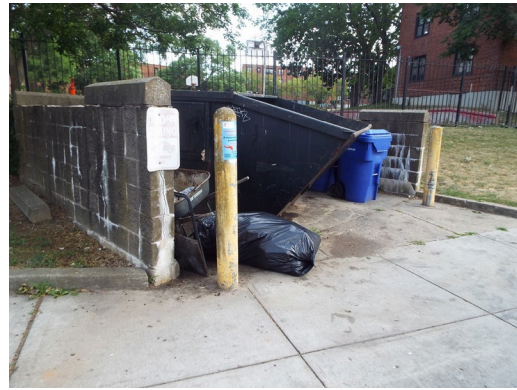
Missing dumpster enclosure cap section - building 15-16 (Non-Critical Repair)

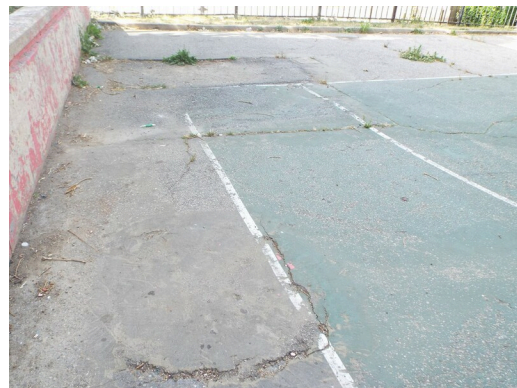
AEI observed concrete cracking and surface coating wear located at the basketball court. Repairs and recoating is recommended. (Non-Critical Repair)

Basketball court surface condition (Non-Critical Repair)

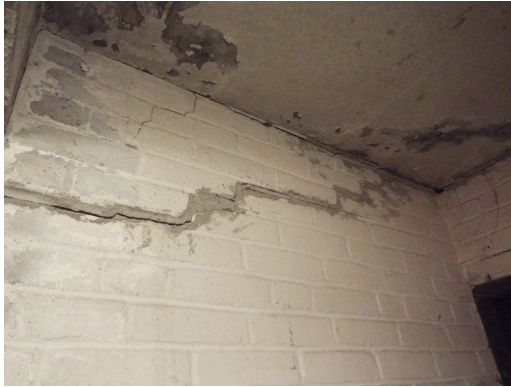
Cracking at mortar joints and previous repairs were observed at isolated areas in brick masonry walls located in building 15 basement. Repointing the affected areas and monitoring for future movement is recommended. (Non-Critical Repair)

Masonry wall cracks - basement building 15
(Non-Critical Repair)

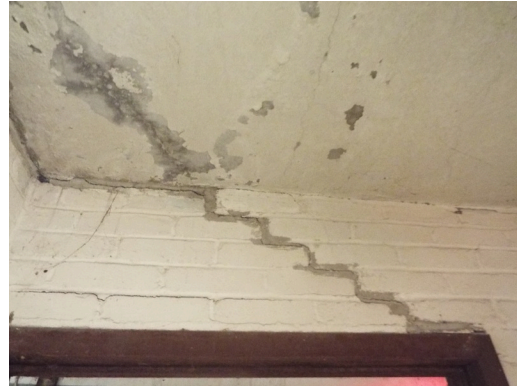
Masonry wall cracks - basement building 15
(Non-Critical Repair)

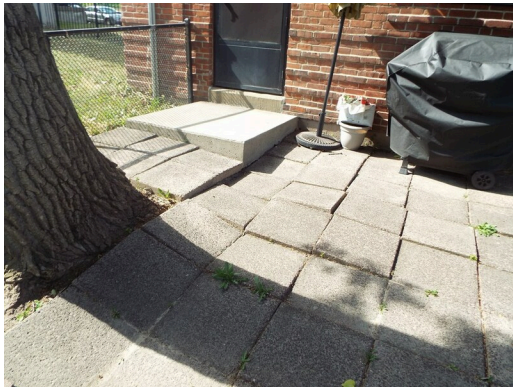
Dislocated concrete pavers and differential settlement was observed at resident patios located at buildings 15 and 16. The conditions represent trip hazards. Repair is required. (Critical Repair)

Concrete patio paver condition - building 15
(Critical Repair)

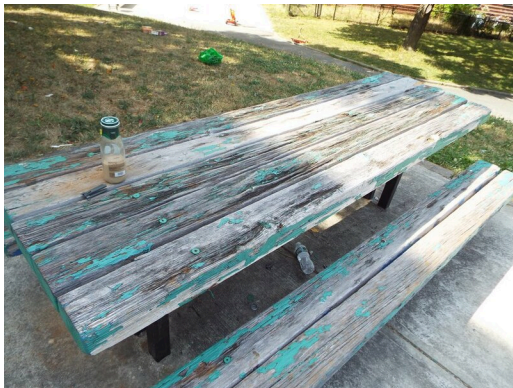
Deterioration of outdoor seating was observed at the terrace at the rear of building 17. Replacement is recommended. (Non-Critical Repair)

Outdoor seating condition - building 17 rear
(Non-Critical Repair)

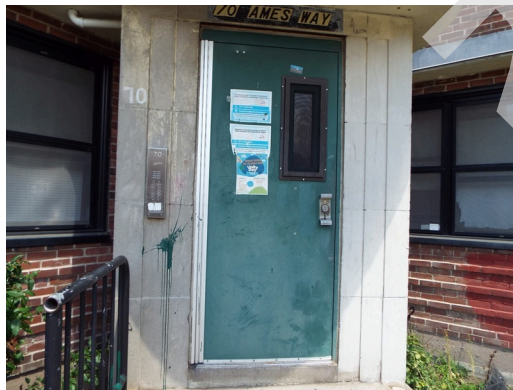
The exterior entry doors are in good to fair condition. There is significant evidence of wear at the building exterior doors throughout the property, and the several of the doors have exceeded their Estimated Useful Life (EUL). AEI recommends that the older doors be replaced. (Non-Critical Repair)

Building entry door condition - building 7
(Non-Critical Repair)

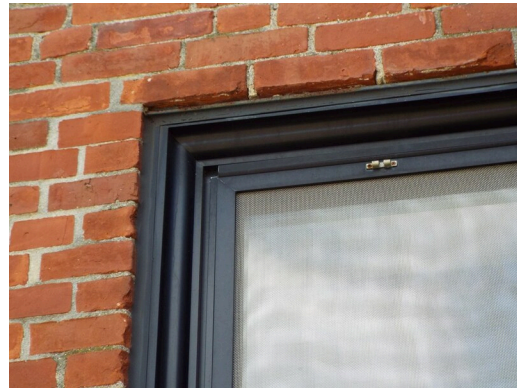
Typical window frame

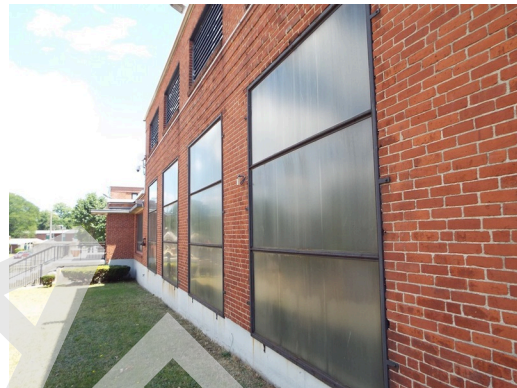
Steel framed fixed windows - building 12

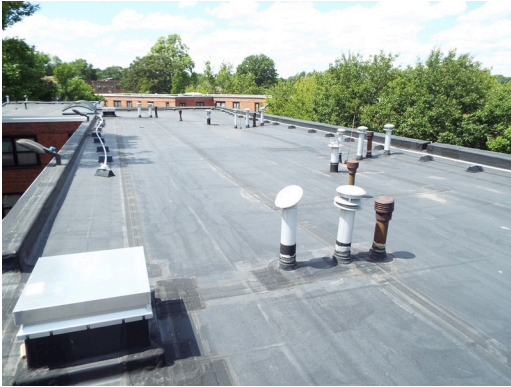
Roof overview - building 2

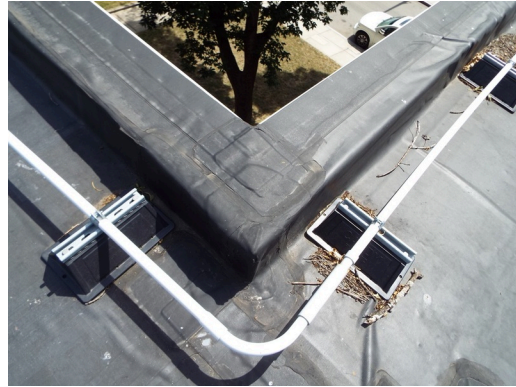
Roof flashing - building 2

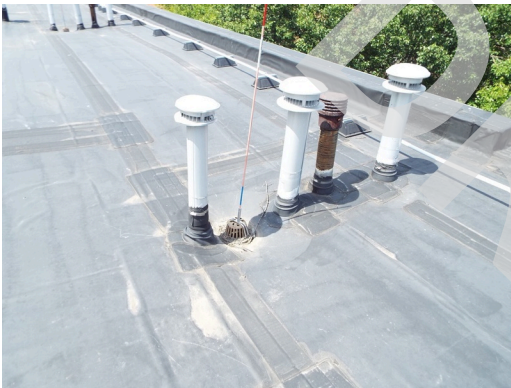
Roof penetrations- building 2

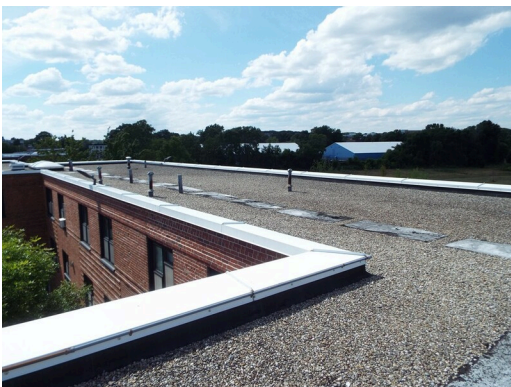
Roof overview - building 14

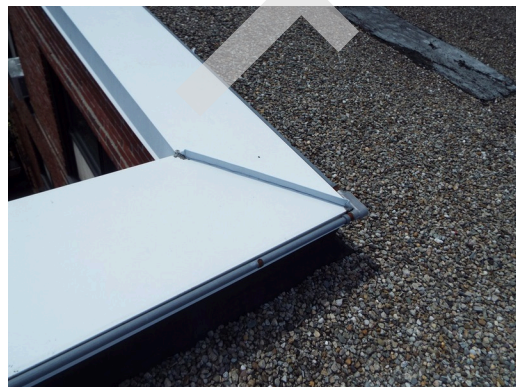
Roof coping - building 14

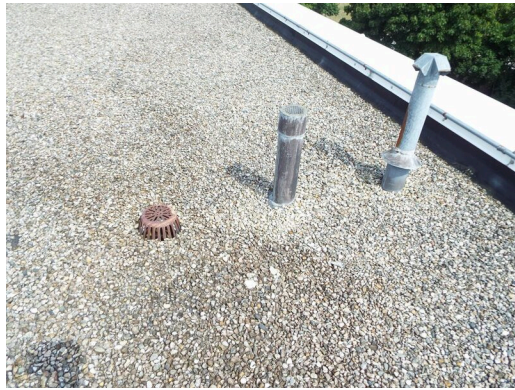
Roof penetrations - building 14

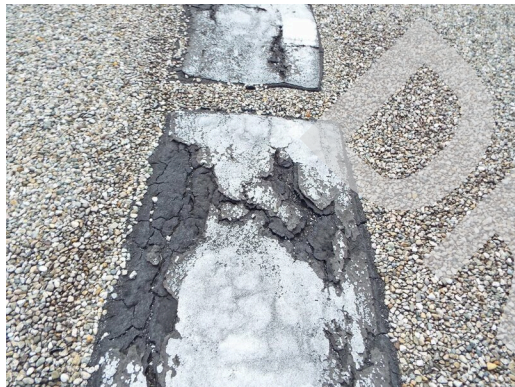
Deterioration was observed at roof traffic pads located at buildings 1, and 3 thru 19. Refurbishing the traffic pads is recommended (Non-Critical Repair)

Roof traffic surface condition (Non-Critical Repair)

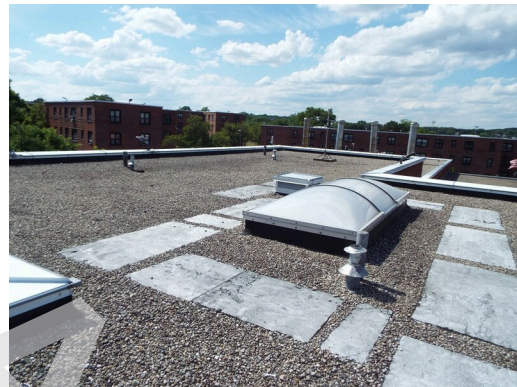
Roof overview - building 12

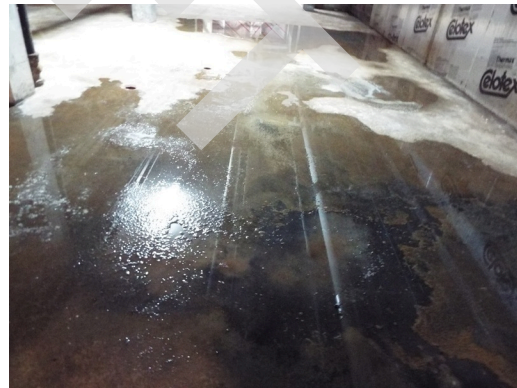
A leak was observed at a repaired section of waste piping located in the building 17 basement. Repair is required (Non-Critical Repair)

Moisture at pipe leak - building 17 basement
(Non-Critical Repair)

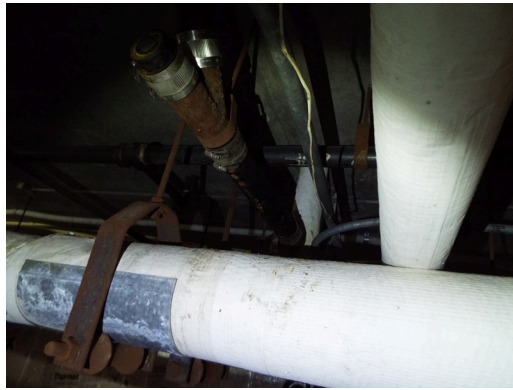
Pipe leak at repair - building 17 basement
(Non-Critical Repair)

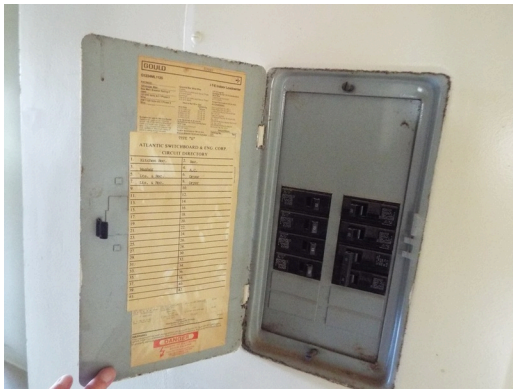
1-bed-1-bath - unit 90D - building 19 - unit electrical panel

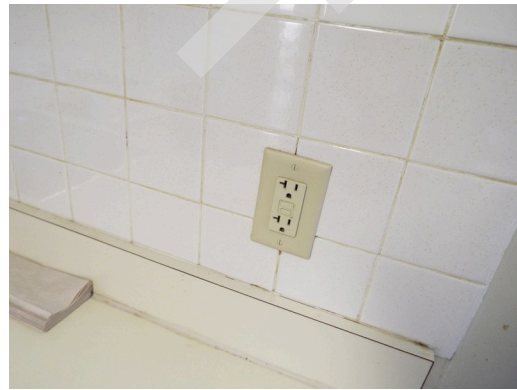
1-bed-1-bath - unit 90D - building 19 - typical kitchen GFCI

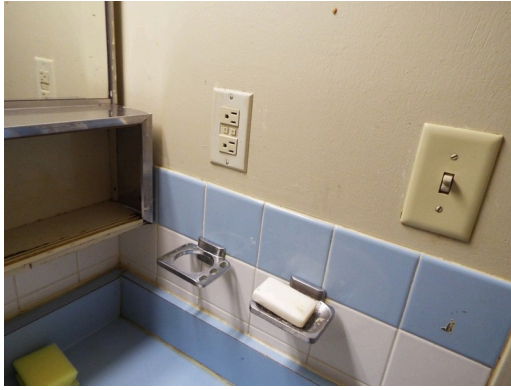
1-bed-1-bath - unit 90D - building 19 - typical bathroom GFCI

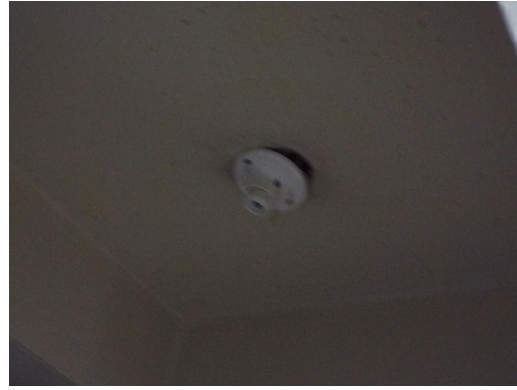
2-bed-1-bath - unit 50G - building 18 - loose light fixture (Critical Repair)

A loose light fixture was observed at the ceiling of unit 50G building 18. Repair is required. (Critical Repair).

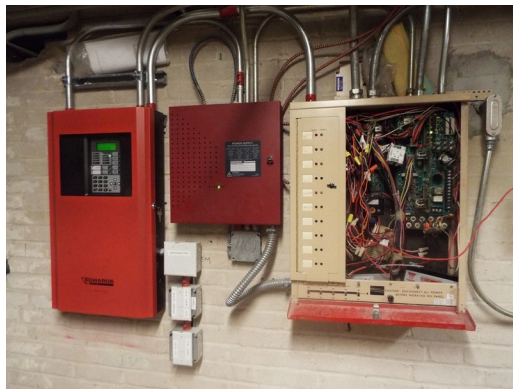
A current fire alarm inspection report was not provided. AEI recommends a current fire alarm inspection be performed and a report be provided. (Critical Repair)

Fire alarm control panel - building 15

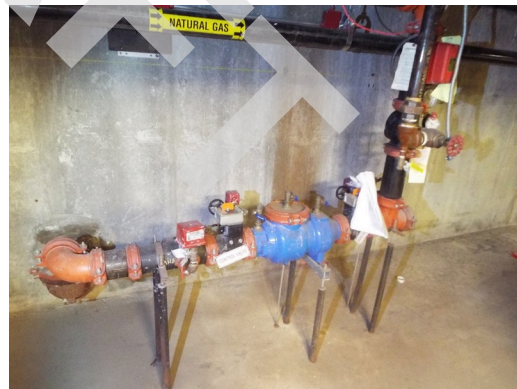
A current fire sprinkler inspection report was not provided. AEI recommends a current fire sprinkler inspection report be provided. (Critical Repair)

Fire sprinkler riser - building 15

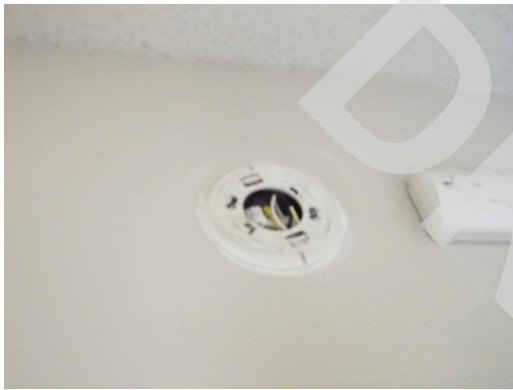
Bedrooms were observed lacking smoke detectors. Installation of HUD compliant smoke detectors either hard-wired units or sealed battery detectors with 10-year life are required. (Critical Repair)

Missing smoke detectors were observed in Unit 17 building 4, unit 31E building 6, Unit 82 building 7, Unit 90D building 19, Unit 190A building 14, and Unit 214 building 3. Replacement of missing smoke detectors is required. (Critical Repair)

1-bed-1-bath - unit 90D - building 19 -
missing smoke detector (Critical Repair)

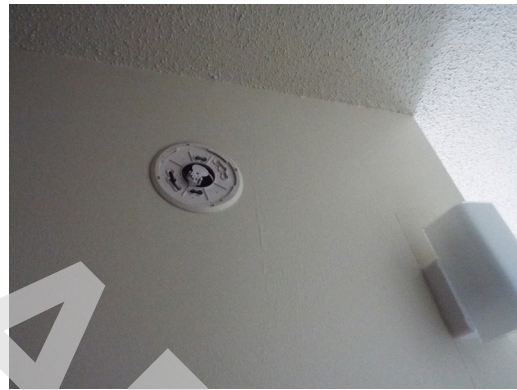
3-bed-1.5-bath-TH - unit 214 - building 3 -
missing smoke detector (Critical Repair)

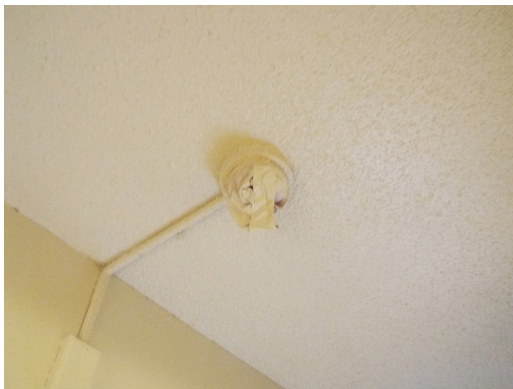
5-bed-2-bath-TH - unit 190A - building 14 -
disabled smoke detector (Critical Repair)

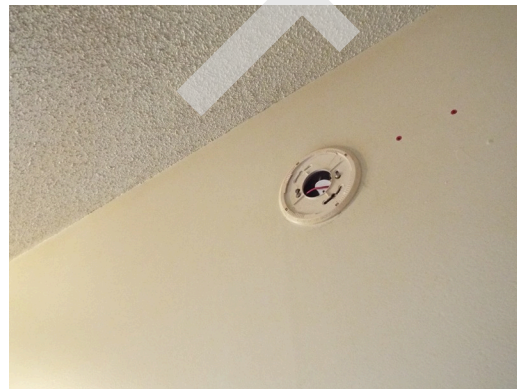
1-bed-1-bath - unit 31E - building 6 - missing
smoke detector (Critical Repair)

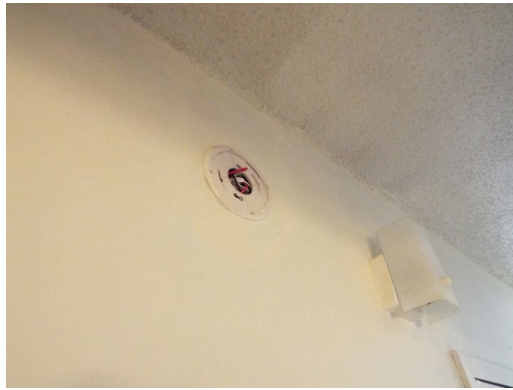
2-bed-1-bath - unit 82 - building 7 UFAS - missing smoke detector (Critical Repair)

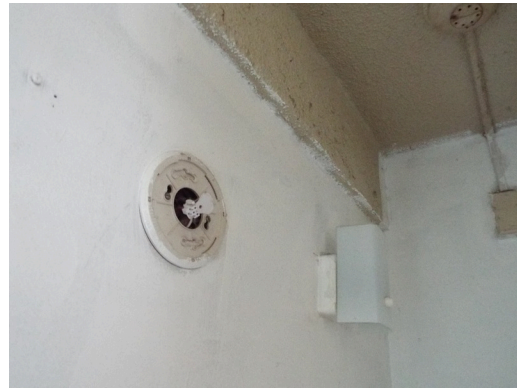
4-bed-2-bath - unit 17 - building 4 - missing smoke detector (Critical Repair)

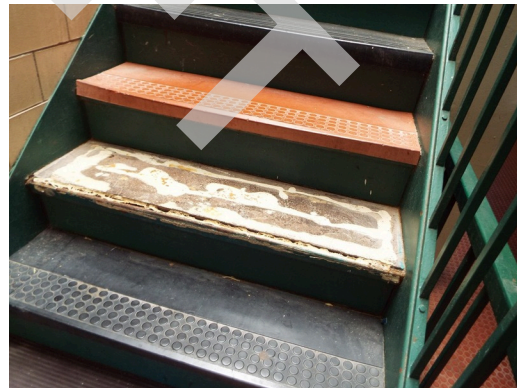
Damaged and missing vinyl tread coverings were observed at interior common stairs located at buildings 7, 10, 15, and 19. The damaged treads represent trip hazards. Repair is required. (Critical Repair)

Interior stair tread condition - building 7 (Critical Repair)

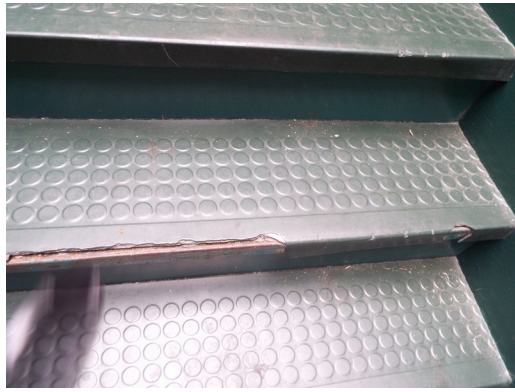
Interior stair tread condition - building 19
(Critical Repair)

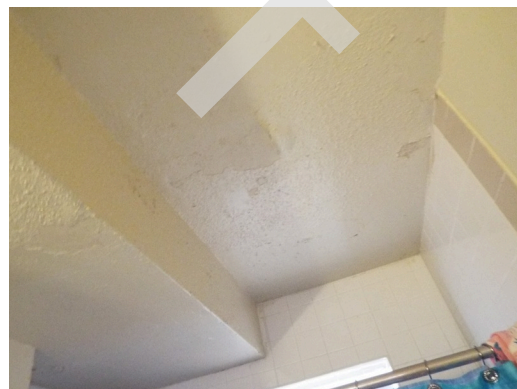
Mold was observed at bathroom shower ceilings located in Unit 13, building 4, Unit 17 building 4, Unit 21A building 6, Unit 22 building 17, Unit 42 building 17, Unit 140A building 16, Unit 160B building 13, Unit 160C building 15, and Unit 230D building 1. Mold was observed at kitchen ceiling located in Unit 21A building 6. Mold was observed at a wall base located in Unit 160B building 13. Remediation is required as described in Section 4.1 of this report. (Critical Repair)

5-bed-2-bath-TH - unit 140A - building 16 -
bathroom ceiling mold (Critical Repair)

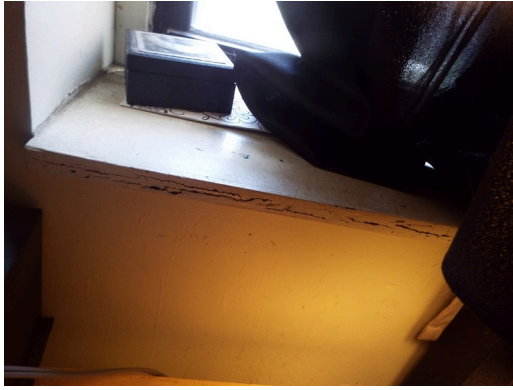
Paint peeling and bubbling was observed at ceilings and walls located in Unit 17 building 4, Unit 50E building 18, Unit 58 building 8, Unit 190A in building 14, and Unit 240A building 1. Proper surface preparation and repainting with compatible paint is required. (Non-Critical Repair).

5-bed-2-bath-TH - unit 190A - building 14 -
bathroom paint condition (Non-Critical Repair)

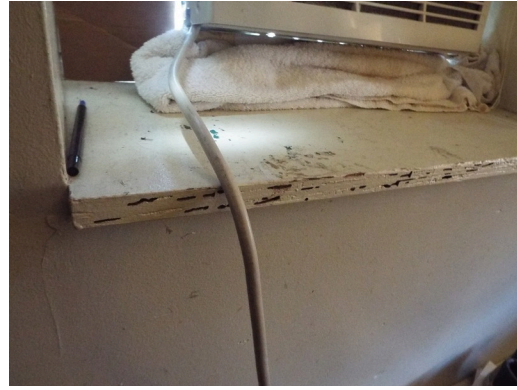
AEI observed isolated evidence of termite activity located at two (2) interior wood window sills in the bedroom of Unit 13 building 4. Repair is required as described in Section 4.2 of this report. (Critical Repair)

3-bed-1-bath-UFAS - unit 13 - building 4 - termites reported (Non-Critical Repair)

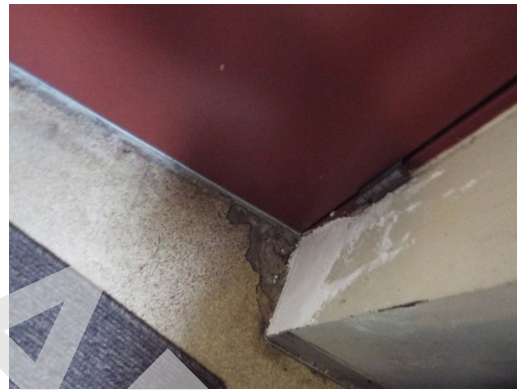
Flooring wear was observed at Unit 21A building 6 and Unit 140A building 16. Repair is required. (Non-Critical Repair)

5-bed-2-bath-TH - unit 140A - building 16 - flooring condition (Non-Critical Repair)

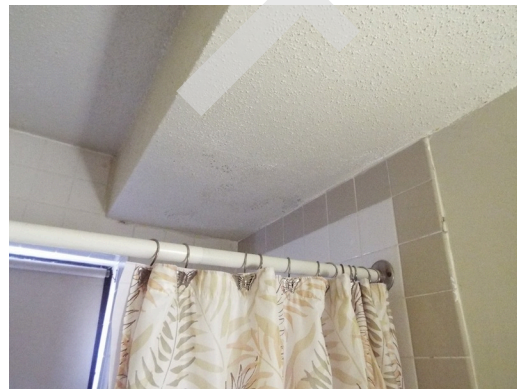
3-bed-1.5-bath-TH - unit 214 - building 3 - bathroom ceiling mold (Critical Repair)

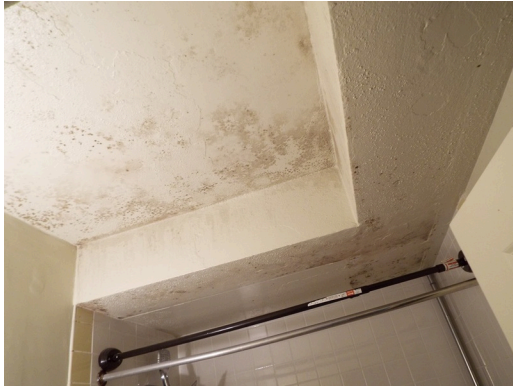
3-bed-1-bath-UFAS - unit 13 - building 4 - bathroom ceiling mold (Critical Repair)

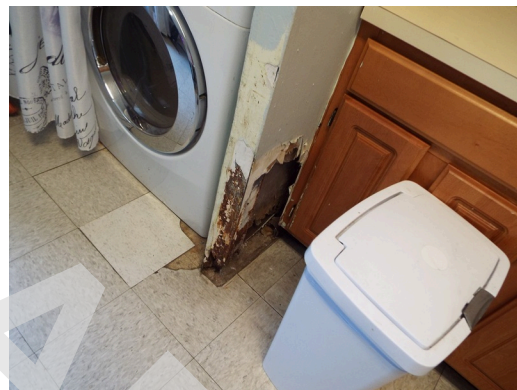
3-bed-1.5-bath-TH - unit 22 - building 17 - washer wall condition (Non-Critical Repair)

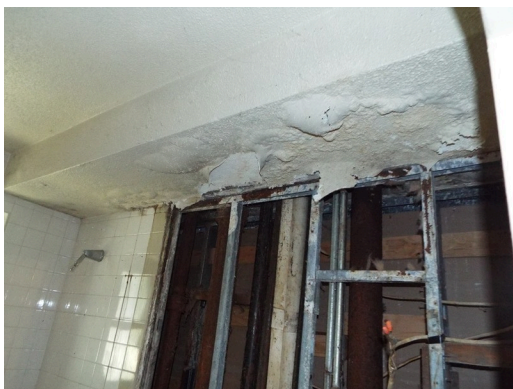
2-bed-1-bath- unit 230A - building 1 - bathroom ceiling repairs (Non-Critical Repair)

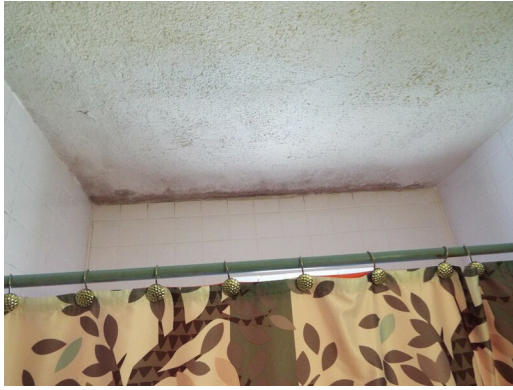
2-bed-1-bath - unit 230D - building 1 - bathroom ceiling mold (Critical Repair)

- Repairs to prevent or correct the source of the water damage should also be performed.

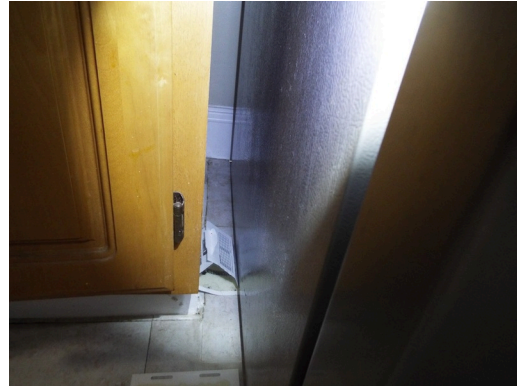
2-bed-1-bath - unit 160C - building 15 - rodents reported - kitchen (Critical Repair)

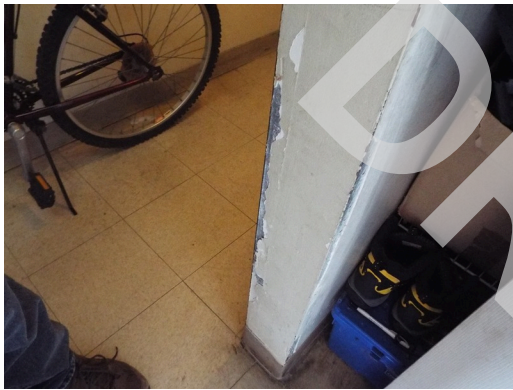
3-bed-1-bath-UFAS - unit 13 - building 4 - wall condition (Non-Critical Repair)

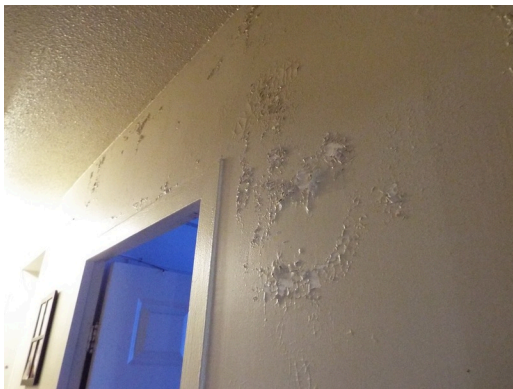
2-bed-1-bath - unit 50E - building 18 - wall paint condition (Non-Critical repair)

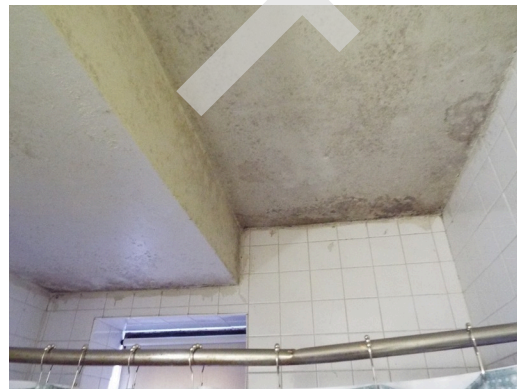
3-bed-1.5 bath - unit 42 - building 17 - bathroom ceiling mold (Critical Repair)

Mold was observed at bathroom shower ceilings located in Unit 13, building 4, Unit 17 building 4, Unit 21A building 6, Unit 22 building 17, Unit 42 building 17, Unit 140A building 16, Unit 160B building 13, Unit 160C building 15, and Unit 230D building 1. Mold was observed at kitchen ceiling located in Unit 21A building 6. Mold was observed at a wall base located in Unit 160B building 13. Remediation is required as described in Section 4.1 of this report. (Critical Repair)

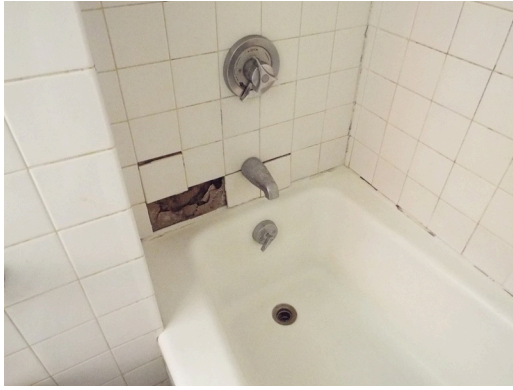
3-bed-1.5 bath - unit 42 - building 17 -
bathroom shower tile condition (Non-Critical
Repair)

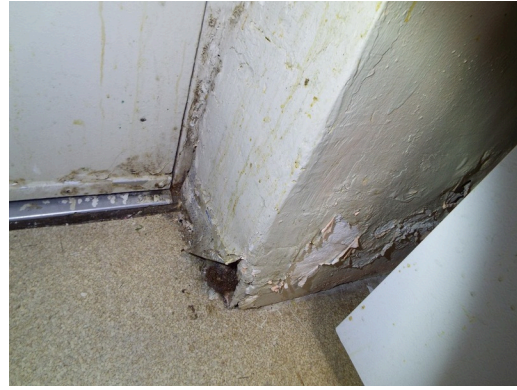
3-bed-1.5 bath - unit 42 - building 17 -
bathroom wall condition (Non-Critical Repair)

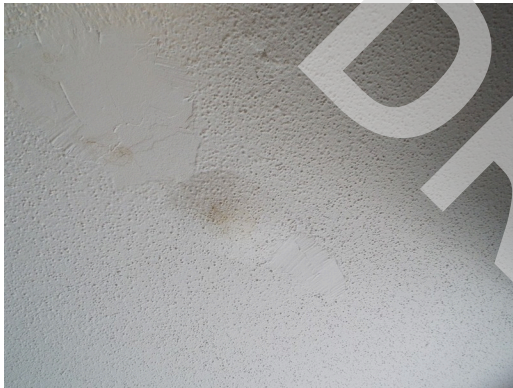
3-bed-1-bath-UFAS - unit 58 - building 8 -
kitchen ceiling condition (Non-Critical Repair)

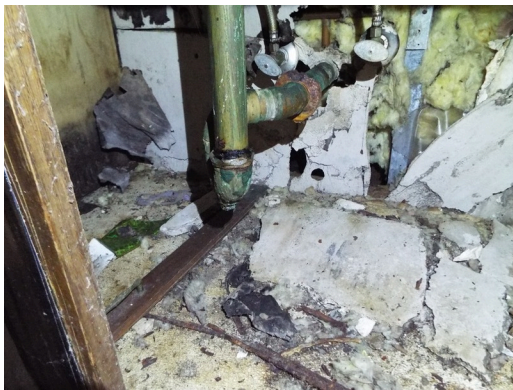
4-bed-2-bath - unit 17 - building 4 wall
damage (Non-Critical Repair)

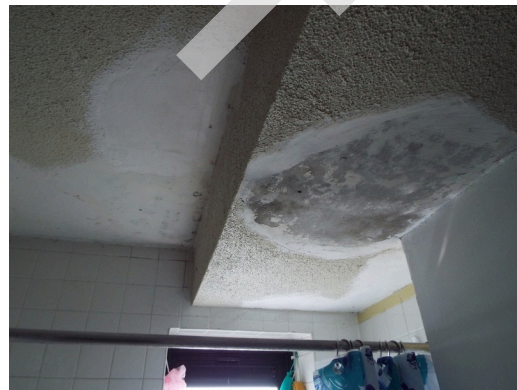
4-bed-2-bath - unit 17 - building 4 - bathroom
ceiling mold (Critical Repair)

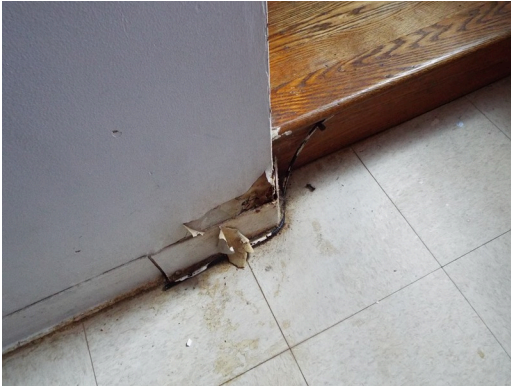
4-bed-2-bath - unit 17 - building 4 - wall condition (Non-Critical Repair)

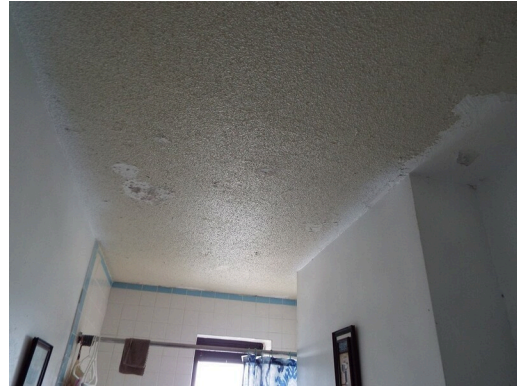
4-bed-2-bath - unit 17 - building 4 - ceiling condition (Non-Critical Repair)

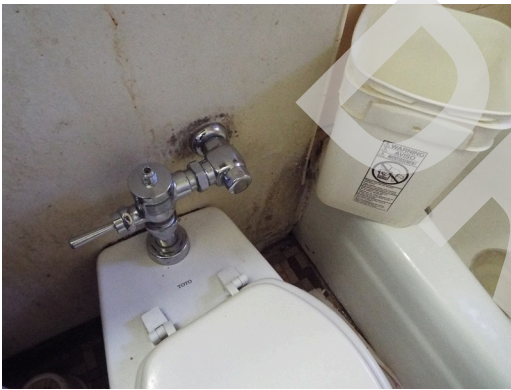
1-bed-1-bath - unit 21A - building 6 - bathroom wall condition (Non-Critical Repair)

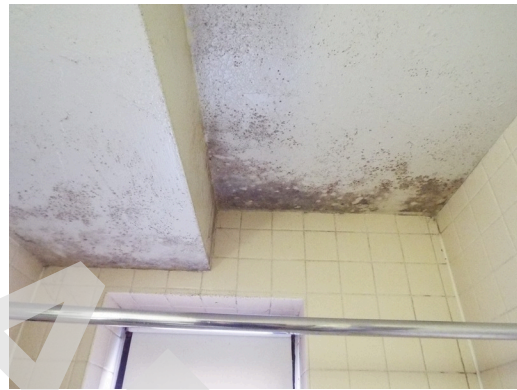
1-bed-1-bath - unit 21A - building 6 - bathroom ceiling mold (Critical Repair)

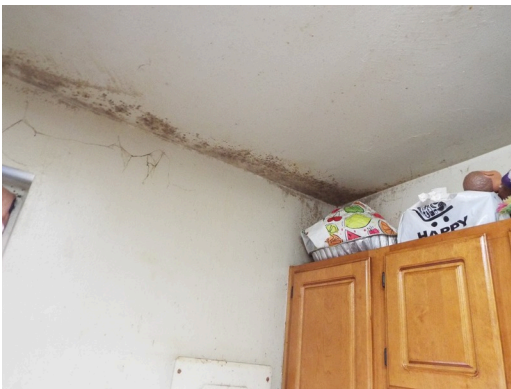
1-bed-1-bath - unit 21A - building 6 - kitchen ceiling mold (Critical Repair)

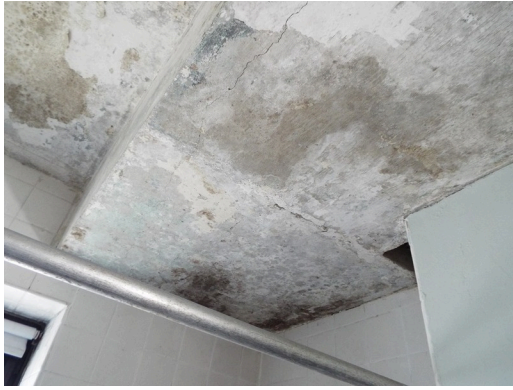
3-bed-1.5-bath-TH - unit 22 - building 17 - bathroom ceiling condition (Critical Repair)

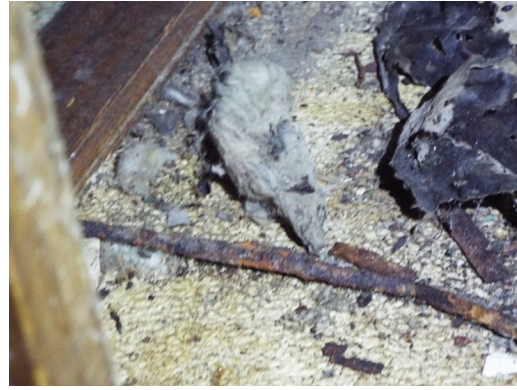
4-bed-2-bath - unit 17 - building 4 - dead rodent (Critical Repair)

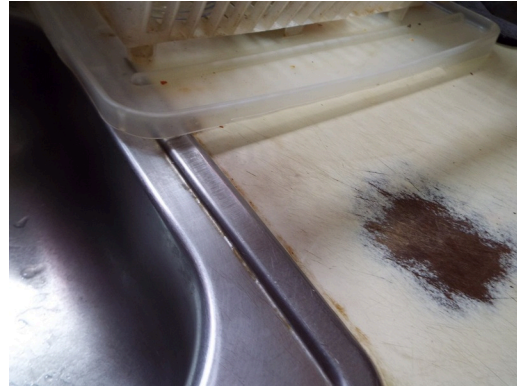
4-bed-2-bath - unit 17 - building 4 - missing kitchen cabinet doors (Non-Critical Repair)

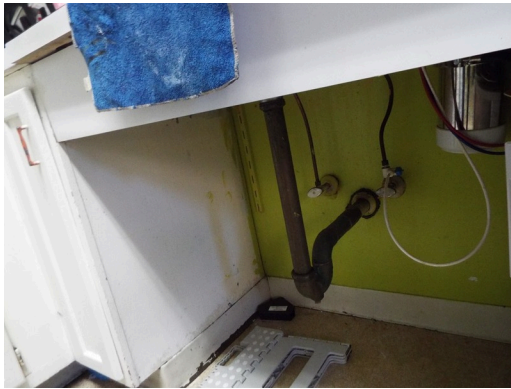
UFAS kitchen sink lacks pipe protection - unit 53 - building 8 (Critical Repair)

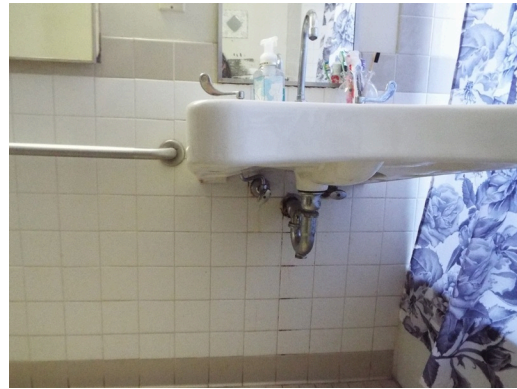
UFAS bathroom sink lacks pipe protection - unit 53 - building 8 (Critical Repair)

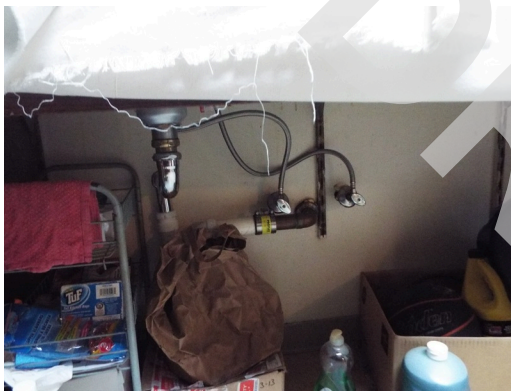
UFAS kitchen sink lacks pipe protection - unit 13 - building 4

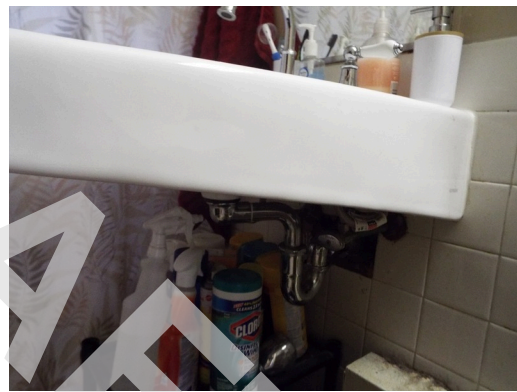
UFAS bathroom sink lacks pipe protection - unit 13 - building 4 (Critical Repair)

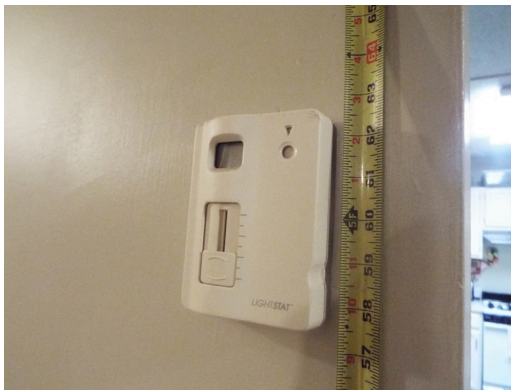
UFAS thermostat exceeds 54 inch height - unit 38 building 2 (Critical Repair)
