HUD CAPITAL NEEDS ASSESSMENT

Franklin Field
180-20 Stratton Street
Dorchester, Massachusetts 02124

AEI Project No. 463341
Site Inspection Date: July 12, 14, 25, and 27, 2022

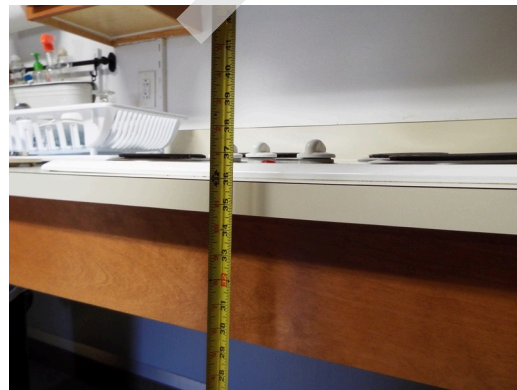
UFAS unit 172 - building 13 - kitchen sink counters exceed 34 inch height (Critical Repair)

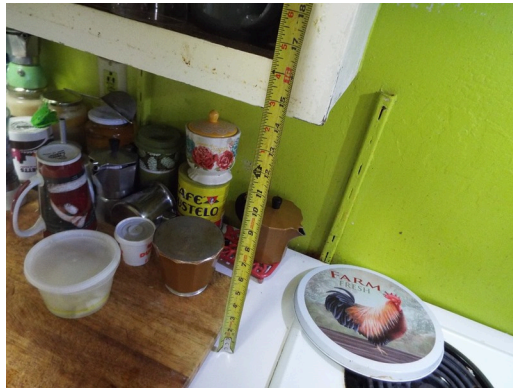
UFAS kitchen cabinet shelf exceeds 48 inch height - unit 13 - building 4 (Critical Repair)

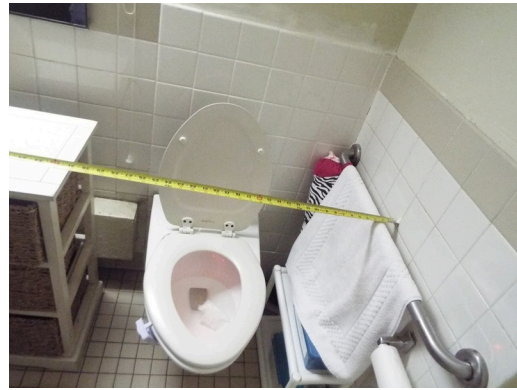
UFAS toilet lacks rear grab bar- unit 13 - building 4 (Critical Repair)

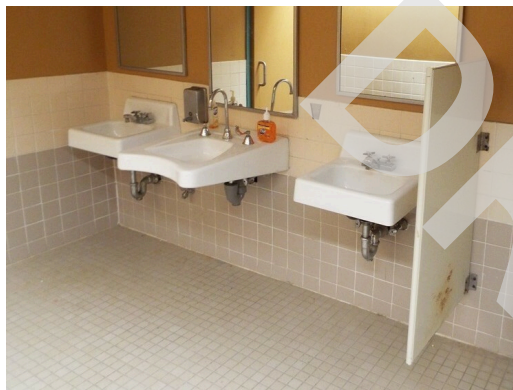
Common area - building 18 - teen center - men's restroom 2 of 3 sinks lack pipe protection (Critical Repair)

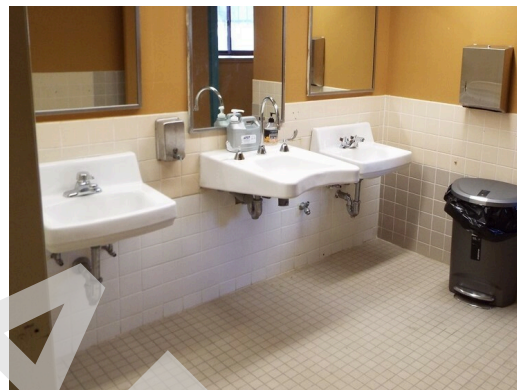
Common area - building 18 - teen center - women's restroom 2 of 3 sinks lack pipe protection (Critical Repair)

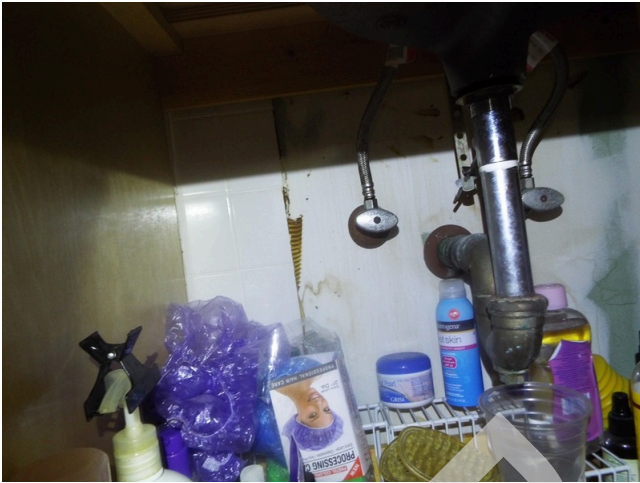
73. 2-bed-1-bath - unit 160C - building 15 - rodents reported - kitchen (Critical Repair)

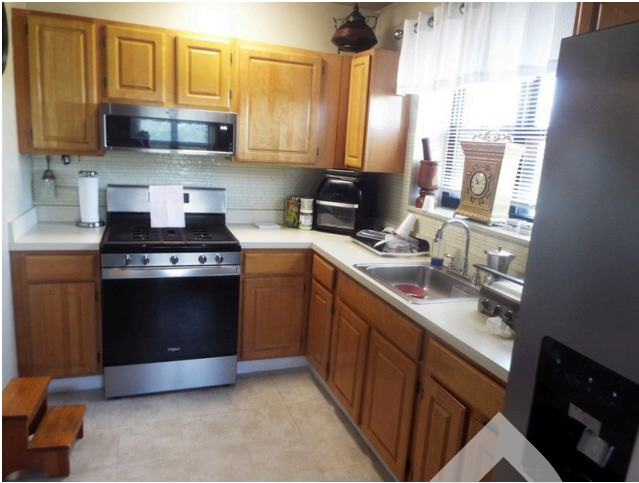
77. 2-bed-1-bath - unit 160C - building 15 - rodents reported - kitchen (Critical Repair)

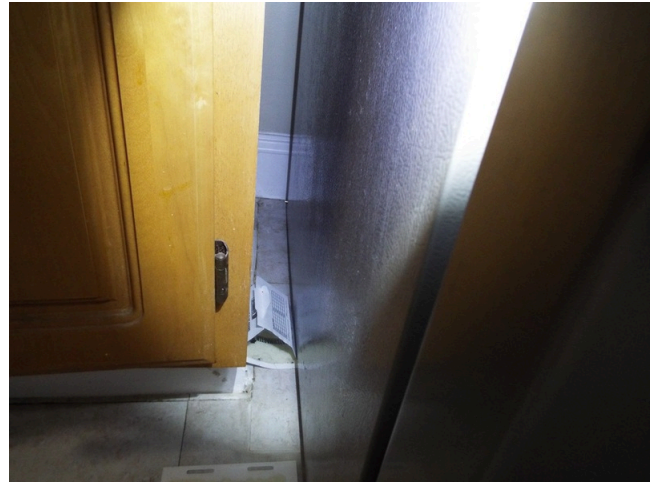
78. 2-bed-1-bath - unit 160C - building 15 - rodents reported - kitchen (Critical Repair)

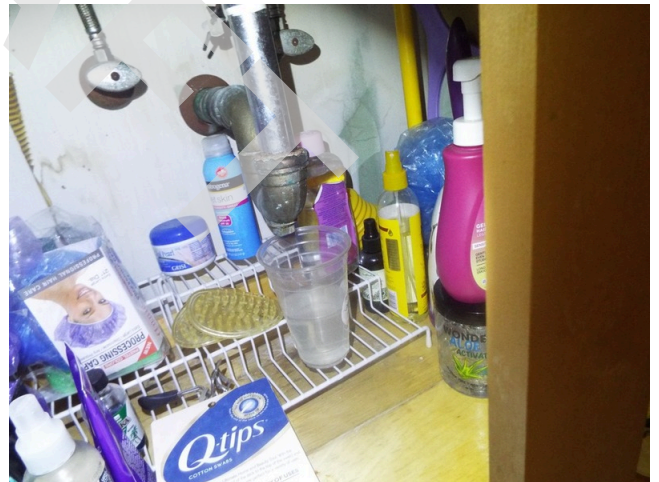
80. 2-bed-1-bath - unit 160C - building 15 - rodents reported - kitchen (Critical Repair)

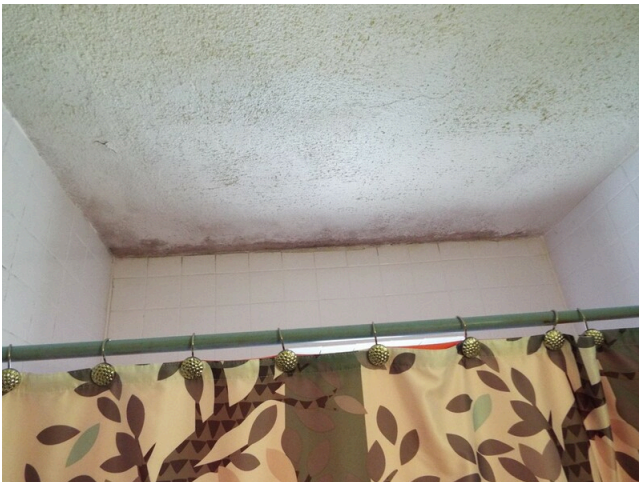
87. 2-bed-1-bath - unit 230D - building 1 - bathroom ceiling mold (Critical Repair)

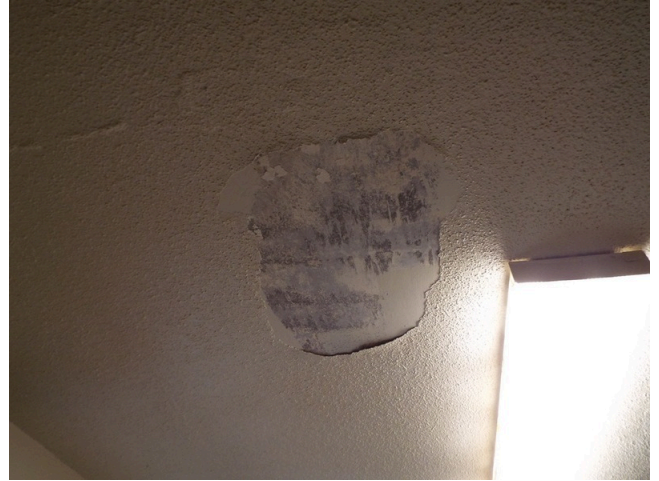
98. 2-bed-1-bath - unit 240A - building 1 - ceiling paint condition (Non-Critical Repair)

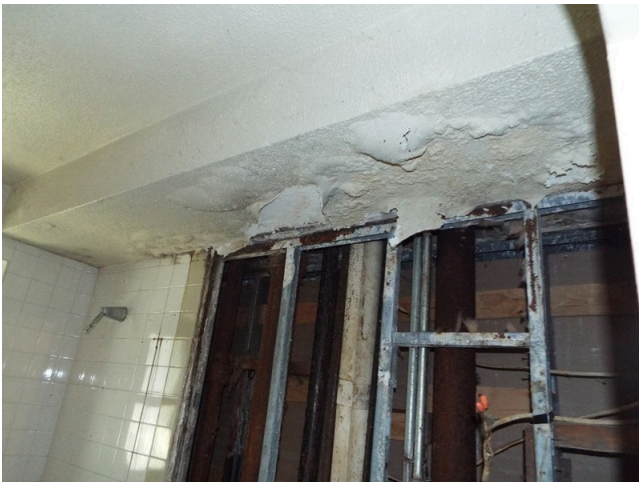
107. 2-bed-1-bath- unit 230A - building 1 -
bathroom ceiling repairs (Non-Critical Repair)

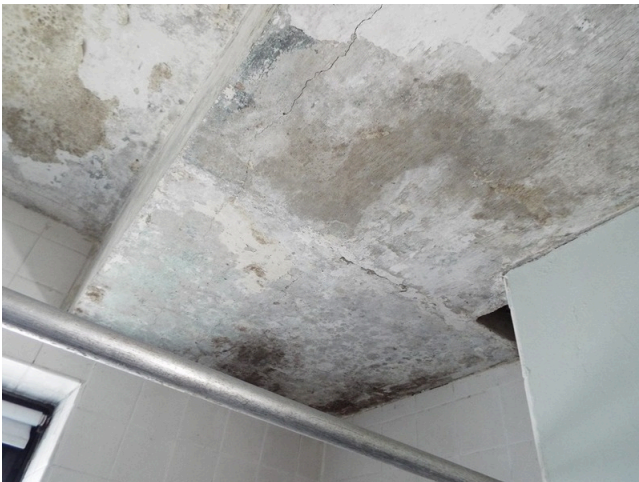
118. 3-bed-1.5-bath-TH - unit 22 - building 17 - bathroom ceiling condition (Critical Repair)

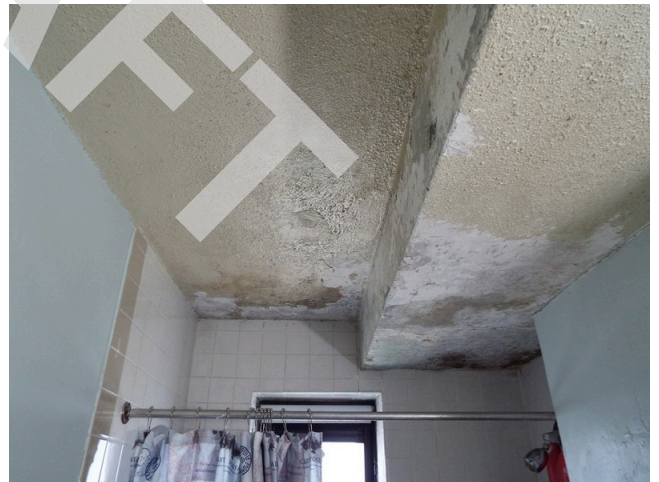
119. 3-bed-1.5-bath-TH - unit 22 - building 17 - bathroom ceiling condition (Critical Repair)

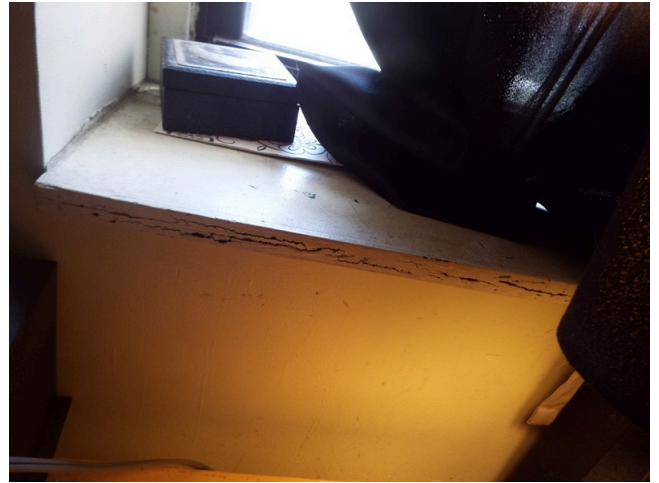
265. 3-bed-1-bath-UFAS - unit 13 - building 4 - termites reported (Non-Critical Repair)

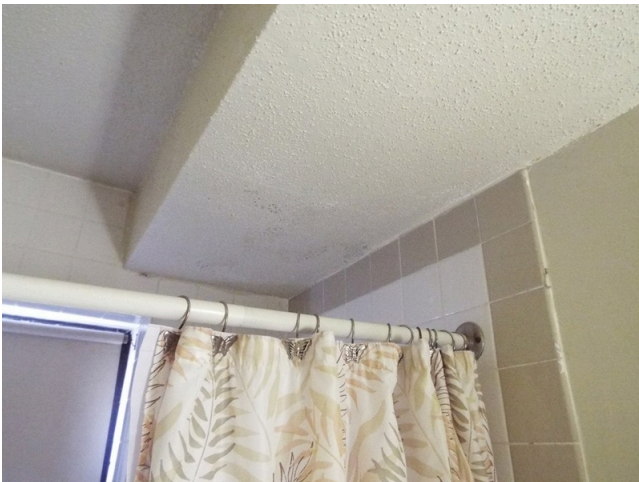
266. 3-bed-1-bath-UFAS - unit 13 - building 4 - termites reported (Non-Critical Repair)

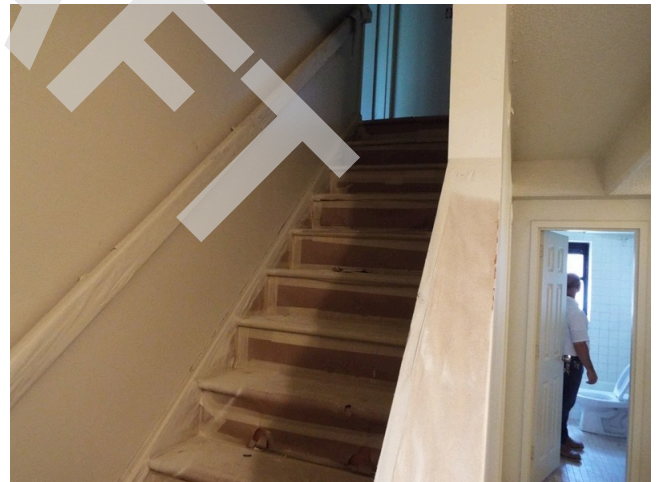
284. 4-bed-2-bath-TH - unit 50A - building 5 - stair

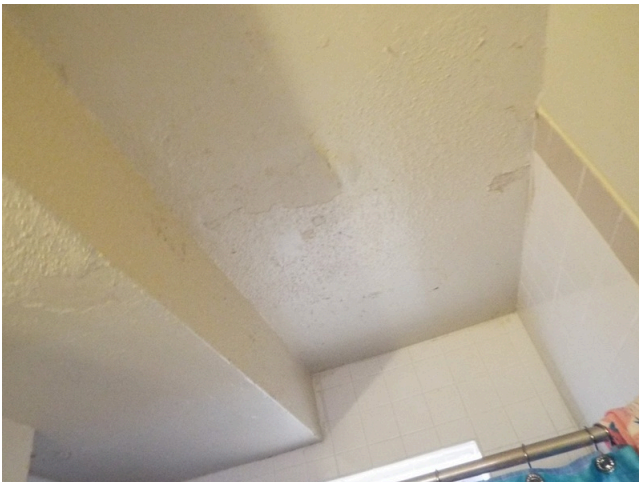
331. 5-bed-2-bath-TH - unit 190A - building 14 -
bathroom paint condition (Non-Critical Repair)

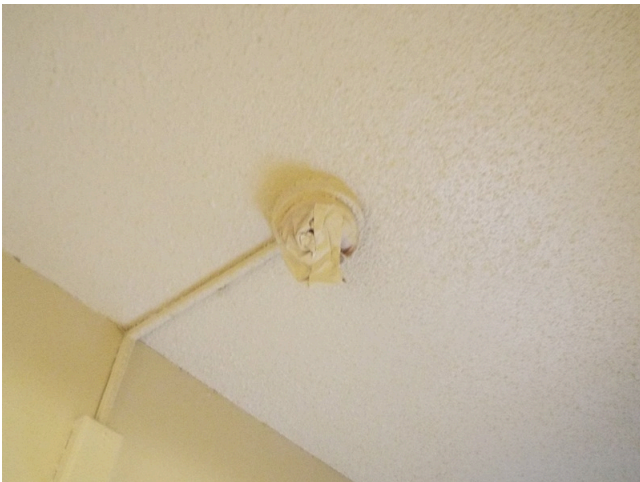
335. 5-bed-2-bath-TH - unit 190A - building 14 - disabled smoke detector (Critical Repair)

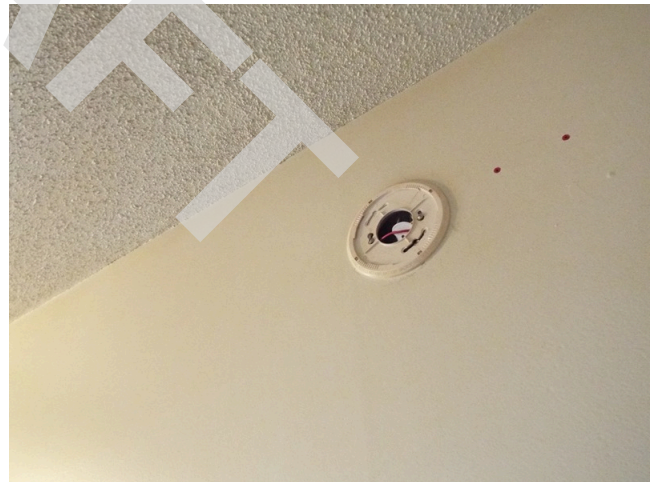
340. 1-bed-1-bath - unit 31E - building 6 - missing smoke detector (Critical Repair)

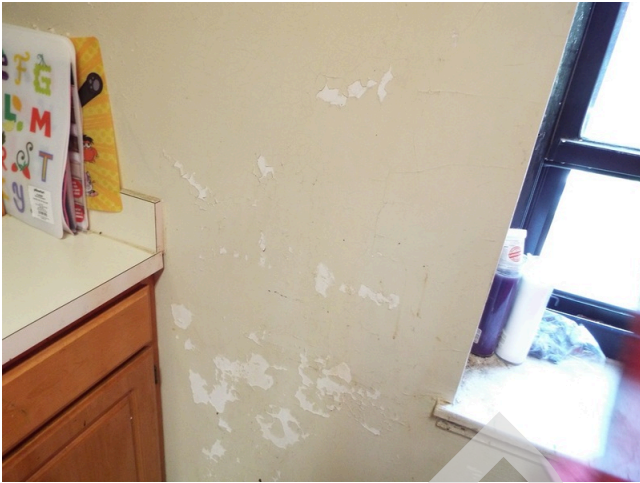
341. 2-bed-1-bath - unit 50E - building 18 - wall paint condition (Non-Critical repair)

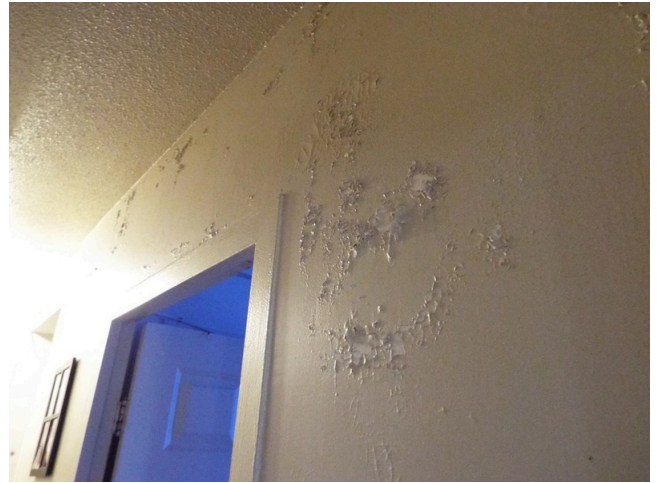
342. 2-bed-1-bath - unit 50E - building 18 - wall paint condition (Non-Critical repair)

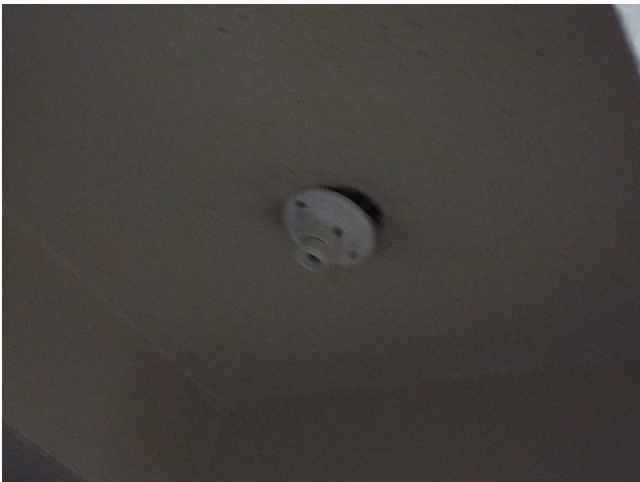
343. 2-bed-1-bath - unit 50G - building 18 - loose light fixture (Critical Repair)

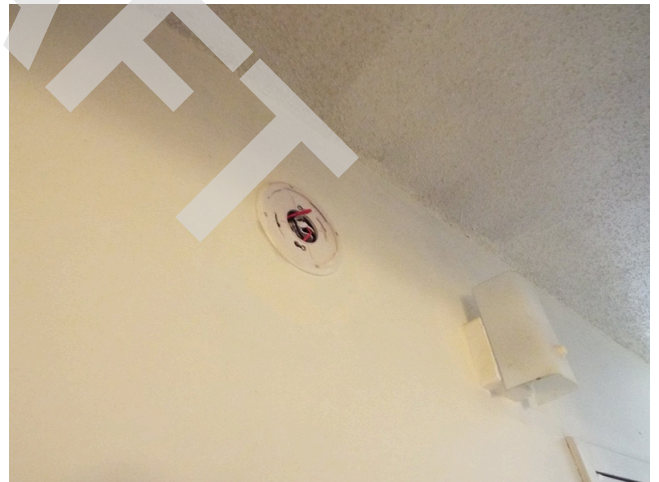
344. 2-bed-1-bath - unit 82 - building 7 UFAS - missing smoke detector (Critical Repair)

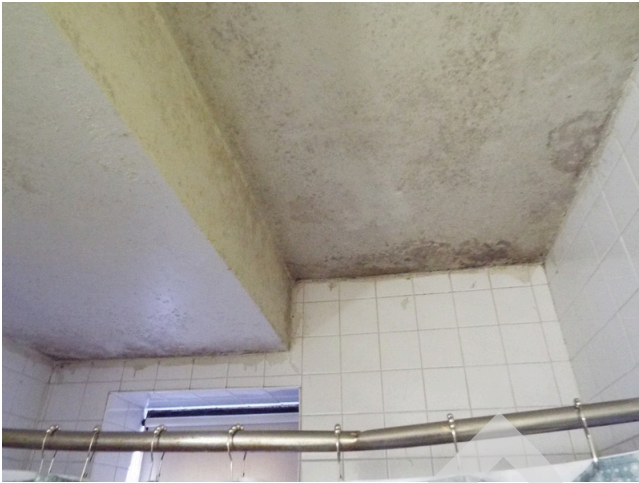
345. 3-bed-1.5 bath - unit 42 - building 17 -
bathroom ceiling mold (Critical Repair)

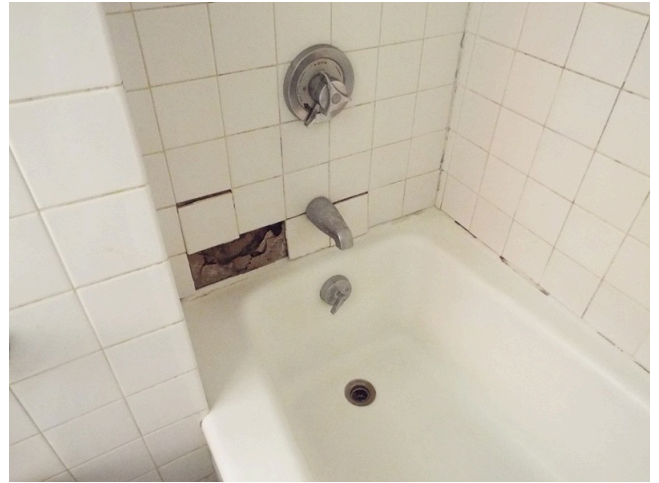
346. 3-bed-1.5 bath - unit 42 - building 17 -
bathroom shower tile condition (Non-Critical Repair)

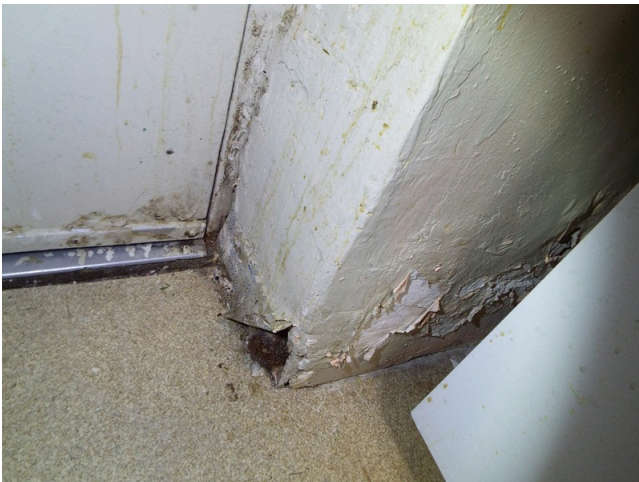
347. 3-bed-1.5 bath - unit 42 - building 17 -
bathroom wall condition (Non-Critical Repair)

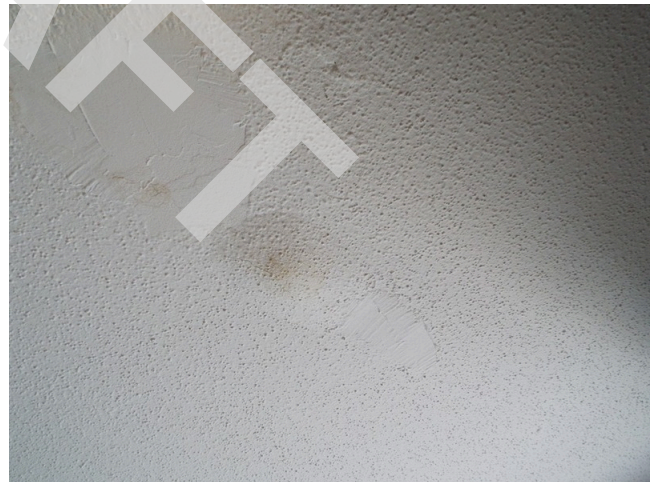
348. 3-bed-1-bath-UFAS - unit 58 - building 8 -
kitchen ceiling condition (Non-Critical Repair)

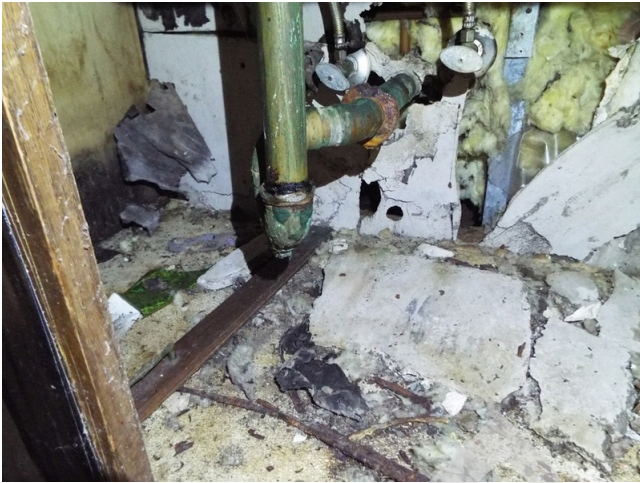
353. 4-bed-2-bath - unit 17 - building 4 wall damage
(Non-Critical Repair)

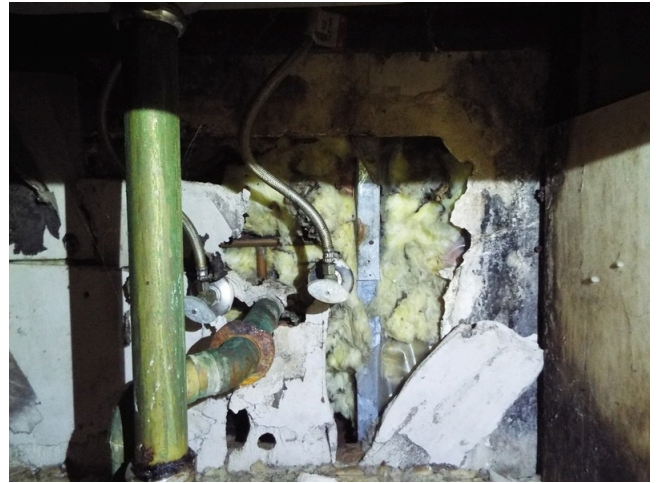
354. 4-bed-2-bath - unit 17 - building 4 wall damage
(Non-Critical Repair)

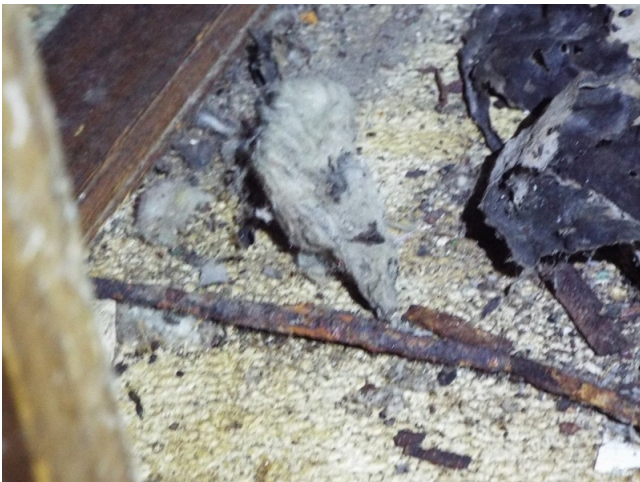
355. 4-bed-2-bath - unit 17 - building 4 - dead
rodent (Critical Repair)

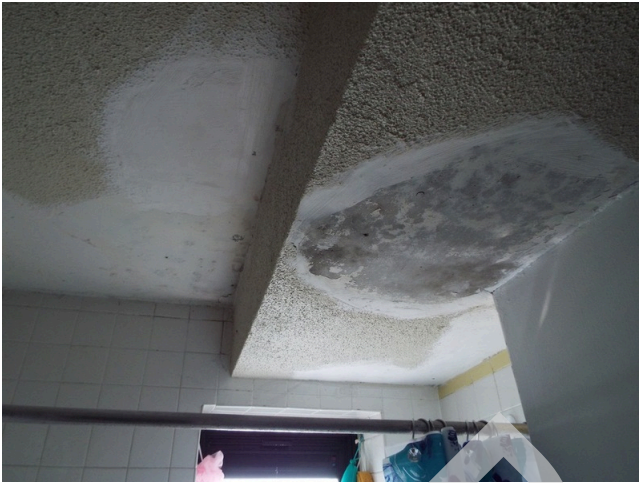
357. 4-bed-2-bath - unit 17 - building 4 - bathroom ceiling mold (Critical Repair)

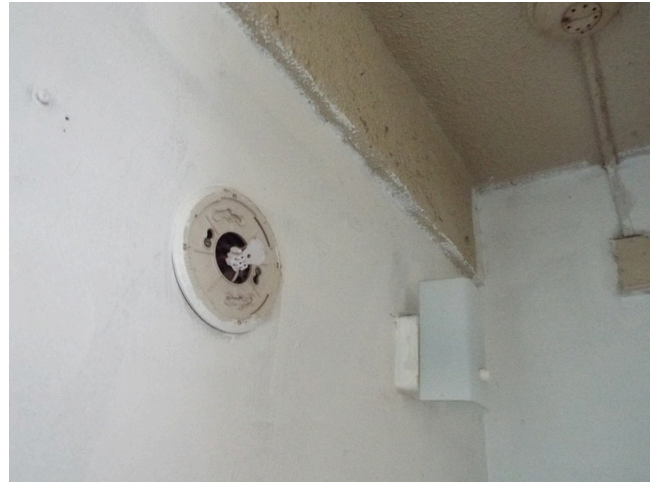
358. 4-bed-2-bath - unit 17 - building 4 - missing smoke detector (Critical Repair)

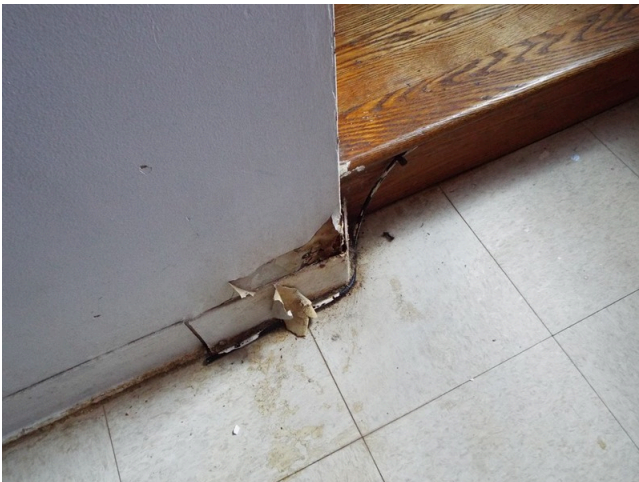
359. 4-bed-2-bath - unit 17 - building 4 - wall condition (Non-Critical Repair)

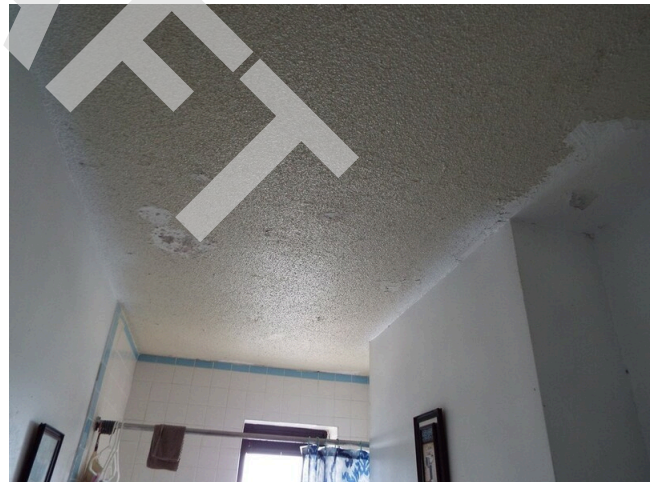
360. 4-bed-2-bath - unit 17 - building 4 - ceiling condition (Non-Critical Repair)

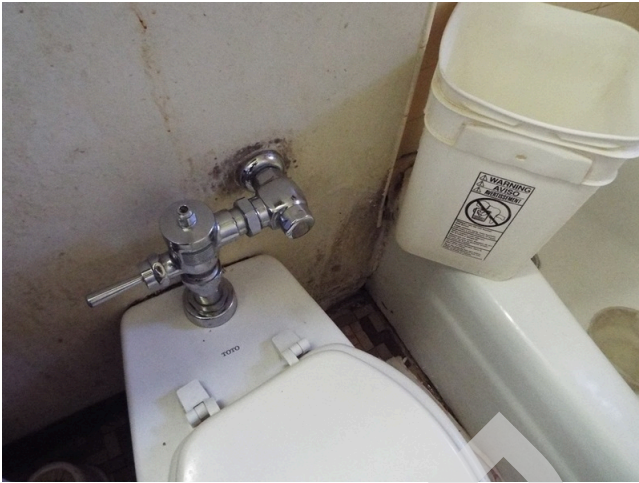
361. 1-bed-1-bath - unit 21A - building 6 - bathroom wall condition (Non-Critical Repair)

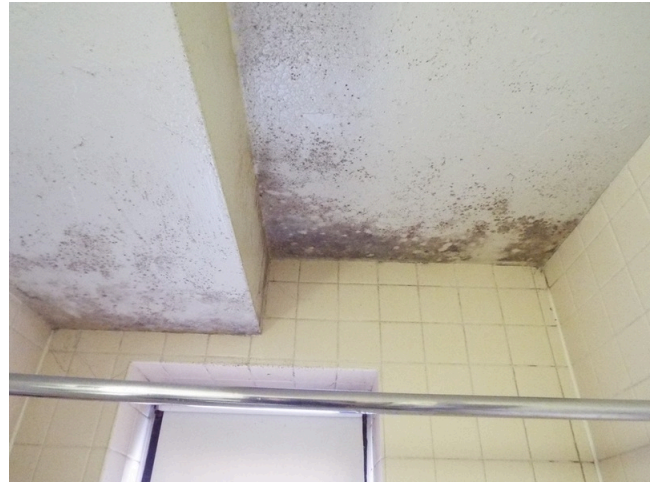
362. 1-bed-1-bath - unit 21A - building 6 - bathroom ceiling mold (Critical Repair)

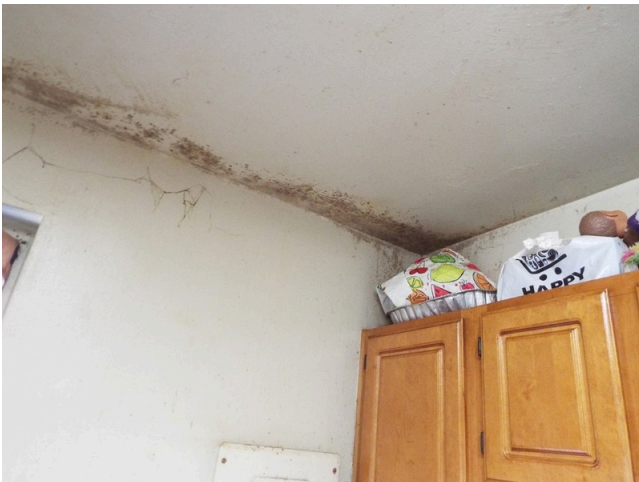
363. 1-bed-1-bath - unit 21A - building 6 - kitchen ceiling mold (Critical Repair)

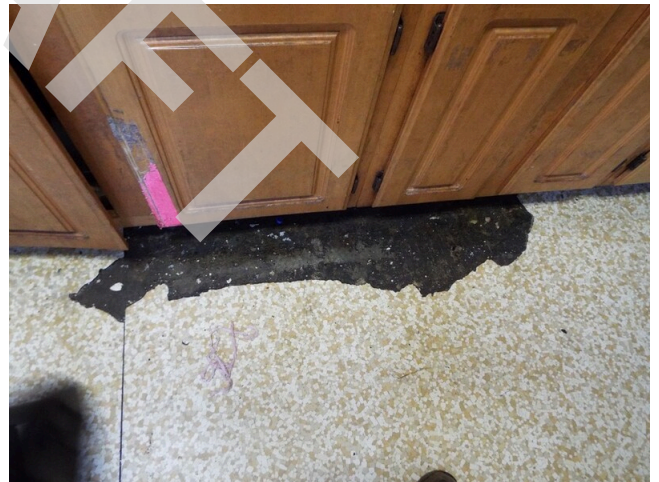
364. 1-bed-1-bath - unit 21A - building 6 - kitchen flooring condition (Non-Critical Repair)

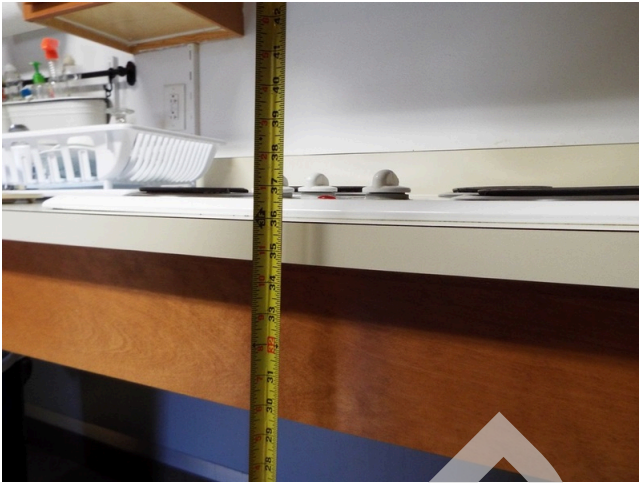
365. UFAS unit 172 - building 13 - kitchen sink counters exceed 34 inch height (Critical Repair)

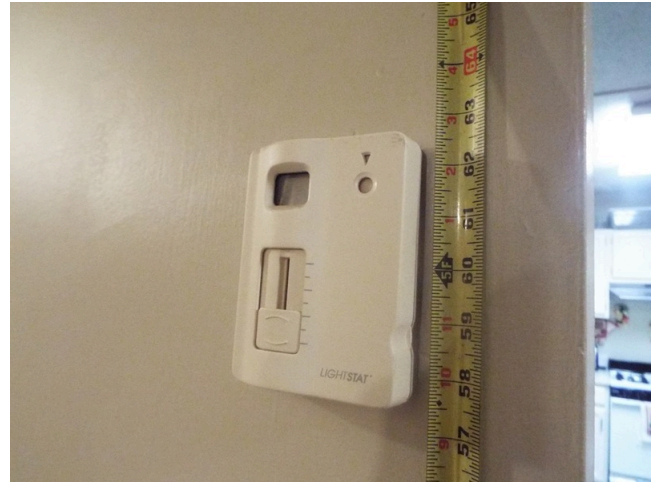
366. UFAS thermostat exceeds 54 inch height - unit 38 building 2 (Critical Repair)

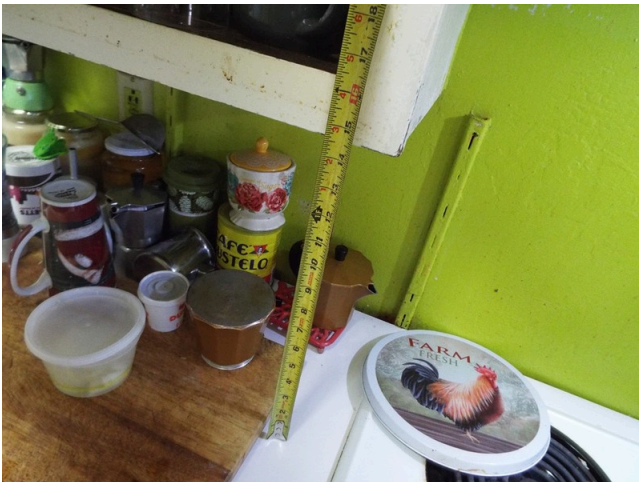
367. UFAS kitchen cabinet shelf exceeds 48 inch height - unit 13 - building 4 (Critical Repair)

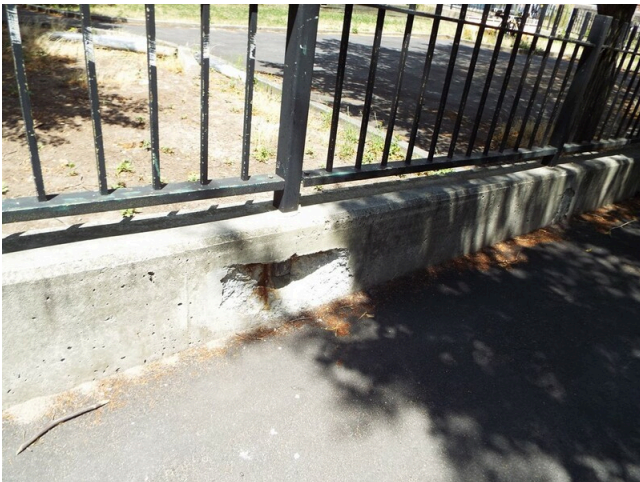
7. Concrete retaining wall spalling - rear building 9
(Non-Critical Repair)

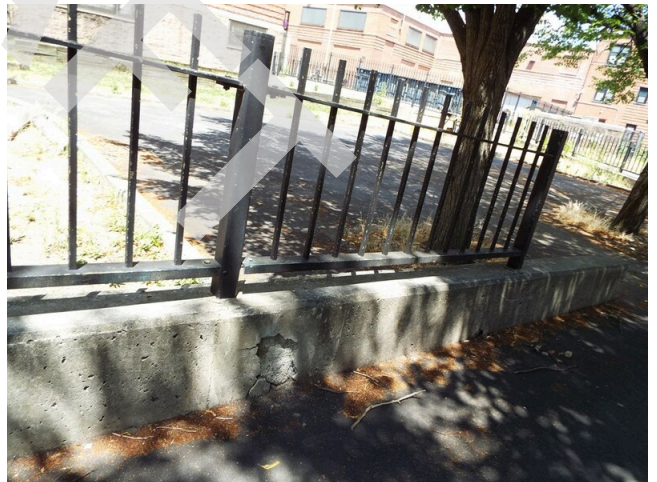
8. Concrete retaining wall spalling - rear building 9
(Non-Critical Repair)

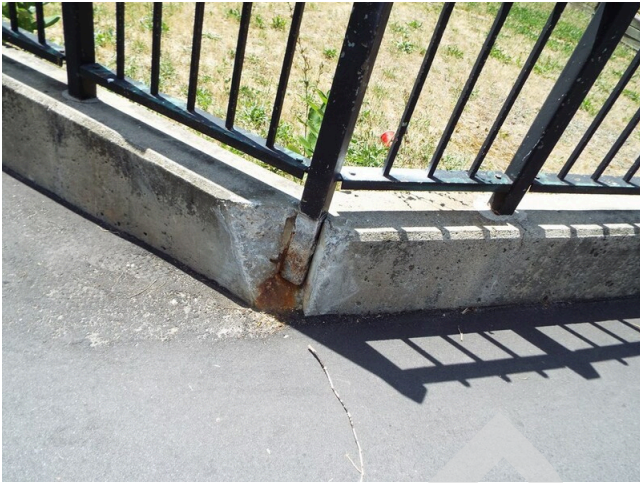
9. Concrete retaining wall spalling - rear building 9
(Non-Critical Repair)

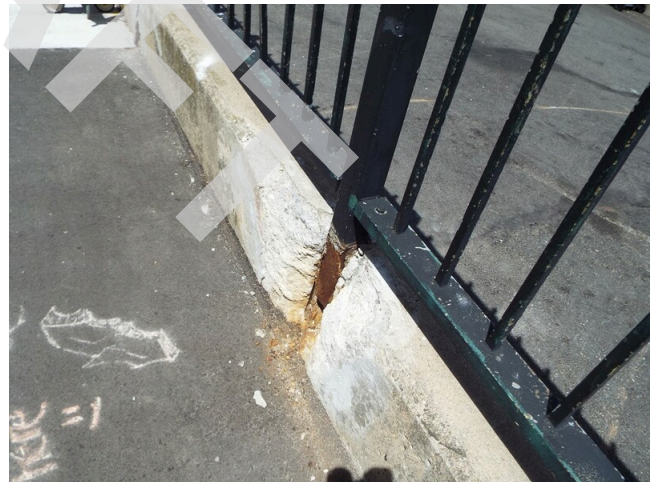
12. Concrete retaining wall spalling - rear building 12
(Non-Critical Repair)

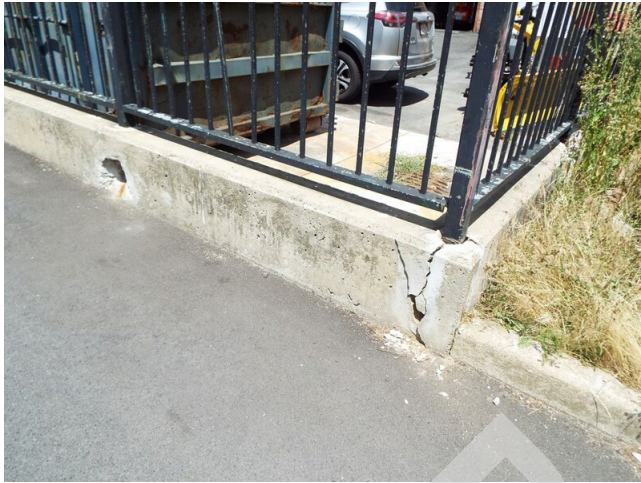
13. Concrete retaining wall spalling - rear building 12 (Non-Critical Repair)

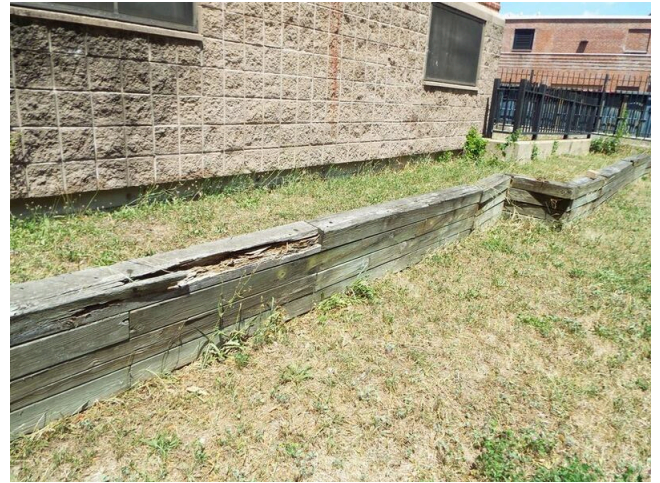
14. Wood timber retaining wall condition - rear building 9 (Non-Critical Repair)

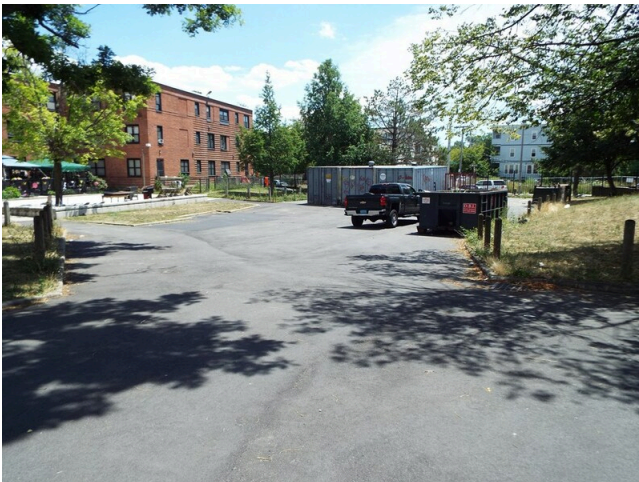
23. Asphalt paving - rear building 12

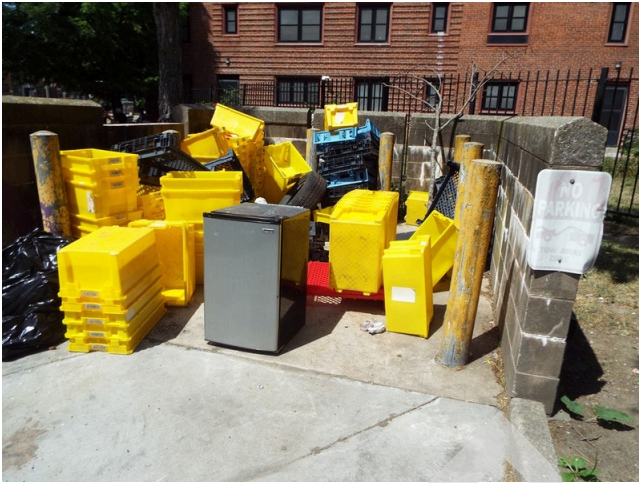
25. Dumpster pad condition - building 1 (Non-Critical Repair)

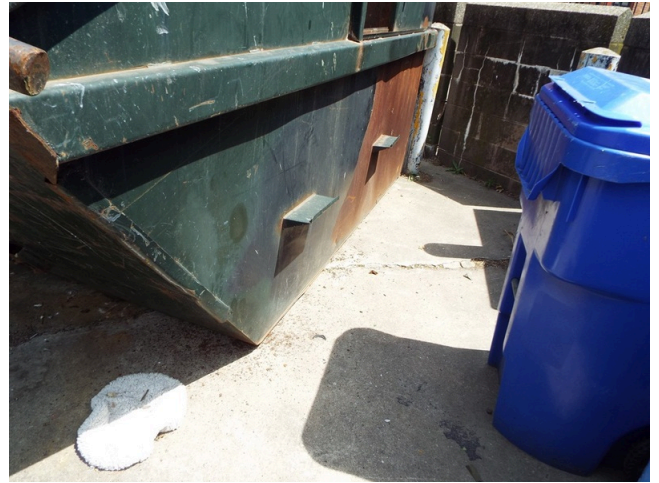
26. Dumpster pad condition - building 1 (Non-Critical Repair)

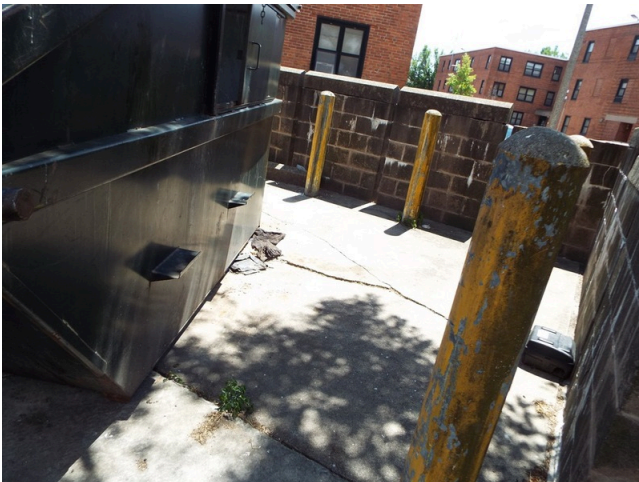
27. Dumpster pad condition - building 7 (Non-Critical Repair)

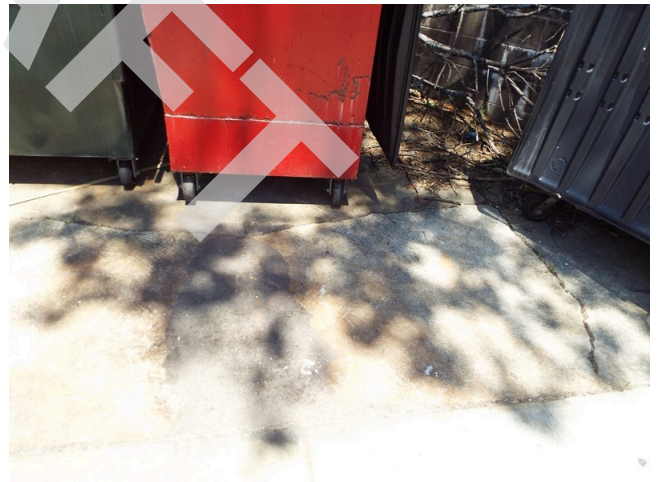
28. Dumpster pad condition - building 10 (Non-Critical Repair)

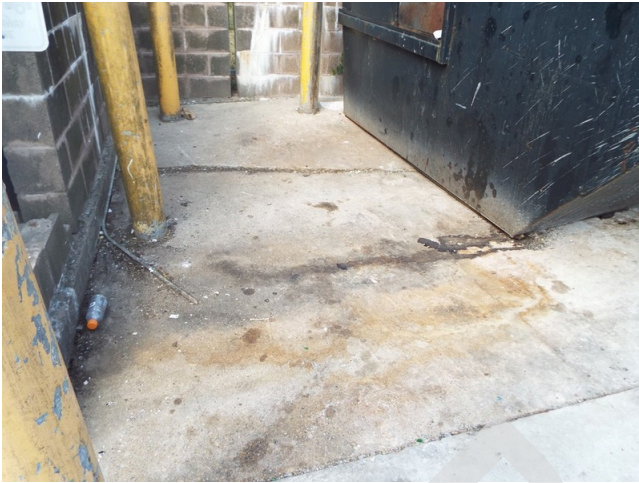
29. Dumpster pad condition - building 14-17 (Non-Critical Repair)

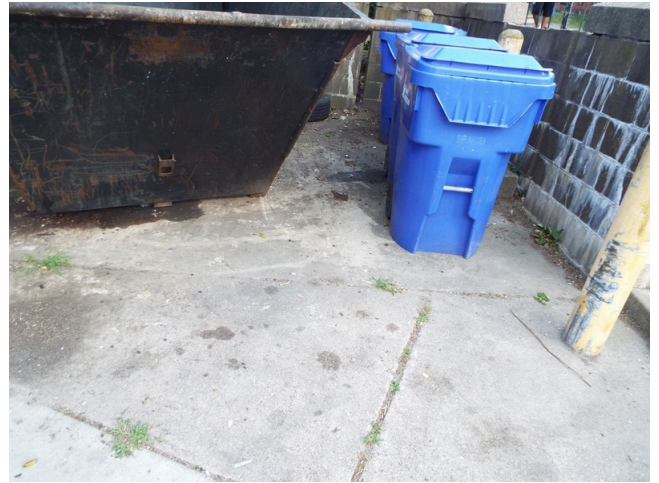
30. Dumpster pad condition - building 15-16 (Non-Critical Repair)

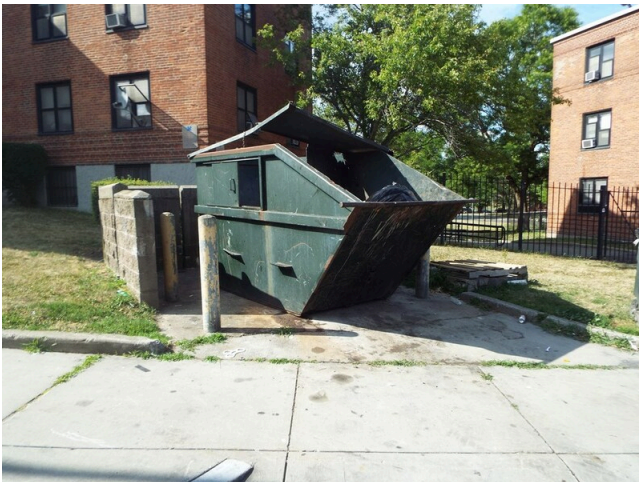
31. Dumpster pad condition - building 18-19 (Non-Critical Repair)

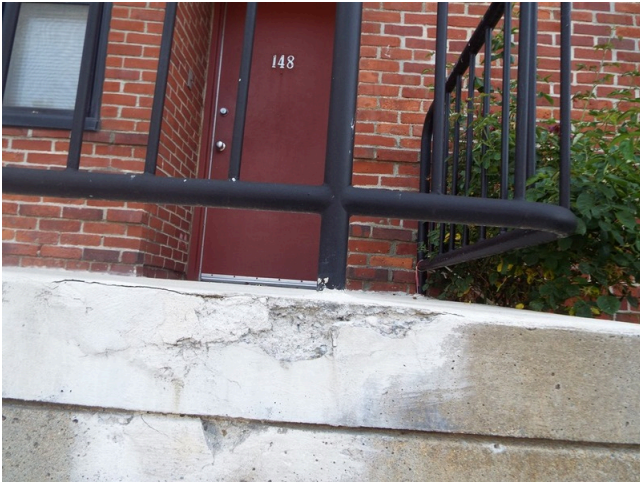
39. Concrete stair spalling - building 16 (Non-Critical Repair)

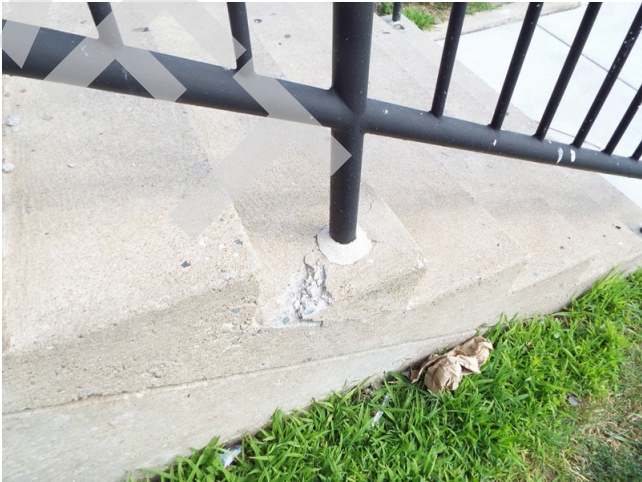
40. Concrete step spalling - building 17 (Non-Critical Repair)

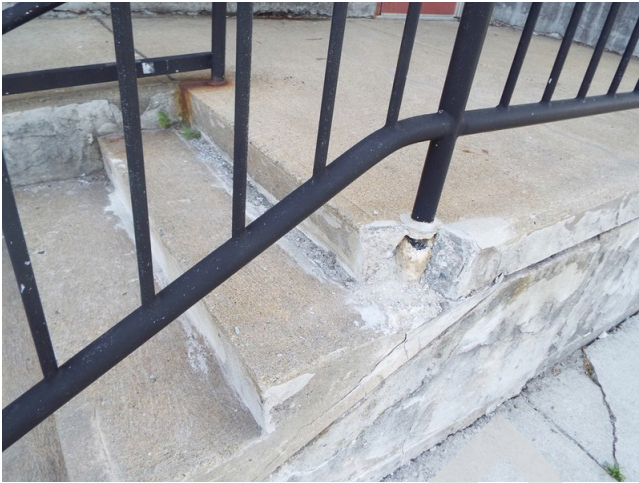
41. Concrete step spalling - building 19 (Non-Critical Repair)

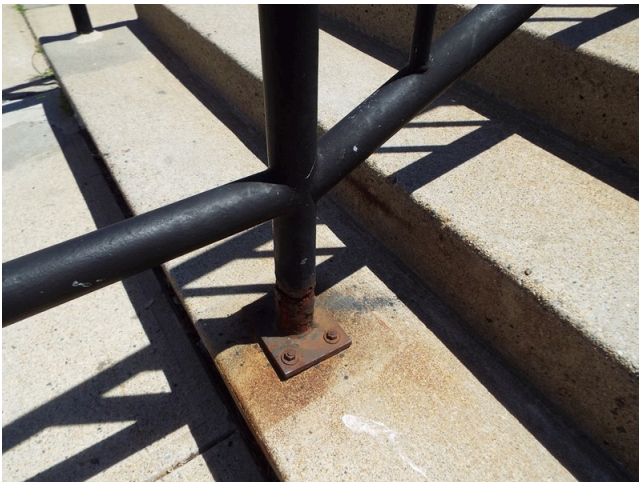
43. Handrail post base condition - building 12 (Non-Critical Repair)

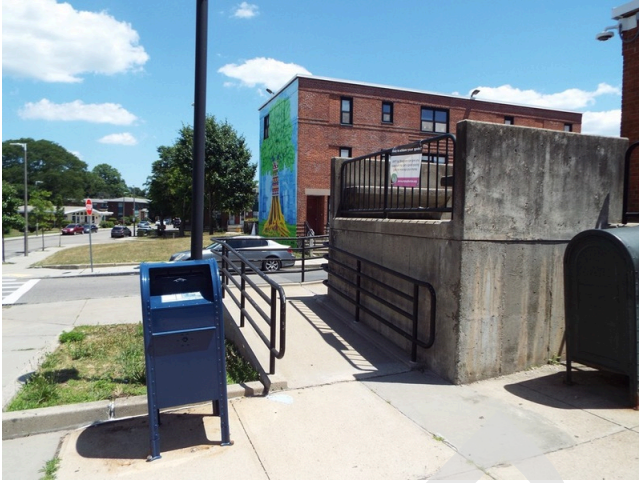
44. Handrail paint condition - building 10 (Non-Critical Repair)

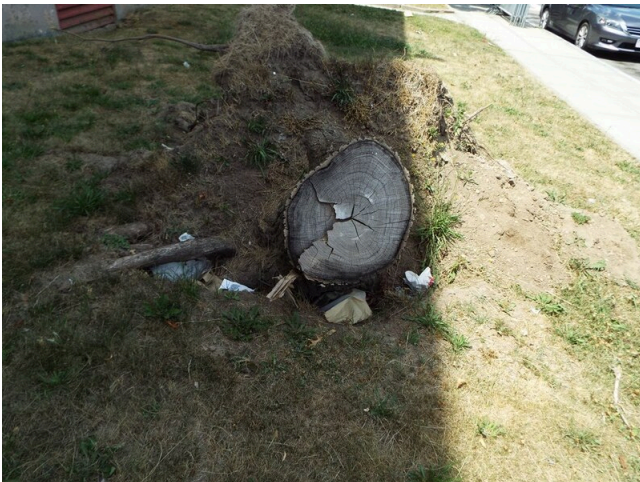
51. Hole at stump - building 4 (Critical Repair)

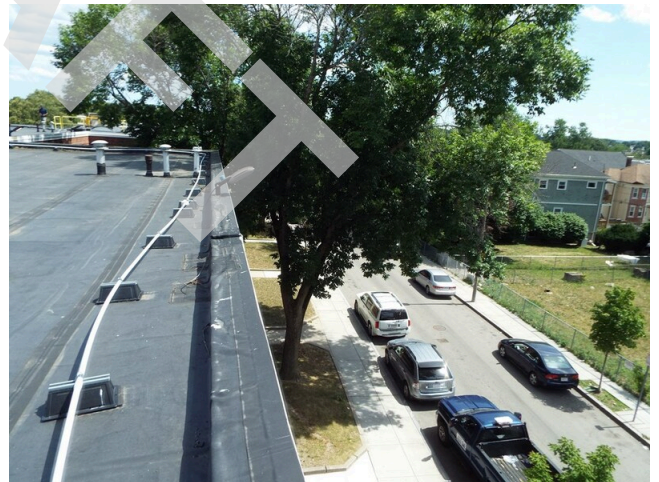
52. Overhanging tree - building 2 (Non-Critical Repair)

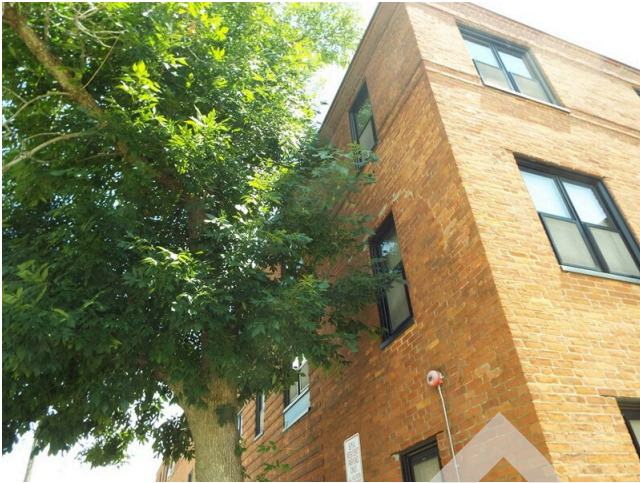
53. Overhanging tree - building 8 (Non-Critical Repair)

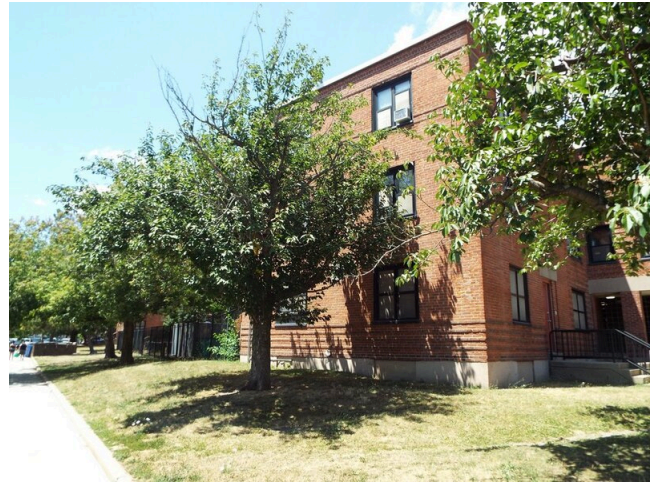
54. Overhanging tree - building 12 (Non-Critical Repair)

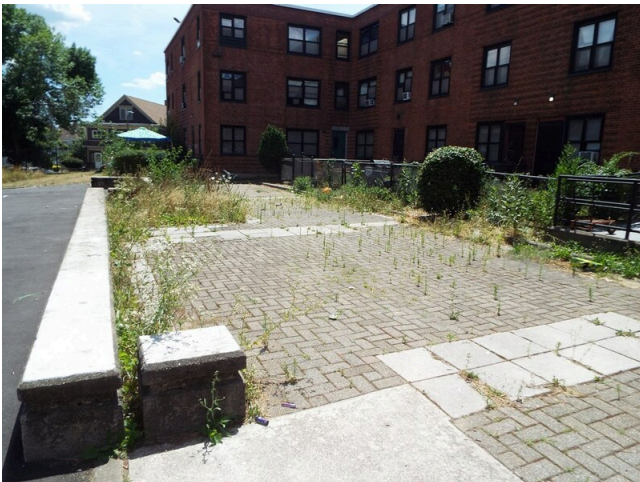
55. Overgrown vegetation - building 7 (Non-Critical Repair)

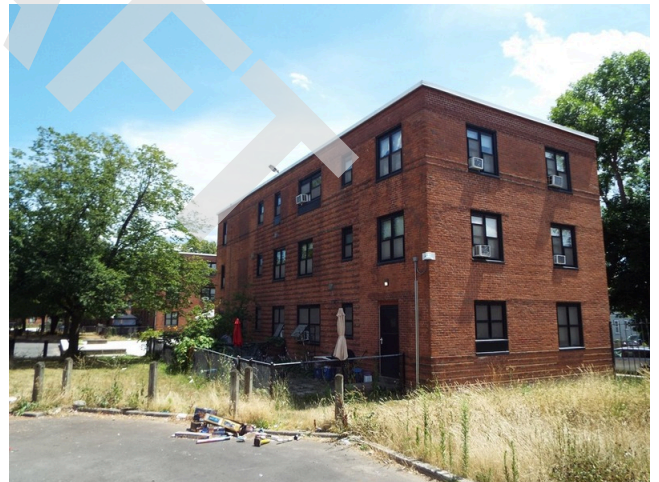
56. Overgrown vegetation - building 10 (Non-Critical Repair)

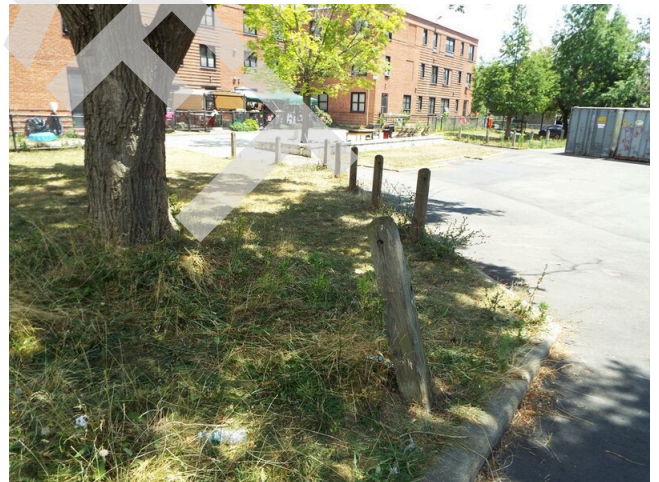
60. Wood fence post condition - rear buildings
9-12(Non-Critical Repair)

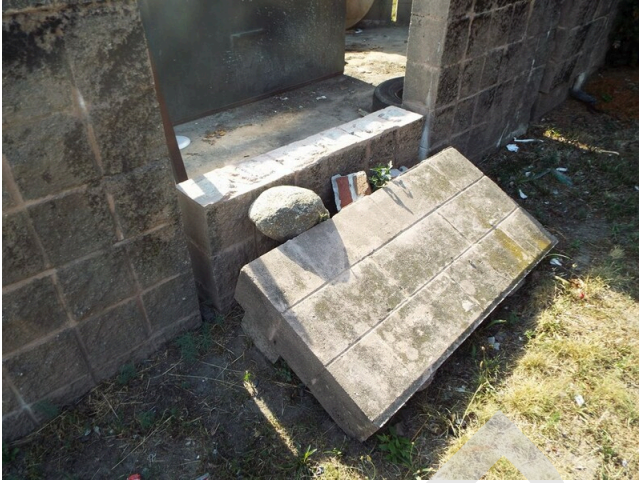
65. Dumpster enclosure wall damage - building 5
(Non-Critical Repair)

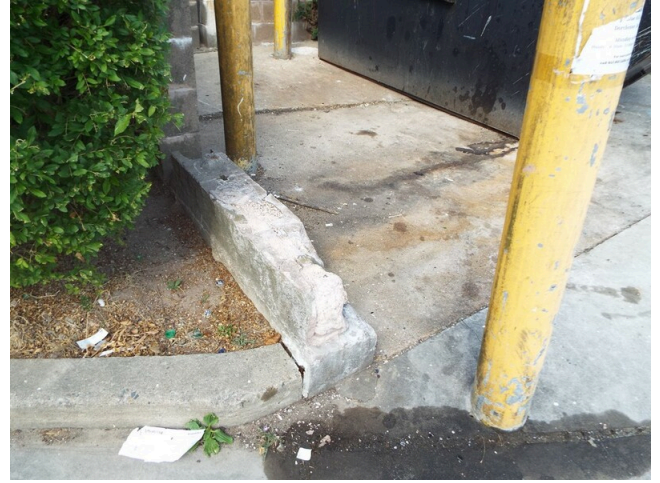
66. Dumpster wall damage - building 14-17 (Non-Critical Repair)

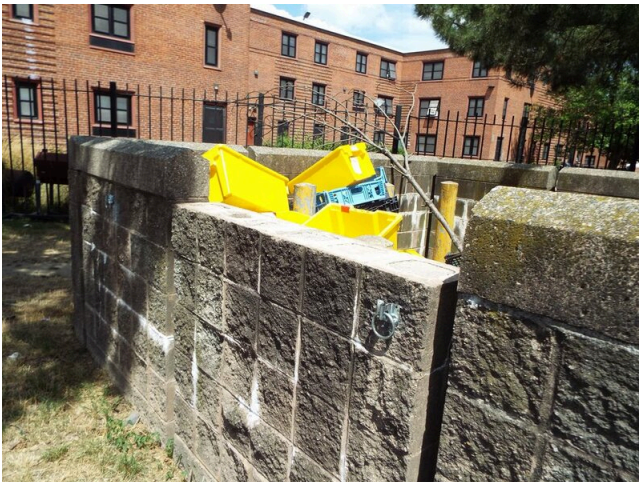
67. Missing dumpster enclosure cap section -
building 1 (Non-Critical Repair)
