HUD CAPITAL NEEDS ASSESSMENT

Franklin Field
180-20 Stratton Street
Dorchester, Massachusetts 02124

AEI Project No. 463341
Site Inspection Date: July 12, 14, 25, and 27, 2022

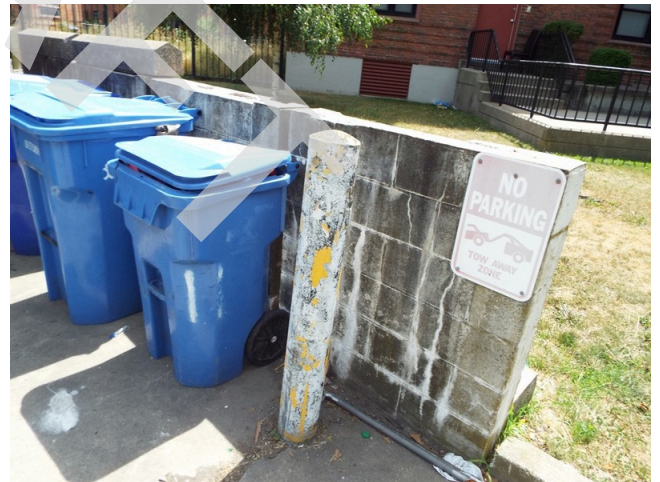
68. Missing dumpster enclosure cap section -
building 1 (Non-Critical Repair)

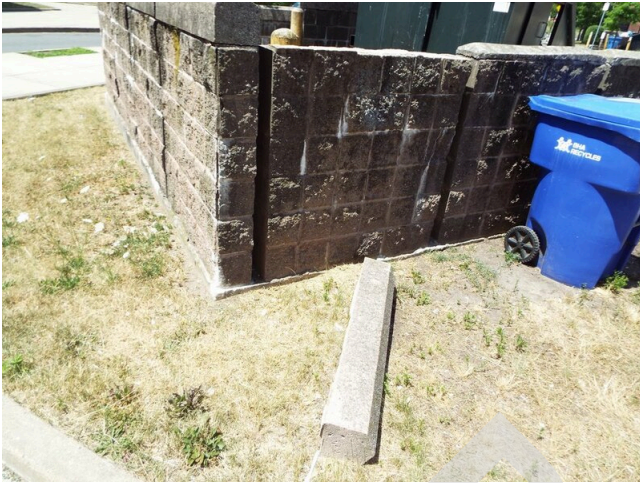
69. Missing dumpster enclosure cap section - building 7 (Non-Critical Repair)

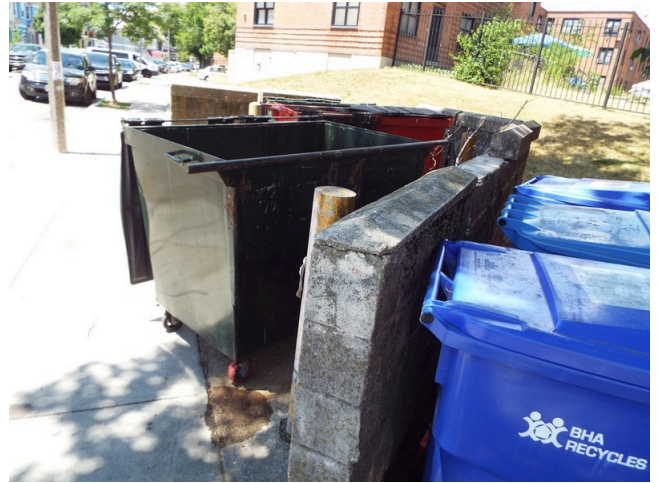
70. Missing dumpster enclosure cap section - building 10 (Non-Critical Repair)

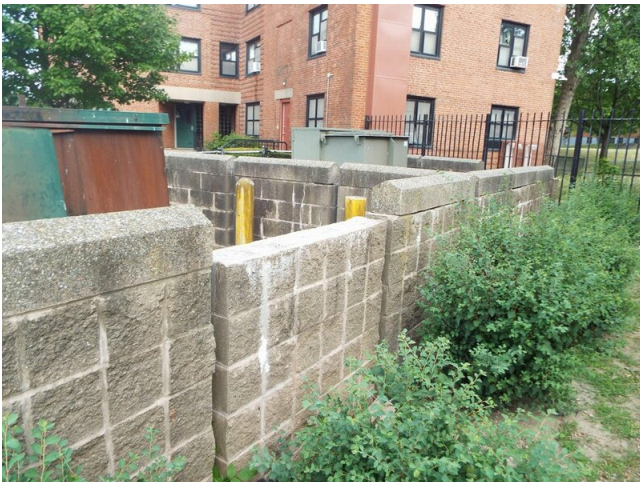
71. Missing dumpster enclosure cap section - building 14-15 (Non-Critical Repair)

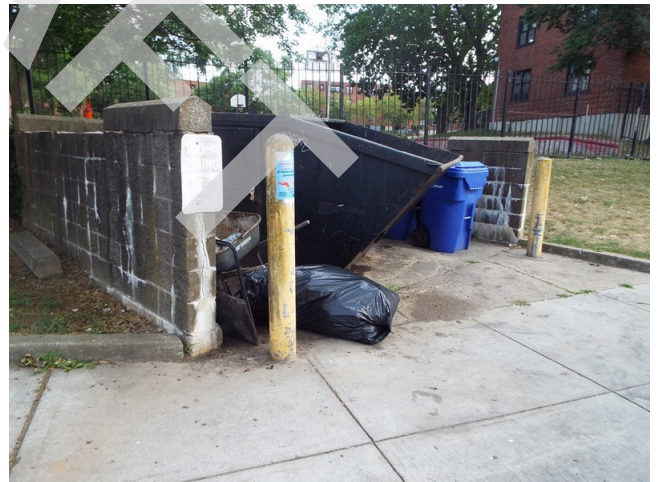
72. Missing dumpster enclosure cap section - building 15-16 (Non-Critical Repair)

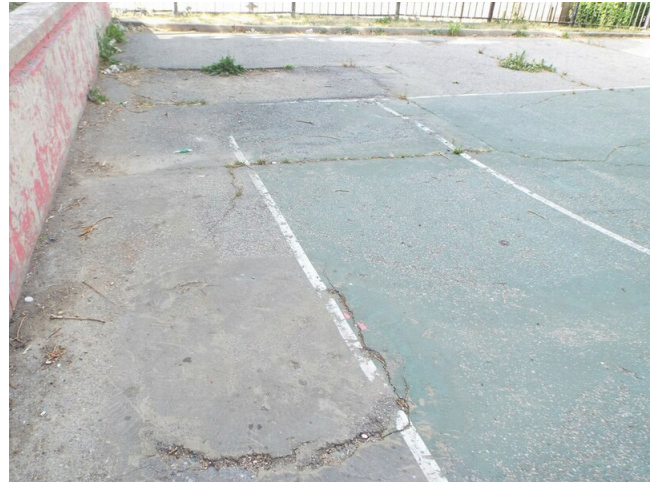
74. Basketball court surface condition (Non-Critical Repair)

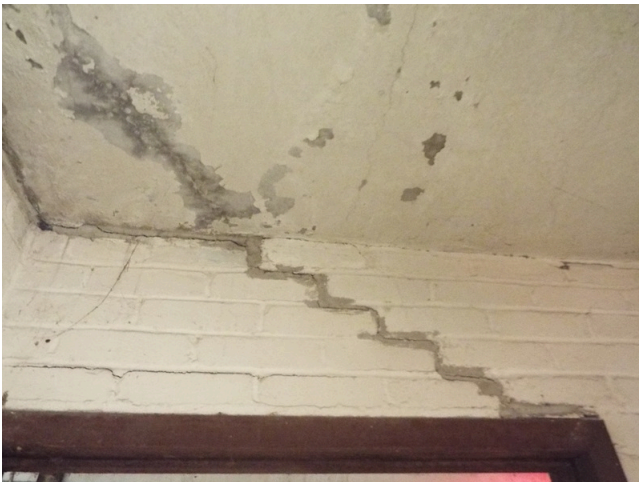
83. Masonry wall cracks - basement building 15
(Non-Critical Repair)

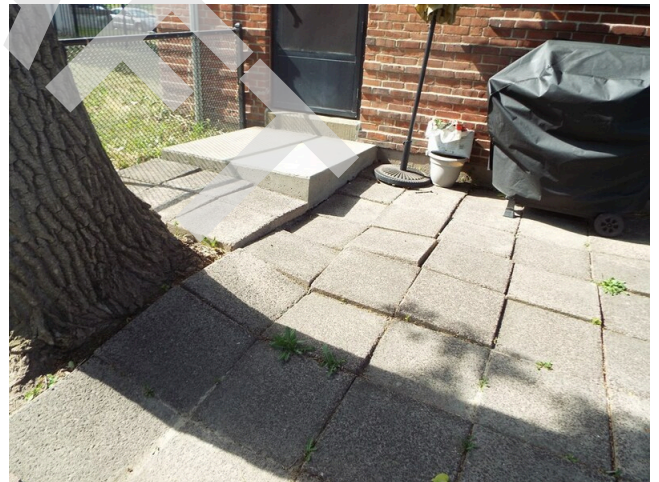
84. Concrete patio paver condition - building 15
(Critical Repair)

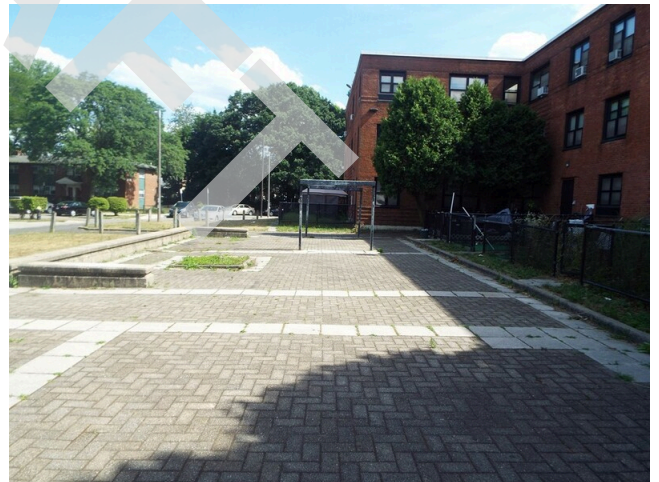
88. Concrete paver terrace - building 19

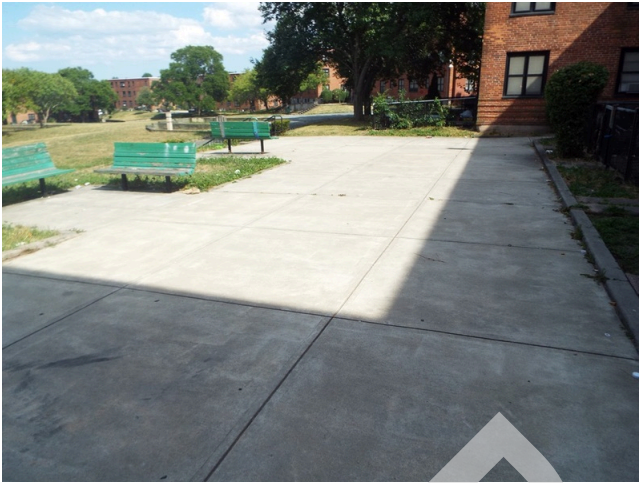
89. Concrete terrace seating area - building 17 rear

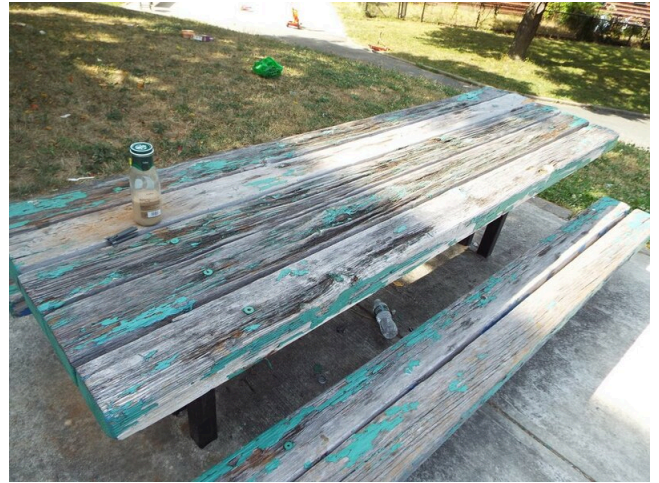
90. Outdoor seating condition - building 17 rear
(Non-Critical Repair)

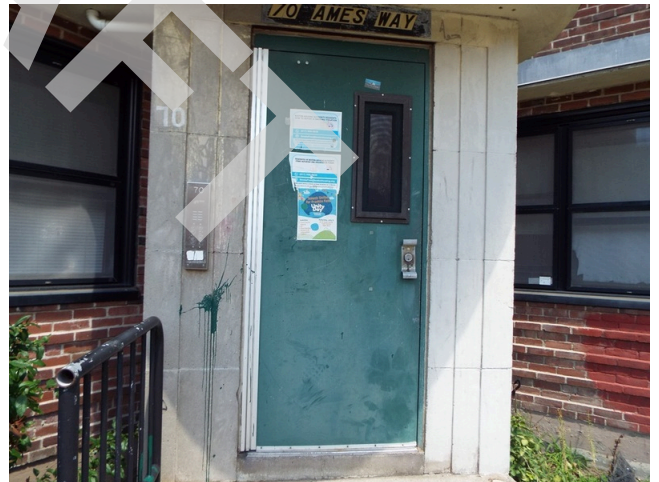
92. Building entry door condition - building 7 (Non-Critical Repair)

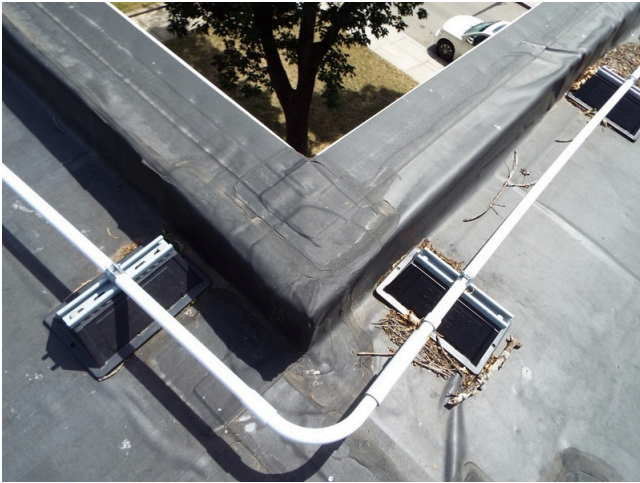
125. Roof overview - building 2

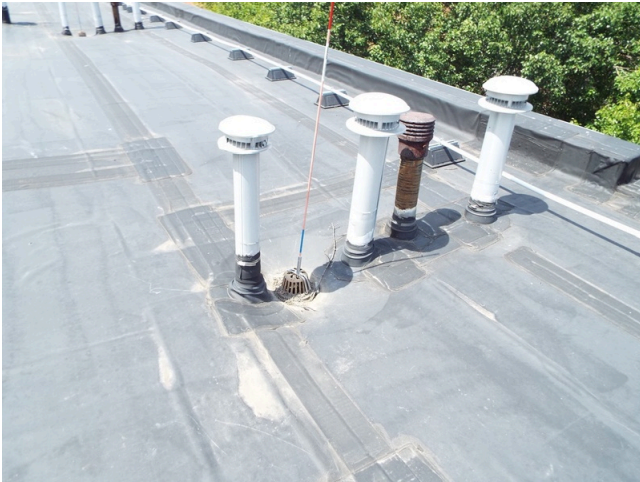
126. Roof flashing - building 2

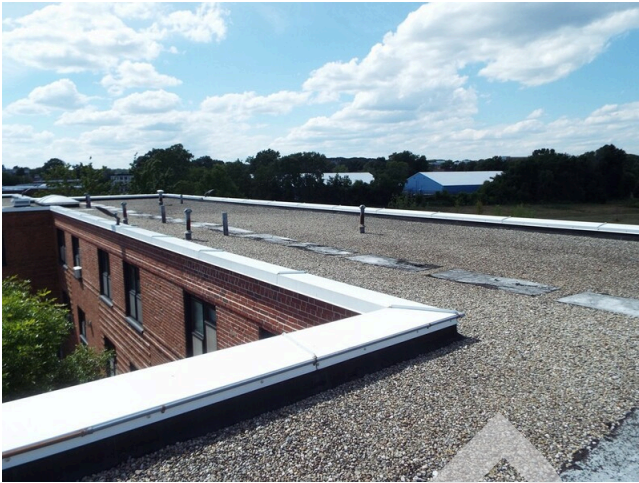
128. Skylight - building 2

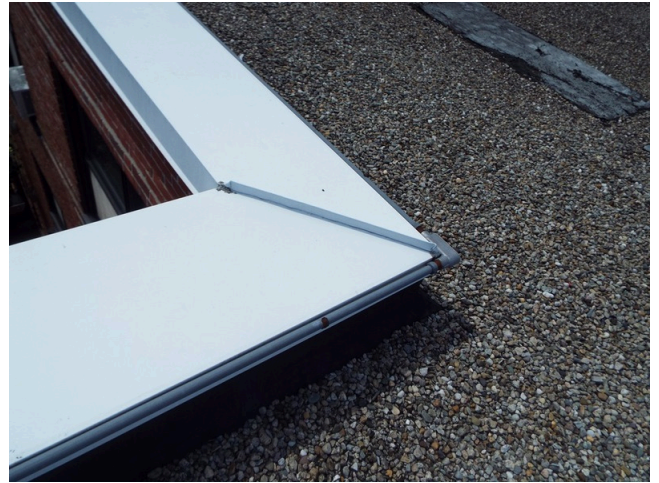
129. Roof overview - building 14

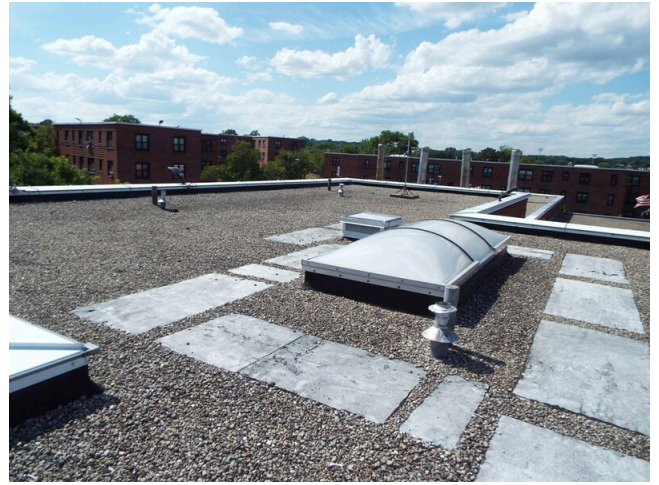
133. Roof traffic surface condition (Non-Critical Repair)

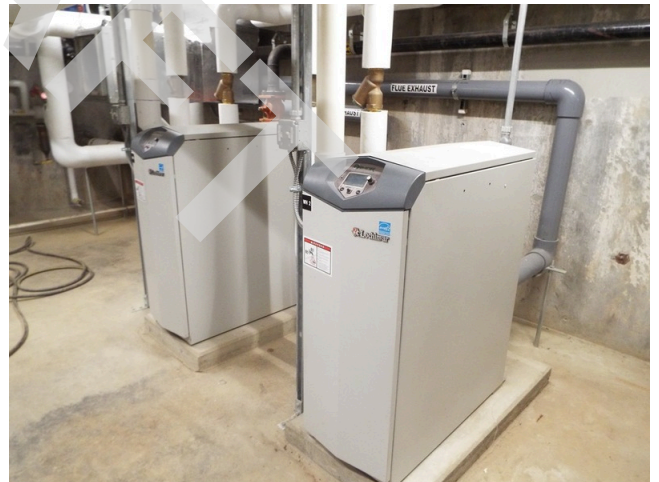
135. Domestic hot water boilers - building 12

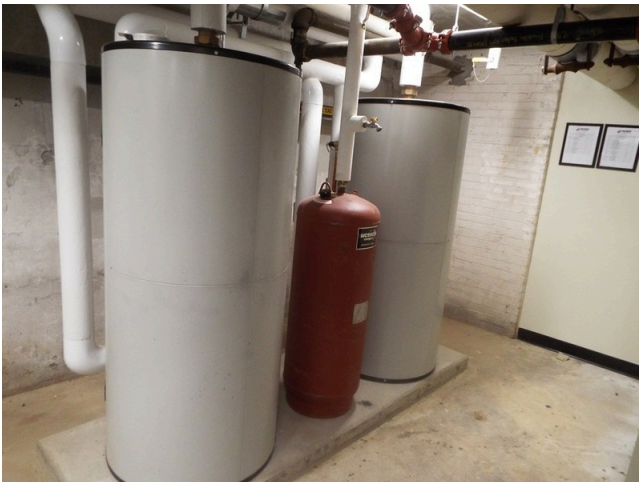
138. Domestic hot water mixing valves - building 12 (2)

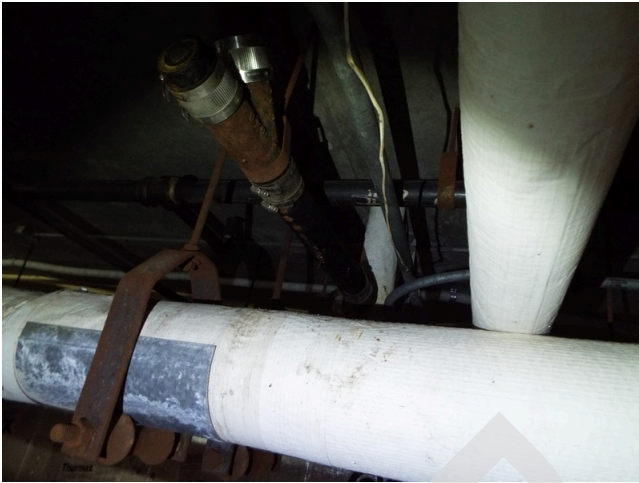
144. Moisture at pipe leak - building 17 basement
(Non-Critical Repair)

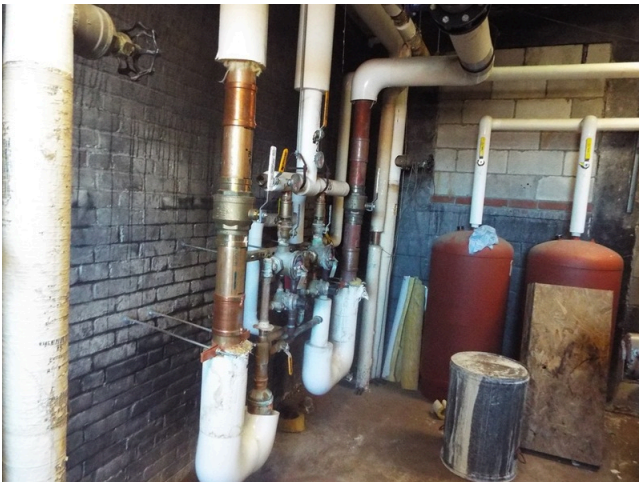
146. Water meter - building 19

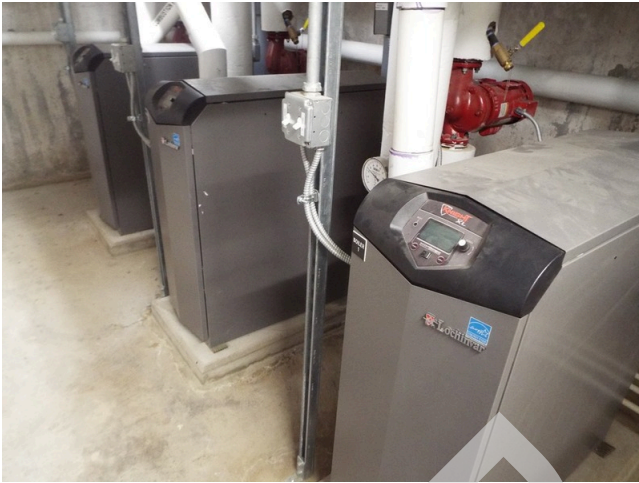
148. Heating hot water boilers - building 12

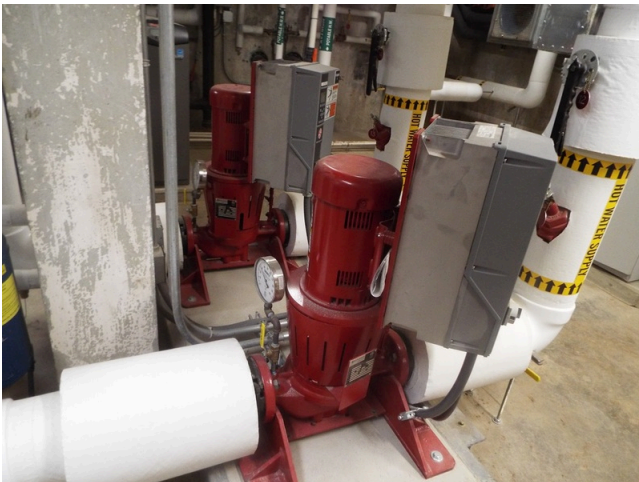
150. Heating hot water pumps - building 12

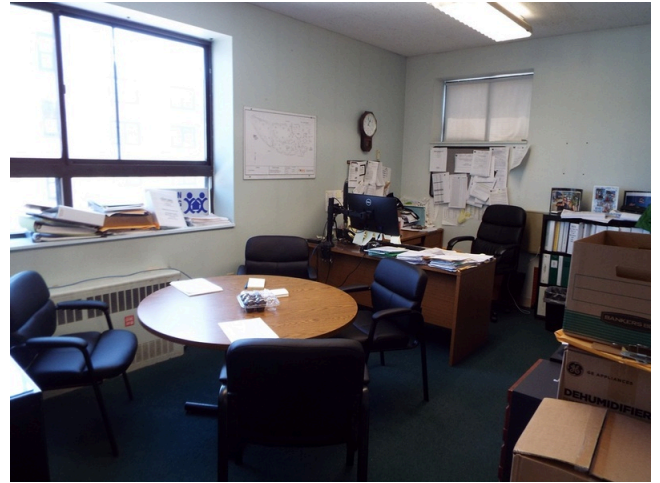
165. Common area - building 12 - leasing area

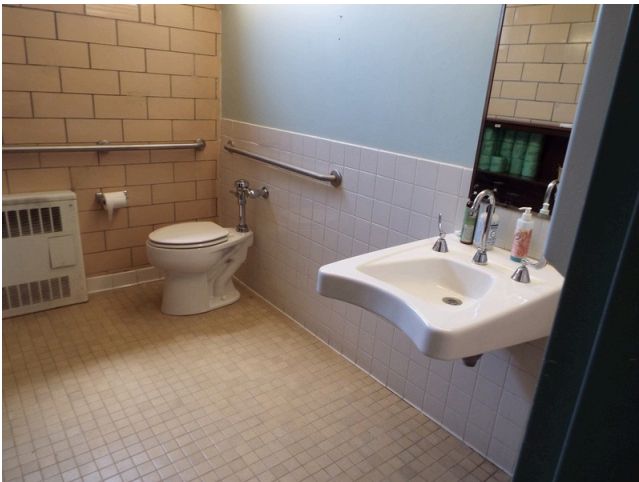
170. Common area - building 12 - men's restroom

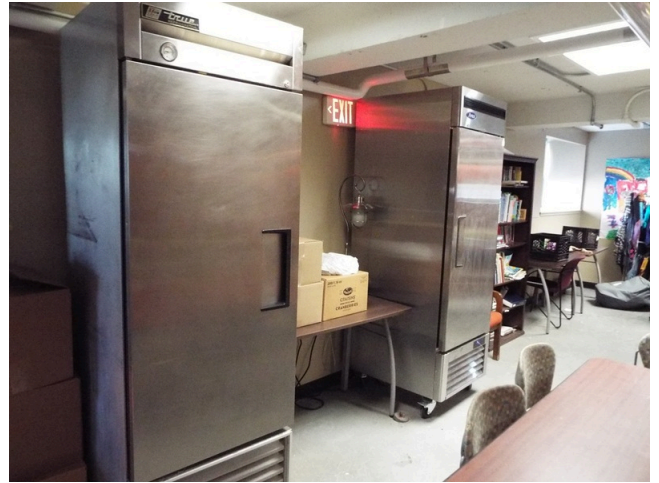
173. Common area - building 18 - teen center interior

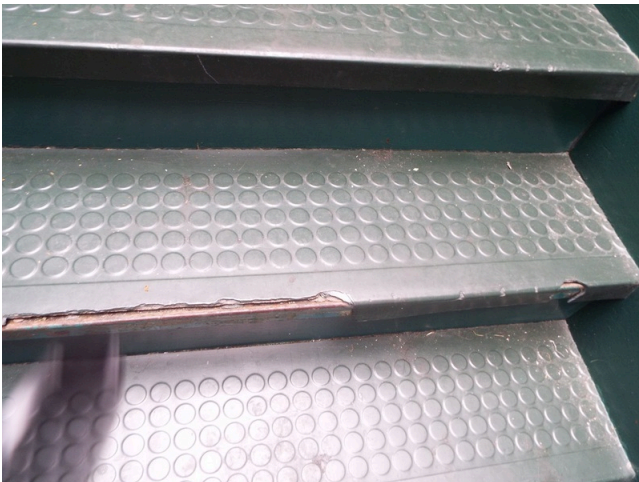
182. Interior stair tread condition - building 7
(Critical Repair)

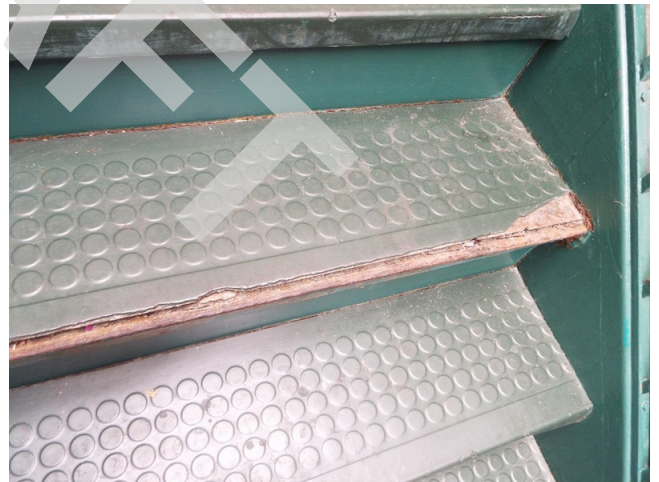
183. Interior stair tread condition - building 19
(Critical Repair)

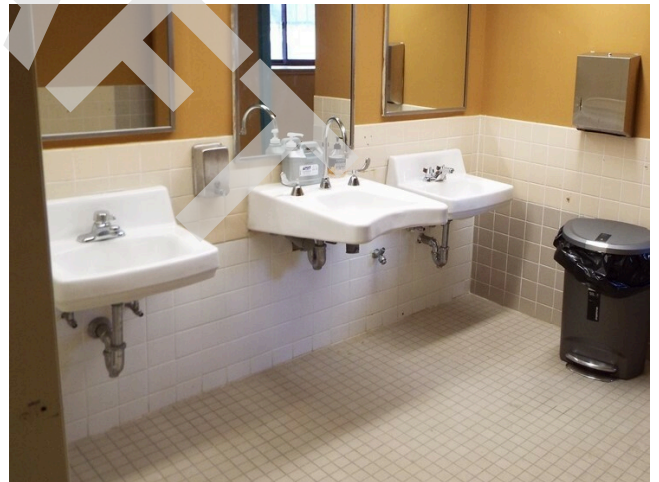
187. Common area - building 18 - teen center -
men's restroom 2 of 3 sinks lack pipe protection
(Critical Repair)

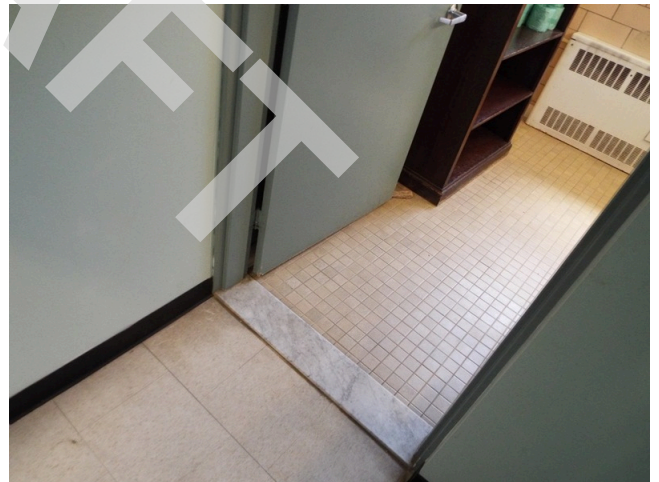
211. Common area - building 12 - office door lacks 32 inch clearance (Critical Repair)
