HUD CAPITAL NEEDS ASSESSMENT

Highland park
50 Highland Street
Boston, Massachusetts 02119

AEI Project No. 463344
Site Inspection Date: July 5, 2022

Boston Housing Authority
52 Chauncy Street
Boston, Massachusetts 02111

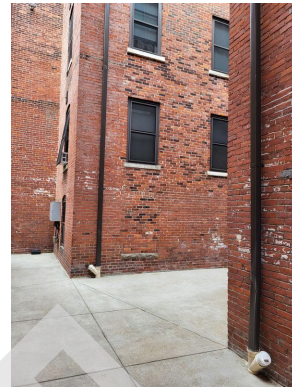
Building downspout and drainage

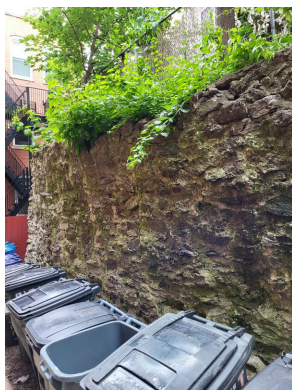
East elevation stone retaining wall

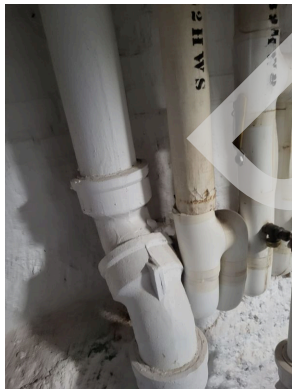
Cast iron pipe

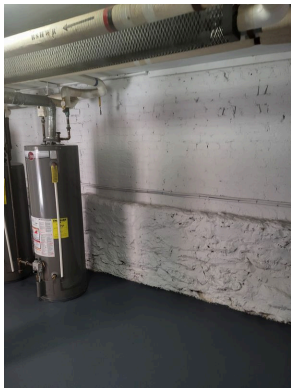
Basement concrete and brick wall

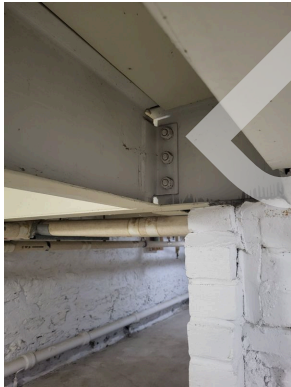
Basement support beam

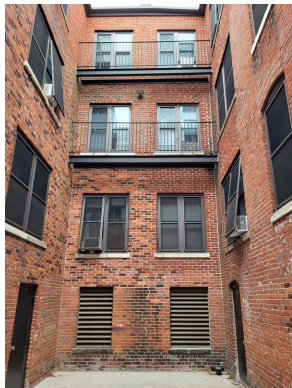
Southeast elevation court yard brick façade, balcony railings, window screens and high density light fixture

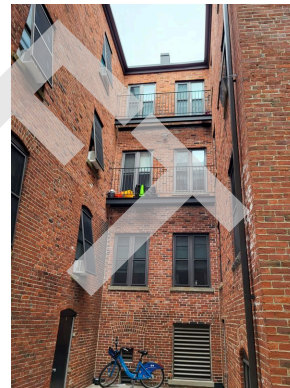
Northeast elevation court yard brick façade, balcony railings, window screens and high density light fixture

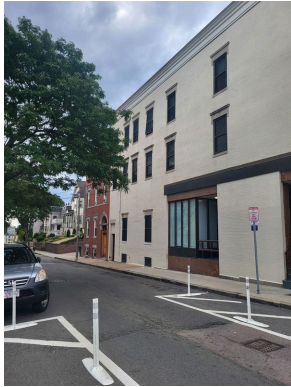
North elevation painted brick façade

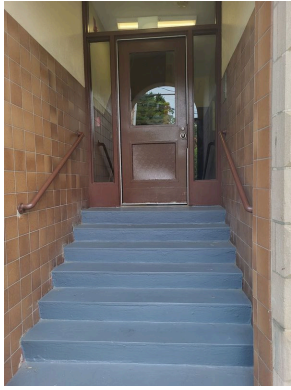
Building ingress/egress painted ingress/egress stairs, handrails and door hardware

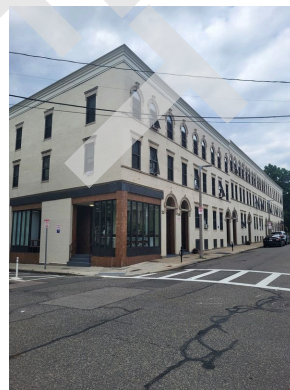
West elevation painted brick façade

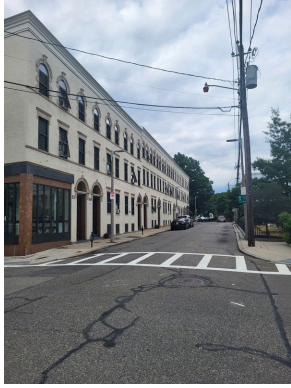
Pole electric transformer

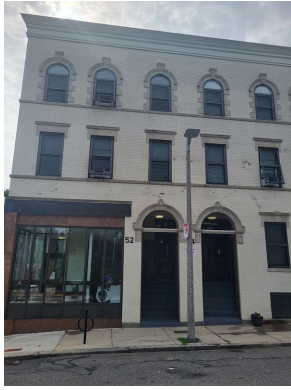
West elevation pole light

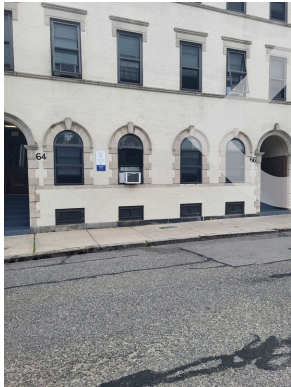
Window-mounted air conditioning, window screens and basement windows

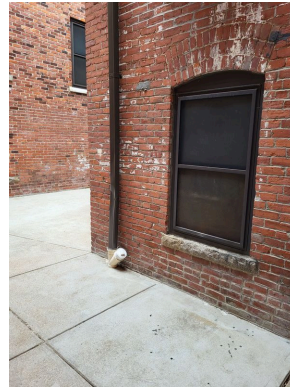
Building downspout and drainage

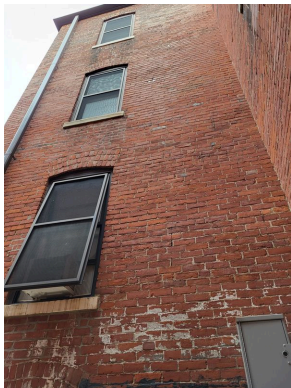
Southeast elevation brick façade

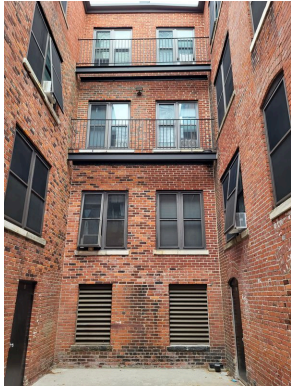
Southeast elevation court yard brick façade, balcony railings, window screens and high density light fixture

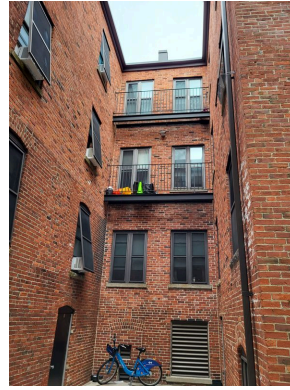
Northeast elevation court yard brick façade, balcony railings, window screens and high density light fixture

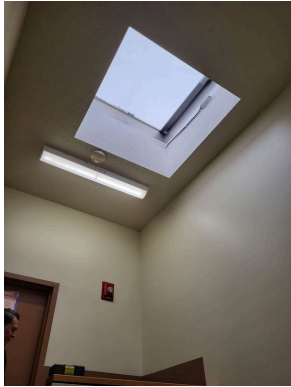
EPDM roofing

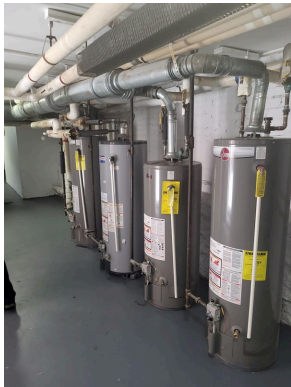
Hot water heaters

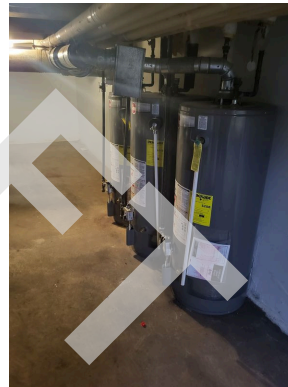
Apartment 40 gallon hot water heater

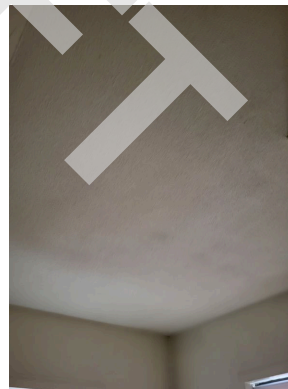
Apartment 56-3 bedroom missing smoke detector (Critical Repair)

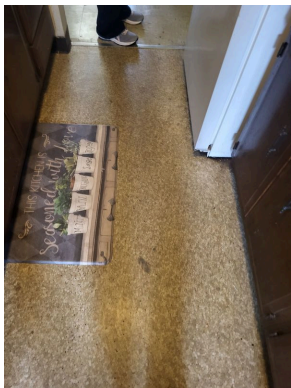
Apartment 56-3 kitchen sheet vinyl flooring (Non-Critical Repair)

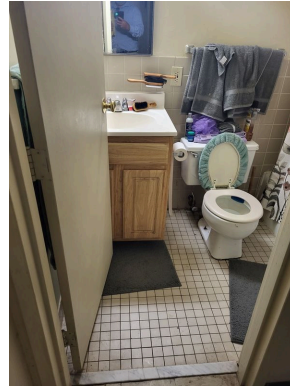
Apartment 56-3 bathroom vanity, sink, toilet and flooring

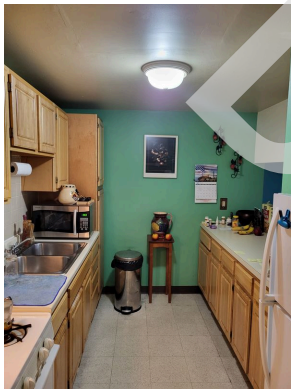
Apartment 58-3 kitchen cabinets, countertops, vinyl tile flooring and appliances

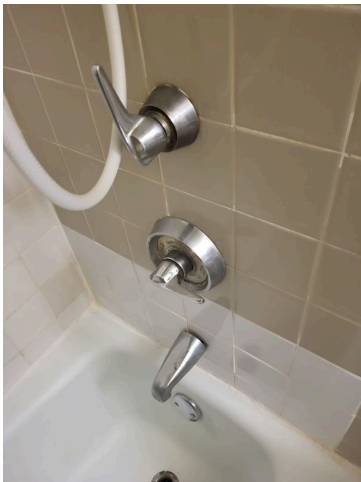
22. Apartment 54-2 bathroom shower head

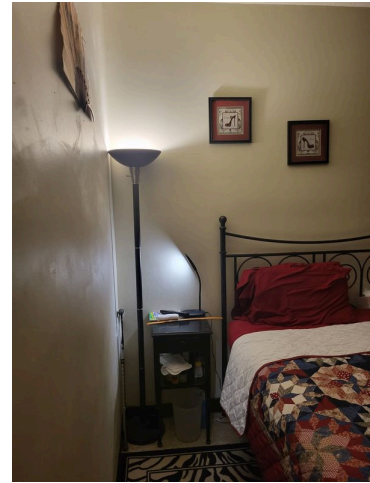
25. Apartment 54-2 bedroom

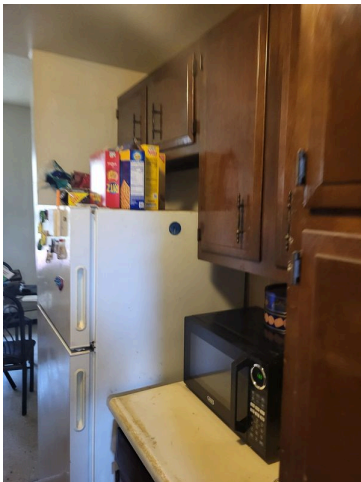
30. Apartment 56-3 kitchen cabinets, countertop and sink

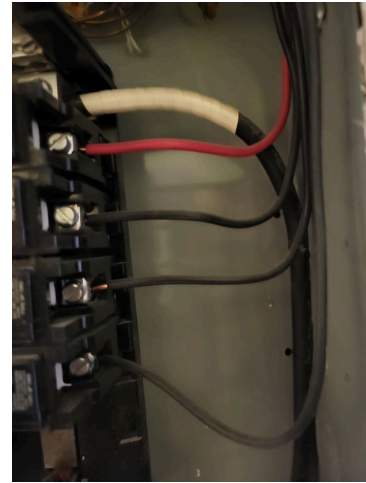
73. Apartment 58-3 circuit breaker box (Critical Repair)

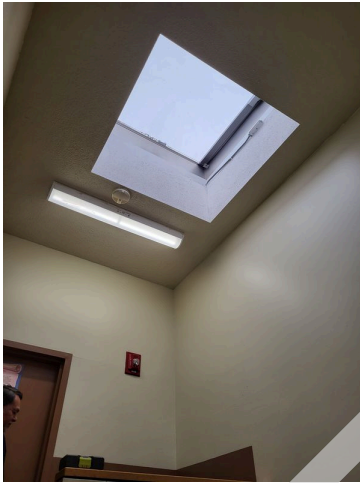
1. Common area skylight, smoke detector, emergency strobe light, and light fixture

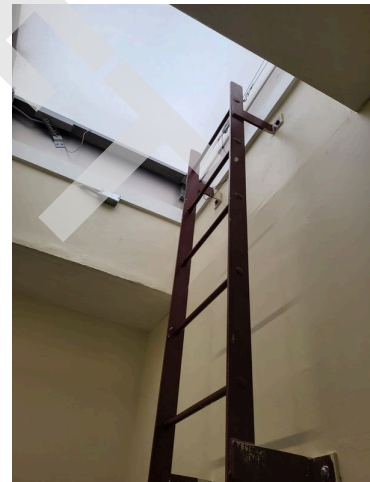
4. Building roof ingress/egress roof hatch

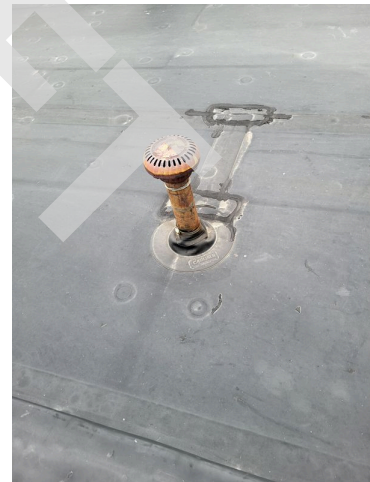
8. Roof ventilation and flashing

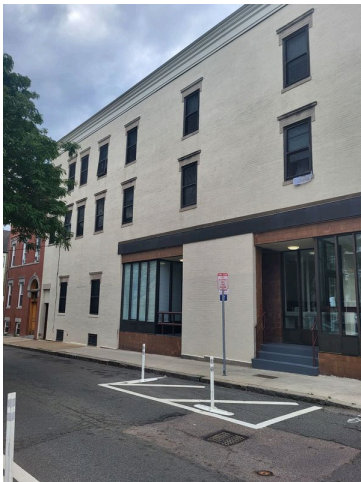
11. North elevation painted brick façade

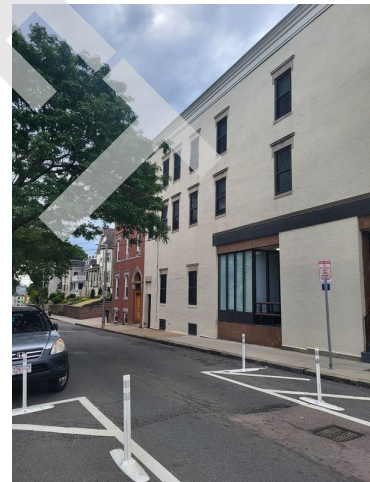
12. North elevation painted brick façade

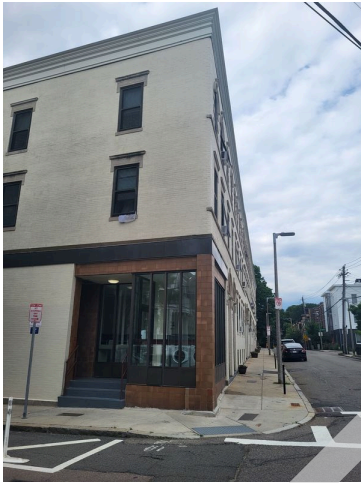
13. North elevation painted brick façade and common area ingress/egress

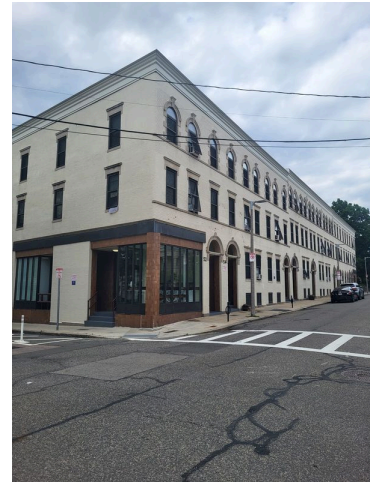
14. West elevation painted brick façade

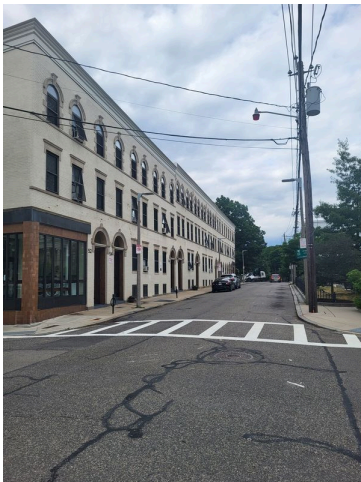
15. Pole electric transformer

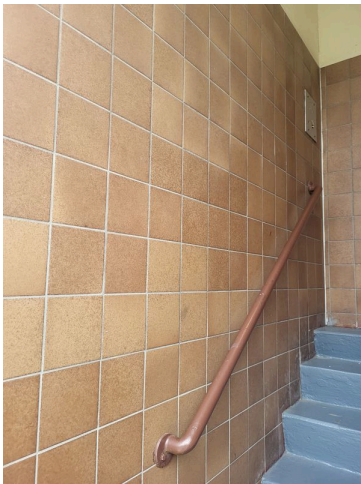
23. Building ingress/egress stairs railing and
intercom

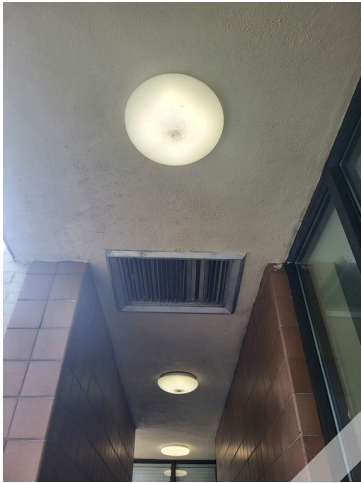
25. Common hallway light fixture

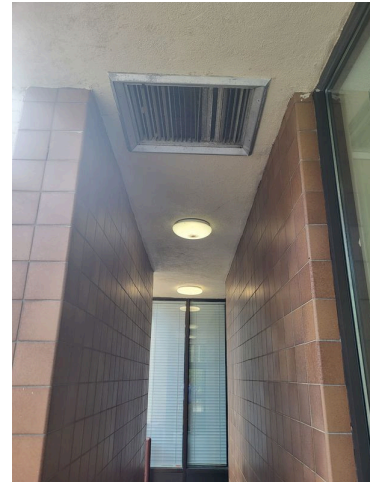
26. Common hallway light fixture

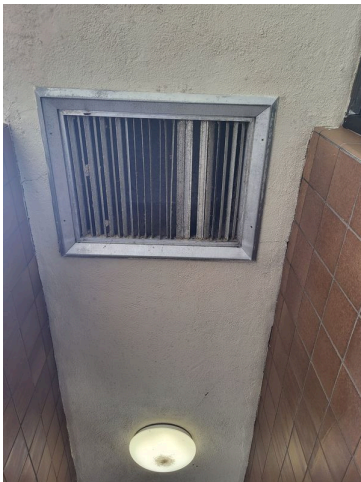
27. Common hallway ventilation

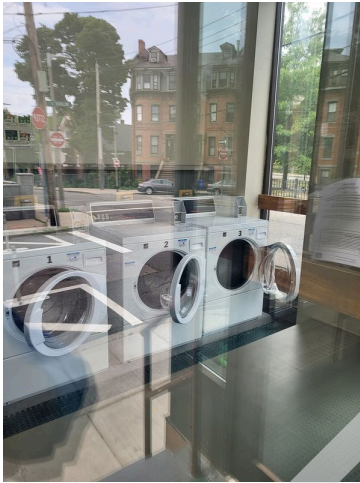
29. Common area laundry room front end loader washers

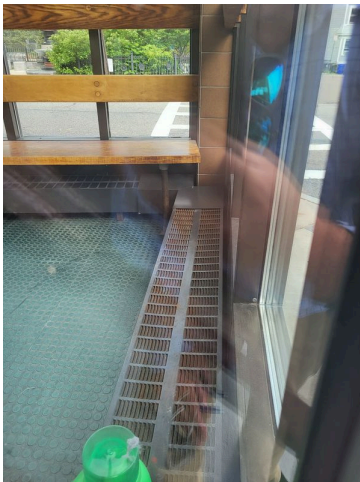
31. Common area hydronic baseboard

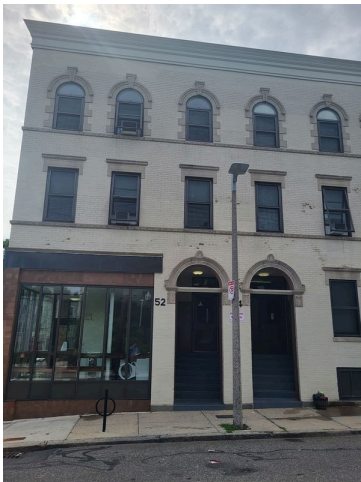
35. West elevation pole light

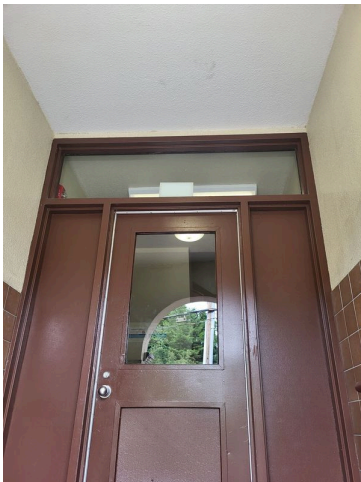
39. Building ingress/egress door

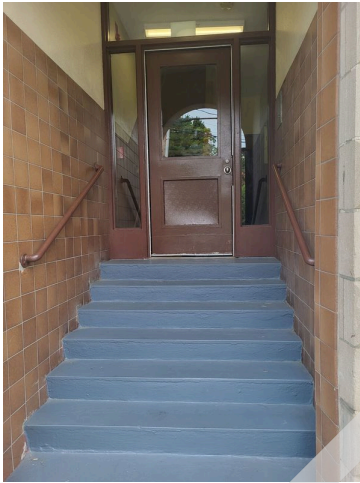
41. Building ingress/egress painted ingress/egress stairs, handrails and door hardware

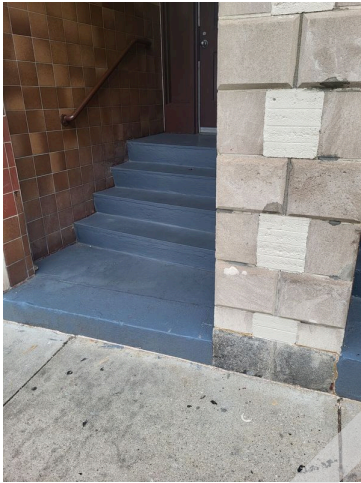
45. Building ingress/egress painted concrete stairs

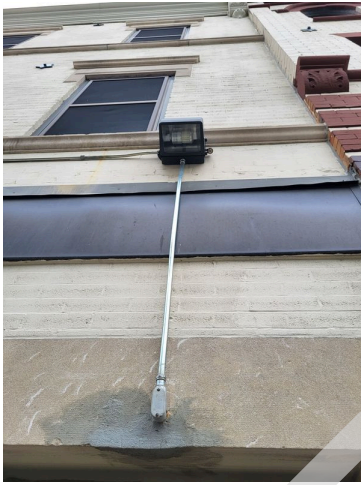
49. Exterior wall mounted high density light fixture

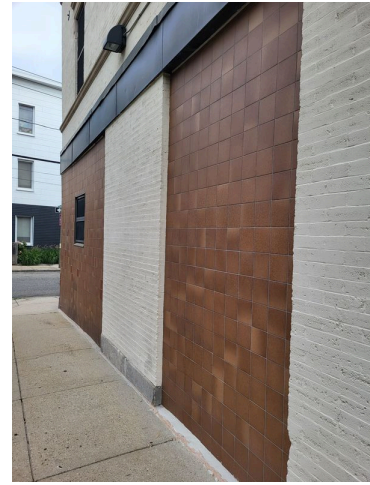
50. South elevation façade painted brick and ceramic tile

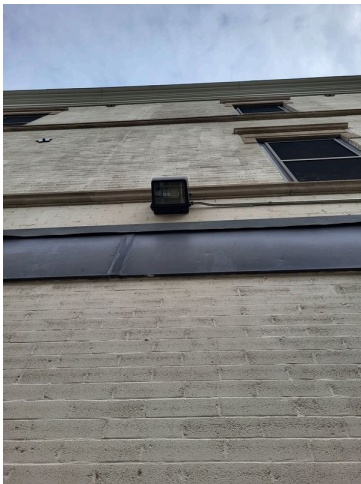
51. Exterior wall mounted high density light fixture

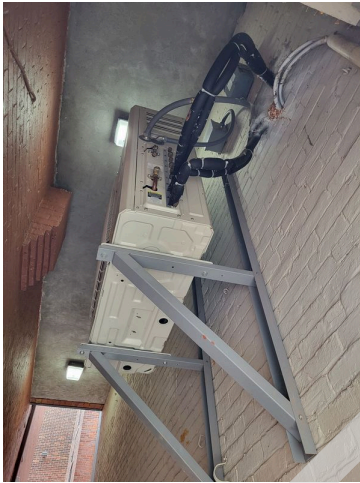
53. Court yard ingress/egress mini split system and light fixtures

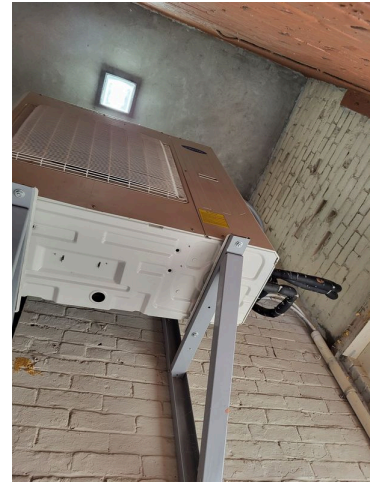
54. Court yard ingress/egress mini split system

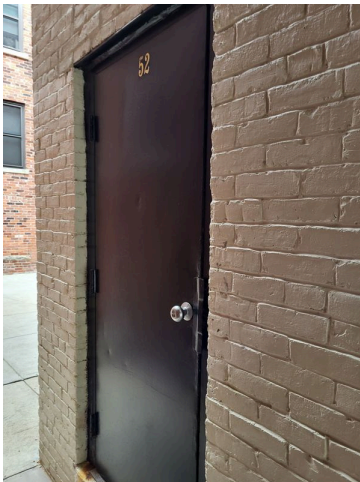
55. Exterior door ingress/egress

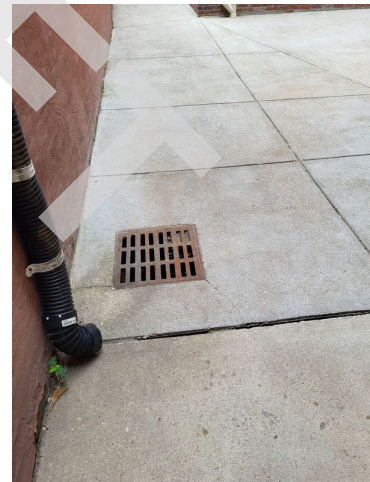
56. Building downspout and drainage

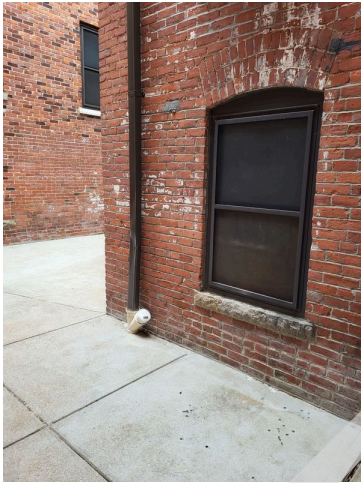
57. Building downspout and drainage

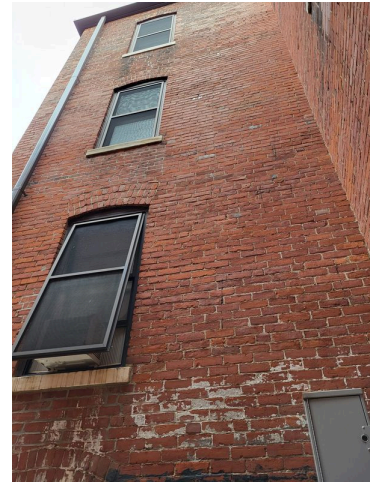
58. Southeast elevation brick façade

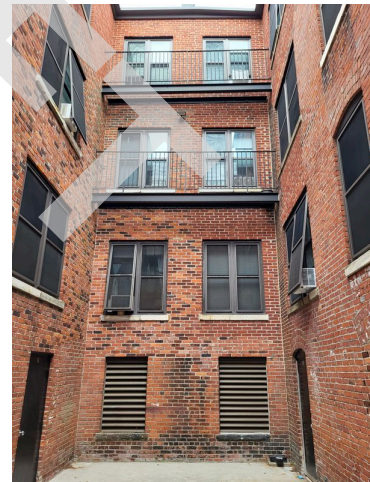
60. Southeast elevation courtyard brick façade, balcony railings, window screens and high density light fixture

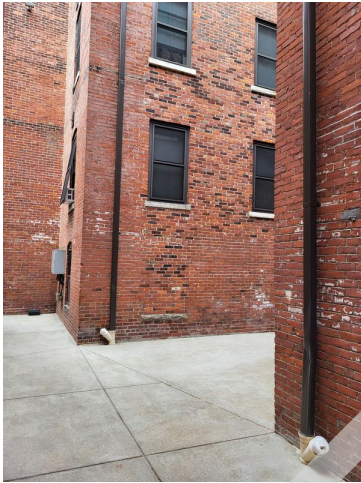
61. Building downspout and drainage

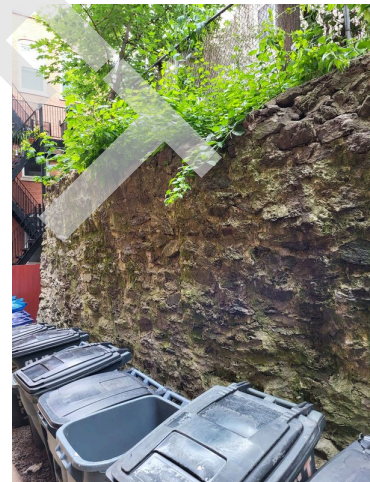
64. East elevation stone retaining wall

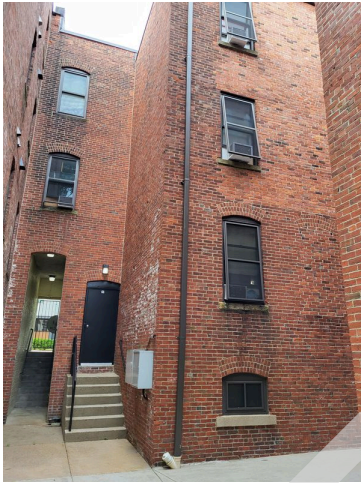
65. Court yard ingress/egress door and stairs

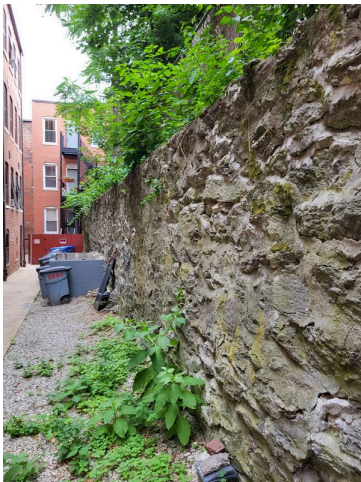
67. East elevation retaining wall and alley wood fence ingress/egress

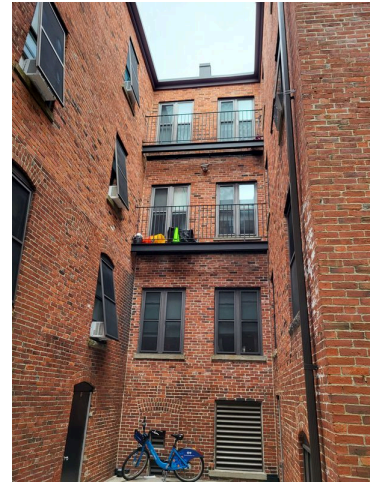
70. Northeast elevation court yard brick façade, balcony railings, window screens and high density light fixture

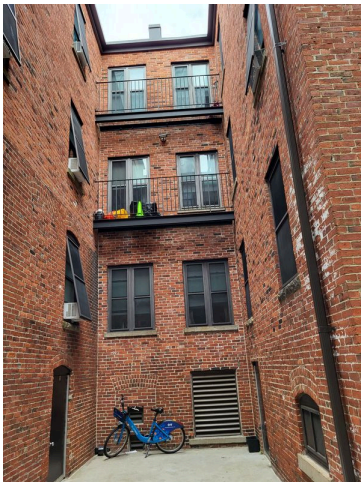
71. Northeast elevation court yard brick façade, balcony railings, window screens and high density light fixture

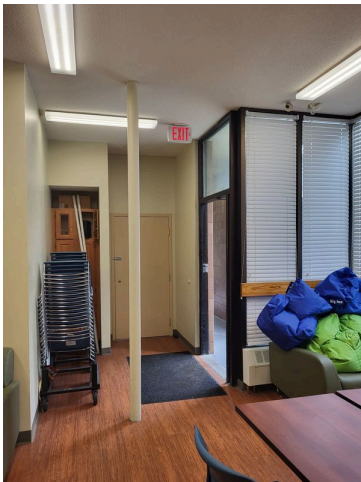
79. Community room and kitchen area emergency exit sign and emergency lighting

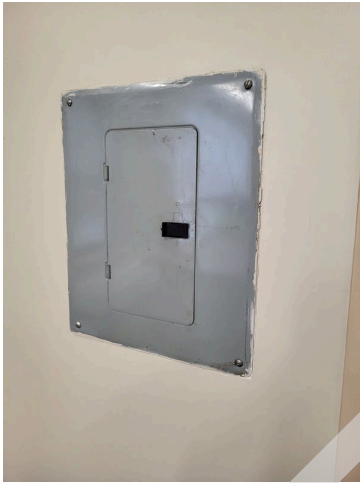
81. Gould electrical Panel

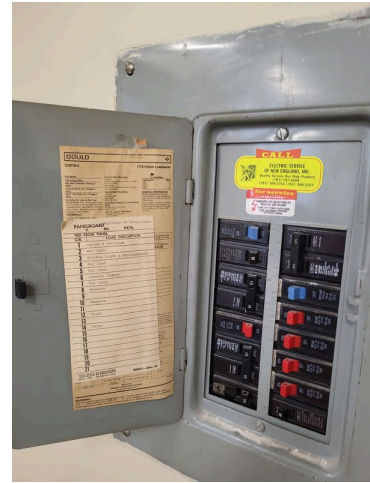
82. Gould electrical Panel

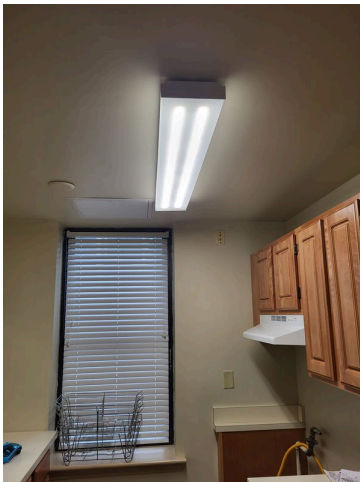
83. Community room kitchen area light fixture
