HUD CAPITAL NEEDS ASSESSMENT

Bellflower
24 Bellflower Street
Dorchester, Massachusetts 02125

AEI Project No. 463347
Site Inspection Date: July 8, 2022

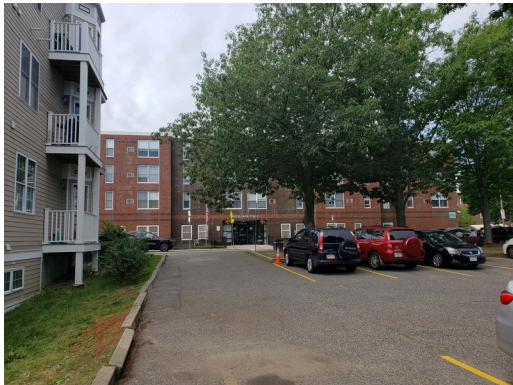
Parking Lot Entry

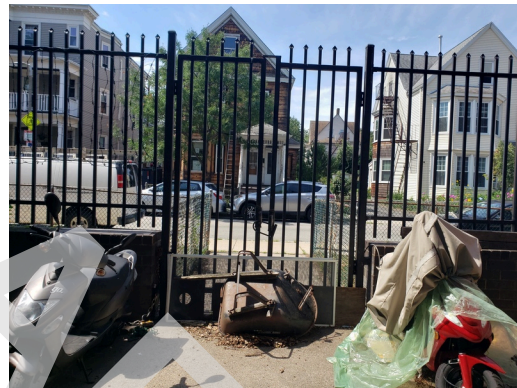
Courtyard Fencing- Gate Not Currently in Use

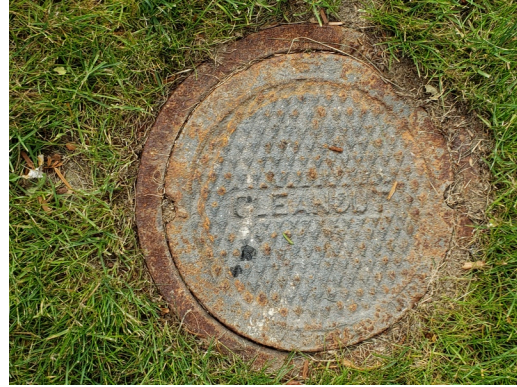
Sewer Clean out

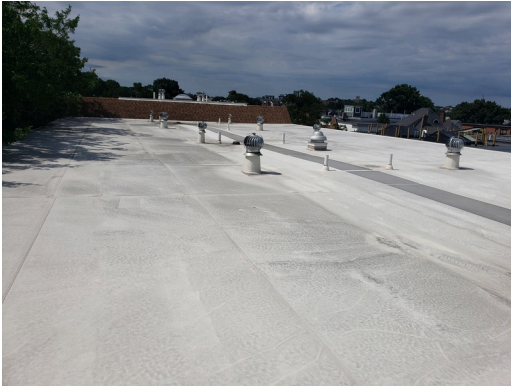
TPO Roofing (Low-Rise) and Asphalt Shingle Roofing

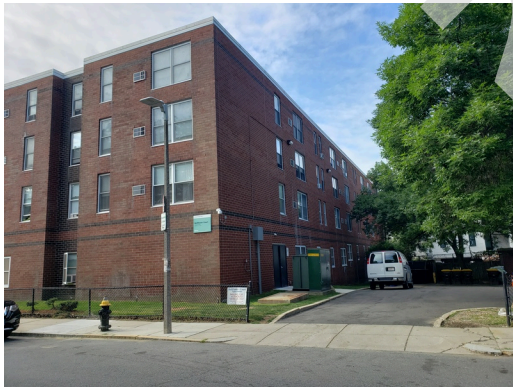
Northwestern Building Exterior

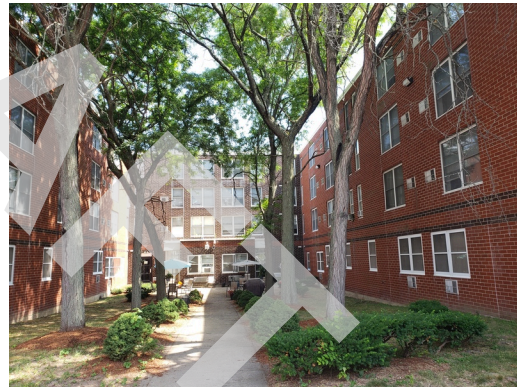
Interior Courtyard- Building Elevation

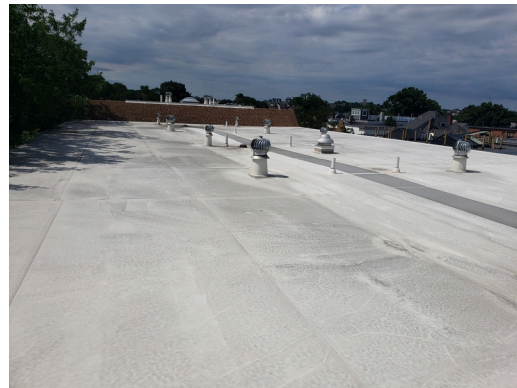
TPO Roofing (Low-Rise) and Asphalt Shingle Roofing

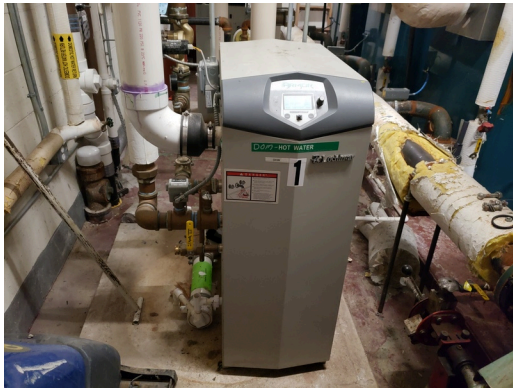
Domestic Hot Water Boiler

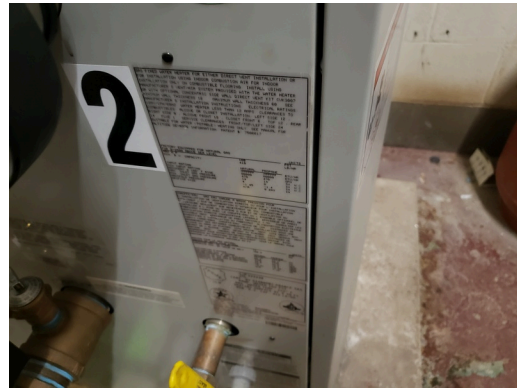
Domestic Hot Water Boiler

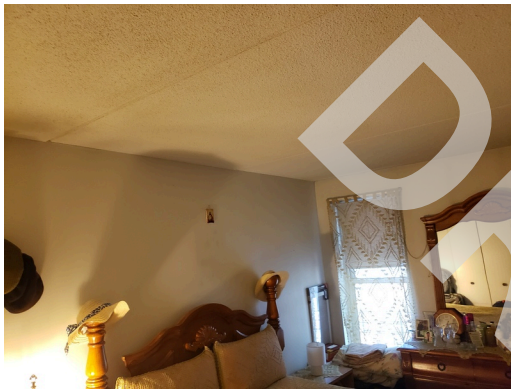
Unit 409- 1bed/1bath- Bedroom- Install Bedroom Smoke Detectors Per HUD (Critical Repair)

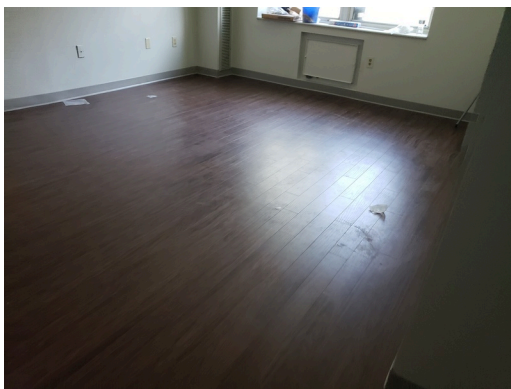
Unit 101-ANSI- 2bed/1bath- Bedroom- Install Audio / Visual Smoke Detectors (Critical Repair)

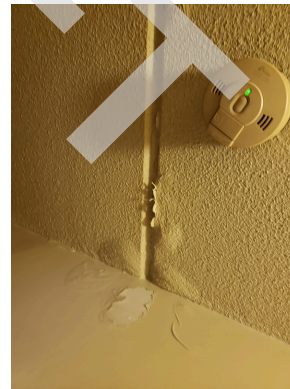
Unit 207- 1bed/1bath- Bathroom- Repair Leak in Hallway- Repair Damaged Ceiling (Non-Critical Repair)

AEI observed water damage to several common area hallway ceiling tiles as well as in-unit drywall ceiling panels. At the time of the site visit, AEI observed the ceiling panels to be dry and reported that the cause of the damage was a leak in unit 320 that had occurred three months ago. One active leak was observed in unit 207. AEI recommends finding the source of this leak. The in-house maintenance staff can accomplish the replacement of the damaged ceiling panels. Suspected microbial growth was observed to be associated with the former roof leaks. AEI observed interior areas of the subject property building in order to identify the presence of mold. During the on-site reconnaissance, the following obvious visible signs of mold growth or conditions conducive for suspect mold growth were observed:

Location	Material Affected	Condition	Size of Area Affected
Unit 207 Bathroom	Drywall	fair/poor	1 sf ft

However, AEI observed active leaks in the bathroom ceiling of unit 207. All active plumbing leaks must be repaired. An opinion of cost for this work is included in the Tables.

Although typically not included in the scope of work for a Phase I ESA, the presence of the suspect mold identified may pose a health and safety concern to any subsequent occupants and/or construction workers during future renovation activities. Based upon the amount of suspect fungal growth observed, AEI recommends clean-up of visible, suspect mold be conducted within the affected area, which should include but not be limited to the following:

- Remediation/cleanup using a mold cleaning solution and mild disinfectant by appropriate personnel utilizing appropriate PPE and engineering controls.
- Disposal of all suspected mold affected building materials that may not be cleaned, as well as used disposable PPE gloves and masks, in sealed plastic bags.
- Repairs to prevent or correct the source of the water damage should also be performed.

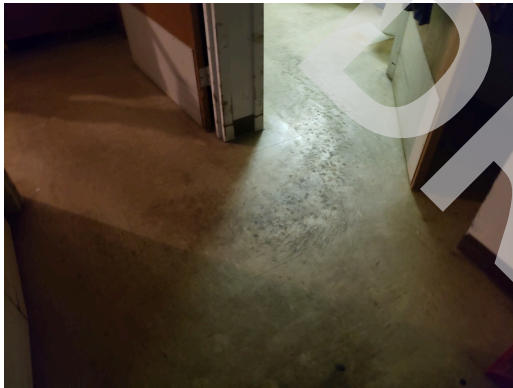
Unit 216- UFAS- 1bed/1bath- Replace Vinyl Flooring -1-Bed-Living Room, Kitchens and Baths (Dwelling Units) (Older) (Non-Critical Repair)

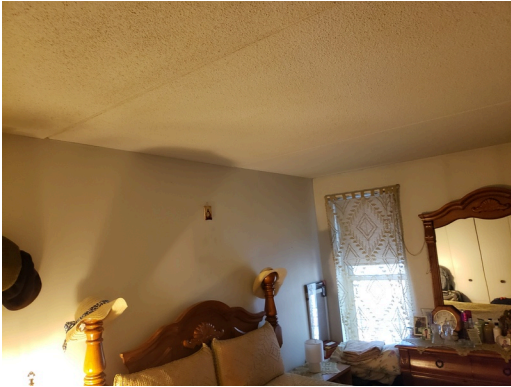
Unit 409- 1bed/1bath- Bedroom- Install Bedroom Smoke Detectors Per HUD (Critical Repair)

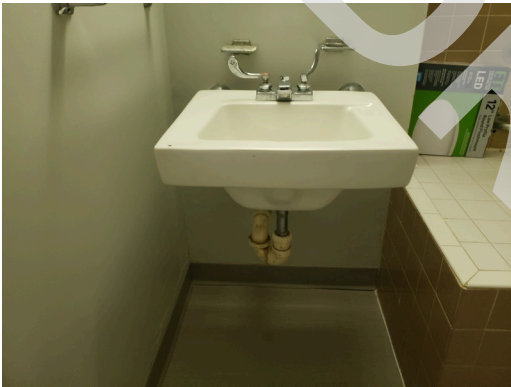
Unit 101-UFAS HDCP- 2bed/1bath- Bathroom- Install Scald and Abrasion Sink Wrap (Critical Repair)

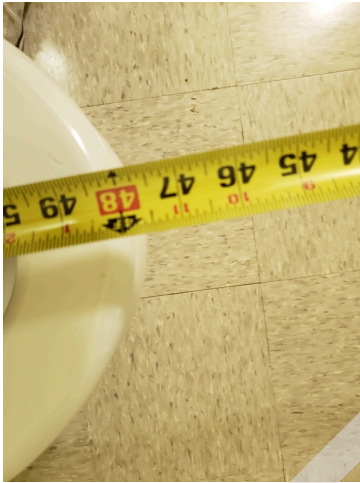
30. Unit 315- UFAS- 1bed/1bath- Bathroom- Clear Floor Space at WC

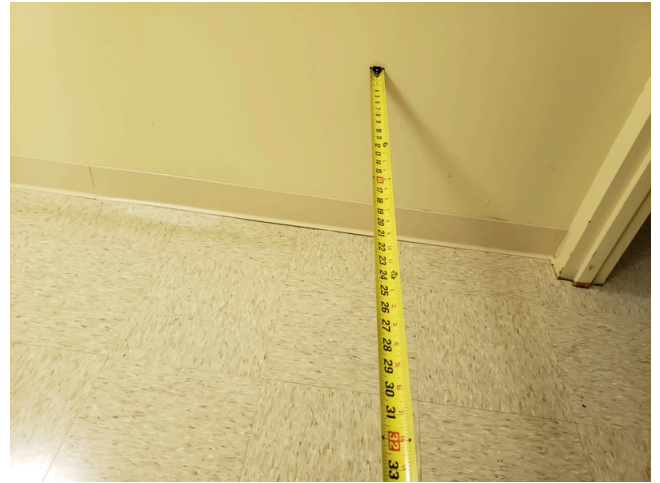
31. Unit 315- UFAS- 1bed/1bath- Bathroom- Clear Floor Space at Door

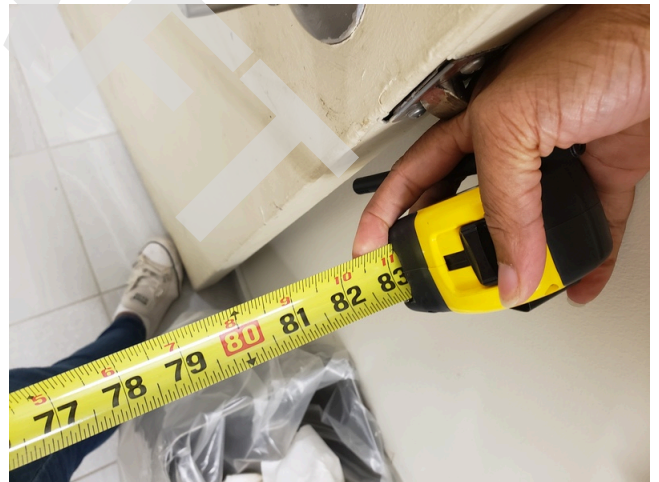
35. Common Area- Public Men's Restroom- Clear Floor Space at Door to Sink

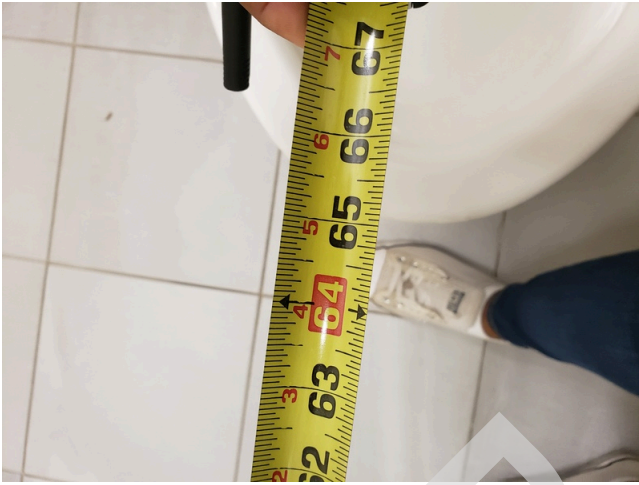
36. Common Area- Public Men's Restroom- Clear Floor Space at Door to Sink

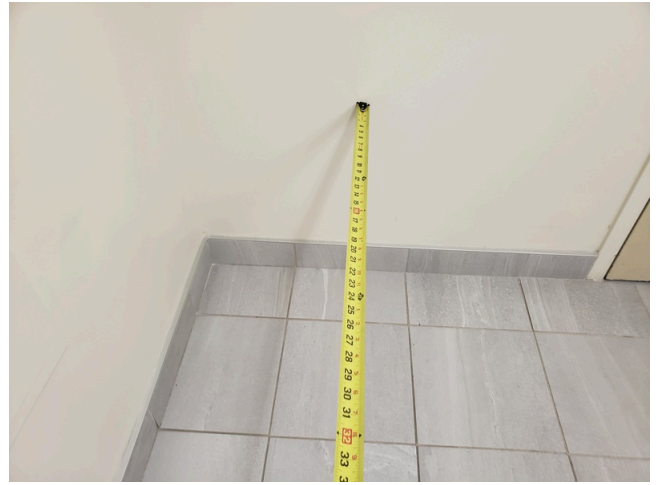
37. Common Area- Public Men's Restroom- Clear Floor Space at WC

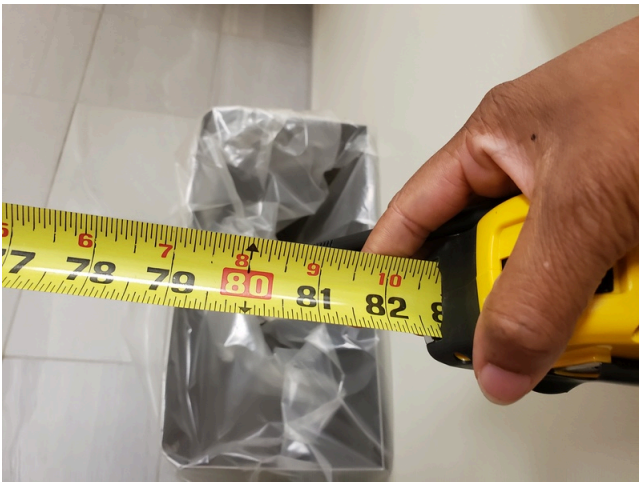
42. Common Area- Public Women's Restroom- Clear Floor Space

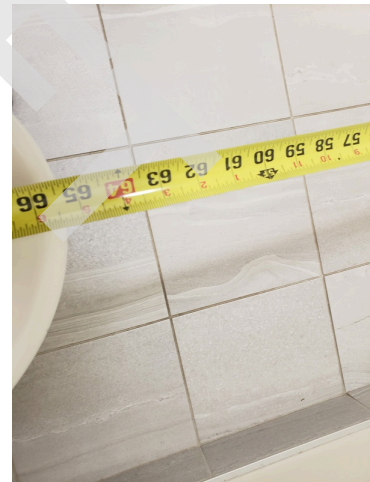
43. Common Area- Public Women's Restroom- Clear Floor Space

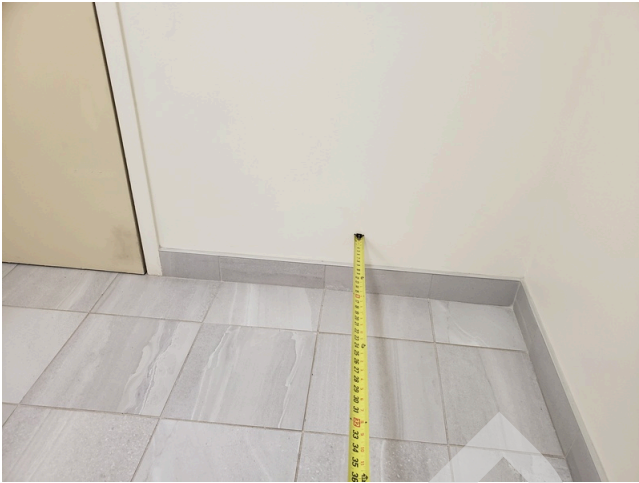
44. Common Area- Public Women's Restroom- Clear Floor Space at WC

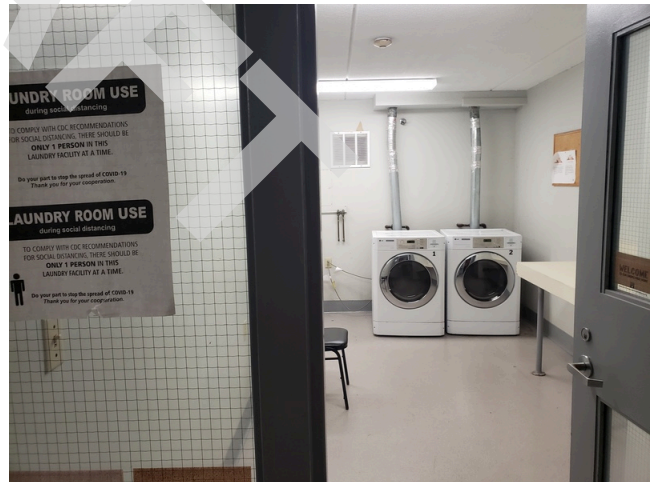
47. Common Area Laundry- Sink

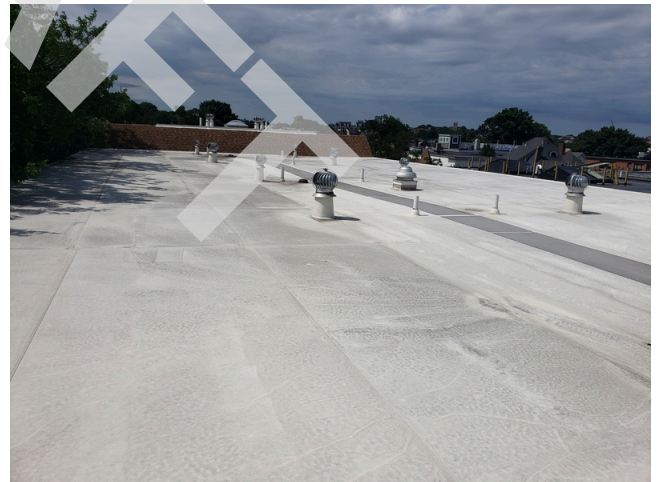
87. TPO Roofing (Low-Rise)
