## HUD CAPITAL NEEDS ASSESSMENT

Washington Street  
91 Washington Street  
Brighton, Massachusetts 02135

AEI Project No. 463351  
Site Inspection Date: July 20, 2022

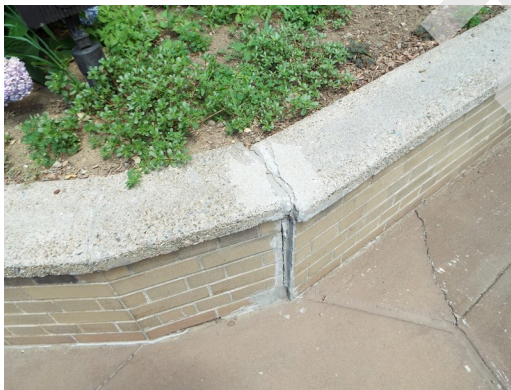
Deterioration of brick masonry landscaping retaining walls was observed at the plaza located at the front of the building. Repair is required. (Non-Critical Repair)

Landscape retaining wall condition  
(Non-Critical Repair)

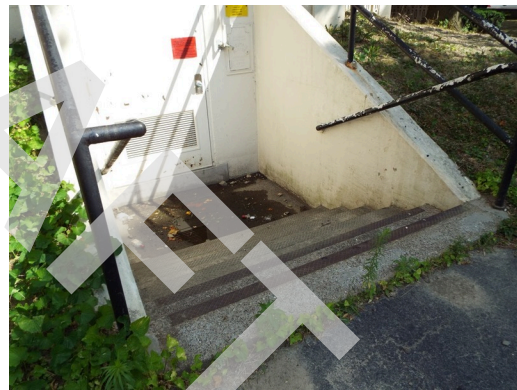
Concrete retaining wall at exterior steps,  
should sand and paint handrails (Non-Critical Repair)

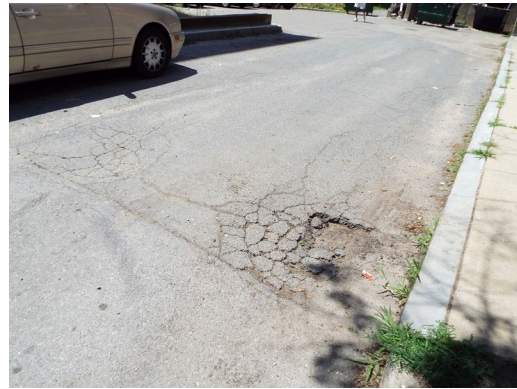
Deterioration, depressions and cracking of asphalt pavement was observed at the rear parking area and rear access drive. Repair is recommended. (Non-Critical Repair)

Rear access drive - pavement condition  
(Non-Critical Repair)

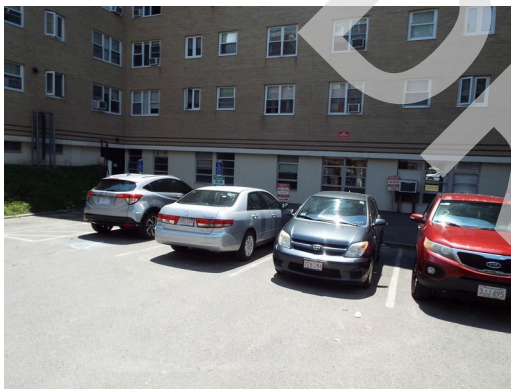
Worn seal coat and faded striping was observed at the rear parking area. Resealing and restriping is recommended. (Non-Critical Repair)

Seal coat and striping condition (Non-Critical  
Repair)

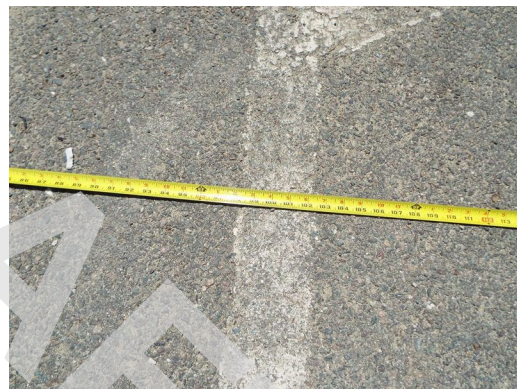
Pavement and striping condition (Non-Critical  
Repair)

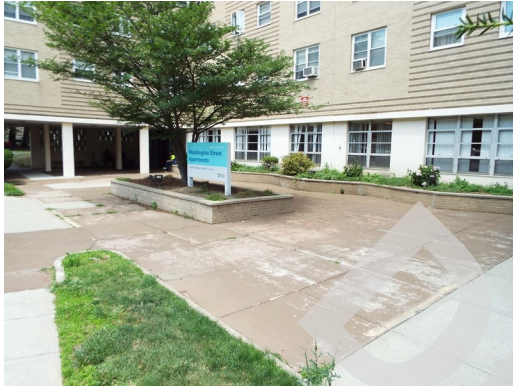
Deterioration and cracking of concrete pavement was observed throughout the sidewalks and plaza located at the front of the building. Repair is recommended. (Non-Critical Repair)

Concrete plaza, cracks/deteriorated stain  
(Non-Critical Repair)

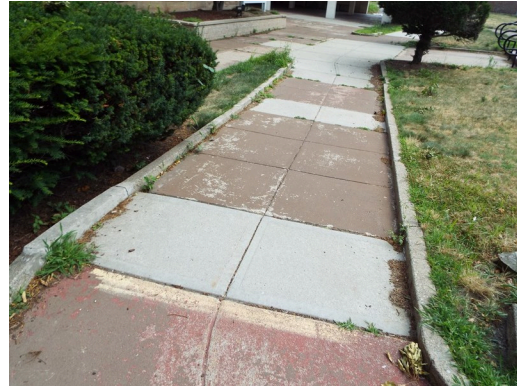
Sidewalk condition (Non-Critical Repair)

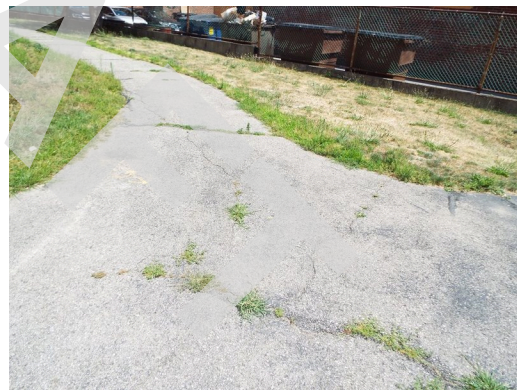
Deterioration and cracking of asphalt pavement was observed throughout the walkways and plazas located at the sides of the building. Repair is recommended. (Non-Critical Repair)

Asphalt walkway condition (Non-Critical Repair)

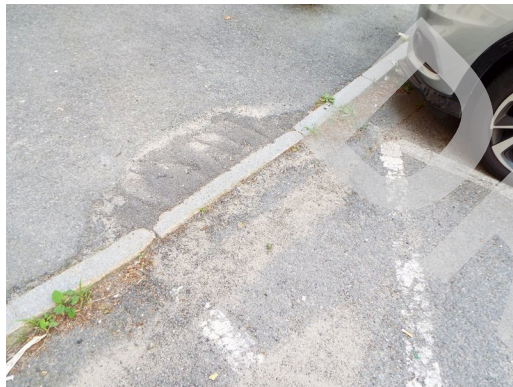
Differential settlement of asphalt pavement and a raised curb was observed at the accessible parking access aisle located at the rear of the building. The conditions represent a trip hazard. Repair is required. (Critical Repair)

Trip hazard - accessible parking access aisle  
(Critical Repair)

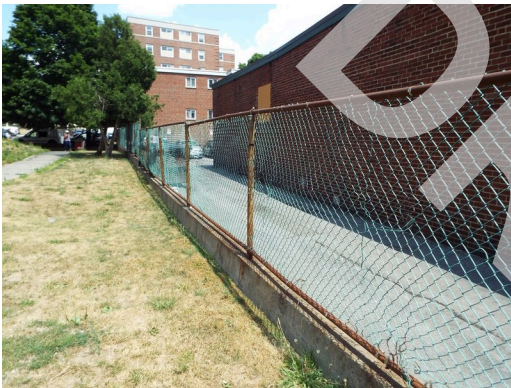
Deterioration and rusted chain link fencing was observed located at the west property boundary. Replacement is recommended. (Non-Critical Repair)

Fencing condition (Non-Critical Repair)

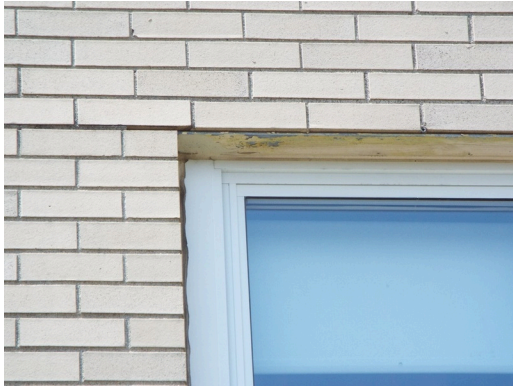
Vertical cracking was observed at exterior masonry located at the corners of the 91 wing and 95 wing south elevations. Horizontal displacement of brick was observed at exterior masonry located above a window at the 91 wing south elevation. Inspection and repair recommendations by a licensed structural engineer is required. (Critical Repair)

Horizontal brick displacement (Non-Critical Repair)

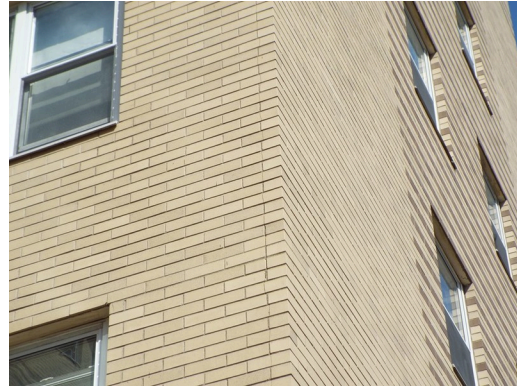
Vertical brick cracking - 91 wing (Non-Critical Repair)

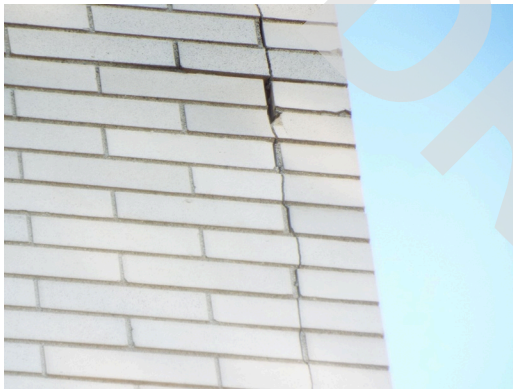
Vertical brick cracking - 95 wing (Non-Critical Repair)

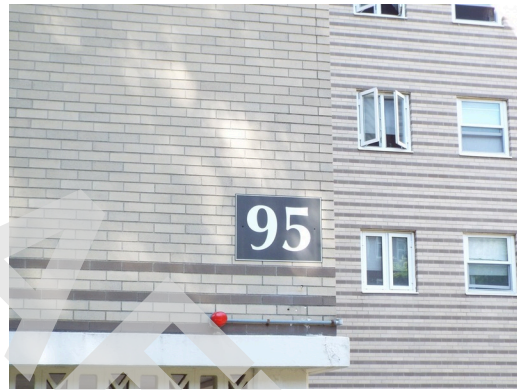
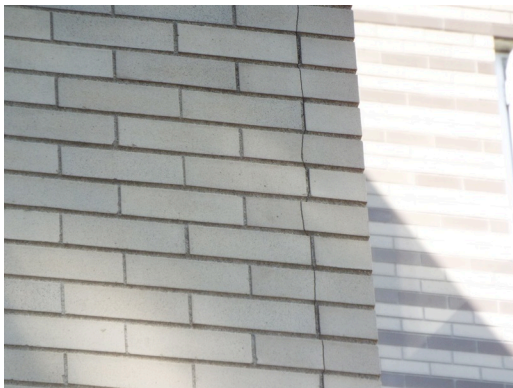
Vertical exterior cracking - 95 wing

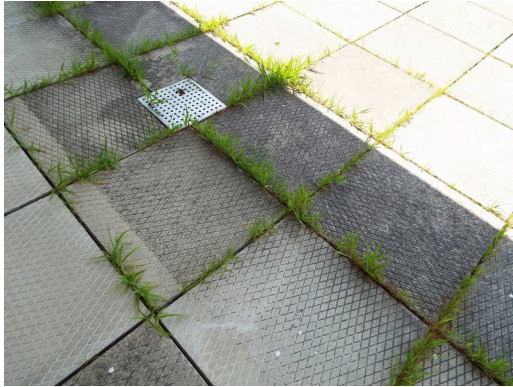
Rooftop terrace vegetation (Non-Critical Repair)

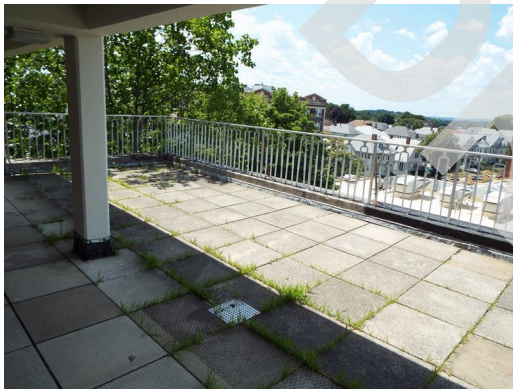
Rooftop terrace - 95 wing, treat weeds (Non-Critical Repair)

Outdoor roof terraces have concrete pavers set over the roofing membrane. Vegetation was observed throughout the seams between concrete pavers. The terrace roof membrane could not be directly observed. However, on-site personnel reported that the roof is approximately 20 years old and, as such, has reached the end of the EUL. AEI recommends terrace roof replacement. (Non-Critical Repair)

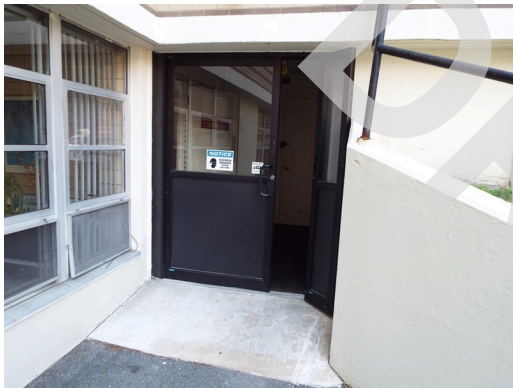
Damage in the form of a missing sidelight and panic hardware was observed at the rear entry door located at wing 95. Repair is required. (Critical Repair)

Damaged rear entry door (Critical Repair)

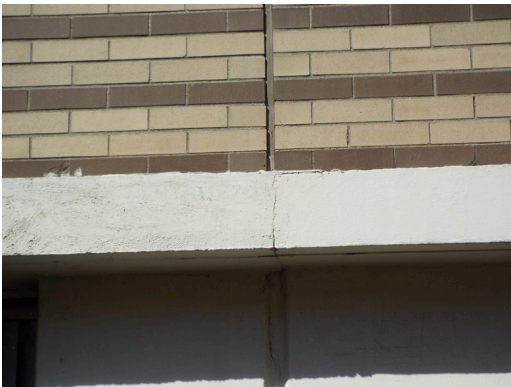
Deterioration of exterior sealant was observed at windows and vertical masonry joints. Replacement is recommended. (Non-Critical Repair)

Sealant condition (Non-Critical Repair)

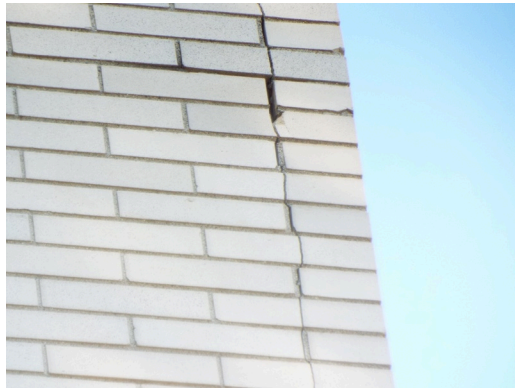
Vertical brick cracking - 95 wing (Non-Critical Repair)

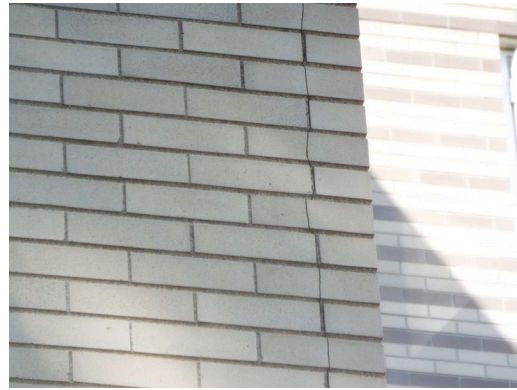
Vertical exterior cracking - 95 wing

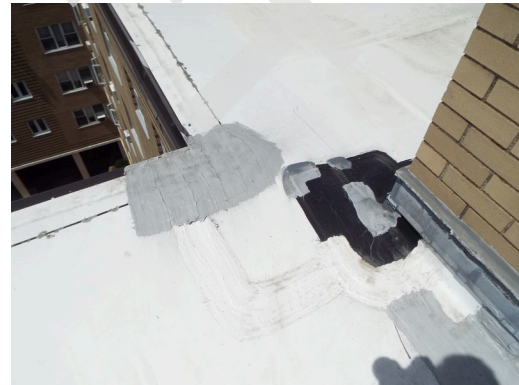
Roof flashing (Non-Critical Repair)

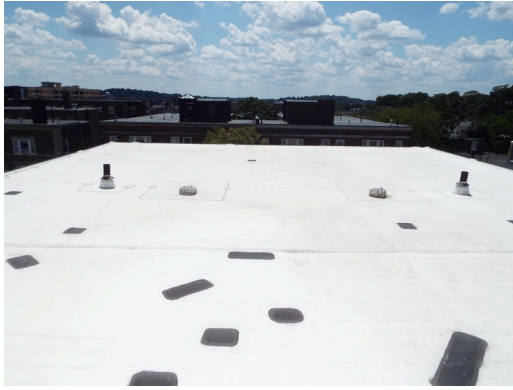
The main roof is generally in overall fair condition. The surfaces are worn and evidence of numerous patching was observed. On-site personnel reported that the roof is approximately 20 years old and, as such, has reached the end of the EUL. AEI recommends roof replacement. (Non-Critical Repair)

Roof overview (Non-Critical Repair)

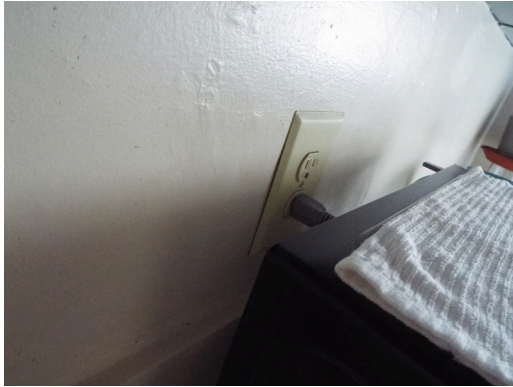
1-bed-1-bath - unit 6 -kitchen lacks GFCI  
(Critical Repair)

Several kitchens were observed lacking GFCI receptacles. Installation of GFCI receptacles is required. (Critical Repair)

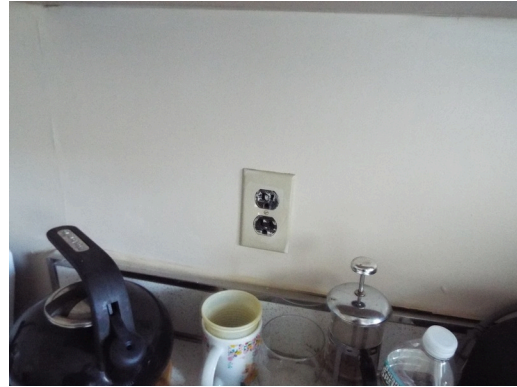
1-bed-1-bath - unit 13 - kitchen lacks GFCI  
receptacle (Critical Repair)

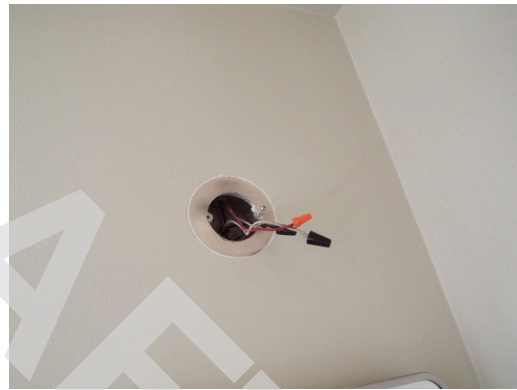
1-bed-1-bath - unit 25 - missing light fixture  
(Critical Repair)

A missing light fixture and exposed wiring was observed in unit 25. Replacement of the fixture is required. (Critical Repair)

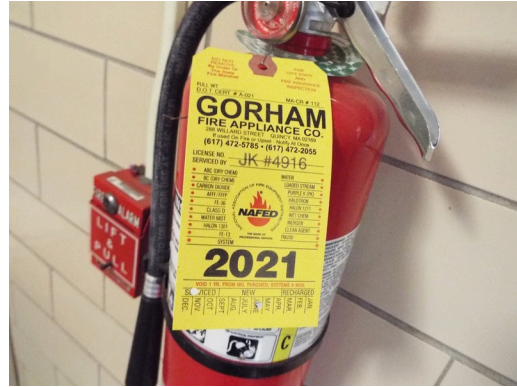
Fire extinguisher - expired service date  
(Critical Repair)

An expired fire extinguisher tag was observed. Servicing of the fire extinguishers is recommended. (Critical Repair)

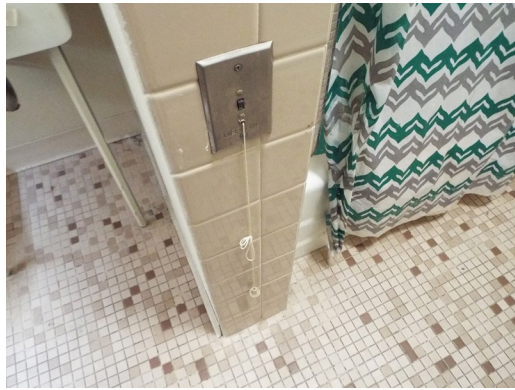
1-bed-1-bath - unit 25 emergency call device  
(Non-Critical Repair)

The emergency call system appears to be original, and is beyond its estimated useful life. Replacement is recommended. (Non-Critical Repair)

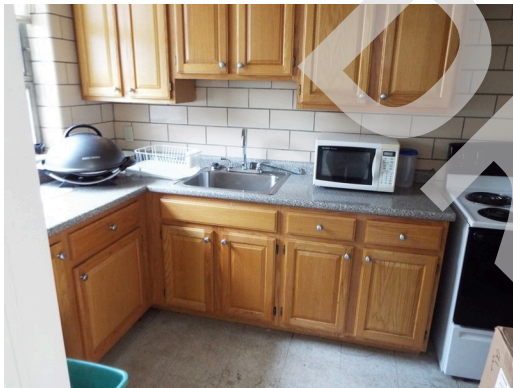
Common area - kitchen, not UFAS compliant  
(Critical Repair)

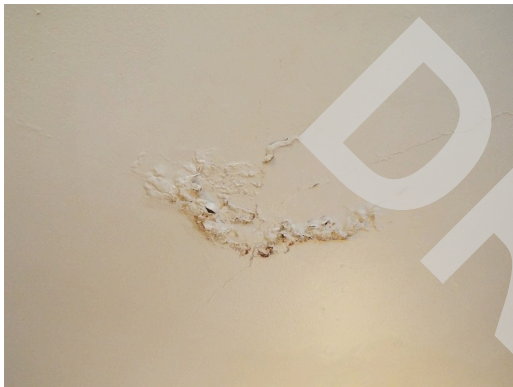
AEI observed scattered areas of moisture conditions and peeling paint located at ceilings at unit 17, 36, unit 47, unit 82; and at the bathroom wall in unit 36. Repairs are required. Refer to Section 3.3.4 for discussion of roof leaks above unit 36.(Non-Critical Repair)

1-bed-1-bath - unit 36 - ceiling condition  
(Non-Critical Repair)

Joel Sanchez was not aware of any roof leaks, water leaks or infiltration and associated damage from pipes, fixtures, or HVAC systems at the Property, with the exception of a roof leak above Unit 36. No flood drain or ground water problems were reported.

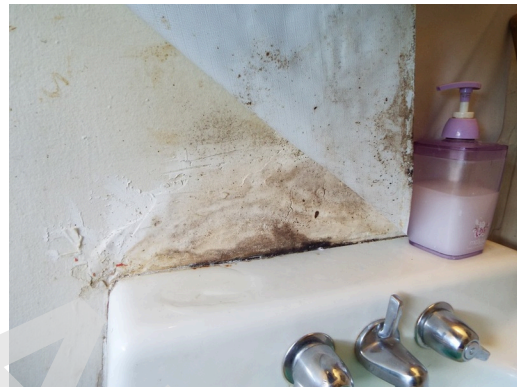
1-bed-1-bath - unit 36 - moisture condition  
(Critical Repair)

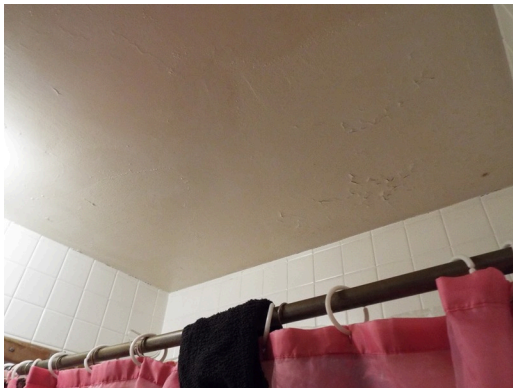
1-bed-1-bath - unit 40 - ceiling paint condition  
(Non-Critical Repair)

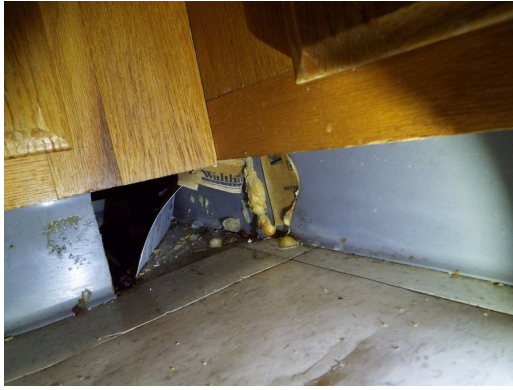
A rodent entry point was reported at the base cabinet located in the kitchen of unit 60. Rodents were reportedly no longer present, however the entry point must be sealed. (Critical Repair)

1-bed-1-bath - unit 60 - rodent entry area  
(Critical Repair)

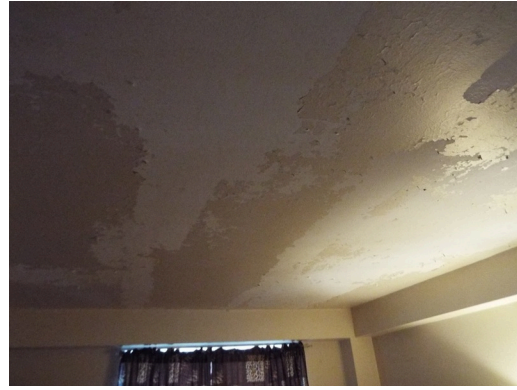
1-bed-1-bath - unit 82 - ceiling paint condition  
(Non-Critical Repair)

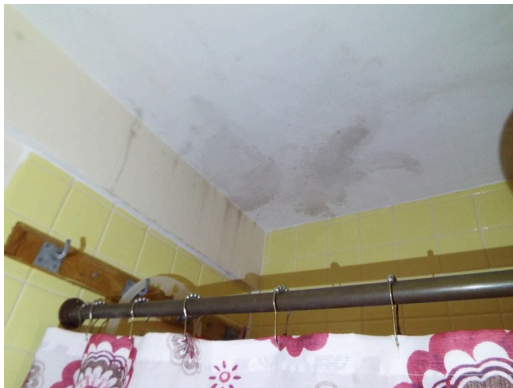
2-bed-1-bath - unit 17 - ceiling condition  
(Non-Critical Repair)

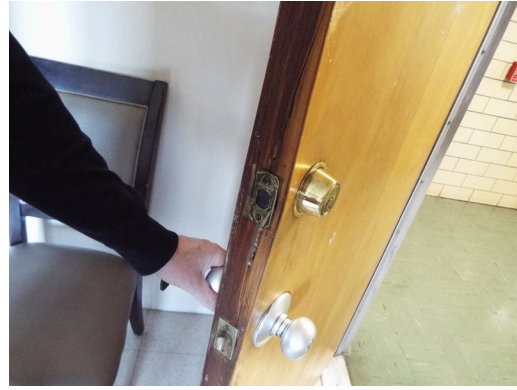
1-bed-1-bath - unit 68 - door lock condition  
(Critical Repair)

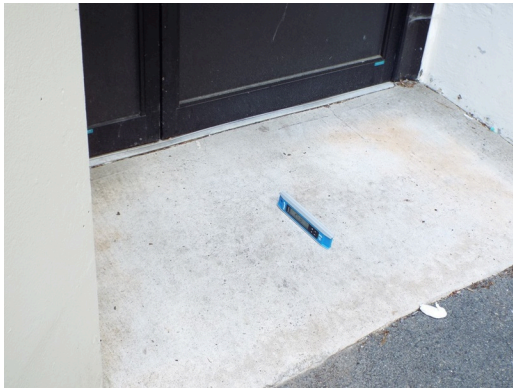
Accessible rear entry - slope exceeds allowable (Critical Repair)

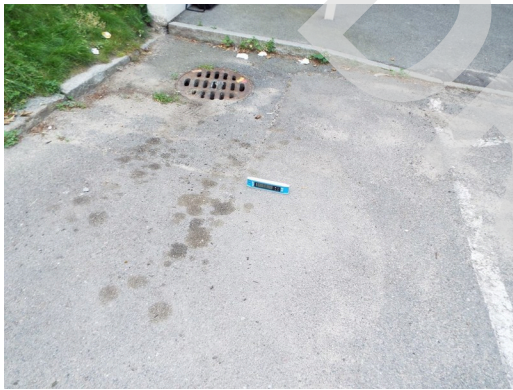
Accessible parking - cross slope exceeds allowable (Critical Repair)

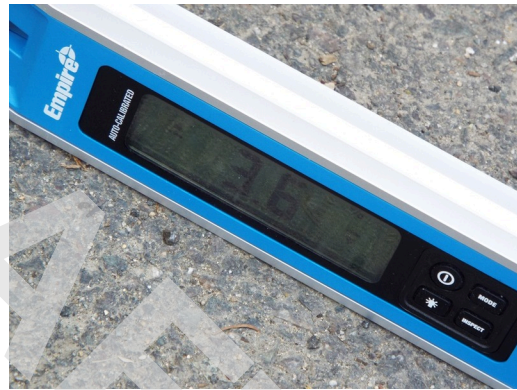
Accessible parking - cross slope exceeds allowable (Critical Repair)

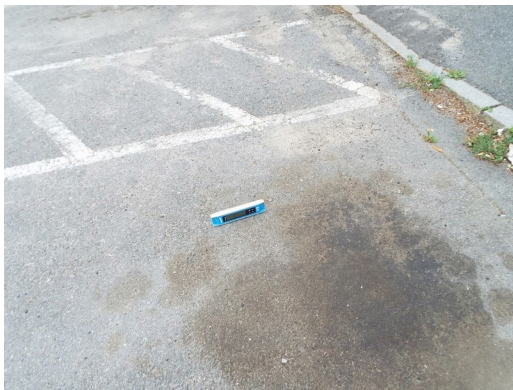
Accessible parking - running slope exceeds allowable (Critical Repair)

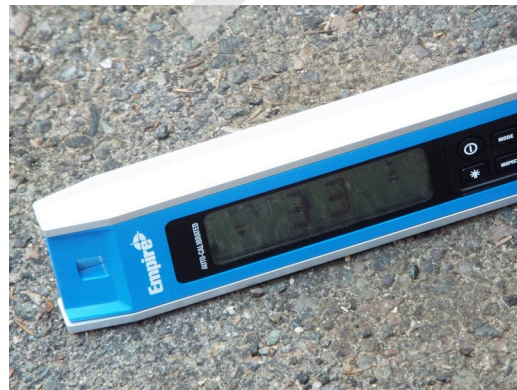
Accessible parking - running slope exceeds allowable (Critical Repair)

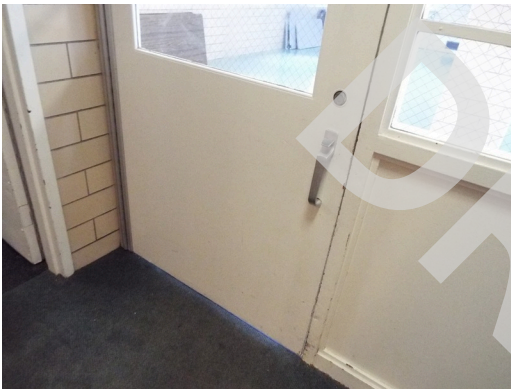
Common area - community room non-compliant thumbblatch hardware (Critical Repair)

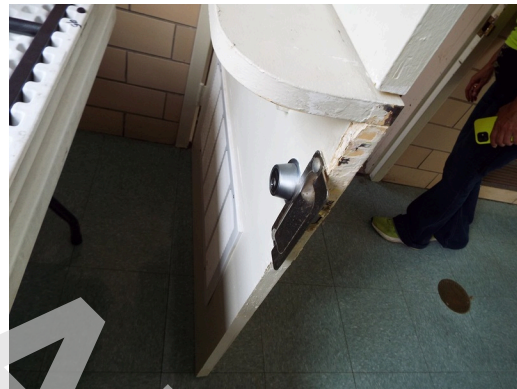
Common area - kitchen door lacks lever hardware (Critical Repair)

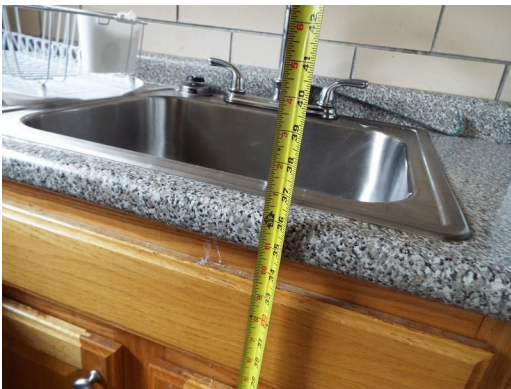
Common area - kitchen sink exceeds 34 inch maximum height

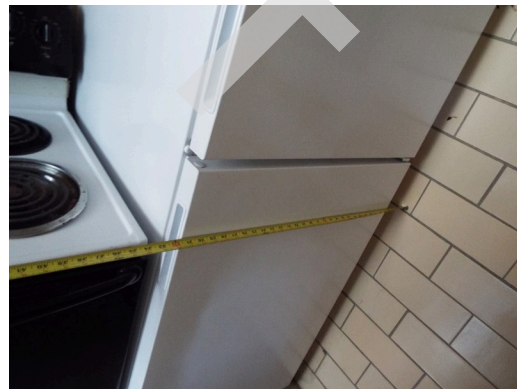
Common area - refrigerator lacks 48 inch side access

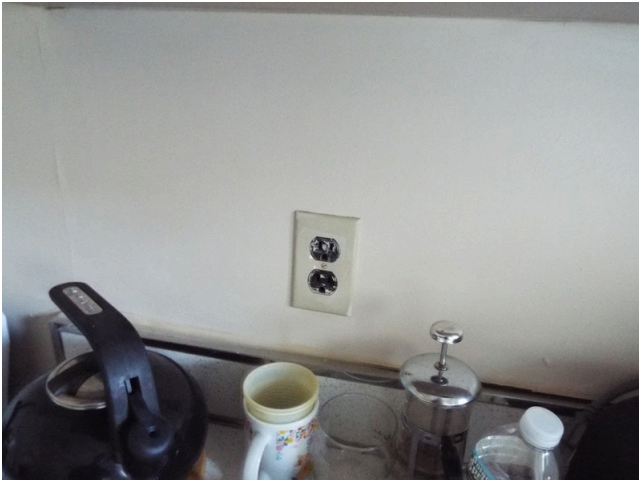
15. 1-bed-1-bath - unit 13 - kitchen lacks GFCI receptacle (Critical Repair)

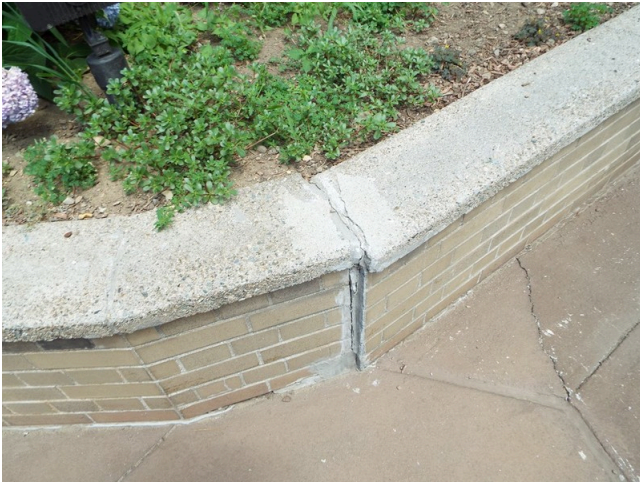
3. Landscape retaining wall condition (Non-Critical Repair)

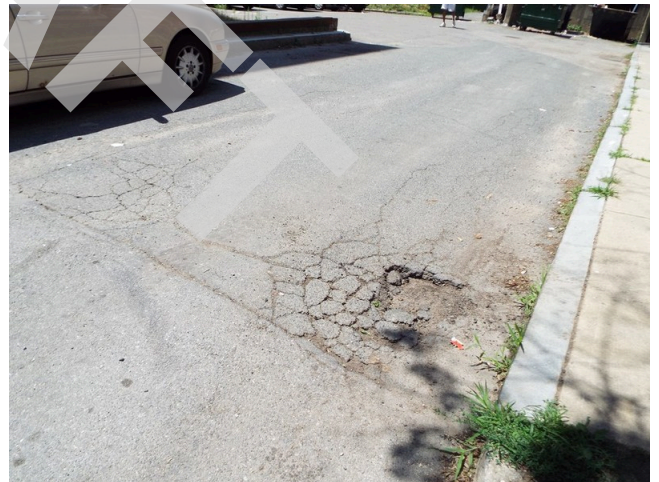
8. Rear access drive - pavement condition (Non-Critical Repair)

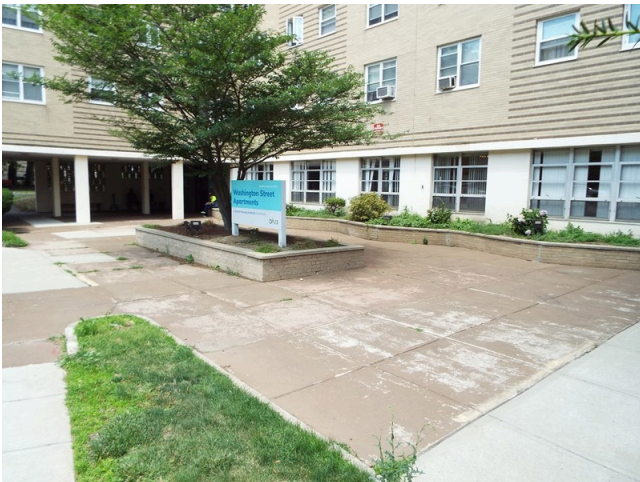
11. Concrete plaza, cracks/deteriorated stain (Non-Critical Repair)

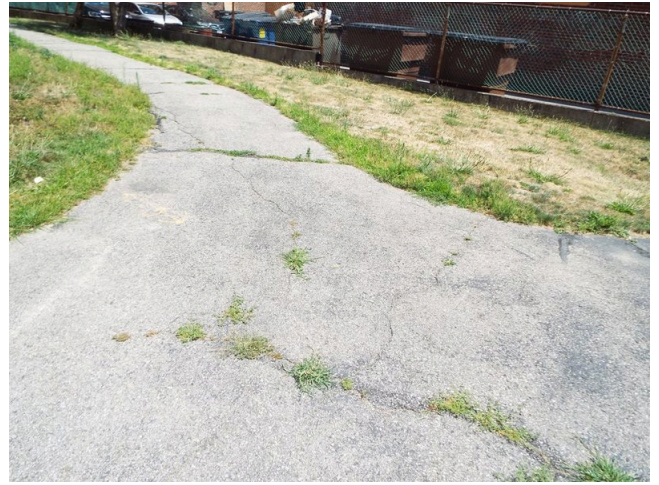
14. Asphalt walkway condition (Non-Critical Repair)

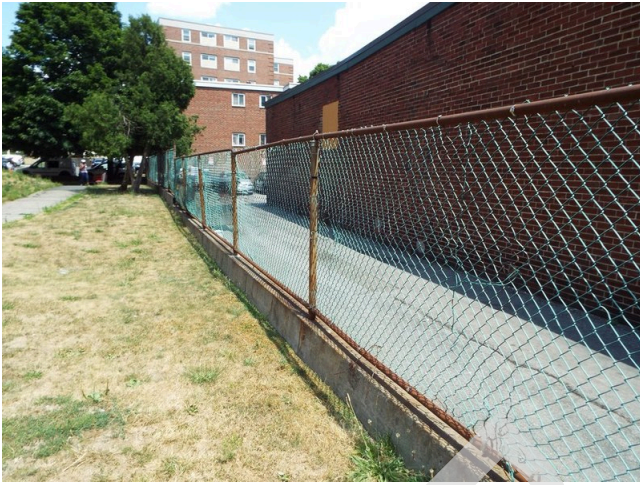
21. Fencing condition (Non-Critical Repair)

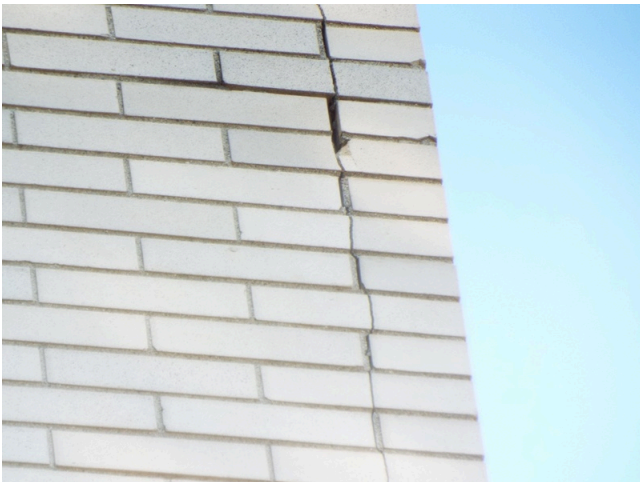
35. Vertical brick cracking - 95 wing (Non-Critical Repair)

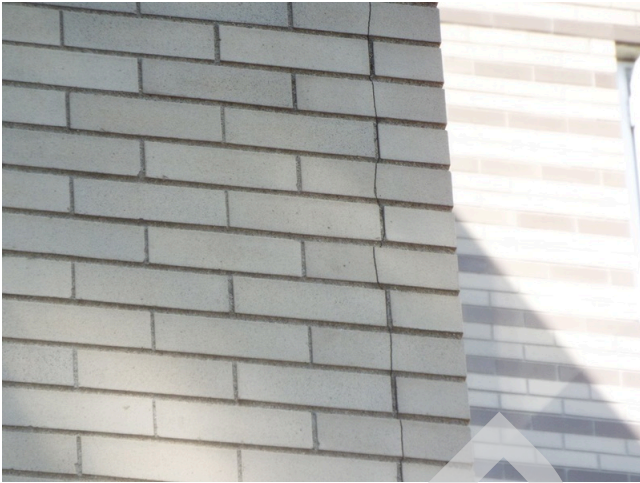
37. Vertical exterior cracking - 95 wing

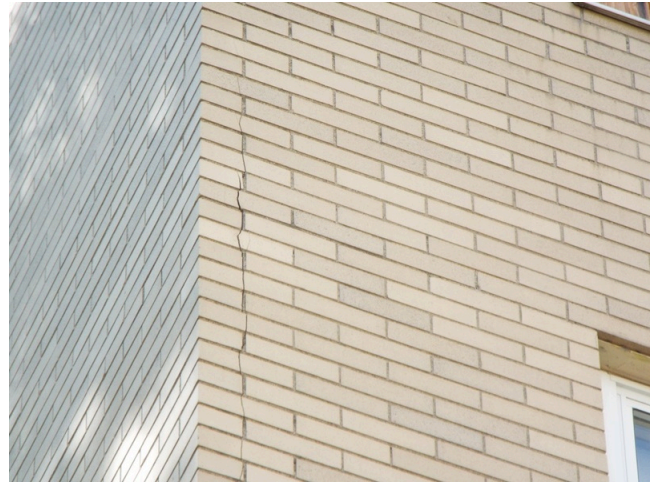
38. Vertical exterior cracking - 95 wing

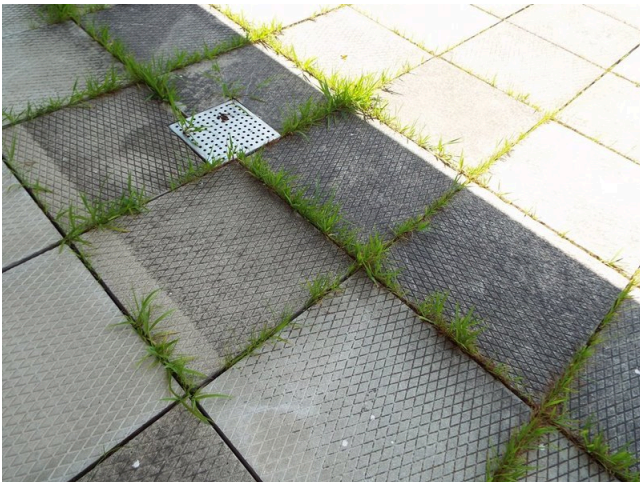
39. Rooftop terrace vegetation (Non-Critical Repair)

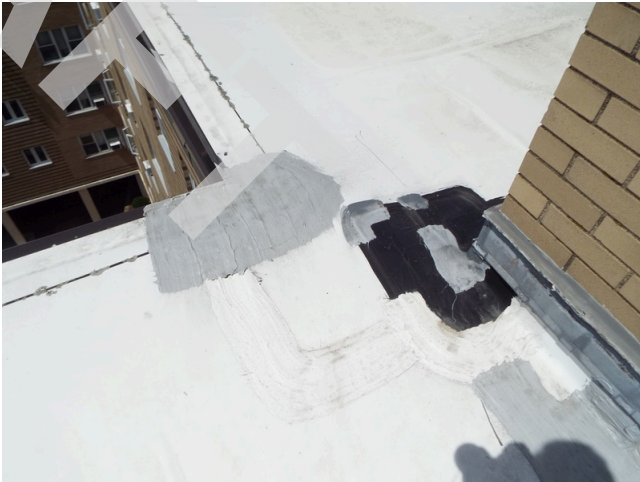
56. Roof flashing (Non-Critical Repair)

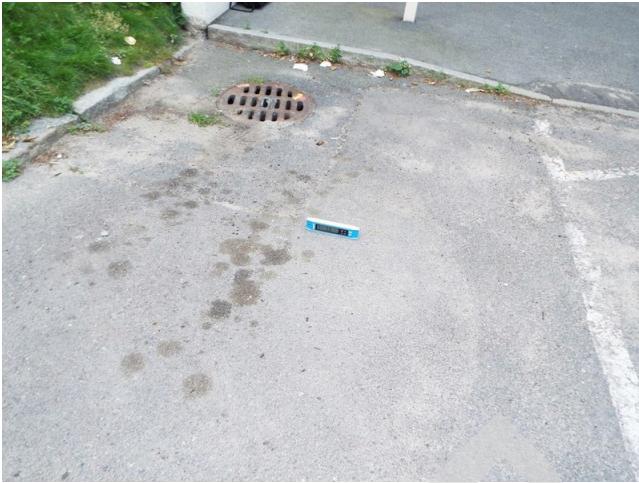
84. Accessible rear entry - slope exceeds allowable  
(Critical Repair)

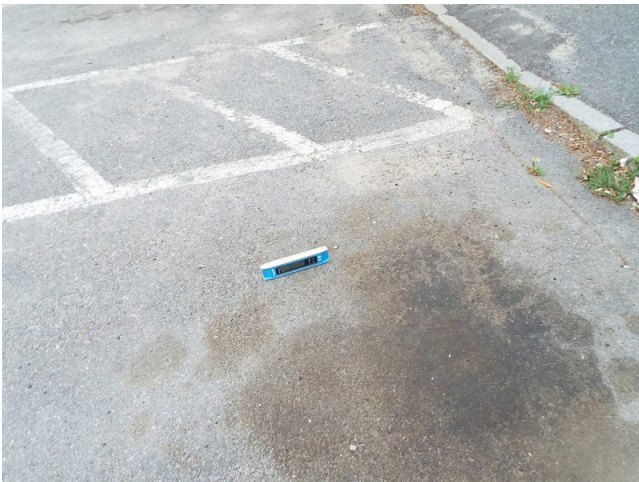
86. Accessible parking - cross slope exceeds allowable (Critical Repair)

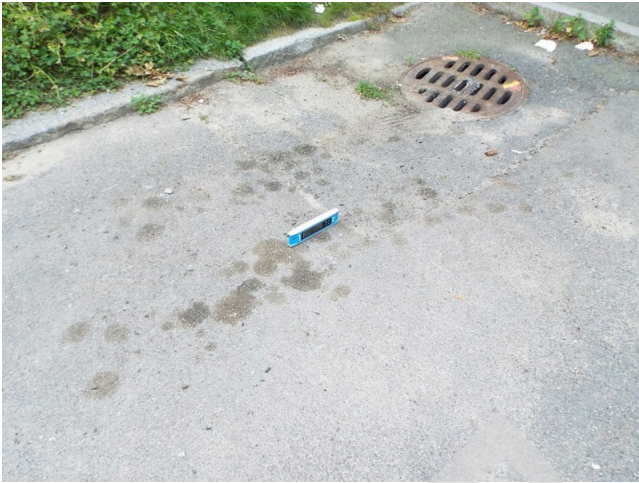
96. Accessible parking - cross slope exceeds allowable (Critical Repair)

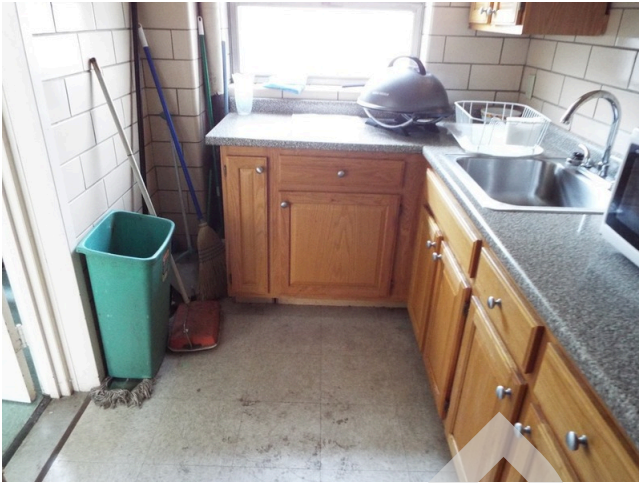
165. Common area - kitchen lacks 60 in turning radius (Critical Repair)

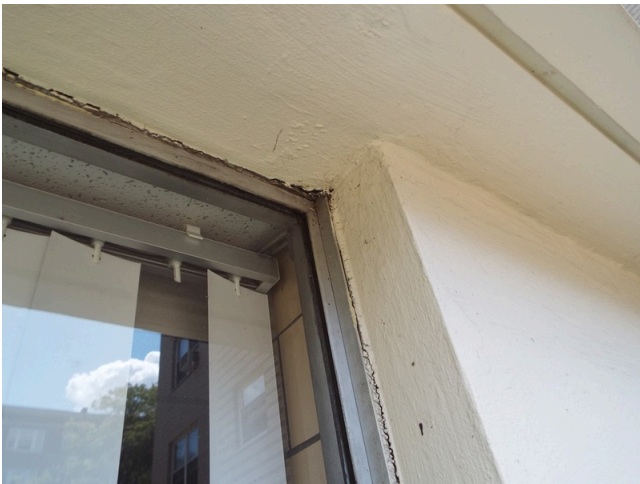
322. Typical unit entry doors
