HUD MAP CAPITAL NEEDS ASSESSMENT

Davison
101 Davison Street
Hyde Park, Massachusetts 02136

AEI Project No. 463352
Site Inspection Date: July 13, 2022

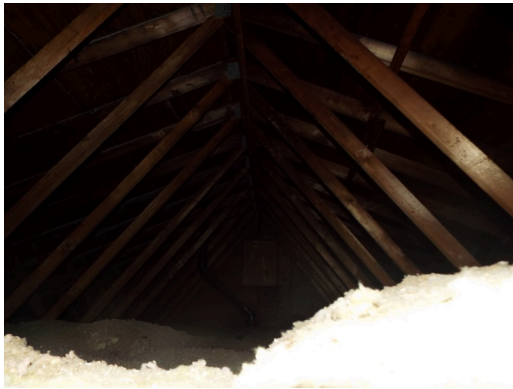
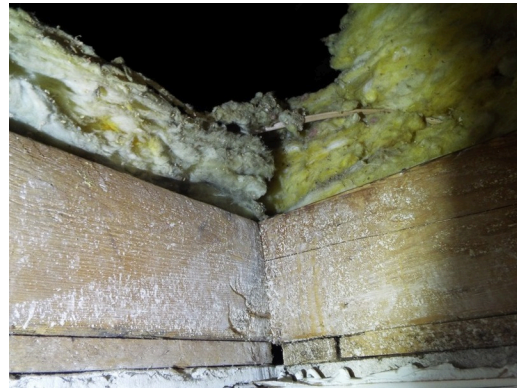
The depth of the insulation was observed to be approximately 10 inches with an R value of approximately 32.

Attic insulation - building 110-112

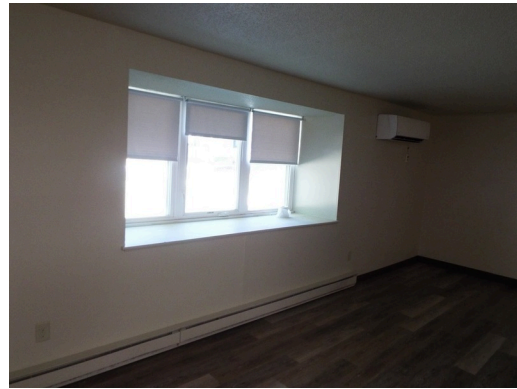
Unit electric baseboard (emergency use)

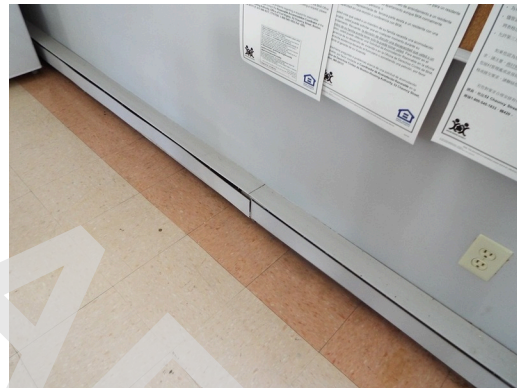
Community building - electric baseboard

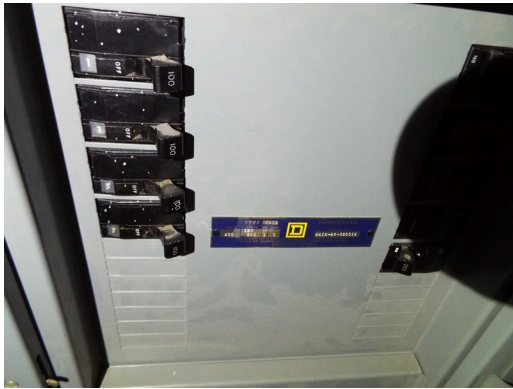
Building electrical panel - building 93-95

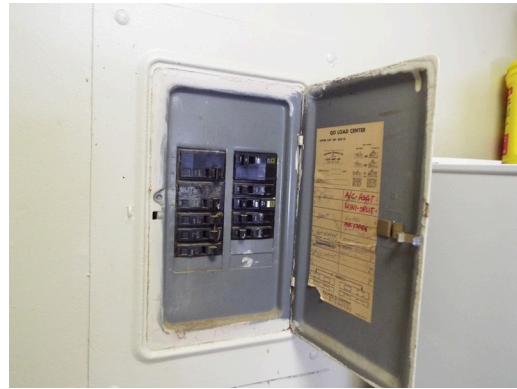
Typical unit electrical panel

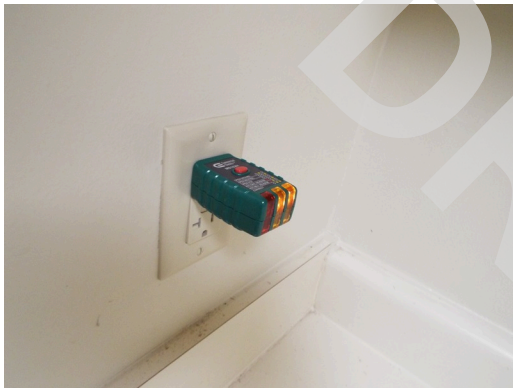
Kitchen GFCI operates correctly

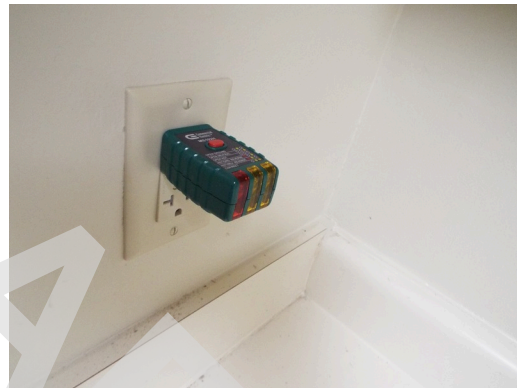
Kitchen GFCI operates correctly

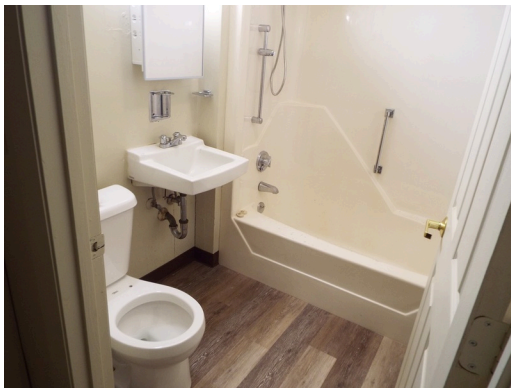
0-bed-1-bath - unit 41 - building 110-112-
bathroom fixtures

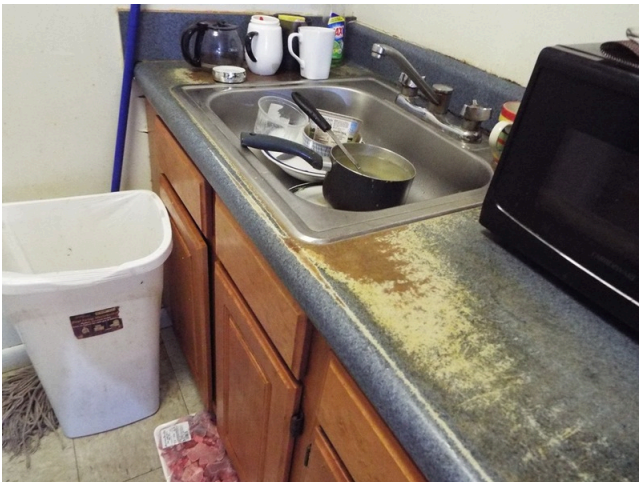
11. 0-bed-1-bath - unit 13 - building 93-95 -
countertop condition (Non-Critical Repair)

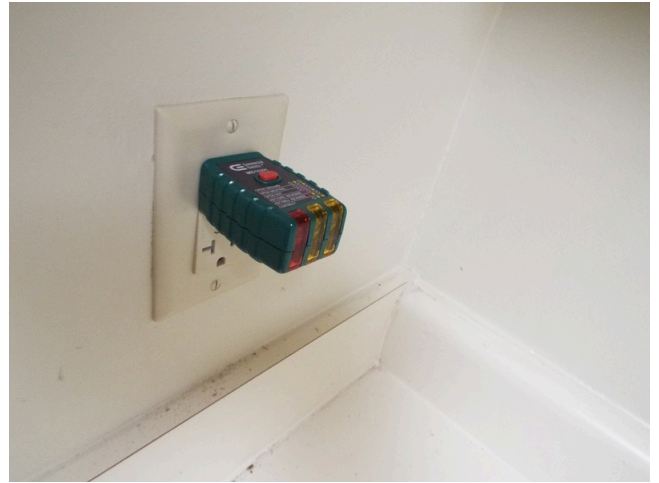
185. Kitchen GFCI operates correctly

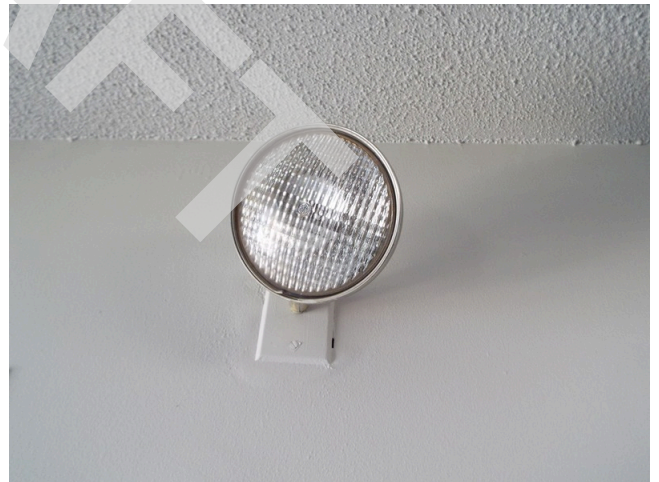
44. Building hallway emergency light

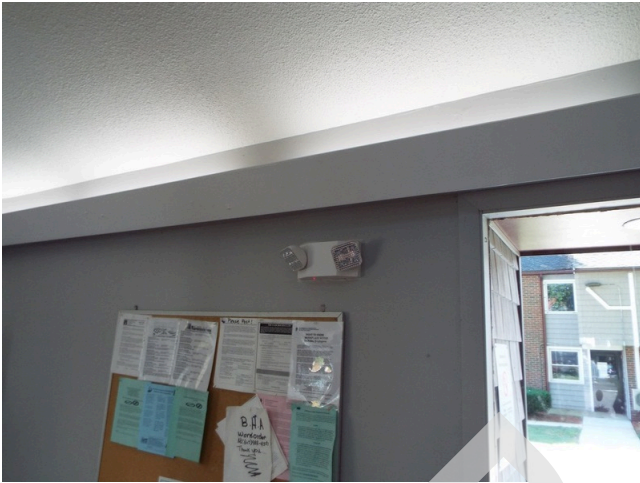
45. Community building - emergency lights

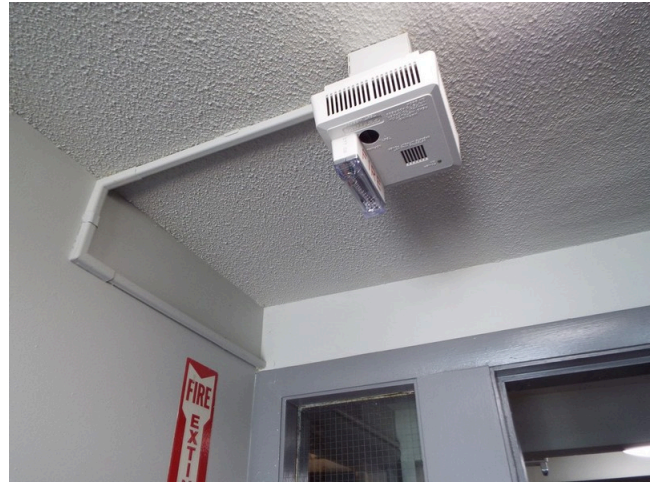
46. Building hallway strobe alarm

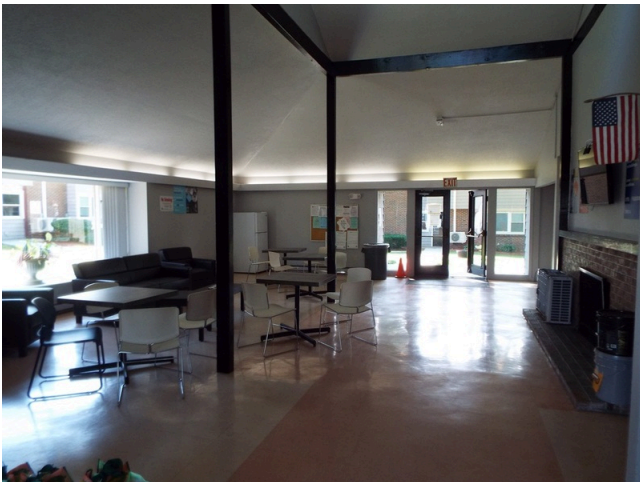
47. Community building - community room

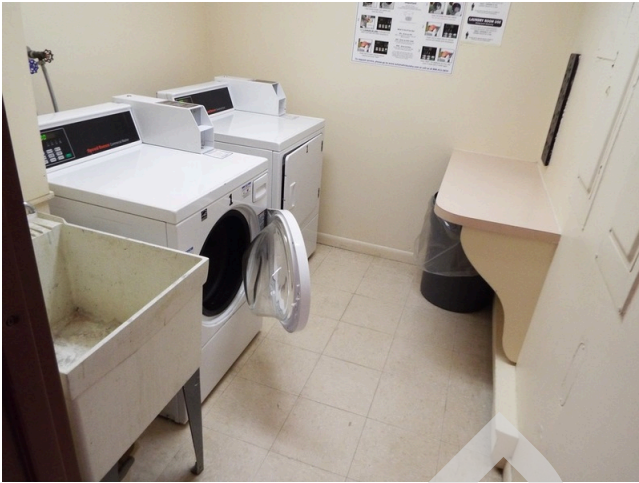
49. Community building - laundry

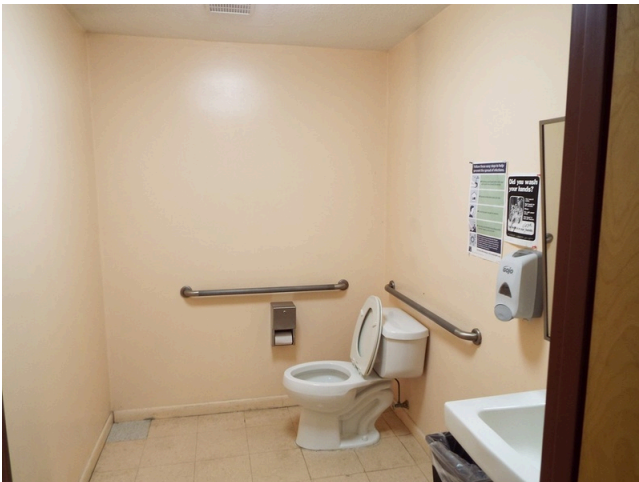
51. Community building - womens restroom

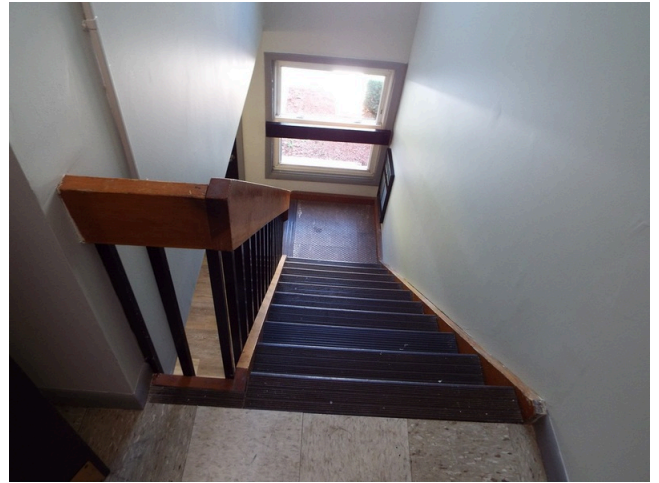
54. Typical stair - building 110-112

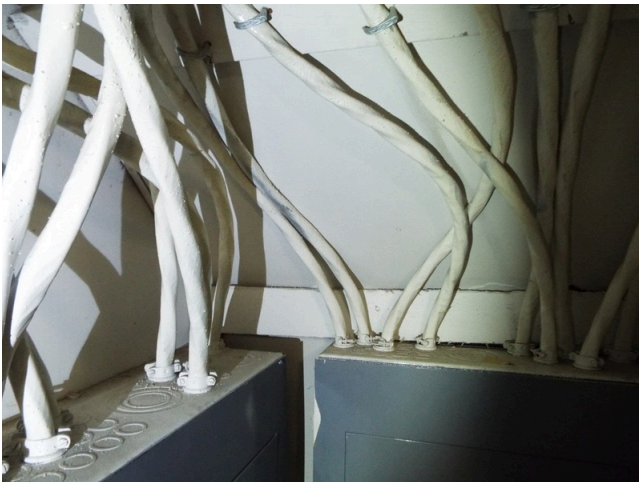
67. Electrical room - building 93-95

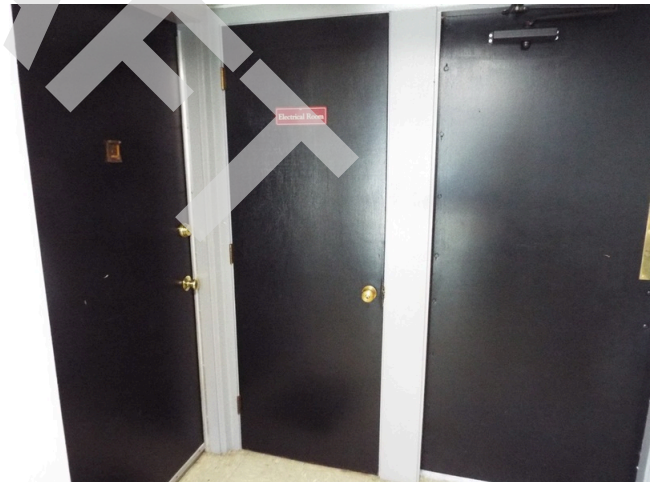
80. Electrical room - building 105-109

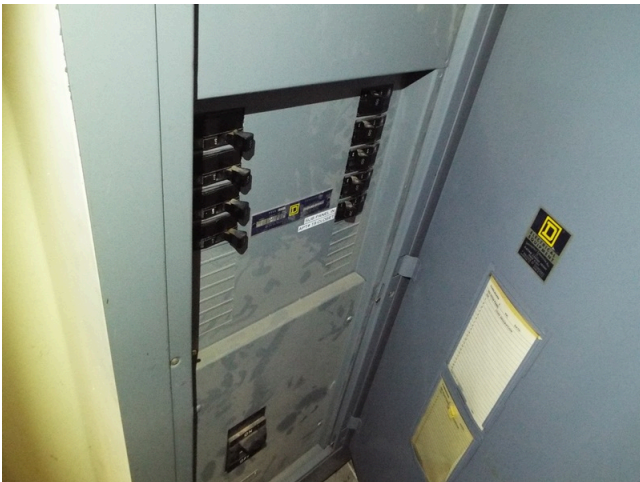
83. Building electrical panel - building 105-109

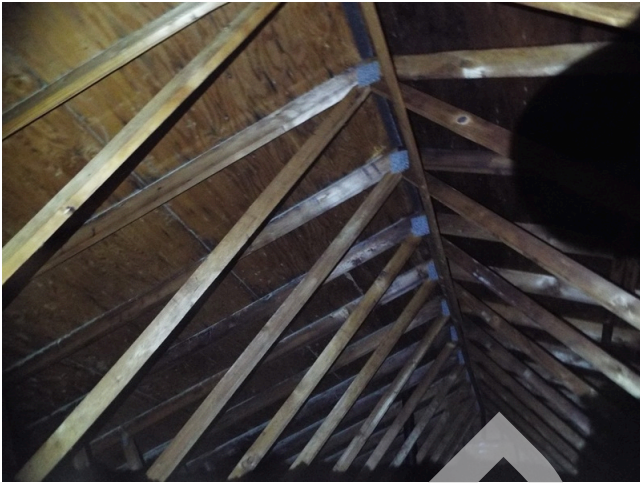
89. Roof framing - building 110-112

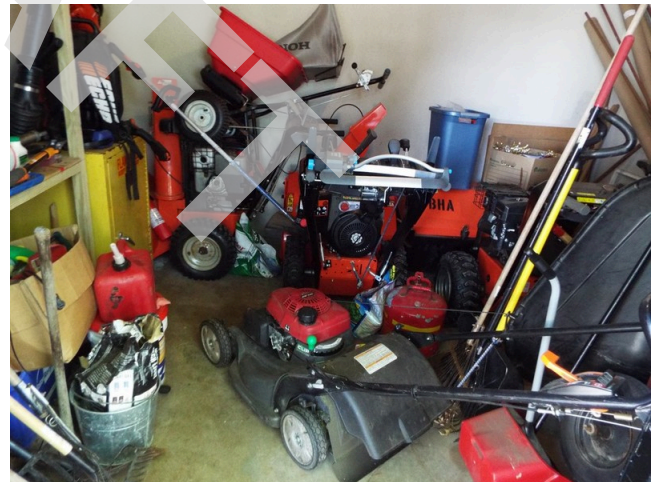
100. Storage building - interior

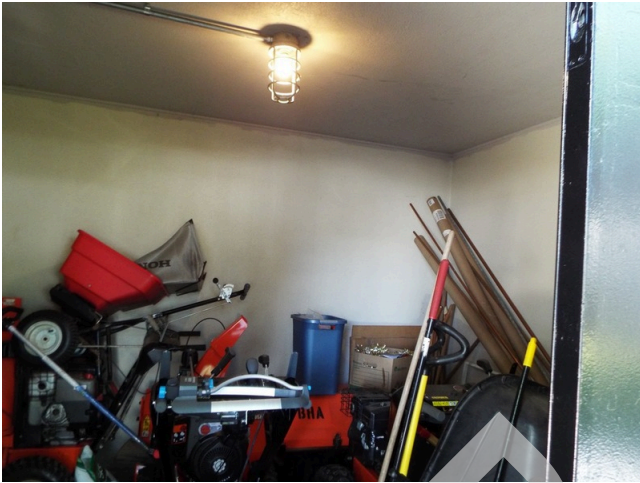
101. Storage building - interior

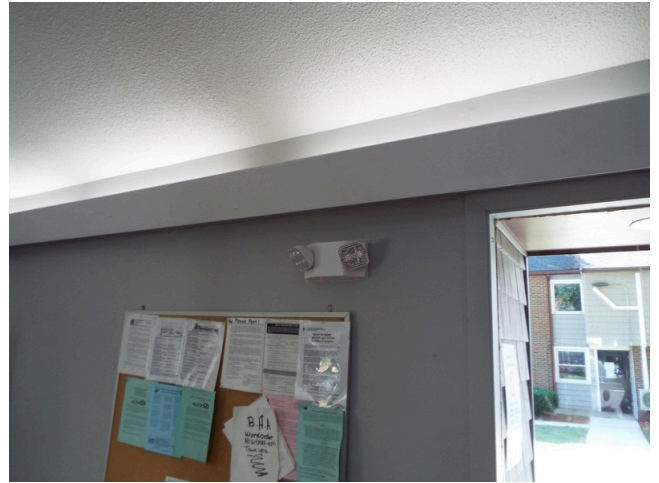
102. Community building - emergency lights

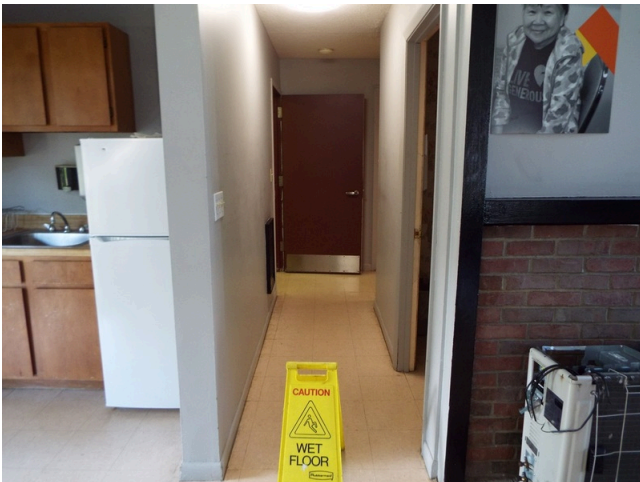
103. Community building - hallway
