HUD MAP CAPITAL NEEDS ASSESSMENT

Ashmont
374 Ashmont Street
Dorchester, Massachusetts 02124

AEI Project No. 463355
Site Inspection Date: July 6, 2022

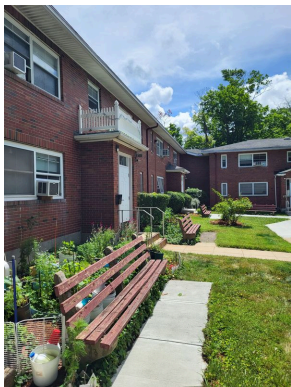
Exterior common area benches (Non-Critical Repair)

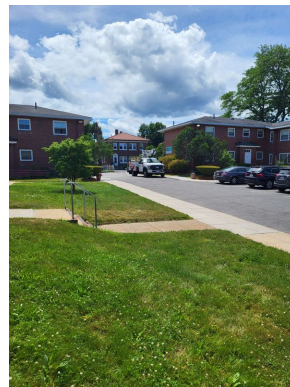
Property parking lot (Non-Critical Repair)

The asphalt driveway and parking area sealcoat was observed deteriorated with select areas of damage and past Estimated Use Life (EUL). In order to maintain the driveways and parking areas and improve the condition of the property, seal coat and restriping of the asphalt driveways and parking areas is recommended. (Non-Critical Repair)

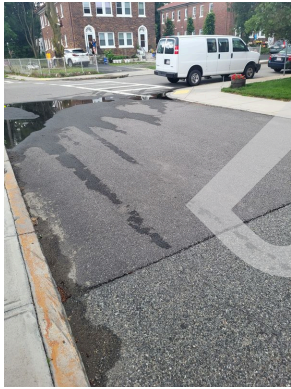
Property parking lot ingress/egress
(Non-Critical Repair)

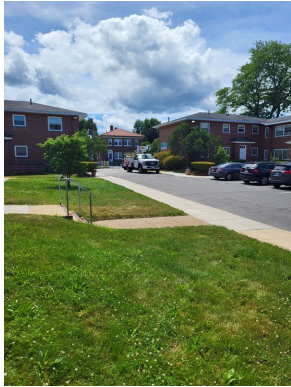
Property parking lot (Non-Critical Repair)

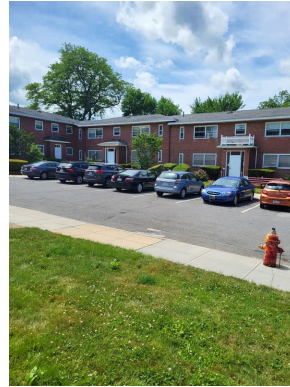
Property parking lot (Non-Critical Repair)

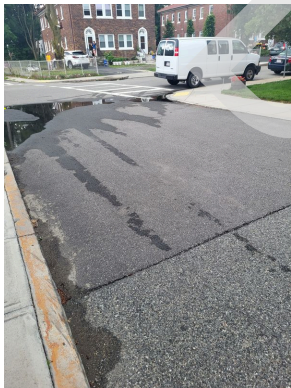
Property parking lot ingress/egress (Non-Critical Repair)

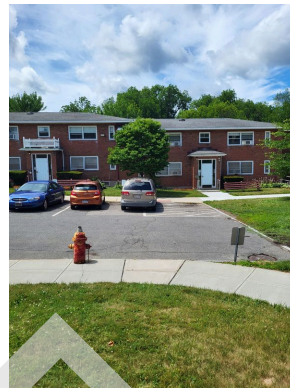
Property parking lot install handicap accessible parking (Critical Repair)

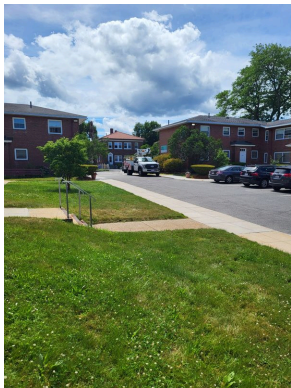
Property parking lot (Non-Critical Repair)

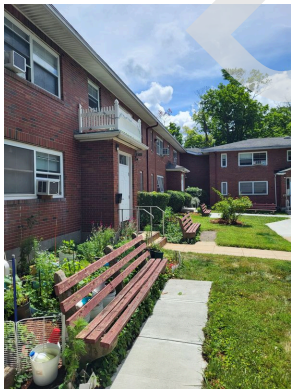
Exterior common area benches (Non-Critical Repair)

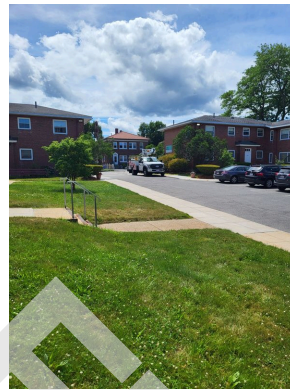
Property parking lot (Non-Critical Repair)

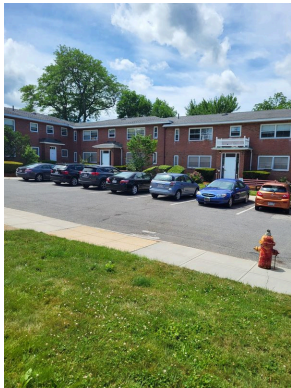
Property parking lot (Non-Critical Repair)

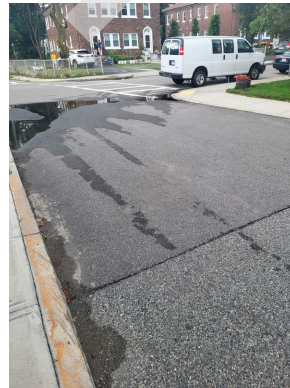
Property parking lot ingress/egress (Non-Critical Repair)

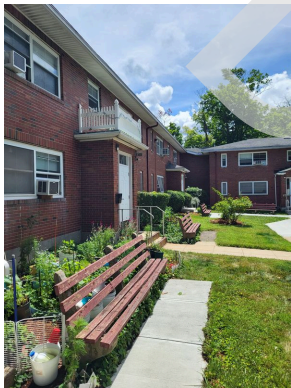
Exterior common area benches (Non-Critical Repair)

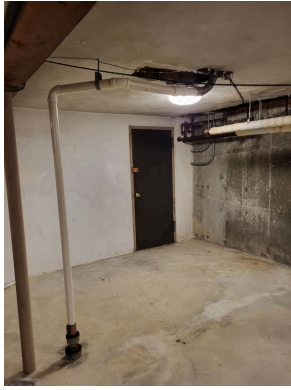
Basement damaged ceiling (Non-Critical Repair)

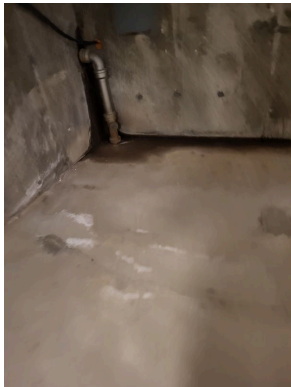
Basement pipe leak (Non-Critical Repair)

AEI observed select areas in the apartment building basements near pipes with standing water on the floor. Repairing the pipes is recommended. (Non-Critical Repair)

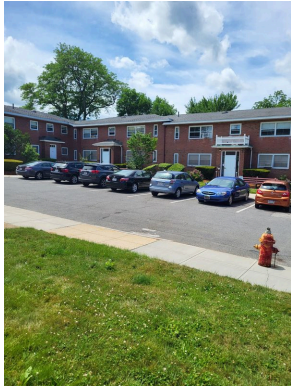
Property parking lot (Non-Critical Repair)

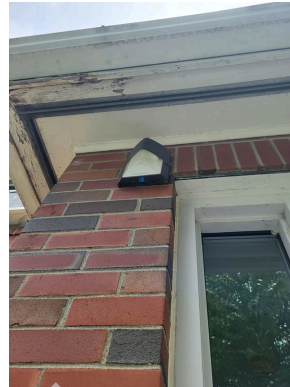
Apartment building 342-356 wood soffit damage

Select areas of soffits and fascia located at building entrance canopy areas were observed damaged. In order to improve the overall appearance of the property and prevent further damage, replacing the damaged soffits and fascia is recommended. (Non-Critical Repair)

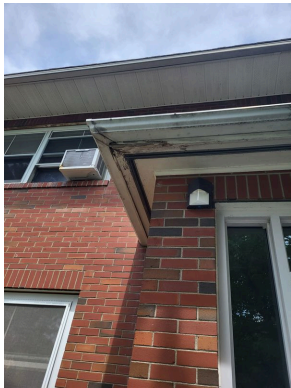
Apartment building 342-356 wood soffit damage (Non-Critical Repair)

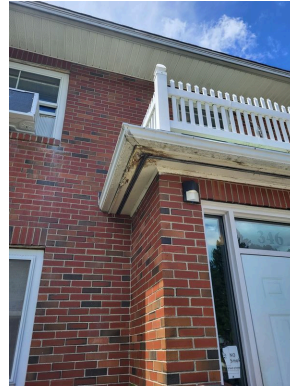
Apartment building 342-356 wood soffit damage (Non-Critical Repair)

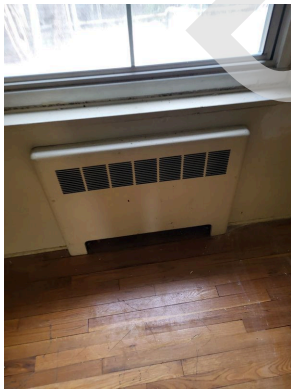
Apartment 356-25 bedroom window, frame and radiator

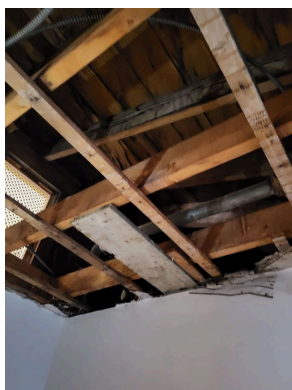
Common area restroom hole in ceiling
(Non-Critical Repair)

AEI observed damaged ceiling in the common area restroom located in the community room. Replacement of the community room roof is recommended. (Non-Critical Repair)

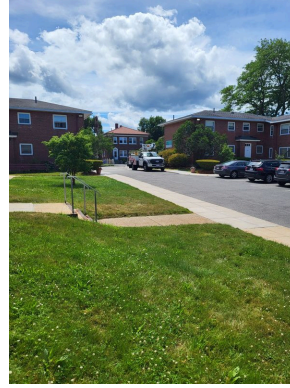
Property parking lot (Non-Critical Repair)

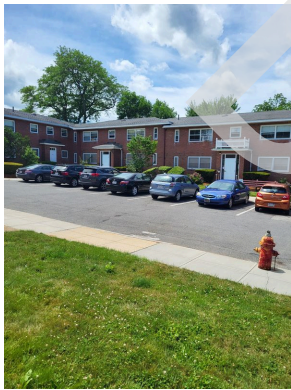
Property parking lot (Non-Critical Repair)

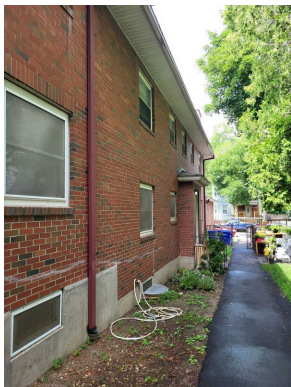
Apartment building fascia

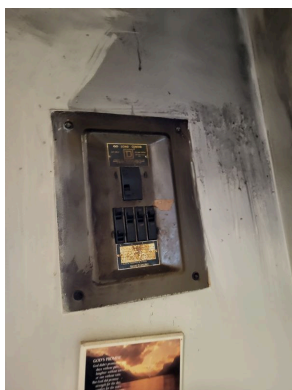
Apartment 370-46 circuit breakers
(Non-Critical Repair)

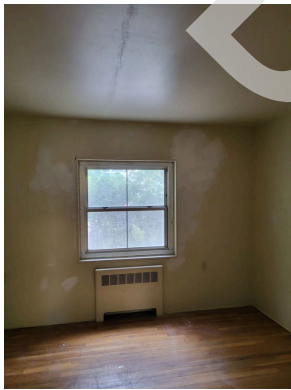
Apartment 356-25 bedroom missing smoke detector (Critical Repair)

The dwelling unit bedrooms and apartment 356-25 living room were observed without smoke detectors or with non-compliant smoke detectors. The hallways outside of the sleeping rooms were observed with hard-wired smoke detectors smoke detectors. Per HUD MAP Guidelines; according to Life Safety Code (NFPA 101), paragraph 31.3.4.5.1, smoke alarms must be installed outside every sleeping area in the immediate vicinity of the bedrooms and on all levels of the dwelling unit, including basements. In addition to the NFPA requirements, the regulation in 24 CFR 200.76 requires that smoke detectors must also be installed inside each sleeping area; therefore, the installation of compliant smoke detectors within all the dwelling unit bedrooms is required. The smoke detectors can be either hard wired or battery powered. Battery powered smoke detectors must have the following features, according to the HUD MAP Guidelines: the cell must be tamper-resistant; the cells cannot be used in any other toy or appliance; the cells must have a ten-year life; the smoke detector may have a manual silencing device to clear unwanted alarms such as cooking smoke. For the purpose of this report we have budgeted battery powered smoke detectors, allowable by the HUD MAP Guidelines. It is recommended to contact the local municipality to determine if battery-operated smoke detectors are allowable. If further clarification is needed regarding smoke detector compliance, please contact the local reviewing HUD office. (Critical Repair)

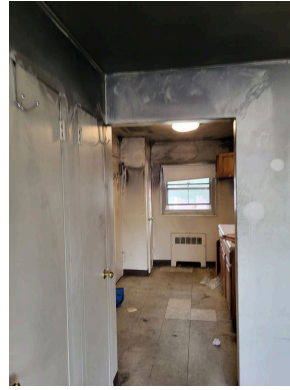
Apartment 370-46 fire and smoke damage
(Non-Critical Repair)

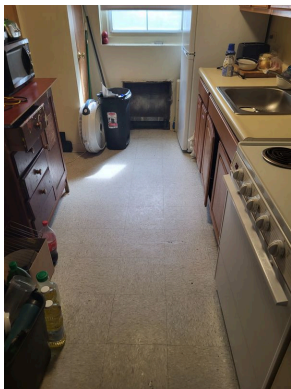
AEI observed that approximately 25% of the vinyl flooring in the kitchens and bathrooms were in poor condition and should be replaced.

Apartment 364-36 kitchen floor (Non-Critical
Repair)

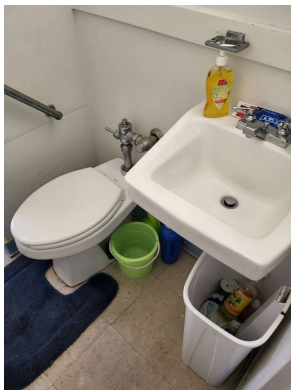
Apartment 352-19 bathroom toilet, sink a faucet

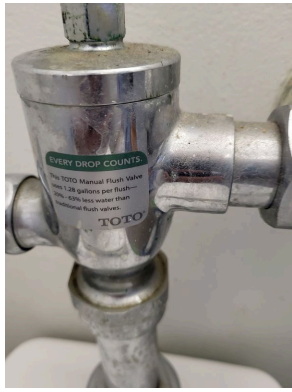
Apartment 352-19 efficiency control flush valve

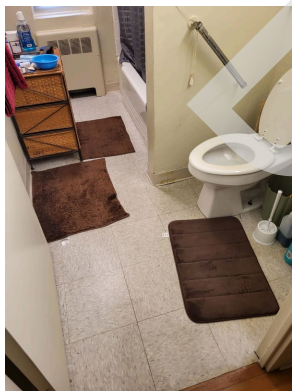
Apartment 354-21 bathroom floor

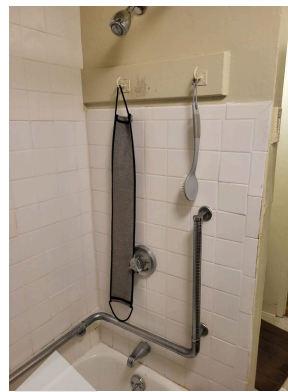
Apartment 354-21 bathroom bathtub hardware

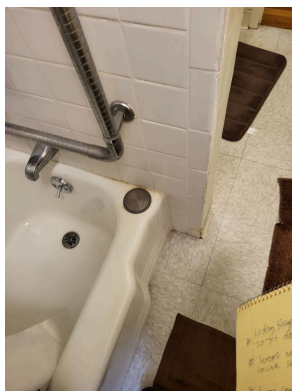
Apartment 354-21 bathroom bathtub tile damage (Non-Critical Repair)

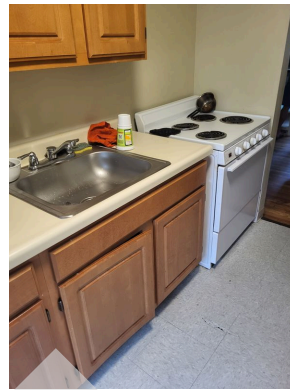
Apartment 364-36 kitchen cabinets, sink, faucet, countertop and range/stove

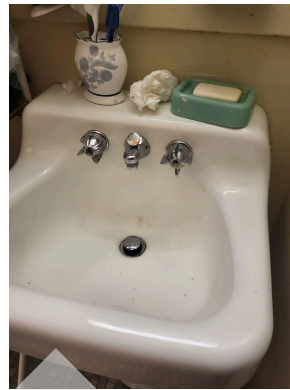
Apartment 342-1 bathroom sink and faucet

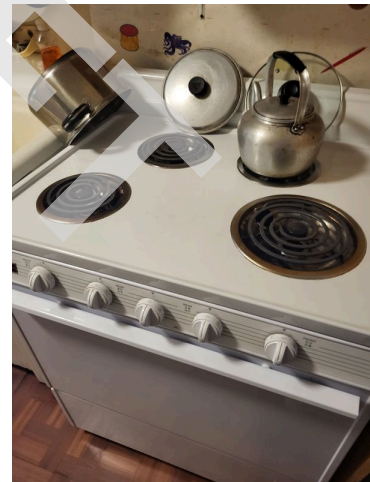
8. Apartment 346-10 kitchen range/stove

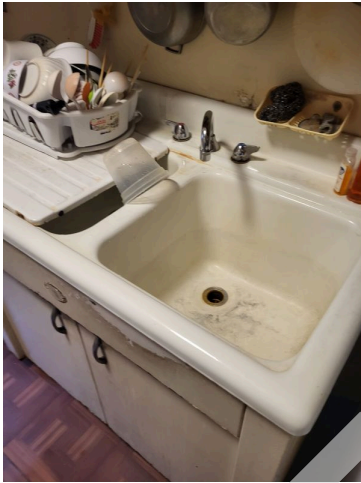
9. Apartment 346-10 kitchen sink

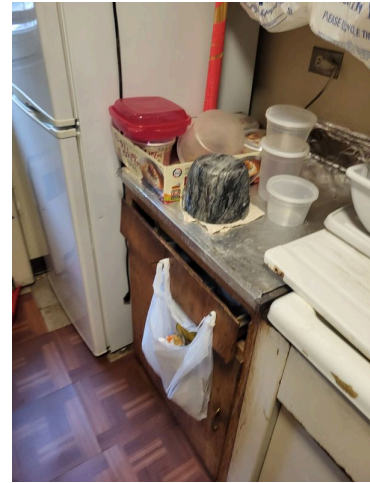
10. Apartment 346-10 countertop and cabinets
(Non-Critical Repair)

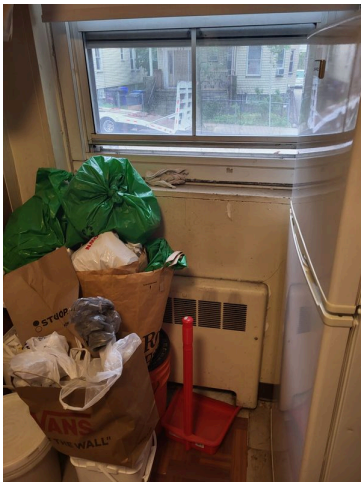
11. Apartment 346-10 kitchen radiator and window

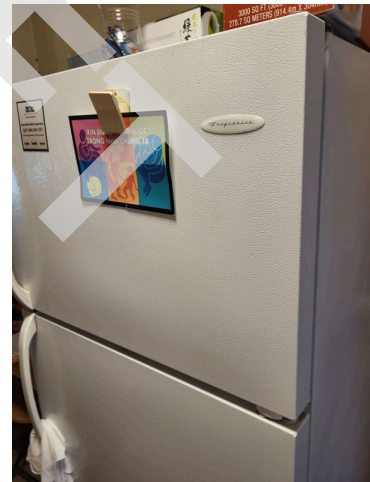
12. Apartment 346-10 kitchen refrigerator

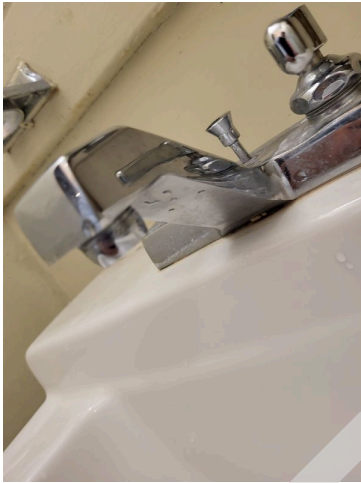
17. Apartment 346-10 bathroom sink faucet

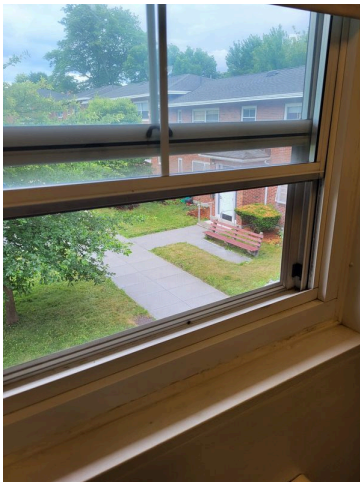
23. Apartment 346-10 bedroom window and frame

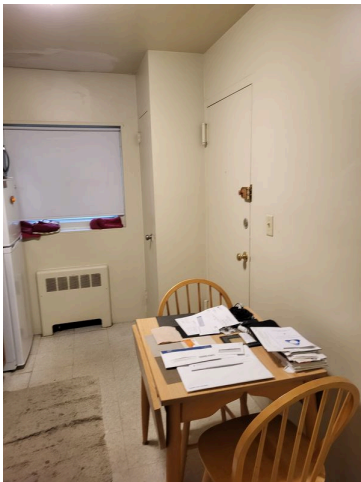
42. Apartment 354-21 kitchen

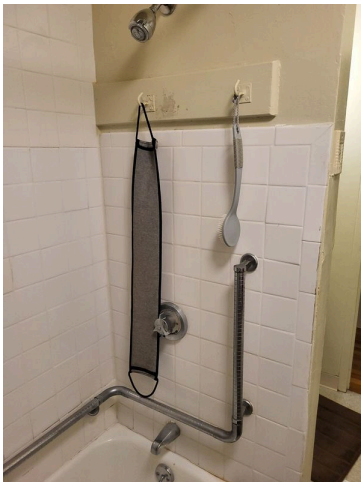
46. Apartment 354-21 bathroom bathtub, radiator, window and light fixture

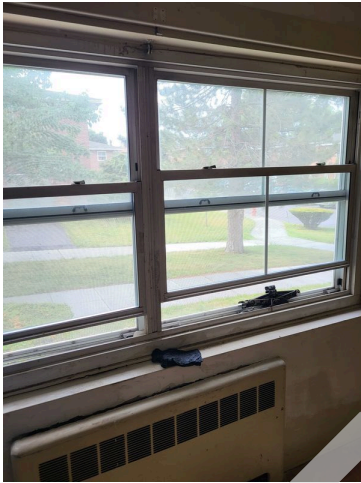
52. Apartment 356-25 living room area

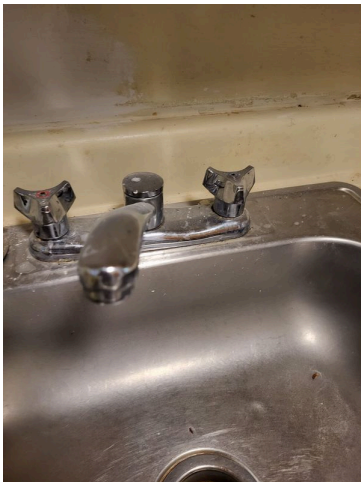
62. Apartment 356-25 kitchen

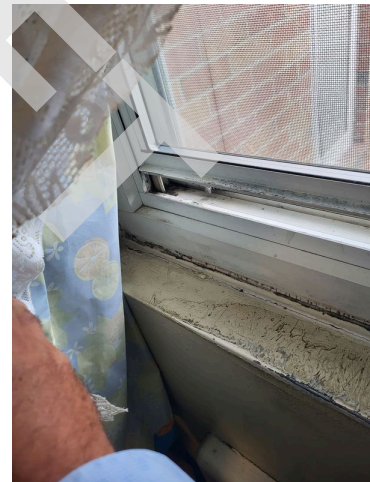
116. Apartment 342-1 kitchen window and frame

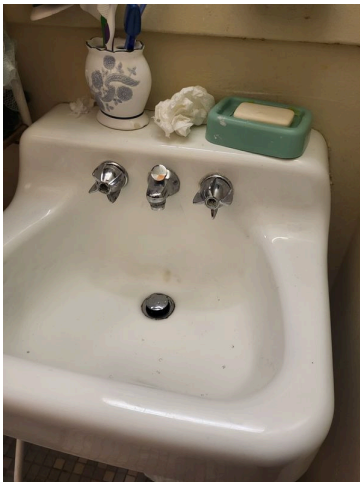
123. Apartment 342-1 bathroom sink and faucet

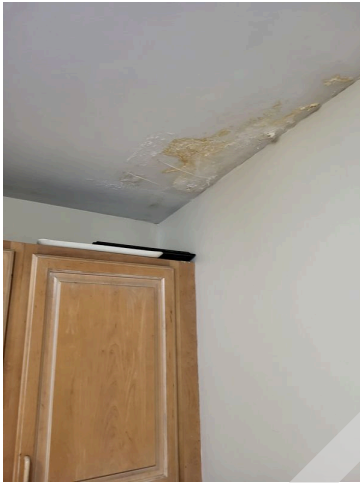
21. Common area kitchen ceiling damage (Non-Critical Repair)

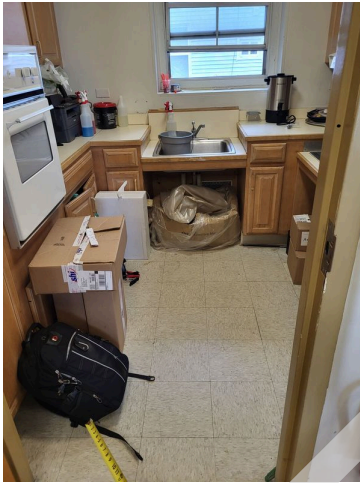
25. Common area kitchen are flooring (Non-Critical Repair)

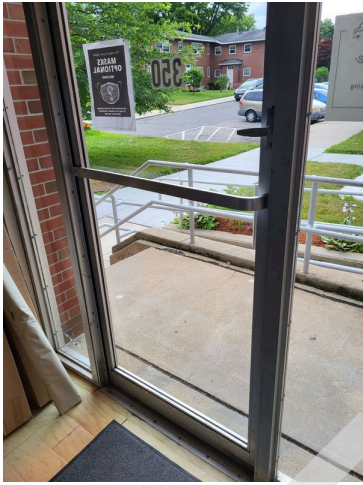
37. Building ingress/egress door

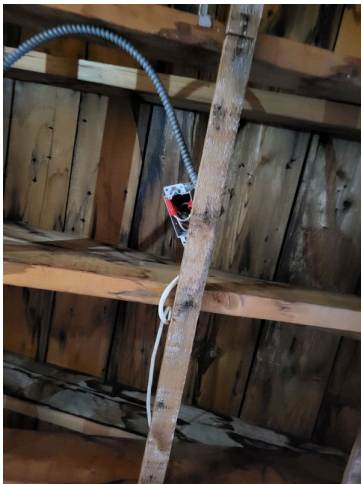
50. Common area restroom hole in ceiling (Non-Critical Repair)

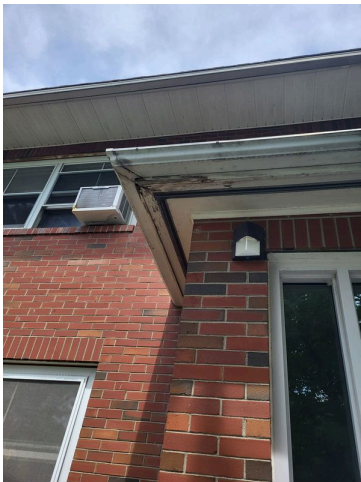
62. Apartment building 342-356 wood soffit damage

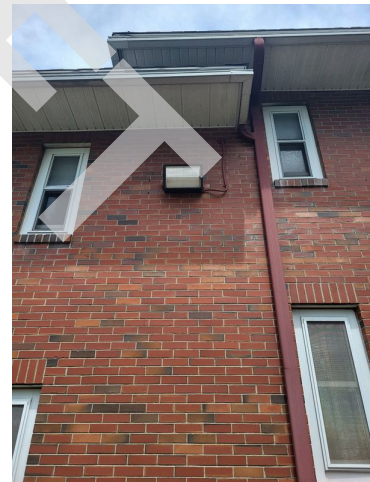
63. Apartment building 342-356 wood soffit damage (Non-Critical Repair)

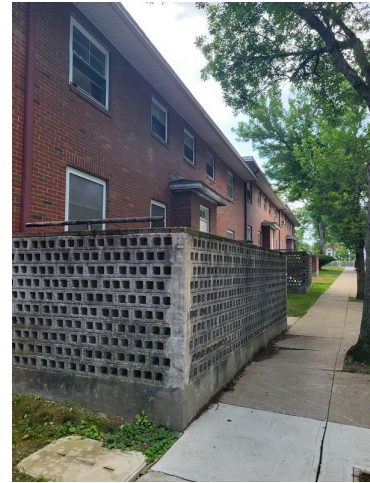
73. Basement ingress/egress railing damaged (Non-Critical Repair)

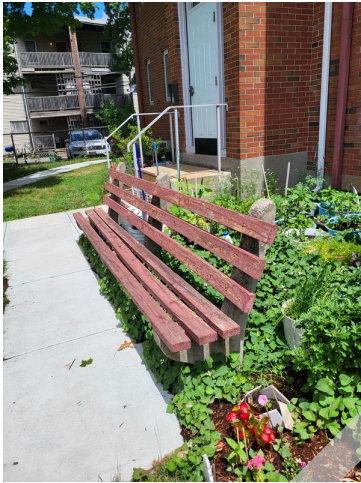
80. Exterior common area bench (Non-Critical
Repair)

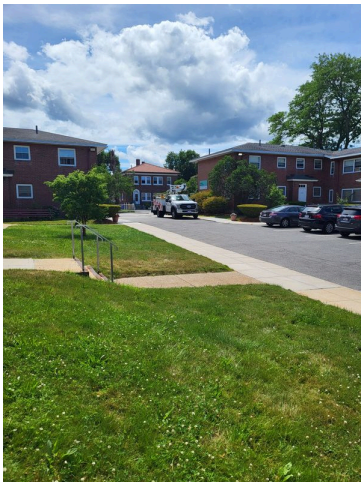
82. Exterior common area benches (Non-Critical Repair)

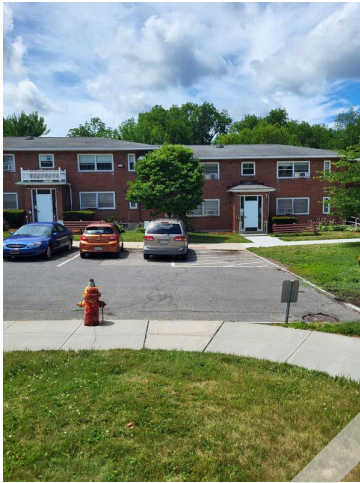
84. Property parking lot (Non-Critical Repair)

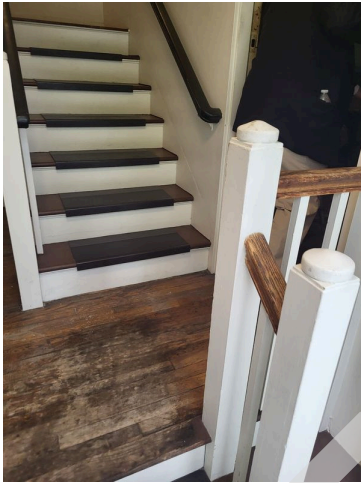
89. Apartment building 358-374 ingress/egress interior stairs

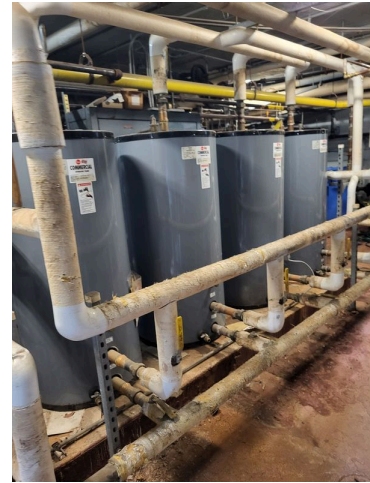
90. Hot water storage tanks (115 gallon each)

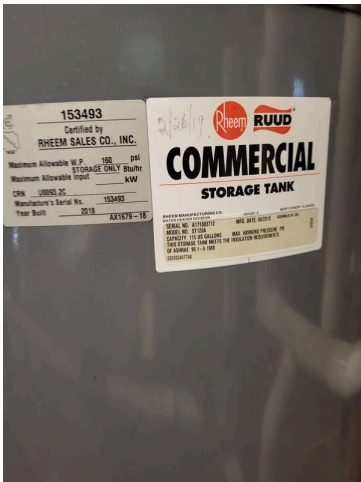
91. Hot water storage tank

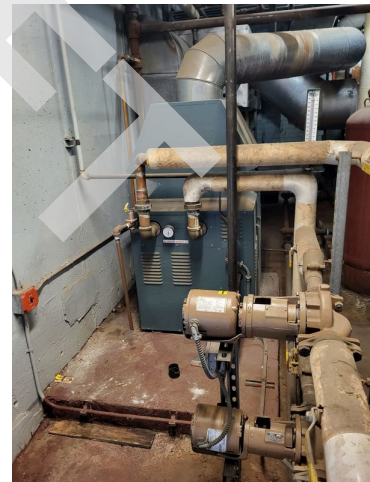
92. Hot water boiler (726,000 btu)

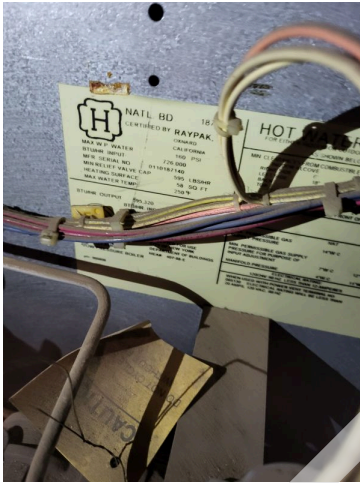
93. Hot water boiler

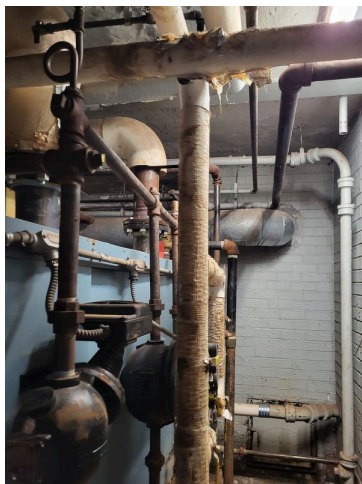
99. Cast iron pipes

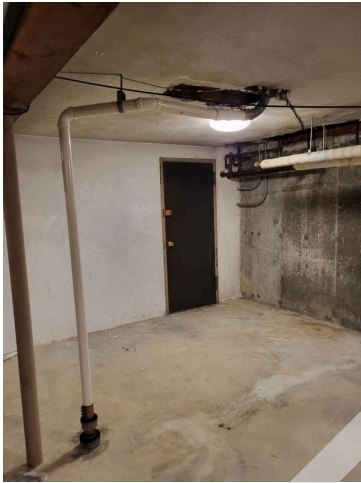
113. Basement damaged ceiling (Non-Critical Repair)

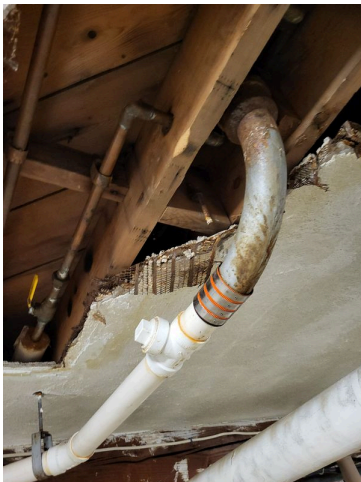
119. Basement ceiling damage (Non-Critical Repair)

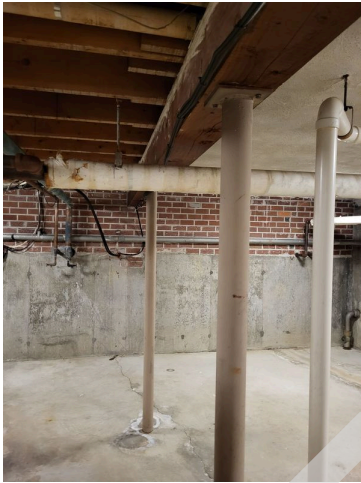
121. Basement ceiling damage (Non-Critical Repair)

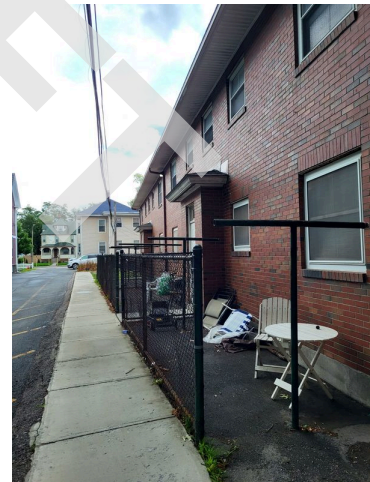
131. Apartment building chain link fence and gutter/
down spout

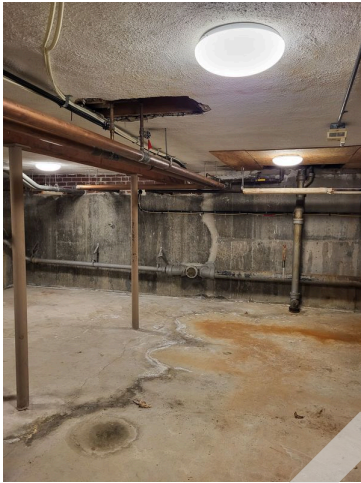
152. Basement ceiling damage (Non-Critical Repair)
