## HUD CAPITAL NEEDS ASSESSMENT

Margaret Collins (Pond St)  
29 Pond Street  
Jamaica Plain, Massachusetts 02130

AEI Project No. 463357  
Site Inspection Date: June 30, 2022

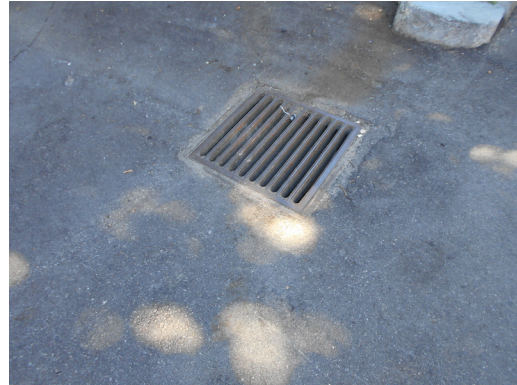
Parking lot drainage

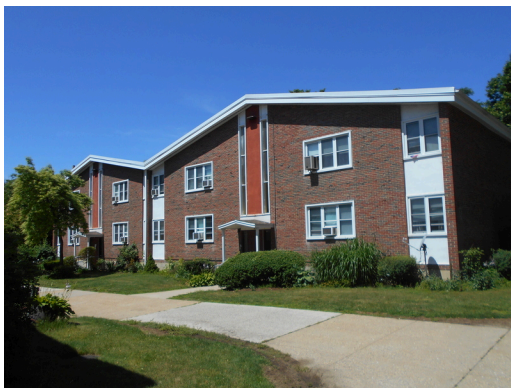
Building B front façade

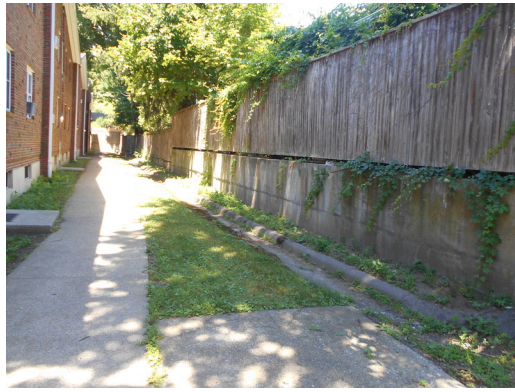
Building wood fencing and concrete retaining wall

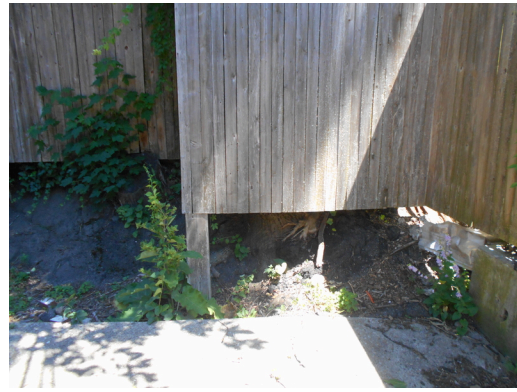
Building wood fencing and concrete retaining wall

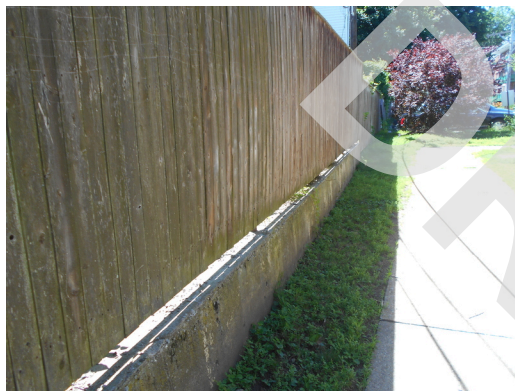
Building wood fencing and concrete retaining wall

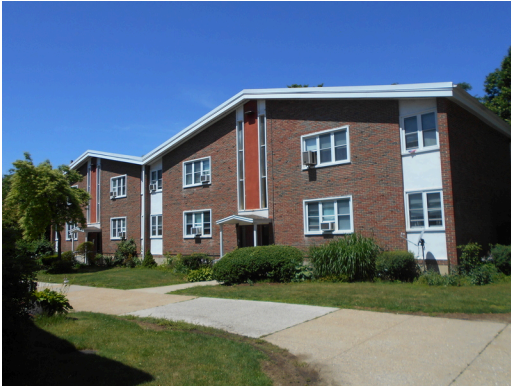
Building B front façade

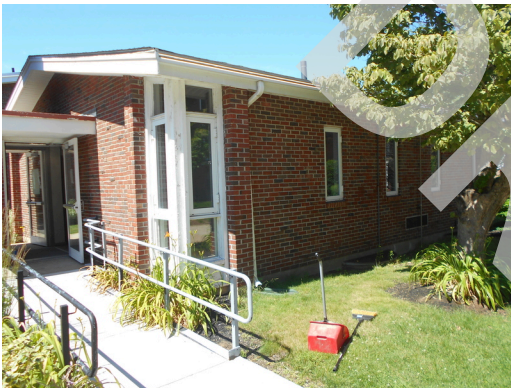
Community building side façade

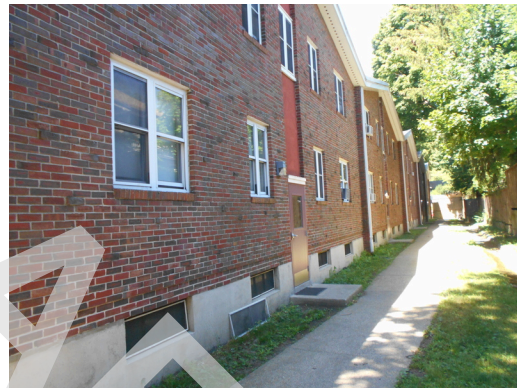
Building A rear façade

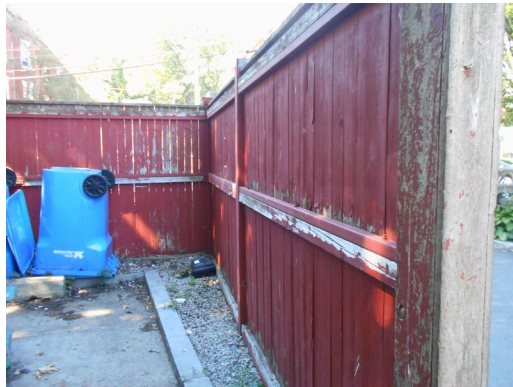
Refuse area wood fencing

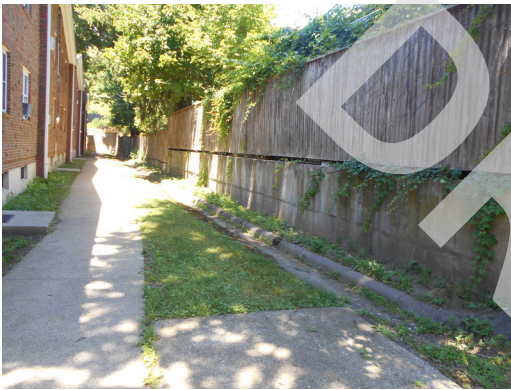
Building wood fencing and concrete retaining  
wall

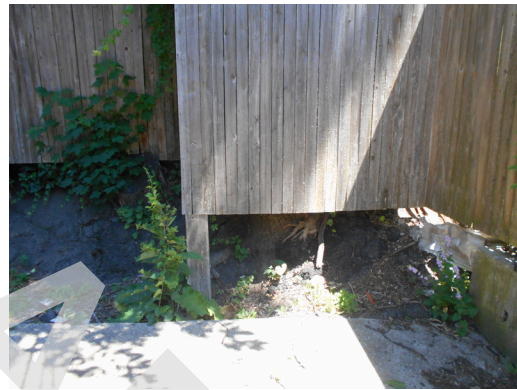
Building wood fencing and concrete retaining  
wall

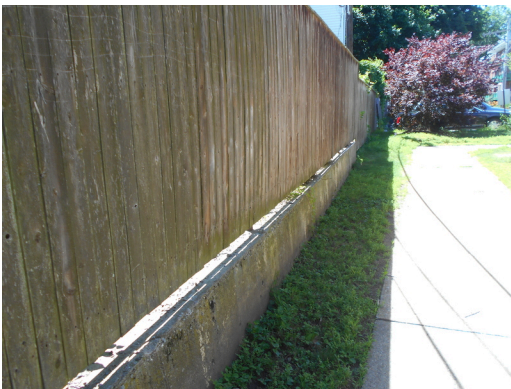
Building wood fencing and concrete retaining  
wall

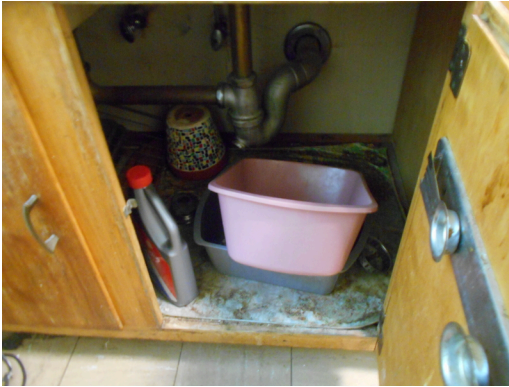
Building B, Unit 27, 2br/1ba - Kitchen sink piping and cabinetry

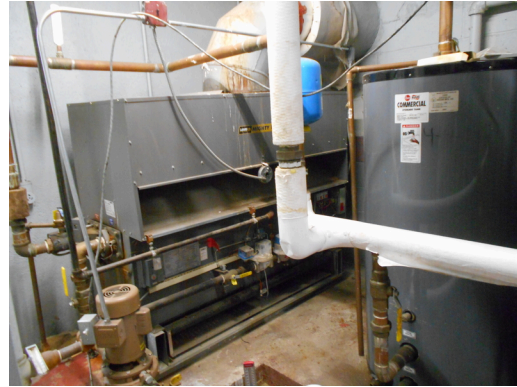
Basement mechanical room, water heater

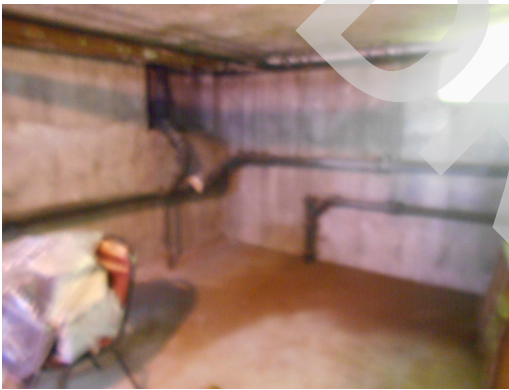
Building A basement

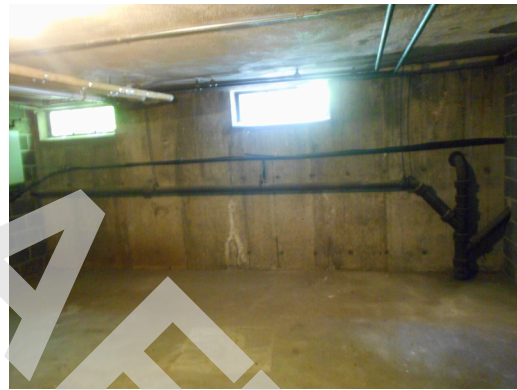
Building B basement

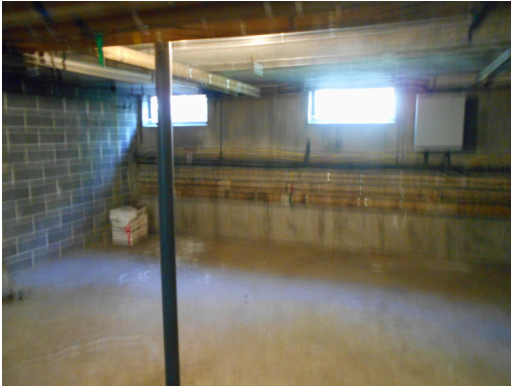
Building A basement

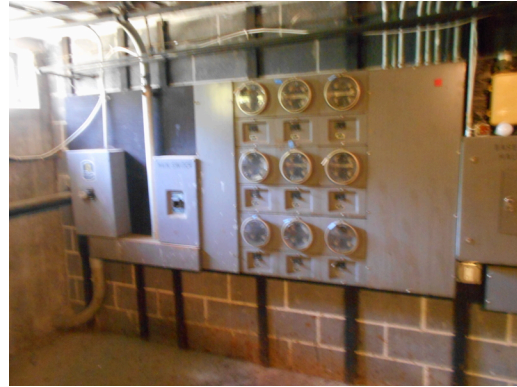
Building B basement electric meters

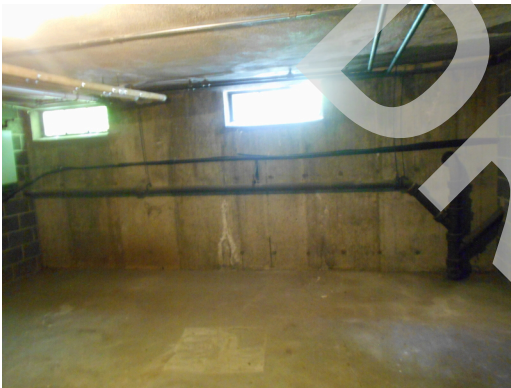
Building B basement

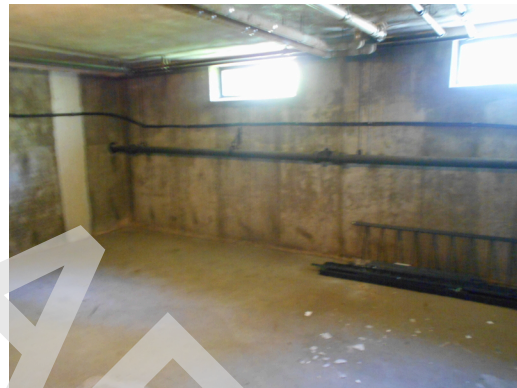
Building B basement

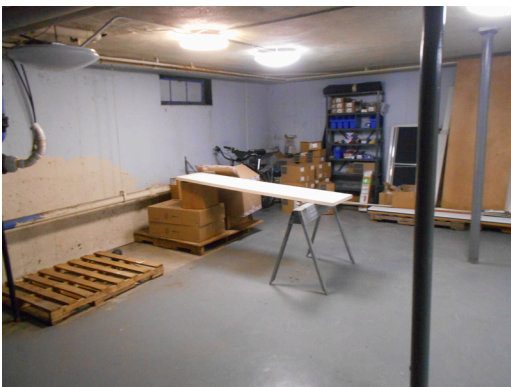
Building C basement maintenance storage

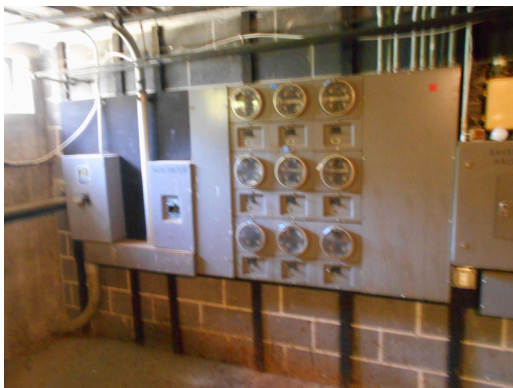
Building B basement electric meters

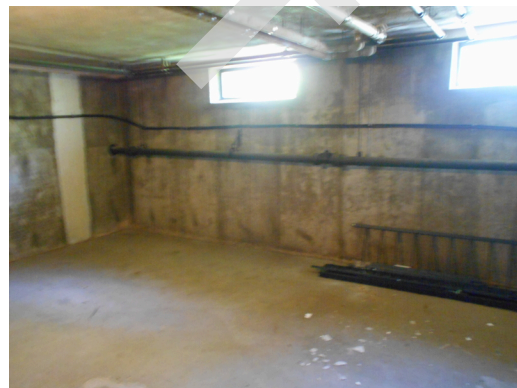
Building B basement

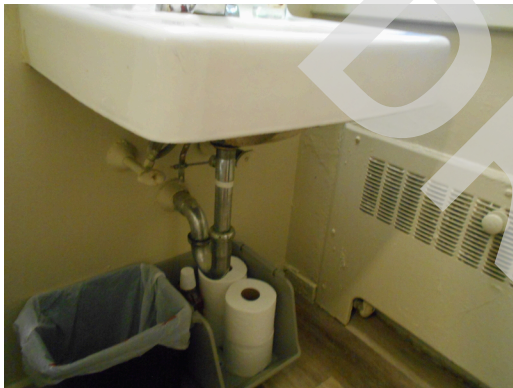
Building A, Unit 9, 1br/1ba - Bathroom sink,  
no scald abrasion protection

- The community building restroom was observed without scald and abrasion protection at the roll under sink. In order to comply with the Americans with Disabilities Act Accessibility Guidelines (ADAAG) and the Uniformed Federal Accessibility Standards (UFAS), the installation of scald and abrasion protection is required. (Critical Repair).

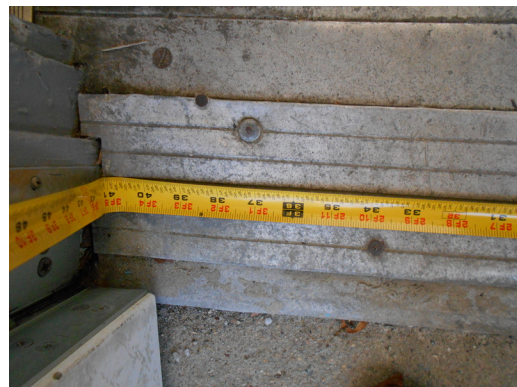
Community building entrance, 41"

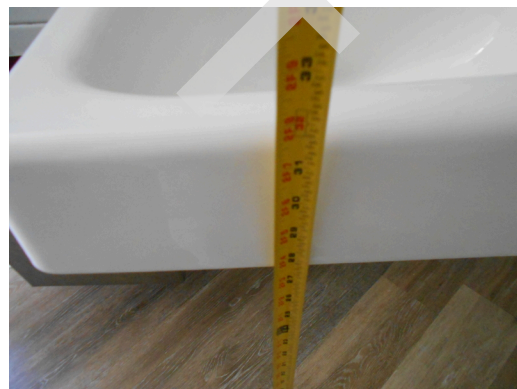
Men's public restroom sink height, 32"

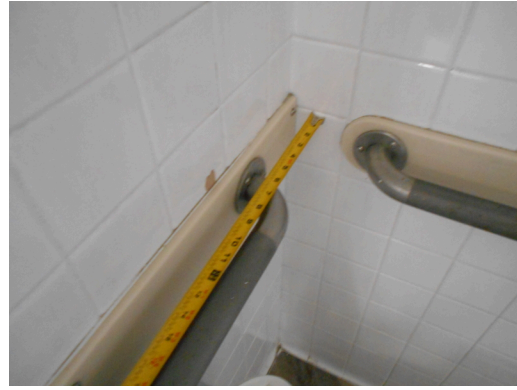
Men's public restroom, rear grab bar

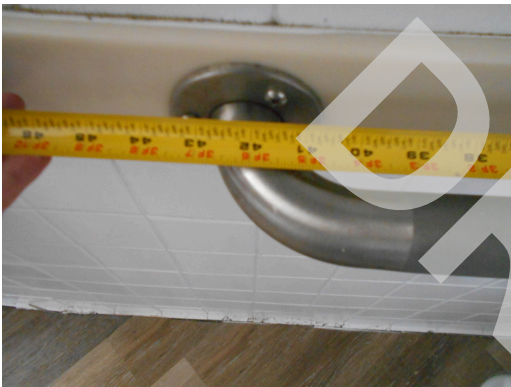
Men's public restroom, rear grab bar, 42"

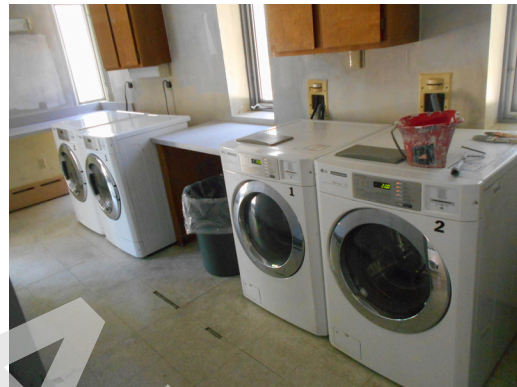
Community building laundry room

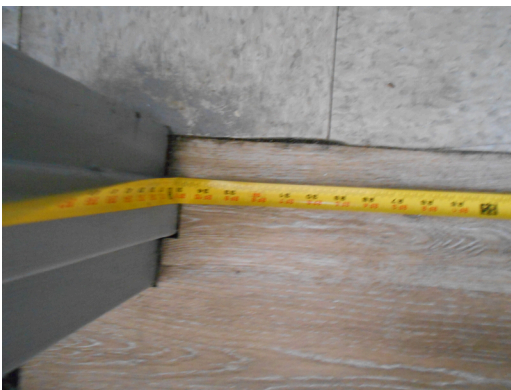
Community building laundry room entrance,  
34"

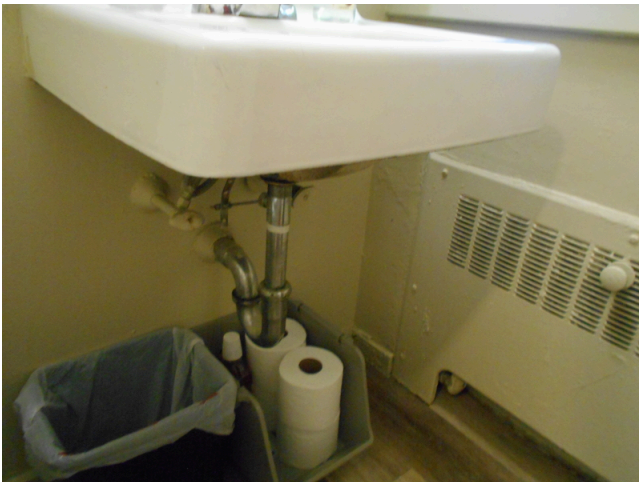
11. Building A, Unit 9, 1br/1ba - Bathroom sink, no scald abrasion protection

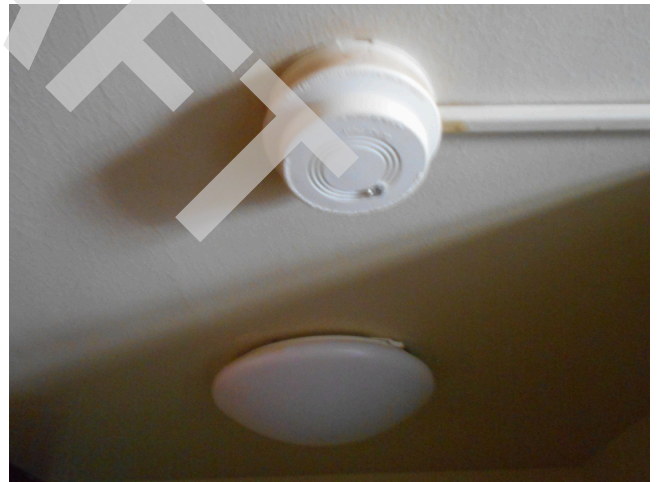
20. Building A, Unit 7, 1br/1ba - Living area area smoke detector

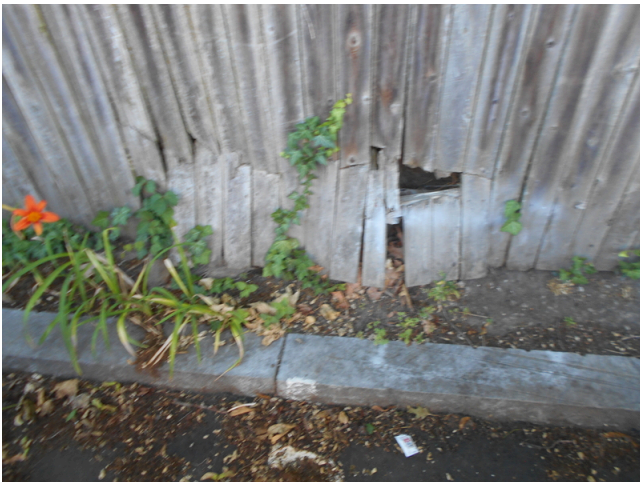
11. Parking lot wood fencing, damaged (Non-Critical Repair)

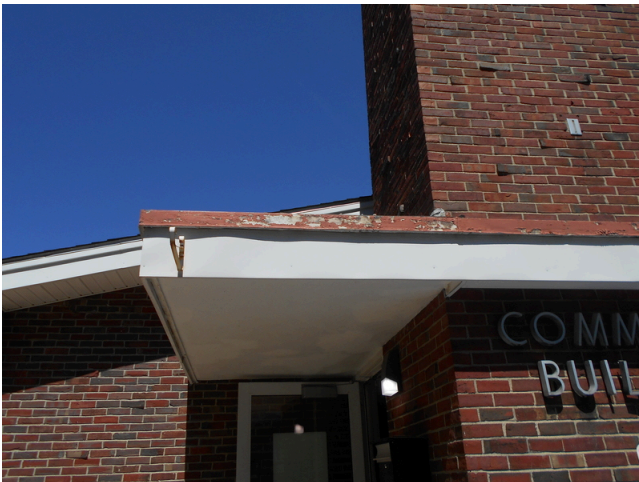
15. Community building, paint chipping (Non-Critical Repair)

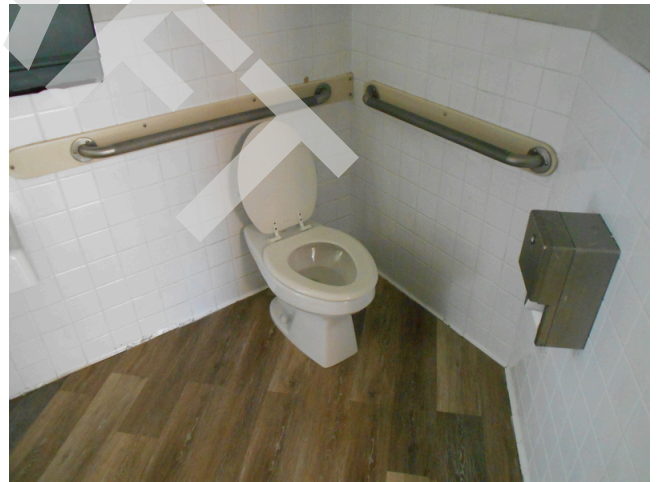
28. Men's public restroom, not enough clear floor space (Critical Repair)

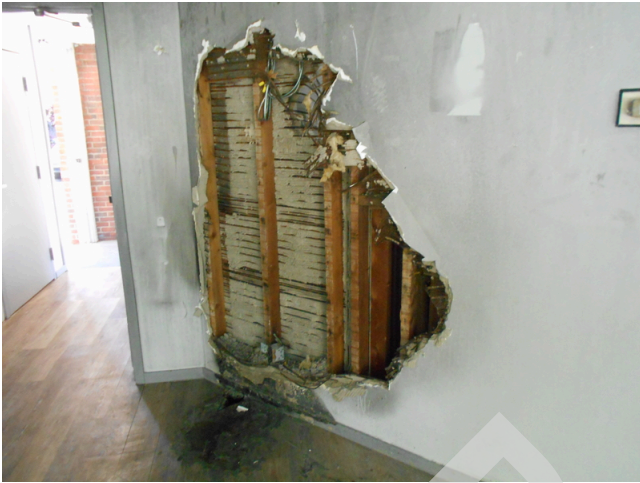
37. Community building main room, damaged by fire (Non-Critical Repair)

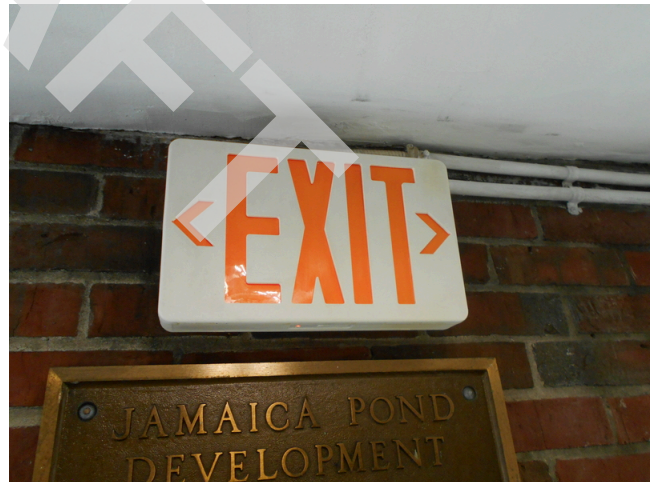
108. Emergency exit sign

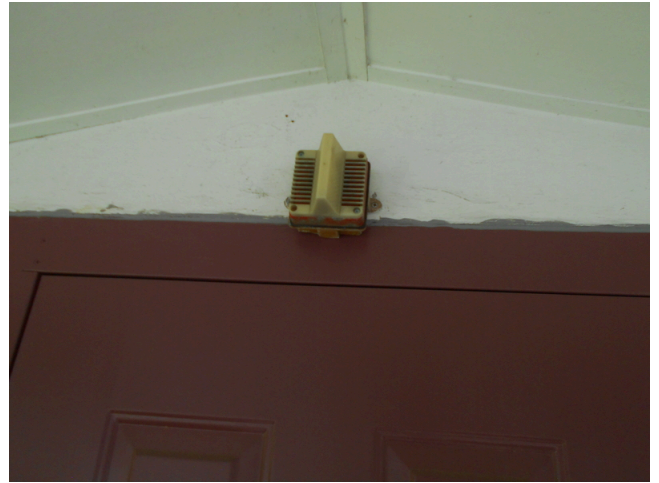
118. Typical emergency pull cord light above stairwell entrances
