HUD CAPITAL NEEDS ASSESSMENT

ME McCormack
10 Kemp Street
South Boston, Massachusetts 02127

AEI Project No. 463360
Site Inspection Date: July 7th & July 8th

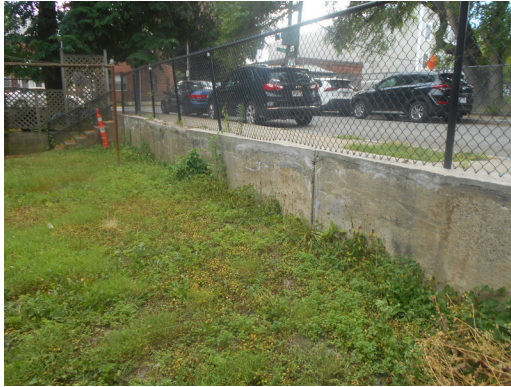
Concrete retaining wall by building 27

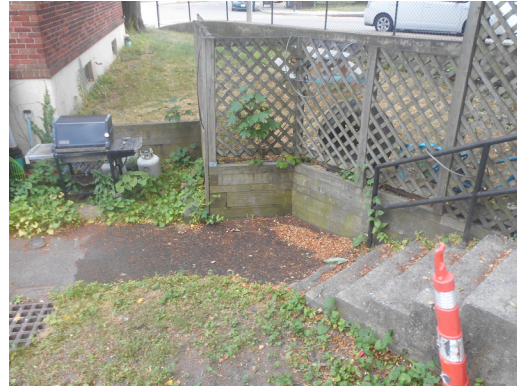
Wood retaining wall by buildings

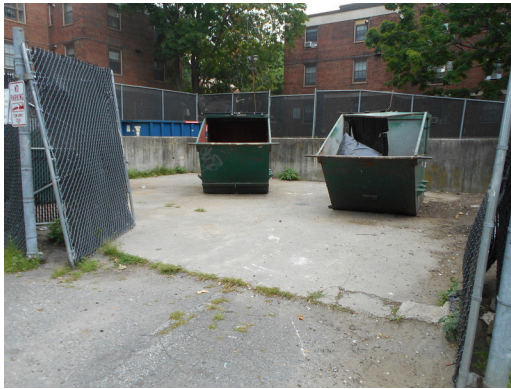
Refuse area by building 30, damaged fencing
(Non-Critical Repair)

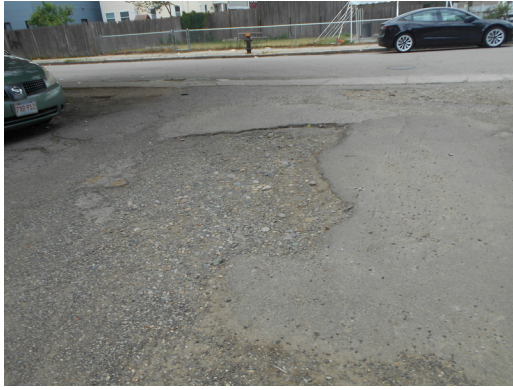
Asphalt parking lot by building 30, damaged
(Non-Critical Repair)

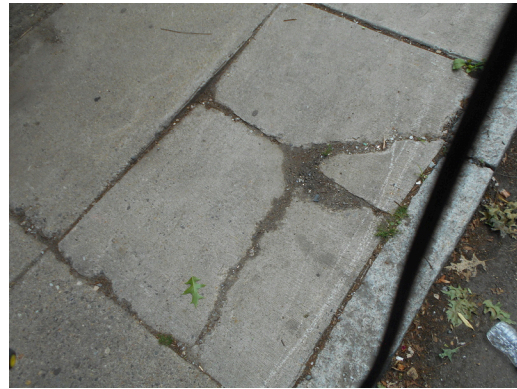
Concrete trip hazard between building 3 and building 4 (Critical Repair)

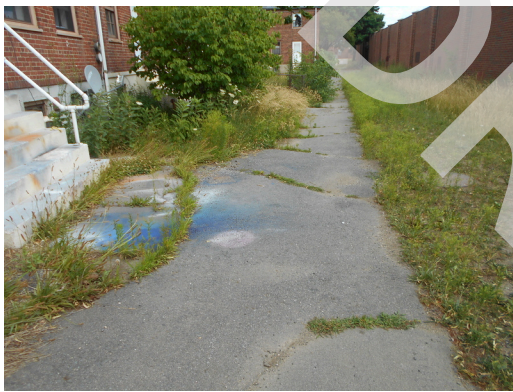
Building 3 rear façade, asphalt pathway overgrown and cracked (Non-Critical Repair)

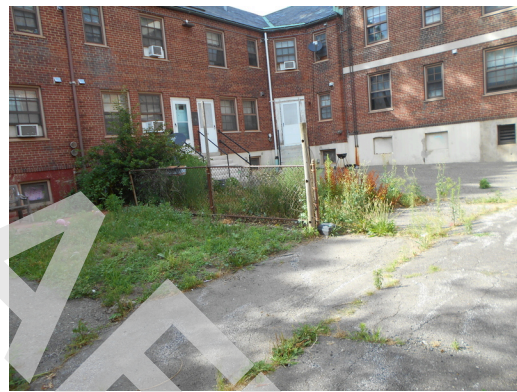
Building 4 rear façade, Cracked asphalt courtyard (Non-Critical Repair)

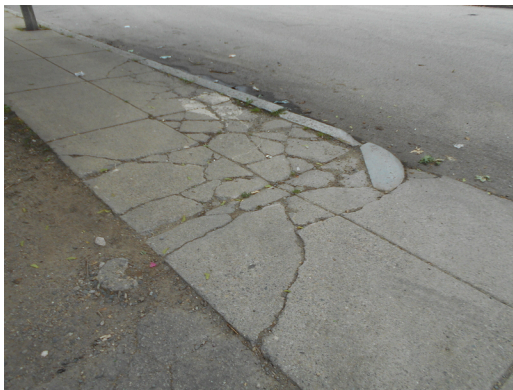
Concrete sidewalk by building 30, damaged (Critical Repair)

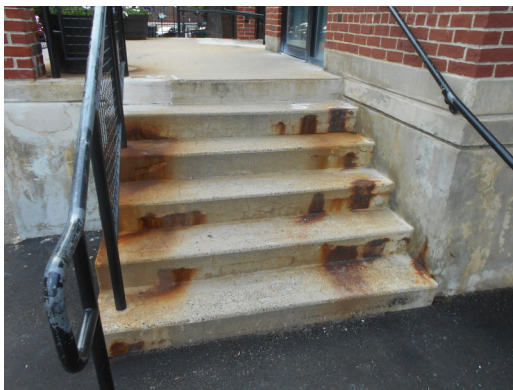
Leasing office concrete stairs, rebar rust
(Non-Critical Repair)

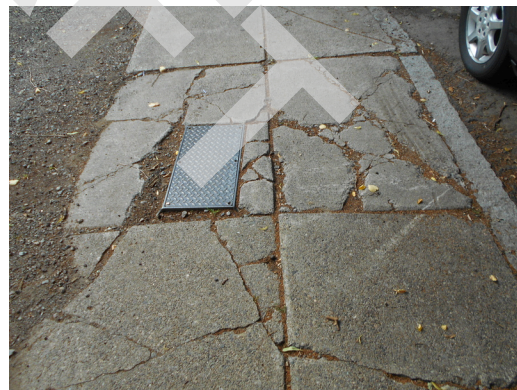
Concrete sidewalk by building 7, damaged
(Critical Repair)

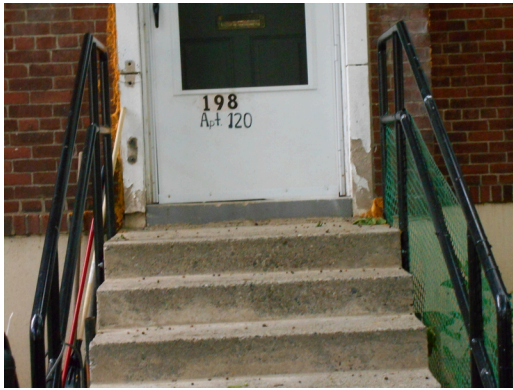
Building 11 front façade, chipping paint on door of 198 O'Callaghan Way, Apartment 120 (Non-Critical Repair)

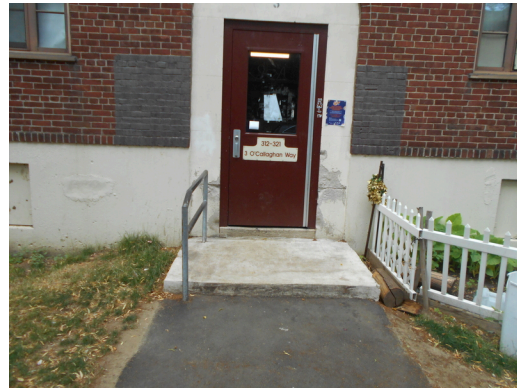
3 O'Callaghan way entrance, damaged entry (Non-Critical Repair)

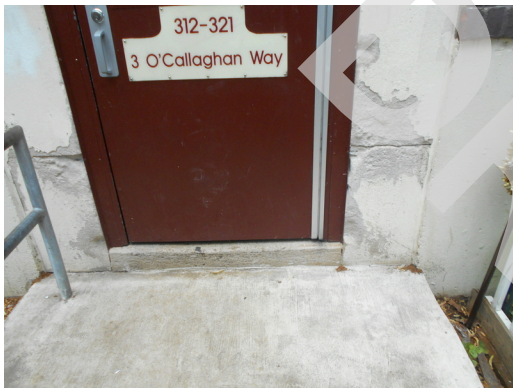
3 O'Callaghan way entrance, damaged entry (Non-Critical Repair)

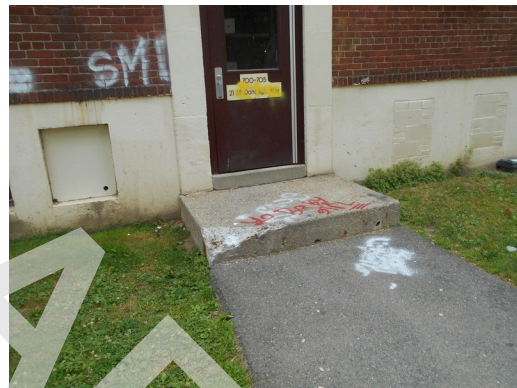
Building 31, 21 McDonough Way, damaged concrete pad by stairwell entrance (Non-Critical Repair)

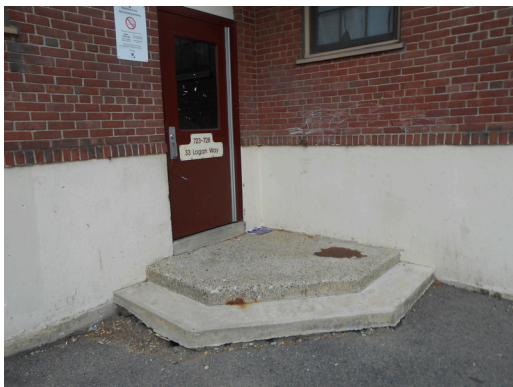
Building 32, 33 Logan way stairwell entrance, Concrete stairs at entrance eroded (Non-Critical Repair)

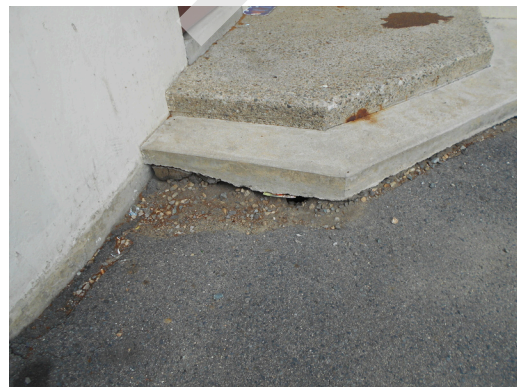
Building 32, 33 Logan way stairwell entrance, Concrete stairs at entrance eroded (Non-Critical Repair)

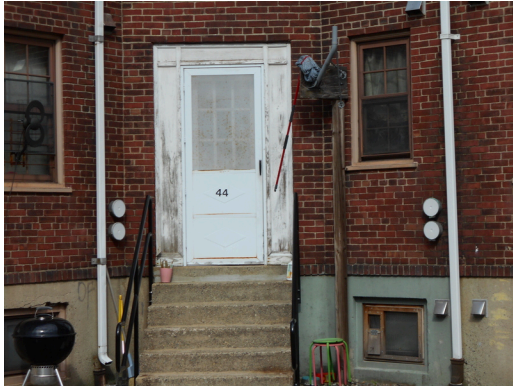
Paint chipping along rear entrance of unit 44 O'Callaghan way, unit 196 (Non-Critical Repair)

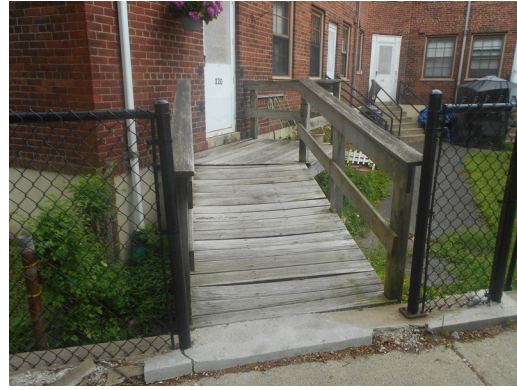
Wood ramp leading to 220 O'Callaghan Way, not a designated handicap unit

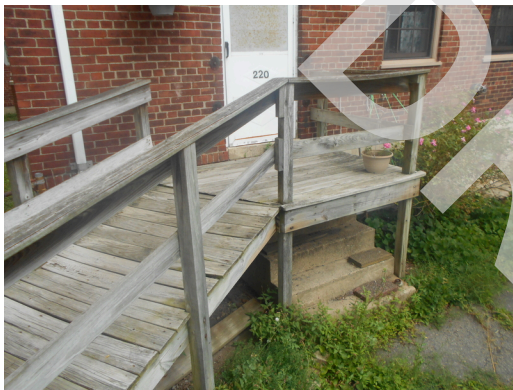
Wood ramp leading to 220 O'Callaghan Way, not a designated handicap unit

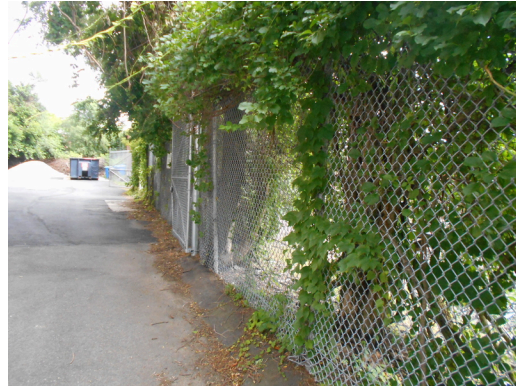
Chain link fence along leasing office driveway, overgrown

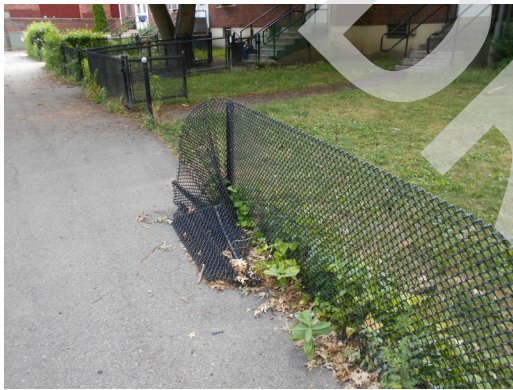
Damaged chain link fence by 198 O'Callaghan way, apartment 120 (Non-Critical Repair)

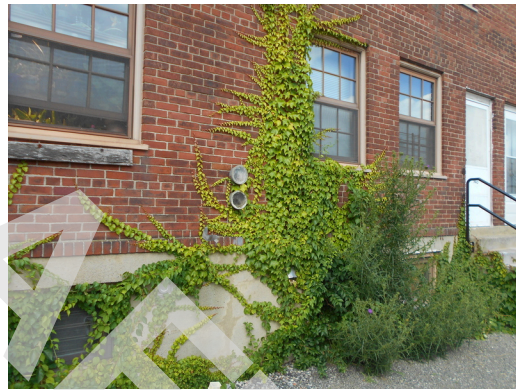
Building 5 rear façade, foliage growing along façade (Non-Critical Repair)

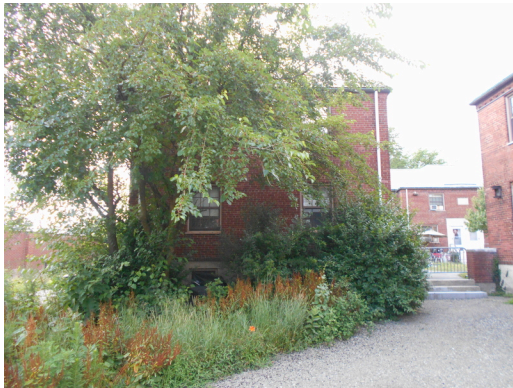
Building 5 side façade, foliage growing along building façade (Non-Critical Repair)

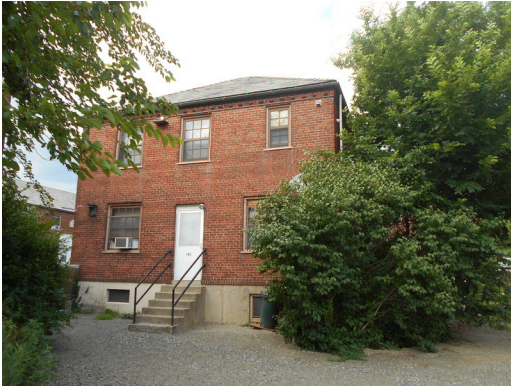
Building 4 side façade, foliage growing along building façade (Non-Critical Repair)

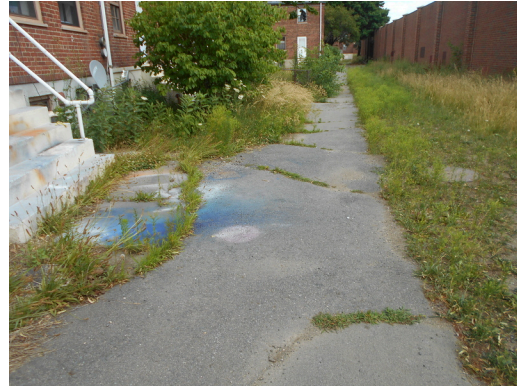
Building 3 rear façade, asphalt pathway overgrown and cracked (Non-Critical Repair)

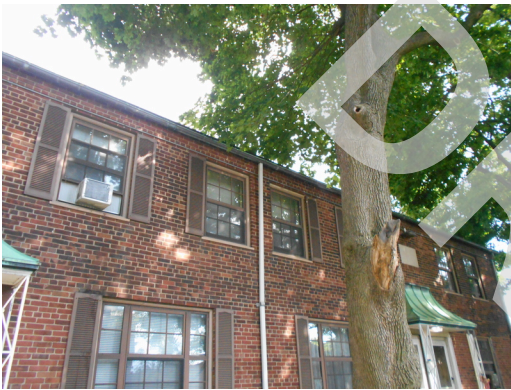
Building 3 front façade, trees growing along side building (Non-Critical Repair)

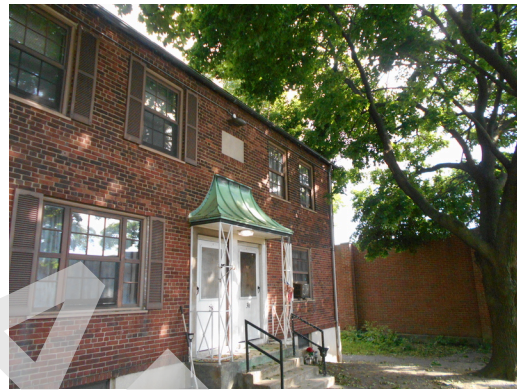
Building 3 side façade, trees growing along side building (Non-Critical Repair)

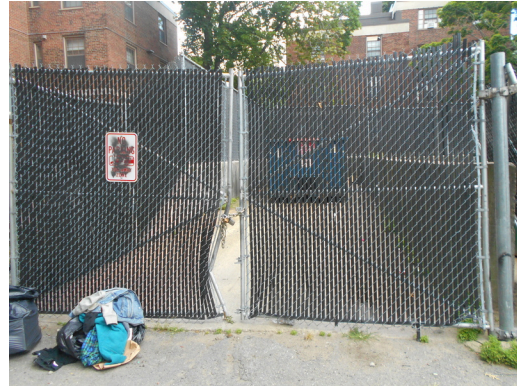
Refuse area by building 30, damaged fencing
(Non-Critical Repair)

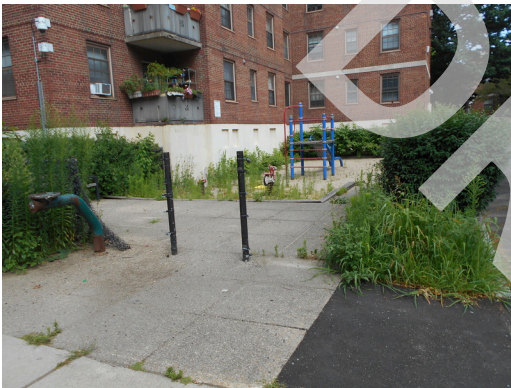
Playground by building 22, overgrown
(Non-Critical Repair)

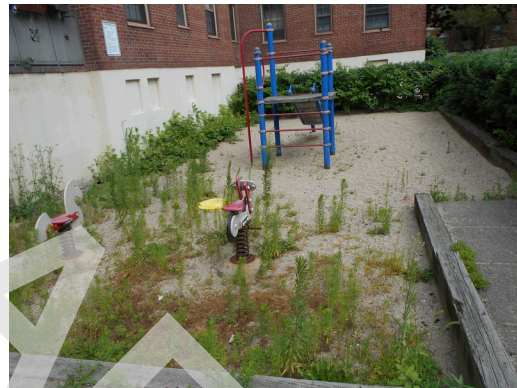
Playground by building 22, overgrown
(Non-Critical Repair)

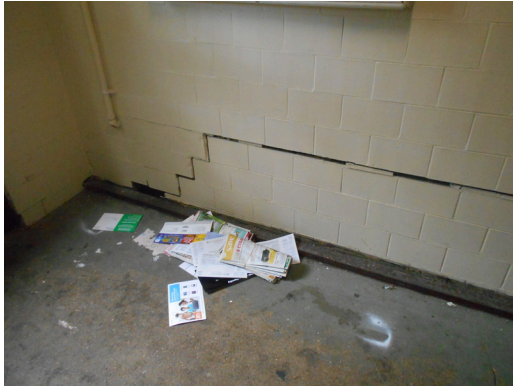
The basements of building 30, building 23 and building 17 was observed with cracking in the basement of the CMU-wall. As this is a sign of a potential structural issue, AEI recommends having a licensed structural engineer inspect the buildings. (Critical Repair)

Building 17 basement, cracked (Non-Critical Repair)

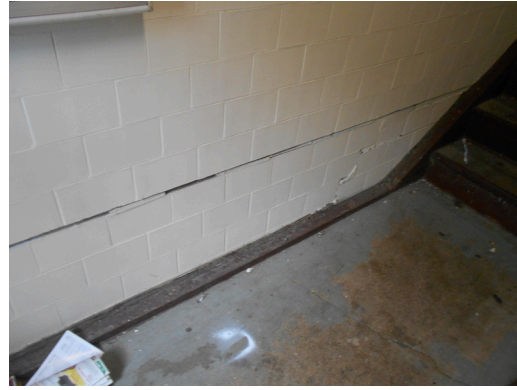
Building 17 basement, cracked (Non-Critical Repair)

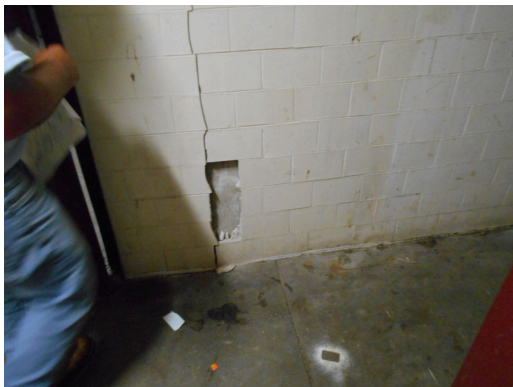
Building 23, 2 Logan Way basement, cracking CMU-wall (Non-Critical Repair)

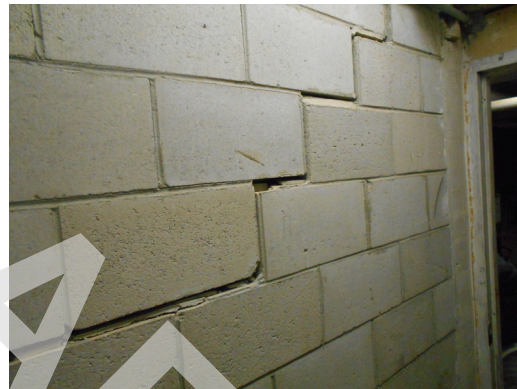
Building 30 basement, 15 Logan way, cracking CMU-wall (Non-Critical Repair)

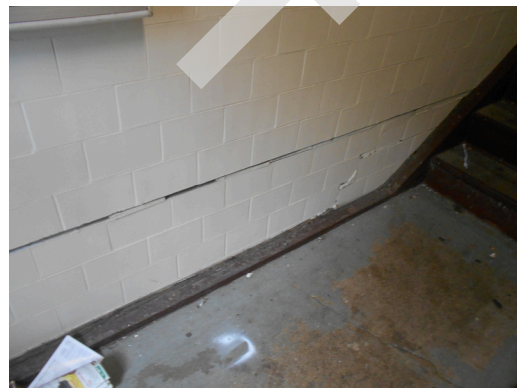
Building 17 basement, cracked (Non-Critical Repair)

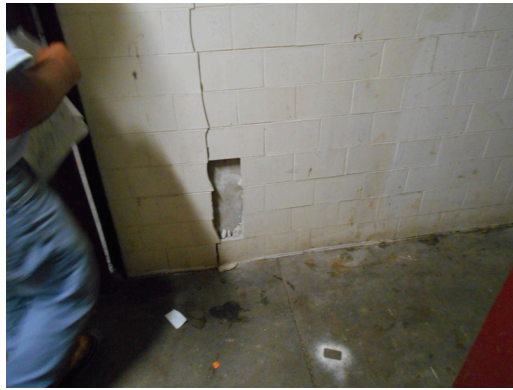
Building 23, 2 Logan Way basement, cracking CMU-wall (Non-Critical Repair)

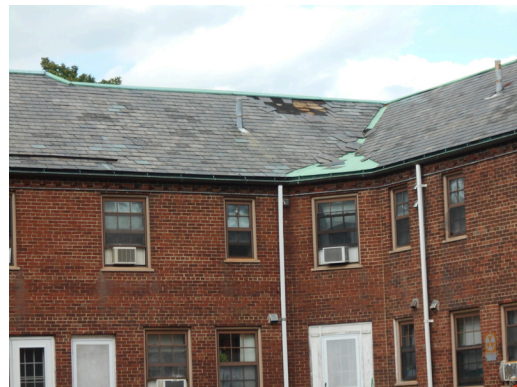
Building 3 rear façade, damaged slate tile roofing (Non-Critical Repair)

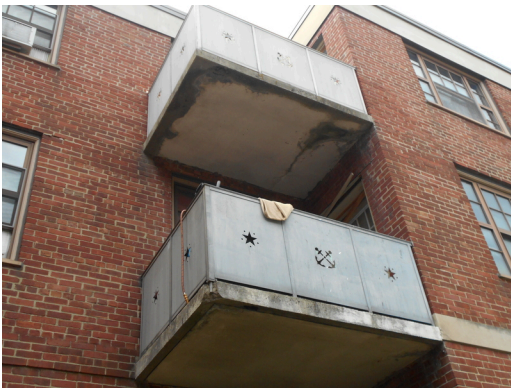
Building 32, concrete balcony, deterioration on underside (Critical Repair)

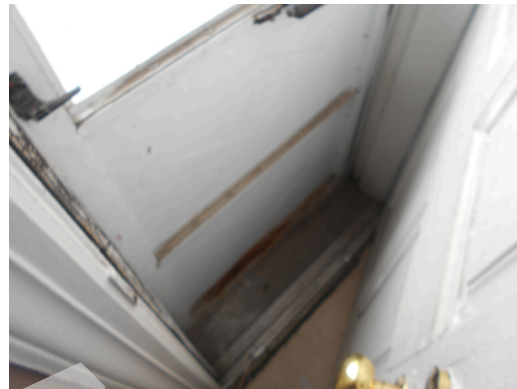
Building 5 unit 186, 64 O'Callaghan Way, 3br/1ba Townhouse - Rear door, damaged (Non-Critical Repair)

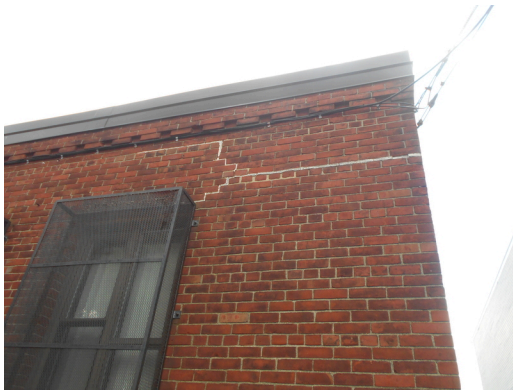
Leasing office front façade, repaired cracking

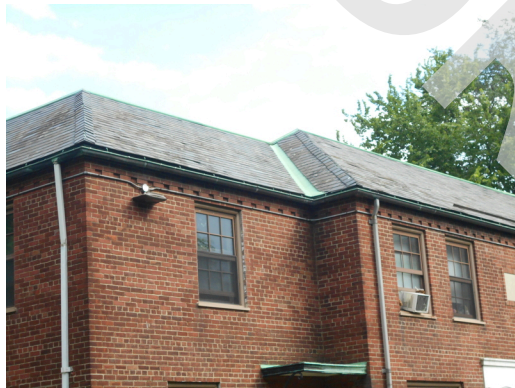
Building 6 front façade, slate tile roof (Non-Critical Repair)

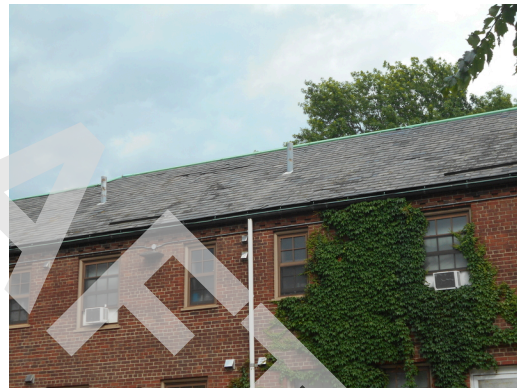
Building 6 slate tile roofing, shingles falling (Non-Critical Repair)

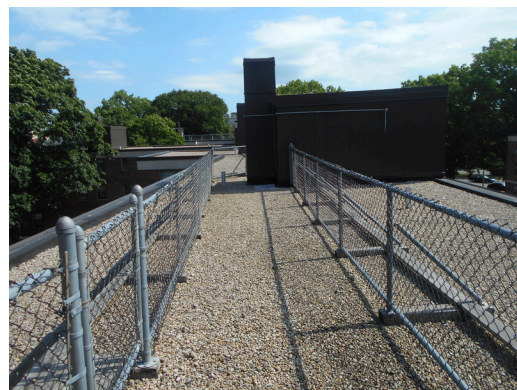
Building 32 EPDM Roof with gravel

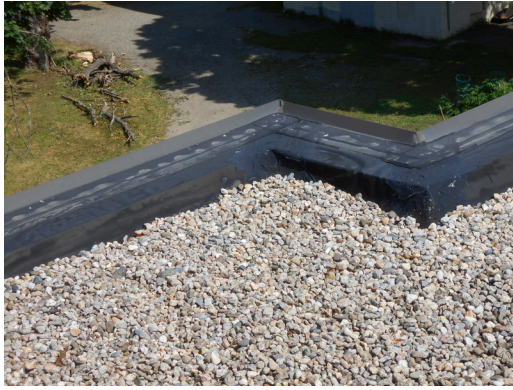
Building 32 EPDM Roof with gravel

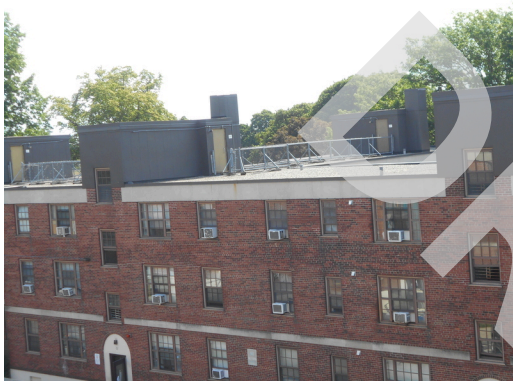
Building 31 EPDM Roof with gravel

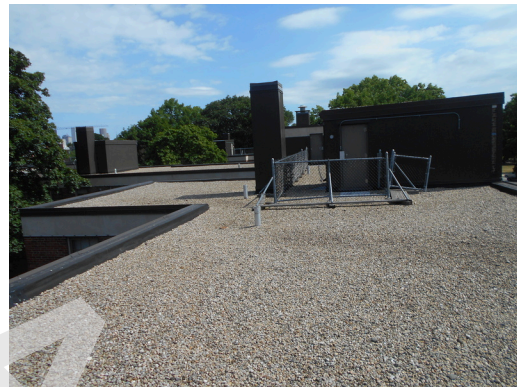
Building 32 EPDM Roof with gravel

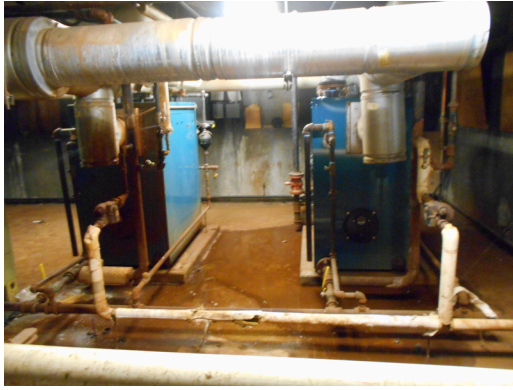
Building 17 basement boiler room, water pooling (Non-Critical Repair)

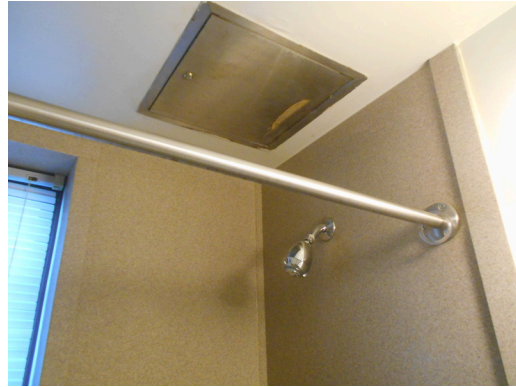
Building 1 unit 238, 1br/1ba - Bathroom shower, pipe access

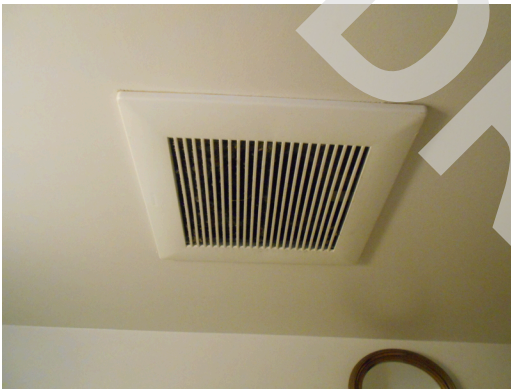
Building 1 unit 238, 1br/1ba - Bathroom shower, vent

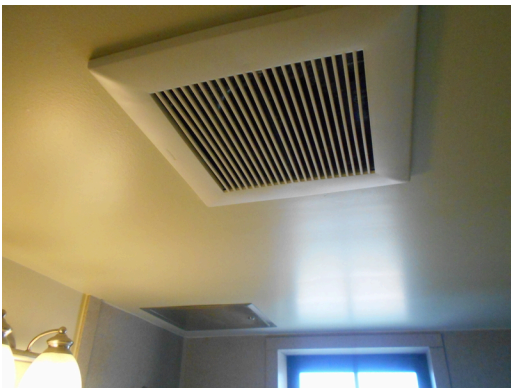
Building 1 unit 247, 1br/1ba - Bathroom ceiling

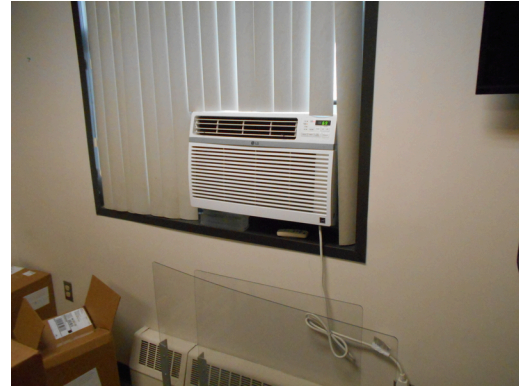
Leasing office, window mounted A/C

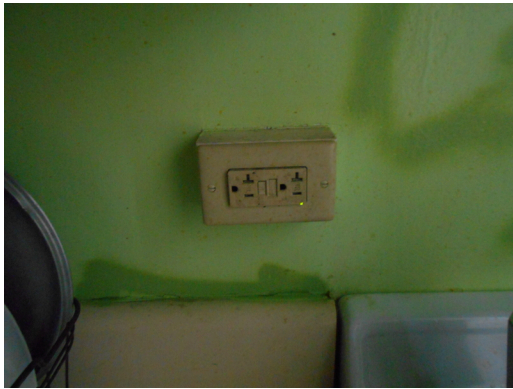
Building 1 unit 238, 1br/1ba - Kitchen GFCI

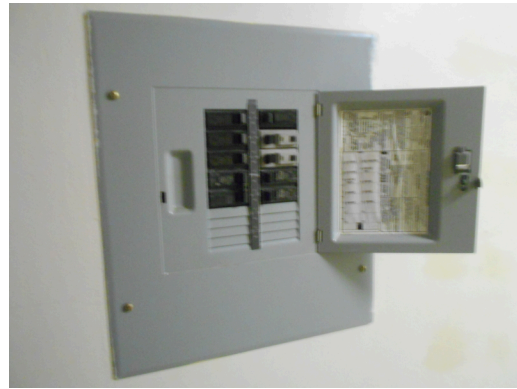
Building 1 unit 238, 1br/1ba - Tenant electrical breaker

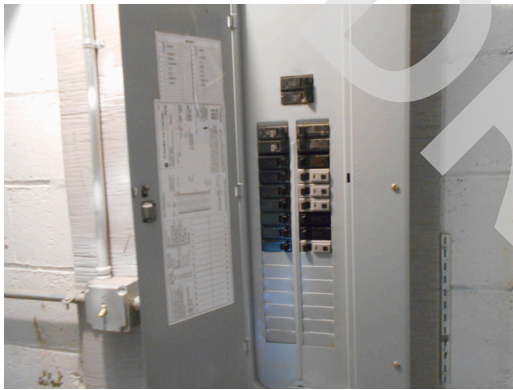
Building 3 unit 204, 28 O'Callaghan Way, 3br/1ba Townhouse - Basement electrical breaker

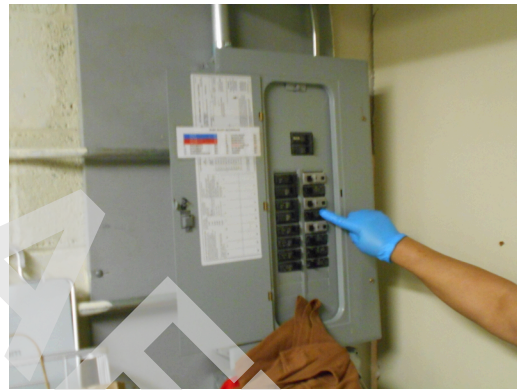
Building 5 unit 186, 64 O'Callaghan Way, 3br/1ba Townhouse - Basement electrical breaker

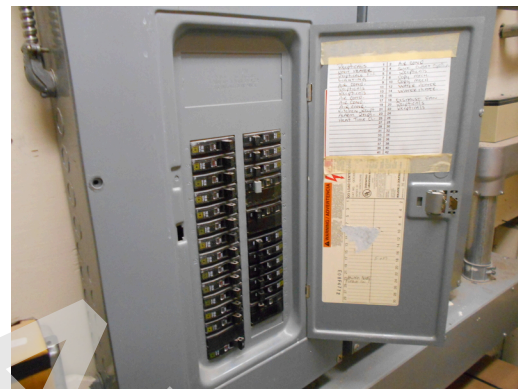
Leasing office electrical panel

The electrical room in the leasing office building was observed with stored items blocking access to the electrical panels. The electrical closet should be cleaned to allow emergency access to the electrical panels.

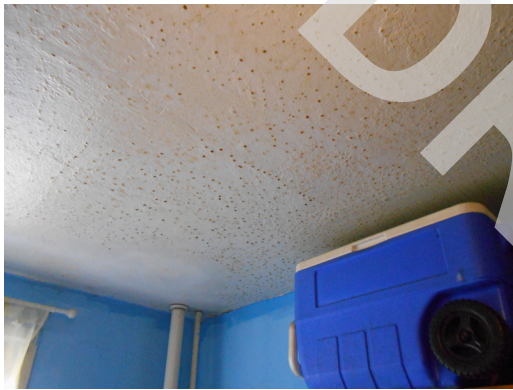
Building 2 unit 222, 2br/1ba - Kitchen ceiling, water damaged from uncovered stove (Non-Critical Repair)

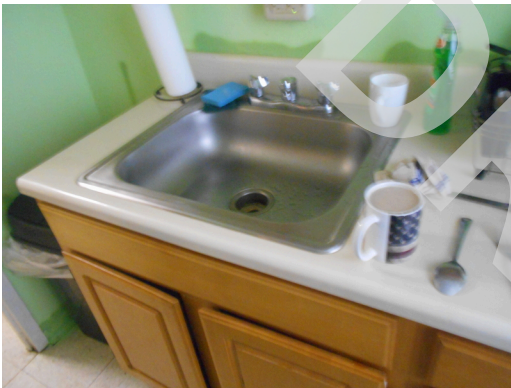
Building 1 unit 238, 1br/1ba - Kitchen sink

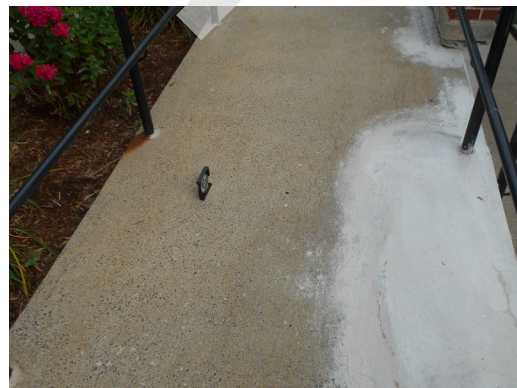
Leasing office handicap ramp slope 2, compliant

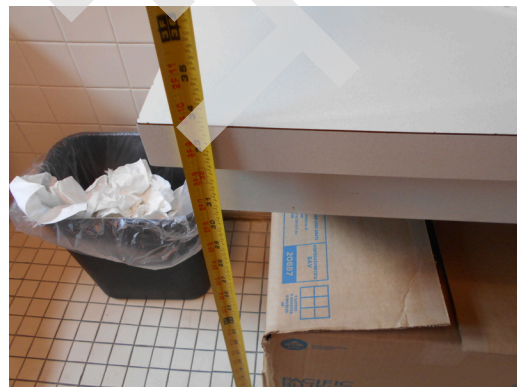
Leasing office public restroom sink height, 33"

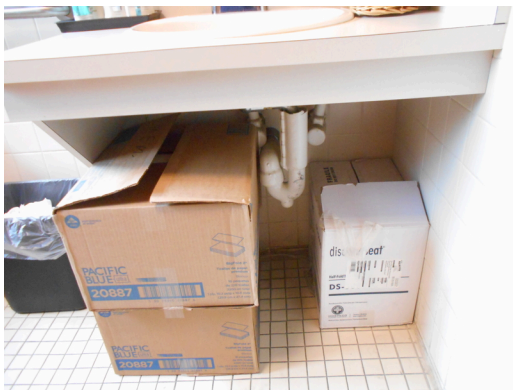
Leasing office public restroom sink scald abrasion protection

- The common area restrooms in the leasing office and community building were observed without scald and abrasion protection at the roll under sink. In order to comply with the Americans with Disabilities Act Accessibility Guidelines (ADAAG) and the Uniformed Federal Accessibility Standards (UFAS), the installation of scald and abrasion protection is required. (Critical Repair)

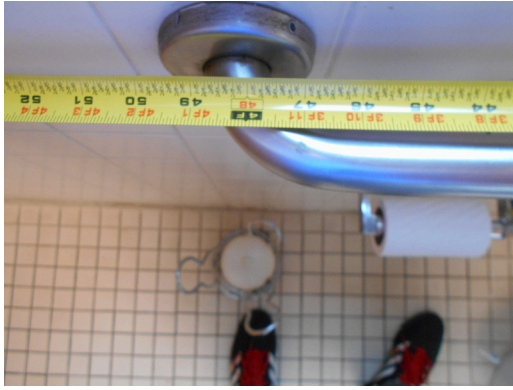
Leasing office public restroom side grab bar, 48" (Critical Repair)

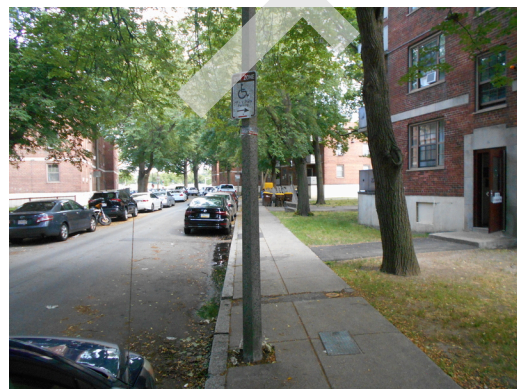
5.	Do curbs on the accessible route have depressed, ramped curb cuts at drives, paths, and drop-offs?		✓		The designated accessible spaces do not have access aisles or curb cuts, (Critical Repair)

Building 3 handicap street parking, no curb cut or access aisle (Critical Repair)

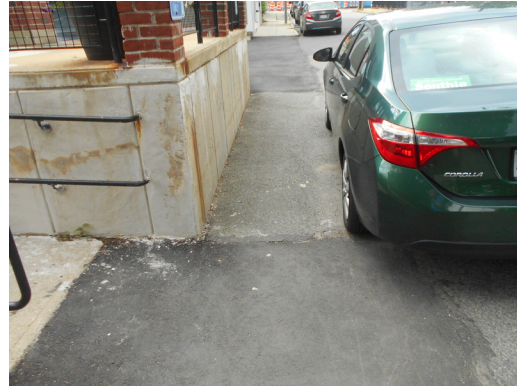
2.	Are there sufficient van-accessible parking spaces available (96" wide aisle for van)?		✓		0 van accessible spaces provided 1 van accessible space required (Critical Repair)

Leasing office accessible parking space sign, no parking space markings, no access aisle, no horizontal signage (Critical Repair)

- Based upon the twelve (12) standard uncovered parking spaces available at the site, one (1) handicapped accessible parking spaces, inclusive of one (1) van accessible handicapped parking space are required by the Americans with Disabilities Act Accessibility Guidelines (ADAAG). The site currently features three (3) designated handicapped spaces; however the existing spaces were observed without without access aisles, curb-cuts, and neither spaces is van accessible. In order for the existing designated handicapped parking space to comply with ADAAG, the installation of access aisles, curb-cuts and conversion of one (1) space to van accessible is required. Standard handicapped spaces require a 60" wide access aisles and vertical and horizontal identification. Van accessible handicapped spaces require a 96" wide access aisle, vertical signage identifying the space as van accessible, and horizontal identification. The designated handicapped parking spaces should be located at the closest accessible route to the building entrances and two (2) spaces may share a single access aisle. (Critical Repair)

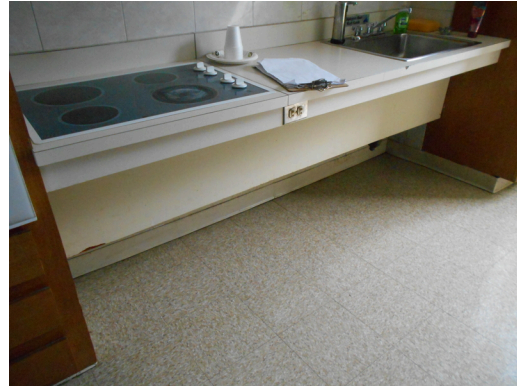
Community building, task force headquarters, kitchen roll-under sink

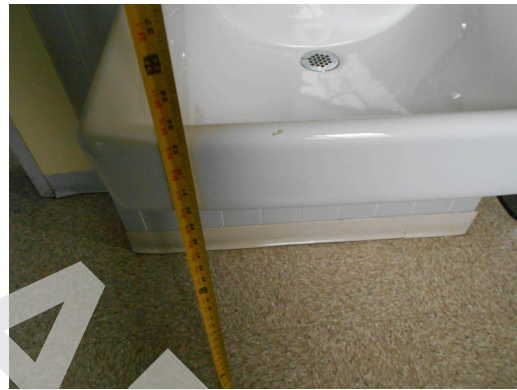
Community building, task force headquarters, restroom, sink height, 33"

Common area bath accessories (towel bars, grab bars, toilet stalls, etc.)	Install Scald and Abrasion Sink Wrap (Critical Repair)	Common area Restrooms	Repair	4	Each	\$ 80.00	\$ 320.00	The common area restrooms in the leasing office and community building were observed without scald and abrasion protection at the roll under sink. In order to comply with the Americans with Disabilities Act Accessibility Guidelines (ADAAG) and the Uniformed Federal Accessibility Standards (UFAS), the installation of scald and abrasion protection is required.	
Common area bath accessories (towel bars, grab bars, toilet stalls, etc.)	Install Compliant Grab Bars (Critical Repair)	Leasing office public restroom	Level 1 Alteration	1	Each	\$ 250.00	\$ 250.00	The leasing office public restroom was observed with non-compliant grab bars. In order to comply with the Americans with Disabilities Act Accessibility Guidelines (ADAAG), the installation of compliant grab bars is required.

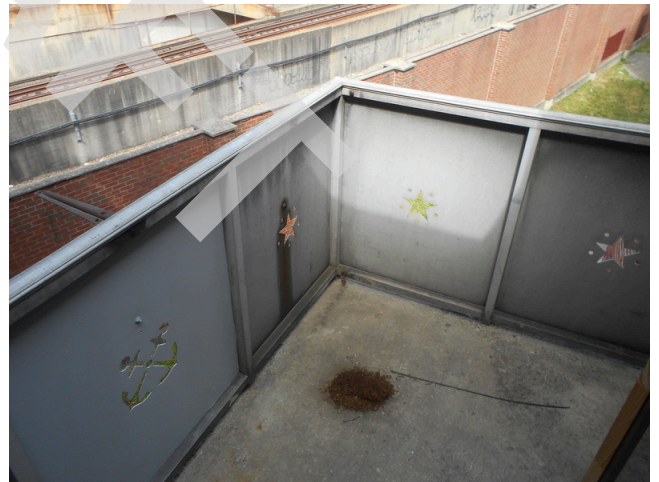
36. Building 1 unit 266, 2br/1ba, vacant - Concrete balcony

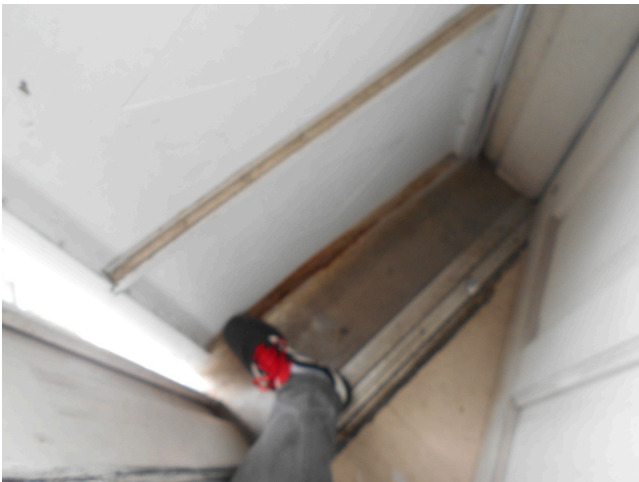
118. Building 5 unit 186, 64 O'Callaghan Way, 3br/1ba Townhouse - Rear door, damaged (Non-Critical Repair)

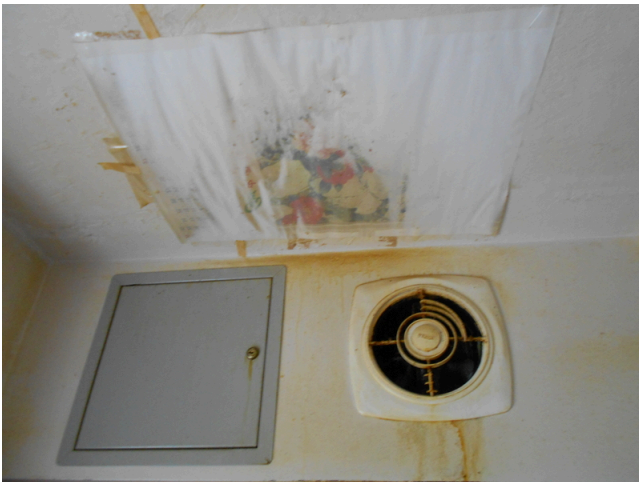
123. Building 9 unit 132, 172 O'Callaghan Way, 3br/
1ba Townhouse - Kitchen, water damaged ceiling
(Non-Critical Repair)

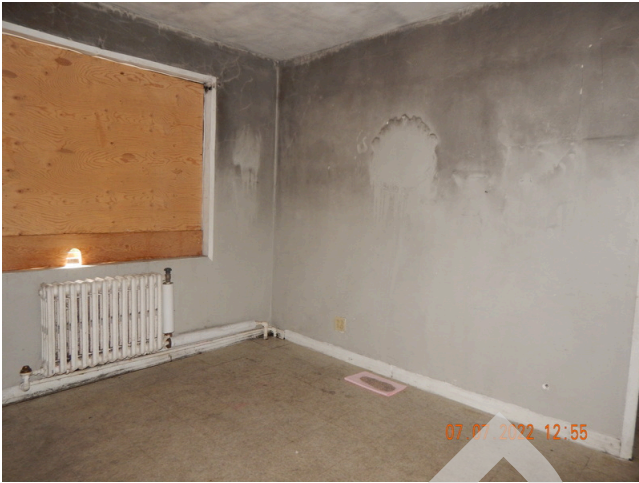
125. Units 1016 and 915 have fire damage

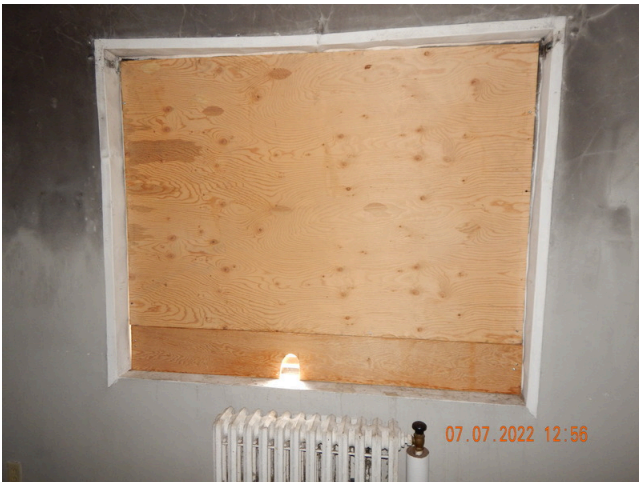
127. Units 1016 and 915 have fire damage

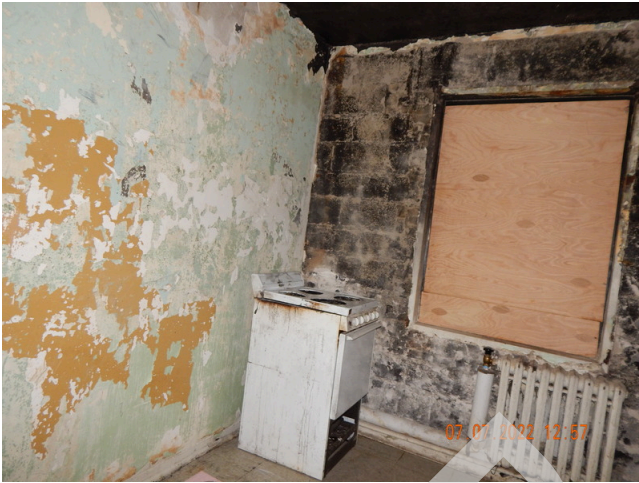
129. Units 1016 and 915 have fire damage

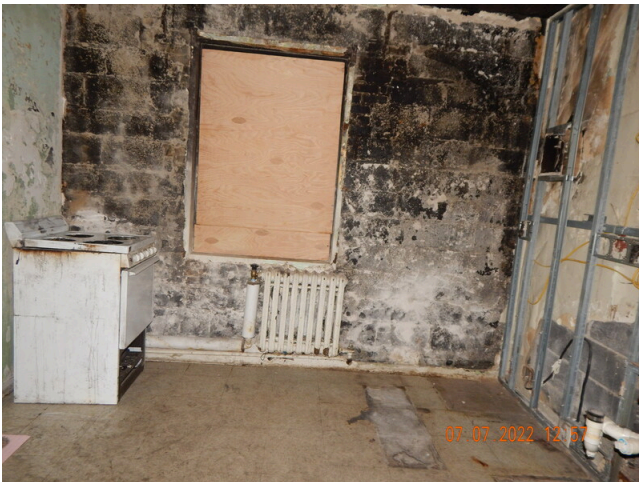
131. Units 1016 and 915 have fire damage

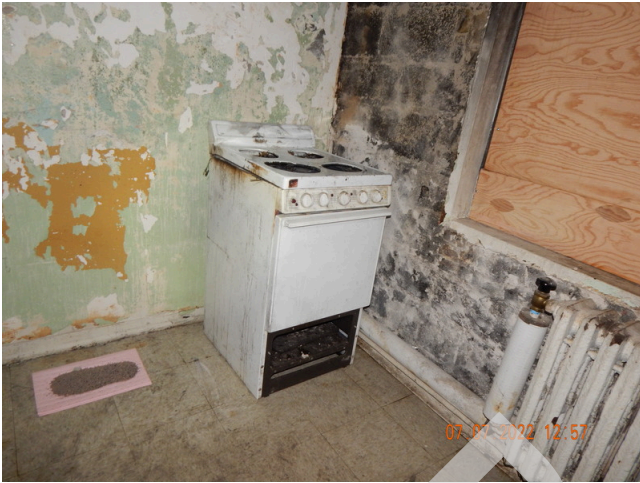
133. Units 1016 and 915 have fire damage

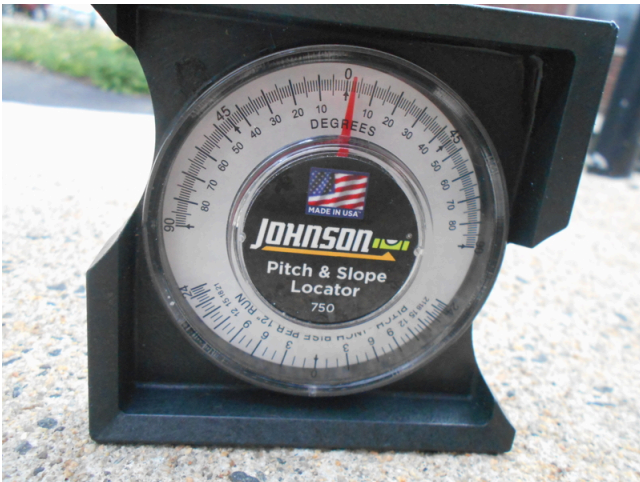
7. Leasing office handicap ramp slope, compliant

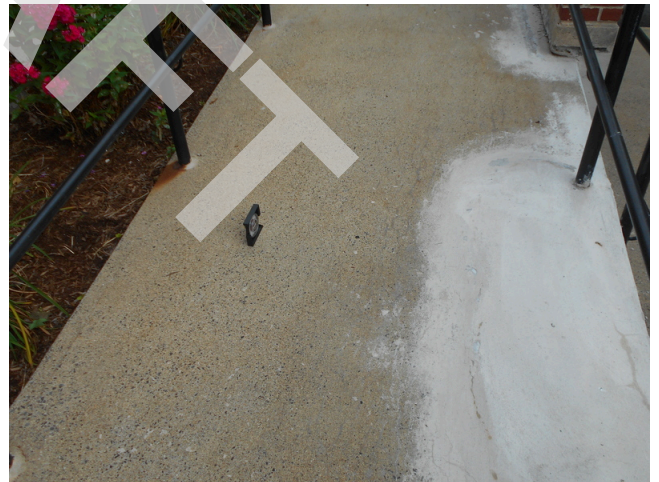
8. Leasing office handicap ramp slope 2, compliant

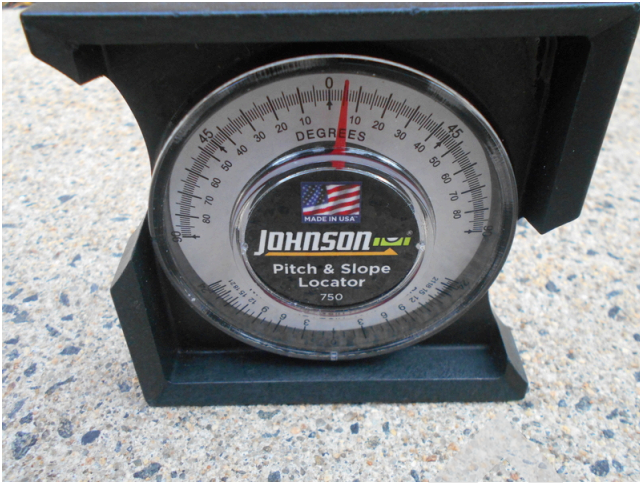
9. Leasing office handicap ramp slope 2, compliant

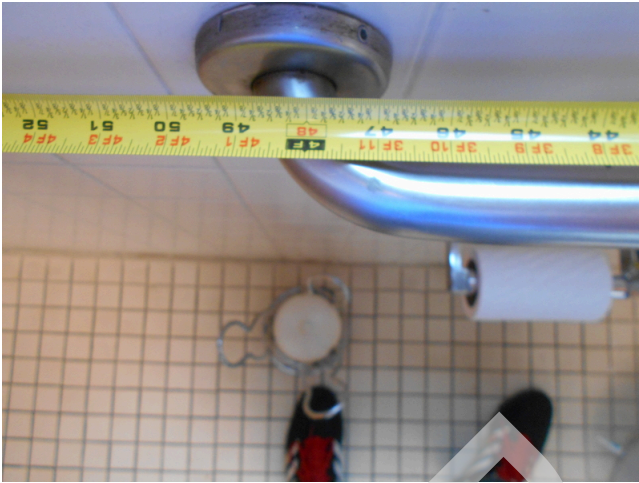
25. Leasing office public restroom side grab bar, 48"
(Critical Repair)

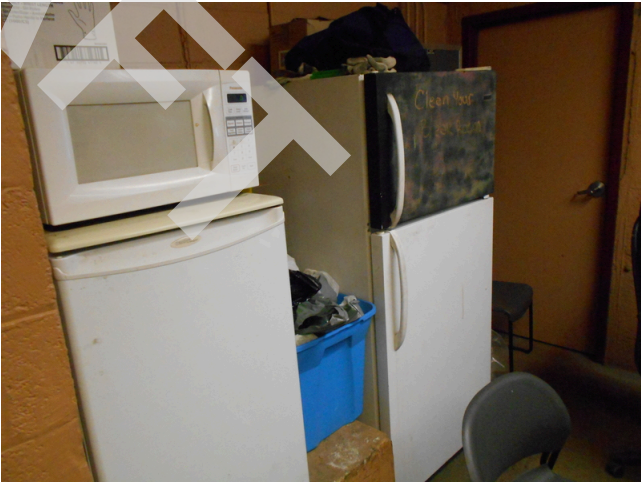
36. Leasing office basement, maintenance area kitchen

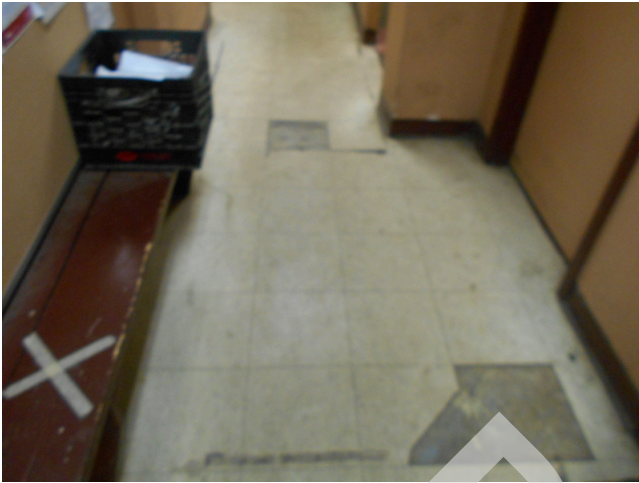
37. Leasing office basement, damaged vinyl tile
(Non-Critical Repair)

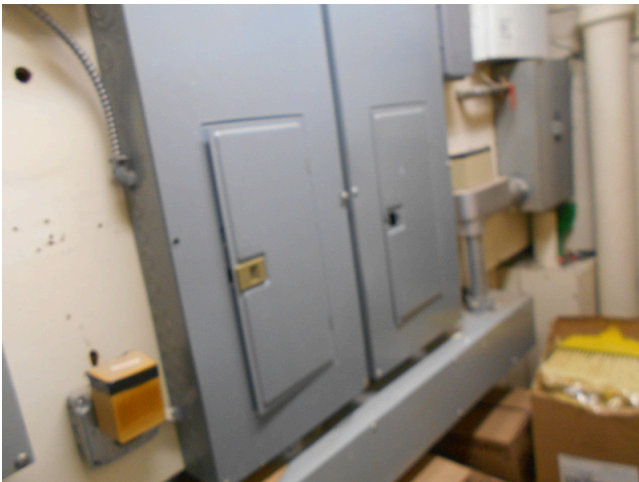
39. Leasing office electrical panel

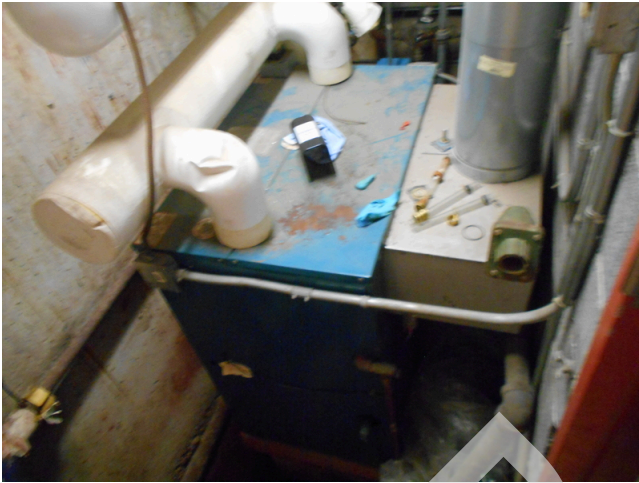
41. Leasing office boiler

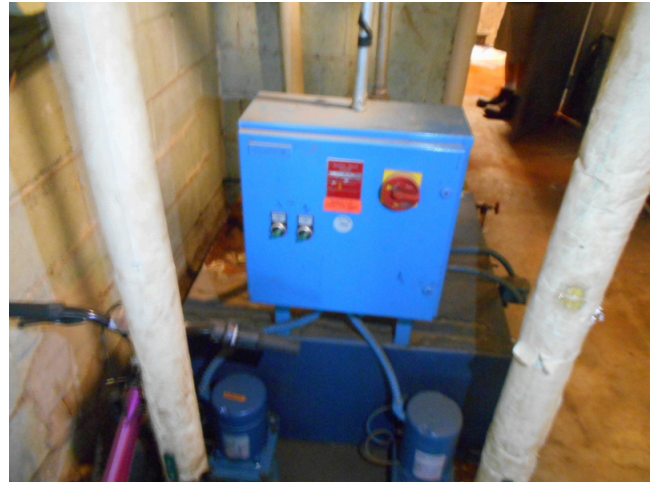
42. Leasing office boiler pump

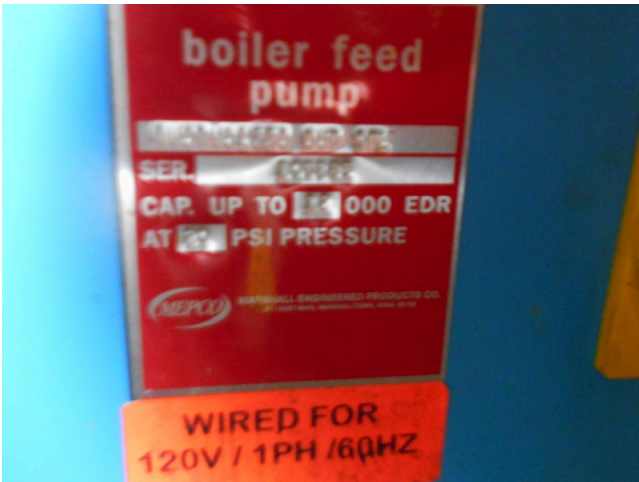
43. Leasing office boiler pump

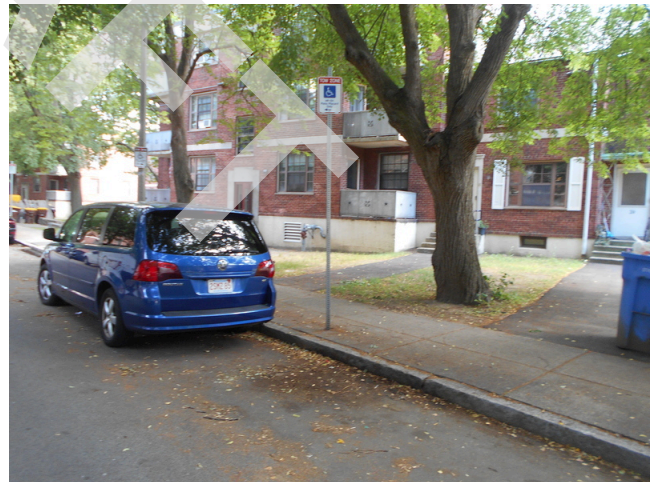
44. Building 3 handicap street parking, no curb cut or access aisle (Critical Repair)

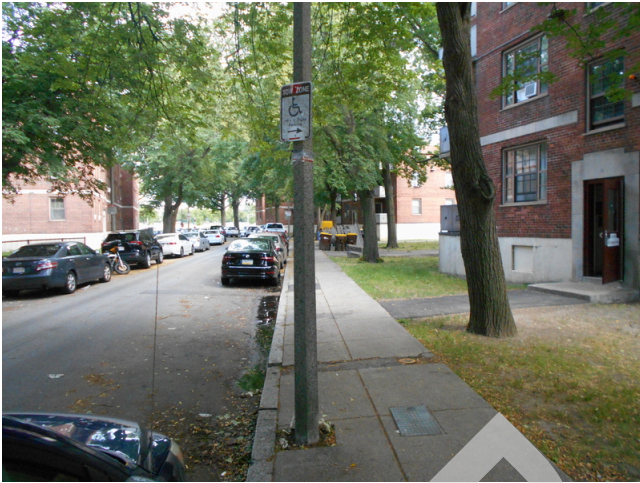
45. Building 3 handicap street parking, no curb cut or access aisle (Critical Repair)

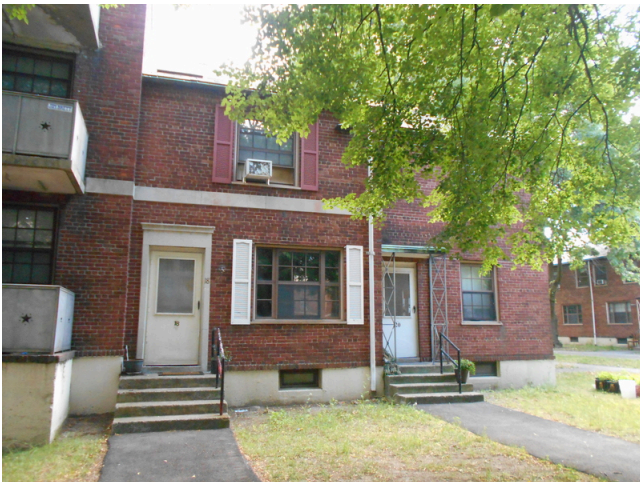
47. Building 3 front façade

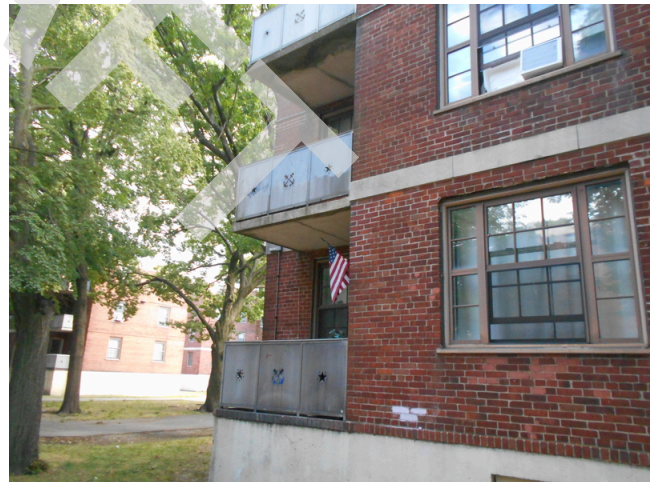
48. Building 3 concrete balconies

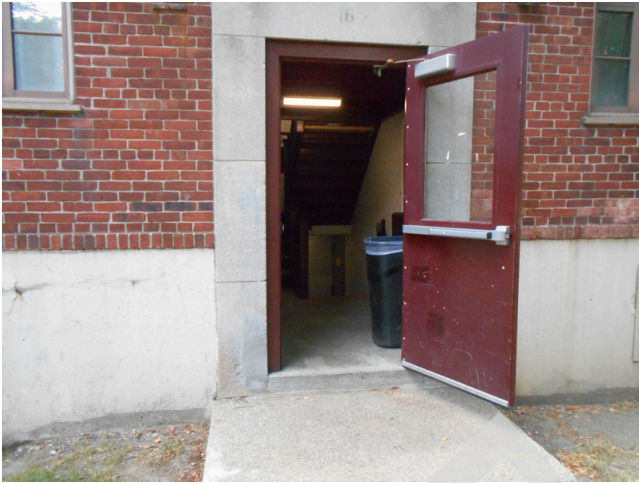
49. Building 3 stairwell entrance
