HUD CAPITAL NEEDS ASSESSMENT

ME McCormack
10 Kemp Street
South Boston, Massachusetts 02127

AEI Project No. 463360
Site Inspection Date: July 7th & July 8th

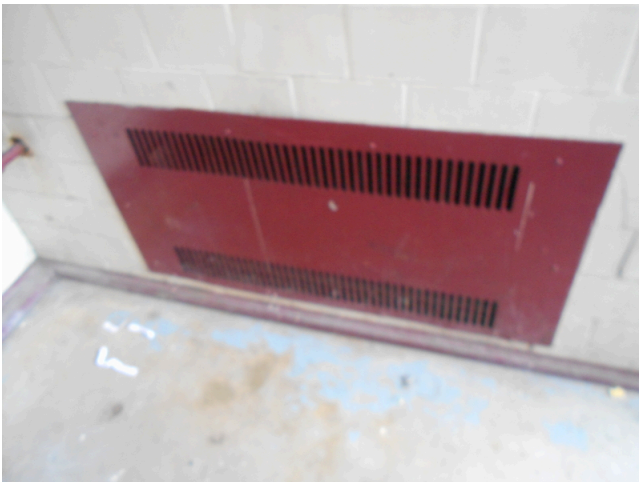
51. Typical Walk-up radiator in stairwell

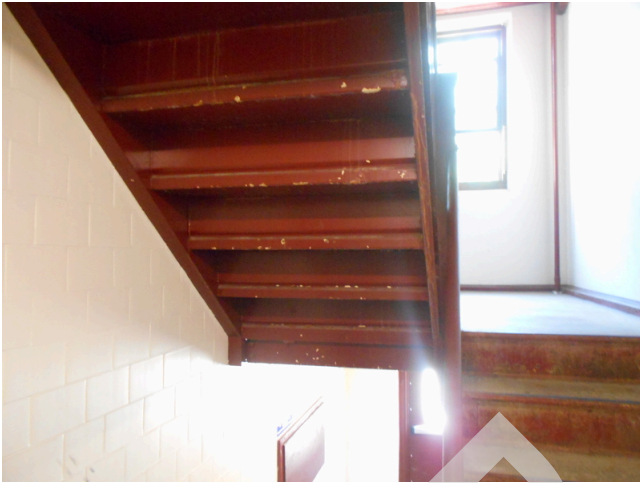
53. Typical stairwell, paint chipping (Non-Critical Repair)

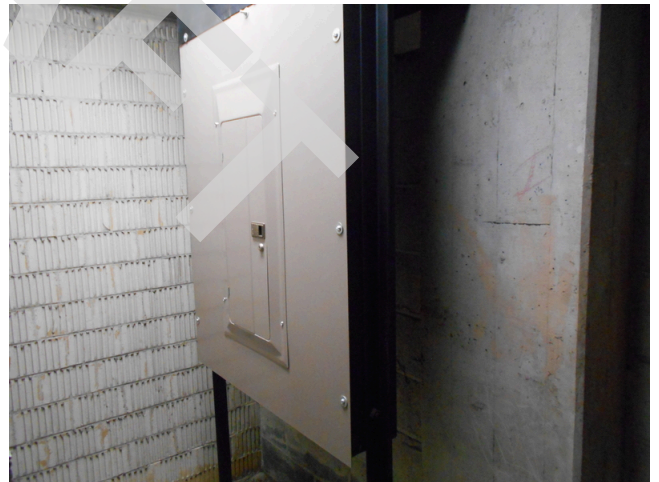
56. Building 1 basement electrical panel

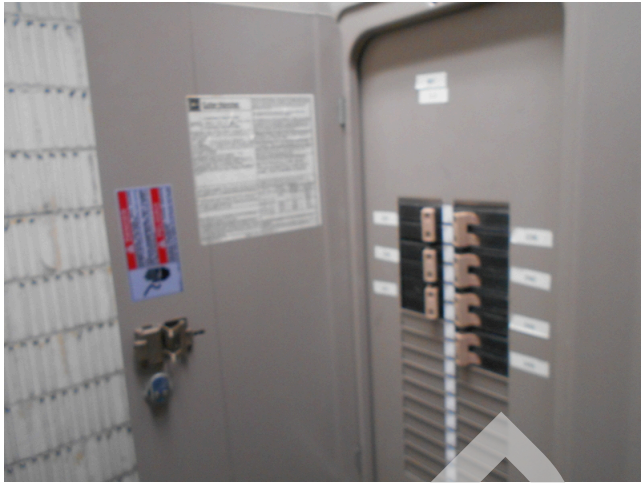
57. Building 1 basement electrical panel

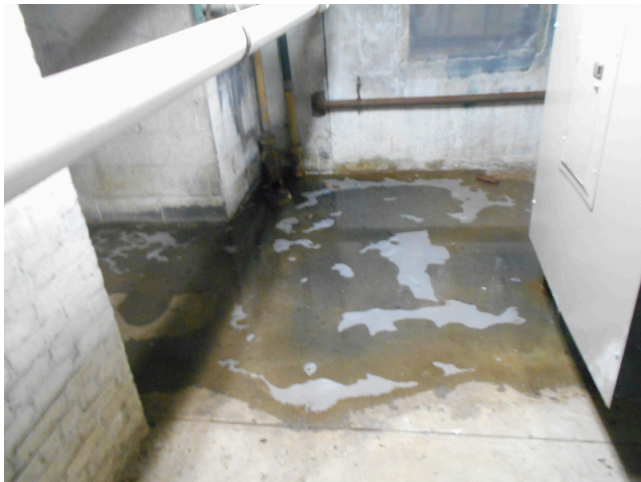
59. Building 1 basement water intrusion (Non-Critical Repair)

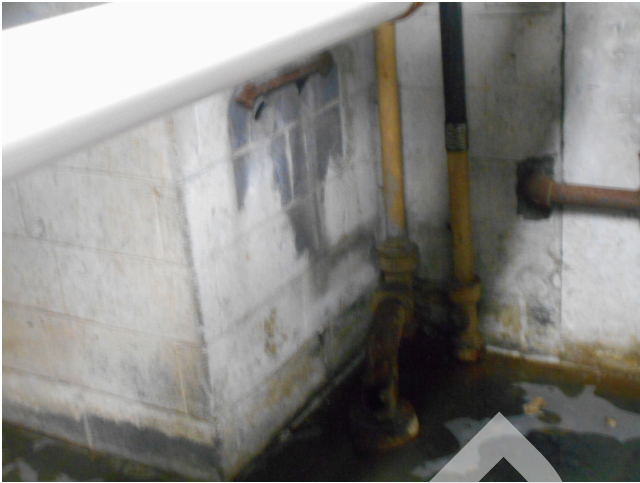
61. Building 1 basement water intrusion (Critical Repair)

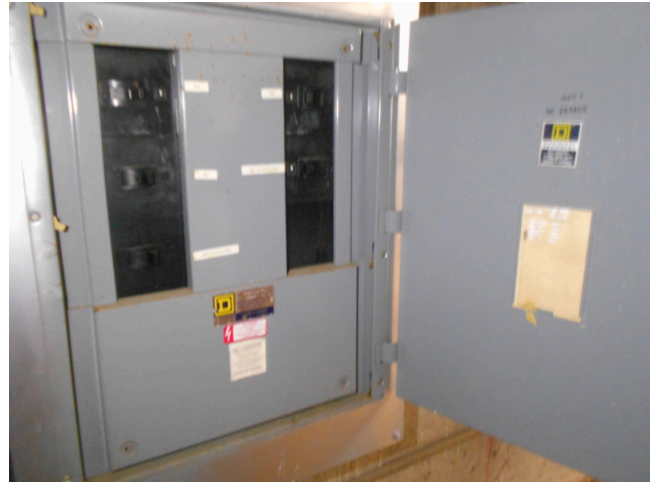
62. Building 1 electrical main

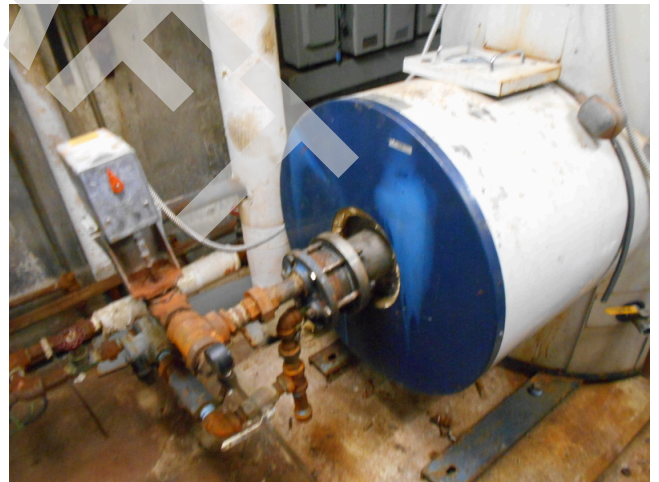
64. Building 4 mechanical room

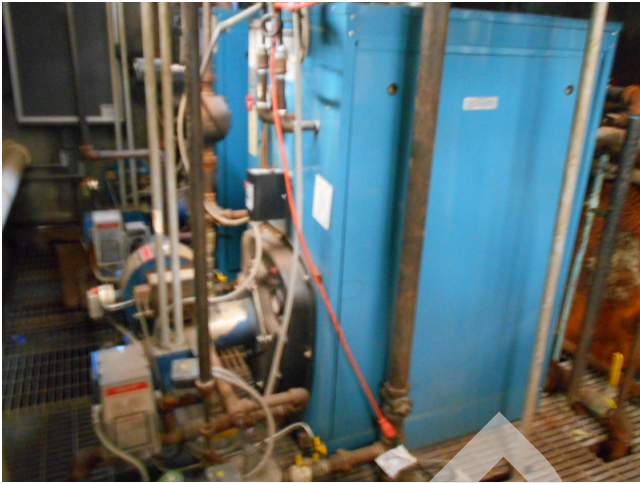
65. Building 4 mechanical room boilers

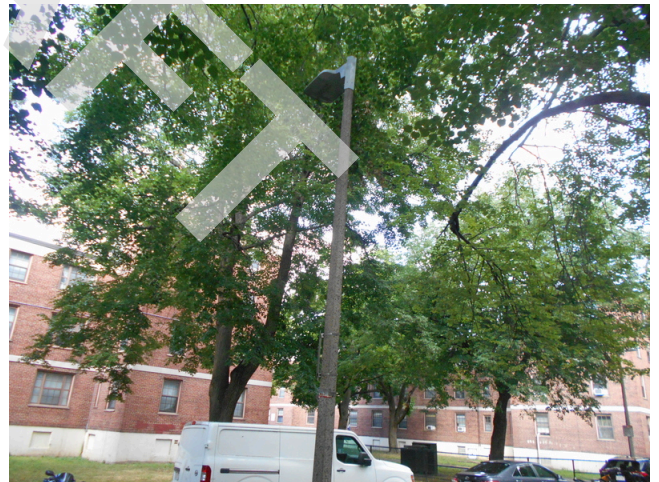
68. Typical pole mounted lighting

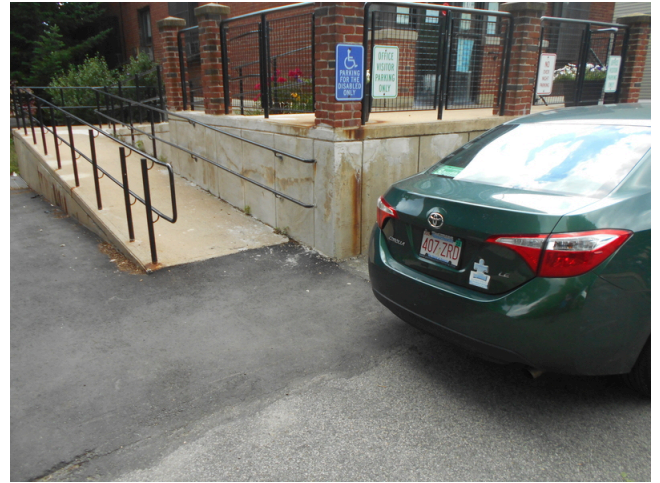
70. Leasing office accessible parking space sign, no parking space markings, no access aisle, no horizontal signage (Critical Repair)

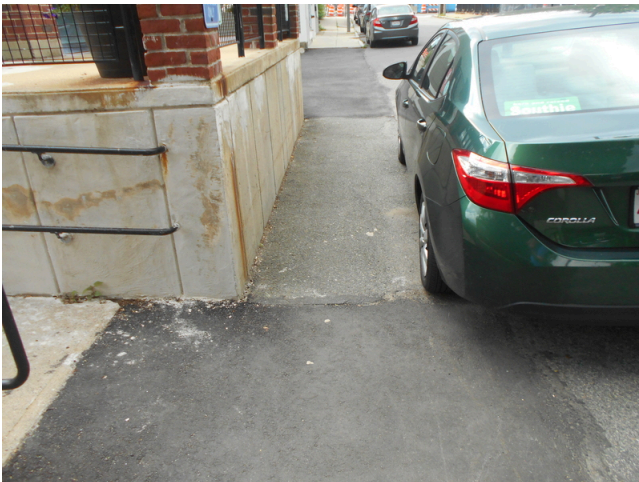
71. Leasing office accessible parking space sign, no parking space markings, no access aisle, no horizontal signage (Critical Repair)

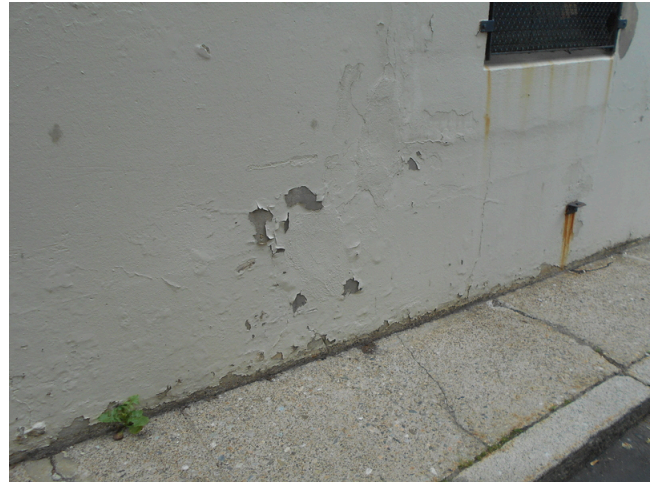
74. Paint chipping along side façade of leasing office
(Non-Critical Repair)

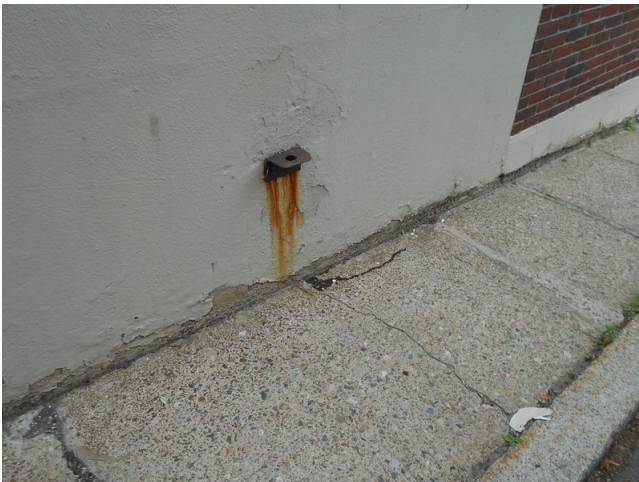
75. Paint chipping along side façade of leasing office
(Non-Critical Repair)

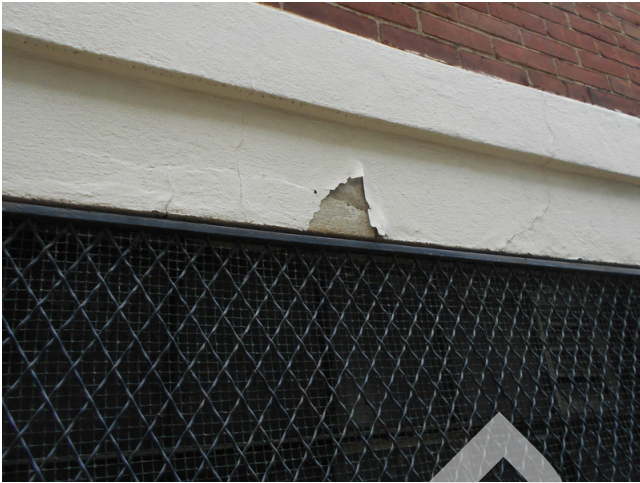
77. Paint chipping along side façade of leasing office
(Non-Critical Repair)

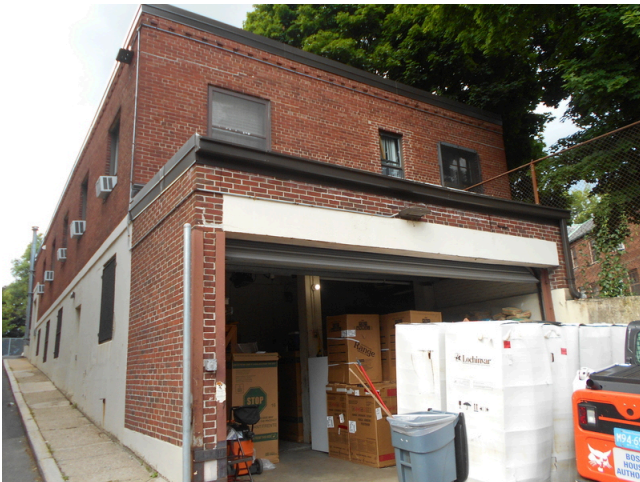
79. Leasing office rear façade and maintenance
garage storage

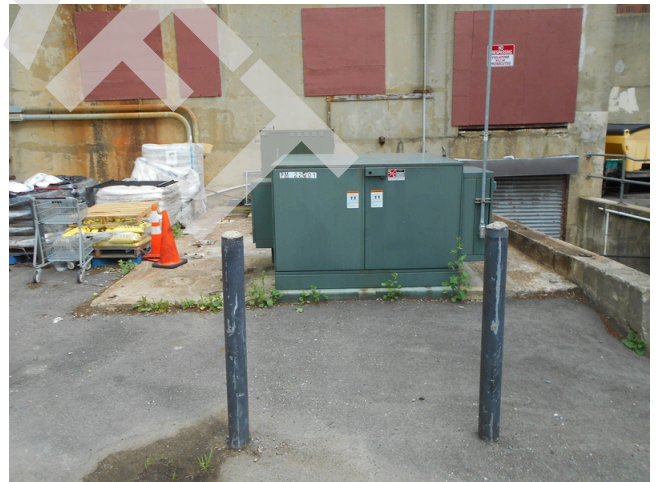
80. Pad mounted electrical transformers

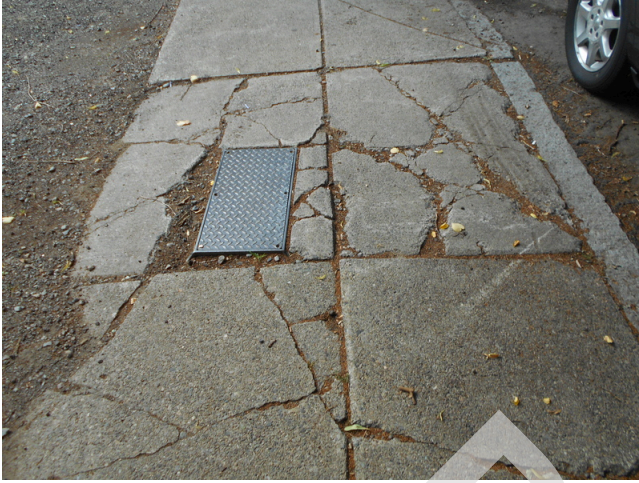
81. Concrete sidewalk by building 7, damaged
(Critical Repair)

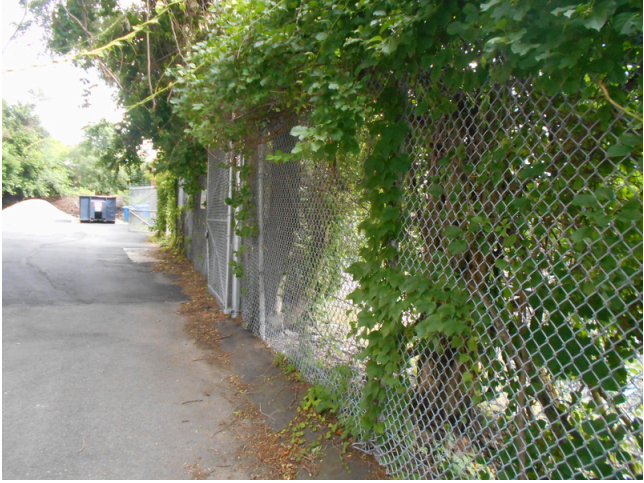
82. Chain link fence along leasing office driveway,
overgrown

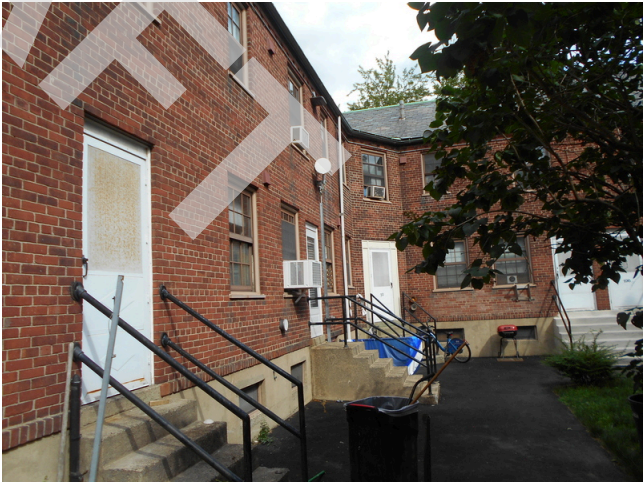
84. Building 11 rear façade

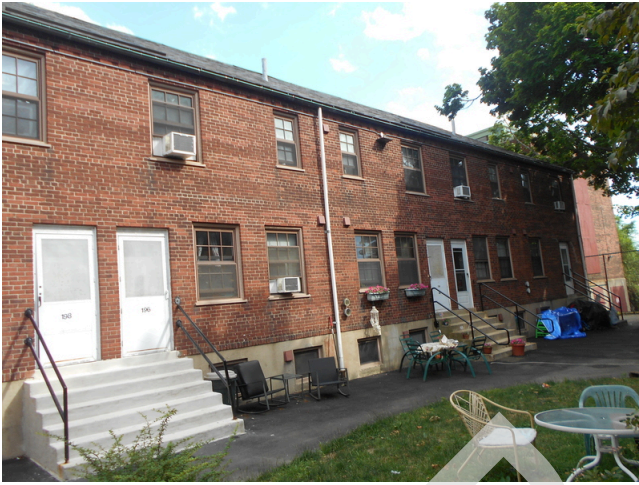
85. Building 11 rear façade

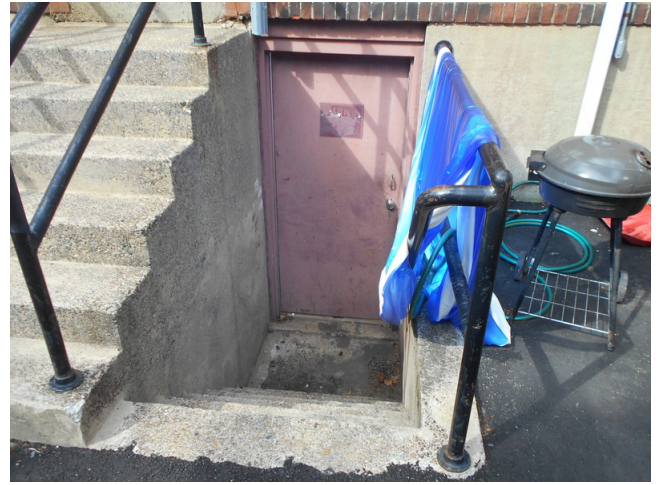
86. Building 11 rear façade, entrance to basement

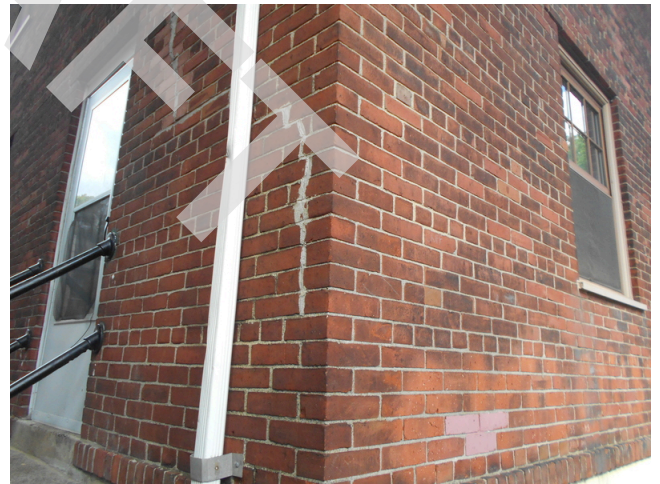
88. Building 11 side façade, repaired facade

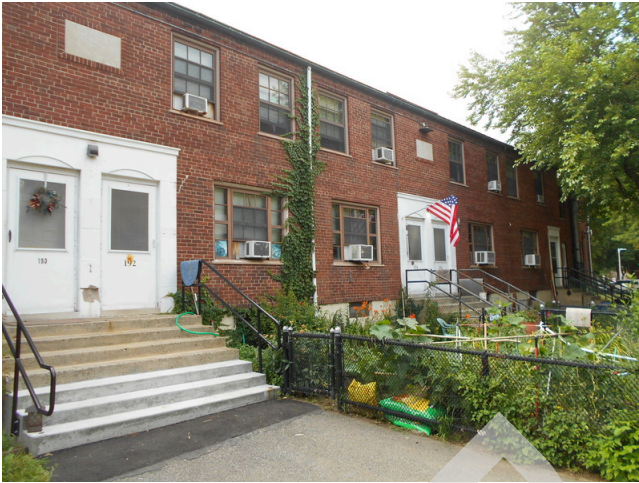
89. Building 11 front façade

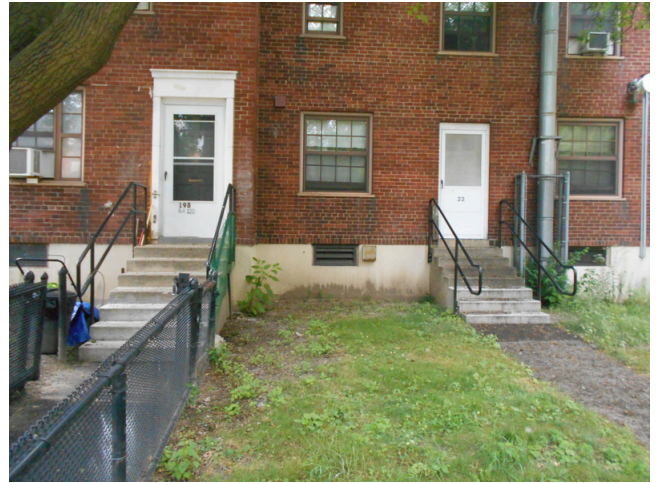
90. Building 11 front façade

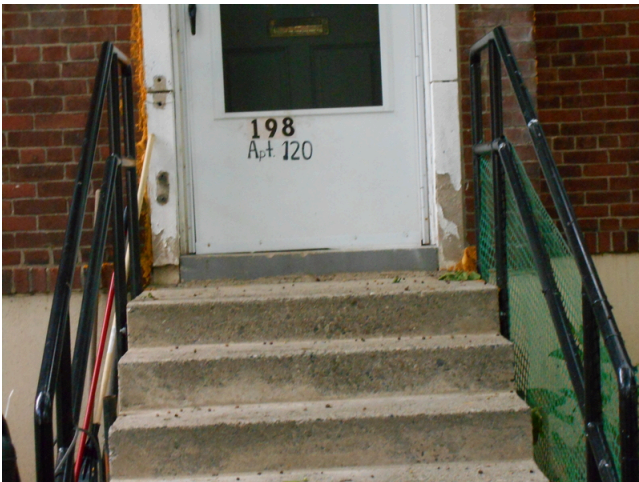
91. Building 11 front façade, chipping paint on door of 198 O'Callaghan Way, Apartment 120 (Non-Critical Repair)

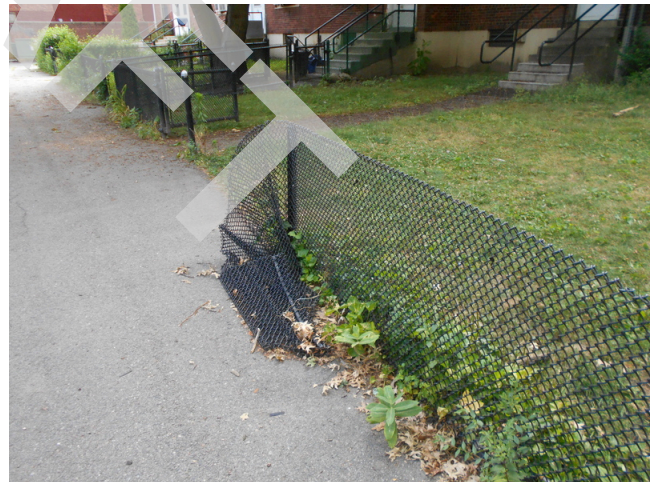
92. Damaged chain link fence by 198 O'Callaghan way, apartment 120 (Non-Critical Repair)

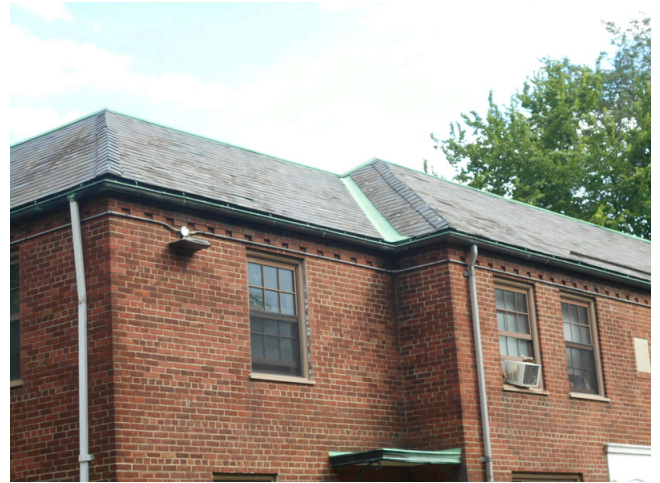
94. Building 6 front façade, slate tile roof (Non-Critical Repair)

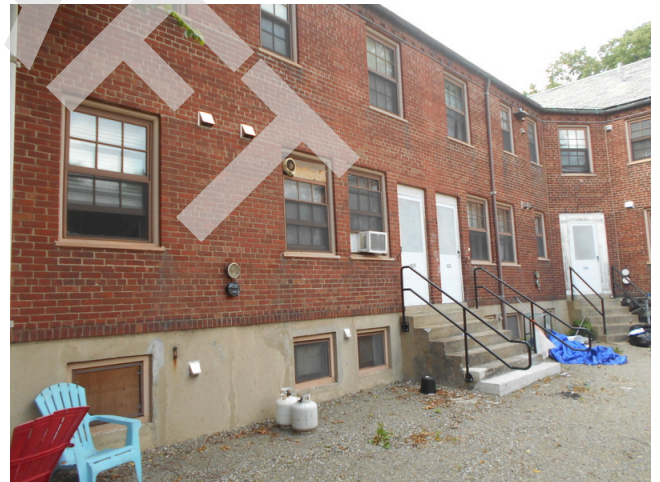
96. Building 6 rear façade

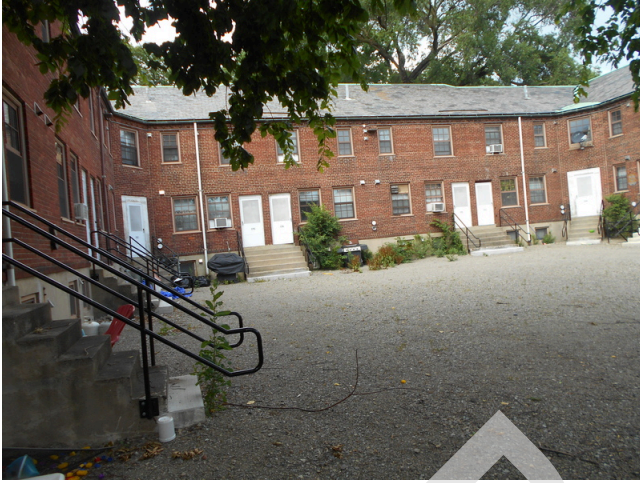
97. Building 6 rear façade

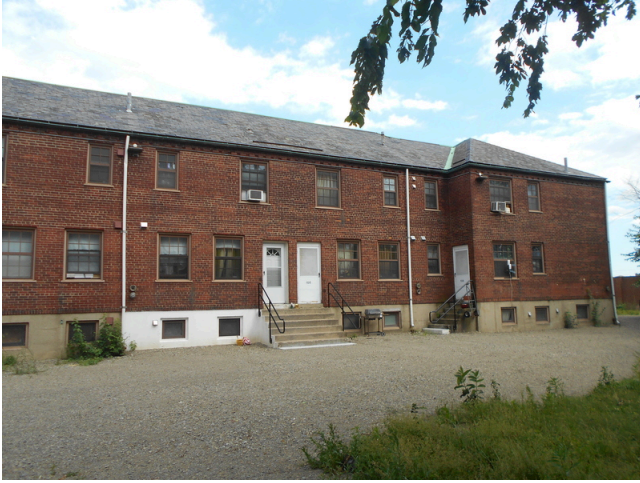
98. Building 6 rear façade, poor condition shingles
(Non-Critical Repair)

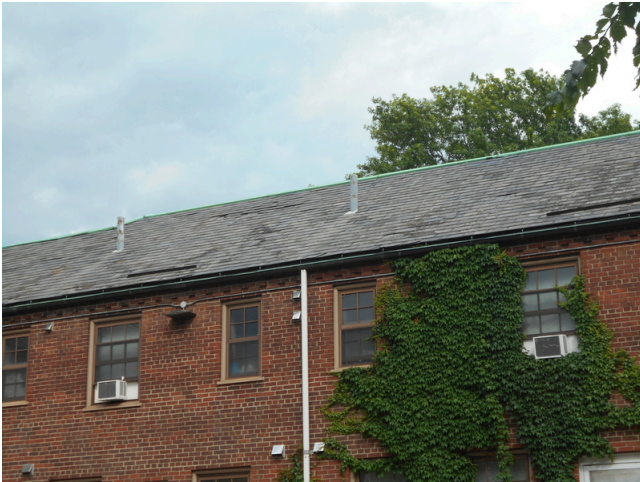
99. Building 6 slate tile roofing, shingles falling
(Non-Critical Repair)

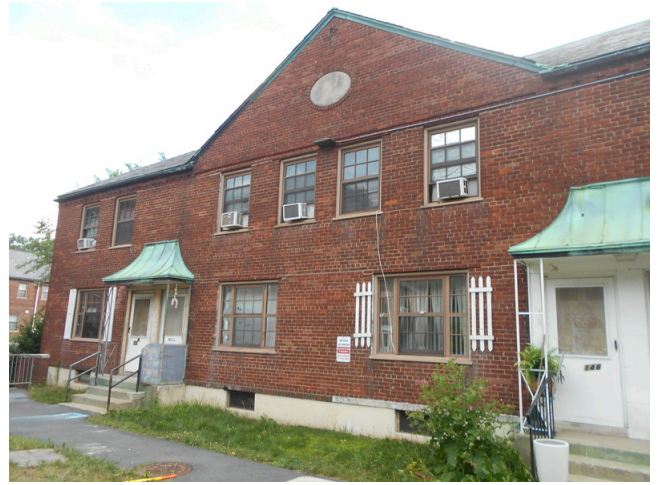
102. Building 5 front façade

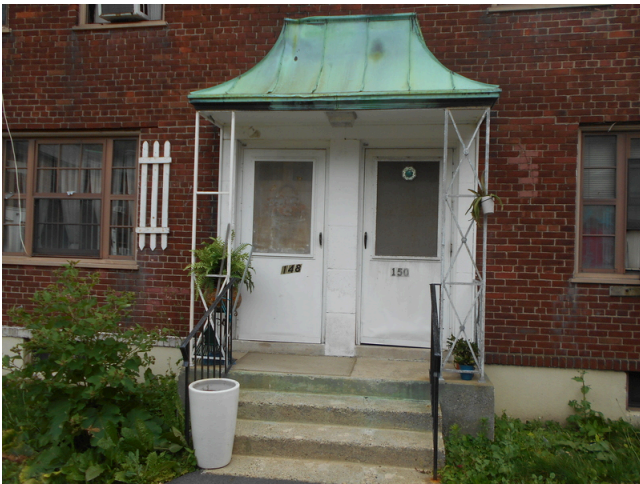
103. Building 5 front façade

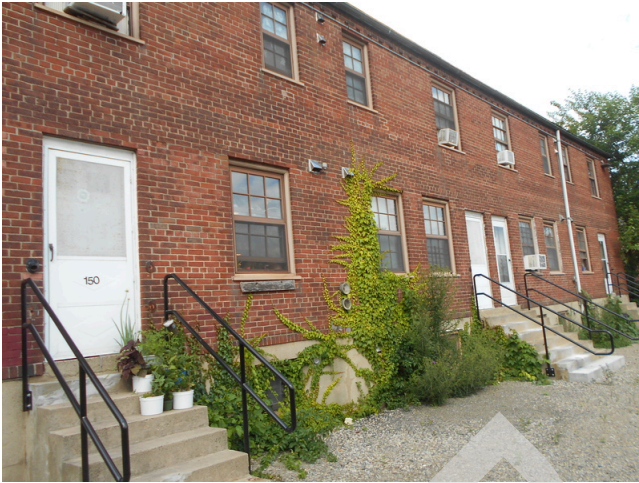
105. Building 5 rear façade

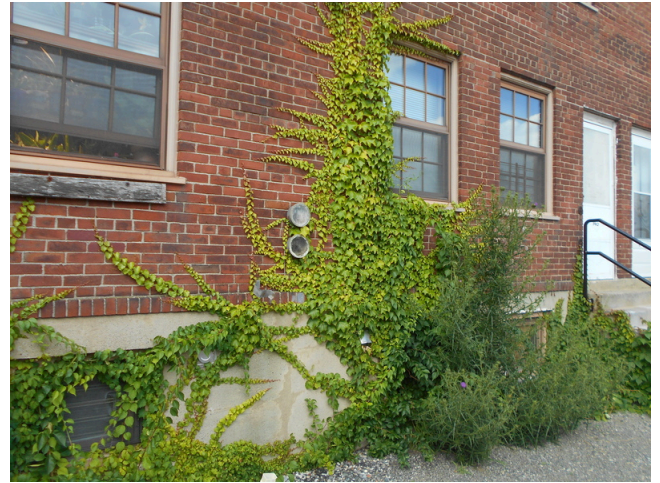
106. Building 5 rear façade, foliage growing along façade (Non-Critical Repair)

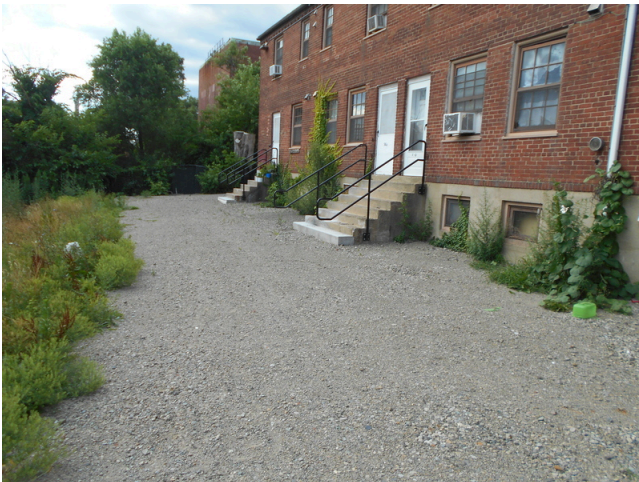
107. Building 5 rear façade

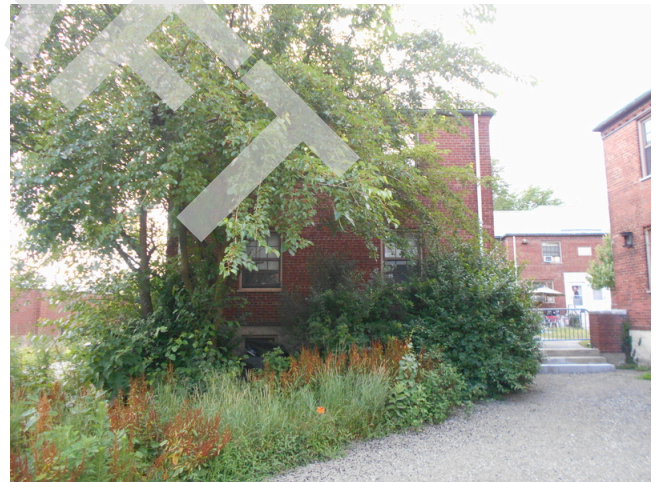
108. Building 5 side façade, foliage growing along building façade (Non-Critical Repair)

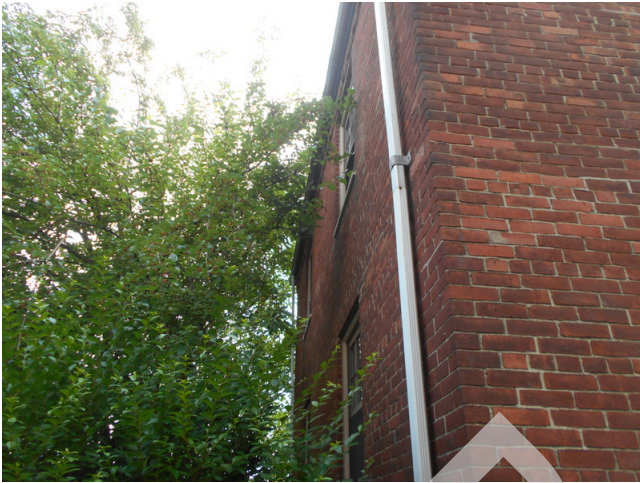
109. Building 5 side façade, foliage growing along building façade (Non-Critical Repair)

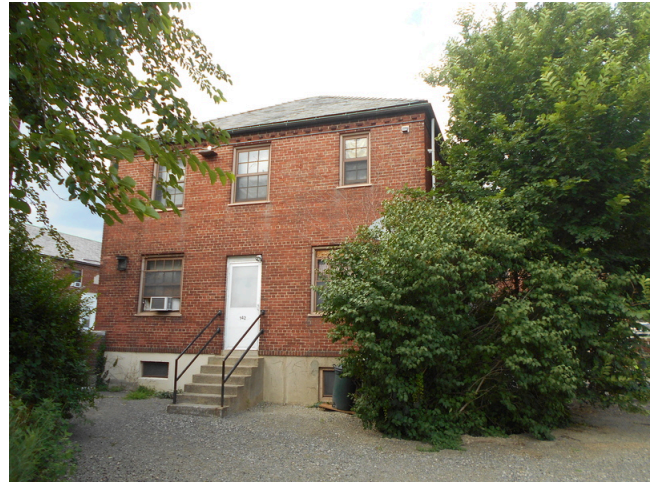
110. Building 4 side façade, foliage growing along building façade (Non-Critical Repair)

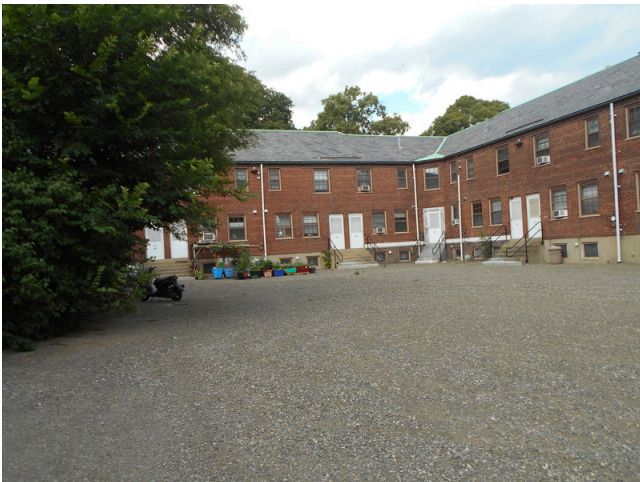
111. Building 4 rear façade

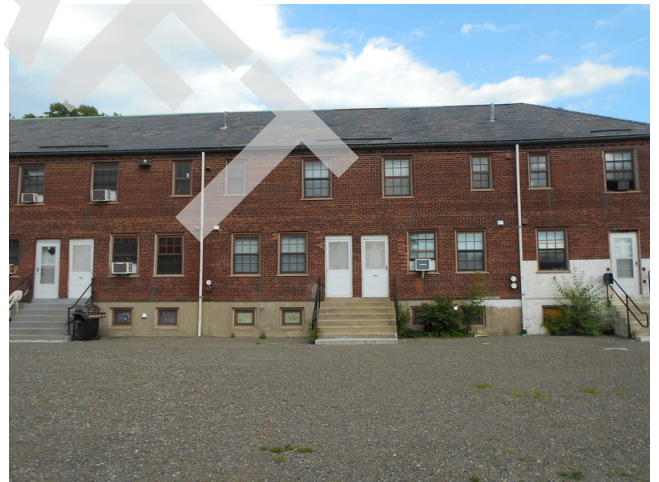
112. Building 4 rear façade, poor condition slate tile (Non-Critical Repair)

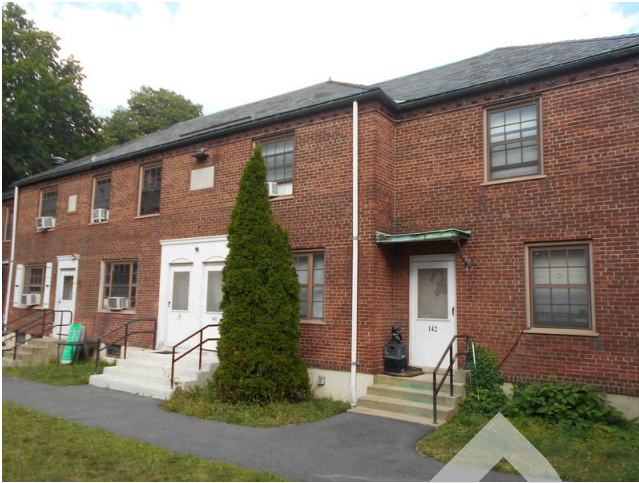
113. Building 4 rear façade

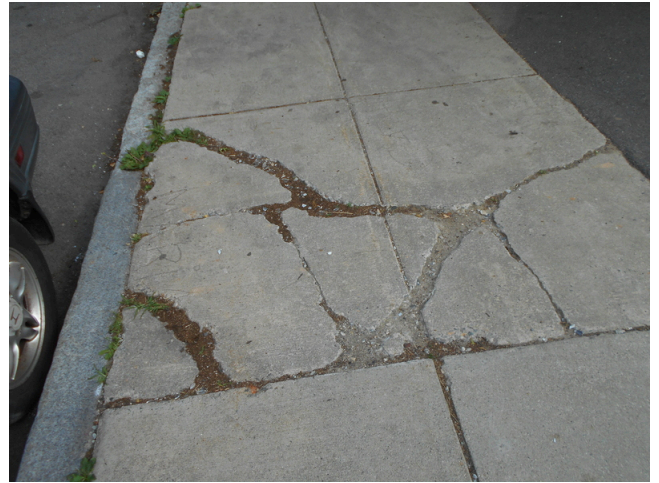
114. Concrete trip hazard between building 3 and building 4 (Critical Repair)

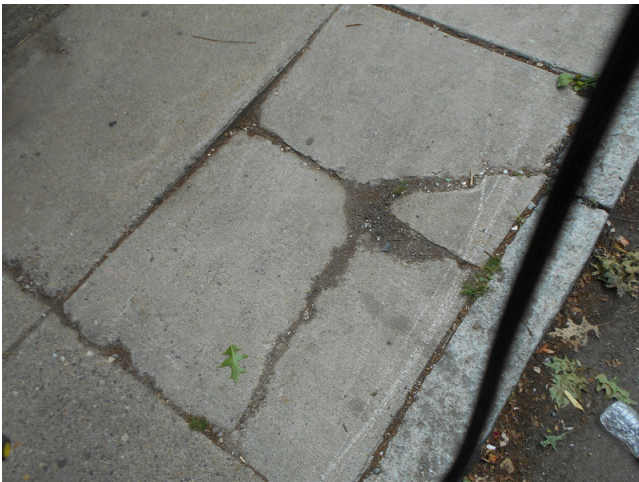
115. Concrete trip hazard between building 3 and building 4 (Critical Repair)

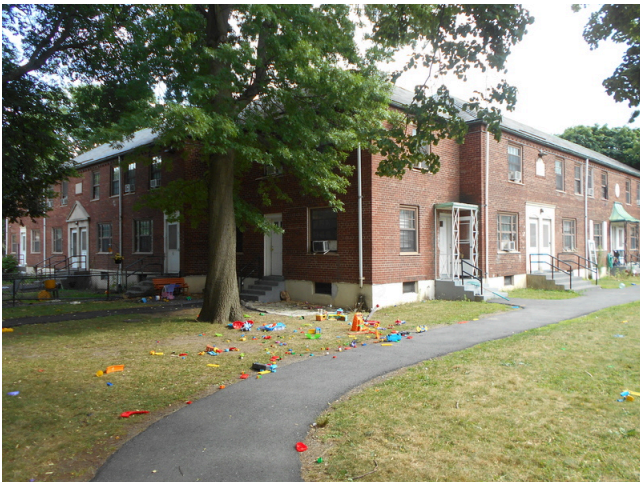
119. Building 3 front façade

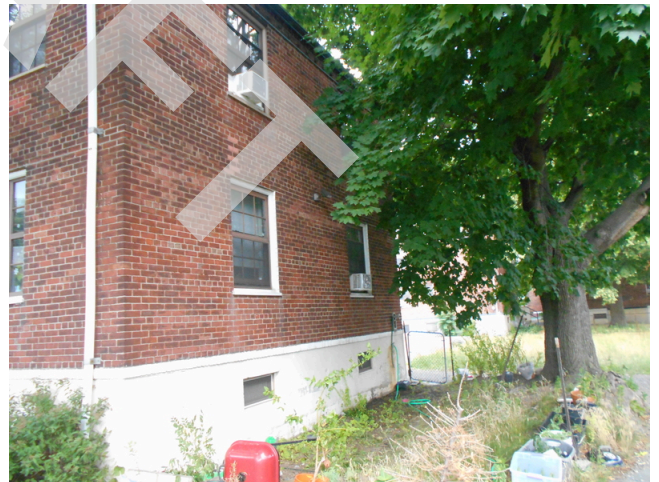
120. Building 3 rear façade, foliage growing along building façade (Non-Critical Repair)

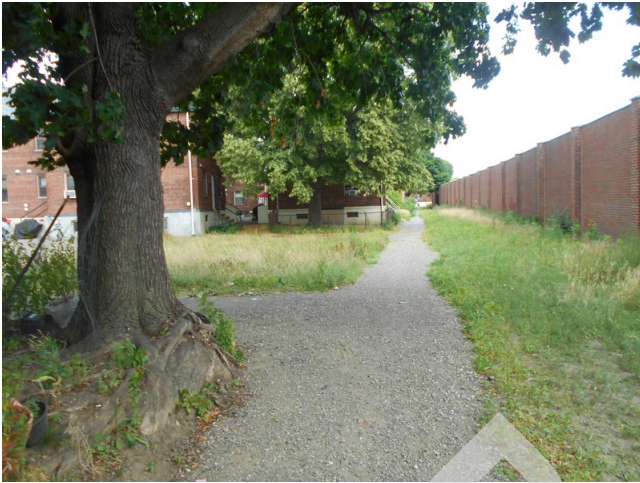
121. Gravel path to the rear of building 3

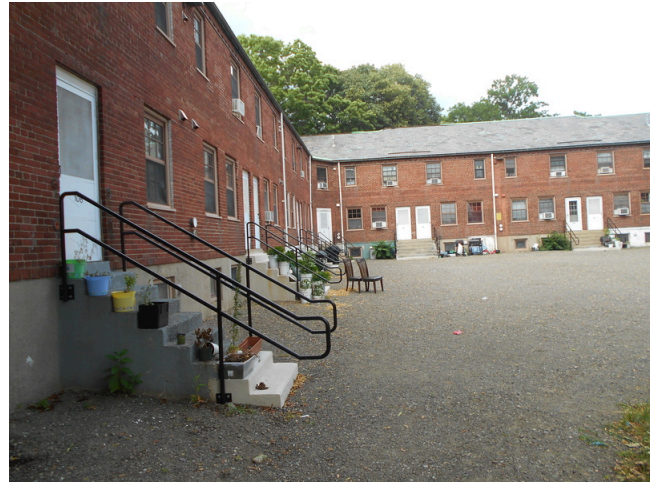
122. Building 3 rear façade

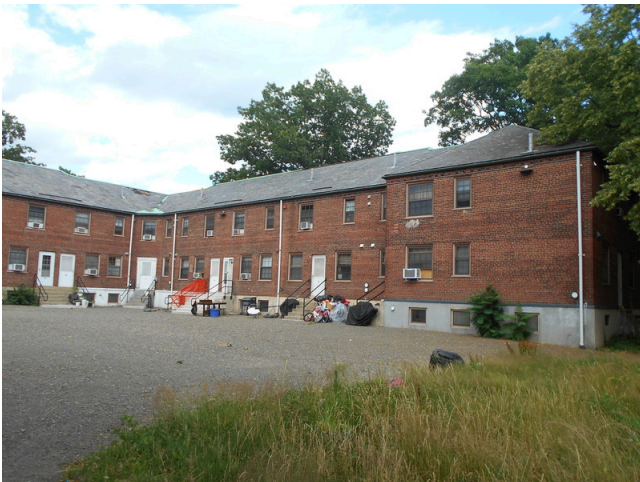
123. Building 3 rear façade

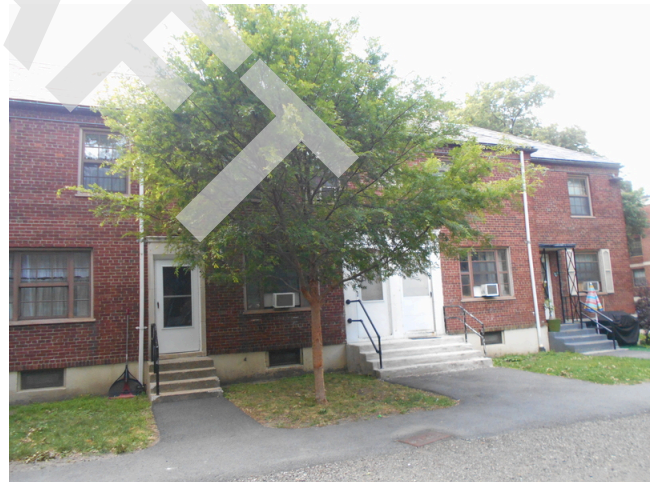
124. Building 3 front façade

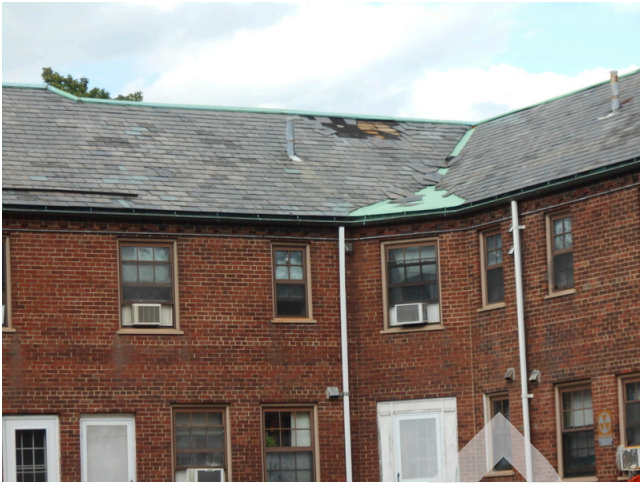
125. Building 3 rear façade, damaged slate tile roofing (Non-Critical Repair)

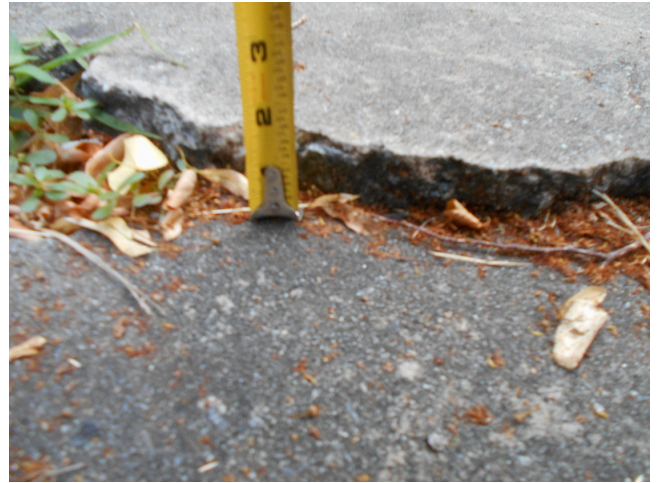
126. Concrete trip hazard by building 3 (Critical Repair)

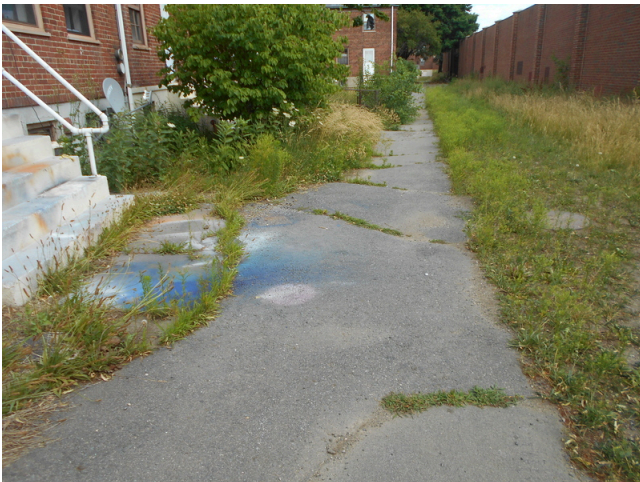
127. Building 3 rear façade, asphalt pathway overgrown and cracked (Non-Critical Repair)

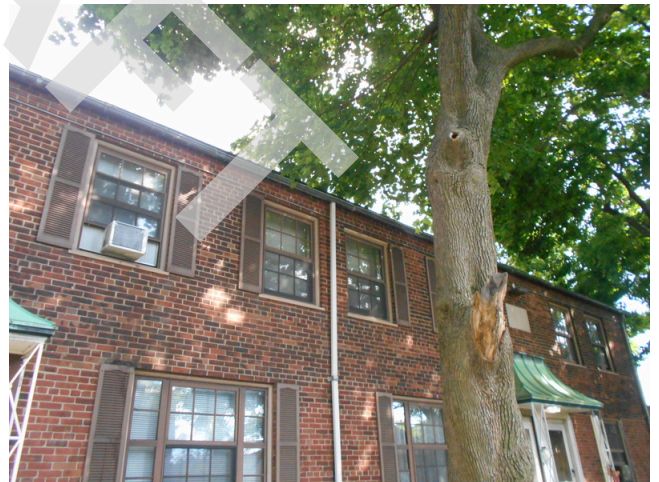
128. Building 3 front façade, trees growing along side building (Non-Critical Repair)

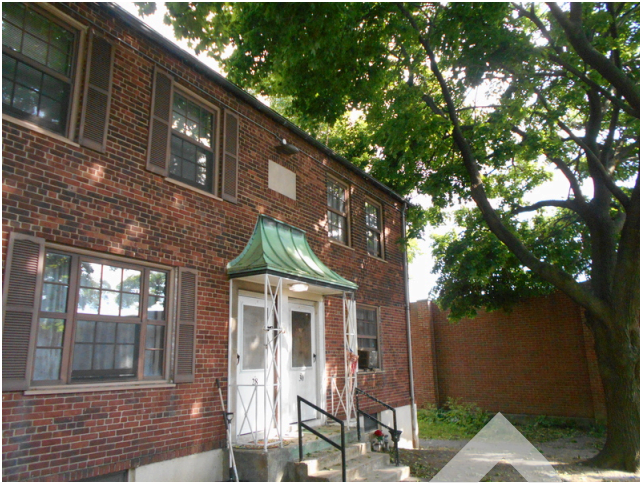
129. Building 3 side façade, trees growing along side building (Non-Critical Repair)

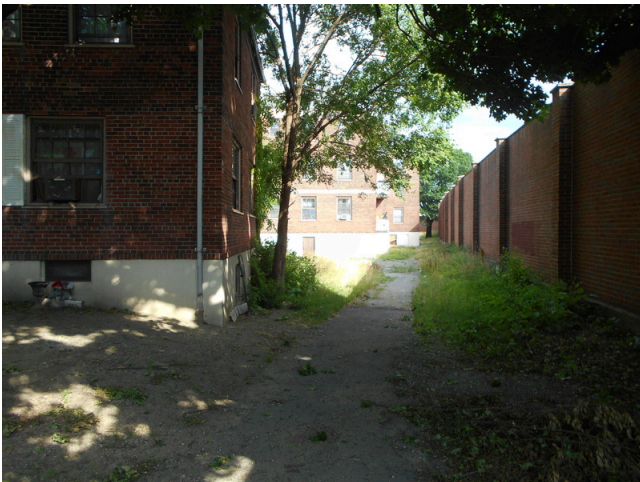
131. Building 4 side façade, trees growing along side building (Non-Critical Repair)

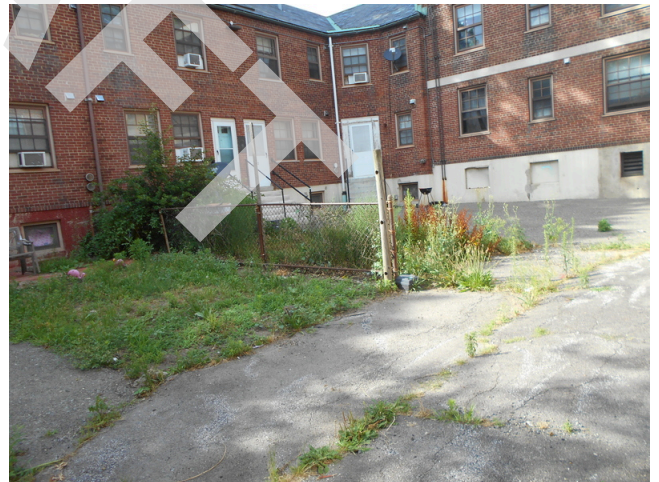
132. Building 4 rear façade, Cracked asphalt courtyard (Non-Critical Repair)

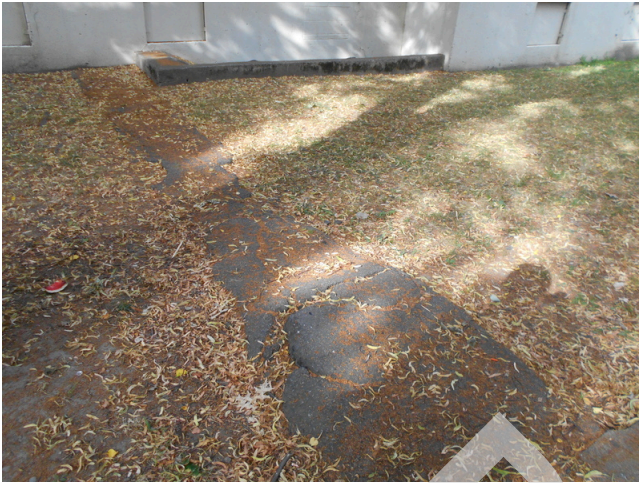
141. Building 12 side façade asphalt walkway, cracked (Non-Critical Repair)

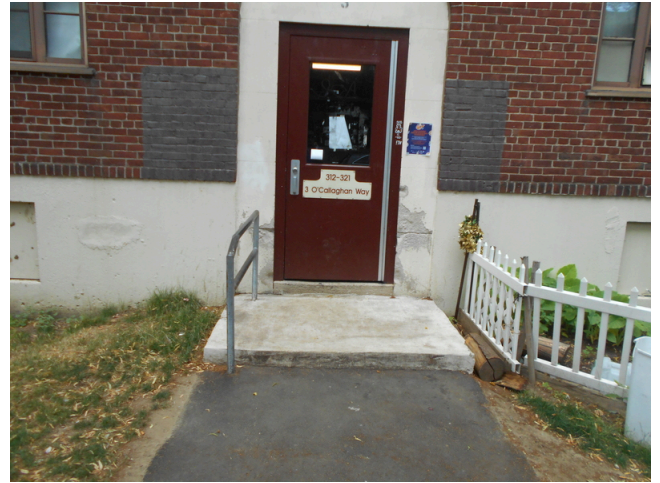
142. 3 O'Callaghan way entrance, damaged entry (Non-Critical Repair)

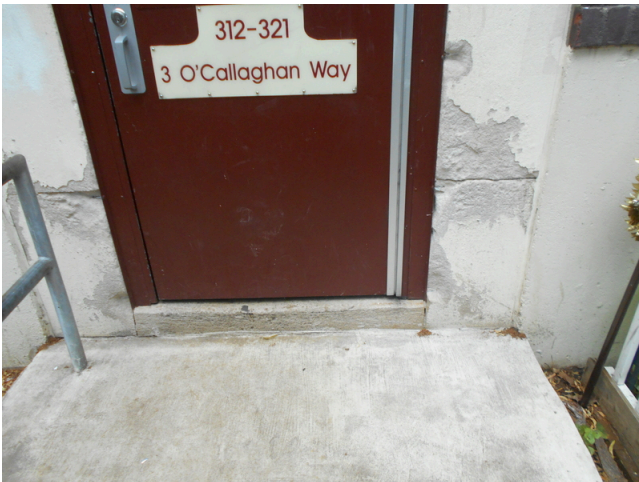
143. 3 O'Callaghan way entrance, damaged entry (Non-Critical Repair)

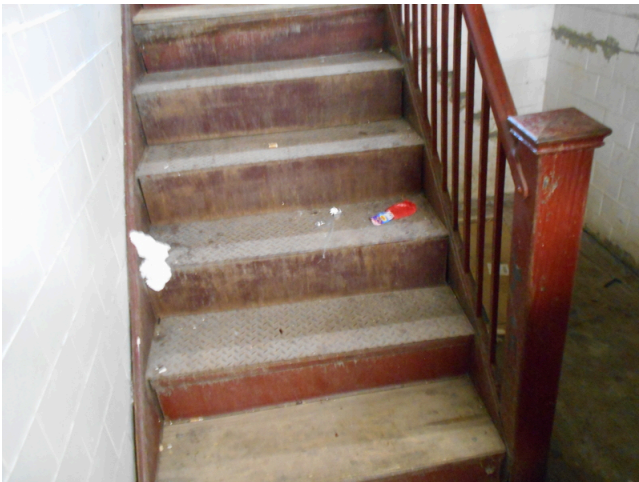
154. Building 32, 37 Logan way stairwell, damaged stairs (Non-Critical Repair)

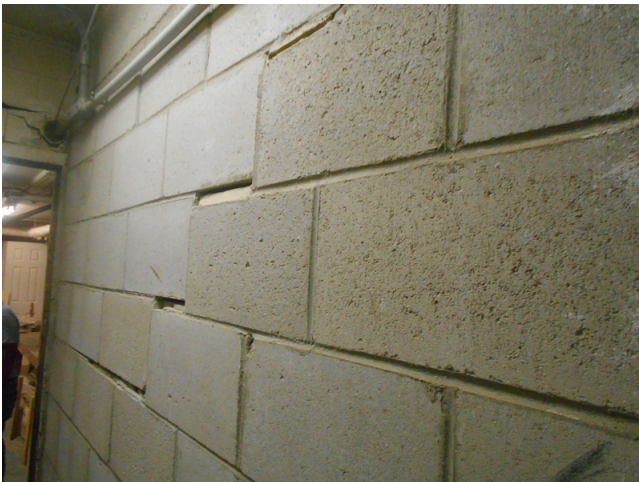
167. Building 30 basement, 15 Logan way, cracking CMU-wall (Non-Critical Repair)

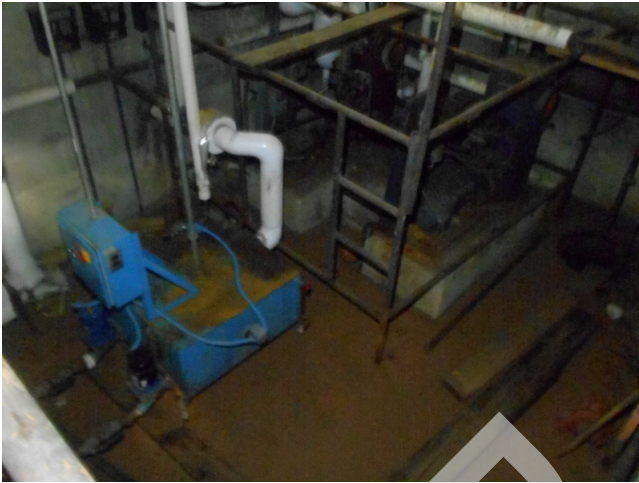
169. Building 30 basement, water pump

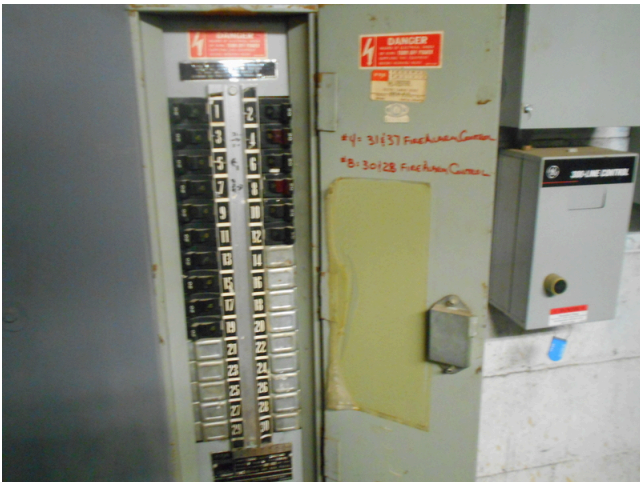
175. Building 30 electrical panel, federal pacific (Non-Critical Repair)

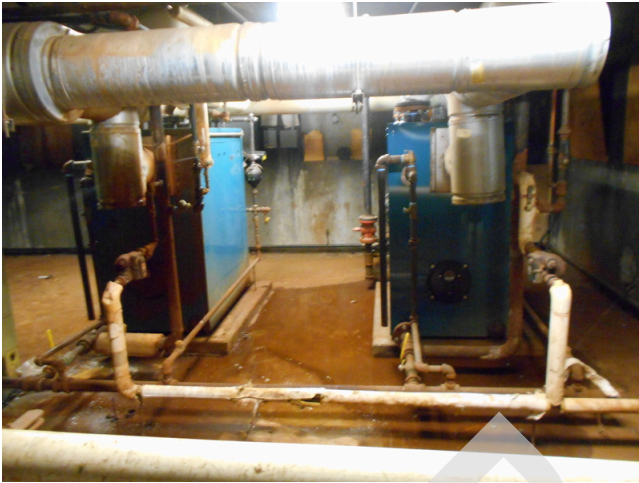
177. Building 17 basement boiler room, water pooling (Non-Critical Repair)

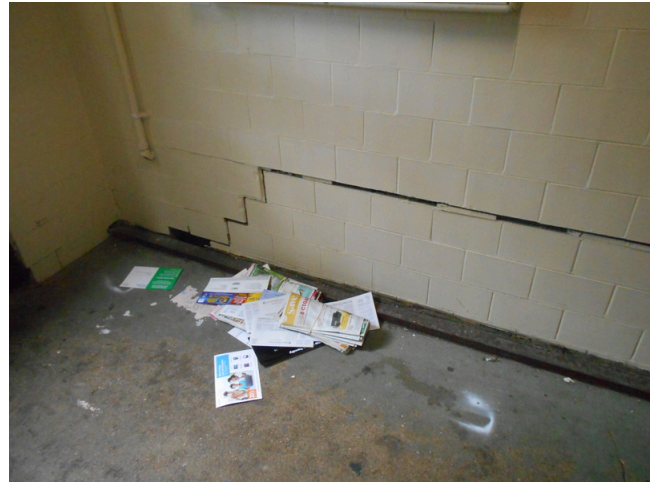
178. Building 17 basement, cracked (Non-Critical Repair)

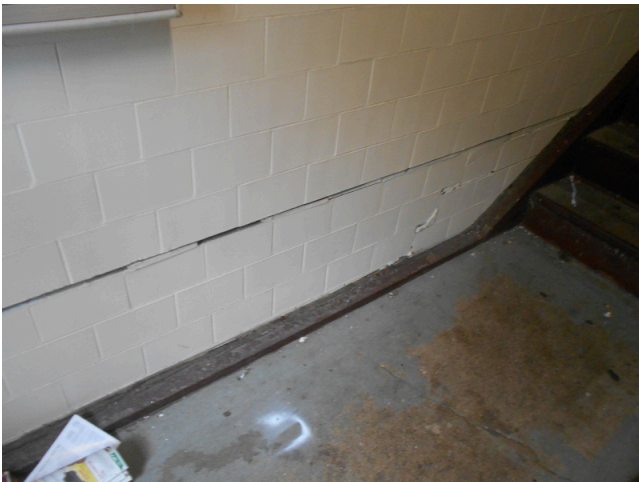
179. Building 17 basement, cracked (Non-Critical Repair)

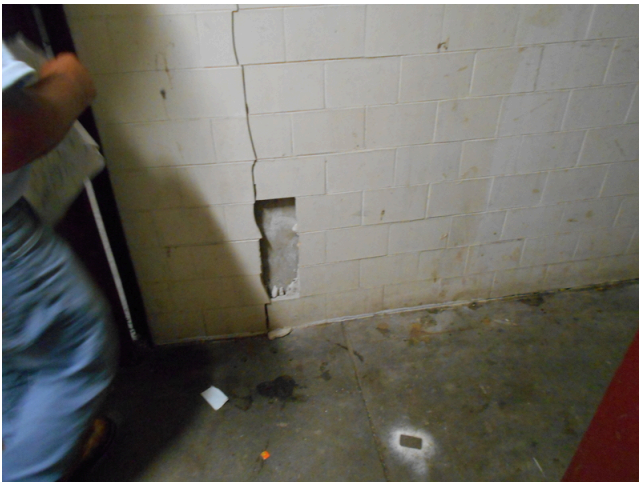
187. Building 23, 2 Logan Way basement, cracking CMU-wall (Non-Critical Repair)

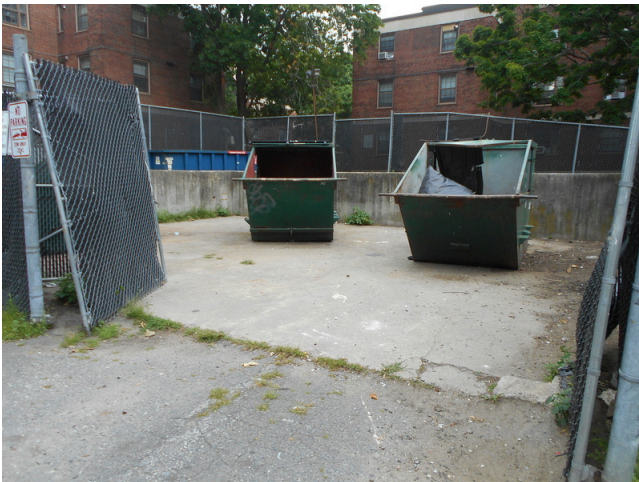
195. Refuse area by building 30, damaged fencing (Non-Critical Repair)
