HUD CAPITAL NEEDS ASSESSMENT

ME McCormack
10 Kemp Street
South Boston, Massachusetts 02127

AEI Project No. 463360
Site Inspection Date: July 7th & July 8th

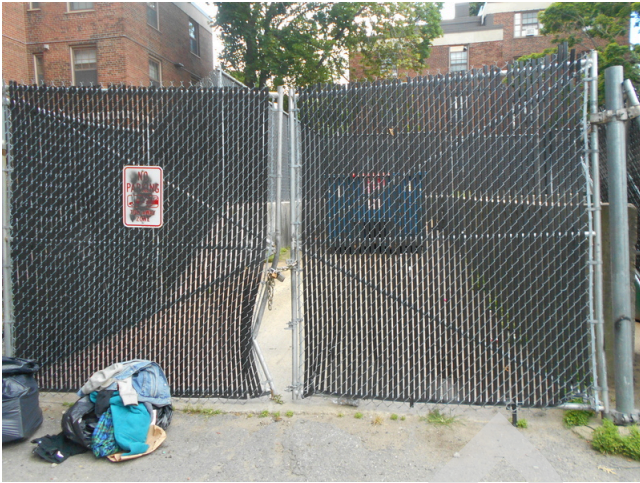
197. Refuse area by building 30, damaged fencing
(Non-Critical Repair)

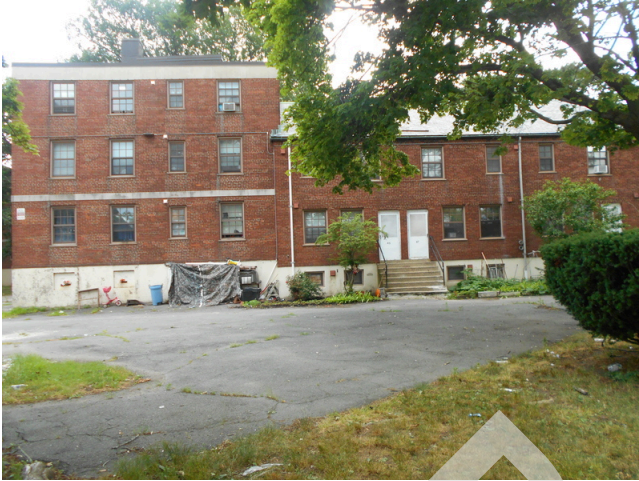
204. Concrete sidewalk by building 30, damaged
(Critical Repair)

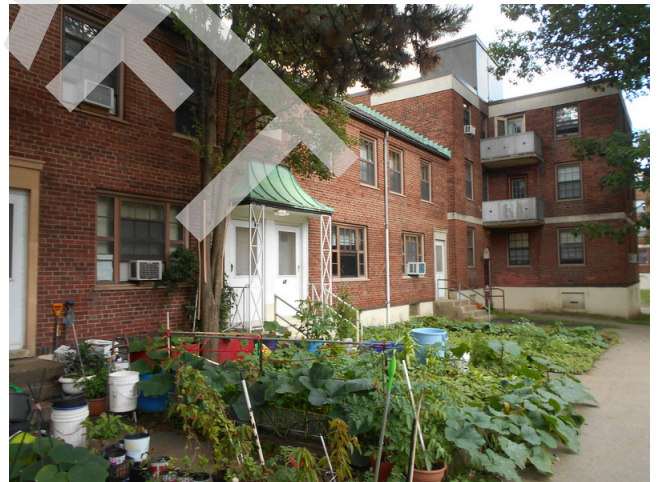
207. Concrete sidewalk by building 34, damaged (Critical Repair)

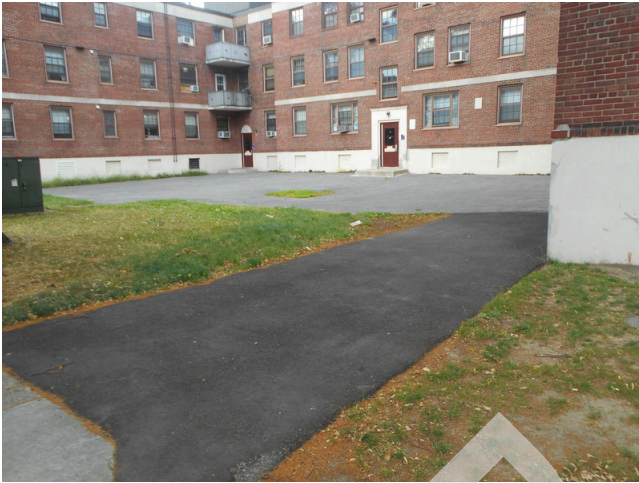
213. Building 32, asphalt paved courtyard

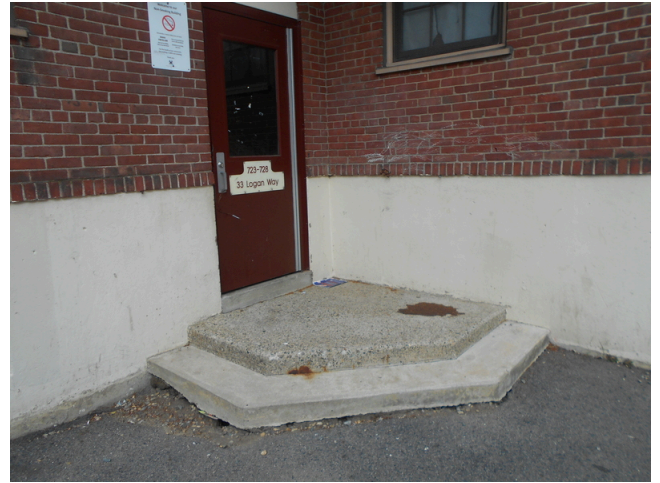
214. Building 32, 33 Logan way stairwell entrance, Concrete stairs at entrance eroded (Non-Critical Repair)

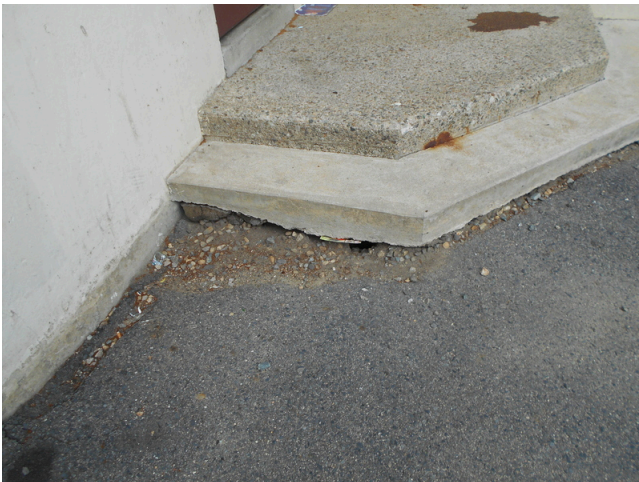
215. Building 32, 33 Logan way stairwell entrance, Concrete stairs at entrance eroded (Non-Critical Repair)

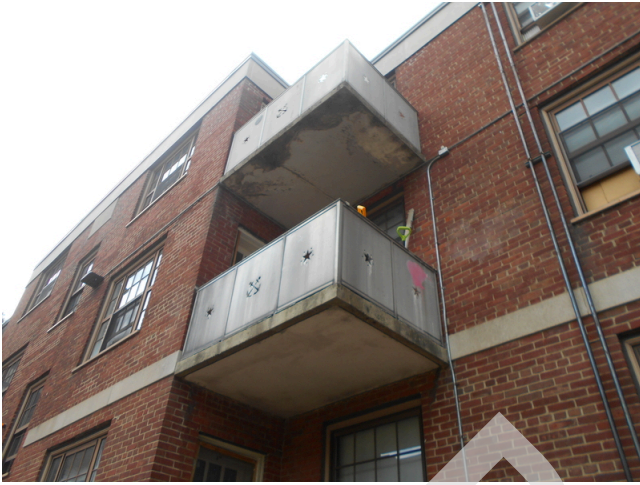
221. Building 32, concrete balcony, deterioration on underside (Critical Repair)

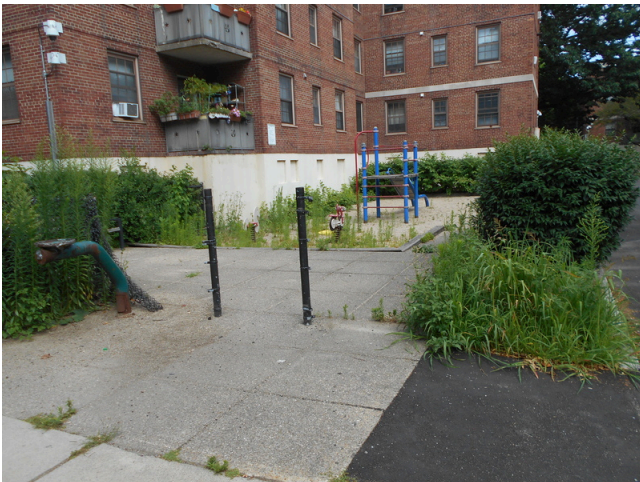
227. Playground by building 22, overgrown (Non-Critical Repair)

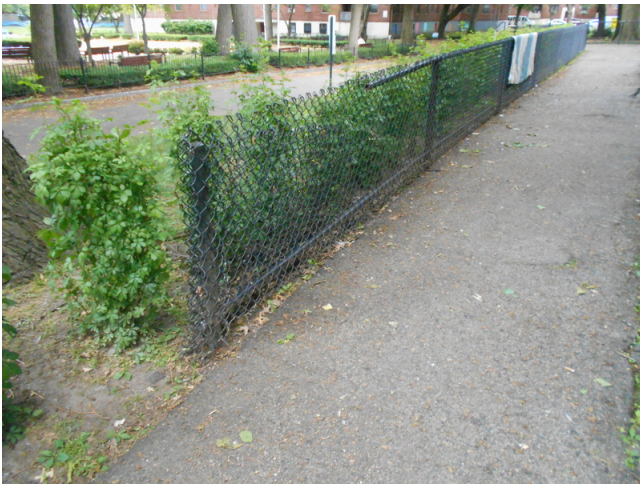
235. Damaged chain link fence by Sterling square drive (Non-Critical Repair)

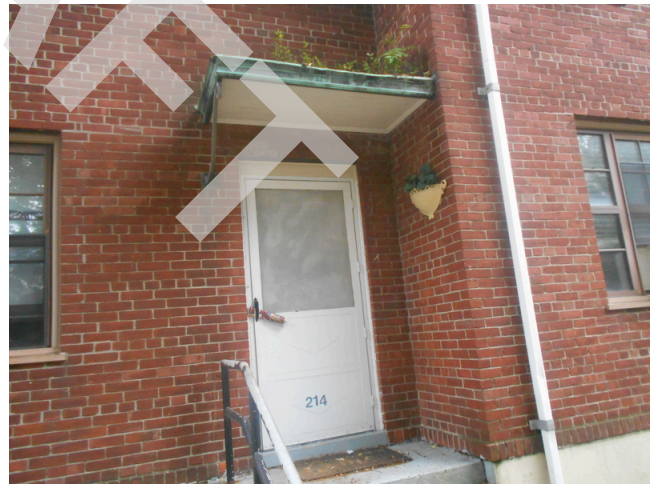
236. Plants growing on awning of 214 O'Callaghan Way, unit 113 (Non-Critical Repair)

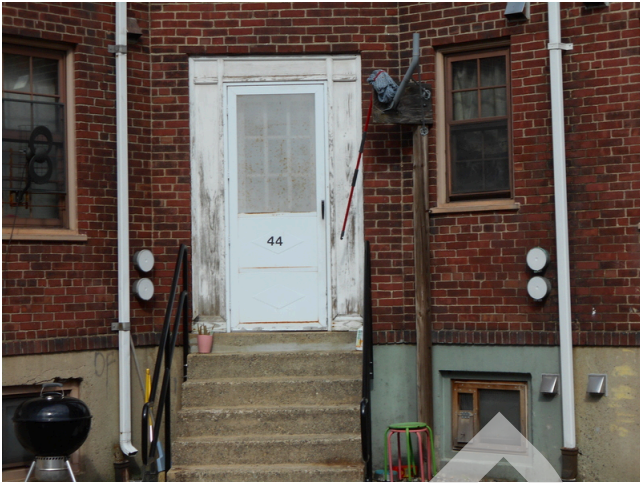
237. Paint chipping along rear entrance of unit 44
O'Callaghan way, unit 196 (Non-Critical Repair)

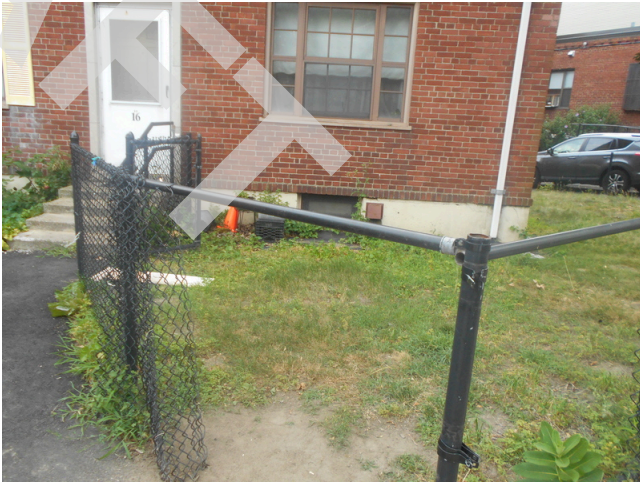
248. Damaged chain link fencing by 16 Kemp Street, unit 116 (Non-Critical Repair)

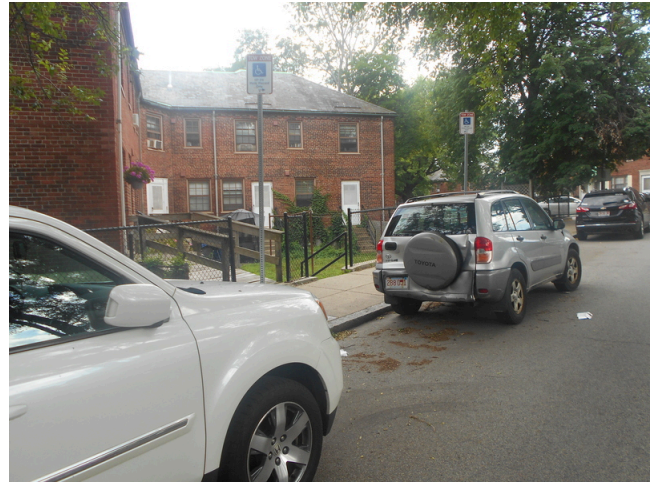
250. Handicap designated street parking by building 11, 16 Kemp Street, unit 116, no access aisle or curb cut (Critical Repair)

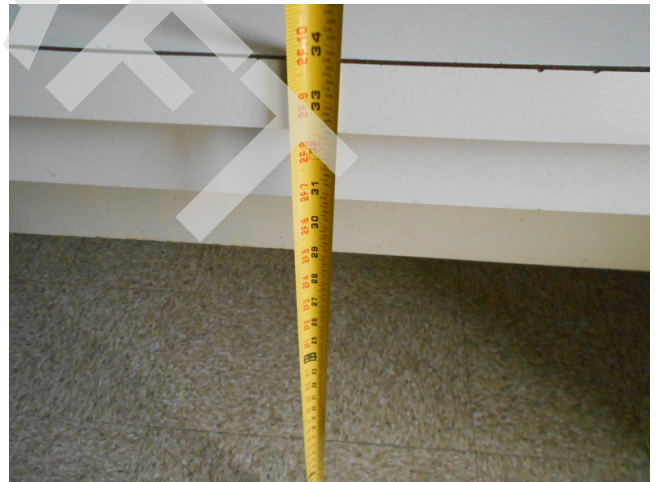
260. Community building, task force headquarters, kitchen countertop height, 34"

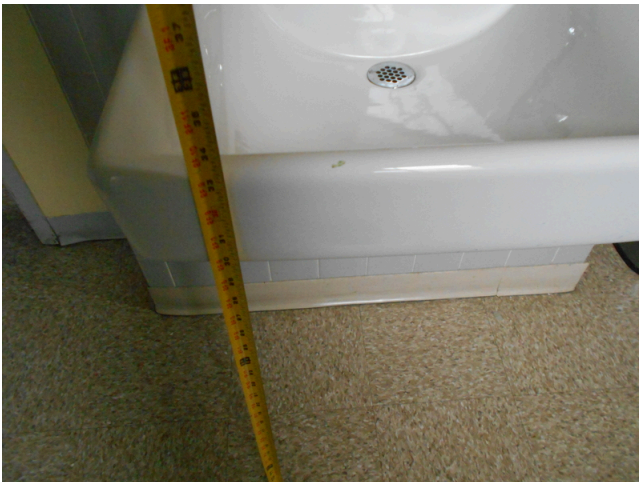
271. Community building, task force headquarters, restroom, sink height, 33"

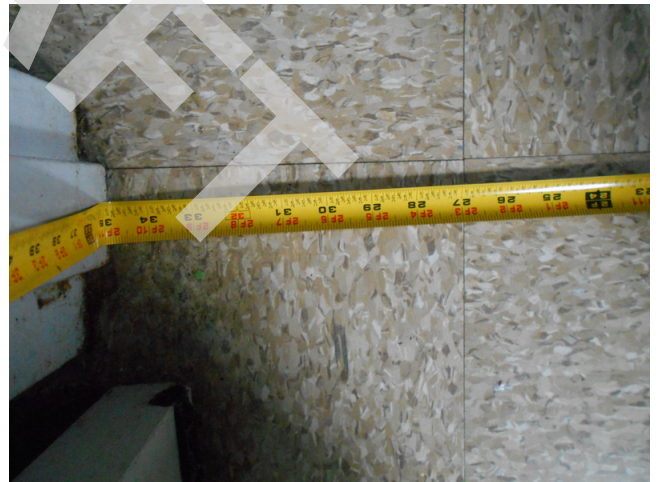
272. Community building, task force headquarters, restroom, entrance door width, 35"

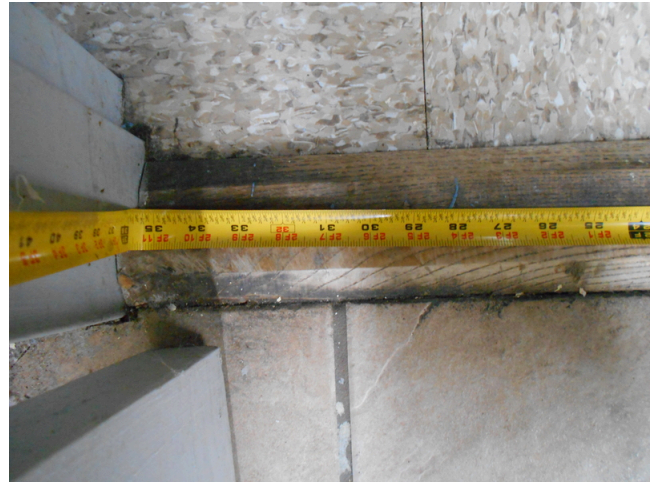
278. Community building, task force headquarters, restroom 2 entrance door width, 36"

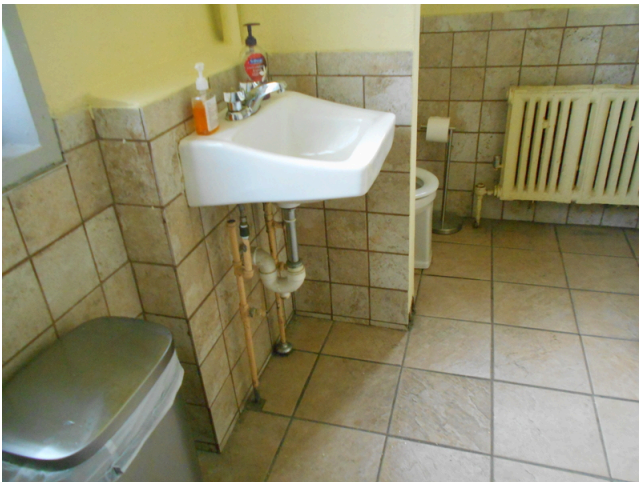
279. Community building, task force headquarters, restroom 2 sink, no scald abrasion protection (Critical Repair)

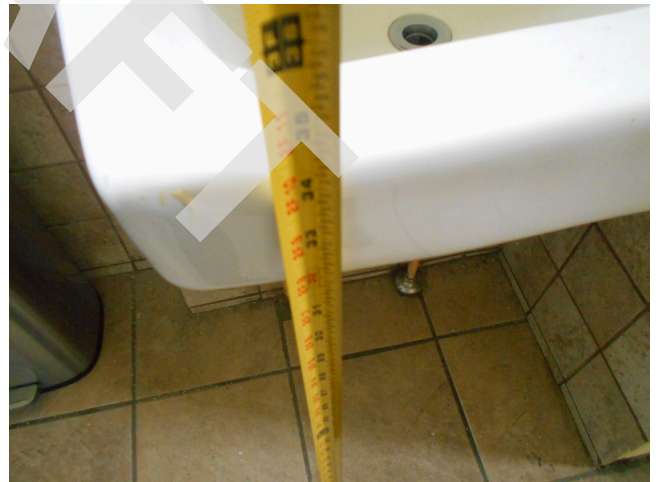
280. Community building, task force headquarters, restroom 2 sink, height, 33"

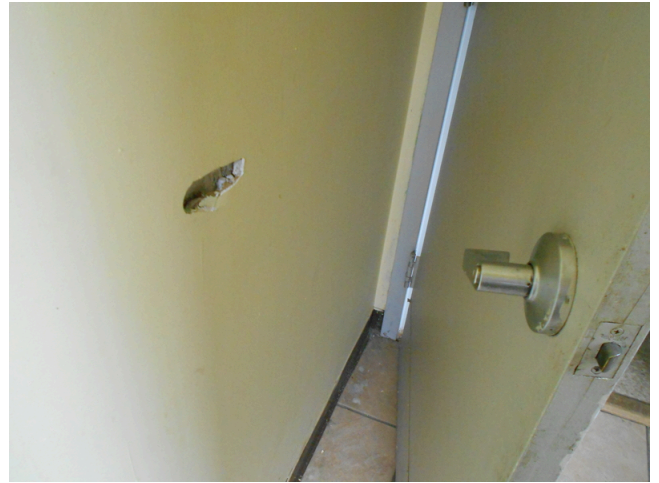
282. Community building, task force headquarters, restroom 2 drywall damaged by door handle (Non-Critical Repair)
