**CAPITAL NEEDS ASSESSMENT (CNA)  
FOLEY APARTMENTS (2-30)  
199 H STREET  
SOUTH BOSTON, MASSACHUSETTS 02127**

**D3G PROJECT NUMBER:  
2021-0372**

**FINAL REPORT ISSUE DATE:  
NOVEMBER 5, 2021**

**INSPECTION DATE:  
APRIL 19-20, 2021**

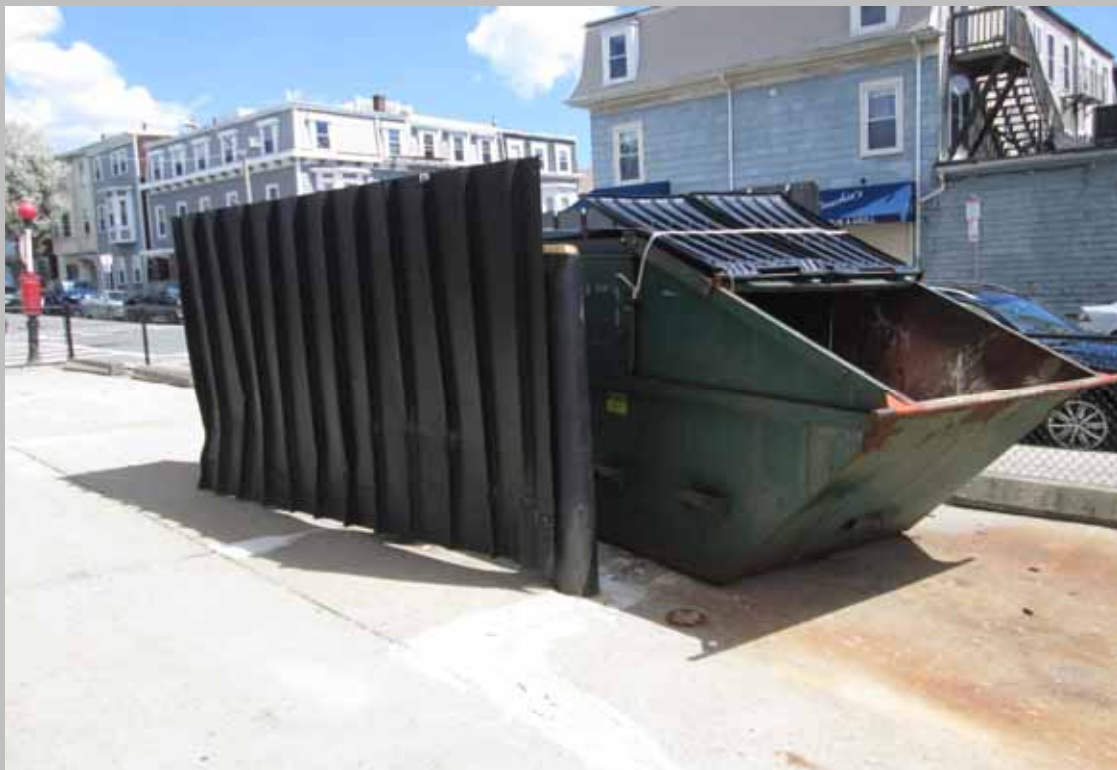
PHOTO #6

The property features one (1) trash compactor with a rolling dumpster that is located within the ground floor of the building. The trash compactor was observed in fair physical condition and replacement is anticipated during the estimate period. The site also features a dumpster with a steel enclosure. The enclosure was observed in good physical condition with the exception of the corner where it was struck by a vehicle.

Dumpster and steel enclosure

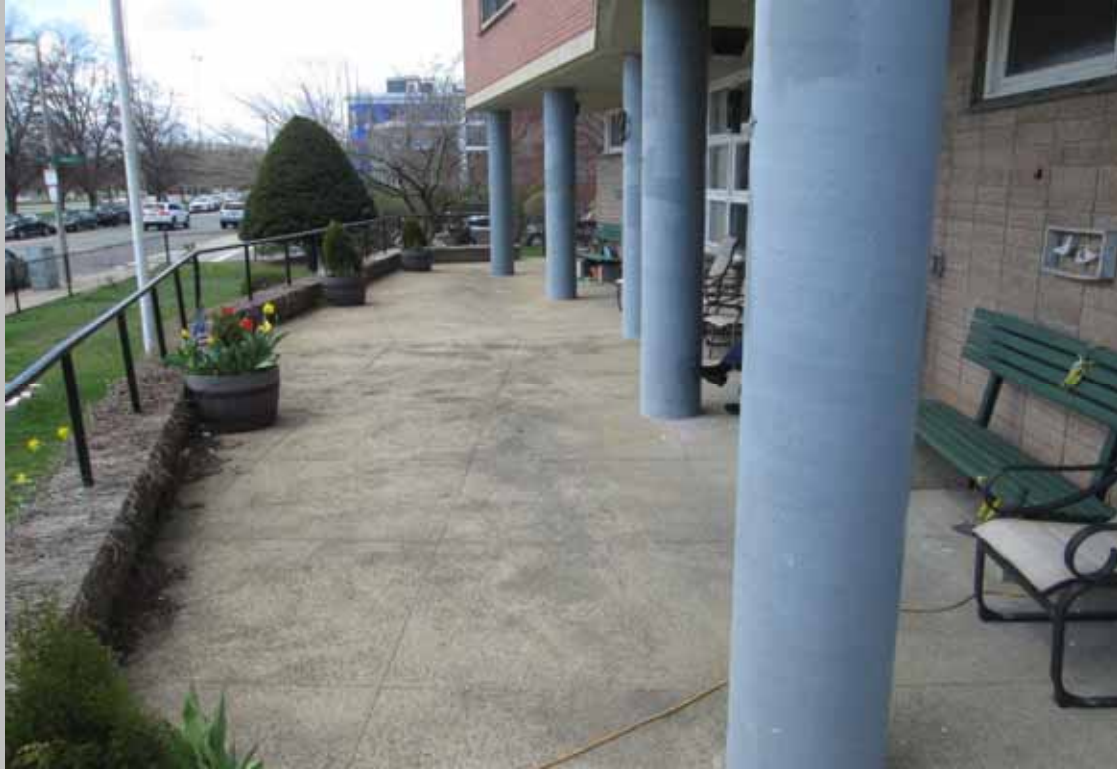
PHOTO #11

Patio/sitting area on south side of building

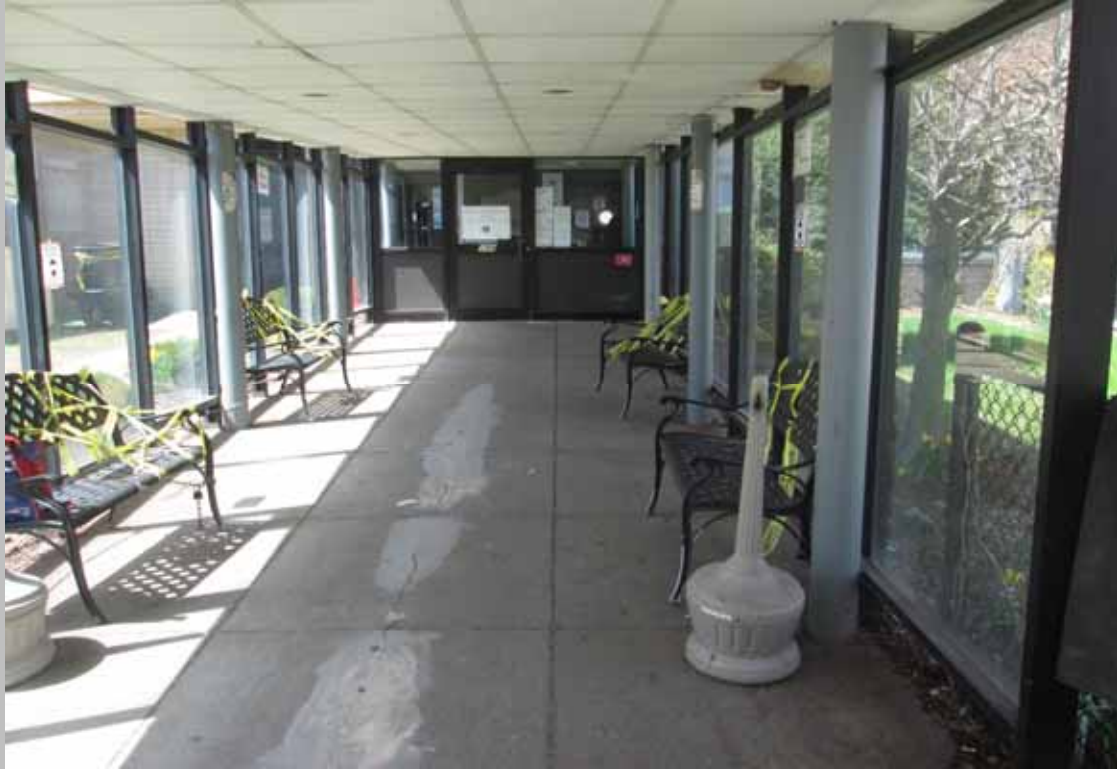
PHOTO #13

Walkway awning at main building entrance

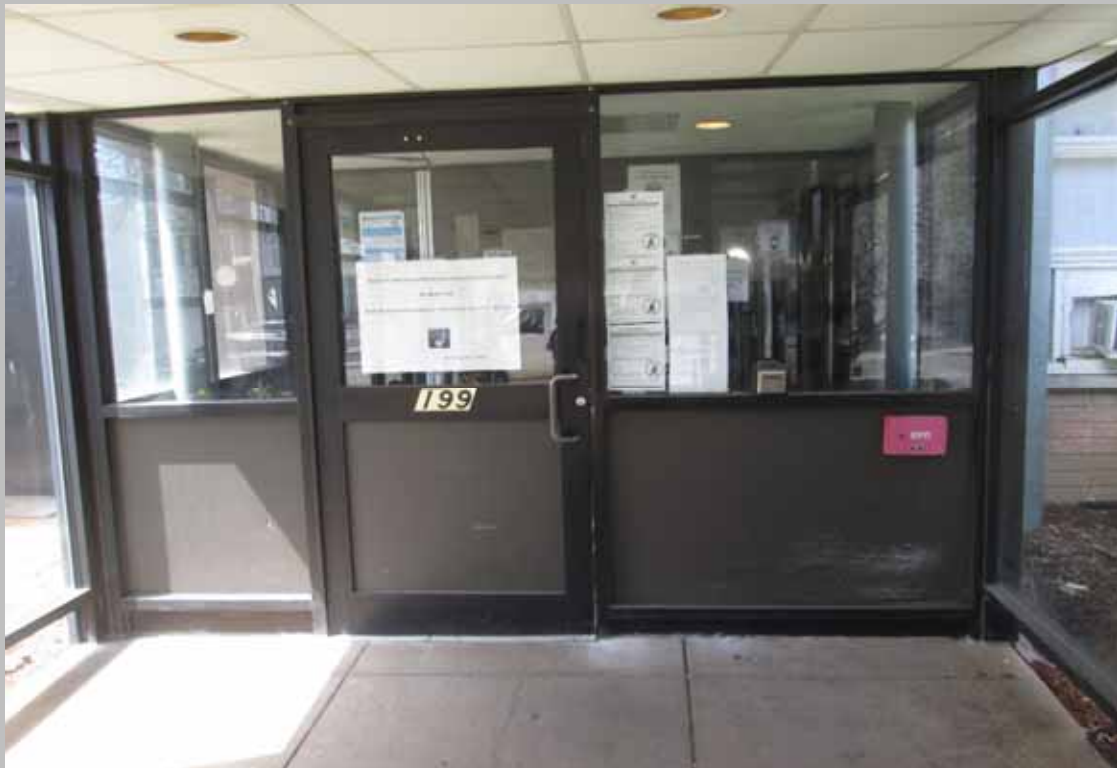
PHOTO #14

Main building entry doors/vestibule area

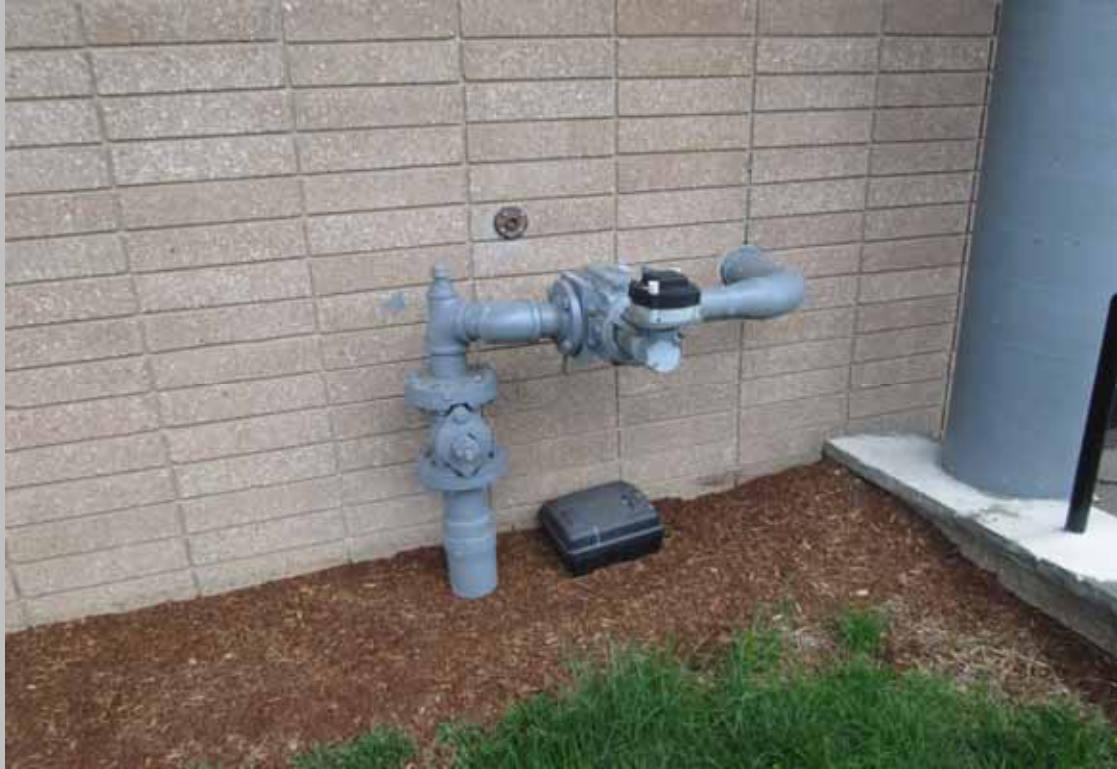
PHOTO #17

Natural gas meter

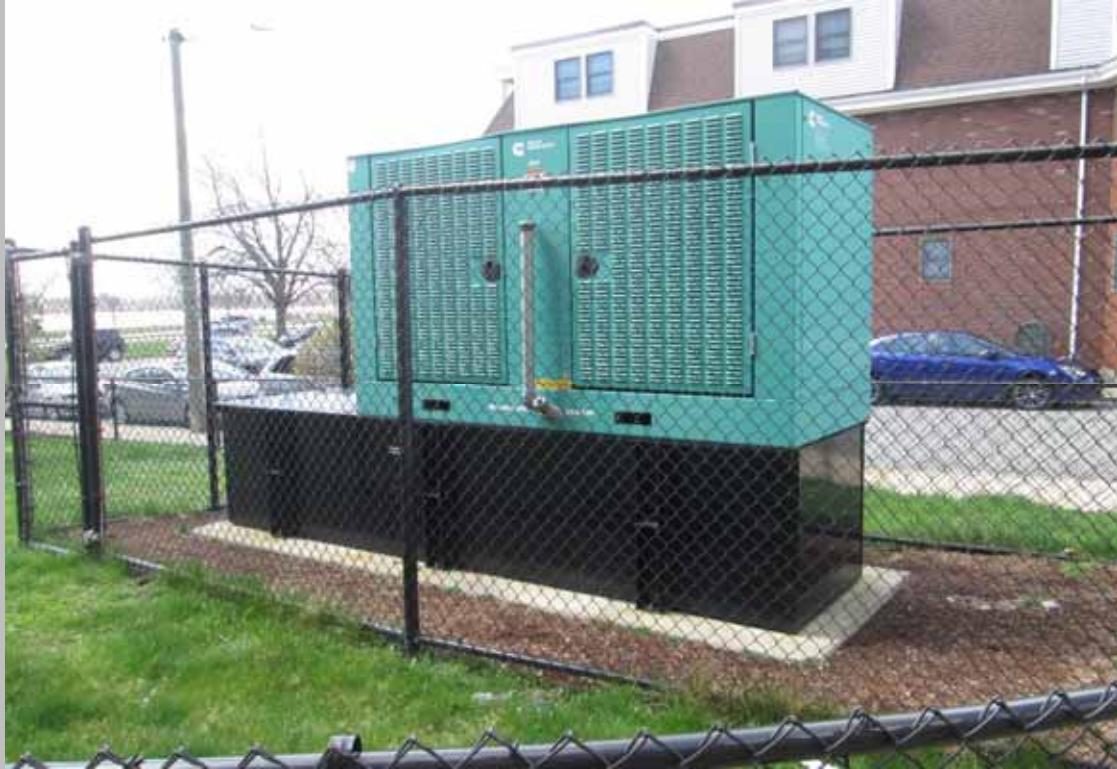
PHOTO #19

Emergency generator and AST

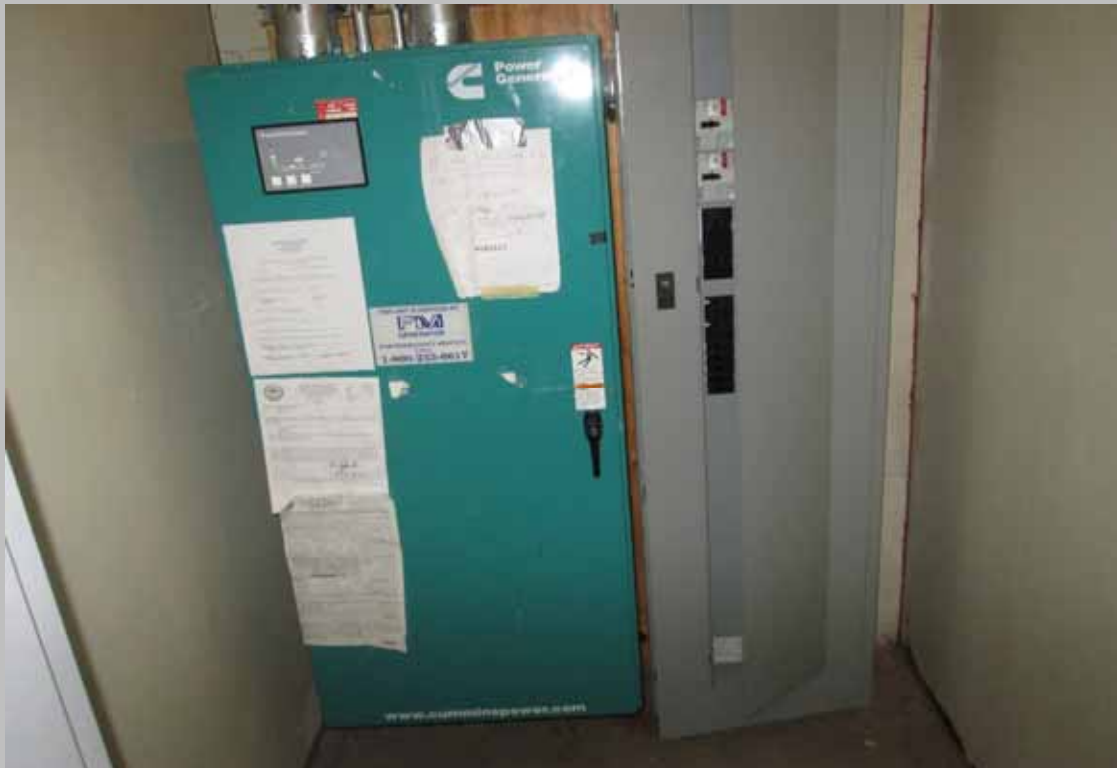
PHOTO #20

Emergency generator transfer switch

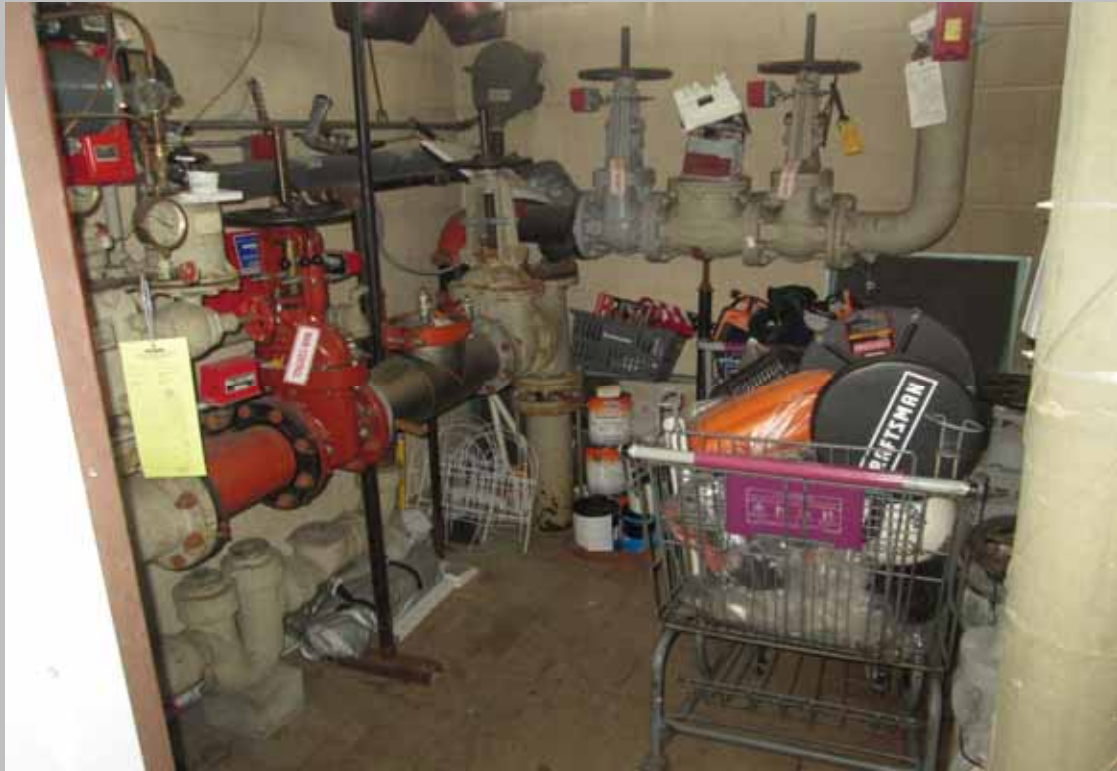
PHOTO #23

Fire pump room

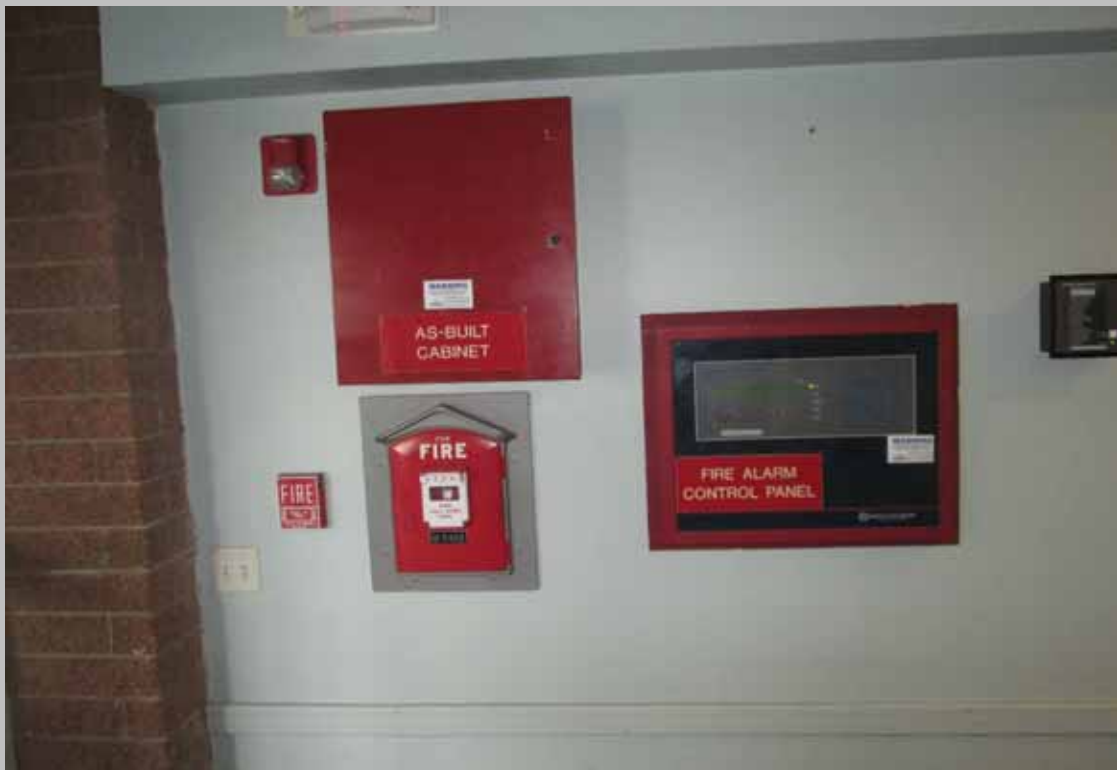
PHOTO #24

Fire alarm panels

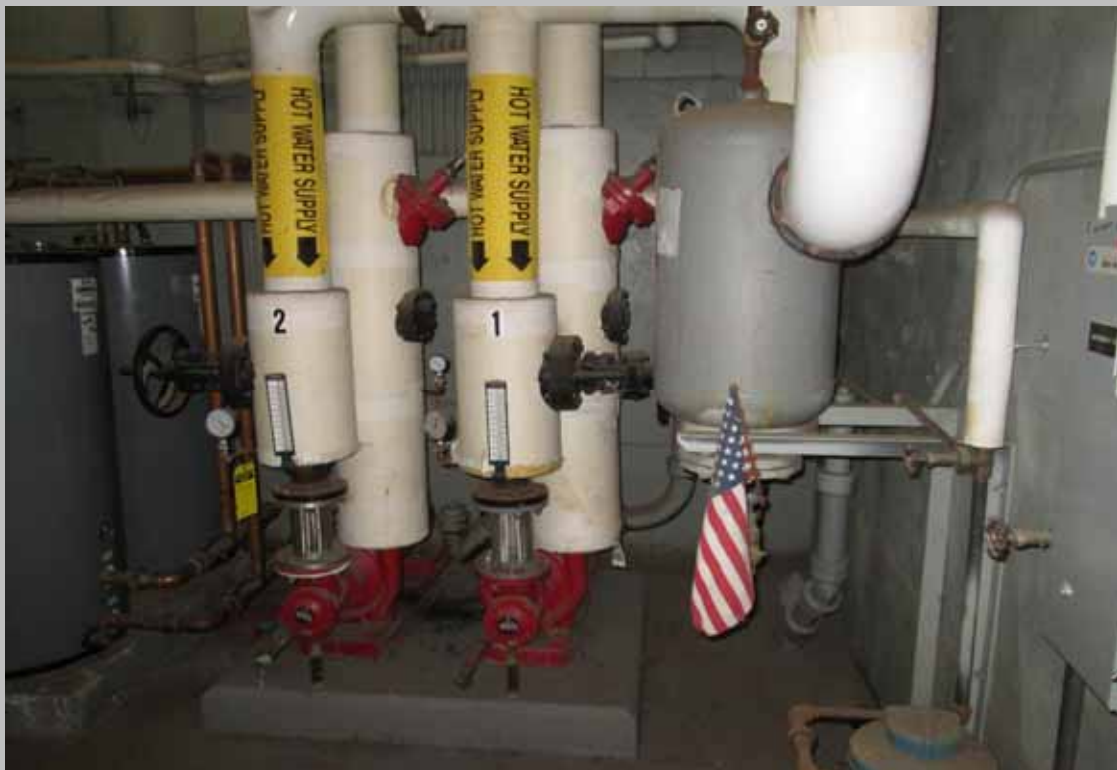
PHOTO #28

DHW circulation pumps

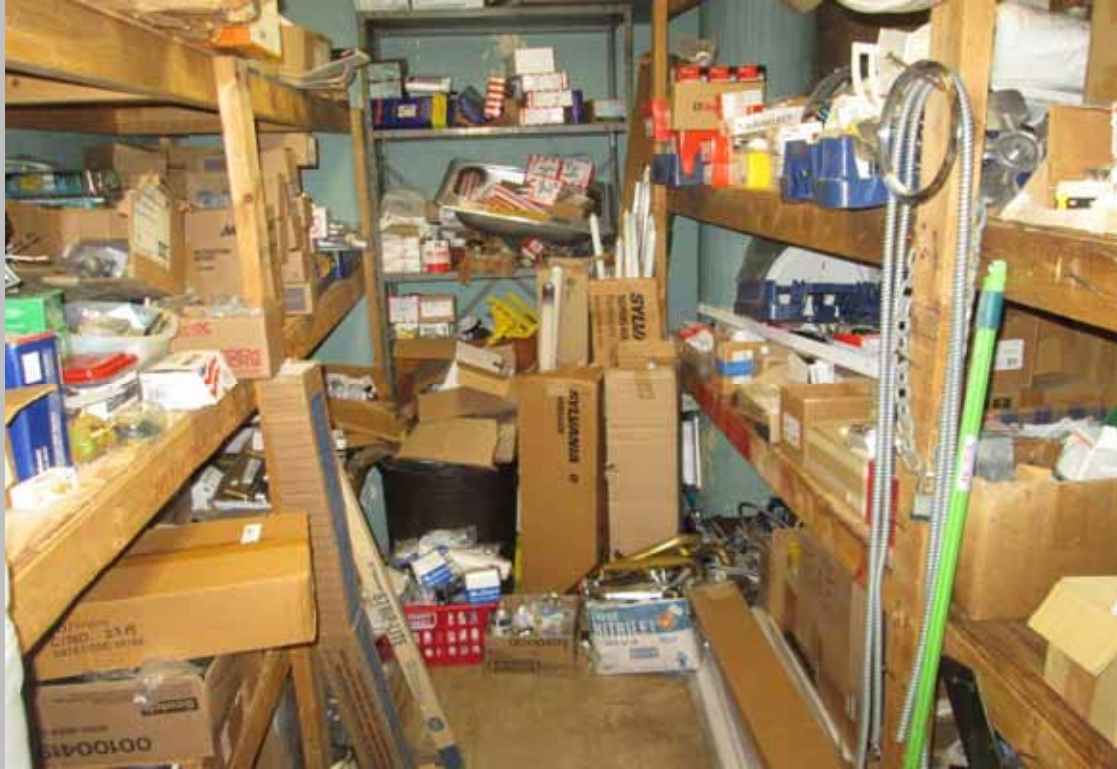
PHOTO #29

Maintenance storage area

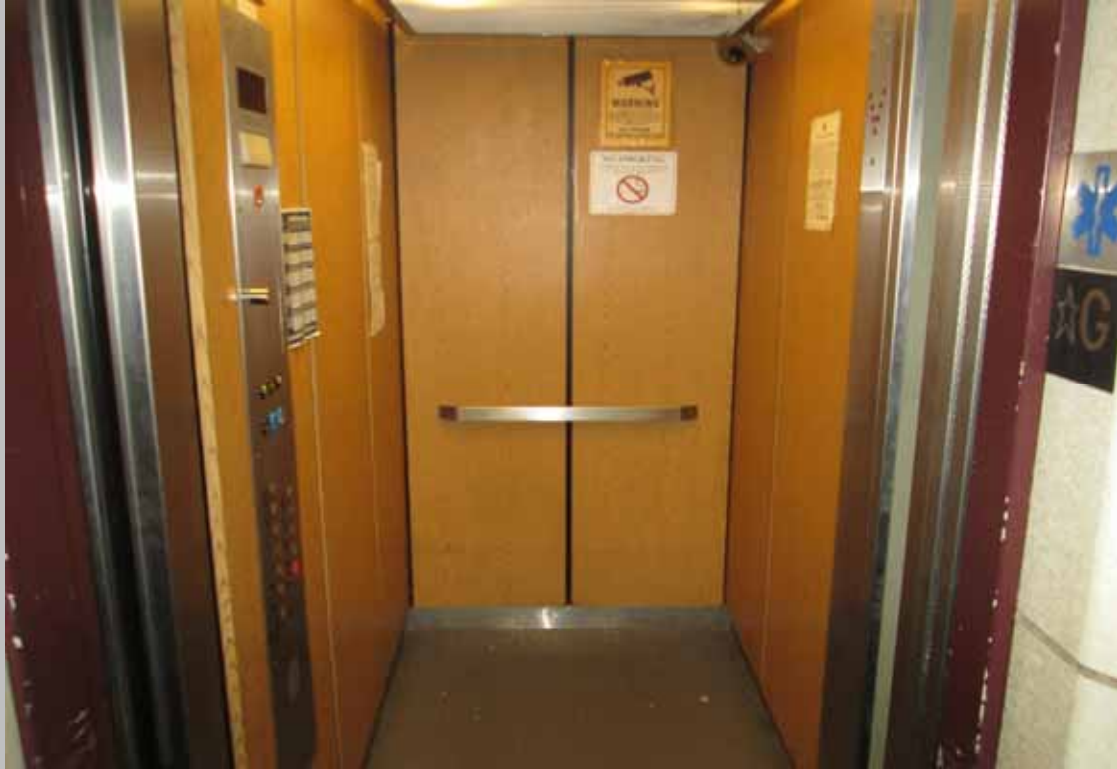
PHOTO #31

Elevator interior cab

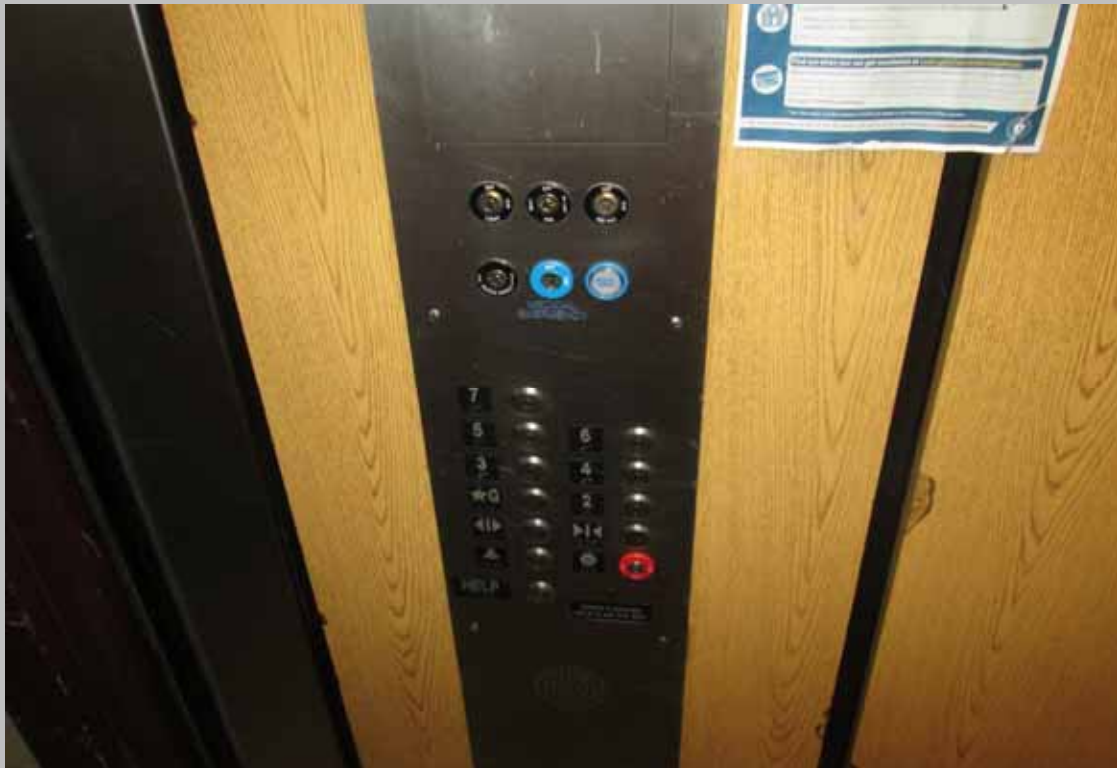
PHOTO #32

Elevator cab controls with ADA and fireman's controls

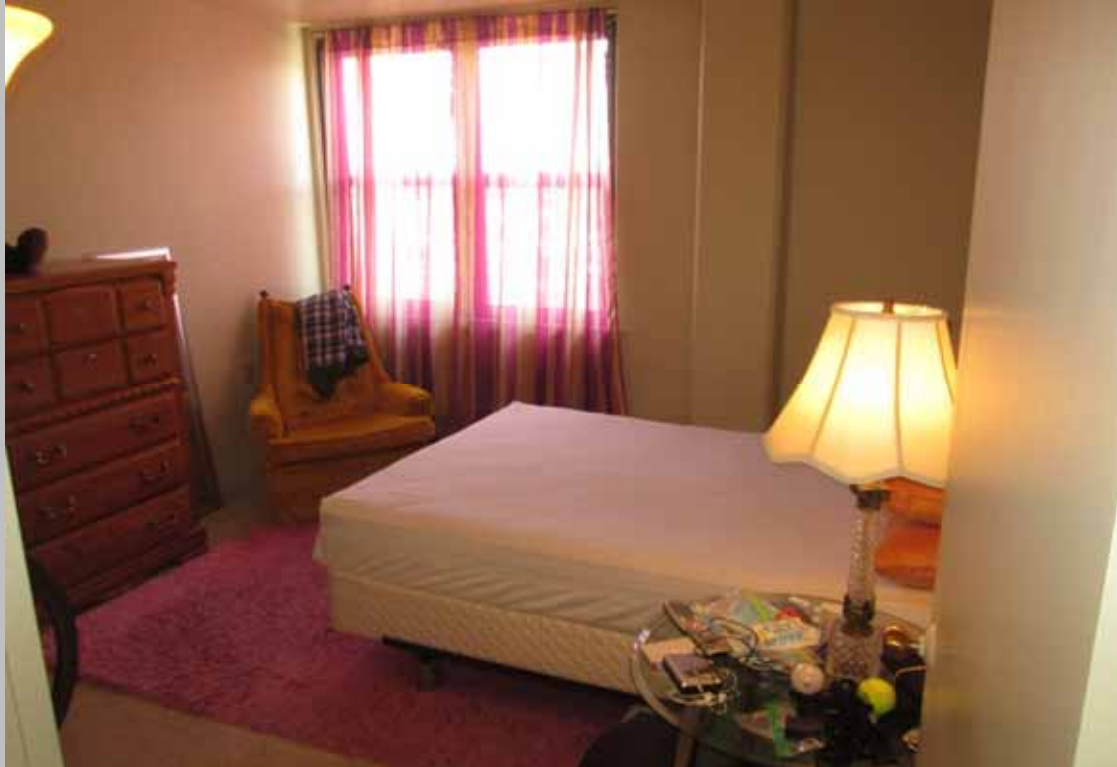
PHOTO #41

Typical dwelling unit bedroom

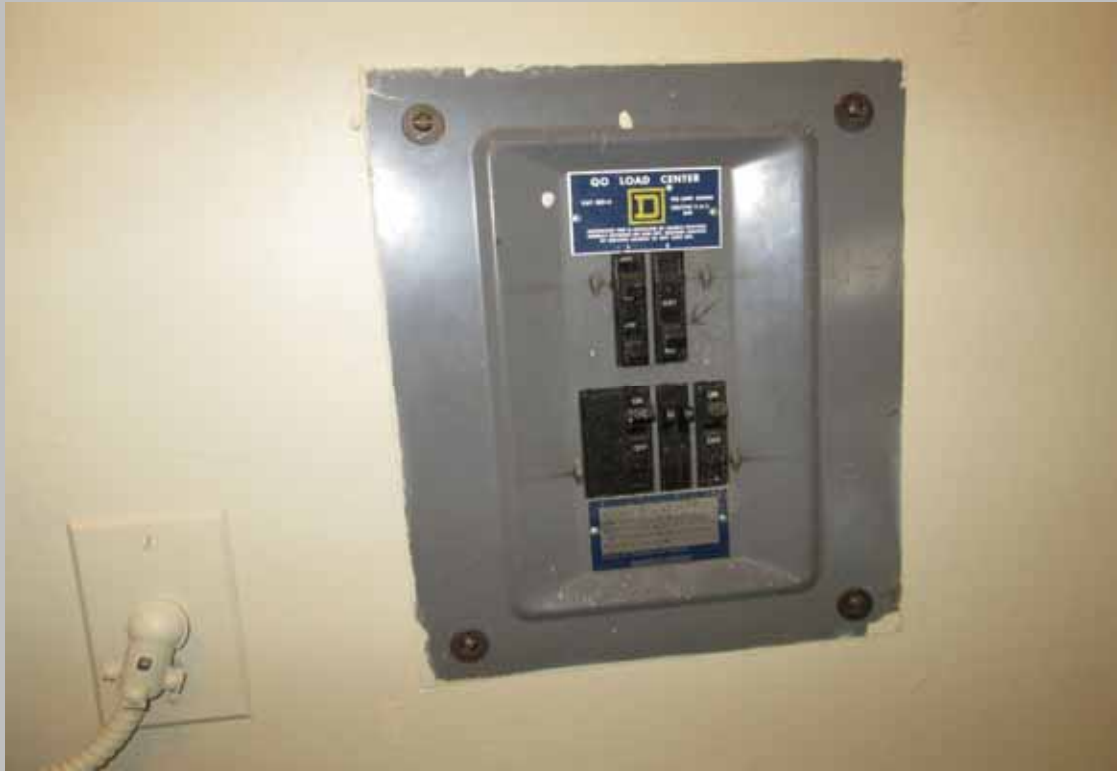
PHOTO #43

Typical dwelling unit breaker panel

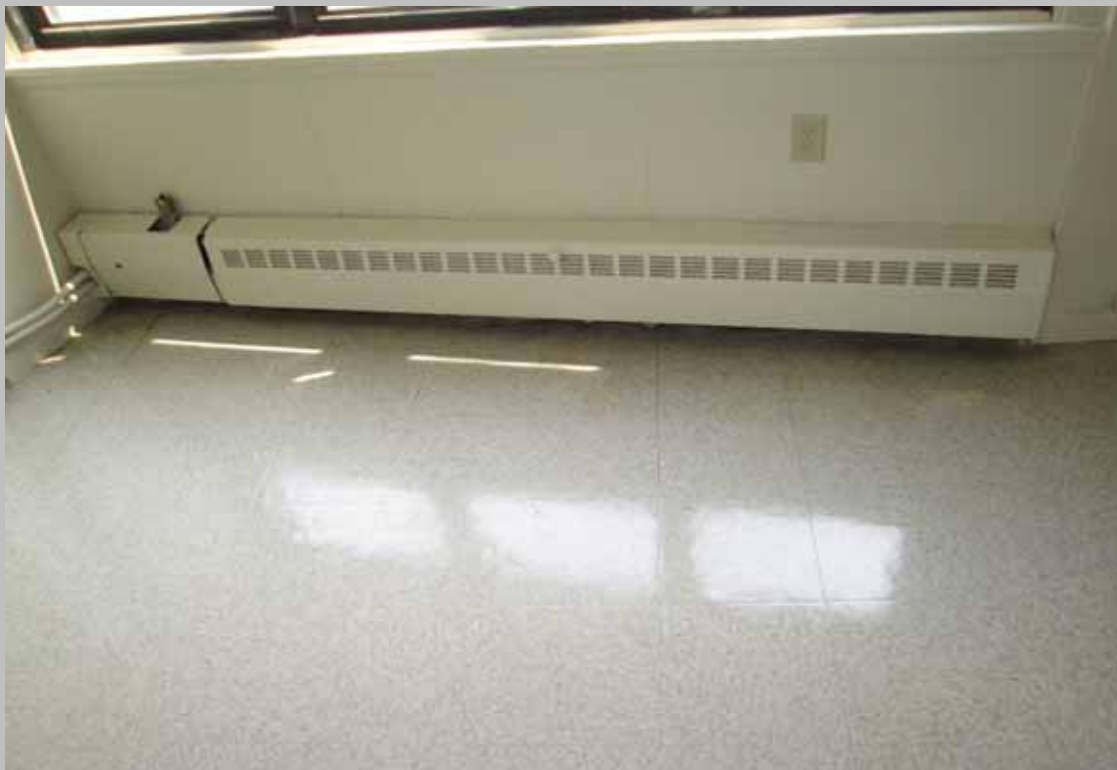
PHOTO #44

Typical dwelling unit hydronic heating

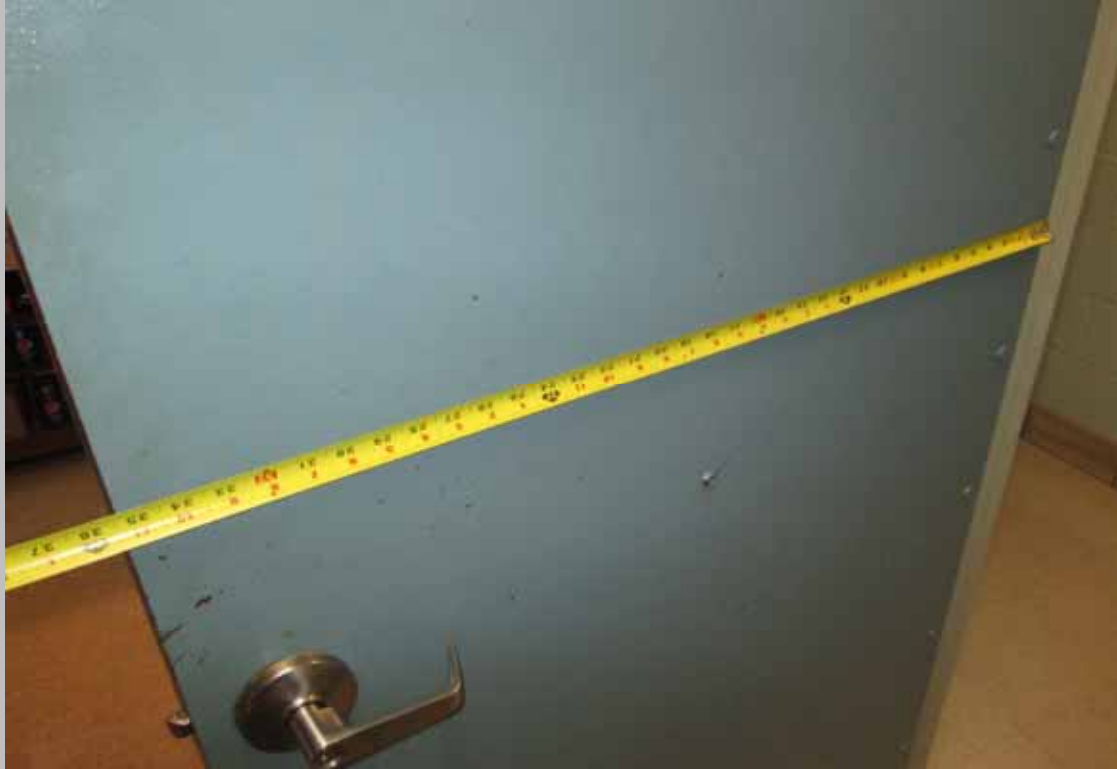
PHOTO #45

Handicapped (HC) dwelling unit with compliant entry door

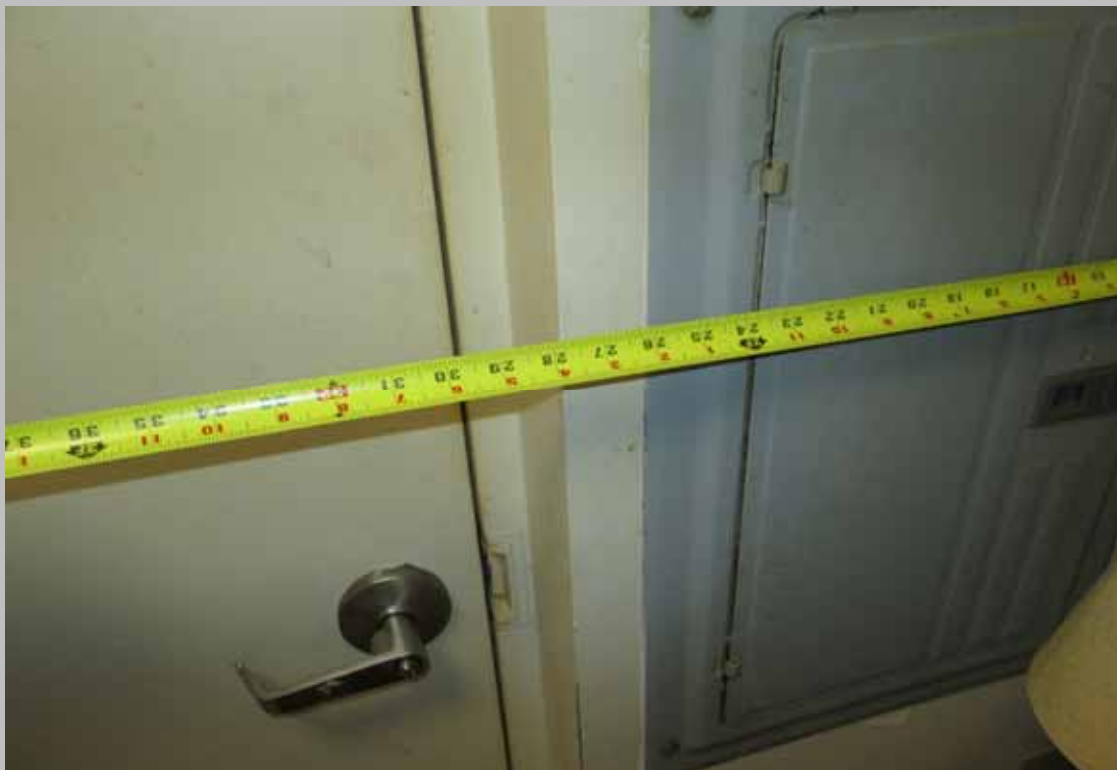
PHOTO #46

HC unit with compliant clear maneuvering space at entry door

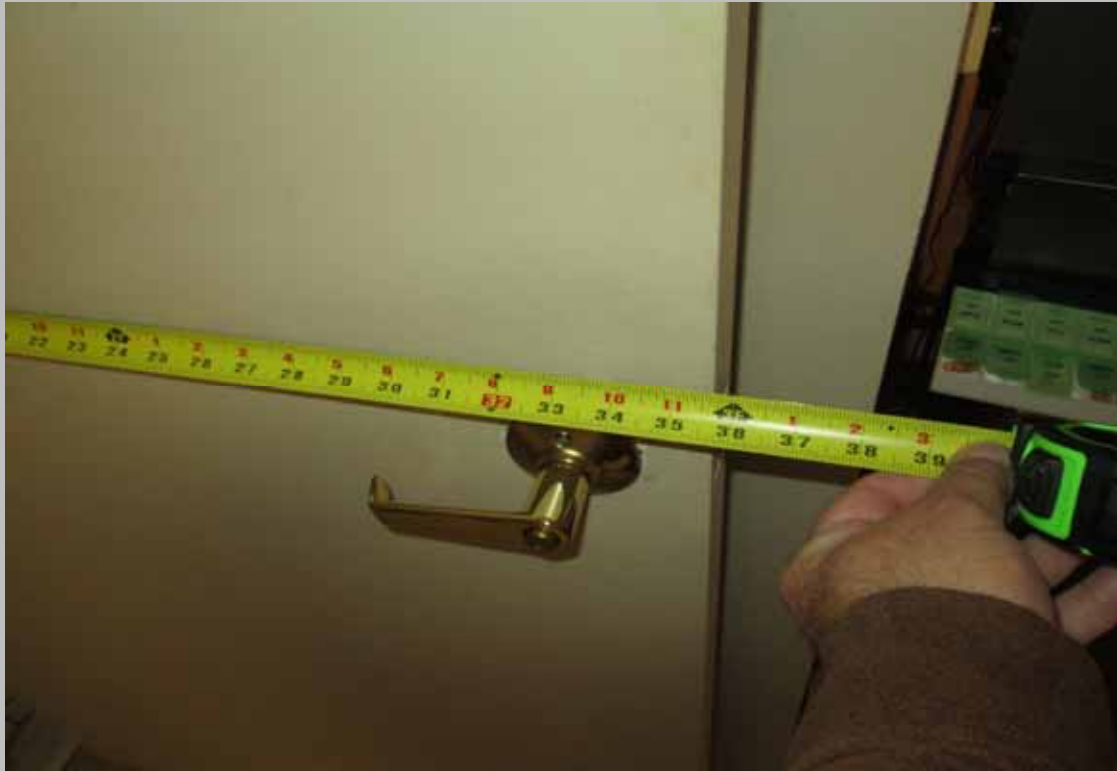
PHOTO #47

HC unit with compliant interior door

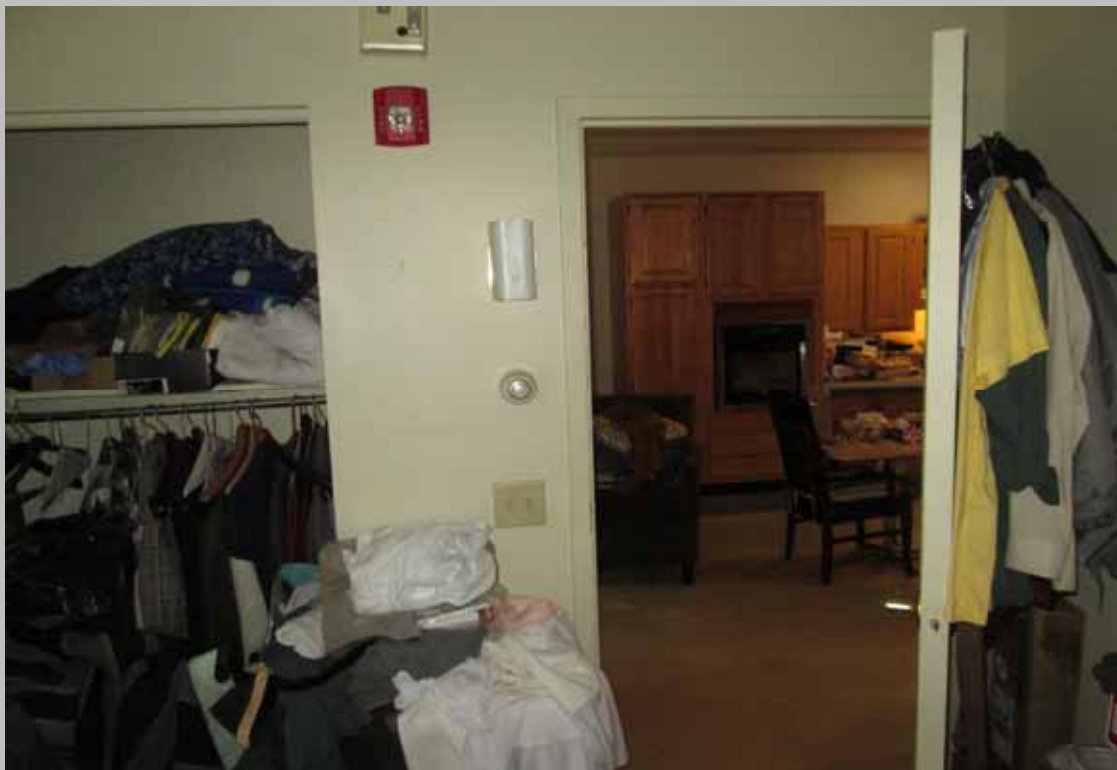
PHOTO #48

HC unit with compliant maneuvering space at interior door

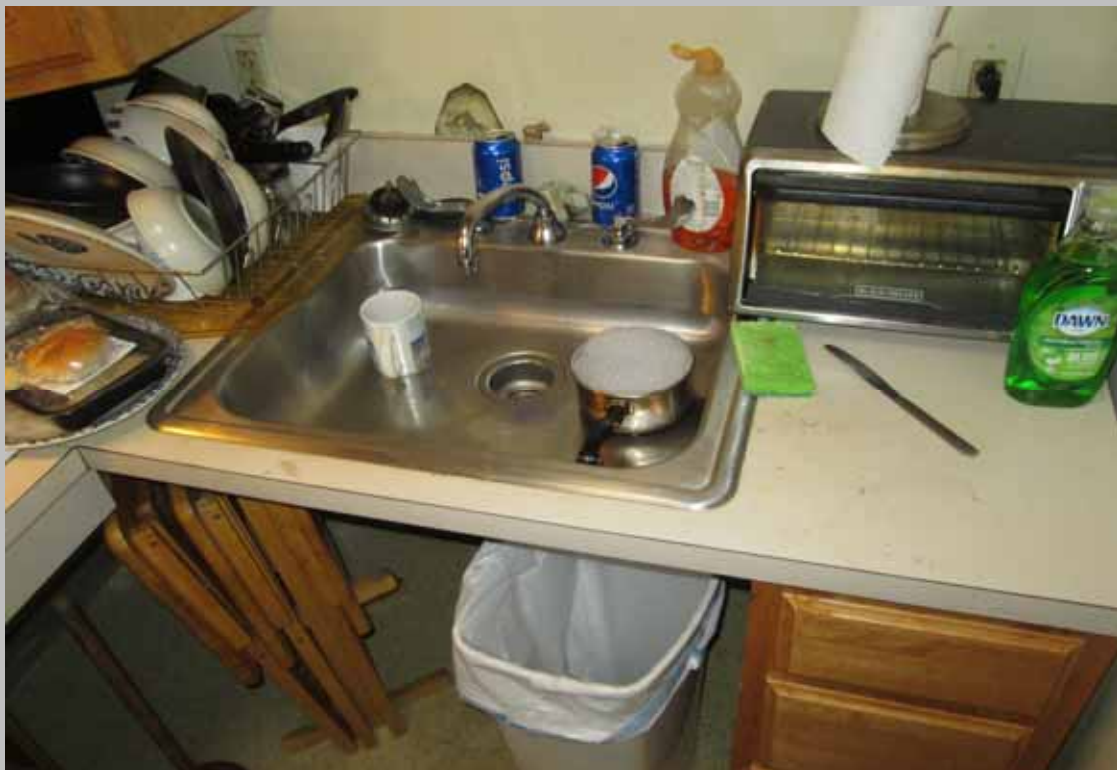
PHOTO #50

HC unit with compliant kitchen sink roll-under access and levered faucet hardware

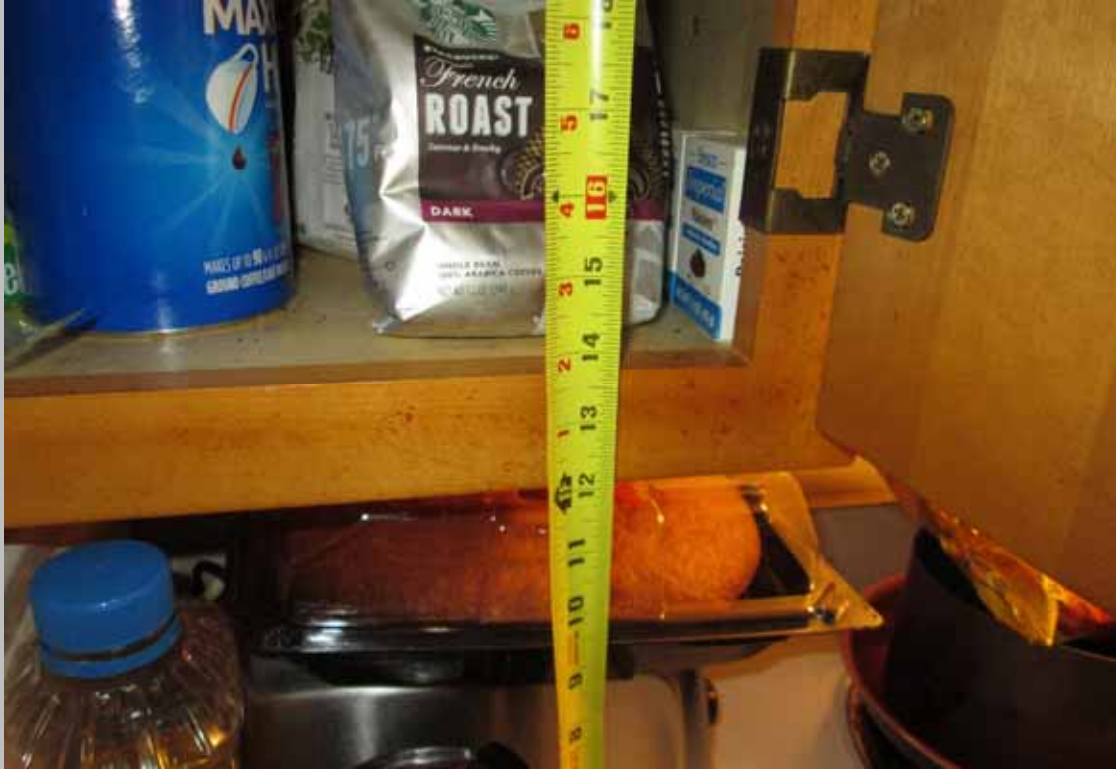
PHOTO #51

HC unit with compliant kitchen upper cabinetry at 48-inches above the finished flooring (AFF)  
[countertop height is 34-inches (AFF)]

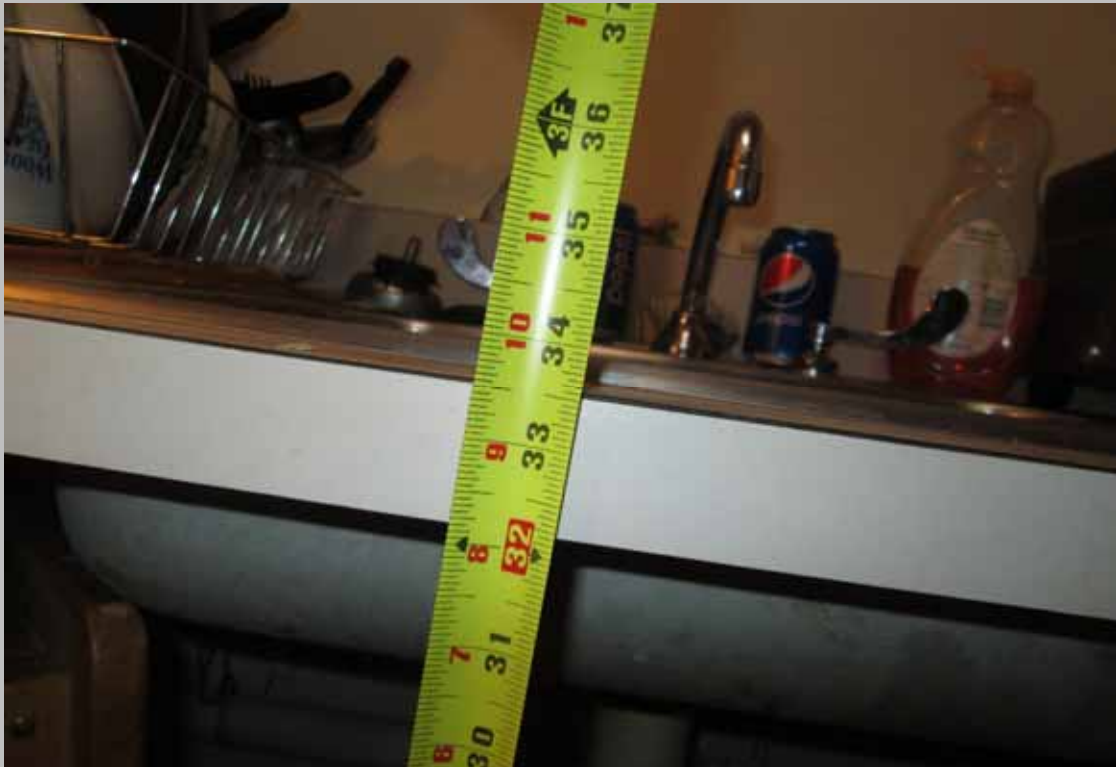
PHOTO #52

HC unit with compliant kitchen countertop/sink height

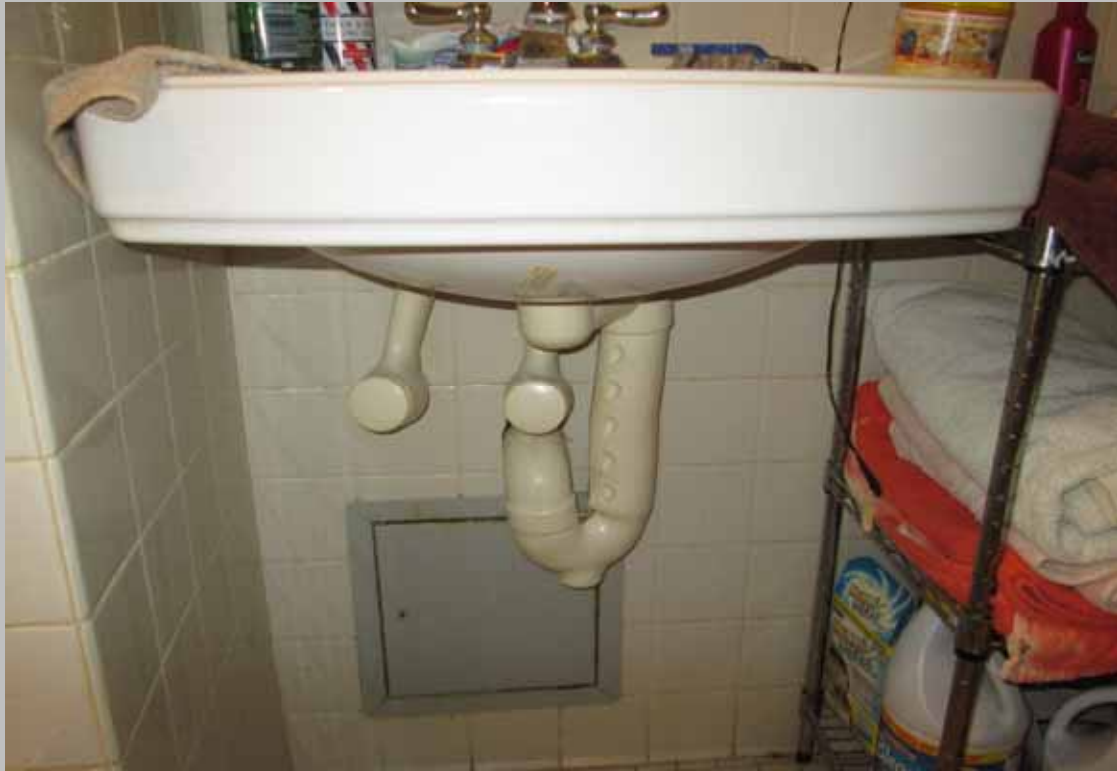
PHOTO #53

HC unit with compliant bathroom sink scald and abrasion protection

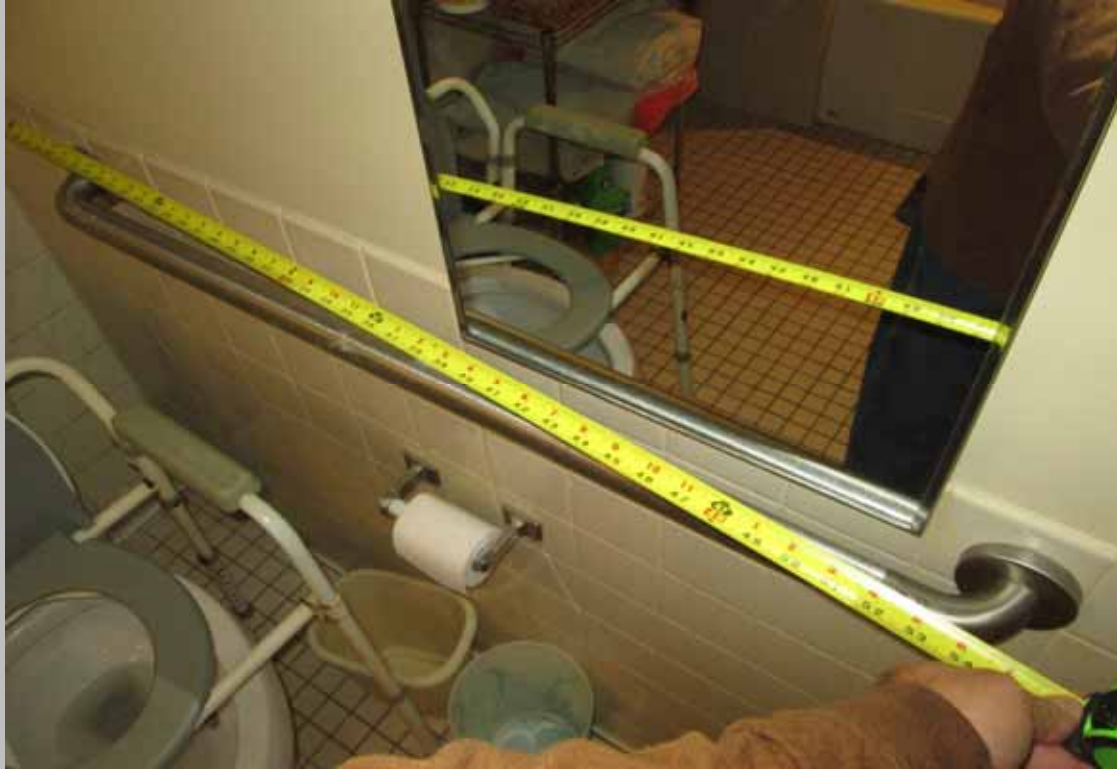
PHOTO #57

HC unit toilet with compliant side grab bar

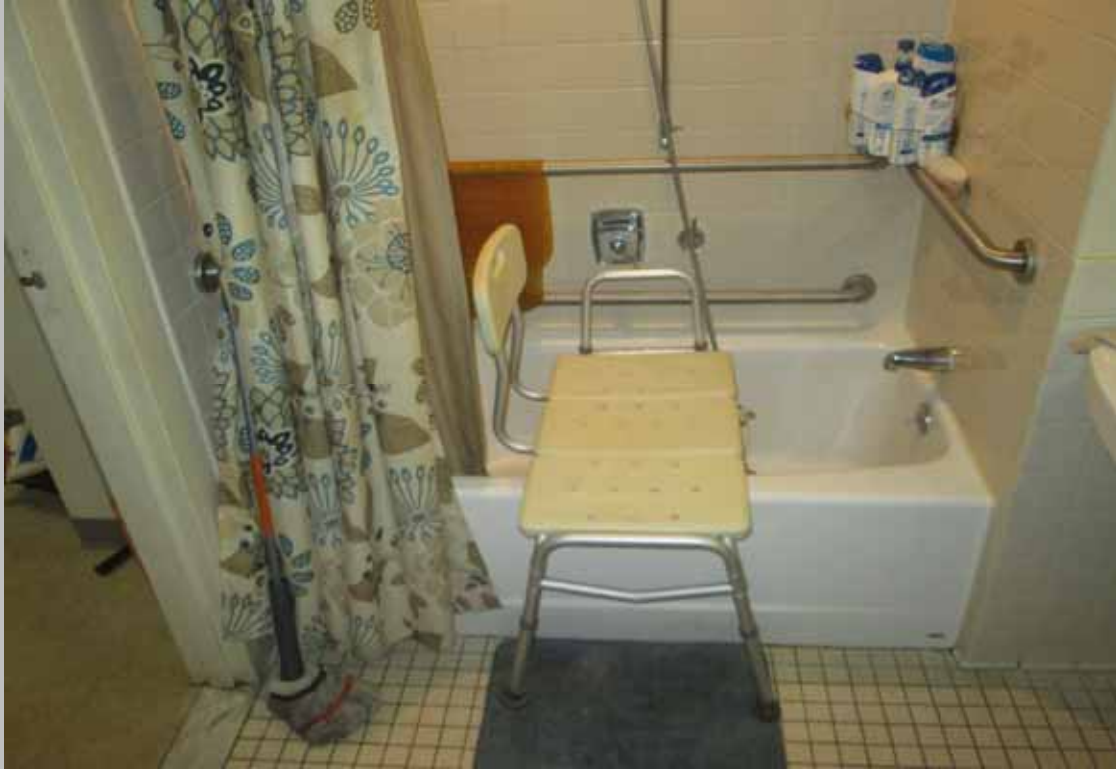
PHOTO #59

HC unit tub with compliant grab bars and levered faucet hardware
