**CAPITAL NEEDS ASSESSMENT (CNA)  
WEST NINTH STREET (2-36)  
185 WEST NINTH STREET  
SOUTH BOSTON, MASSACHUSETTS 02127**

**2021-0383**

**NOVEMBER 5, 2021**

**APRIL 19-20, 2021**

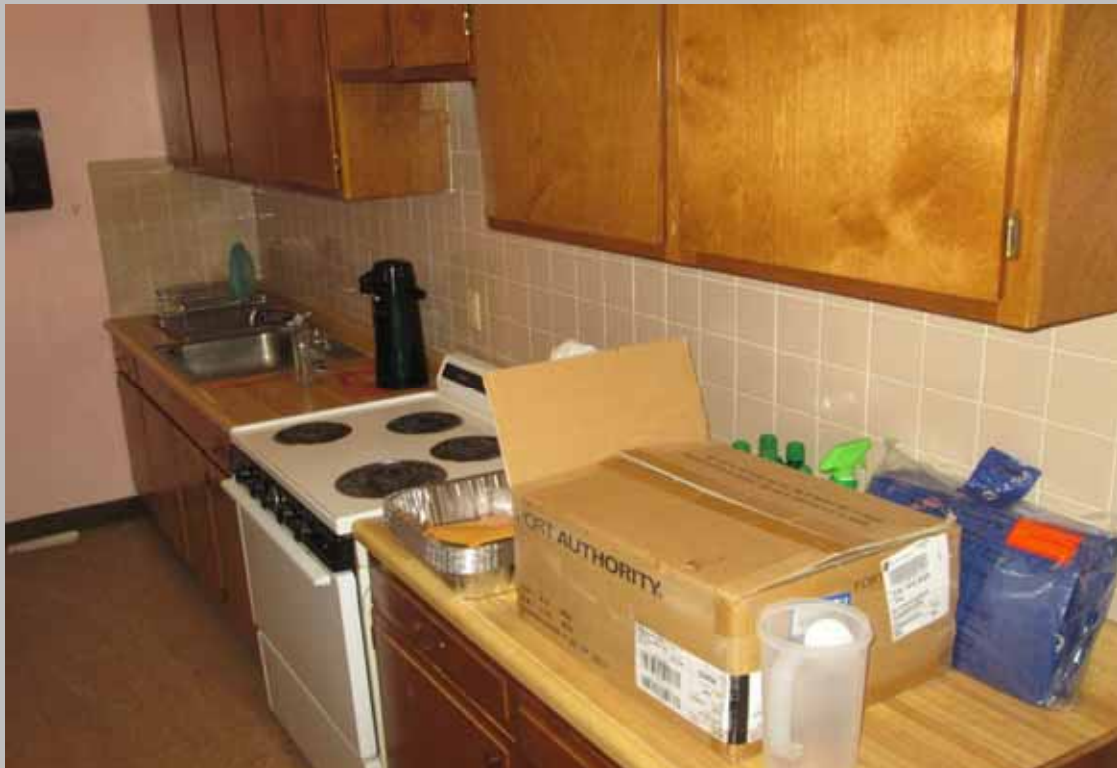
PHOTO #40

View of community kitchen

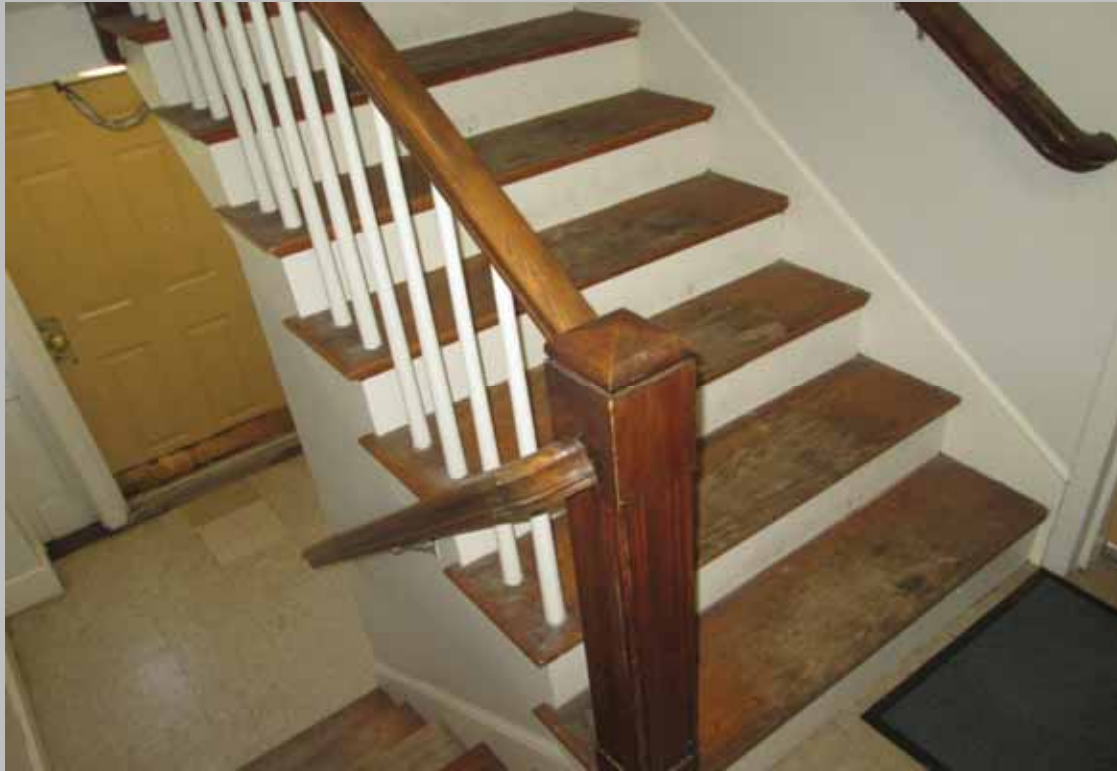
PHOTO #41

View of common interior stairwell

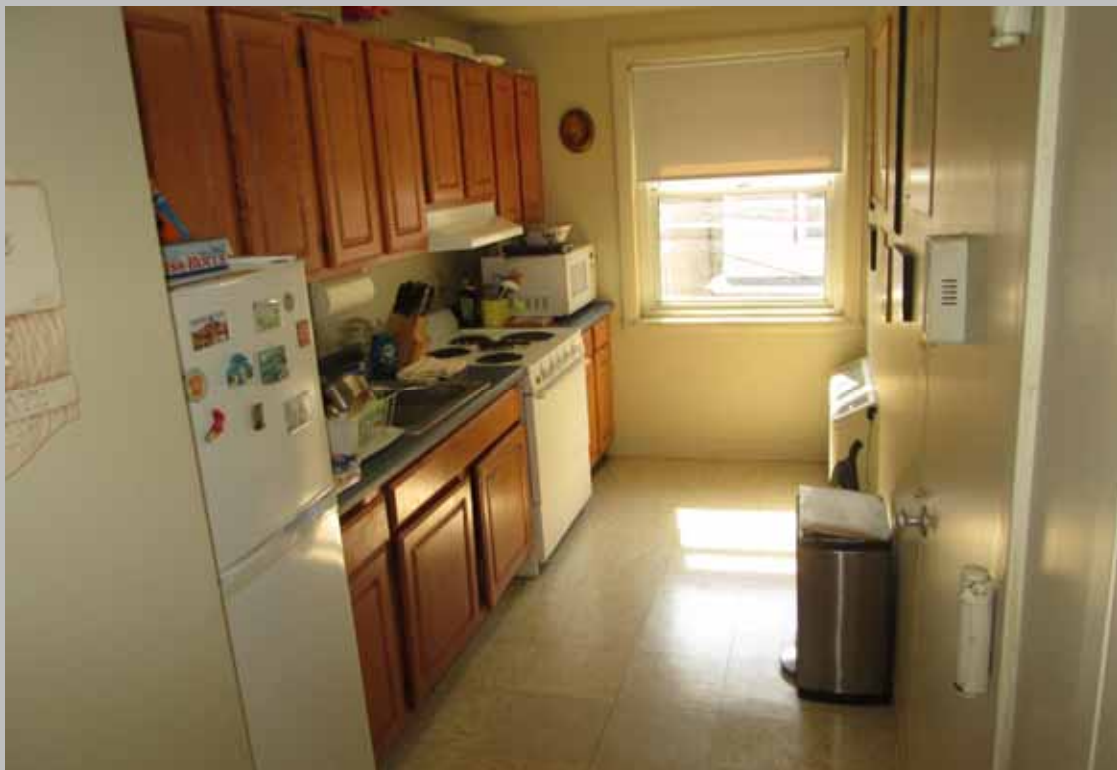
PHOTO #42

View of kitchen at Unit 3

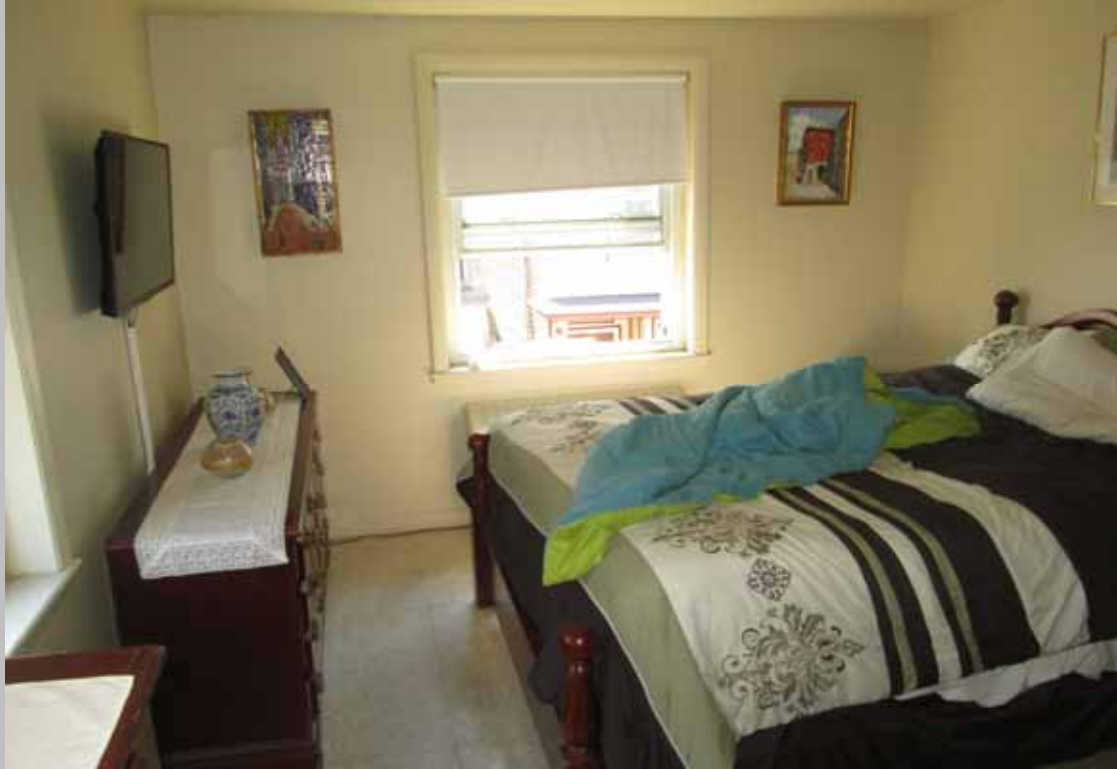
PHOTO #43

View of bedroom at Unit 3

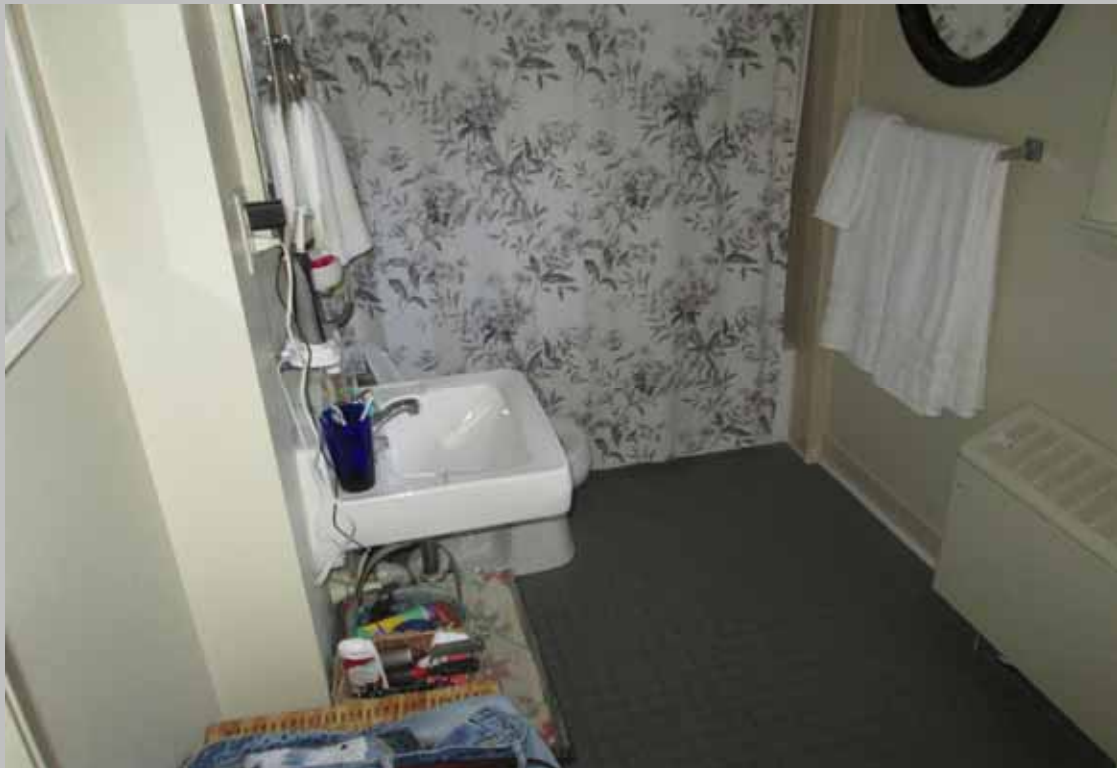
PHOTO #44

View of bathroom at Unit 3

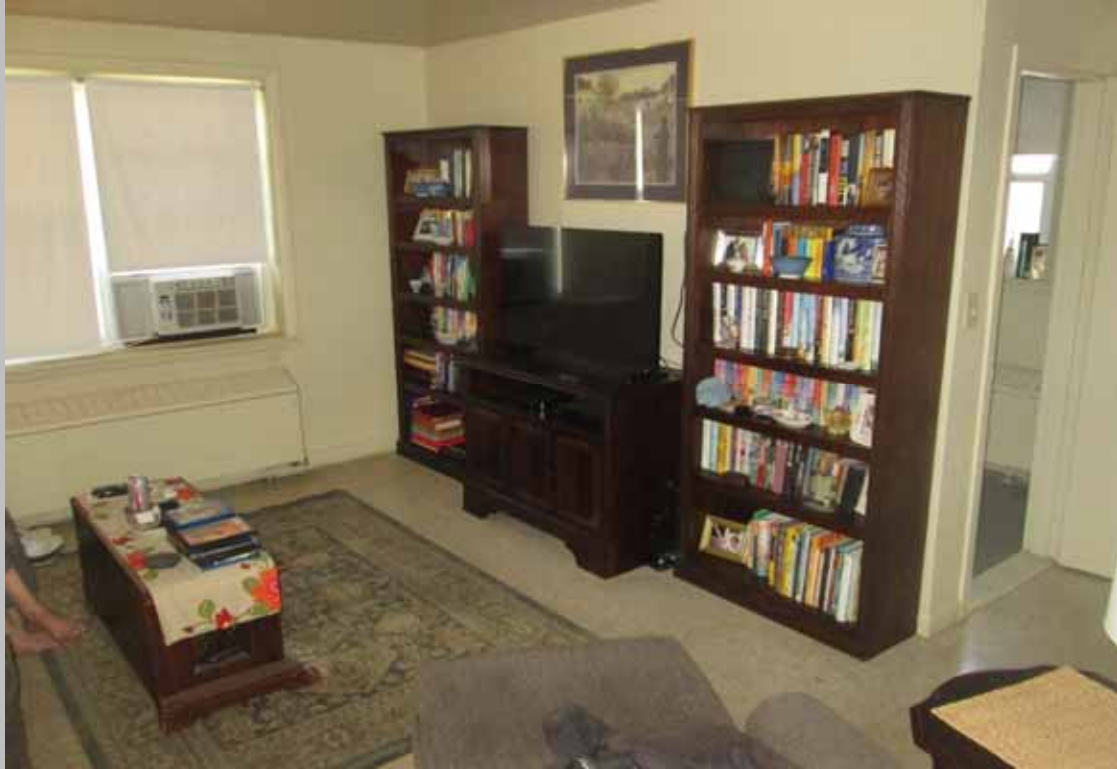
PHOTO #45

View of living room at Unit 3

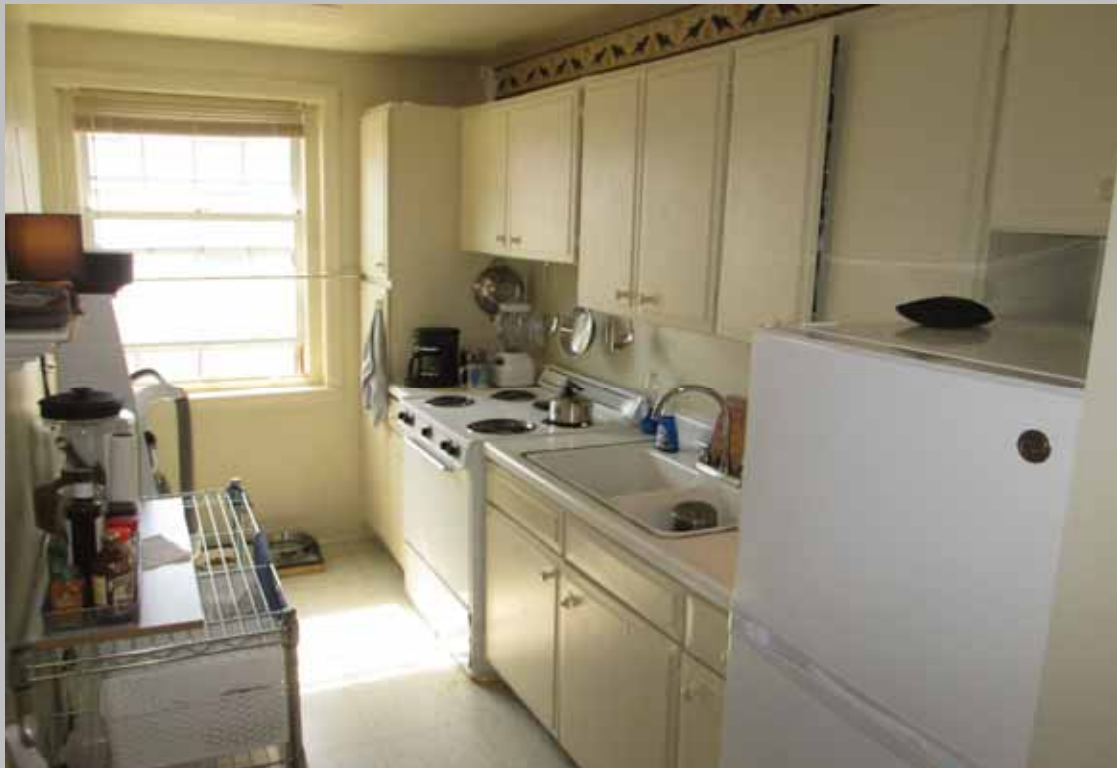
PHOTO #46

View of kitchen at Unit 8

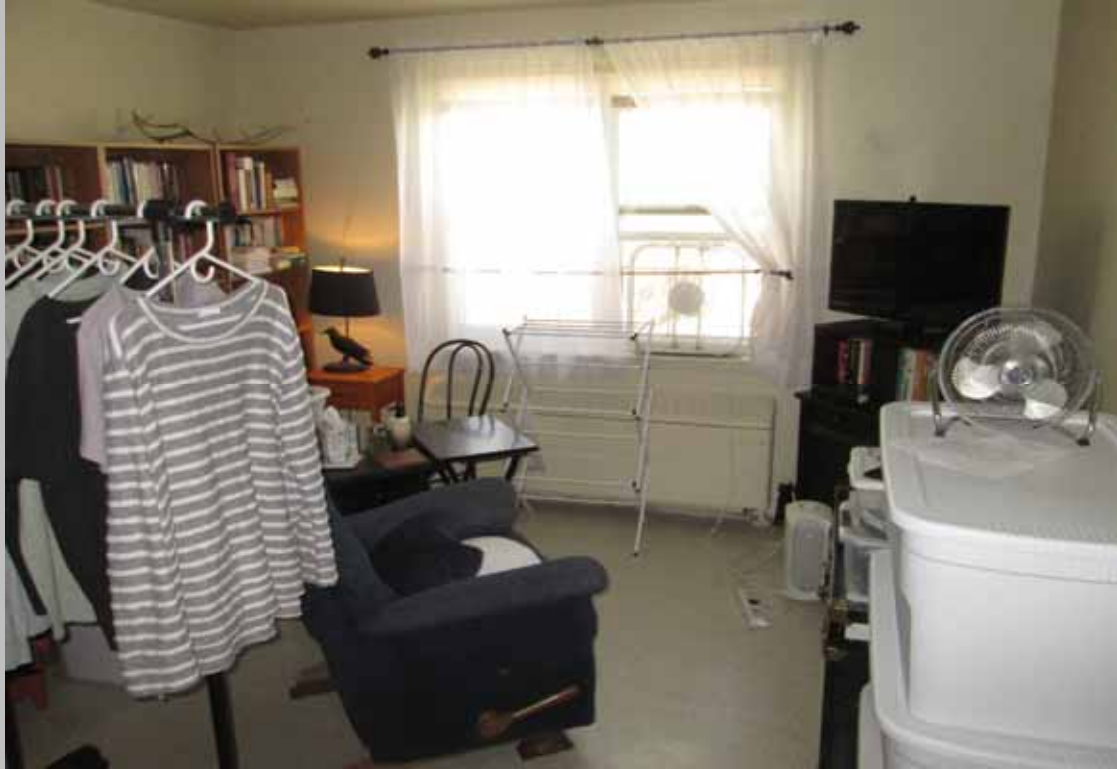
PHOTO #47

View of living room at Unit 8

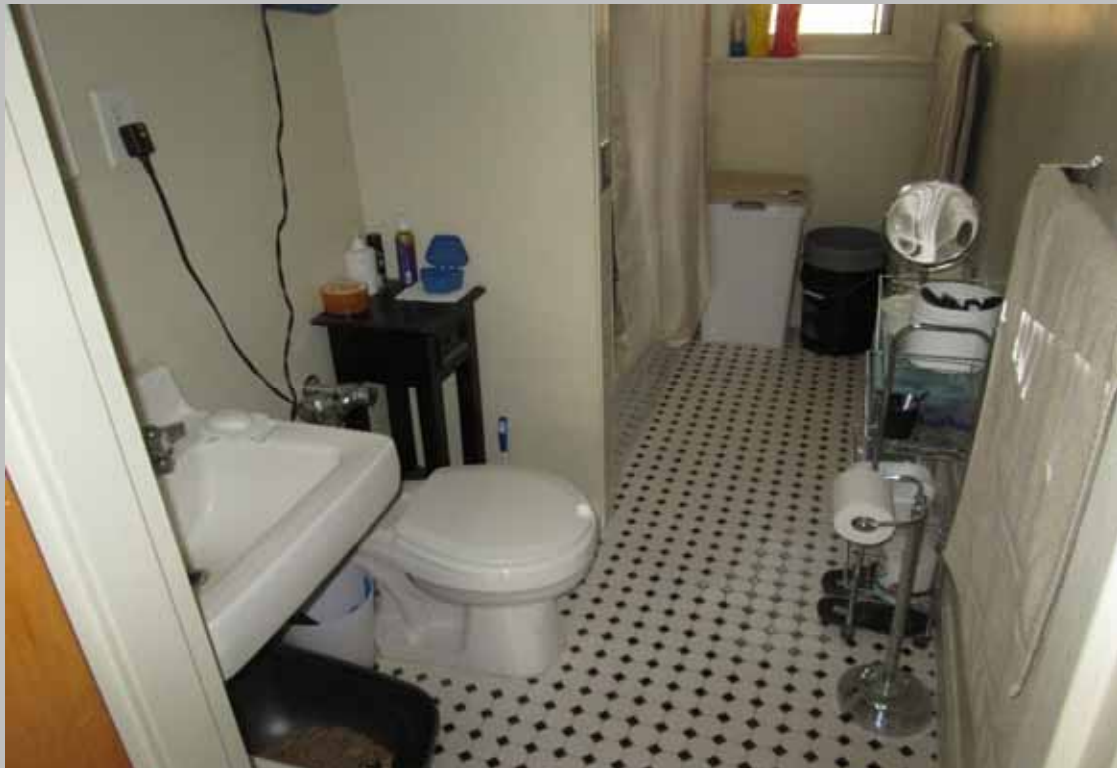
PHOTO #48

View of bathroom at Unit 8

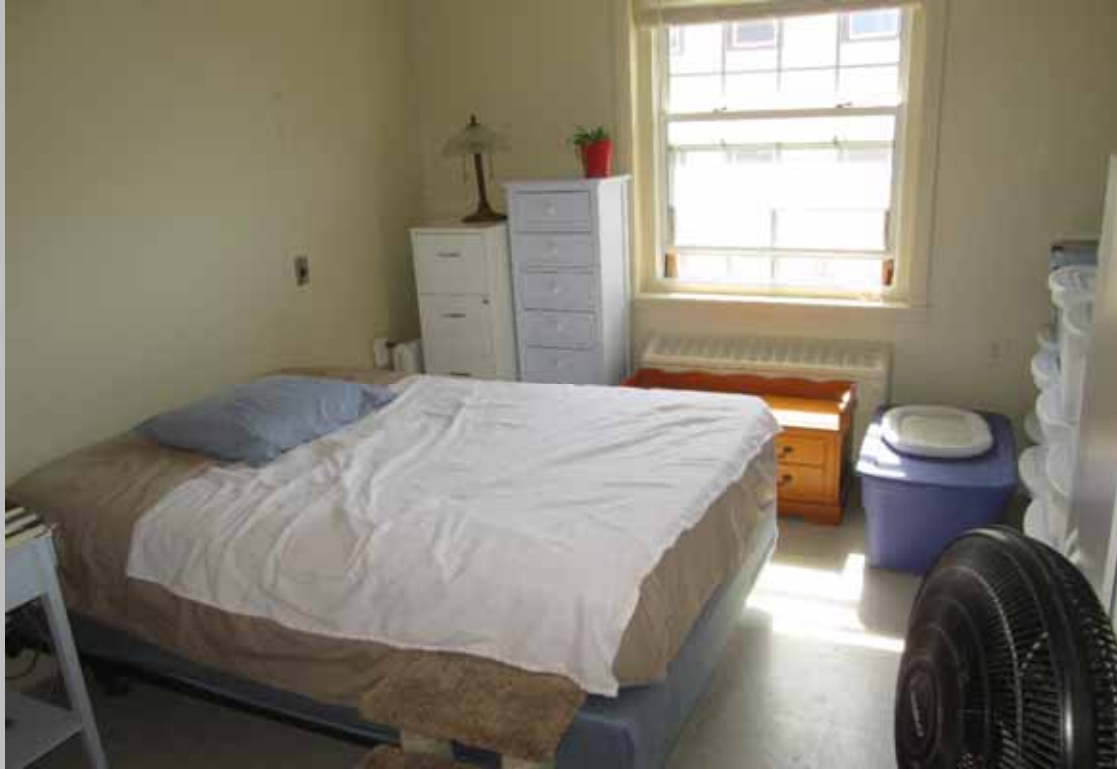
PHOTO #49

View of bedroom at Unit 8

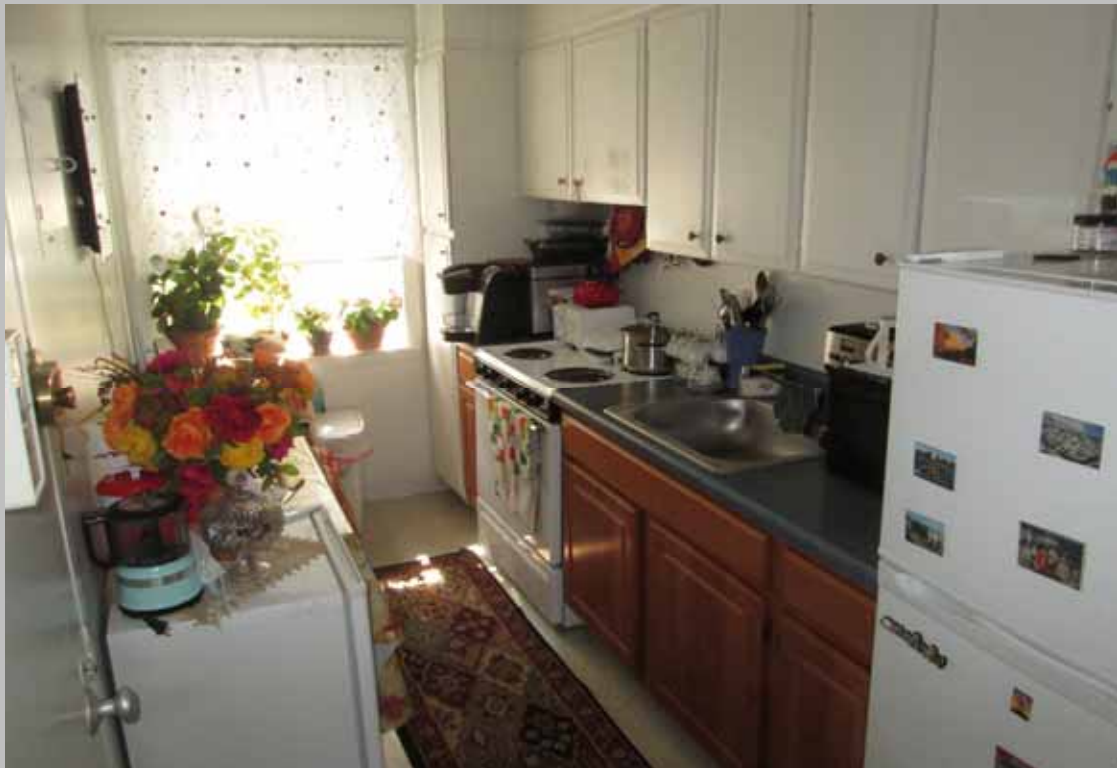
PHOTO #50

View of kitchen at Unit 16

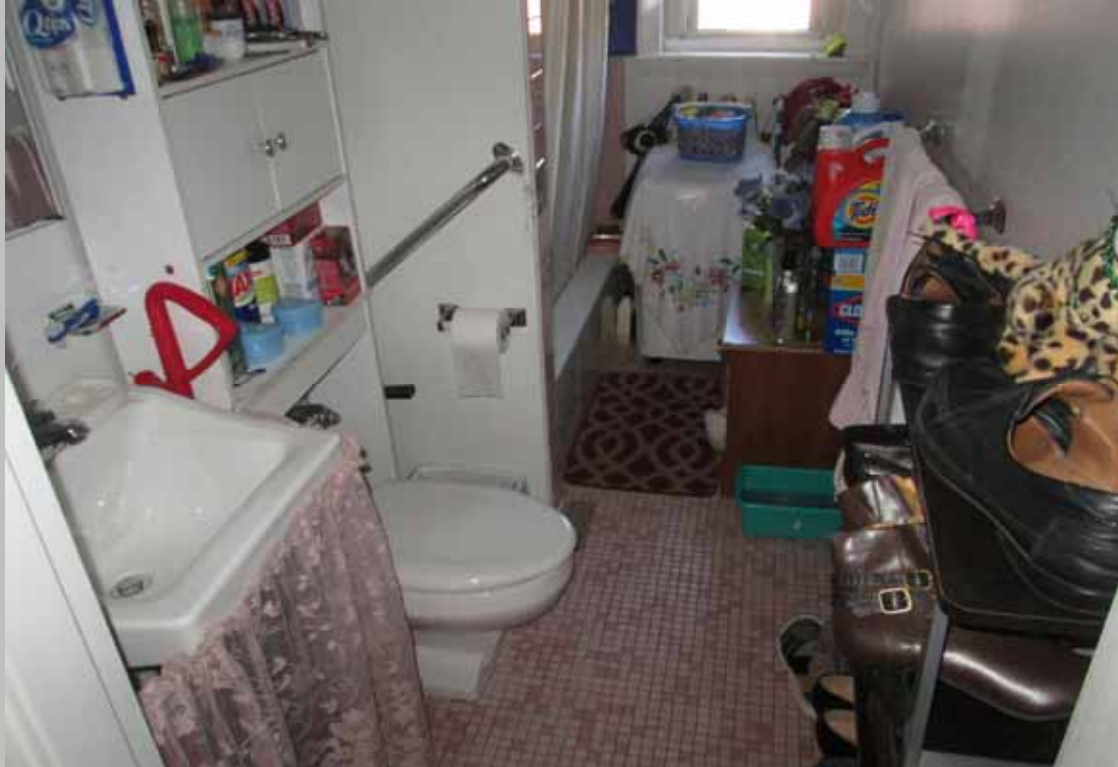
PHOTO #51

View of bathroom at Unit 16

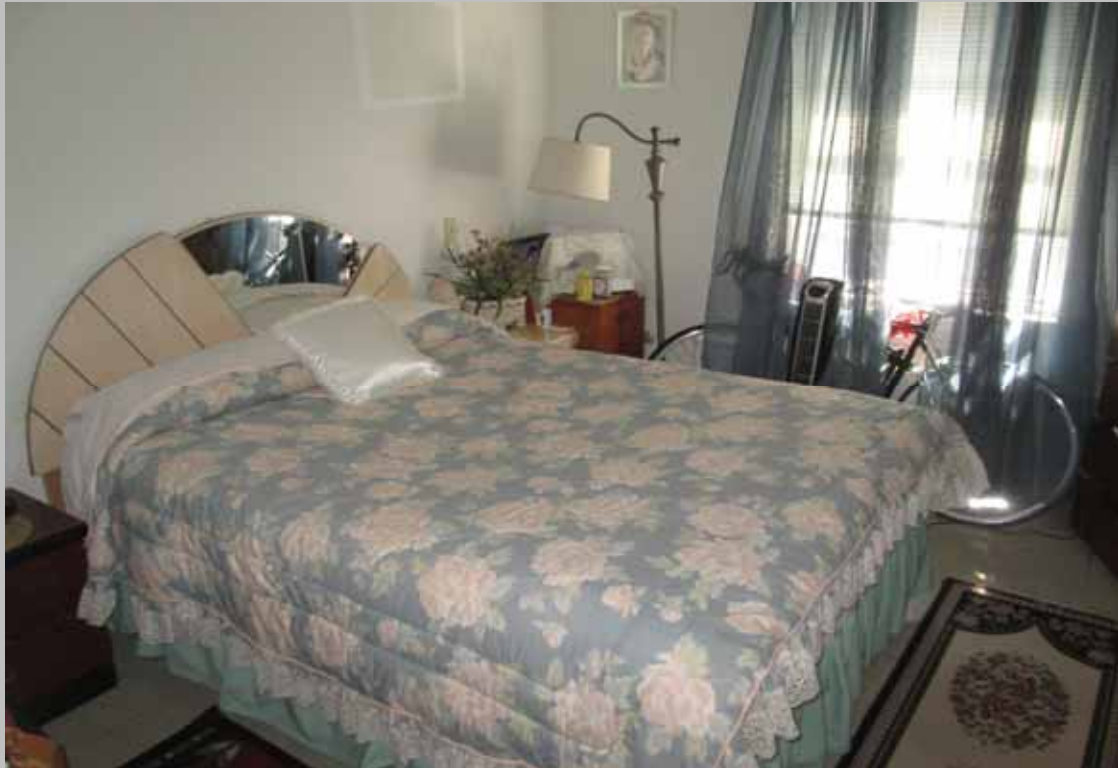
PHOTO #52

View of bedroom at Unit 16

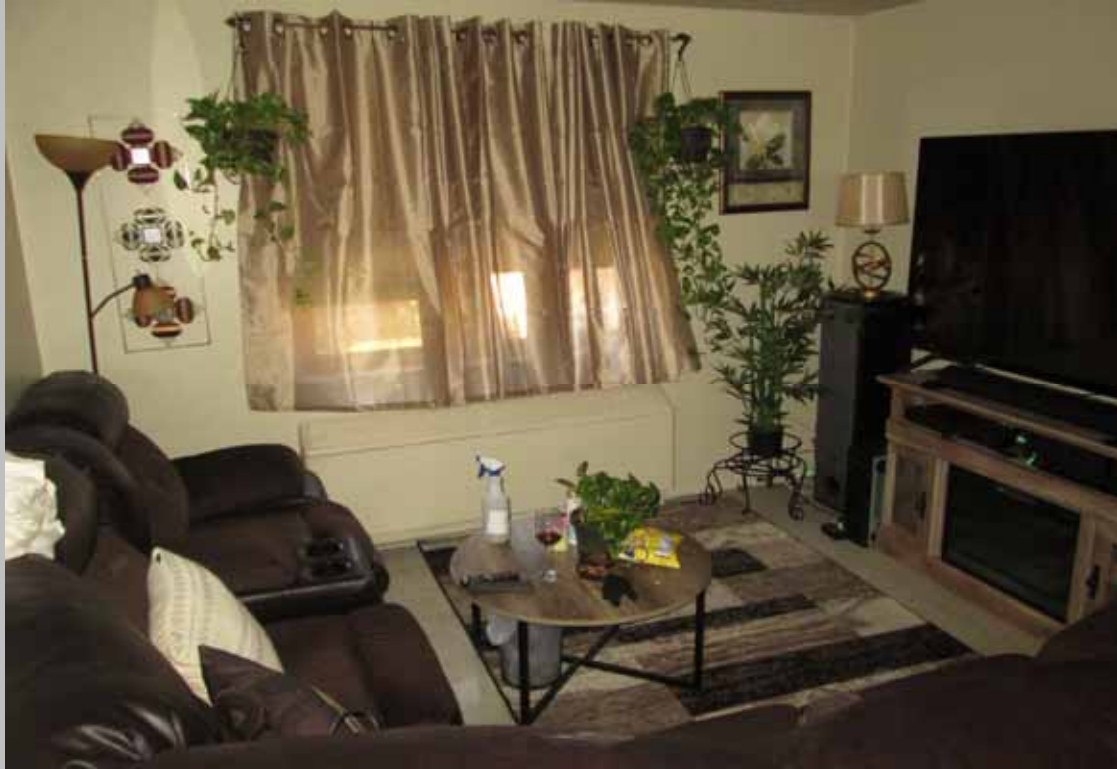
PHOTO #53

View of living room at Unit 6

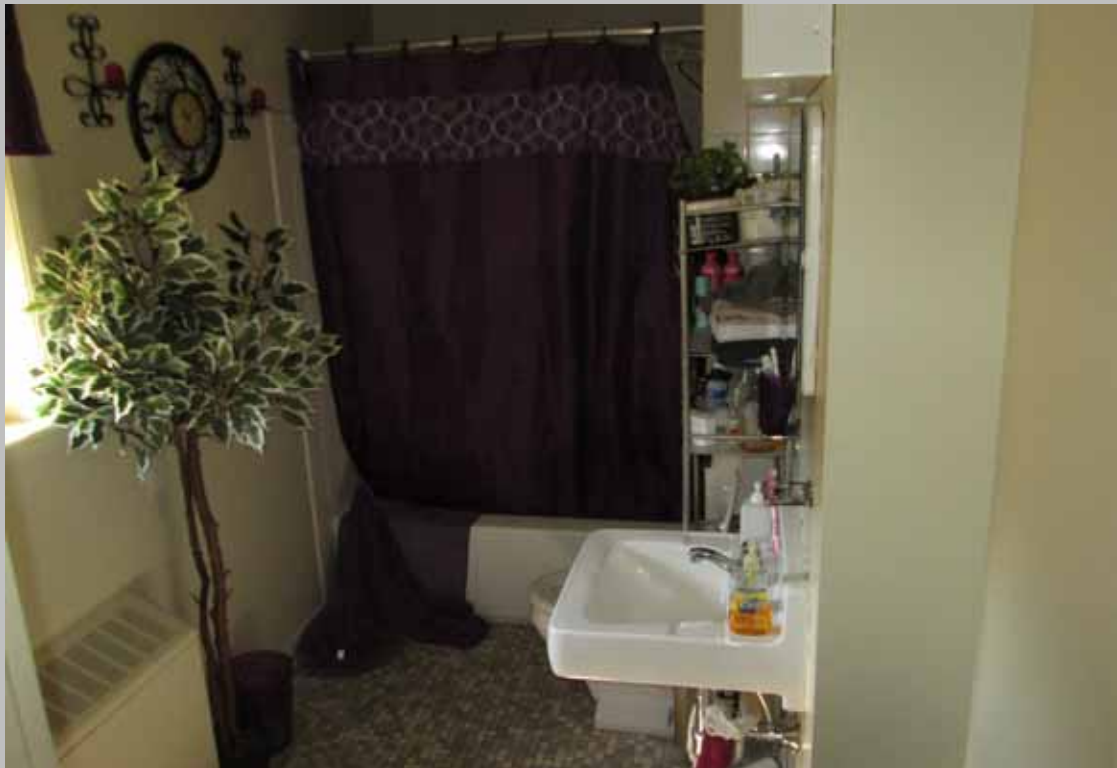
PHOTO #54

View of bathroom at Unit 6

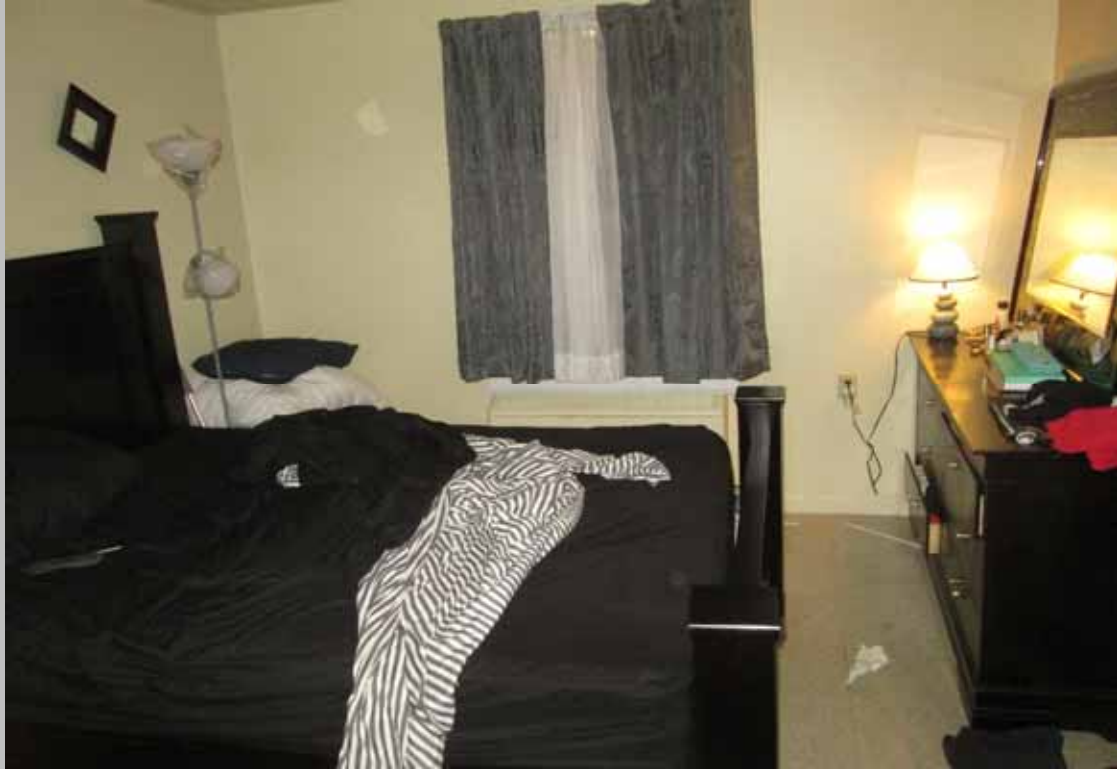
PHOTO #55

View of bedroom at Unit 6

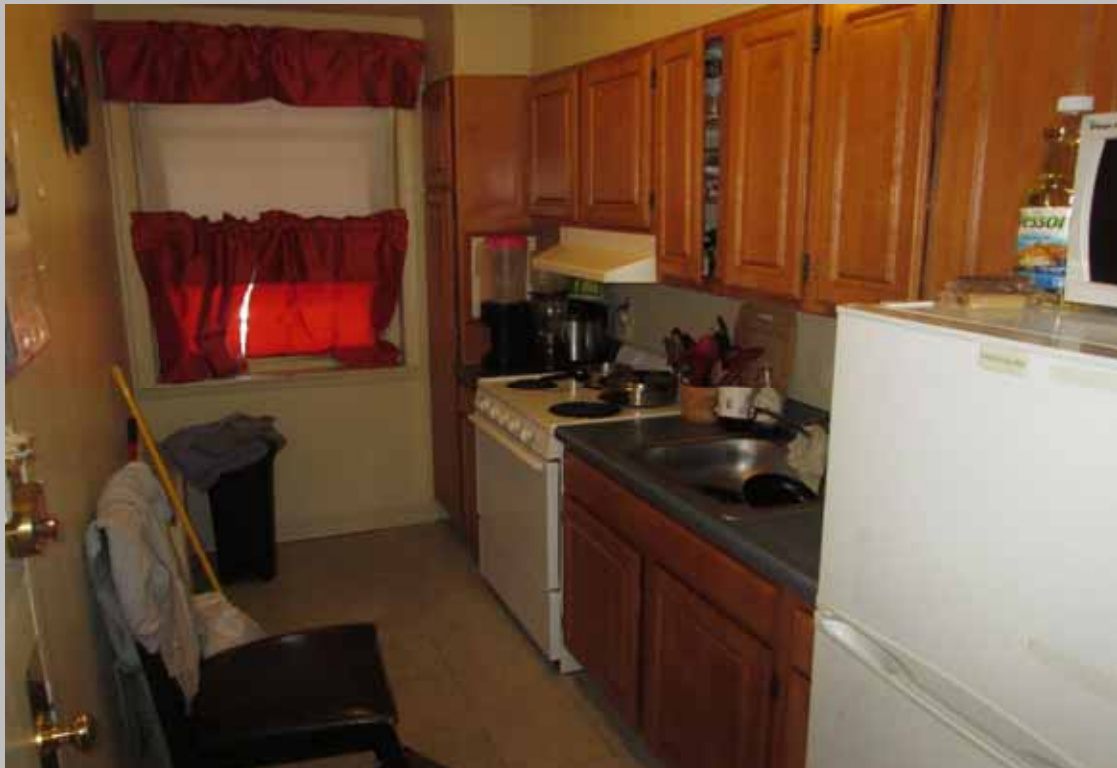
PHOTO #56

View of kitchen at Unit 6

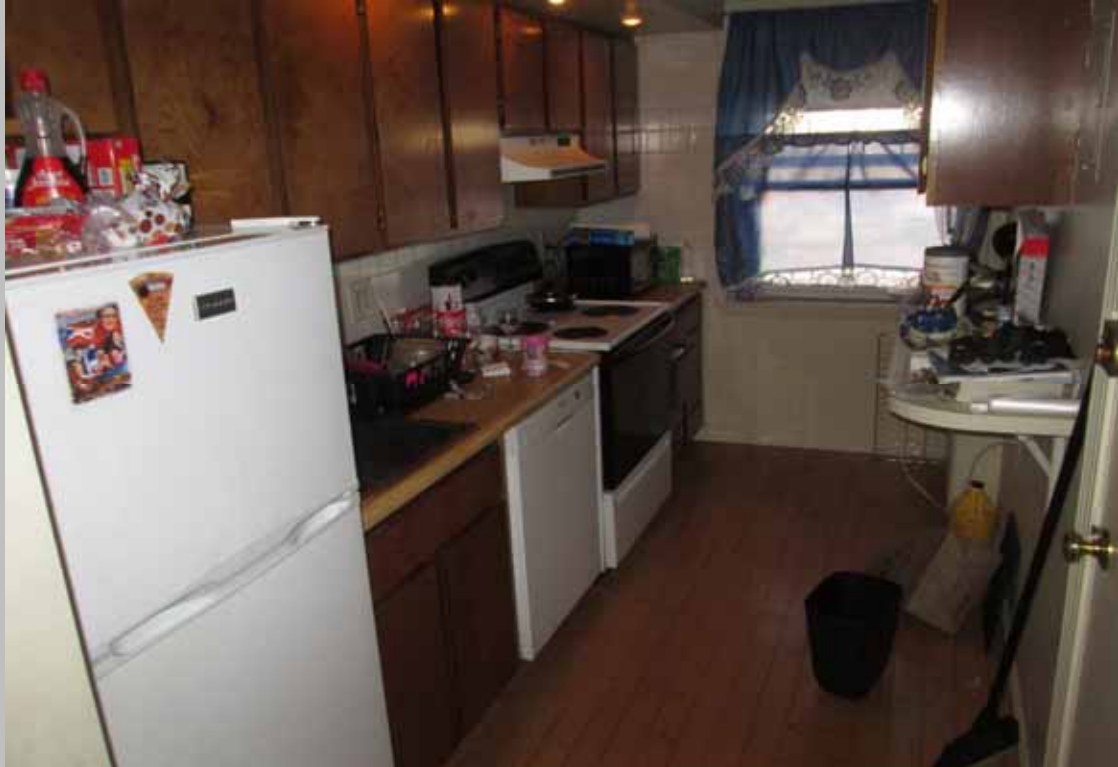
PHOTO #57

View of kitchen at Unit 49

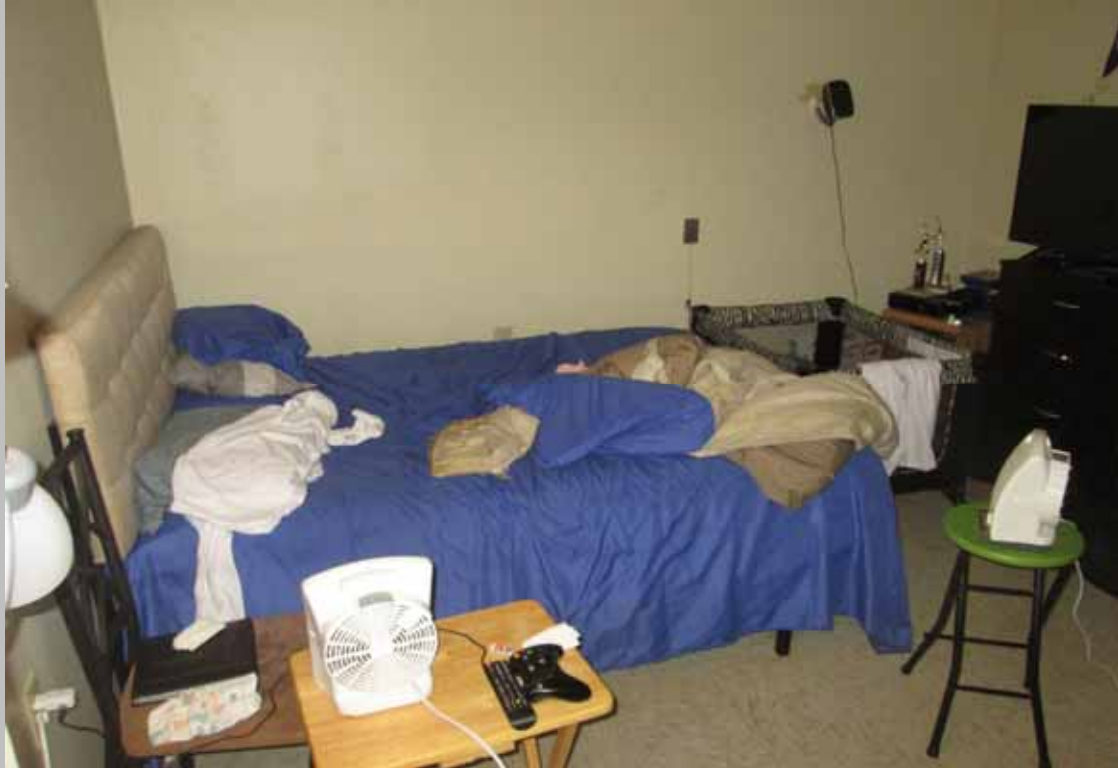
PHOTO #58

View of bedroom at Unit 49
