HUD CAPITAL NEEDS ASSESSMENT

JJ Meade
5 Melville Avenue
Boston, Massachusetts 02124

AEI Project No. 463349
Site Inspection Date: July 27, 2022

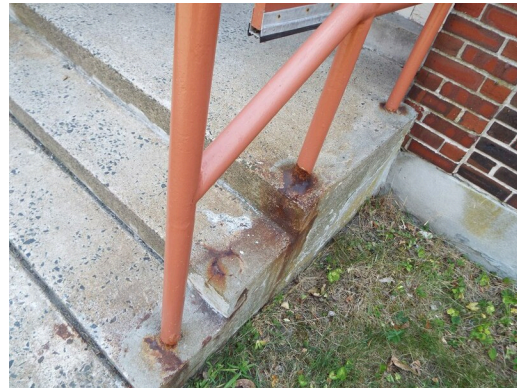
AEI observed deterioration of metal handrail post bases located at building entry steps at building 13 and 15, and concrete spalling at building 13. Repair is required to make the assemblies safe (Critical Repair).

Handrail post base condition - building 15
(Critical Repair)

AEI observed deterioration of metal handrail post bases located at building entry steps at building 13 and 15. Repair is required to make the assemblies safe. (Critical Repair)

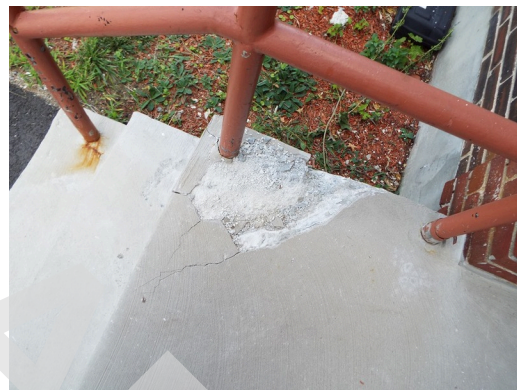
Building 13 entry - concrete step spalling
(Critical Repair)

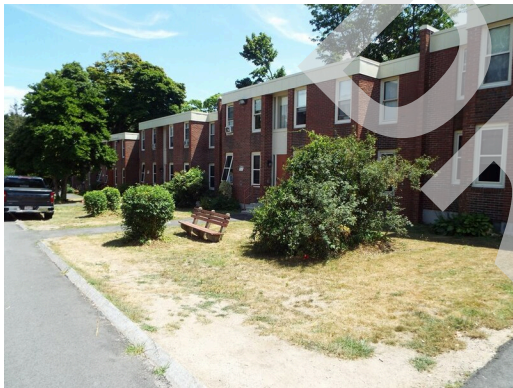
AEI observed areas of bare earth on the lawn adjacent to the asphalt paved access drive on the north side of building 11-15A. Restoration of the area is required. (Non-Critical Repair)

Landscaping - bare earth (Non-Critical Repair)

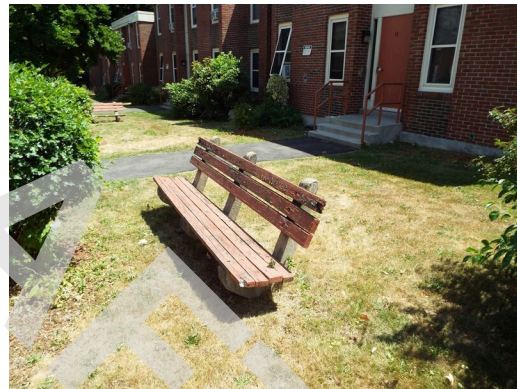
AEI observed significant deterioration of wood benches located throughout the property. Repairs are required. (Non-Critical Repair)

Bench condition (Non-Critical Repair)

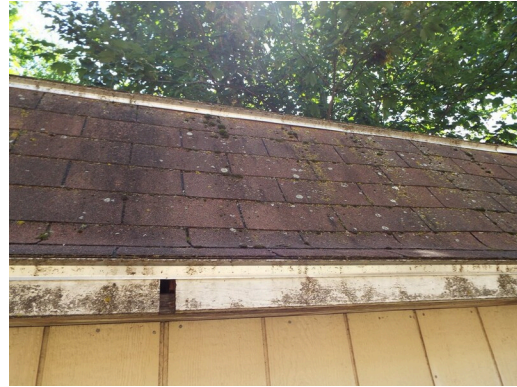
AEI observed paint wear and mildew on the exterior wood surfaces and asphalt shingle roofing at the utility shed. Pressure washing and repainting are required. (Non-Critical Repair)

Utility shed fascia and roof condition
(Non-Critical Repair)

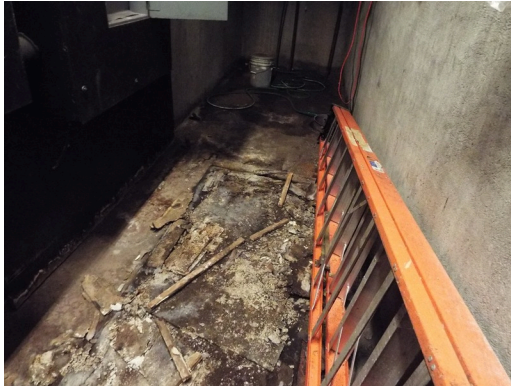
AEI observed moisture in the basement boiler room floor slab. The moisture appears to be caused by groundwater seepage at wall to slab intersections. Repairs are required. (Non-Critical Repair)

Boiler room - moisture condition (Non-Critical Repair)

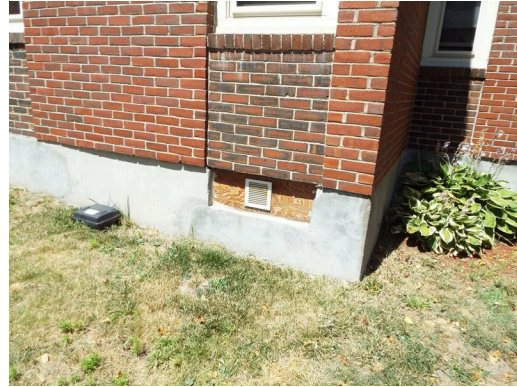
AEI observed an undersized crawlspace vent located adjacent to the building 9A door. Replacement with a full-sized vent is required. (Non-Critical Repair)

Crawlspace vent undersized (Non-Critical Repair)

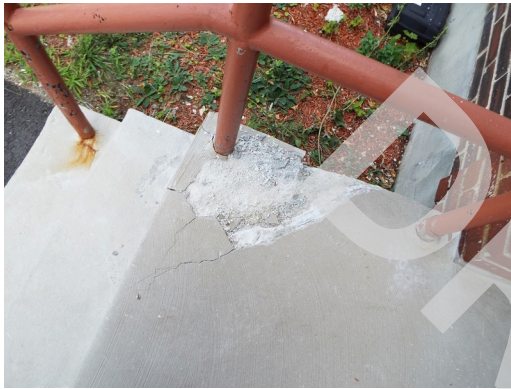
Building 13 entry - concrete step spalling
(Critical Repair)

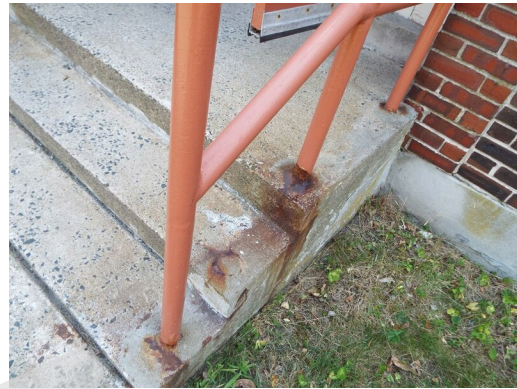
Handrail post base condition - building 15
(Critical Repair)

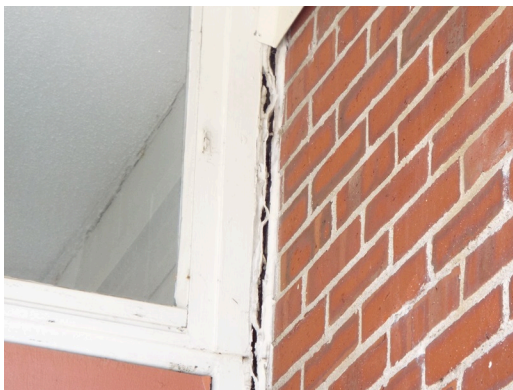
AEI observed gaps in sealant located at the rear door at the community room. Resealing is required.

Sealant condition - community center rear door (Non-Critical Repair)

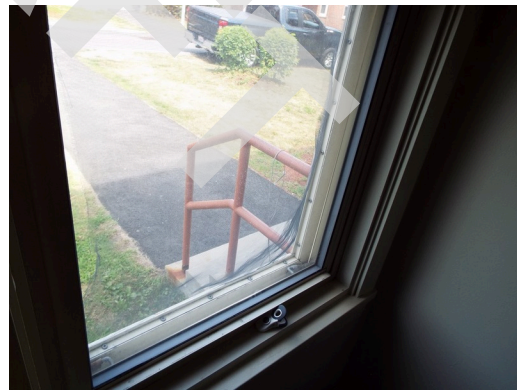
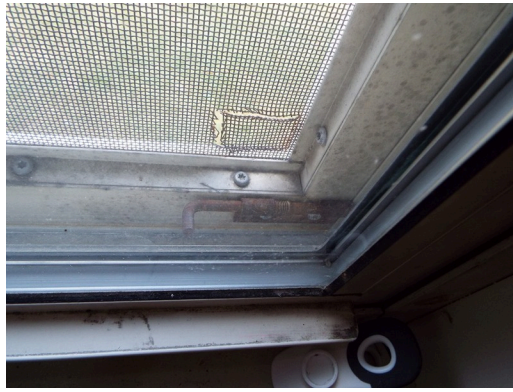
AEI observed window screen damage located at units 22 and 27, and missing screens at units 22. Replacement of damaged and missing screens is required (Non-Critical Repair)

1-bed-1-bath - unit 27 - screen damage
(Non-Critical Repair)

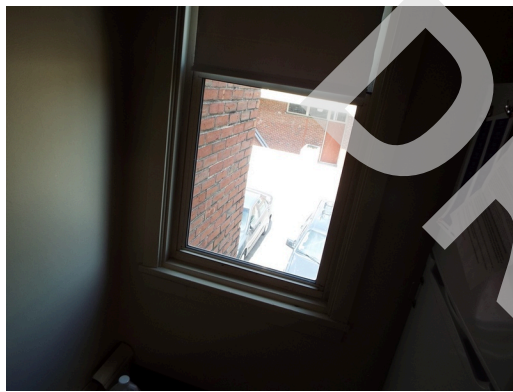
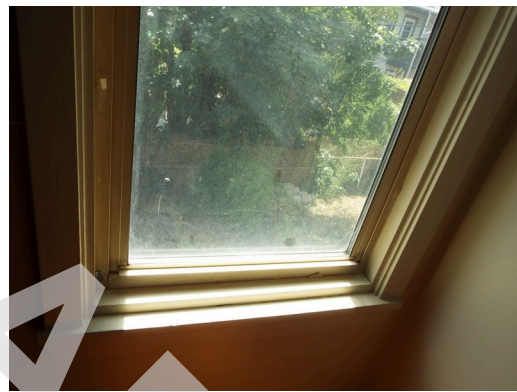
1-bed-1-bath - unit 22 - missing screen
(Non-Critical Repair)

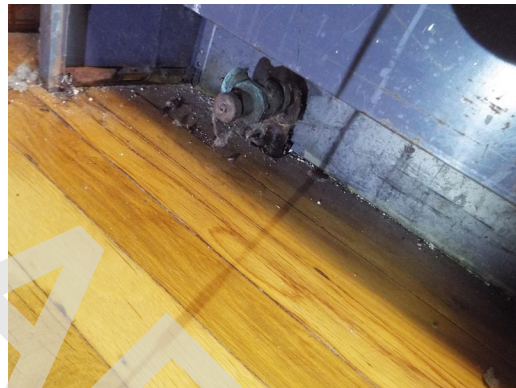
Disconnected baseboard heaters were observed located at ground floor vestibules in buildings 7 and 15. Reconnecting the heaters is recommended. (Non-Critical Repair)

Vestibule heater disconnected - building 15A
(Non-Critical Repair)

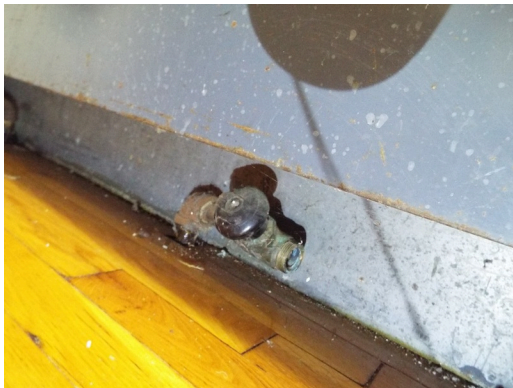
Vestibule heater disconnected - building 7
(Non-Critical Repair)

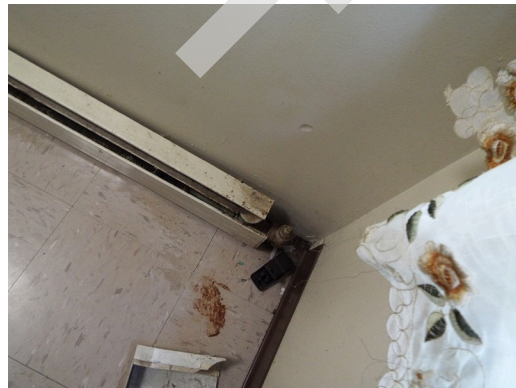
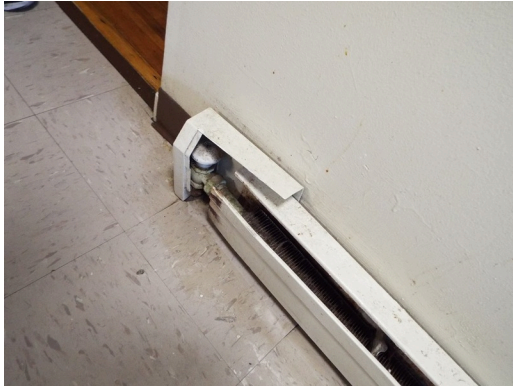
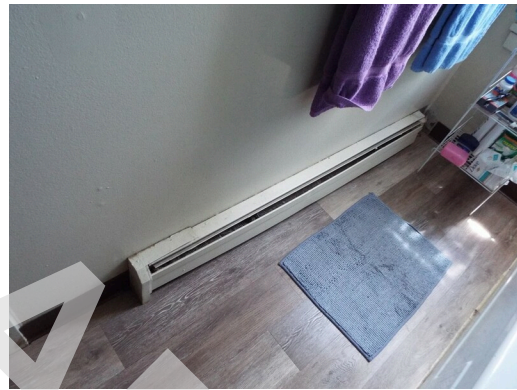
AEI observed damaged baseboard heat covers at most resident units. Replacement is recommended throughout the property. (Non-Critical Repair)

1-bed-1-bath - unit 6 - baseboard heat cover
condition (Non-Critical Repair)

1-bed-1-bath - unit 6 - baseboard heat cover condition (Non-Critical Repair)

1-bed-1-bath - unit 2 - baseboard heat cover condition (Non-Critical Repair)

1-bed-1-bath - unit 5 - baseboard heat cover condition (Non-Critical Repair)

1-bed-1-bath - unit 22 - baseboard heat cover condition (Non-Critical Repair)

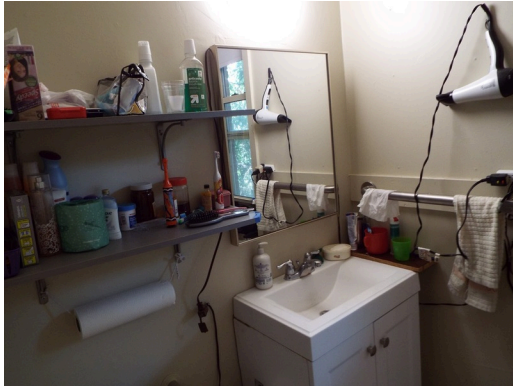
2-bed-1-bath - unit 40 - non-GFCI protected electric devices (Critical Repair)

AEI observed several non-GFCI protected electrical appliance devices located in the bathroom in unit 40 which are fed via a tenant-installed extension cord from a non-GFCI outlet located in the living room. Removal of the extension cord and a permanent installation of a GFCI receptacle in the bathroom is required. (Critical Repair)

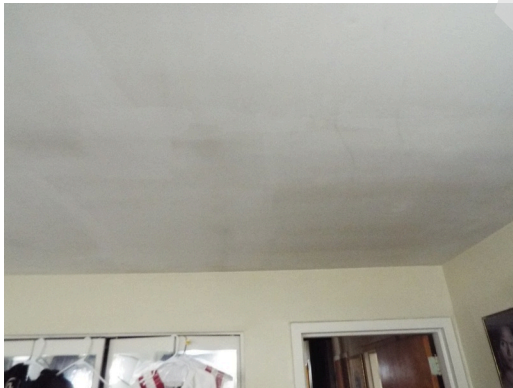
Typical unit bedroom lacks smoke detector - unit 38 (Critical Repair)

Bedrooms were observed lacking smoke detectors. Installation of HUD compliant smoke detectors either hard-wired units or sealed battery detectors with 10-year life are required. (Critical Repair)

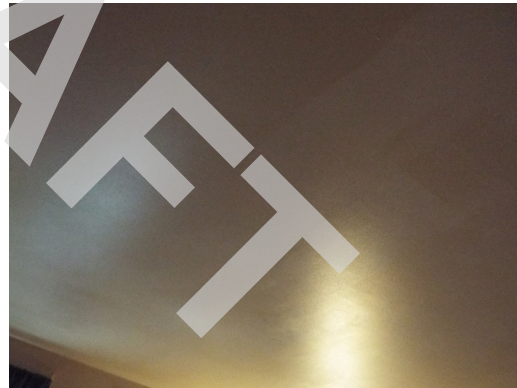
Typical unit bedroom lacks smoke detector - unit 36 (Critical Repair)

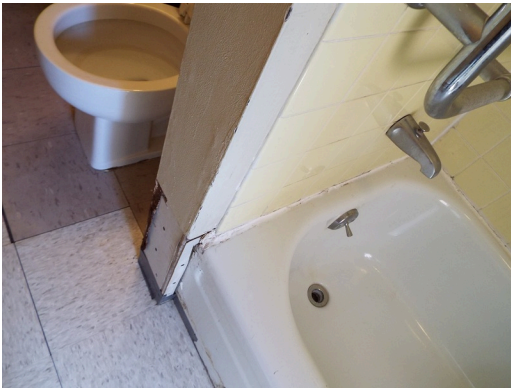
1-bed-1-bath - unit 6 - wall condition
(Non-Critical Repair)

AEI observed drywall damage at walls located in bathrooms in units 5 and 6. Repair is required. (Non-Critical Repair)

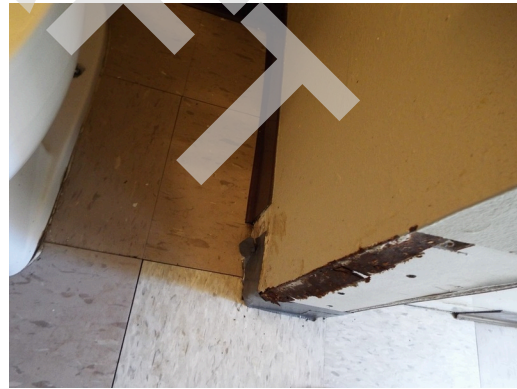
1-bed-1-bath - unit 6 - wall condition
(Non-Critical Repair)

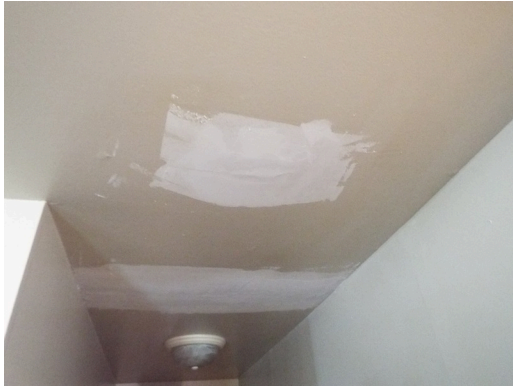
1-bed-1-bath - unit 2 - ceiling condition
(Non-Critical Repair)

AEI observed poor drywall ceiling repairs located in unit 2, and missing ceiling drywall at plumbing repairs in the bathroom in unit 15. Repair is required. (Non-Critical Repair)

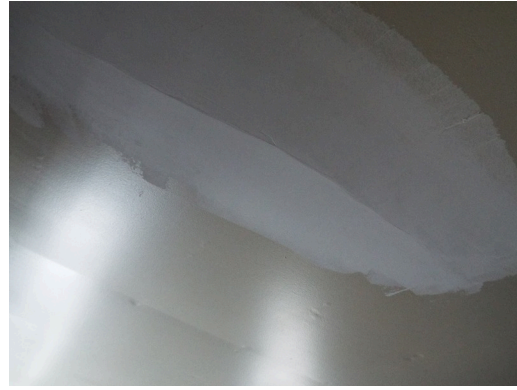
1-bed-1-bath - unit 2 - ceiling condition
(Non-Critical Repair)

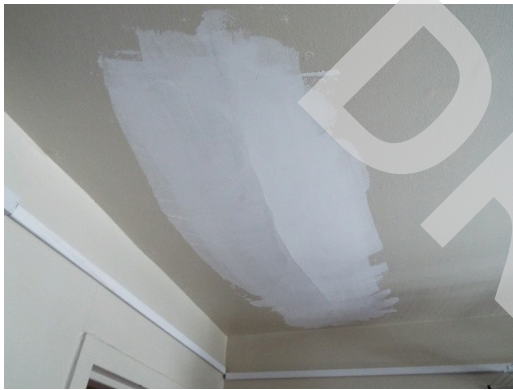
1-bed-1-bath - unit 2 - ceiling condition
(Non-Critical Repair)

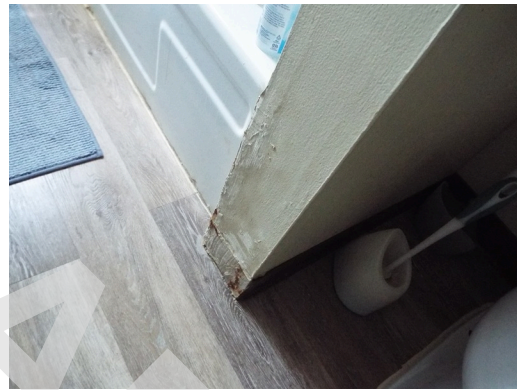
1-bed-1-bath - unit 5 - bed-1-bath - wall
condition (Non-Critical Repair)

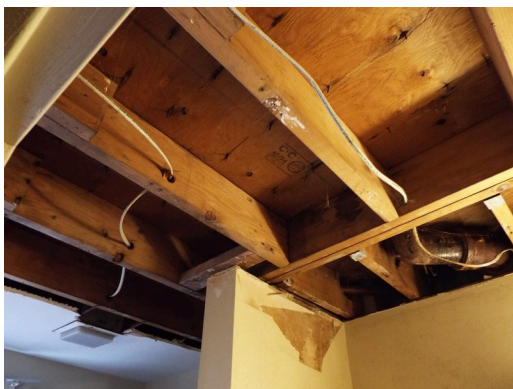
1-bed-1-bath - unit 15 - ceiling condition
(Non-Critical Repair)

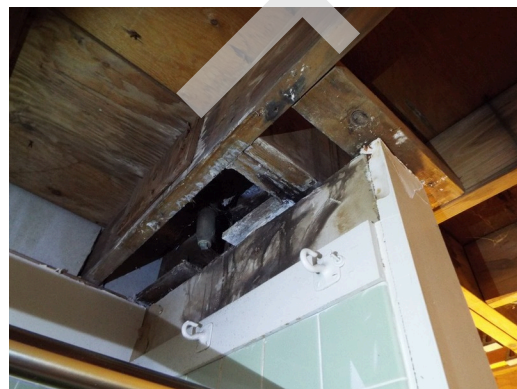
1-bed-1-bath - unit 15 - ceiling condition
(Non-Critical Repair)

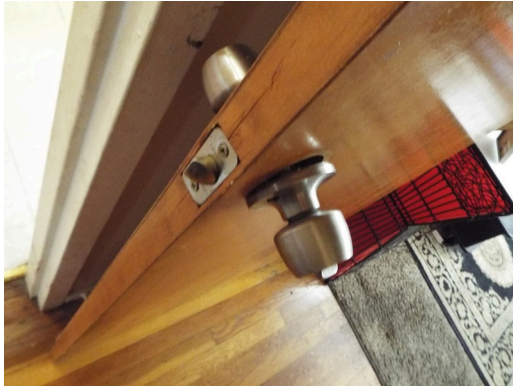
1-bed-1-bath - unit 38 - door lock condition
(Critical Repair)

AEI observed the interior entry door lock located in unit 38 fails to operate properly. Repair is required to provide tenant security. (Critical Repair)

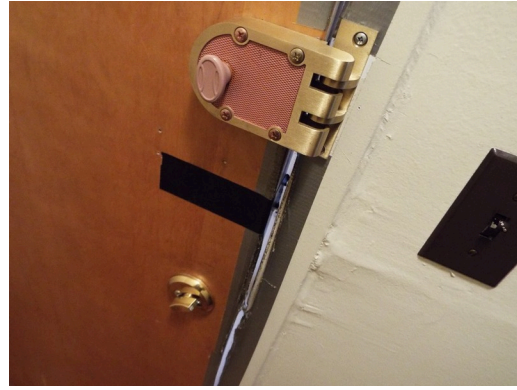
1-bed-1-bath - unit 6 - door gap (Non-Critical
Repair)

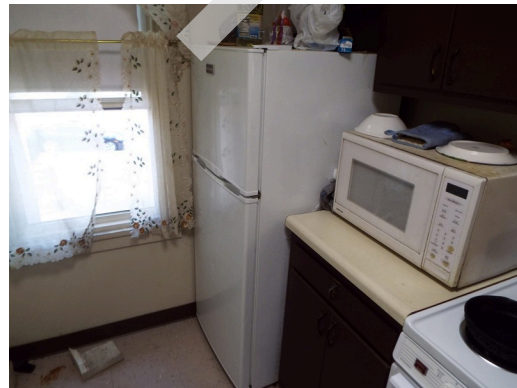
1-bed-1-bath - unit 6 - typical refrigerator

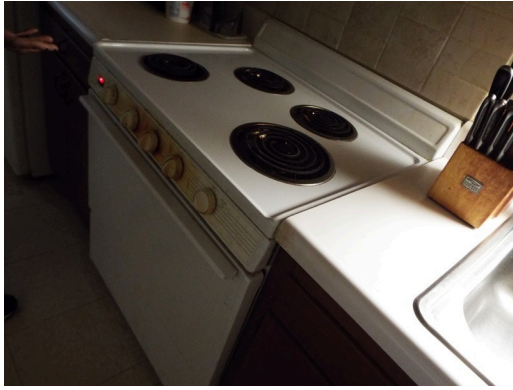
1-bed-1-bath - unit 38 - range malfunction
(Critical Repair)

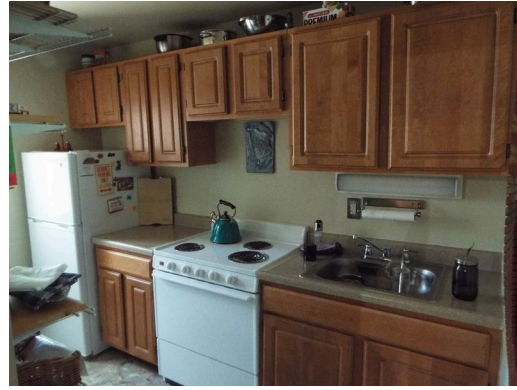
1-bed-1-bath - unit 2 - range malfunction
(Critical Repair)

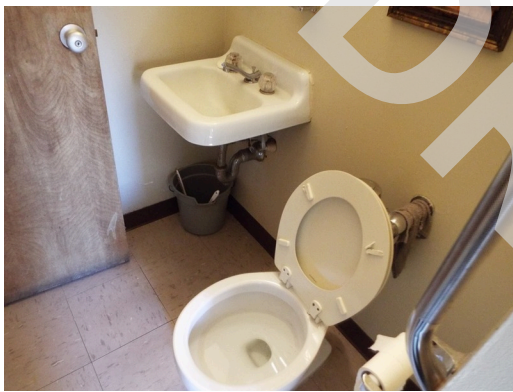
1-bed-1-bath - unit 6 - bathroom fixtures

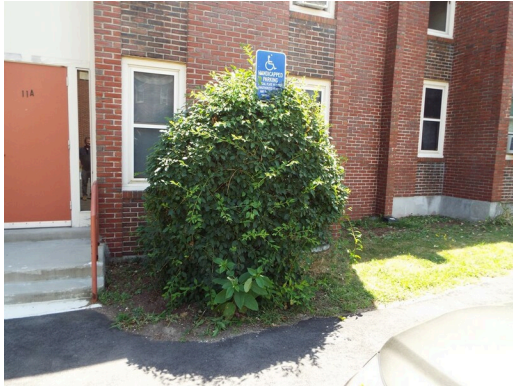
Accessible parking lacks van sign (Critical Repair)

- The designated handicapped parking space at the rear parking area was missing a van accessible sign. Installation of van signage is required to comply with ADAAG. (Critical Repair).
- The property lacks directional signage to the public community room entry from the accessible parking space located at the rear parking area. Installation of directional signage is required to comply with ADAAG. (Critical Repair)
- The community room kitchenette door lacks lever hardware. Installation of levered hardware is required to comply with ADAAG. (Critical Repair)

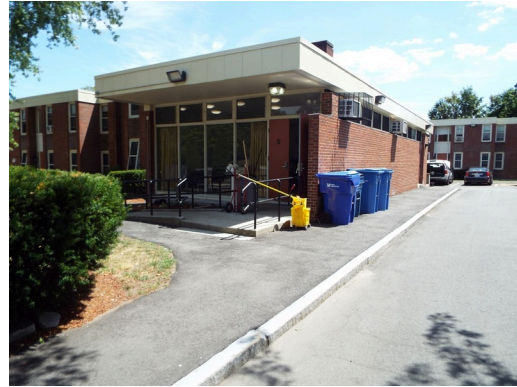
Community room entry lacks directional signage to accessible parking (Critical Repair)

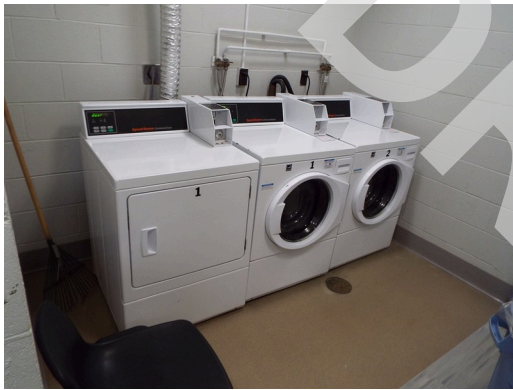
Community room - washer lacks front controls (Critical Repair)

- The common area laundry room lacks a front controlled washing machine. Installation of a front controlled washing machine is required to comply with UFAS requirements. According to property management, the washing machine is leased. Arrangements with the leasing company should be made to install a front controlled washing machine. (Critical Repair)

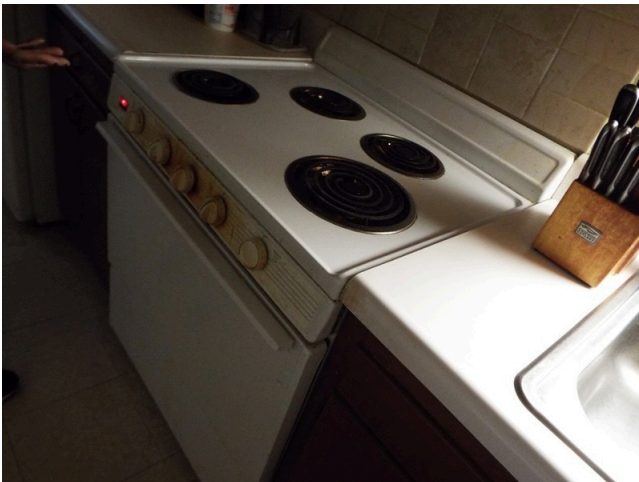
3. 1-bed-1-bath - unit 38 - range malfunction
(Critical Repair)

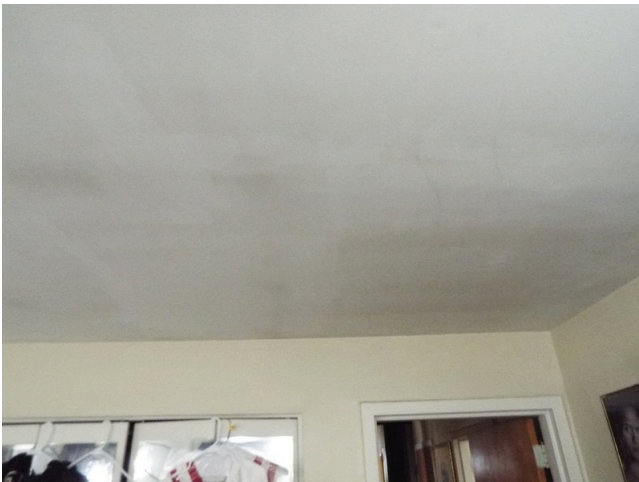
15. Typical unit bedroom lacks smoke detector - unit 38 (Critical Repair)

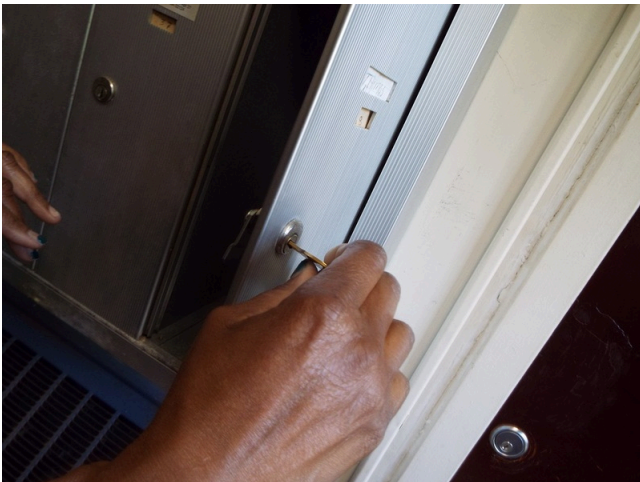
23. Mailbox key operation - building 15

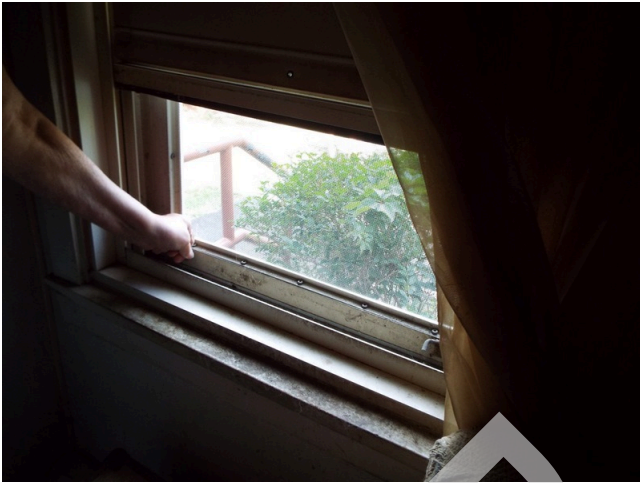
25. 1-bed-1-bath - unit 36 - inoperable screen locking device (Non-Critical Repair)

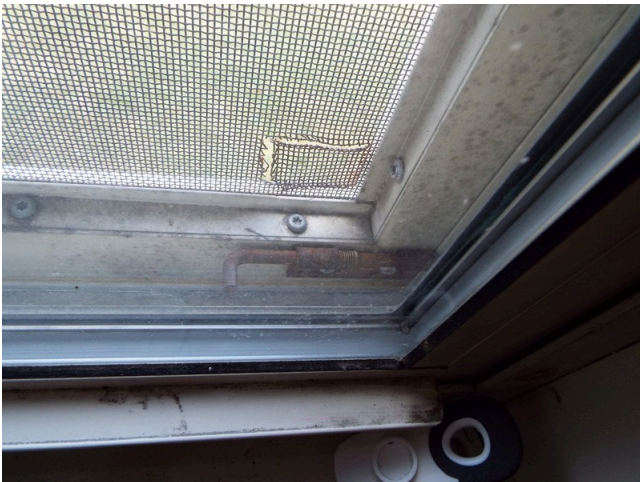
122. 1-bed-1-bath - unit 27 - screen damage (Non-Critical Repair)

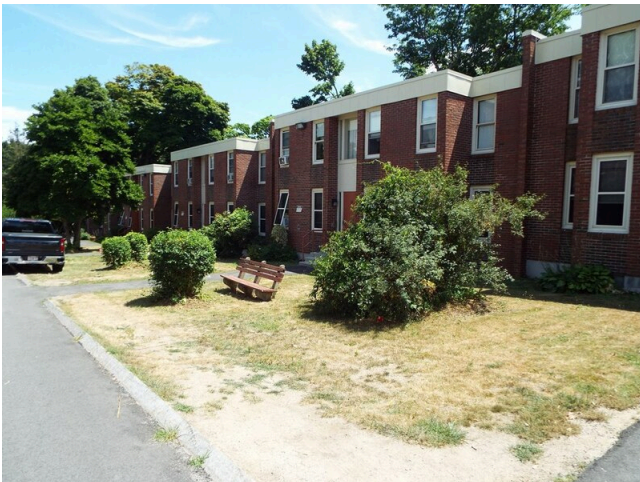
23. Landscaping - bare earth (Non-Critical Repair)

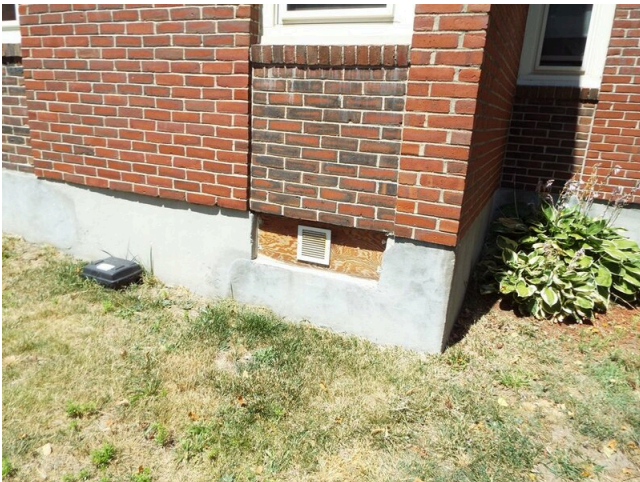
35. Crawlspace vent undersized (Non-Critical Repair)

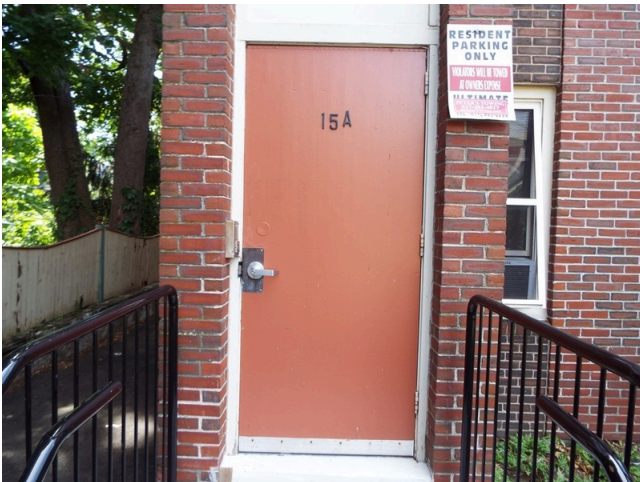
42. Sealant condition - community center rear door
(Non-Critical Repair)
