HUD CAPITAL NEEDS ASSESSMENT

Groveland
15 Mary Moore Beatty Circle
Mattapan, Massachusetts 02126

AEI Project No. 463353
Site Inspection Date: July 7, 2022

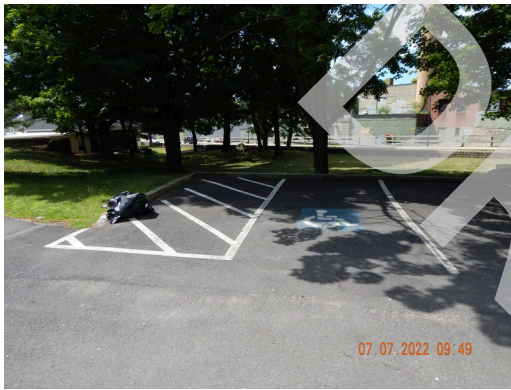
Paving, Curbing, & Parking: Typical accessible parking spaces found throughout the property, missing vertical sign (Critical Repair)

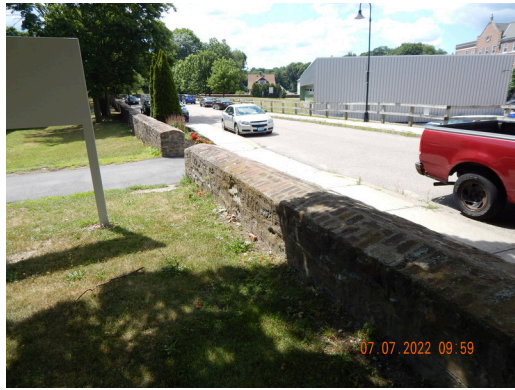
The perimeter masonry wall located on the west side of the property was observed damaged, with sections of plaster missing or falling off. AEI recommends repairing the perimeter wall to prevent further damage. (Non-Critical Repair)

Landscaping & Appurtenances: Damaged Masonry wall found on the south perimeter of the property. (Non-Critical Repair)

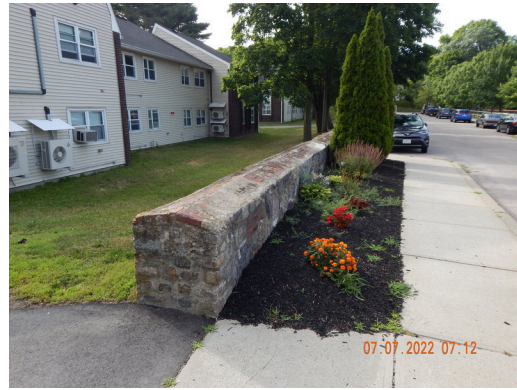
Landscaping & Appurtenances: Damaged Masonry wall found on the south perimeter of the property. (Non-Critical Repair)

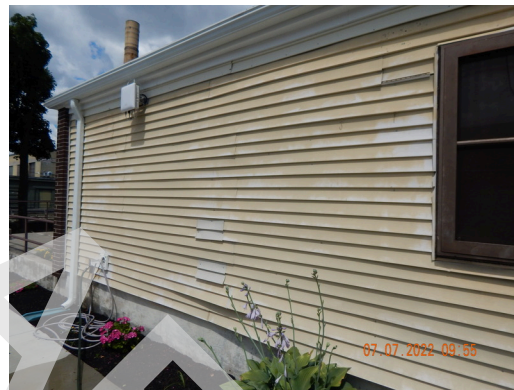
Sections of damaged vinyl siding were observed throughout the site but predominantly around the community building and Building 3. Any damaged section of siding can be a source of water intrusion and allow pests to access the building. Therefore, AEI recommends addressing any damaged sections of siding to maintain the building's structural integrity. (Non-Critical Repair)

Sidewall System: Typical damaged or weathered sidewall vinyl siding found throughout the site. (Non-Critical Repair)

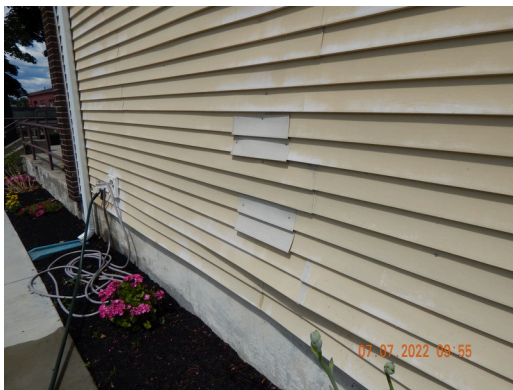
Sidewall System: Typical damaged or weathered sidewall vinyl siding found throughout the site. (Non-Critical Repair)

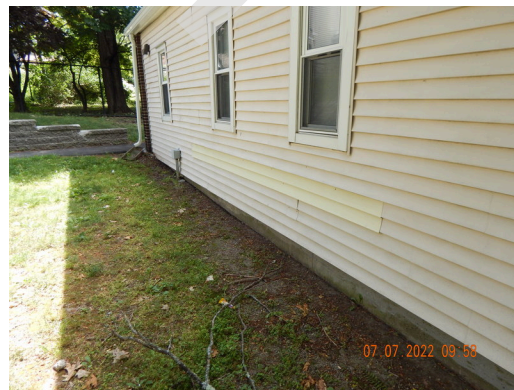
Sidewall System: Typical damaged or weathered sidewall vinyl siding found throughout the site. (Non-Critical Repair)

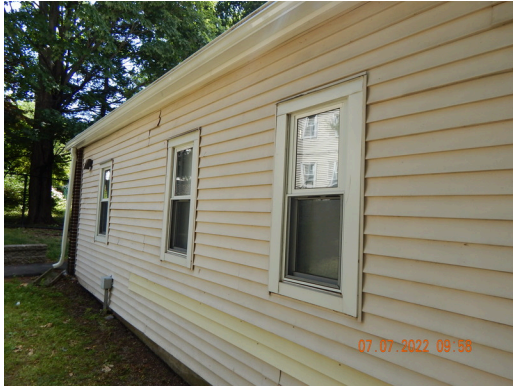
Sidewall System: Typical damaged or weathered sidewall vinyl siding found throughout the site. (Non-Critical Repair)

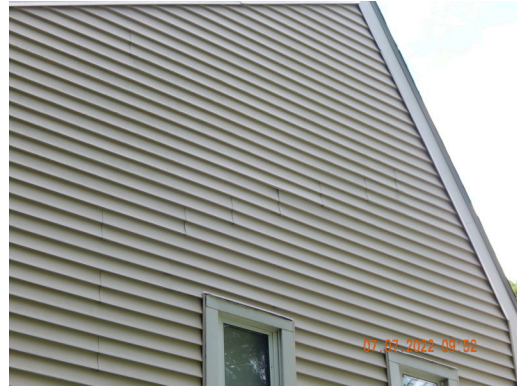
Sidewall System: Typical damaged or weathered sidewall vinyl siding found throughout the site. (Non-Critical Repair)

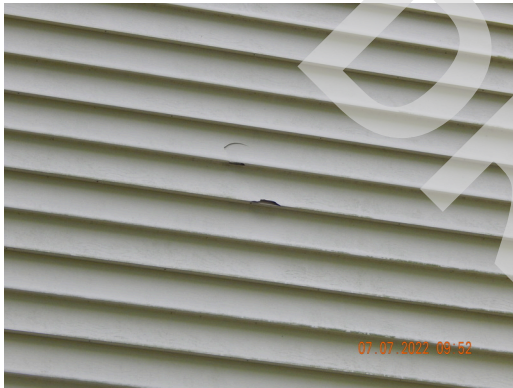
Sidewall System: Typical damaged or weathered sidewall vinyl siding found throughout the site. (Non-Critical Repair)

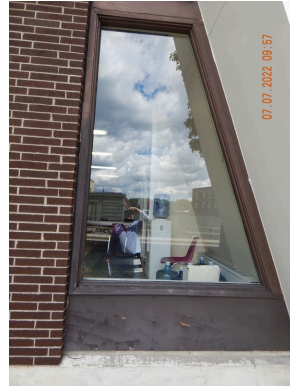
Sections of damaged wood trim were observed around the windows of the community building. Any damaged or weathered wood trim can be a source of water intrusion and allow pests to access the building. Therefore, AEI recommends addressing any damaged sections of wood trim to maintain the building's structural integrity. (Non-Critical Repair)

Sidewall System: Typical damaged or weathered wood trim found throughout the community building. (Non-Critical Repair)

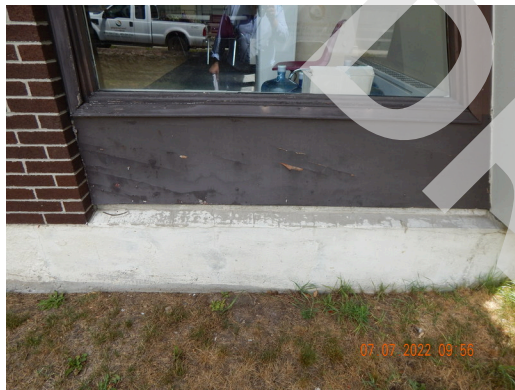
Sidewall System: Typical damaged or weathered wood trim found throughout the community building. (Non-Critical Repair)

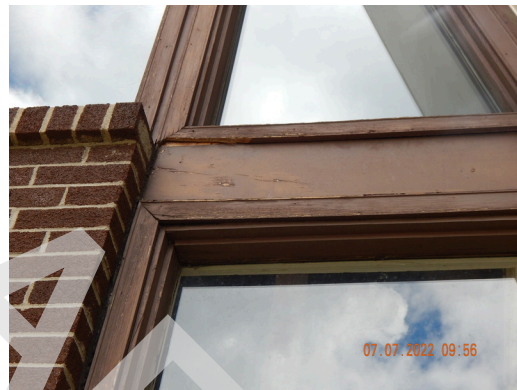
Sidewall System: Typical damaged or weathered wood trim found throughout the community building. (Non-Critical Repair)

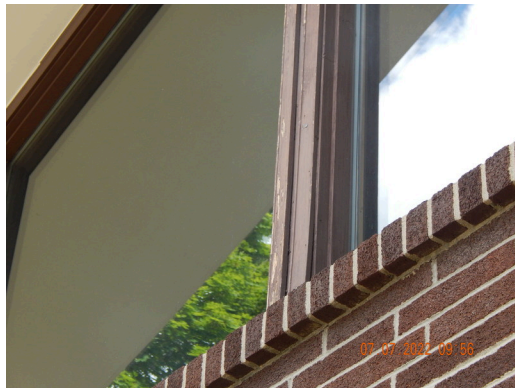
Sidewall System: Typical damaged or weathered wood trim found throughout the community building. (Non-Critical Repair)

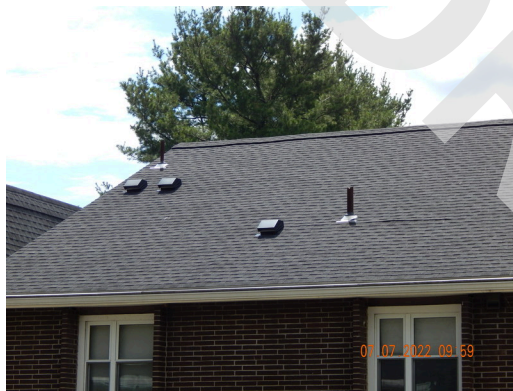
Roofing Finish: Typical asphalt shingle roofing found throughout the site.

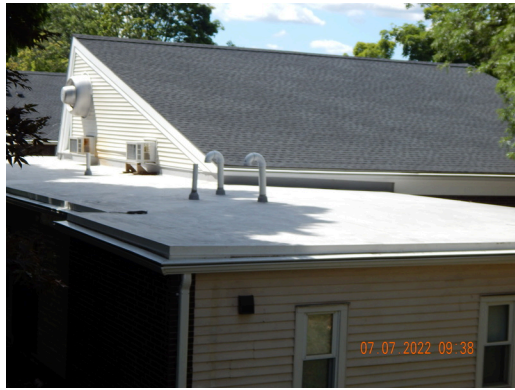
Roofing Finish: Typical TPO roofing found throughout the site.

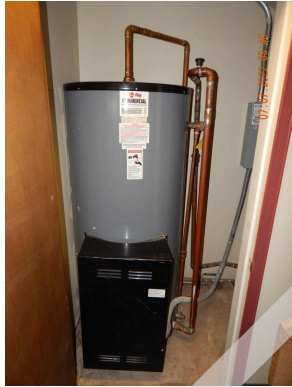
Plumbing: Typical central electric water heater found at the property.

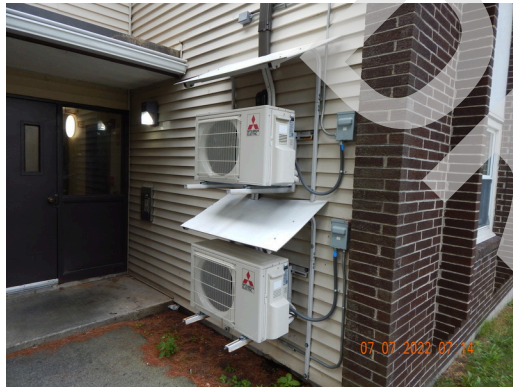
HVAC Systems: Typical 1.5 ton individual heat pump units found throughout the site.

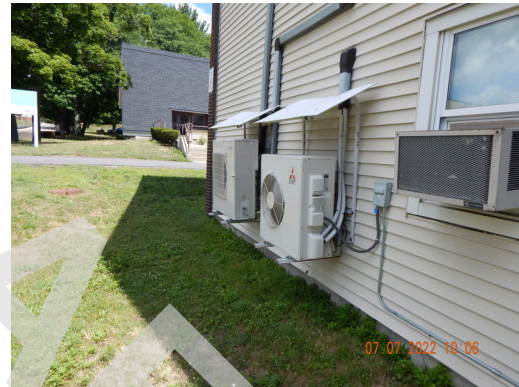
HVAC Systems: Typical 2 ton individual heat pump units found throughout the site.

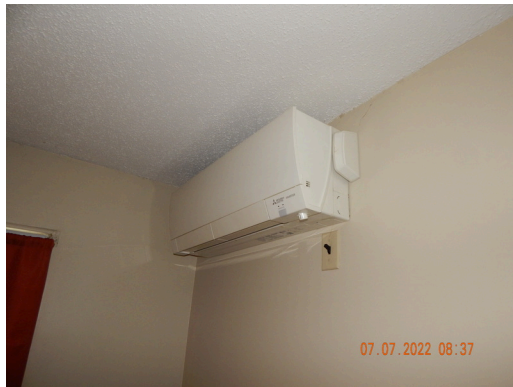
HVAC Systems: Typical individual heat pump units found throughout the site.

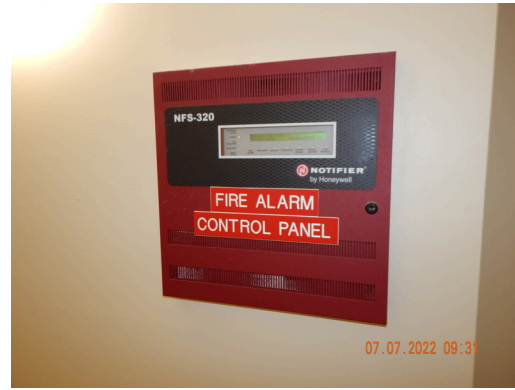
The fire alarm system did not have inspection tags during the time of the assessment. AEI recommends providing a copy of the latest fire alarm inspection. (Critical Repair)

Life & Fire Safety: Fire alarm system found throughout the site (Missing inspection tag). (Critical Repair)

Building fire suppression sprinklers, standpipes	Inspect Fire Alarm System (Critical Repair)	Fire Alarm System	Repair	4	Each	\$ 1,000.00	\$ 4,000.00	The fire alarm system did not have inspection tags during the time of the assessment. AEI recommends providing a copy of the latest fire alarm inspection.

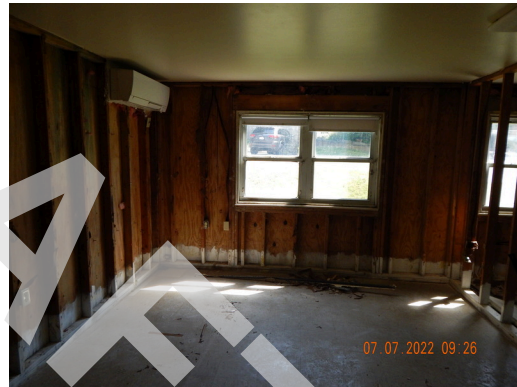
AEI observed two (2) units that had been gutted down to the studs (Unit B2 in Building and unit B# in Building 3). The site personnel informed AEI that the units would be finished shortly. Therefore, AEI recommends that the work be completed, and proof of occupancy be provided. (Critical Repair)

Dwelling Unit Interior Elements: Unit 26 gutted and unfinished. (Critical Repair)

CRITICAL REPAIRS								
Need Category	Component	Repair or Replacement Location	Classification of Work	Quantity	Unit of Measure	Unit Cost	Total	Comments
CRITICAL REPAIRS (ACCESSIBILITY)								
Common area bath accessories (towel bars, grab bars, toilet stalls, etc.)	Install Accessible Designation Signage (Critical Repair)	Common Accessible Restroom	Repair	1	Each	\$ 125.00	\$ 125.00	The common unisex accessible restroom was observed to not have wheelchair accessible designation signage. Installation of signage is recommended to comply with ADAAG design requirements.
Signage, Roadway / Parking	Install Vertical Sign (Critical Repair)	HDCP Parking	Level 1 Alteration	1	Each	\$ 125.00	\$ 125.00	The existing HDCP parking stall was missing a vertical sign, which is required by ADAAG.
CRITICAL REPAIRS (LIFE SAFETY)								
Cabinets & vanities	Finish Guttered Dwelling Units (Critical Repair)	Down Units	Level 1 Alteration	2	Each	\$ 25,000.00	\$ 50,000.00	AEI observed two (2) units that had been guttered down to the studs (Unit B2 in Building and unit B# in Building 3). The site personnel informed AEI that the units would be finished shortly. Therefore, AEI recommends that the work be completed, and proof of occupancy be provided.

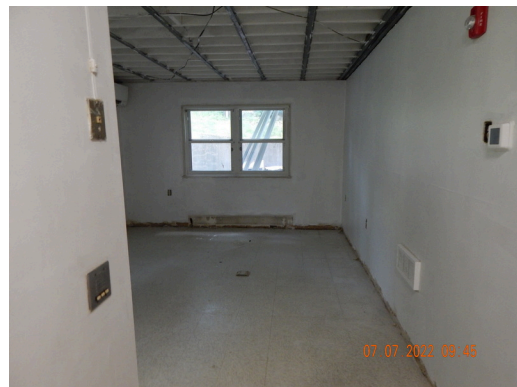
Dwelling Unit Interior Elements: Unit 42 gutted and unfinished. (Critical Repair)

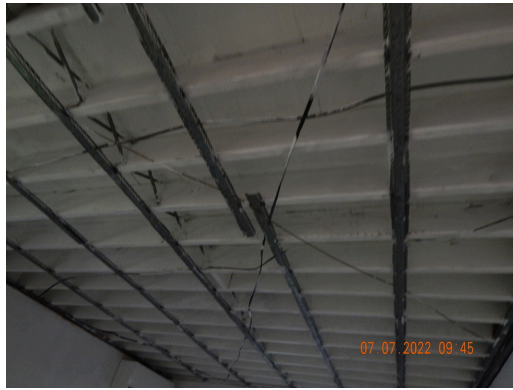
Dwelling Unit Interior Elements: Unit 42 gutted and unfinished. (Critical Repair)

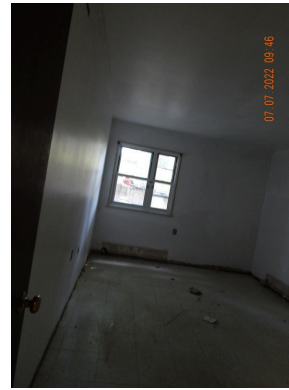
Dwelling Unit Interior Elements: Unit 42 gutted and unfinished. (Critical Repair)

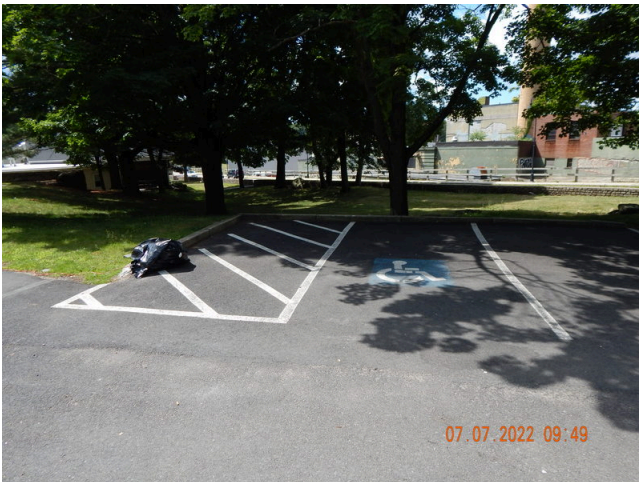
15. Paving, Curbing, & Parking: Typical accessible parking spaces found throughout the property, missing vertical sign (Critical Repair)

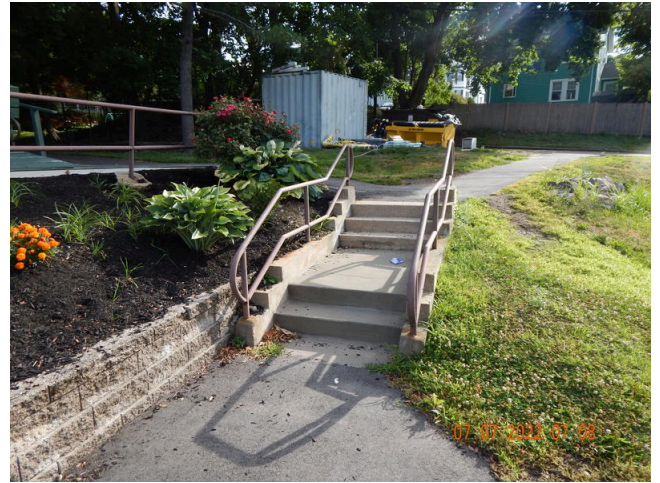
21. Flatwork (Walks, Plazas, Terraces, Patios):
Poured in place concrete ramp found at the property.

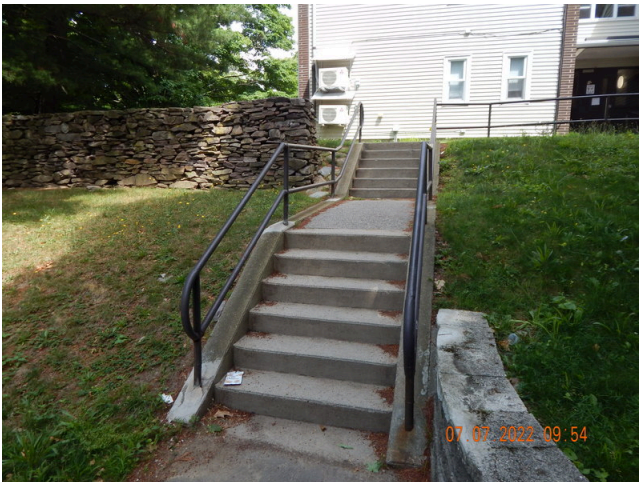
22. Flatwork (Walks, Plazas, Terraces, Patios):
Concrete steps with steel handrails found at the property.

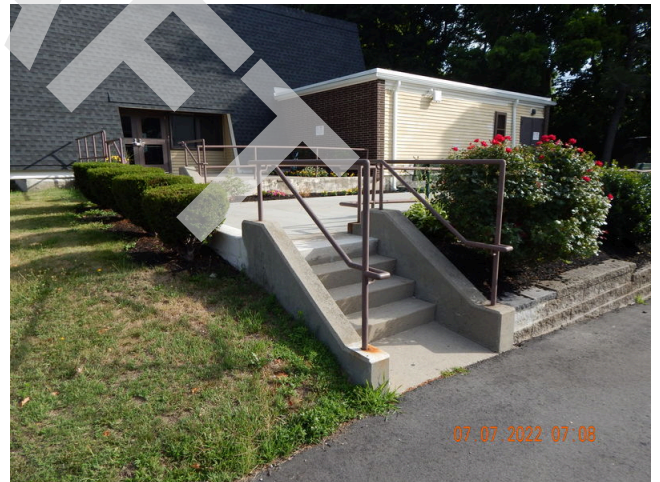
23. Flatwork (Walks, Plazas, Terraces, Patios):
Concrete steps with steel handrails found at the property.

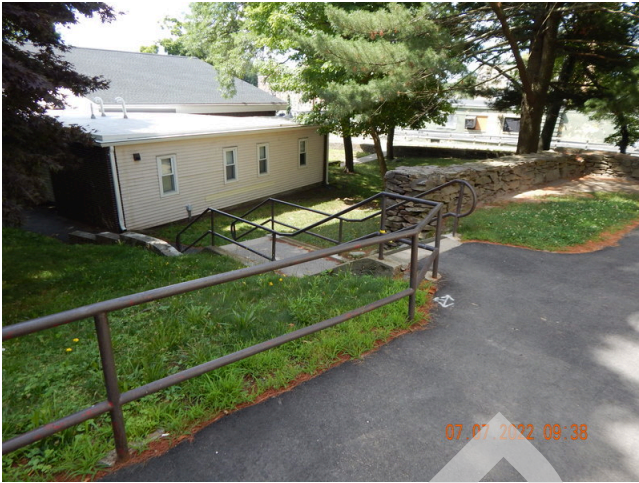
24. Flatwork (Walks, Plazas, Terraces, Patios):
Concrete steps with steel handrails found at the property.

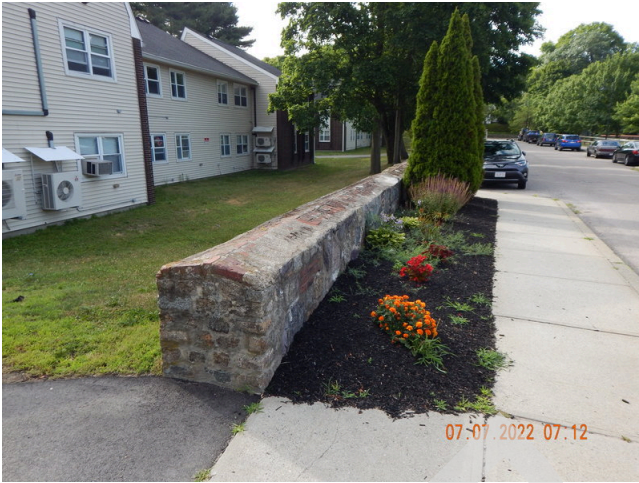
28. Landscaping & Appurtenances: Damaged Masonry wall found on the south perimeter of the property. (Non-Critical Repair)

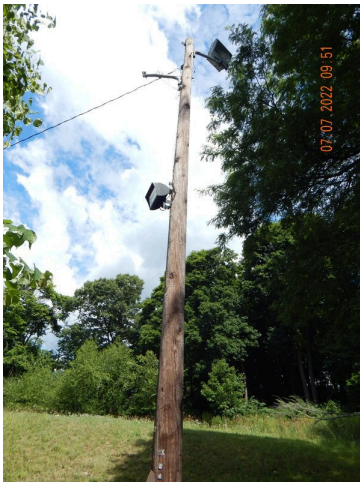
30. Landscaping & Appurtenances: Typical building lighting found throughout the property.

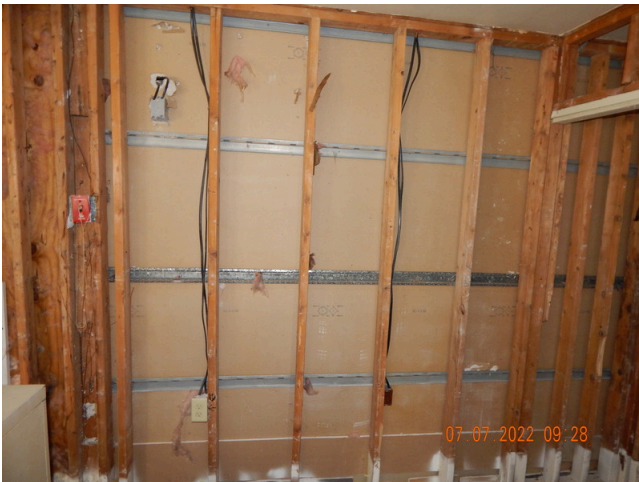
38. Framing System, Floors & Walls: Typical wood framing found throughout the site.

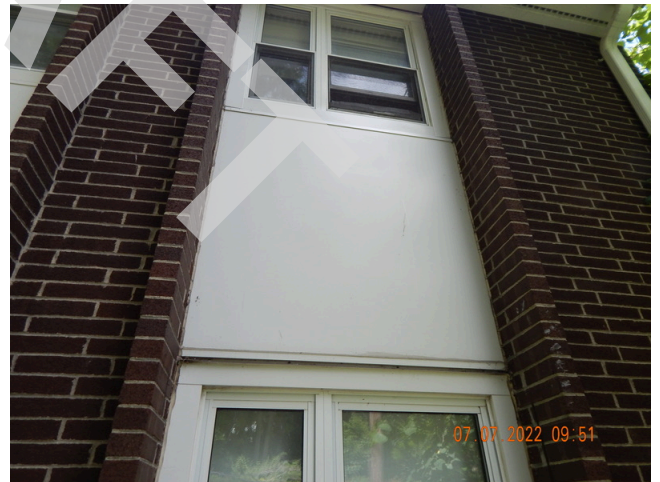
39. Framing System, Floors & Walls: Typical wood framing found throughout the site.

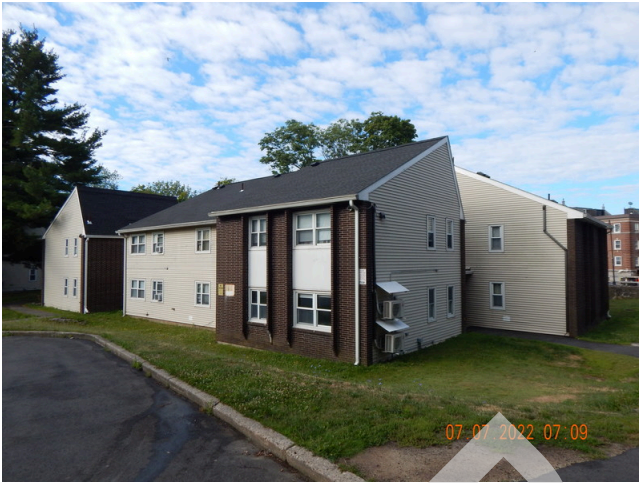
40. Framing System, Floors & Walls: Typical steel lintels at window and door openings found throughout the site.

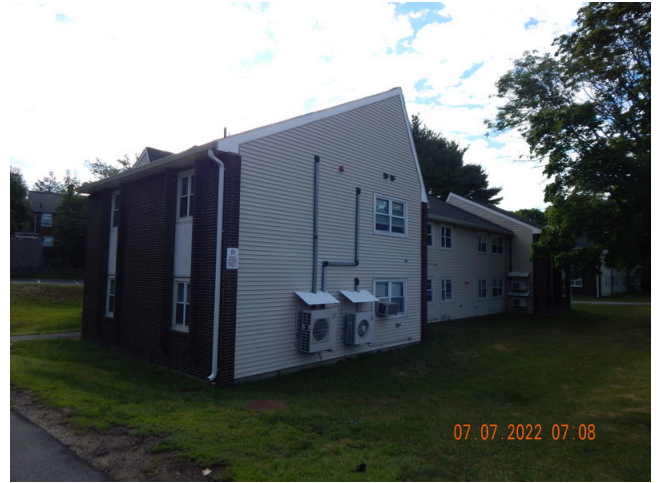
41. Roof Frame & Sheathing: Typical sloped roofs found throughout the property.

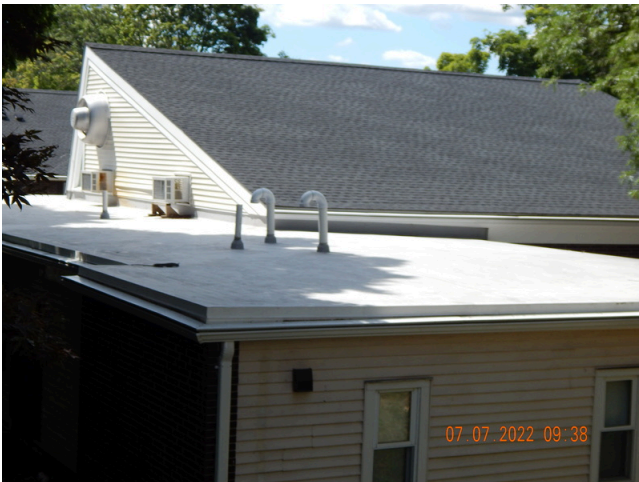
42. Roof Frame & Sheathing: Typical sloped roofs found throughout the property.

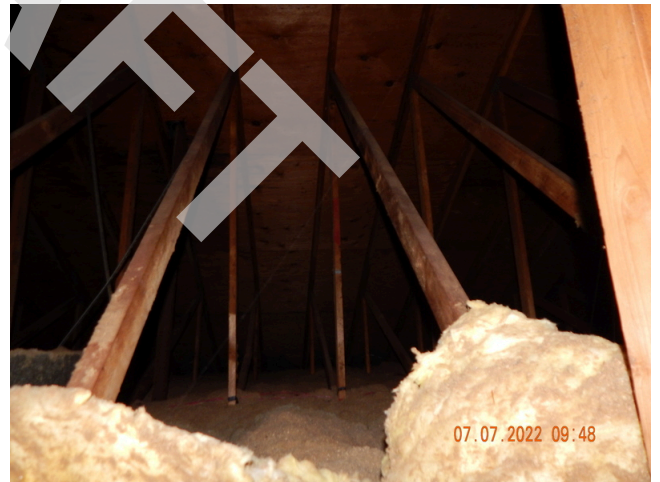
43. Roof Frame & Sheathing: Typical low-slope roofs found throughout the property.

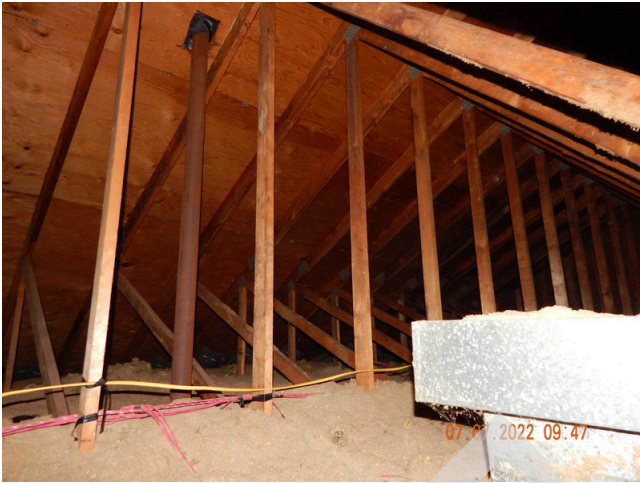
44. Roof Frame & Sheathing: Typical wood trusses and plywood decking found throughout the property.

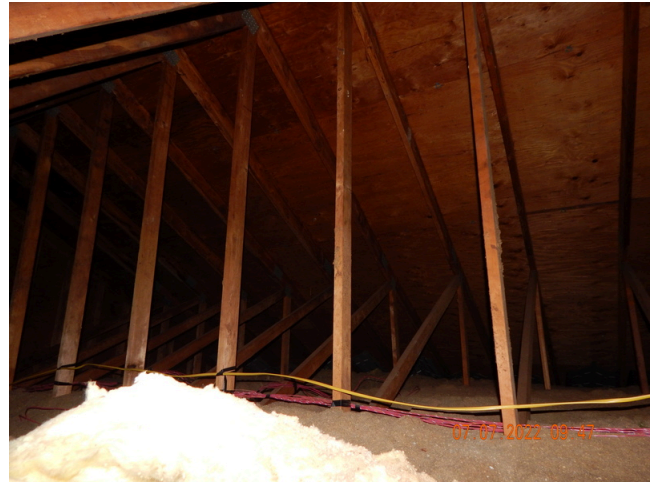
45. Roof Frame & Sheathing: Typical wood trusses and plywood decking found throughout the property.

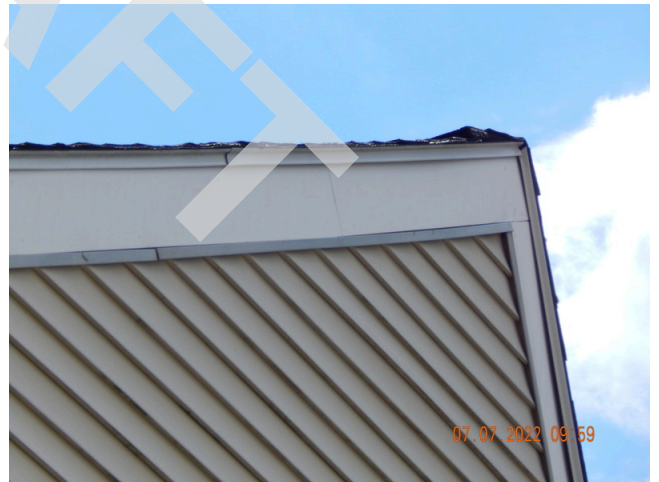
47. Flashing & Moisture Protection: Typical flashing found throughout the site.

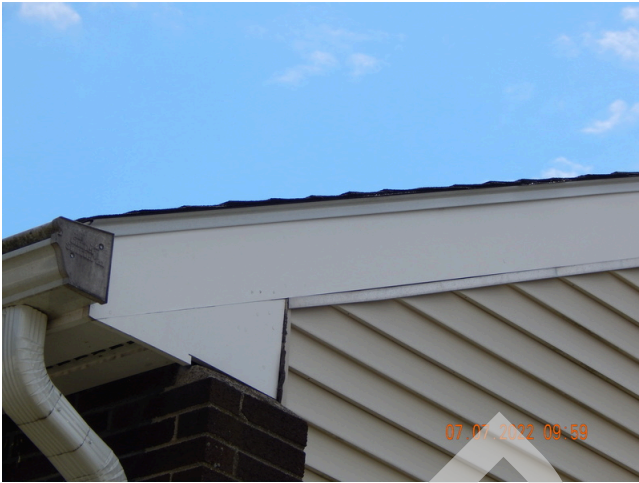
48. Flashing & Moisture Protection: Typical flashing found throughout the site.

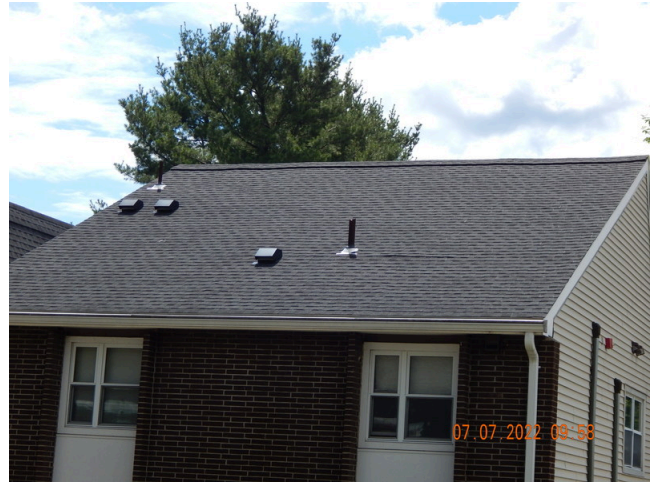
49. Flashing & Moisture Protection: Typical flashing found throughout the site.

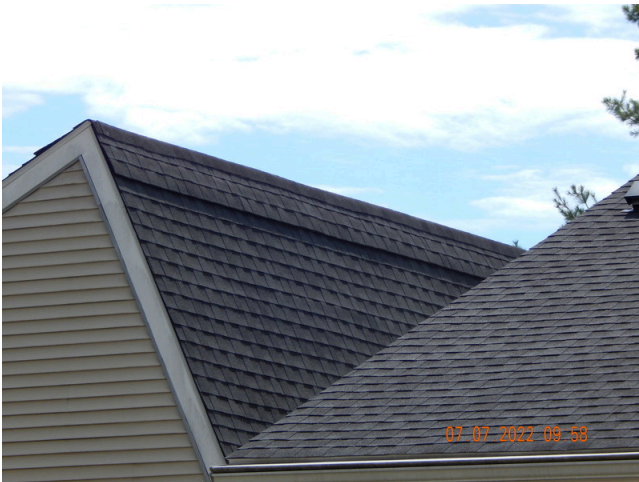
50. Attics & Eaves: Typical ridge vents found throughout the site.

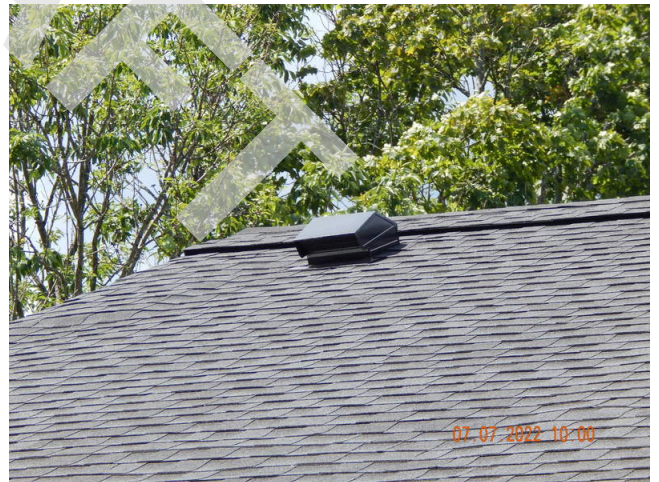
51. Attics & Eaves: Typical ridge vents found throughout the site.

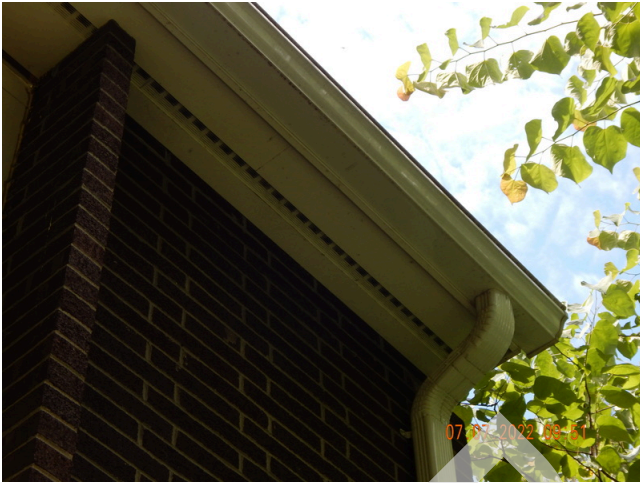
52. Attics & Eaves: Typical roof vents found throughout the site.

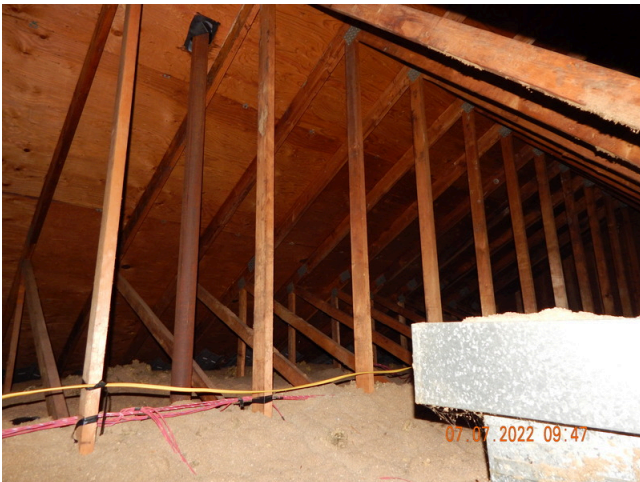
54. Insulation: Typical blown-in cellulose and fiber glass batt insulation found throughout the site.

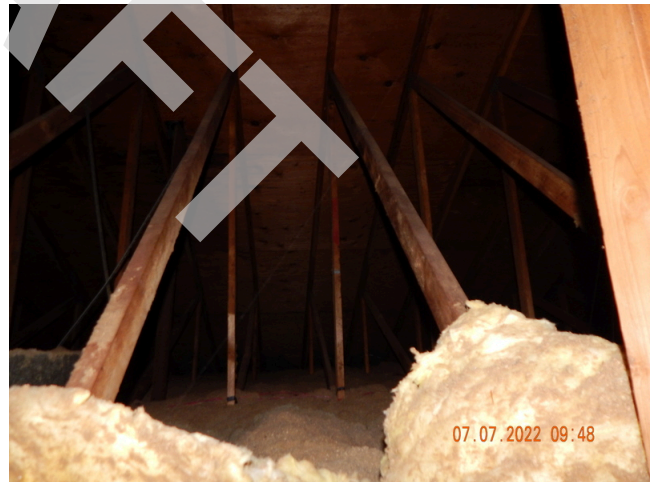
55. Insulation: Typical blown-in cellulose insulation found throughout the site.

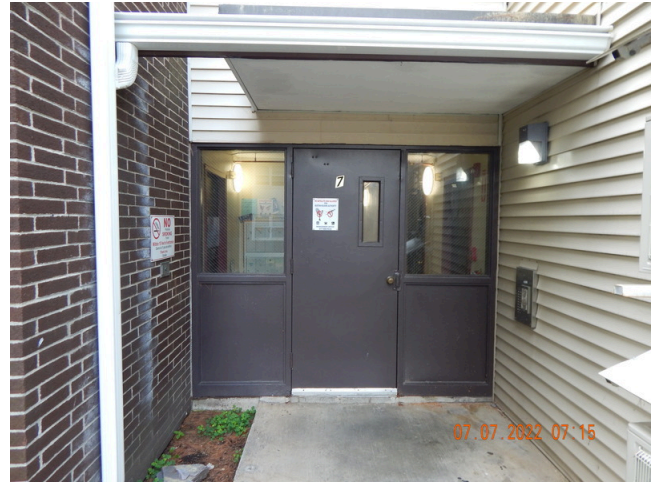
57. Exterior Doors & Entry Systems: Typical metal-clad unit door found throughout the site.

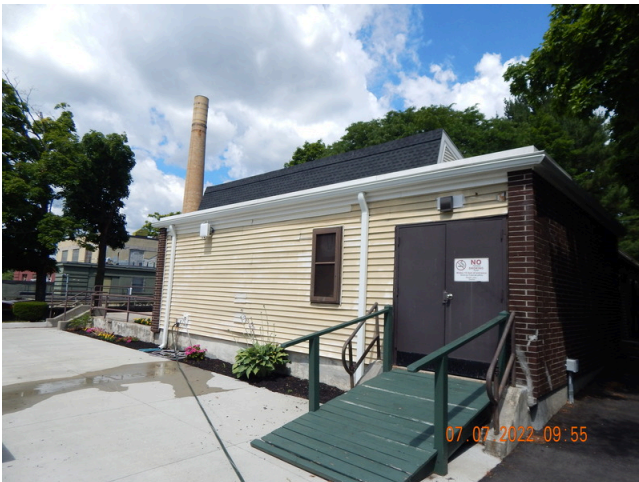
58. Exterior Doors & Entry Systems: Typical building access door found throughout the site.

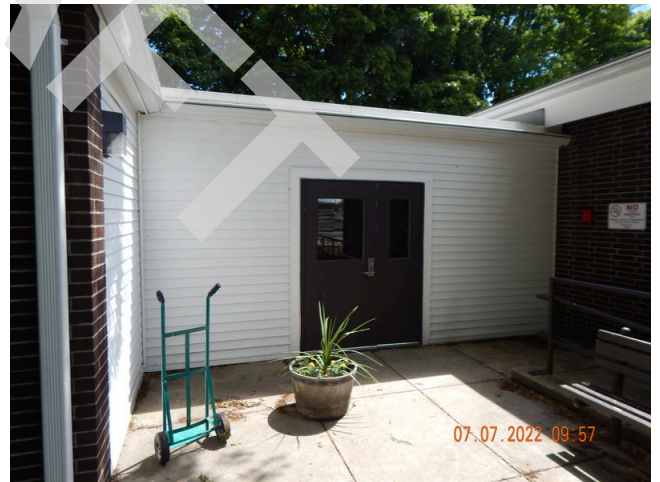
59. Exterior Doors & Entry Systems: Typical service door found throughout the site.

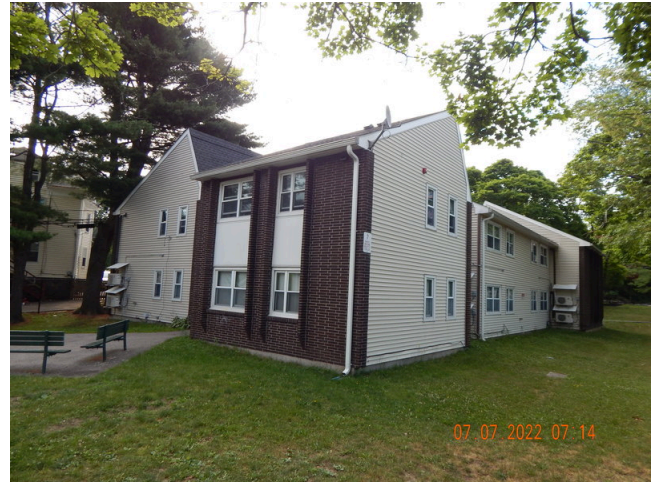
61. Sidewall System: Typical sidewall vinyl siding and unpainted brick found throughout the site.

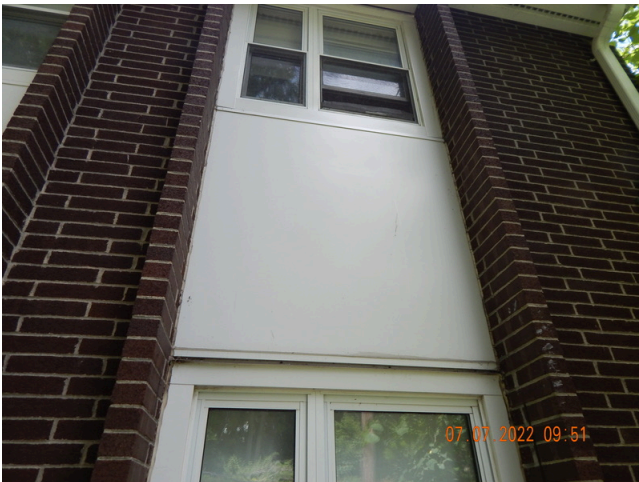
62. Sidewall System: Typical sidewall vinyl siding and unpainted brick found throughout the site.

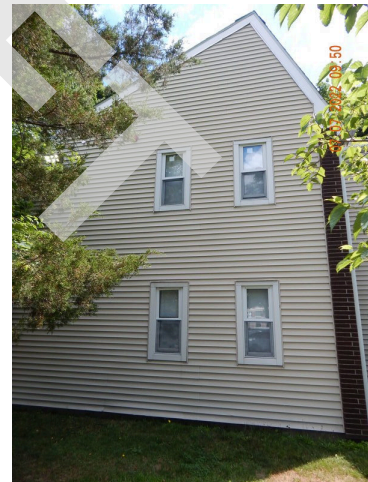
63. Sidewall System: Typical sidewall vinyl siding and unpainted brick found throughout the site.

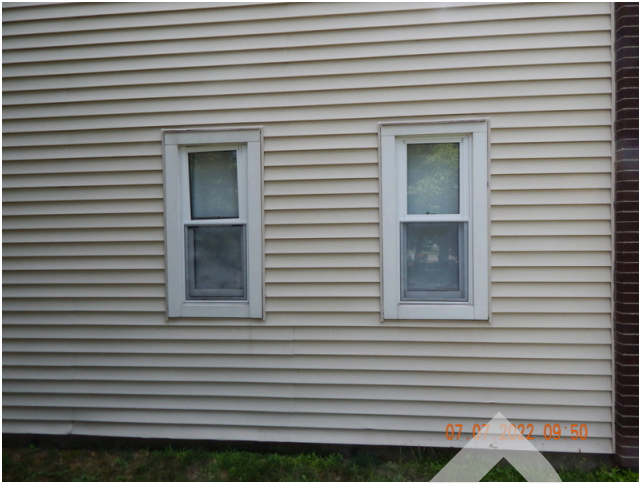
64. Sidewall System: Typical sidewall vinyl siding found throughout the site.

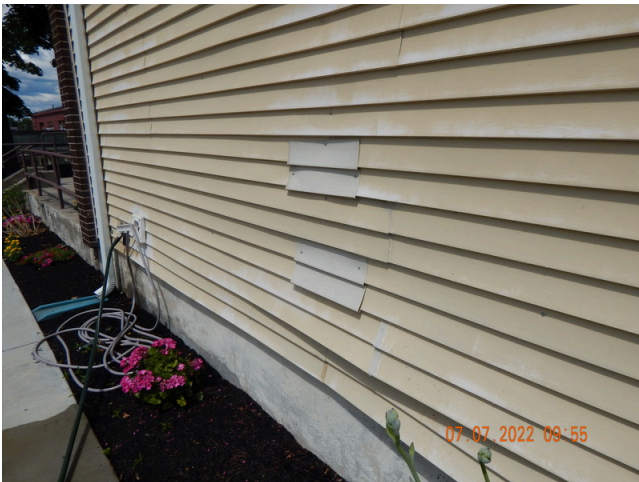
66. Sidewall System: Typical damaged or weathered sidewall vinyl siding found throughout the site. (Non-Critical Repair)

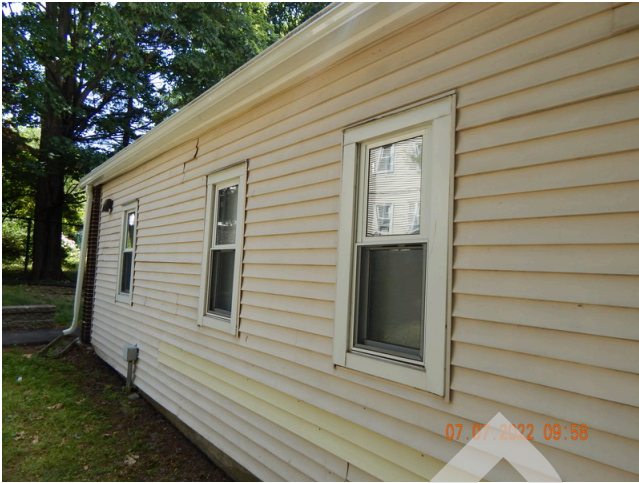
68. Sidewall System: Typical damaged or weathered sidewall vinyl siding found throughout the site. (Non-Critical Repair)

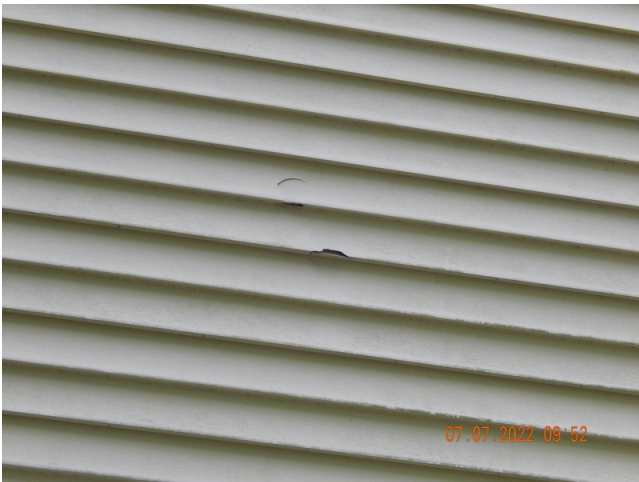
70. Sidewall System: Typical damaged or weathered sidewall vinyl siding found throughout the site.
(Non-Critical Repair)

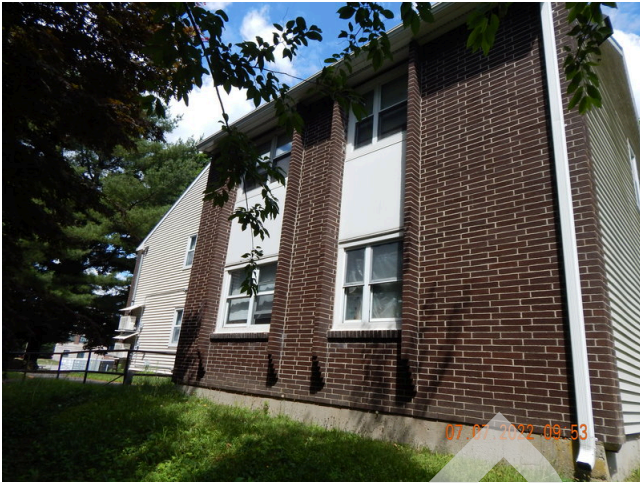
72. Sidewall System: Typical sidewall unpainted brick found throughout the site.

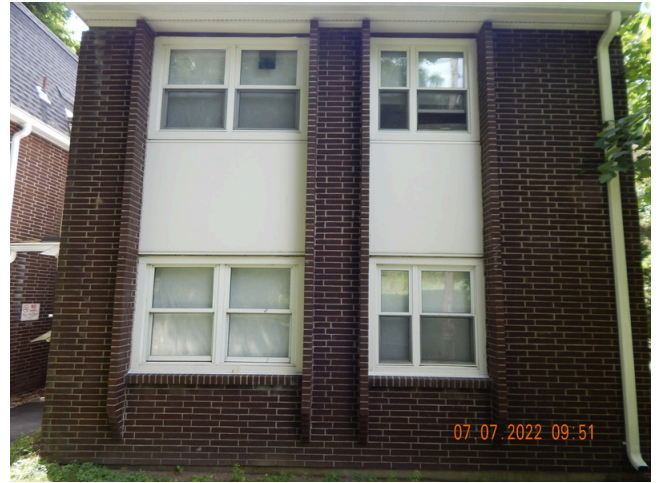
73. Sidewall System: Typical sidewall unpainted brick found throughout the site.

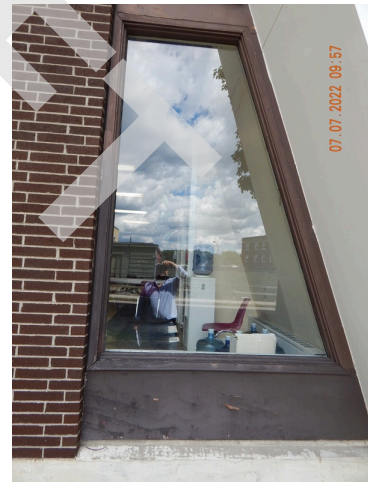
75. Sidewall System: Typical vinyl trim found throughout the site.

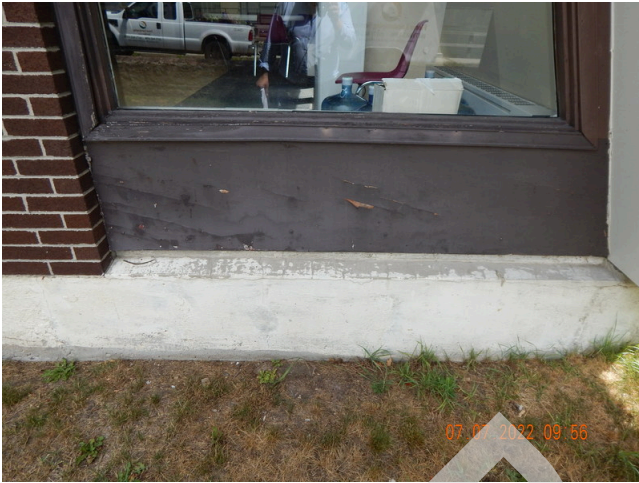
76. Sidewall System: Typical damaged or weathered wood trim found throughout the community building. (Non-Critical Repair)

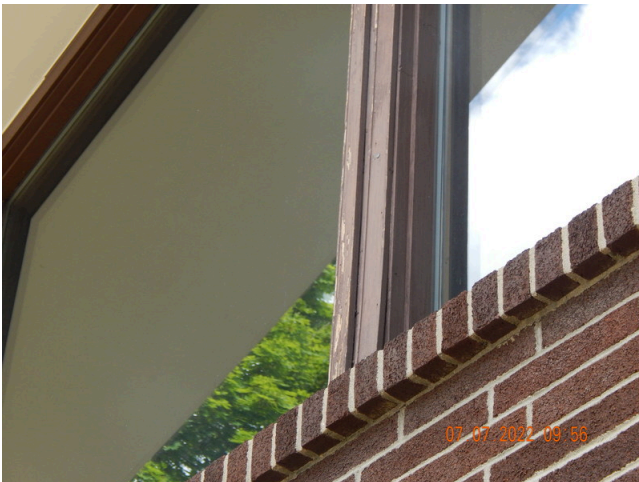
78. Sidewall System: Typical damaged or weathered wood trim found throughout the community building. (Non-Critical Repair)

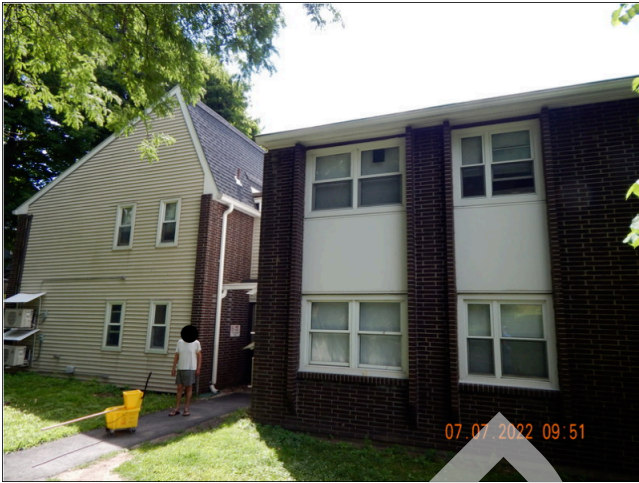
80. Sidewall System: Building 3 south facade.

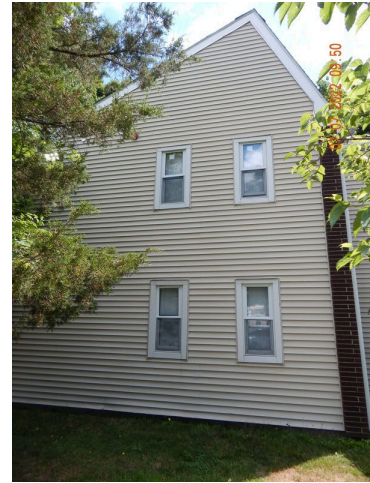
81. Sidewall System: Building 3 west facade.

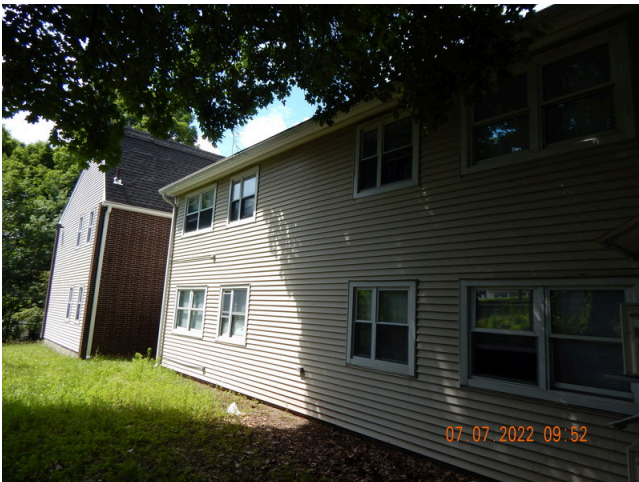
82. Sidewall System: Building 3 west facade.

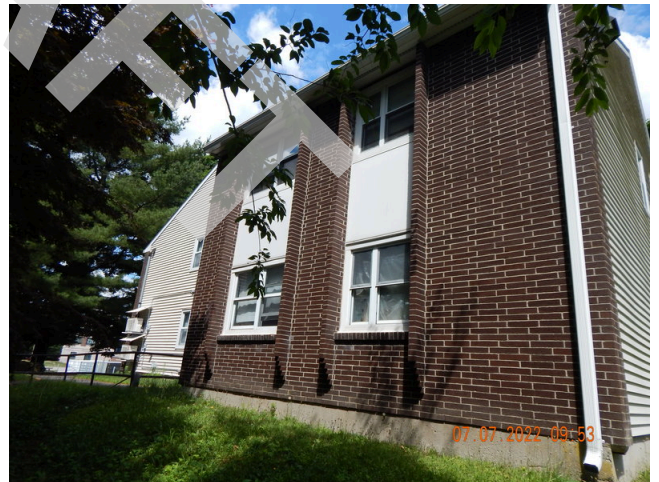
83. Sidewall System: Building 3 north facade.

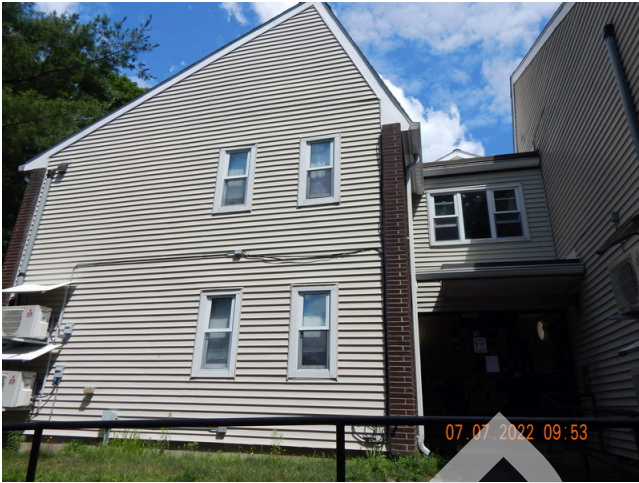
84. Sidewall System: Building 3 east facade.

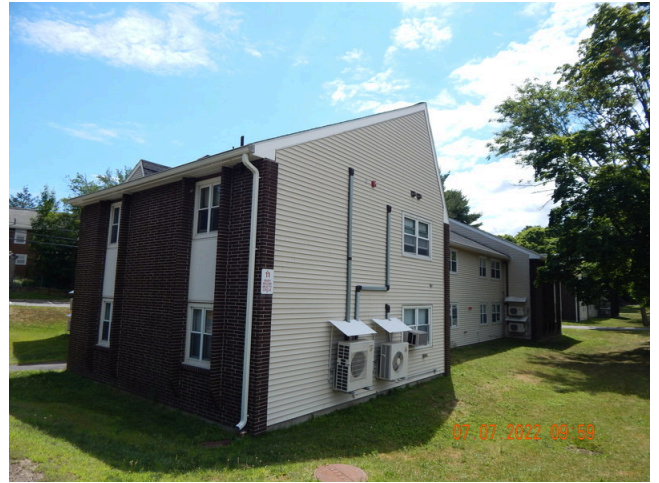
85. Sidewall System: Building 3 east facade.

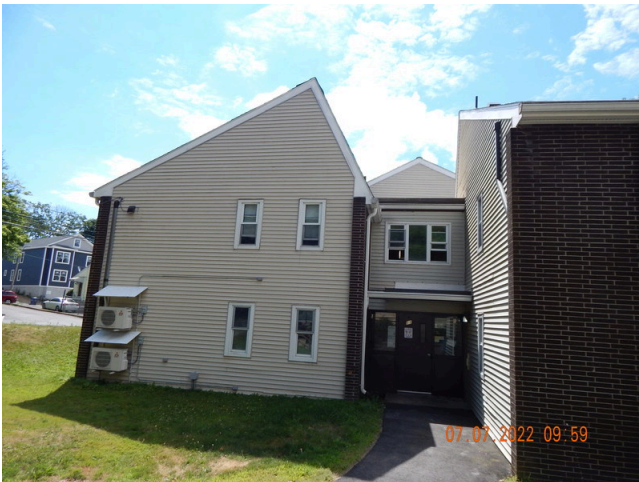
86. Sidewall System: Building 2 southeast facade.

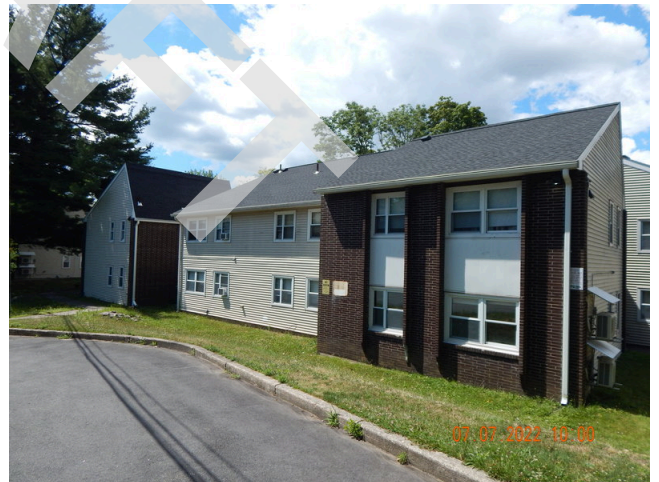
87. Sidewall System: Building 2 east facade.

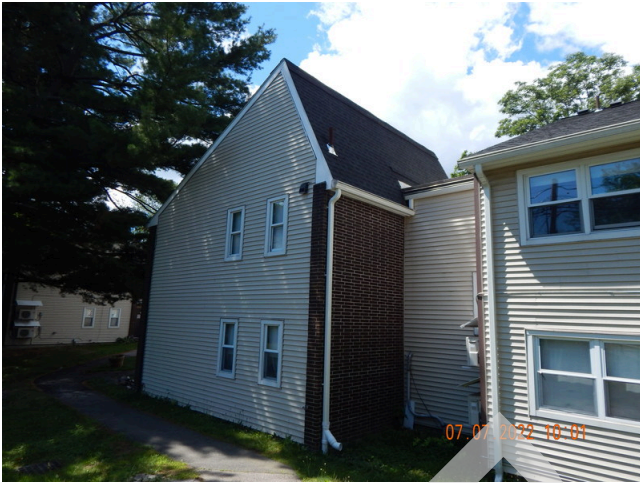
88. Sidewall System: Building 2 north facade.

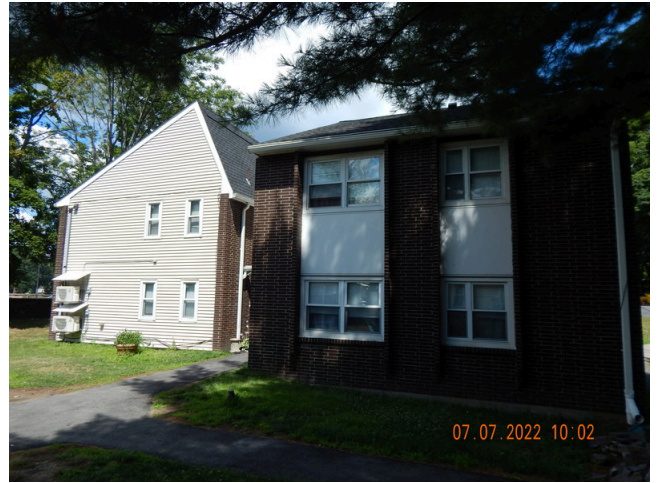
89. Sidewall System: Building 2 north facade.

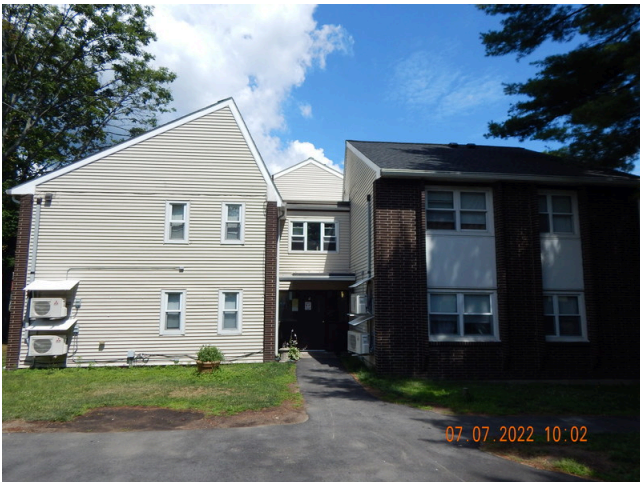
90. Sidewall System: Building 2 east facade.

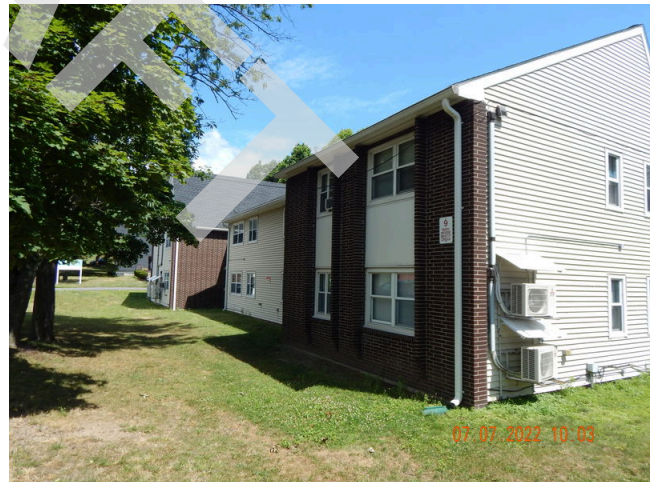
91. Sidewall System: Building 2 east facade.

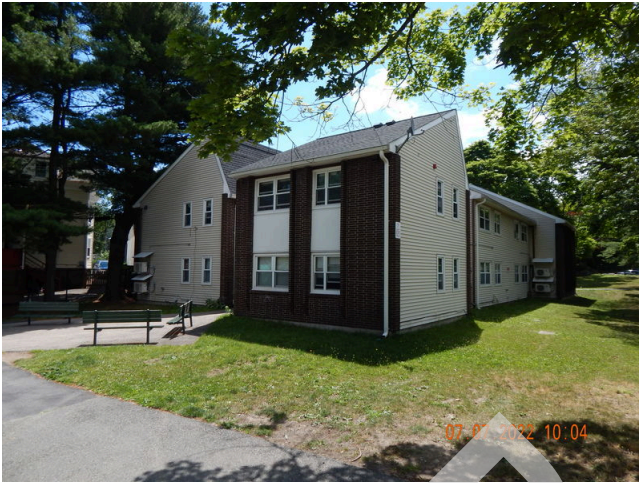
92. Sidewall System: Building 2 southeast facade.

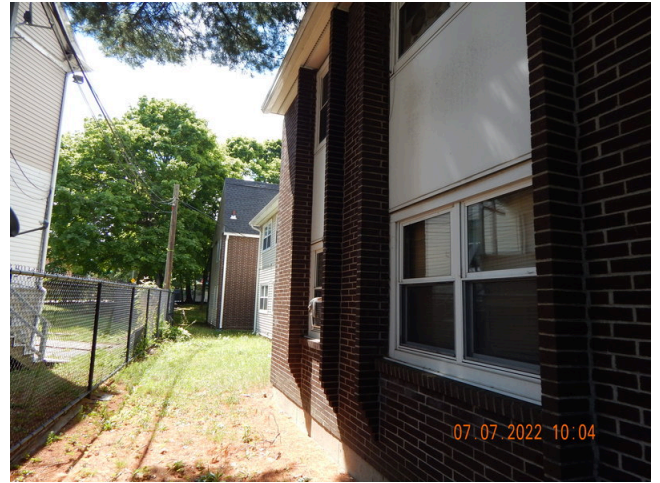
93. Sidewall System: Building 3 southeast facade.
