HUD CAPITAL NEEDS ASSESSMENT

Groveland
15 Mary Moore Beatty Circle
Mattapan, Massachusetts 02126

AEI Project No. 463353
Site Inspection Date: July 7, 2022

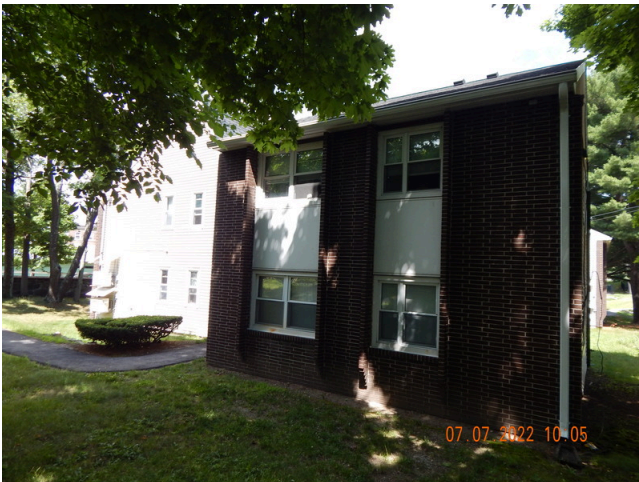
94. Sidewall System: Building 3 north facade.

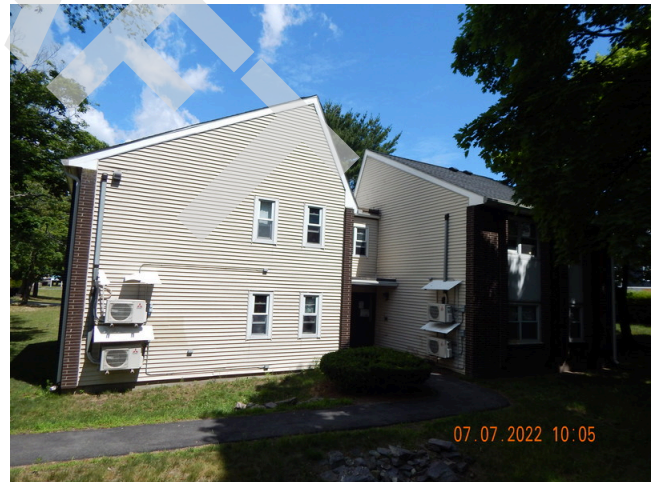
95. Sidewall System: Building 3 west facade.

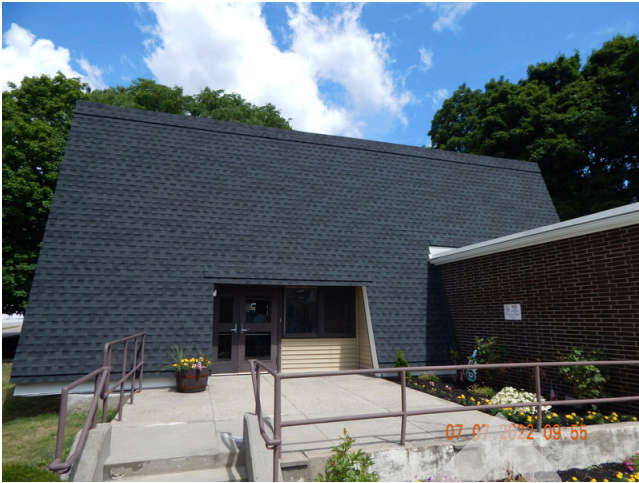
96. Sidewall System: Building 3 north facade.

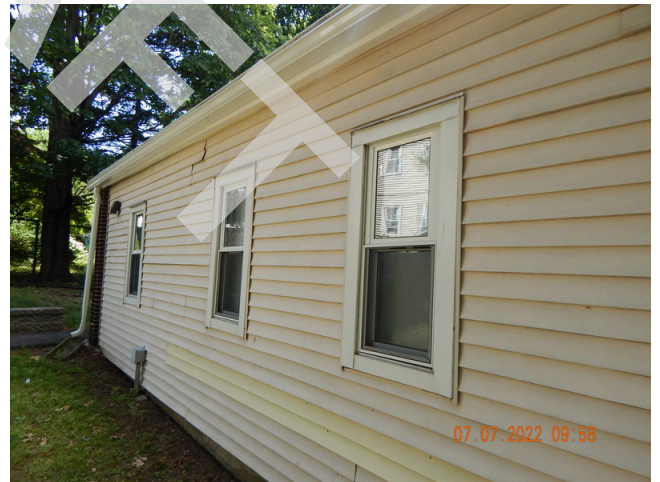
99. Sidewall System: Community Building south facade.

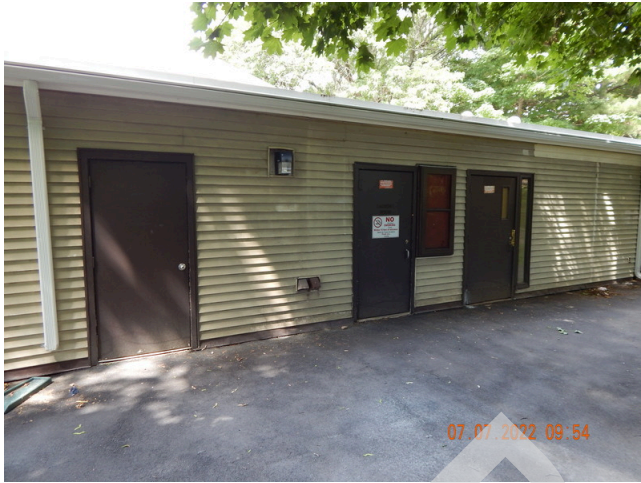
100. Sidewall System: Community Building west facade.

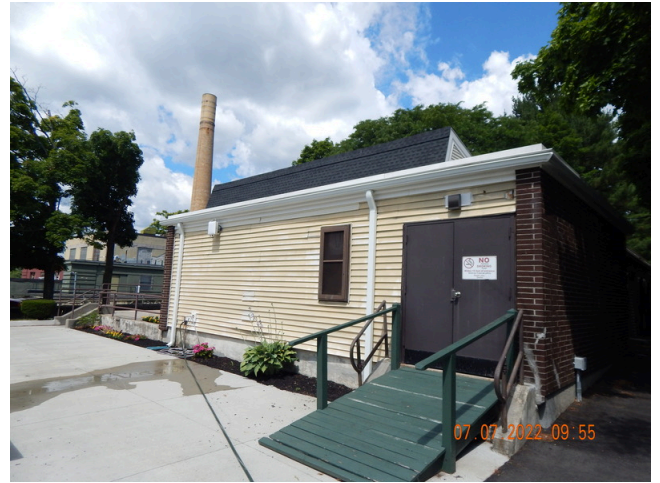
101. Sidewall System: Community Building north facade.

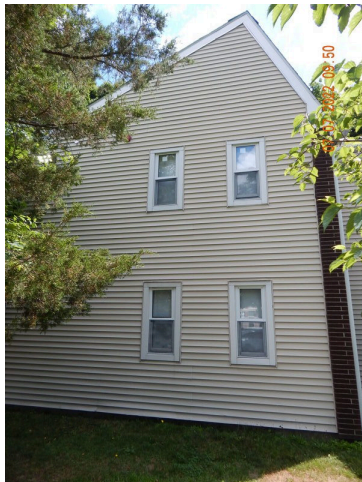
102. Sidewall System: Community Building east facade.

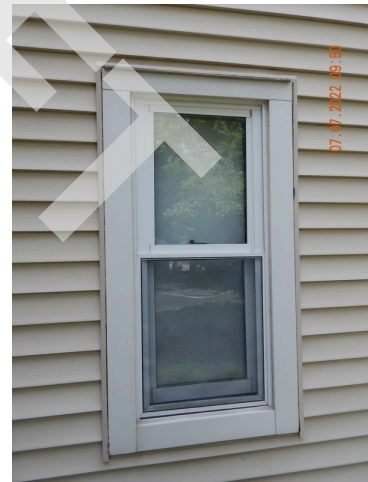
103. Windows: Typical single-hung style double-pane vinyl windows found throughout the site.

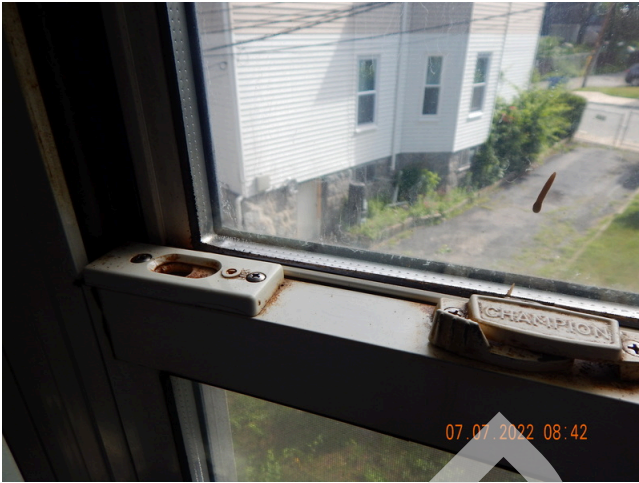
104. Windows: Typical single-hung style double-pane vinyl windows found throughout the site.

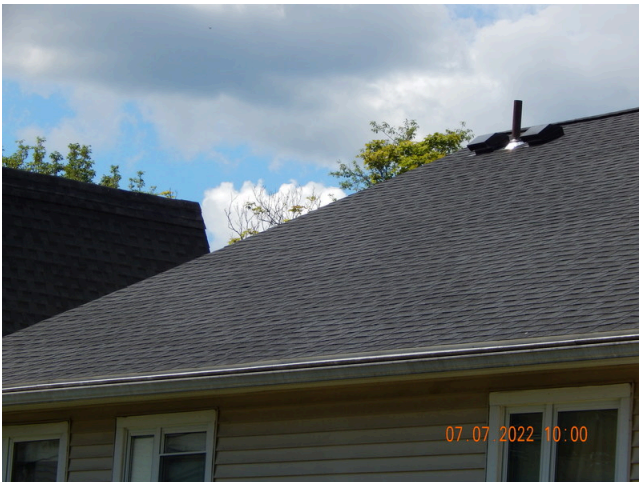
106. Roofing Finish: Typical asphalt shingle roofing found throughout the site.

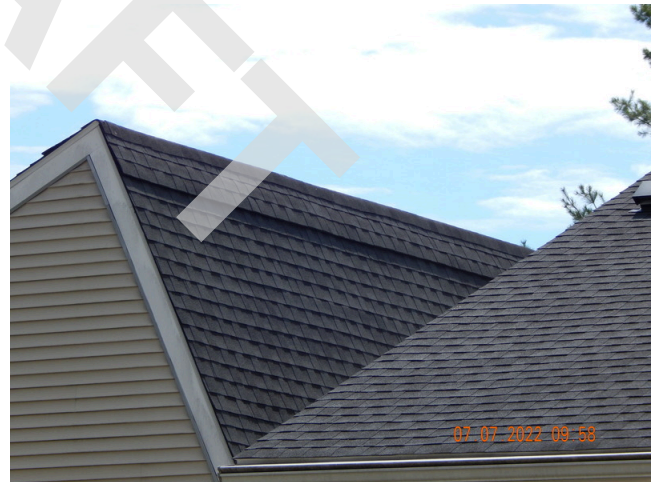
107. Roofing Finish: Typical asphalt shingle roofing found throughout the site.

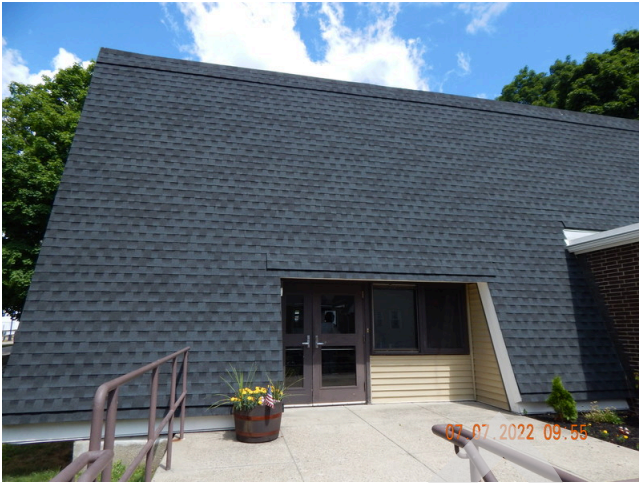
109. Roofing Finish: Typical asphalt shingle roofing found throughout the site.

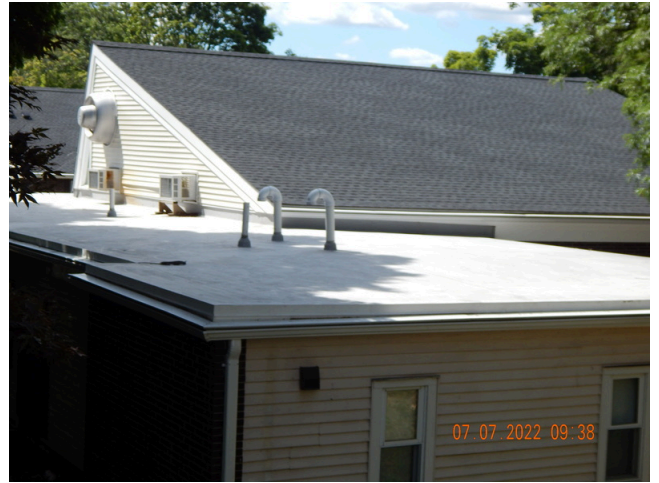
110. Roofing Finish: Typical TPO roofing found throughout the site.

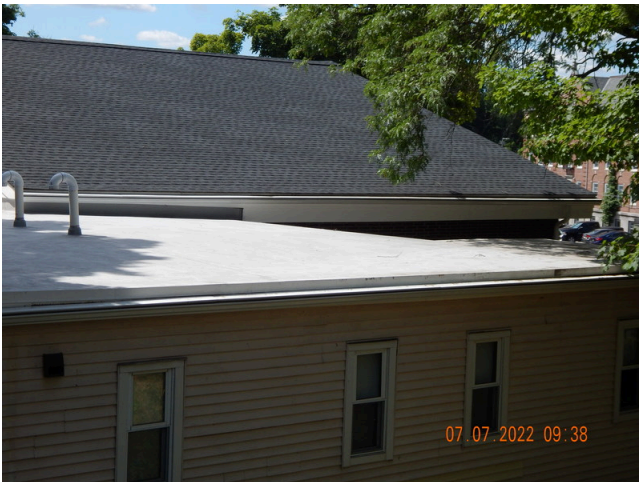
111. Roofing Finish: Typical TPO roofing found throughout the site.

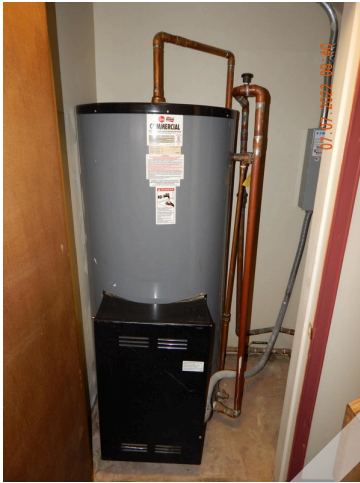
113. Plumbing: Typical central electric water heater found at the property.

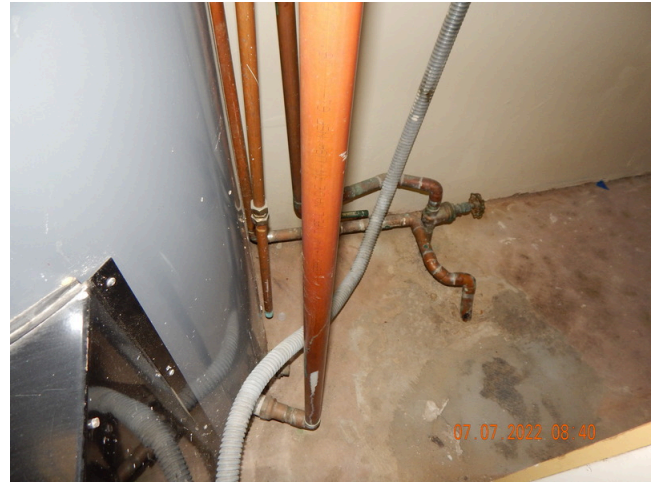
114. Plumbing: Typical copper distribution pipes found throughout property.

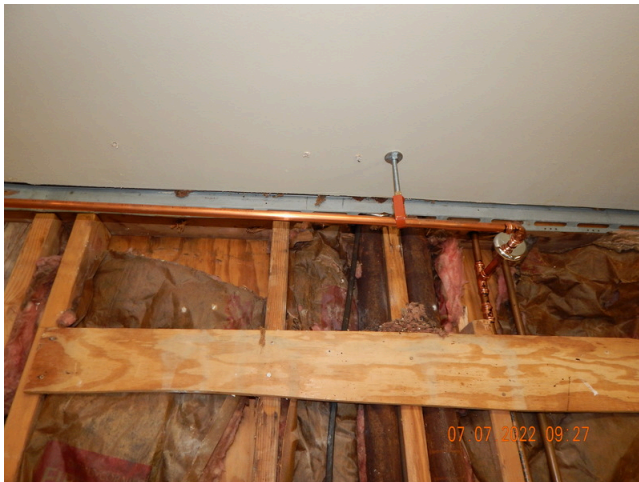
115. Plumbing: Typical copper distribution pipes found throughout property.

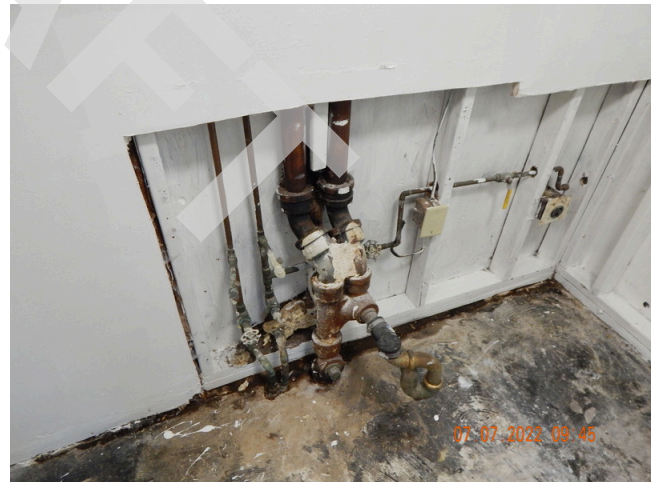
116. Plumbing: Typical cast iron waste pipes found throughout the exterior of the property.

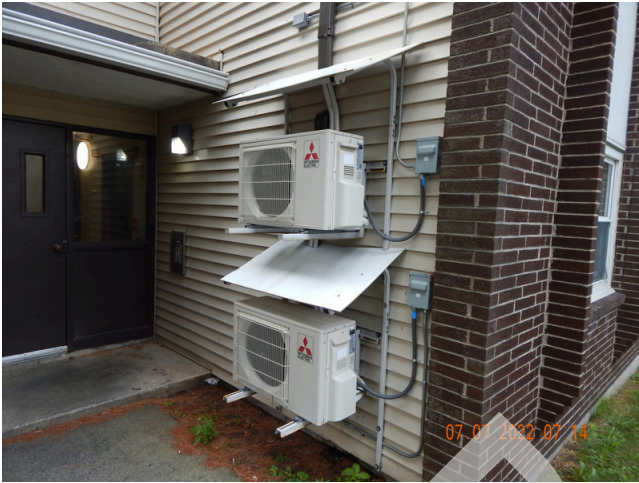
117. HVAC Systems: Typical 1.5 ton individual heat pump units found throughout the site.

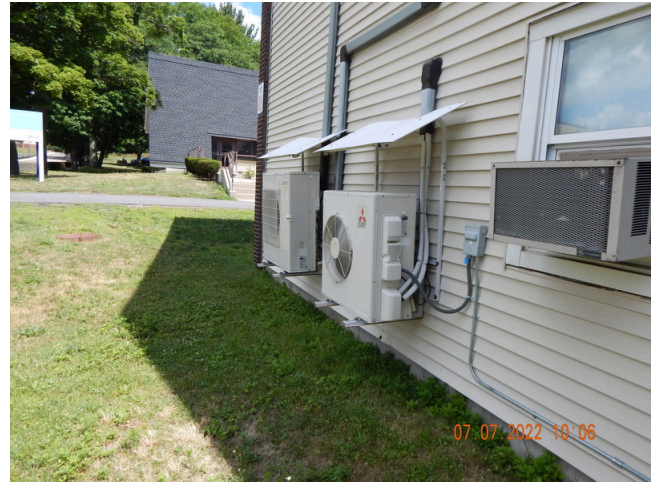
118. HVAC Systems: Typical 2 ton individual heat pump units found throughout the site.

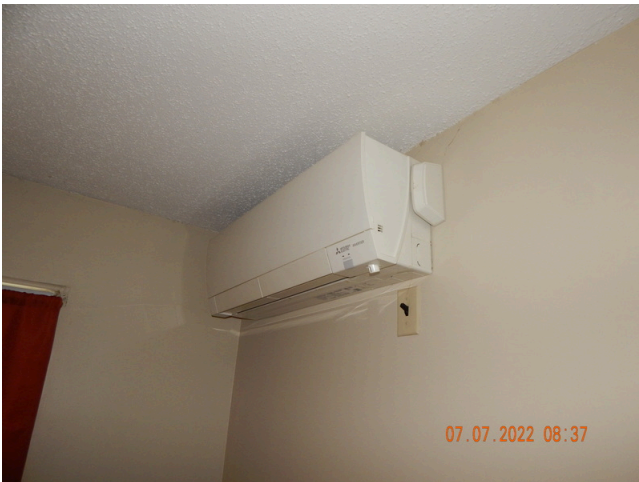
119. HVAC Systems: Typical individual heat pump units found throughout the site.

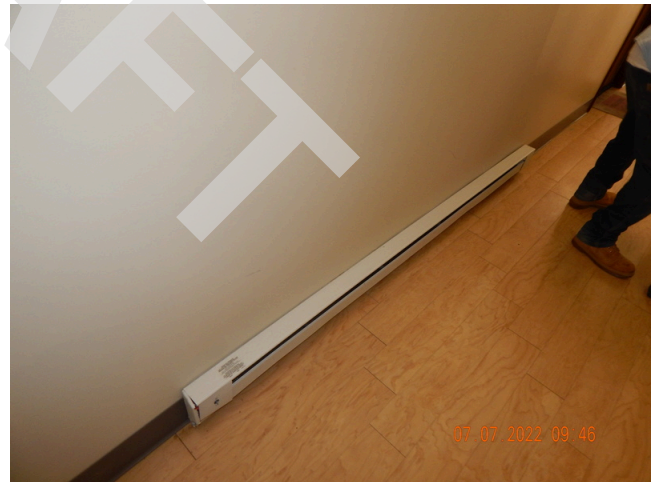
120. HVAC Systems: Typical electric baseboard heater found in common areas throughout the site.

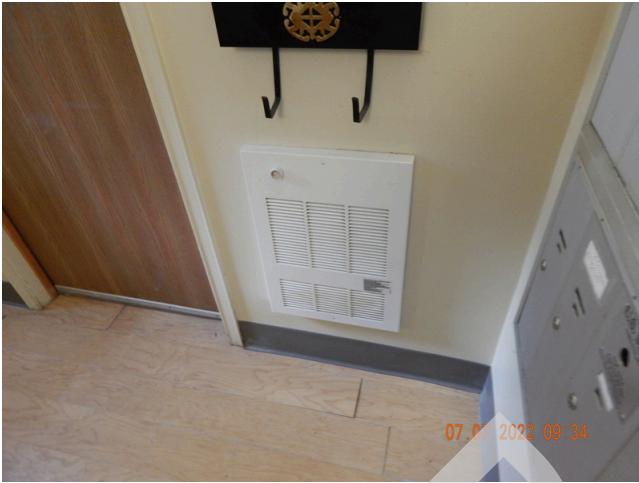
121. HVAC Systems: Typical electric in-wall heater found in common areas throughout the site.

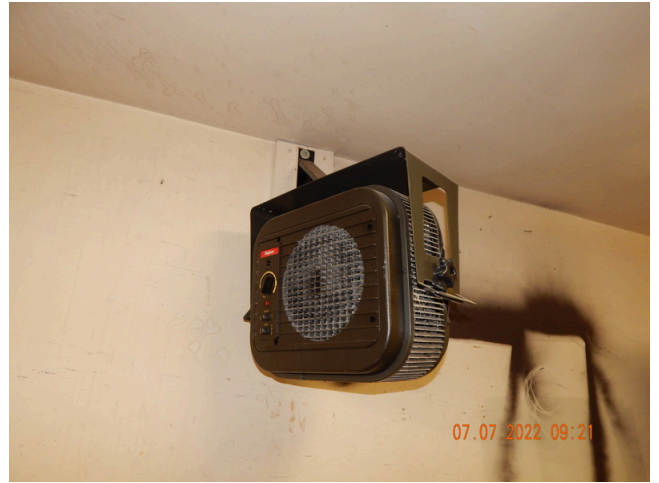
122. HVAC Systems: Typical electric ceiling mounted heater found in common areas throughout the site.

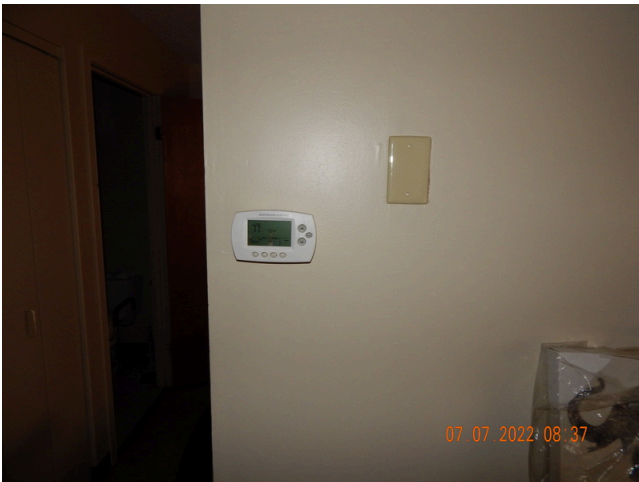
123. HVAC Systems: Typical thermostat found throughout the site.

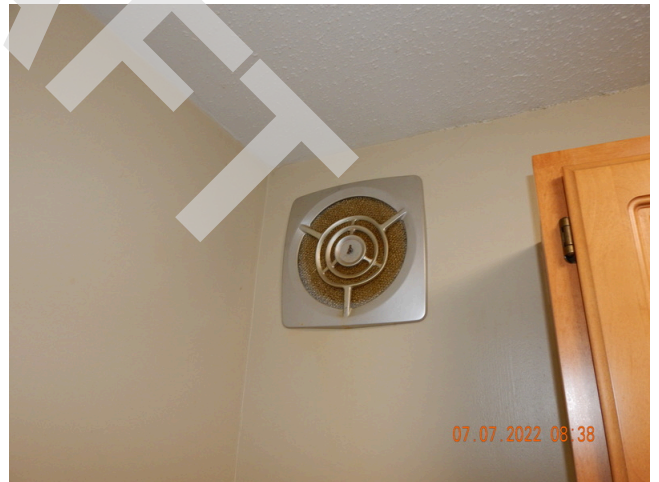
124. HVAC Systems: Typical kitchen exhaust fan found throughout the site.

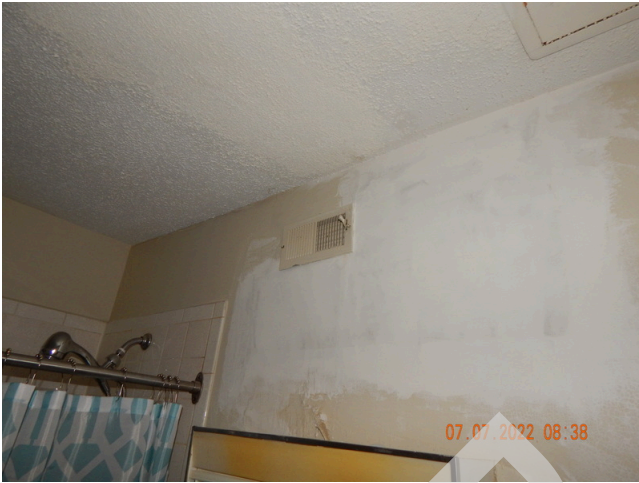
125. HVAC Systems: Typical bathroom exhaust fan found throughout the site.

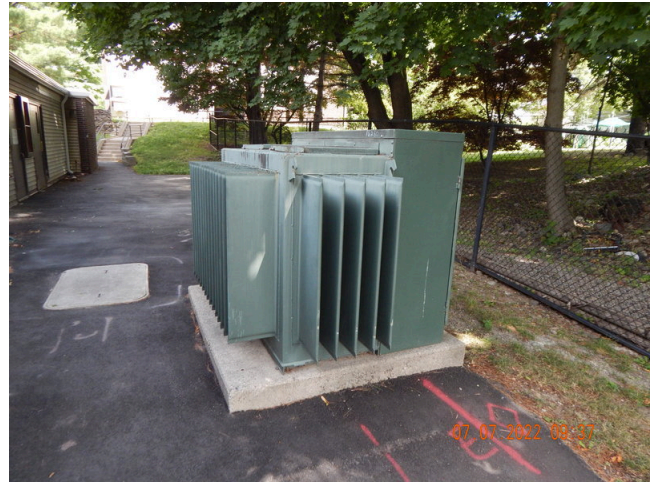
126. Electrical System: Typical pad-mounted transformer found at the site.

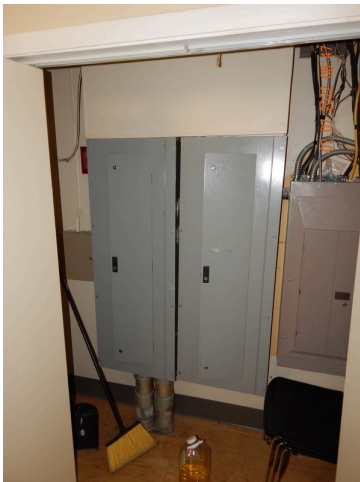
127. Electrical System: Typical central electric panel found throughout the site.

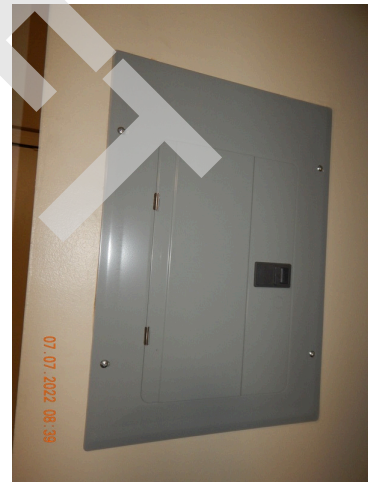
128. Electrical System: Typical dwelling unit electric panel found throughout the site.

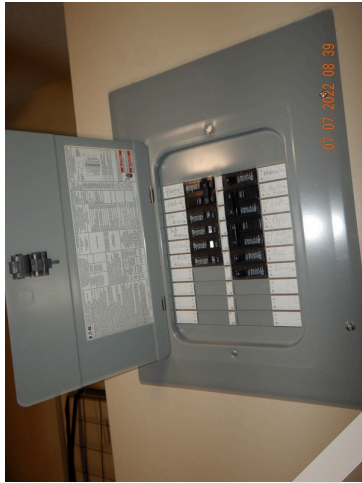
129. Electrical System: Typical dwelling unit electric panel found throughout the site.

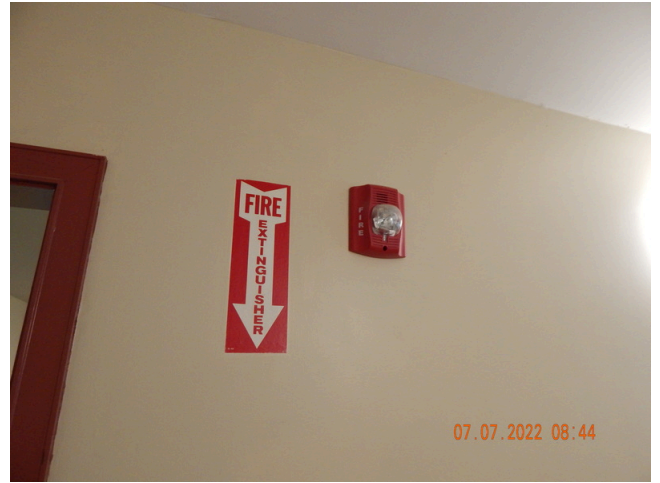
130. Life & Fire Safety: Typical strobe light found in common areas throughout the site.

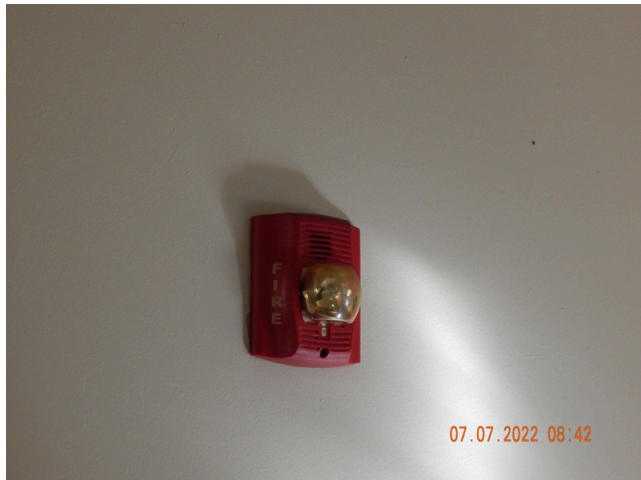
131. Life & Fire Safety: Typical strobe light found in individual units throughout the site.

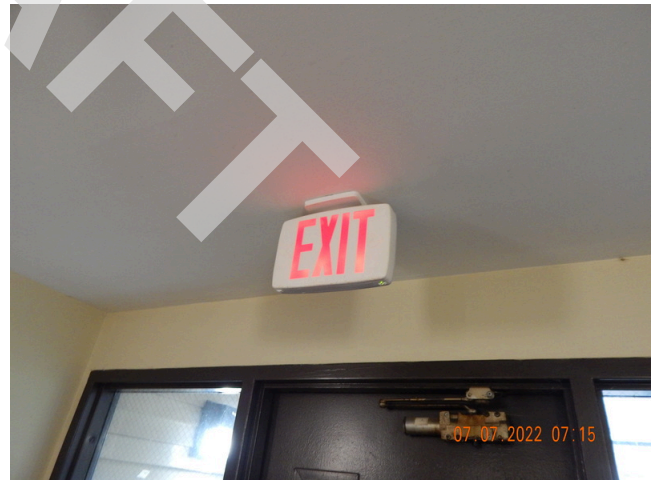
132. Life & Fire Safety: Typical illuminated exit sign found throughout the site.

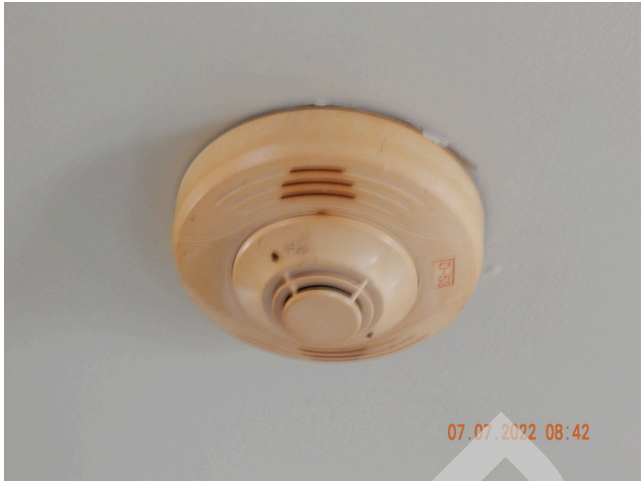
133. Life & Fire Safety: Typical hardwired smoke detector found throughout the site.

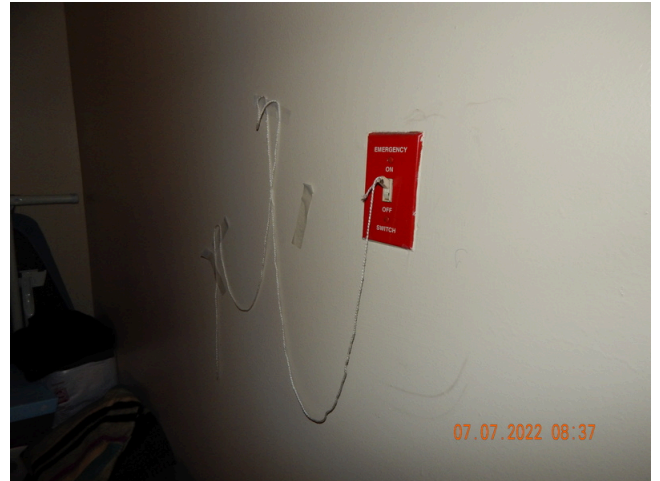
134. Life & Fire Safety: Typical emergency pull cord throughout the site.

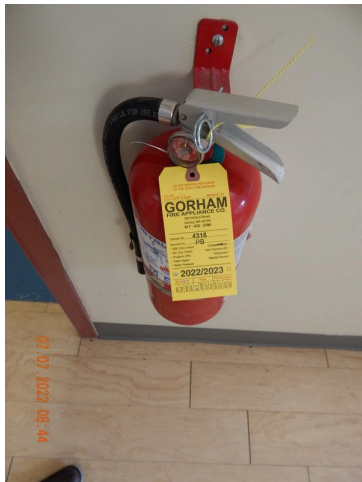
135. Life & Fire Safety: Typical fire extinguisher found throughout the site.

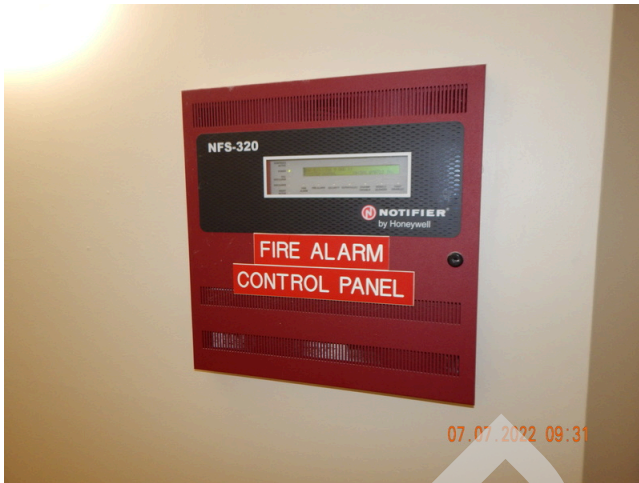
137. Life & Fire Safety: Fire alarm system found throughout the site (Missing inspection tag). (Critical Repair)

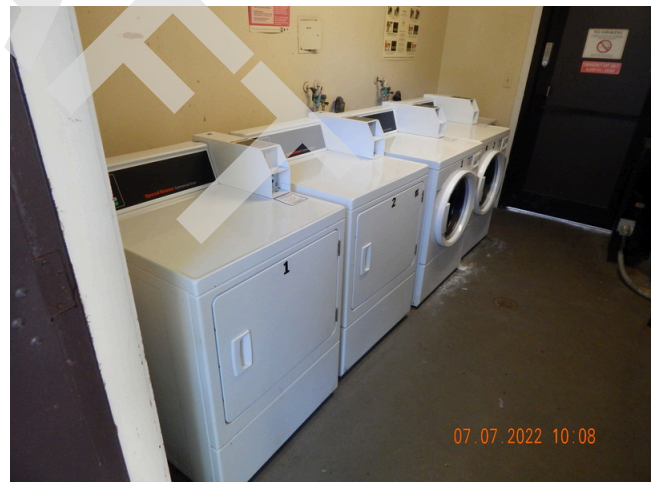
140. Common Area Interior Elements: Common laundry room.

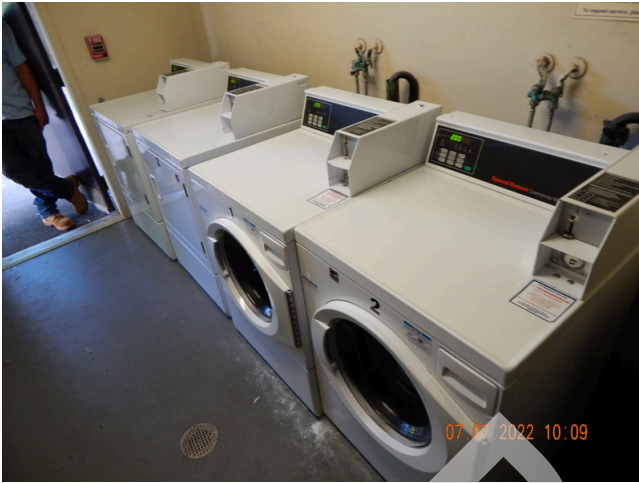
141. Common Area Interior Elements: Common laundry room.

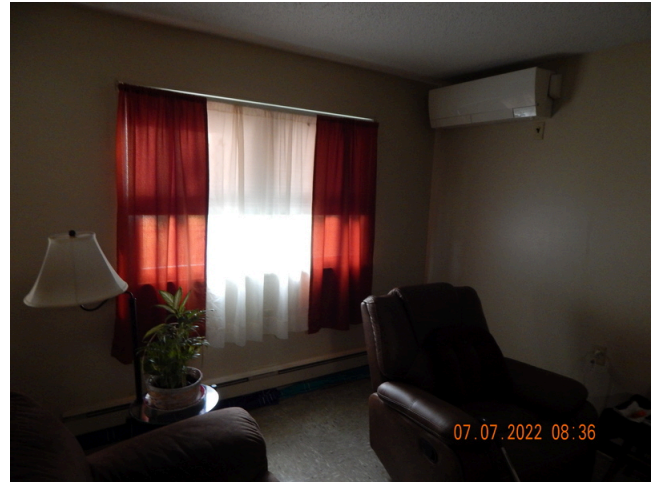
142. Dwelling Unit Interior Elements: Typical vinyl flooring and sheetrock finish found in dwelling units throughout the site.

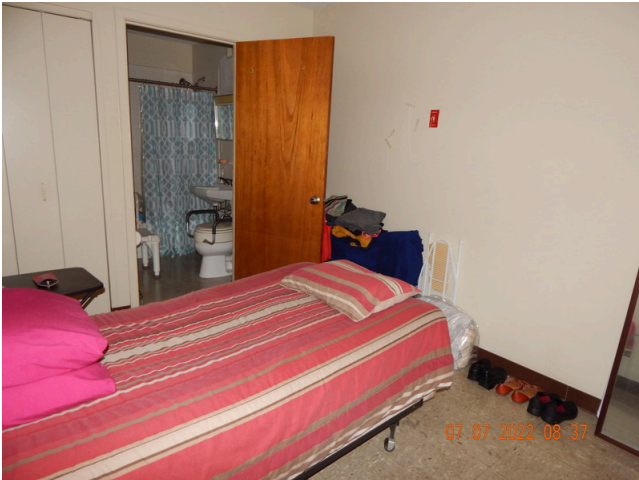
143. Dwelling Unit Interior Elements: Typical vinyl flooring and sheetrock finish found in dwelling units throughout the site.

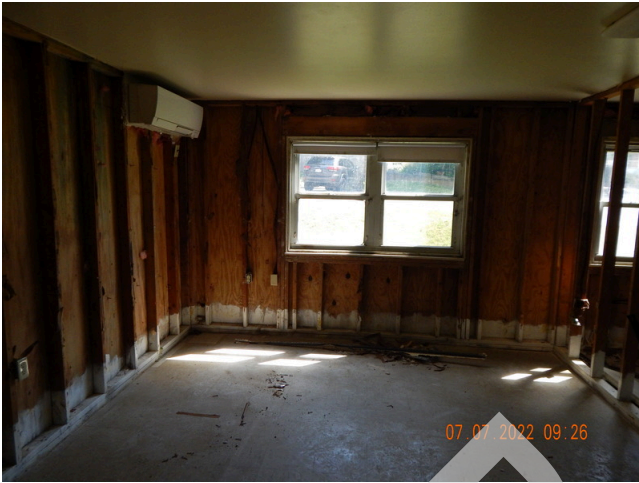
145. Dwelling Unit Interior Elements: Unit 26 gutted and unfinished. (Critical Repair)

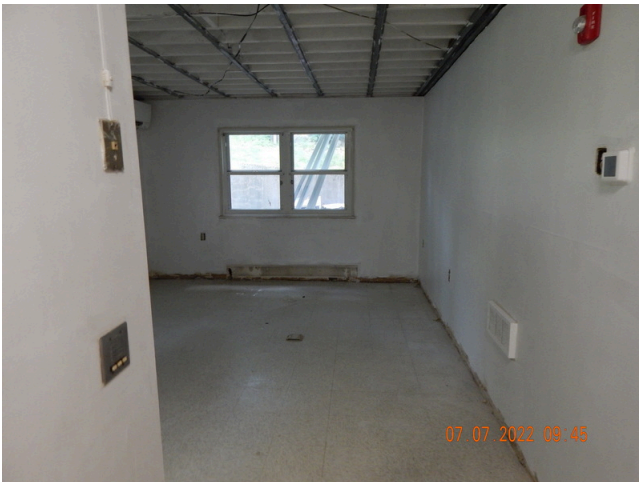
147. Dwelling Unit Interior Elements: Unit 42 gutted and unfinished. (Critical Repair)

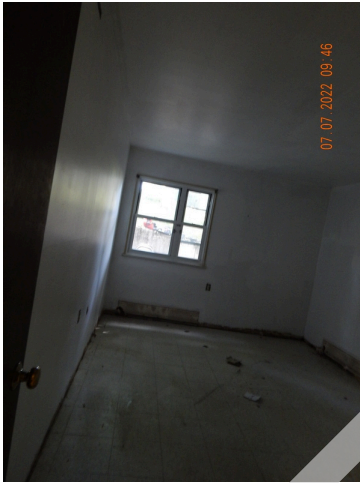
149. Dwelling Unit Interior Elements: Unit 42 gutted and unfinished. (Critical Repair)

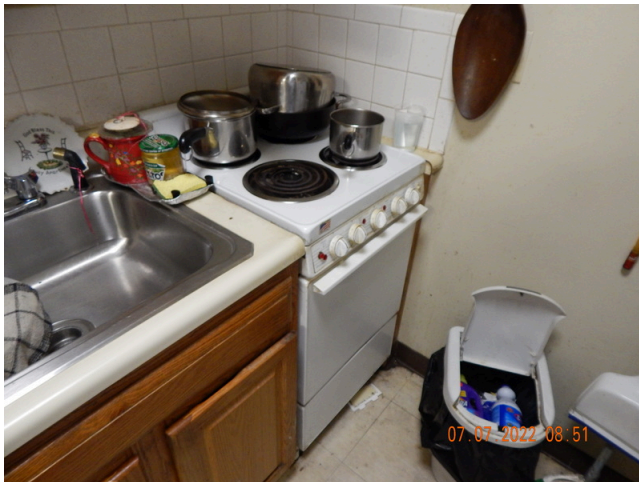
151. Appliances: Typical range found throughout the site.

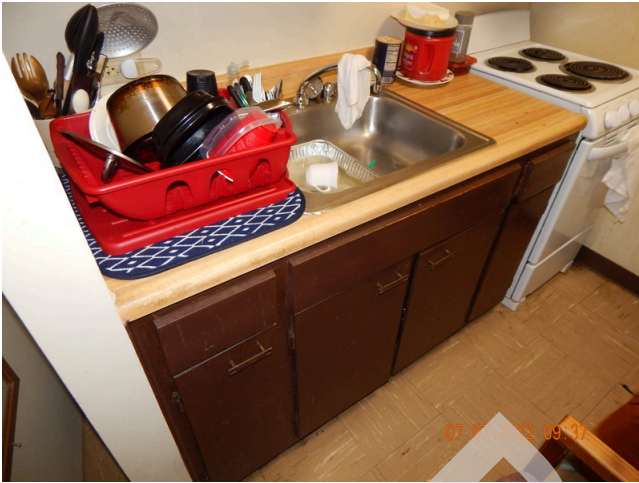
153. Cabinets & Fixtures: Typical dwelling unit kitchen sink, countertop, and wood cabinets found throughout the site.

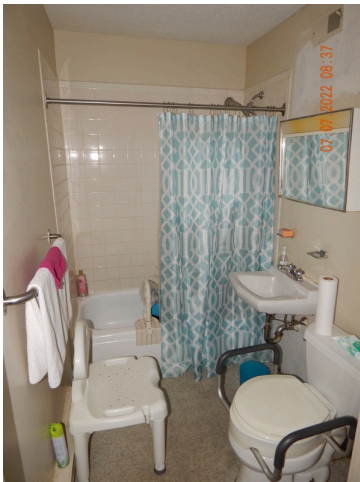
154. Cabinets & Fixtures: Typical dwelling unit porcelain sink and toilet found throughout the site.
