## HUD MAP CAPITAL NEEDS ASSESSMENT

Annapolis  
52 Sumner Street  
Dorchester, Massachusetts 02125

AEI Project No. 463356  
Site Inspection Date: July 6, 2022

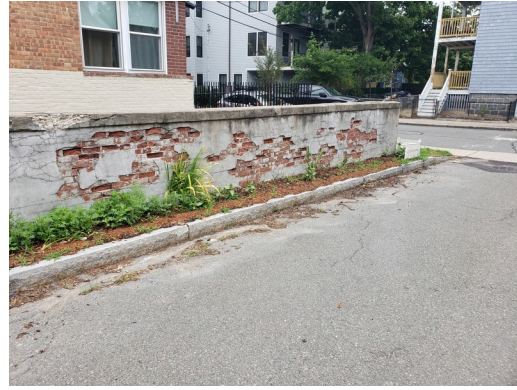
Landscaping & Appurtenances: Damaged CMU wall found on the north perimeter of the property. (Non-Critical Repair)

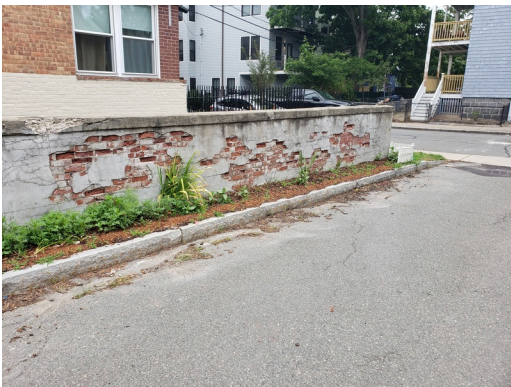
The perimeter brick wall located on the north side of the property was observed damaged, with sections of plaster missing or falling off. AEI recommends repairing the perimeter wall to prevent further damage. (Non-Critical Repair)

Landscaping & Appurtenances: Damaged CMU wall found on the north perimeter of the property. (Non-Critical Repair)

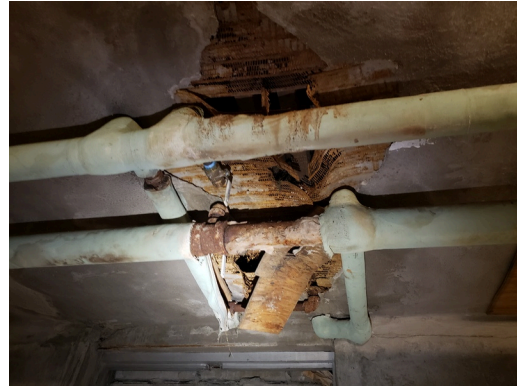
Foundation: Typical cracks on basement walls and ceilings found throughout the site. (Critical Repair)

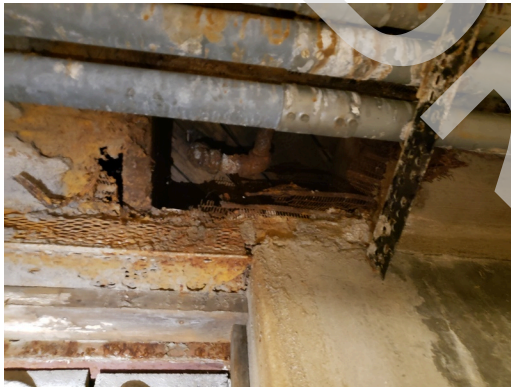
Foundation: Typical cracks on basement walls and ceilings found throughout the site. (Critical Repair)

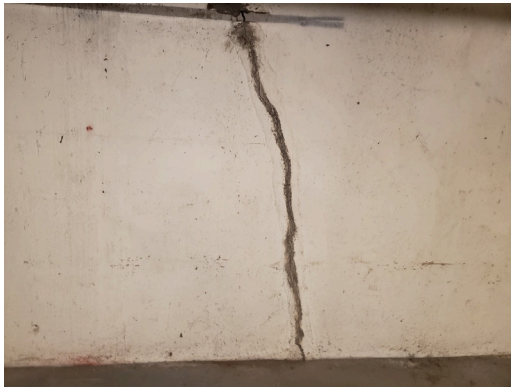
AEI observed significant concrete cracking and splitting at the basements throughout the site. This may be a sign of a structural problem with the concrete structure. AEI recommended having a structural engineer assess this issue for safety reasons. (Critical Repair)

Foundation: Typical cracks on basement walls and ceilings found throughout the site. (Critical Repair)

Address findings by a structural engineer to prevent future damage to the buildings. (Non-Critical Repair)

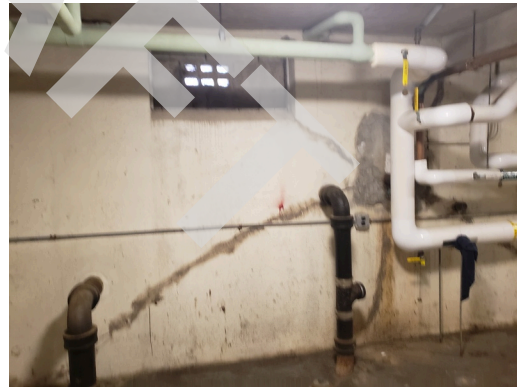
Foundation: Typical cracks on basement walls and ceilings found throughout the site. (Critical Repair)

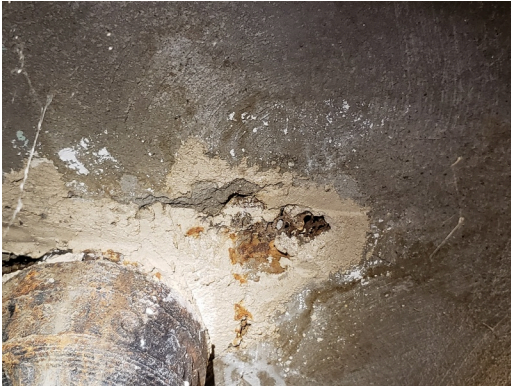
Foundation: Typical cracks on basement walls and ceilings found throughout the site.  
(Critical Repair)

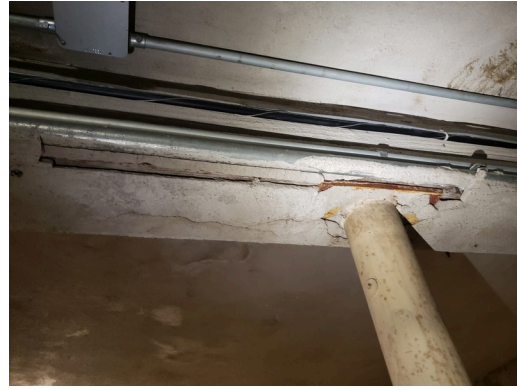
Foundation: Typical cracks on basement walls and ceilings found throughout the site.  
(Critical Repair)

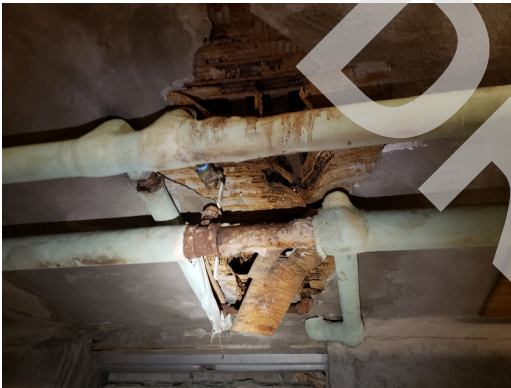
Foundation: Typical cracks on basement walls and ceilings found throughout the site.  
(Critical Repair)

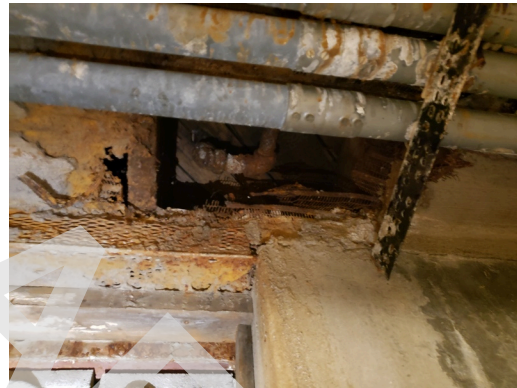
Foundation: Typical cracks on basement walls and ceilings found throughout the site.  
(Critical Repair)

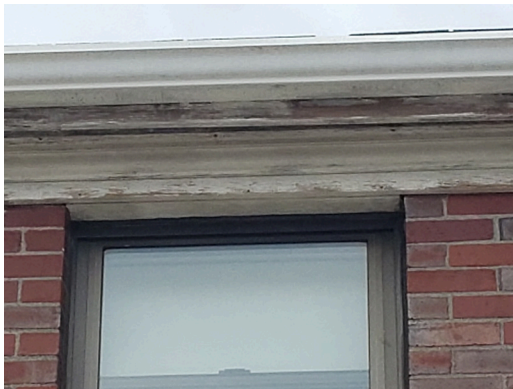
Attics & Eaves: Typical perforated eaves vents found throughout the site (Non-Critical Repair)

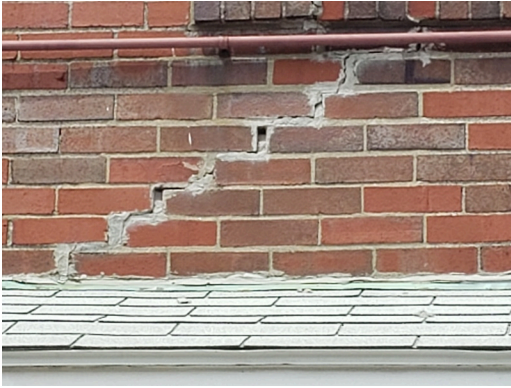
Large sections of cracked brick were observed at 52-56 Summer street and other sections throughout the site. Cracks on the brick can be a source of water intrusion and allow pests to access the building. Therefore, AEI recommends addressing any damaged brick sections to maintain the building's structural integrity. (Non-Critical Repair)

Sidewall System: Typical cracked unpainted brick found throughout the site. (Non-Critical Repair)

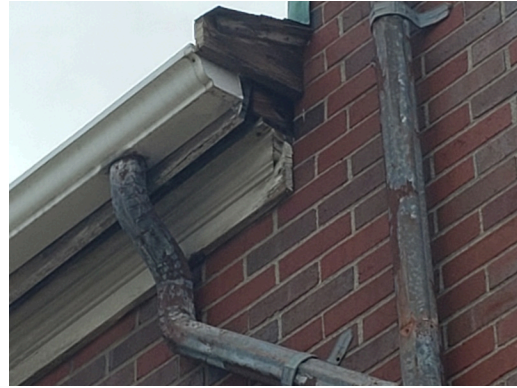
The wood trim on the soffits throughout the site was observed damaged, weathered, and rotted. Any damaged or weathered wood trim can be a source of water intrusion and allow pests to access the building. Therefore, AEI recommends addressing any damaged sections of wood trim to maintain the building's structural integrity. (Non-Critical Repair)

Sidewall System: Typical weathered and damaged wood trim found throughout the site. (Non-Critical Repair)

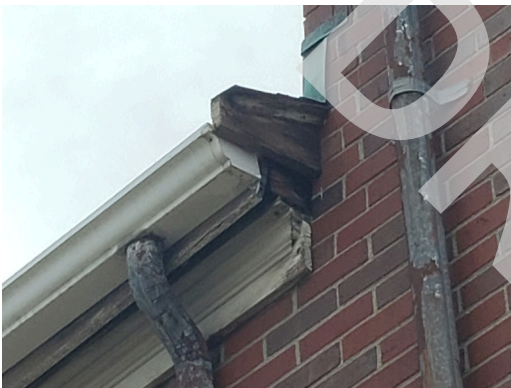
Sidewall System: Typical weathered and damaged wood trim found throughout the site. (Non-Critical Repair)

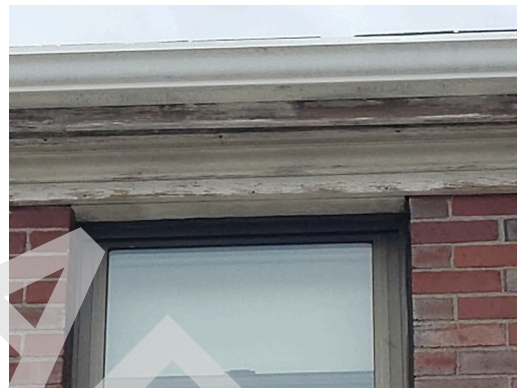
Sidewall System: Typical weathered and damaged wood trim found throughout the site. (Non-Critical Repair)

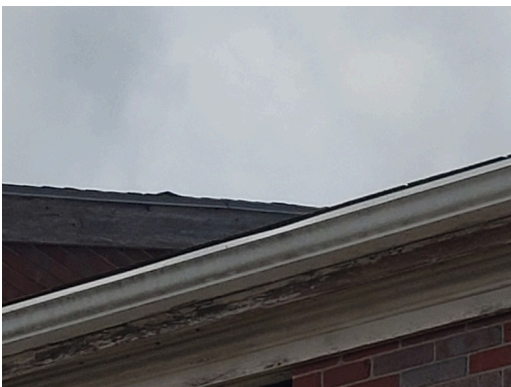
Sidewall System: Typical weathered and damaged wood trim found throughout the site. (Non-Critical Repair)

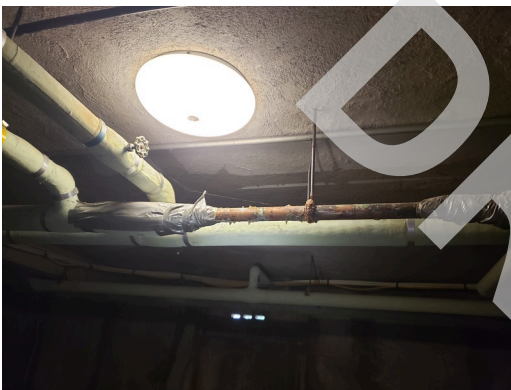
Sections of pipe corrosion were observed in the basement on 15-19 Basketfield st. The pipes showed signs of deterioration that will cause significant leaks in the short term. Therefore, AEI recommends addressing the issue causing the corrosion and replacing any damaged piping sections. (Non-Critical Repair)

Plumbing: Typical corroded pipes found throughout the property. (Non-Critical Repair)

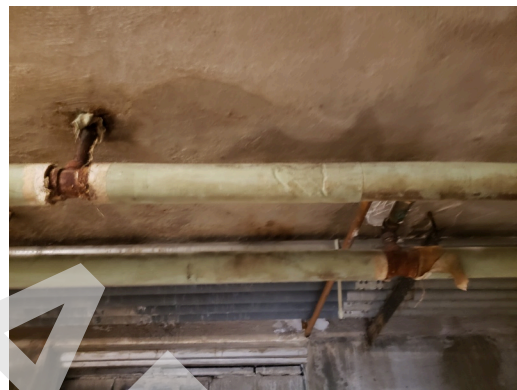
Item	Description	Action	Condition
Hot and Cold Water Distribution	Copper pipe	IM/RR	Fair/Poor
Polybutylene Water Piping	No polybutylene piping was observed or reported.	NA	Not applicable
Sanitary Waste and Vent	Cast iron and PVC pipes	IM	Poor
Domestic Water Circulation Pumps	Four (4) water circulation pumps on site	RR	Good
Domestic Water Heaters	Not applicable	NA	Not applicable
Domestic Water Boilers	Central high-efficiency boiler with separate storage tank	IM/RR	Good
Boiler Peripherals	Not applicable	NA	Not applicable
Water Softening / Treatment	Not applicable	NA	Not applicable

Plumbing: Typical corroded pipes found throughout the property. (Non-Critical Repair)

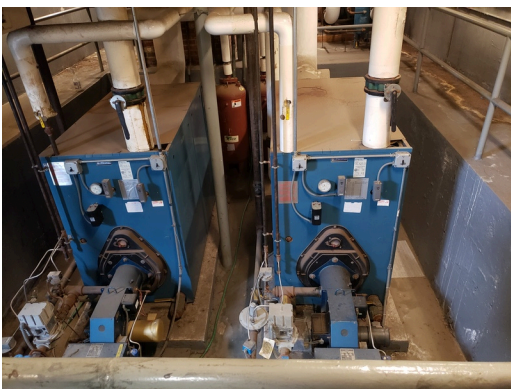
Central gas-fired boilers found on the property.

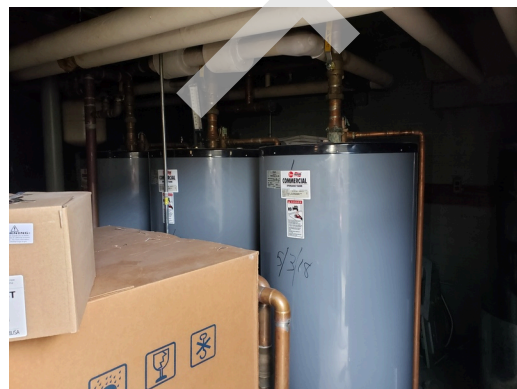
Plumbing: Storage tanks found on the property.

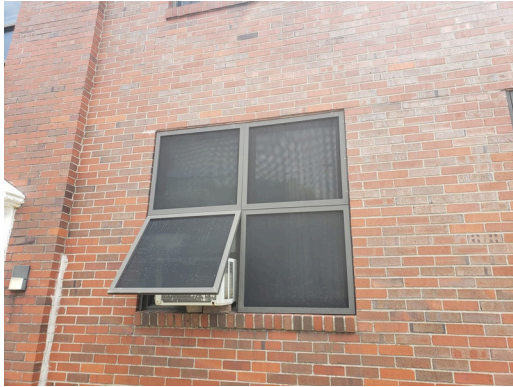
HVAC Systems: Typical tenant owned window unit AC system found throughout the site.

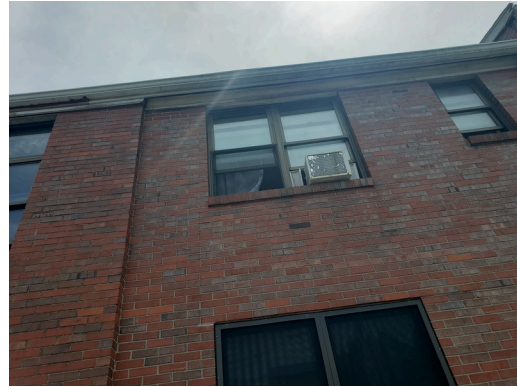
HVAC Systems: Typical tenant owned window unit AC system found throughout the site.

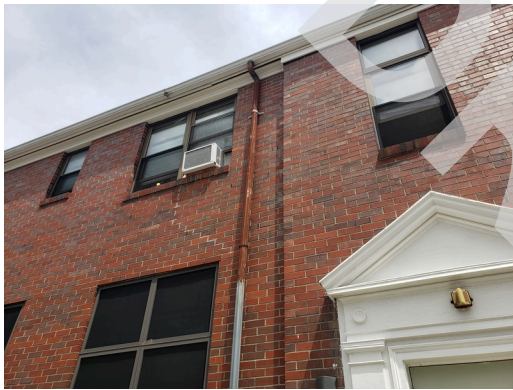
HVAC Systems: Typical tenant owned window unit AC system found throughout the site.

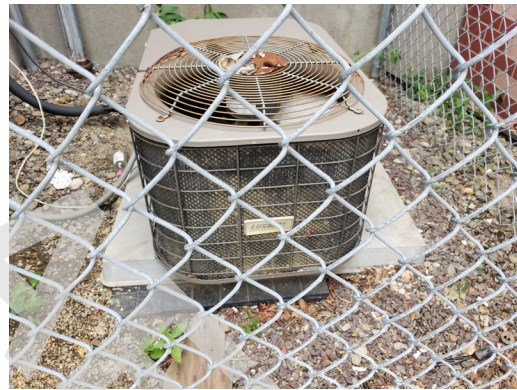
HVAC Systems: 3 ton AC system found at the community room.

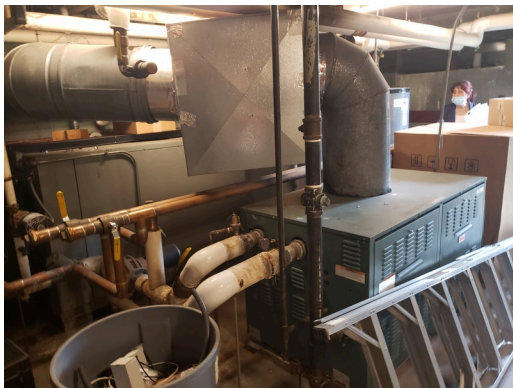
Central gas boilers found on the property.

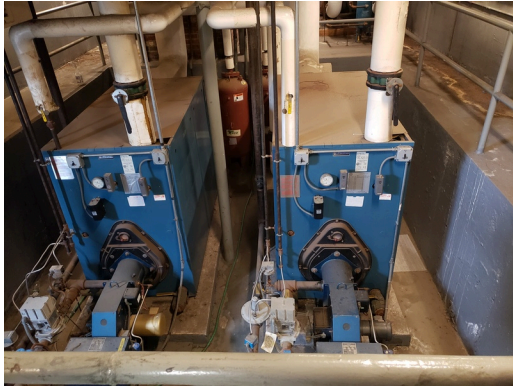
Central gas-fired boilers found on the property.

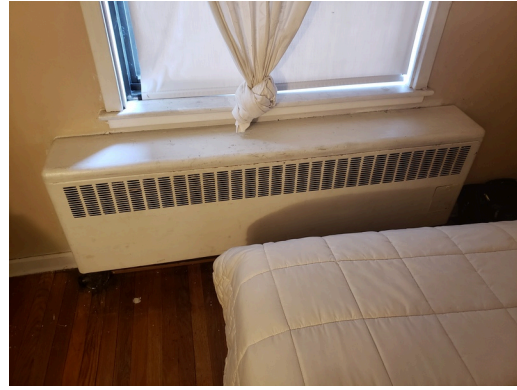
HVAC Systems: Typical hydronic radiant heater found in dwelling units throughout the property.

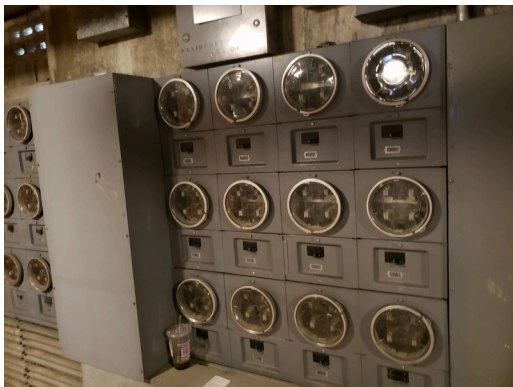
Electrical System: Typical electric meter bank found throughout the site.

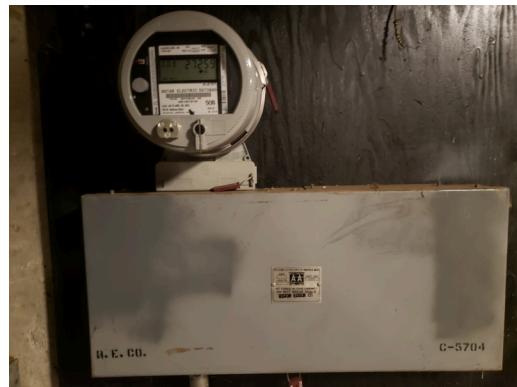
Electrical System: Central electric meter found at the site.

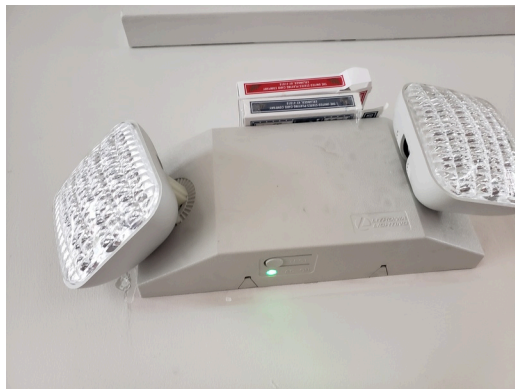
Life & Fire Safety: Typical emergency lighting found throughout the site.

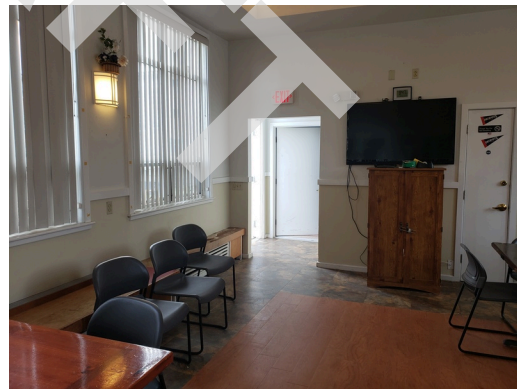
Life & Fire Safety: Typical illuminated exit sign found throughout the site.

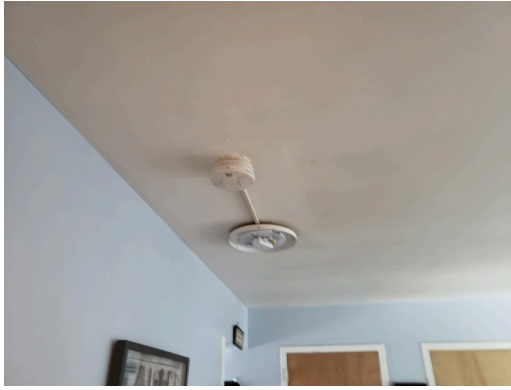
Life & Fire Safety: Typical non-compliant smoke detector found throughout the site. (Critical Repair)

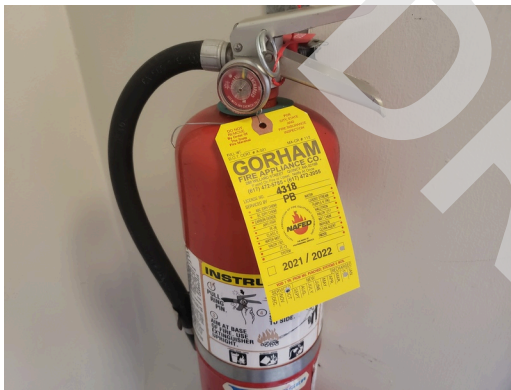
Life & Fire Safety: Typical fire extinguisher found throughout the site.

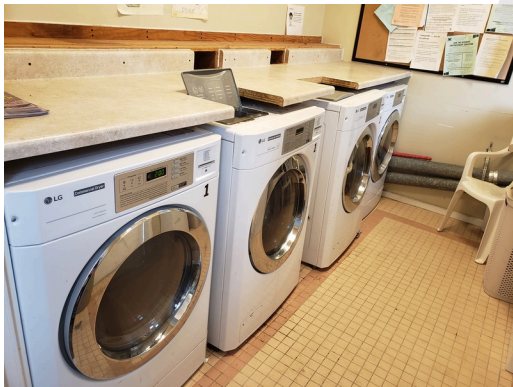
Common Area Interior Elements: Common laundry room.

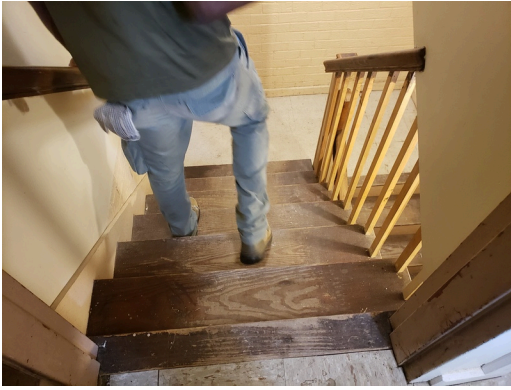
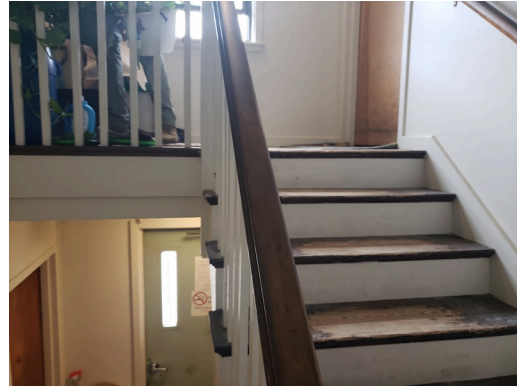
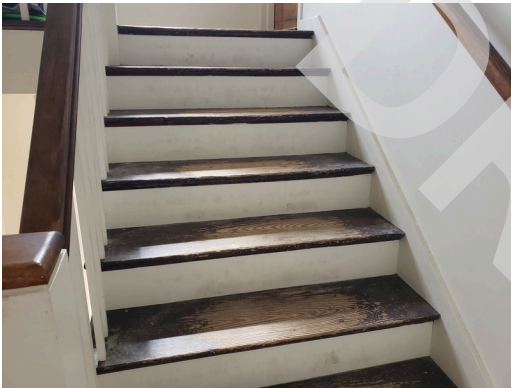
Common Area Interior Elements: Typical staircase with worn down finishes found throughout the site. (Non-Critical Repair)

The majority of the hallway staircases were observed with worn down or damaged finishes. Therefore, sanding and repainting the railings and replacing all floor and wall finishes are recommended. (Non-Critical Repair)

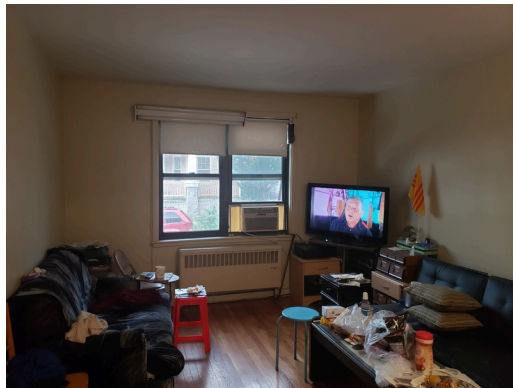
Dwelling Unit Interior Elements: Typical wood laminate flooring and sheetrock finish found in dwelling units throughout the site.

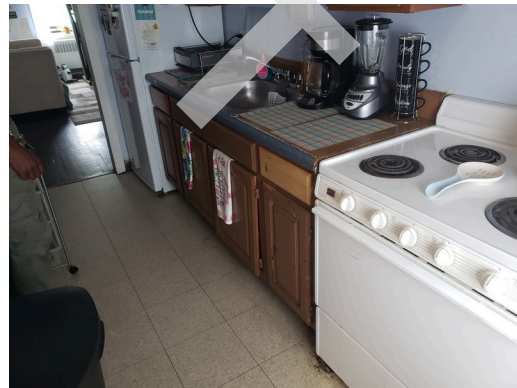
Dwelling Unit Interior Elements: Typical vinyl flooring and sheetrock finish found in dwelling units throughout the site.

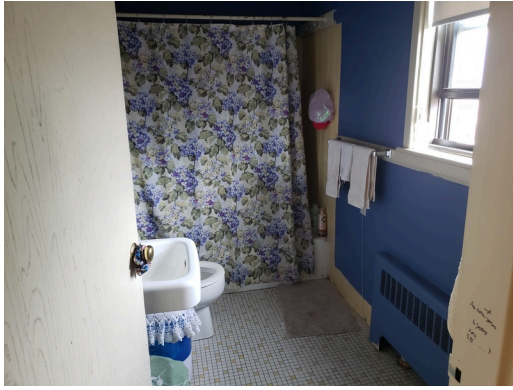
Dwelling Unit Interior Elements: Typical tile flooring and sheetrock finish found in dwelling units throughout the site.

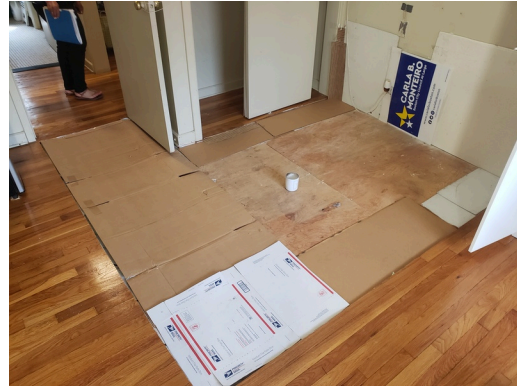
Dwelling Unit Interior Elements: Removed flooring and finishes due to decomposing body removal. (Critical Repair)

The flooring and some of the finishes in unit 35 were removed due to hazmat concerns after the death of a person occurred in the unit. AEI was informed that the property got the all-clear to address all repairs in the unit. Therefore, AEI recommends that the work be completed, and proof of occupancy be provided. (Critical Repair)

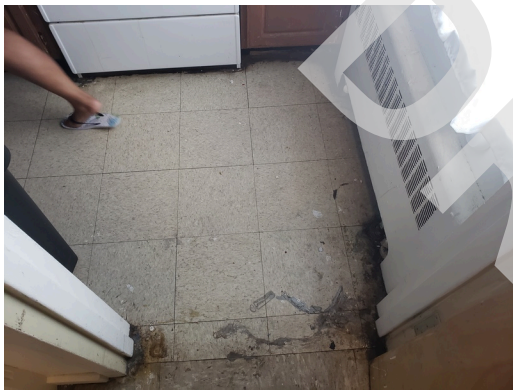
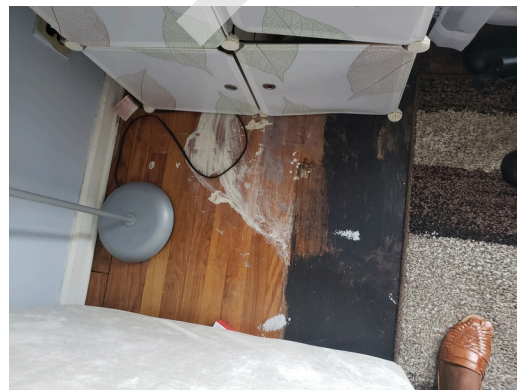
Dwelling Unit Interior Elements: Damaged finishes observed in unit 4. (Non-Critical Repair)

Units 4 and 20 were observed with damaged finishes ranging from damaged doors, wood flooring, vinyl flooring, and paint. The tenants reported that the damages were present when they moved in, and work orders had been issued. AEI recommends addressing this and any other work order that has not been addressed. (Non-Critical Repair)

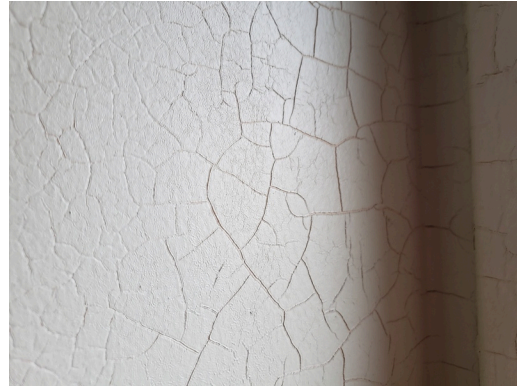
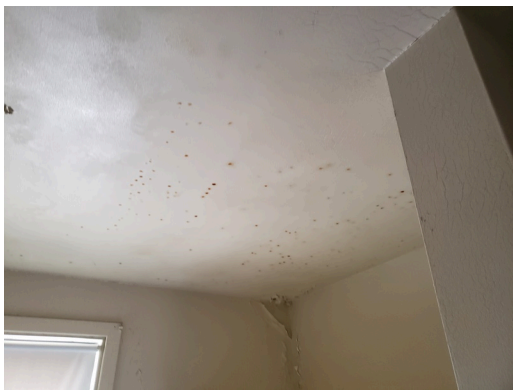
Dwelling Unit Interior Elements: Damaged finishes observed in unit 20. (Non-Critical Repair)

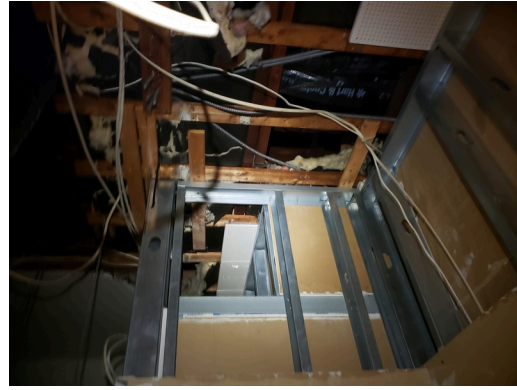
Dwelling Unit Interior Elements: Typical damaged sheetrock ceilings found throughout the site. (Non-Critical Repair)

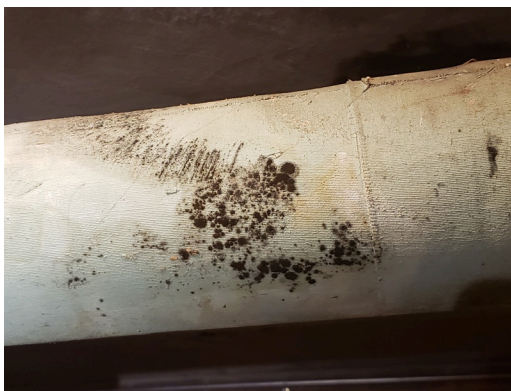
Suspect Mold growth was observed in a large number of pipes in many of the basements. Therefore, EAI recommends addressing any suspect Mold growth throughout the property for safety reasons. (Critical Repair)

Moisture and Microbial Growth: Mold on water pipes observed throughout the site. (Critical Repair)

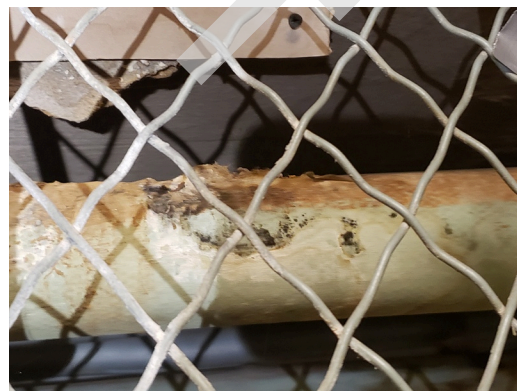
Moisture and Microbial Growth: Mold on water pipes observed throughout the site. (Critical Repair)

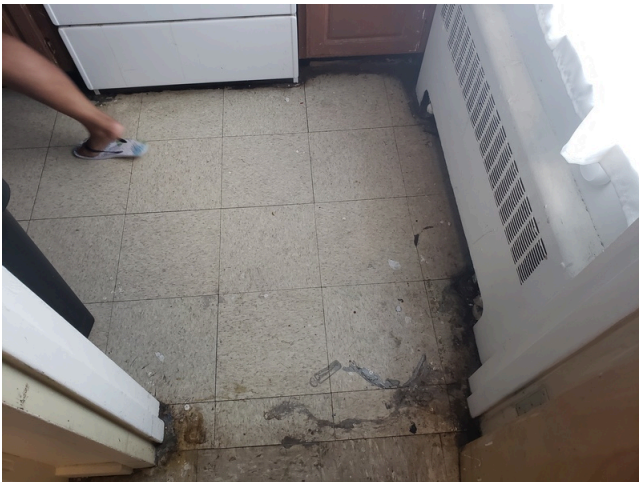
3. Building 1; Unit: 4; Floor: 2; Style: 2 Bed / 1 Bath: Damaged kitchen finishes. (Non-Critical Repair)

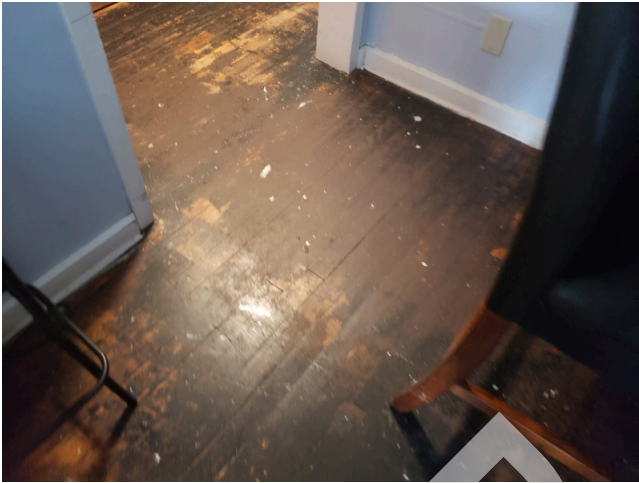
5. Building 1; Unit: 4; Floor: 2; Style: 2 Bed / 1 Bath: Damaged living room finishes. (Non-Critical Repair)

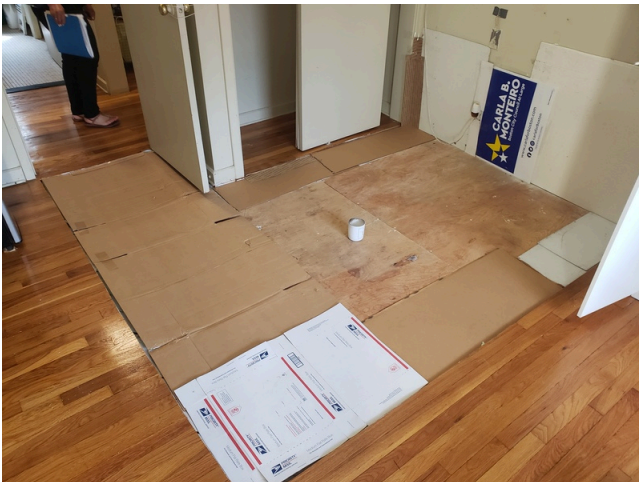
19. Building 2; Unit: 35; Floor: 2; Style: 1 Bed / 1 Bath: Living room with missing finishes. (Critical Repair)

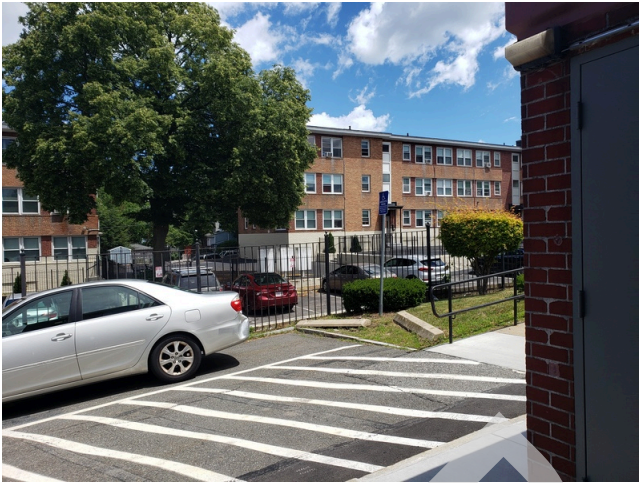
12. Paving, Curbing, & Parking: Typical parking spaces found throughout the property.

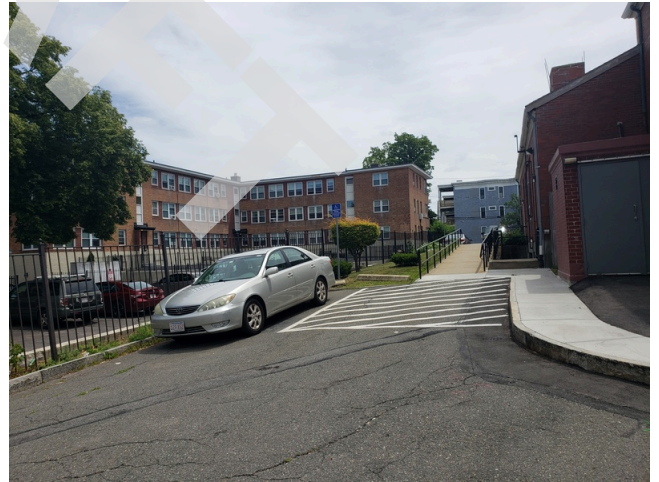
19. Landscaping & Appurtenances: Typical landscaping found throughout at the property.

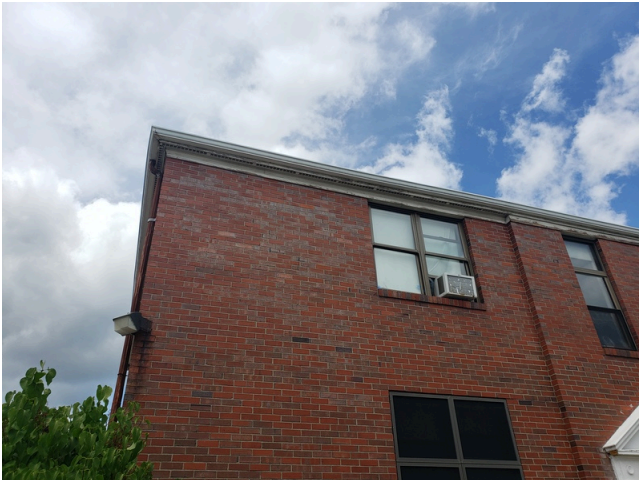
22. Landscaping & Appurtenances: Typical building lighting found throughout the property.

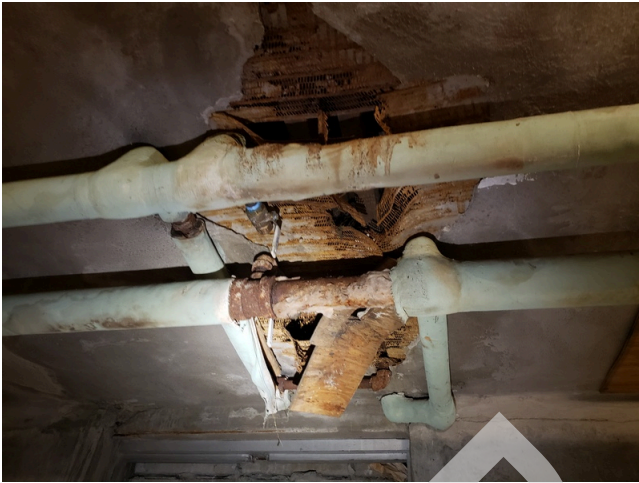
28. Foundation: Typical basement found throughout the site.

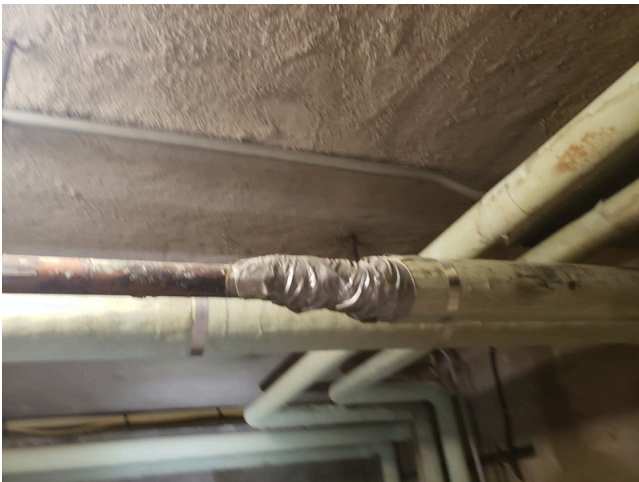
30. Foundation: Typical cracks on basement walls and ceilings found throughout the site. (Critical Repair)

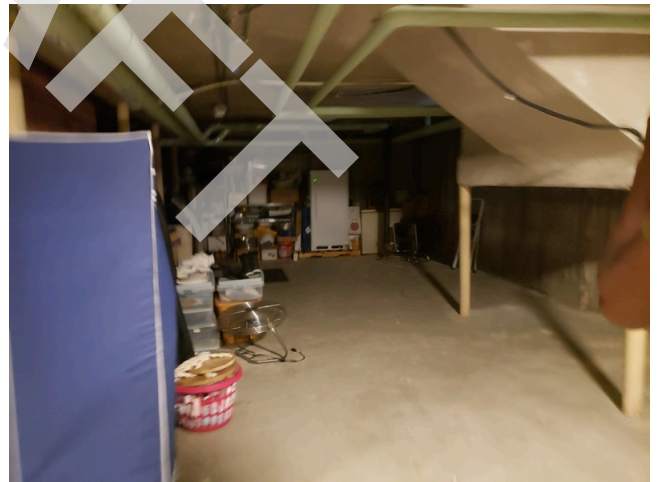
31. Plumbing: Typical corroded pipes found throughout the property. (Non-Critical Repair)

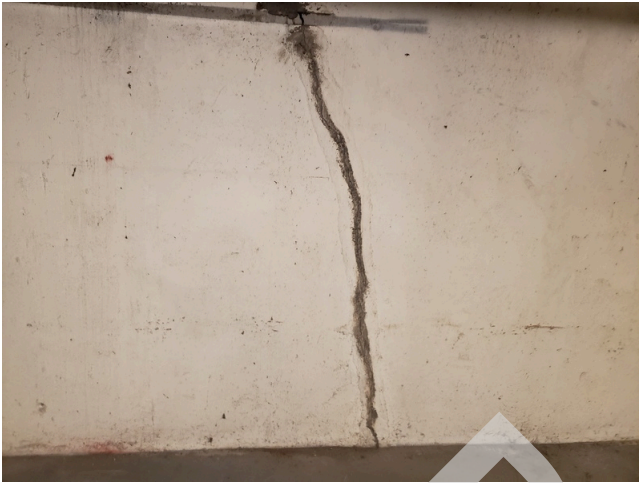
32. Foundation: Typical basement found throughout the site.

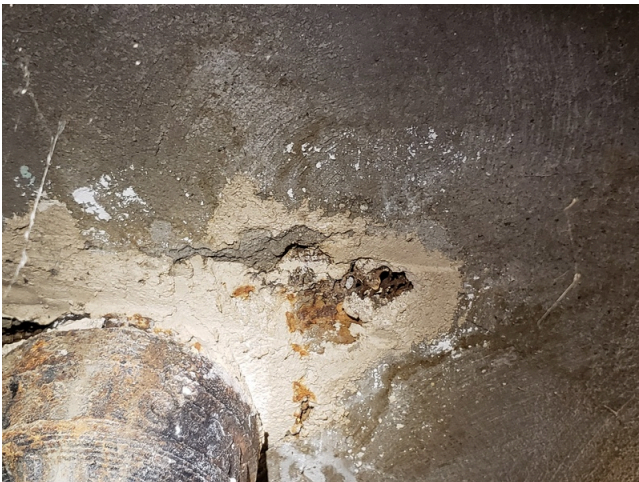
34. Foundation: Typical cracks on basement walls and ceilings found throughout the site. (Critical Repair)

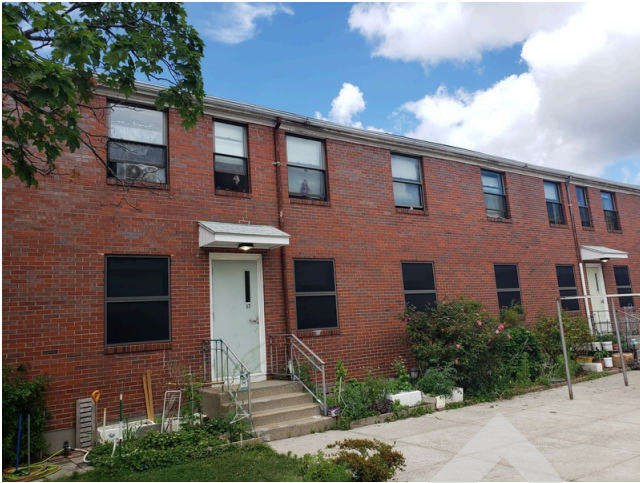
40. Exterior Doors & Entry Systems: Typical building access door found throughout the site.

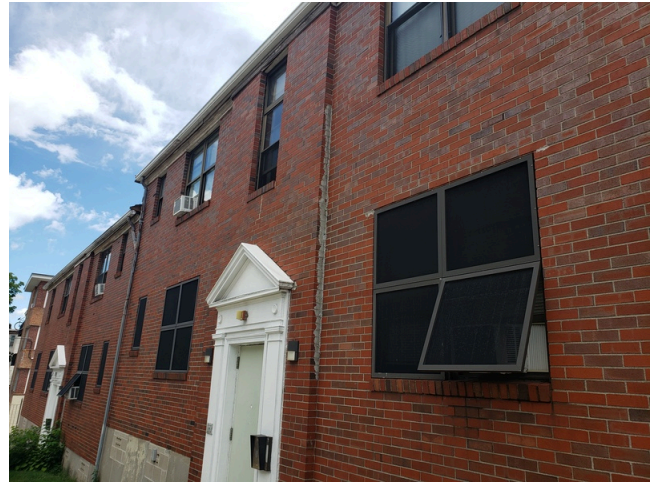
41. Sidewall System: Typical sidewall unpainted brick found throughout the site.

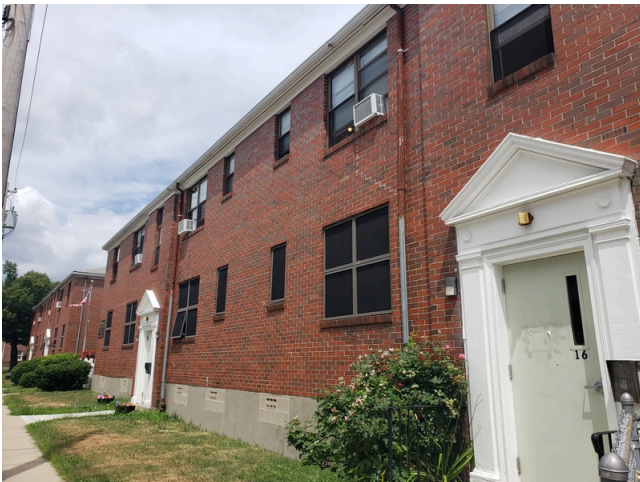
42. Sidewall System: Typical sidewall unpainted brick found throughout the site.

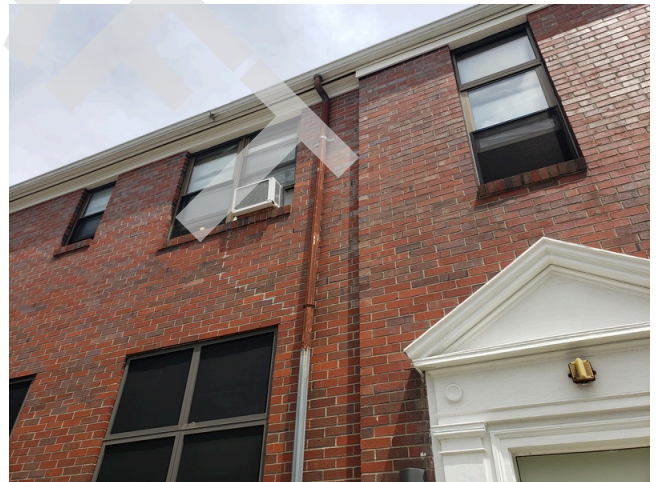
43. Sidewall System: Typical sidewall unpainted brick found throughout the site.

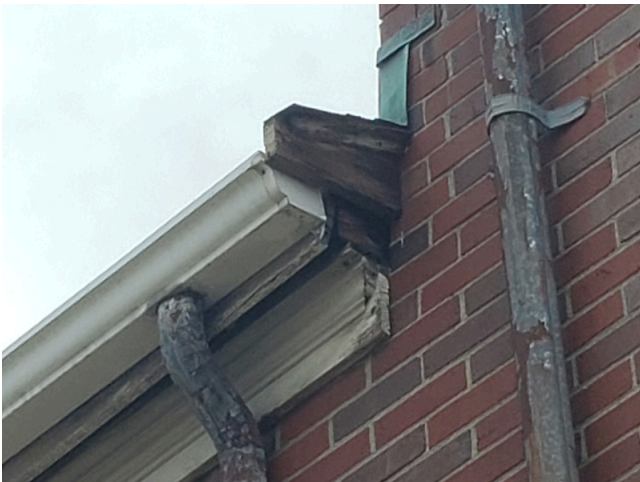
46. Sidewall System: Typical weathered and damaged wood trim found throughout the site. (Non-Critical Repair)

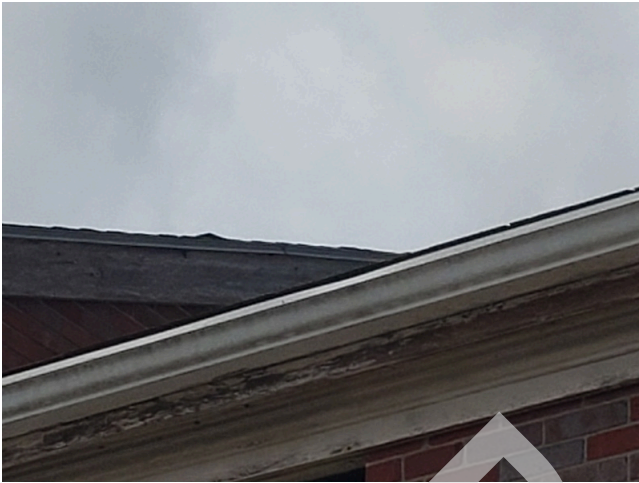
48. Sidewall System: Typical weathered and damaged wood trim found throughout the site. (Non-Critical Repair)

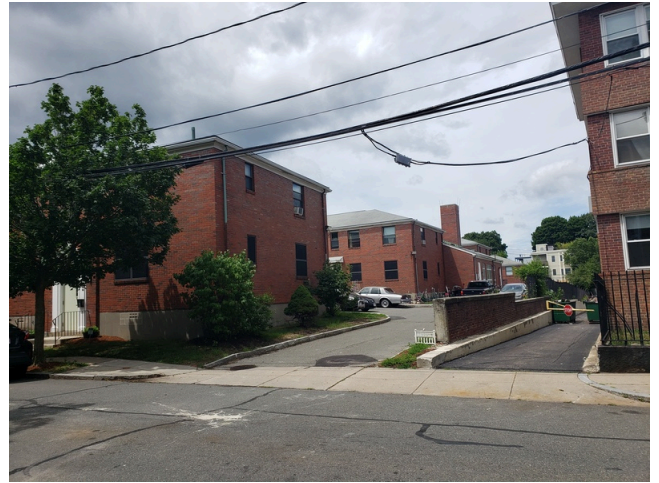
49. Sidewall System: Typical weathered and damaged wood trim found throughout the site.  
(Non-Critical Repair)

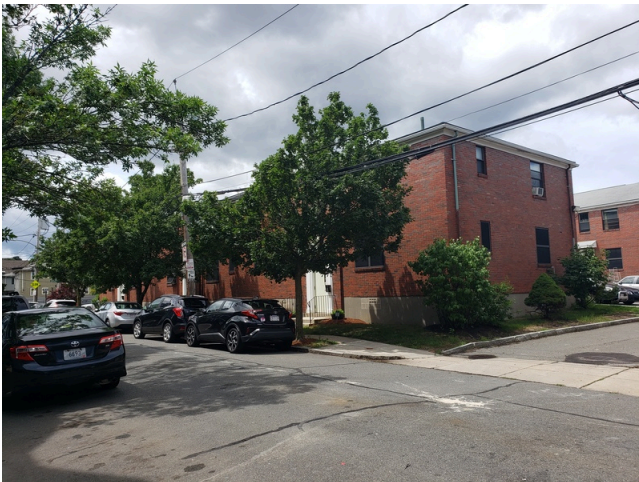
50. Sidewall System: Building 2 northeast corner facade.

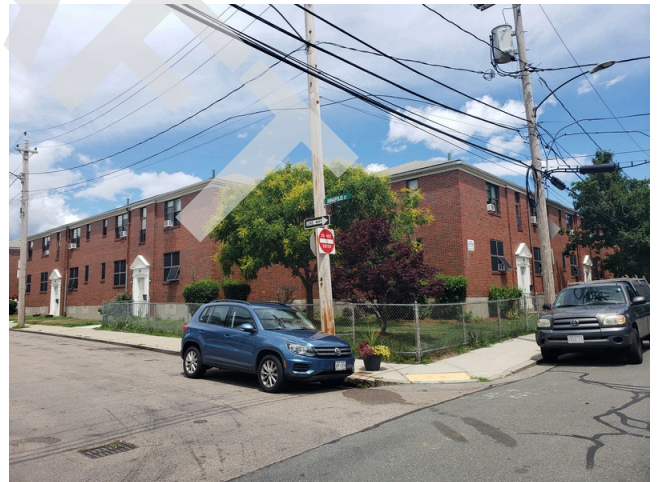
51. Sidewall System: Building 2 east facade.

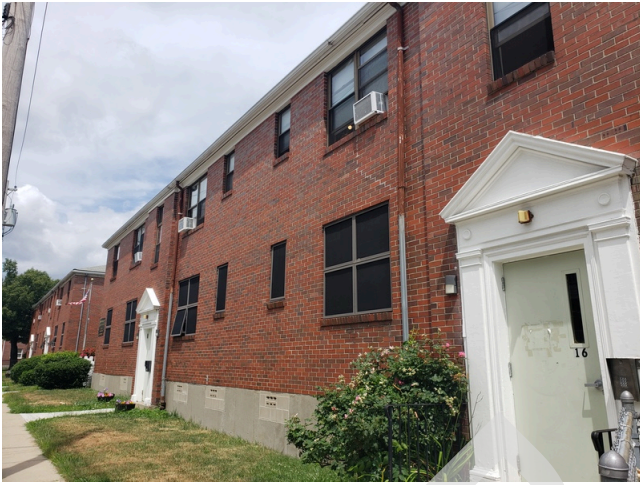
52. Sidewall System: Building 2 southeast corner facade.

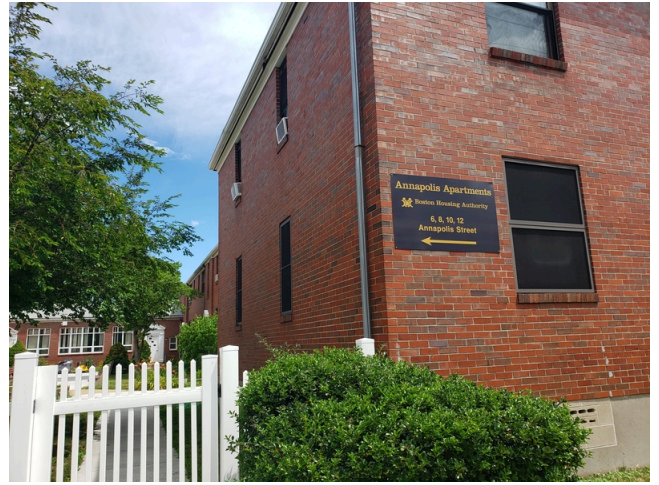
53. Sidewall System: Building 2 south facade.

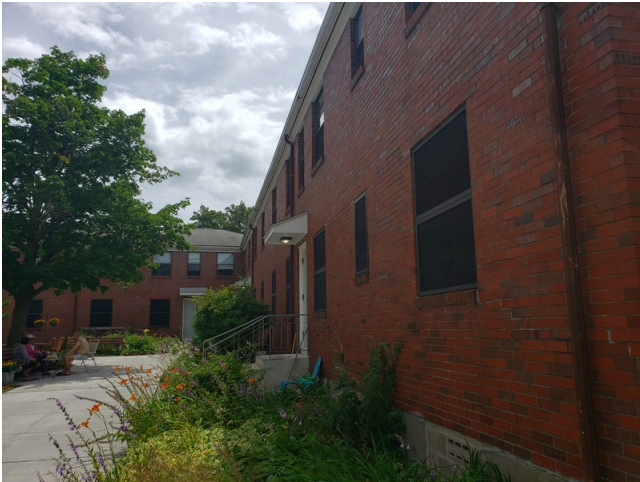
54. Sidewall System: Building 2 southwest corner facade.

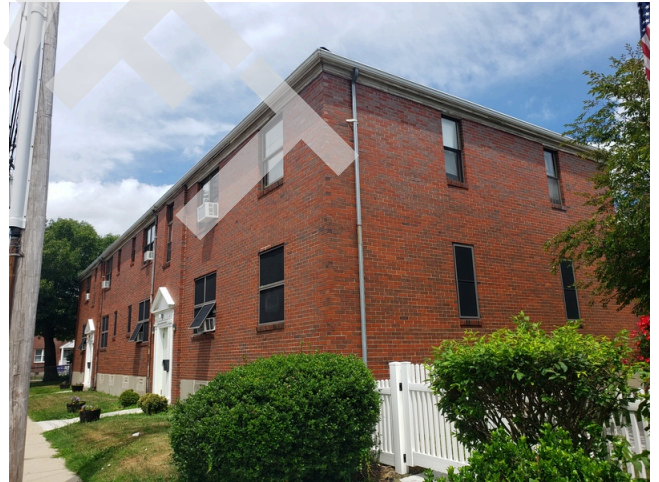
55. Sidewall System: Building 2 west internal facade.

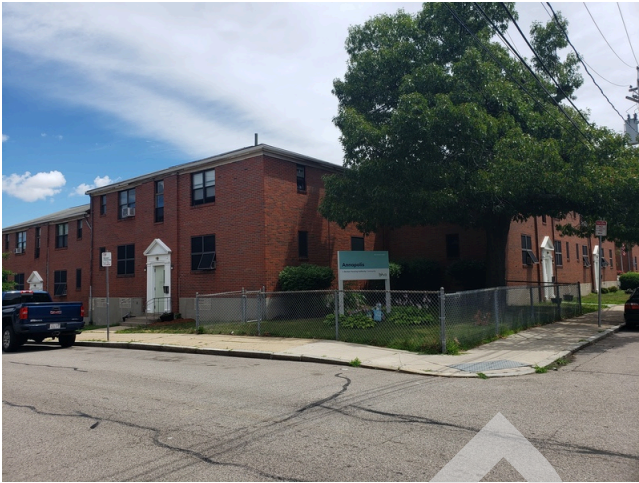
56. Sidewall System: Building 1 southeast corner facade.

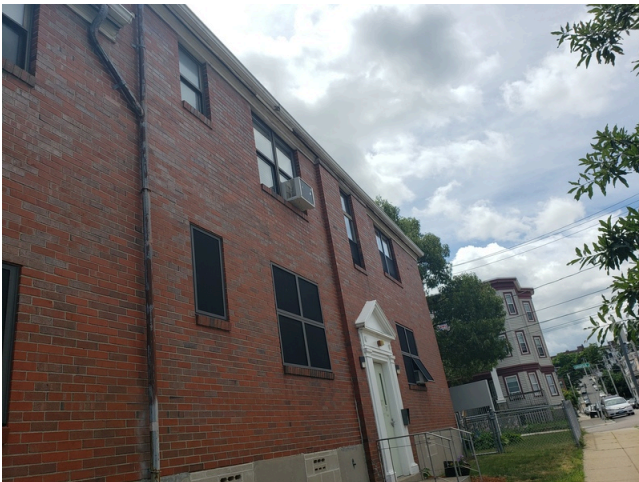
58. Sidewall System: Building 1 west facade.

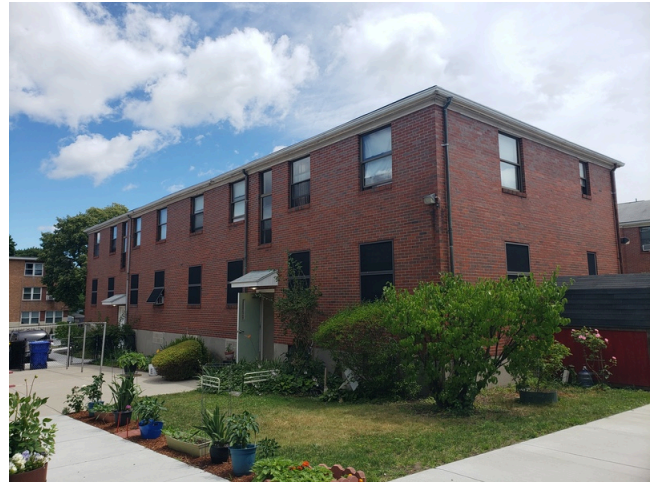
62. Sidewall System: Building 3 southwest corner facade.

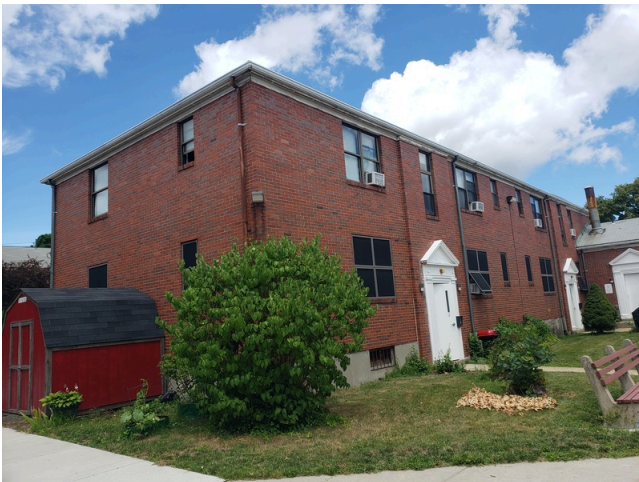
63. Sidewall System: Building 3 southwest corner facade.

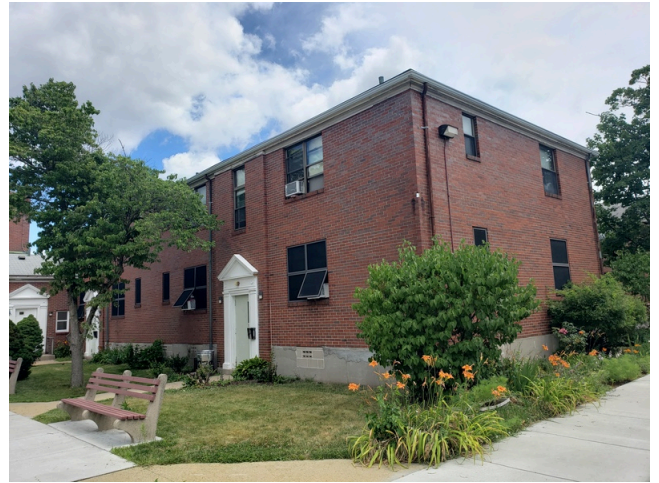
66. Sidewall System: Building 3 northwest corner facade.

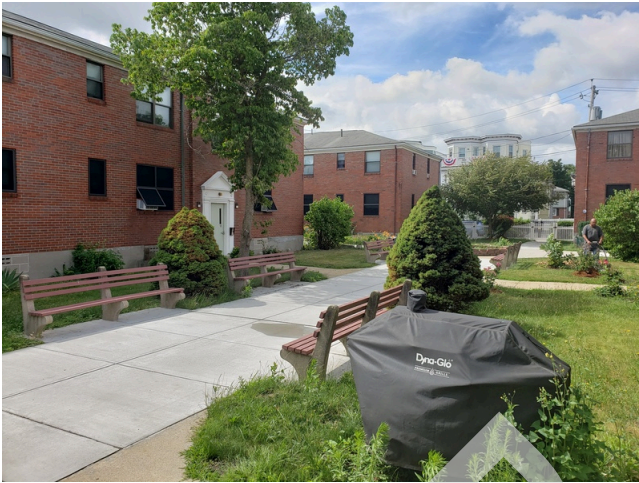
69. Roofing Finish: Typical asphalt shingle roofing found throughout the site.

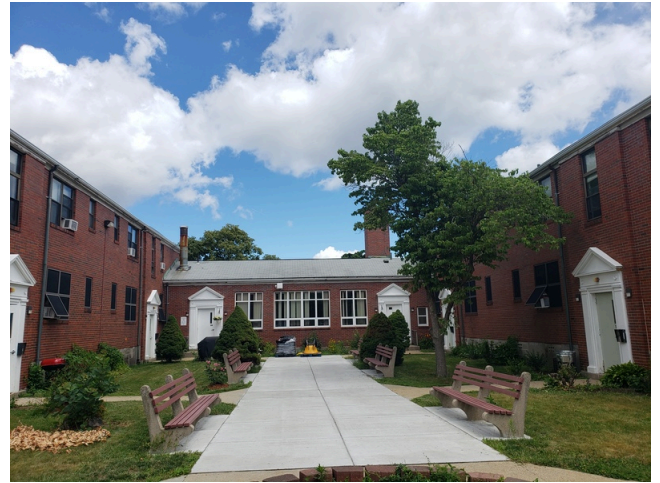
70. Roofing Finish: Typical asphalt shingle roofing found throughout the site.

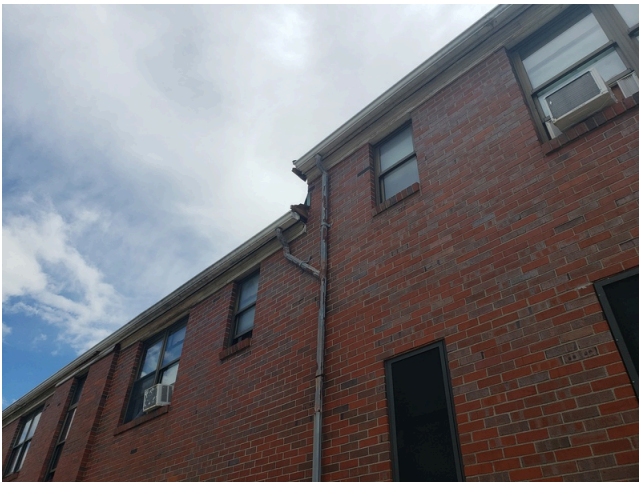
71. Roofing Finish: Typical gutters and downspouts found throughout the site.

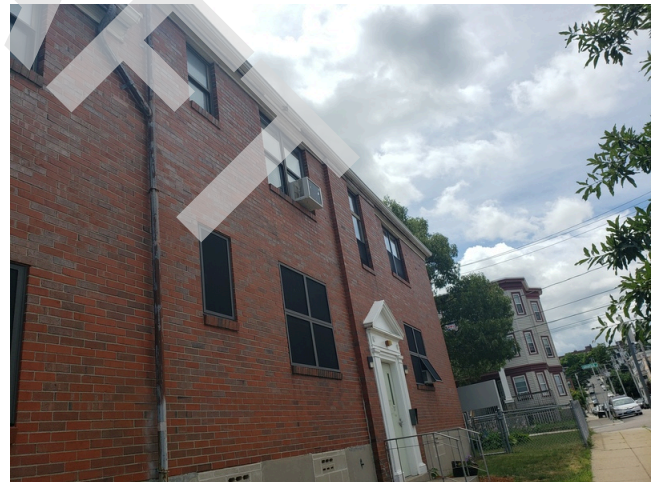
72. Roofing Finish: Typical gutters and downspouts found throughout the site.

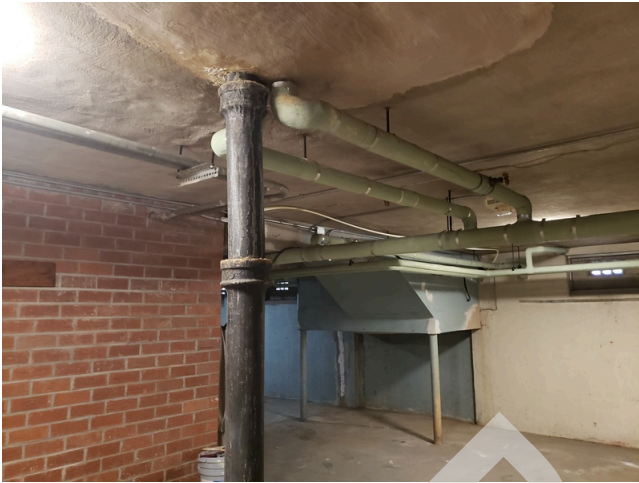
73. Plumbing: Typical cast iron and PVC waste pipes found throughout the property.
