## HUD MAP CAPITAL NEEDS ASSESSMENT

Annapolis  
52 Sumner Street  
Dorchester, Massachusetts 02125

AEI Project No. 463356  
Site Inspection Date: July 6, 2022

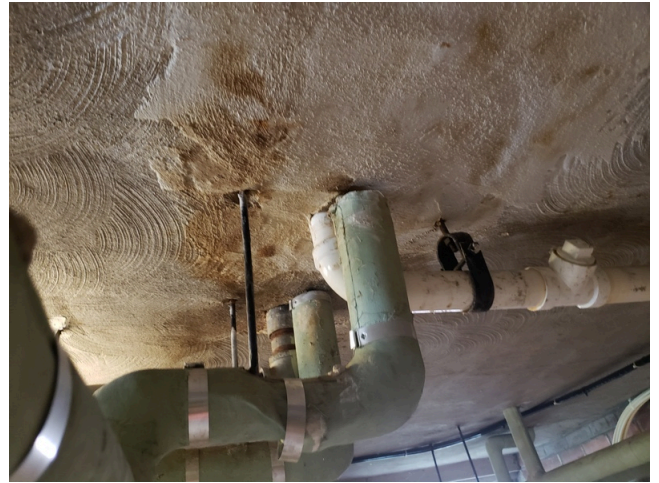
74. Plumbing: Typical cast iron and PVC waste pipes found throughout the property.

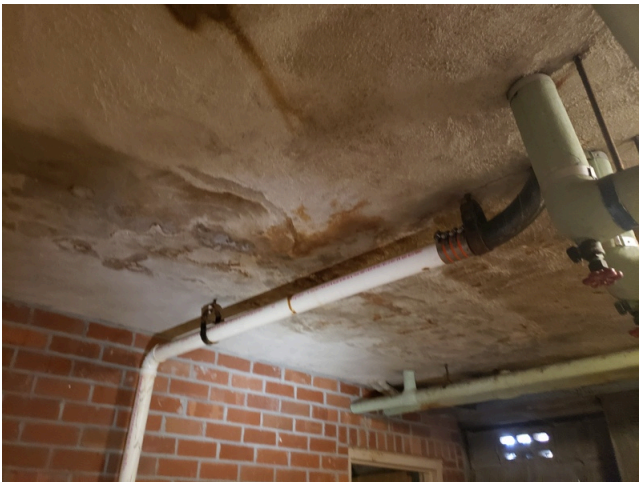
75. Plumbing: Typical cast iron and PVC waste pipes found throughout the property.

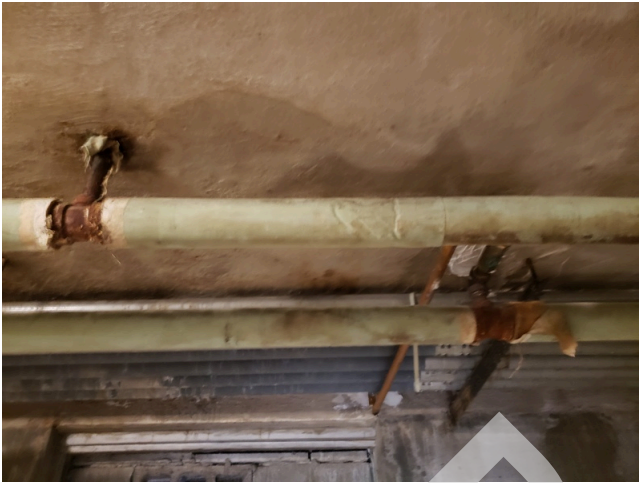
77. Plumbing: Typical corroded pipes found throughout the property. (Non-Critical Repair)

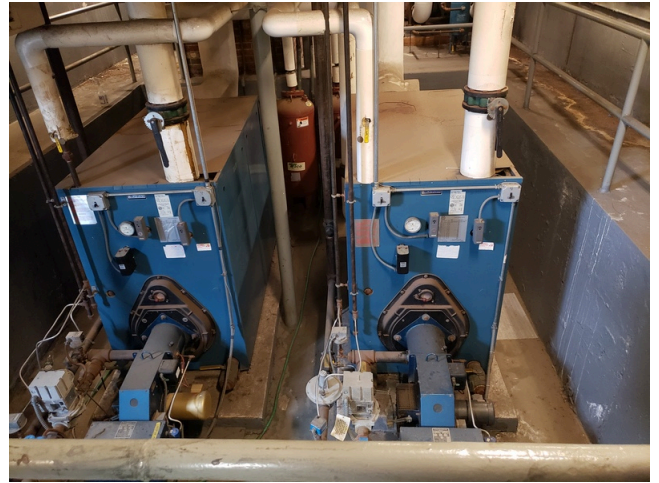
78. Central gas-fired boilers found on the property.

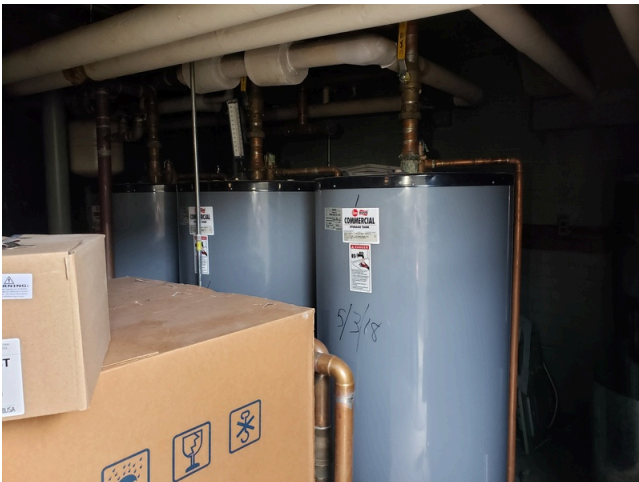
79. Plumbing: Storage tanks found on the property.

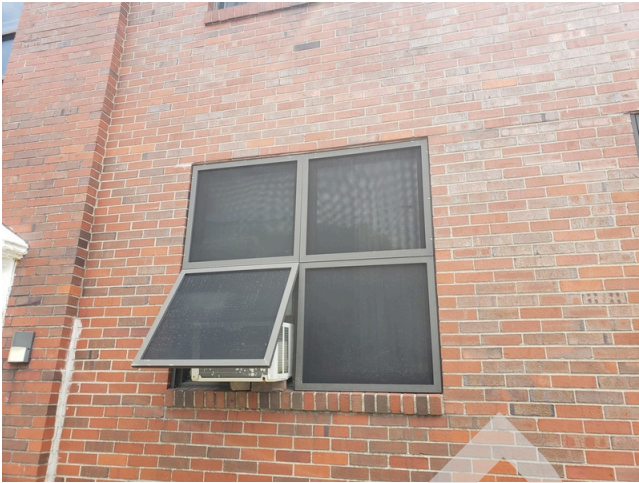
81. HVAC Systems: Typical tenant owned window unit AC system found throughout the site.

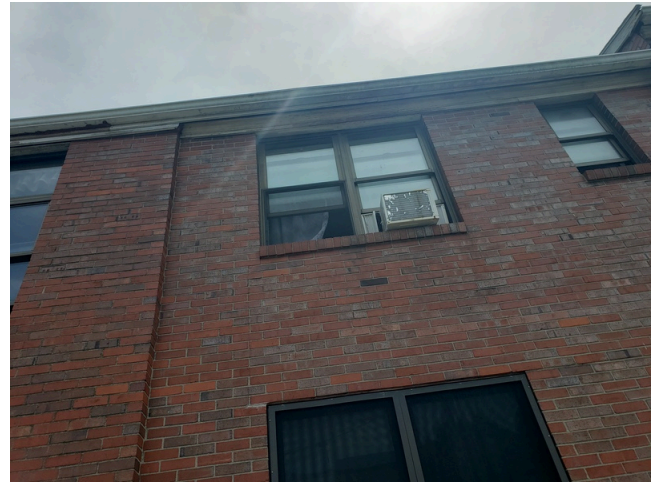
82. HVAC Systems: Typical tenant owned window unit AC system found throughout the site.

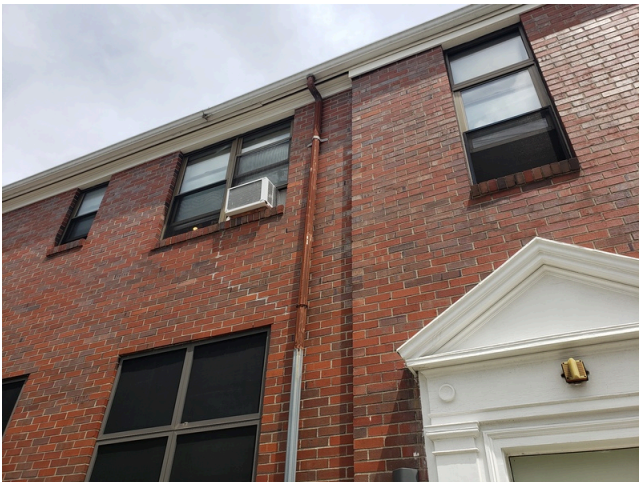
83. HVAC Systems: Typical tenant owned window unit AC system found throughout the site.

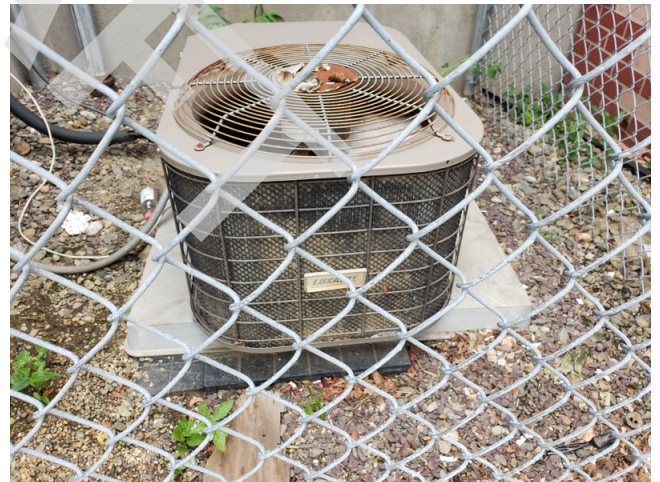
84. HVAC Systems: 3 ton AC system found at the community room.

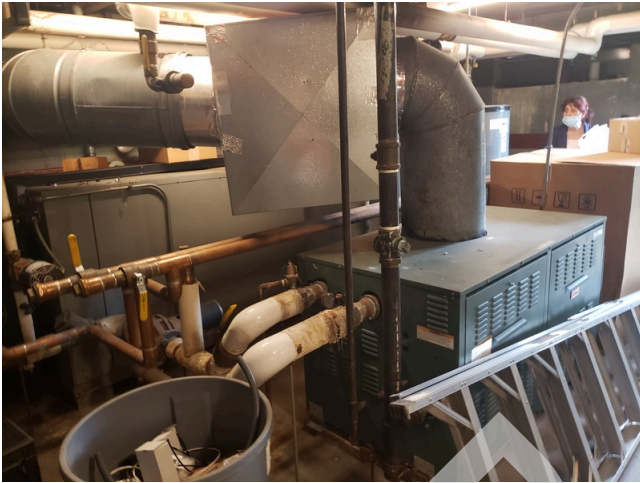
85. Central gas boilers found on the property.

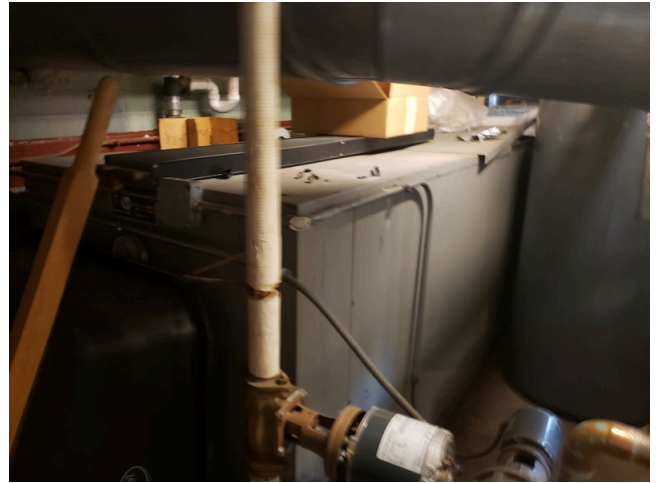
86. Central gas boilers found on the property.

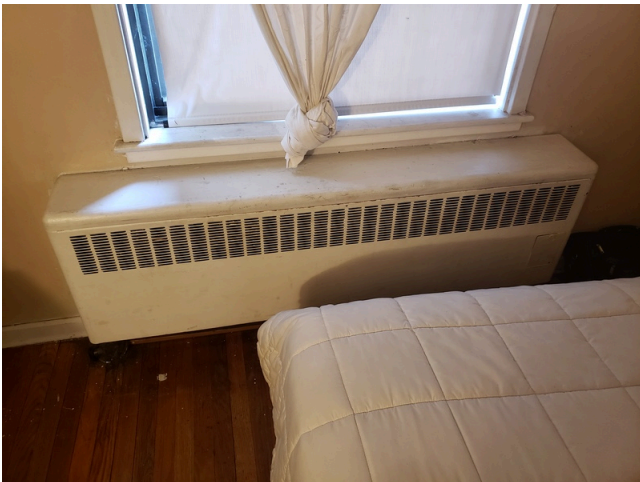
87. HVAC Systems: Typical hydronic radiant heater found in dwelling units throughout the property.

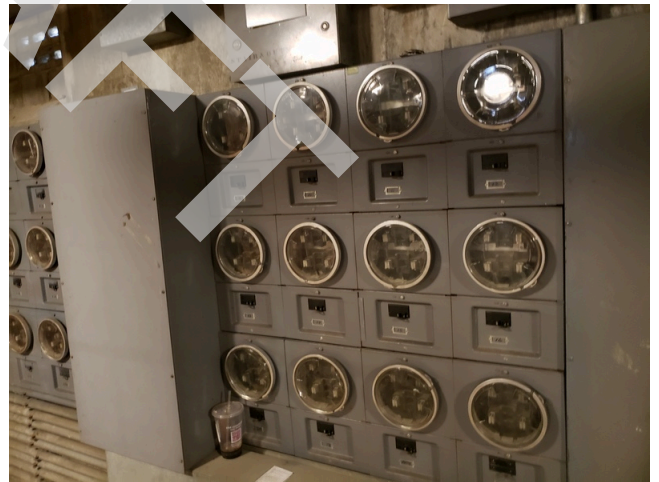
88. Electrical System: Typical electric meter bank found throughout the site.

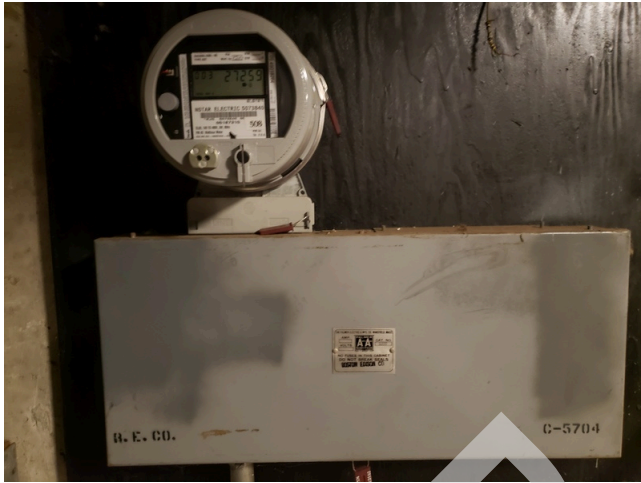
89. Electrical System: Central electric meter found at the site.

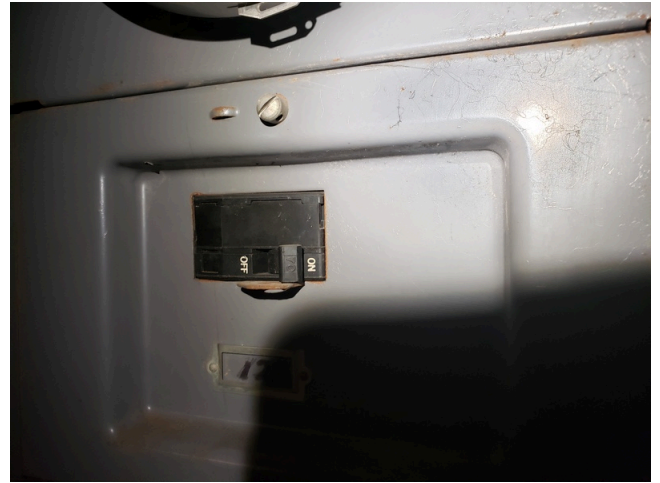
90. Electrical System: Typical master breaker found throughout the site.

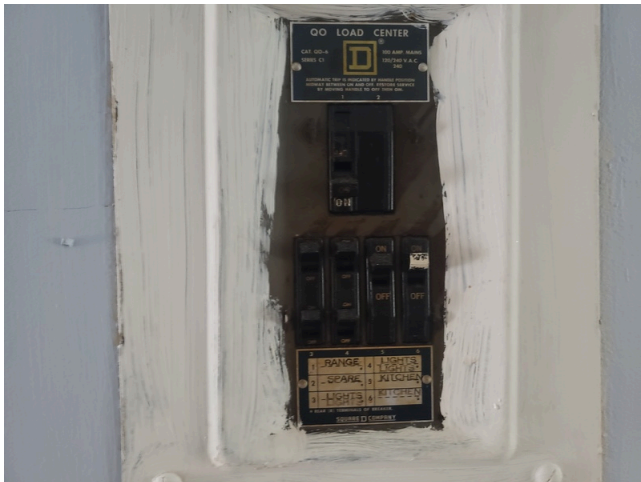
91. Electrical System: Typical dwelling unit electric panel found throughout the site.

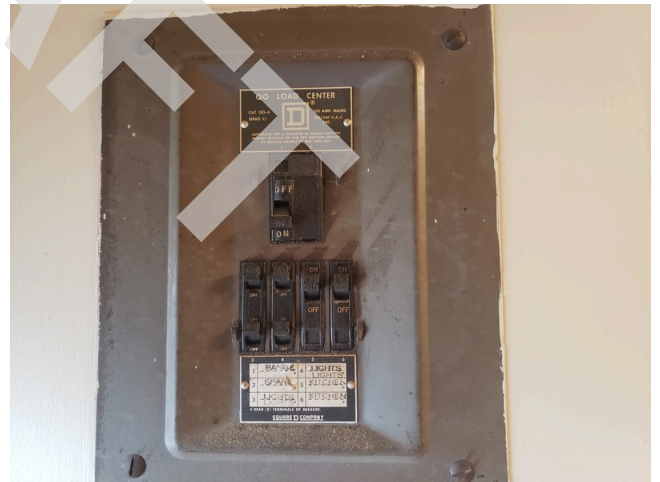
92. Electrical System: Typical dwelling unit electric panel found throughout the site.

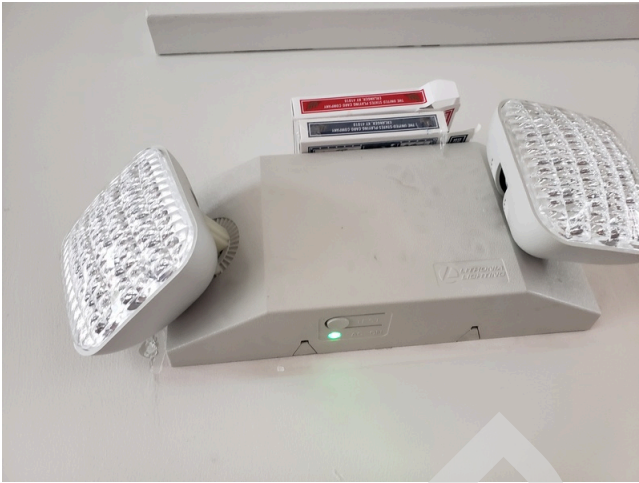
93. Life & Fire Safety: Typical emergency lighting found throughout the site.

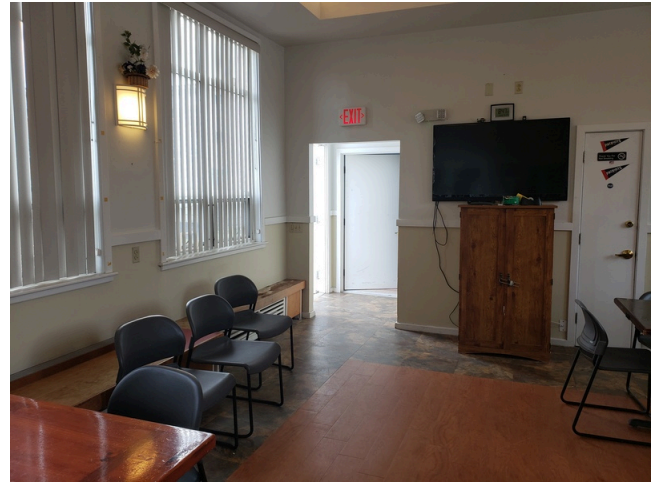
94. Life & Fire Safety: Typical illuminated exit sign found throughout the site.

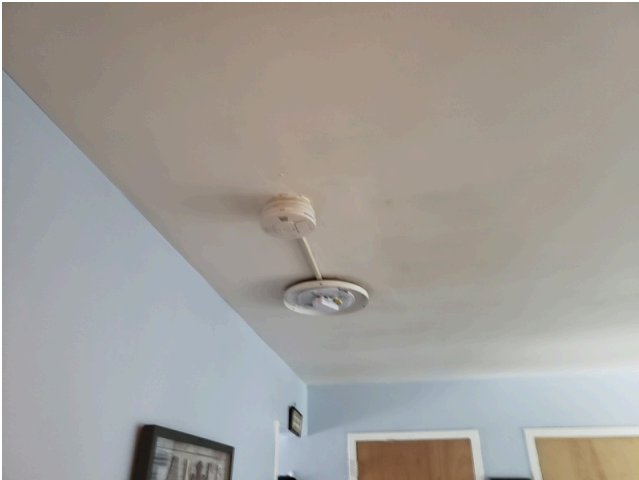
95. Life & Fire Safety: Typical non-compliant smoke detector found throughout the site. (Critical Repair)

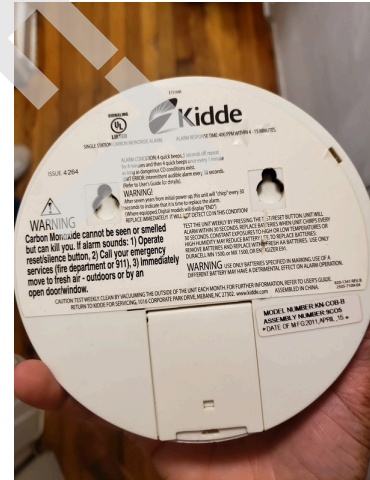
96. Life & Fire Safety: Typical non-compliant smoke detector found throughout the site. (Critical Repair)

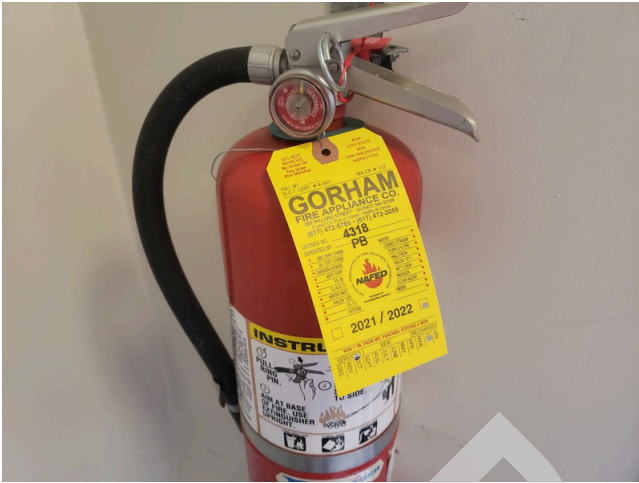
97. Life & Fire Safety: Typical fire extinguisher found throughout the site.

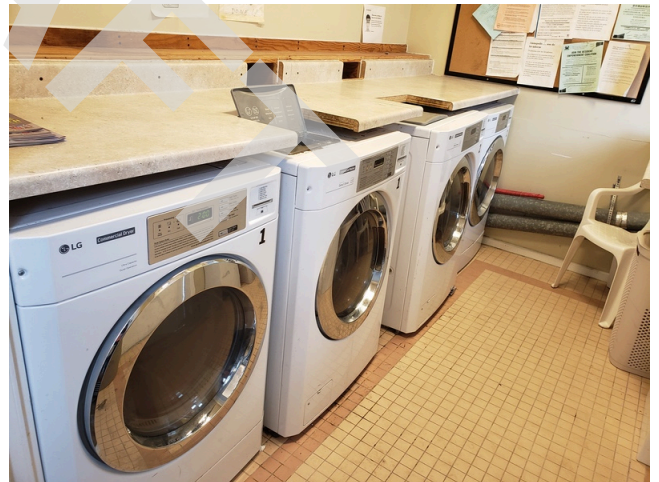
100. Common Area Interior Elements: Common laundry room.

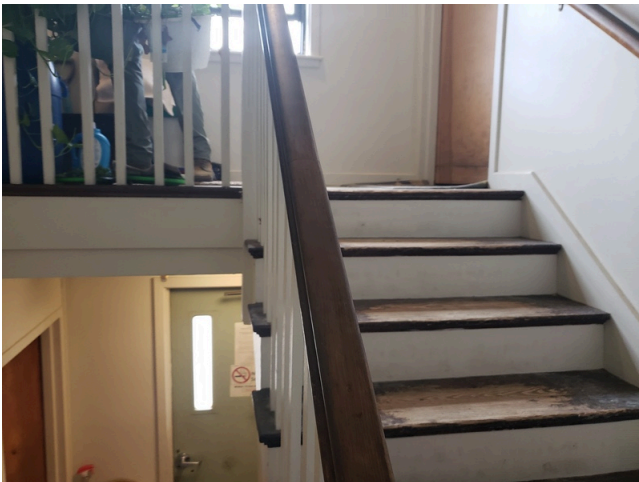
103. Common Area Interior Elements: Typical staircase with worn down finishes found throughout the site. (Non-Critical Repair)

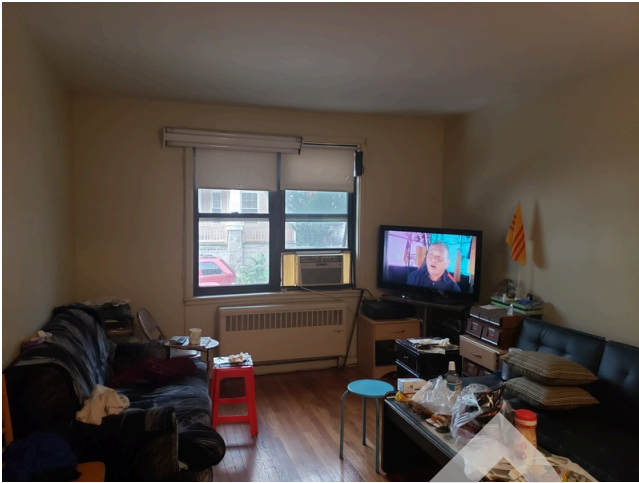
105. Dwelling Unit Interior Elements: Typical wood laminate flooring and sheetrock finish found in dwelling units throughout the site.

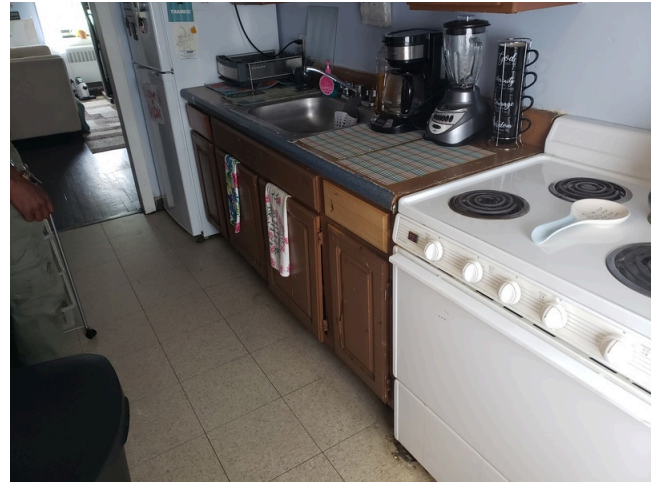
106. Dwelling Unit Interior Elements: Typical vinyl flooring and sheetrock finish found in dwelling units throughout the site.

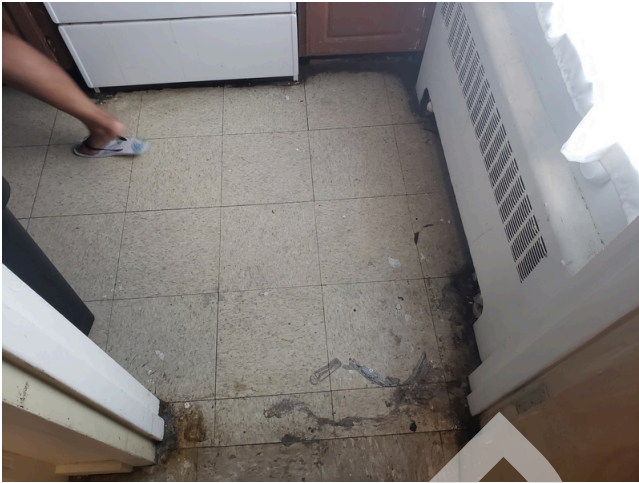
108. Dwelling Unit Interior Elements: Removed flooring and finishes due to decomposing body removal. (Critical Repair)

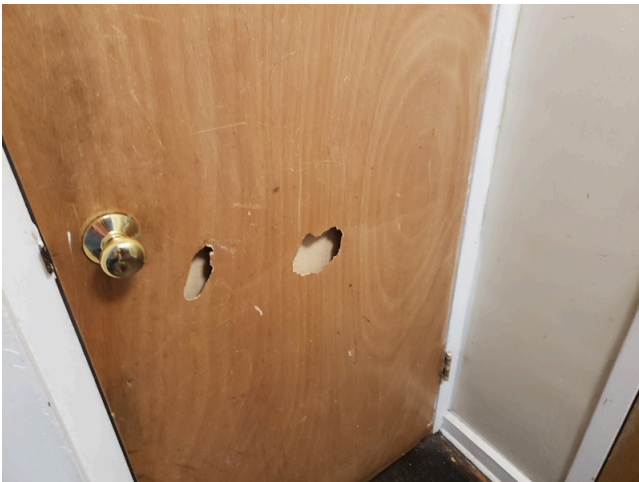
110. Dwelling Unit Interior Elements: Damaged finishes observed in unit 4. (Non-Critical Repair)

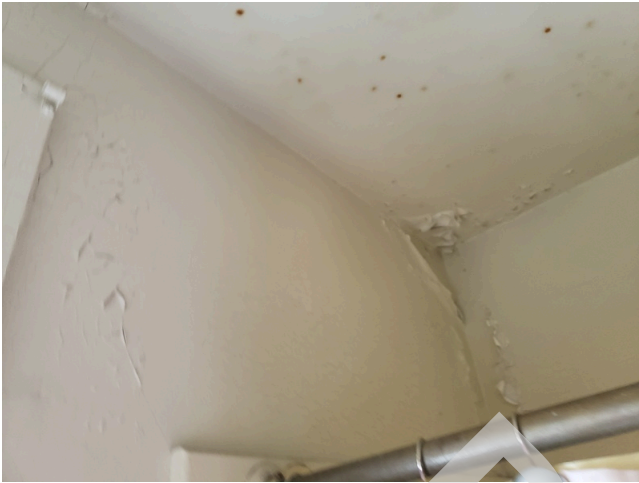
112. Dwelling Unit Interior Elements: Damaged finishes observed in unit 4. (Non-Critical Repair)

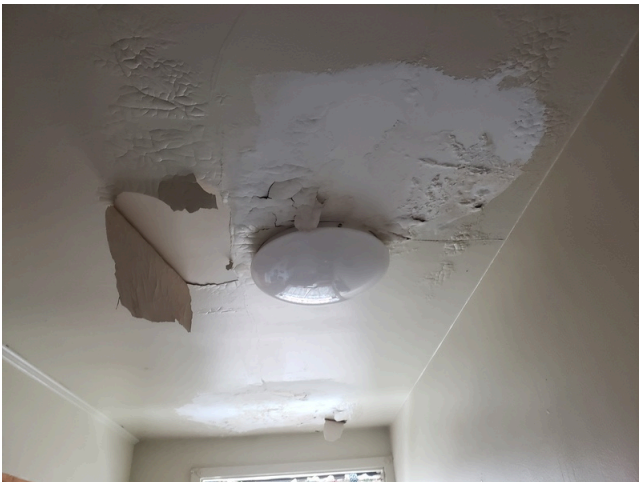
114. Dwelling Unit Interior Elements: Damaged finishes observed in unit 20. (Non-Critical Repair)

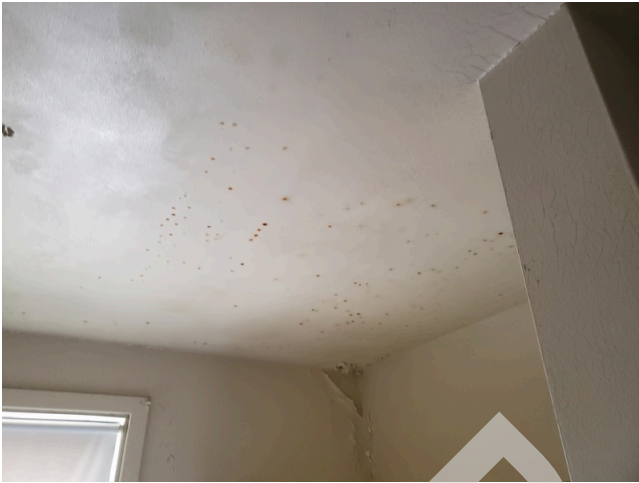
116. Dwelling Unit Interior Elements: Damaged finishes observed in unit 20. (Non-Critical Repair)

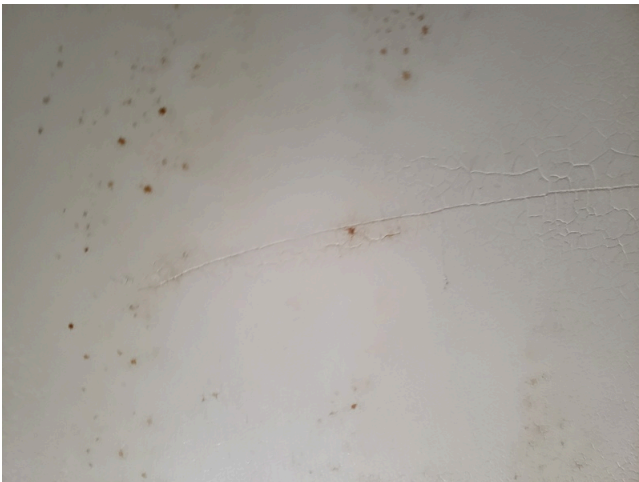
118. Dwelling Unit Interior Elements: Damaged finishes observed in unit 20. (Non-Critical Repair)

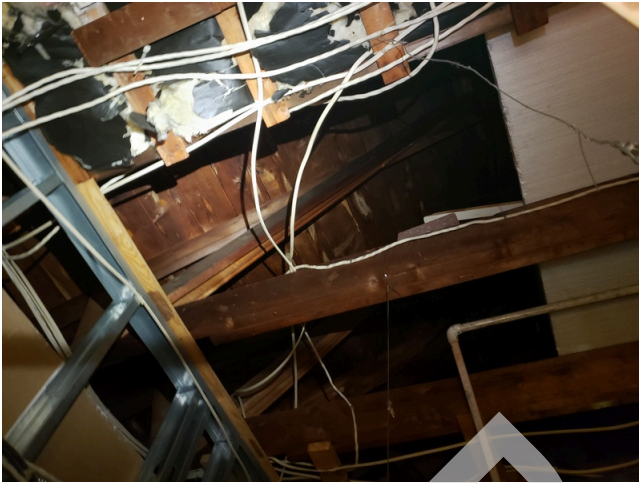
120. Dwelling Unit Interior Elements: Typical damaged sheetrock ceilings found throughout the site. (Non-Critical Repair)

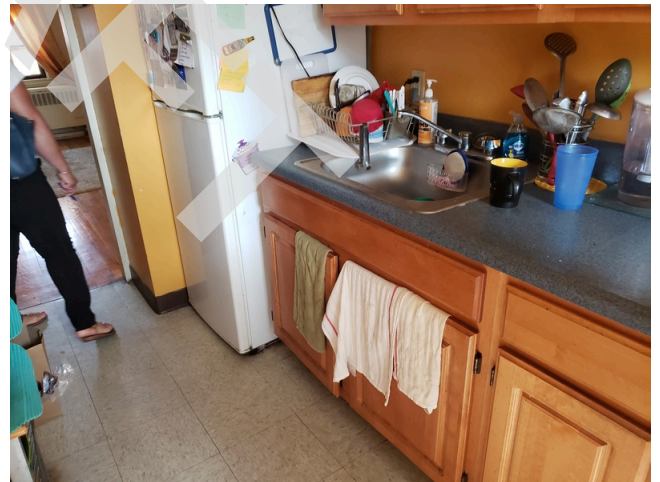
123. Appliances: Typical appliance package found throughout the site.

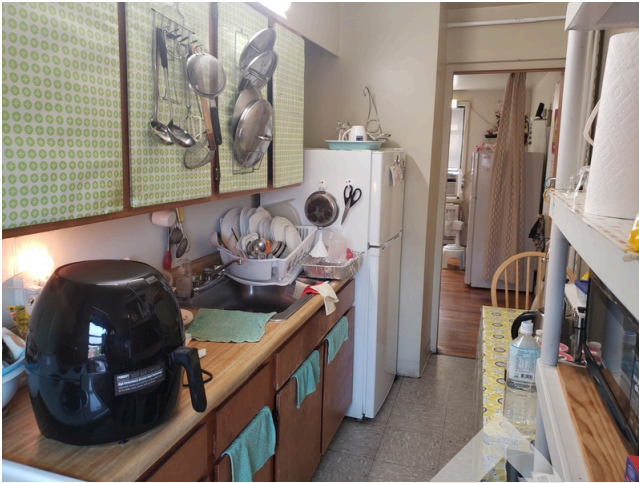
124. Cabinets & Fixtures: Typical dwelling unit kitchen sink, countertop, and wood cabinets found throughout the site.
