**CAPITAL NEEDS ASSESSMENT (CNA)
GENERAL WARREN APARTMENTS (2-44)
114 RUTHERFORD AVENUE
CHARLESTOWN, MASSACHUSETTS 02129**

D3G PROJECT NUMBER:

2021-0374

FINAL REPORT ISSUE DATE:

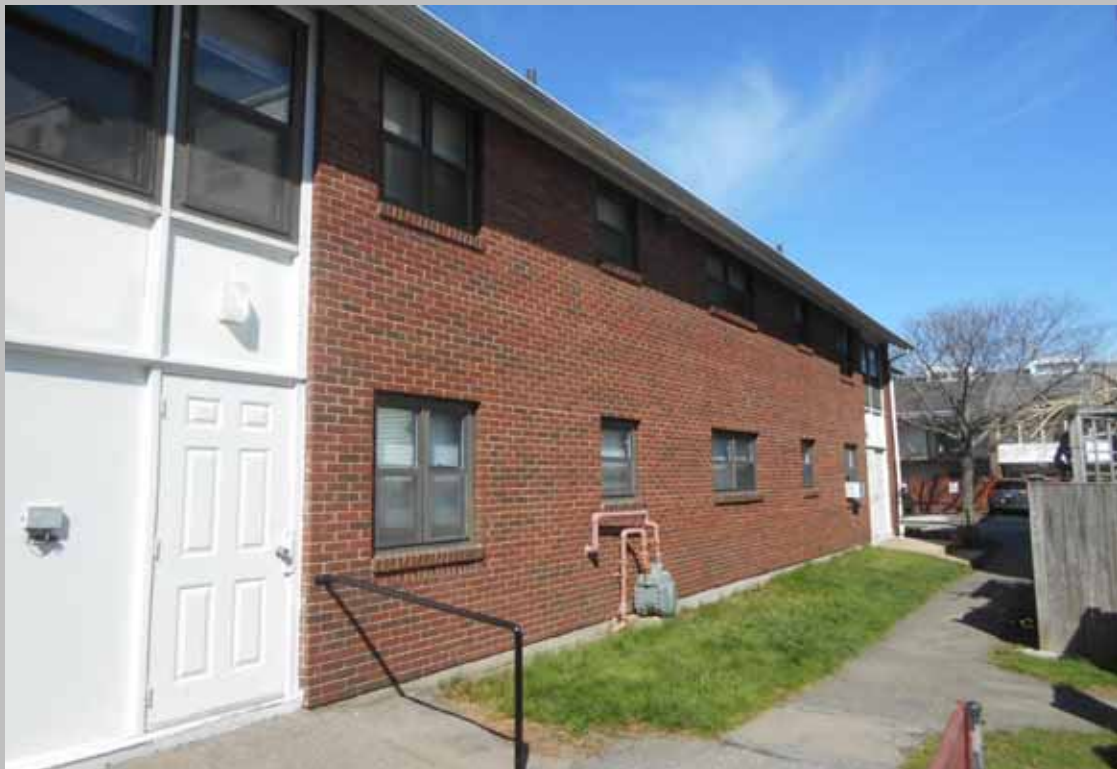
PHOTO #12

Typical asphalt sidewalks

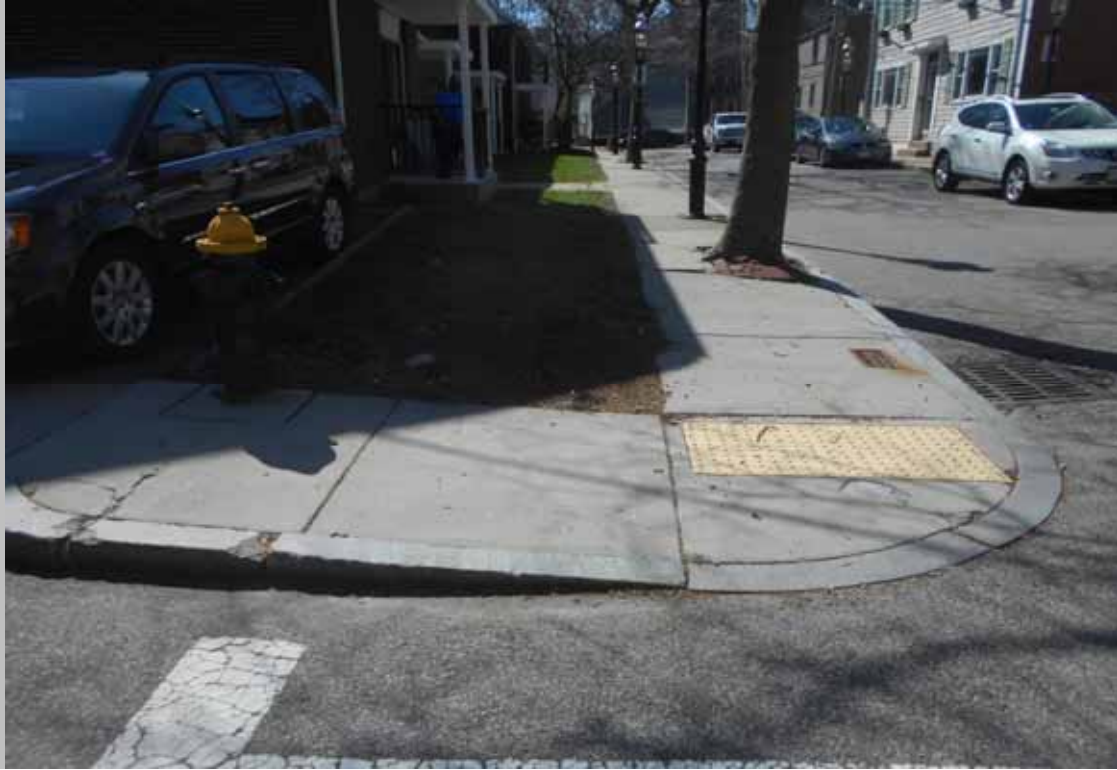
PHOTO #15

Typical municipal sidewalk

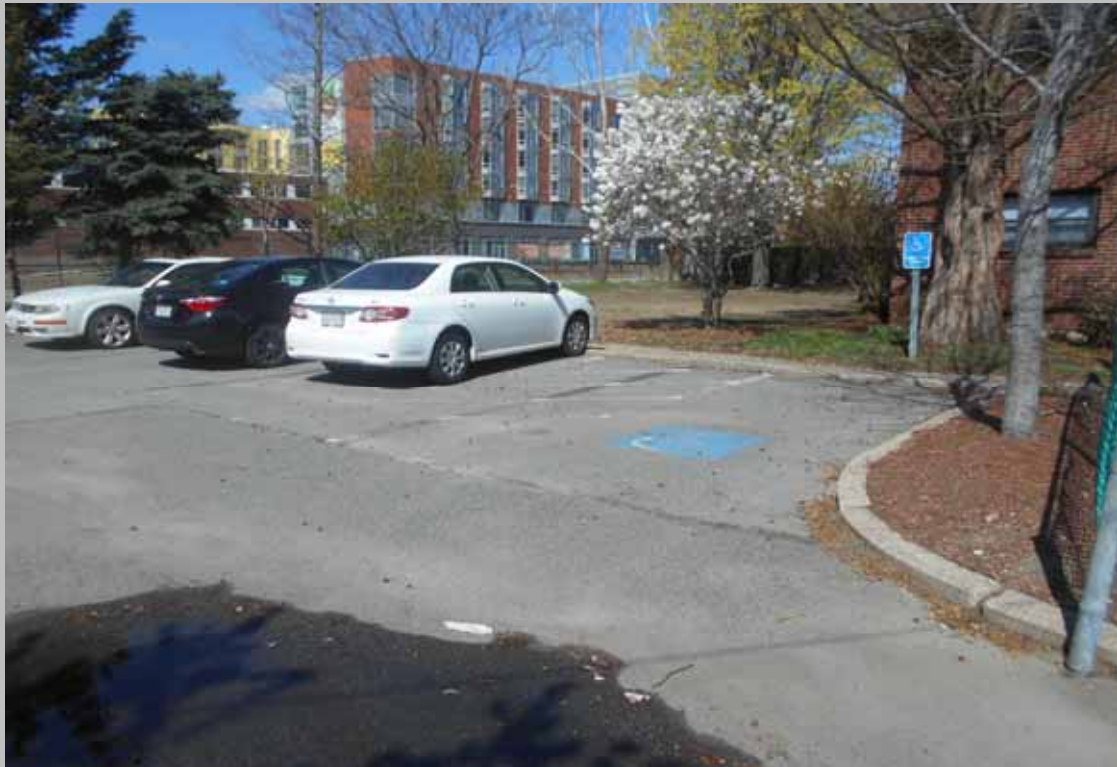
PHOTO #16

Asphalt parking area and handicapped parking space (5-9 Middlesex Street)

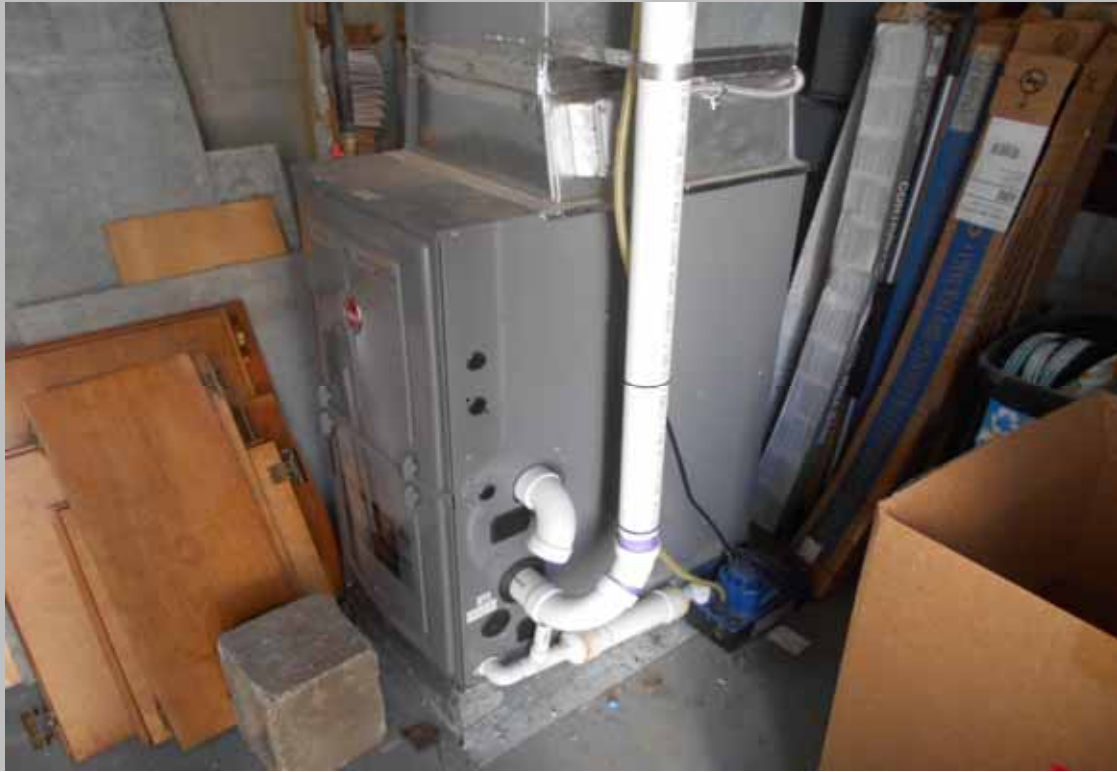
PHOTO #19

Typical gas furnace (Community Centers)

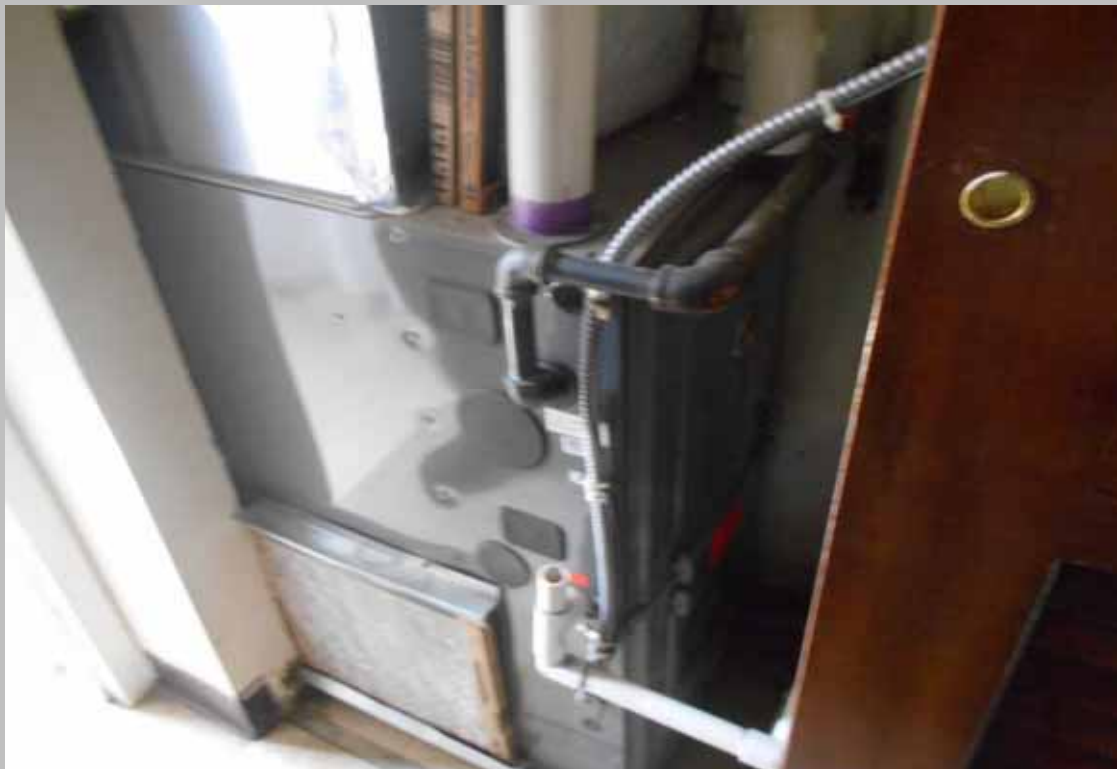
PHOTO #20

Typical gas furnace (dwelling units)

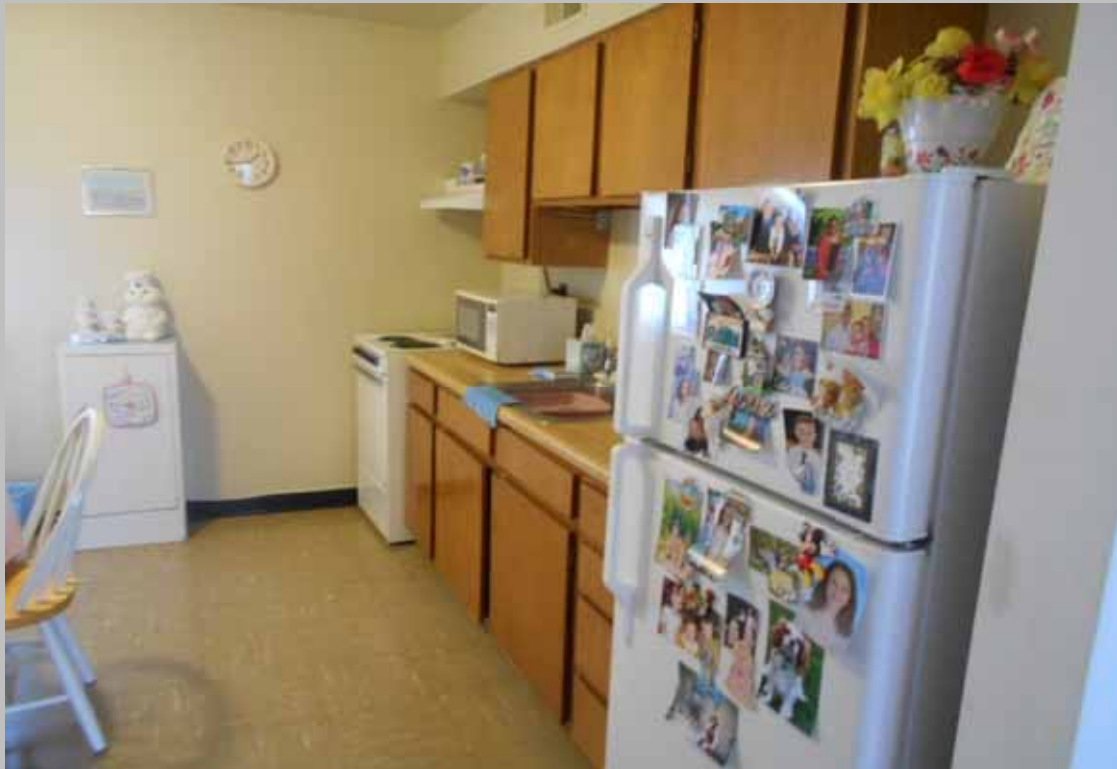
PHOTO #42

2-bedroom dwelling unit – typical kitchen

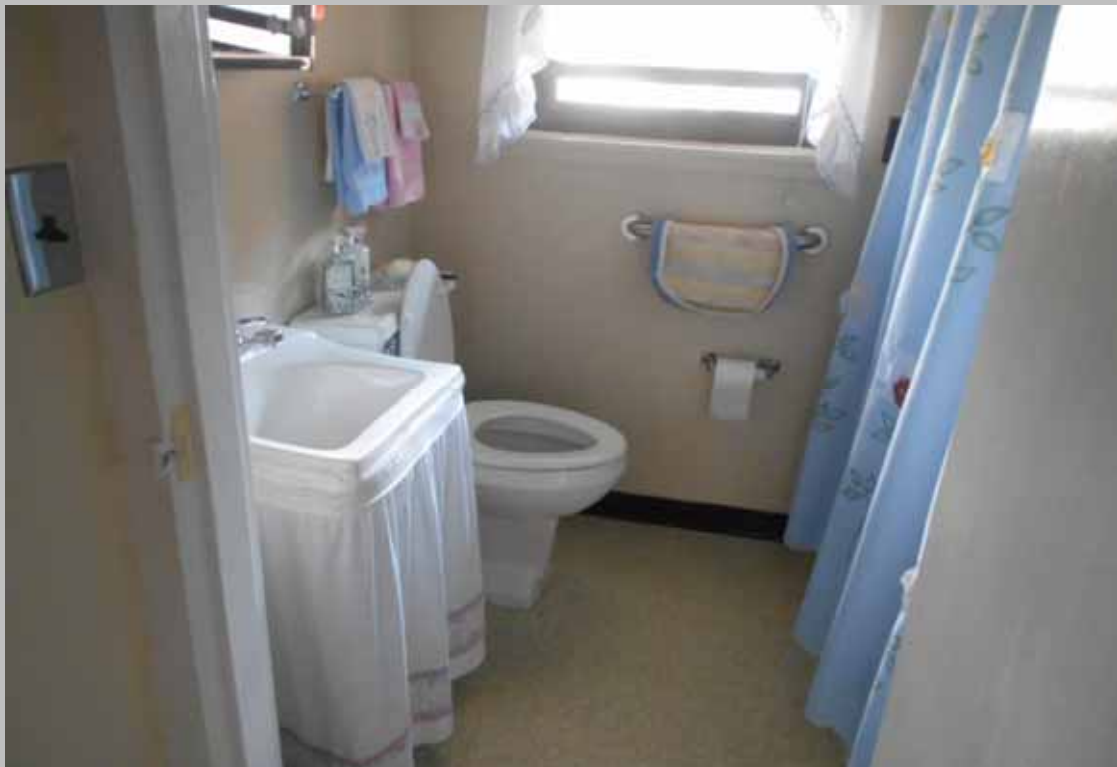
PHOTO #44

2-bedroom dwelling unit – typical bathroom

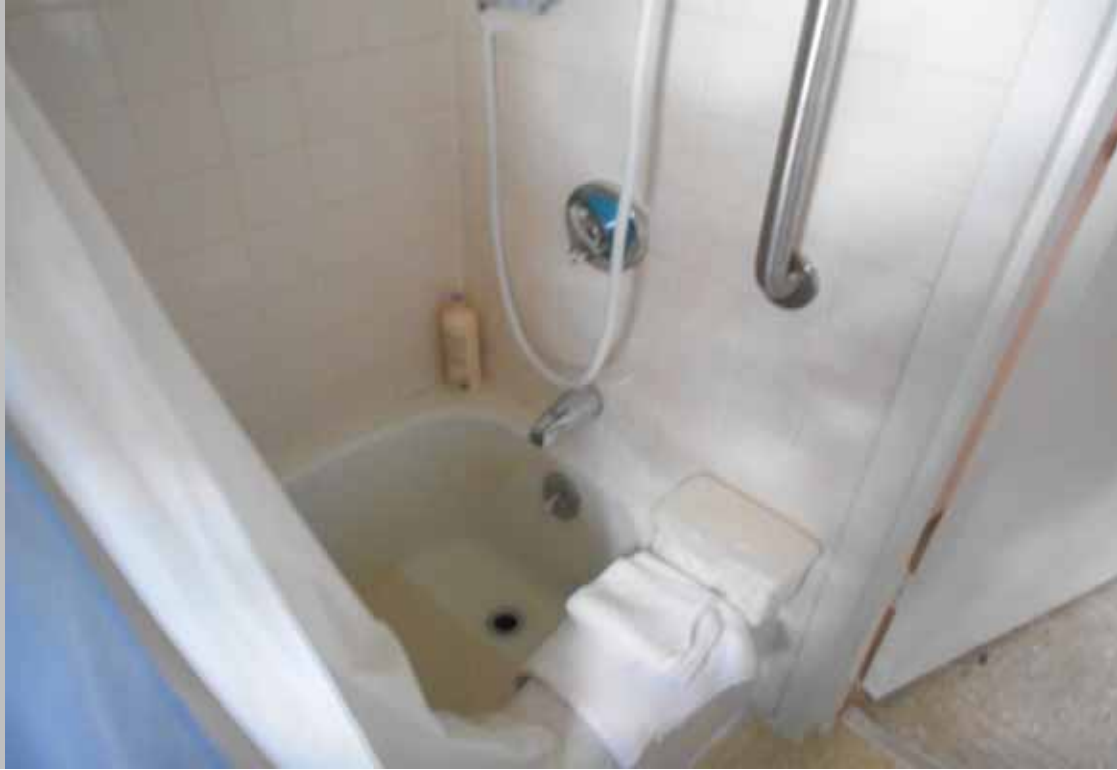
PHOTO #45

2-bedroom dwelling unit – typical bathtub/shower

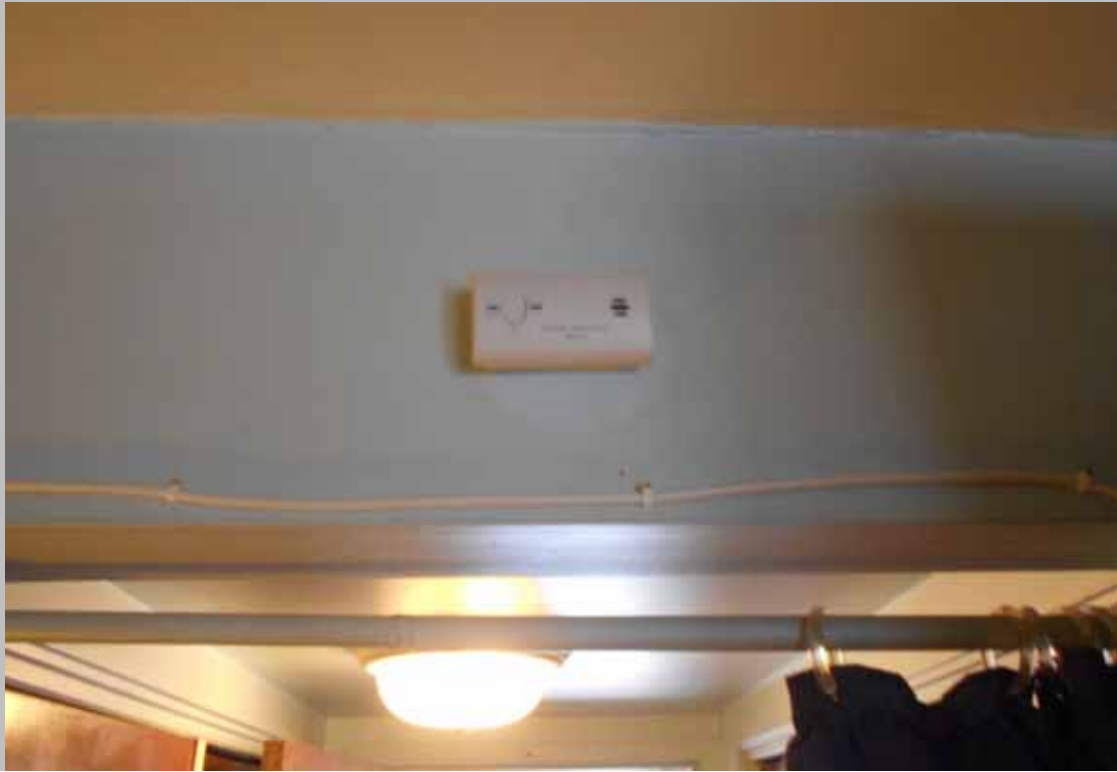
PHOTO #47

carbon monoxide detector (dwelling units)

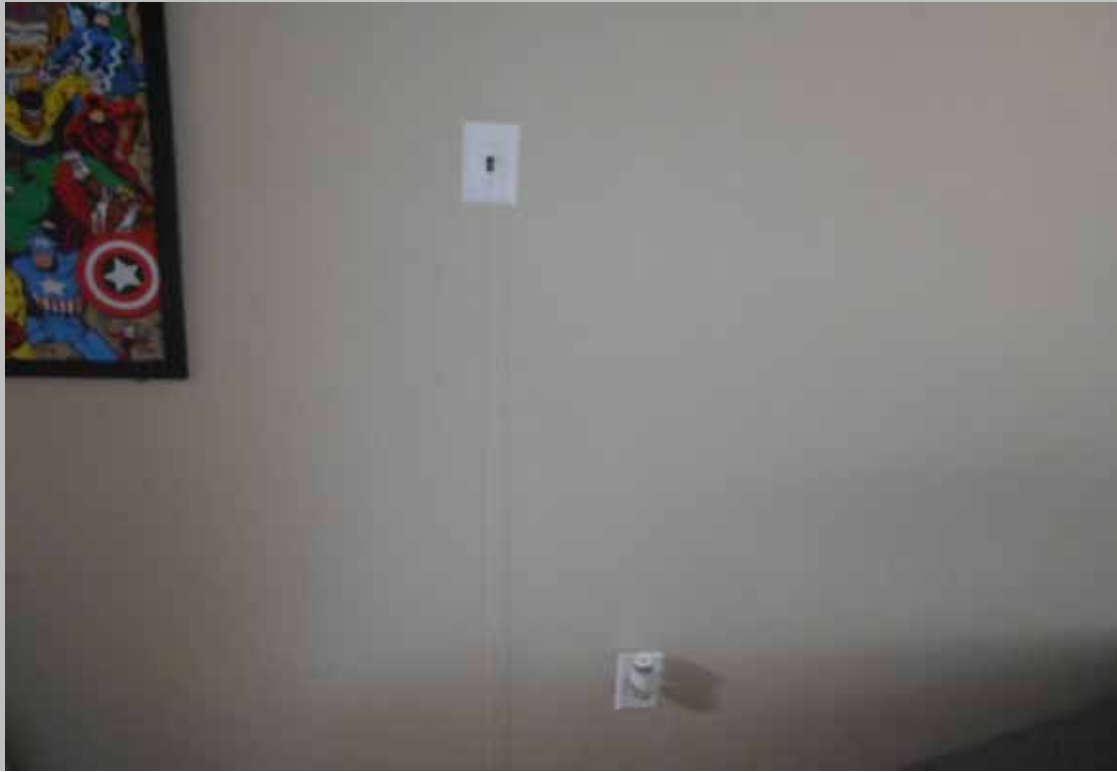
PHOTO #49

Typical emergency call pull cord (dwelling unit bedrooms and bathrooms)

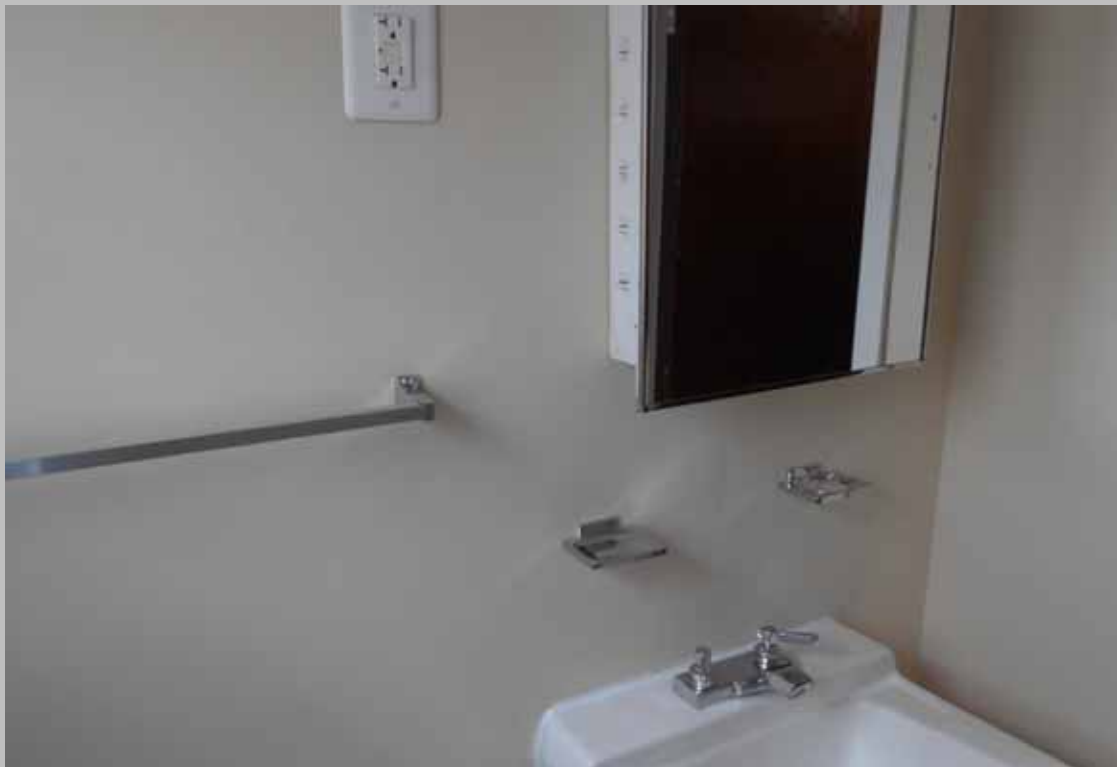
PHOTO #50

Typical GFCI outlet (dwelling unit kitchens and bathrooms)

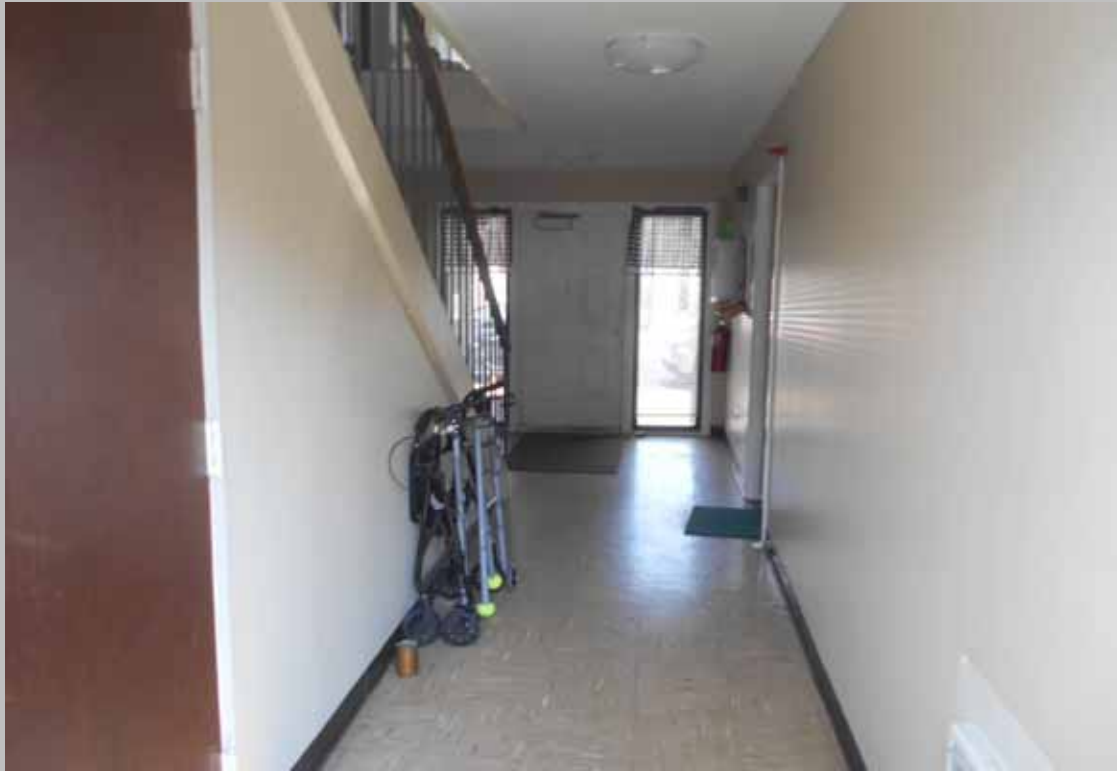
PHOTO #51

Typical fire extinguisher (common hallways)

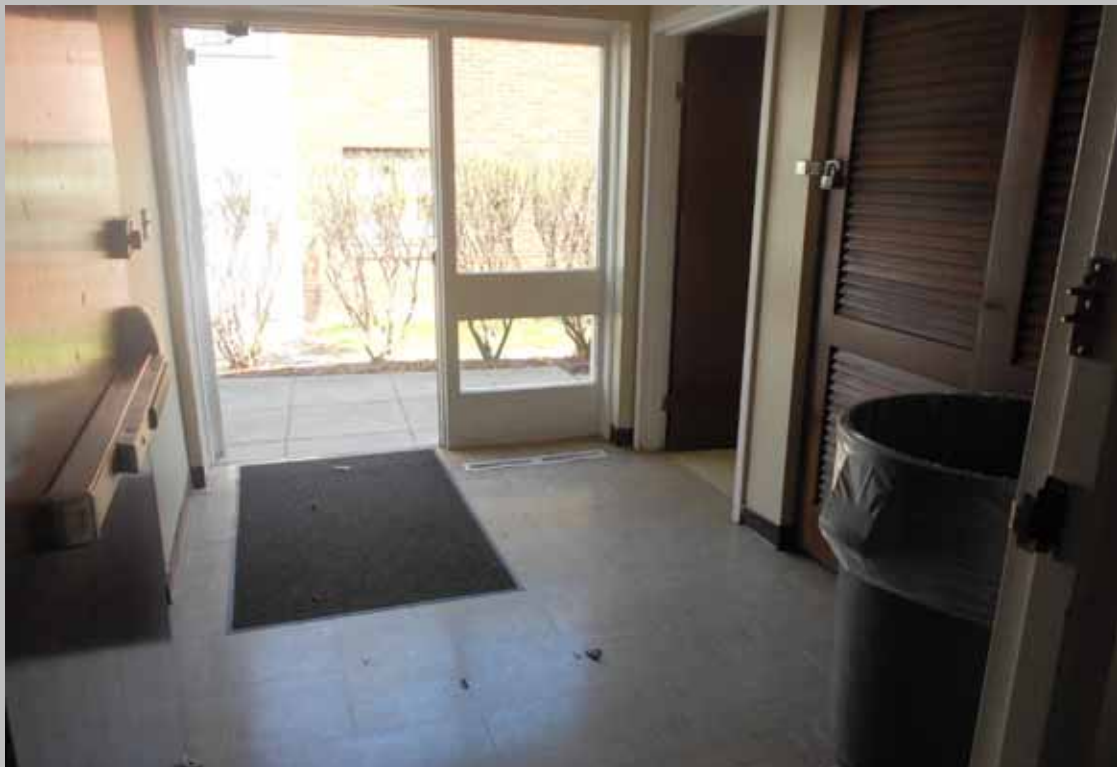
PHOTO #54

Accessible route at Community Building 1 entrance (Compliant, UFAS)

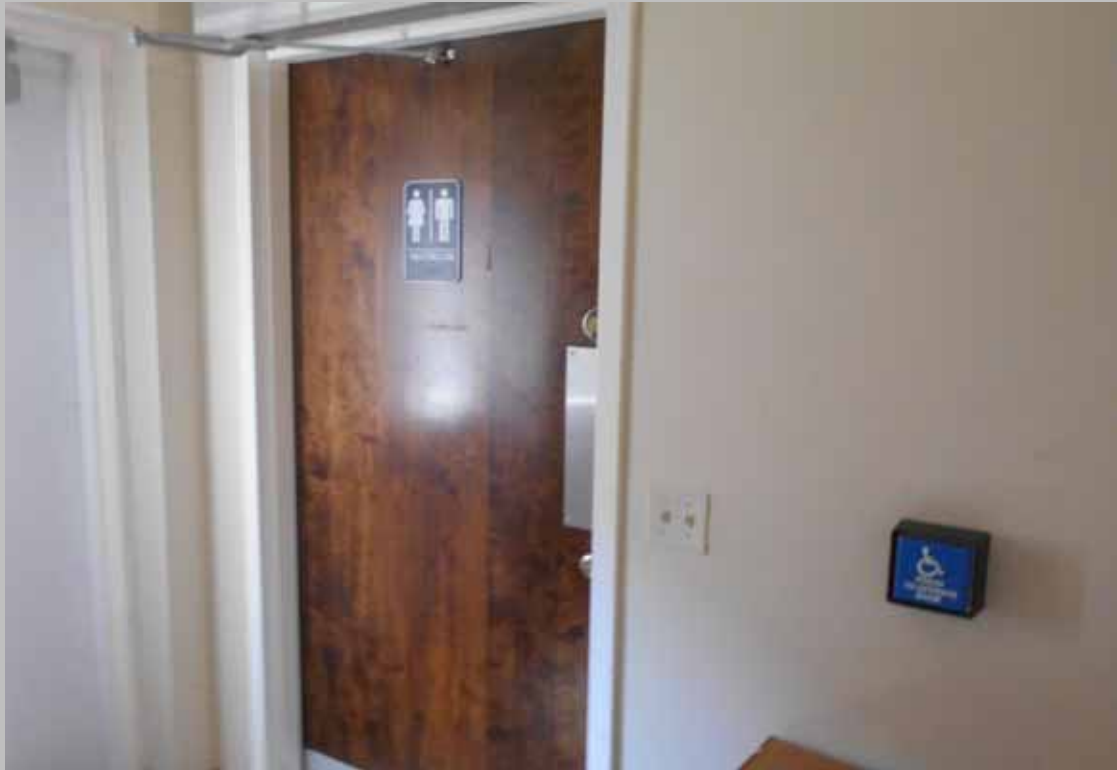
PHOTO #55

Accessible automatic door – common area public unisex restroom (Compliant, UFAS)

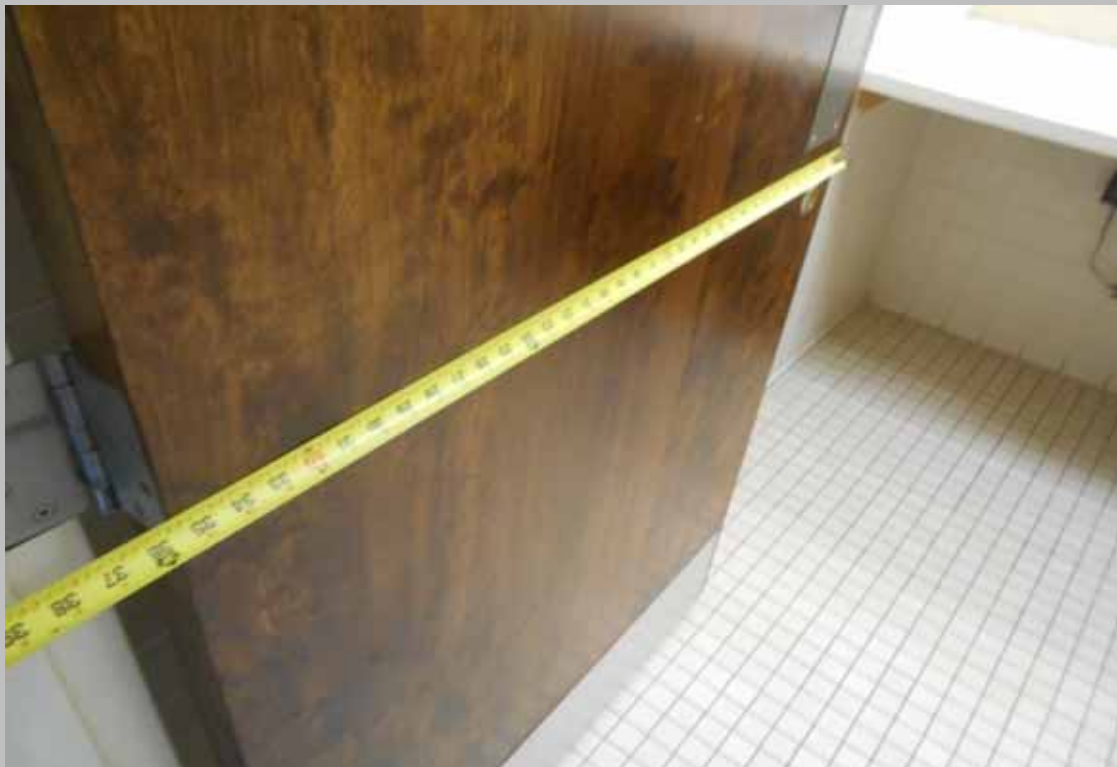
PHOTO #56

Sufficient clear door opening of at least 32-inches – common area public unisex restroom
(Compliant, UFAS)

The 47 Washington Street building features one (1) unisex public restroom. The single occupant restroom was observed with a sufficient entry door opening and levered handle door hardware, roll under access at the sink with scald and abrasion protection and levered sink hardware, compliant clear floor space at the fixtures, and complaint rear and side grab bars at the toilet.

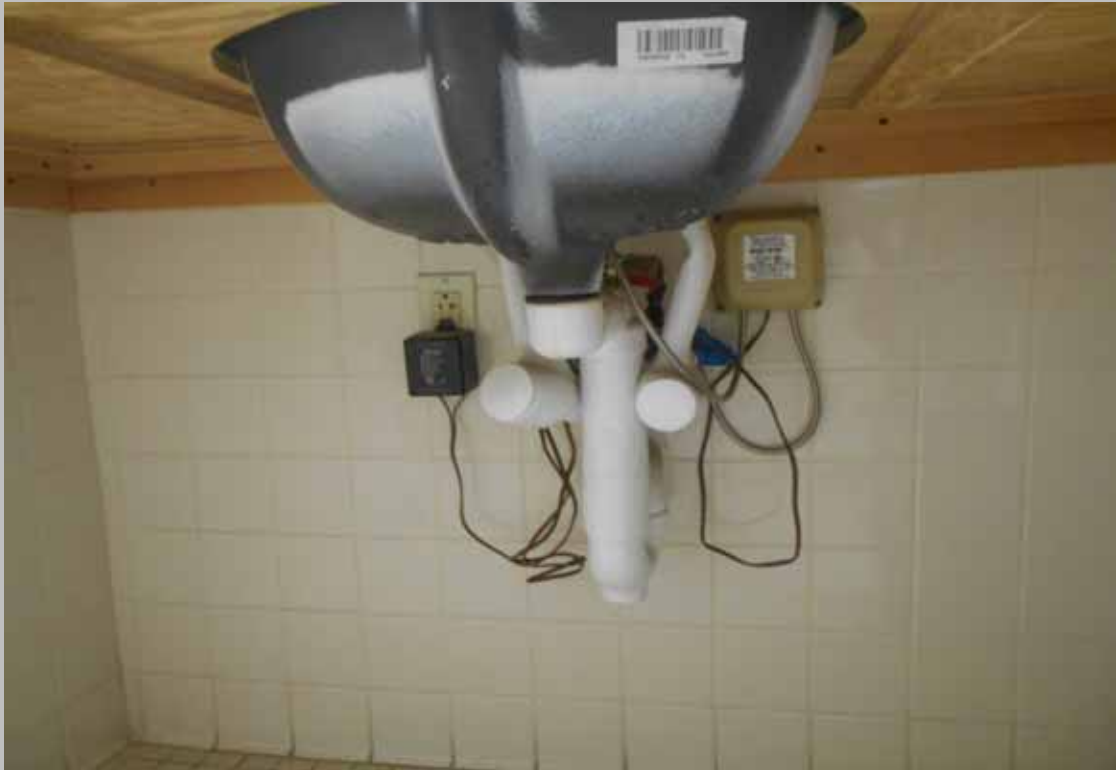
PHOTO #57

Roll-under sink with scald and abrasion protection – common area public unisex restroom
(Compliant, UFAS)

- The common area restroom was observed with a roll-under forward approach sink that features scald and abrasion protection and levered handle hardware.

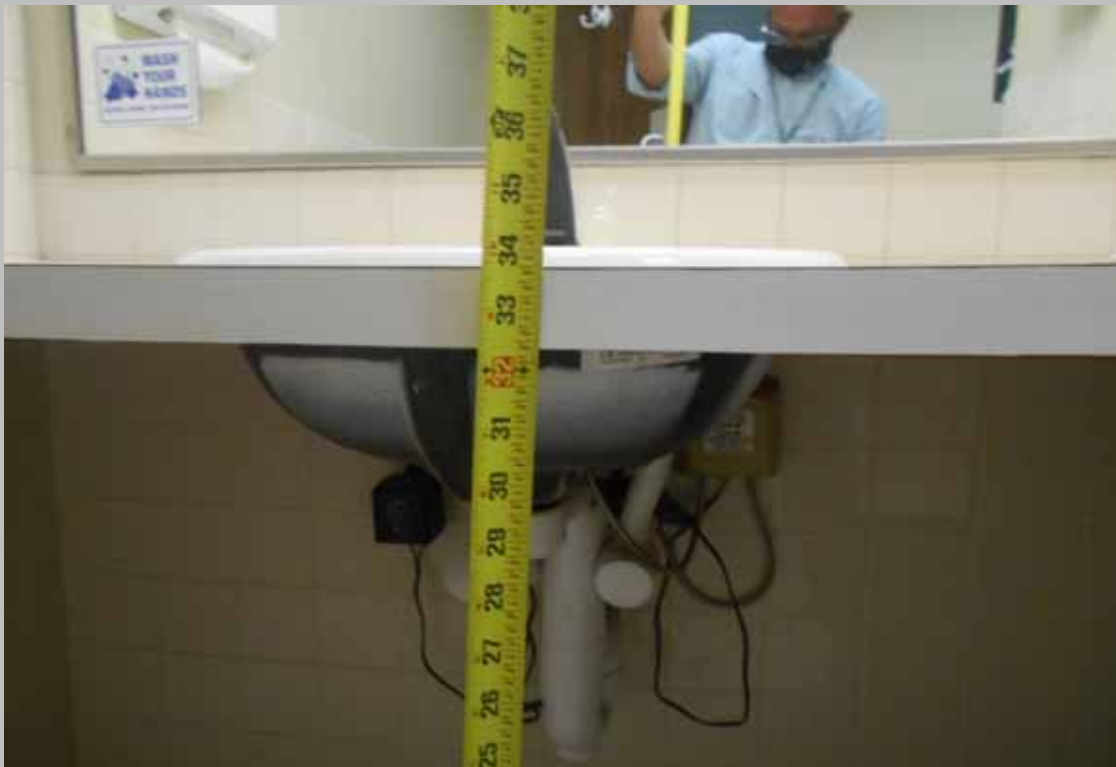
PHOTO #58

Restroom sink mounted at required 34-inches from floor – common area public unisex restroom
(Compliant, UFAS)

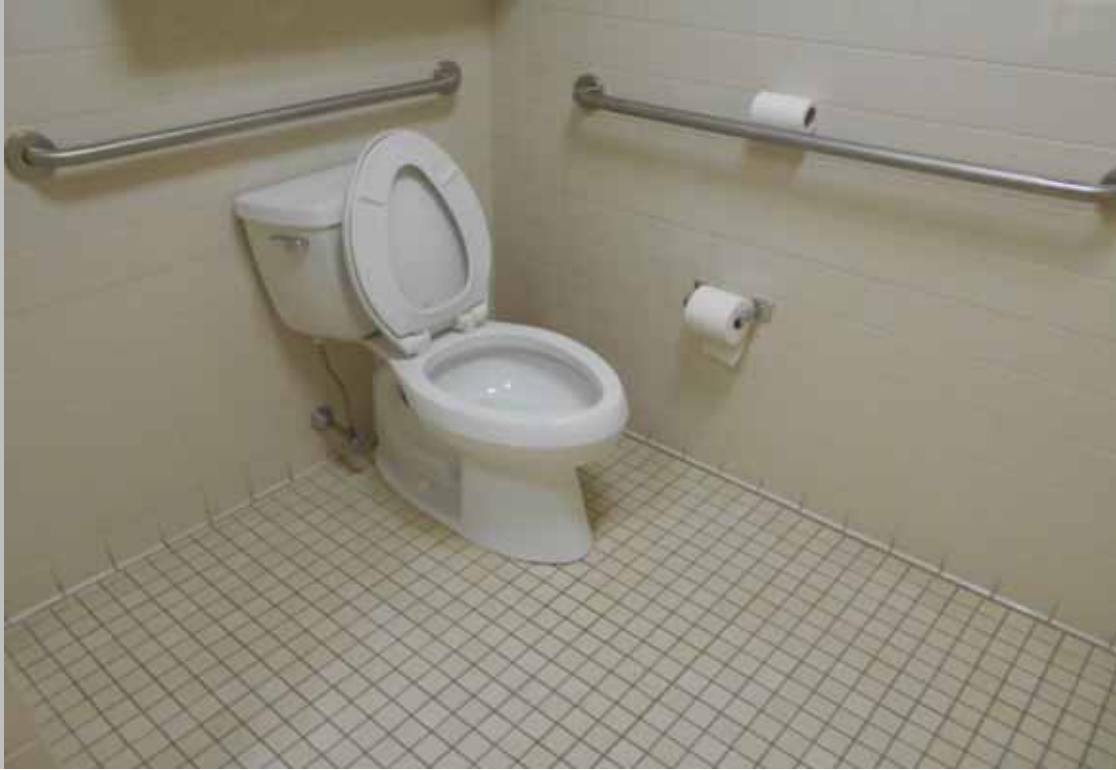
PHOTO #59

Side and rear grab bars at toilet – common area public unisex restroom (Compliant, UFAS)

- The common area restroom was observed with compliant side and rear grab bars present at the toilet.
- The common area laundry features at least one (1) front controlled washing machine.
