**CAPITAL NEEDS ASSESSMENT (CNA)
PATRICIA WHITE APARTMENTS
20 WASHINGTON STREET
BRIGHTON, MASSACHUSETTS 02135**

**D3G PROJECT NUMBER:
2020-2130**

**FINAL REPORT ISSUE DATE:
FEBRUARY 4, 2021**

**INSPECTION DATES:
NOVEMBER 23 AND 24, 2020**

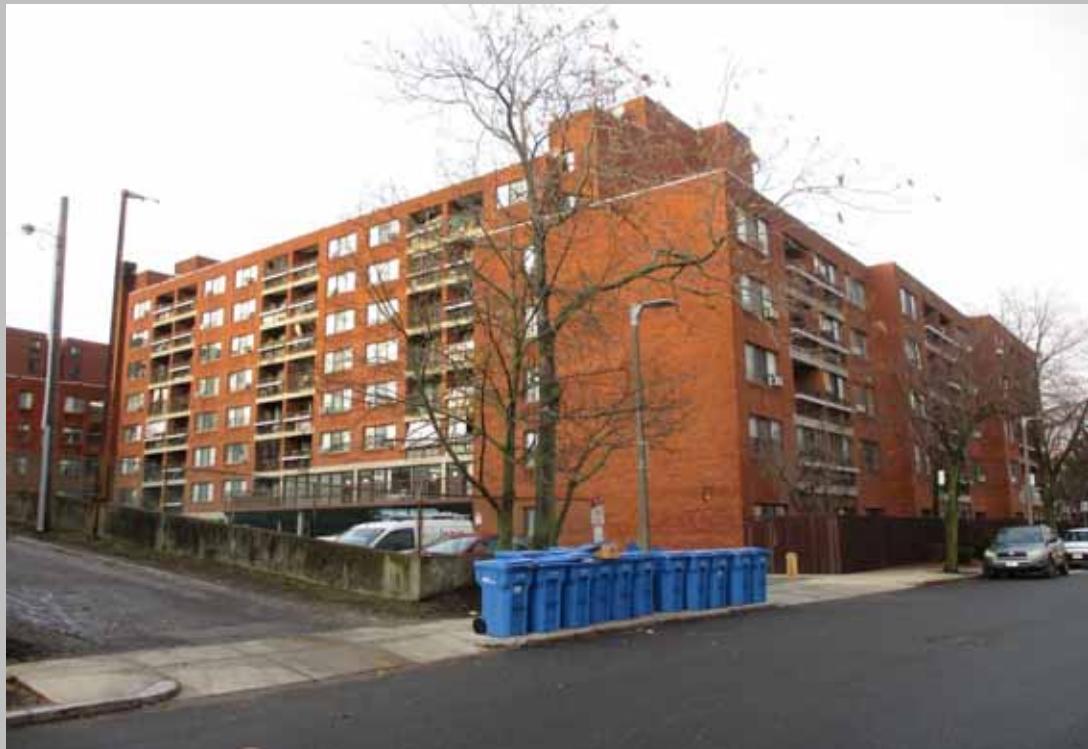
PHOTO #2

Southern and southeastern facades off Corey Road.

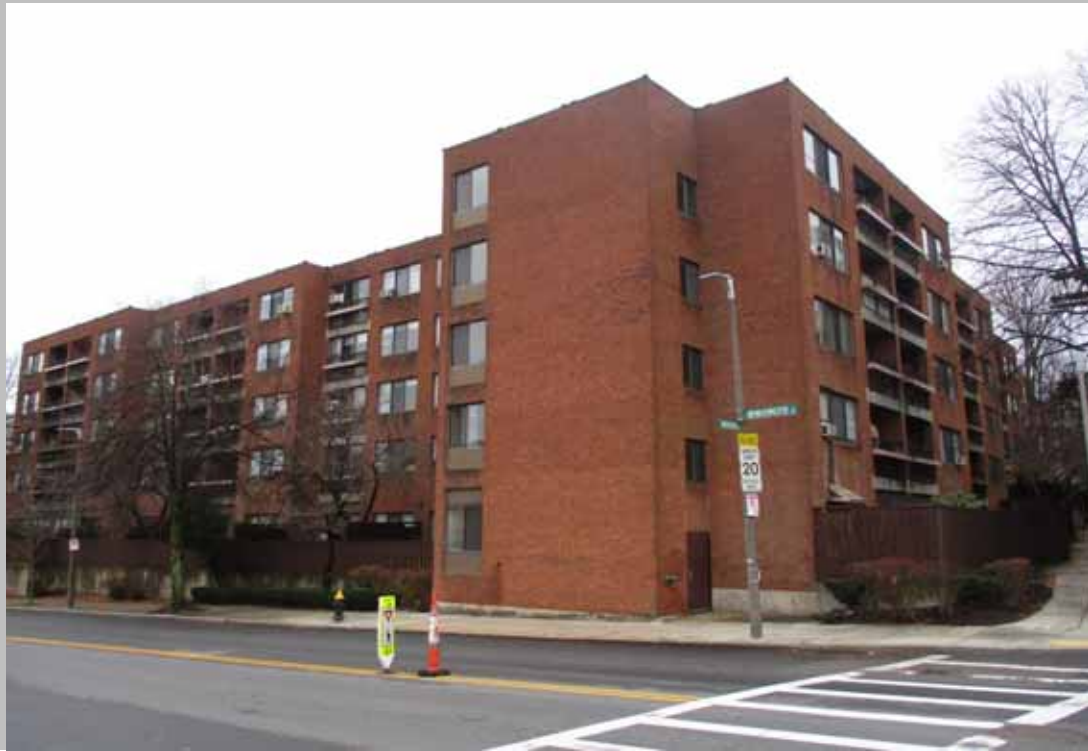
PHOTO #5

Northern façade on Washington Street.

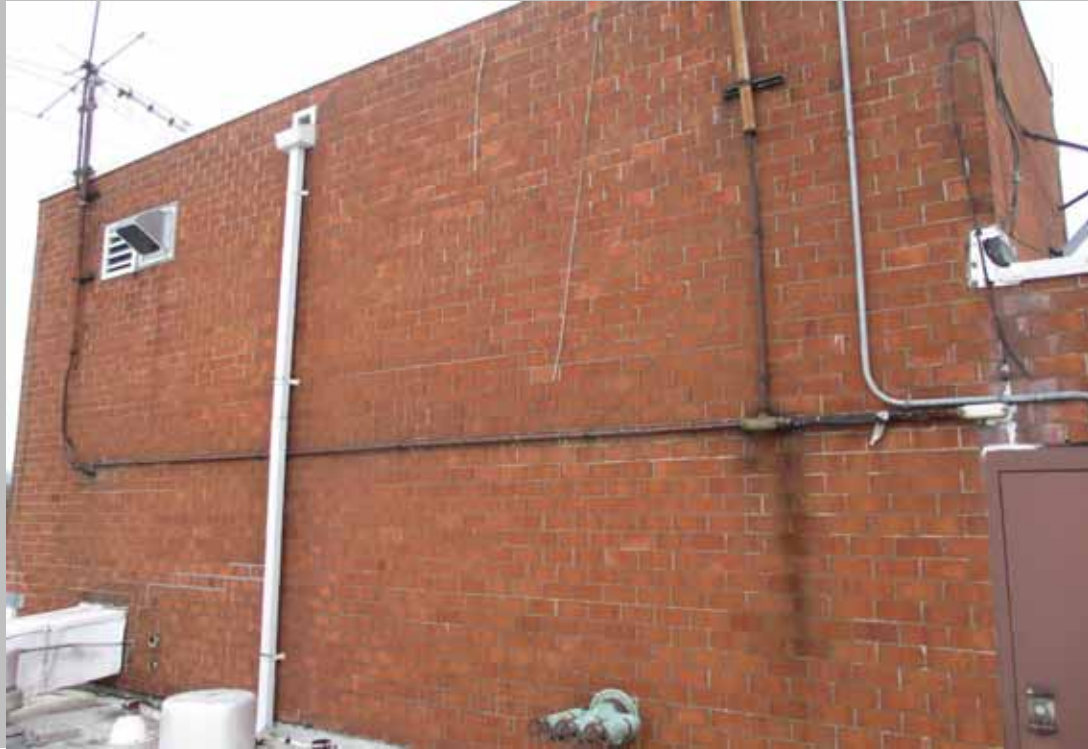
PHOTO #7

A side wall and elevator tower on roof between building sections.

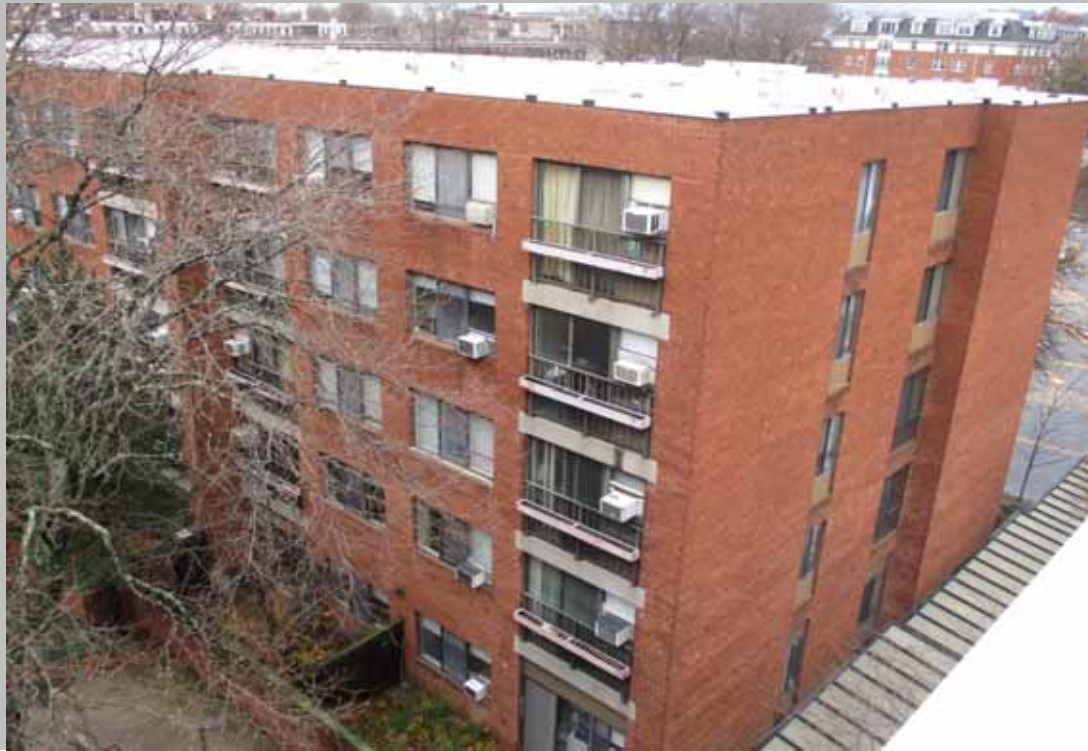
PHOTO #9

Inside portion of Washington Street portion of building.

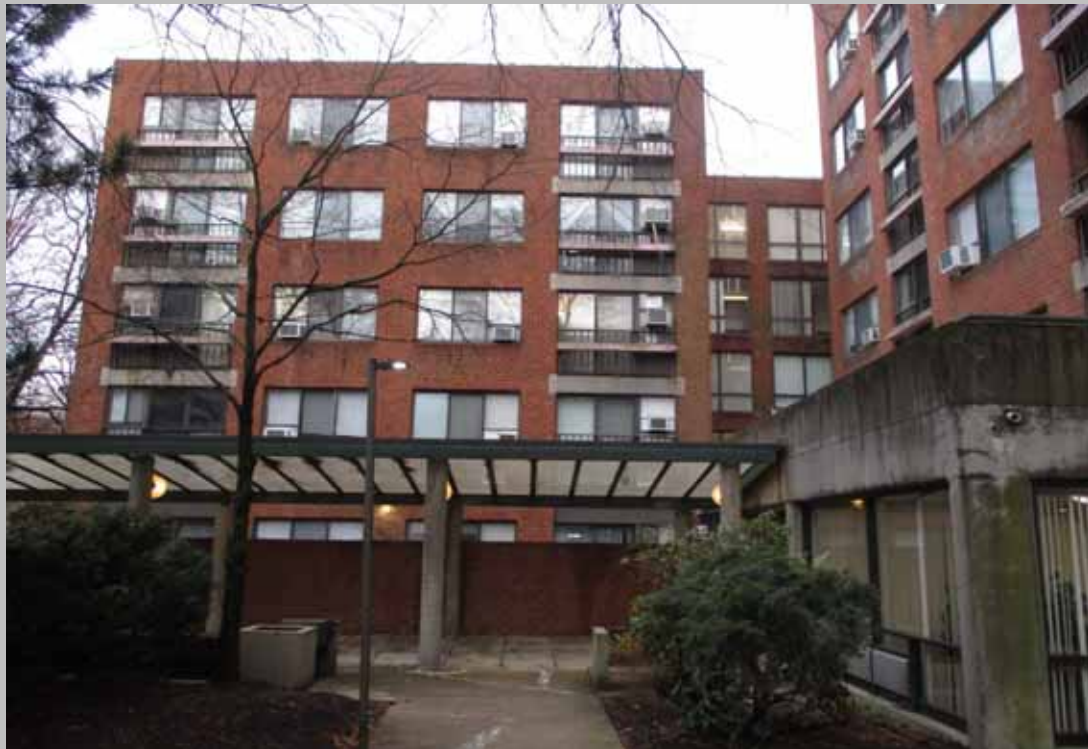
PHOTO #10

Inside portion of Corey Road portion of building.

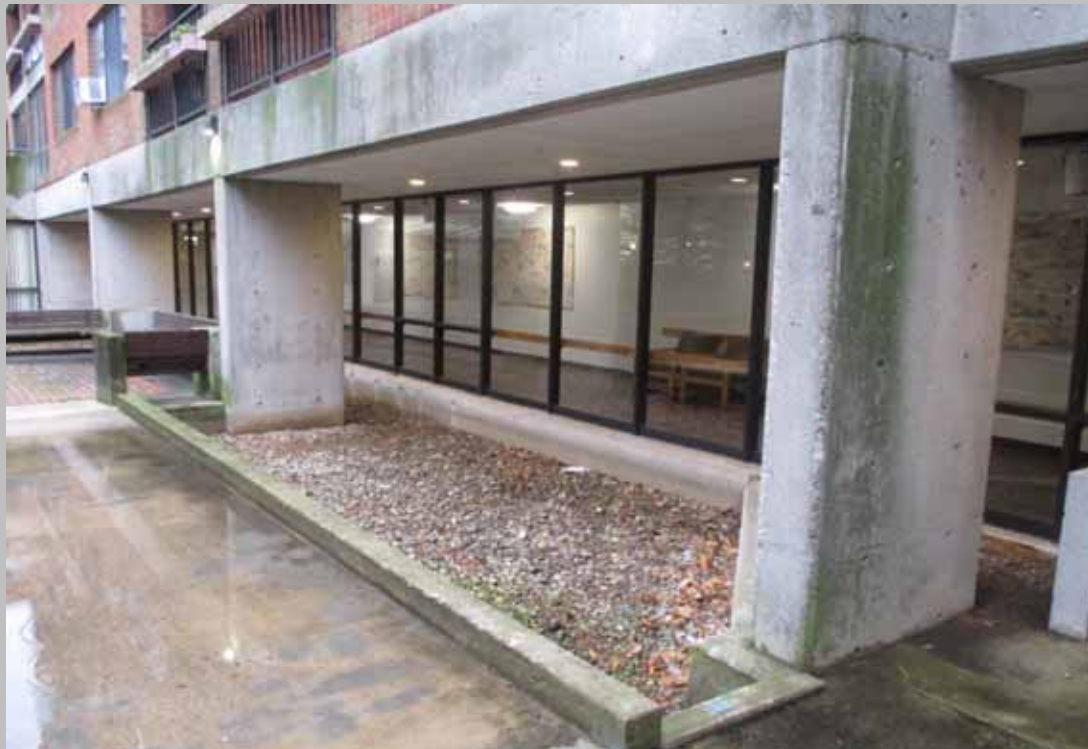
PHOTO #12

Concrete support pillars.

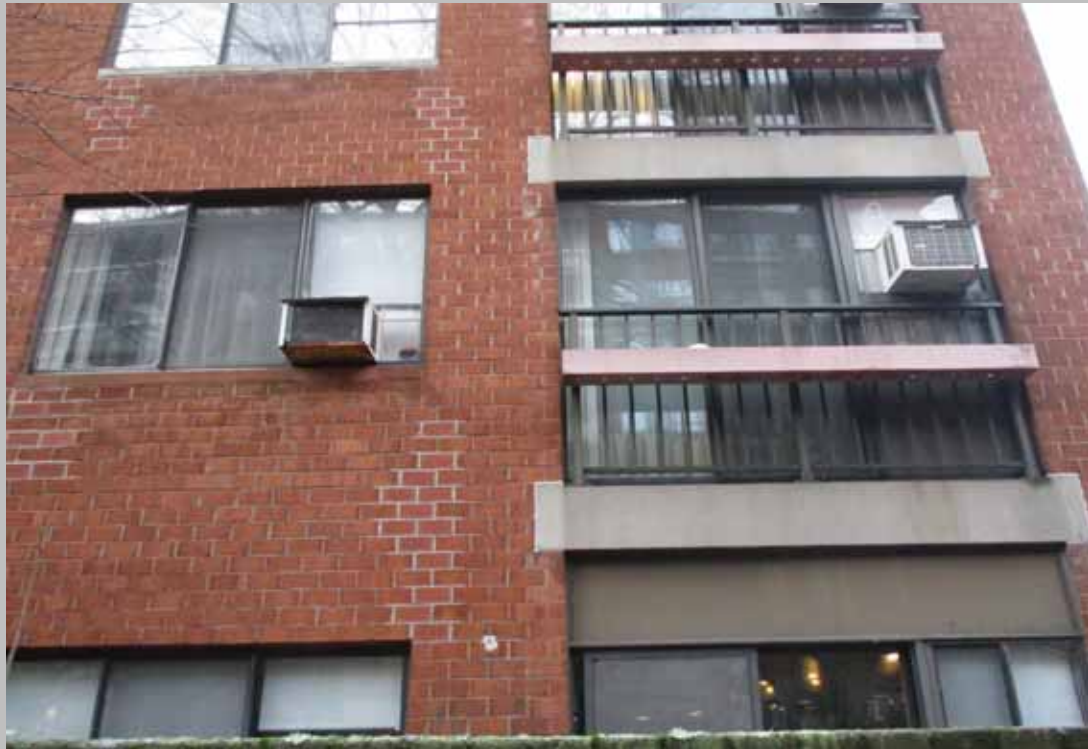
PHOTO #13

Close up of brick facades and balconies.

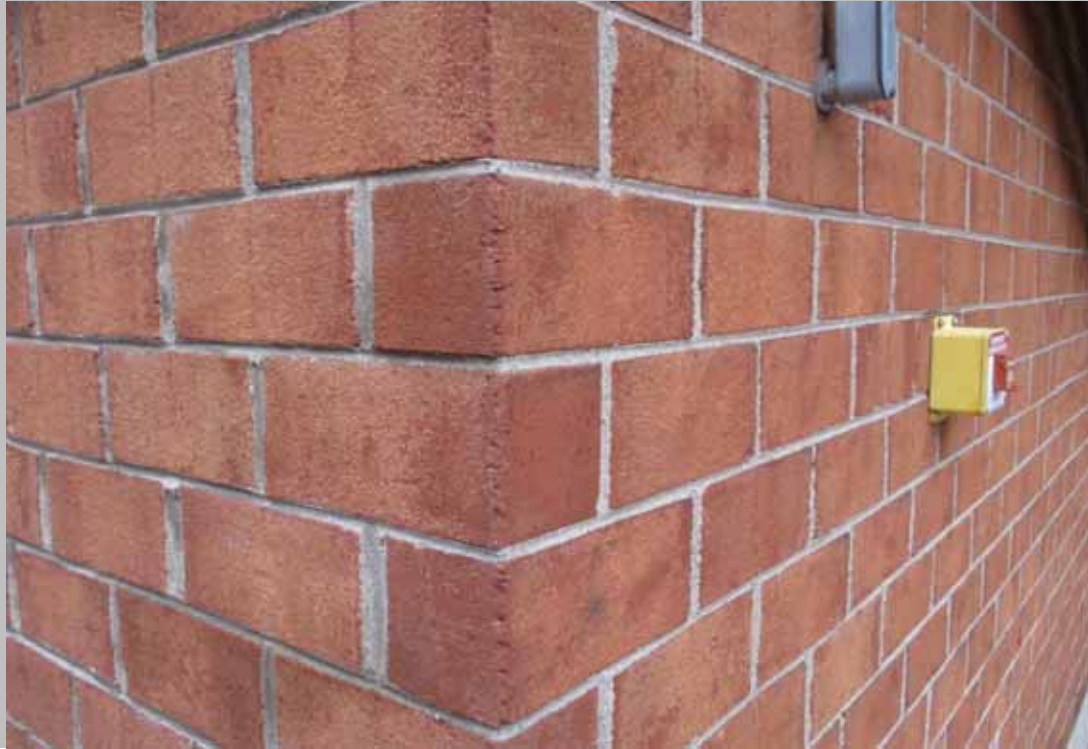
PHOTO #14

A close-up of brick façade.

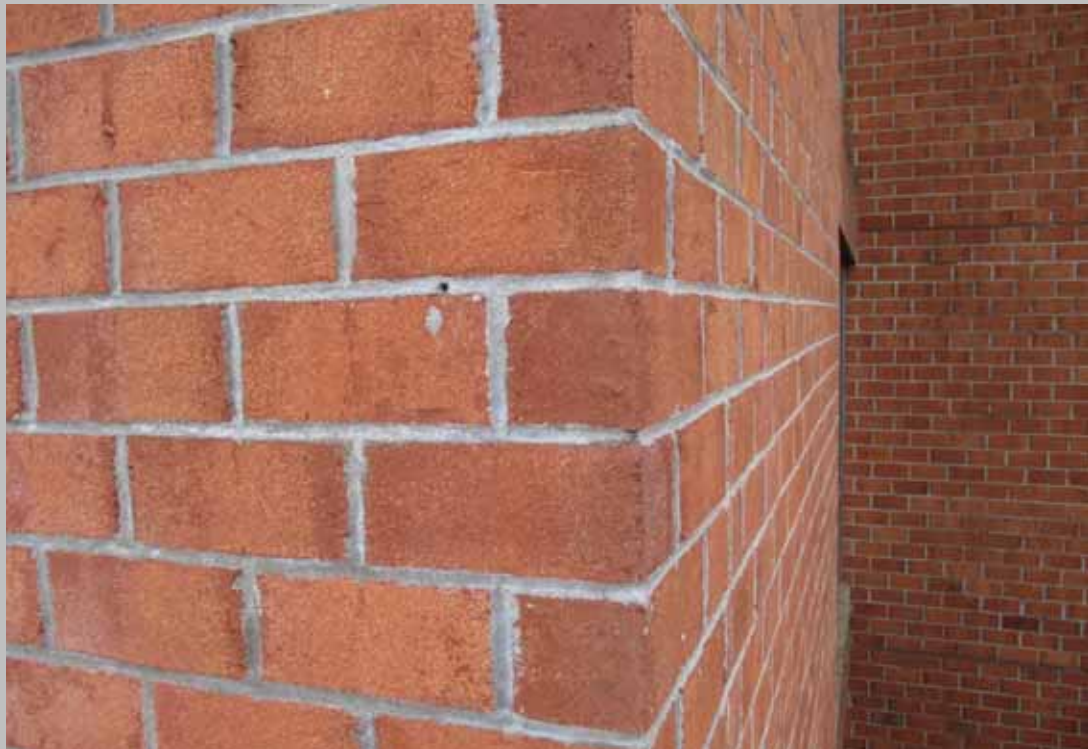
PHOTO #15

Another close-up of brick façade.

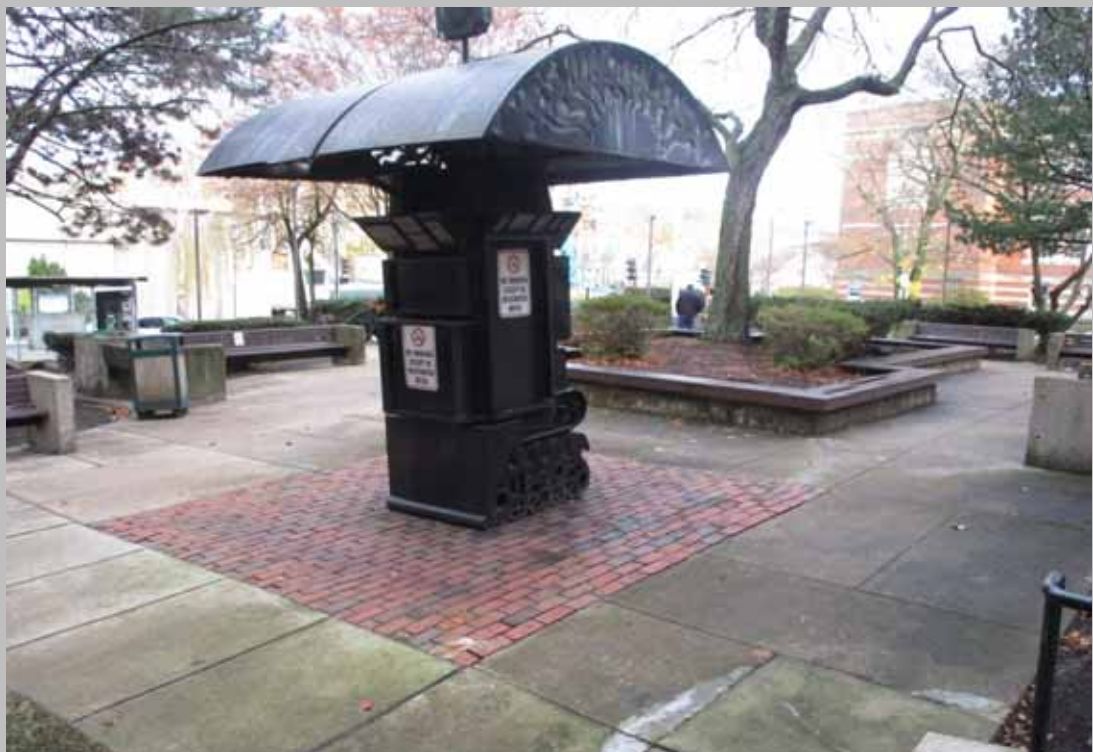
PHOTO #23

Kiosk and seating area at northeast side of property.

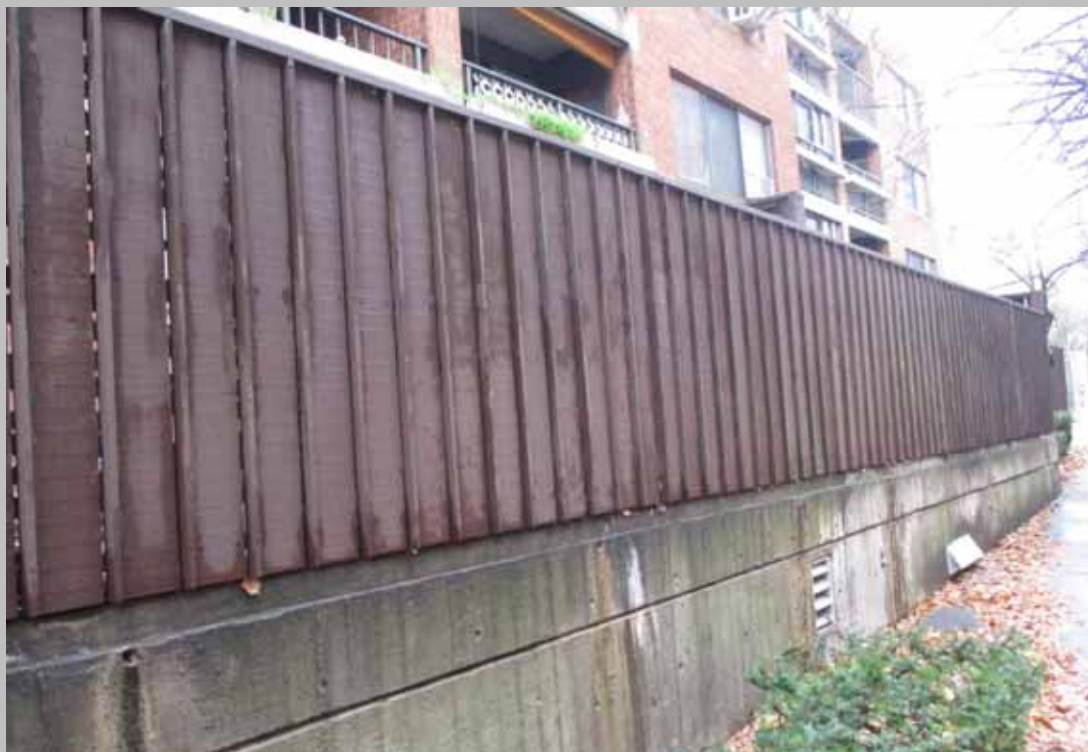
PHOTO #25

Concrete wall and wood privacy fence along northern, eastern, and southeast side of building.

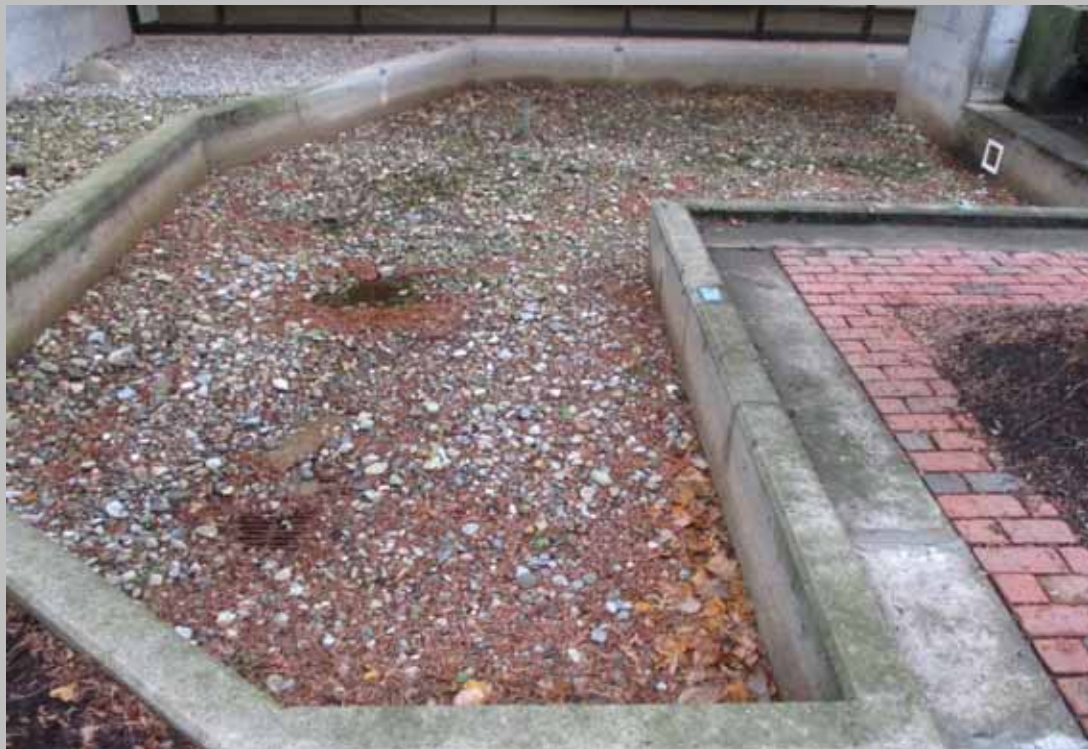
PHOTO #27

Concrete forms in courtyard.

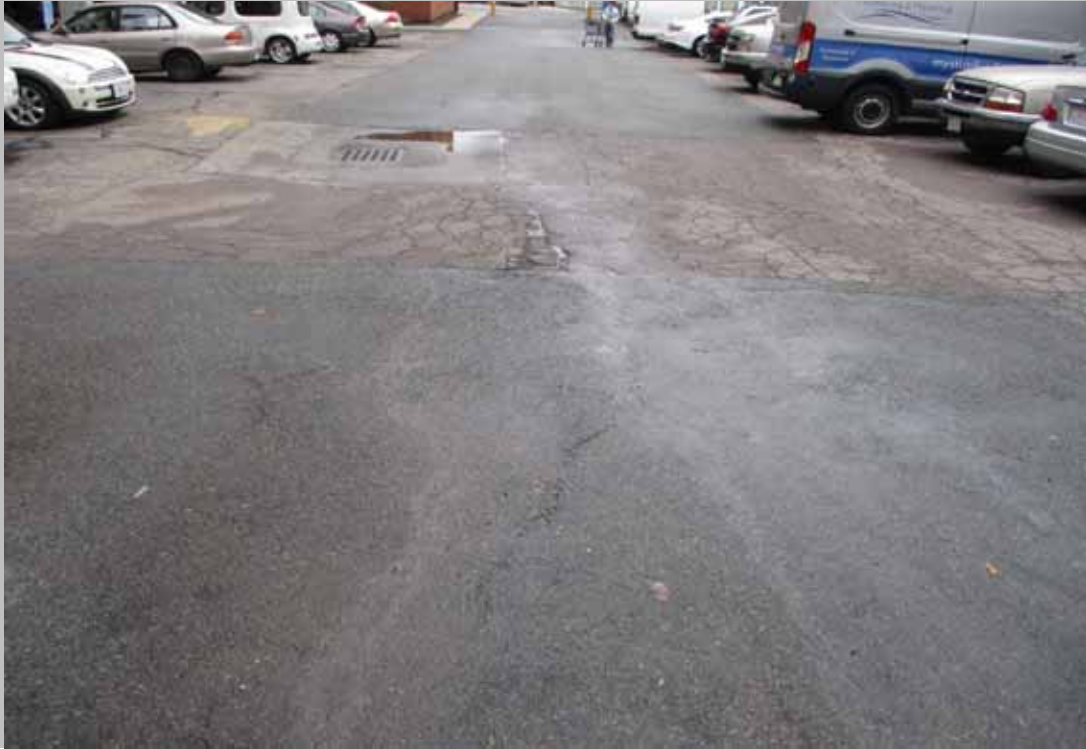
PHOTO #30

Close up of parking lot drive lane.

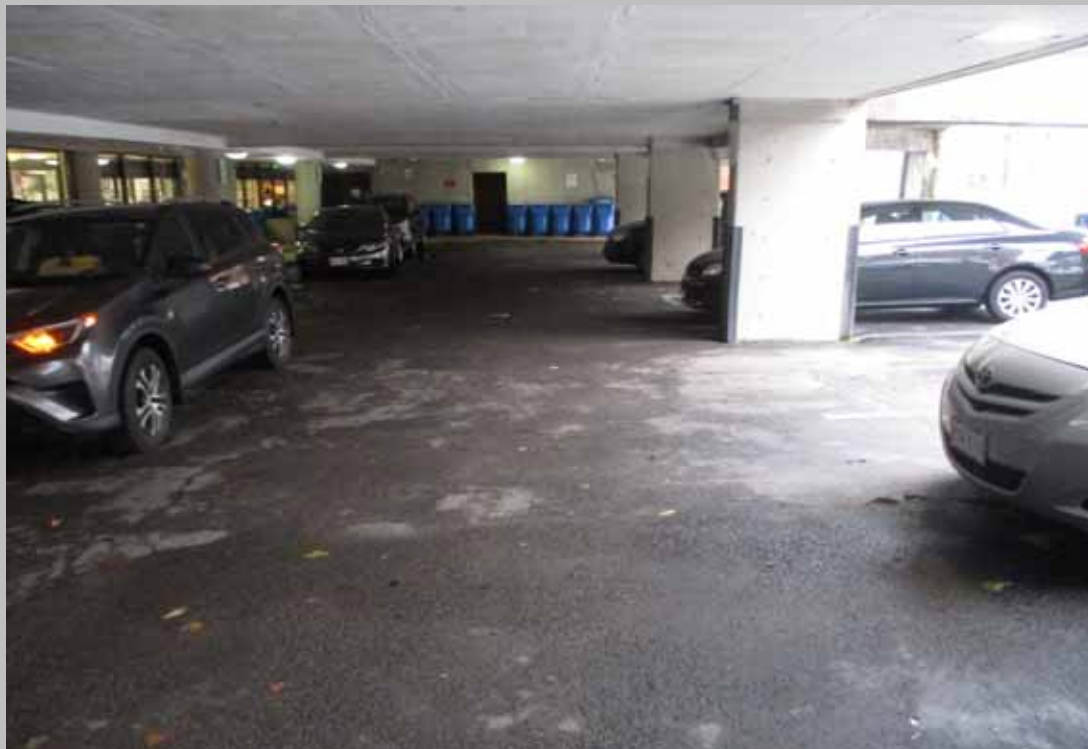
PHOTO #33

Another view under carport.

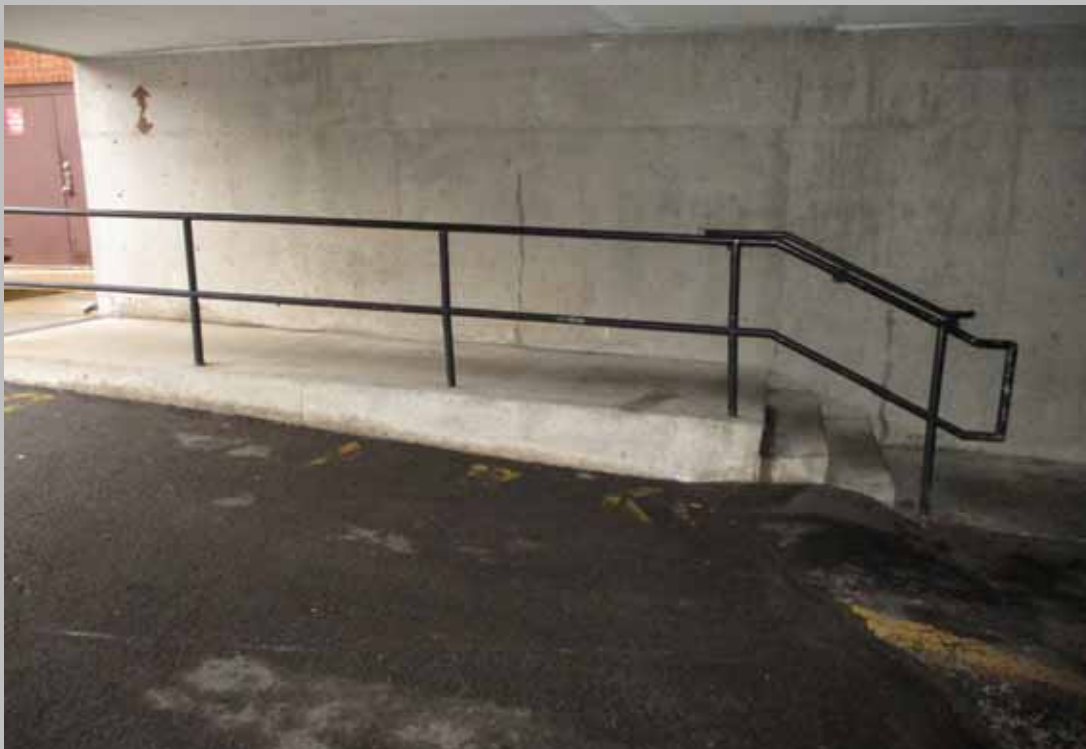
PHOTO #35

Stairs under carport leading to boiler room.

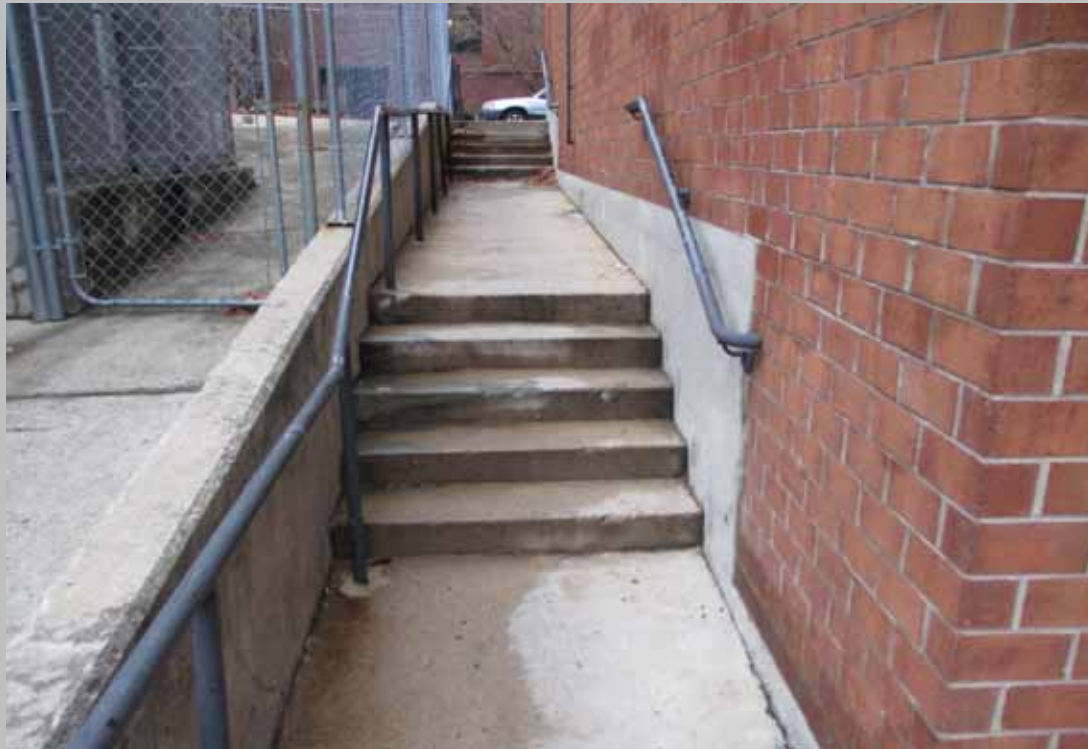
PHOTO #36

Stairs from parking lot up to Egremont Road.

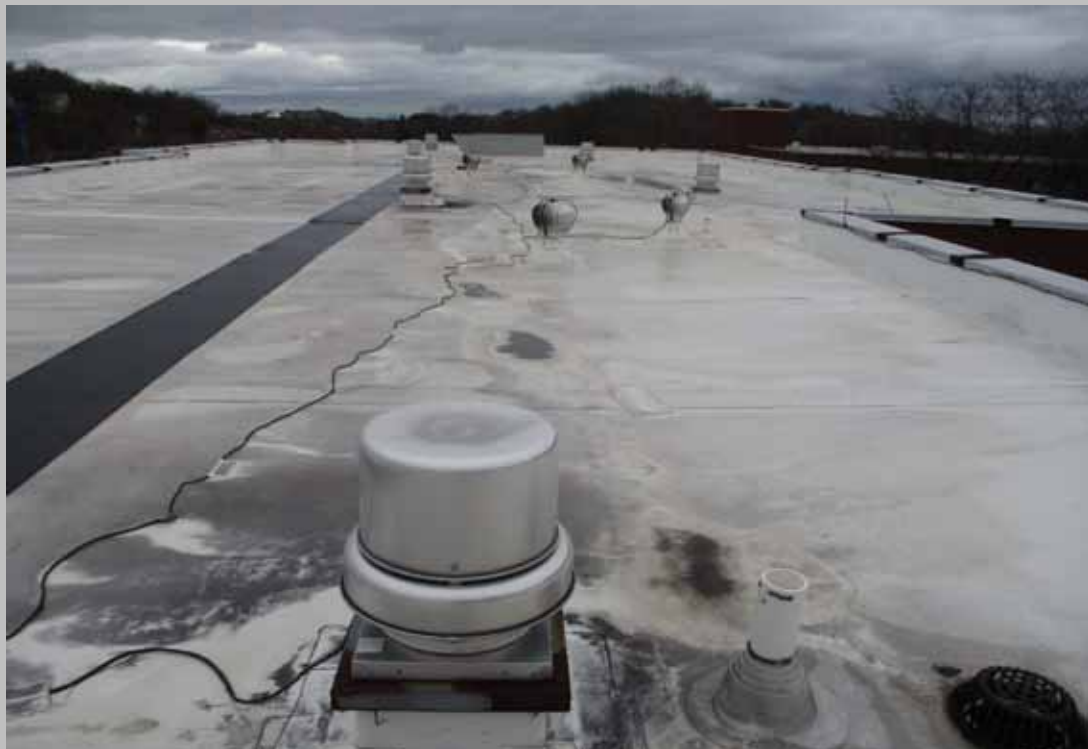
PHOTO #39

Another portion of roof.

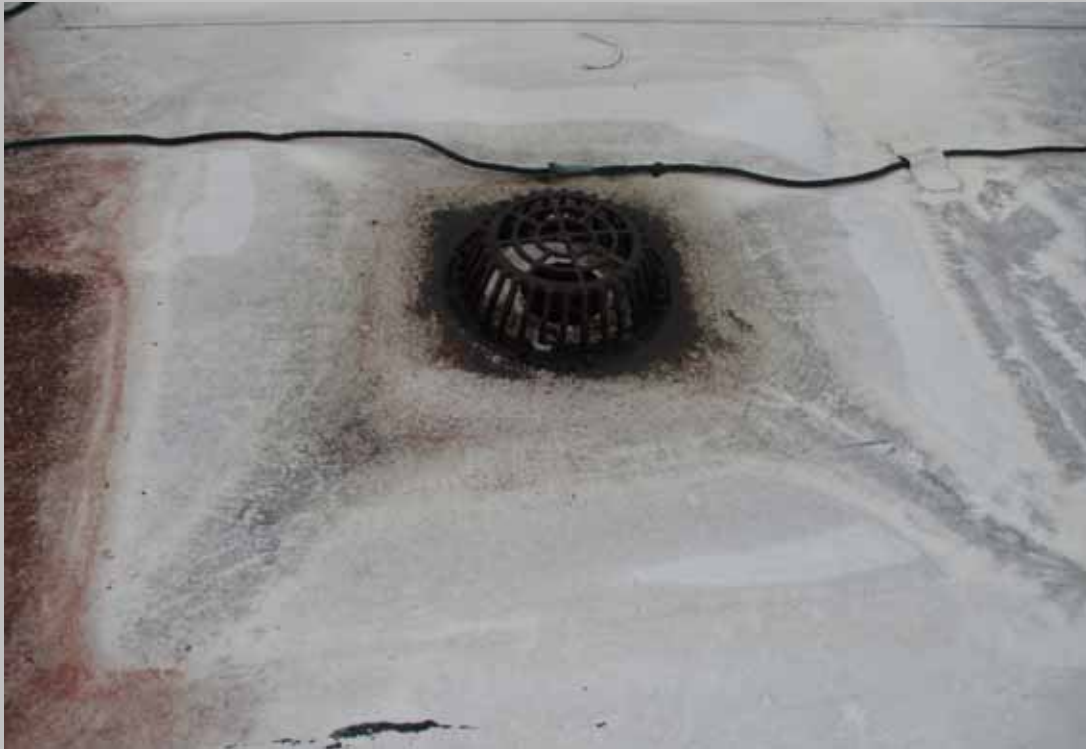
PHOTO #41

Typical roof drain.

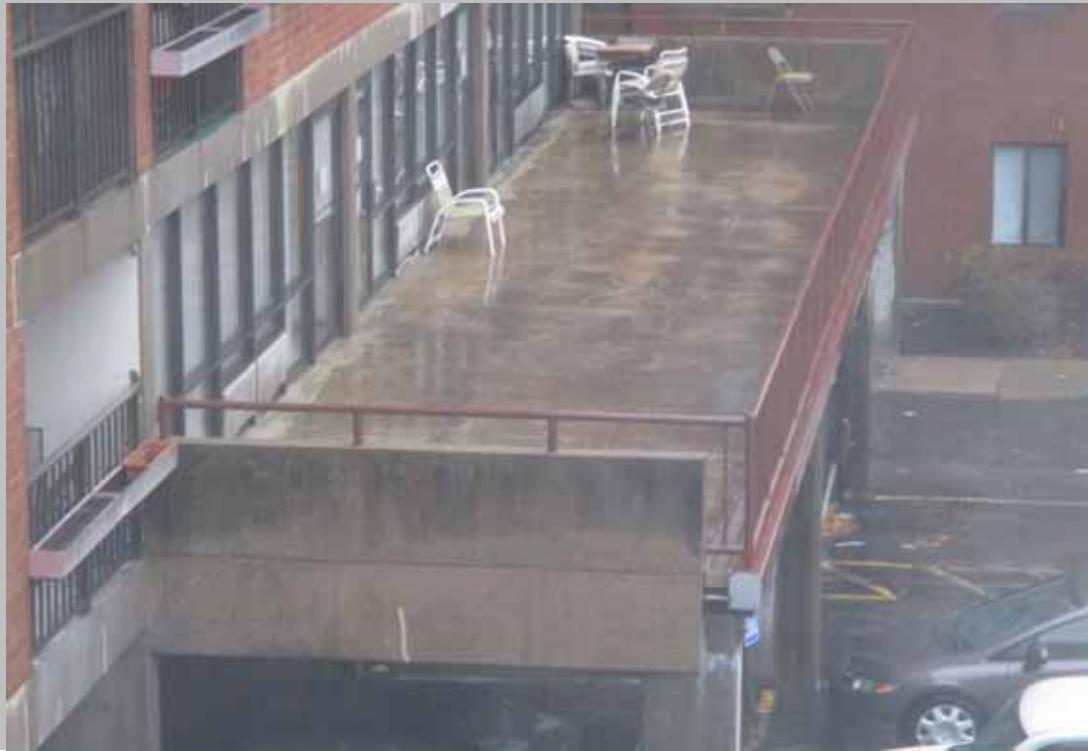
PHOTO #42

Roof deck outside community room.

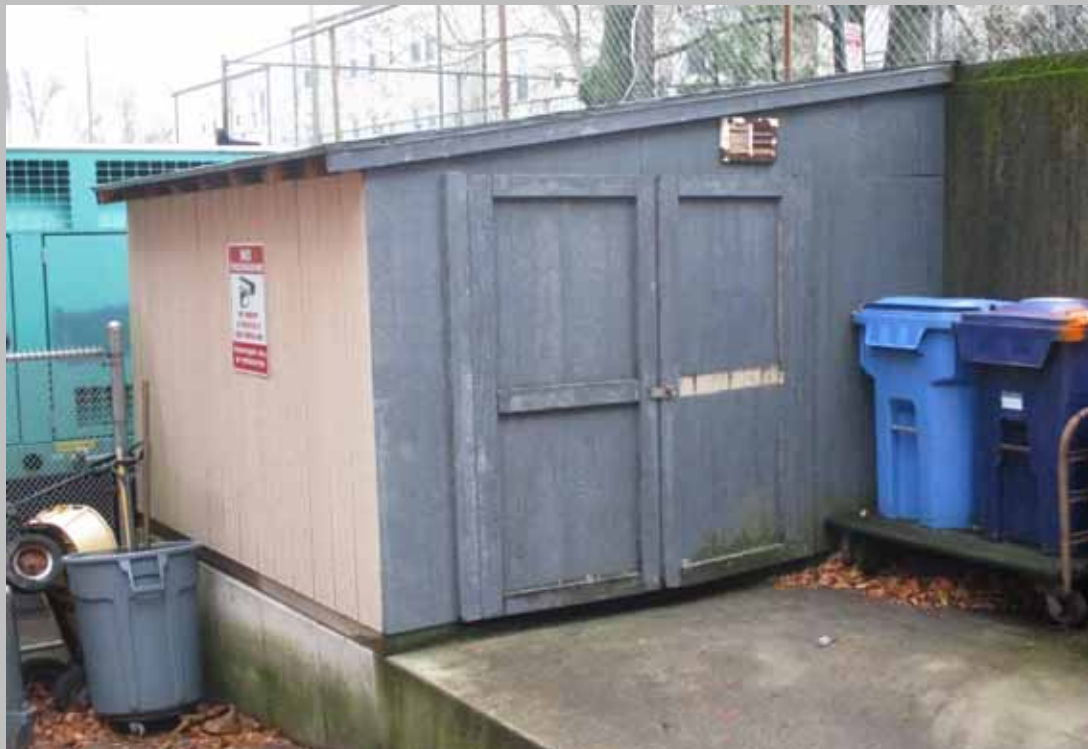
PHOTO #43

Wooden storage shed.

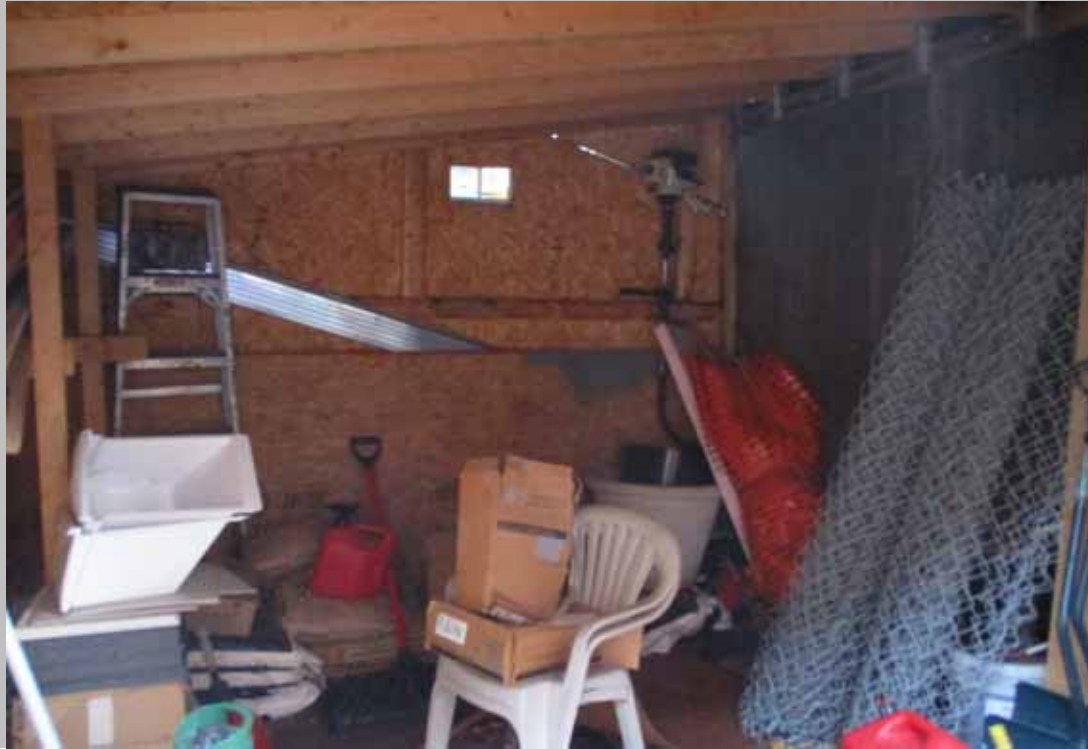
PHOTO #44

Interior of wooden storage shed.

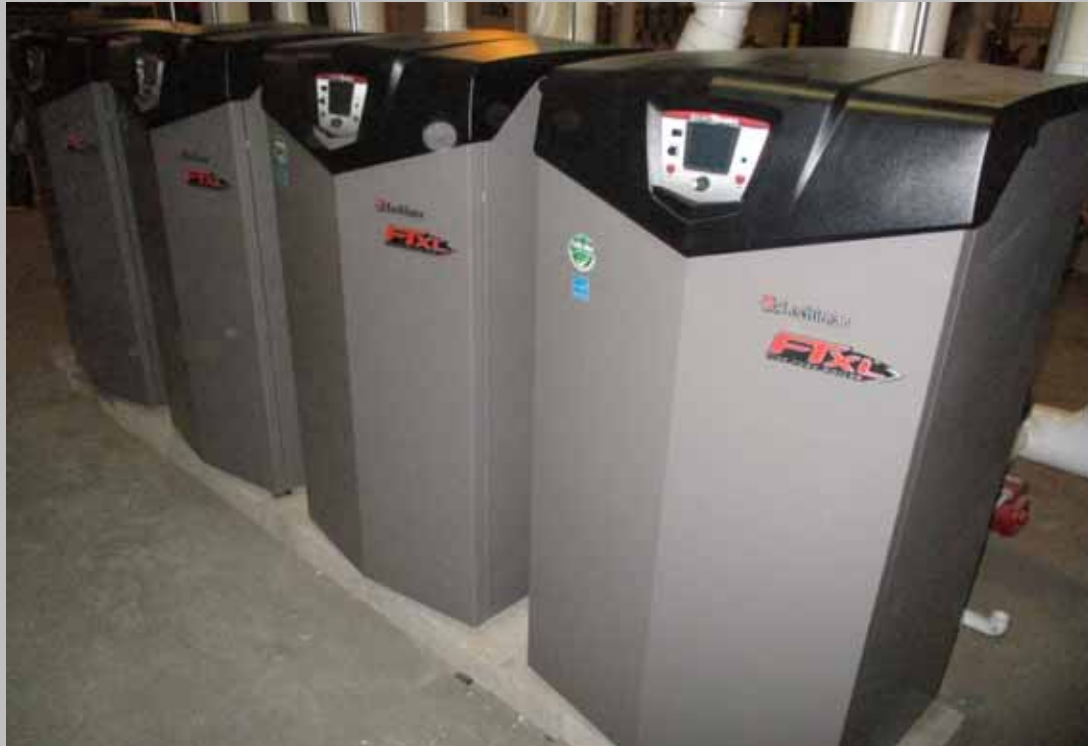
PHOTO #45

Hot water boilers for heating.

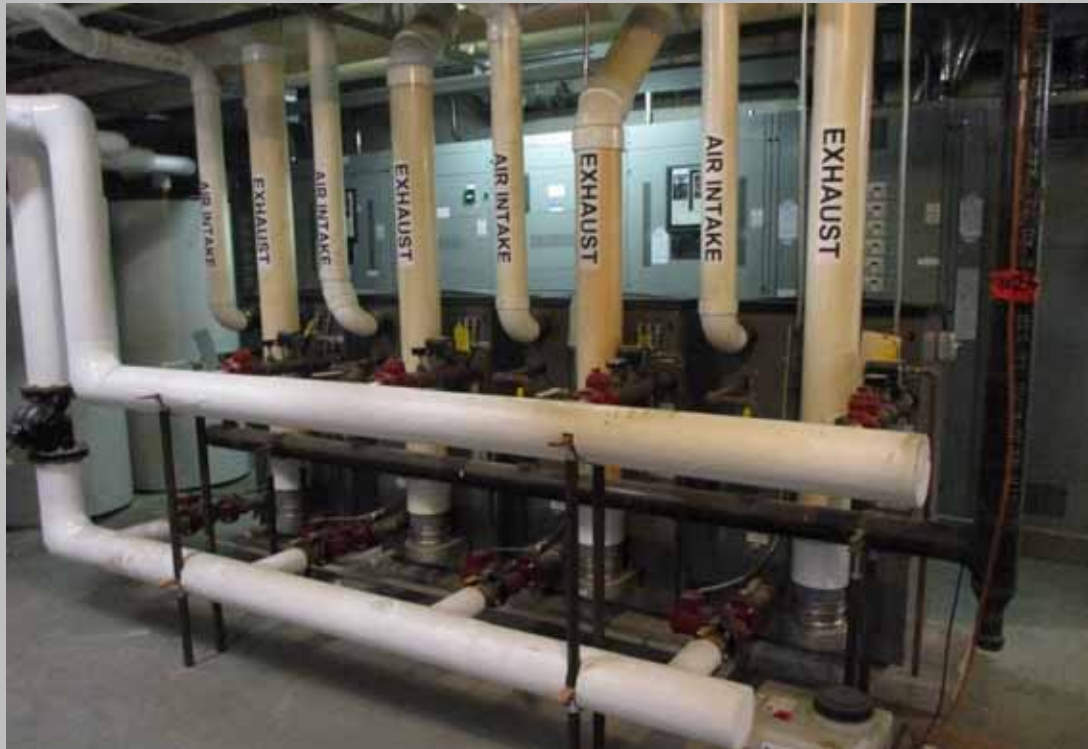
PHOTO #46

Back side of heating hot water boilers.

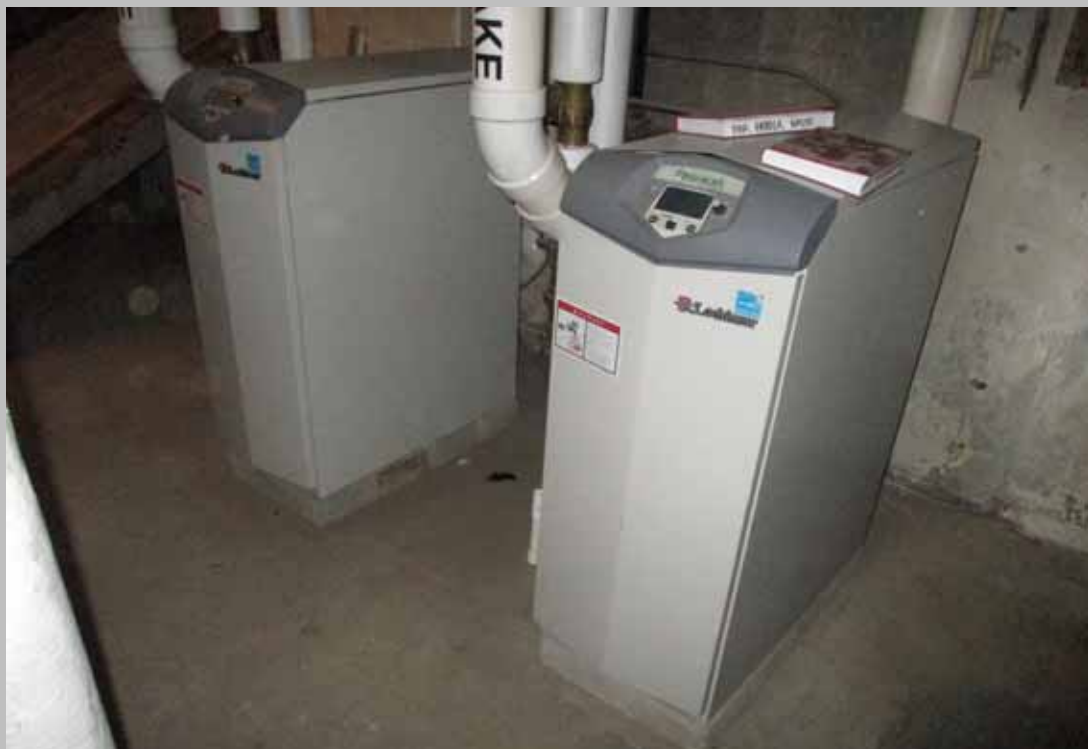
PHOTO #47

Boilers for domestic hot water.

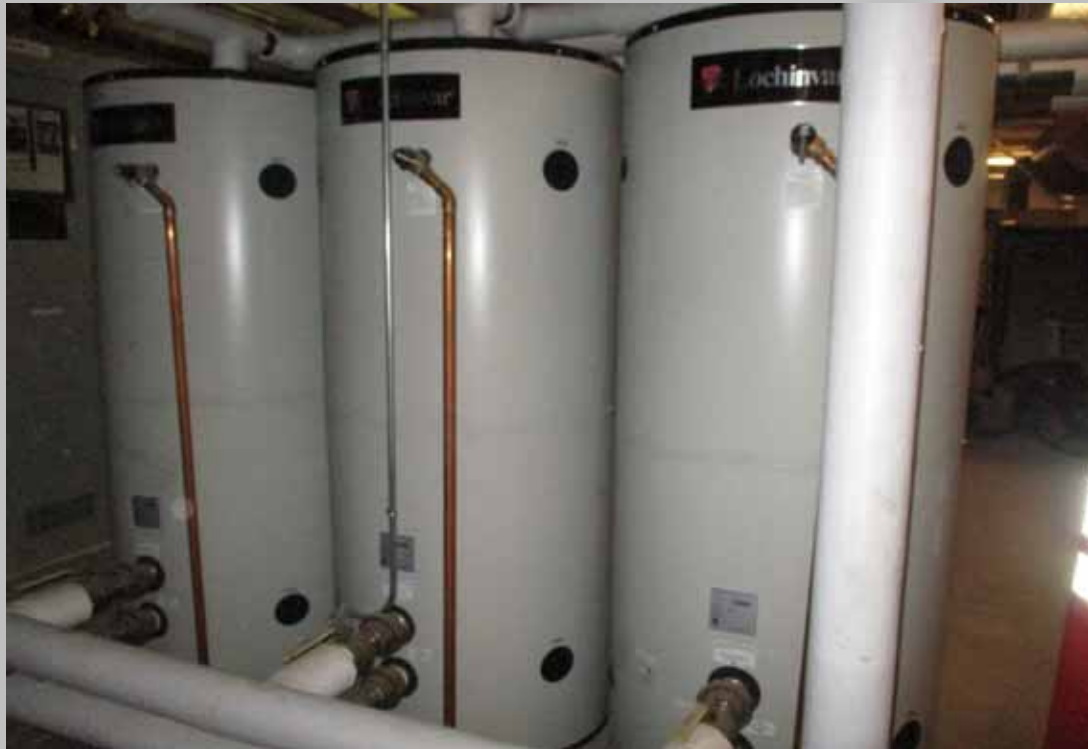
PHOTO #48

Three hot water holding tanks.

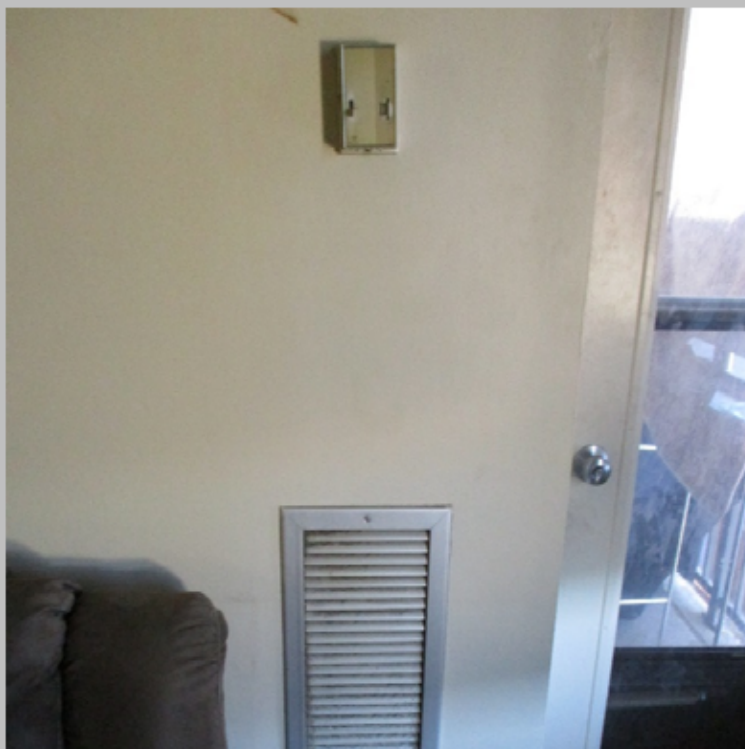
PHOTO #49

Fan coil unit in apartment.

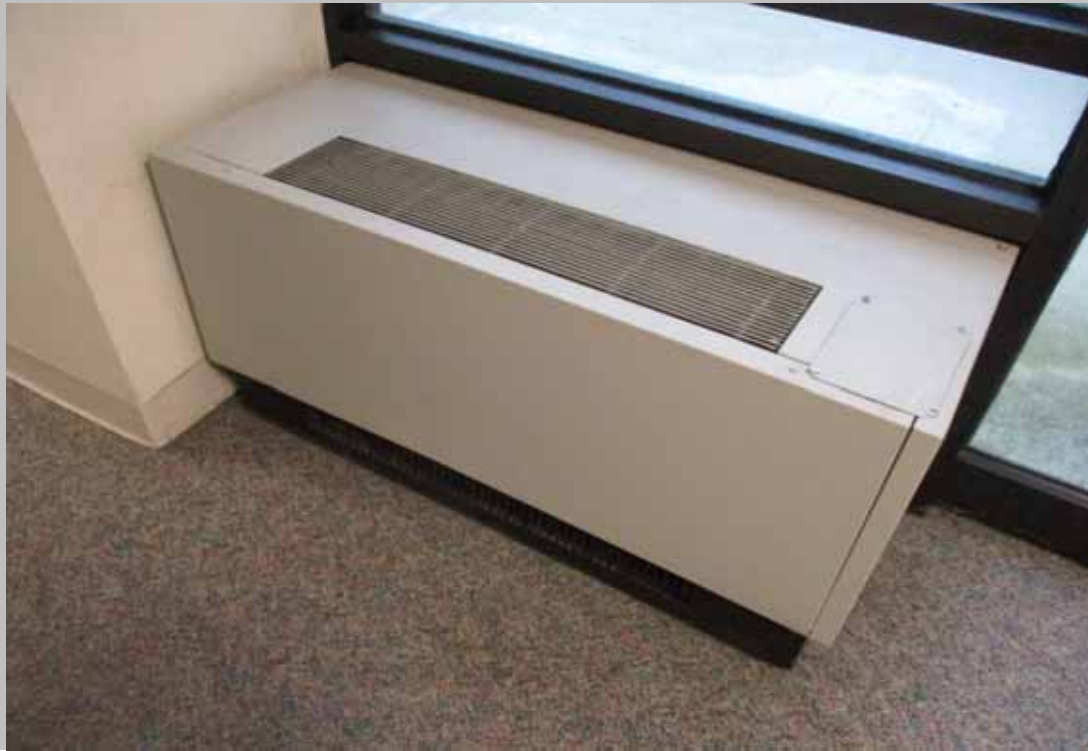
PHOTO #50

A fan coil unit in hallway.

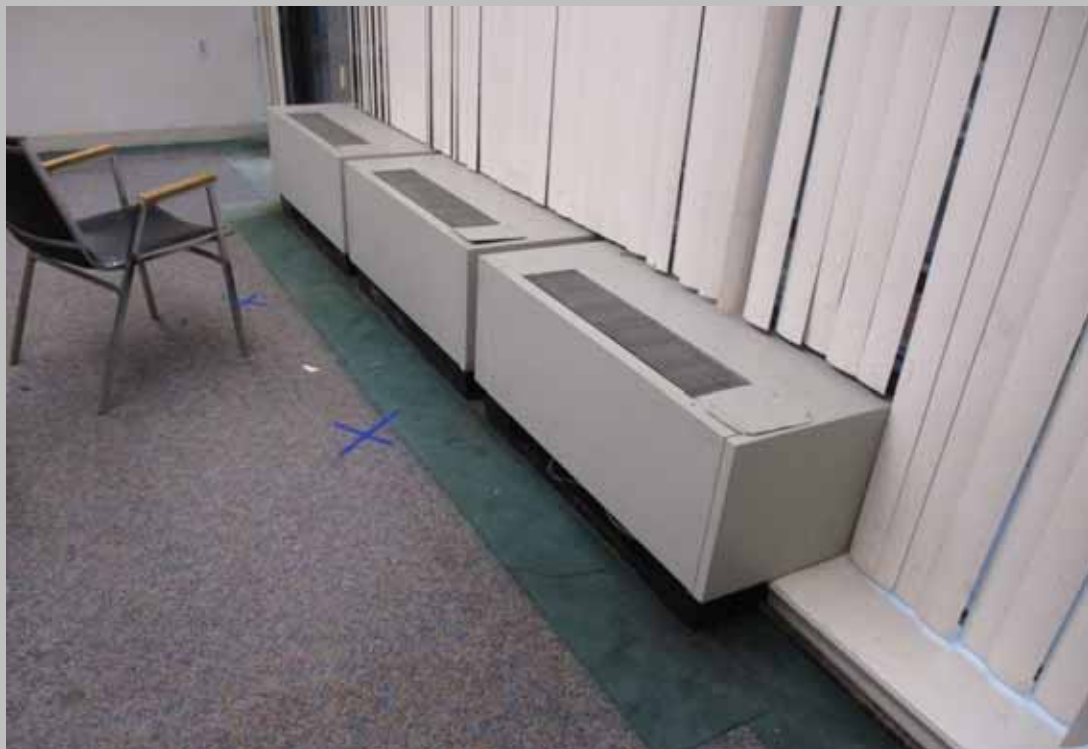
PHOTO #51

Fan coil units in common areas.
