**CAPITAL NEEDS ASSESSMENT (CNA)
PATRICIA WHITE APARTMENTS
20 WASHINGTON STREET
BRIGHTON, MASSACHUSETTS 02135**

**D3G PROJECT NUMBER:
2020-2130**

**FINAL REPORT ISSUE DATE:
FEBRUARY 4, 2021**

**INSPECTION DATES:
NOVEMBER 23 AND 24, 2020**

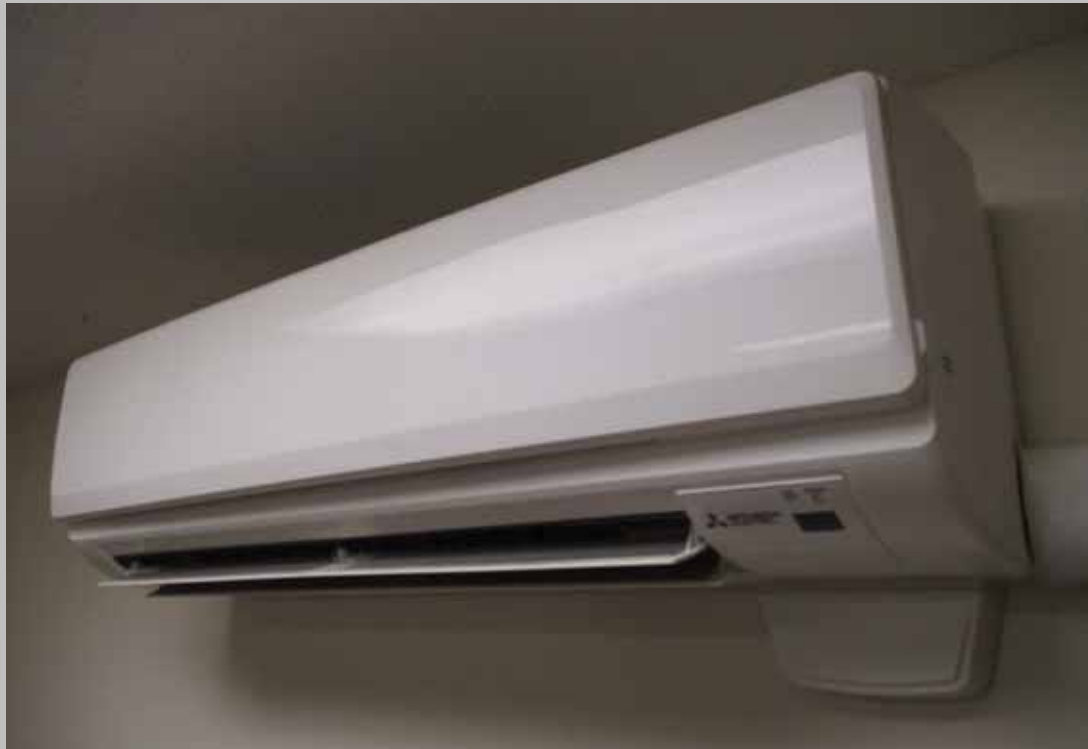
PHOTO #52

Ductless units in Task Force offices.

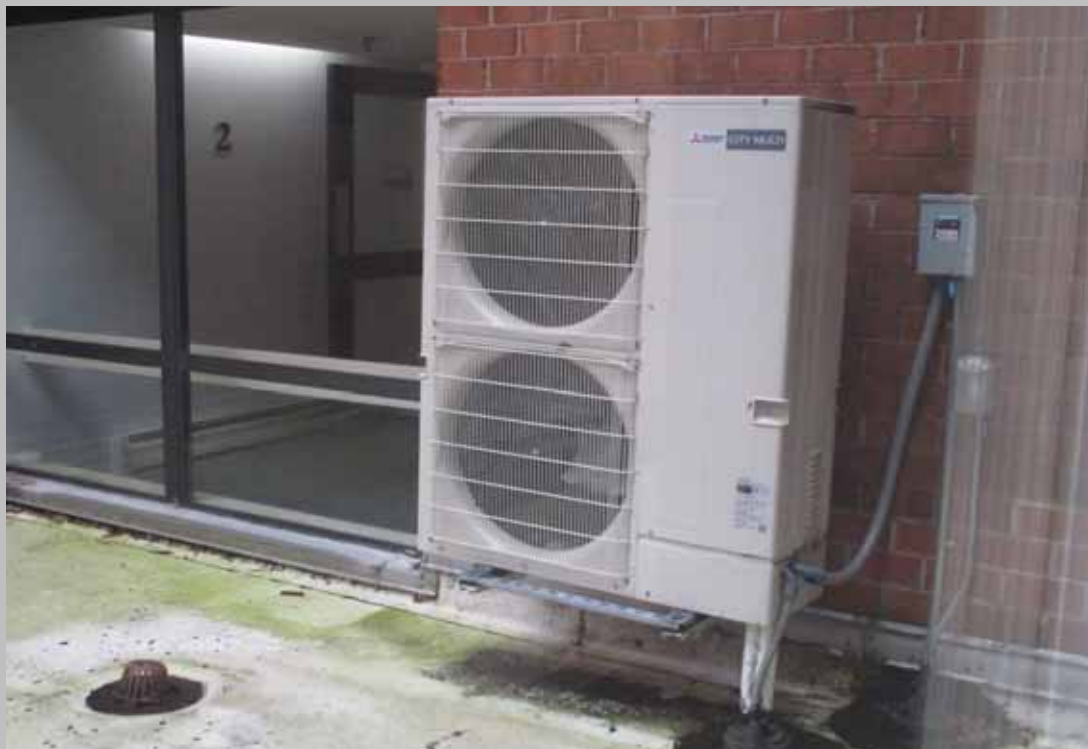
PHOTO #53

Condensers for ductless units.

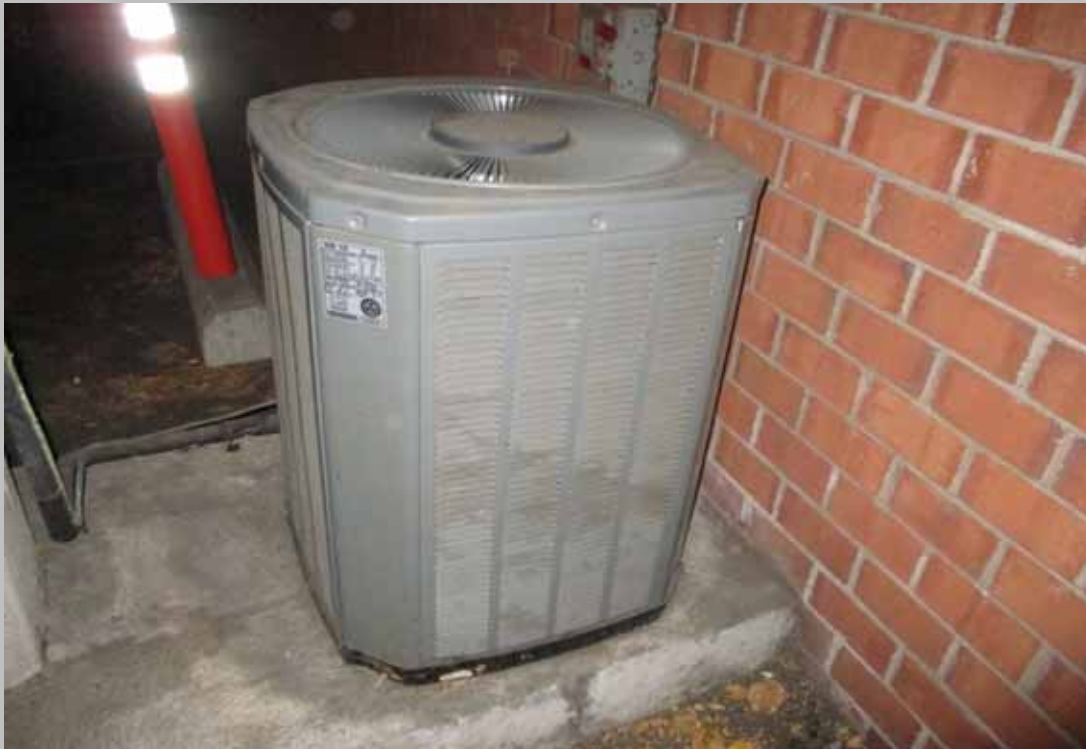
PHOTO #54

One of three ground-mounted condensers.

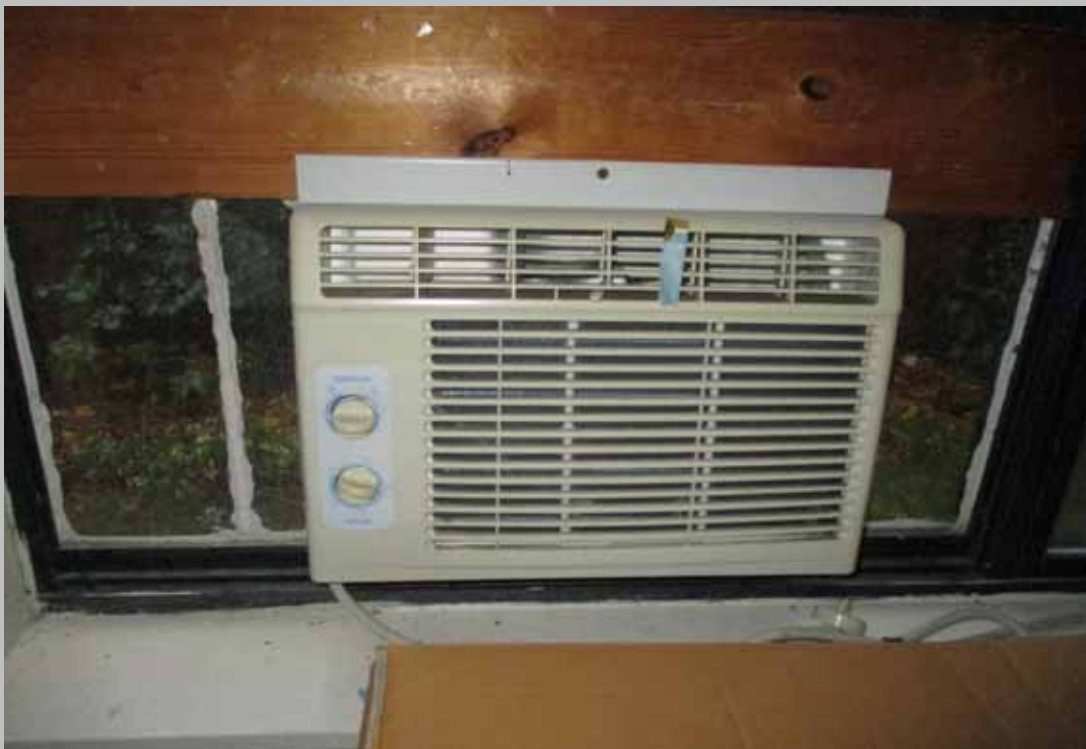
PHOTO #55

Typical window-mounted A/C unit in apartments.

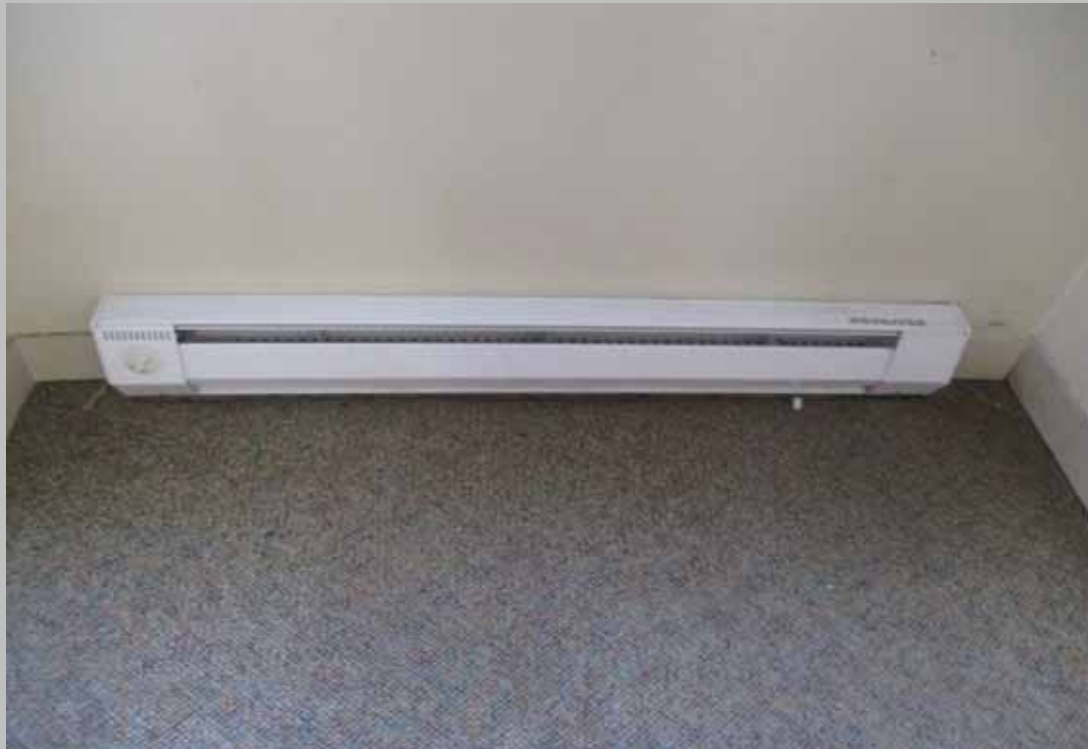
PHOTO #56

Typical floor-mounted electric space heater in stairwells.

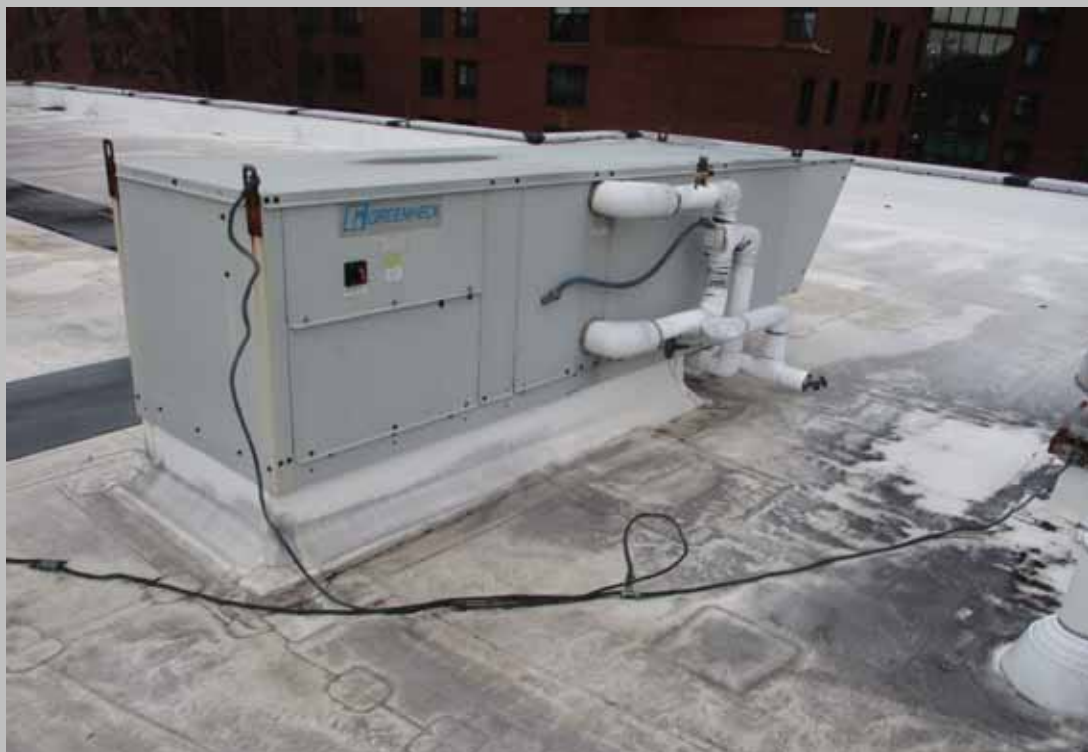
PHOTO #57

One of the Greenheck make-up air systems.

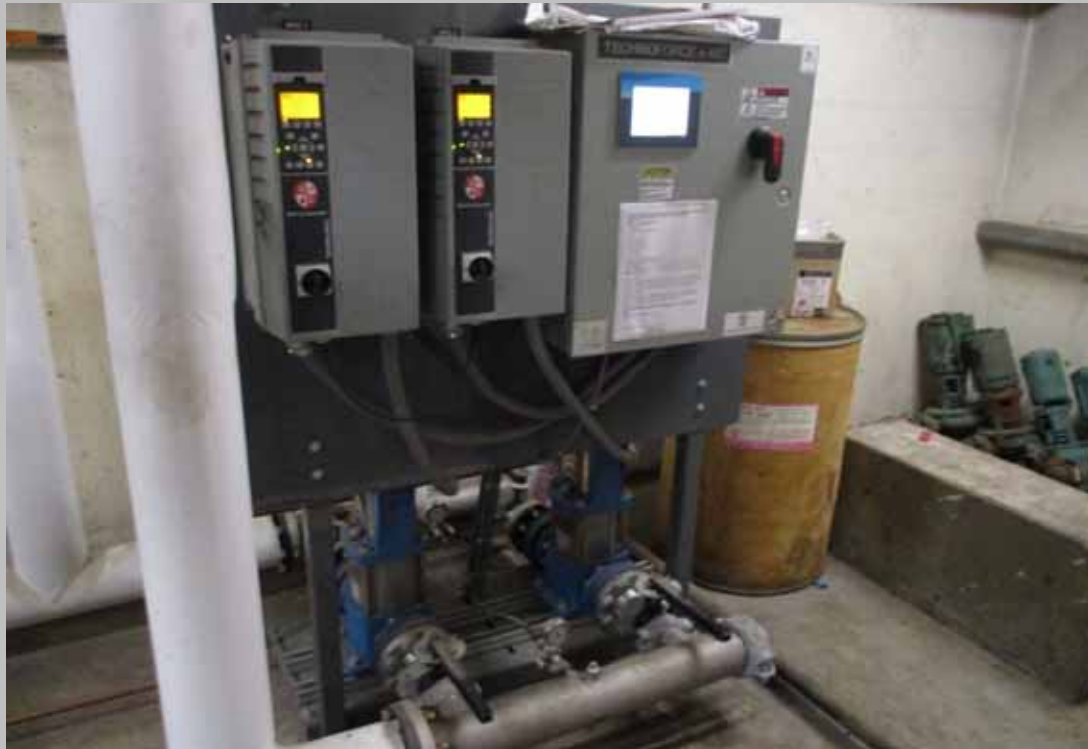
PHOTO #58

Domestic water circulating system.

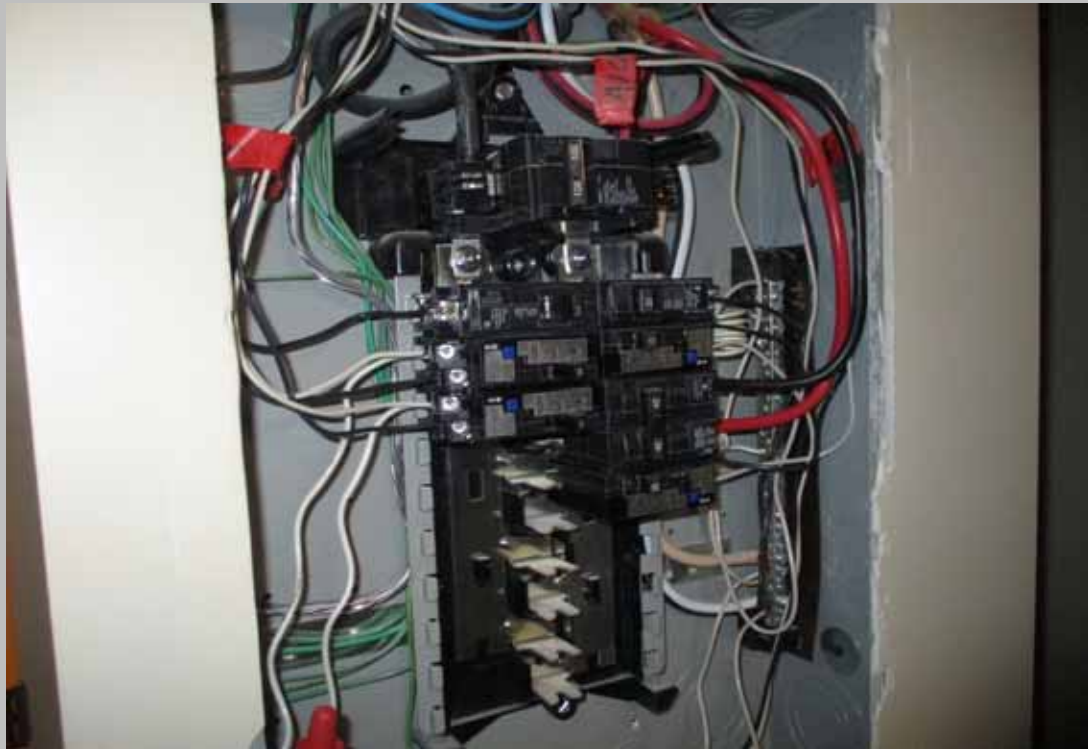
PHOTO #60

Example of newer circuit breaker panel in select apartments.

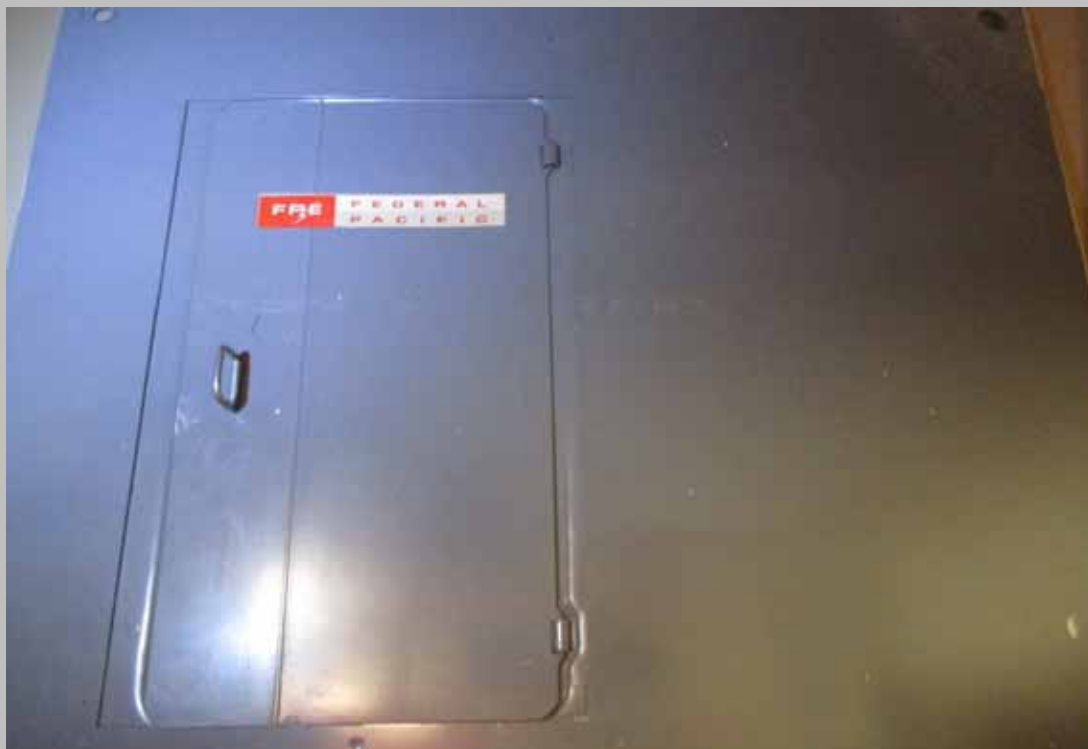
PHOTO #61

Example of Federal Pacific circuit breaker panel.

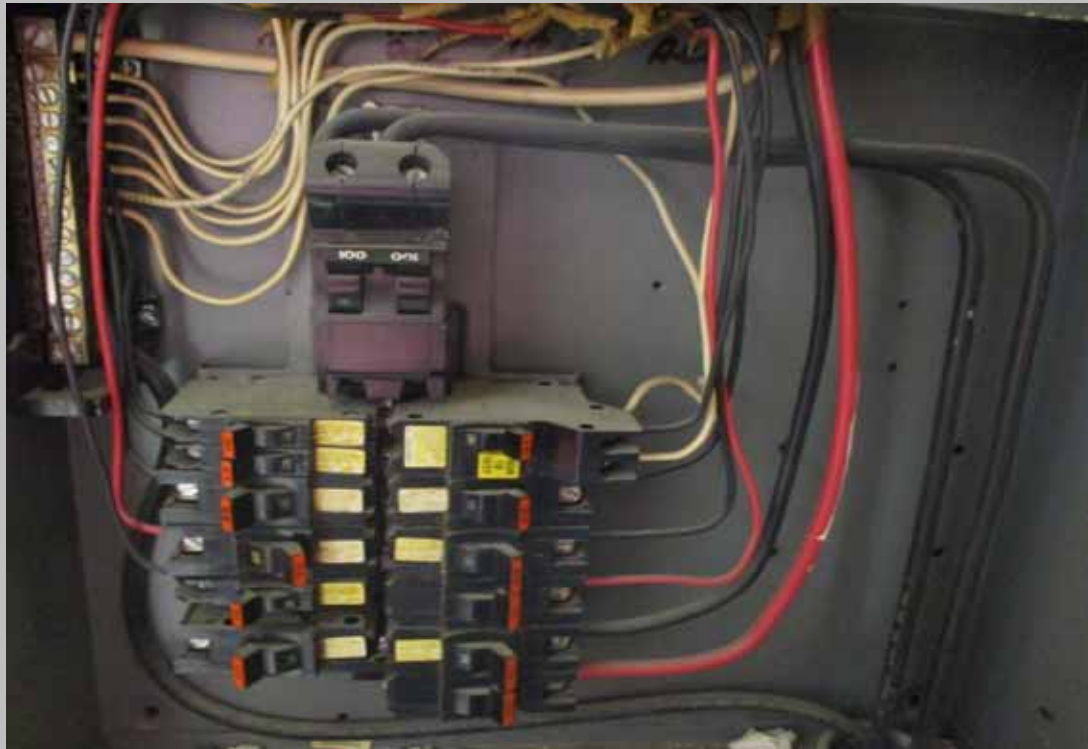
PHOTO #62

Inside of a typical Federal Pacific circuit breaker panel.

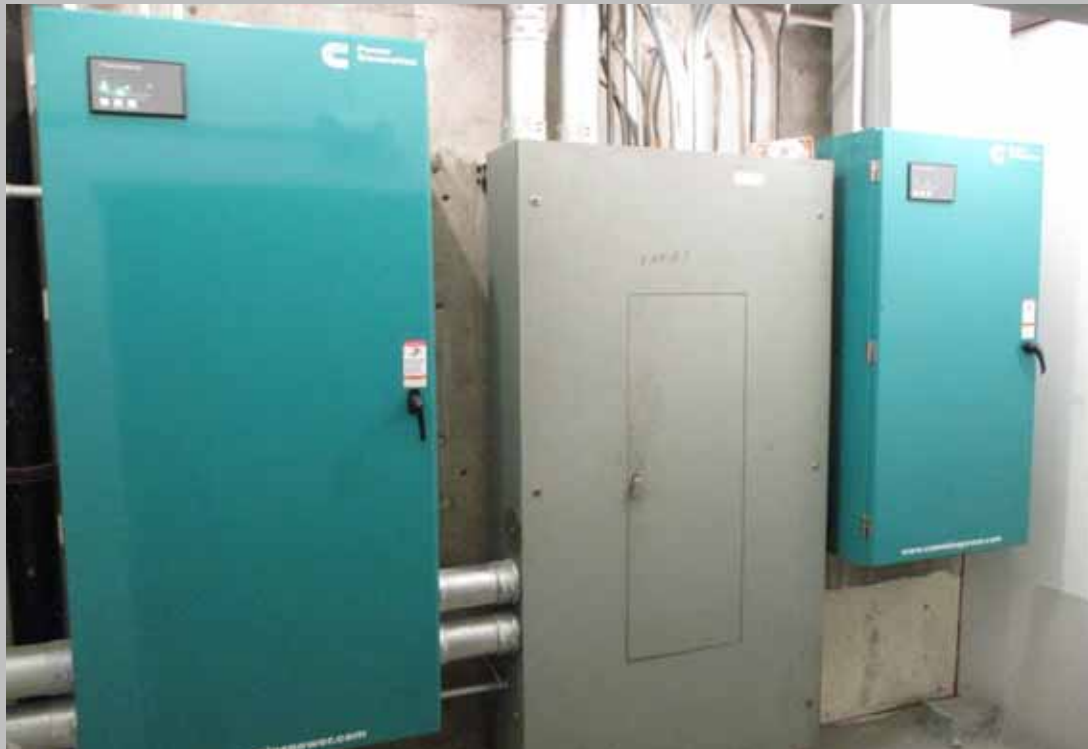
PHOTO #65

Generator control panels.

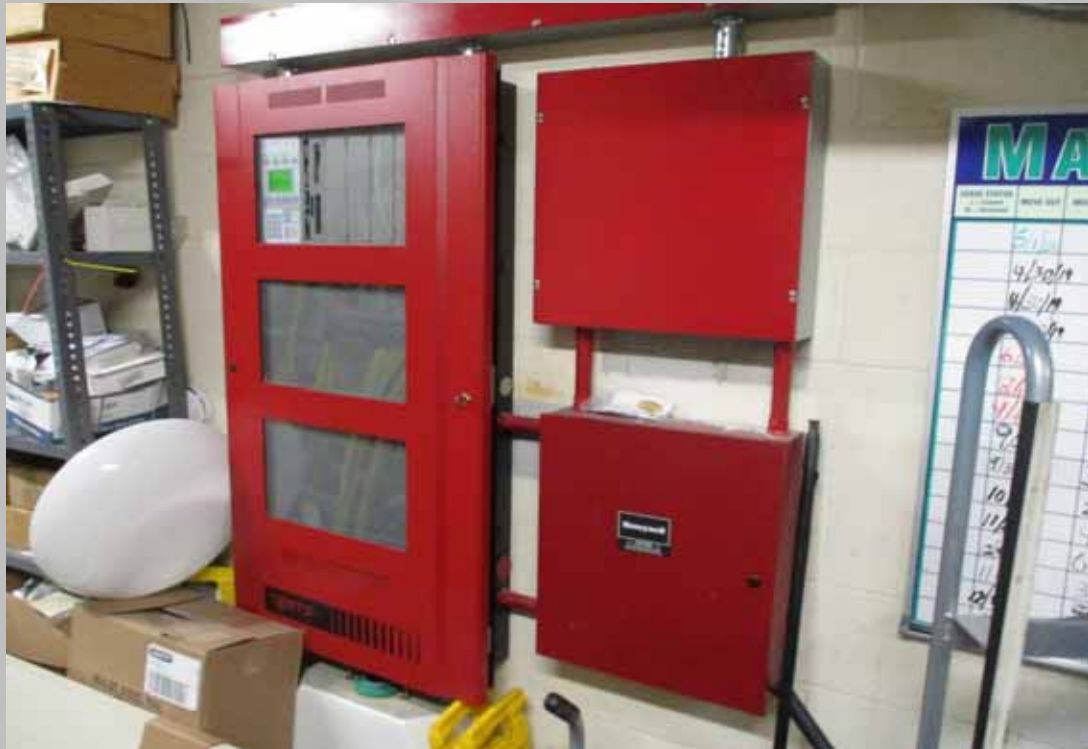
PHOTO #66

Main fire panel.

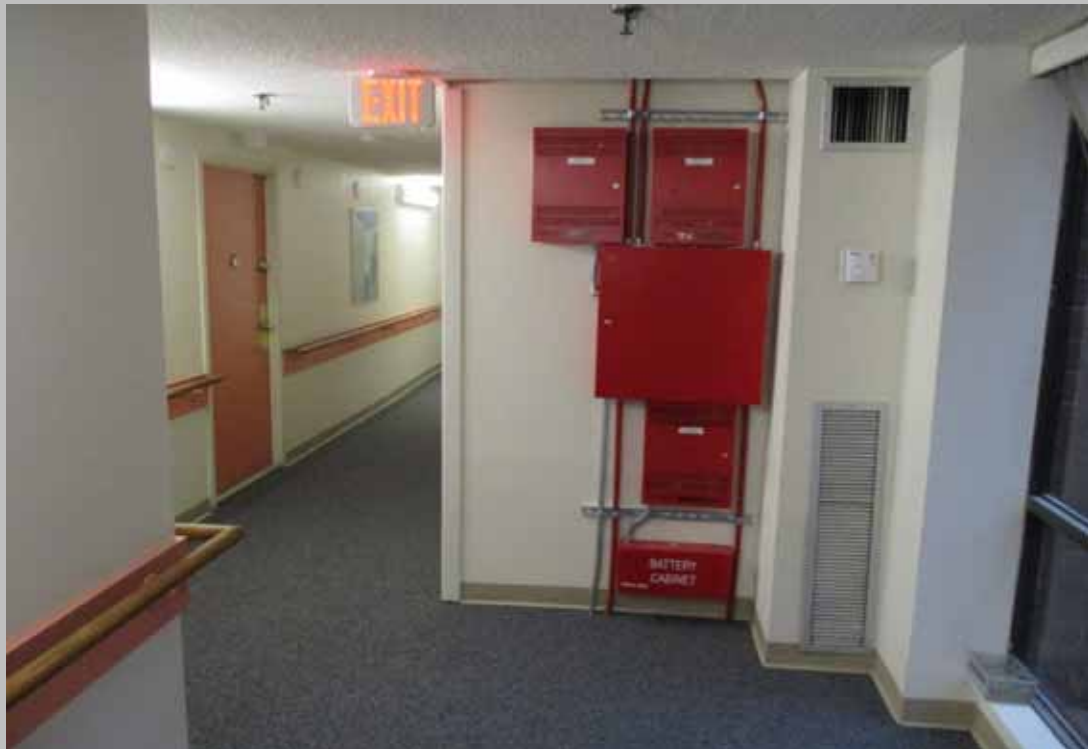
PHOTO #67

Booster fire panels in hallway.

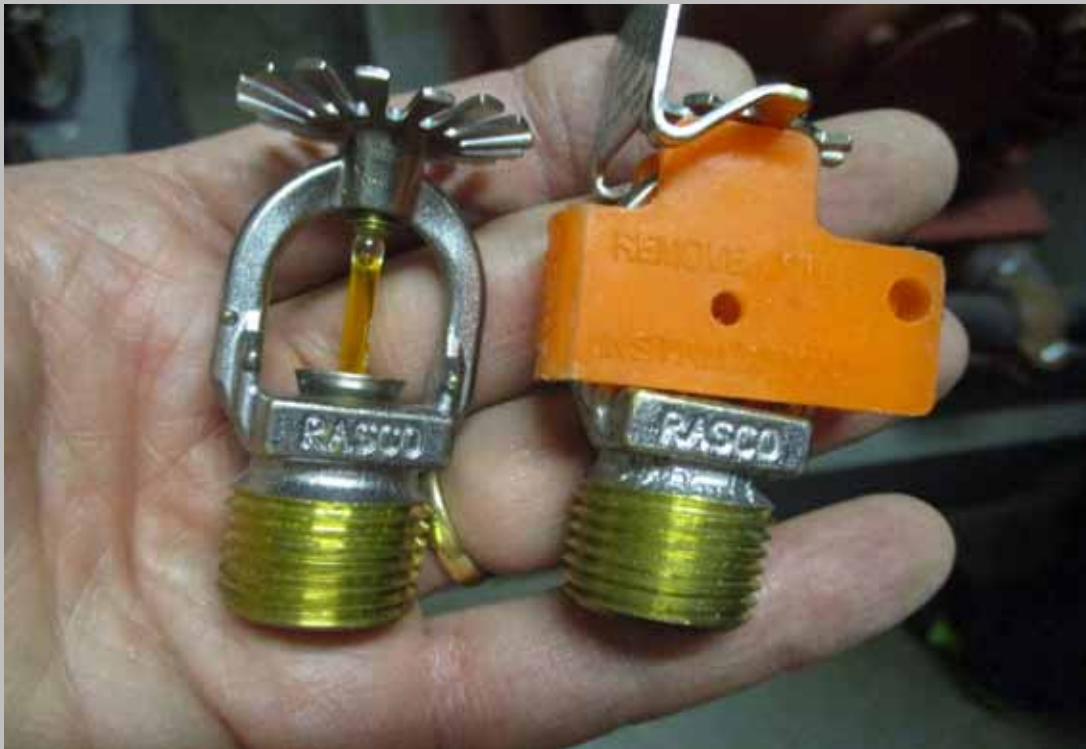
PHOTO #69

Rasco sprinkler heads.

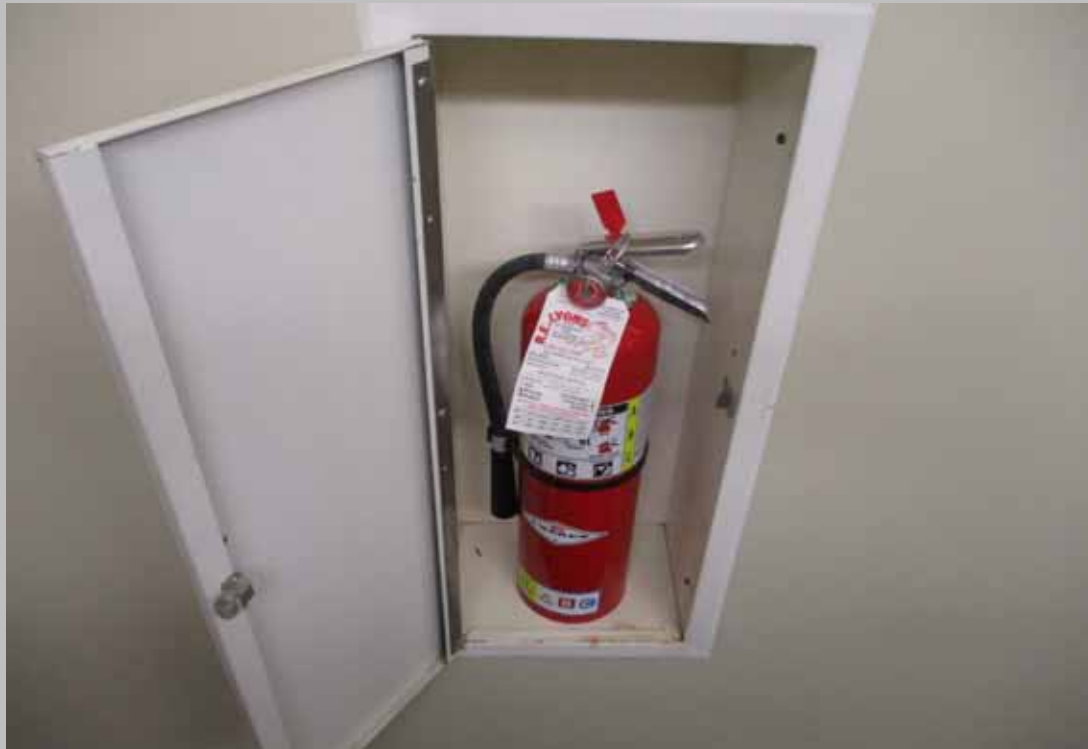
PHOTO #70

Typical fire extinguisher throughout building.

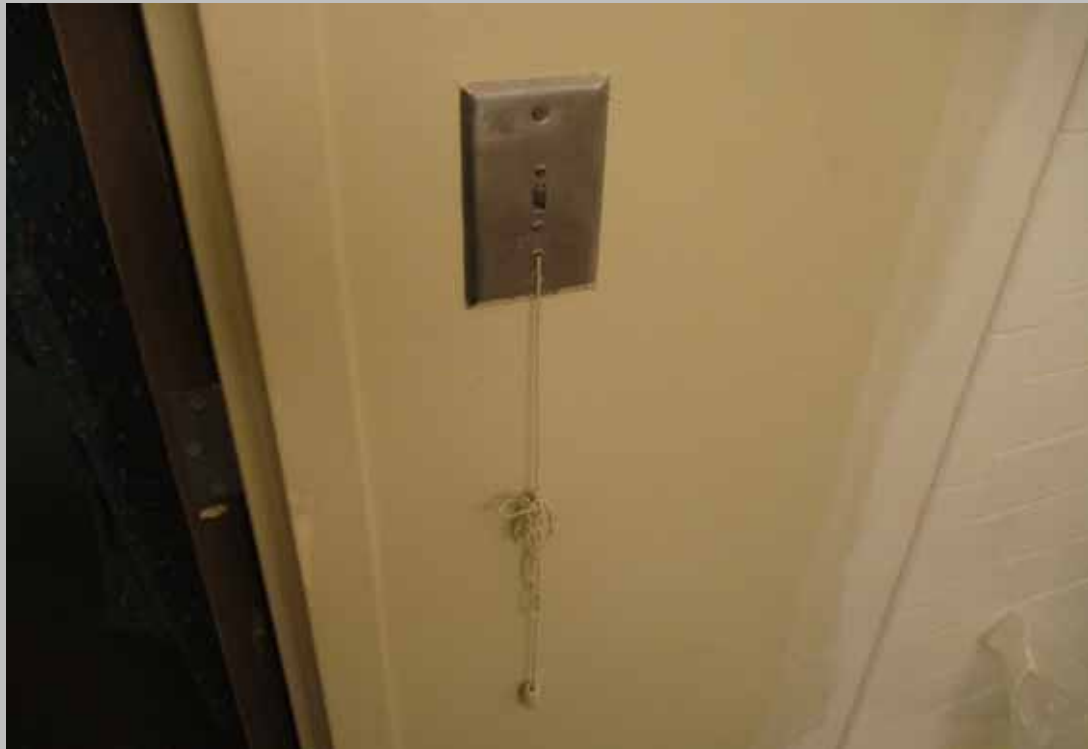
PHOTO #74

Example of emergency call pull-cord system in bathrooms.

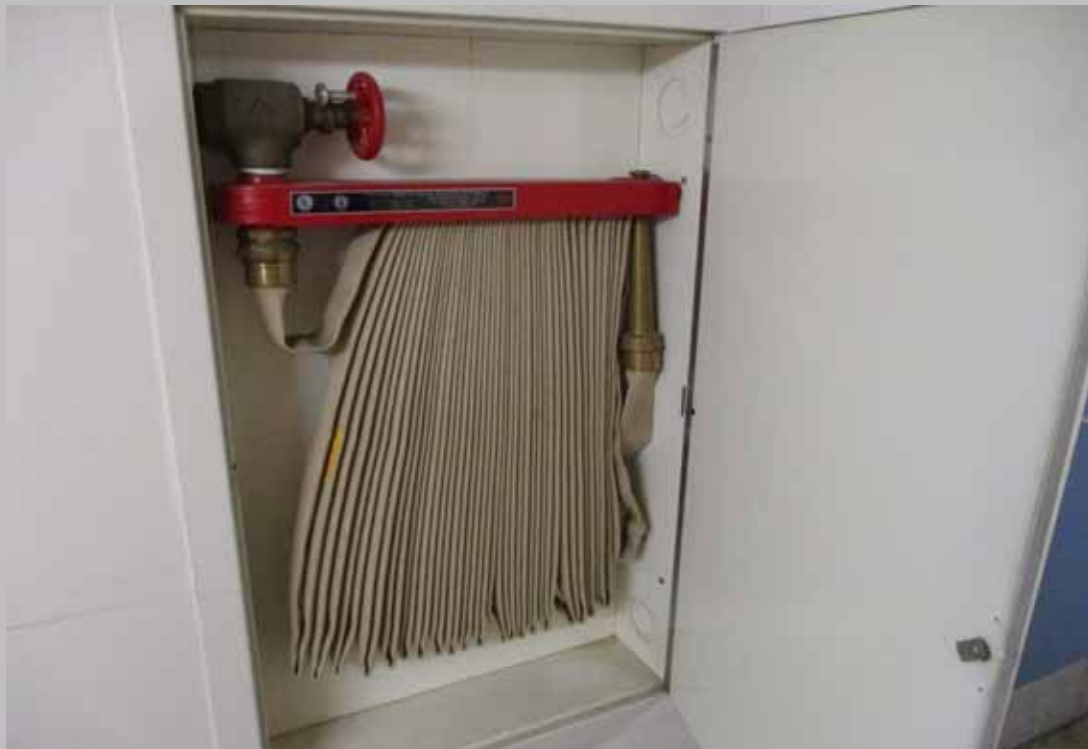
PHOTO #75

Fire hoses in hallways.

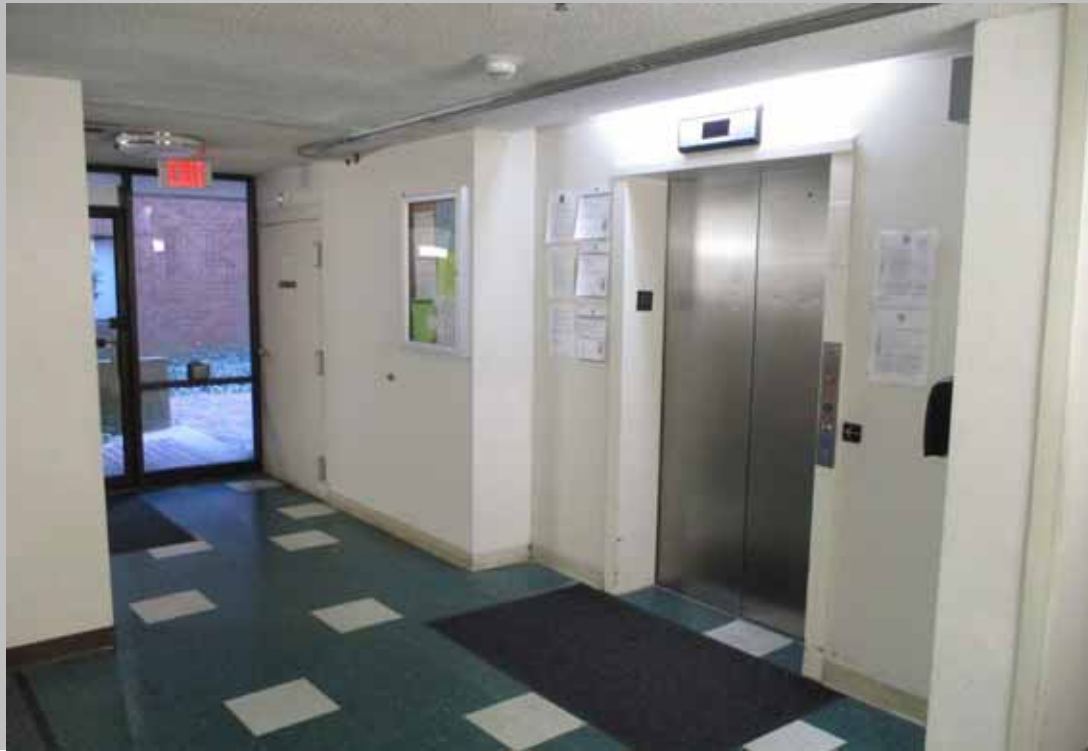
PHOTO #76

Typical elevator lobby.

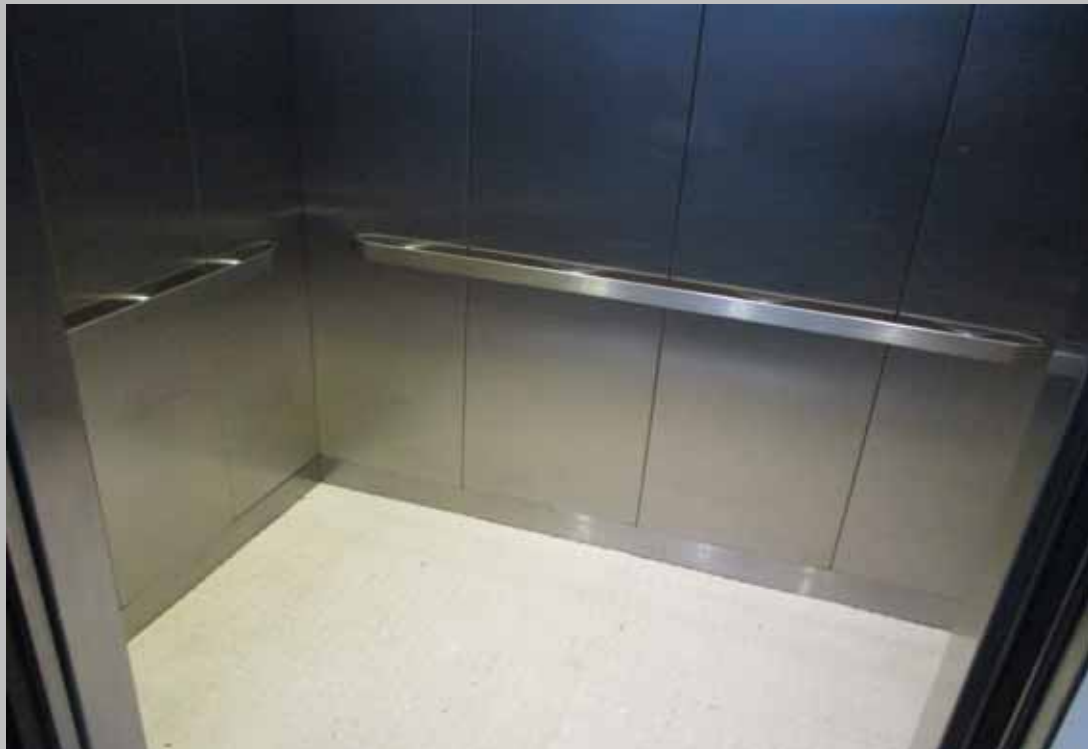
PHOTO #77

An elevator cab interior.

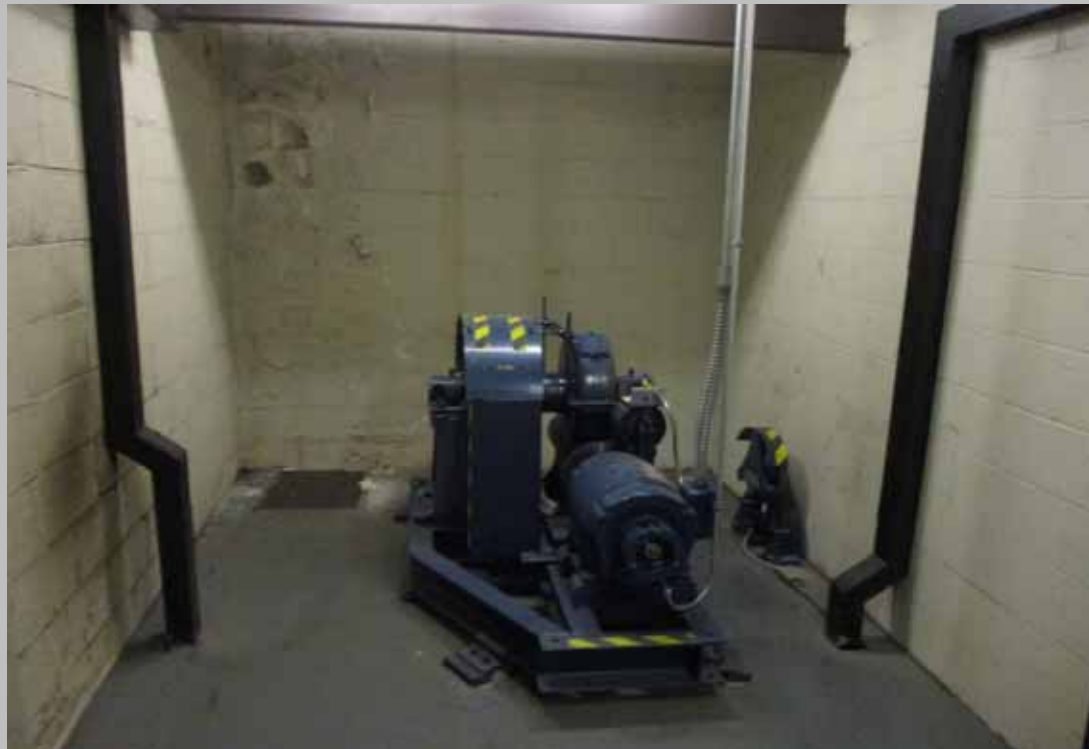
PHOTO #79

Overhead traction elevator machinery.

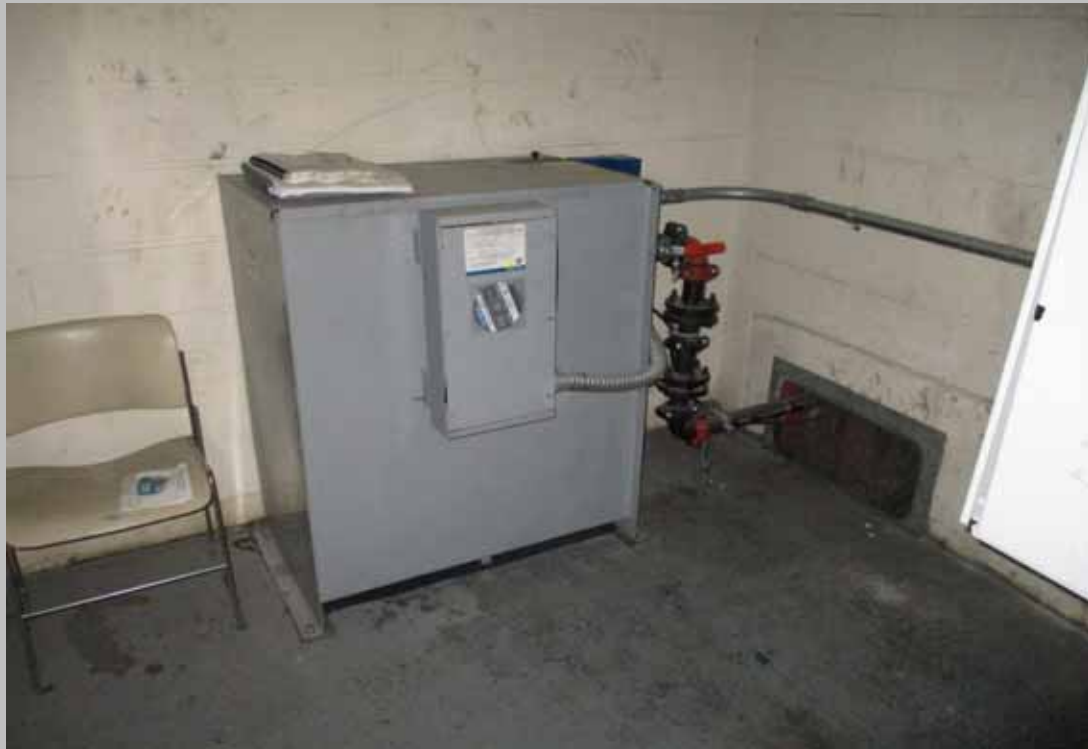
PHOTO #80

Hydraulic elevator control machinery.

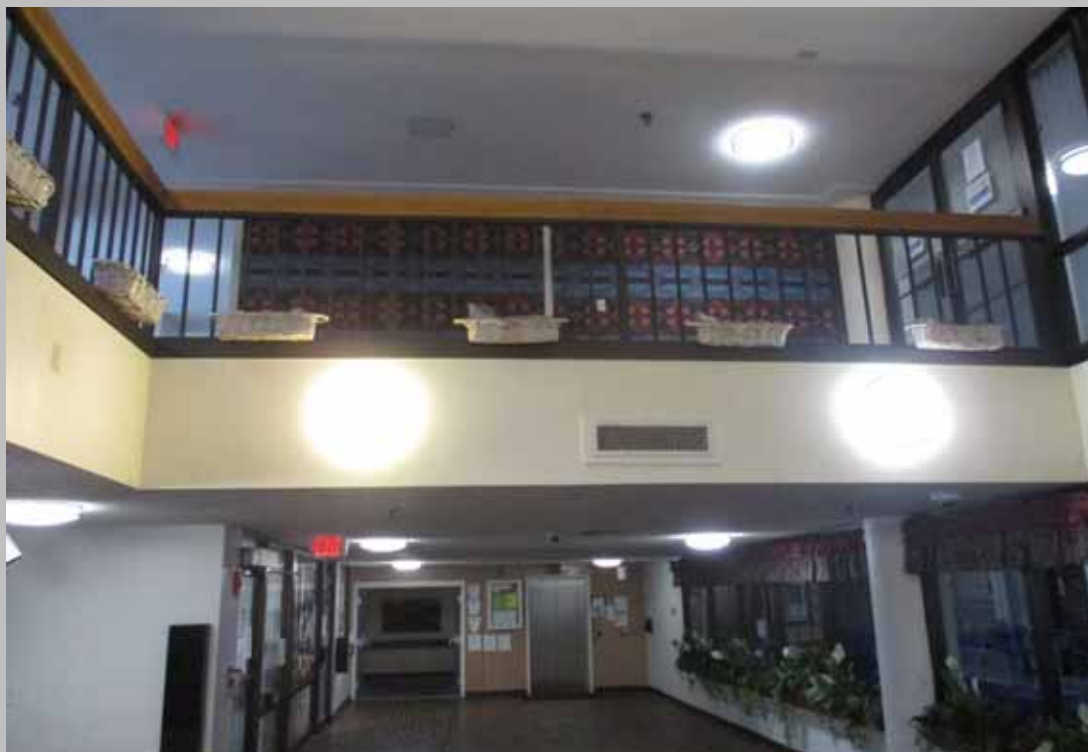
PHOTO #81

Main entry foyer.

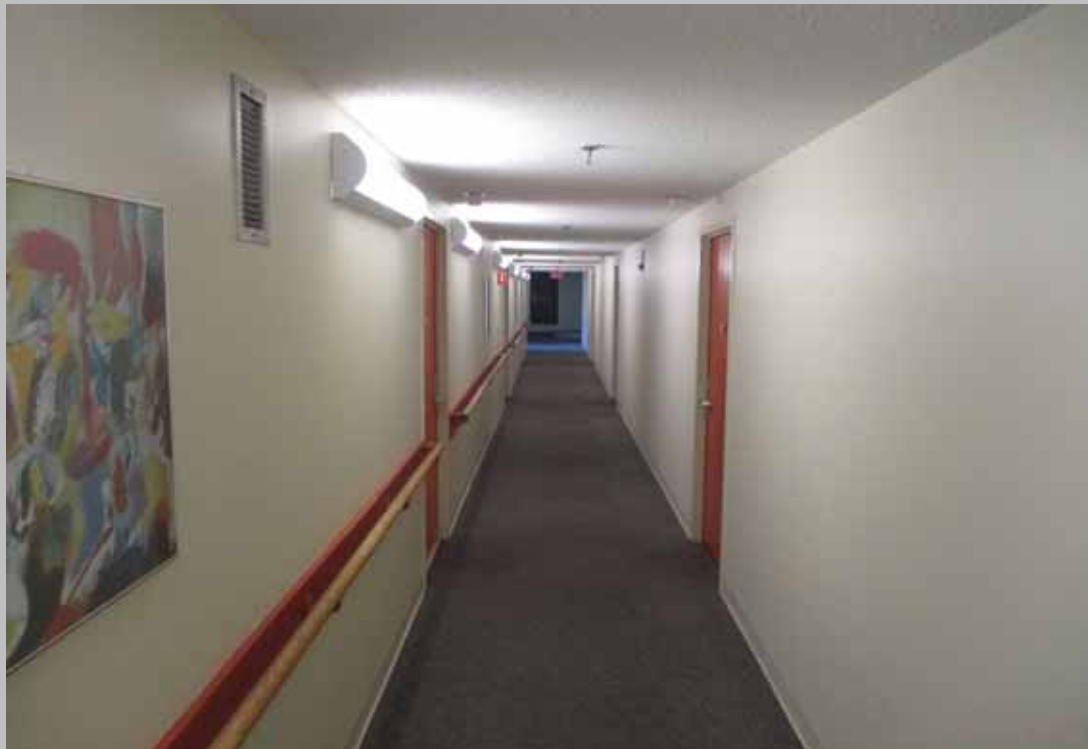
PHOTO #83

Typical upper floor corridor.

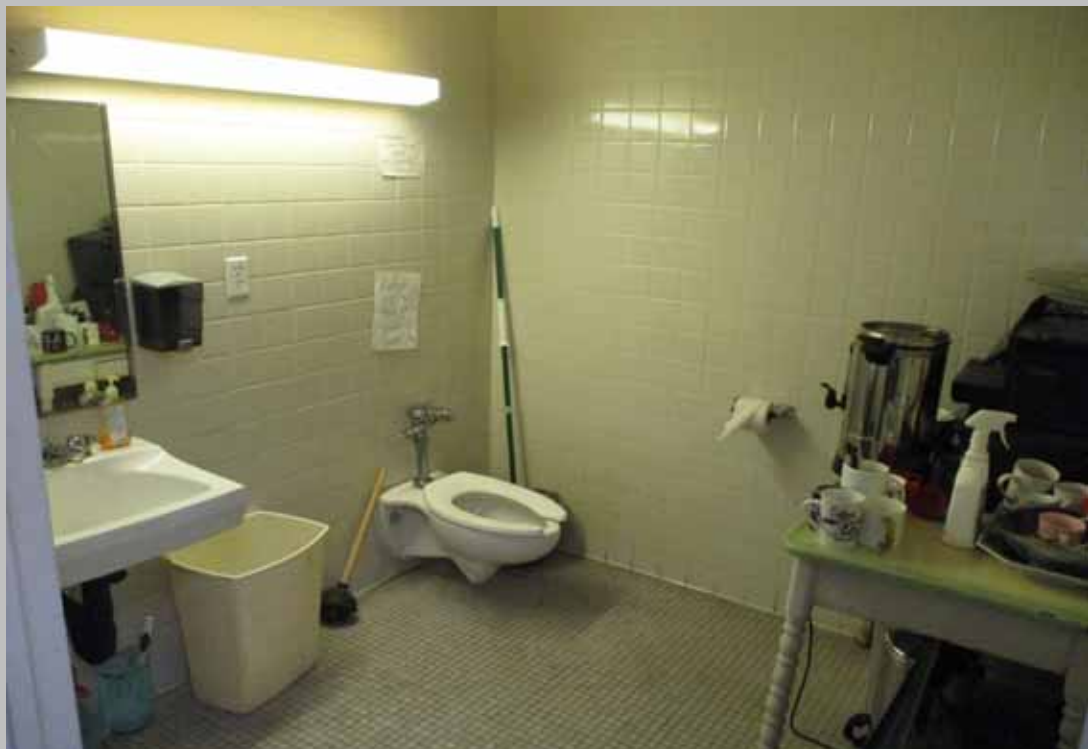
PHOTO #89

Bathroom in Task Force offices.

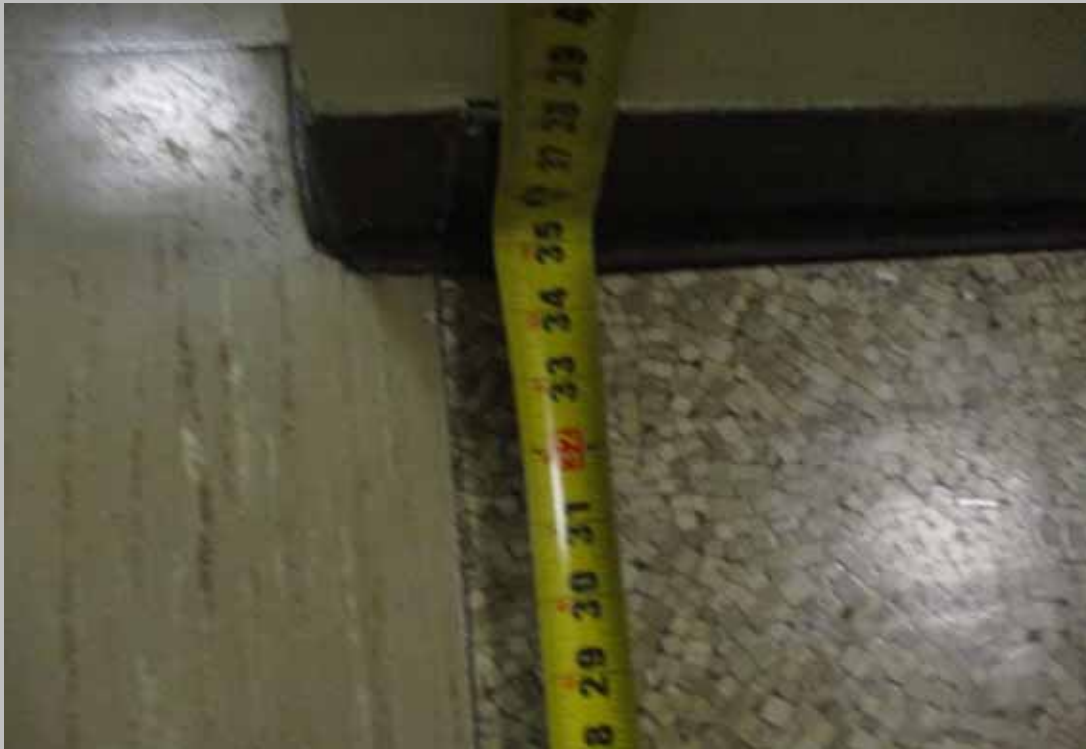
PHOTO #134

Correct kitchen entry width.

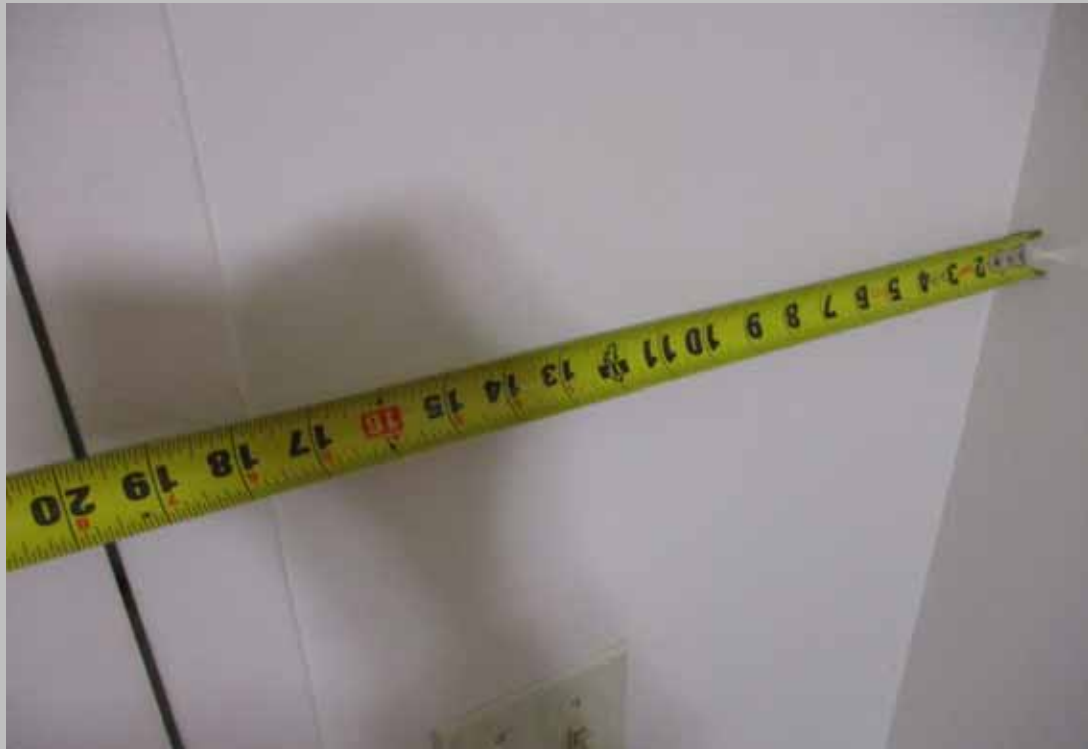
PHOTO #146

Correct latch side spacing in Unit 227.

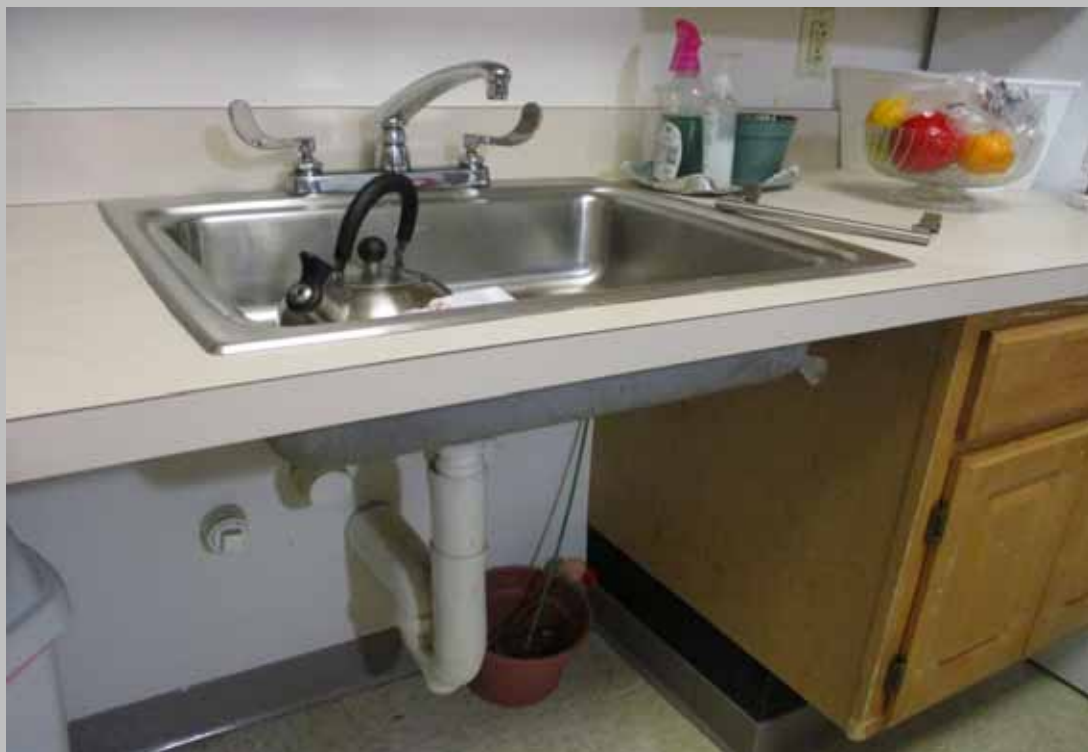
PHOTO #147

Correct scald proof piping in Unit 227.

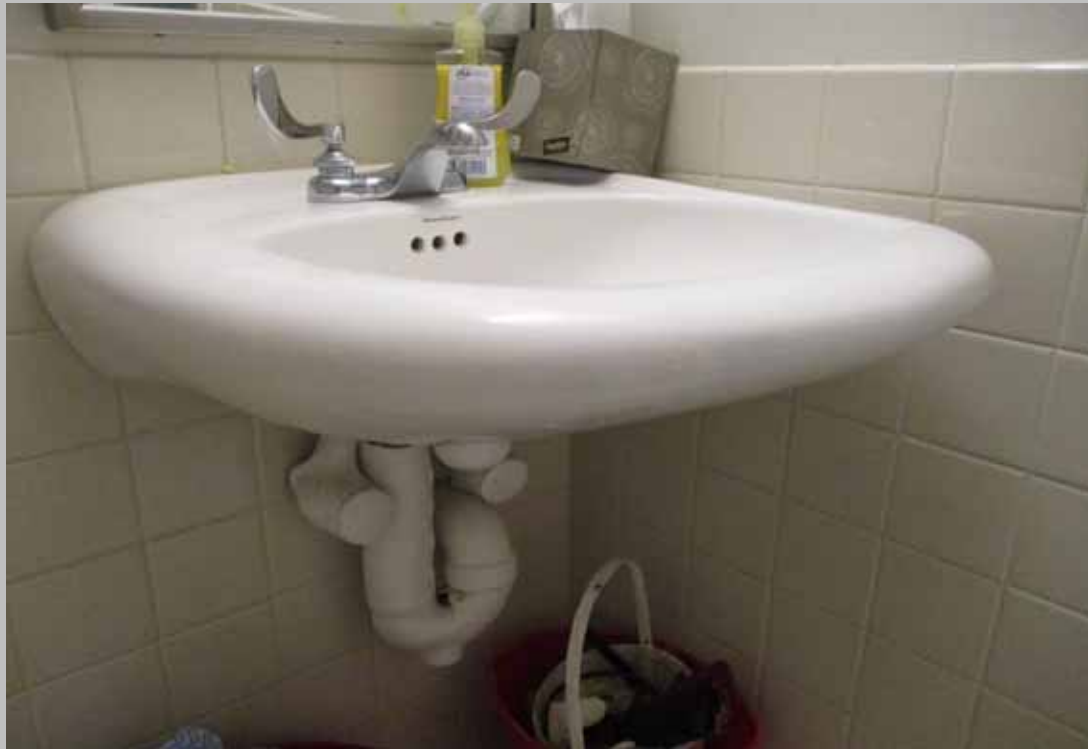
PHOTO #148

Correct scald proof piping in bathroom Unit 227
