**CAPITAL NEEDS ASSESSMENT (CNA)
PATRICIA WHITE APARTMENTS
20 WASHINGTON STREET
BRIGHTON, MASSACHUSETTS 02135**

**D3G PROJECT NUMBER:
2020-2130**

**FINAL REPORT ISSUE DATE:
FEBRUARY 4, 2021**

**INSPECTION DATES:
NOVEMBER 23 AND 24, 2020**

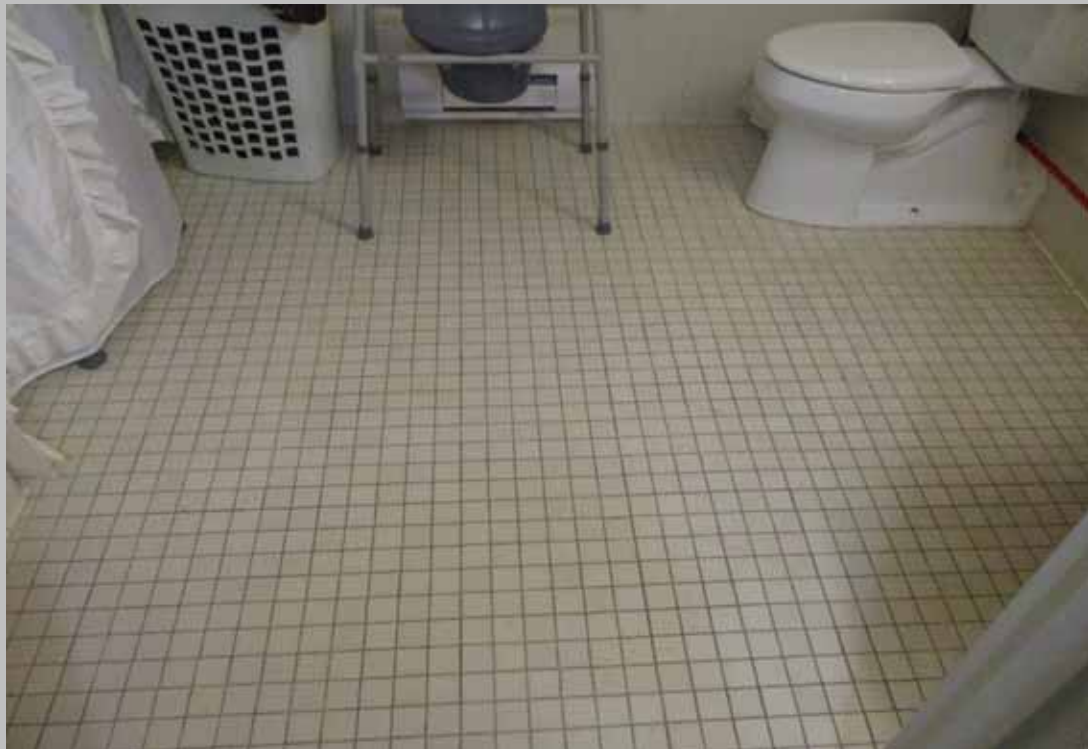
PHOTO #149

Proper clear floor space in bathroom of Unit 227.

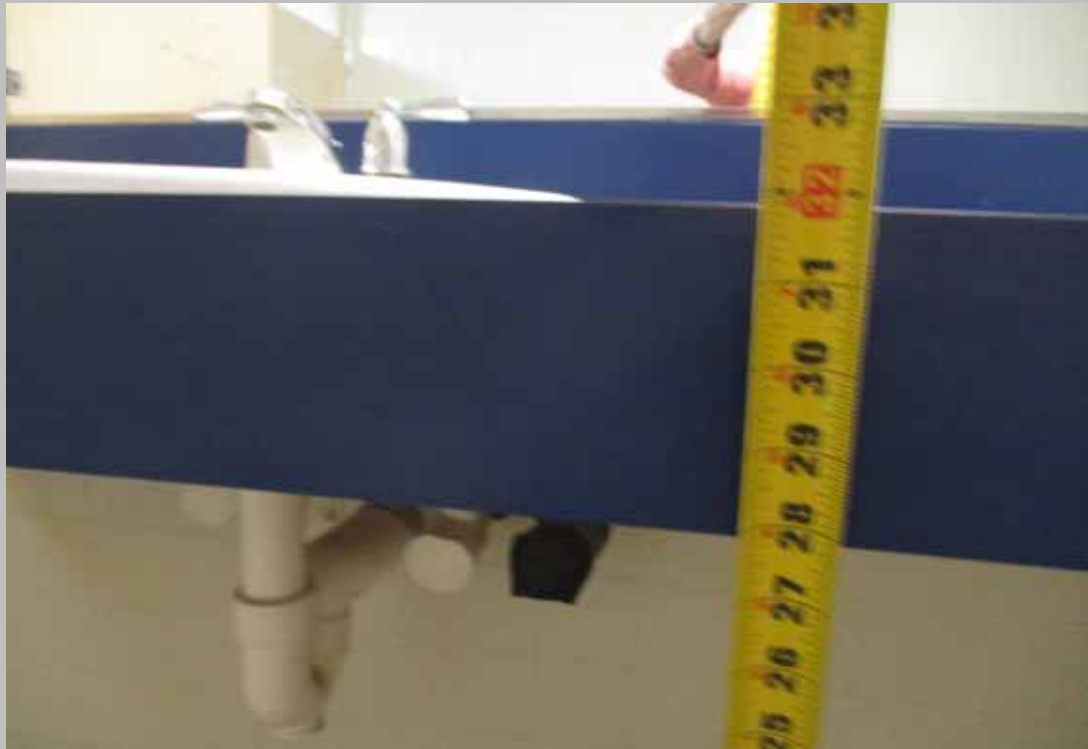
PHOTO #152

Correct sink height, levered hardware, and scald proof piping.

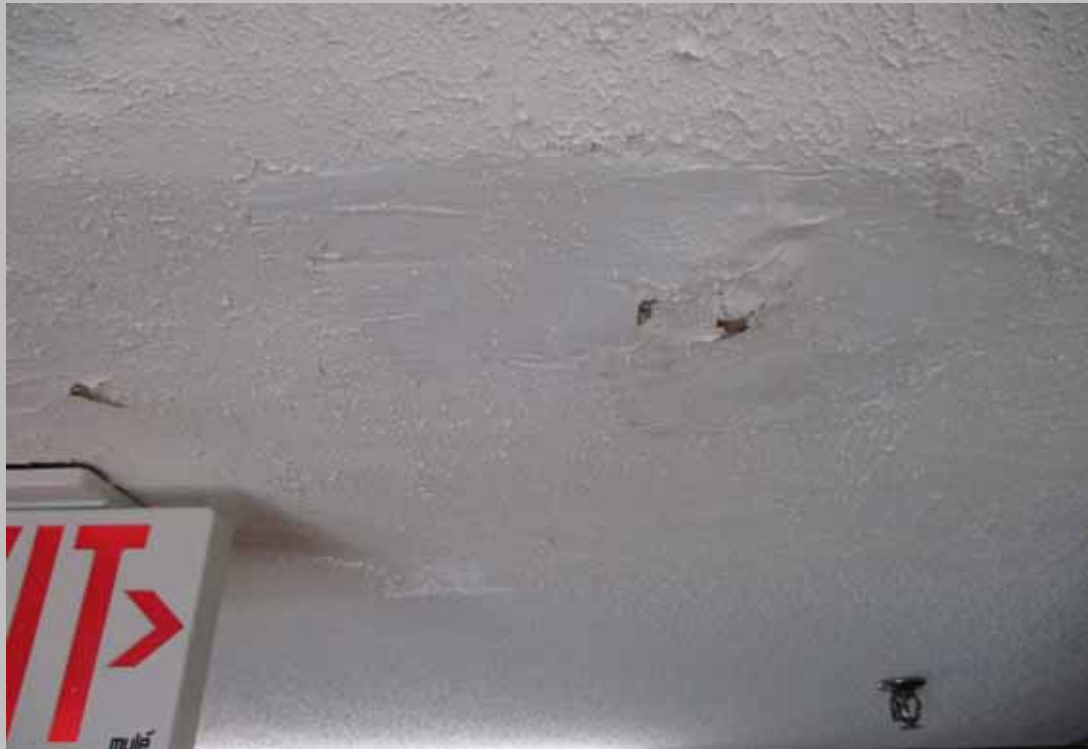
PHOTO #168

Another view of ceiling water penetration 5th floor corridor.
