**CAPITAL NEEDS ASSESSMENT (CNA)
ROCKLAND TOWERS (2-50)
5300 WASHINGTON STREET
WEST ROXBURY, MASSACHUSETTS 02132**

**D3G PROJECT NUMBER:
2021-0378**

**FINAL REPORT ISSUE DATE:
OCTOBER 14, 2021**

**INSPECTION DATES:
APRIL 19 & 22, 2021**

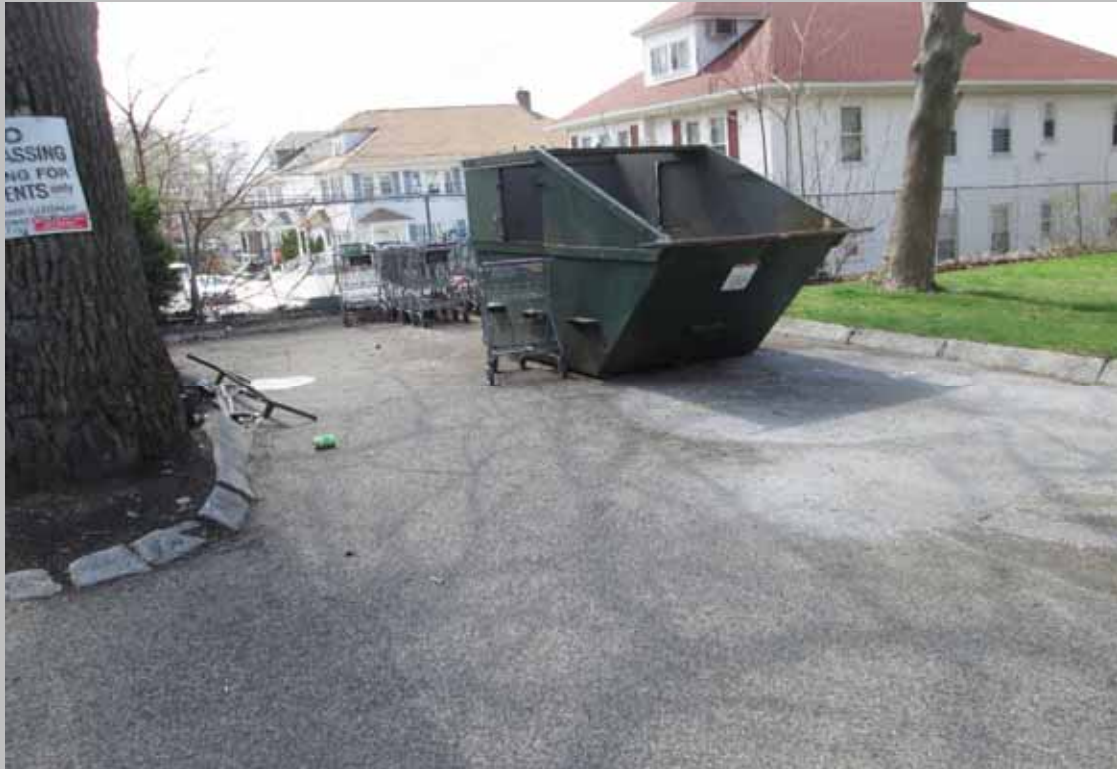
PHOTO #11

View of the property dumpster

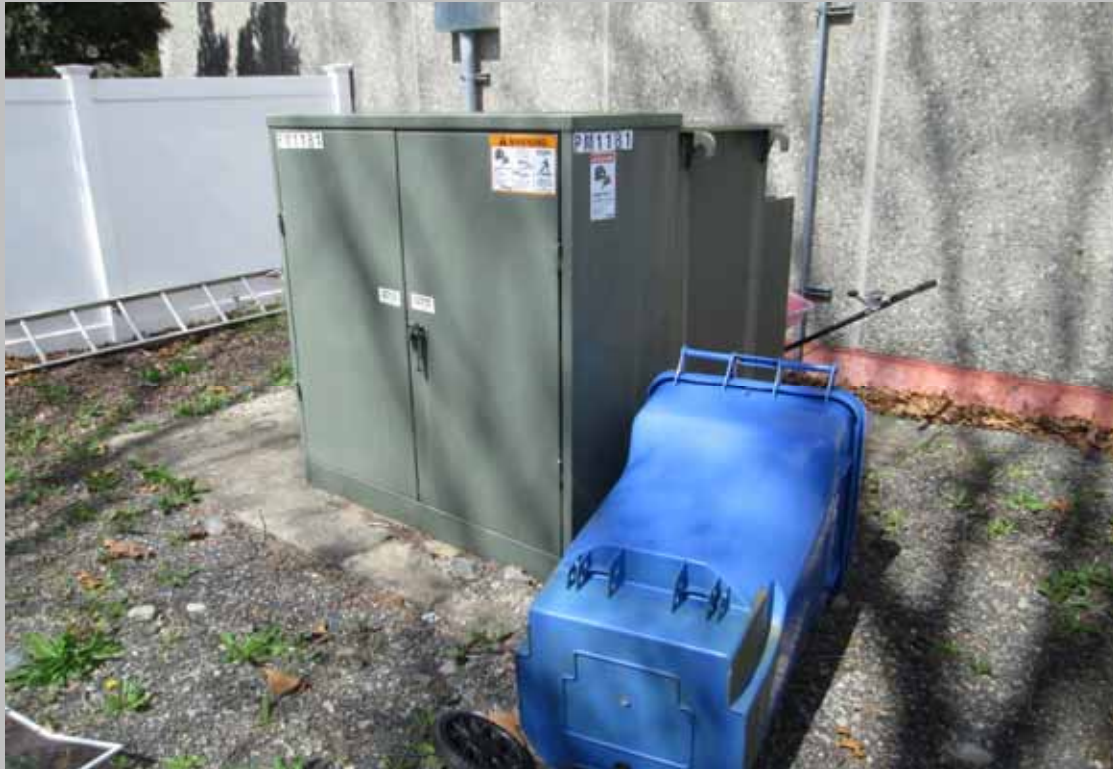
PHOTO #15

View of pad mounted electrical transformer

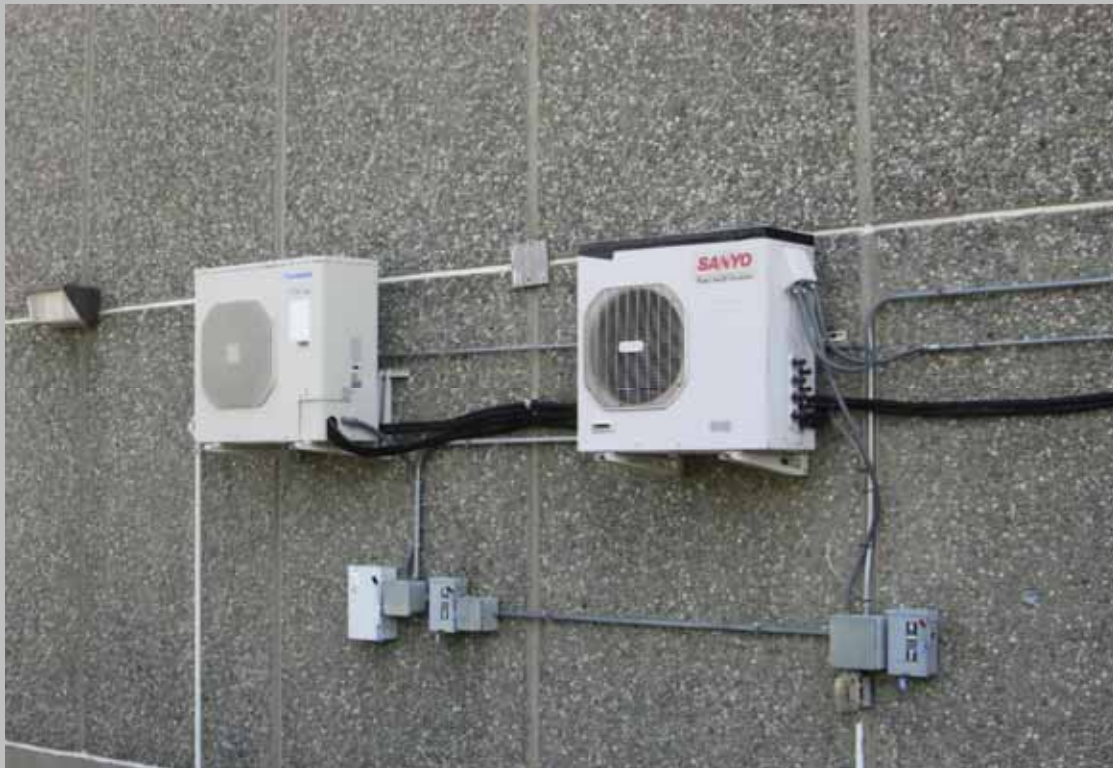
PHOTO #16

View of mini-split HVAC units

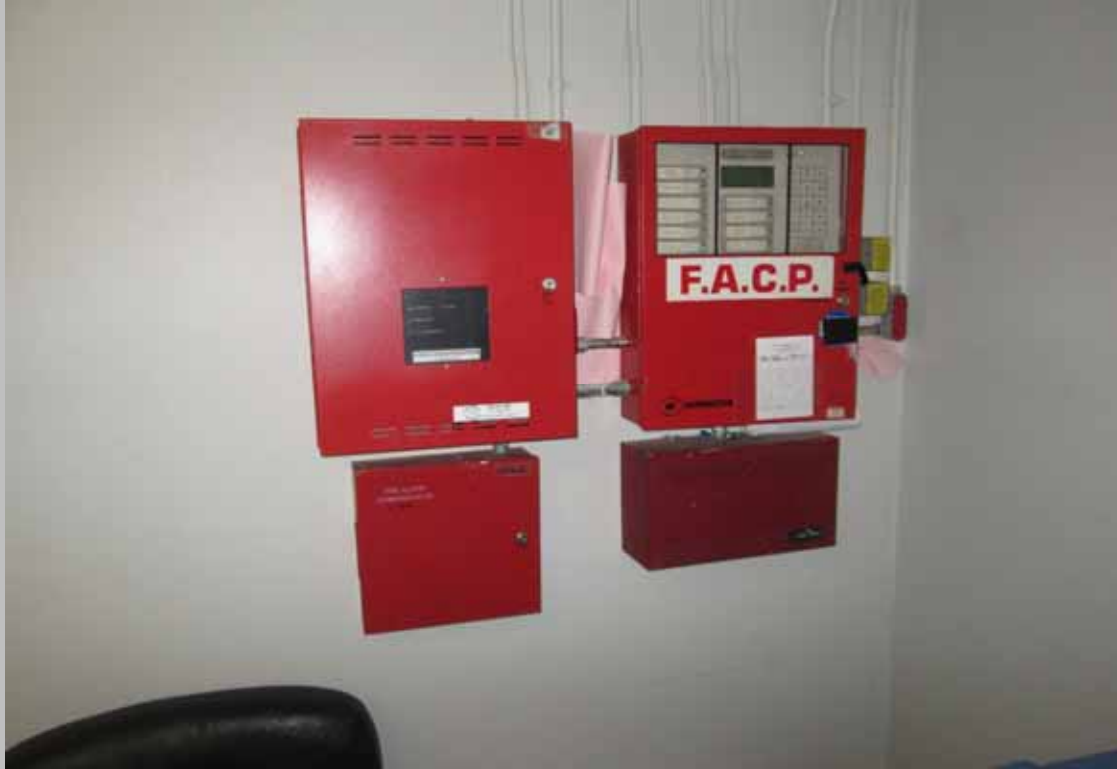
PHOTO #17

View of fire alarm control panel

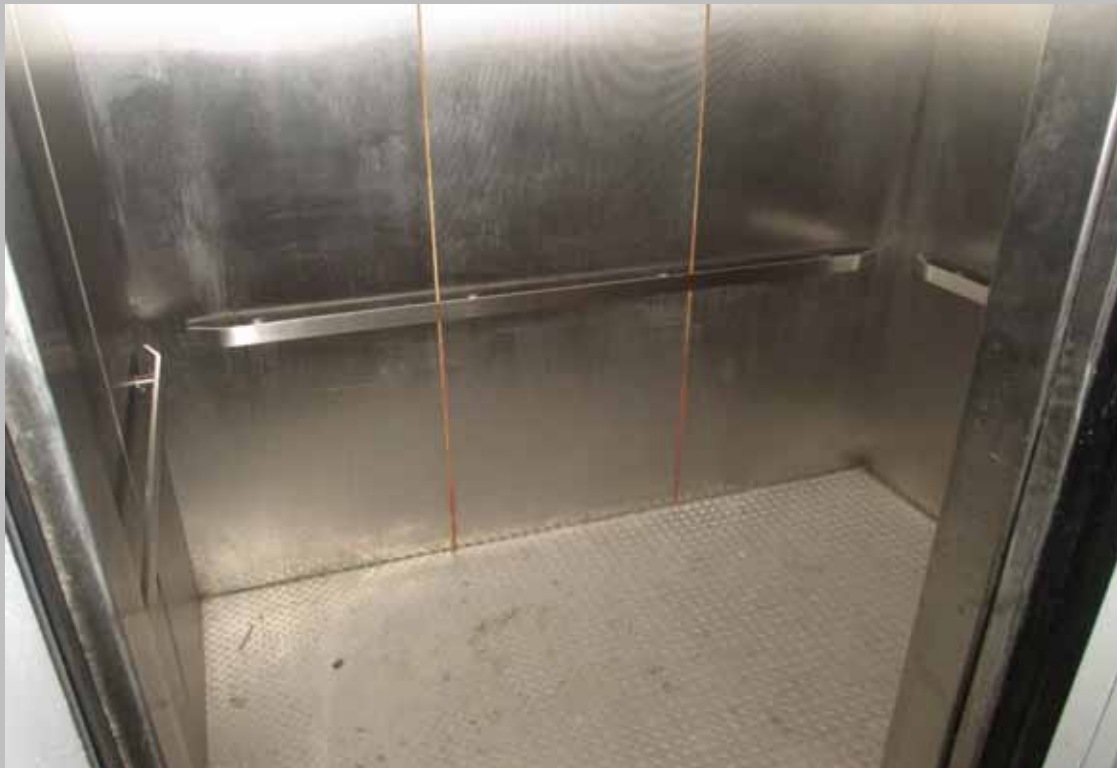
PHOTO #18

View of an elevator cab

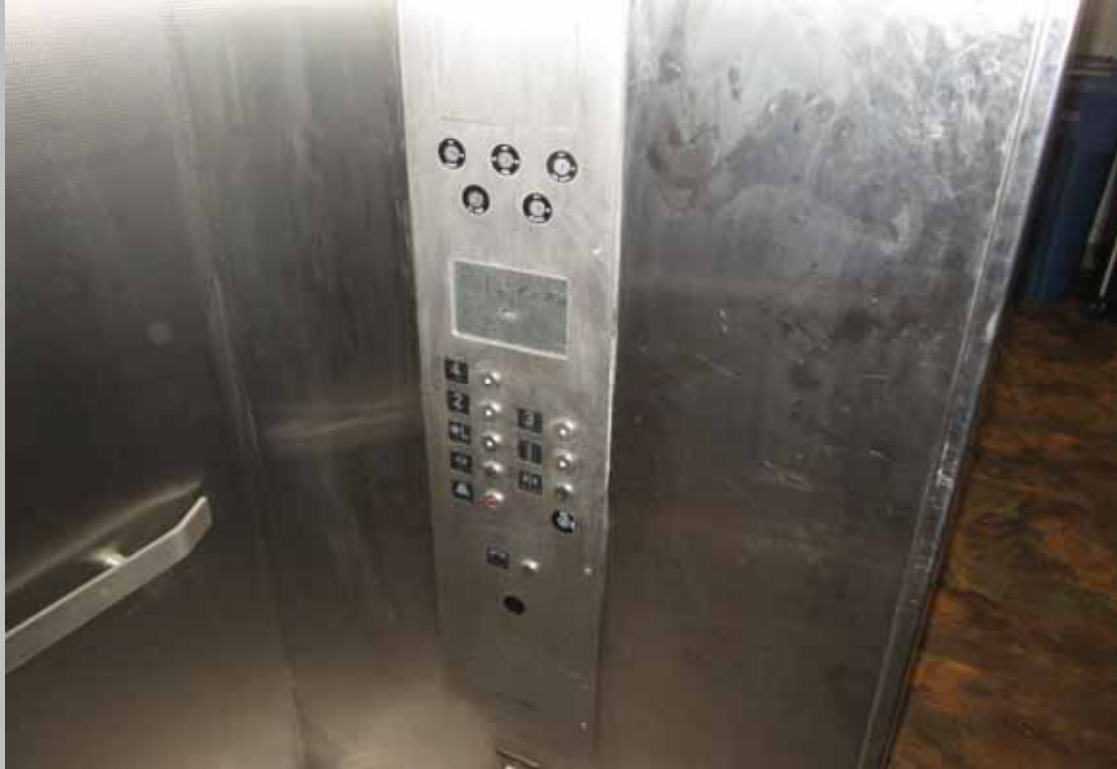
PHOTO #19

View of an elevator cab

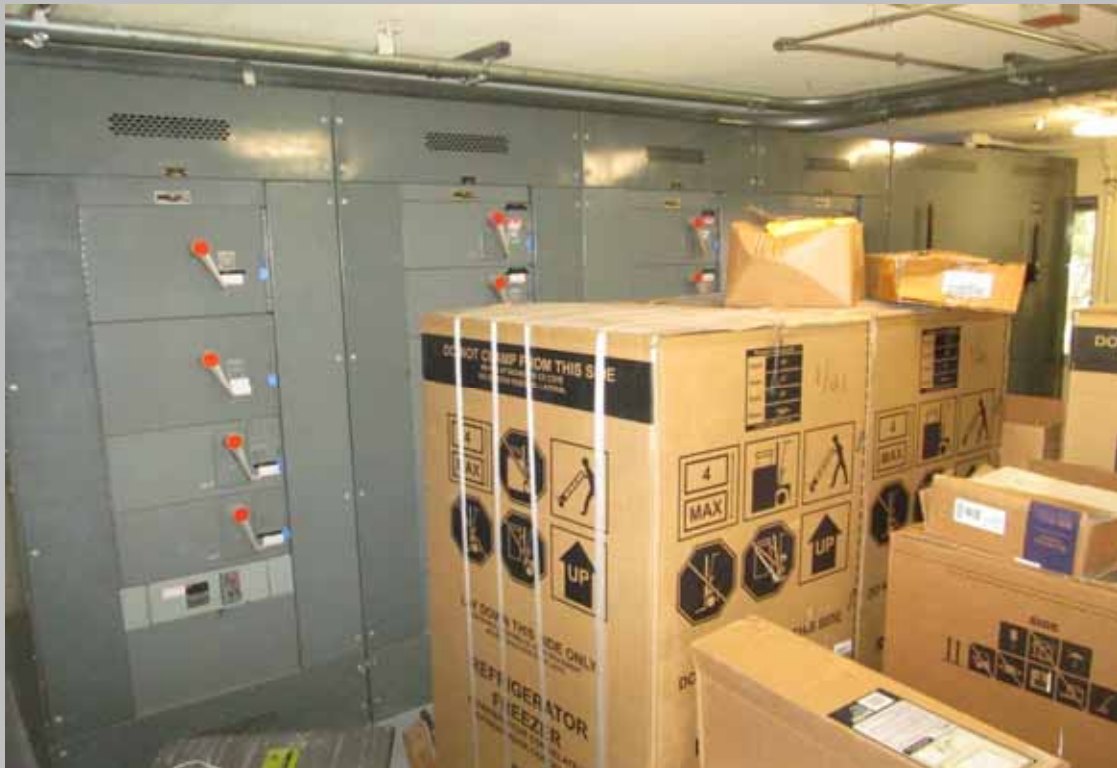
PHOTO #20

View of switchboard

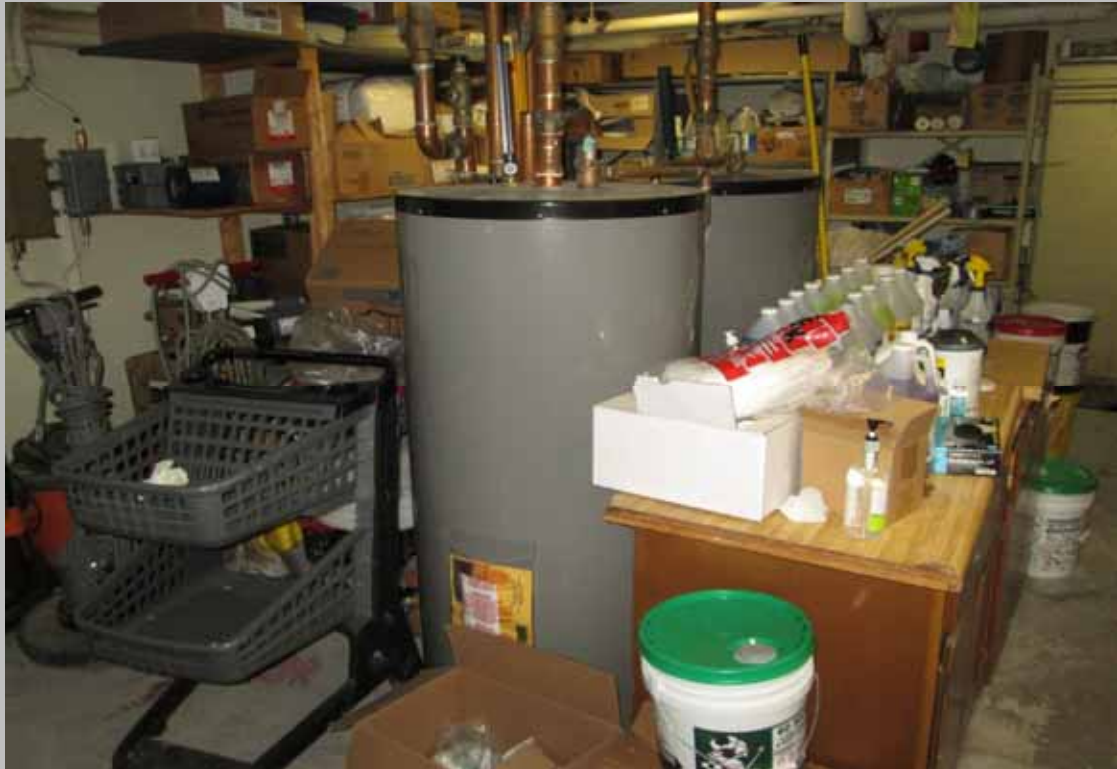
PHOTO #21

View of water storage tanks

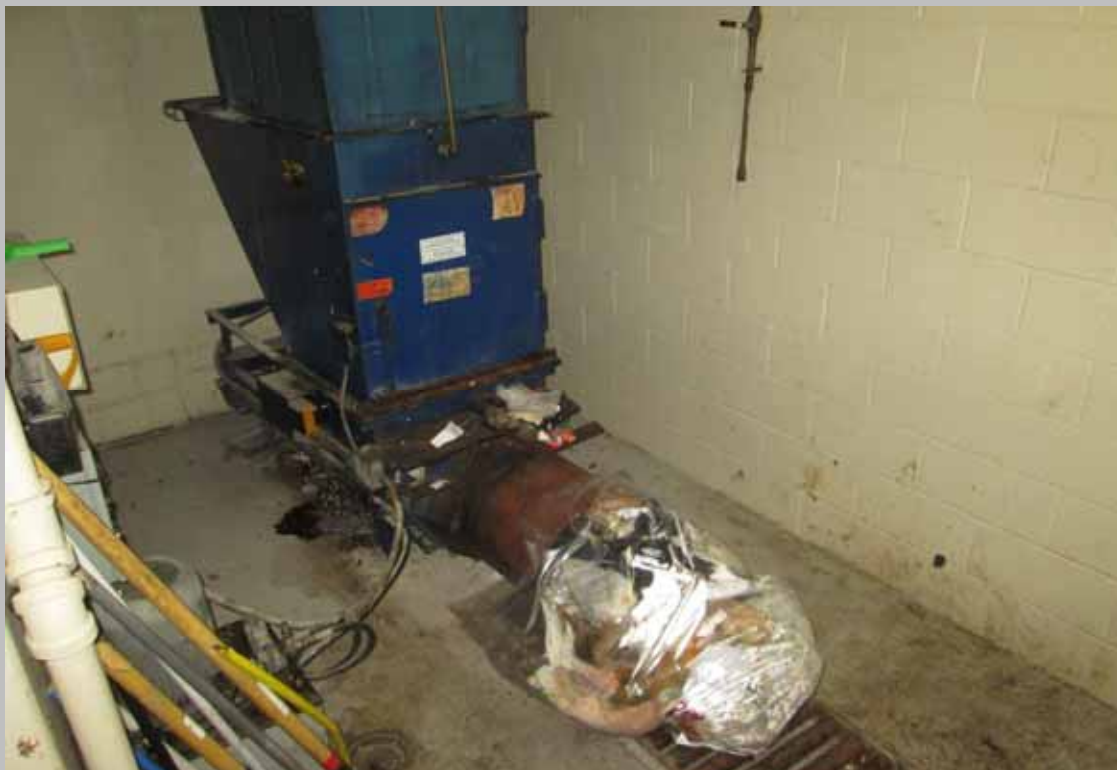
PHOTO #22

View of the trash compactor

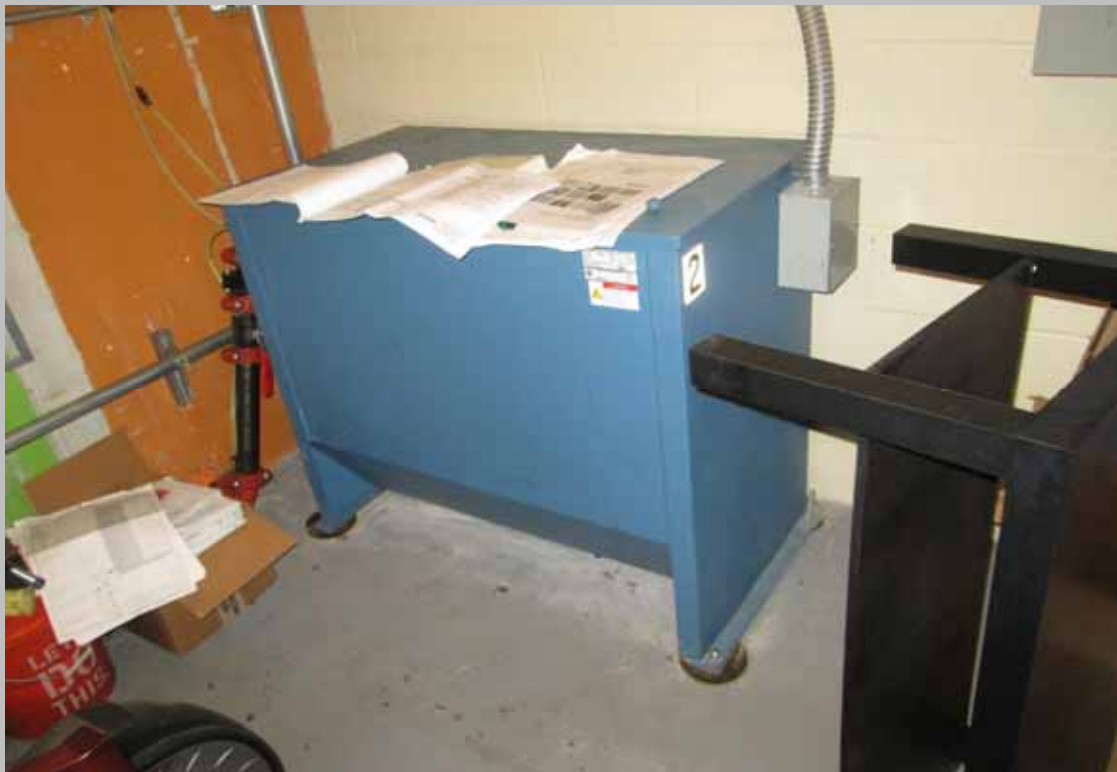
PHOTO #23

View of the elevator equipment

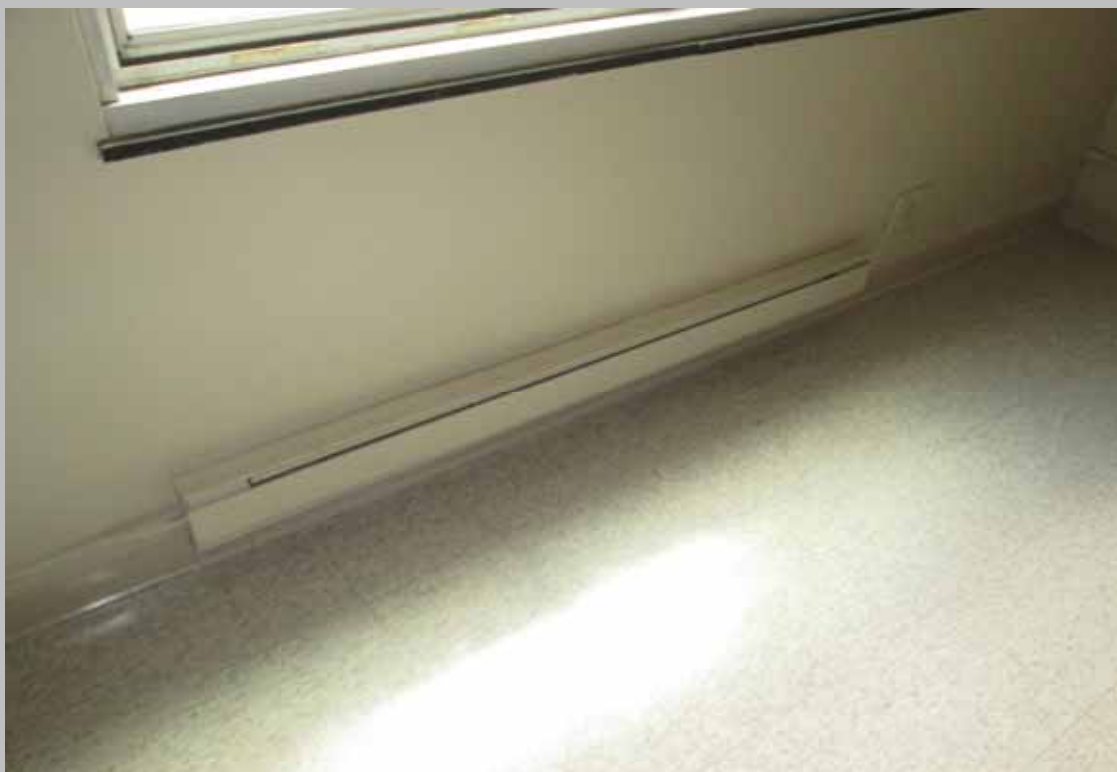
PHOTO #24

View of electric baseboard heater - dwelling unit

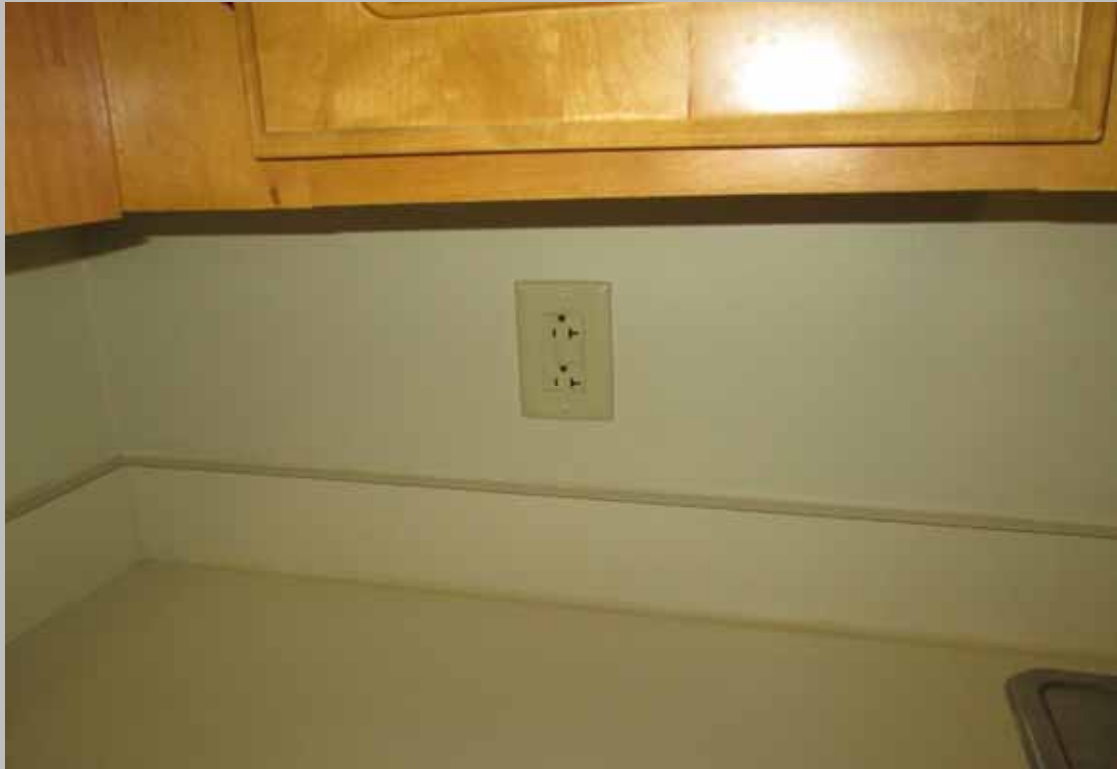
PHOTO #27

View of GFCI electrical outlet – dwelling unit

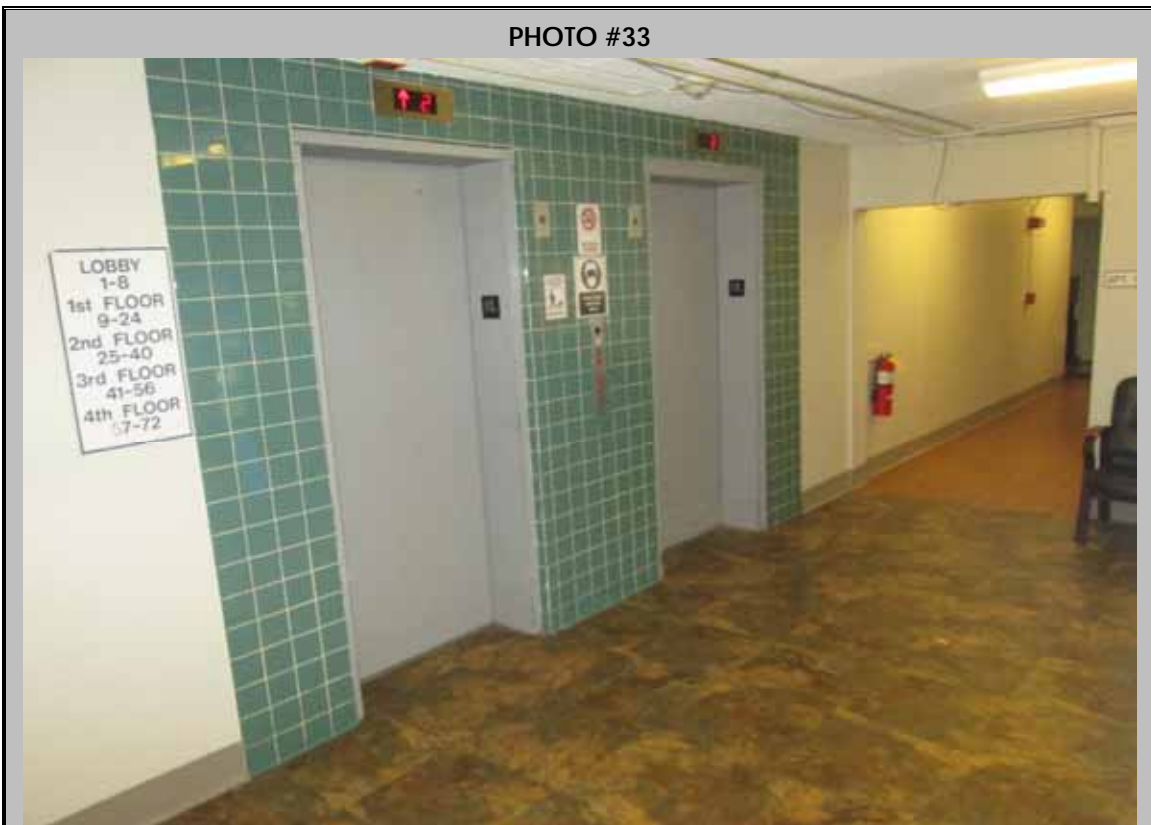
PHOTO #33

View of an elevator lobby

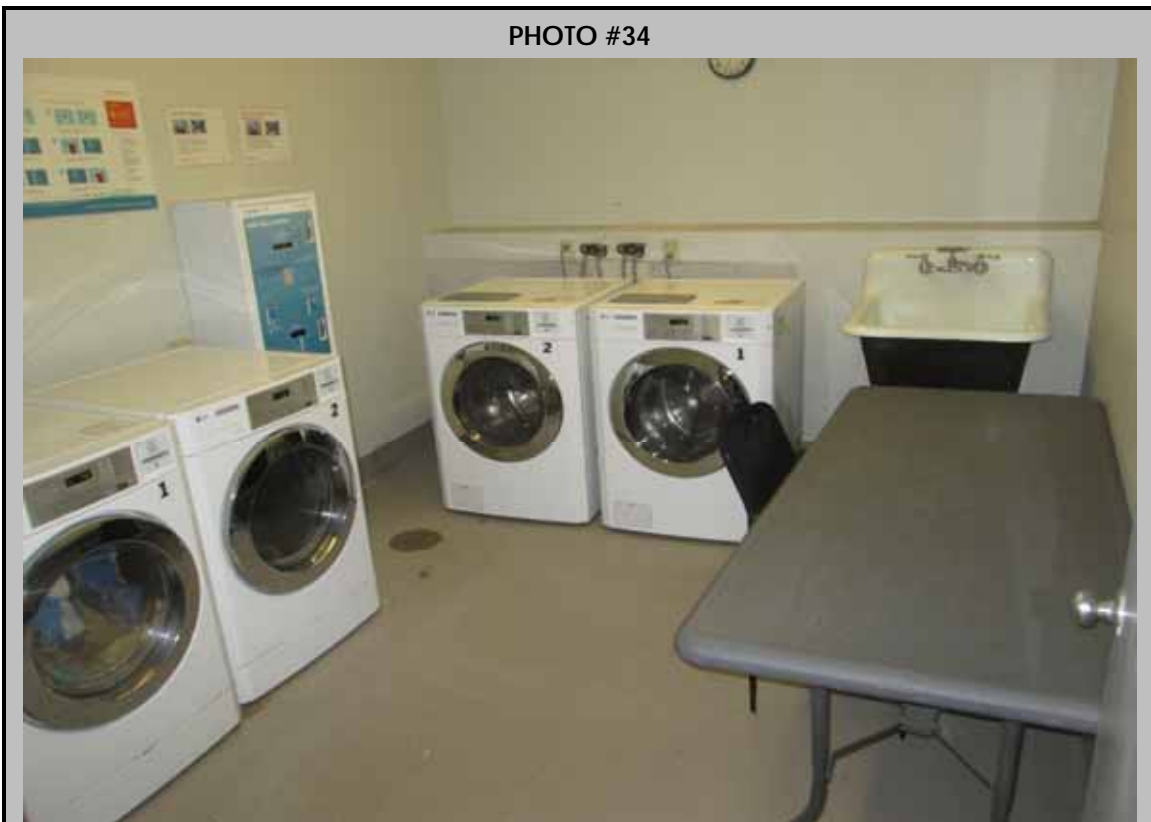
PHOTO #34

View of the community laundry room

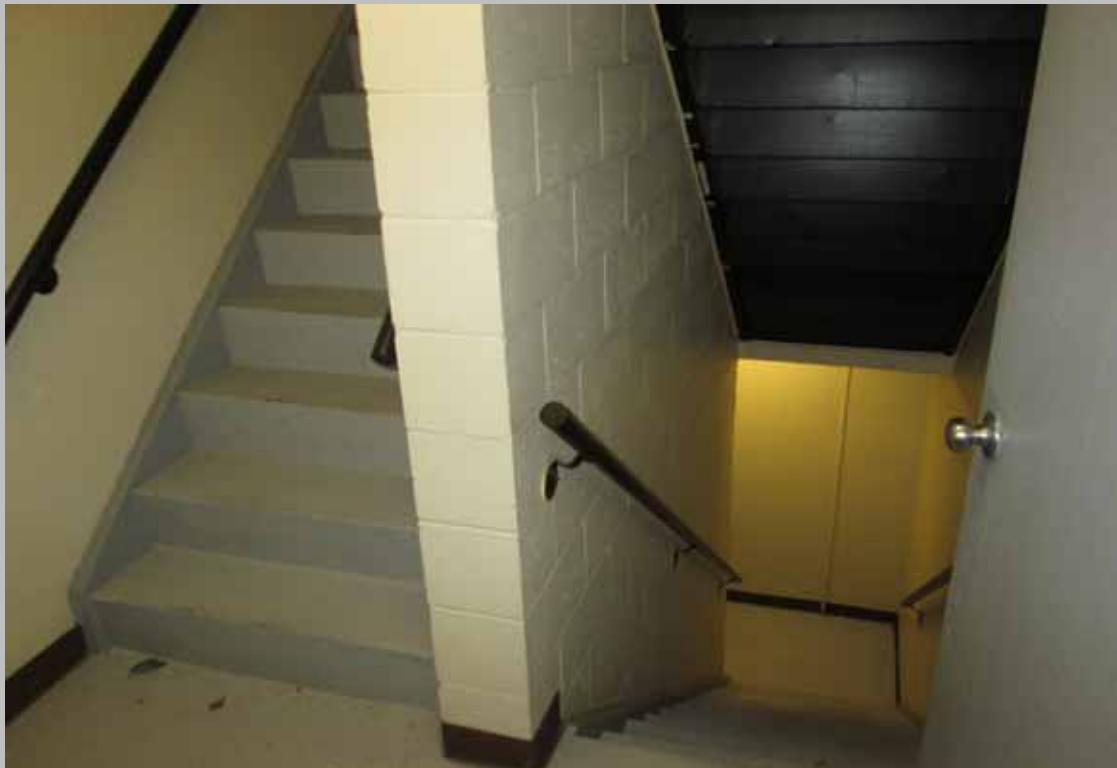
PHOTO #36

View of common interior stairwell

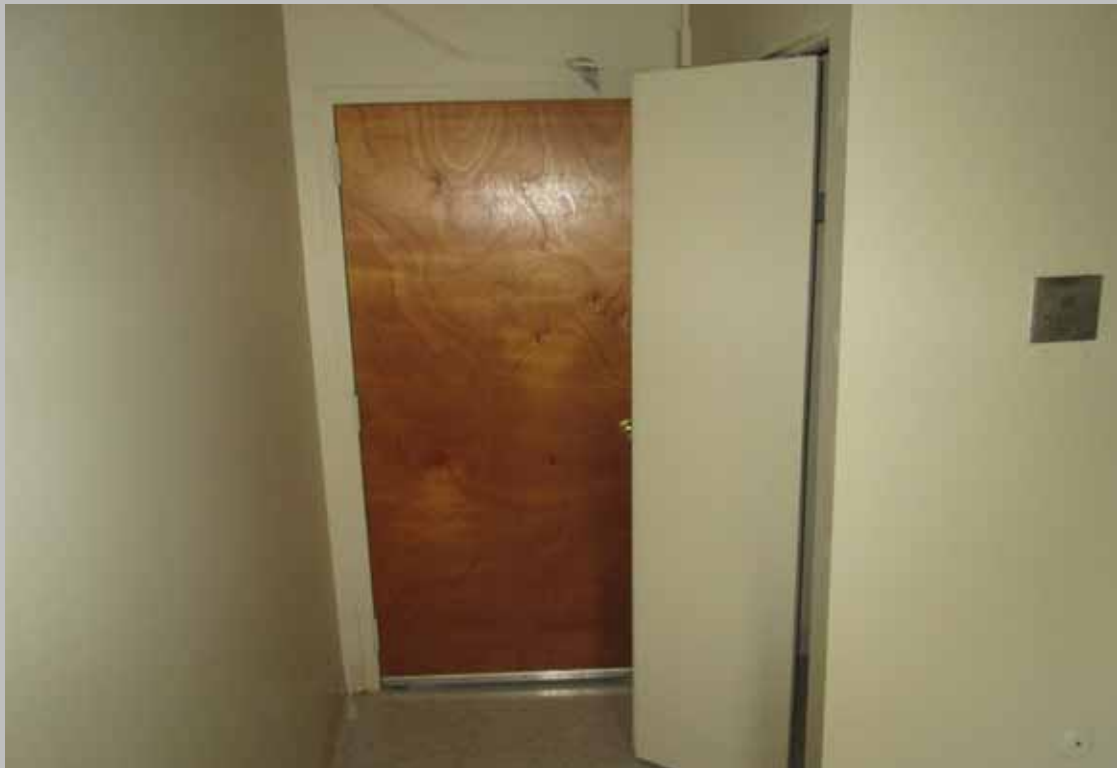
PHOTO #38

View of entry area at Unit 45

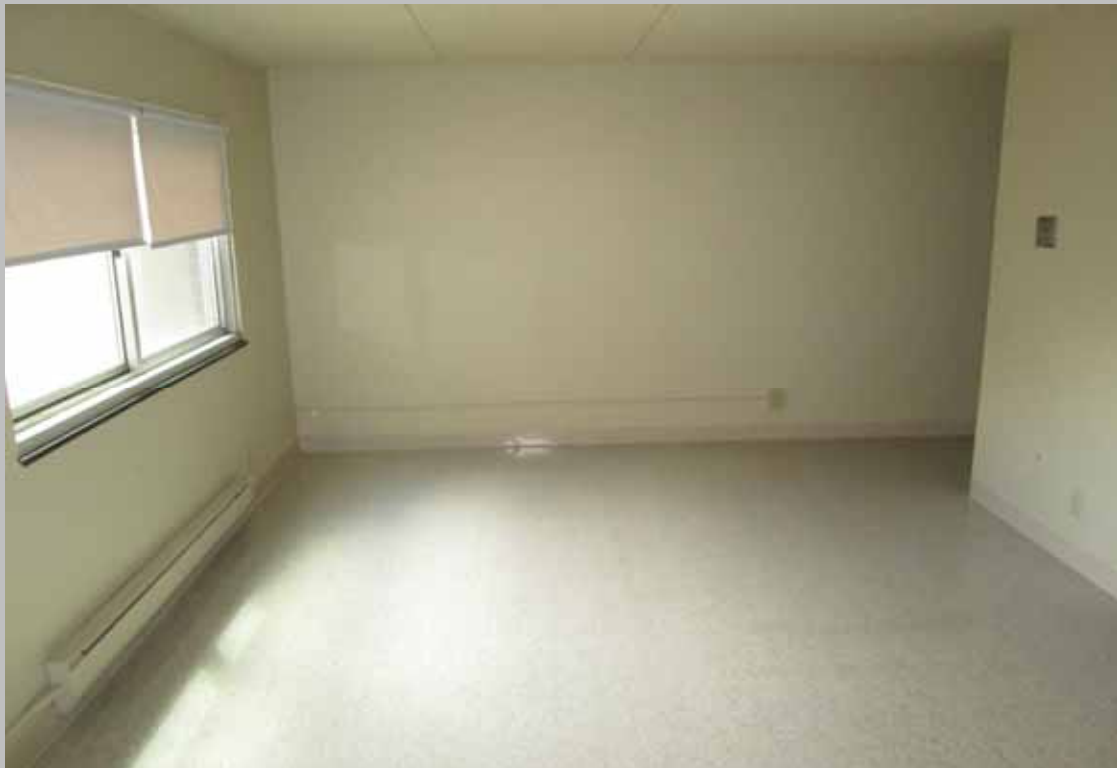
PHOTO #40

View of the living room at Unit 45

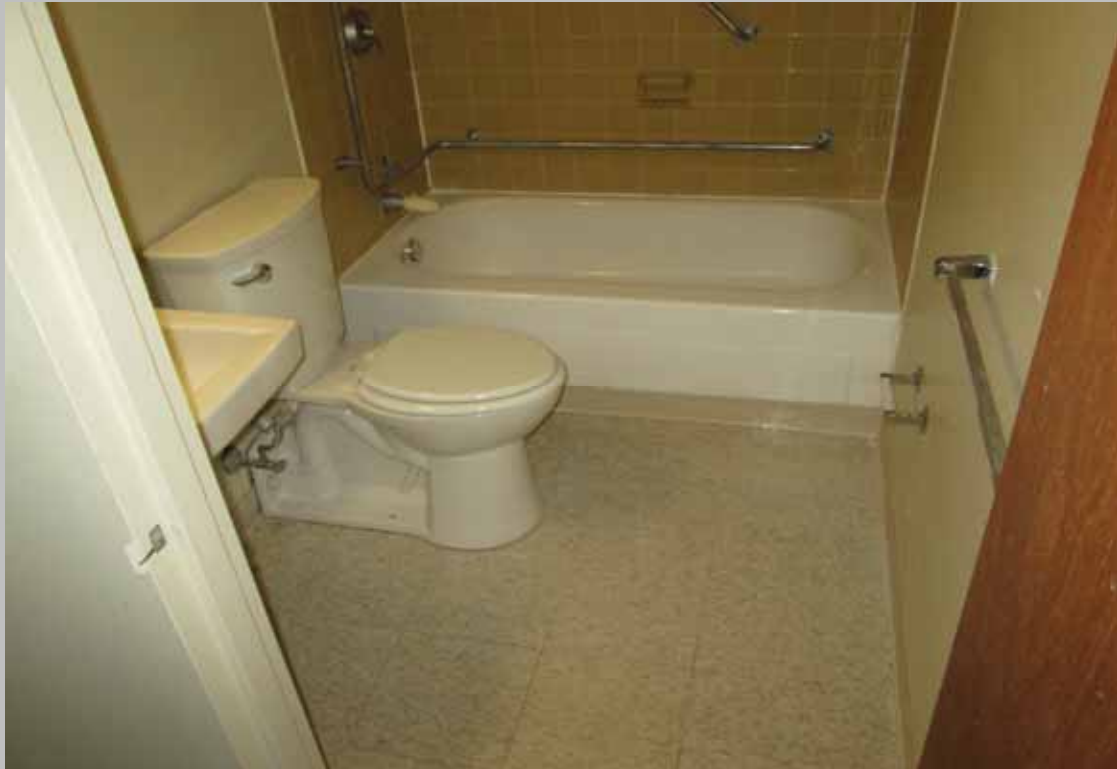
PHOTO #41

View of bathroom at Unit 45

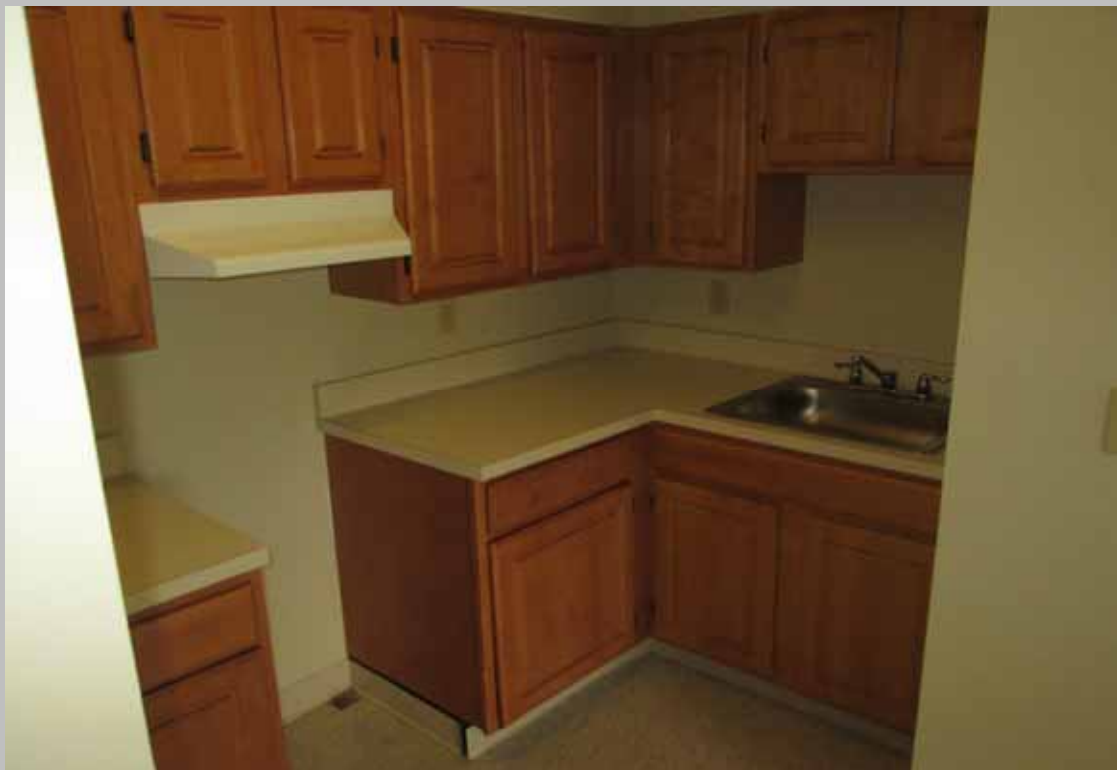
PHOTO #42

View of kitchen at Unit 45

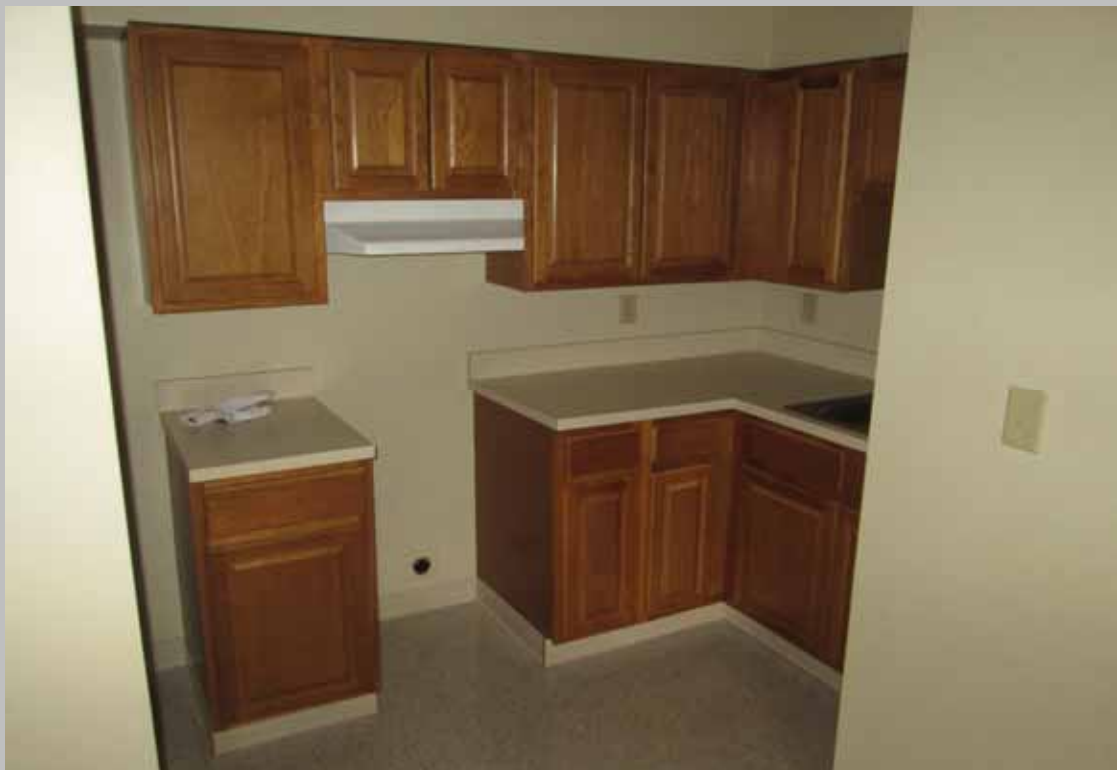
PHOTO #44

View of the kitchen at Unit 25

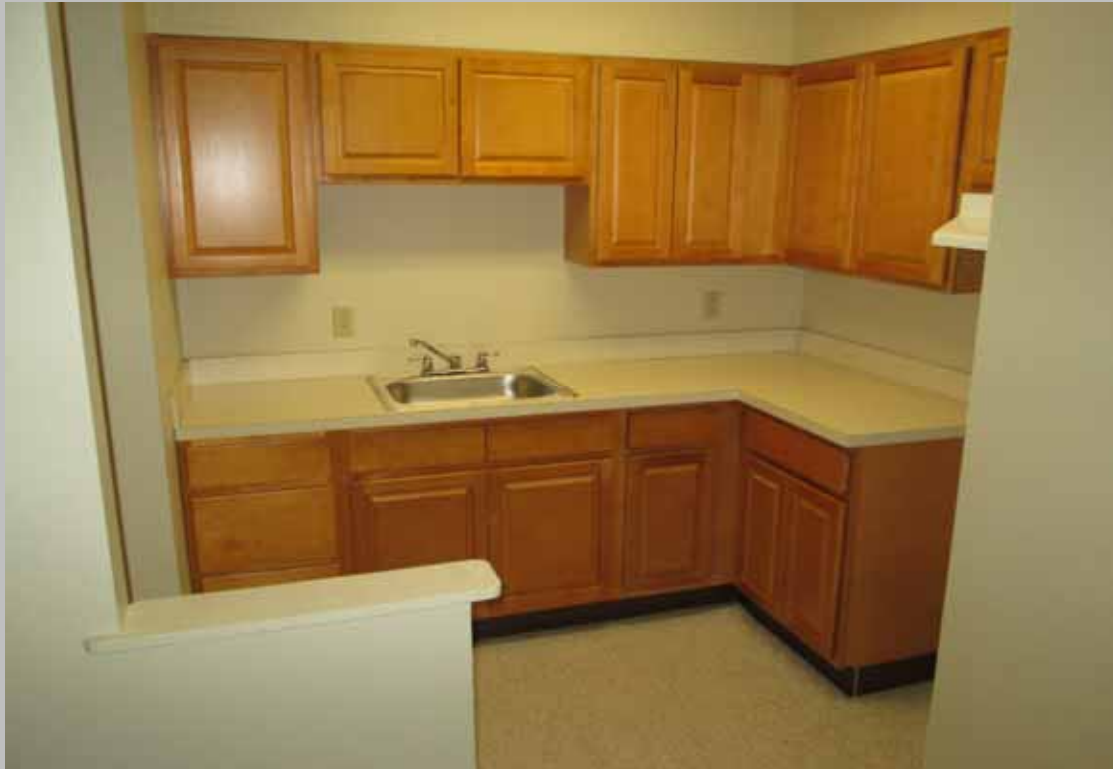
PHOTO #47

View of the kitchen at Unit 7

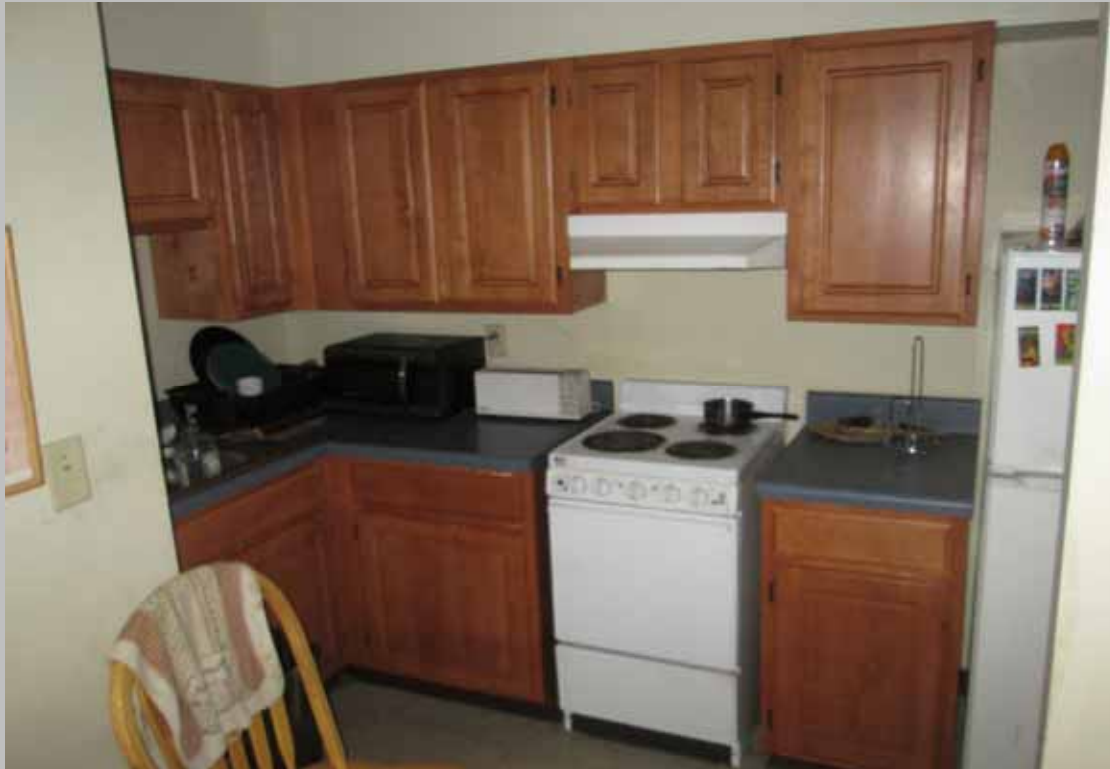
PHOTO #49

View of the kitchen at Unit 16

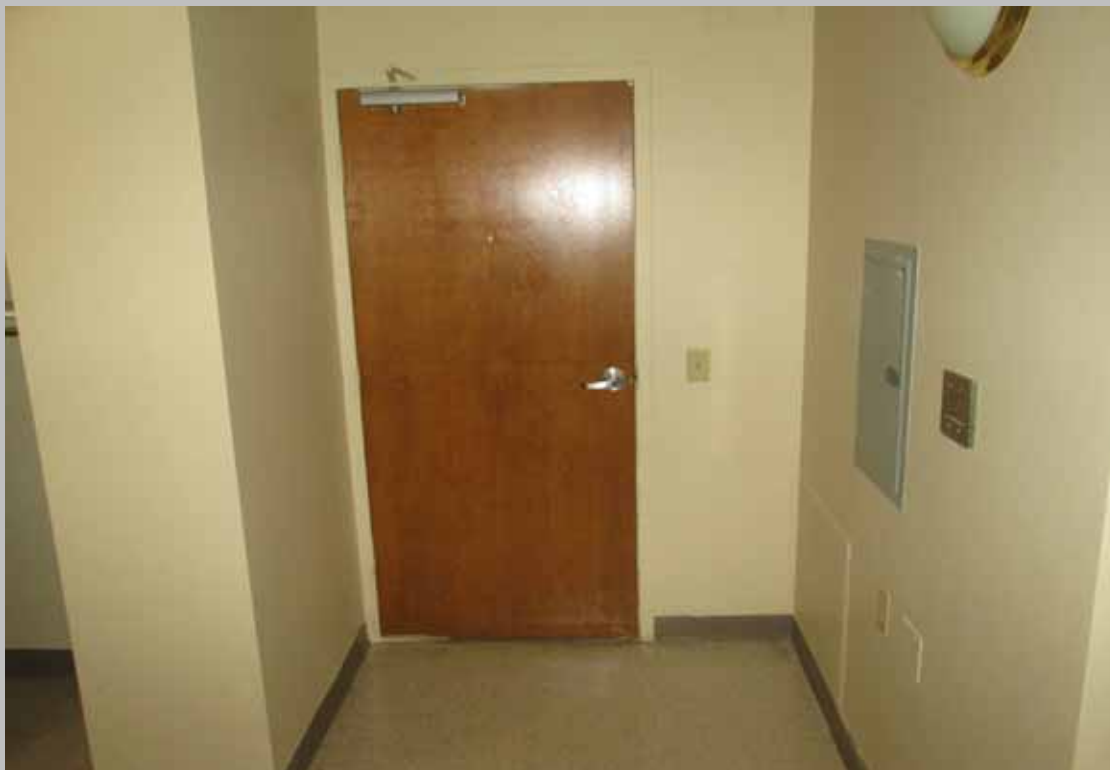
PHOTO #50

View of the entrance area within designated handicapped dwelling unit 17 featuring compliant levered door hardware and 18-inches at the pull-side of the door

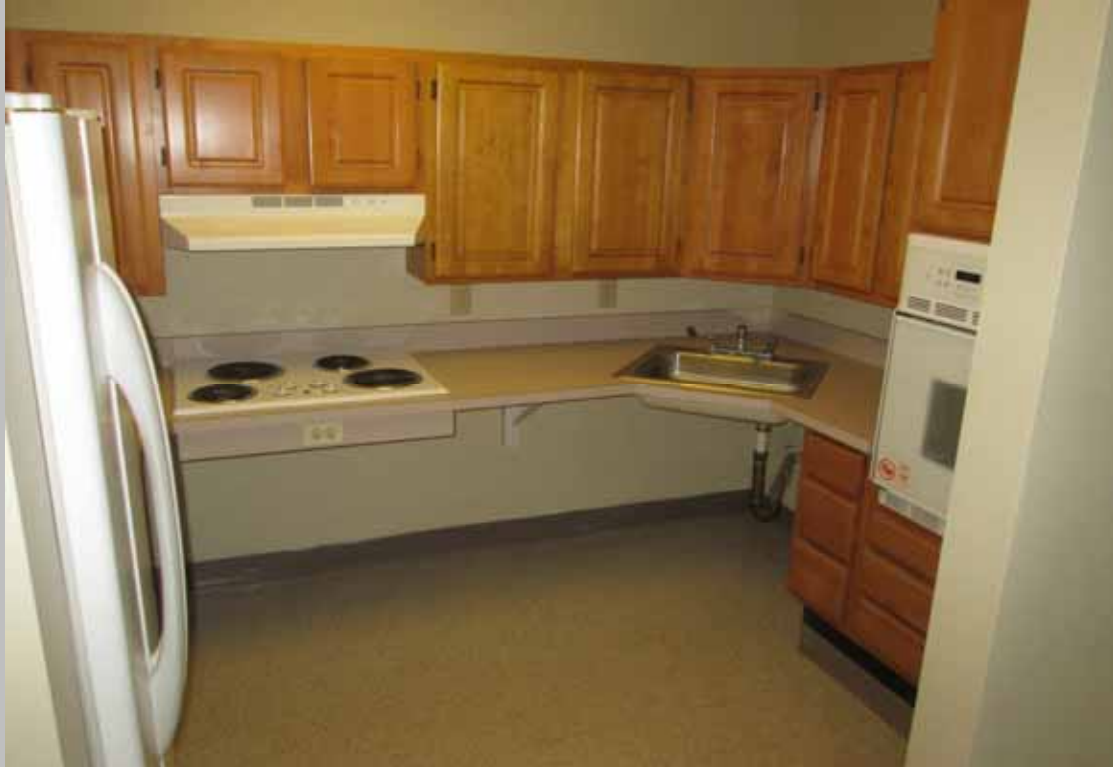
PHOTO #51

View of the kitchen within designated handicapped dwelling unit 17 featuring roll-under sink and cook-top, levered handle sink hardware, and compliant clear floor space

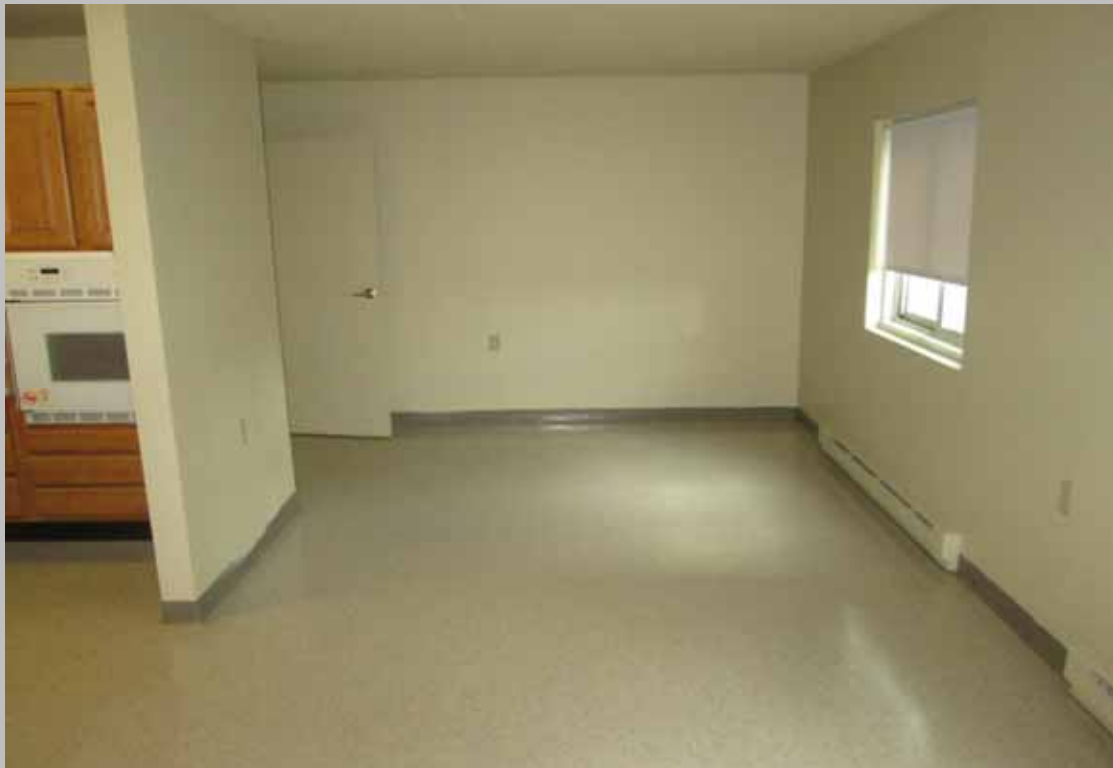
PHOTO #52

View of the living room within designated handicapped dwelling unit 17

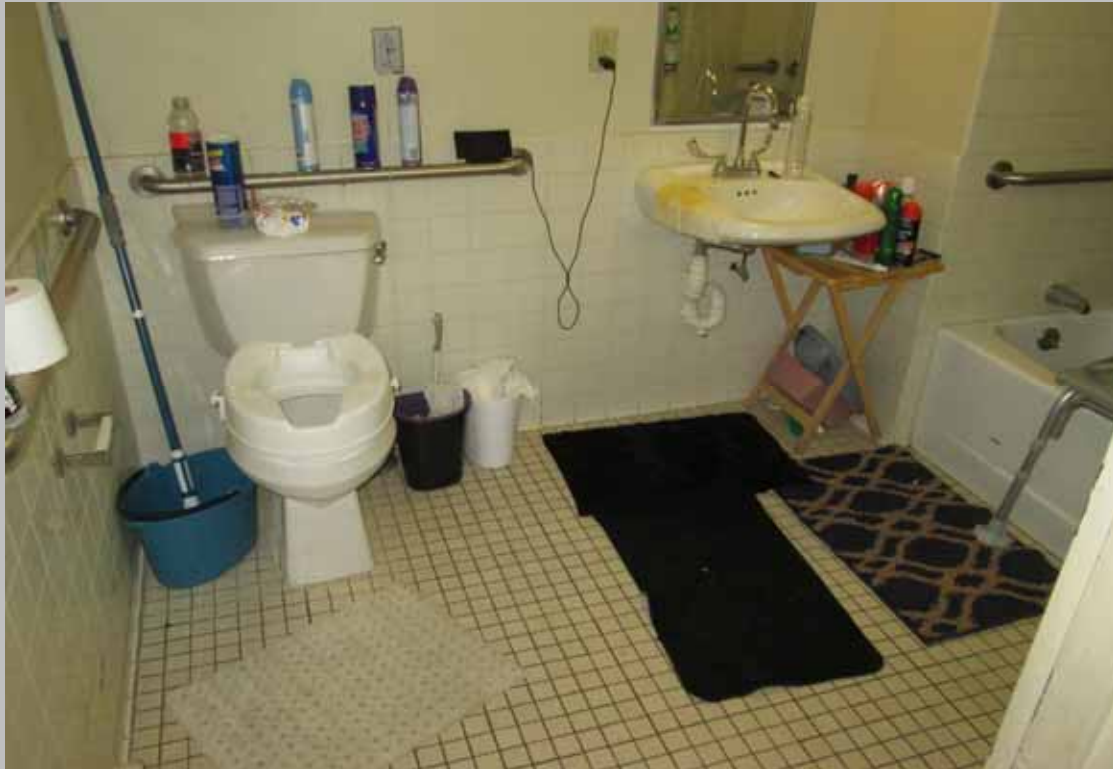
PHOTO #53

View of the bathroom within designated handicapped Unit 35 featuring compliant side and rear grab bars at the toilet and compliant clear floor space
